Port Angeles Primary Atlantic Salmon Net Pens Engineering Assessment

January 29, 2018

Document reference: 391980 | 2 | b

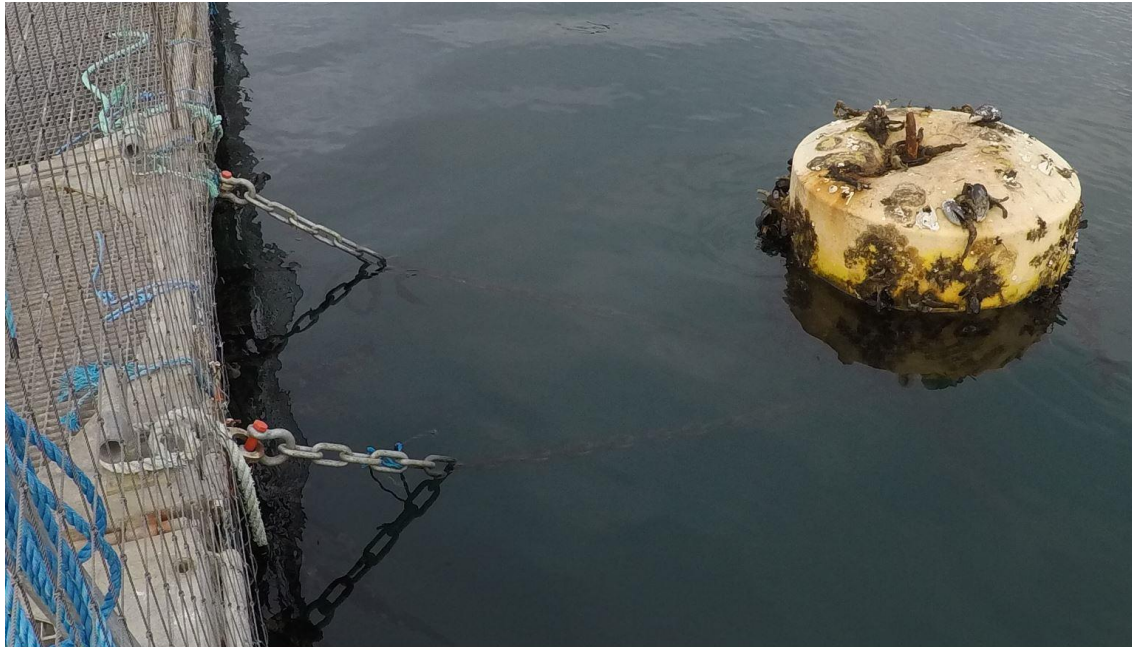
Mooring brackets were attached to the walkway structure frame via the hinges near the walking surface. The hinge assembly were approximately 18-inches long and included a 1-inch diameter stainless steel bolt. Figure 7: Mooring Brackets, Chain and Buoy at Port Angeles Net Pen Figure 7 is a photo of a typical connection.

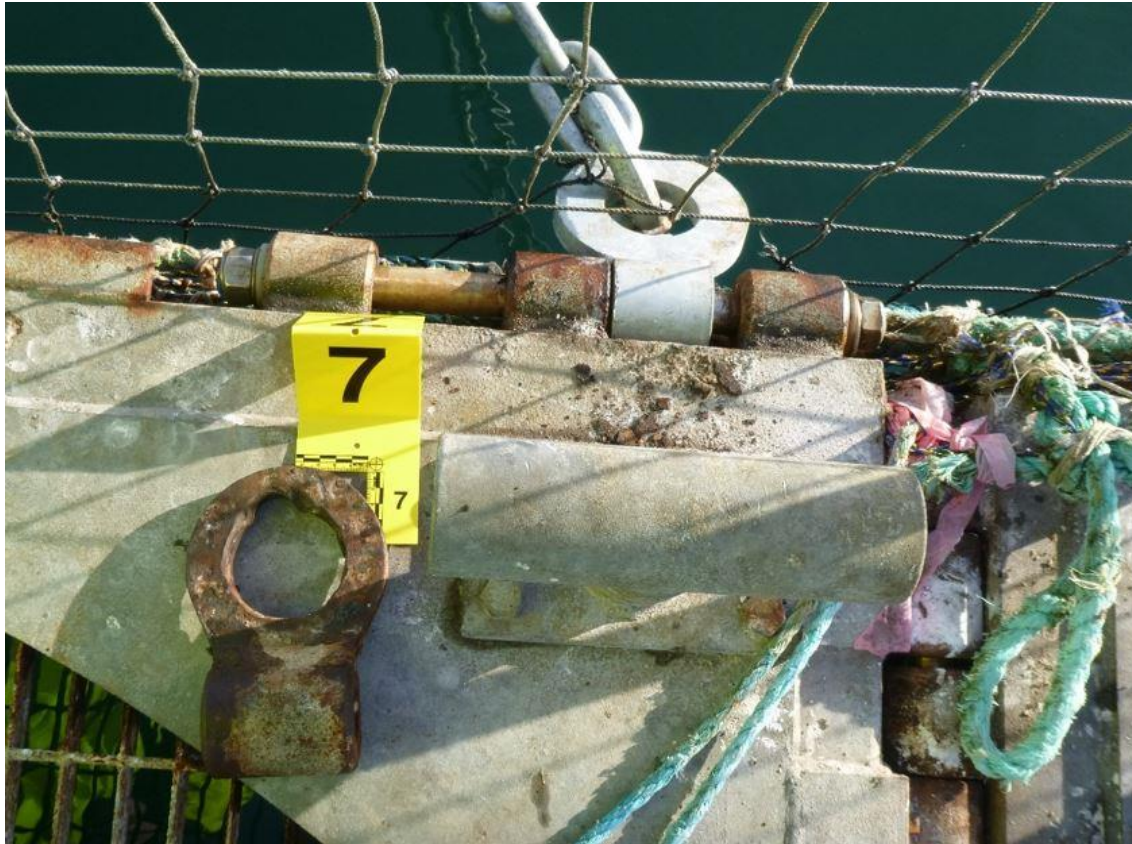
Figure 10: Mooring Brackets – New and Old

- Anchor lines 10A1, and 10A2 did not have a buoy. Each line had one bridal chain connected to a padeye shared with an adjacent anchor line.
- Above water mooring brackets were observed during our site visit to be in satisfactory condition. Minor corrosion was observed at connecting elements to the steel frame. Wear and deformation of the hole in the mooring brackets was observed, resulting in lower load capacity. The mooring bracket appeared to be the weak link in the mooring lines. Workers on site were observed replacing old mooring brackets with new larger brackets. The workers said they were replacing all the mooring brackets. **Figure 10** shows an old bracket at mooring line No. 7 with wear at the point of contact with the shackle. A new, larger bracket is shown installed. See also Figure C-23 in Appendix C.

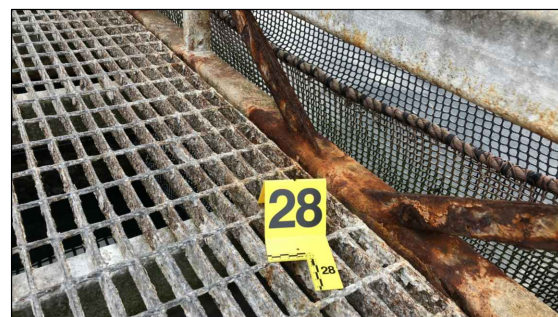
PHOTO 1
TYPICAL CORROSION ON EXTERIOR CORNER WALKWAY GRATING

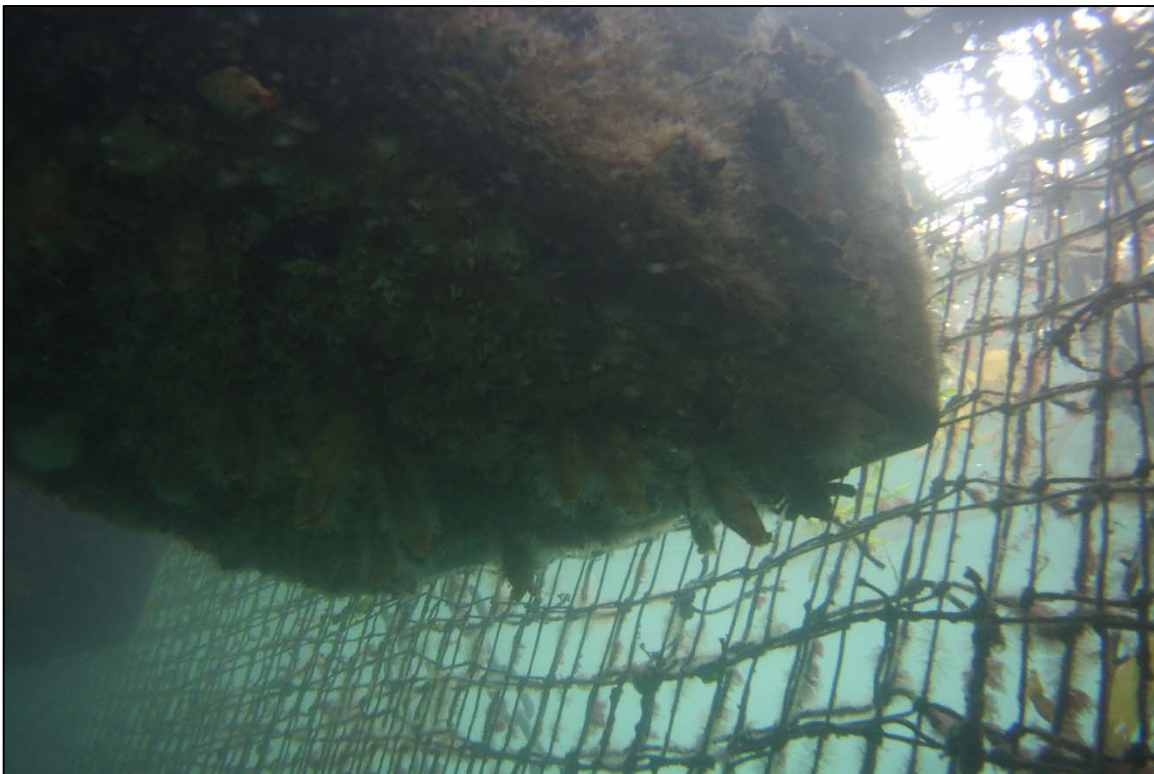
Photograph 11: View of the Depressed Pen Support Float at the Southeast Corner, Looking Northeast.

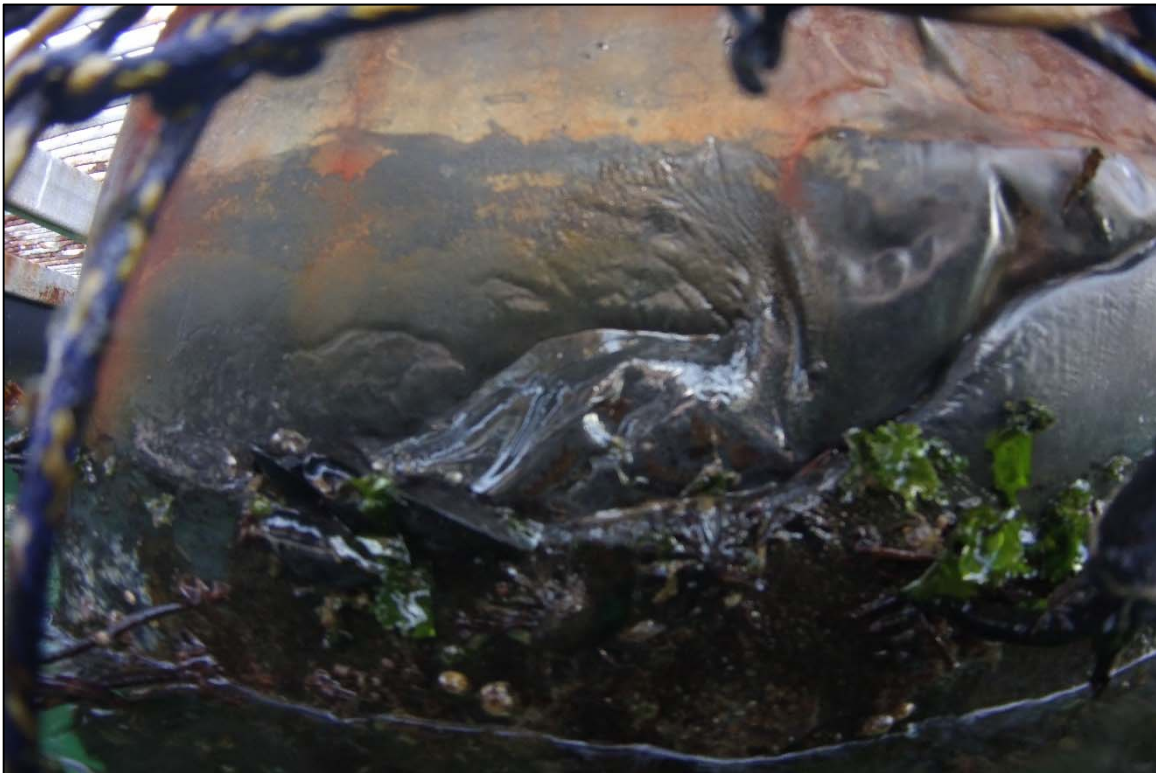
Photograph 17: View of the Heat Damage (Melted Plastic) Float 4 Shown, Looking North.

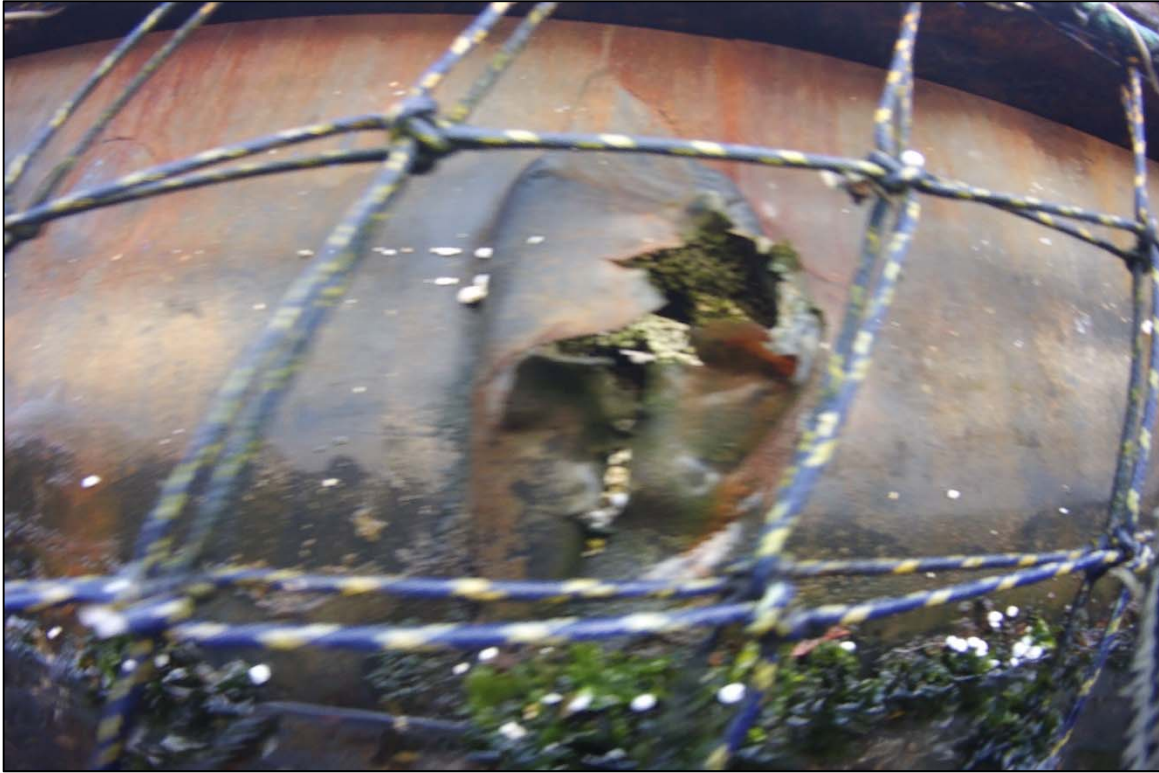
Photograph 18: View of the Heat Damage (Melted Plastic) Float 2 Shown, Looking North.

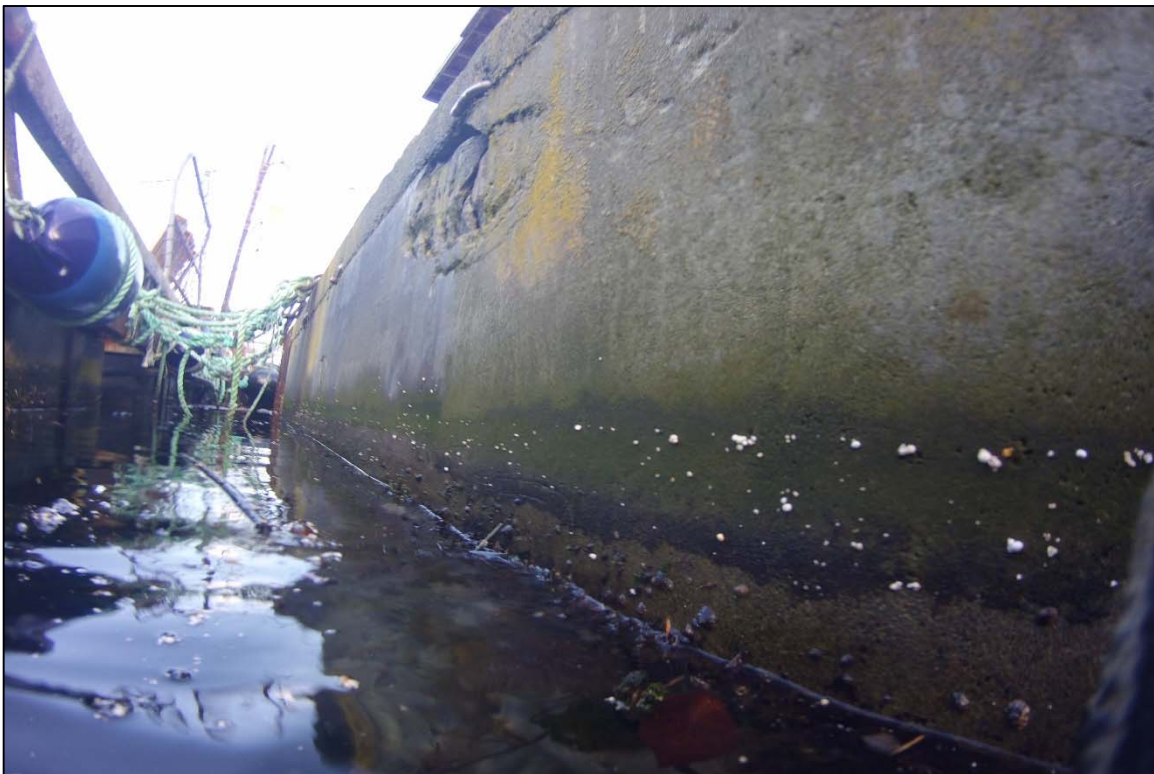
Photograph 23: View of the Area of Section Loss and Exposed Foam Floatation on the Southeast Corner of the Building Barge Float, Looking South.

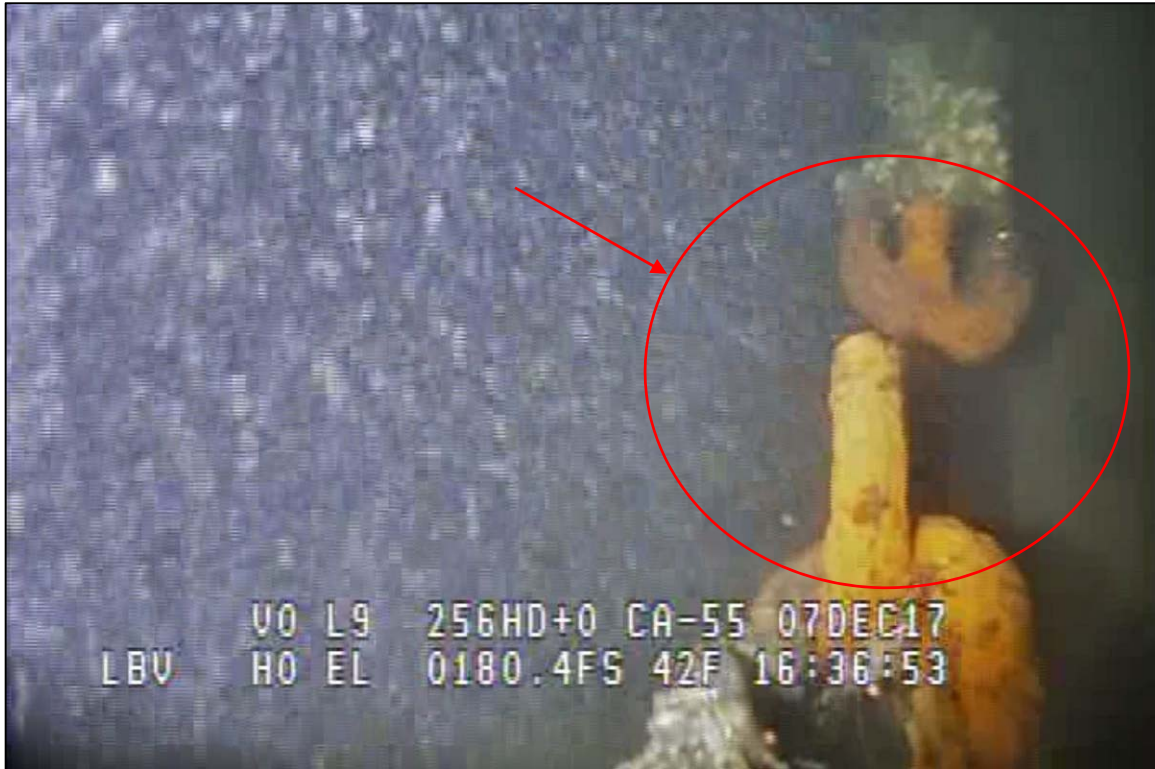
Photograph 48: View of Lower Anchor Chain to Rope Connection (Thimble and Shackle) at Primary System Anchor Line 14, Looking West.

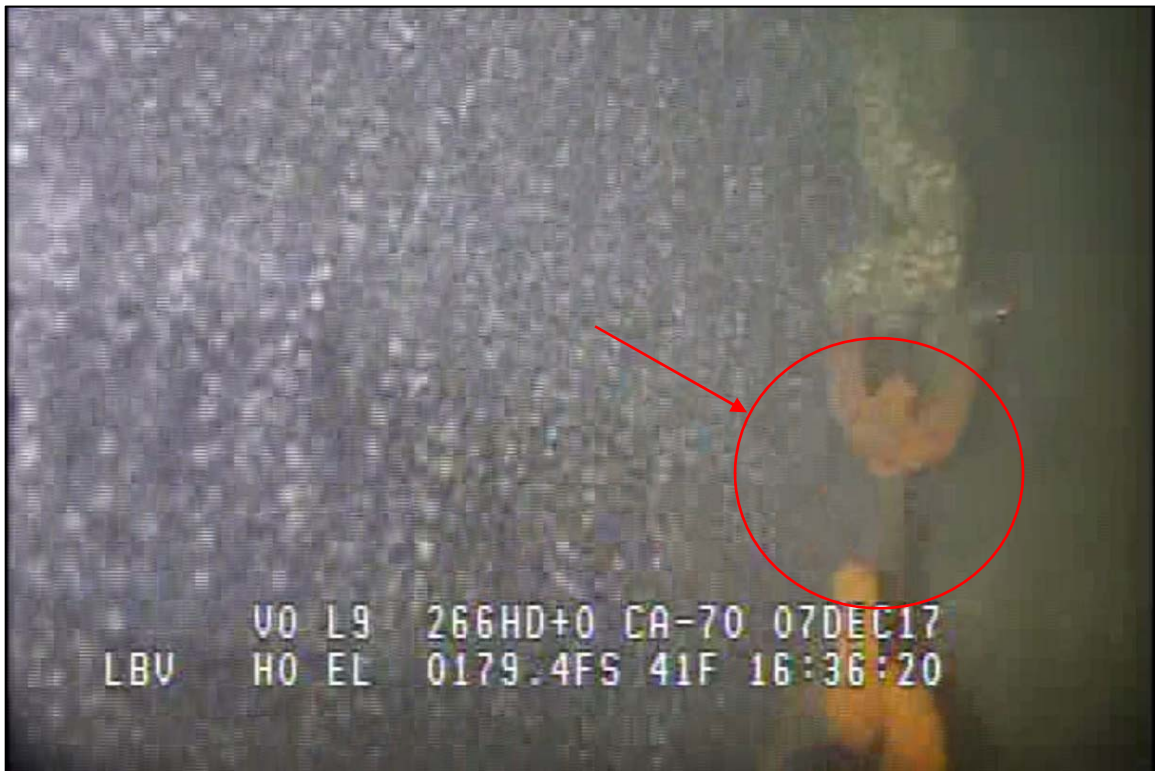
Component	Year Built (estimate)	Description	Deficiencies	Overall Assessment
Anchors	varies	The mooring plan provided by the Owner says the anchors are 2,000 to 3,000-pound Danforth type anchors.	<p>The drag anchors on the surface should be fully buried. Anchors 18, 19, 21, 22 and 22A were found partially exposed. There may be design deficiencies.</p> <p>Anchor line 14 must be addressed immediately. There is a broken link in the section of chain near the anchor</p>	<p>Satisfactory, but most anchors were not observed because they were buried. Anchor line 14 in critical condition with a broken link in the system.</p> <p>Anchor Lines 6 and 7 were not present</p>
Mooring Lines	varies	Typically, a 1-inch shackle at the mooring bracket, two 2.75-inch chain lines leading to a buoy, then 30-feet of chain, a length of synthetic rope, 60-feet of chain,	Mooring lines missing, mooring lines wrapped around other lines, lines too steep, severe damage on some lines, unusual combinations/sequences of line and chain,	<p>Fair, but with serious deficiencies in some areas.</p> <p>Anchor line 14 in critical condition with a broken link in the</p>

Photograph 49: View of a Broken Chain Link in the Lower Anchor Chain at Primary System Anchor Line 14, Looking West.

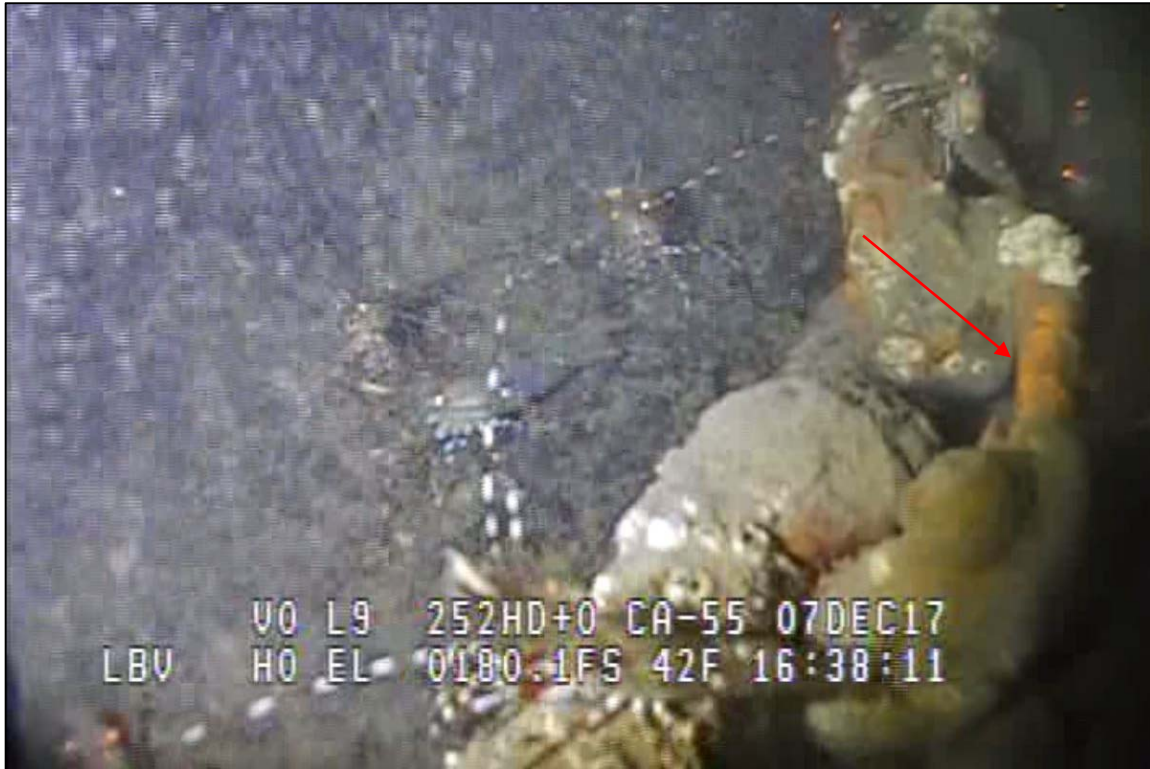
Photograph 50: View of a Broken Chain Link in the Lower Anchor Chain at Primary System Anchor Line 14, Looking West.

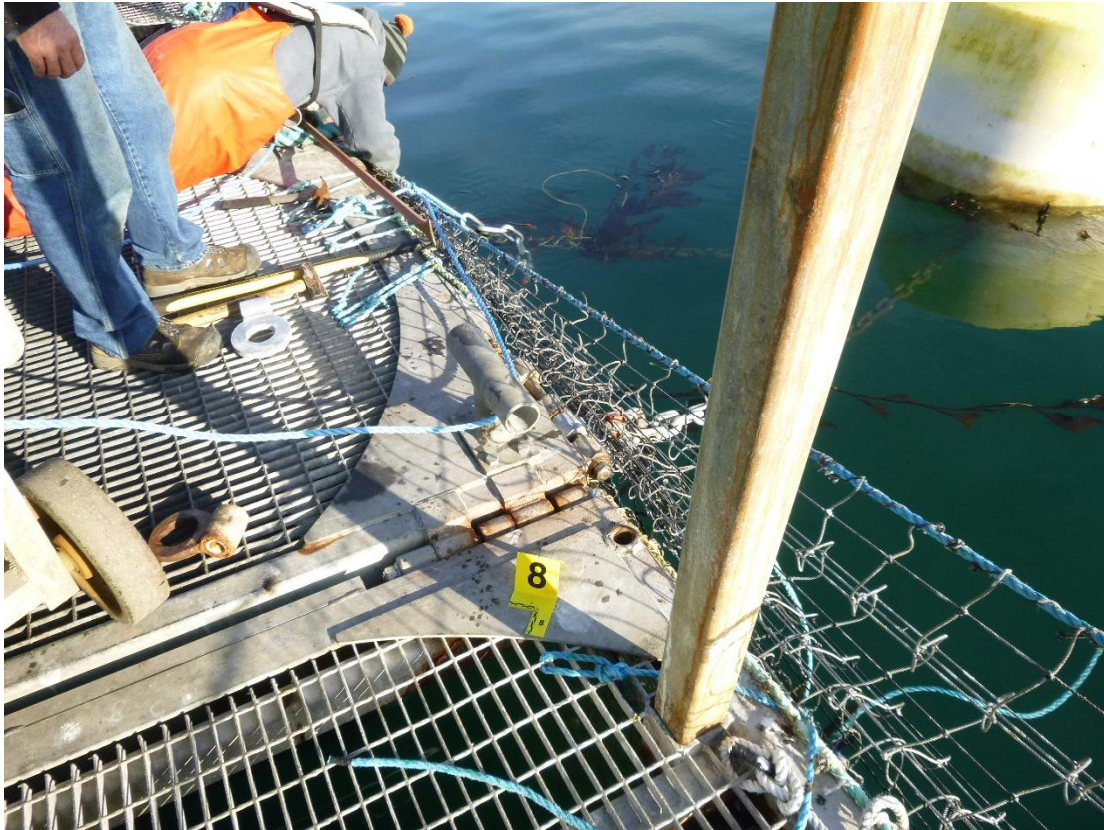
Figure C-23: Comparison of Old and New Padeye

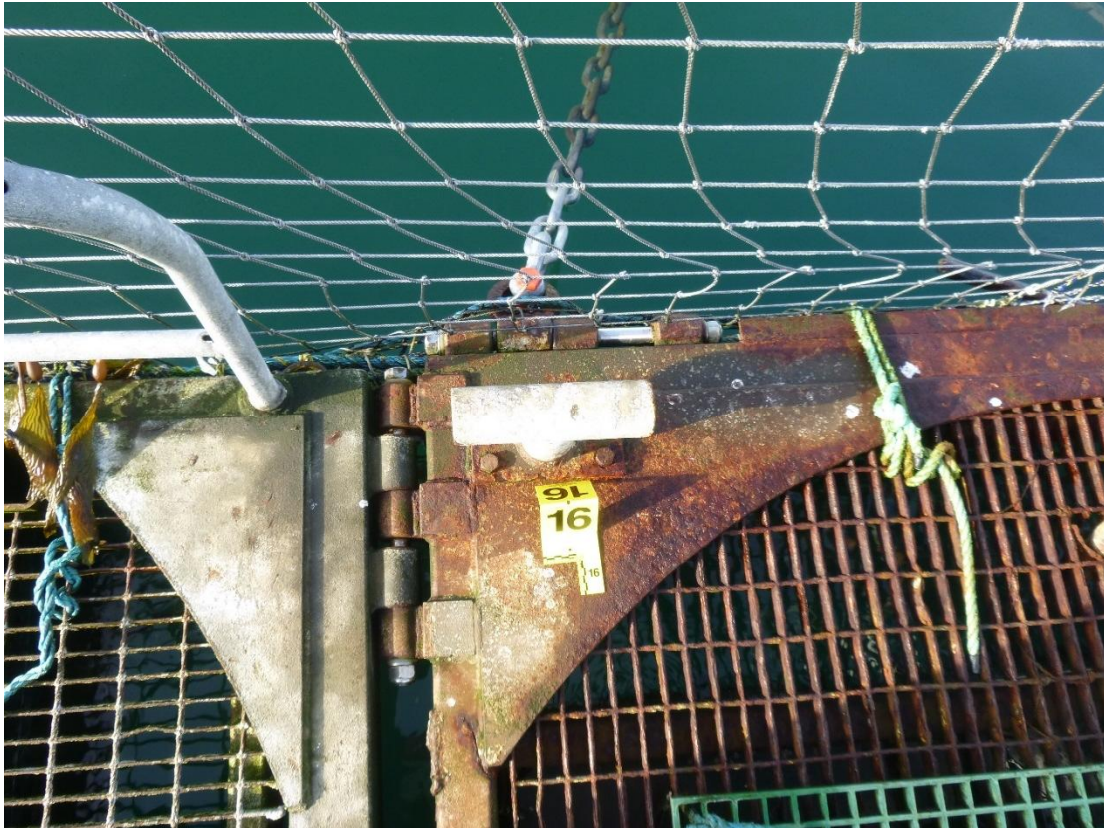
Figure C-49: Anchor 16 Showing Moderate to Severe Corrosion of Grating

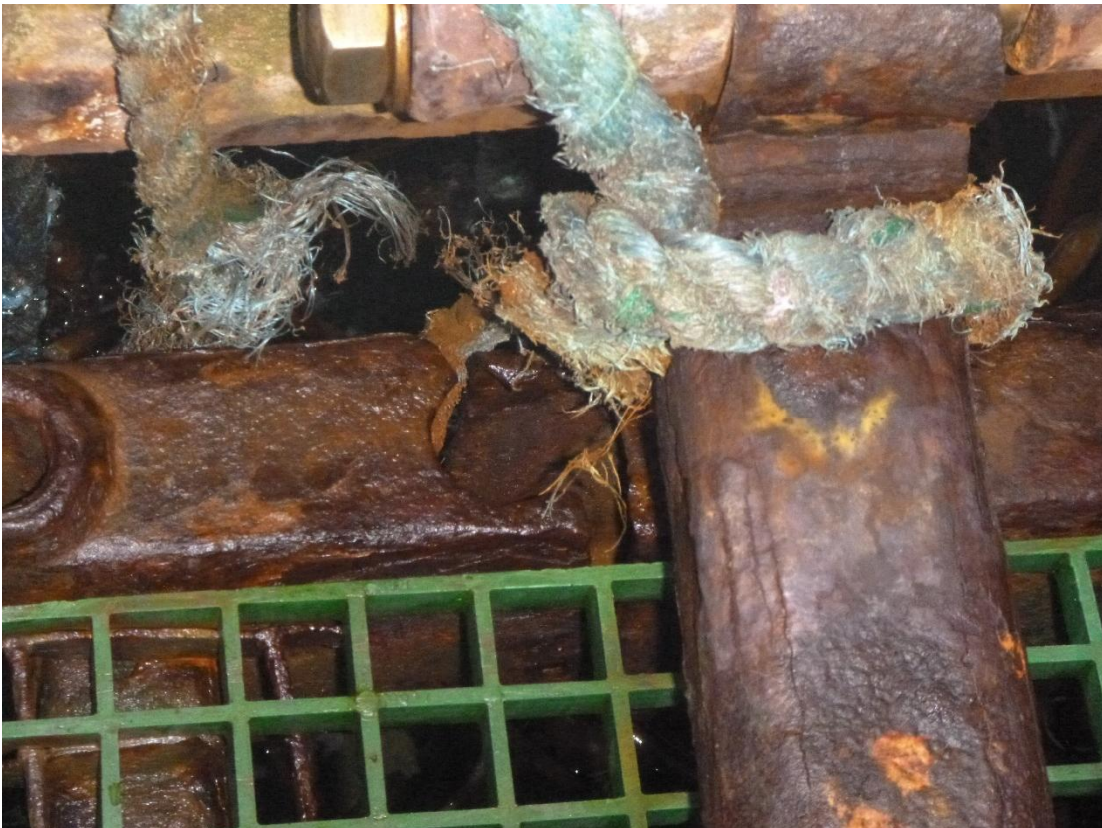
Figure C-54: Floating Dock Boarding Area, Damage to Dock Frame From Arms

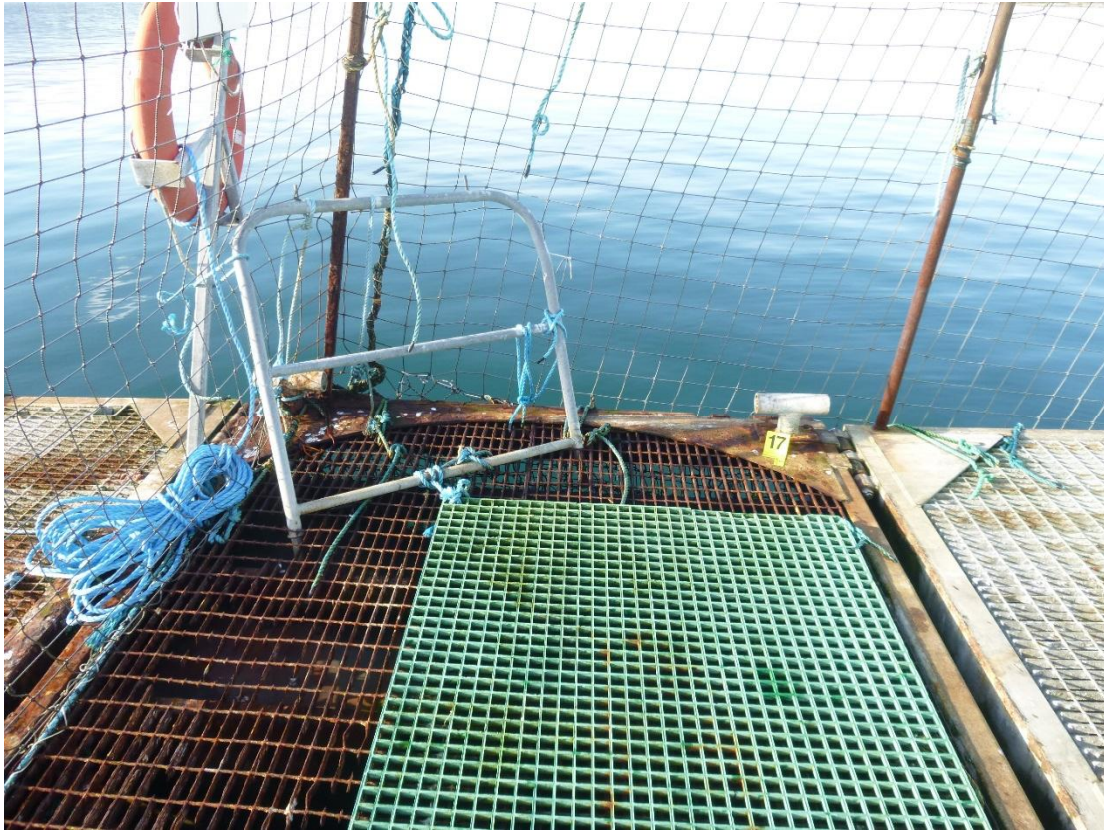
Figure C-55: Floating Dock Boarding Area, Broken Dock Frame From Arms

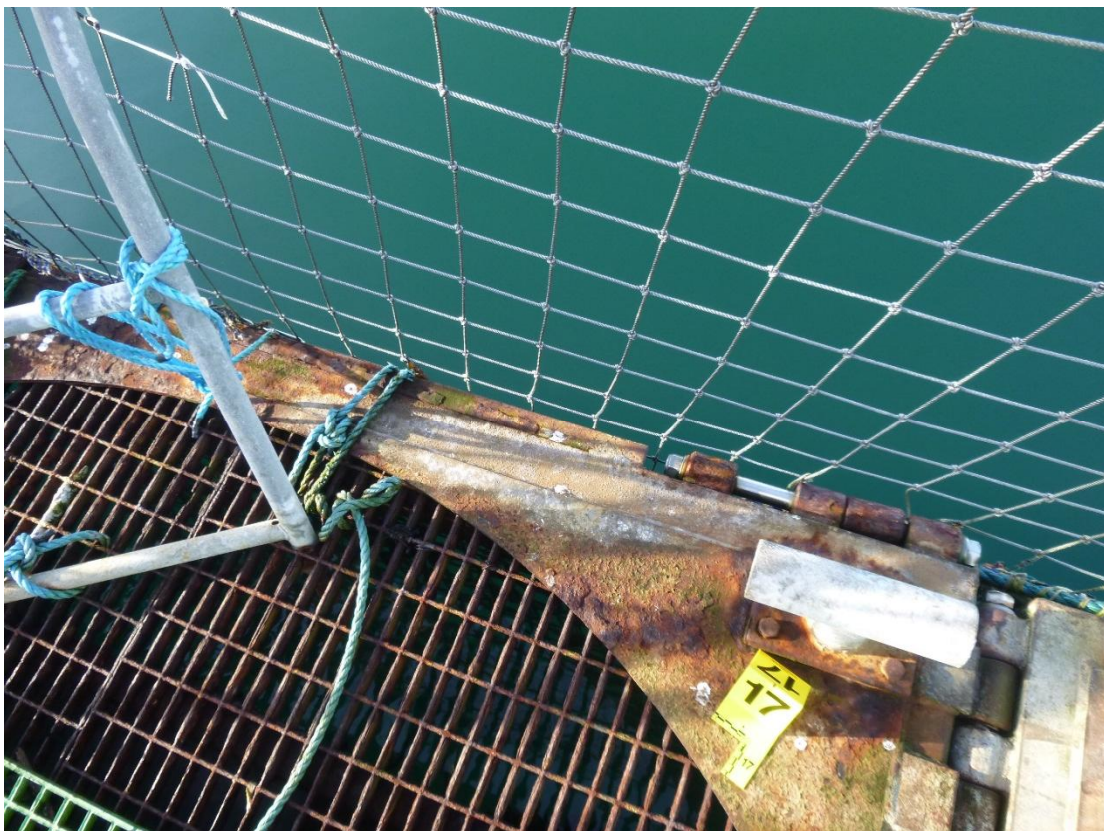
Figure C-56: Anchor 17 Missing. Showing Severe Corrosion of Grating

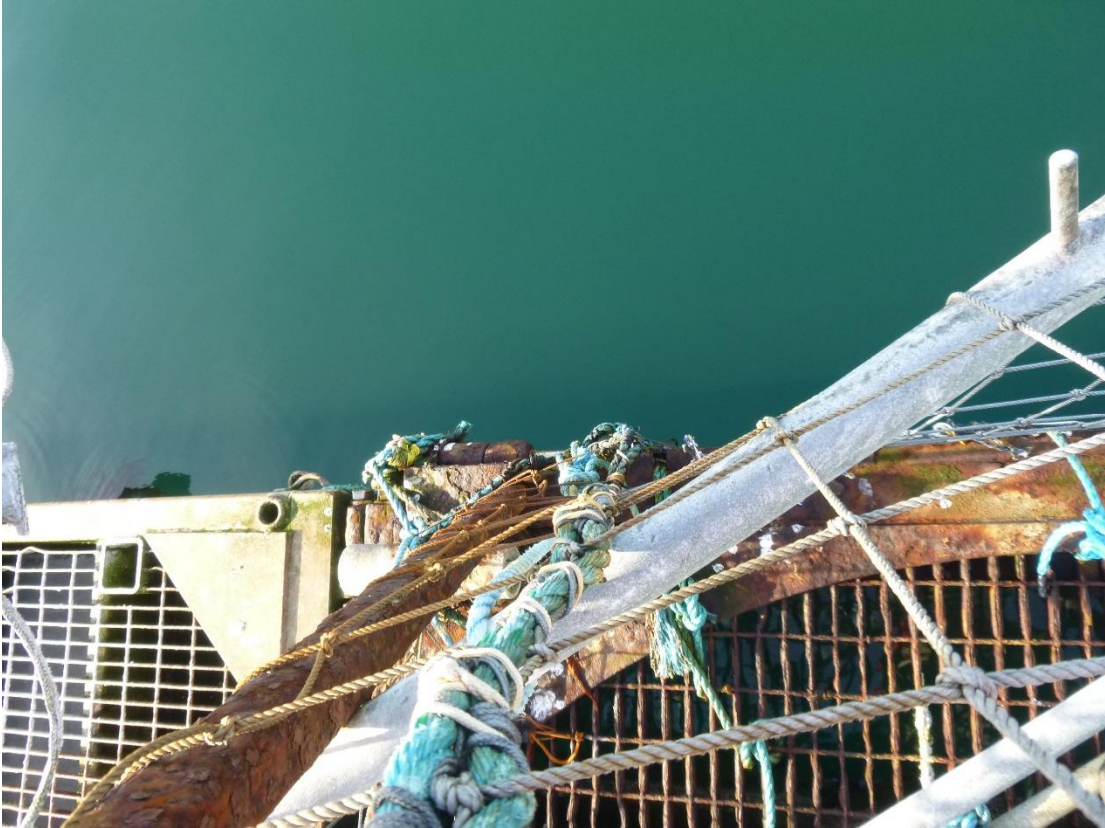
Figure C-57: Anchor 17 Missing - Right Padeye Hinge

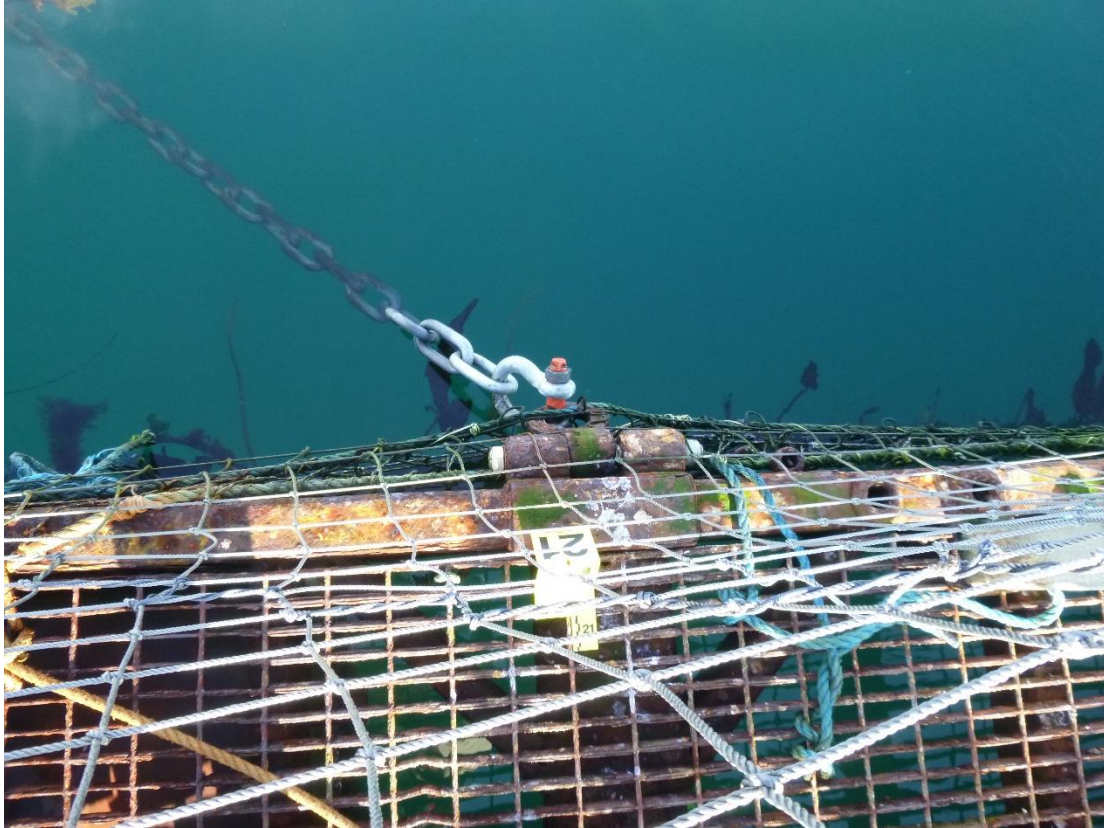
Figure C-69: Anchor 21 Showing Severe Corrosion in Grating

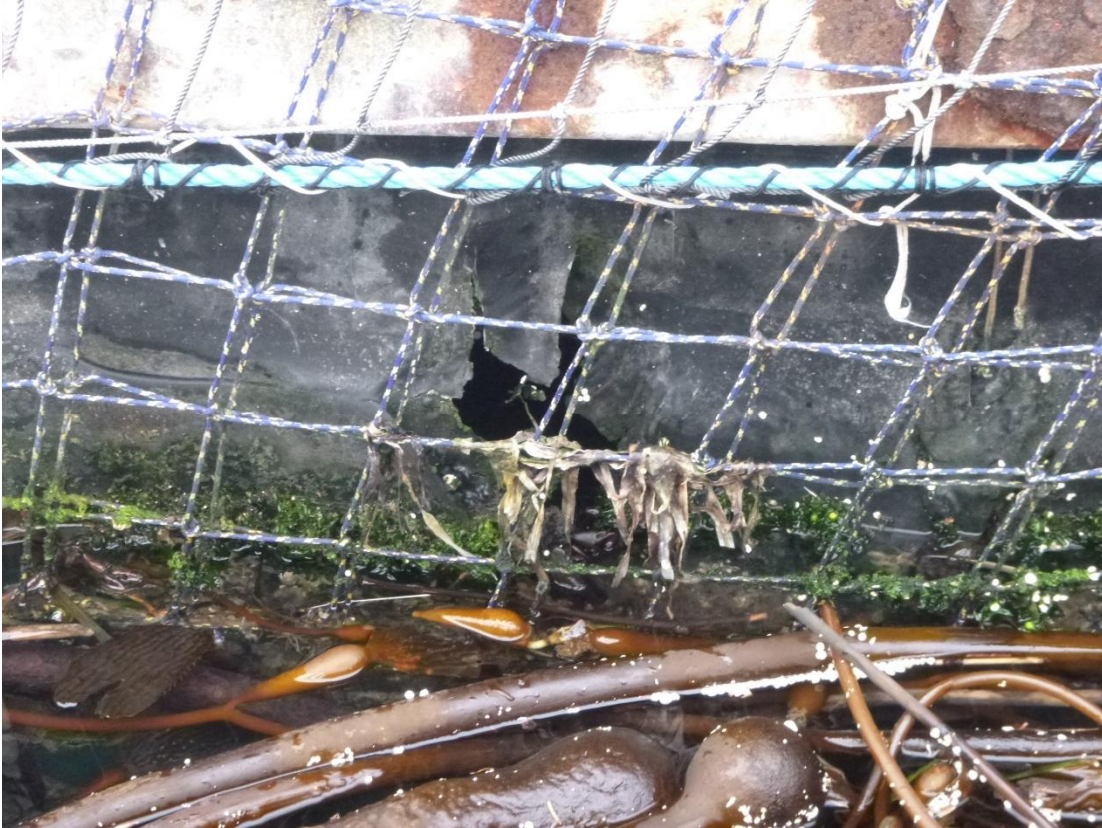
Figure C-75: Location 23 Damaged Pontoon (South Edge of Pen 5)

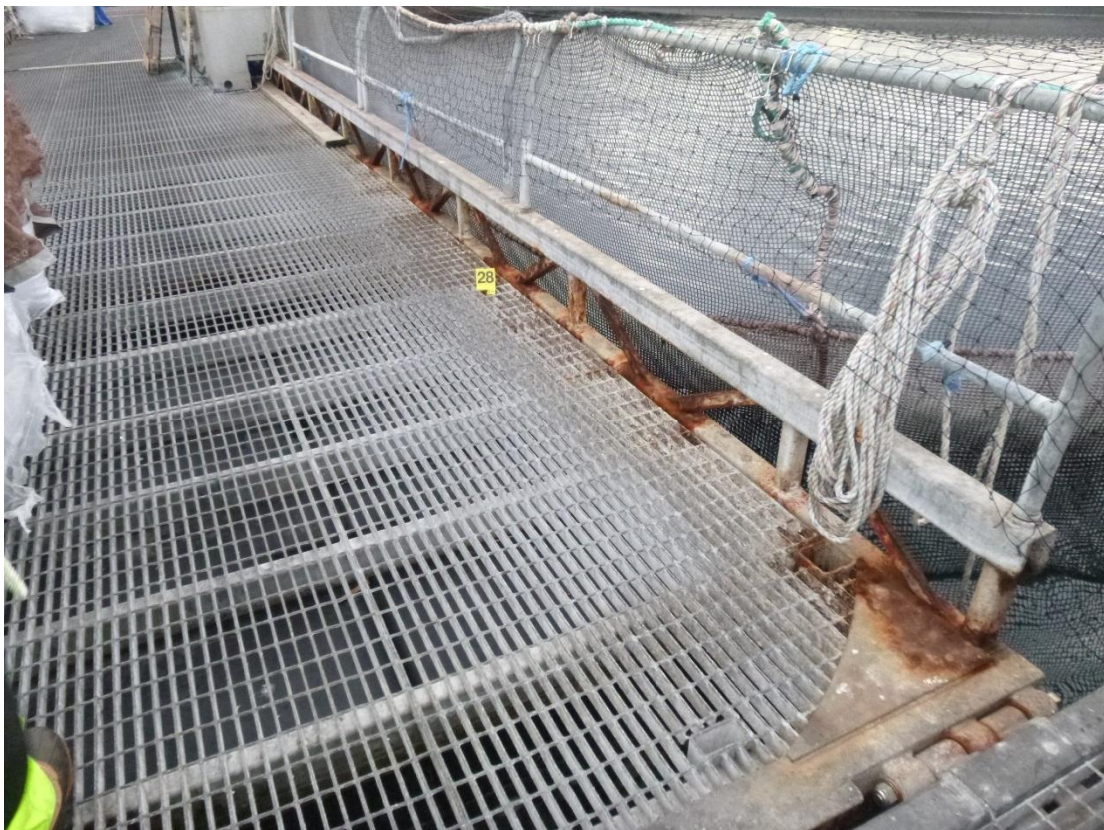
Walkways and Railings	2000	Steel fabrication with metal grate walking surface and hinge connections. Temporary Walkway repairs made with an Overlay of fiberglass grating	Surface rust, localized severe corrosion, holes in walkway,	Fair, permanent repairs are necessary

Figure C-78: Fiberglass Mesh Covers Severe Corrosion in Grating

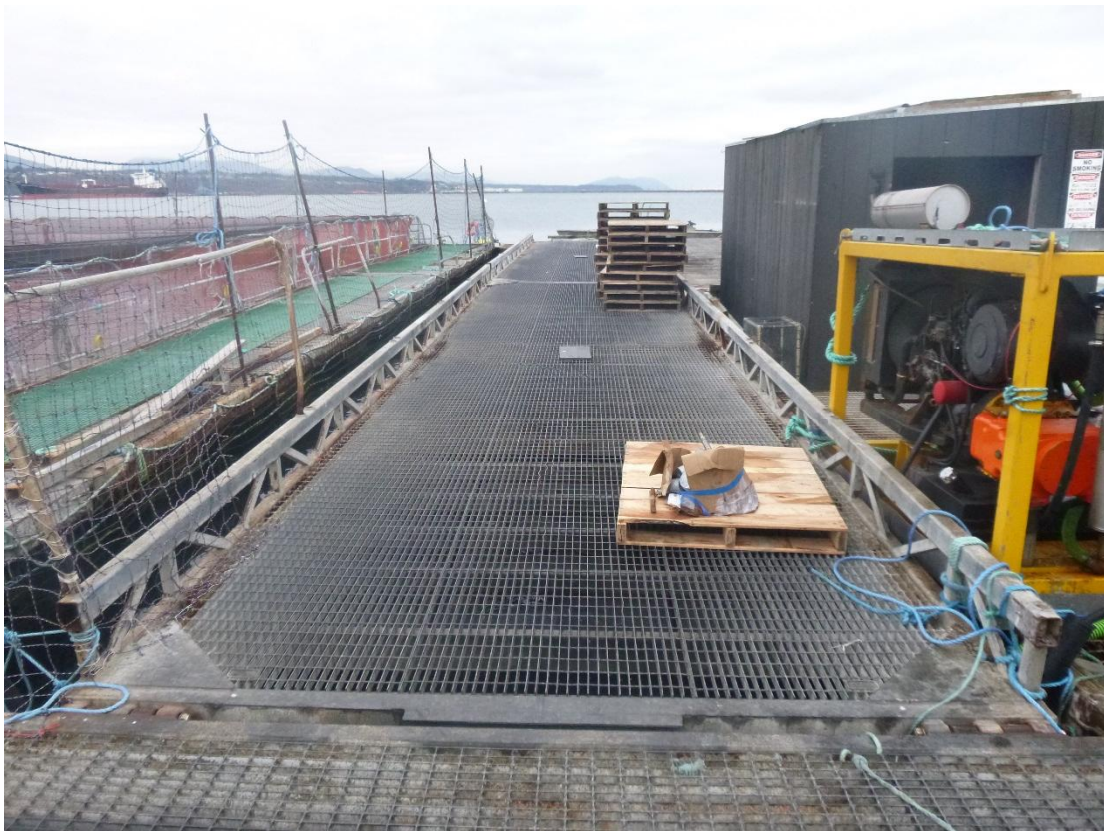
Figure C-79: Typical 10ft Wide Dock Section with Light to Moderate Corrosion on Truss Members
