# **Rich Passage Orchard Rocks Atlantic Salmon Net Pens Engineering Assessment**

January 29, 2018

Mott MacDonald  
110 James Street  
Suite 101  
Edmonds WA 98020  
United States of America

State of Washington  
Department of Natural  
Resources  
1111 Washington Street SE  
Olympia Washington 98504

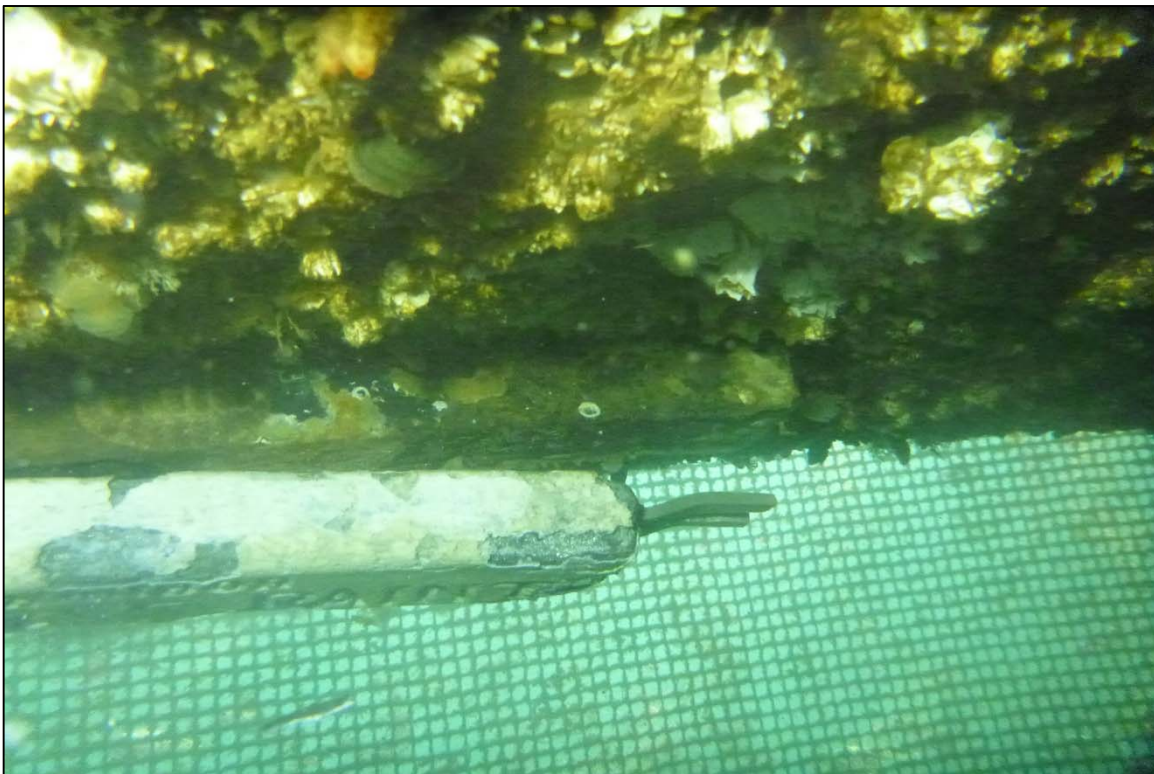
Photograph 7: View of the Steel Pontoon Condition at Orchard Rocks North Fish Net Pens System, Looking North.

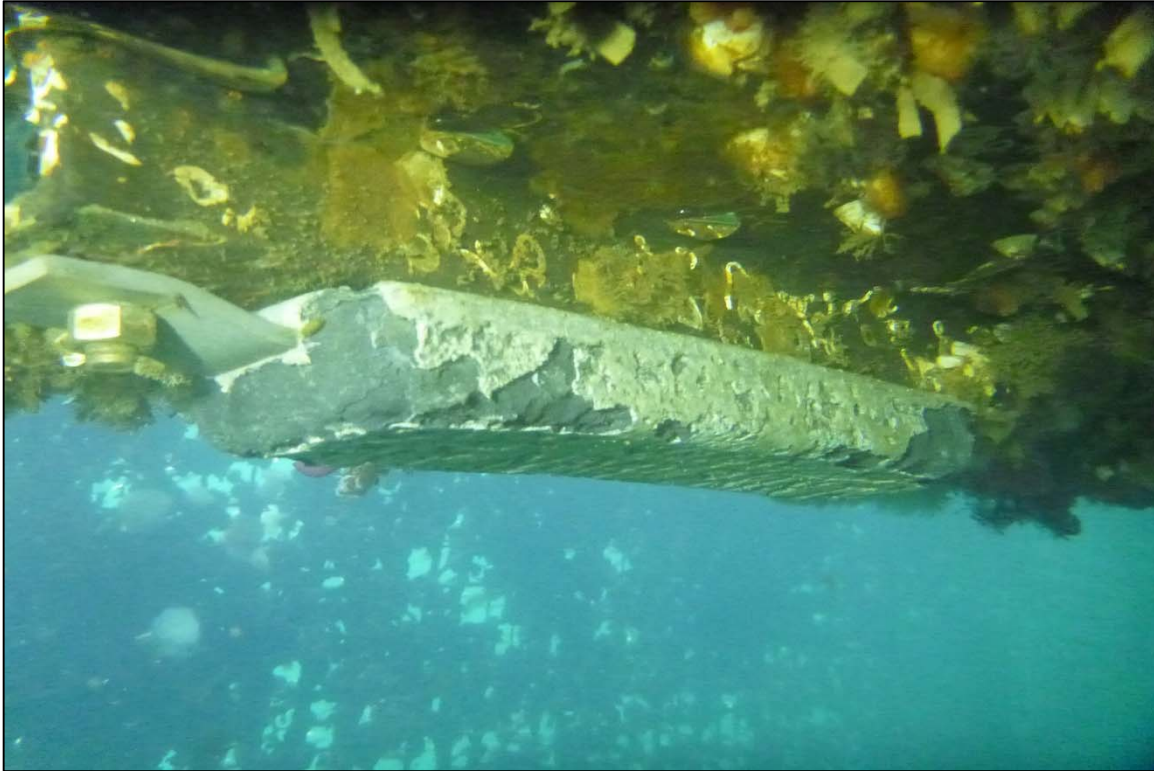
Photograph 8: View of Missing Connection of the Anode on the Steel pontoons at Orchard Rocks North Fish Net Pens System, Looking Northwest.

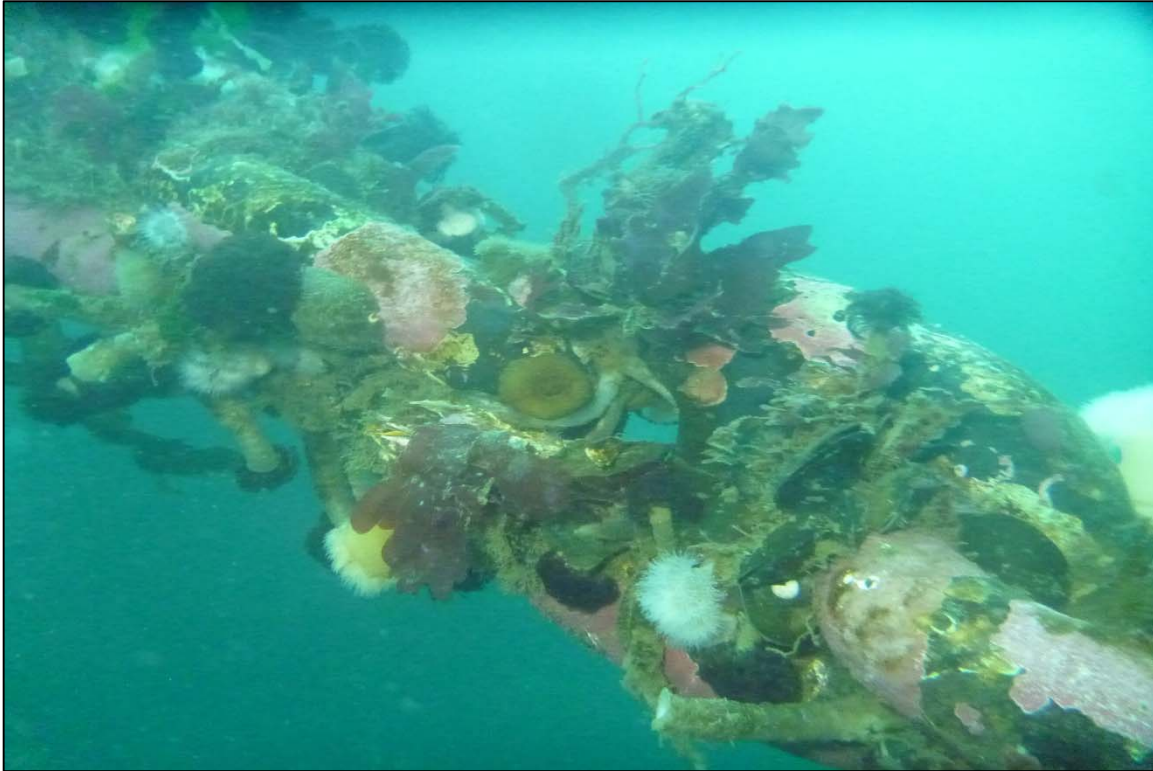
Photograph 20: View of Upper Anchor Chain to Float Connection with Severe Corrosion at Orchard Rocks North Anchor Line 3, Looking West.

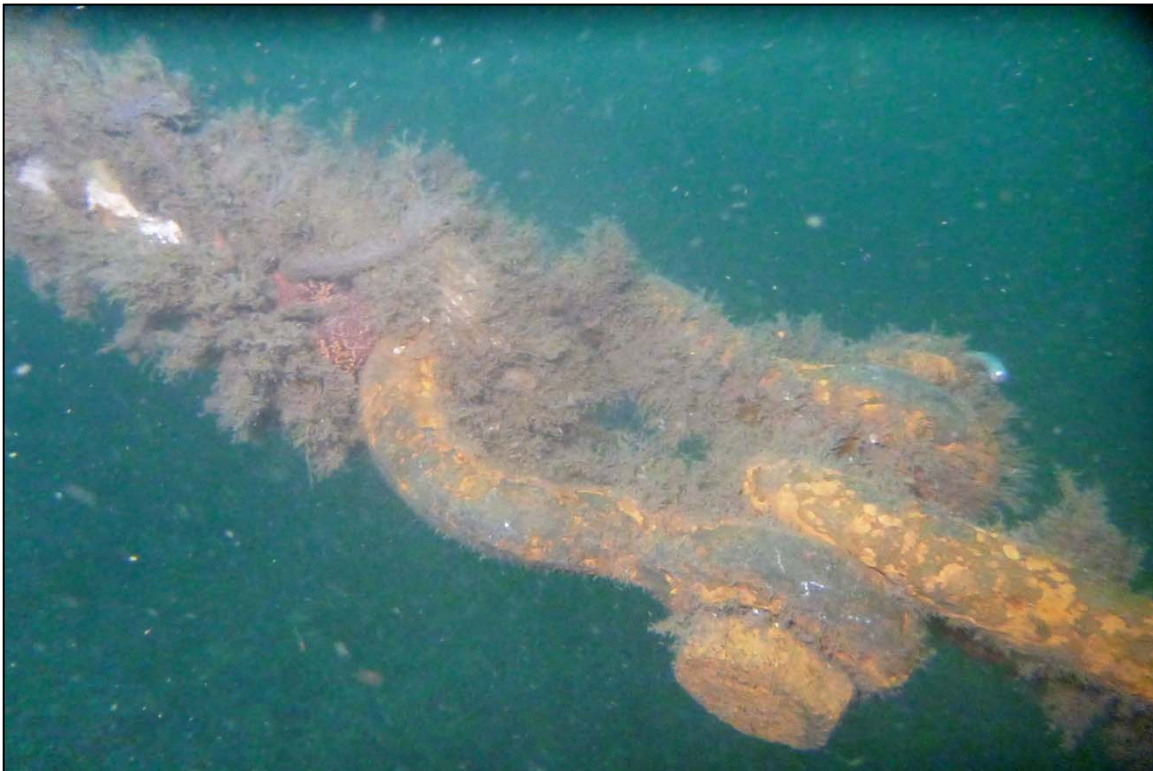
Photograph 21: View of Upper Anchor Chain Condition with Heavy Marine Growth at Orchard Rocks North Anchor Line 3, Looking North.

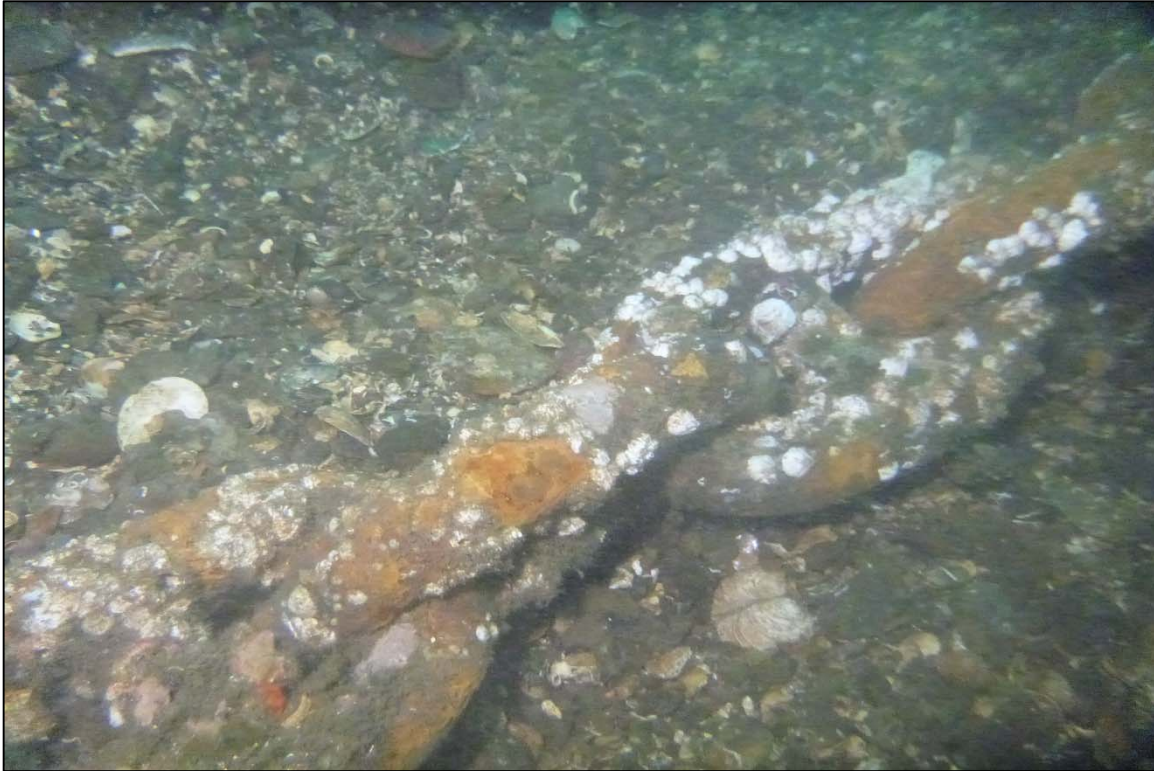
Photograph 22: View of Rope to Lower Anchor Chain Connection (Shackle) with Severe Corrosion and Thread Loss on the Bolt at Orchard Rocks North Anchor Line 3, Looking North.

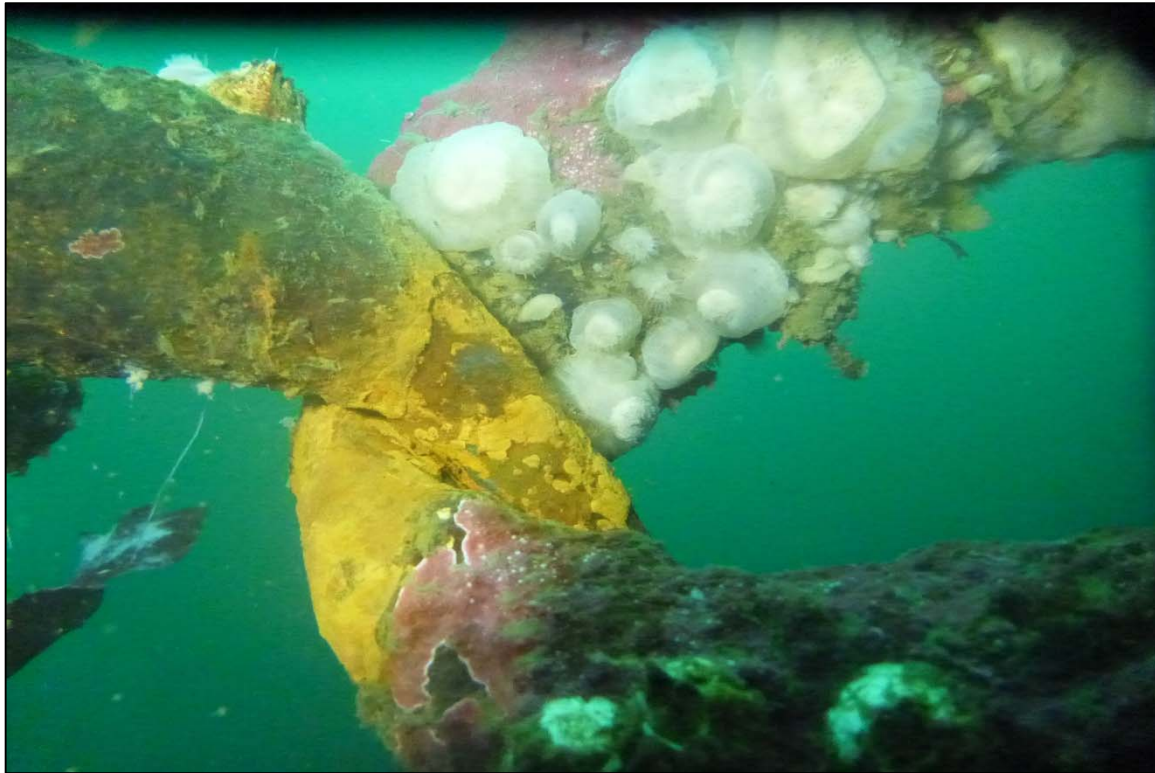
Photograph 24: View of Upper Anchor Chain Condition with Heavy Corrosion and Delamination at Orchard Rocks North Anchor Line 4, Looking West.

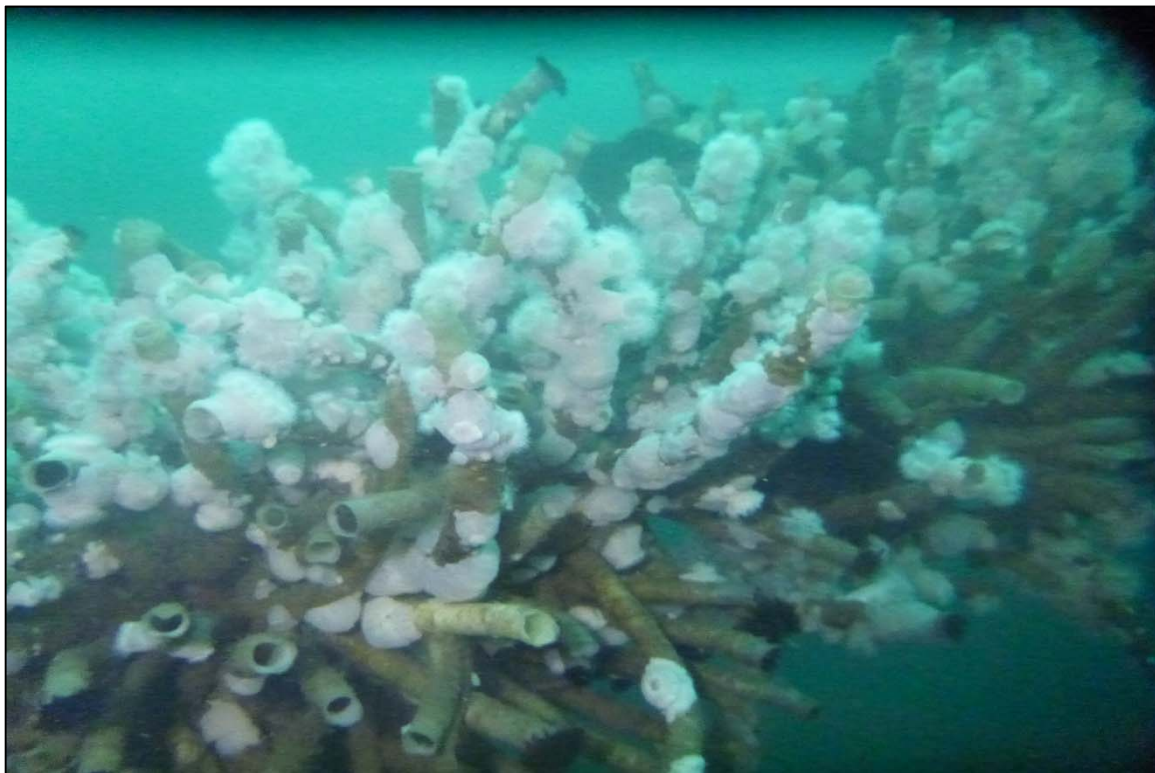
Photograph 25: View of Upper Anchor Chain Shackle with up to 75% Section Loss at Orchard Rocks North Anchor Line 4, Looking North.

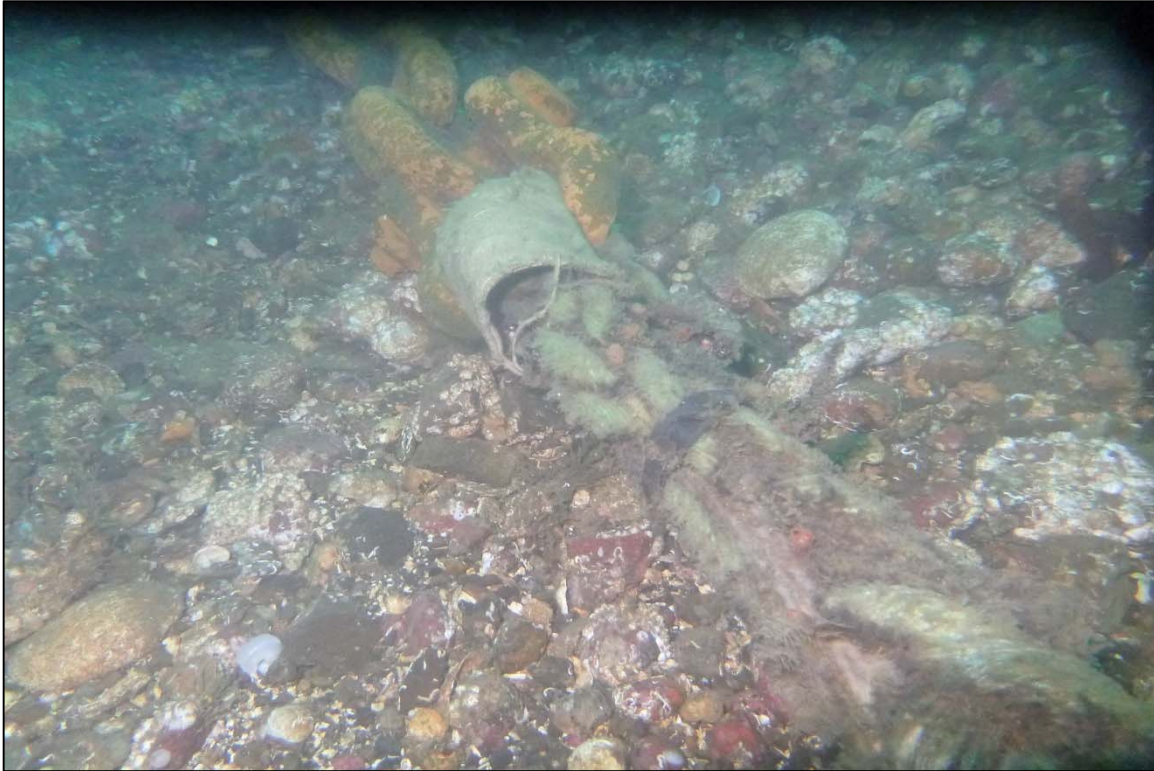
Photograph 26: View of Rope Condition with Heavy Marine Growth at Orchard Rocks North Anchor Line 4, Looking Northeast.

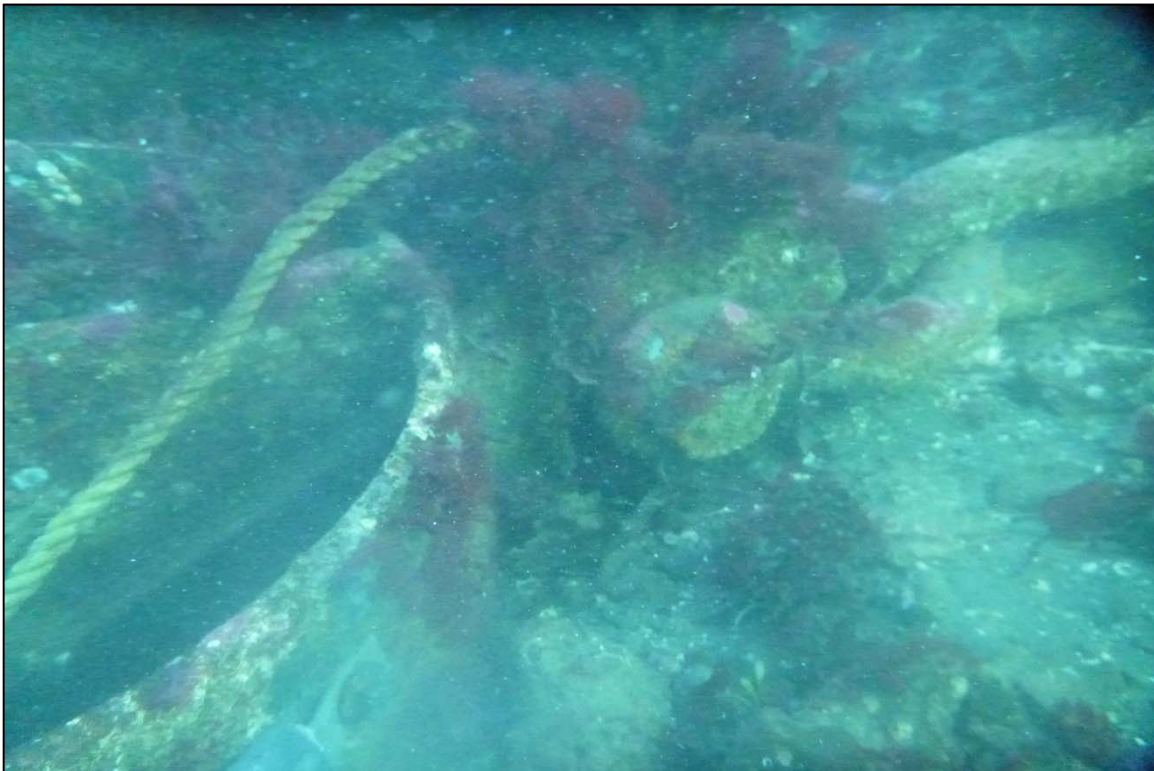
Photograph 45: View of Section Loss and Missing Stud in the Anchor Chain at Orchard Rocks North Anchor Line 15, Looking East.

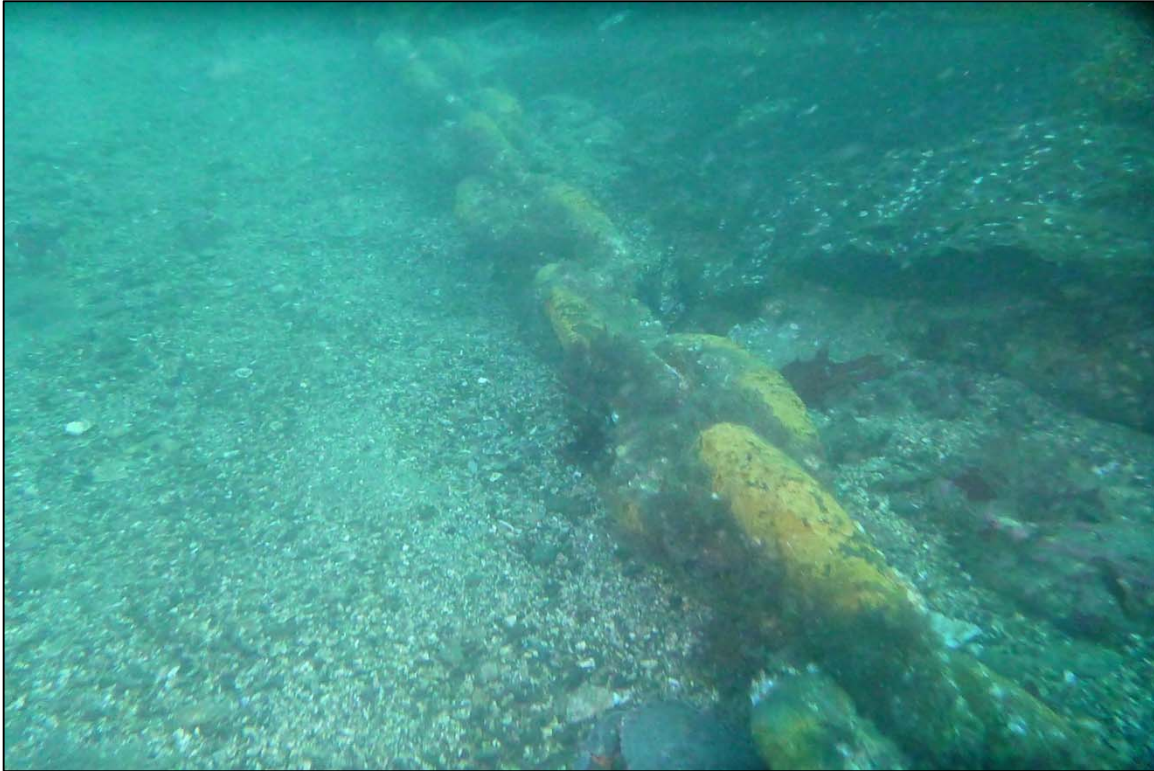
Photograph 48: View of Lower Anchor Shackle with Heavy Corrosion and Section Loss at Orchard Rocks North Anchor Line 16, Looking North.

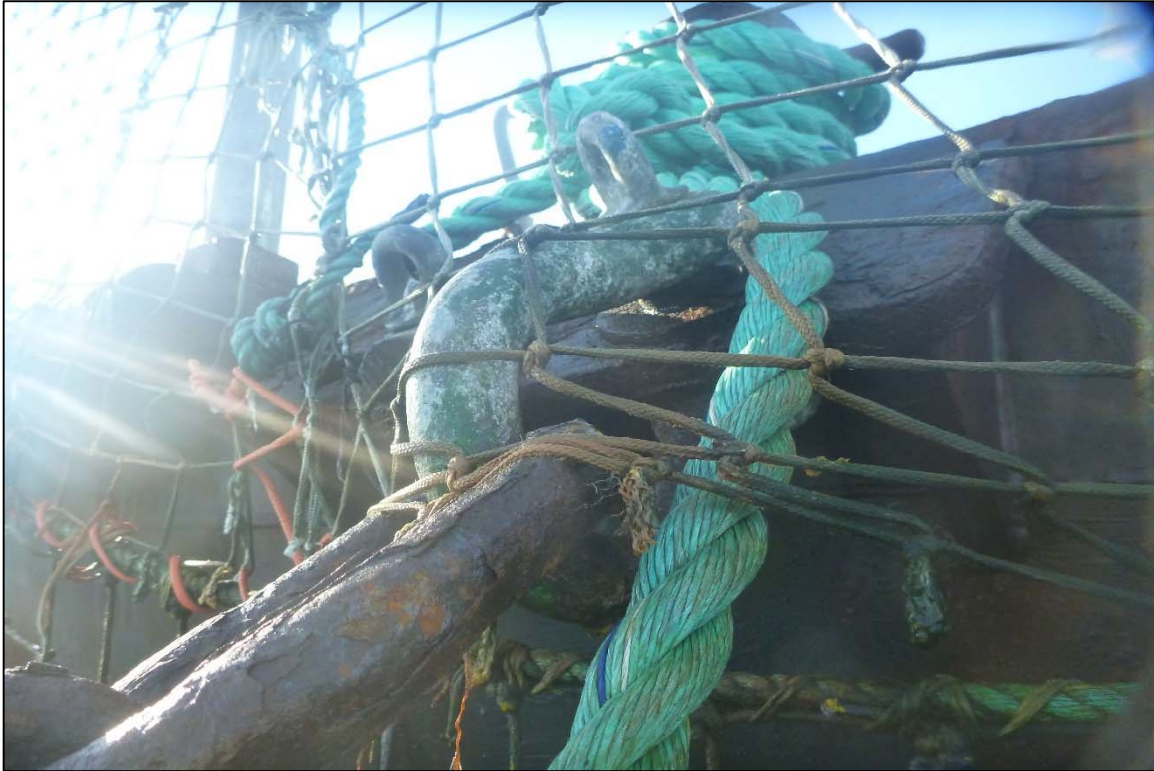
Photograph 52: View of the Partially Detached Anode Condition on the Steel pontoons at Orchard Rocks South Fish Net Pens System, Looking North.

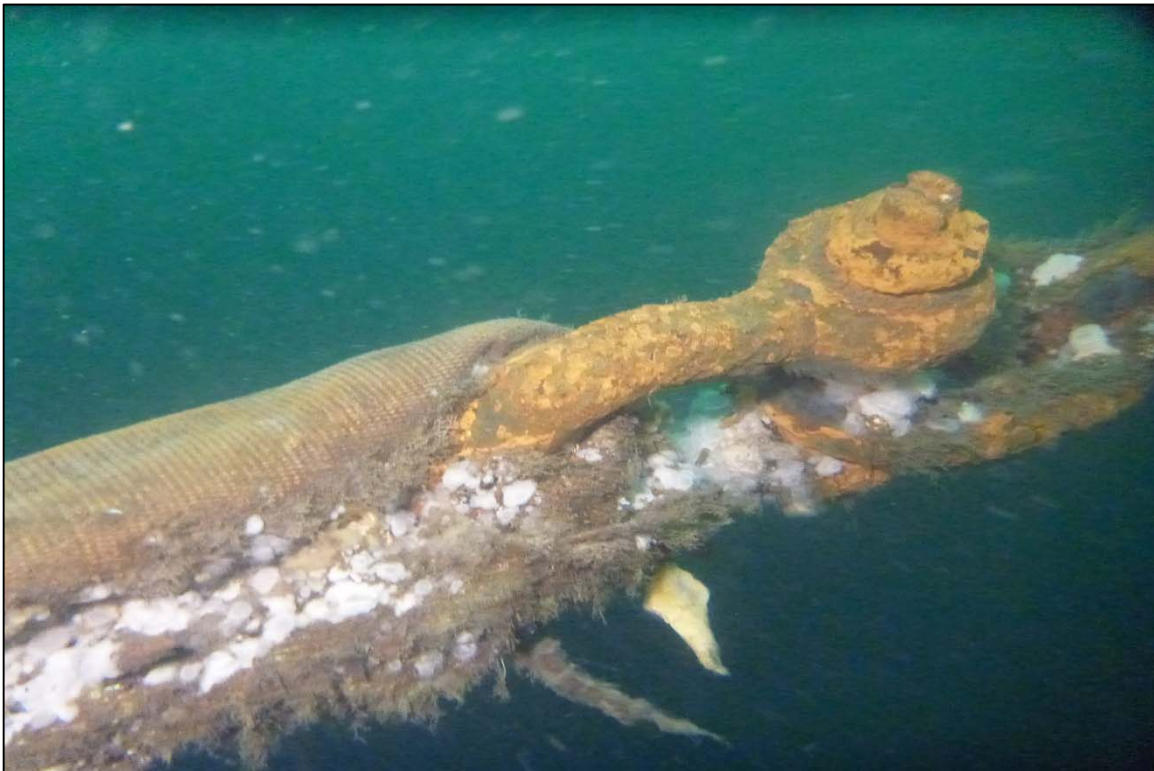
Photograph 59: View of Rope to Lower Anchor Chain Connection (Shackle and Sleeve) with Missing Nut and Cotter Pin at Orchard Rocks South Anchor Line 2, Looking South.

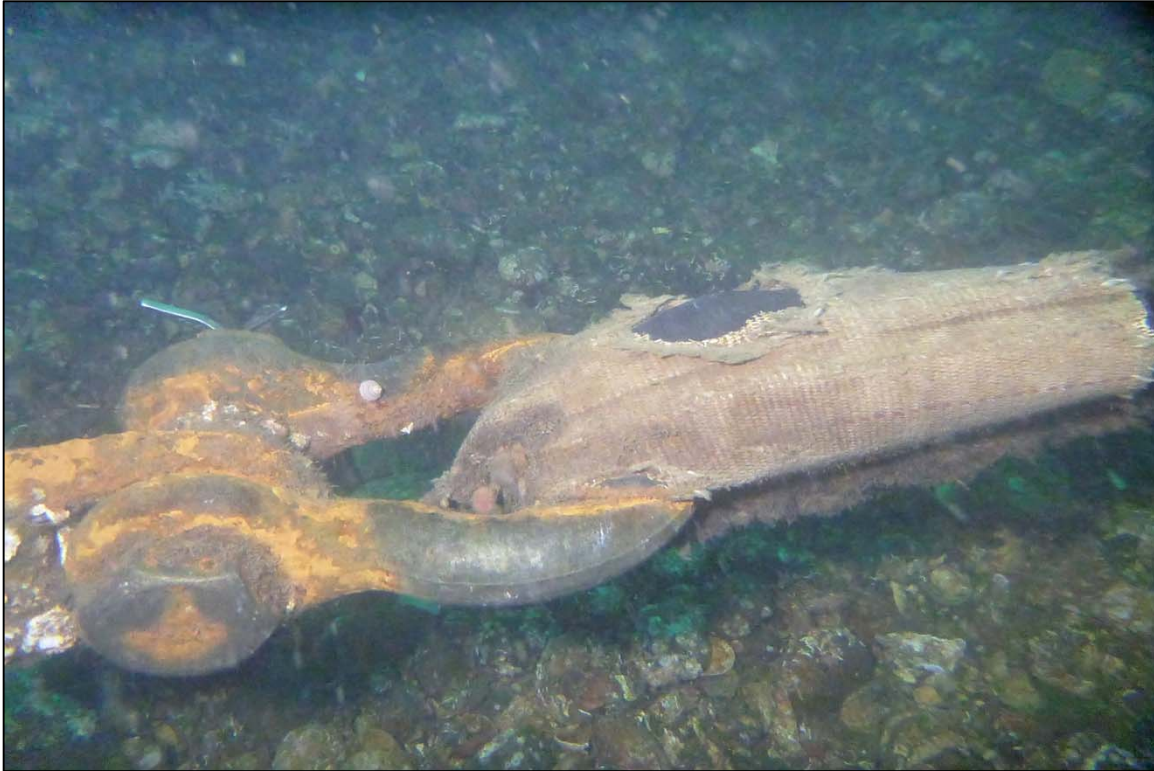
Photograph 60: View of Upper Anchor Chain to Rope Connection (Shackle and Sleeve) with Missing Cotter Pin at Orchard Rocks South Anchor Line 3, Looking South.

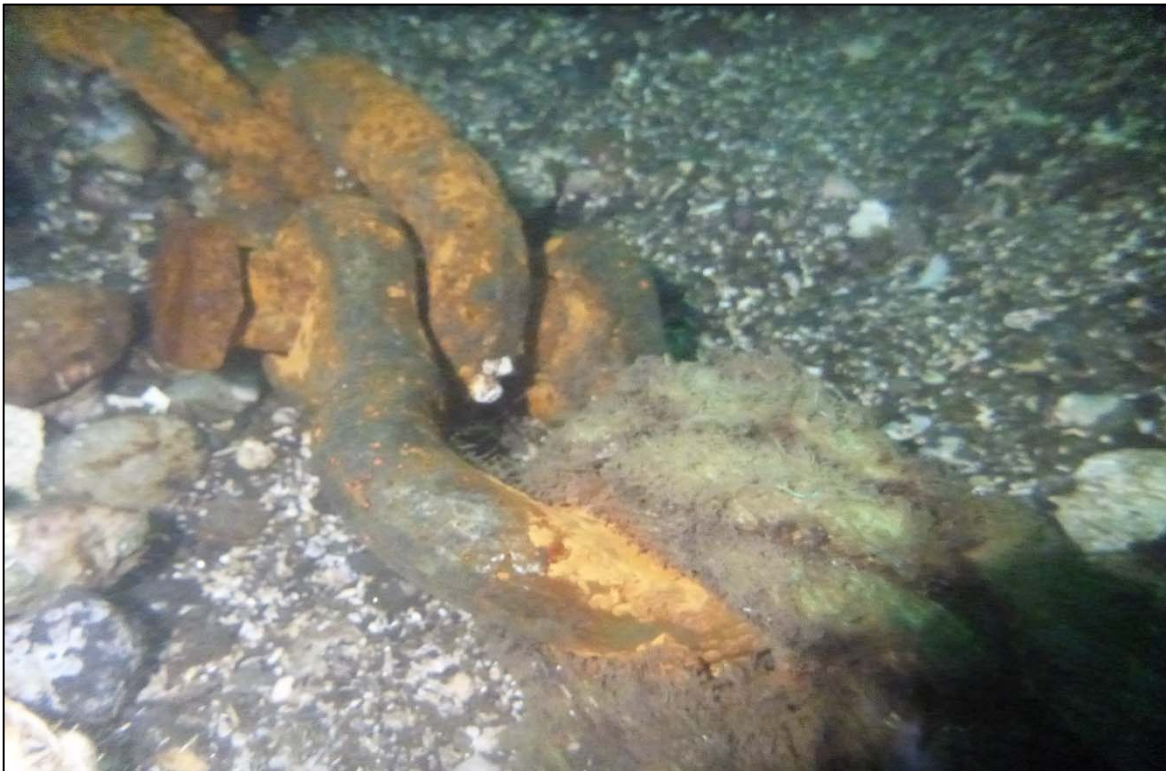
Photograph 67: View of Lower Anchor Chain Moderate Corrosion at Orchard Rocks South Anchor Line 5, Looking East.

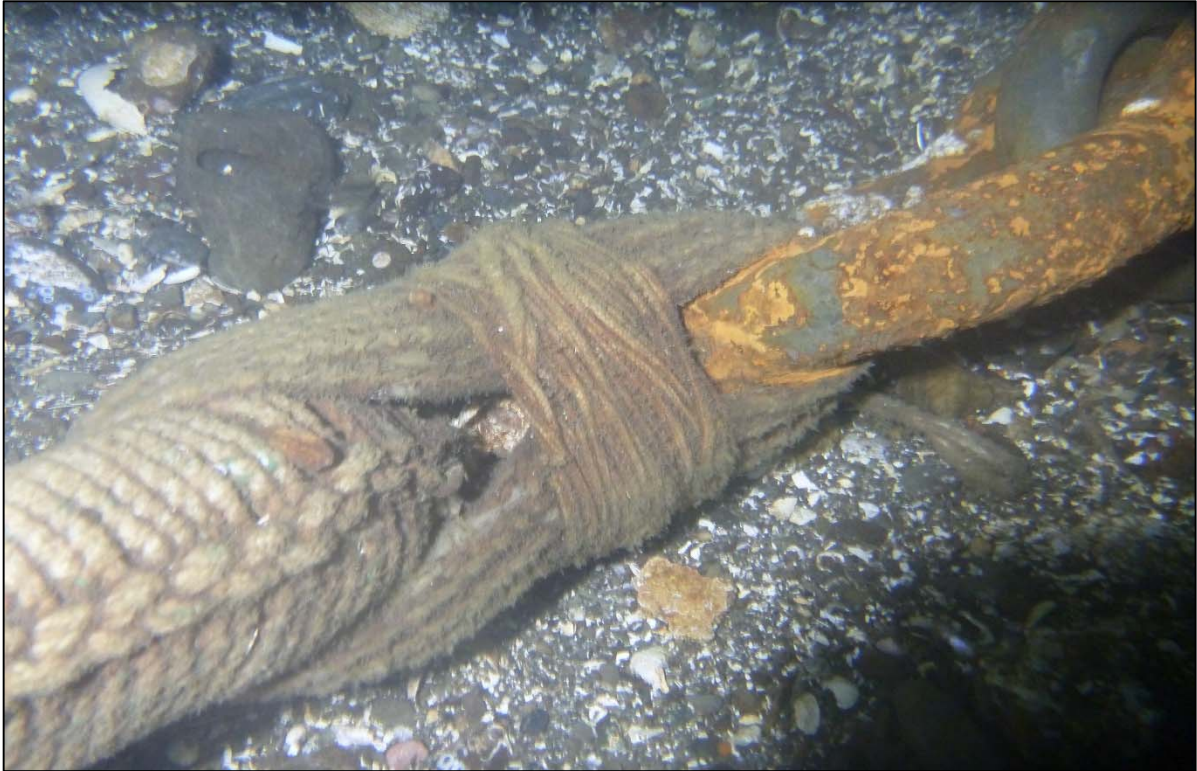
Photograph 76: View of Upper Anchor Chain to Float Connection Moderate Corrosion at Orchard Rocks South Anchor Line 7, Looking West.

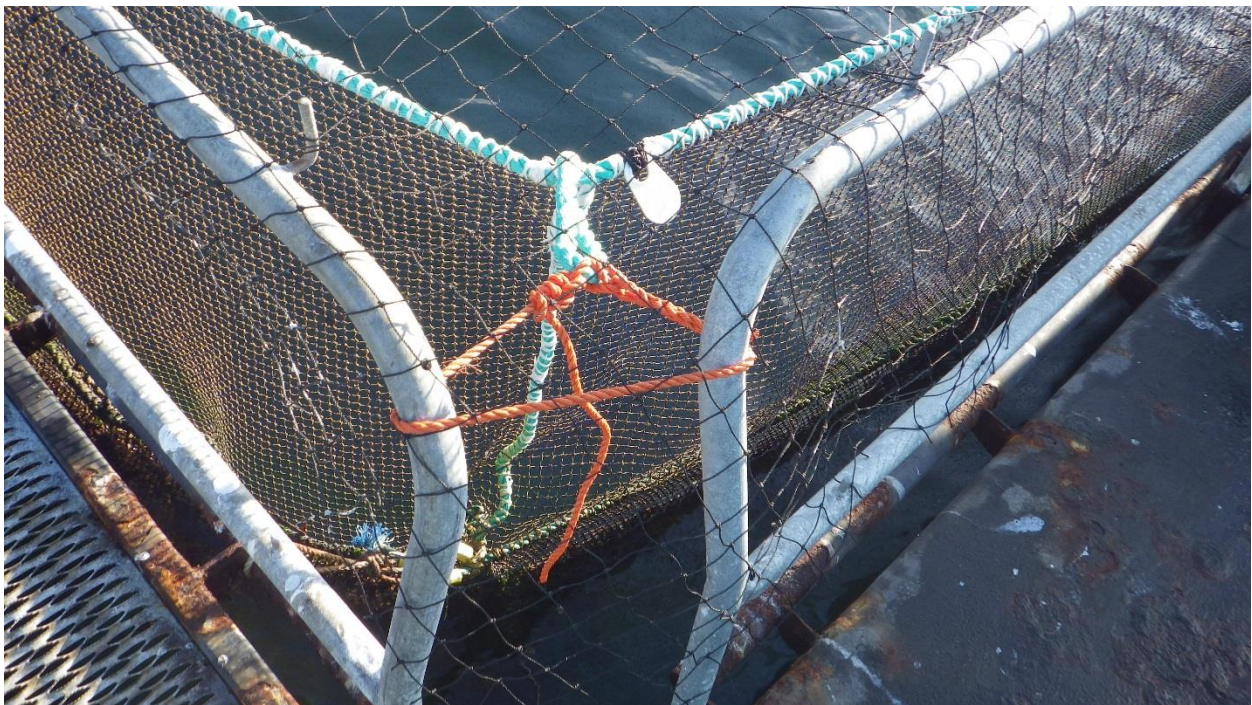
Figure C-46: Rusted Net Pen Support Rail and Handrail Bracket. Major corrosion.

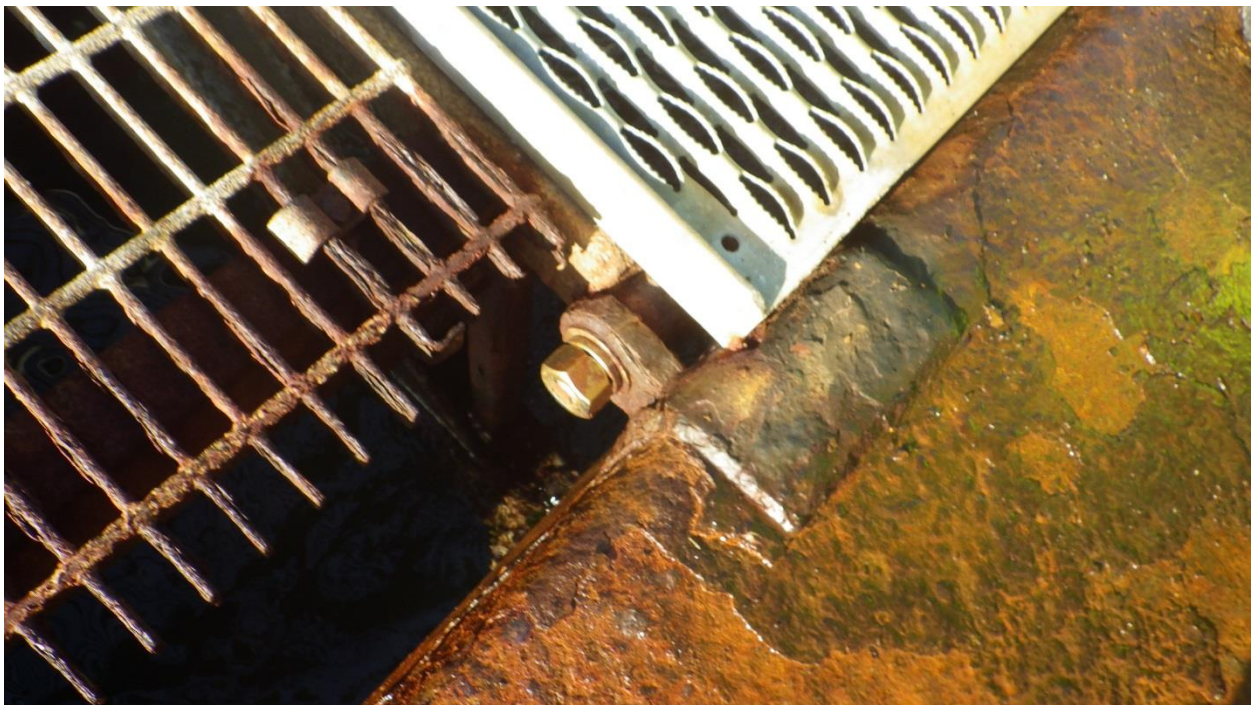
Figure C-48: Rusted Handrail Bracket and Structural Framing. Major corrosion.

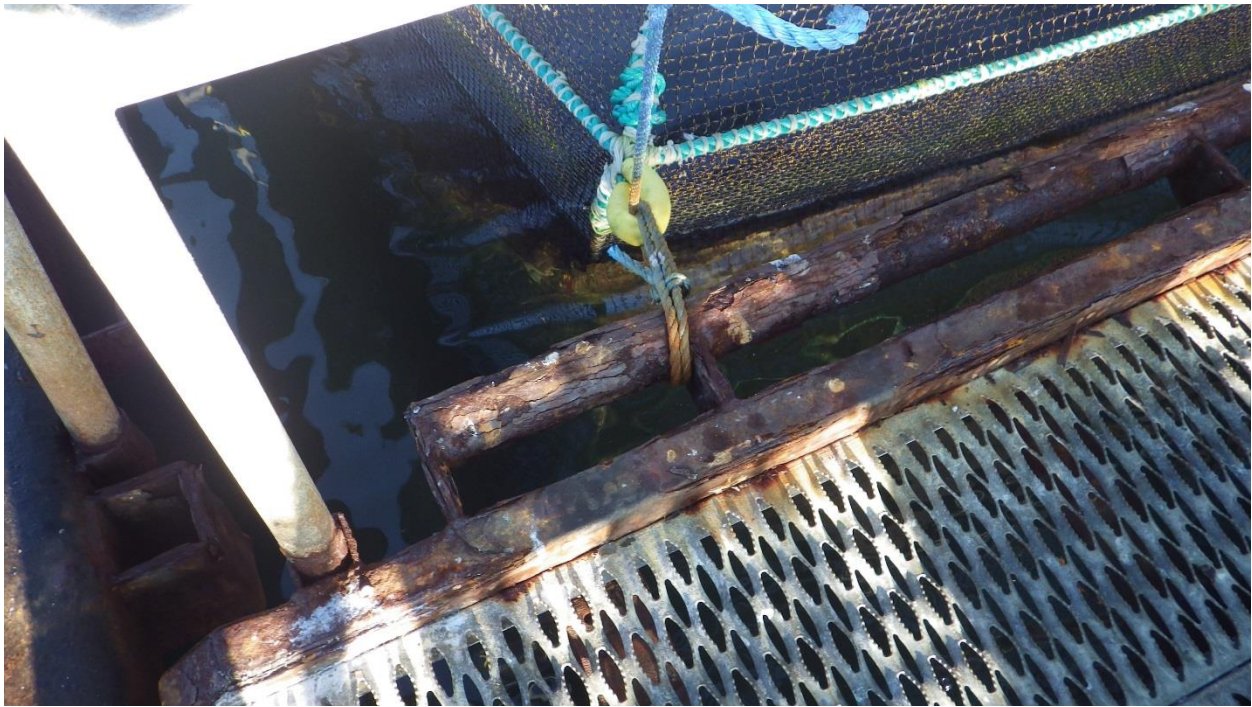
Figure C-49: Rusted Grating and Steel Walkway Framing. Old grating has lost section. New grating not bolted down.

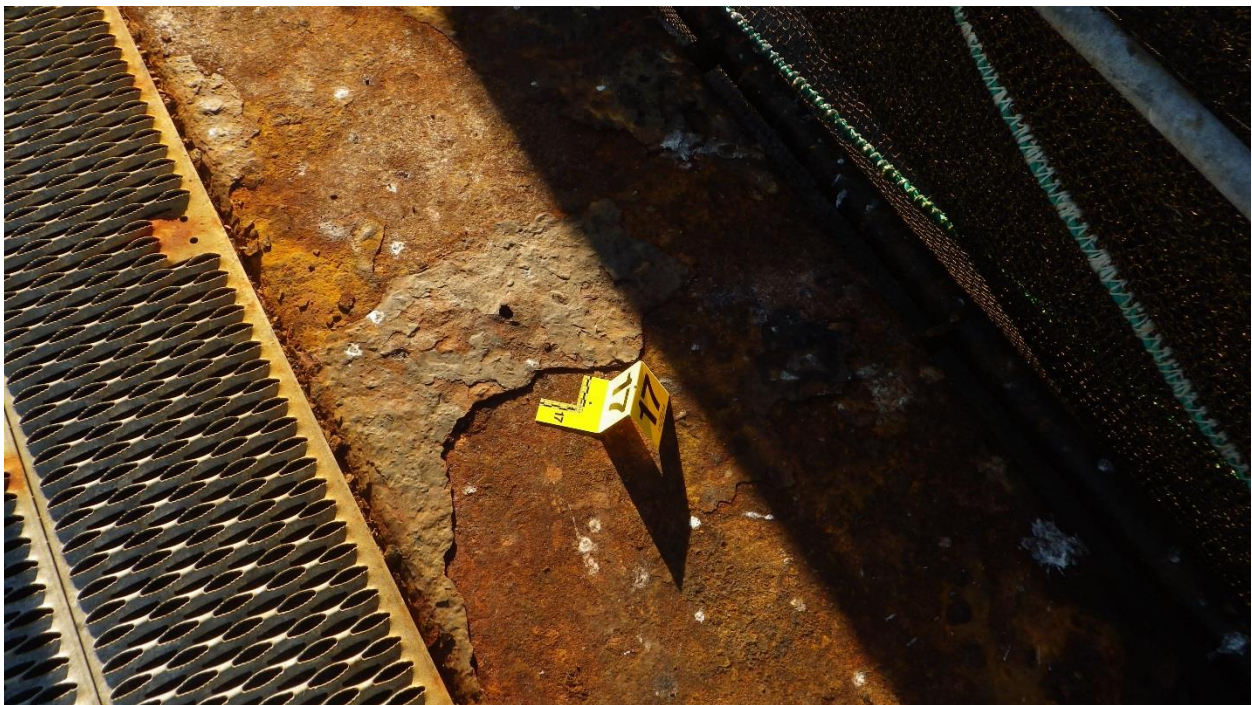
Figure C-50: Rusted Net Pen Support Railing. Major corrosion.

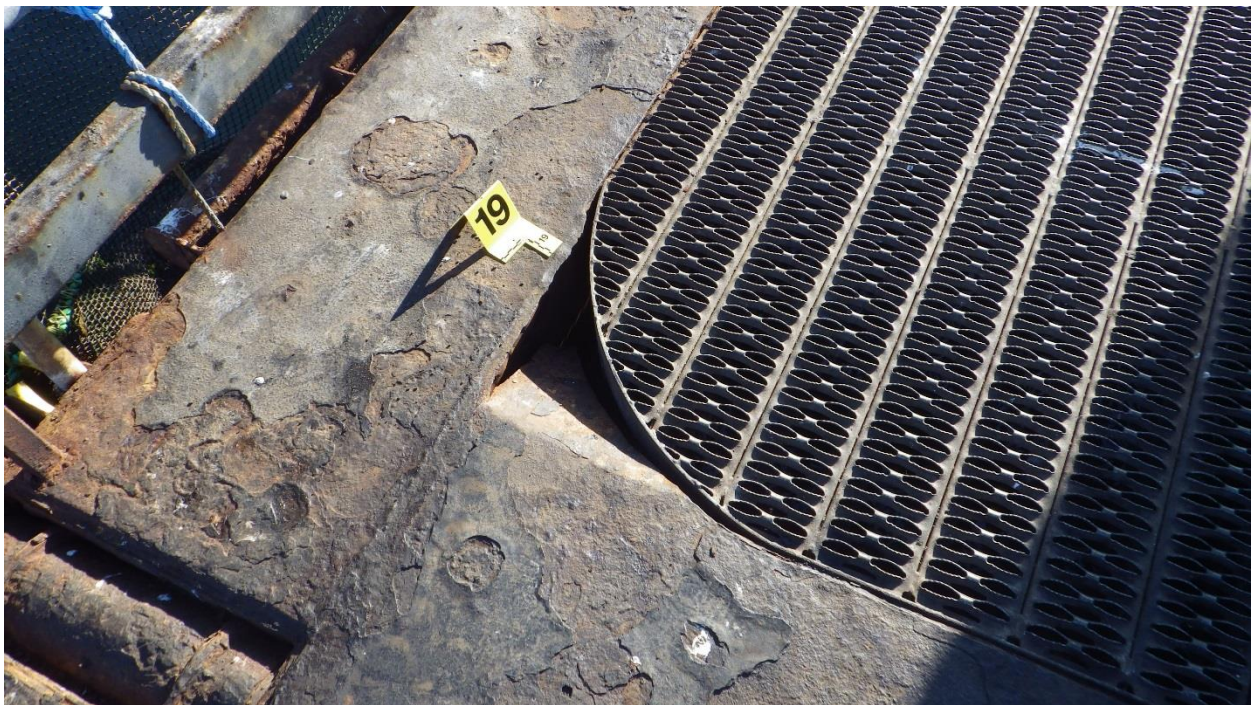
Figure C-52: Damaged Grating Panel at Center Bridge.

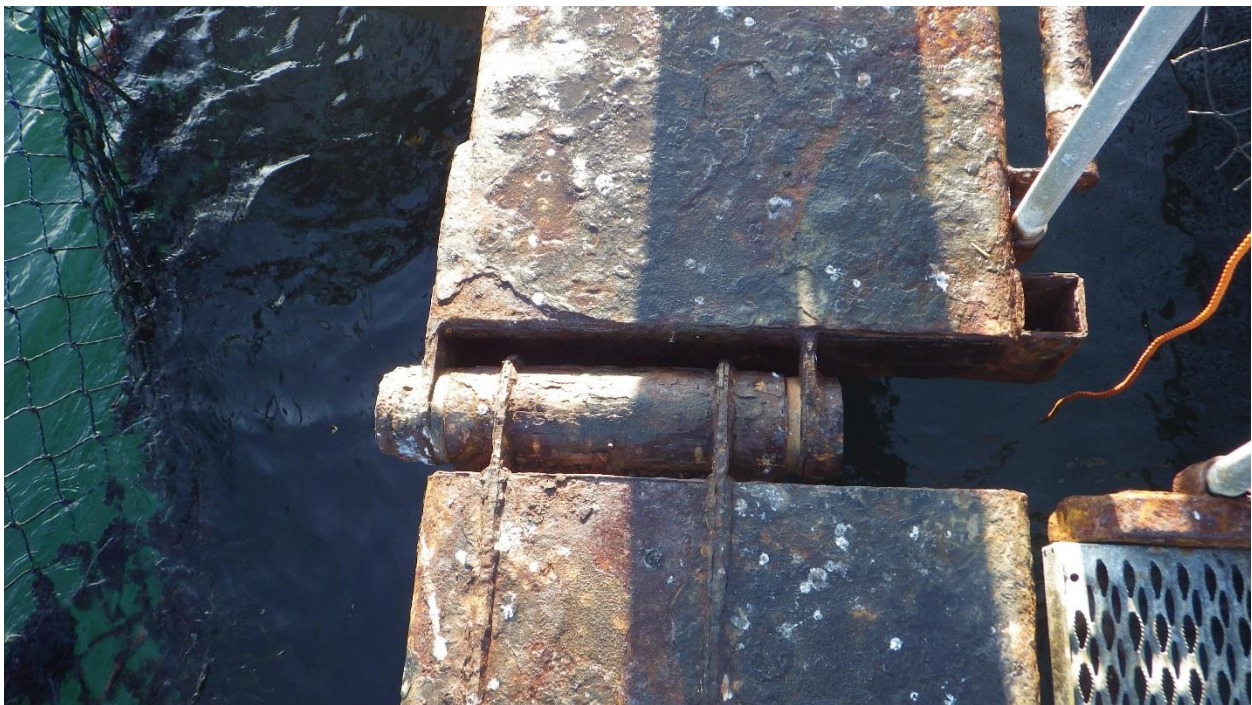
Figure C-56: Near Anchor 10, Discontinuous Predator Net Railing – Bent due chain connection load.

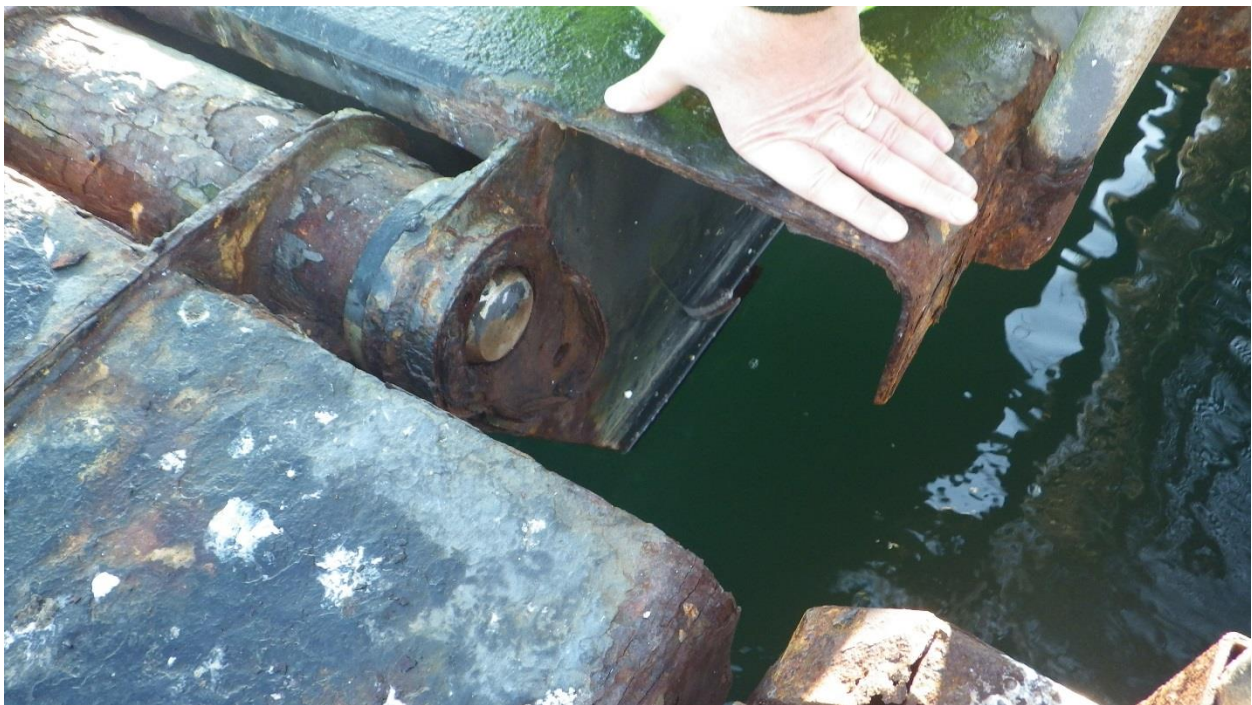
Figure C-58: Rusted Hinge between anchors 2 and 3. Major corrosion.

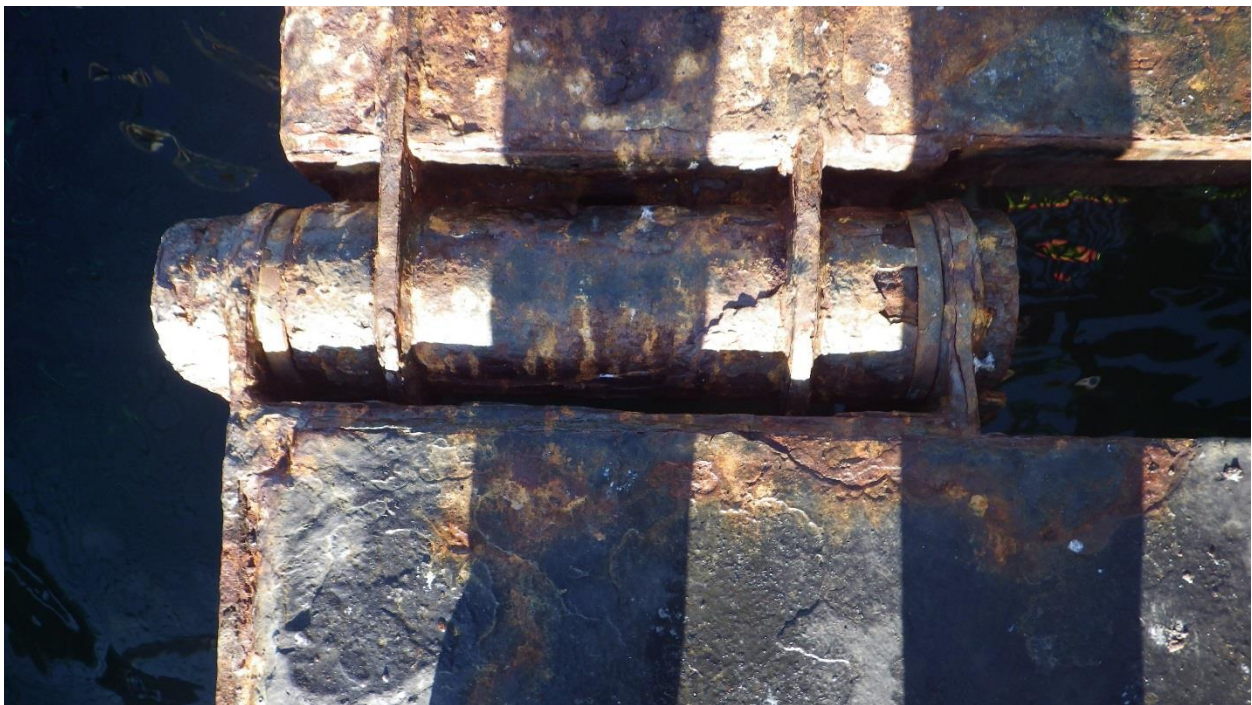
Figure C-60: Rusted Hinge between anchors 9 and 10. Moderate corrosion.

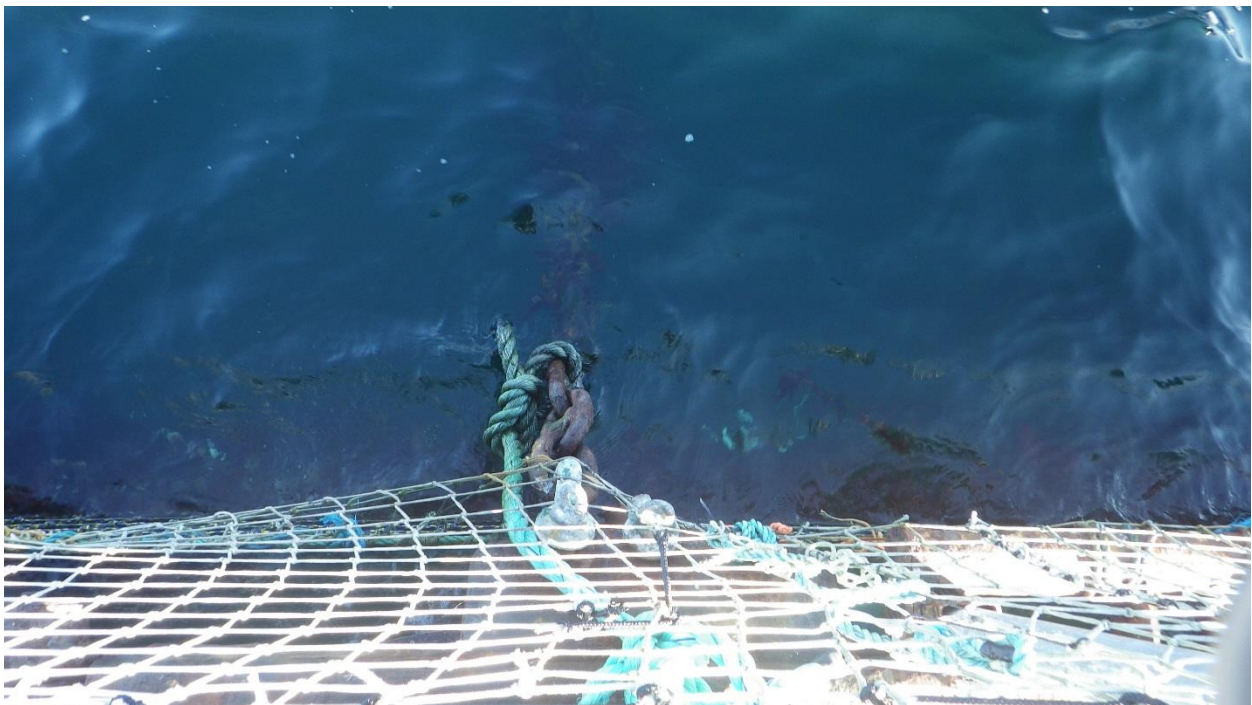
Figure D-9: Anchor #3, East Side of the South Net Pen

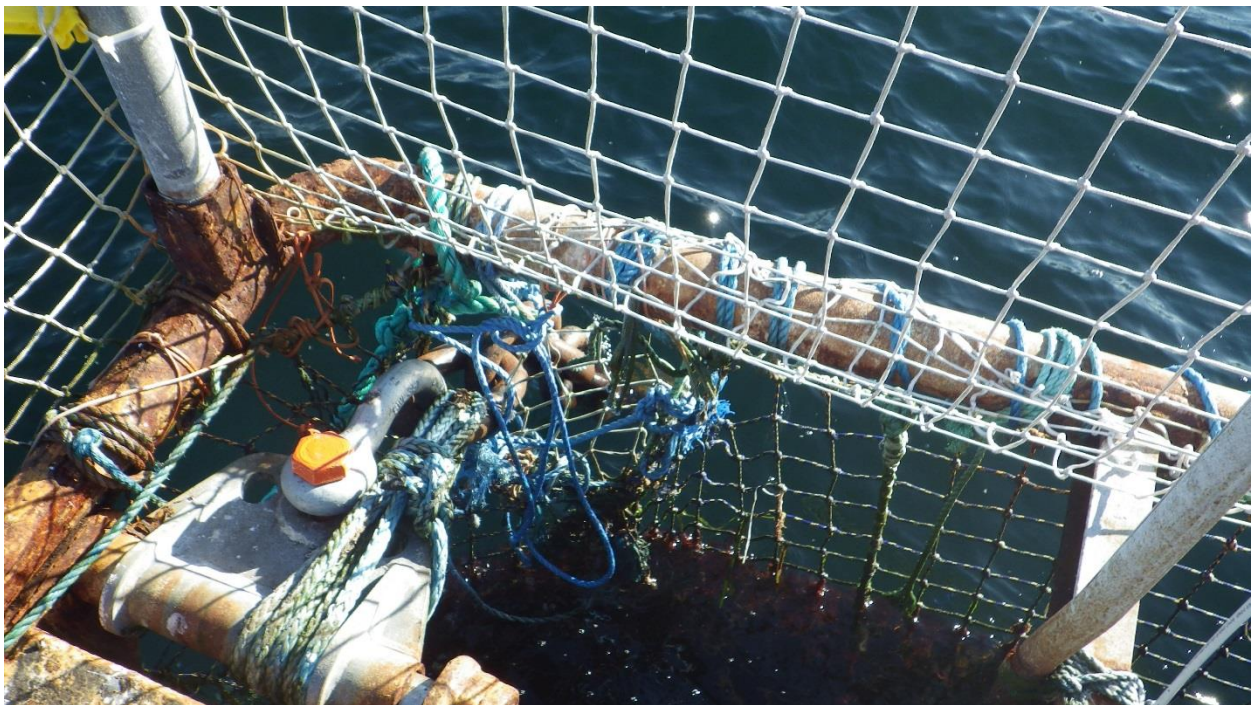
Figure D-17: Anchor #7, SE Corner of the South Net Pen. Hinge with minor to moderate corrosion.
