# **Rich Passage Orchard Rocks Atlantic Salmon Net Pens Engineering Assessment**

January 29, 2018

Mott MacDonald  
110 James Street  
Suite 101  
Edmonds WA 98020  
United States of America

State of Washington  
Department of Natural  
Resources  
1111 Washington Street SE  
Olympia Washington 98504

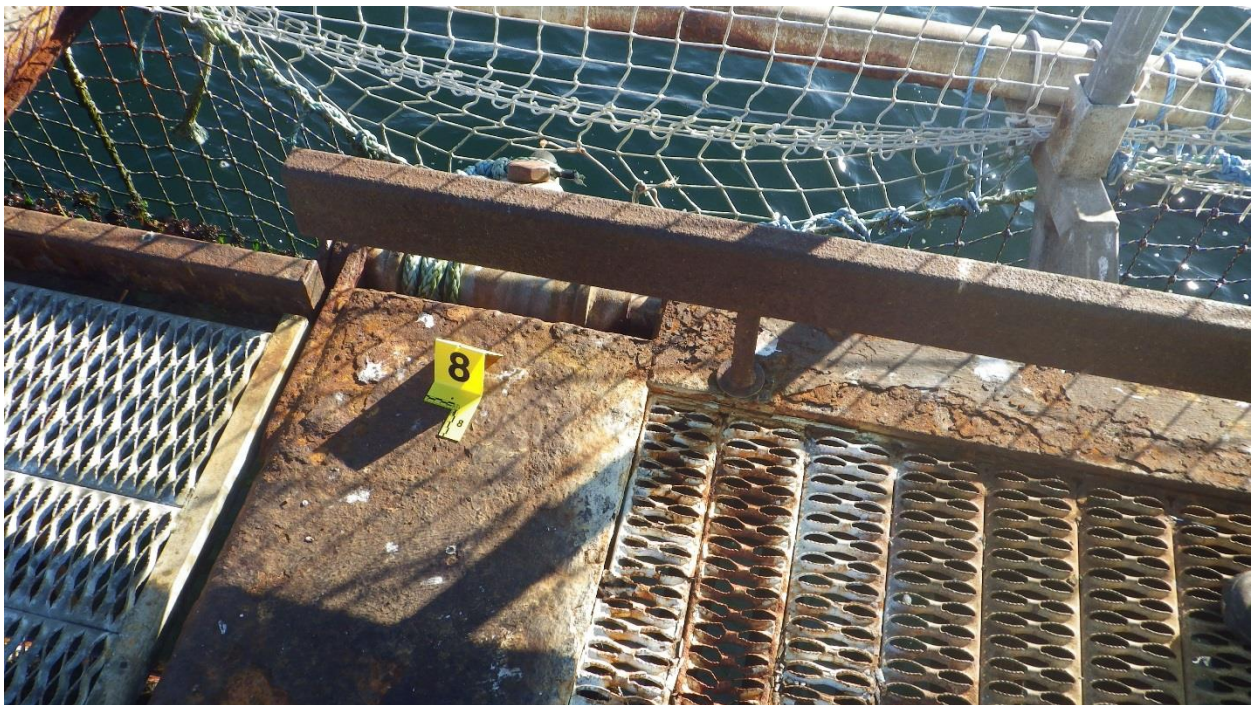
Figure D-19: Anchor #8, South Side of the South Net Pen. Hinge with moderate corrosion.

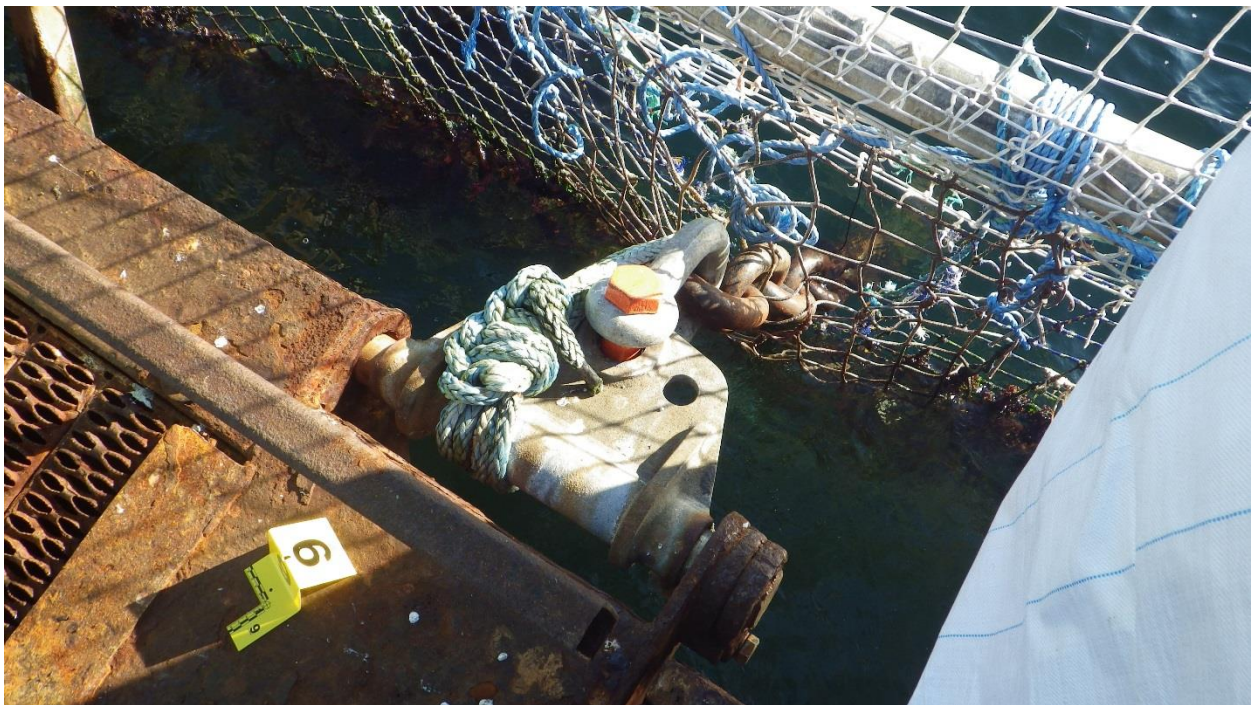
Figure D-23: Anchor #9, South Side of the South Net Pen. Hinge with moderate corrosion.

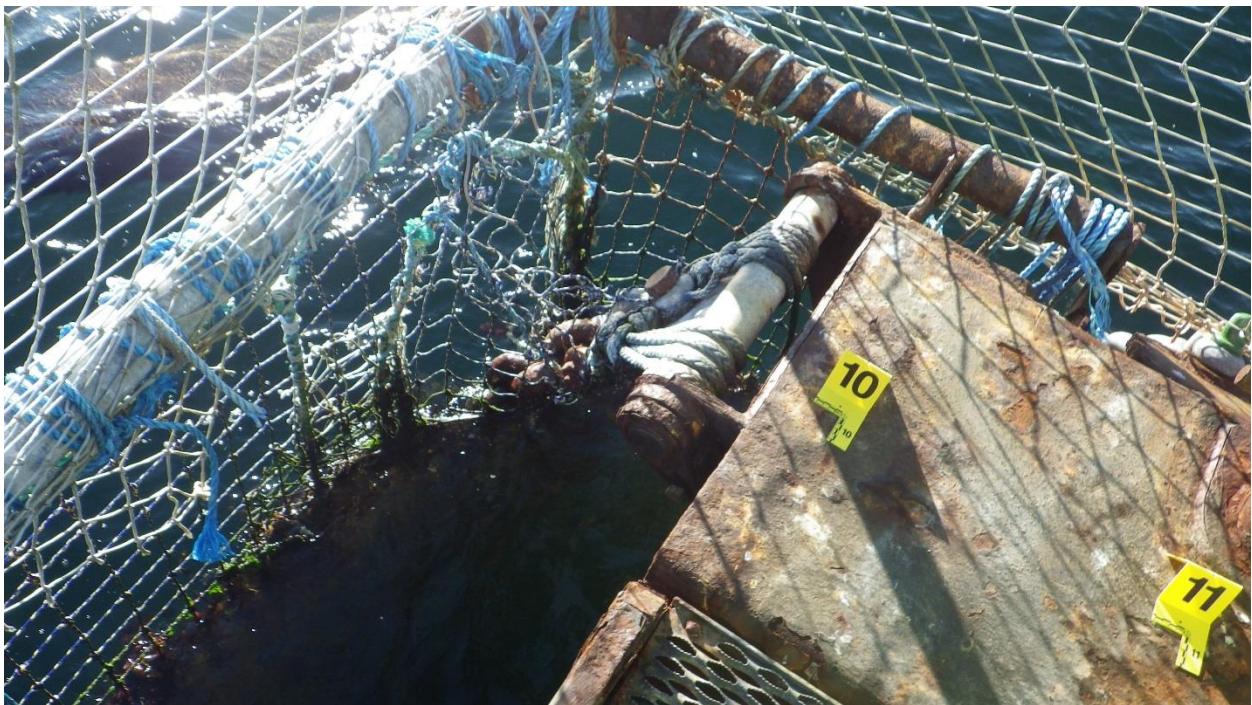
Figure D-25: Anchors #10 and #11, SW Corner of the South Net Pen.

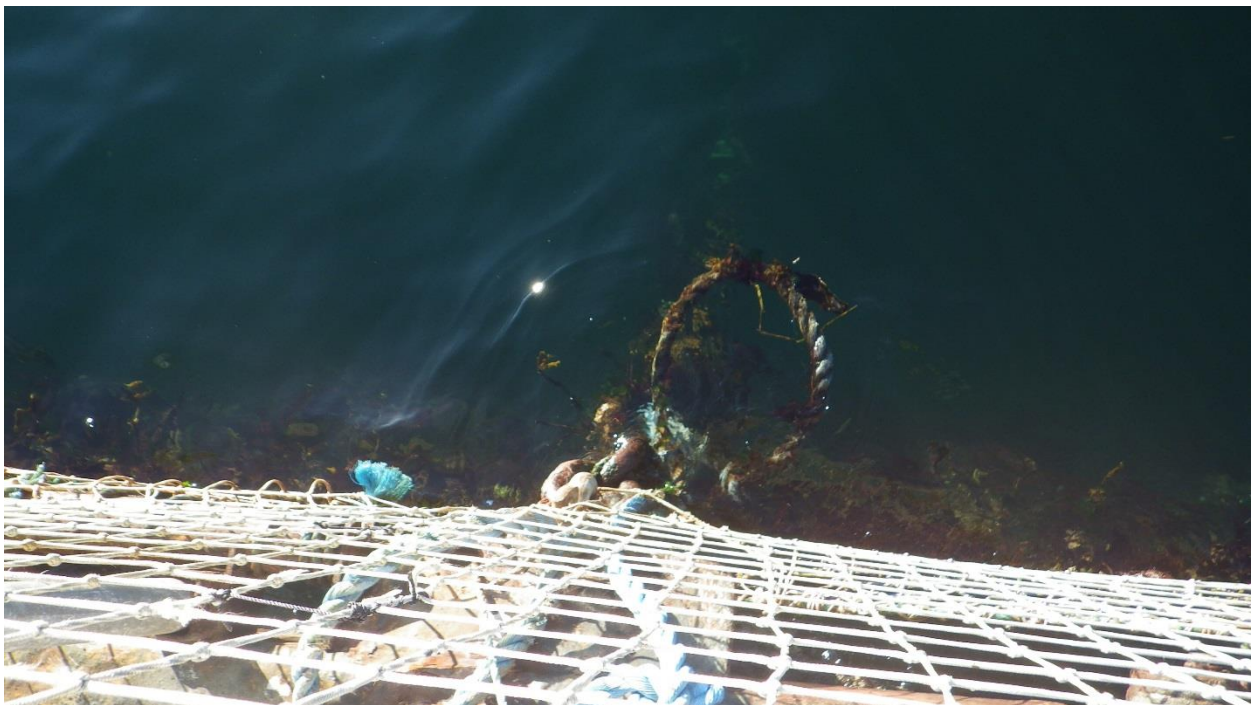
Figure D-35: Anchor #15, West Side of the South Net Pen, with reduced edge hole distance.

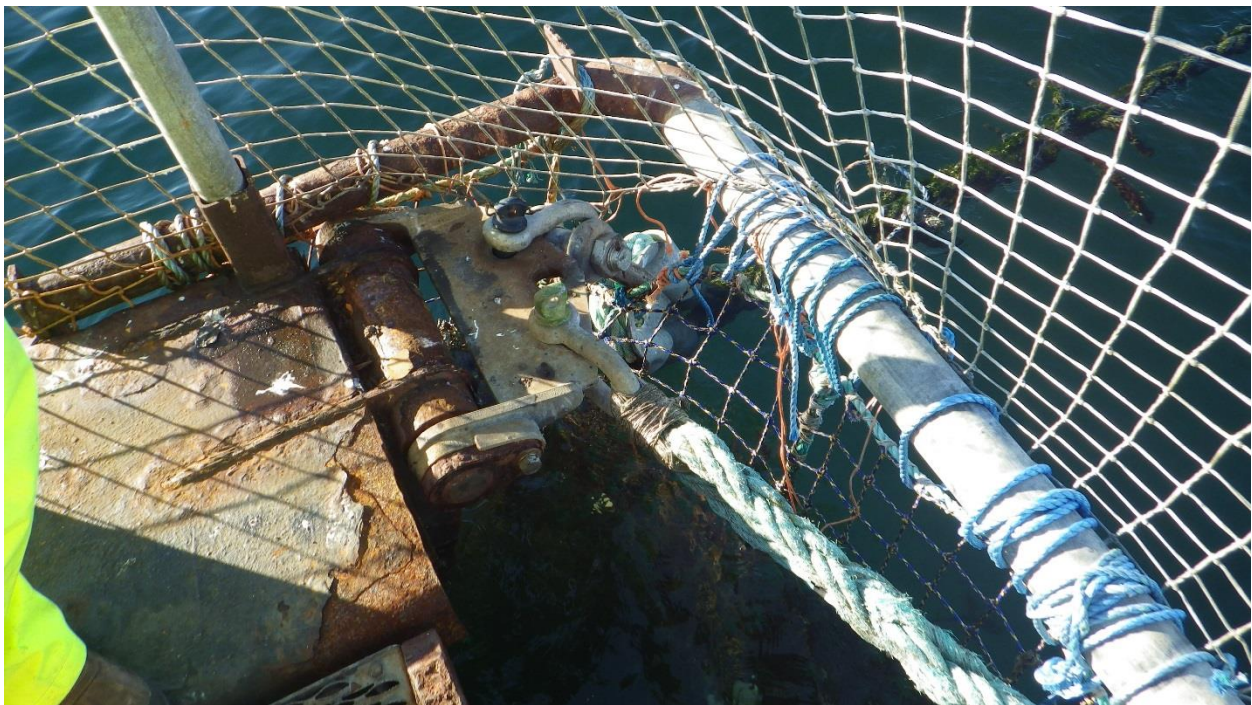
Figure D-41: South East Mid Hinge connected to North pen with minor corrosion.

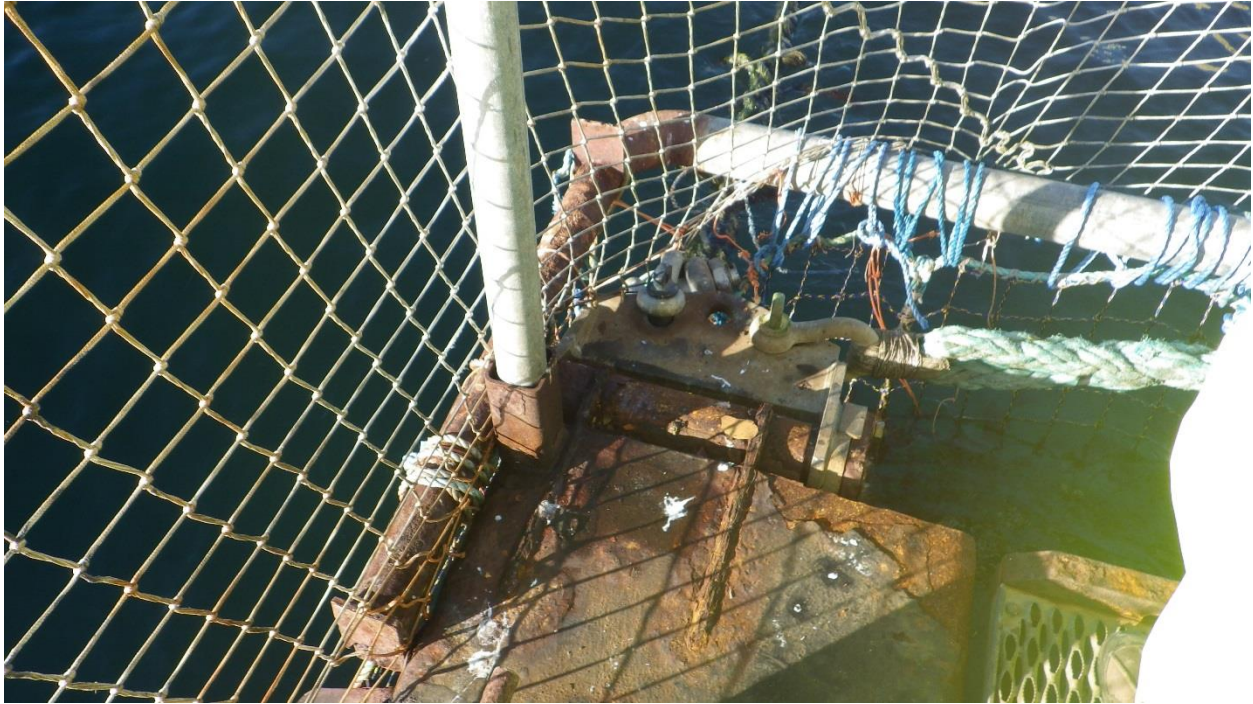
Figure D-42: South West Hinge connected to North pen with moderate to major corrosion.

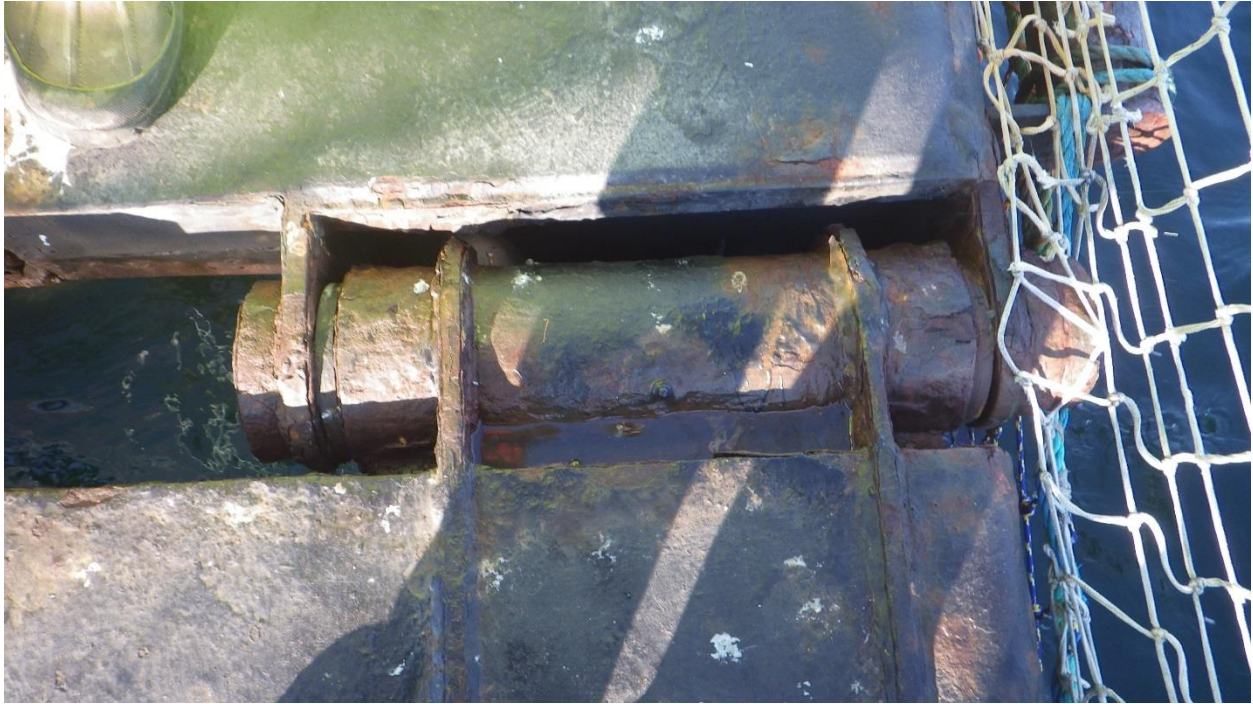
Figure D-44: South West Mid Hinge connected to North pen.

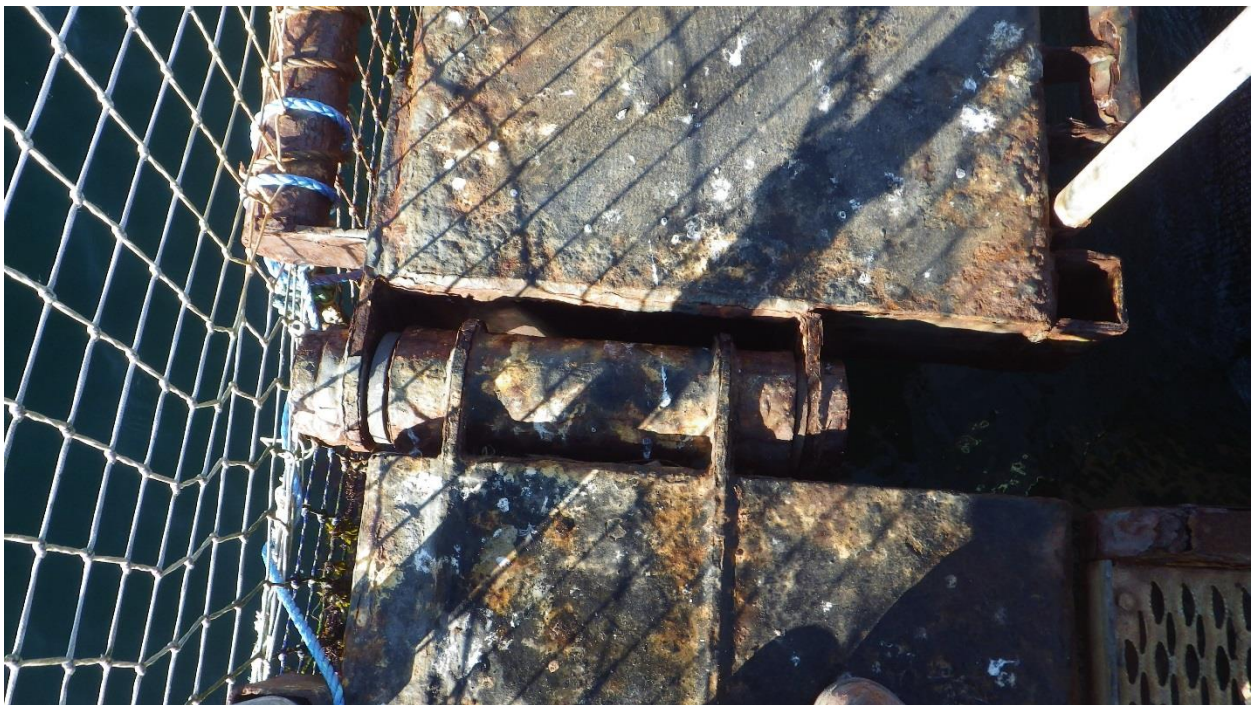
Figure D-45: Rusted Hinge Between Anchors #2 and #3 with moderate corrosion.

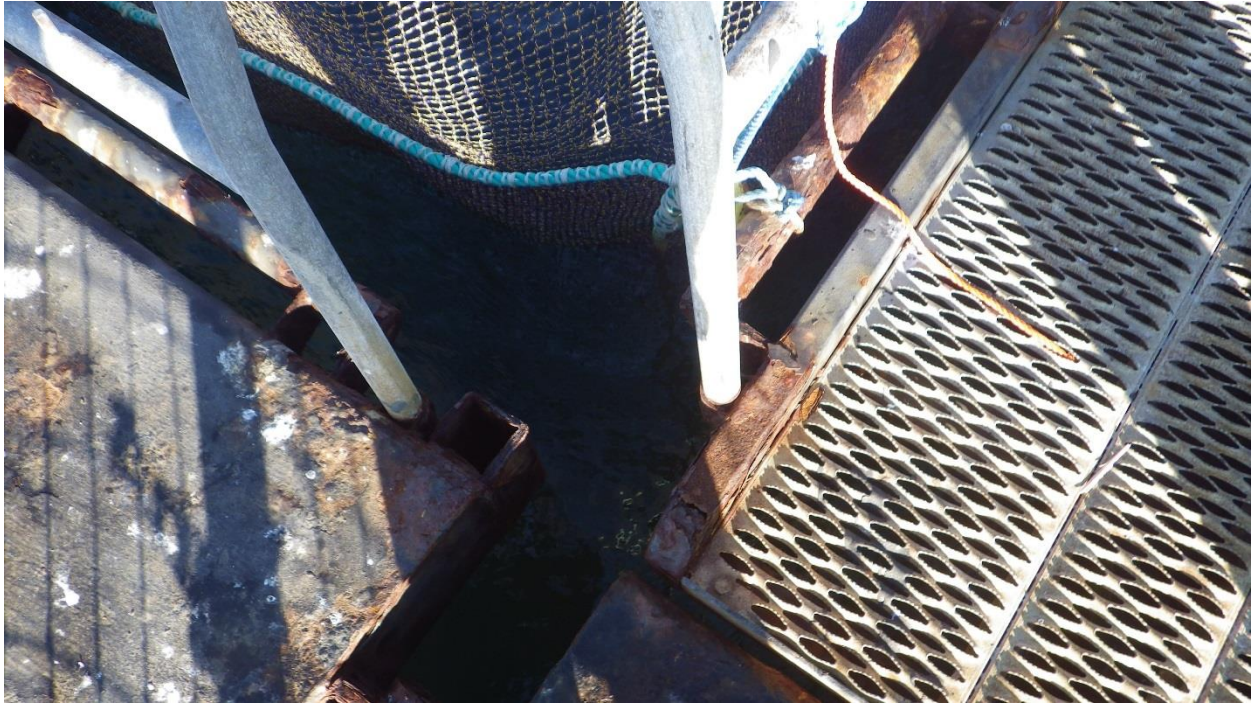
Figure D-54: Central Bridge with moderate corrosion.

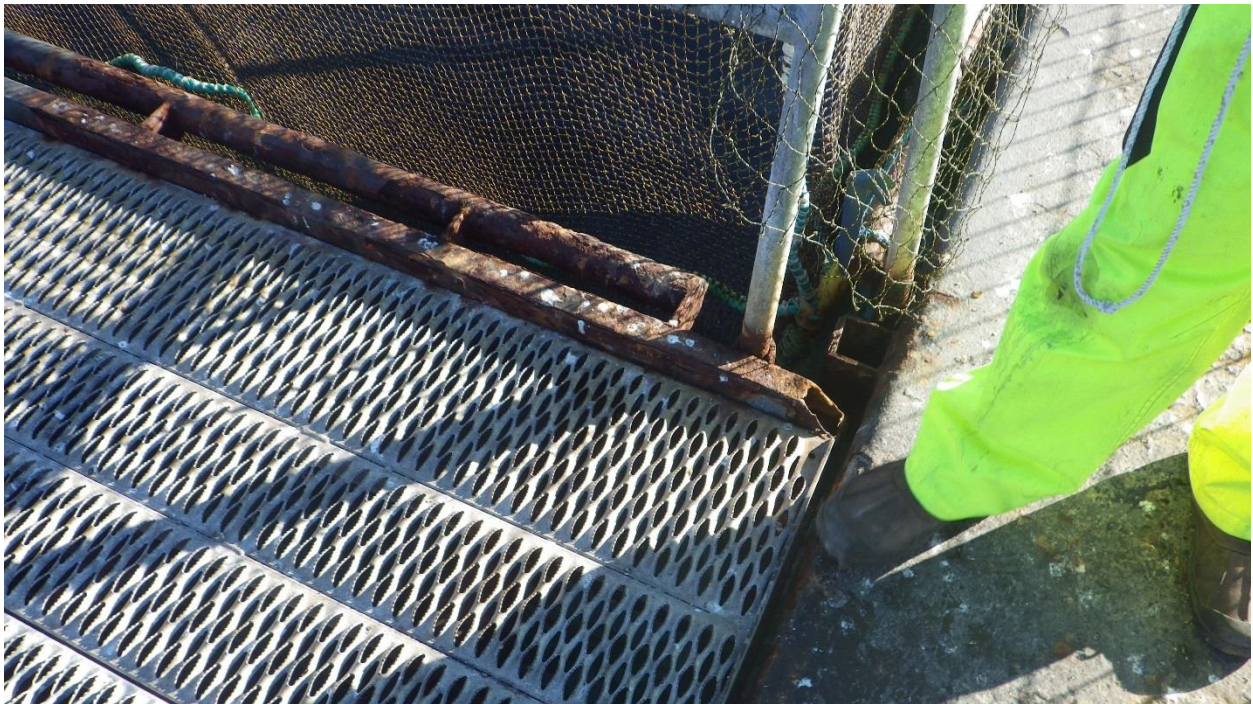
Figure D-55: Rusted Steel Framing, Handrail Brackets, and Net Pen Support Railings with moderate to major corrosion.
