Re: Houston Wood Preserving Works Site

FIGURE 2
SWMU AND AOC LOCATION MAP

APPENDIX
VSI PHOTOGRAPHS

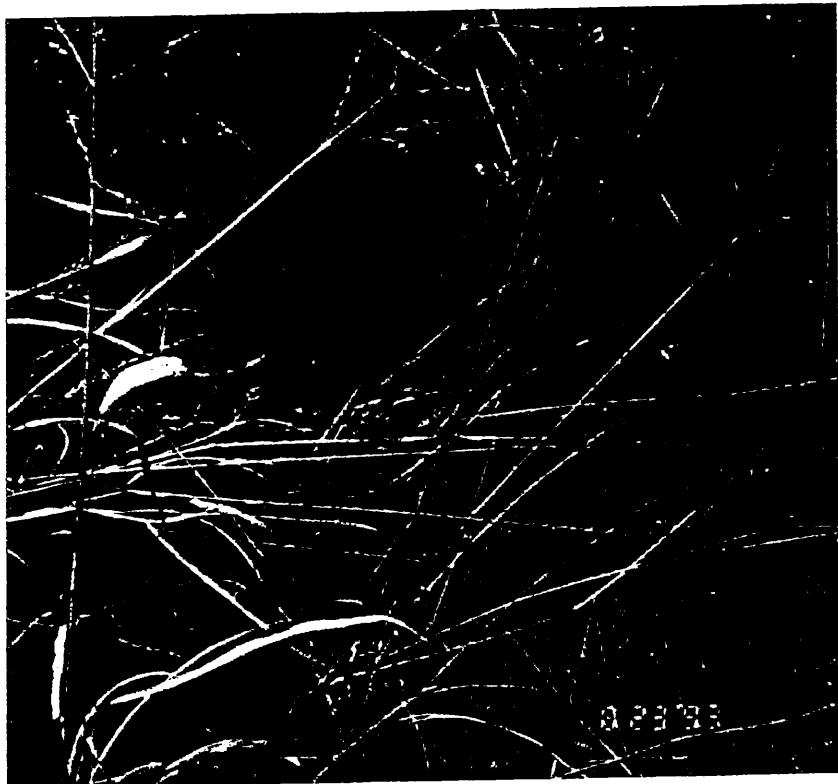
PHOTOGRAPH NO. 3

en by: K. Matherne Direction Facing: North
ainage ditch (SWMU No. 2), west of the facility boundary.

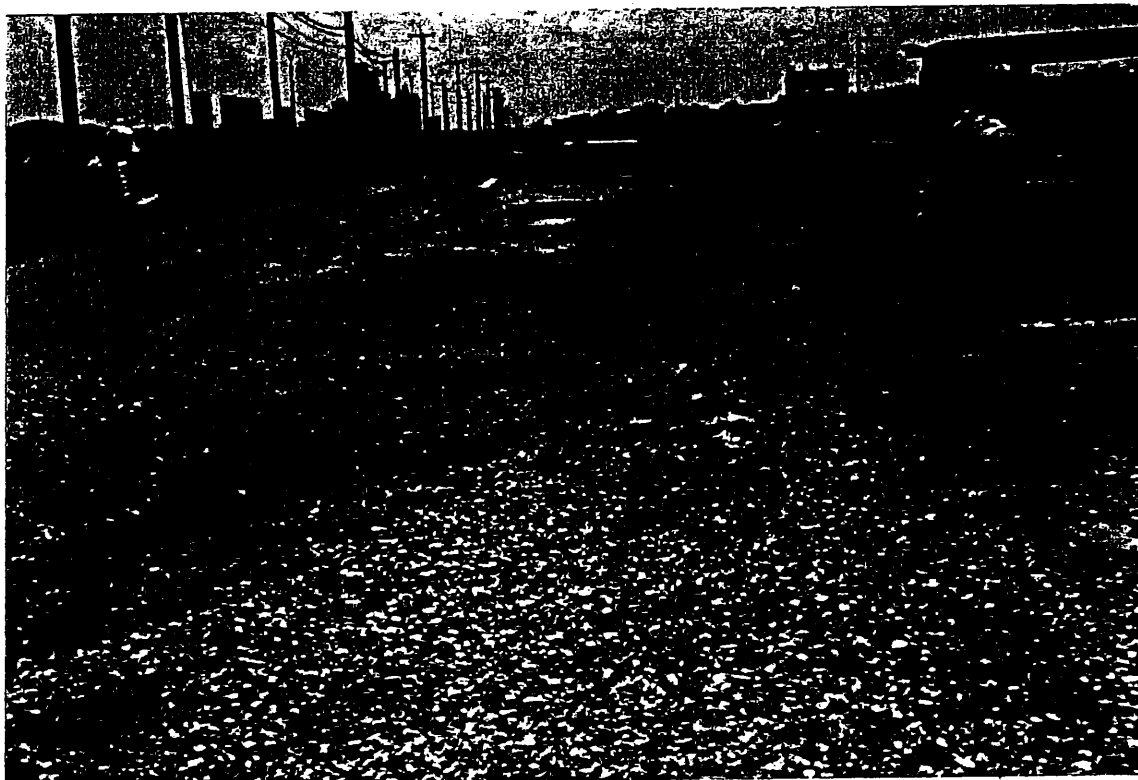
PHOTOGRAPH NO. 5

Date: 08/23/93 Picture Taken by: K. Matherne Direction Facing: Southwest
Picture Description: Location of Former UST no. 44-023-05 (SWMU No. 9), which is within the
original process area (SWMU No. 5)

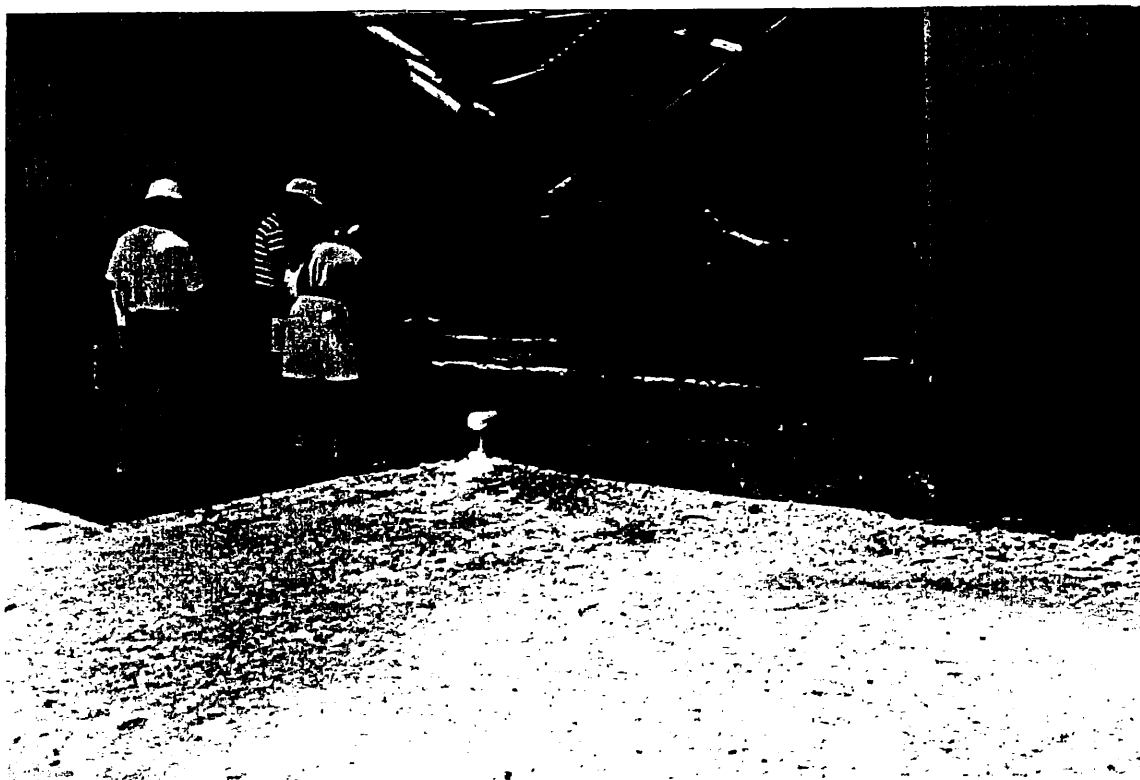
Date: 08/23/93 Picture Taken by: K. Matherne Direction Facing: Northwest
Picture Description: Above-grade concrete tank in the former water treatment area (SWMU No. 6);
note the white crystalline powder in the pipe protruding from the side of the wall (center of
photograph).

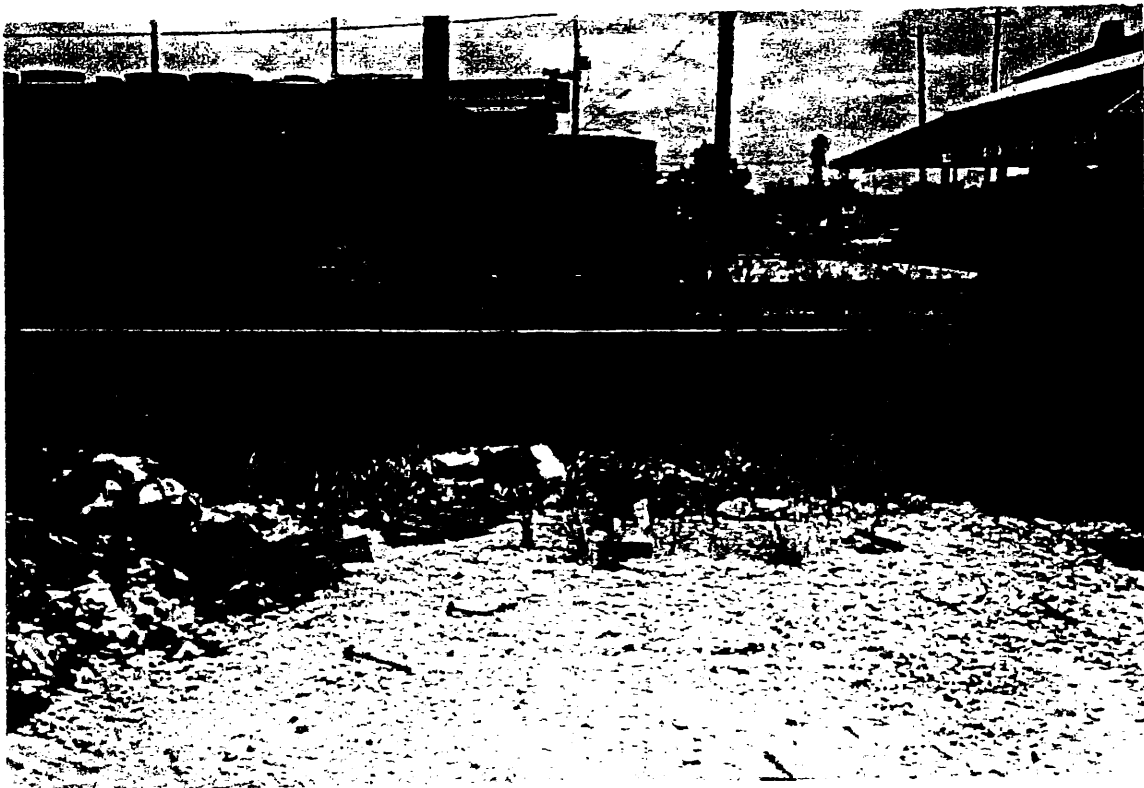
PHOTOGRAPH NO. 10

Date: 08/23/93 Picture Taken by: K. Matherne Direction Facing: Southeast
Picture Description: A portion of the retaining wall that originally surrounded the entire AST
(SWMU No. 8); wall is now limited to the southeast side of the SWMU.

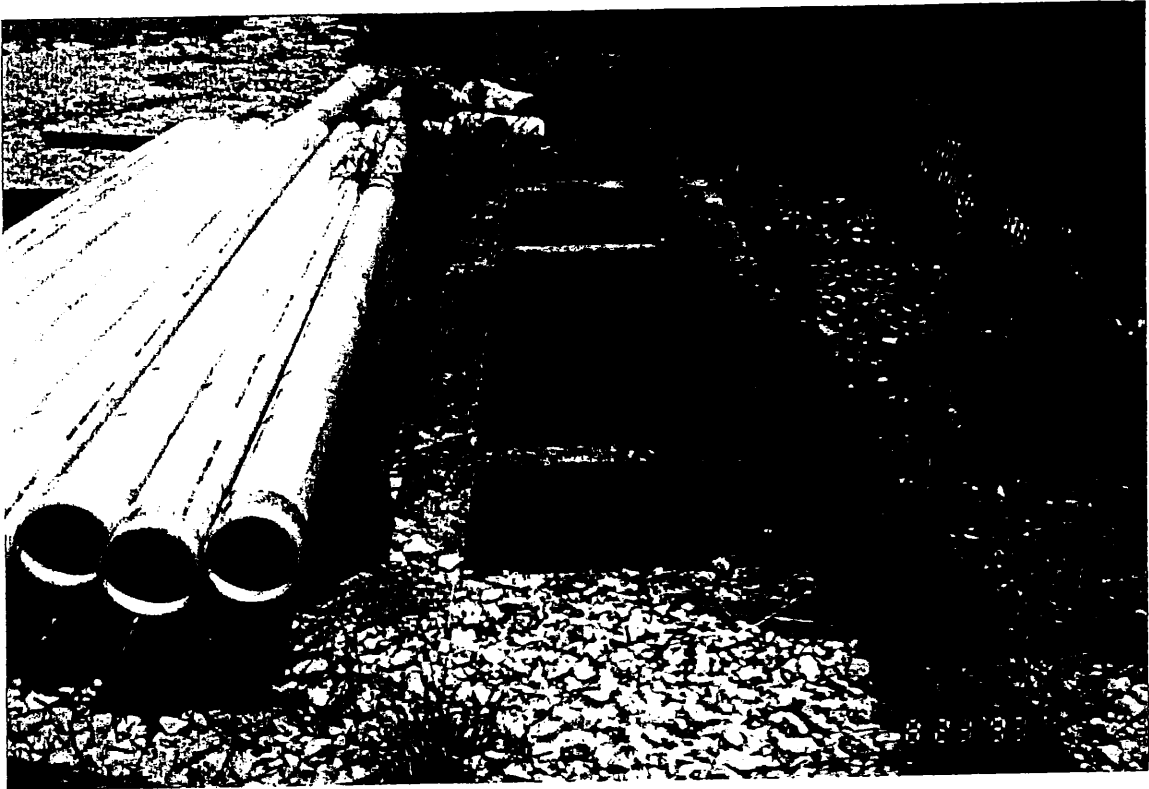
Date: 08/23/93 Picture Taken by: K. Matherne Direction Facing: East
Picture Description: An oil/water separator (SWMU No. 11) used in sap water treatment; this separator was located next to the location of the former sap water treatment tank area (SWMU No. 10), which is partially covered by the white PVC pipe visible on the left edge of the photograph.

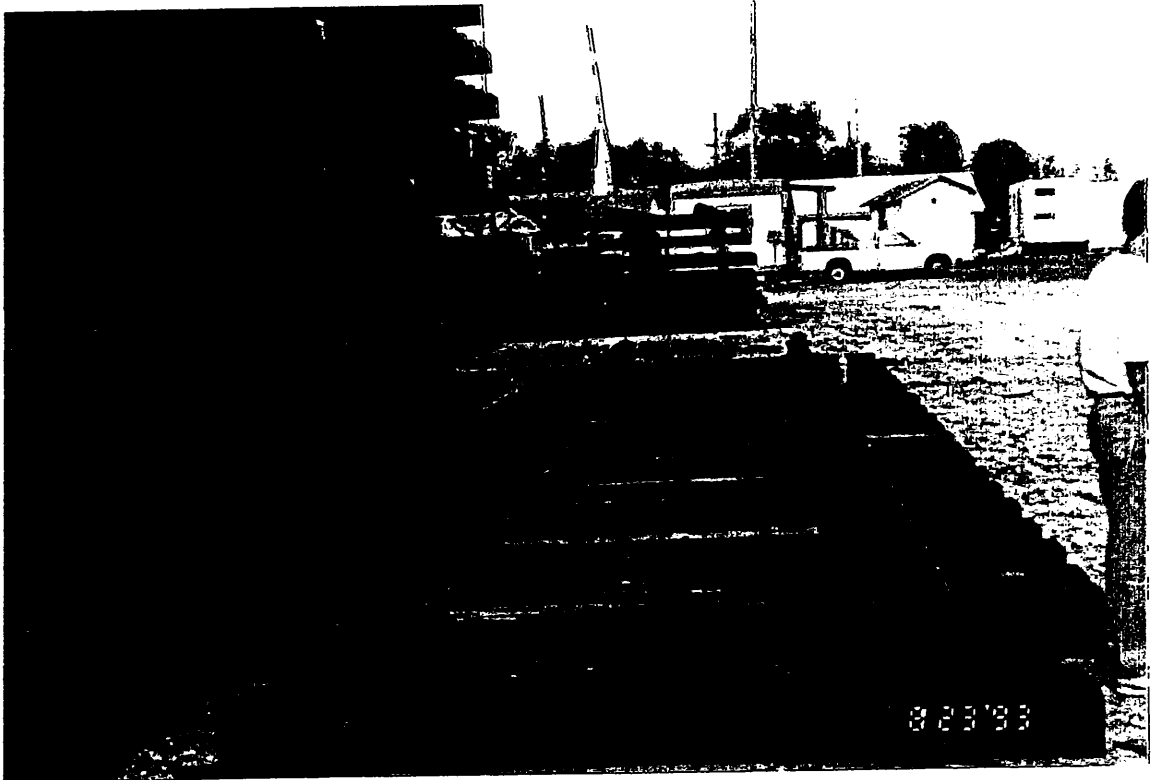
PHOTOGRAPH NO. 15

Date: 08/23/93 Picture Taken by: K. Matherne Direction Facing: Northeast
Picture Description: Close-up of the switch panel plant in the railroad tie storage area
(SWMU No. 12); the switch panel plant now assembles sections of track and treated ties, and stores
them in this area.

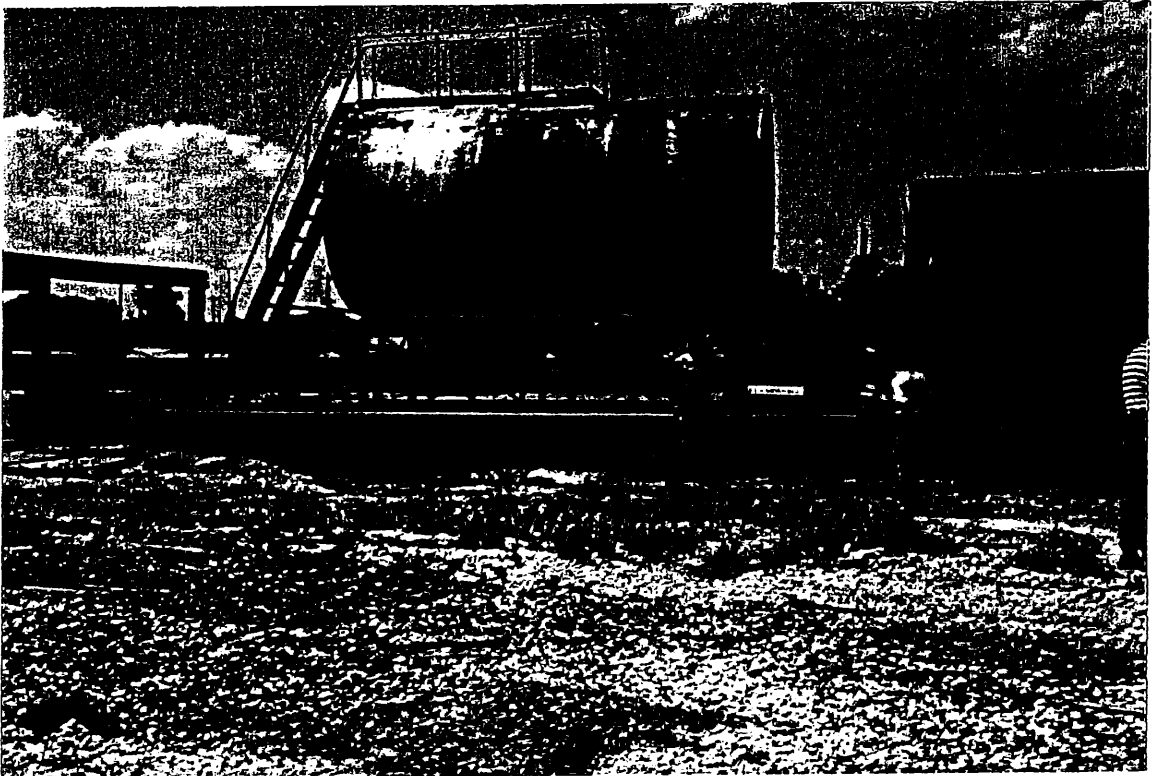
PHOTOGRAPH NO. 16

Date: 08/23/93 Picture Taken by: K. Matherne Direction Facing: North
Picture Description: Diesel storage tank (AOC No. 1); note the concrete containment wall around the tank area.

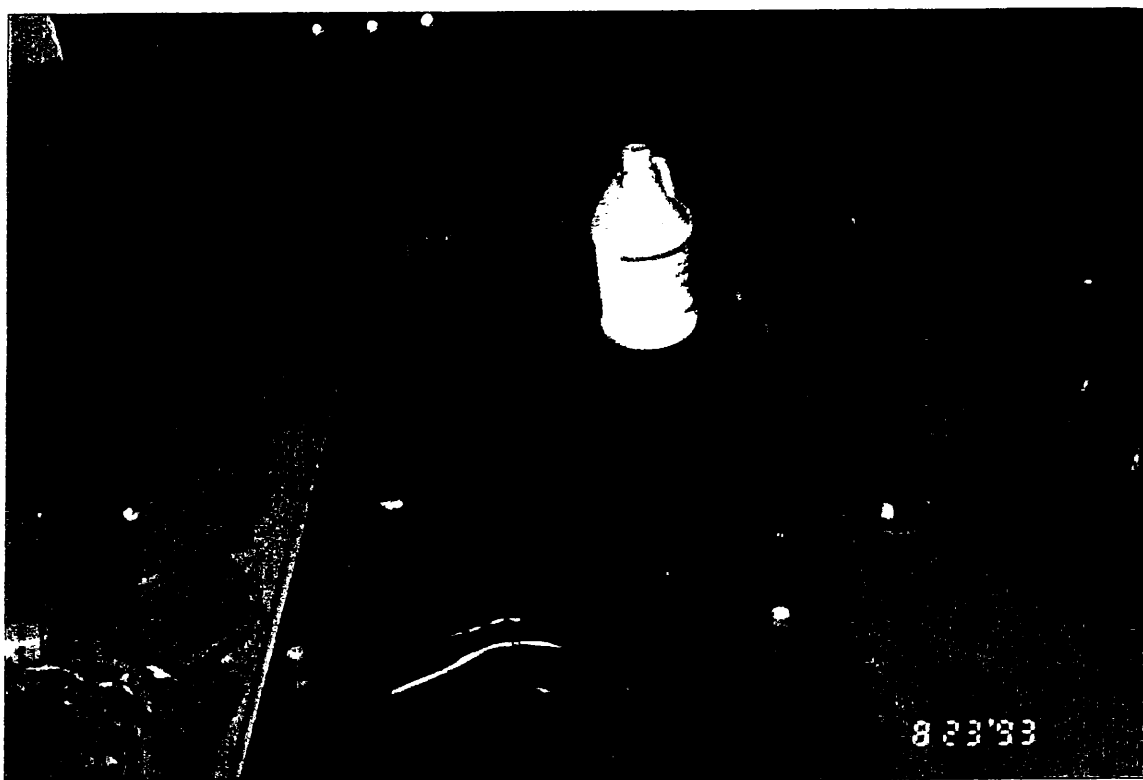
Date: 08/23/93 Picture Taken by: K. Matherne Direction Facing: Southeast
Picture Description: Inside the hose house (AOC No. 2); note recent oil staining (center) and floor
drain cap (upper right).

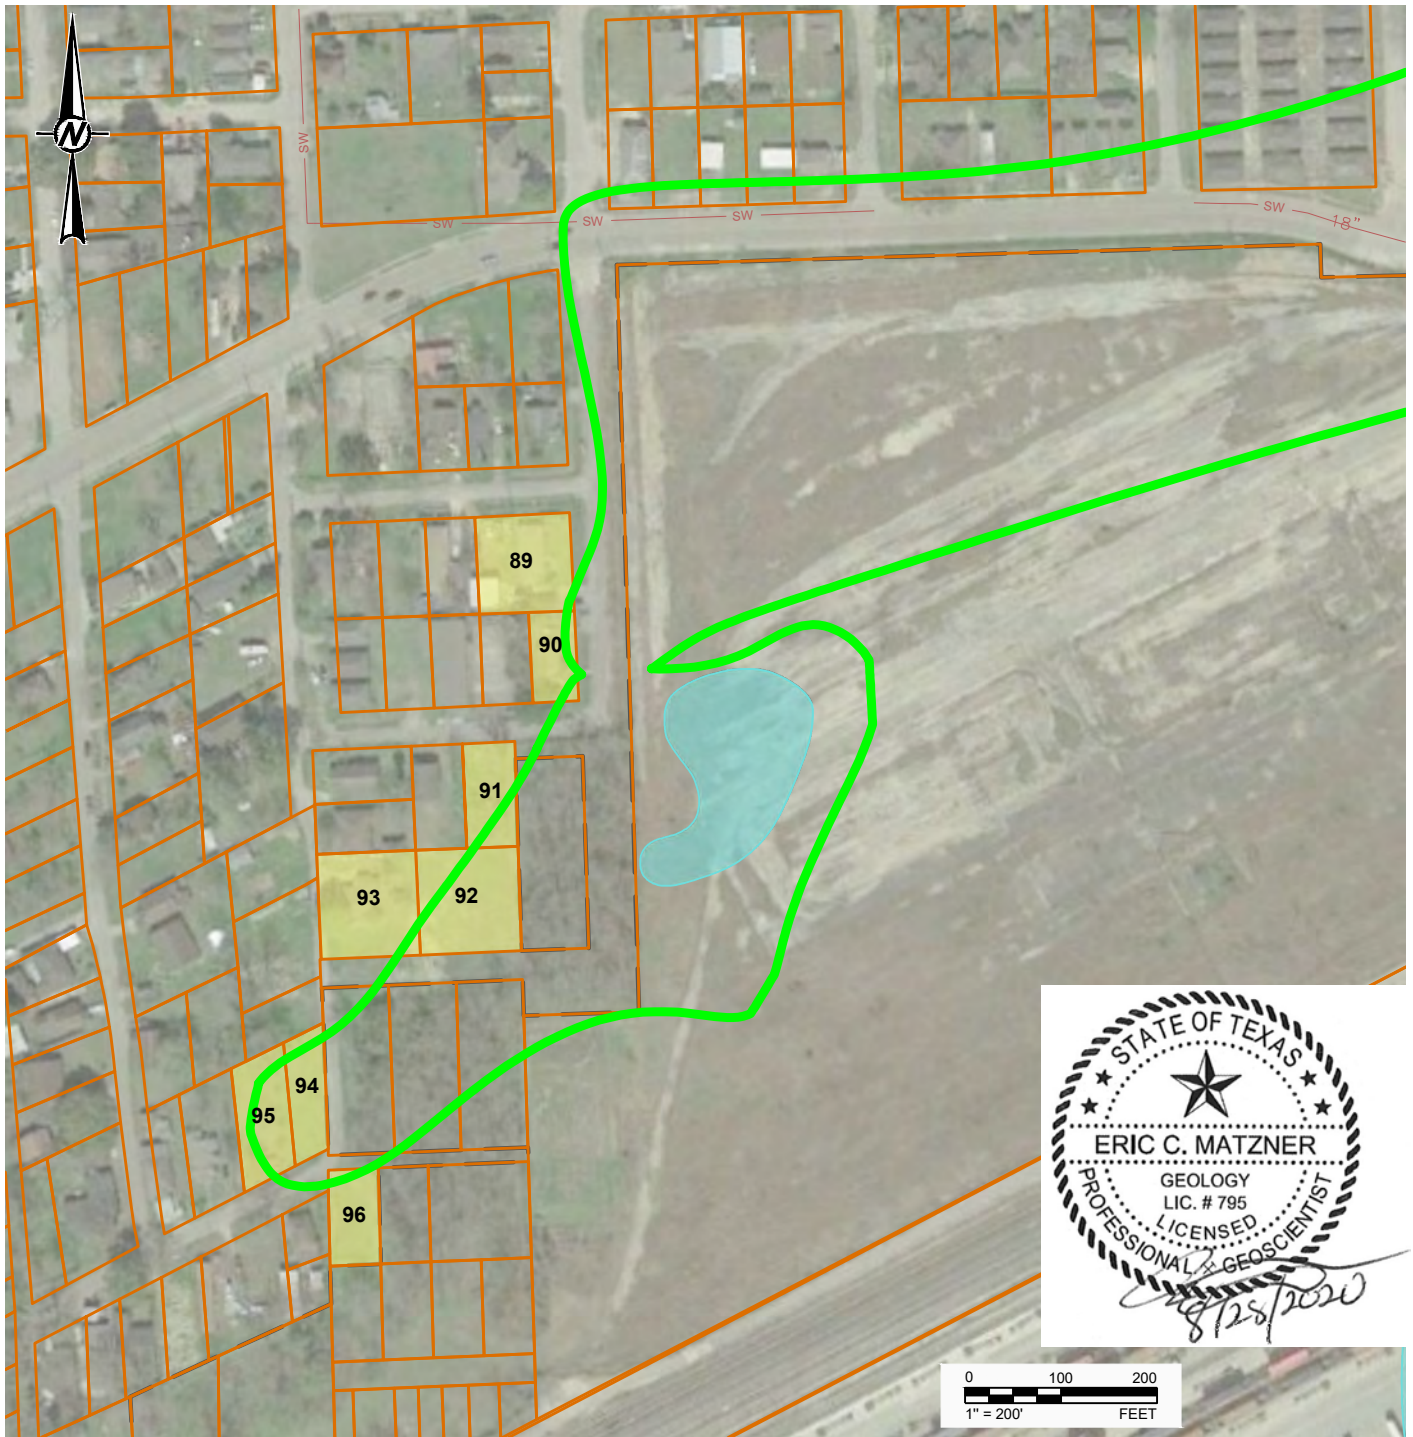
**Appendix 5: Figure 1A-3
(Off-Site Affected Properties [West])**

Response: Details of the groundwater including directional flow are included as Figure 1A-2 (Off-Site Affected Properties [North]) and Figure 1A-3 (Off-Site Affected Properties [West]), attached as Appendices 4 and 5, respectively. Union Pacific has submitted several groundwater potentiometric surface maps in the Groundwater Monitoring Reports, APARs, and RAPs to the TCEQ or predecessor agencies. These reports are included on the USB drive submitted with these responses and can also be found at Union Pacific's public website (<https://hwpwinfo.com/>), as well as in the TCEQ records storage repository, see footnote 4.
