ROANOKE PARKS AND RECREATION  
EUREKA PARK RECREATION CENTER  
**FEASIBILITY STUDY**

SPECTRUM DESIGN P.C.  
Plaza Suite 1  
10 Church Avenue SE  
Roanoke, VA 24011-2104  
540.342.6001 PH | 540.342.6055 FAX  
[www.spectrumpc.com](http://www.spectrumpc.com)

AUGUST 4, 2017  
PROJECT NO. 16100

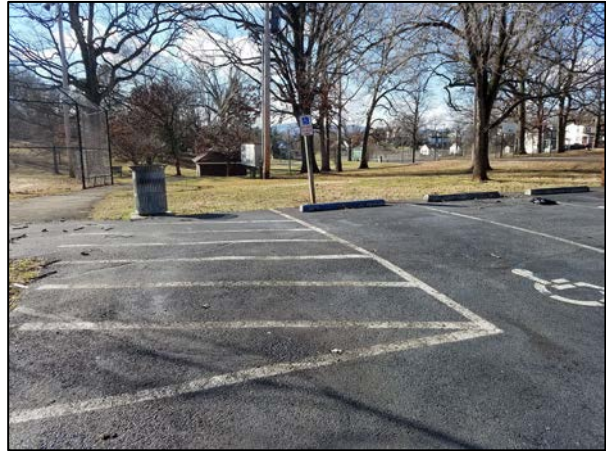
Handicapped Accessible Parking Spot

At the building handicapped parking space aisle, remove the asphalt ramp and install a standard curb cut ramp within the sidewalk.

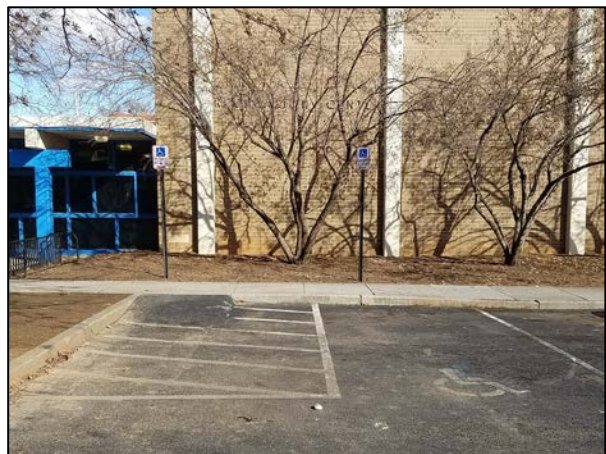
Asphalt Ramp at Handicapped Parking

The existing built-up asphalt curb ramp for the space nearest the building's main entrance does not meet current code.

**Recommendation:** Remove the built-up asphalt ramp and adjacent sidewalk and replace with a depressed curb cut. Coordinate with any building entrance improvements to ensure proper drainage and avoid ponding conditions.

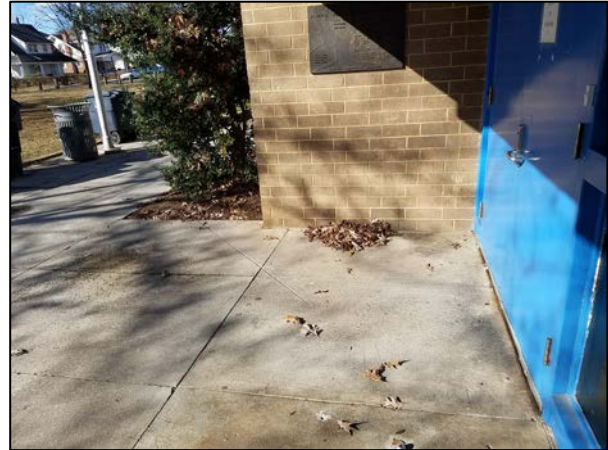
Sidewalk at Main Entry Doors

**Recommendation:** Replace the entry sidewalk area and adjust the surface elevation to drain away from the doors at a minimum of ¼" per foot to the parking lot.

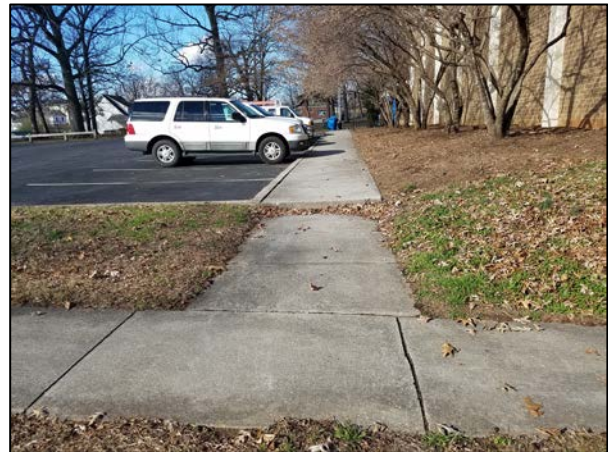
The front sidewalk at the southeast corner of the building has an unnecessary step either on purpose or due to the walk sinking over time. Accessibility can be easily improved with replacement of this 10 foot segment of walk without exceeding 1:12 or 5% slope by tying the walk surface at the head of the parking spaces to the perpendicular walk connection.

Step at Southeast Corner

Replace a 10 foot segment of concrete sidewalk at the southeast corner of the building.

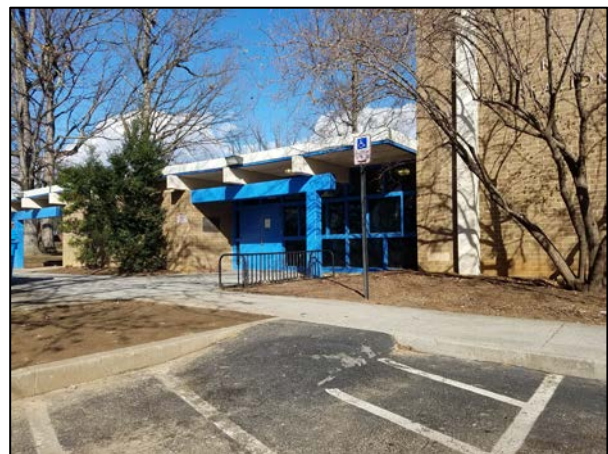
Handicapped Ramp

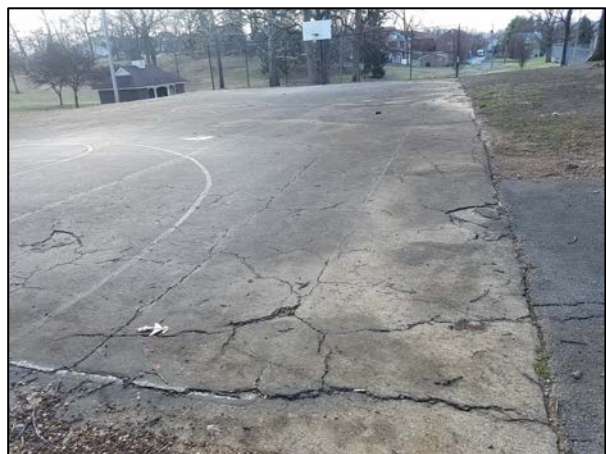
The existing basketball court just south of the parking area is showing serious signs of deterioration. The perimeter fencing is too close to the playing surface and is showing distress from this proximity and age.

Basketball Court

**Recommendation:** Completely remove the basketball court paving surface and replace with a new gravel base and asphalt system within the next two years. Study the shape, size, and location to ensure longevity of any new investment. Install new goals.

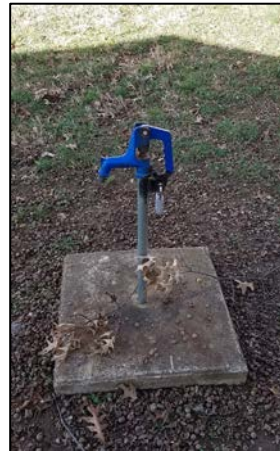
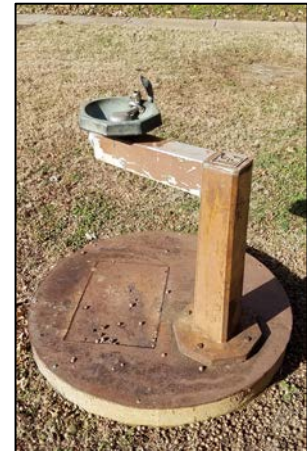
A yard hydrant and drinking fountain system is provided just east of the existing building. This system's operational function is questioned and should be evaluated during routine de-winterization operations.

Yard Hydrant and Drinking Fountain

**Recommendation:** Replace the existing drinking fountain system located between the building and picnic pavilion and provide ADA compliant access to such.

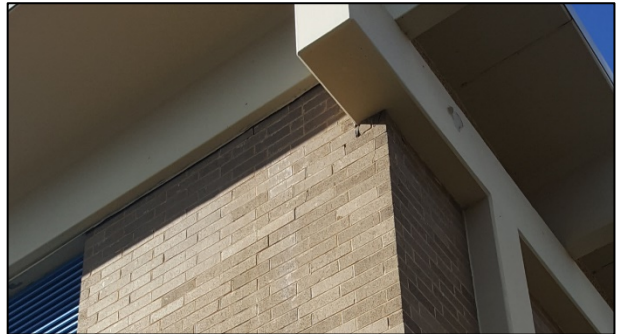
The gymnasium appears to be multi-wythe masonry walls infilling a concrete beam and column frame. The brick is cracked at the northeast corner of the gymnasium. The crack appears to be caused by relative movement of the precast concrete beam at roof level.

Location of Crack at Northeast Corner

**Recommendation:** Brick at the northeast corner of the gymnasium should be repointed to prevent water infiltration which could result in additional damage to the wall system.

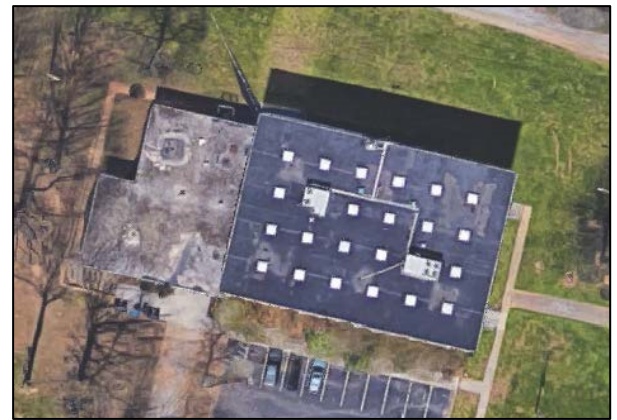
Roof

The roof over the gymnasium is an EPDM membrane with a number of skylights. Framing around the skylights is damaged by water, indicating that the skylights are no longer water tight. The average life span of an EPDM roof is 20 years. Although the installation date of the EPDM roof is not known, the roof appears to be nearing the end of its useful life.

**Recommendation:** Replace the entire roof with a flexible sheet membrane (EPDM or TPO), new rigid insulation to meet current energy code, and new flashings and copings. Replace the gymnasium roof and repair interior skylight framing. A roof system with integral skylights may be considered.

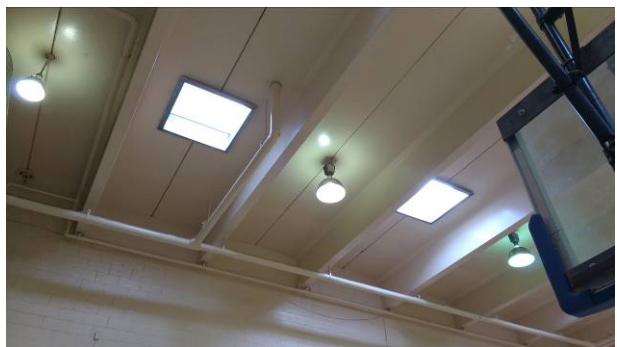
Syklights

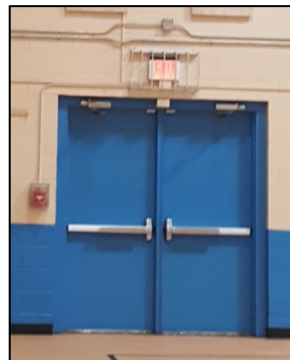
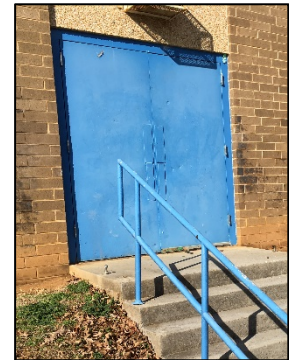
Gymnasium doors

exterior doors. Paint is fading and damaged on many exterior surfaces.

**Recommendation:** Repaint all exterior doors and replace damaged sweeps.

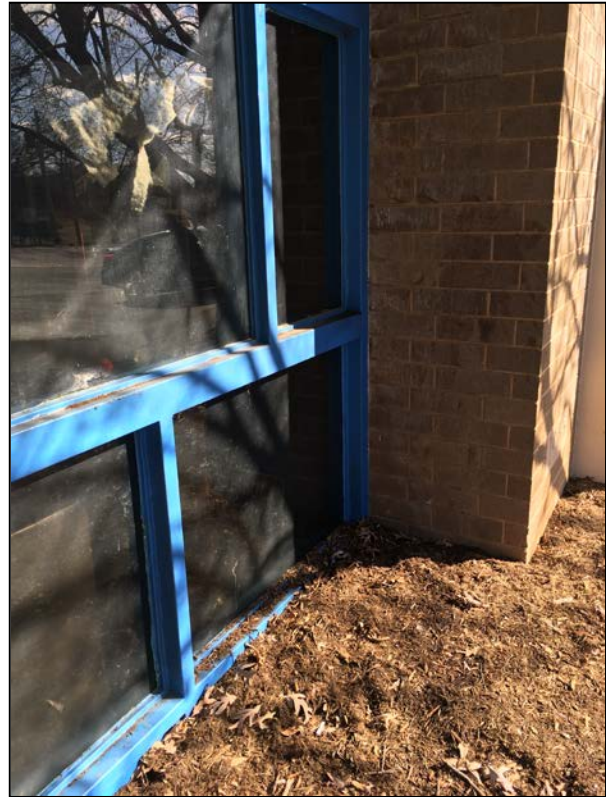
The energy performance of the building could be improved with the addition of an entrance vestibule and replacement of the existing single pane hollow frames with thermally broken frames and insulated glass. An entrance vestibule would provide an air-lock and reduce the infiltration of outside air into the space when people enter the facility.

Hollow Metal Frames with Single Pane Glass

**Recommendation:** Reconfigure the entrance to provide a secure entrance vestibule. The new entrance should be constructed with modern thermally broken frames and insulated glass. Increase the amount of insulation on the roof during the next roof-replacement.

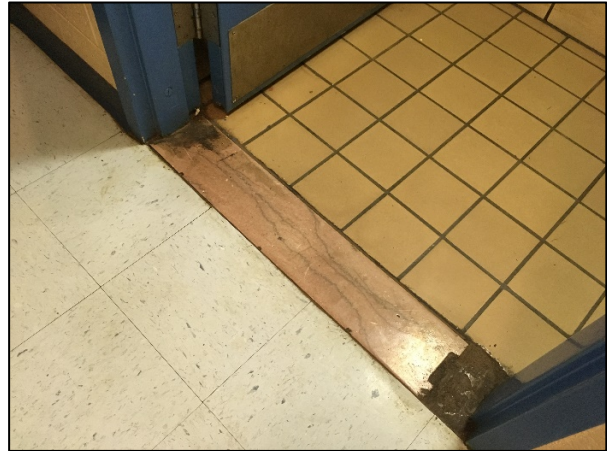
The floor in the toilet rooms are 6 x 6 quarry tile with marble threshold at the doors. The flooring is in good condition, although there are areas visible where patching has occurred.

Corridor & Toilet Room Flooring

**Recommendations:** Replace the VCT with new VCT flooring in the office/program area. Perform abatement if necessary.

If only minor toilet room modifications occur the quarry tile could remain, with some repairs. If the toilet rooms are to be replaced, an epoxy resinous flooring is recommended.

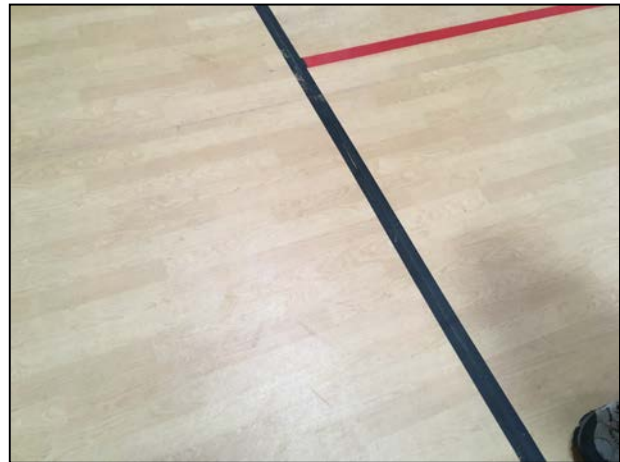
The gymnasium floor is a resilient athletic flooring, heat seam welded, vinyl surfaced with a wood appearance. The floor is showing signs of age with some seams beginning to fail.

Gymnasium Floor

Replace the athletic floor with a new resilient athletic floor. The thickness / resilience should be selected based on anticipated use of the space. If a new gym were to be constructed a true wood athletic floor is preferred. Since these systems require a 3 ½" – 5" recessed floor slab it is not feasible to retrofit the existing gym with wood.

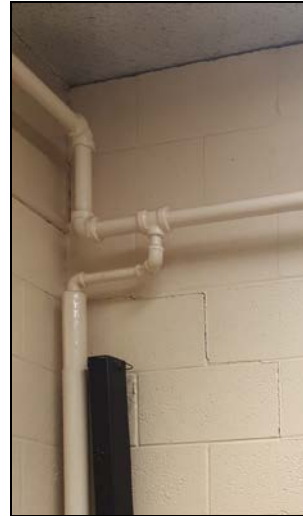
Cracks were observed at the northwest corner of the building in the Computer Room. These could be from a small amount of settlement in the foundation wall. The cracks were only evident in the concrete masonry, and were not observed in the brick veneer.

Interior CMU walls

**Recommendation:** Repoint masonry in the northwest corner of the building. Monitor the wall for any additional settlement. The noise reflection in the gym is high. Addition of sound attenuation panels is recommended.

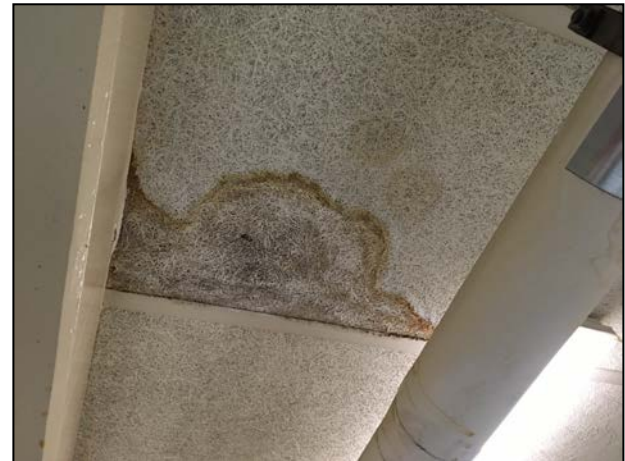
In the classroom spaces, the tectum roof deck serves as the ceiling material. In general the roof deck is in acceptable condition. One area of damage was noted in the Computer Room.

Water Damage at Roof Deck

**Recommendation:** Roof leaks should be repaired to prevent further damage of the interior finishes.

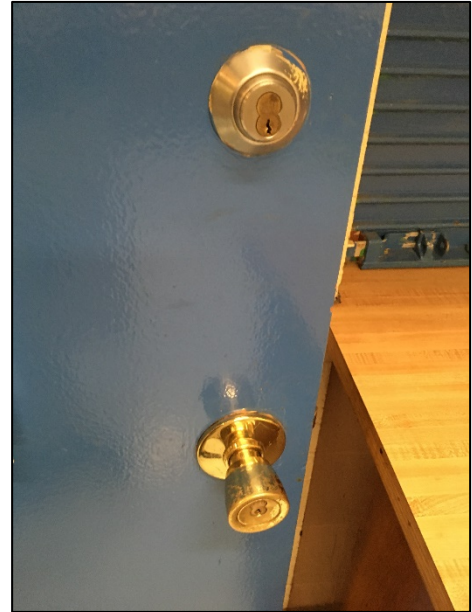
Interior doors are primarily painted wood doors with knob type hardware. The hardware is not ADA compliant. Separate dead bolts are installed at the kitchen, which does not meet the current code requirement for single action existing. A removable mullion is missing at the pair of doors to the gym from the entrance, preventing them from latching or locking. That pair of doors also has the original open push bar panic hardware which could be chained together by an intruder.

Interior Door Hardware

**Recommendation:** Replace door hardware with ADA compliant levers. Replace the missing removable mullion and replace the two panic bars at the gym with a flush mount egress hardware.

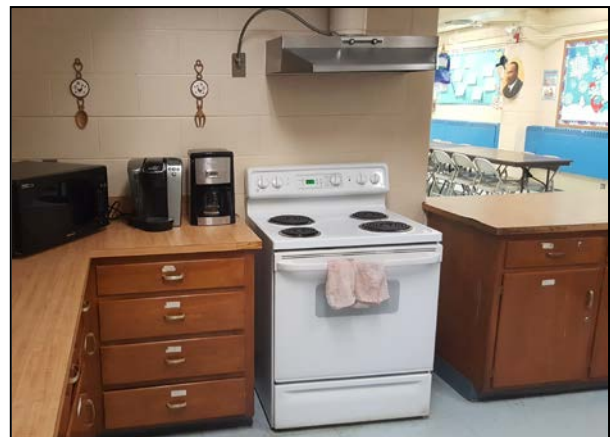
Kitchen

The kitchen consists of wood cabinets with a double sink and residential grade appliances (refrigerator, range, and hood). There is no commercial exhaust hood, fire suppression system, hand sink, triple sink or grease trap. The floor is VCT, which has joints between tiles.

**Recommendation:** Equip space with new equipment, a commercial exhaust hood, fire suppression system, hand sink, triple sink or grease trap. Install a seamless floor and a scrubbable ceiling.

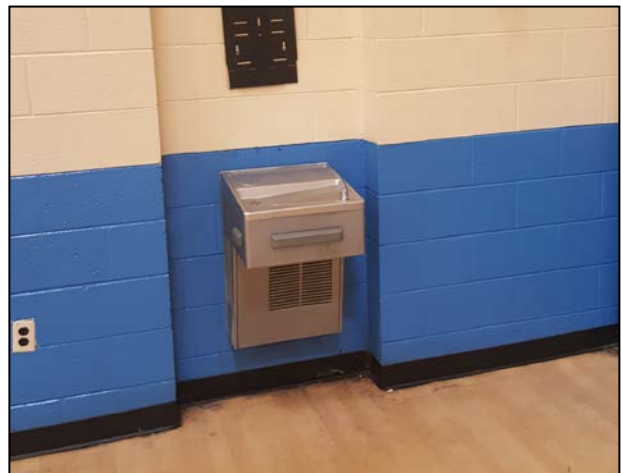
Typical Water Cooler

**Recommendation:** Install an additional water cooler at the higher level or provide a new dual level water cooler.

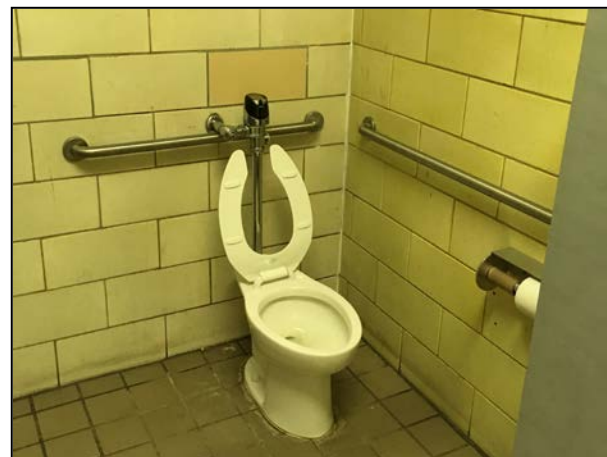
Typical Accessible Toilet Stall

**Recommendation:** Provide vertical grab bar at men's and women's accessible stalls.

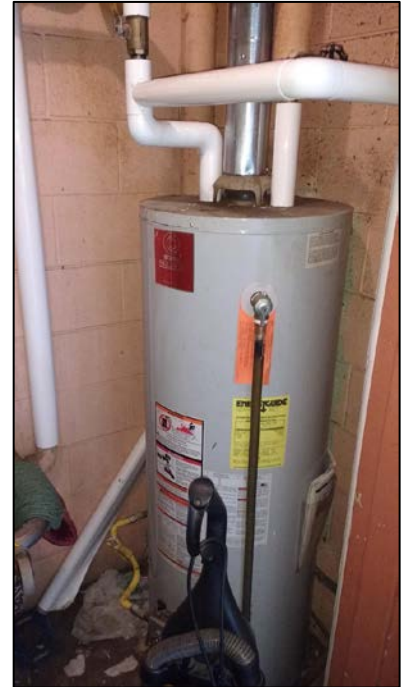
Domestic hot water is produced using a 50-gallon, 40,000 btu input gas-fired water heater that appears to be in fair condition. No expansion tanks is evident on water heater. No floor drain or drip pan was observed (floor drain may have been covered).

DHW Heater

**Recommendation:** Provide a drip pan at the water heater.

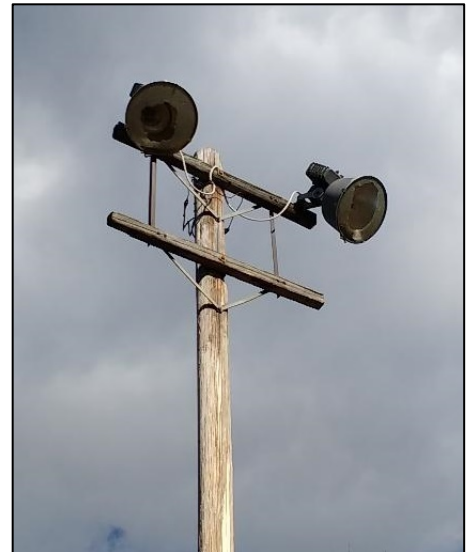
Damaged Ballfield Lights
