DEPARTMENT OF THE AIR FORCE  
HEADQUARTERS 341ST SPACE WING (AFSPC)

On 18 May 2001, we received your Freedom of Information Act (FOIA) request dated 9 May 2001, for records pertaining to a March 16, 1967 incident, in which there was a malfunction of missile silos. Copies of excerpts, as well as supporting documents, of the below listed documents are releasable and are attached:

- a. 341st Strategic Missile Wing History (1 Jan – 31 Mar 1967)
- b. 341st Strategic Missile Wing History (1 Apr – 30 Jun 1967)
- c. 341st Strategic Missile Wing History (1 Jul – 30 Sep 1967)
- d. 341st Strategic Missile Wing History (1 Oct – 31 Dec 1967)
- e. 341st Strategic Missile Wing History (1 Jan – 31 Mar 1968)

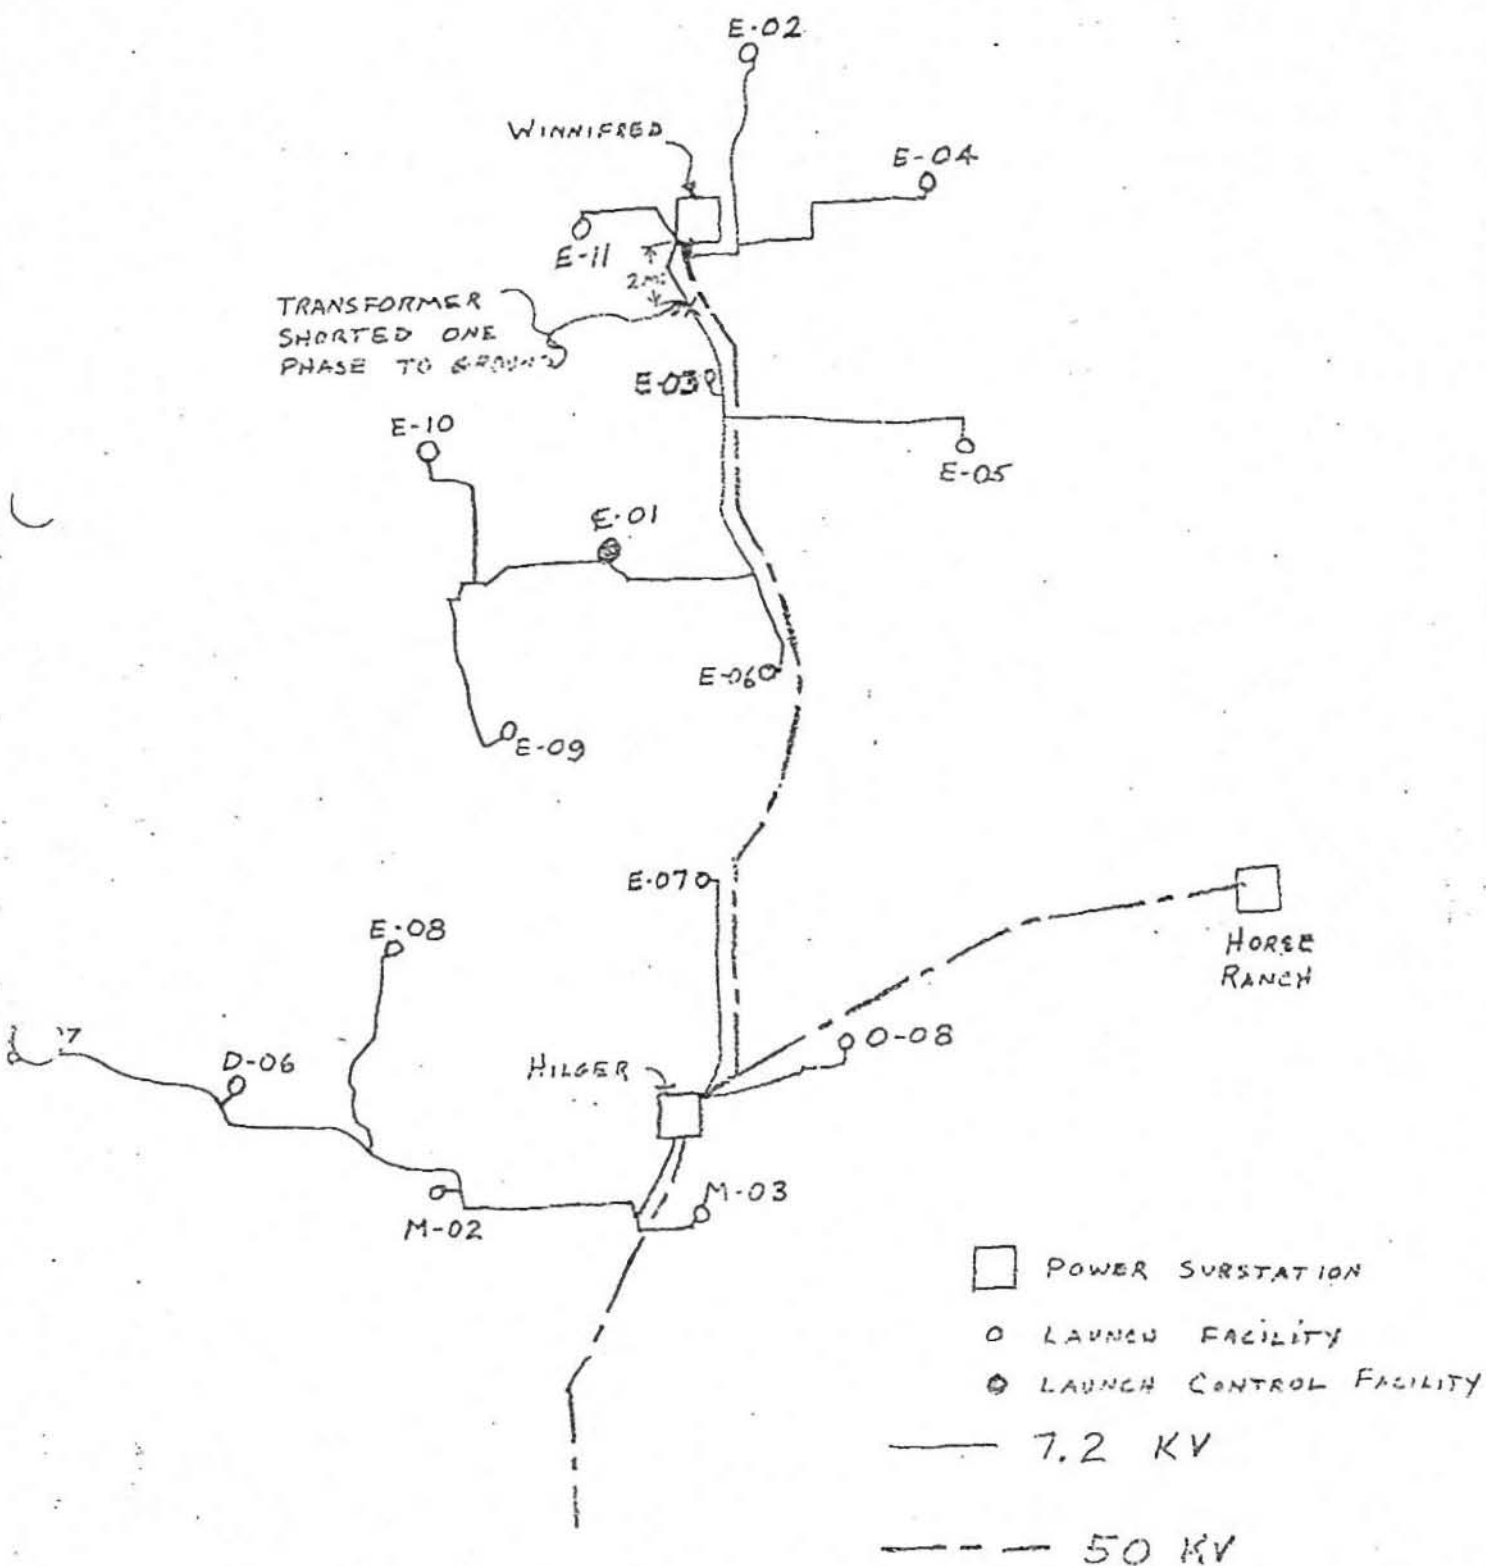
FIGURE 1.

E FLIGHT POWER DISTRIBUTION

A 7.2 KV transformer shorted in the line to site E-3 at 1450, 16 March 67. This transformer is located on a farm two miles south of the Winifred substation. Automatic reclosure switches at Winifred substation opened, and were reclosed manually after transformer replacement later in the day. This caused the Brine Chiller problem at E-1. The transformer was in the West phase. It was not determined which phase this corresponds to at the sites. Sites E-3, E-5, E-6, E-9, and E-10 transferred to Standby Power. Sites E-1 transferred to Direct Current (DC) operation. <sup>92</sup> (U)

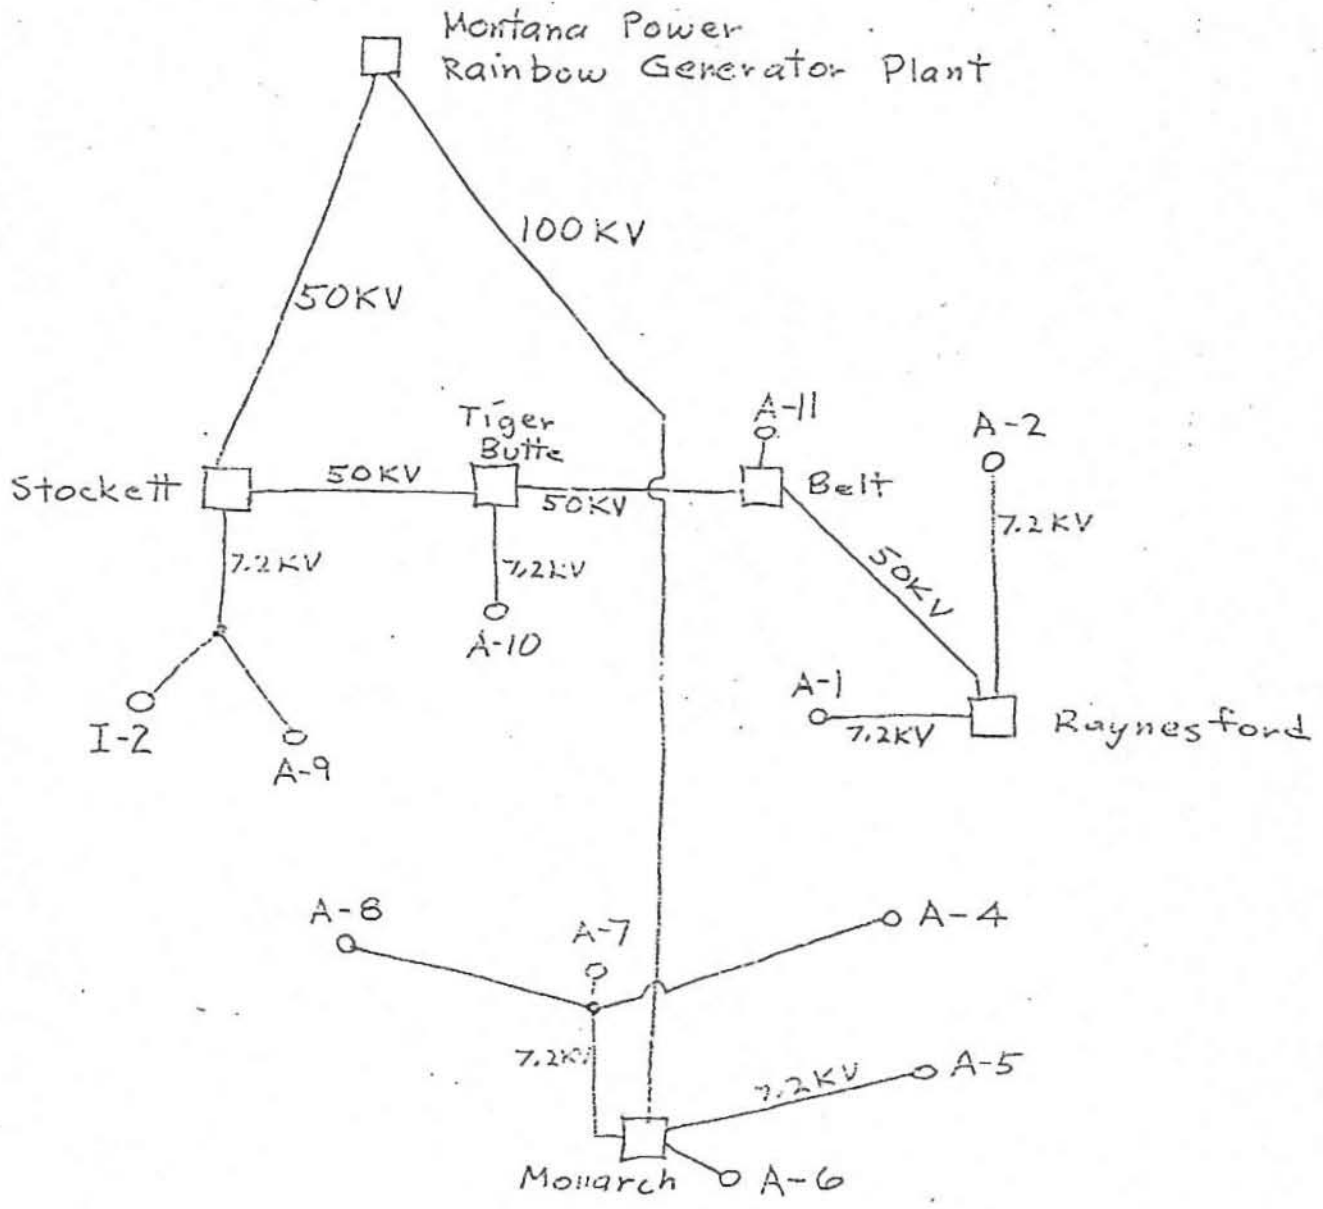
A FLIGHT POWER DISTRIBUTION  
 FIGURE 3.

December 1966. On 19 December 66, A Flight had some of it's  
 LF's shutdown (A-6, A-7, and A-10). The similarity between the  
 two flights was: The same Capsule crew, adverse weather con-  
 ditions, and commercial power failure after the facilities  
 88  
 shutdown. (U)
