Washington State  
School Seismic Safety Assessments Project

# SOUTH BEND JR/SR HIGH SCHOOL MAIN BUILDING South Bend Public Schools

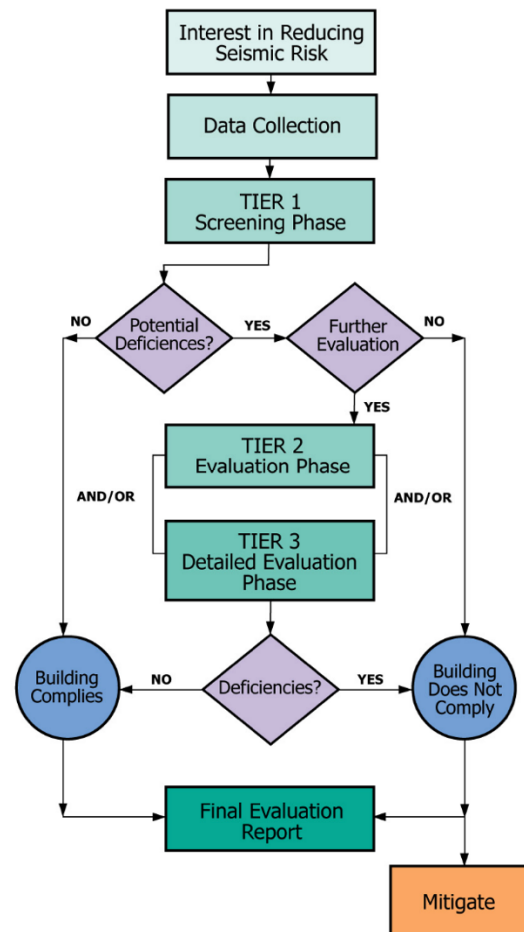
Figure 2-1. Flow Chart and Description of ASCE 41 Seismic Evaluation Procedure.

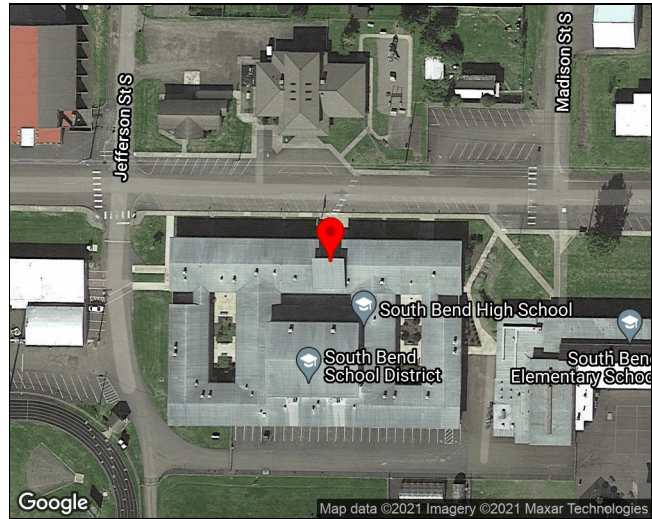
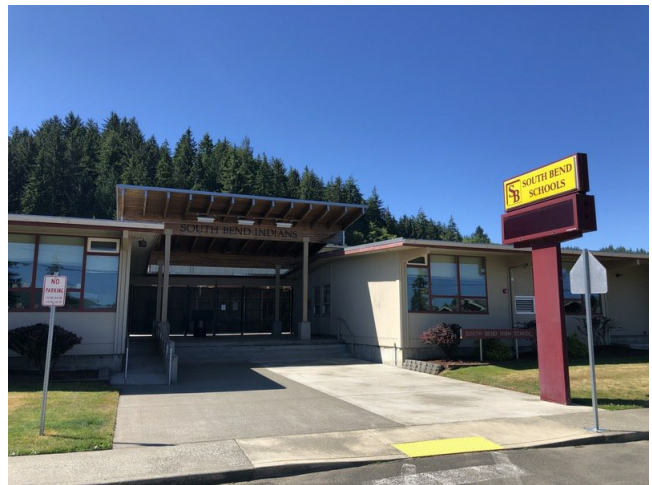
Constructed in 1968, South Bend High School is a one-story structure which was renovated in 2010. The structure is on level ground and located south of the Willapa River in South Bend, Washington. The building footprint is approximately 51,000 square feet and is rectangular with two interior court yards and a gable roof. The 1966 drawings indicated the building's construction consisted of a wood-framed roof system spanning between wood shear and bearing walls. The roof is a flexible diaphragm with plywood sheathing over wood joists. The floor structure is a combination of concrete slab on grade and an elevated wood floor assembly with wood joists spanning between concrete piers. The foundation system is composed of concrete pile caps with driven wood piles.

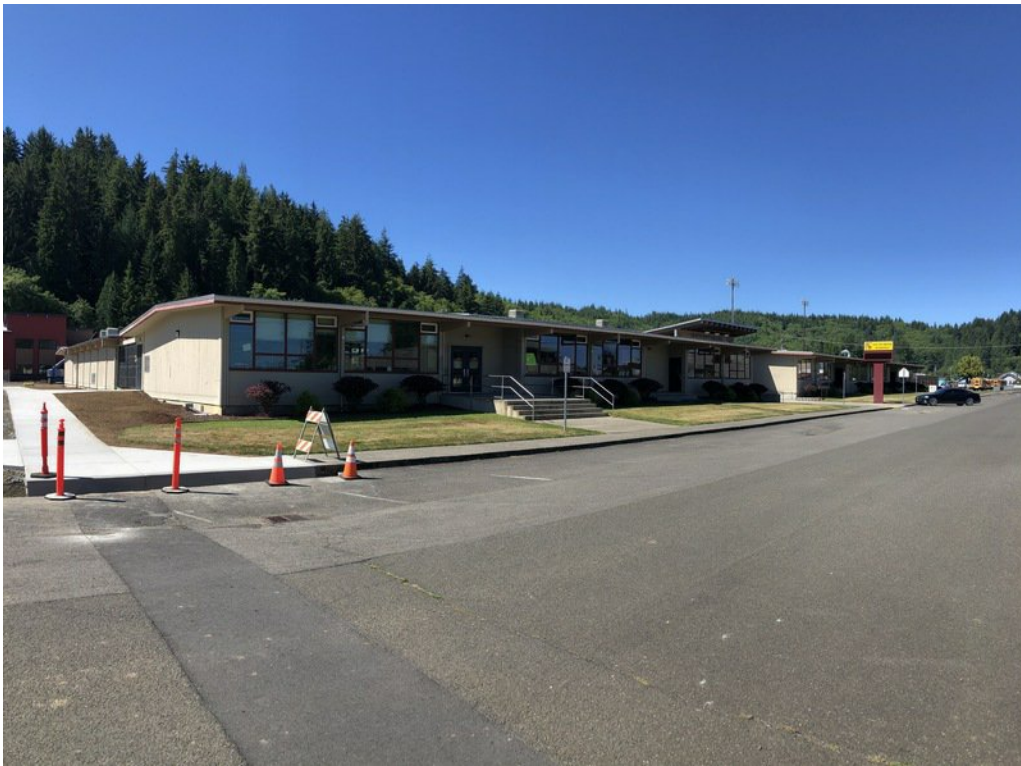
**Figure 1-1. Northeast Building Elevation**

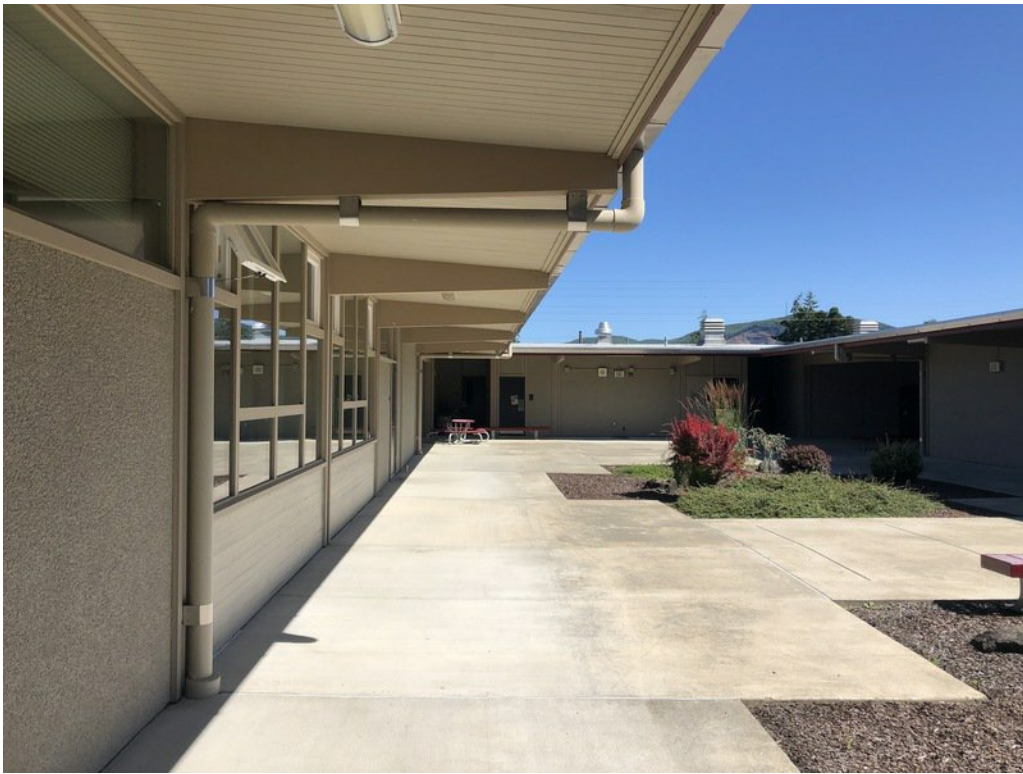
**Figure 1-9. Roof Overhang Framing Condition**

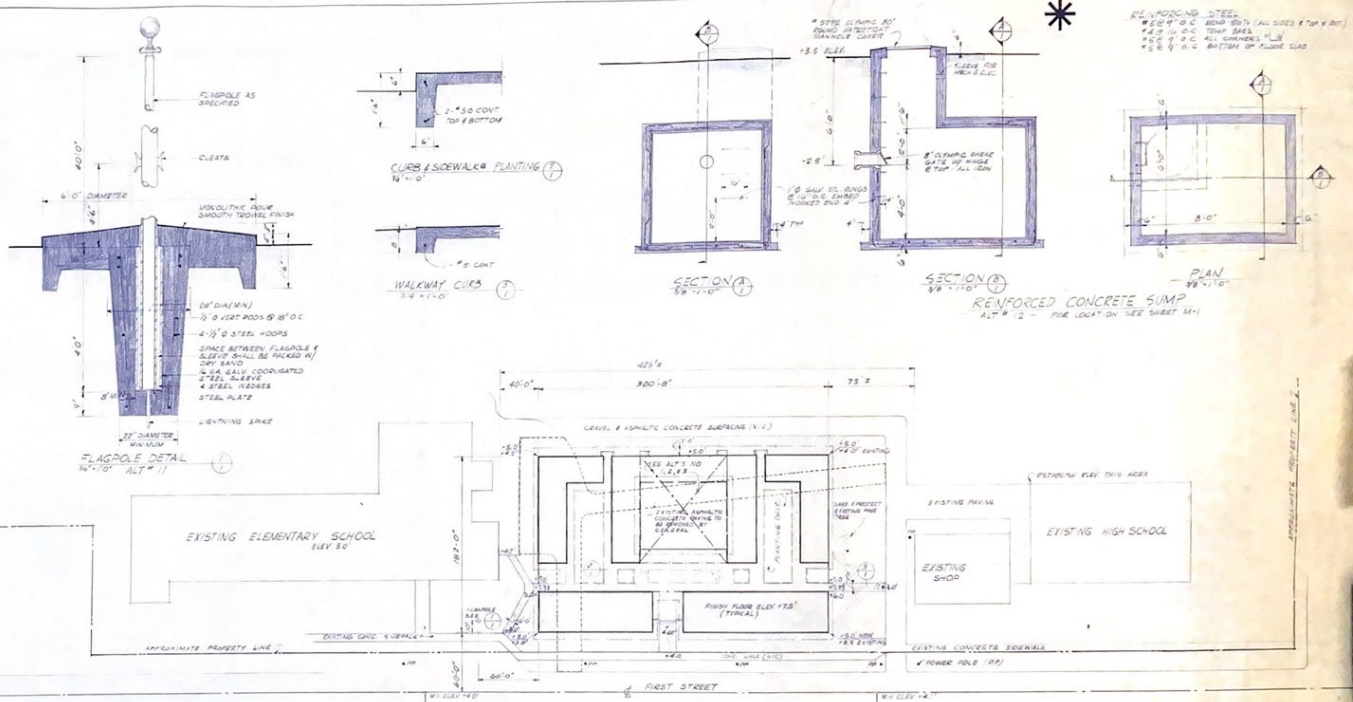
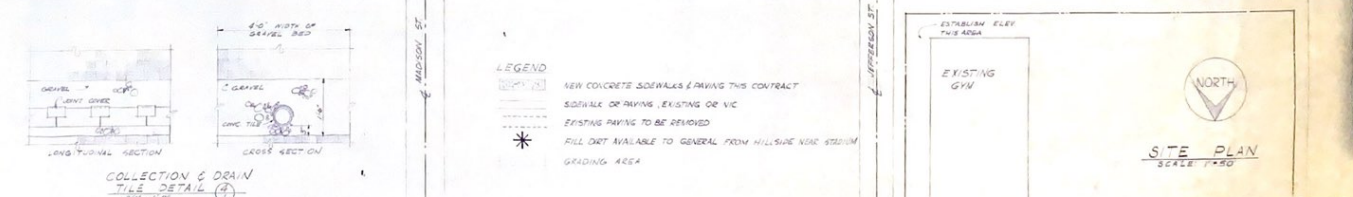
HOVIND · HARTHORNE & SMITH  
ARCHITECTS 1500 WESTLAKE NORTH SEATTLE 9, WASH

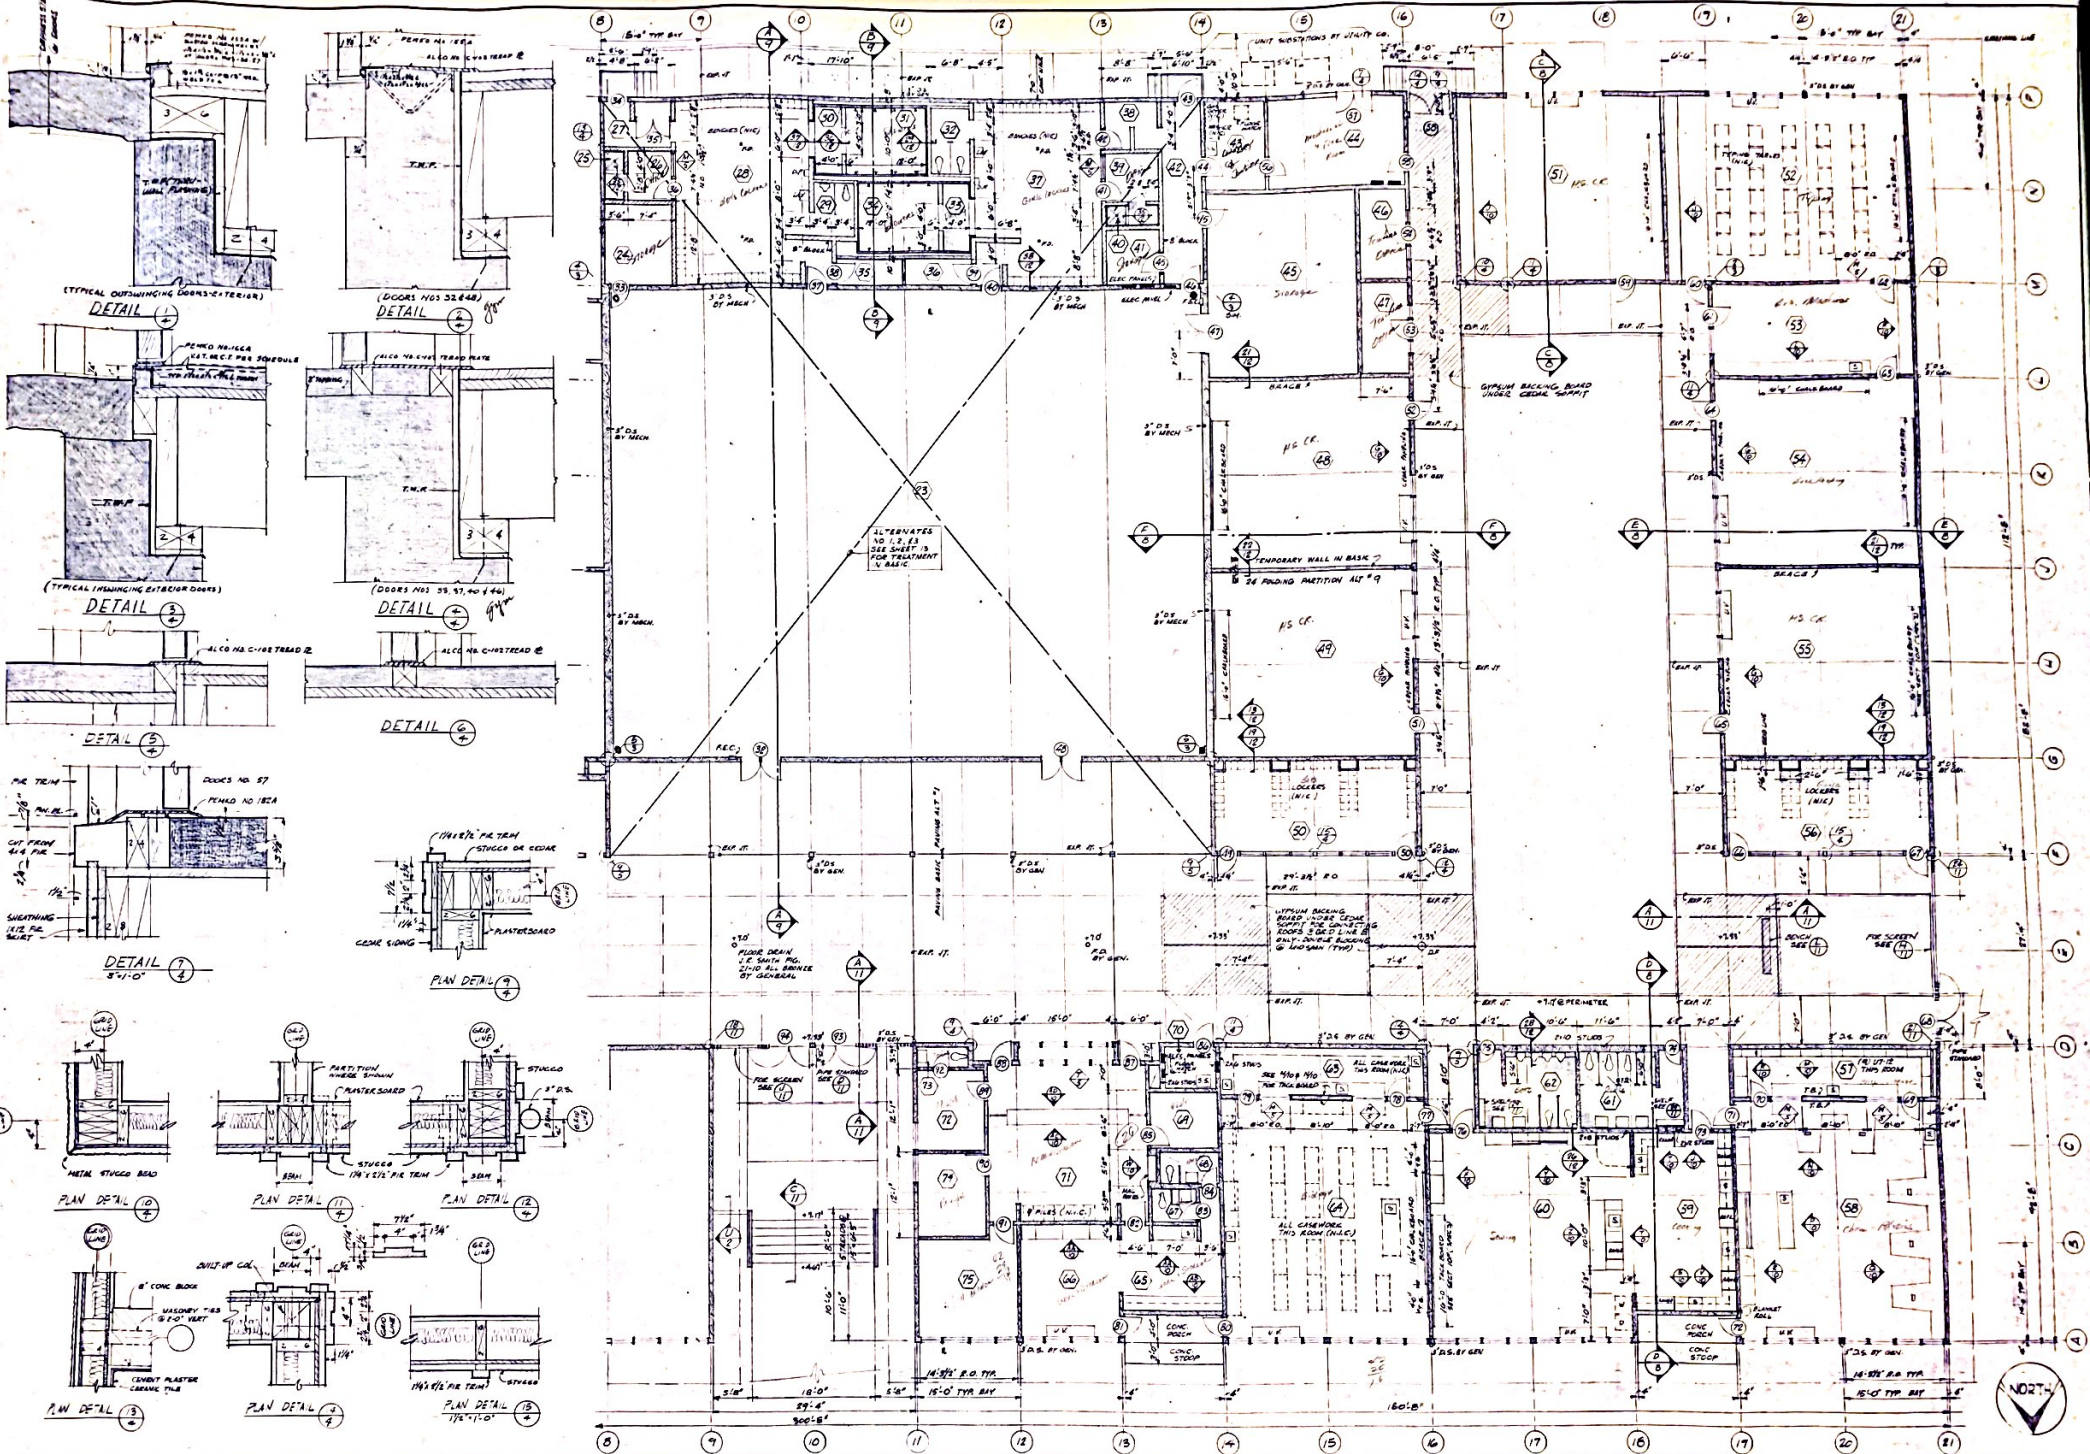
DATE DEC '66  
DRAWN BY AT  
CHECKED BY LWA/AT  
CHECKED BY WDS  
JOB NO.

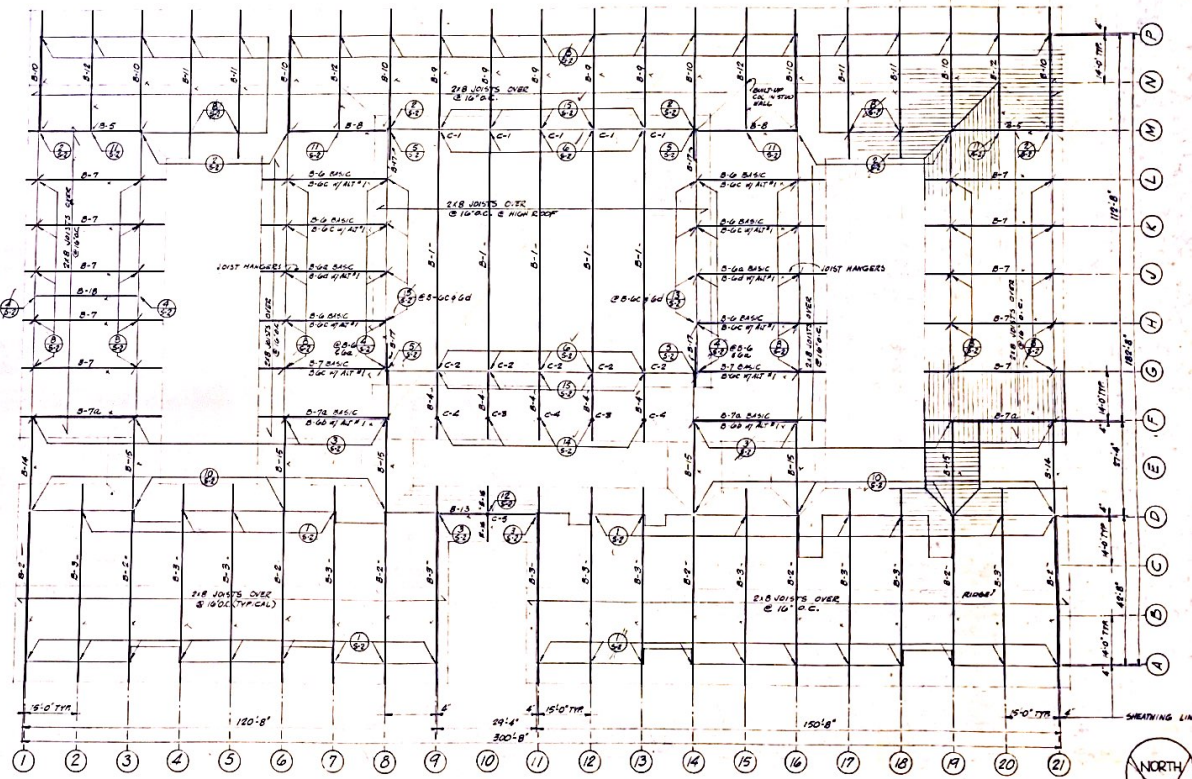
ROOF FRAMING PLAN  
SCALE 1/16" = 1'-0"

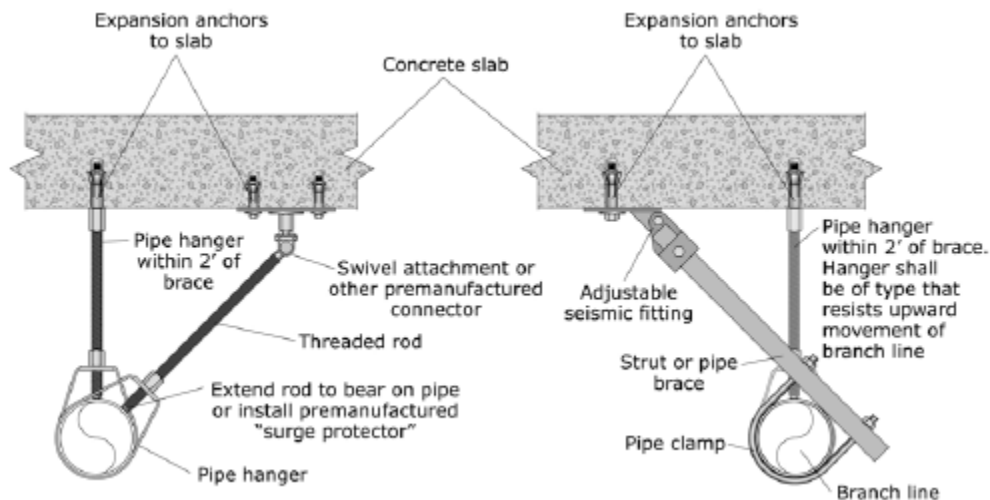
**Figure G-2. End of Line Restraint.**

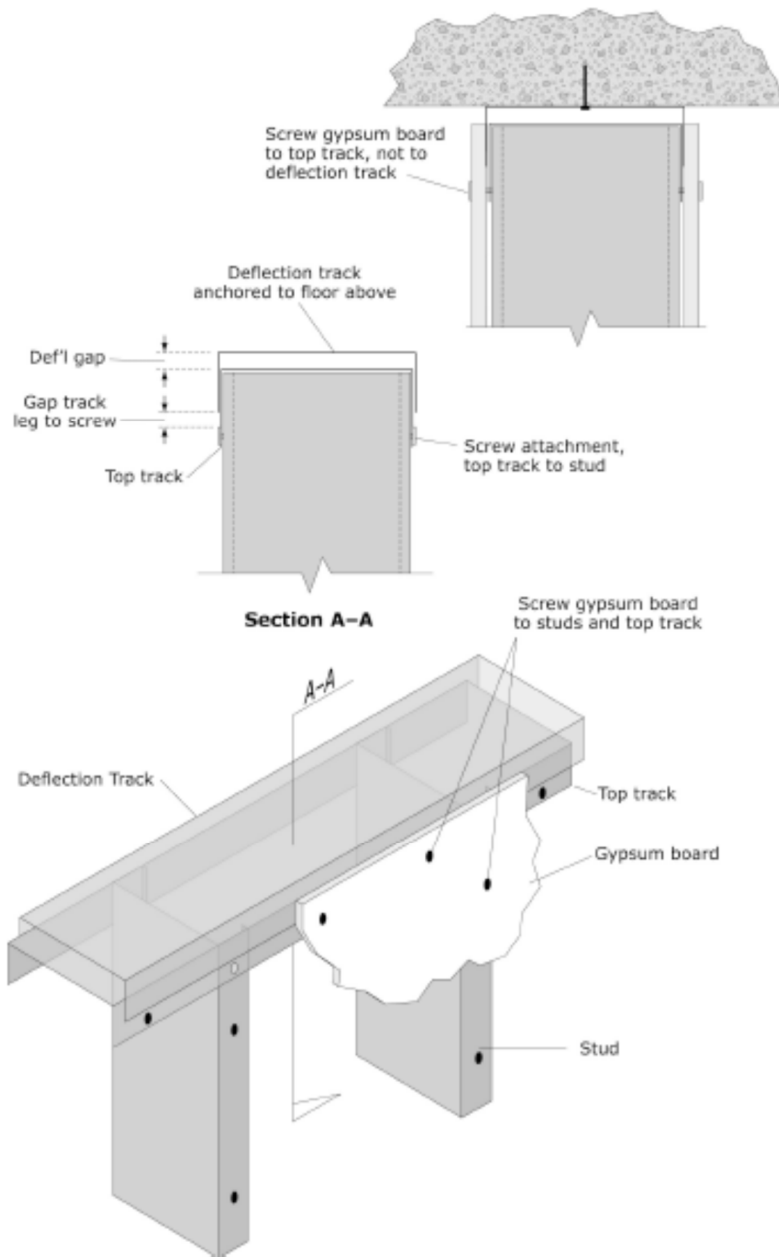
**Figure G-3. Mitigation Schemes for Bracing the Tops of Metal Stud Partition Walls.**  
*(FEMA E-74, 2012, Reducing the Risks of Nonstructural Earthquake Damage)*

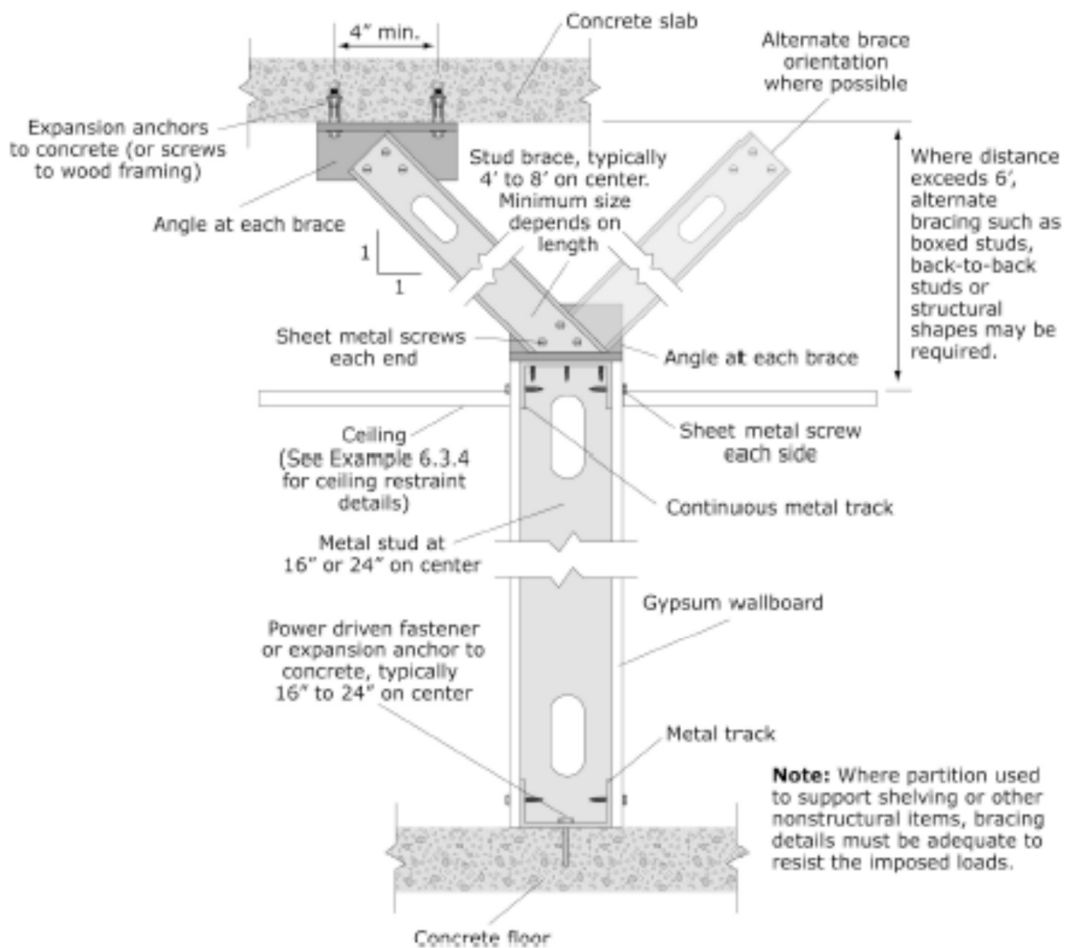
**Figure G-4. Mitigation Schemes for Bracing the Tops of Metal Stud Partitions Walls.**  
*(FEMA E-74, 2012, Reducing the Risks of Nonstructural Earthquake Damage)*

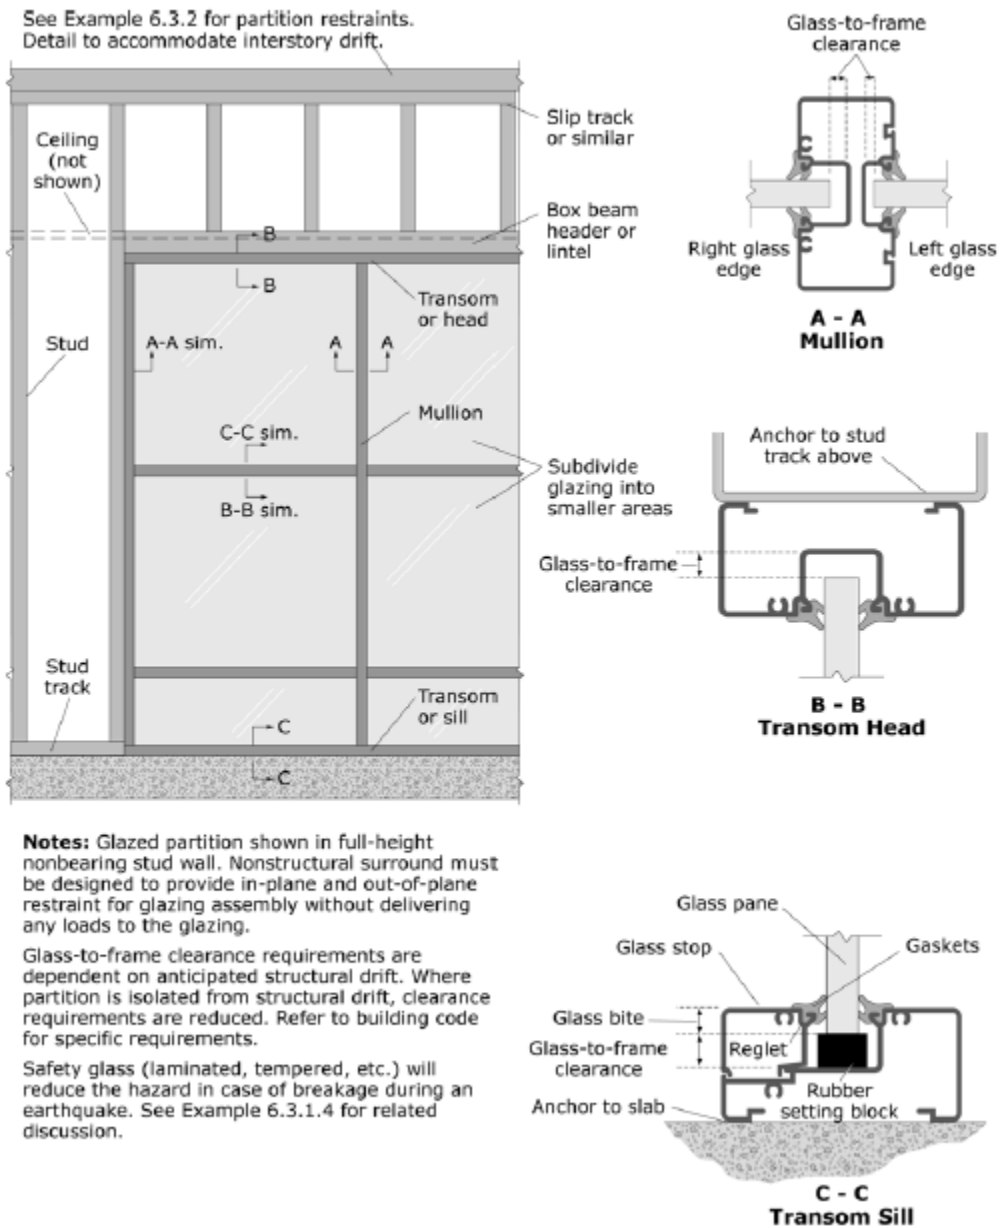
**Figure G-5. Full-height Glazed Partition.**  
(FEMA E-74, 2012, *Reducing the Risks of Nonstructural Earthquake Damage*)

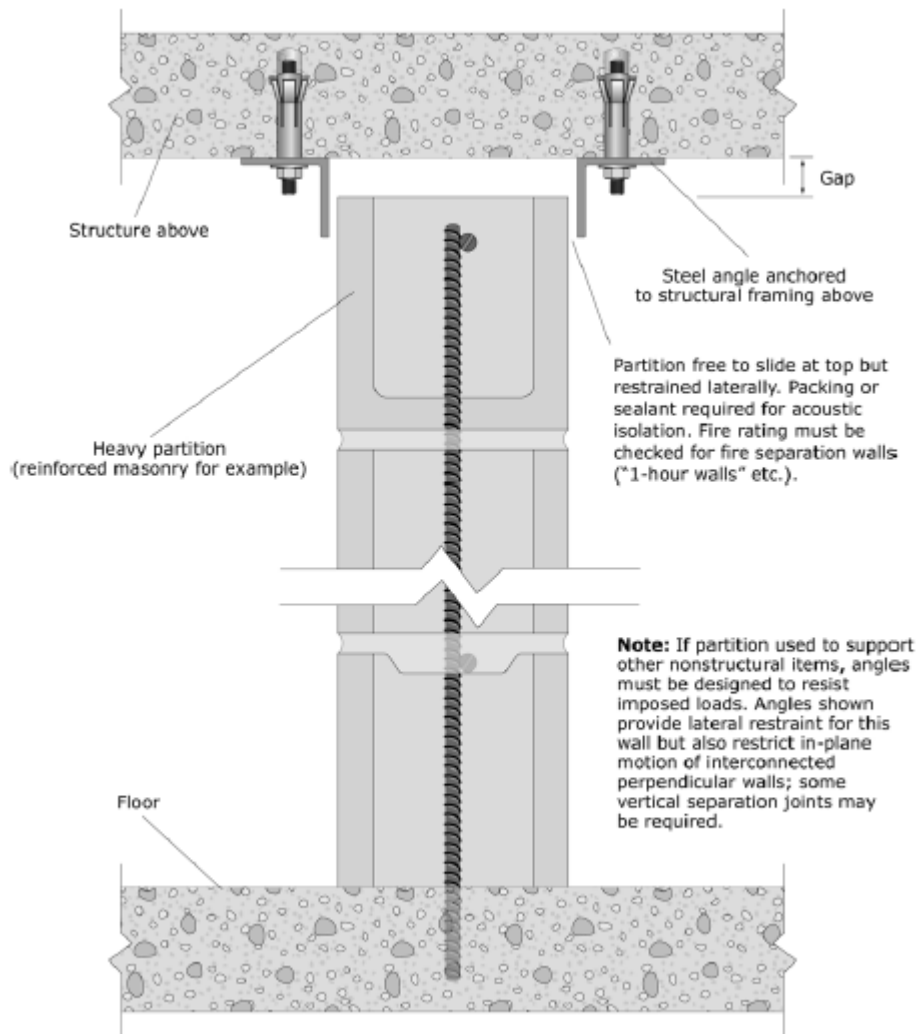
**Figure G-6. Full-height Heavy Partition.**

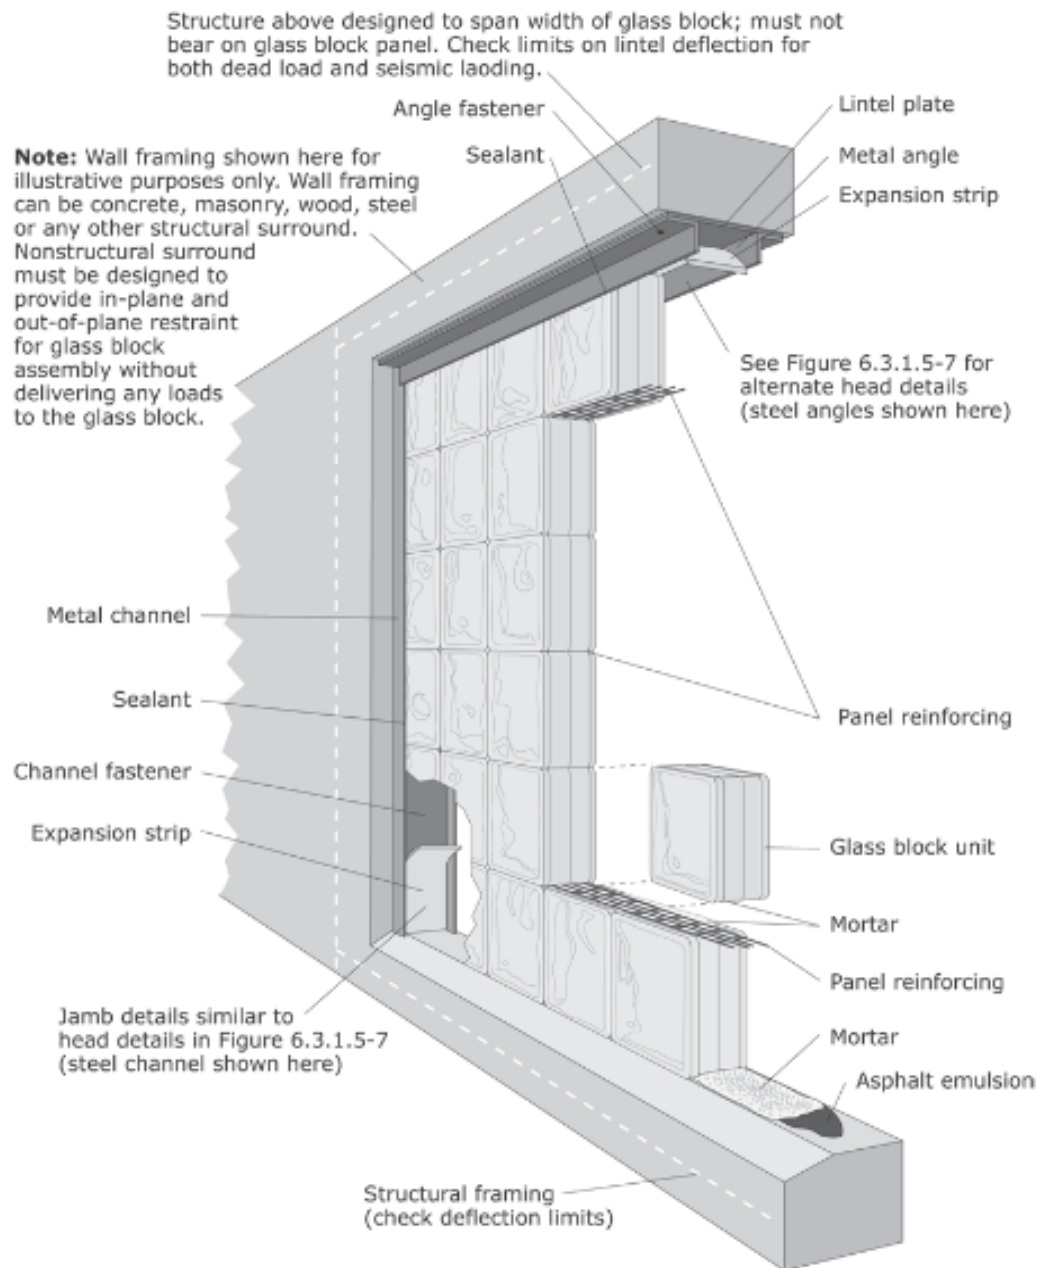
**Figure G-7. Typical Glass Block Panel Details.**  
*(FEMA E-74, 2012, Reducing the Risks of Nonstructural Earthquake Damage)*

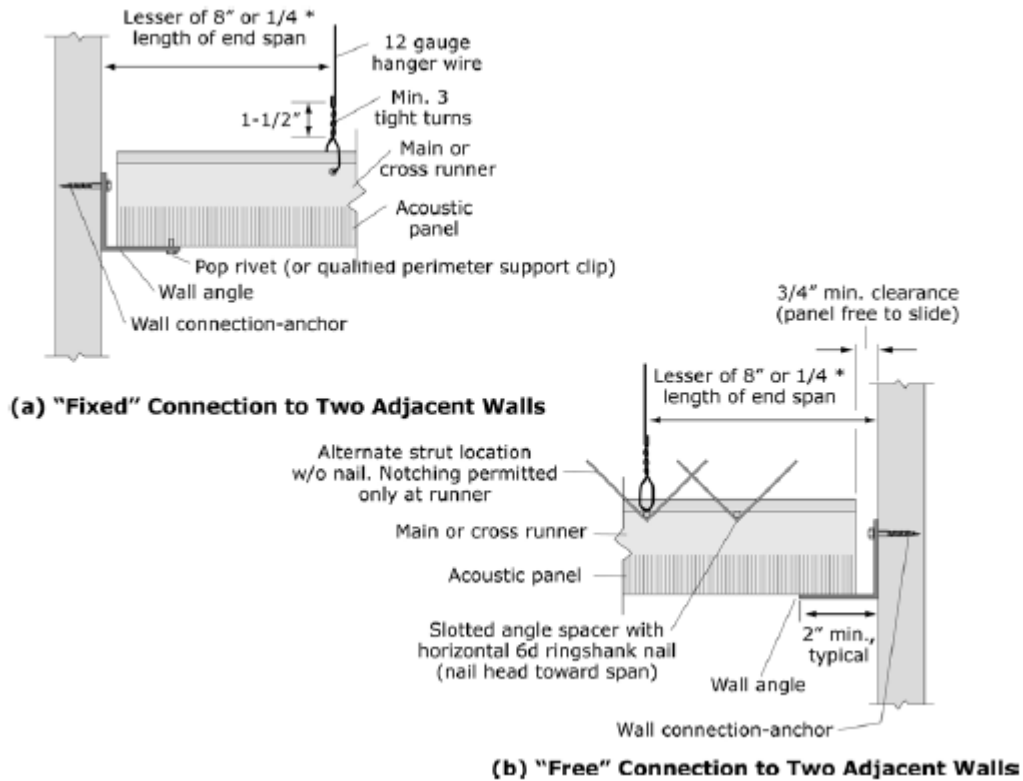
**Figure G-8. Suspension System for Acoustic Lay-in Panel Ceilings – Edge Conditions.**  
*(FEMA E-74, 2012, Reducing the Risks of Nonstructural Earthquake Damage)*

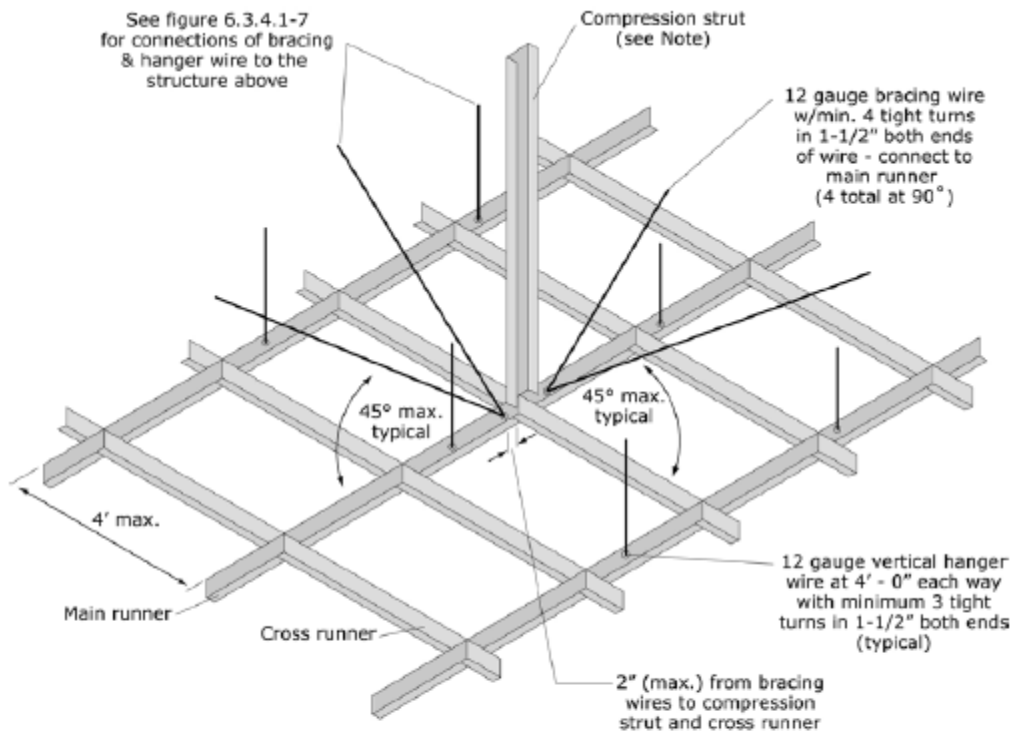
**Note:** Compression strut shall not replace hanger wire. Compression strut consists of a steel section attached to main runner with 2 - #12 sheet metal screws and to structure with 2 - #12 screws to wood or 1/4" min. expansion anchor to structure. Size of strut is dependent on distance between ceiling and structure ( $l/r \leq 200$ ). A 1" diameter conduit can be used for up to 6'; a 1-5/8" X 1-1/4" metal stud can be used for up to 10'

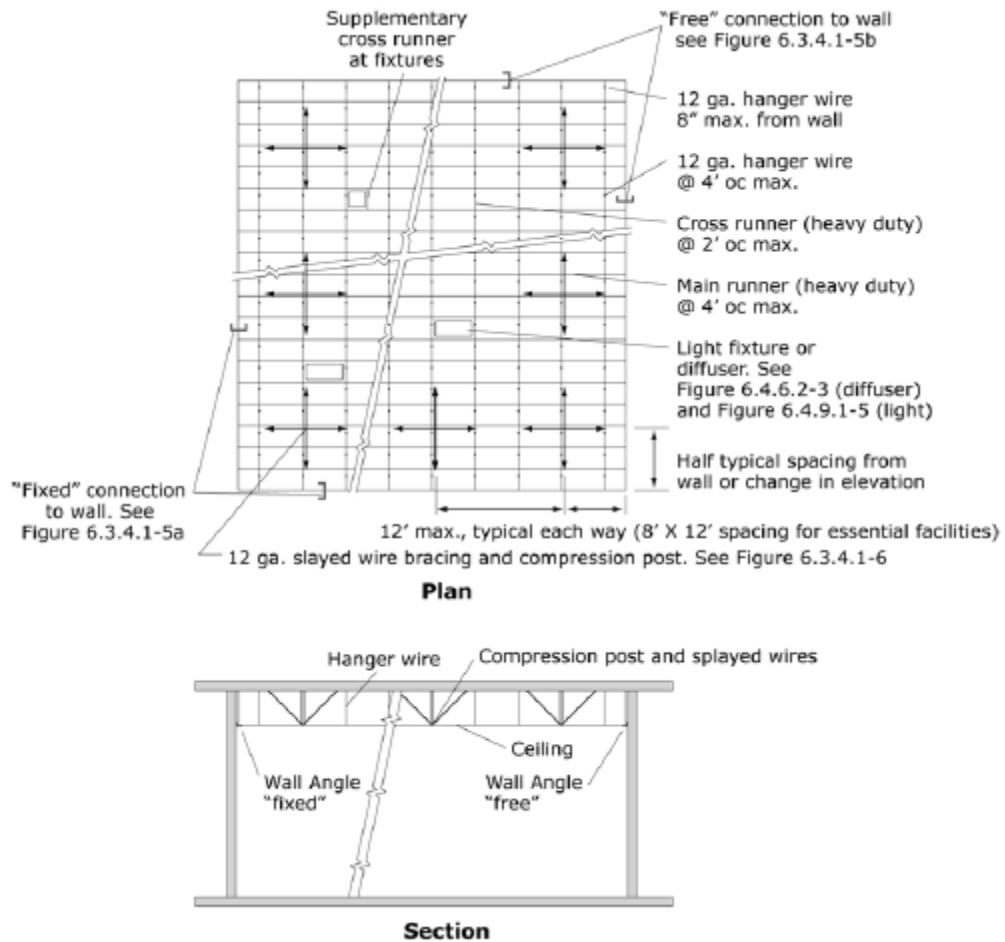
**Figure G-10. Suspension System for Acoustic Lay-in Panel Ceilings – General Bracing Layout.**  
*(FEMA E-74, 2012, Reducing the Risks of Nonstructural Earthquake Damage)*

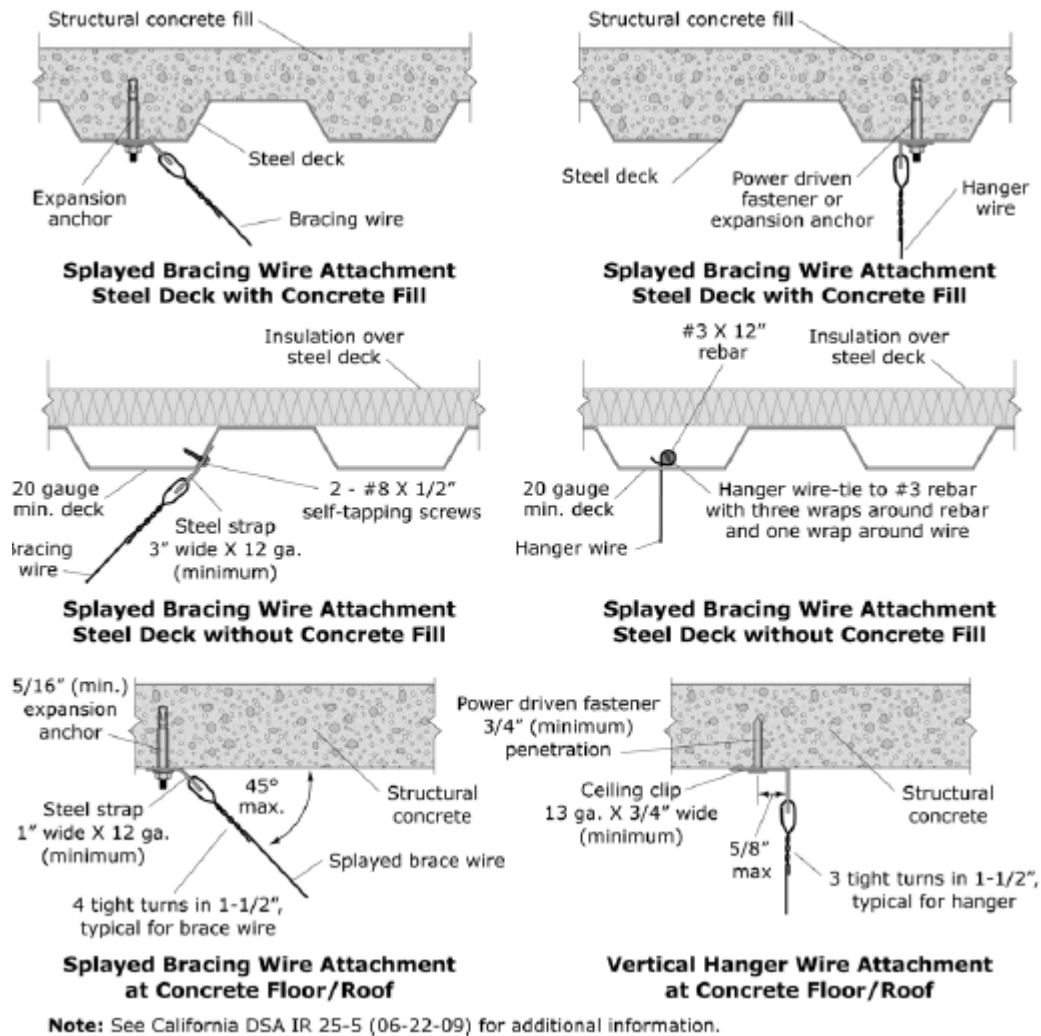
**Figure G-11. Suspension System for Acoustic Lay-in Panel Ceilings – Overhead Attachment Details.**

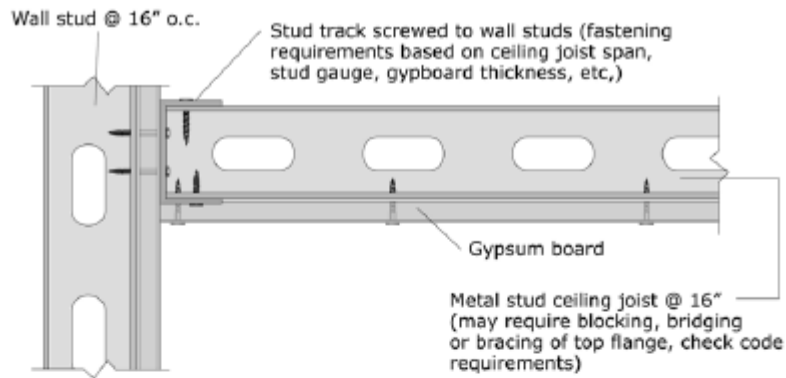
**a) Gypsum board attached directly to ceiling joists**

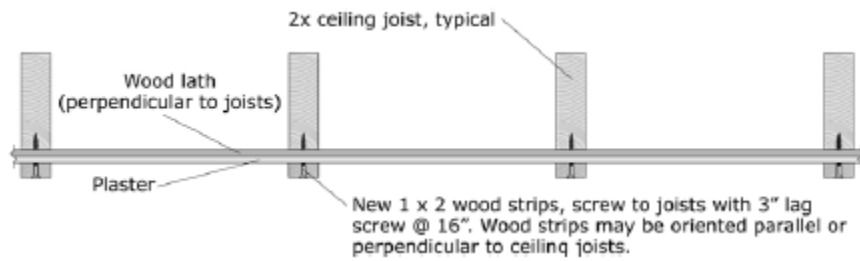
**Figure G-13. Retrofit Detail for Existing Lath and Plaster.**  
*(FEMA E-74, 2012, Reducing the Risks of Nonstructural Earthquake Damage)*

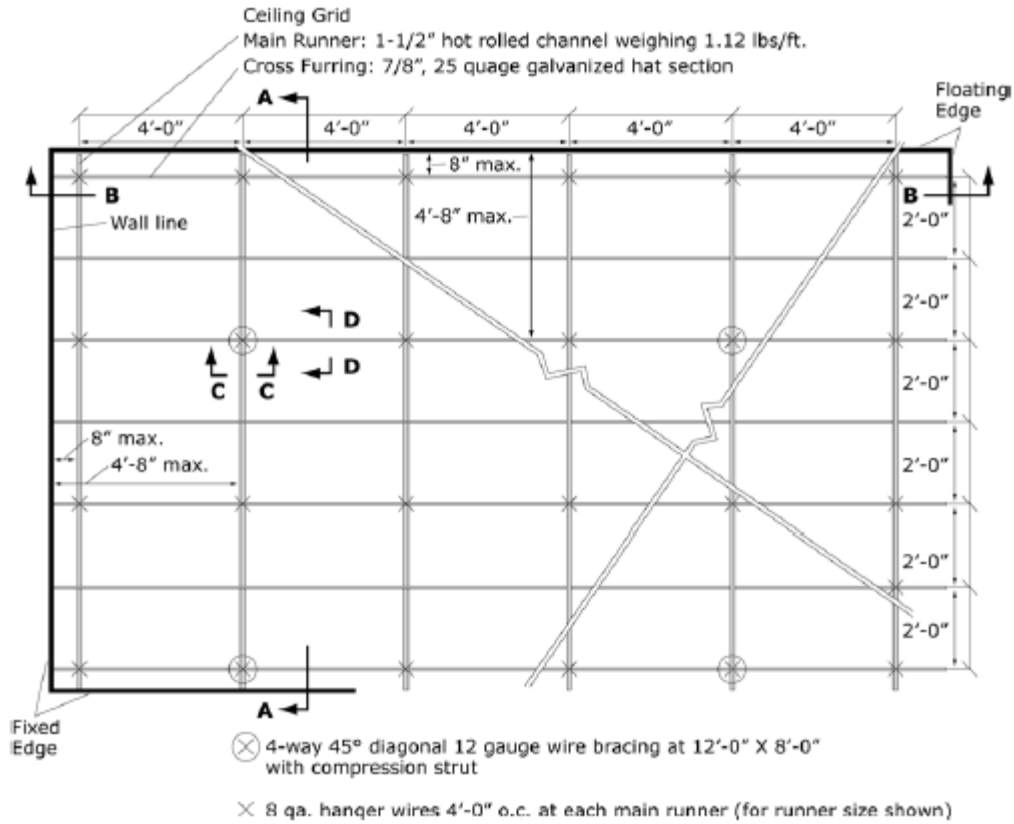
**Figure G-14. Diagrammatic View of Suspended Heavy Ceiling Grid and Lateral Bracing.**  
*(FEMA E-74, 2012, Reducing the Risks of Nonstructural Earthquake Damage)*

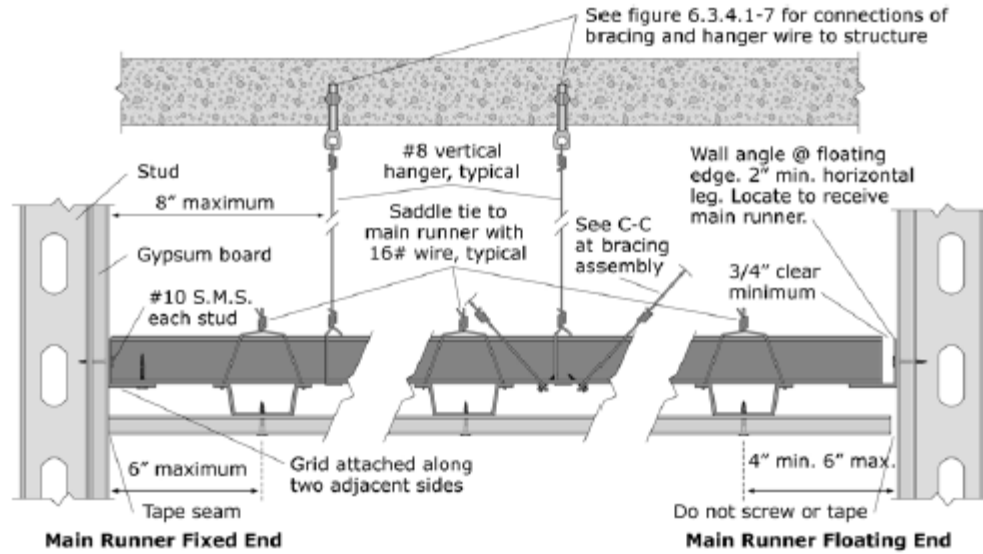
**A-A Main Runner at Perimeter**

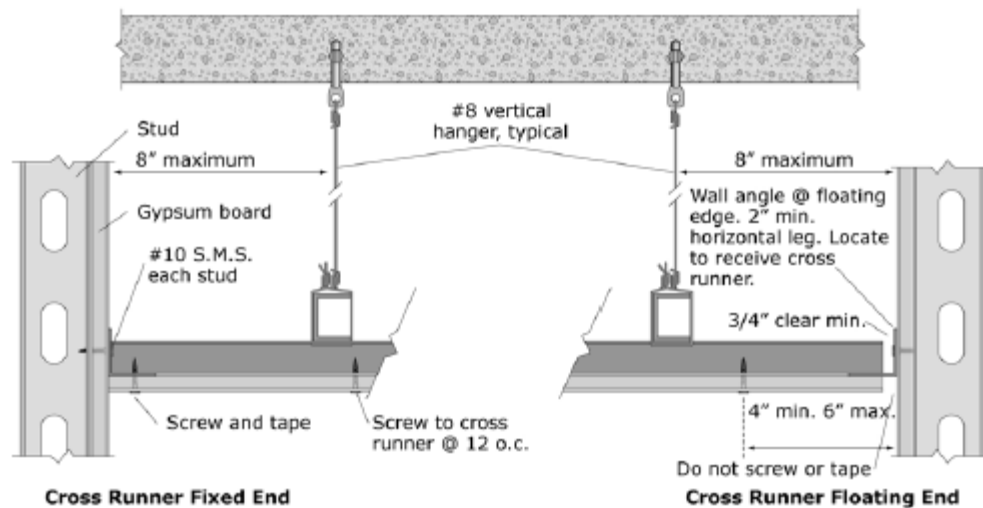
**B-B Cross Runner at Perimeter**

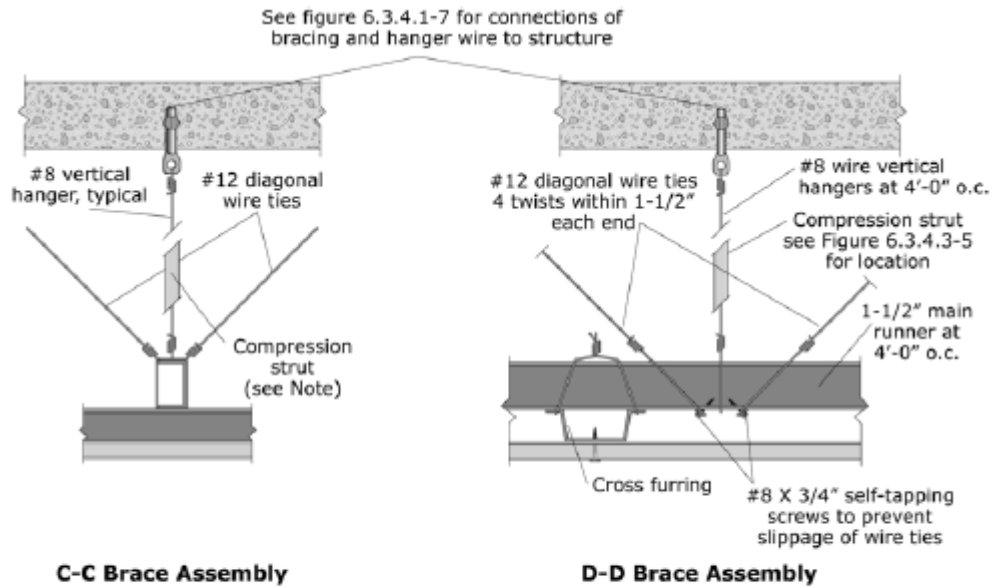
**Note:** Compression strut shall not replace hanger wire. Compression strut consists of a steel section attached to main runner with 2 - #12 sheet metal screws and to structure with 2 - #12 screws to wood or 1/4" min. expansion anchor to concrete. Size of strut is dependent on distance between ceiling and structure ( $l/r \leq 200$ ). A 1" diameter conduit can be used for up to 6', a 1-5/8" X 1-1/4" metal stud can be used for up to 10'. See figure 6.3.4.1-6 for example of bracing assembly.

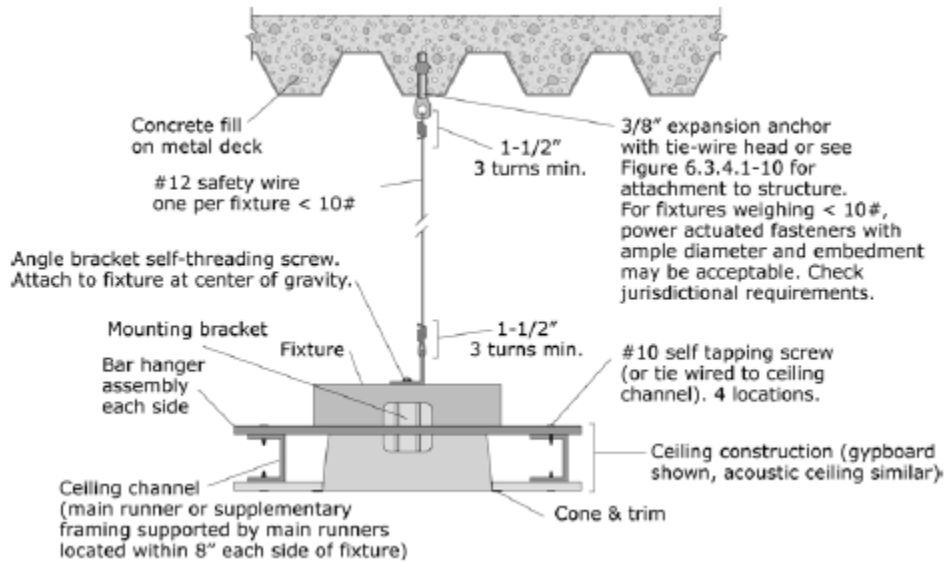
**Figure G-17. Recessed Light Fixture in suspended Ceiling (Fixture Weight < 10 pounds).**  
*(FEMA E-74, 2012, Reducing the Risks of Nonstructural Earthquake Damage)*

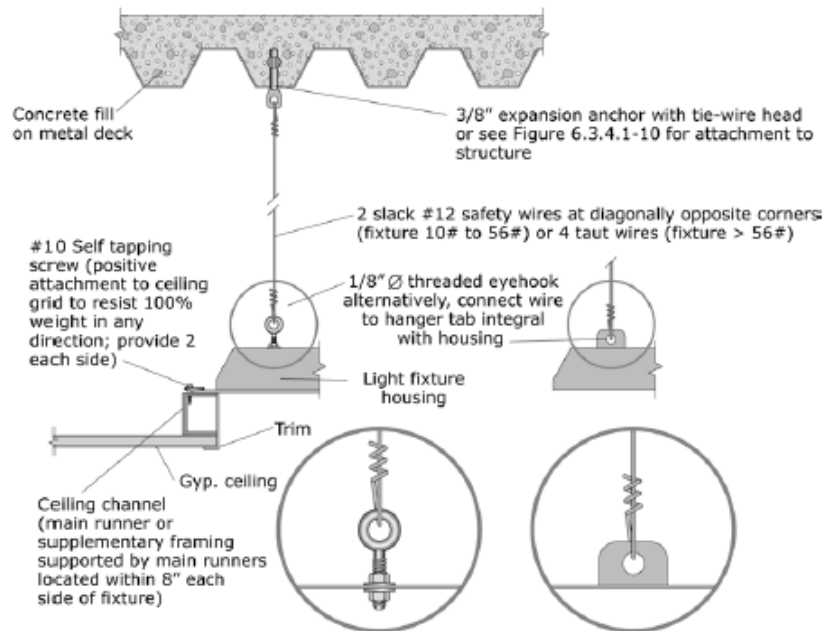
**Figure G-18. Recessed Light Fixture in suspended Ceiling (Fixture Weight 10 to 56 pounds).**  
*(FEMA E-74, 2012, Reducing the Risks of Nonstructural Earthquake Damage)*

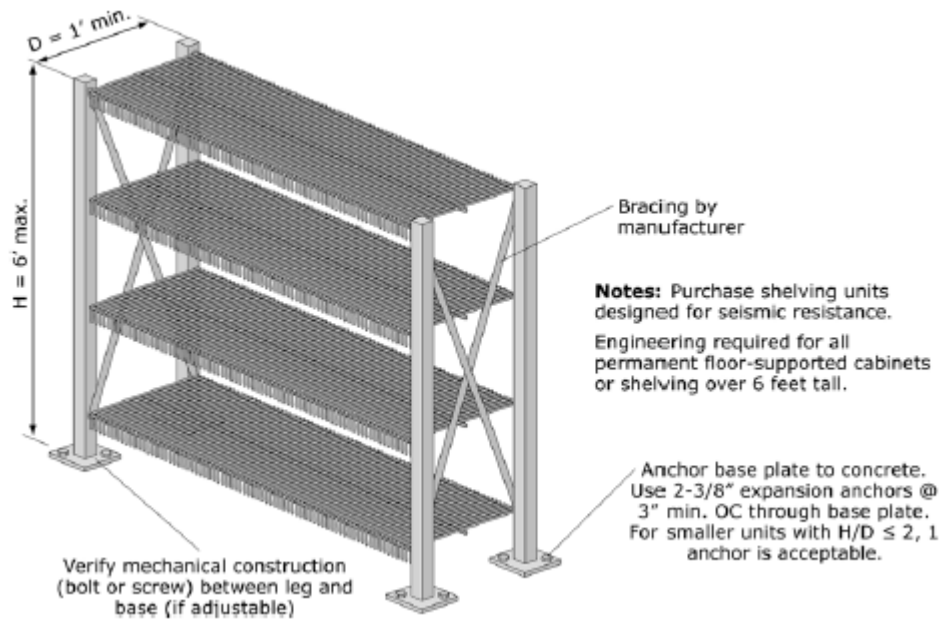
**Figure G-19. Light Storage Racks.**  
(FEMA E-74, 2012, *Reducing the Risks of Nonstructural Earthquake Damage*)
