Washington State  
School Seismic Safety Assessments Project

# SOUTH BEND JR/SR HIGH SCHOOL MAIN BUILDING South Bend Public Schools

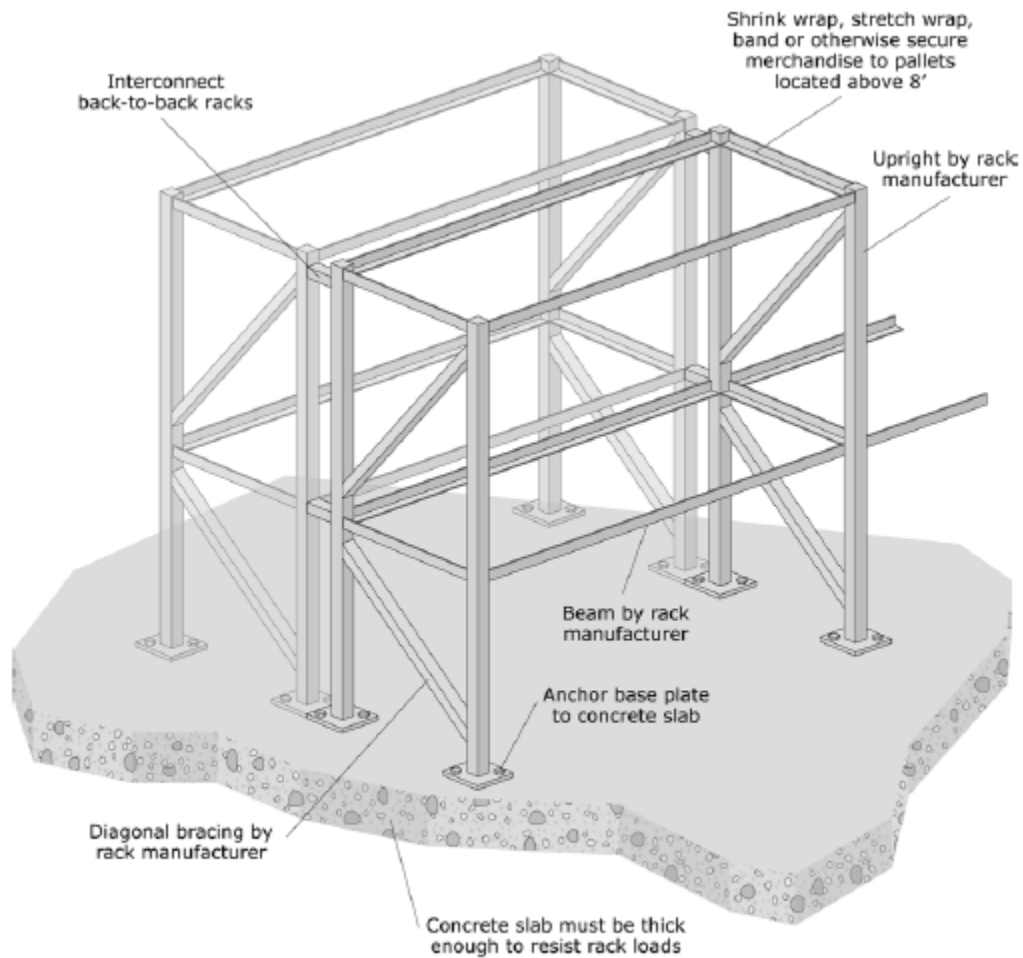
**Note:** Purchase storage racks designed for seismic resistance. Storage racks may be classified as either nonstructural elements or nonbuilding structures depending upon their size and support conditions. Check the applicable code to see which provisions apply.

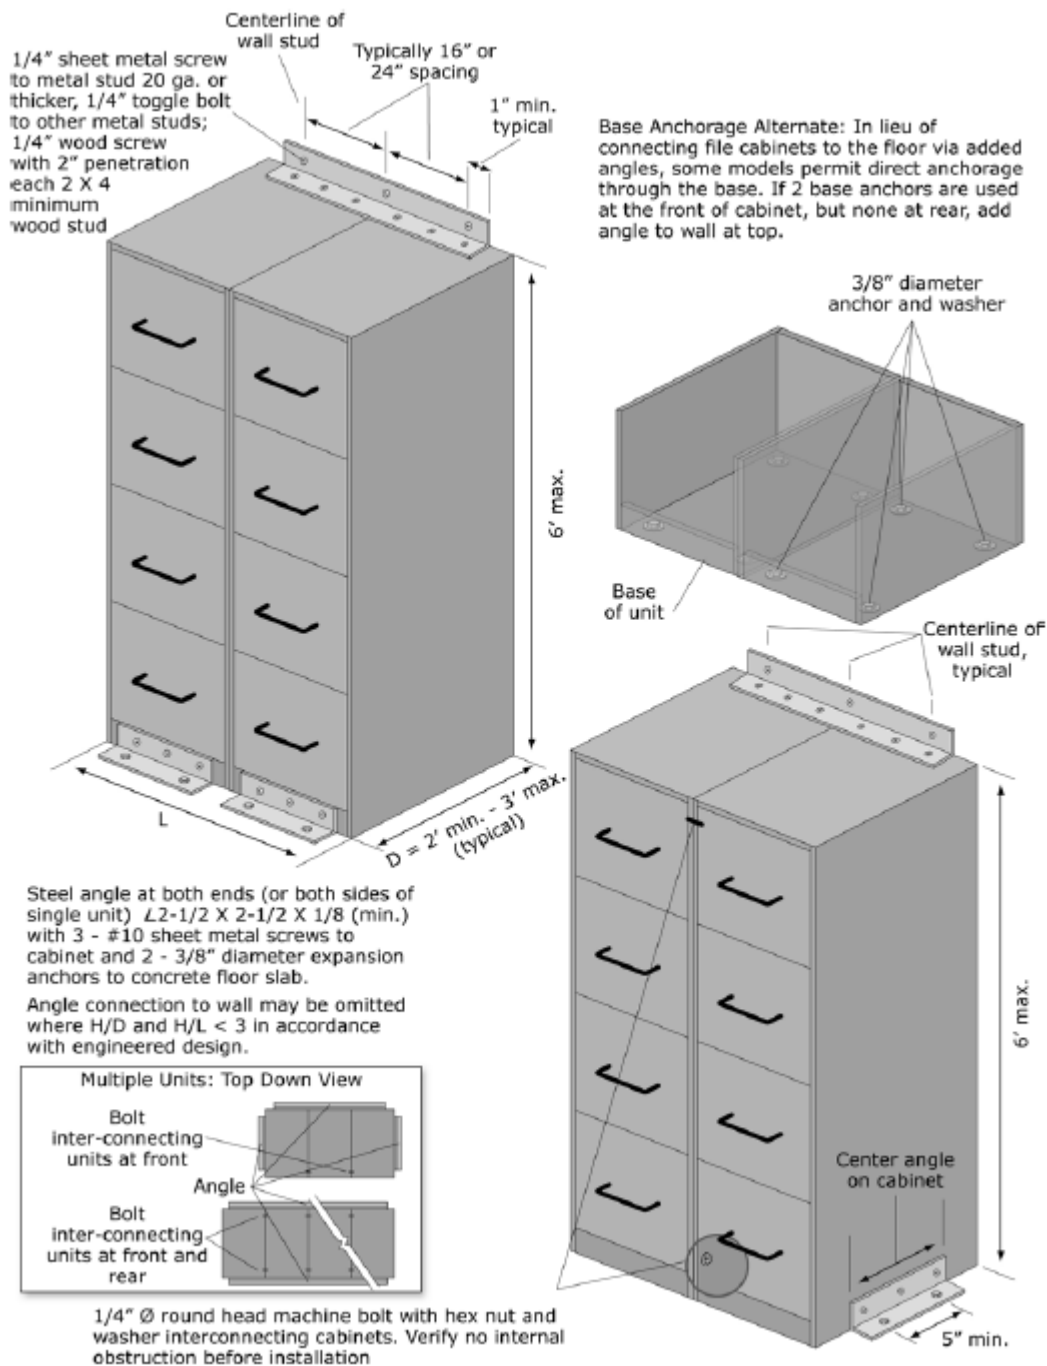
**Figure G-21. Wall-mounted File Cabinets.**

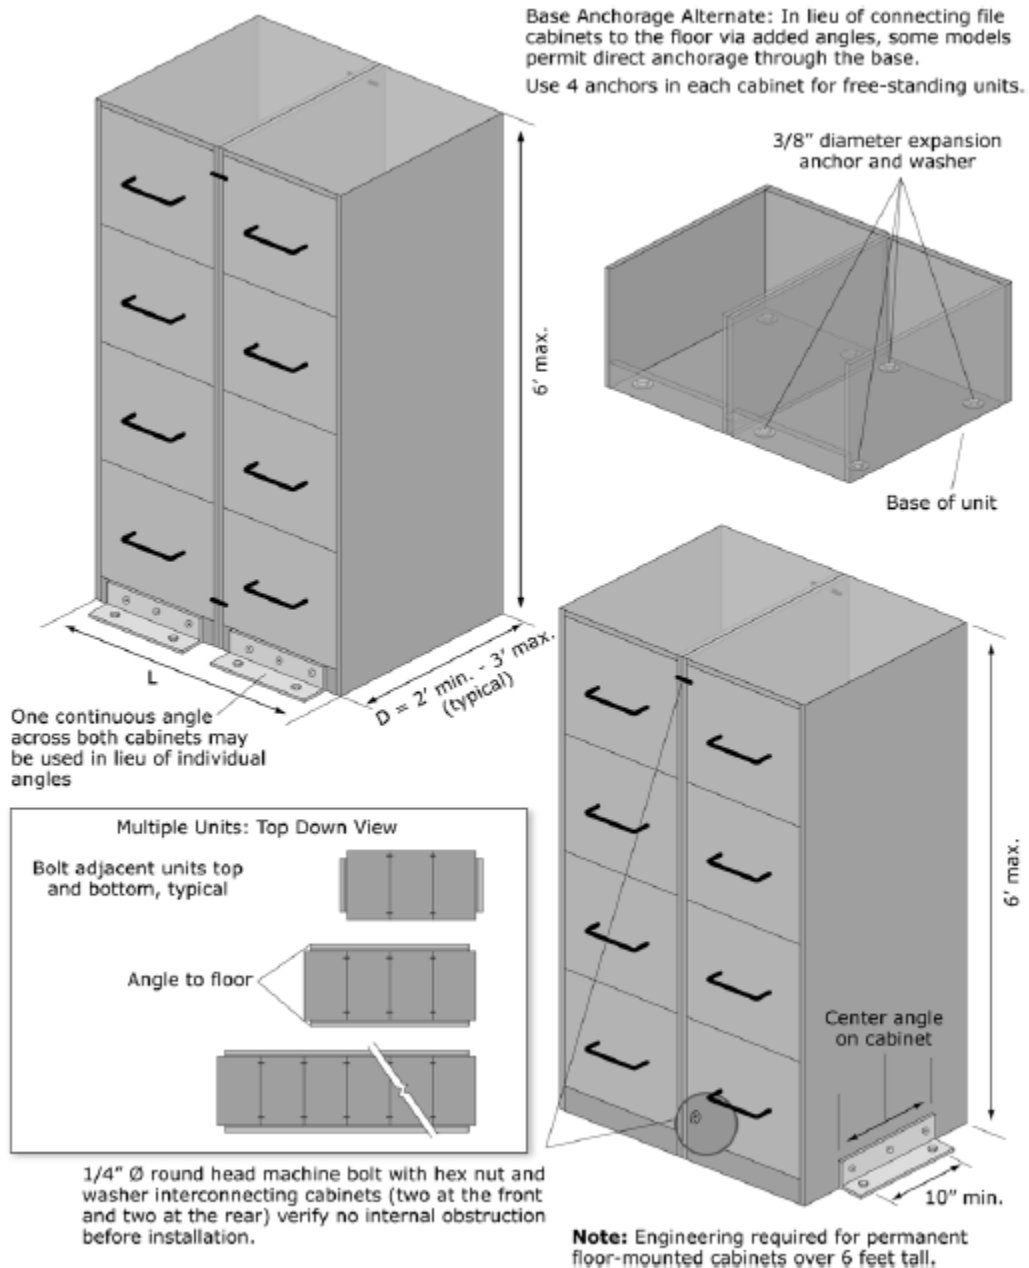
**Figure G-22. Base Anchored File Cabinets.**  
*(FEMA E-74, 2012, Reducing the Risks of Nonstructural Earthquake Damage)*

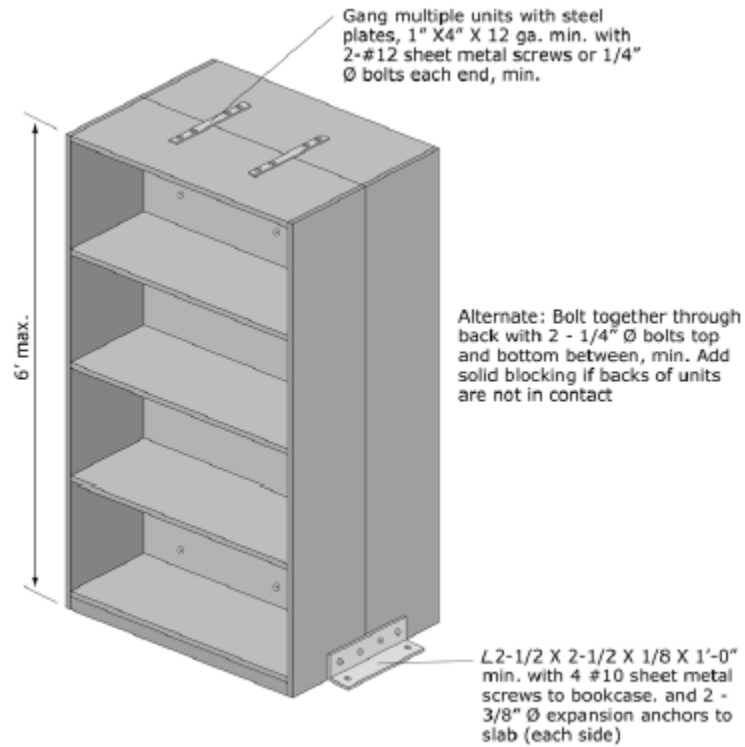
**Note:** Engineering required for all permanent floor-supported cabinets or shelving over 6 feet tall. Details shown are adequate for typical shelving 6 feet or less in height.

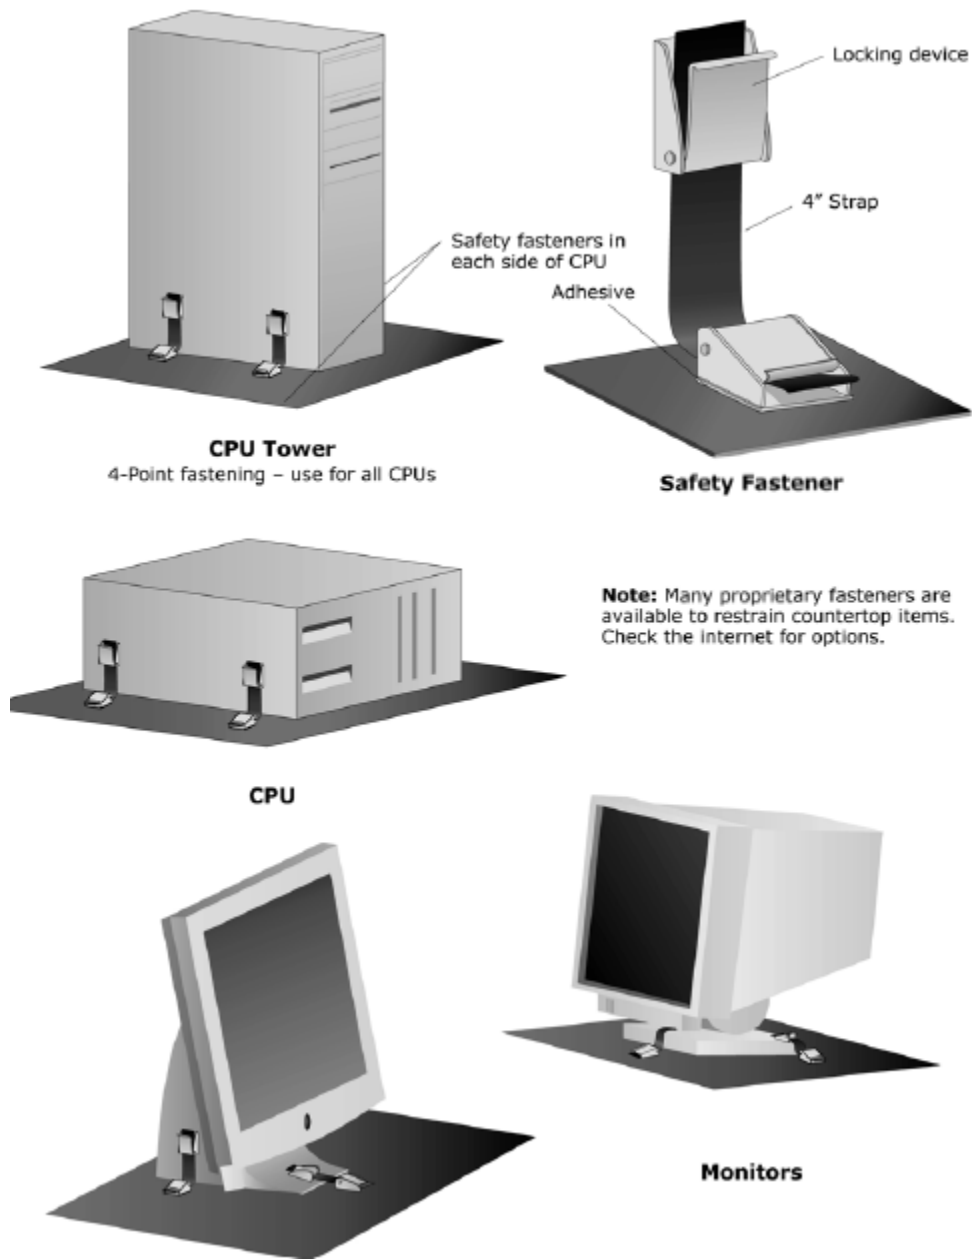
**Figure G-24. Desktop Computers and Accessories.**  
*(FEMA E-74, 2012, Reducing the Risks of Nonstructural Earthquake Damage)*

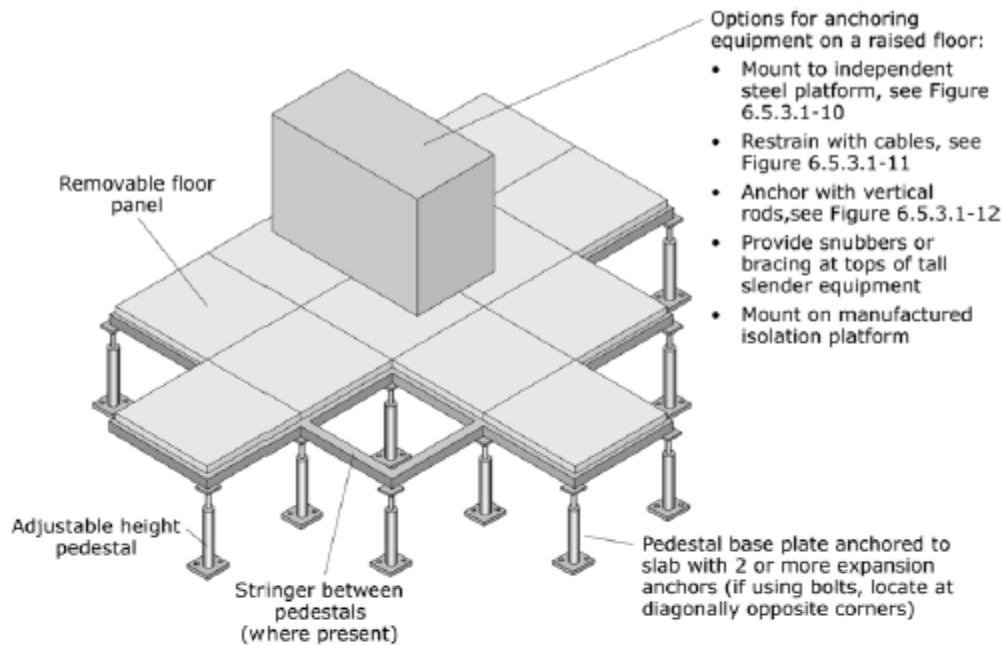
**Cantilevered Access Floor Pedestal**

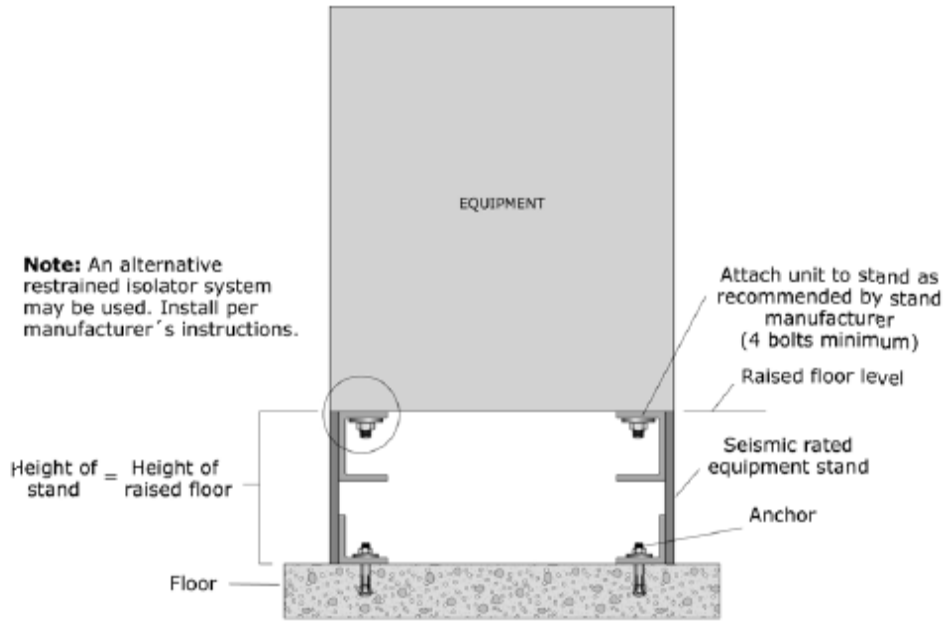
**Equipment installed on an independent steel platform within a raised floor**

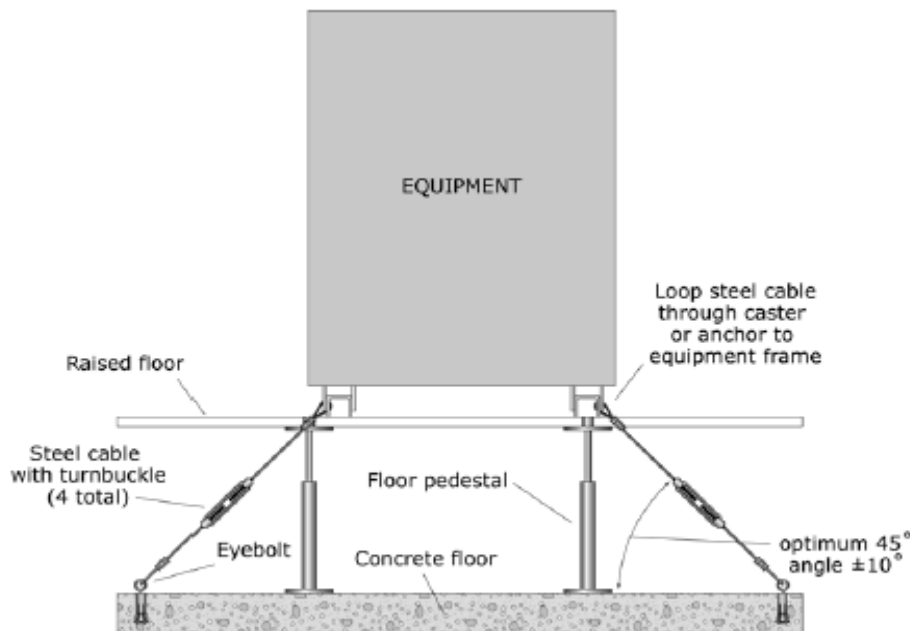
**Equipment restrained with cables beneath a raised floor**

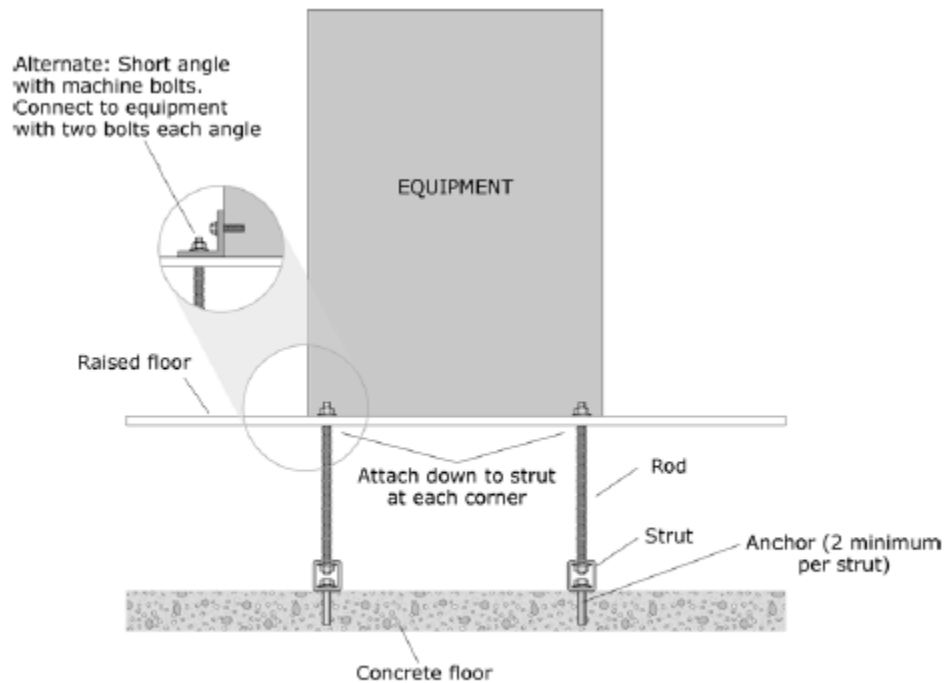
**Equipment anchored with vertical rods beneath a raised floor**

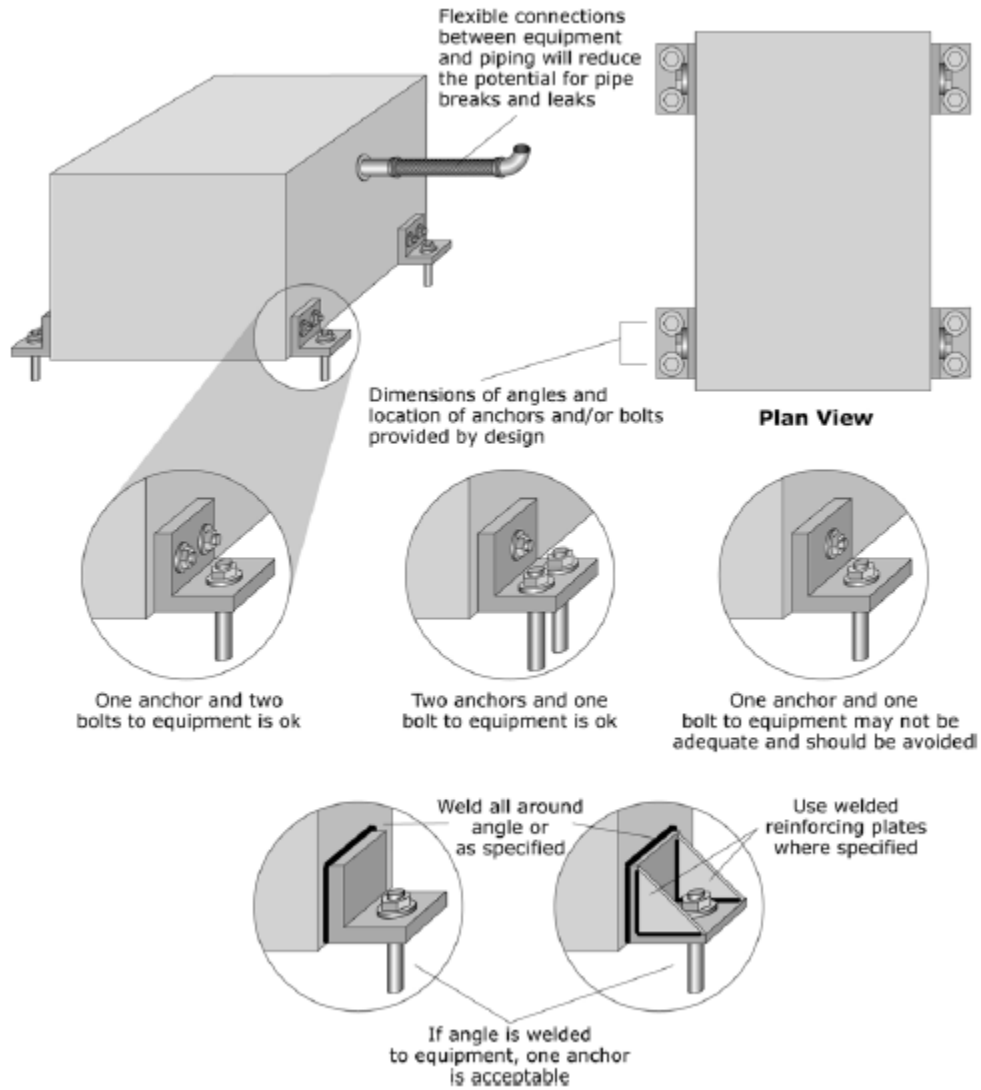
**Note:** Rigidly mounted equipment shall have flexible connections for the fuel lines and piping.

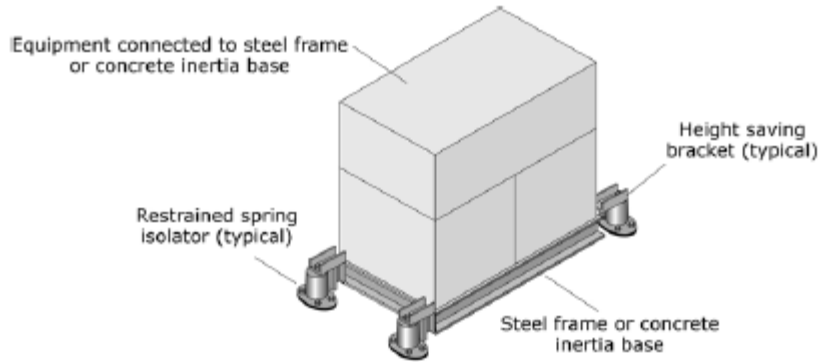
**Supplemental base with restrained spring isolators**

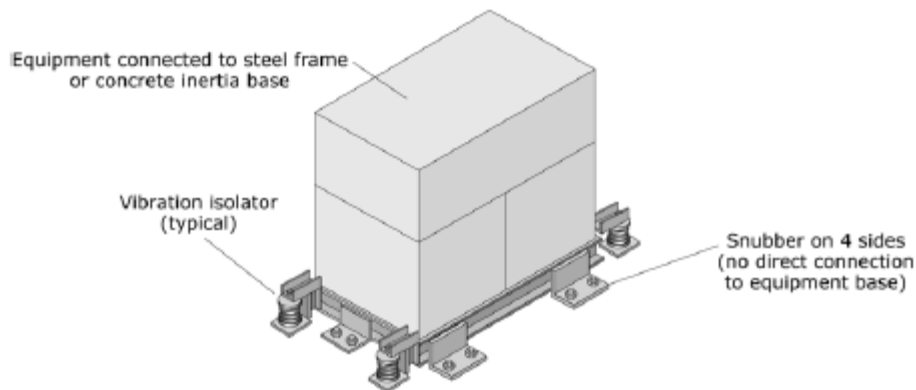
**Supplemental base with open springs and one-directional snubbers**

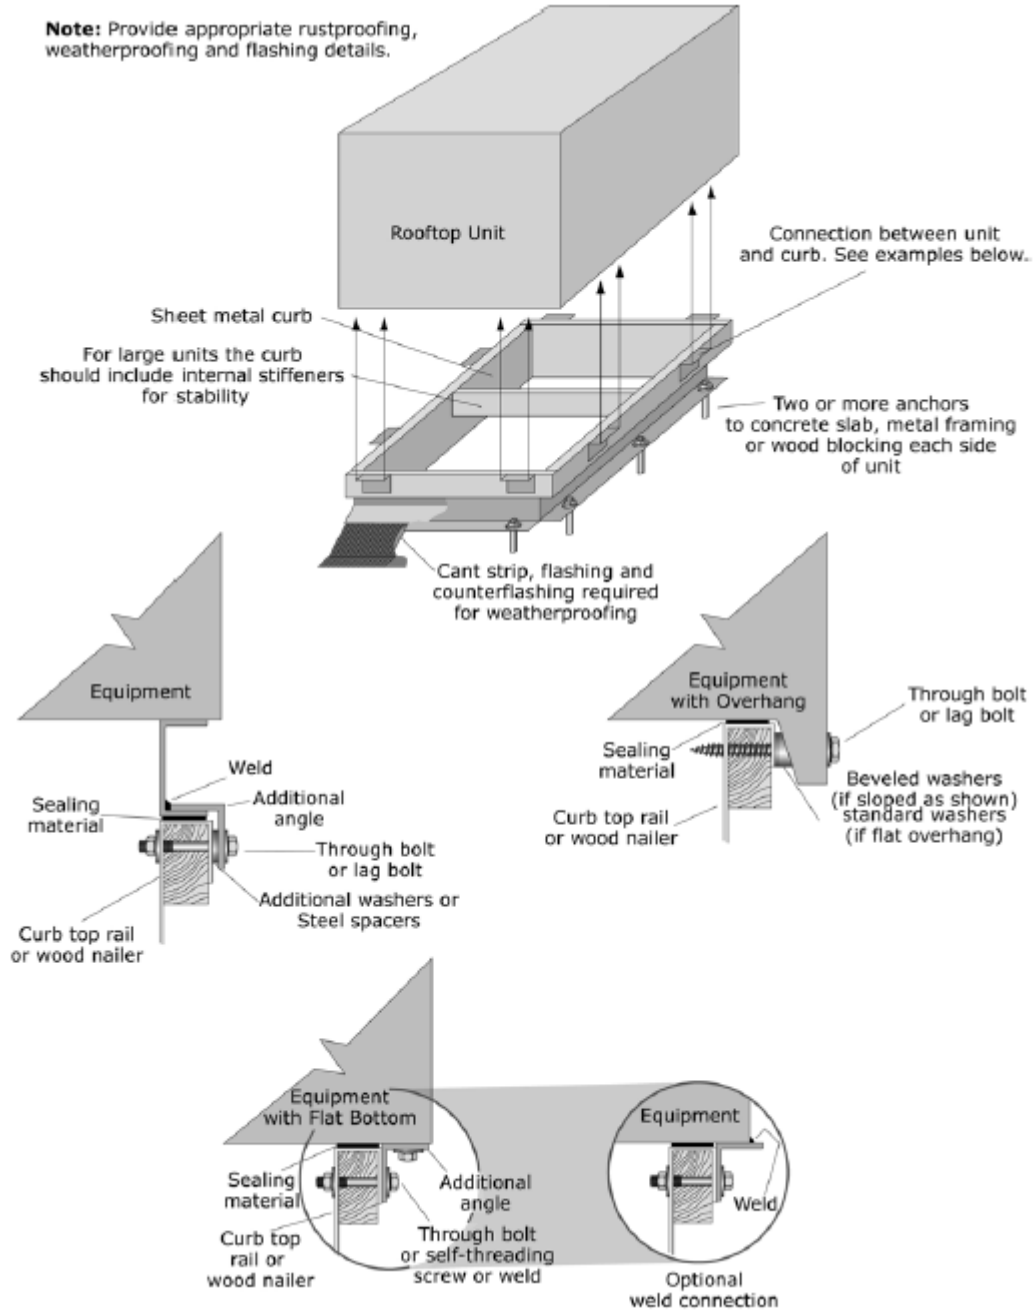
**Figure G-31. Rooftop HVAC Equipment.**

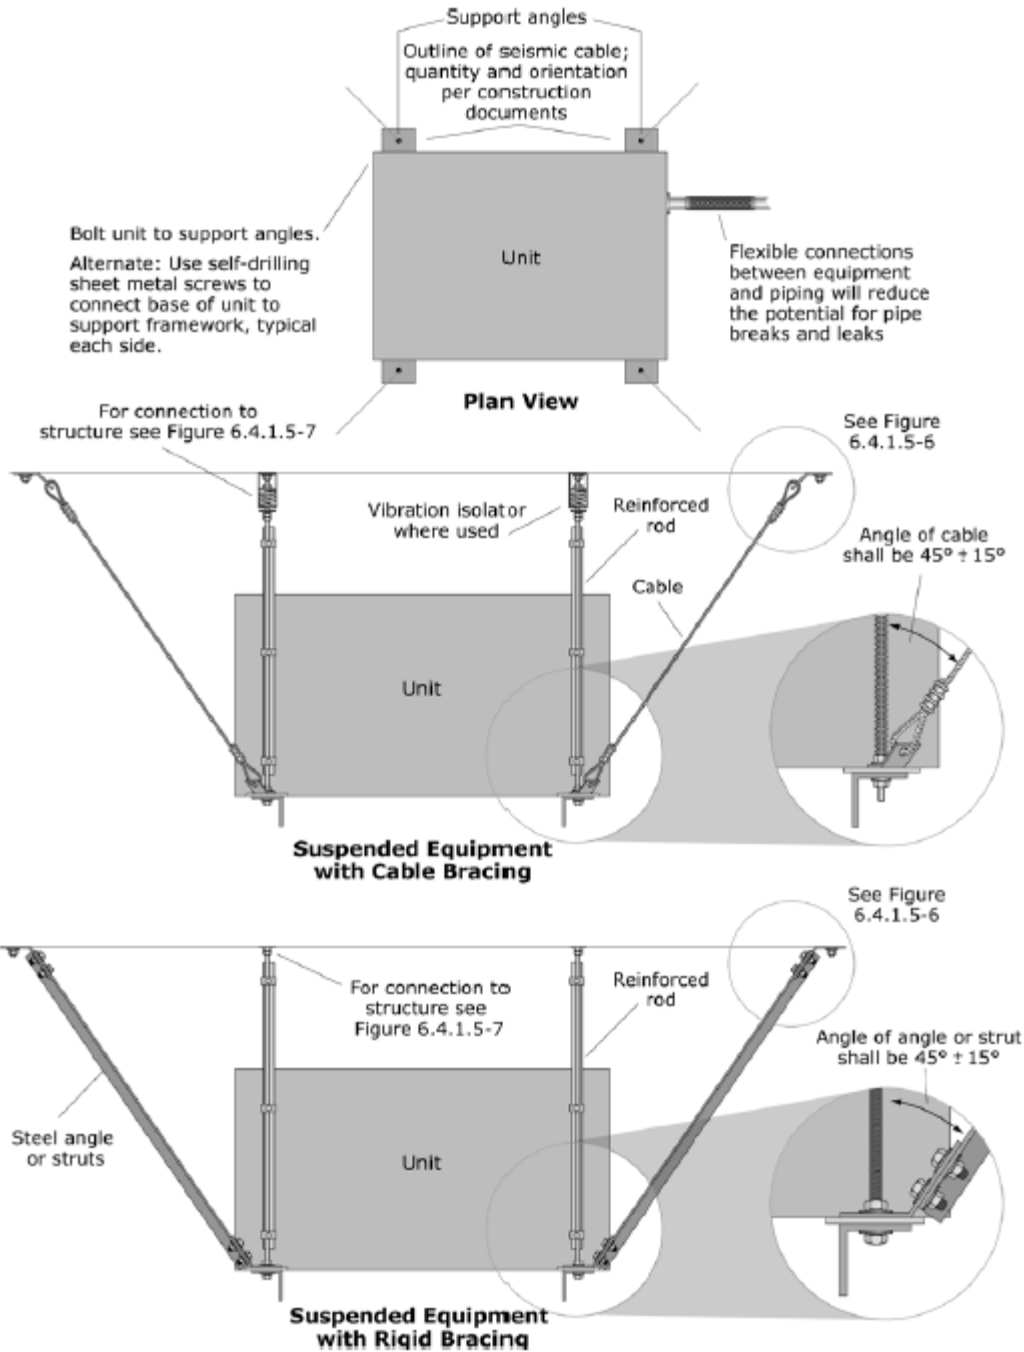
**Figure G-32. Suspended Equipment.**  
*(FEMA E-74, 2012, Reducing the Risks of Nonstructural Earthquake Damage)*

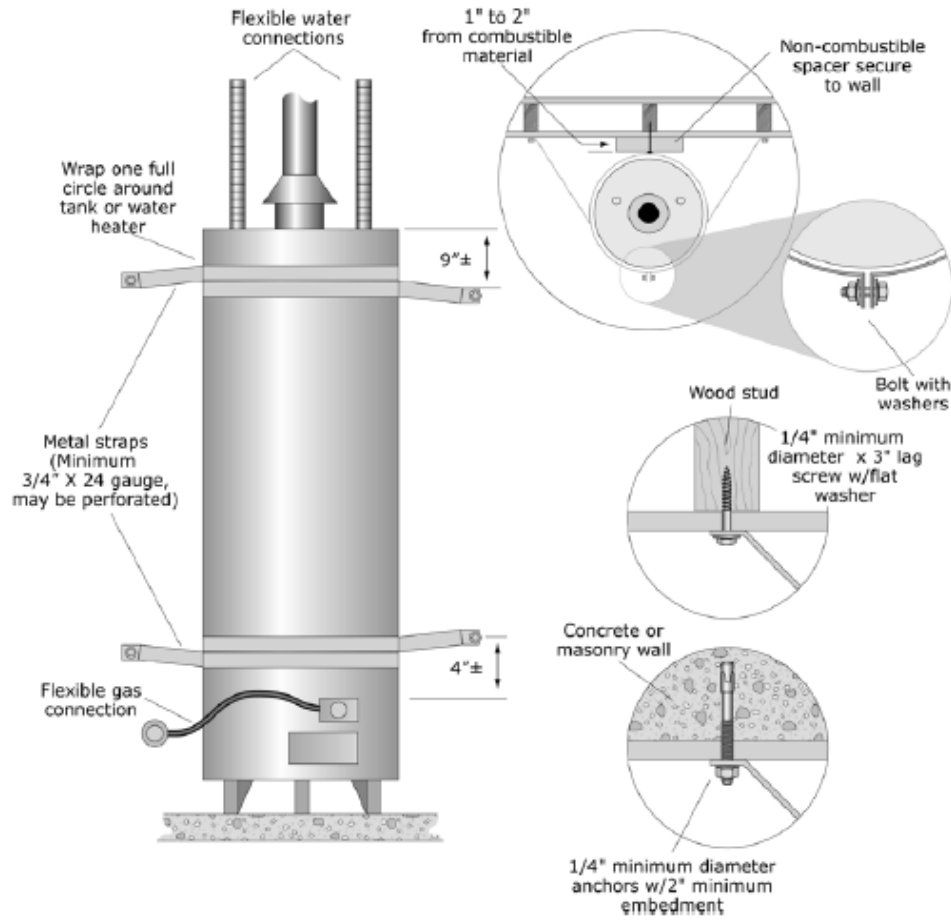
**Figure G-33. Water Heater Strapping to Backing Wall.**  
*(FEMA E-74, 2012, Reducing the Risks of Nonstructural Earthquake Damage)*

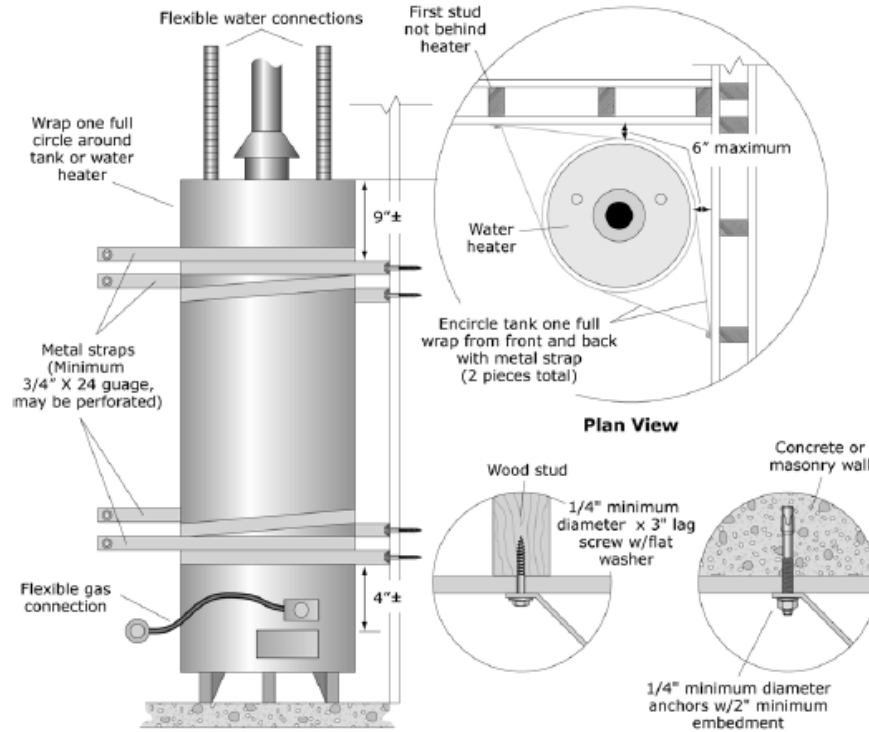
**Figure G-34. Water Heater – Strapping at Corner Installation.**  
*(FEMA E-74, 2012, Reducing the Risks of Nonstructural Earthquake Damage)*

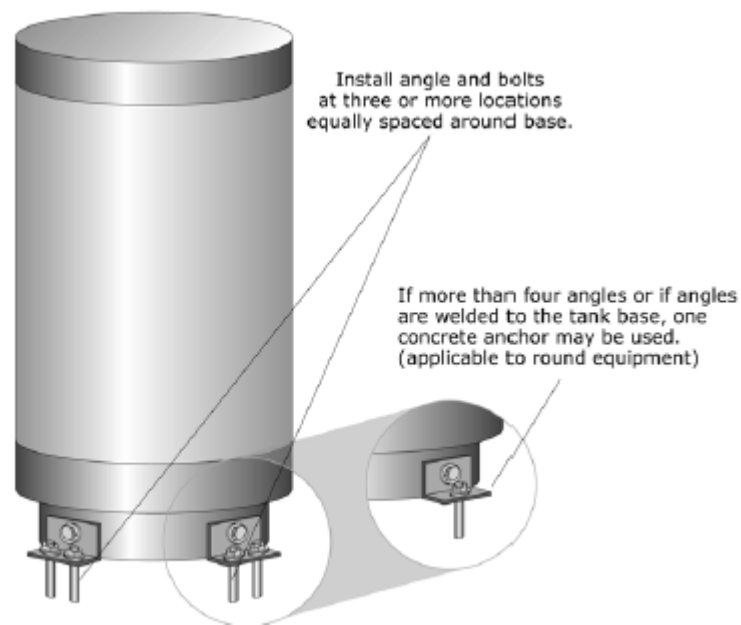
**Figure G-35. Water Heater – Base Mounted.**  
*(FEMA E-74, 2012, Reducing the Risks of Nonstructural Earthquake Damage)*

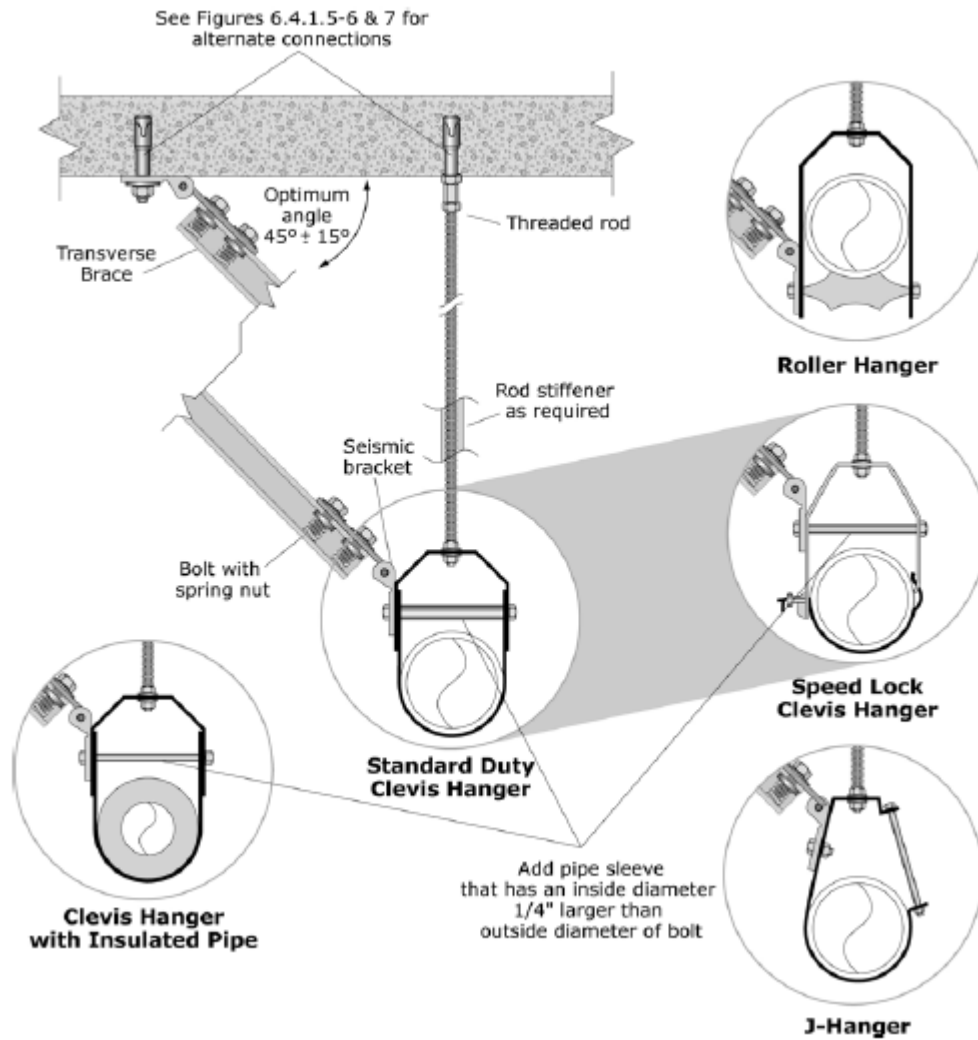
**Figure G-36. Rigid Bracing – Single Pipe Transverse.**  
*(FEMA E-74, 2012, Reducing the Risks of Nonstructural Earthquake Damage)*

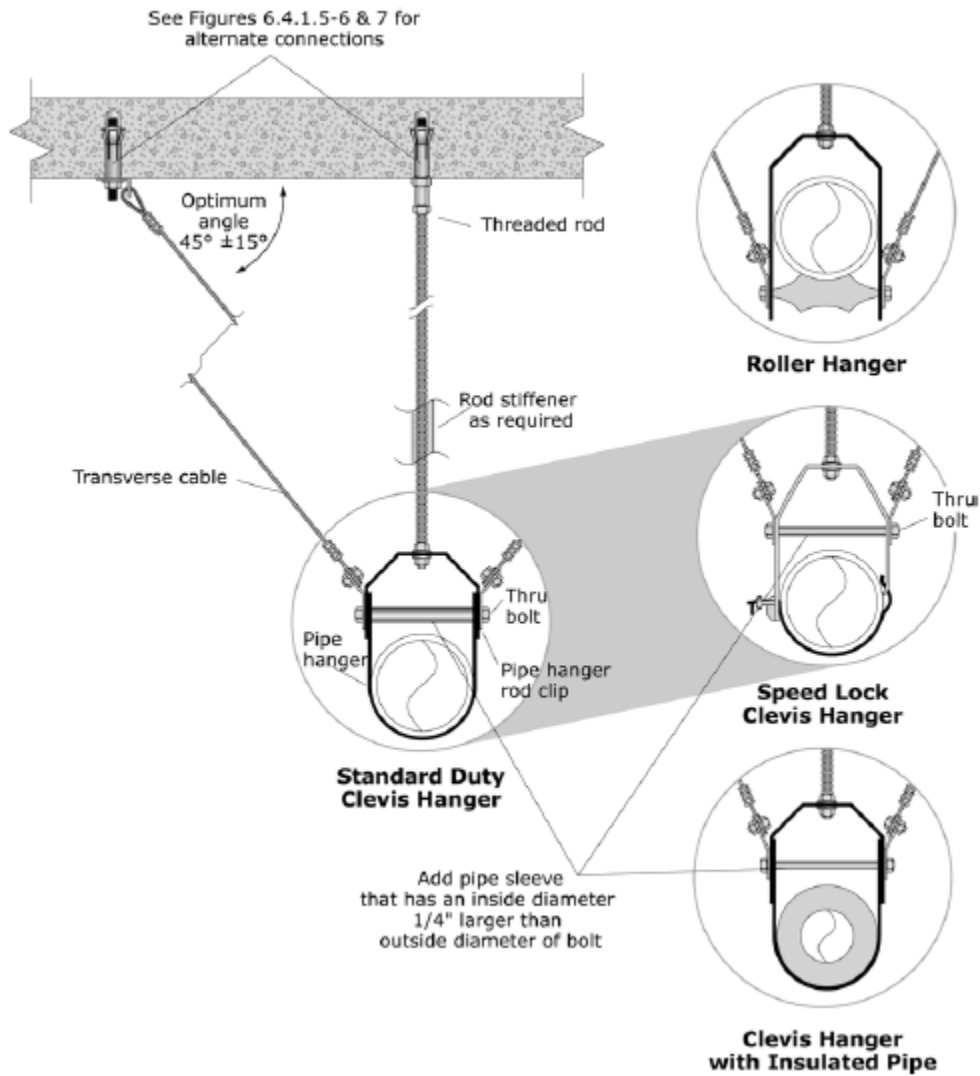
**Figure G-37. Cable Bracing – Single Pipe Transverse.**  
*(FEMA E-74, 2012, Reducing the Risks of Nonstructural Earthquake Damage)*

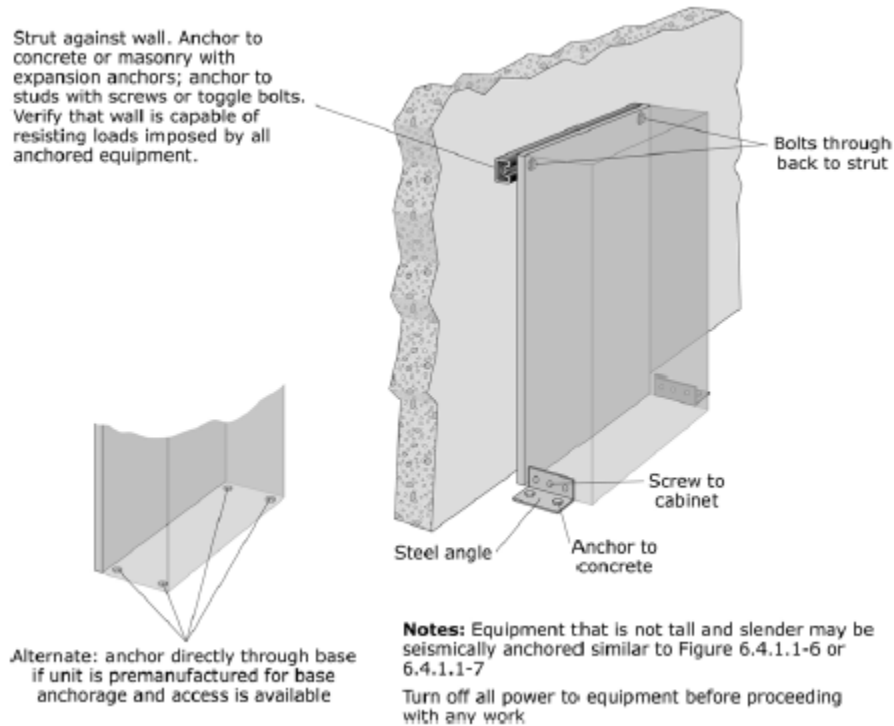
**Figure G-38. Electrical Control Panels, Motor Controls Centers, or Switchgear.**  
(FEMA E-74, 2012, Reducing the Risks of Nonstructural Earthquake Damage)

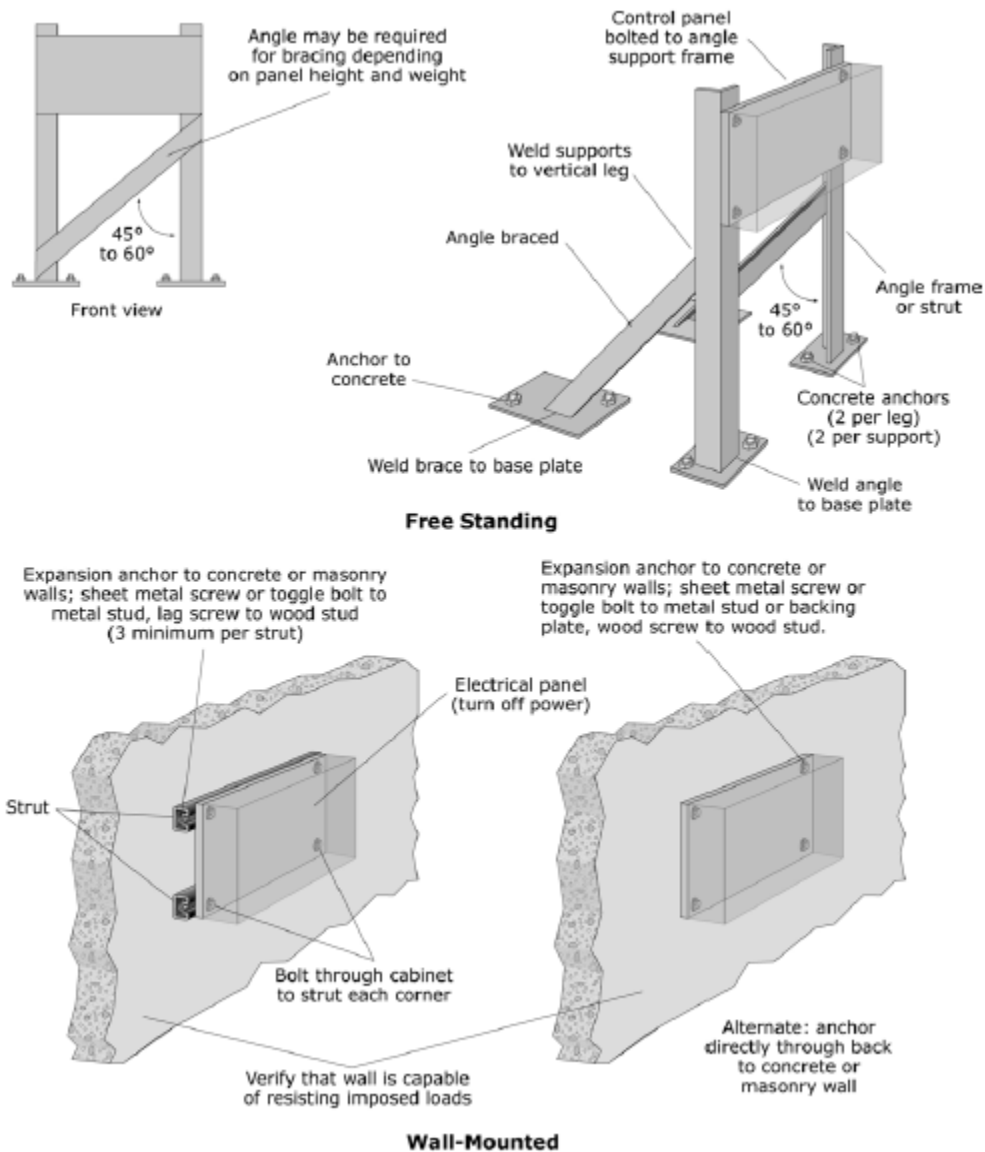
**Figure G-39. Freestanding and Wall-mounted Electrical Control Panels, Motor Controls Centers, or Switchgear.**  
*(FEMA E-74, 2012, Reducing the Risks of Nonstructural Earthquake Damage)*

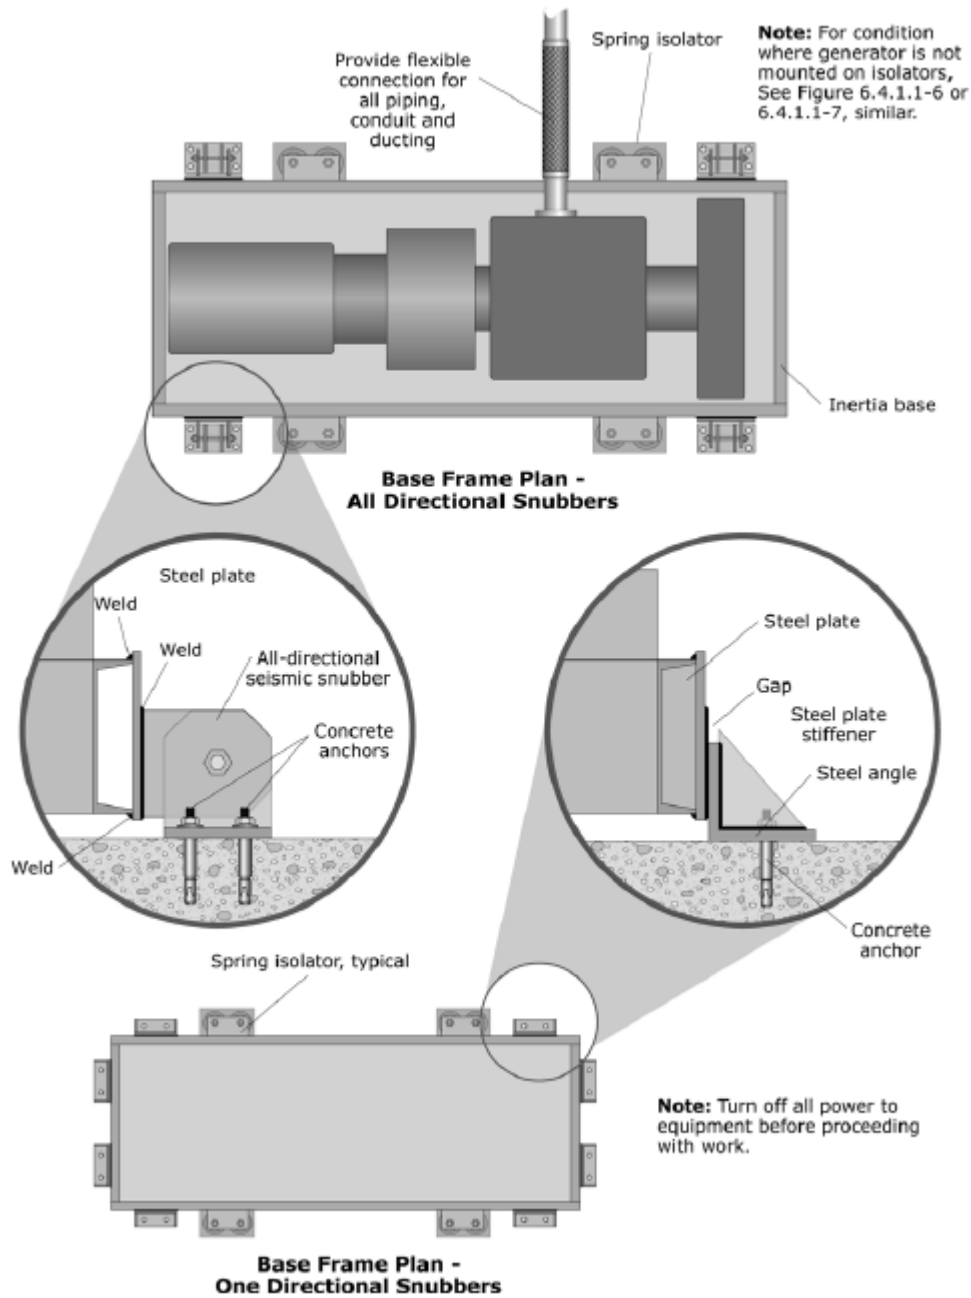
**Figure G-40. Emergency Generator.**  
*(FEMA E-74, 2012, Reducing the Risks of Nonstructural Earthquake Damage)*
