BEACHAM/WILLIAMS STREET CORRIDOR STUDY

CITY OF CHELSEA,
MASSACHUSETTS

JUNE 26 2018

ROAD SAFETY AUDIT (RSA)
FINAL REPORT

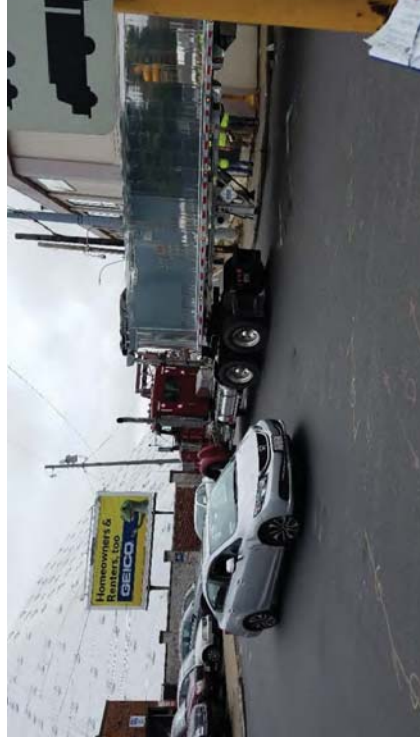
Additionally, there is an offset between Marginal Street and Williams Street so vehicles crossing through the intersection must adjust to enter the correct lane exiting the opposite side of the intersection.
 2. Corner radii are small in this intersection. It was observed that eastbound trucks turning from Williams onto the bridge encroach into the oncoming lane to execute the movement. There was also evidence of vehicles clipping obstructions as they encroached on the curb while executing turning movements. This included damaged signs and poles. This creates a concern for the safety of pedestrians waiting on the corner.

Image 1: Williams Street at Pearl Street – Truck attempting to turn right from Williams onto McArdle Bridge

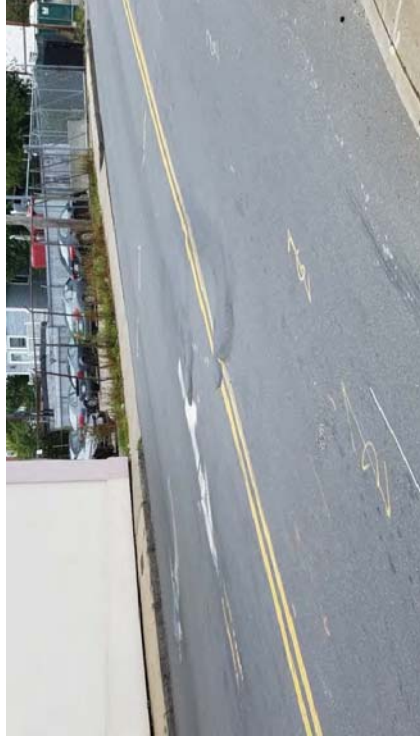
- The pavement on Williams Street is worn and has numerous patches. There are also areas of rutting most likely due to the heavy vehicles and braking as vehicles approach the intersection from the West. The rutting can make controlling a vehicle or bicycle difficult.

Image 2: Williams Street at Pearl Street – Williams Street approach showing worn pavement markings and rutted pavement.

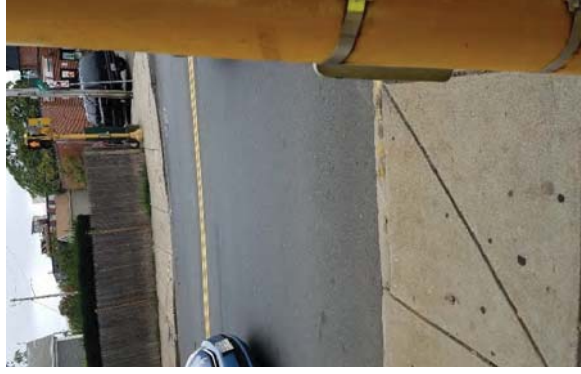
- There is currently a pedestrian signal and crossing across Williams Street, south of Tremont Street. There are no crosswalk markings and the post-mounted signal is hard to see since the post is located against the building. In addition, there is a sign that says, "Stop here on Red". This combined with the proximity to the Broadway signal creates confusion as to where vehicles should stop when waiting at a red light. There was a pedestrian crash that occurred at this location. Another pedestrian crash occurred while a pedestrian was crossing the western crosswalk.

Image 3: Crossing at Williams Street at Tremont Street. No crosswalk but pedestrian signals present.

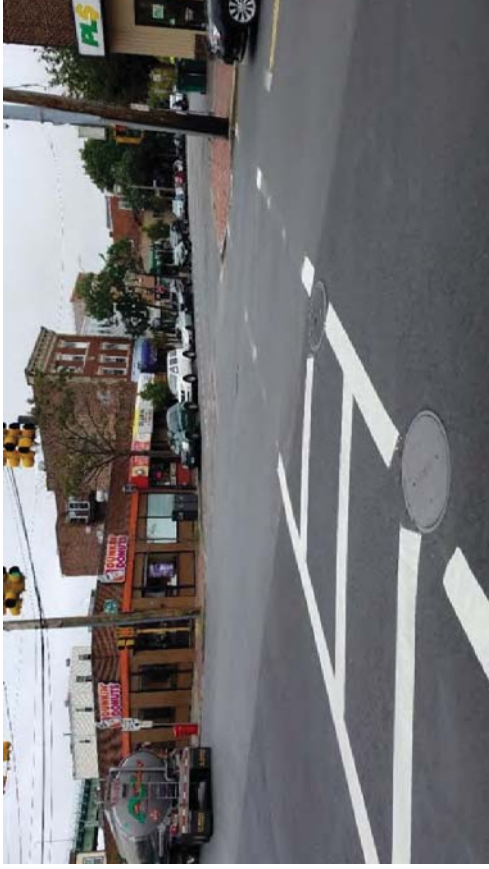
Image 4: Williams Street at Broadway.

- **Potential Enhancement:** Review clearance intervals to allow traffic to clear based on Institute of Transportation Engineers guidelines and update if necessary. This includes evaluating yellow/red clearance intervals. Coordinating timing with the intersection at Pearl Street could potentially help alleviate congestion.

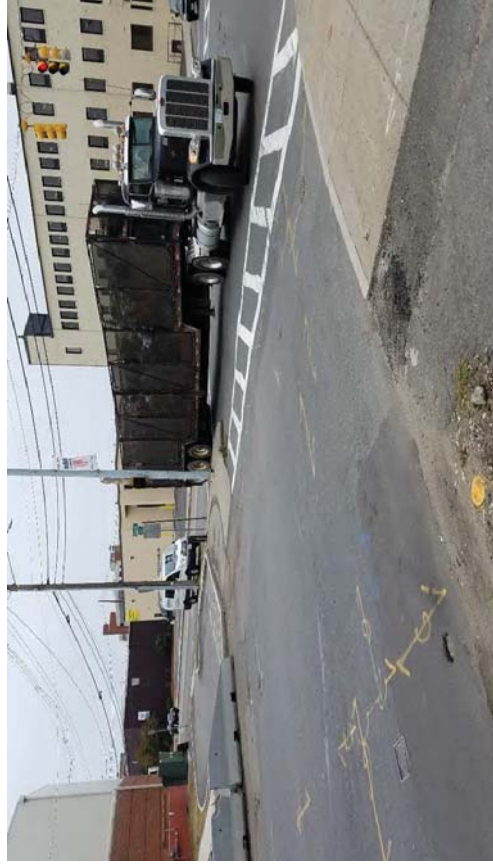
Image 5: Williams Street at Spruce Street – Truck turning right from Spruce onto Williams. Encroaching into oncoming lane on Williams Street.

Potential Enhancement: Evaluate curb radii for truck turns and consider relocating any potential obstructions (utility poles, signs, etc.) to ensure that vehicles can execute movements without encroaching on curb. Evaluate location of stop bars and ensure that pavement markings/signage clearly convey stop location to vehicles.
