# Southeast Trees:

## A Multi-Site Tree Planting and Evaluation Project in Southeast Los Angeles County

### Part 1. Introduction and El Dorado East Regional Park

DONALD R. HODEL

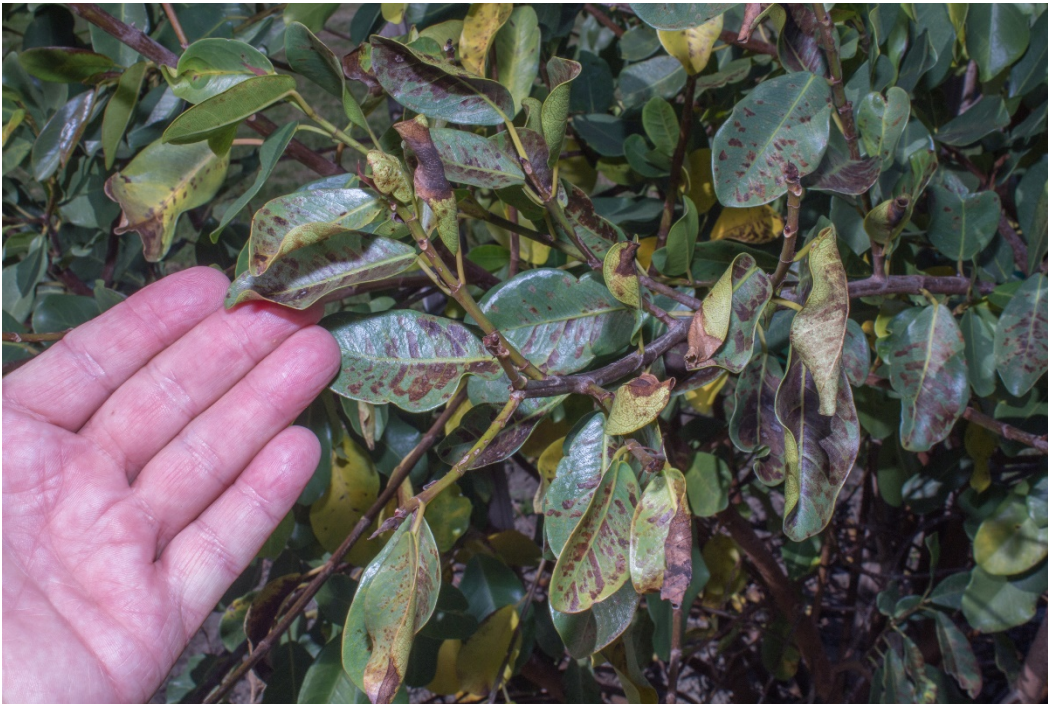
4. *Ficus natalensis* (2016-06-ED38) shows cold damage, January 2019.

5. Cold damage on *Ficus natalensis* (2016-06-ED38) , January 2019.

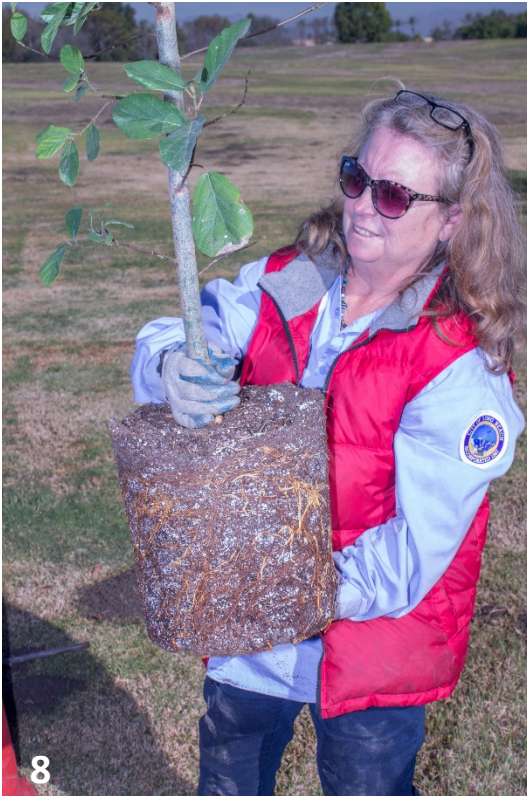
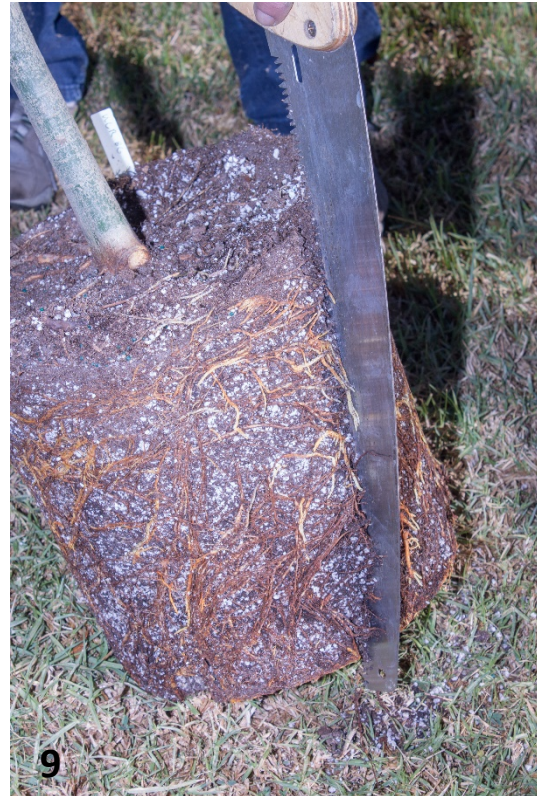
**8–9.** We carefully inspected root systems before planting and if necessary corrected circling or kinked roots.

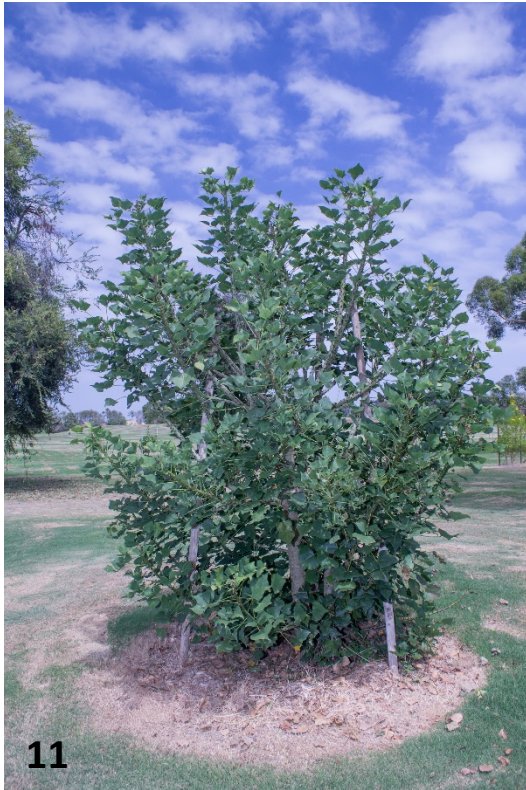
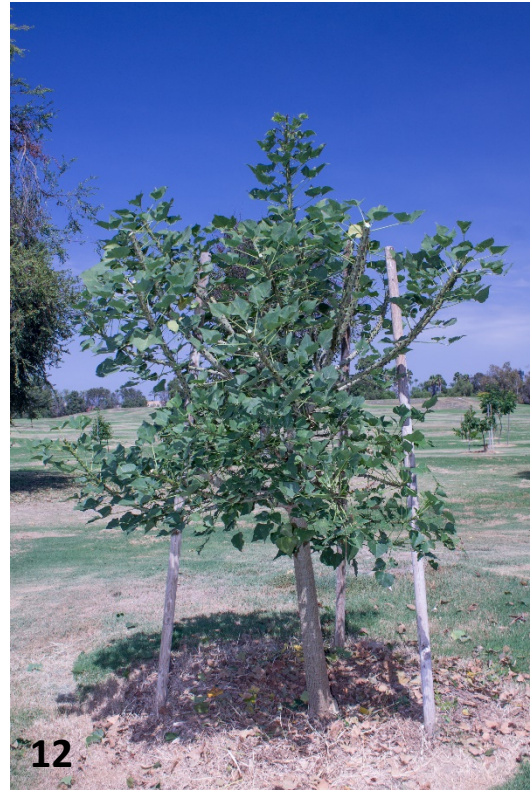
11–12. Structural pruning of *Erythrina sandwicensis* showing before (left) and after (right) pruning.

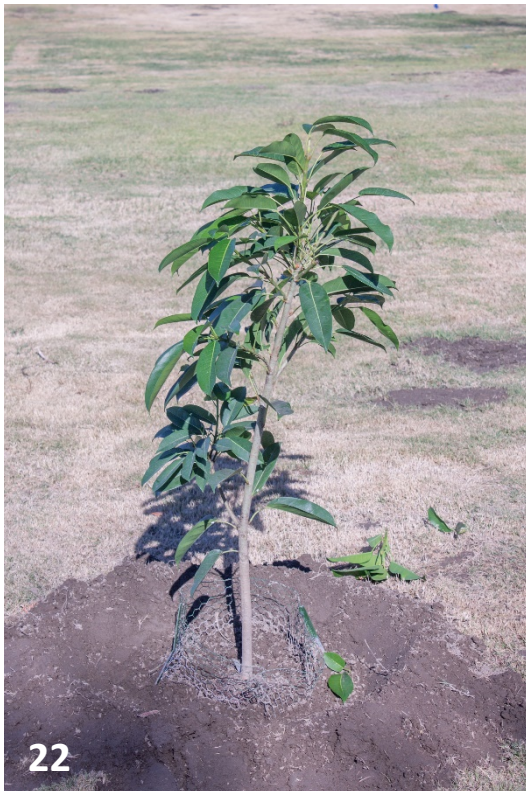
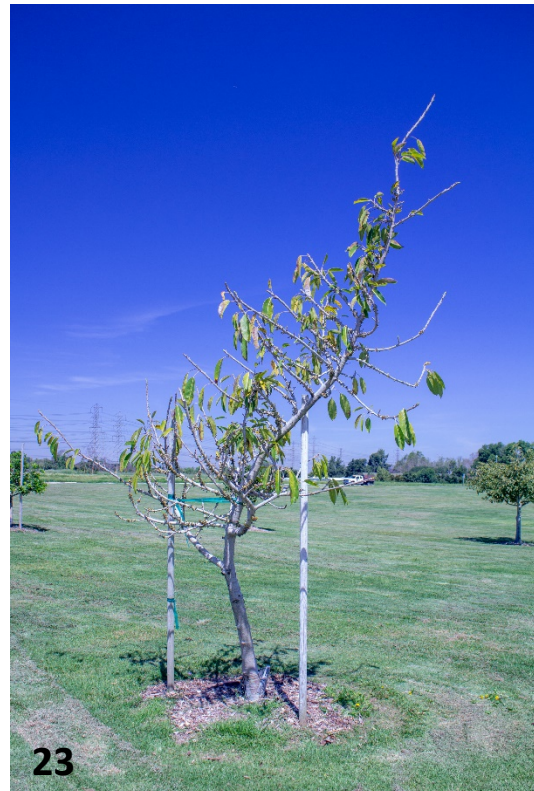
**Ficus caulocarpa** 33.822725N, 118.087779W 2015-12-ED30 **Figs. 22–23**

**22–23.** *Ficus caulocarpa* 2015 and 2020, the latter just coming out of dormancy.

Notes: This handsome plant has been a steady grower with few problems. It typically suffers slight leaf damage from the cold but recovers quickly in the spring and summer. Judicious structural pruning has been needed to attain and maintain a suitable central leader. It was erroneously planted as *F. superba* but the petiole epidermis flaking off proximally and distally confirms *F. caulocarpa*. It attained maturity and produced figs in 2019.

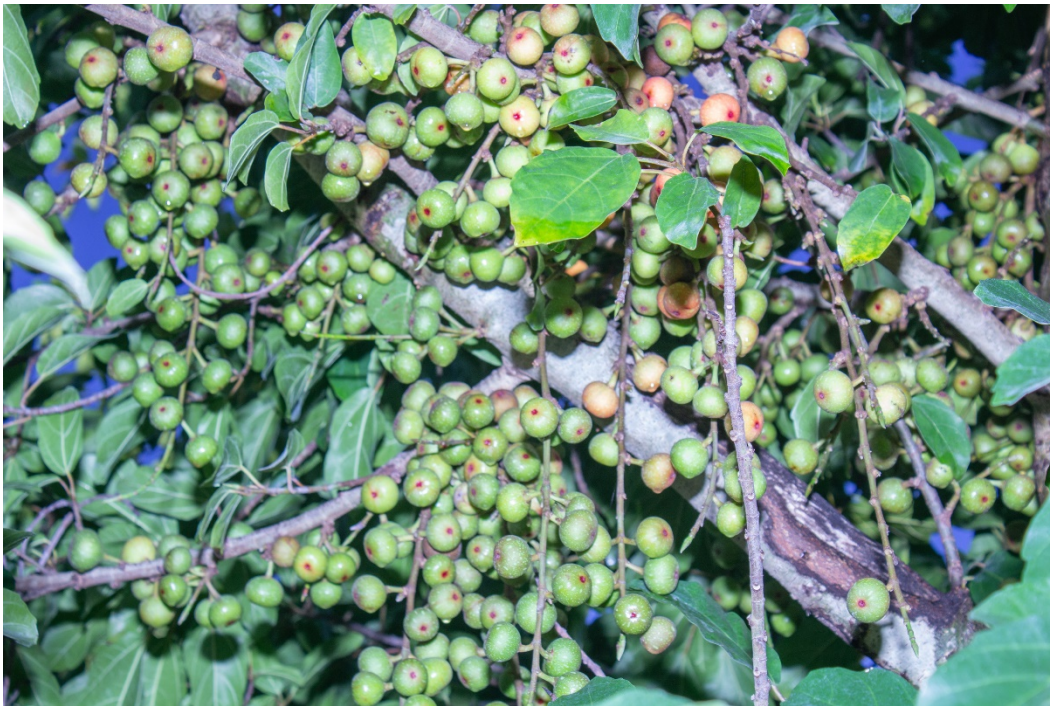
45. *Ficus sur* showing profuse production of figs on specialized leafless branchlets hanging from main branches and the trunk. Note old damaged bark from squirrels in lower right.

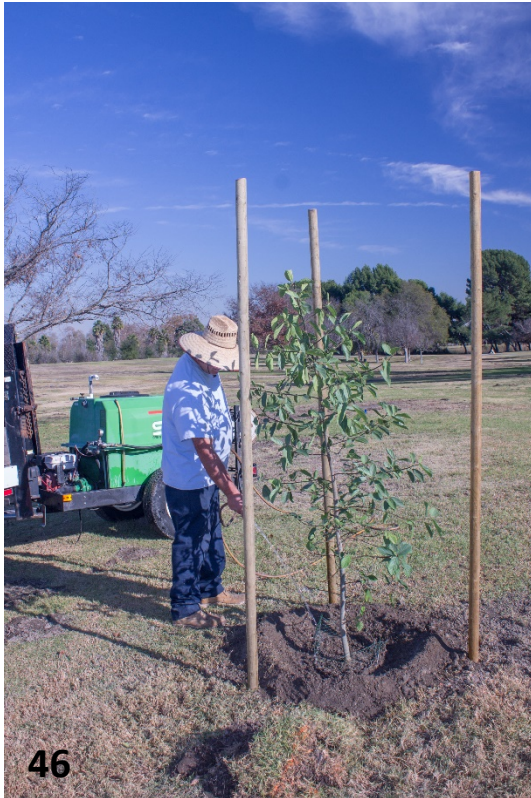
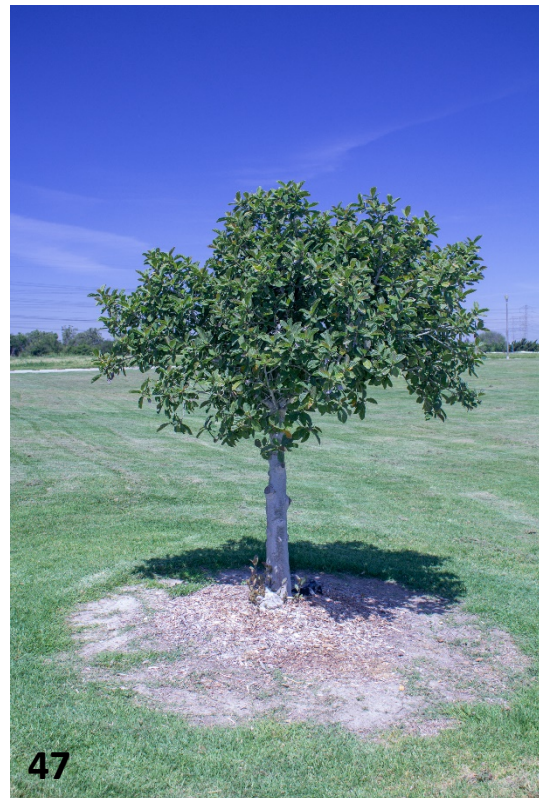
46–47. *Ficus sycomorus* 2015 and 2020.

Notes: This handsome, cutting-grown plant grew extremely fast initially, despite having been killed to the ground by cold its first two winters (2015–2016 and 2016–2017), each time recovering during the following growing season from basal sprouting and growing to two m tall by August. Each time I had to select one of the basal sprouts as the new leader, removing the rest, and after doing so in late 2017, no further serious cold damage occurred but the plant slowed remarkably over the last two years, perhaps from gophers that breached the gopher basket and tunneled around the base of the tree. This plant is the *Ficus cocculifolia* form, considered a synonym of the highly variable *F. sycomorus* and characterized by a strong central leader and upright growth, whitish bark with an attractive greenish tinge, and leaves uncannily like those of the alder, *Alnus rhombifolia*. It attained maturity in late 2019 and produced a few, large, oblate figs directly from proximal parts of major branches near the central leader.

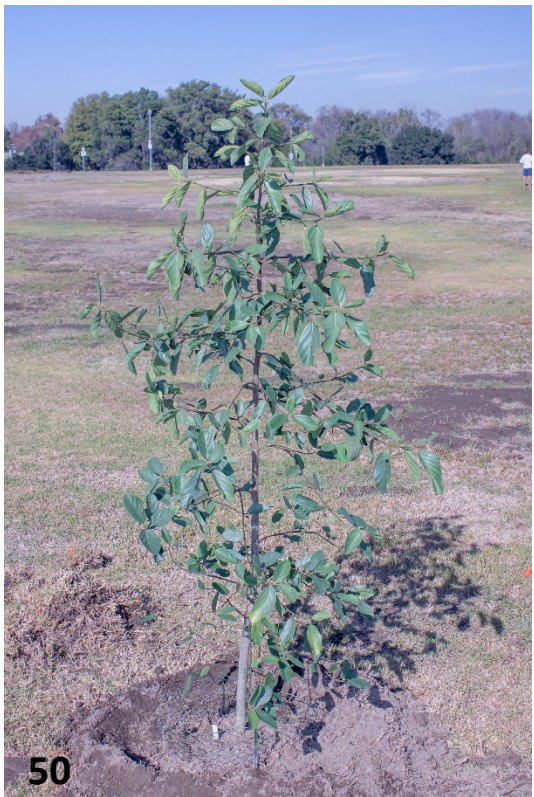
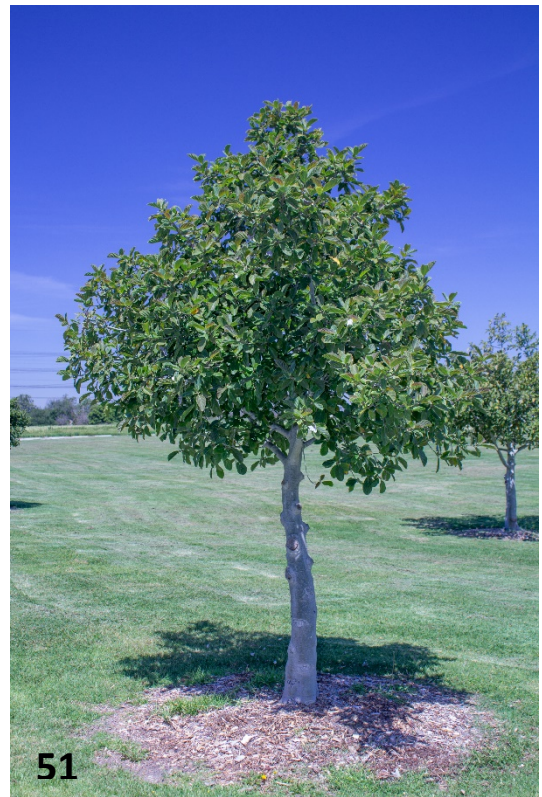
50–51. *Ficus sycomorus* 2015 and 2020.

Notes: This handsome, cutting-grown plant was initially fast growing but has slowed somewhat over the last two years. It suffered moderate leaf burn and slight shoot tip dieback from cold during the first winter (2016–2017). This plant is the *Ficus cocculifolia* form, considered a synonym of the highly variable *F. sycomorus* and characterized by a strong central leader and upright growth, whitish bark with an attractive greenish tinge, and leaves uncannily like those of the alder, *Alnus rhombifolia*.

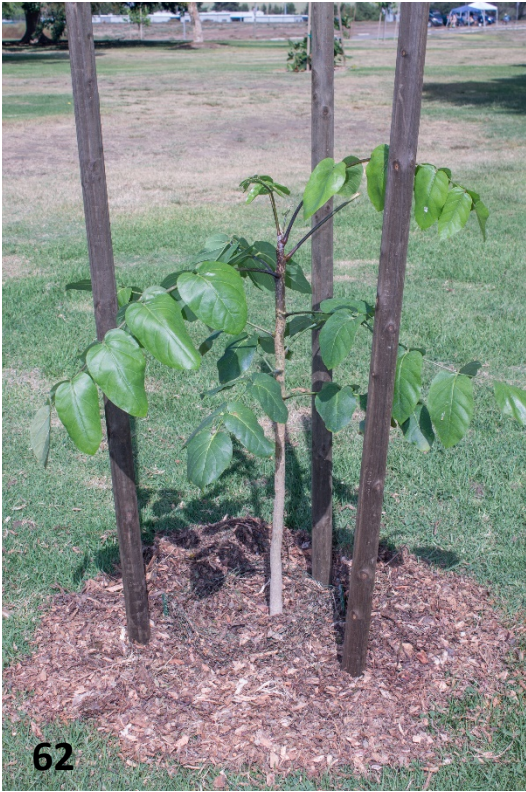
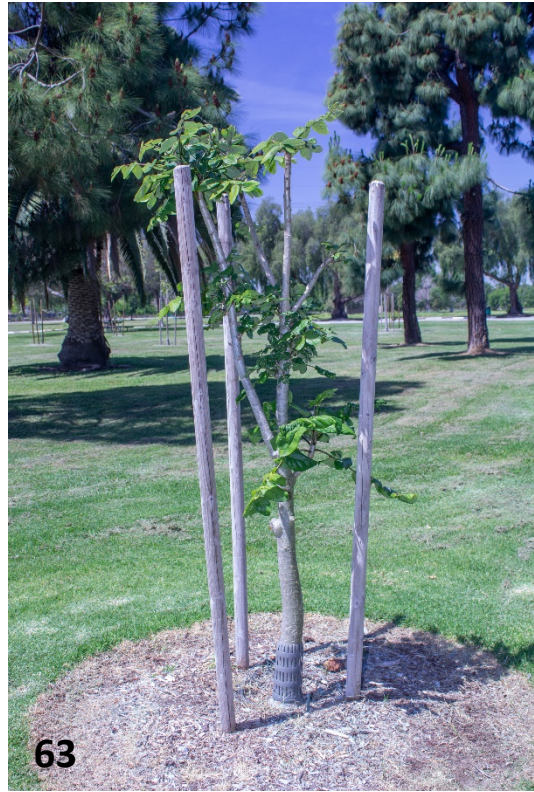
62–63. *Polyscias racemosa* 2016 and 2020.

Notes: This Hawaiian endemic, a purchased plant and formerly known as *Munroidendron racemosa*, has been a steady, moderate grower. New growth is often stunted and distorted, likely from eriophyid mites in the vegetative buds.

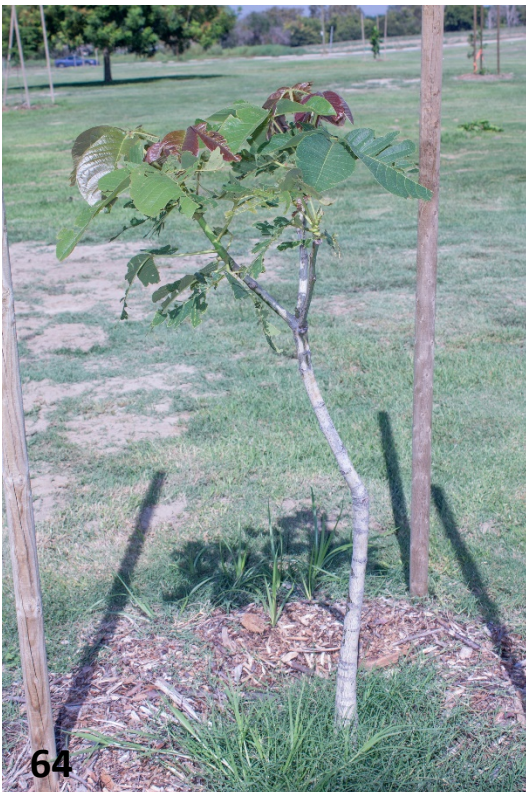
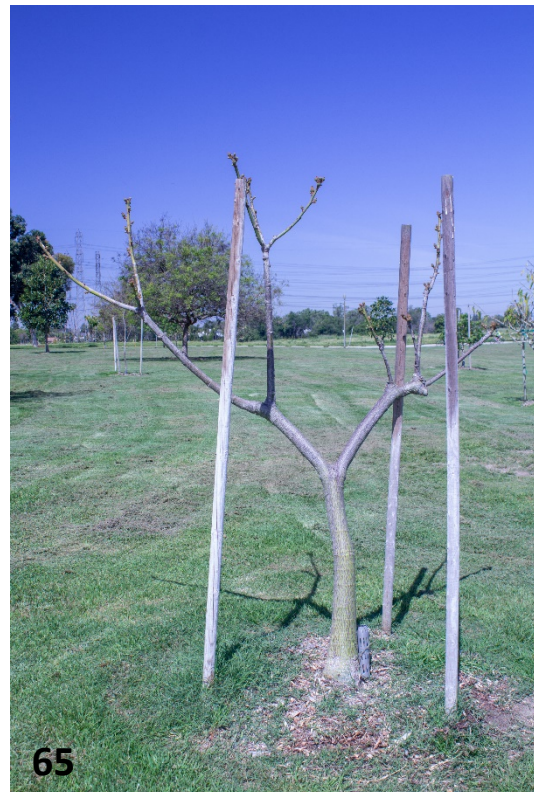
64–65. *Pseudobombax ellipticum* 2016 and 2018, the latter with buds ready to break.
