Conservation Assessment of City-Owned Public Artworks

City of Alexandria, Virginia

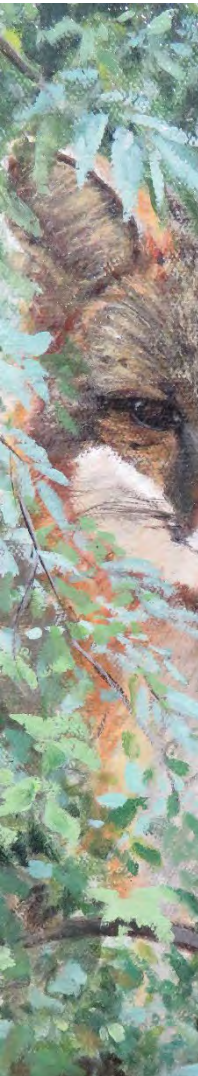
Introduction	1
Methodology	2
Condition Rating	3
Treatment Priority	4
Classification	4
Recommendations	5
Cost Estimates	6
Photo-Documentation of Existing Conditions	9
Appendix A: Location of City-Owned Public Artworks	30

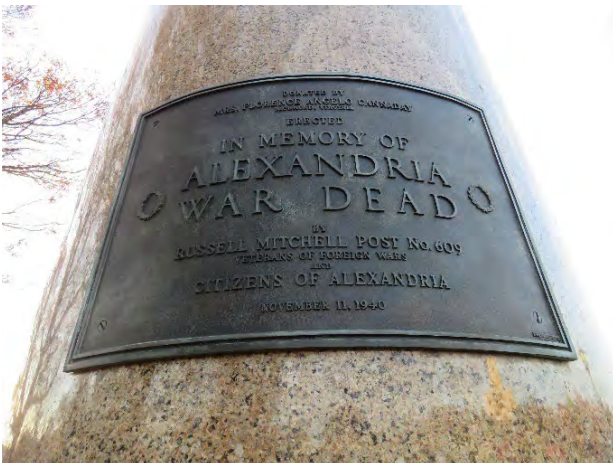
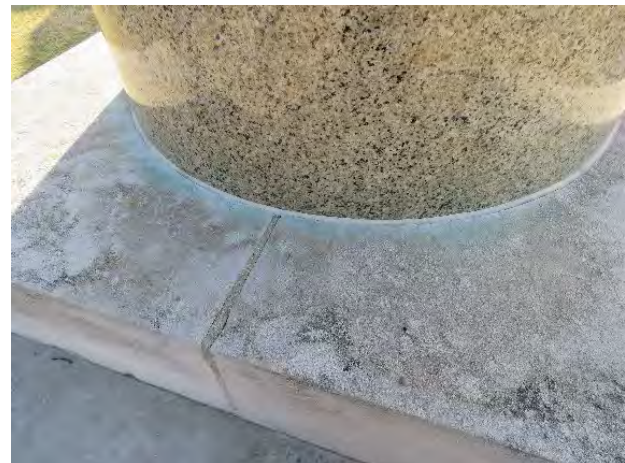
(Left) The protective wax coating on the bronze plaque is weathered and requires replenishing. (Right) Cupric staining on the top step of the limestone base, in the area directly underneath the plaque.

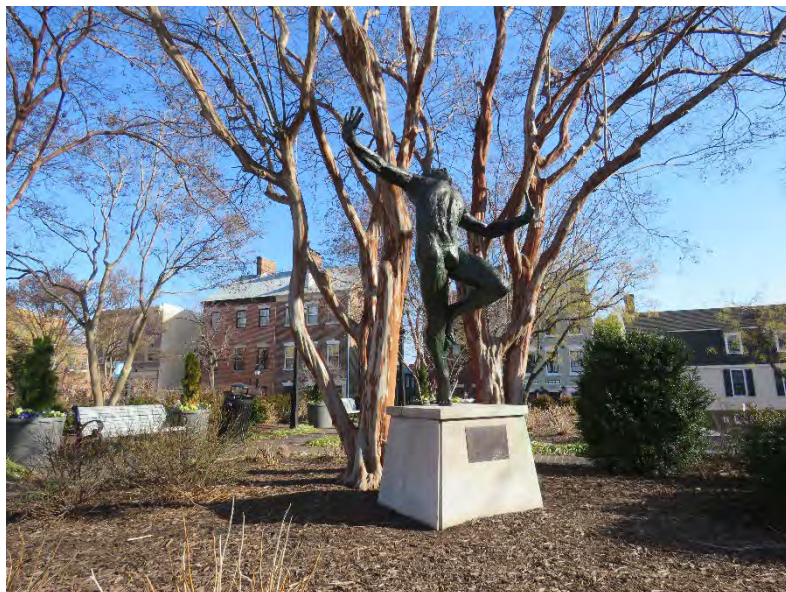
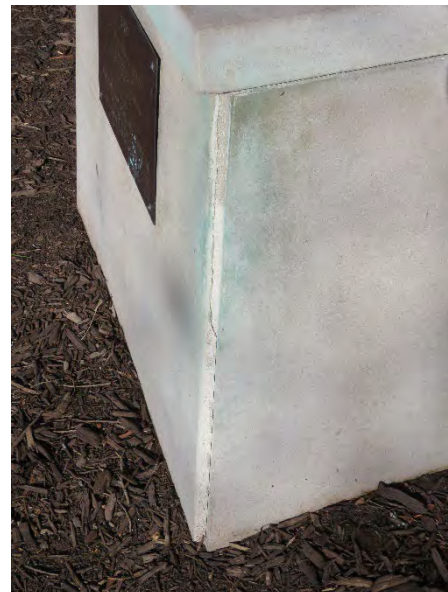
(Left) Siting of the public artwork in front of a group of trees within Market Square, with City Hall located directly north. (Right) Cupric staining on the limestone cladding, with cracking limited to the vertical mortar joints on the southeast side of the plinth.

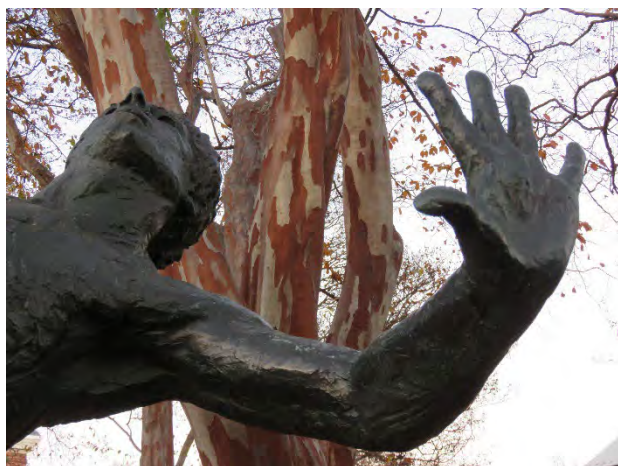
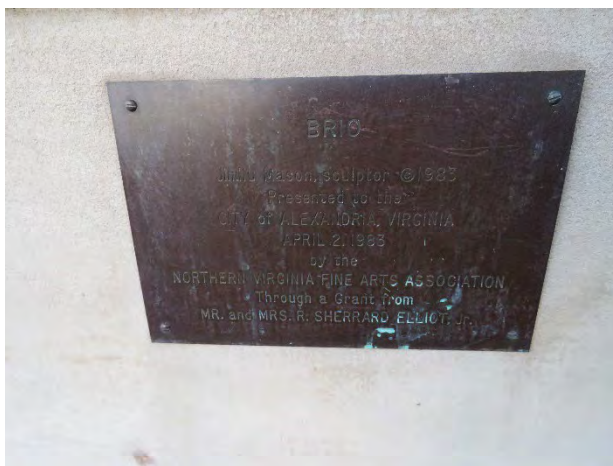
(Left) The protective wax coating on the bronze remains intact, except for localized sky-facing surfaces and other areas where water tends to pool. (Right) Soiling, streaking, and localized bright green corrosion products on the plaque.

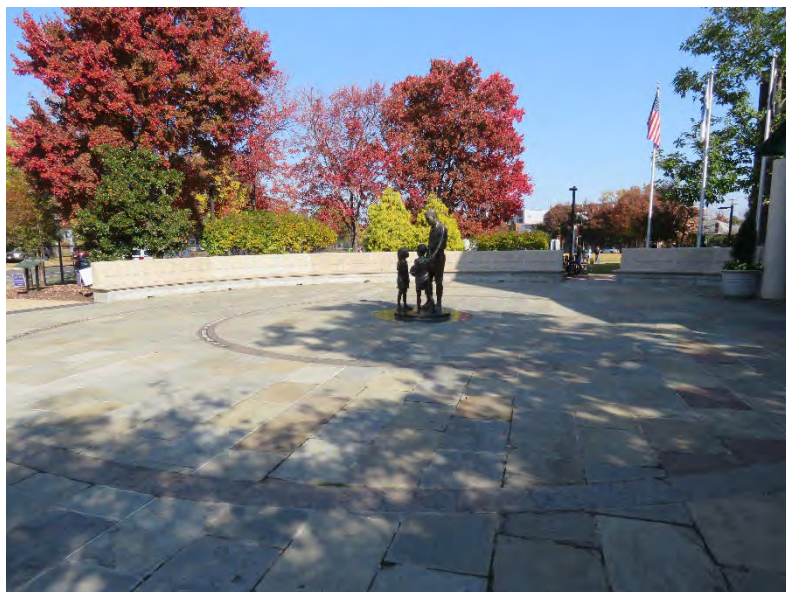
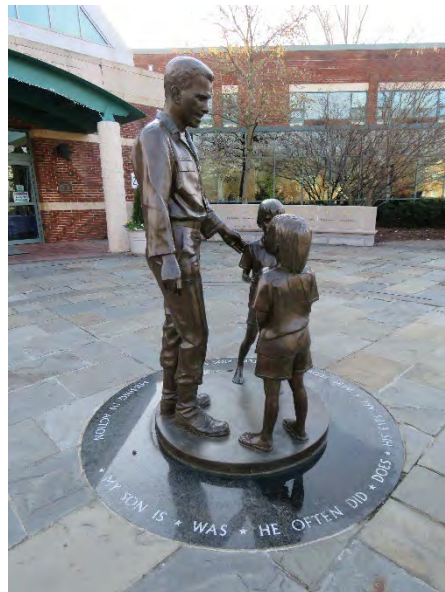
(Left) The bronze statue of Captain Rocky Versace in the middle of the Vietnam Veterans Memorial Plaza, surrounded by limestone and granite benches. (Right) The wax coating on the statue has begun to weather, with greater losses noted on skyward surfaces.

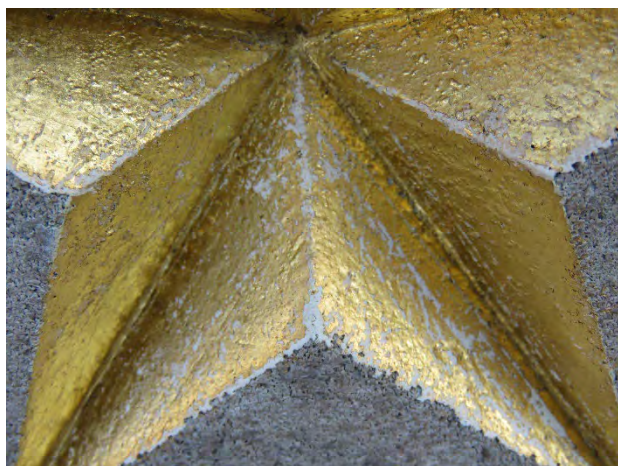
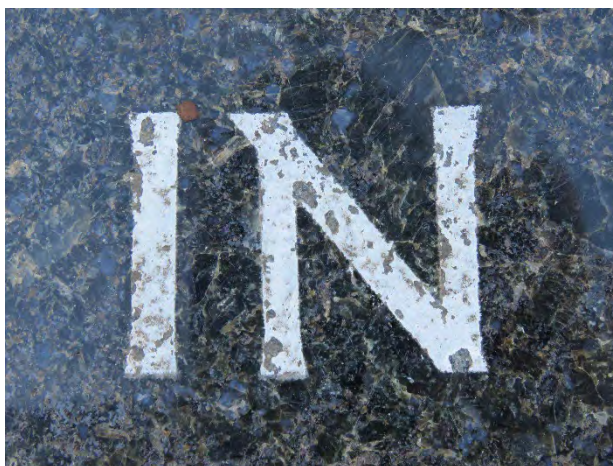
(Left and right) Losses of the finishes on the stars in the limestone benches and the incised lettering in the granite pavers.

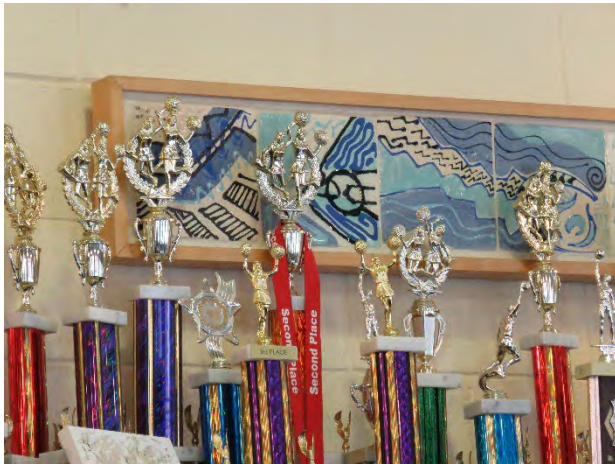
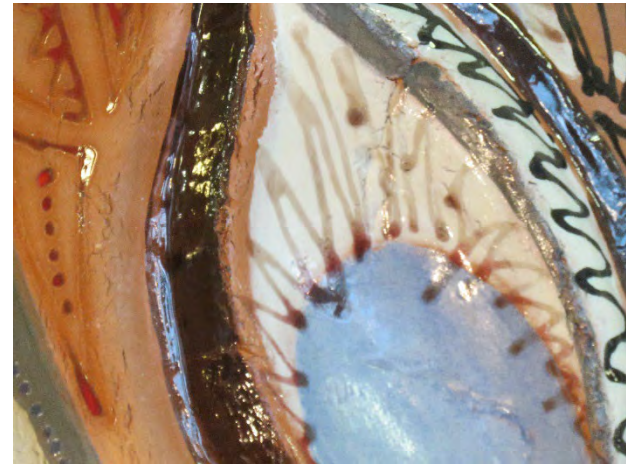
(Left) Trophies are displayed on the top of the cabinets underneath the artwork. (Right) Close-up views of the artwork show it to be in good condition, with no apparent damage noted.

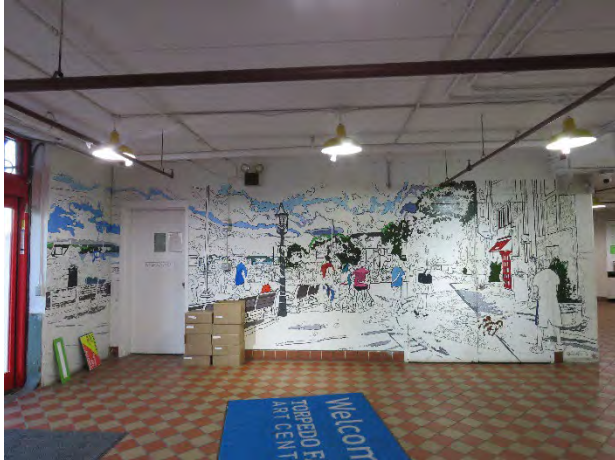
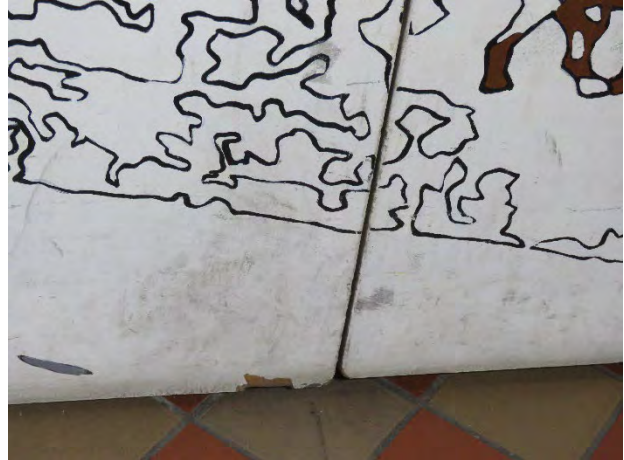
(Left) The mural covers several walls on the ground floor of the Torpedo Factory Art Center. (Right) The area around one of the painted doors shows greater damage due to constant handling, with heavier soiling, abrasions, and finish loss.

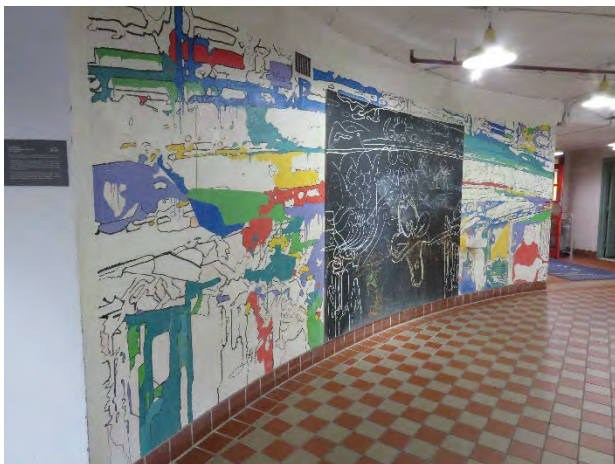
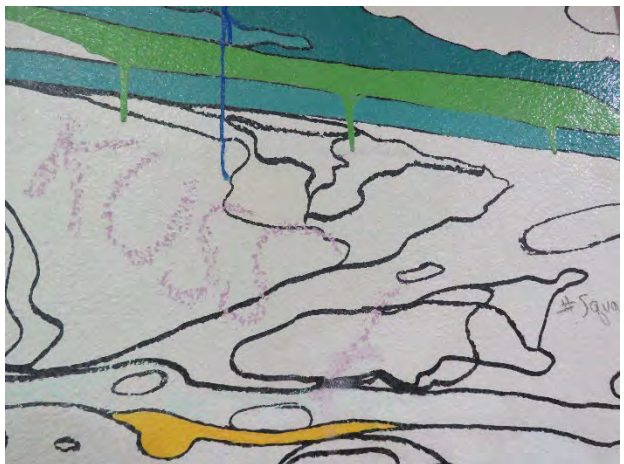
(Left) A chalk board in the middle of one of the walls. This area has a dusty and hazy appearance due to considerable chalk dust on surfaces. (Right) There is also more graffiti, using both chalk and pencil.

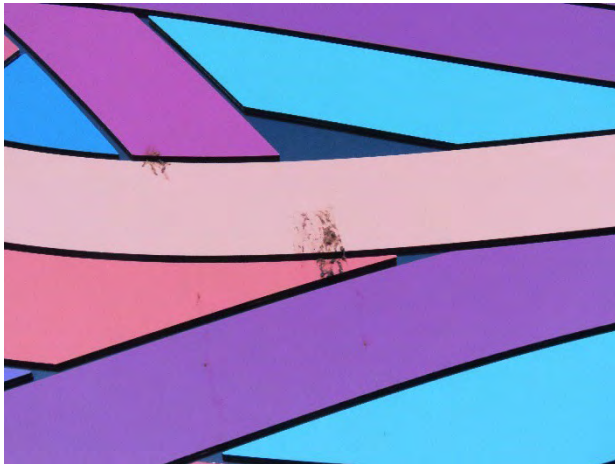
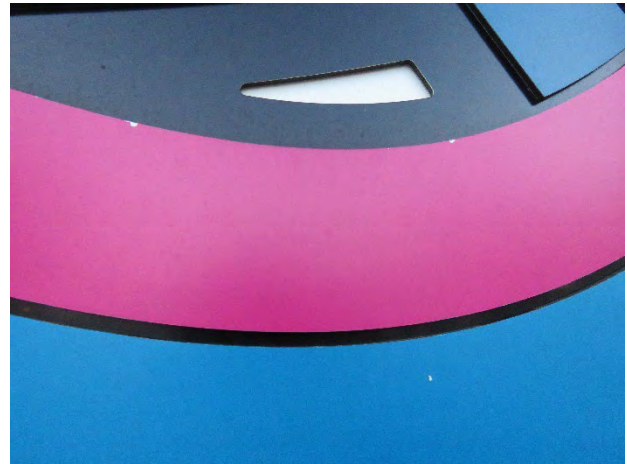
(Left) The painted aluminum composite panels are in excellent condition, exhibiting some localized soiling on surfaces. (Right) Losses in the paint finishes are minor.

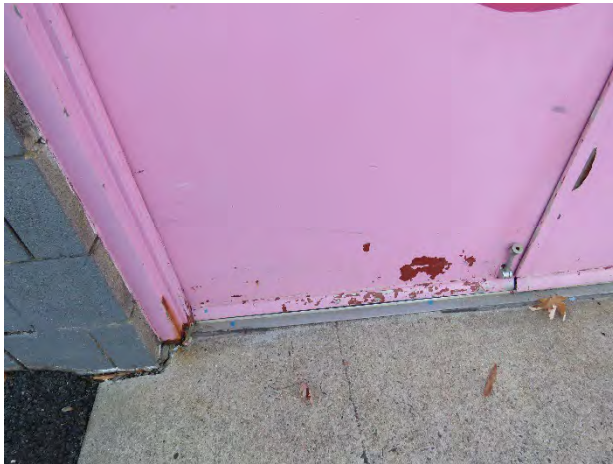
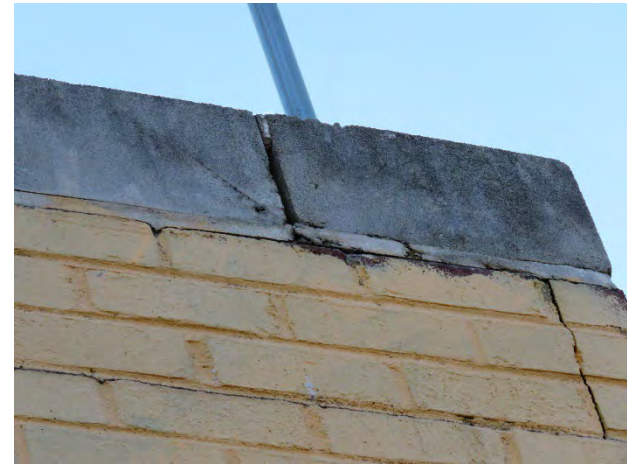
(Left) Loss of paint finishes on the doorway, with corrosion of exposed metal around the frame. (Right) Open and weathered joints above the mural, with cracking along the joints.

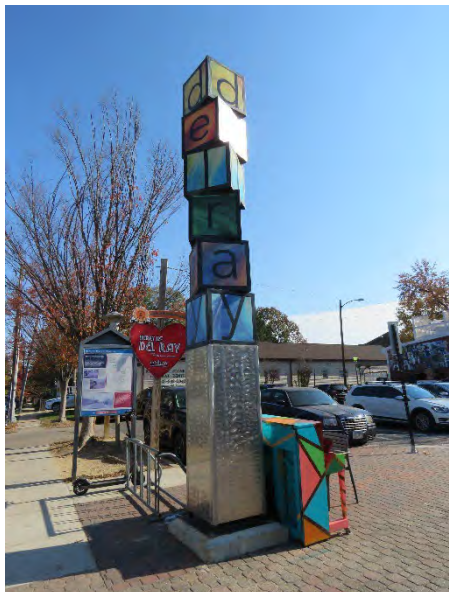
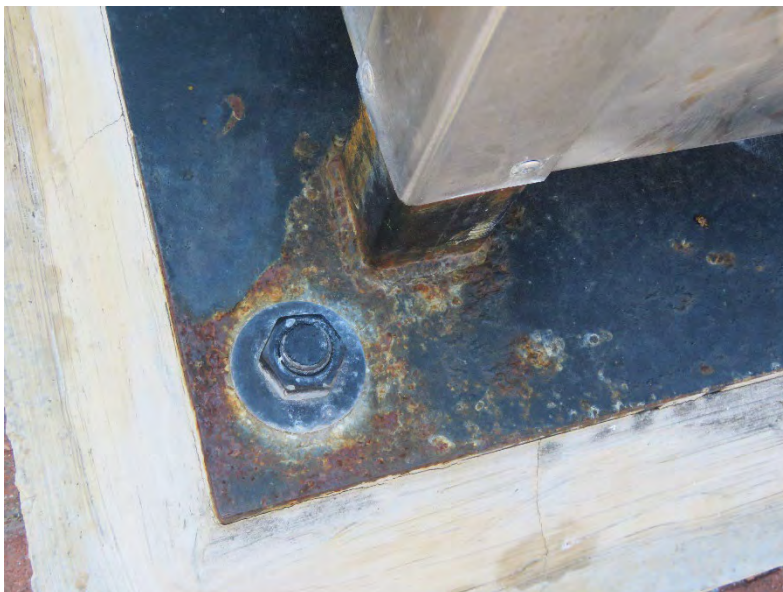
(Left) The public artwork is located at the corner of a busy pedestrian street in the Del Ray neighborhood. (Right) Loss of paint finishes on the mild steel plate, with corrosion of the metal.

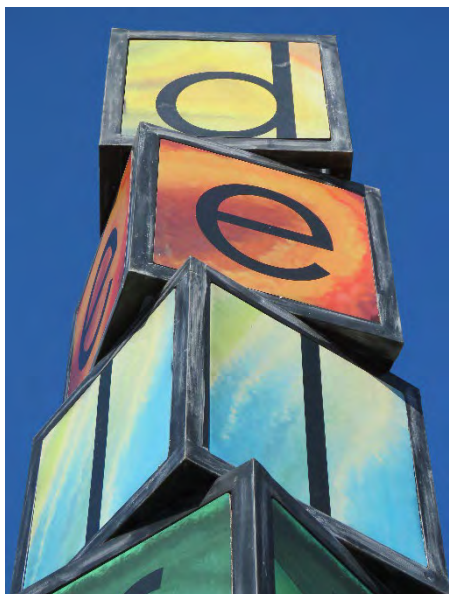
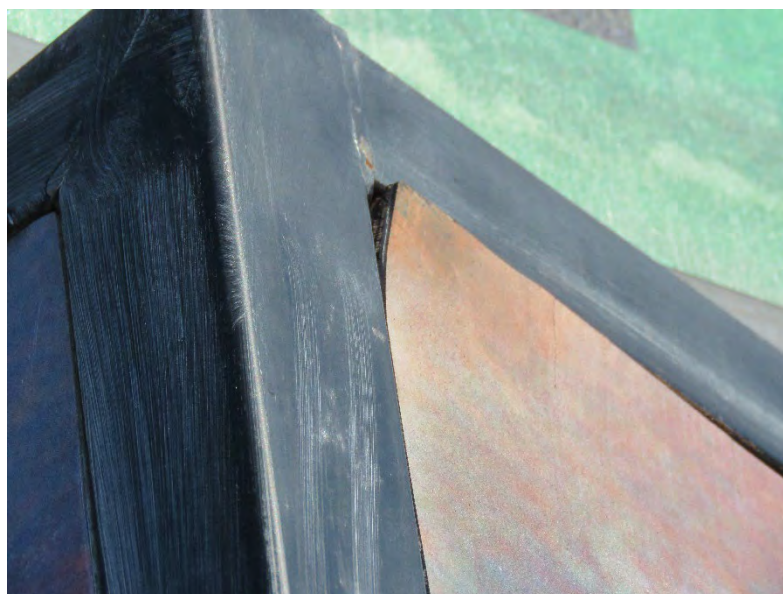
(Left) White discoloration on the painted metal frames in the form of brush strokes. (Right) Slight warping of the MDO printed ink panels.

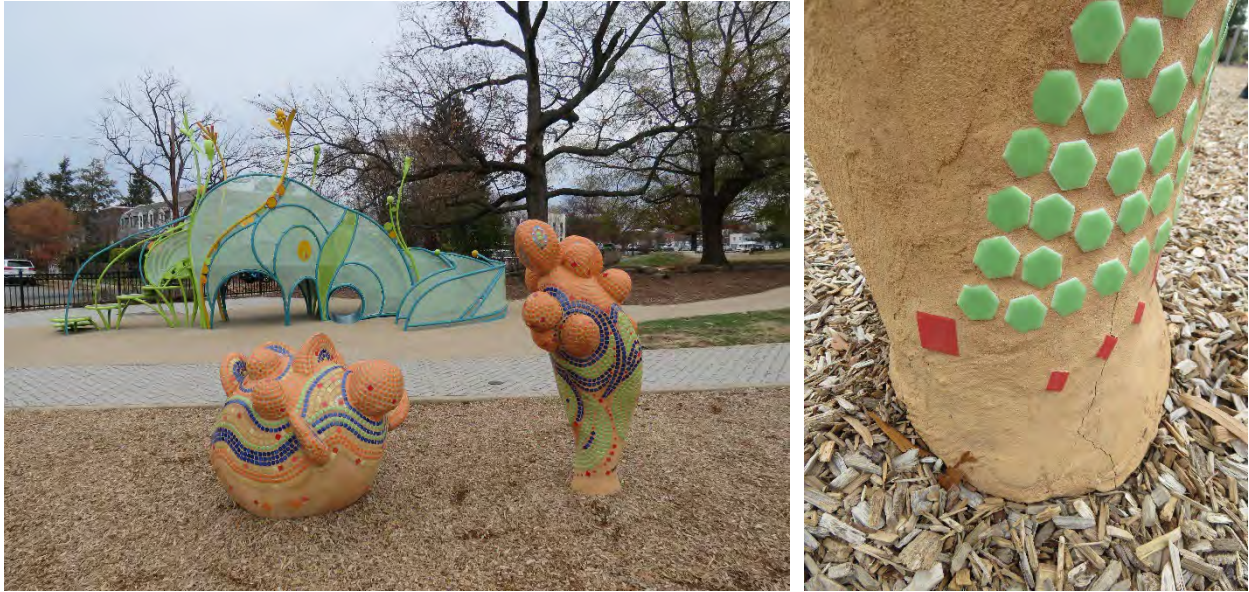
(Left) The public artwork consists of three main components, including a large climb-on structure, two mosaic sculptures, and an entrance gate. (Right) Cracking at the base of the mosaic sculpture.

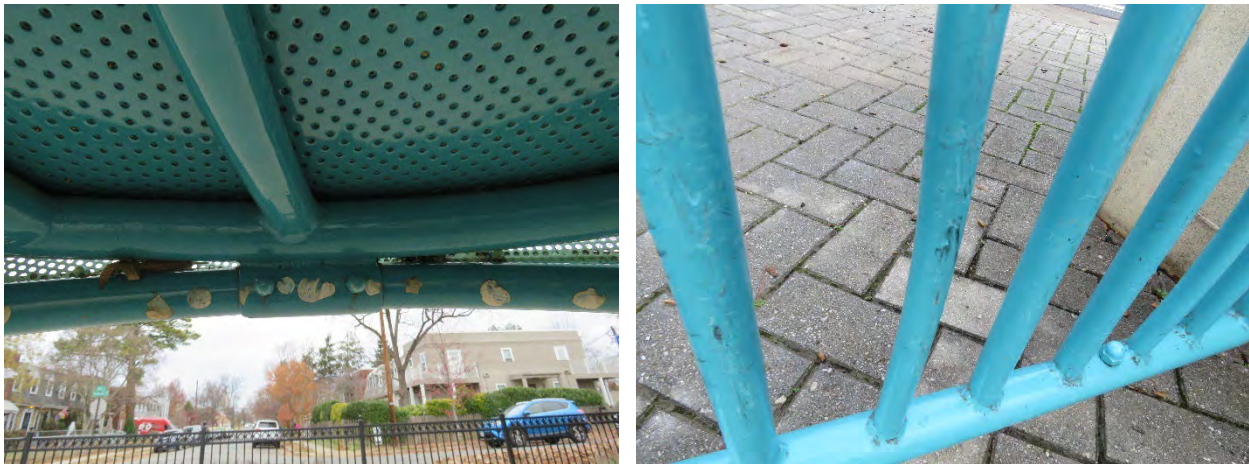
(Left) Numerous stickers and remnants of stickers are present on the underside of the large climb-on structure. (Right) Scuff marks and abrasions are seen at the base of the gate.

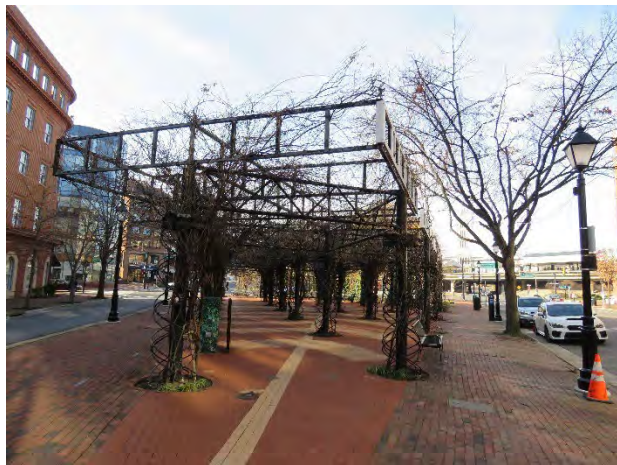
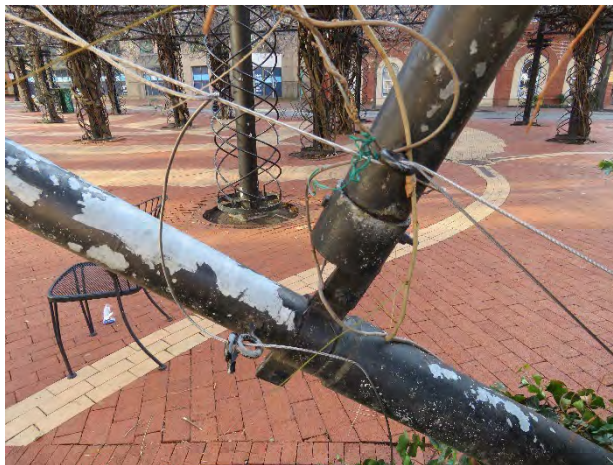
(Left) King Street Gardens Park occupies a triangular-shaped city block. (Right) There is at least one loose stainless-steel cable on the vine-covered topiary structure.

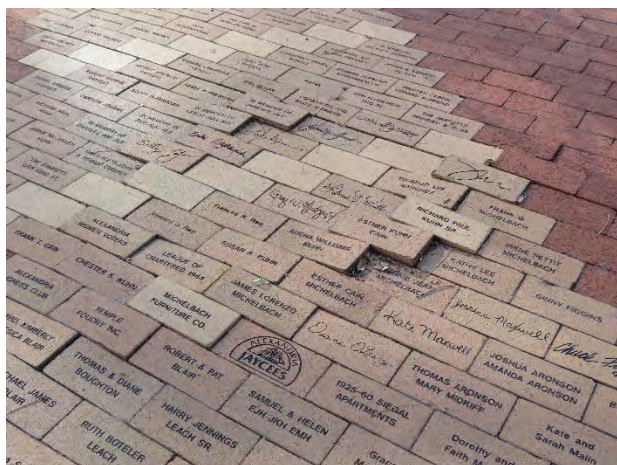
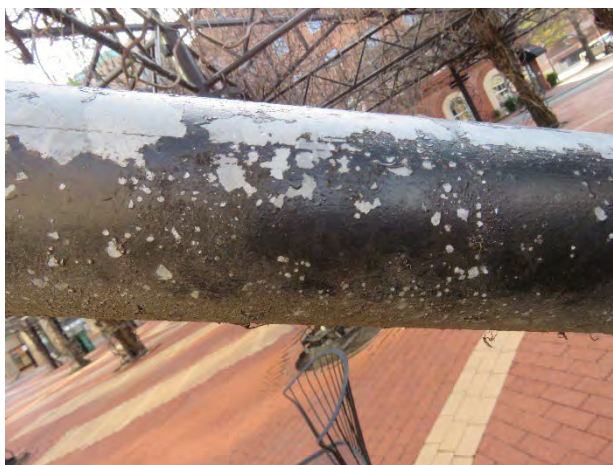
(Left) The named bricks are part of the park's design. There is displacement of several units in localized areas. (Right) Significant losses in the paint coating accompanied by heavy soiling on the galvanized steel surfaces, a condition that is observed throughout.

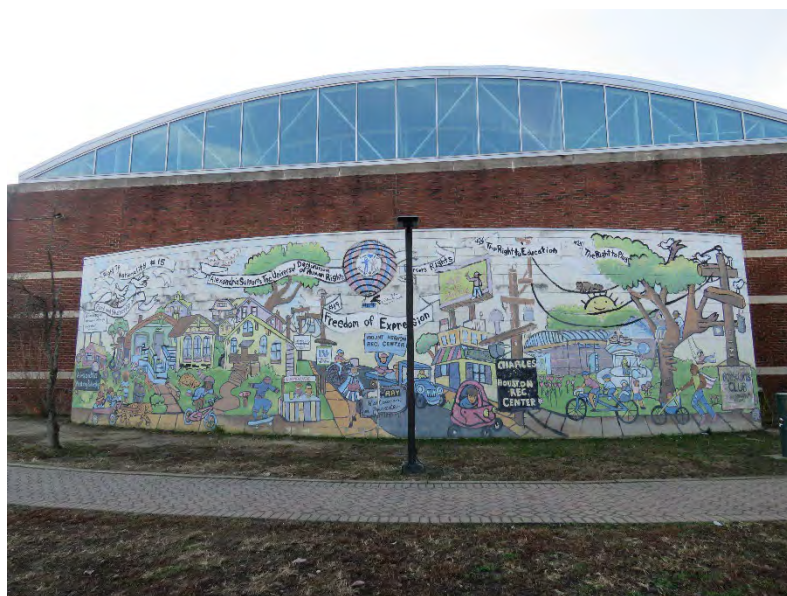
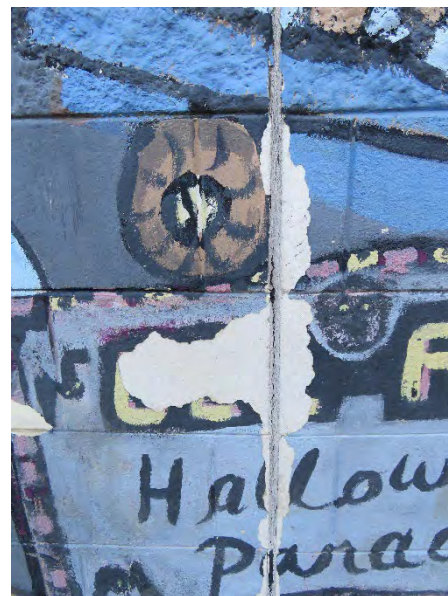
(Left) The mural is installed on the north wall of the Mount Vernon Recreation Center, with the Nicholas A. Colasanto Park Baseball Field directly in front. (Right) Failure of the sealant with the expansion joint, accompanied by losses in the paint layer.

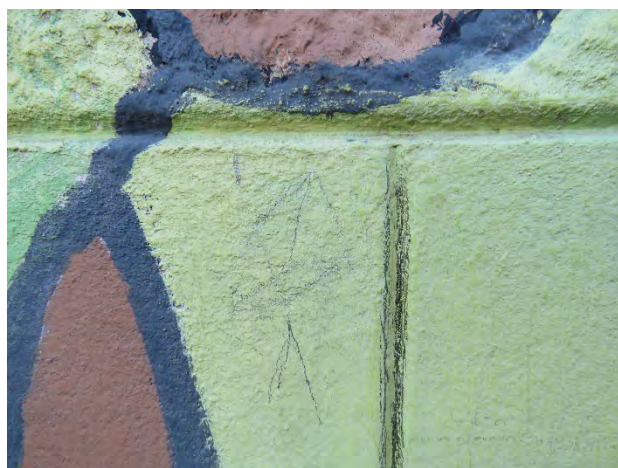
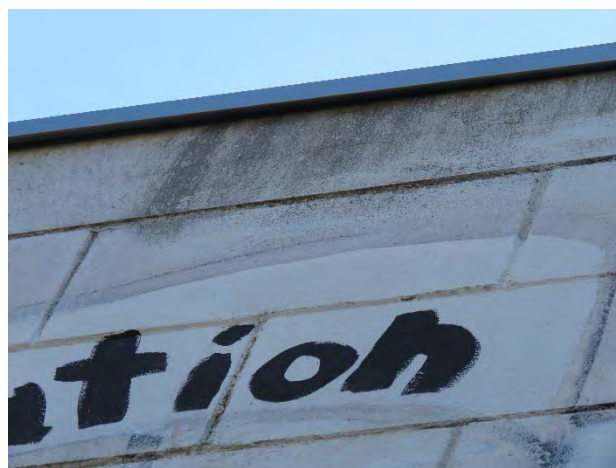
(Left) One of several graffiti markings on the surface of the mural. (Right) Soiling and biological growth at the top of the mural, directly below the flashing.

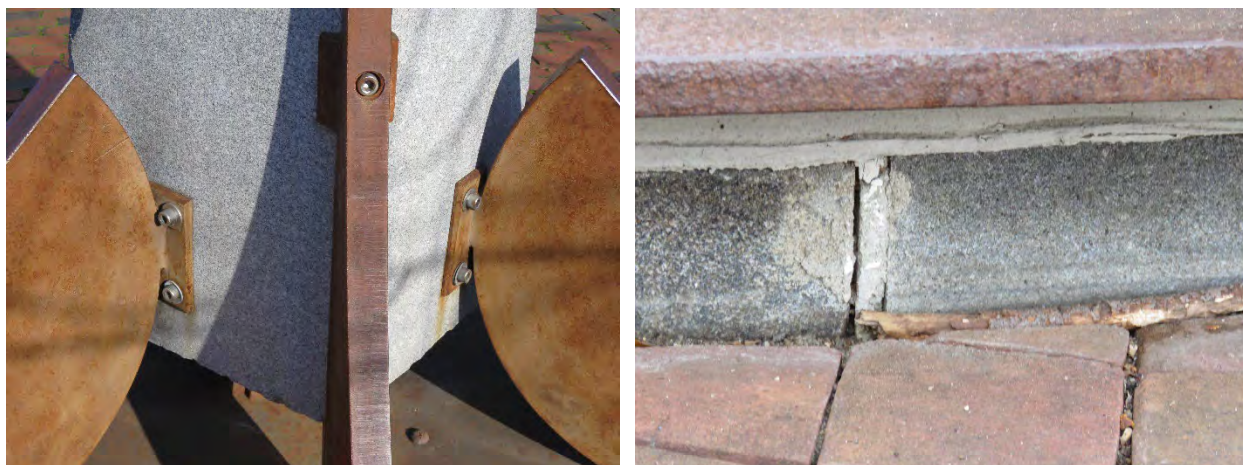
(Left) Minor localized ferrous staining on the granite, in areas where the metal has contact with the masonry. (Right) Deterioration of the mortar within the joints on the base.

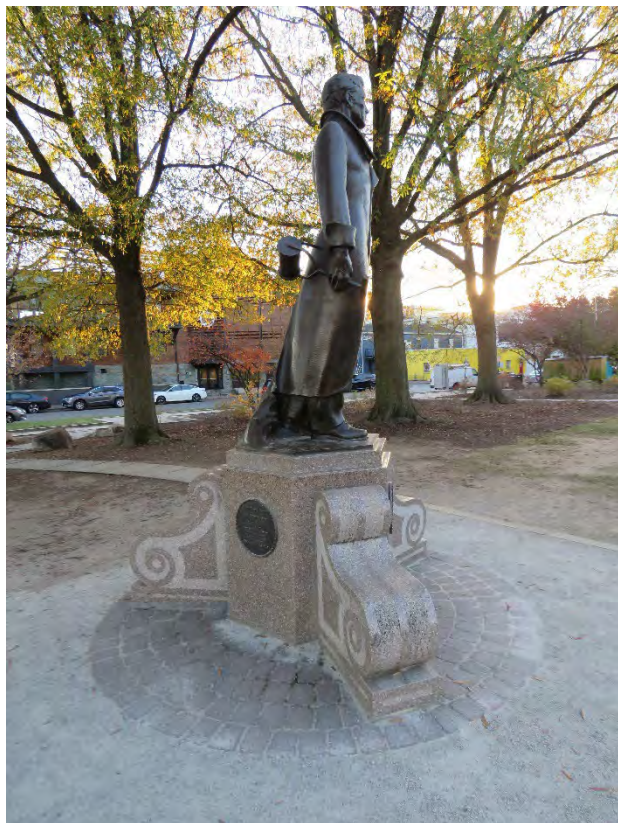
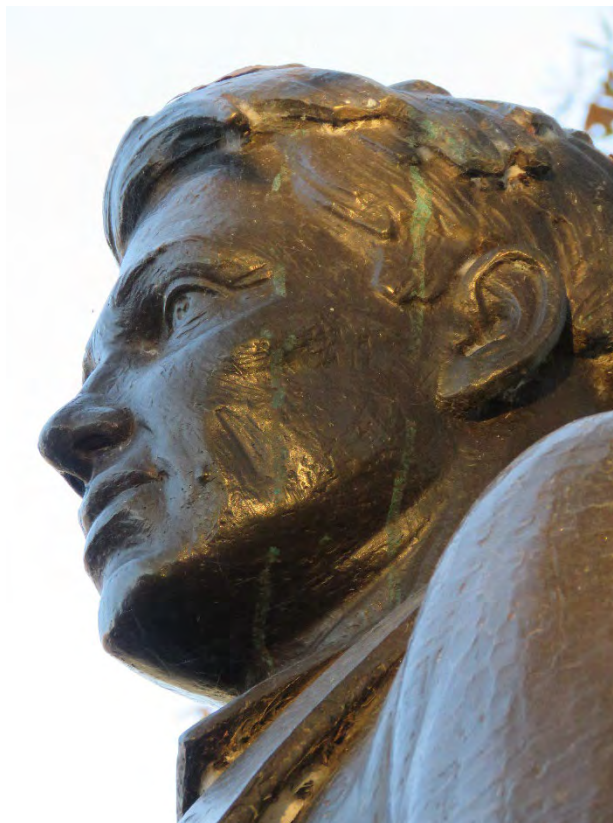
(Left) *Shipbuilder* is in Waterfront Park, with the Potomac River located directly east of the artwork. (Right) Corrosion streaking, possibly caused by bird guano.

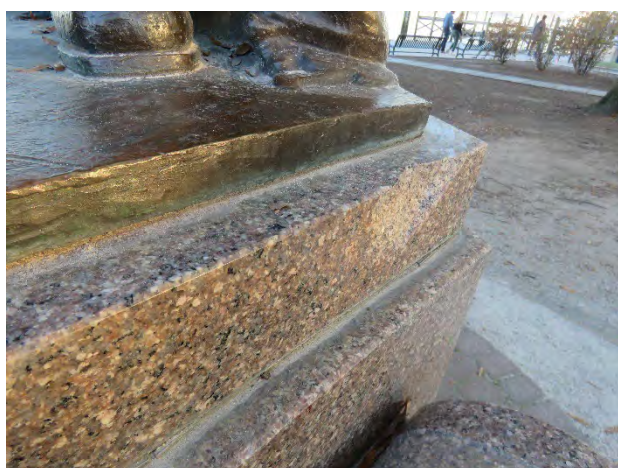
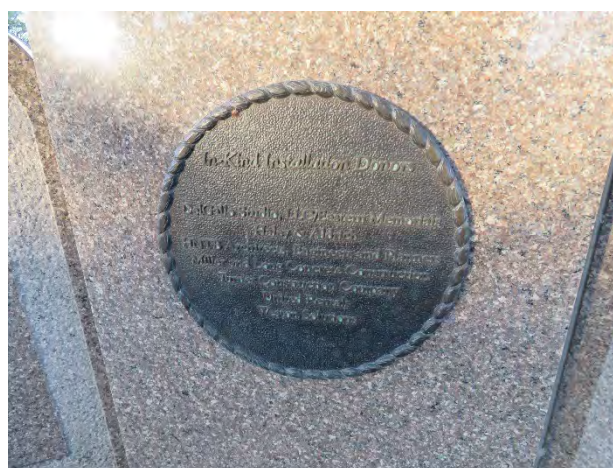
(Left) A spall in the stone, located at the top of the granite base. (Right) One of three plaques installed on the base, showing localized corrosion products.

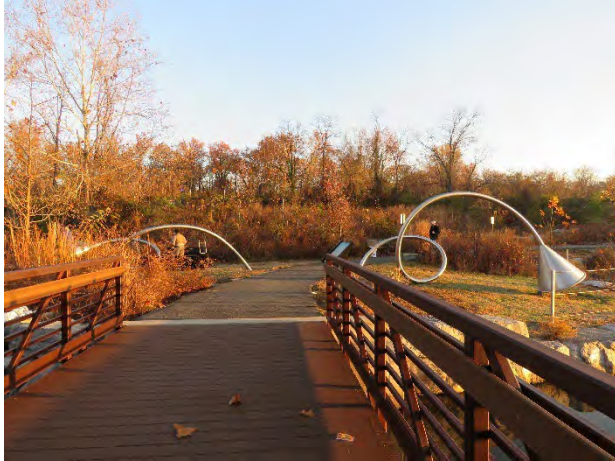
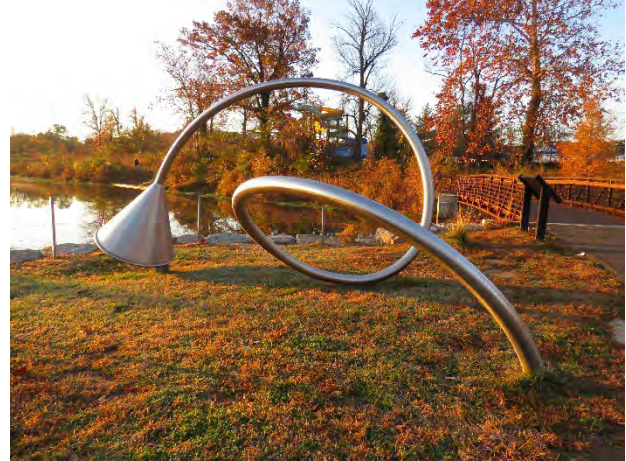
(Left) *Sound Stream* is installed on the grounds of Lake Cook. A paved walkway bisects the sculpture. (Right) The park is one of the few urban fishing locations in Northern Virginia.

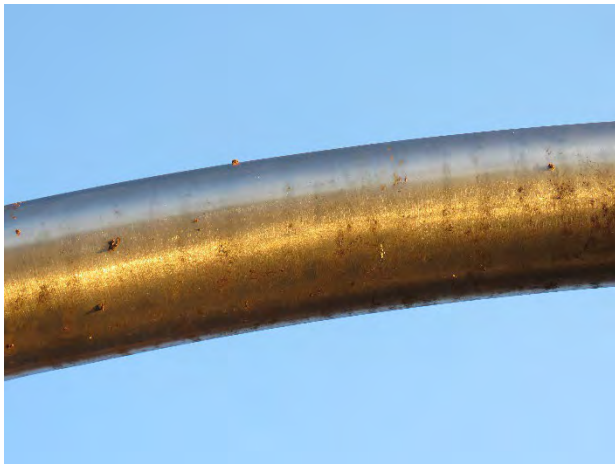
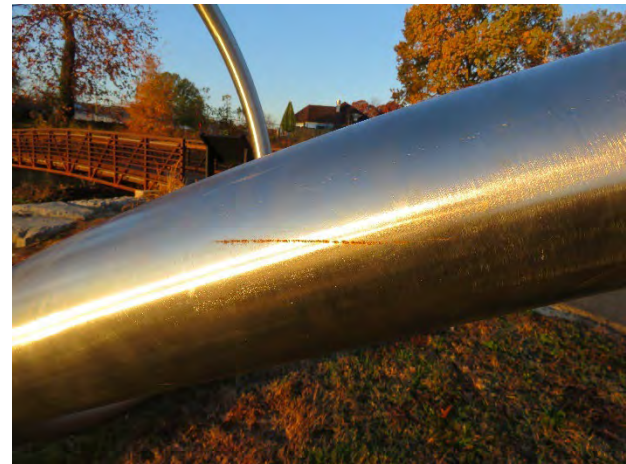
(Left) Soiling and bird guano on the stainless steel. (Right) A scratch accompanied by corrosion.

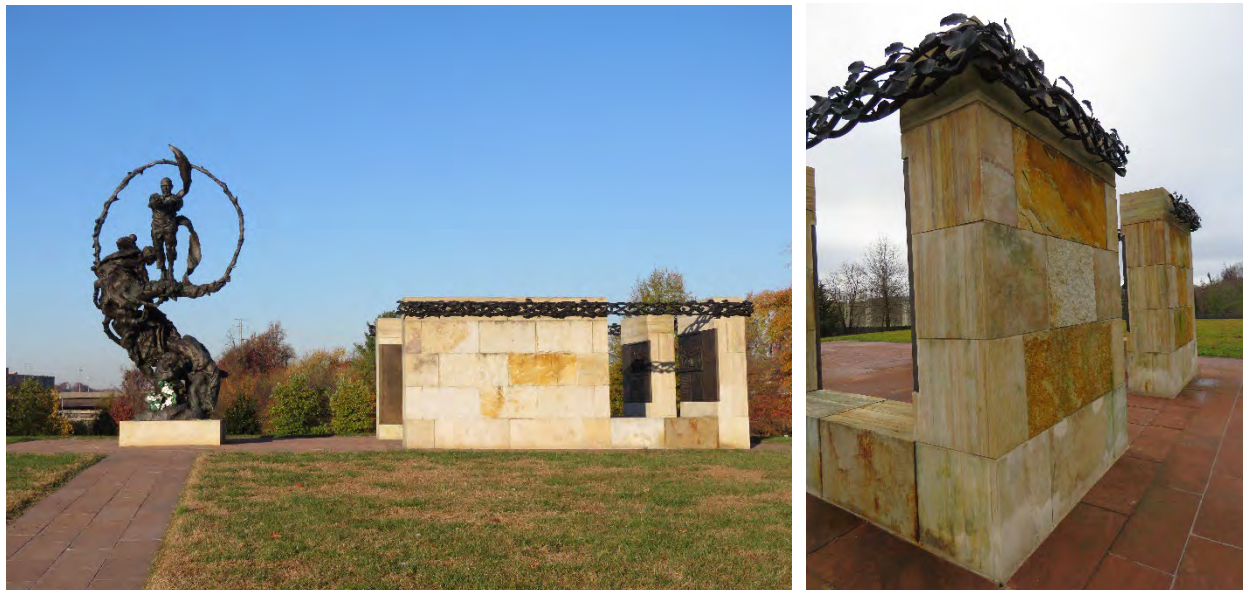
(Left) The public artwork is on the grounds of the Contrabands and Freedmen Cemetery, which served as a burial place for about 1,800 African Americans who fled to Alexandria to escape from bondage during the Civil War. (Right) Biological growth on the sandstone. The iron staining is an inherent condition.

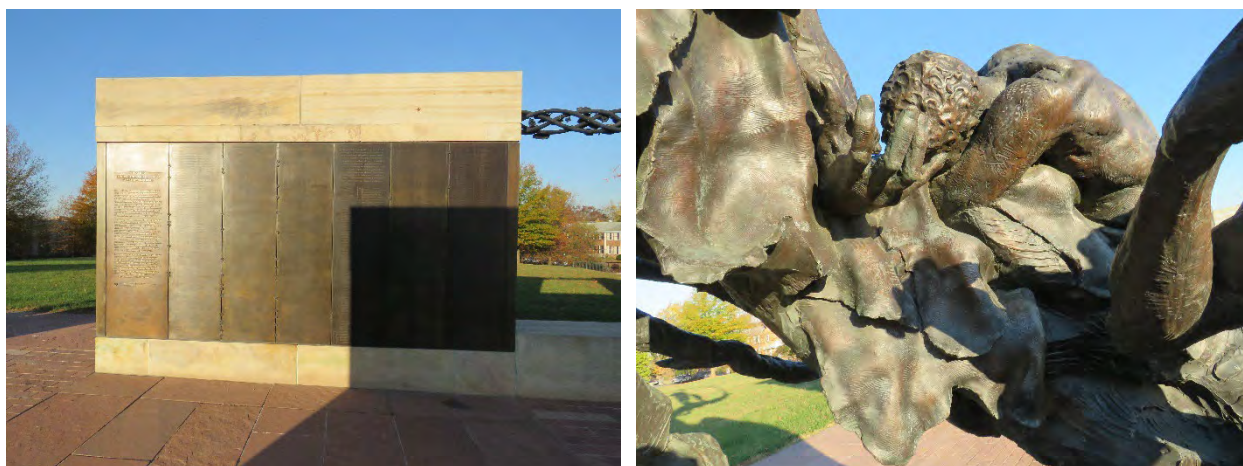
(Left) The bronze plaques display a mottled appearance, a condition that has been present since the time of fabrication. (Right) Weathering of the protective wax coating and light corrosion of bronze surfaces.

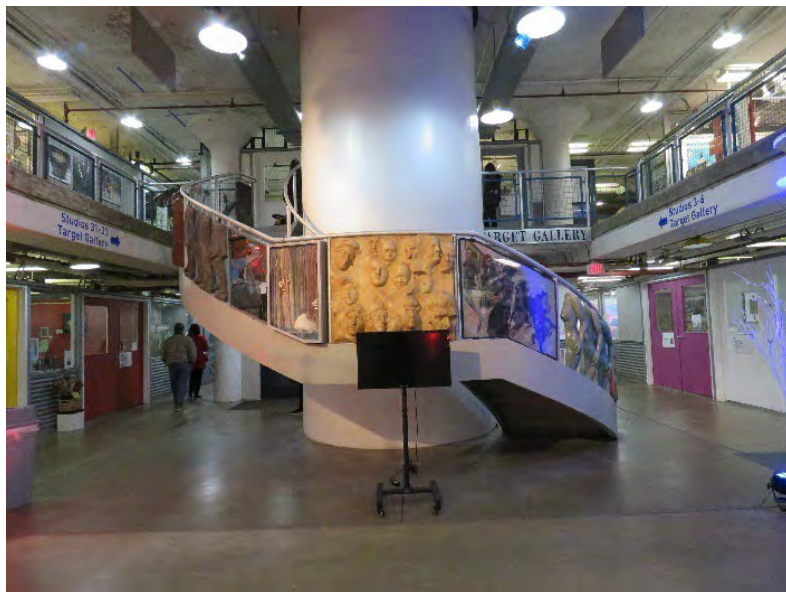
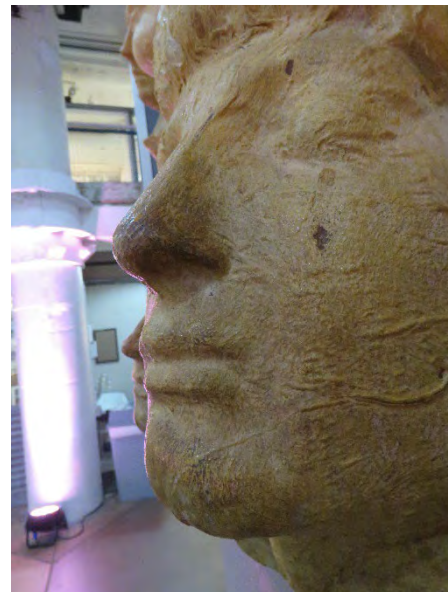
(Left) The spiral staircase includes twelve artworks by resident artists at the time of fabrication. (Right) Soiling and finish loss on surfaces.

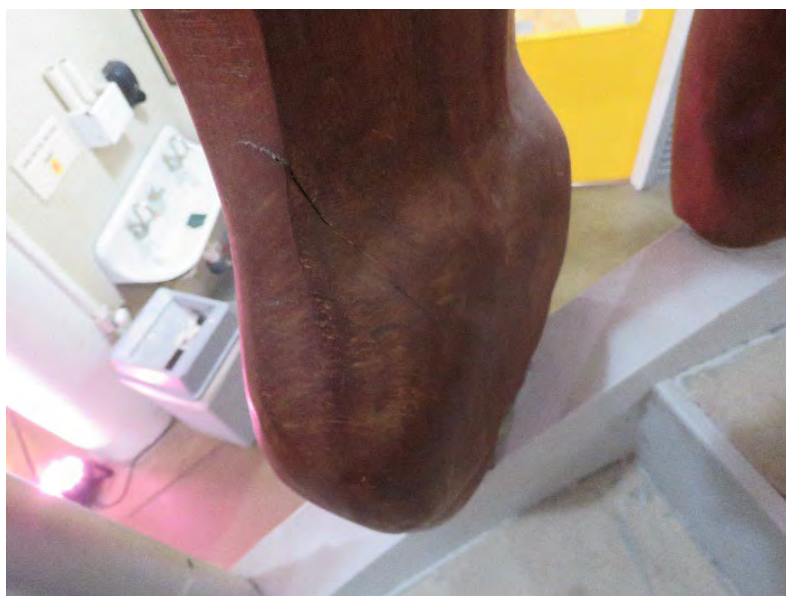
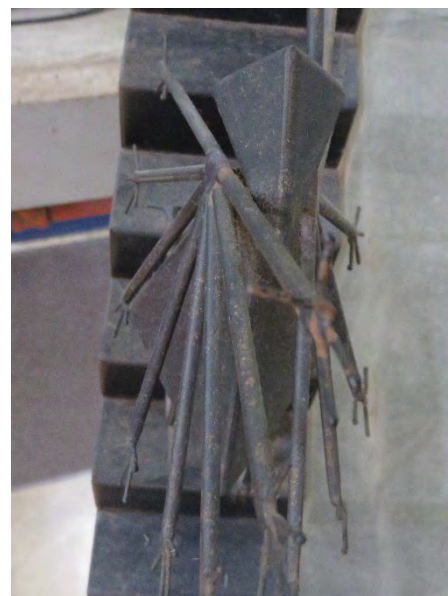
(Left) A crack on the proper left side of the stained wood torso. (Right) Close-up showing excessive dust and dirt and localized corrosion of the iron.

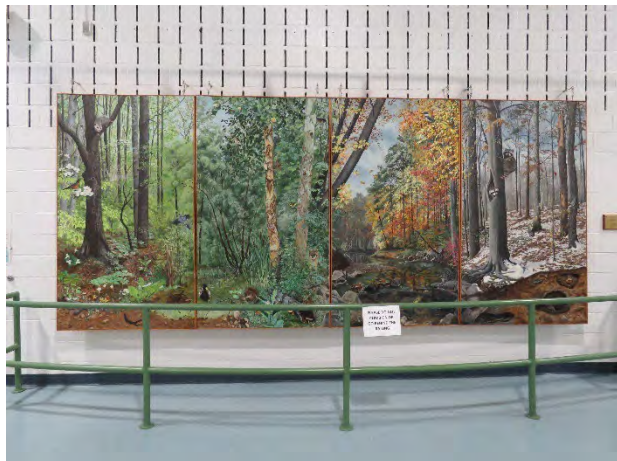
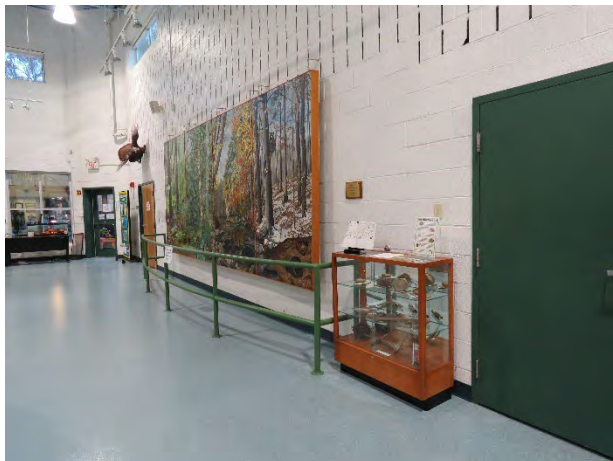
(Left) *Wildlife of the Dora Kelley Nature Park* consists of four panels, each one representing a different season of the park. (Right) The artwork is installed behind a protective metal railing inside the Jerome “Buddie” Ford Nature Center.

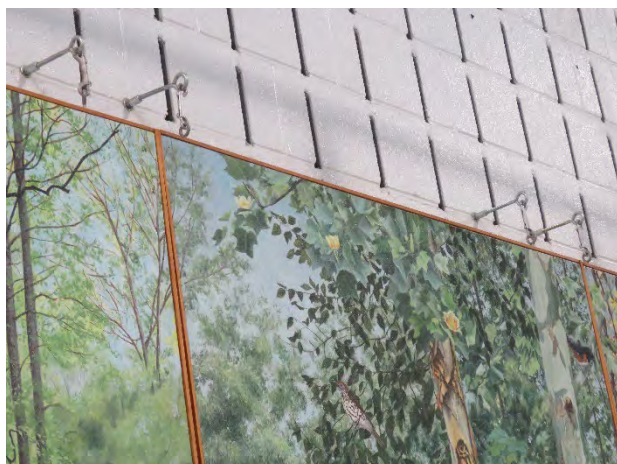
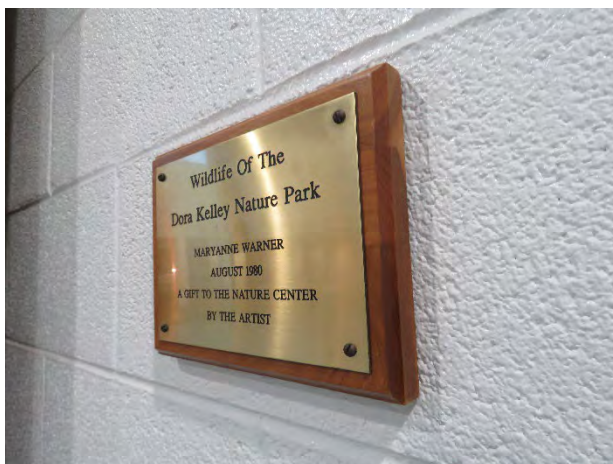
(Left) All panels look to be fully secure. (Right) Both the artwork and associated plaque are in excellent condition.

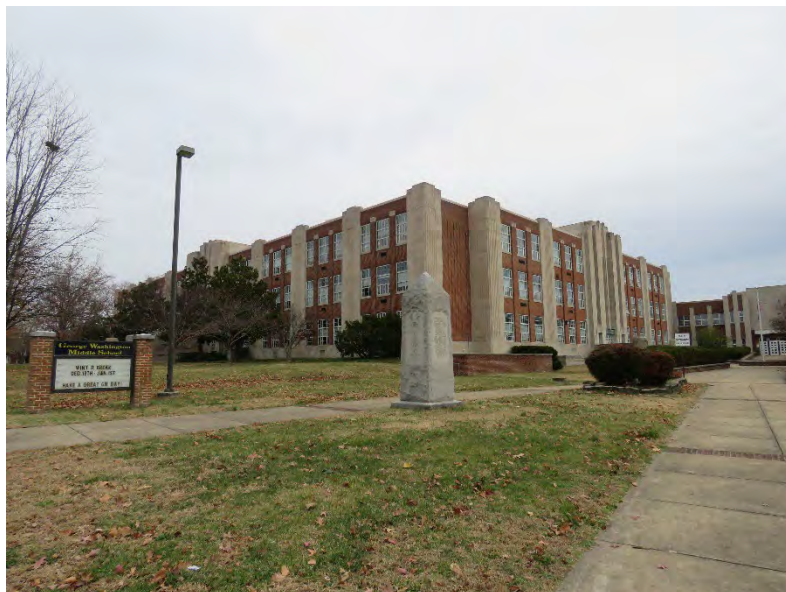
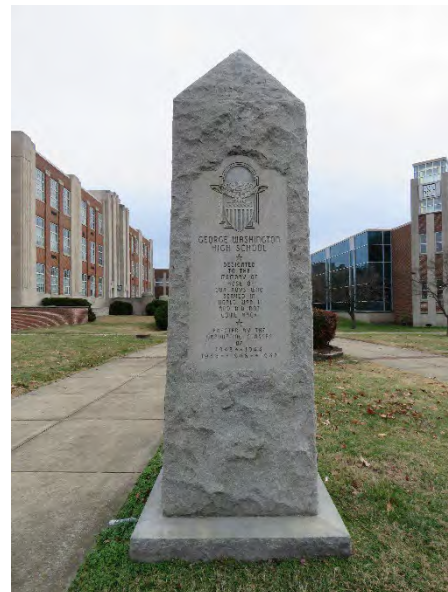
(Left) The commemorative memorial is installed on the lawn in front of the George Washington Middle School. (Right) The granite obelisk is in relatively good condition.

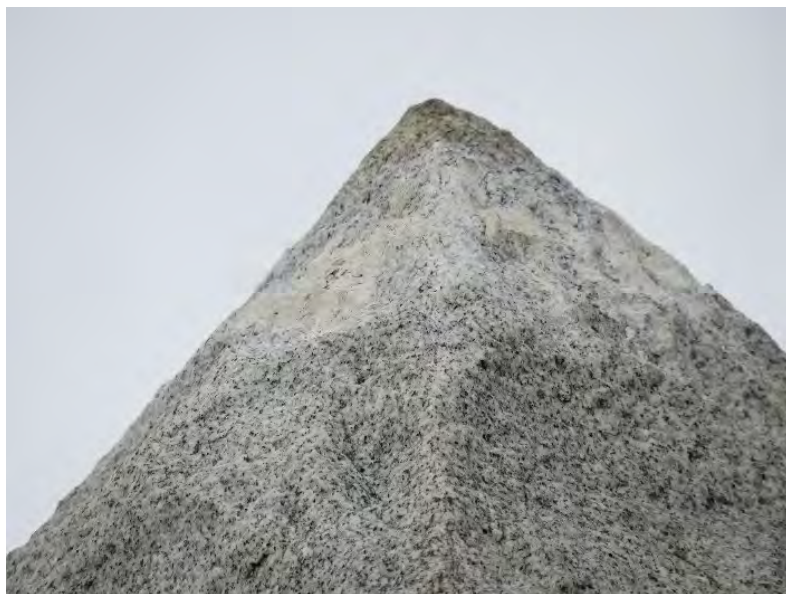
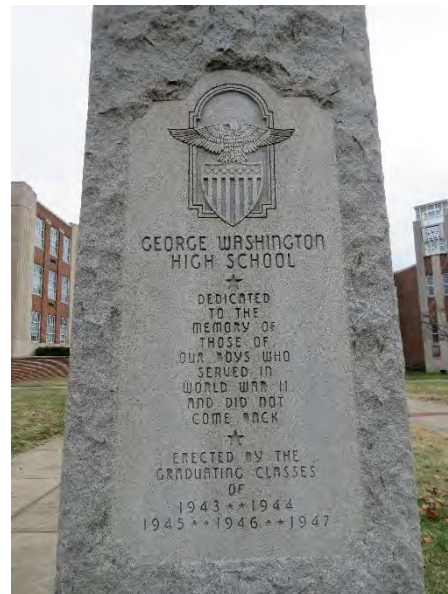
(Left) Heavy accumulation of bird guano noted at the top. (Right) Moderate overall soiling on surfaces and minor spalling of stone present within select letters.

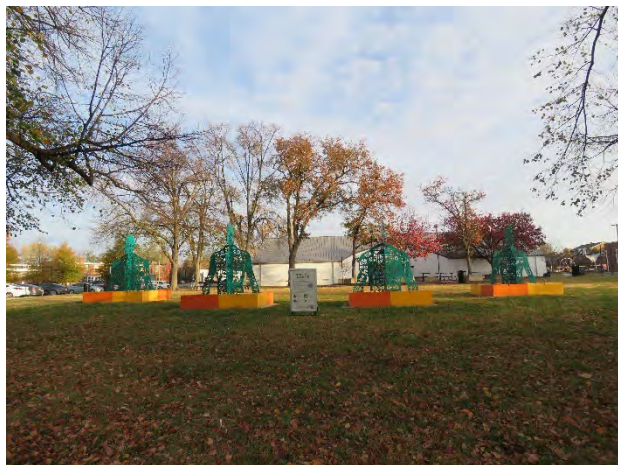
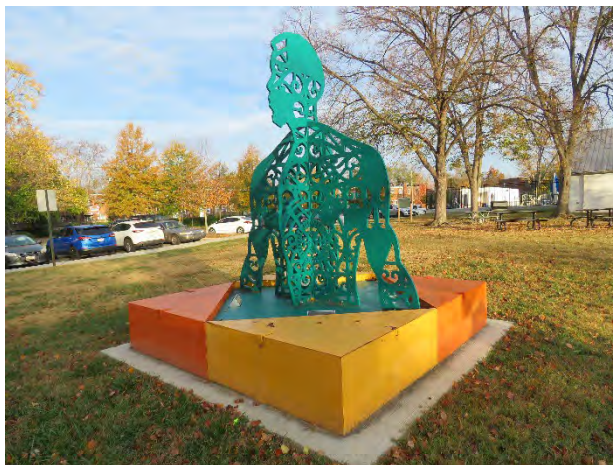
(Left) The public artwork was relocated from Waterfront Park, where it was originally installed, to the Old Town Pool Park, where it will remain on temporary loan from the artist. (Right) The painted aluminum profiles are soiled but in excellent condition.

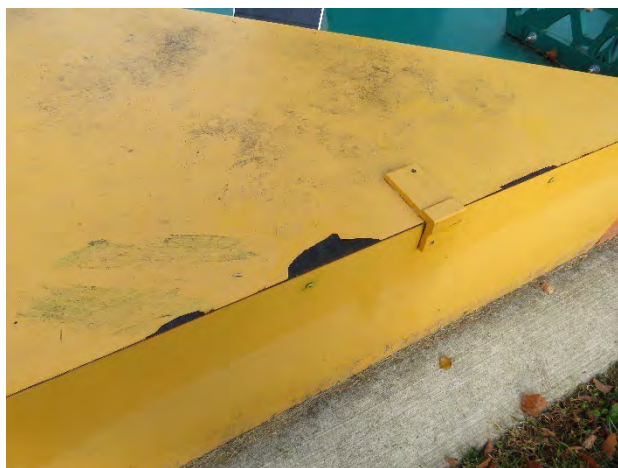
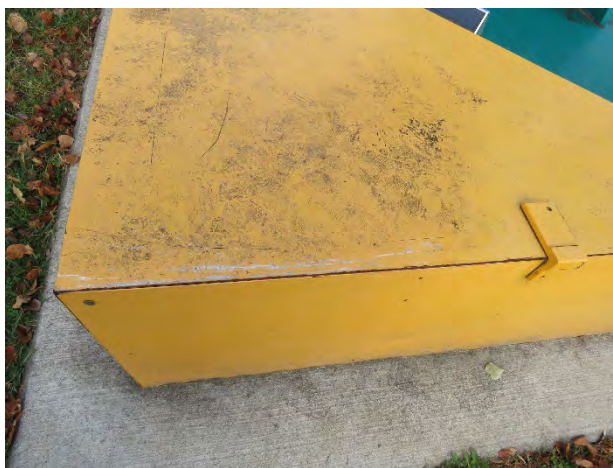
(Left) The painted mild steel platforms on which the sculptural profiles are installed exhibit heavy soiling, footprints, loss of paint finishes, and corrosion of exposed metal. (Right) Linear abrasions at the edge of one platform.
