**ACCESS METHODS, COORDINATION,  
TEST EQUIPMENT & MOT**

3/7/2024 IL NBI Refresher Course 2024

**Access Methods, Coordination, Test Equip. & MOT**

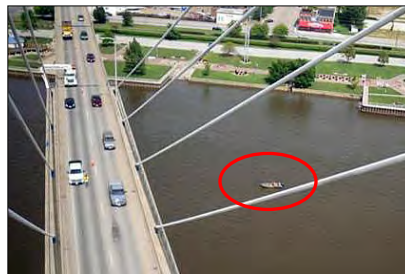
### Boat

**Boats provide access for water-level inspections including soundings for scour measurements.**

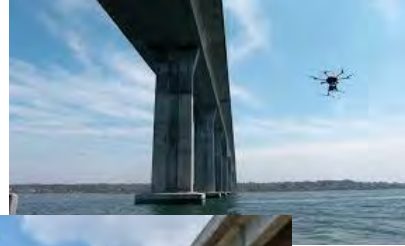
S-9

- UAS – Unmanned Aerial System
- UAS/Drones may be used for a recon or initial assessment of conditions at an inspection site
- They do not take the place of arms length inspection requirements
- IDOT still considering policy on their use

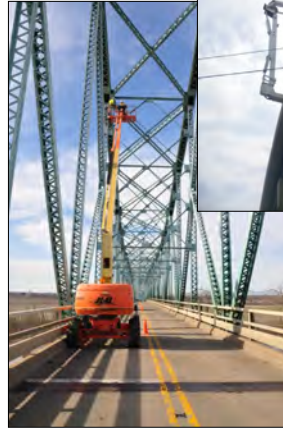
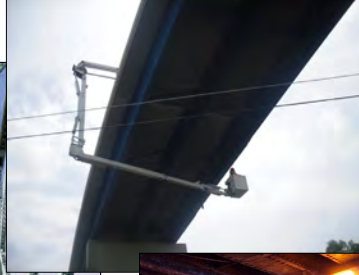
### Inspection Access

- Operator equip. training
- Safety practices in the bucket
  - Safety harness
  - Hard hat
- Hazards in the bucket
  - Power lines!
  - Vehicles / trains / barges
- Wildlife around bridge
  - Actual animals
  - Animal "residue"

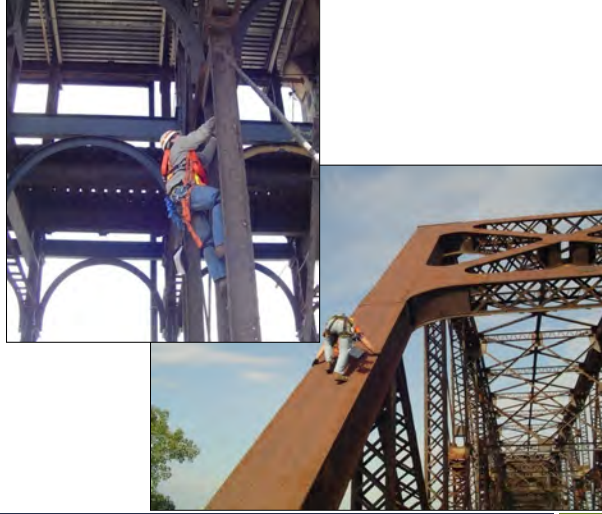
### Climbing

- Inspector training
- Safety practices
  - Safety harness
  - Hard hat
  - Special rigging
- Structure specific safety plan

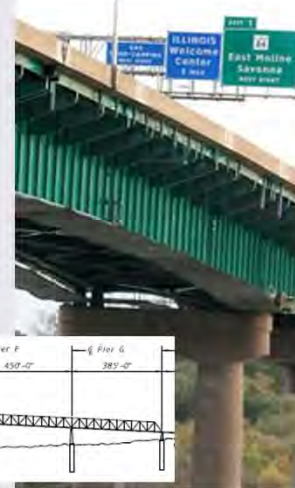
### Types of Span Configuration:

**Cantilever Span** – A span or portion of a span being supported at only one end. Typically, only a portion/s of a bridge will be a cantilever.

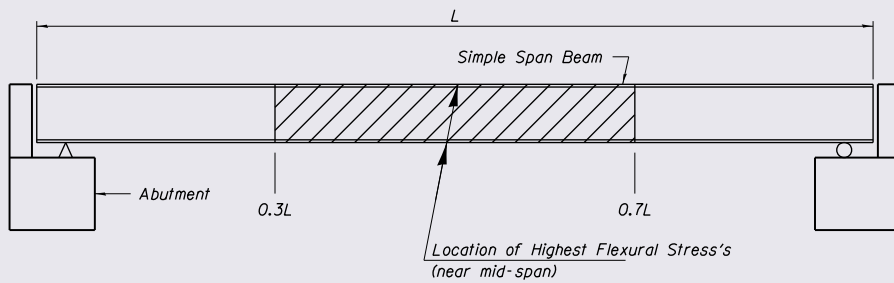
D-17

High flexural stress in **simple span** structural members is typically found in the location shown here.

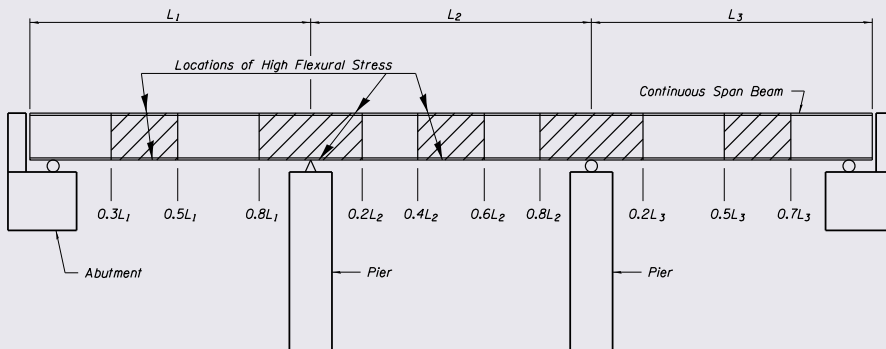
D-18

High flexural stresses in **continuous span** structural members are typically found in the locations shown here. (Note: These locations vary depending on the span ratios.)

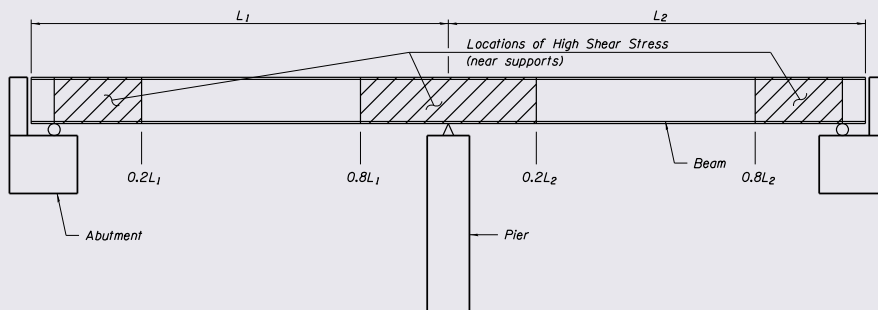
D-22

High shear stress in structural members is typically found in the locations shown here near the bearing points. (Note: These locations vary depending on the span ratios.)

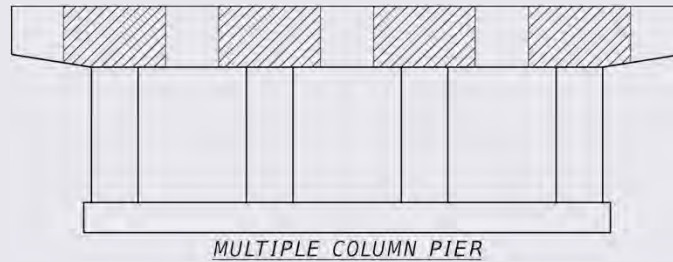
D-23

High shear stress in **pier caps** is typically found in the locations shown here near the bearing points. (Note: These locations vary depending on the span ratios and superstructure beam locations.)

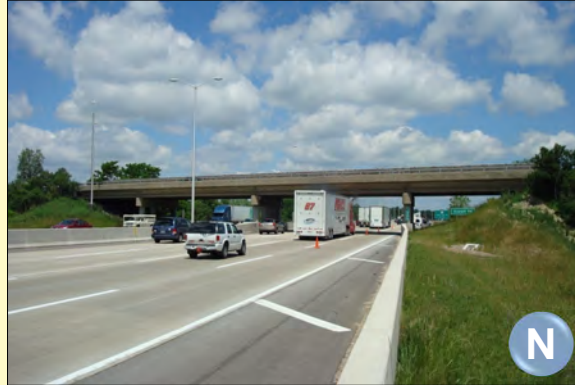
## Item 71 – Waterway Adequacy

| Interstate | Other Principal and Minor Arterials and Major Collectors | Minor Collectors, Local | Description |
|---|--|---|---|
| N | N | N | Bridge not over a waterway. |

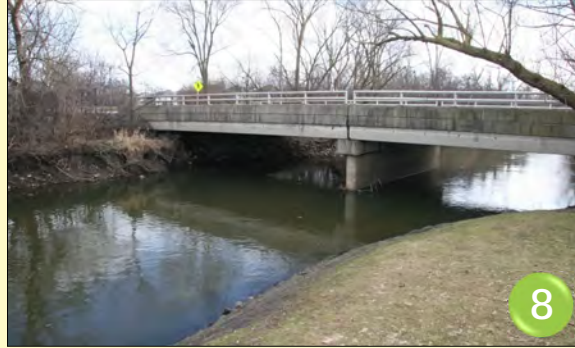
## Item 71 – Waterway Adequacy

| Interstate | Other Principal and Minor Arterials and Major Collectors | Minor Collectors, Local | Description |
|---|--|---|--|
| 8 | 8 | 8 | Bridge deck above roadway approaches. Slight chance of overtopping roadway approaches. |

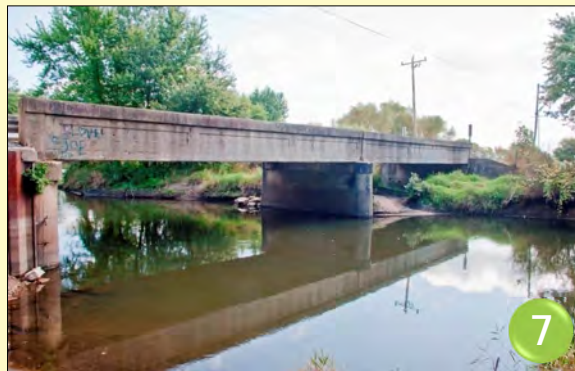
## Item 71 – Waterway Adequacy

| Interstate | Other Principal and Minor Arterials and Major Collectors | Minor Collectors, Local | Description |
|---|--|---|--|
| 6 | 6 | 7 | Slight chance of overtopping bridge deck and roadway approaches. |

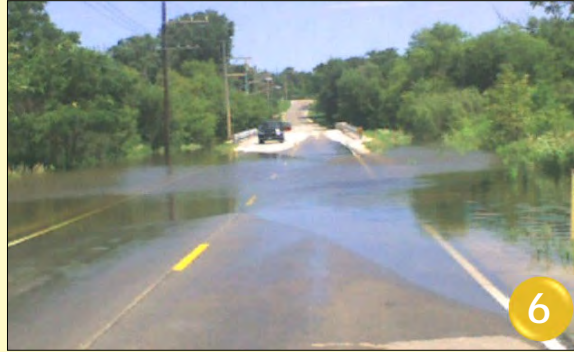
## Item 71 – Waterway Adequacy

| Interstate | Other Principal and Minor Arterials and Major Collectors | Minor Collectors, Local | Description |
|---|--|---|---|
| 4 | 5 | 6 | Bridge deck above roadway approaches. Occasional overtopping of roadway approaches with insignificant traffic delays. |

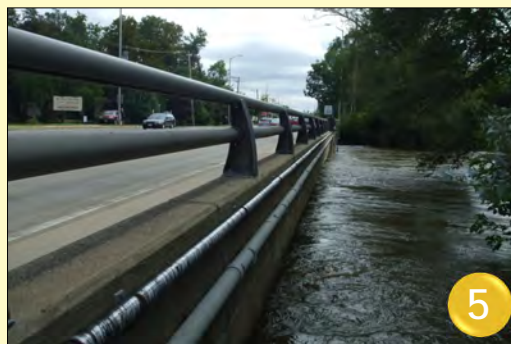
## Item 71 – Waterway Adequacy

| Interstate | Other Principal and Minor Arterials and Major Collectors | Minor Collectors, Local | Description |
|---|--|---|---|
| 3 | 4 | 5 | Bridge deck above roadway approaches. Occasional overtopping of roadway approaches with significant traffic delays. * |

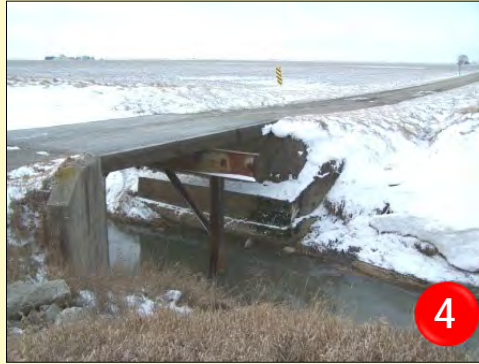
## Item 71 – Waterway Adequacy

| Interstate | Other Principal and Minor Arterials and Major Collectors | Minor Collectors, Local | Description |
|---|--|---|---|
| 2 | 3 | 4 | Occasional overtopping of bridge deck and roadway approaches with significant traffic delays. * |

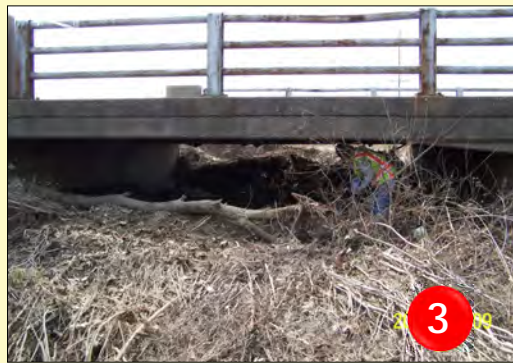
## Item 71 – Waterway Adequacy

| Interstate | Other Principal and Minor Arterials and Major Collectors | Minor Collectors, Local | Description |
|---|--|---|---|
| 2 | 2 | 3 | Frequent overtopping of bridge deck and roadway approaches with significant traffic delays. * |

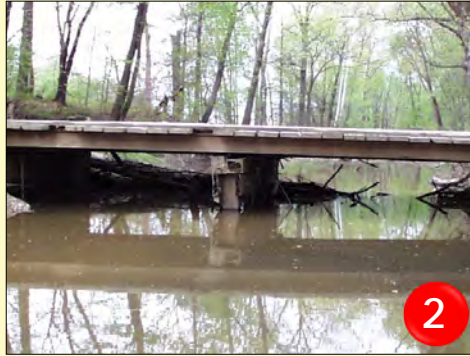
## Item 71 – Waterway Adequacy

| Interstate | Other Principal and Minor Arterials and Major Collectors | Minor Collectors, Local | Description |
|---|--|---|--|
| 2 | 2 | 2 | Occasional or frequent overtopping of bridge deck and roadway approaches with severe traffic delays. * |

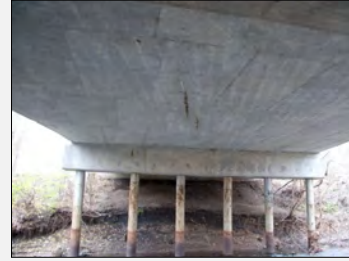
### Cast in Place Conc. Slabs

- Common since early 1900's
- "Slab Superstructure" vs. "Deck"
  - Top of the slab superstructure serves as an integral deck
  - Slab superstructures span longitudinally vs. decks that usually span transversely
- Deck (Item 58) shall be rated same as Super (Item 59). The rating is based on the Super criteria

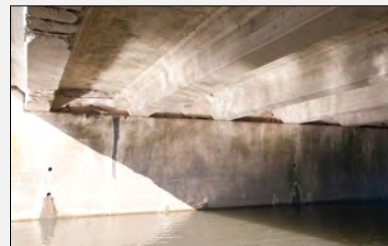
### Concrete T-Beams

- Common in 1930's - 50's
- Monolithic deck and stem forms the shape of a letter "T"
- Typically cast-in-place construction
- Top flange is considered the Deck (Item 58)
- Deck and stem act together as the superstructure (Item 59)

- Look for heavy section loss in girder stem bars
  - Primary longitudinal bars
  - Shear bars (stirrups)
- Damage at beam ends around bearing

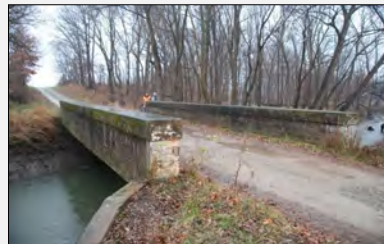
### Concrete Through Girders

- Common in 1940's, rarely used now
- Monolithic deck supported by a two-girder system
- Deck is cast between girders
- Upper portions of through girders serve as bridge railing
- Even though it is a two-girder system, girders are not FCMs

- Look for heavy section loss in beam leg bars
  - Primary longitudinal bars
  - Shear bars (stirrups)
- Heavy concrete spalling and delamination at girder ends

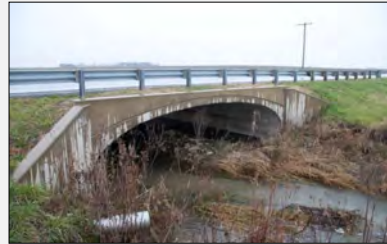
### 3-Sided Precast Structures

- Top may be arched or flat
- Most common version is precast concrete
- Top is considered the Superstructure (Item 59)
- Sides are considered the Substructure (Item 60)
- Deck (Item 58) is coded “N”

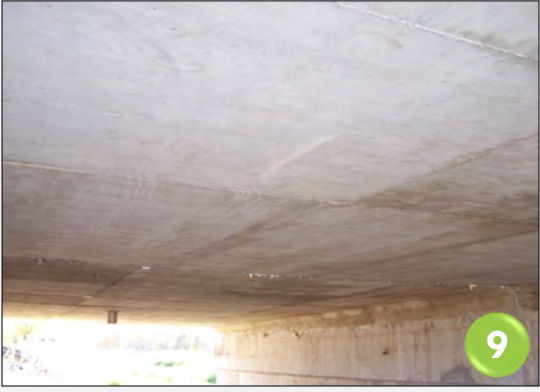
- Slab
- No Defects

New superstructure – Allowed first inspection only

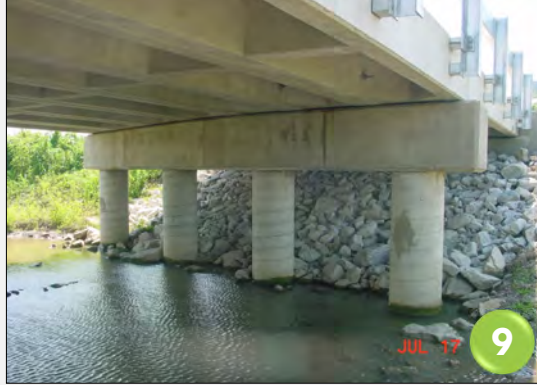
- Channel Beam
- No Defects

New superstructure – Allowed first inspection only

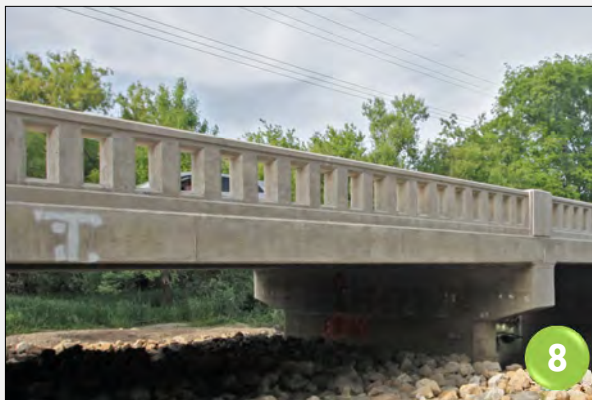
- Slab
- No significant defects

**VERY GOOD.** No significant defects, very minor shrinkage **cracks**, surface **scaling**, **spalling** or pop-outs which do not expose reinforcing steel.

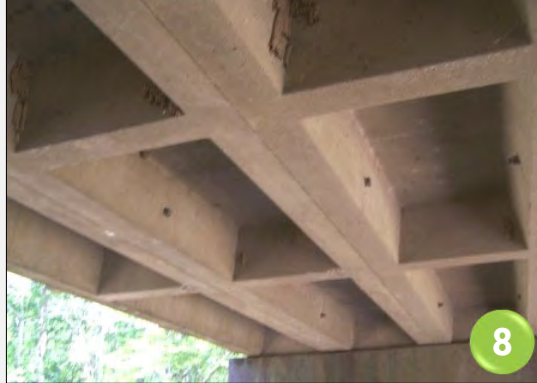
- Channel Beam
- Minor shrinkage cracks in legs

VERY GOOD. No significant defects, very minor shrinkage **cracks**, surface **scaling**, **spalling** or pop-outs which do not expose reinforcing steel.

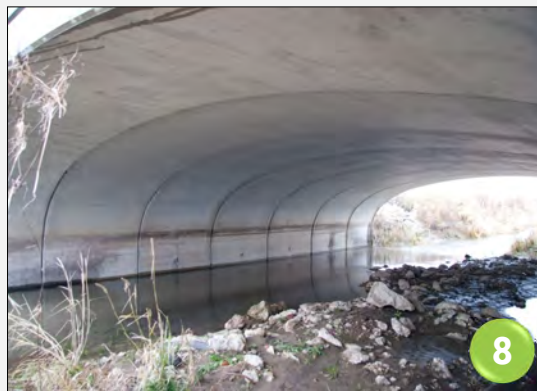
- 3-Sided Precast
- No significant defects

VERY GOOD. No significant defects, very minor shrinkage **cracks**, surface **scaling**, **spalling** or pop-outs which do not expose reinforcing steel.

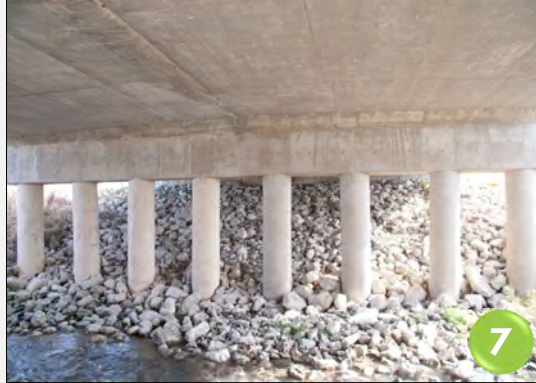
- Slab
- Minor non-structural cracks less than 0.03” present

GOOD. Isolated non-structural **cracks** up to 0.03”, minor pop-outs or **spalls** without exposed primary reinforcing steel, stirrups may be exposed in a few locations.

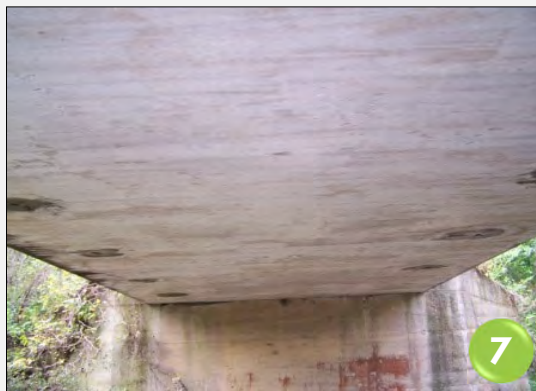
- Through Girder
- Minor spalling without exposed reinforcement

GOOD. Isolated non-structural **cracks** up to 0.03”, minor pop-outs or **spalls** without exposed primary reinforcing steel, stirrups may be exposed in a few locations.

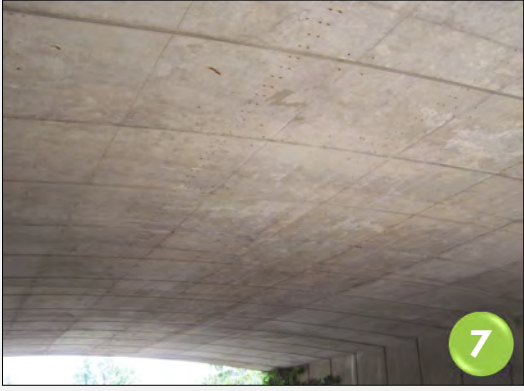
- 3-Sided Precast
- Non-structural cracks less than 0.03" present

**GOOD.** Isolated non-structural **cracks** up to 0.03", minor pop-outs or **spalls** without exposed primary reinforcing steel, stirrups may be exposed in a few locations.

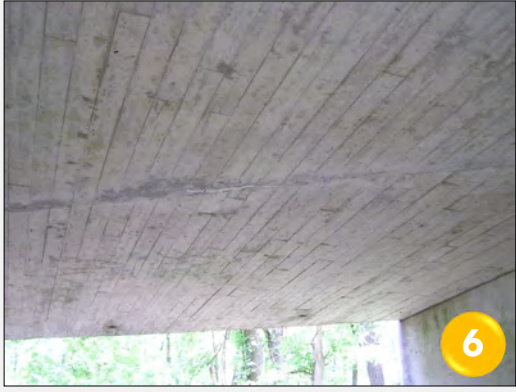
- Slab
- Non-structural cracks less than 0.06" present
- 7% of surface area is delaminated with leaching present over a 6' wide section

**SATISFACTORY.** Extensive non-structural **cracks** up to 0.06", isolated hairline structural **cracks, spalls and delaminations** may be present on up to 10% of a beams cross section or 6' width of a slab with exposed primary reinforcement with surface rust only, up to 20% of a beam cross section or 6' width of a slab may be map **cracked, spalled and delaminated**. Spalls and delaminations up to 5% on the sides of a beam cross section.

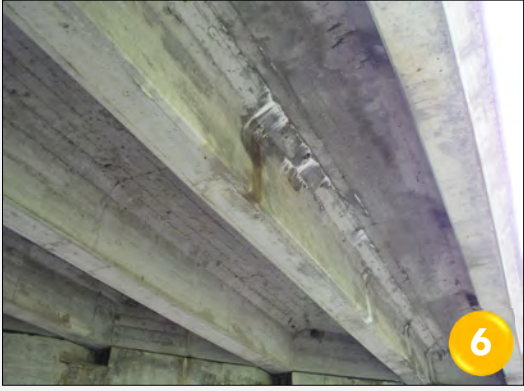
- T-Beam
- Non-structural cracks less than 0.06” present
- 9% of a beam surface area has spalls, delaminations, and leaching present

**SATISFACTORY.** Extensive non-structural **cracks** up to 0.06”, isolated hairline structural **cracks, spalls and delaminations** may be present on up to 10% of a beams cross section or 6’ width of a slab with exposed primary reinforcement with surface rust only, up to 20% of a beam cross section or 6’ width of a slab may be map cracked, spalled and delaminated. Spalls and delaminations up to 5% on the sides of a beam cross section.

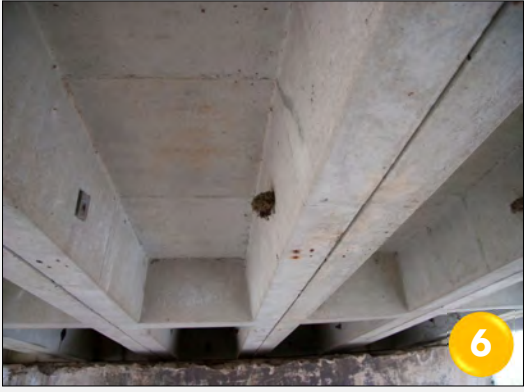
- Channel Beam
- Non-structural cracks less than 0.06” present
- 5% of a beams surface area has delaminations and map cracking
- Be sure cracks are due to delaminations!

**SATISFACTORY.** Extensive non-structural **cracks** up to 0.06”, isolated hairline structural **cracks, spalls and delaminations** may be present on up to 10% of a beams cross section or 6’ width of a slab with exposed primary reinforcement with surface rust only, up to 20% of a beam cross section or 6’ width of a slab may be map cracked, spalled and delaminated. Spalls and delaminations up to 5% on the sides of a beam cross section.

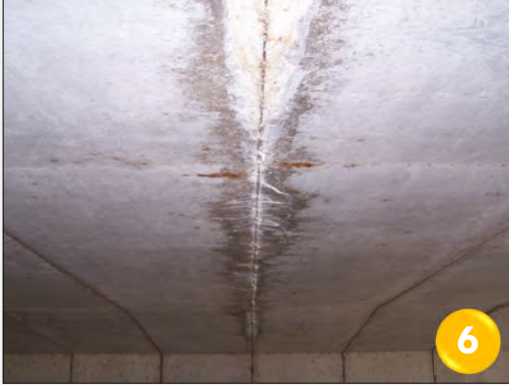
- 3-Sided Precast
- Tight non-structural cracks less than 0.06" present
- Leaching keyway

**SATISFACTORY.** Extensive non-structural cracks up to 0.06", isolated hairline structural cracks, spalls and delaminations may be present on up to 10% of a beams cross section or 6' width of a slab with exposed primary reinforcement with surface rust only, up to 20% of a beam cross section or 6' width of a slab may be map cracked, spalled and delaminated. Spalls and delaminations up to 5% on the sides of a beam cross section.

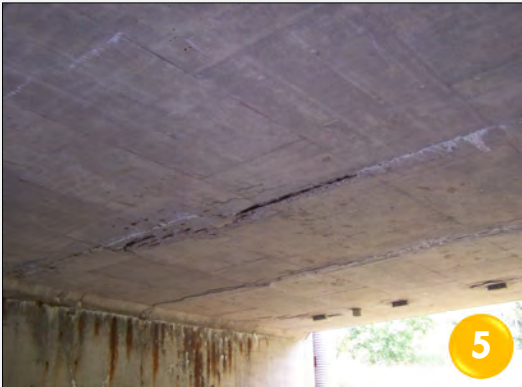
- Slab
- 8% spalls and delaminations present
- Less than 10% section loss in reinforcement over 6' width

**FAIR.** Non-structural cracks greater than 0.06", structural cracks up to 0.03", spalling with section loss of reinforcing steel up to 10% in a beam or 6' width of slab, up to 10% of compression surface area spalled or delaminated in a beam cross section or 6' width of slab. Up to 10% section loss of the concrete cross section.

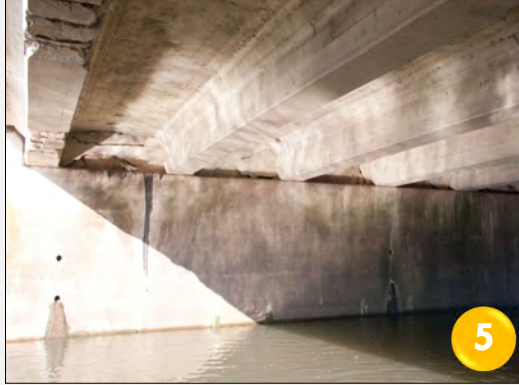
- T-Beam
- Spalling and delaminations present
- 10% section loss in beam primary reinforcement

FAIR. Non-structural cracks greater than 0.06", structural cracks up to 0.03", **spalling with section loss** of reinforcing steel up to 10% in a beam or 6' width of slab, up to 10% of compression surface area spalled or delaminated in a beam cross section or 6' width of slab. Up to 10% section loss of the concrete cross section.

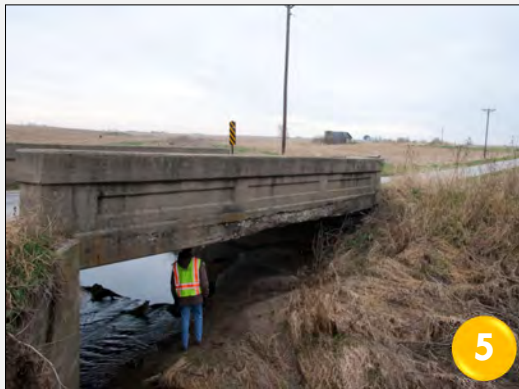
- Through Girder
- Isolated structural cracks less than 0.03" wide
- Spalling with 6% section loss in beam primary reinforcement

FAIR. Non-structural cracks greater than 0.06", **structural cracks** up to 0.03", **spalling with section loss** of reinforcing steel up to 10% in a beam or 6' width of slab, up to 10% of compression surface area spalled or delaminated in a beam cross section or 6' width of slab. Up to 10% section loss of the concrete cross section.

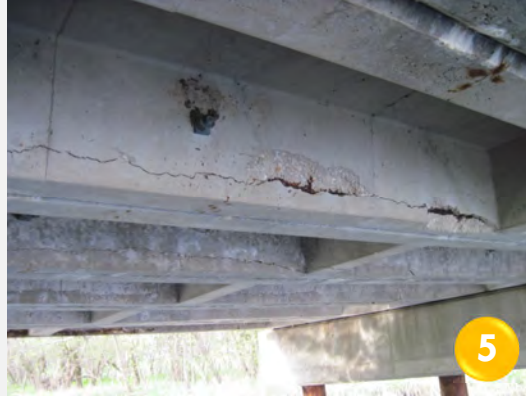
- Channel Beam
- Map cracking, delaminations, and leaching present on 10% of beam surface
- No significant section loss in exposed steel

**FAIR.** Non-structural cracks greater than 0.06", structural cracks up to 0.03", **spalling with section loss** of reinforcing steel up to 10% in a beam or 6' width of slab, up to 10% of compression surface area spalled or delaminated in a beam cross section or 6' width of slab. Up to 10% section loss of the concrete cross section.

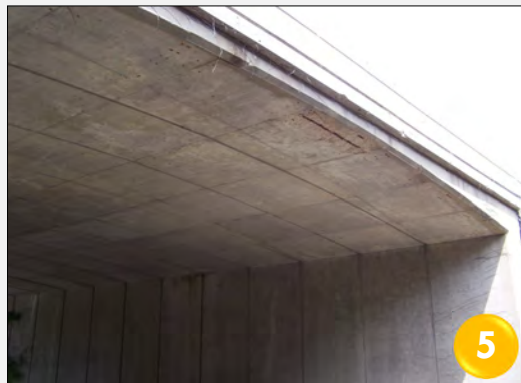
- 3-Sided Precast
- 8% of surface area is spalled or delaminated
- 6% section loss in reinforcement

**FAIR.** Non-structural cracks greater than 0.06", structural cracks up to 0.03", **spalling with section loss** of reinforcing steel up to 10% in a beam or 6' width of slab, up to 10% of compression surface area spalled or delaminated in a beam cross section or 6' width of slab. Up to 10% section loss of the concrete cross section.

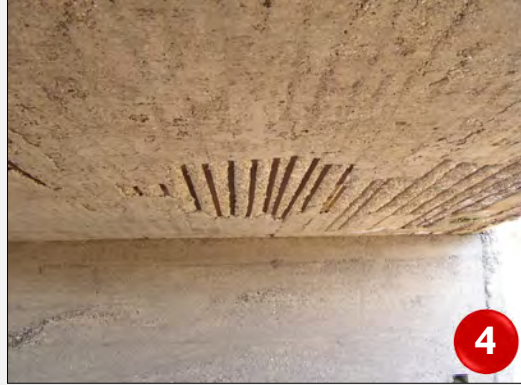
- Slab
- Spalling with exposed reinforcement present
- 15% section loss in primary reinforcement over a 6' width

POOR. Flexural or shear cracks up to 0.06", primary reinforcing steel exposed with **section loss** up to 30% in a 6' width of slab or in a beam cross section, up to 50% of the compression surface area **spalled or delaminated**, channel beams spalled or delaminated up to 30% section loss of the beam concrete cross section around the bottom primary reinforcement steel but not within 4' of beam ends.

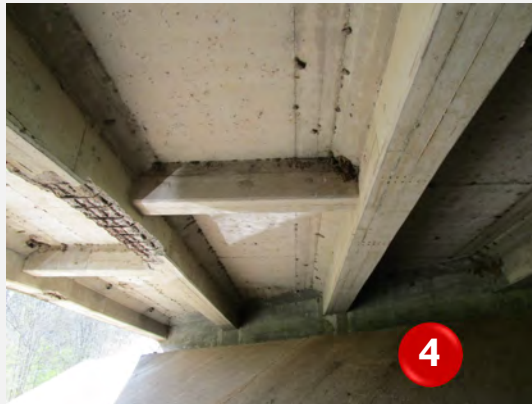
- T-Beam
- Structural cracks near beam ends less than 0.06" in width
- Delaminations and widespread leaching present
- 25% section loss in beam primary reinf.

POOR. Flexural or shear **cracks** up to 0.06", primary reinforcing steel exposed with **section loss up to 30%** in a 6' width of slab or in a beam cross section, up to 50% of the compression surface area **spalled or delaminated**, channel beams spalled or delaminated up to 30% section loss of the beam concrete cross section around the bottom primary reinforcement steel but not within 4' of beam ends.

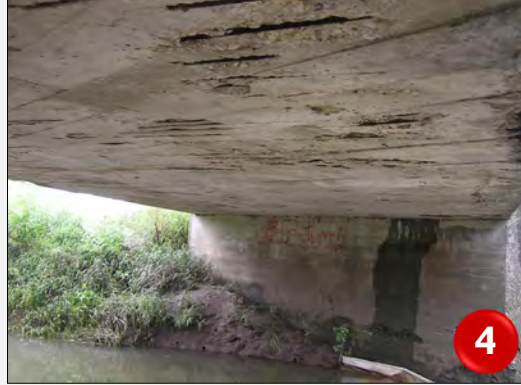
- Through Girder
- Spalled concrete with exposed reinforcement
- 20% section loss in exposed primary reinforcement

POOR. Flexural or shear cracks up to 0.06", primary reinforcing steel exposed with **section loss** up to 30% in a 6' width of slab or in a beam cross section, up to 50% of the compression surface area spalled or delaminated, channel beams spalled or delaminated up to 30% section loss of the beam concrete cross section around the bottom primary reinforcement steel but not within 4' of beam ends.

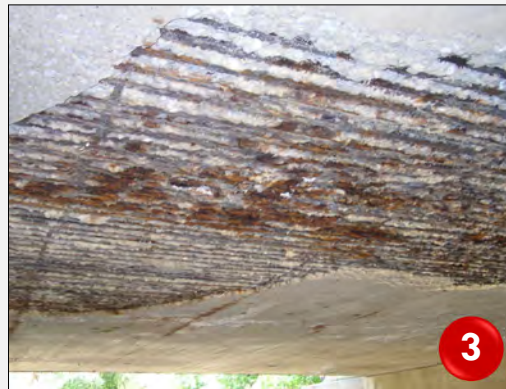
- Slab
- Concrete spalling with reinforcement exposed
- 35% section loss in exposed primary reinforcement
- Concrete cores may be needed

SERIOUS. Primary reinforcing steel exposed with **section loss** up to 50% on a 6' width for slabs or cross section for beams, up to 100% section loss of compression surface area in a 6' width of slab or beam cross section, up to 50% section loss of the concrete cross section of a beam, channel beams spalled or delaminated around the bottom primary reinforcement steel within 4' of beam ends.

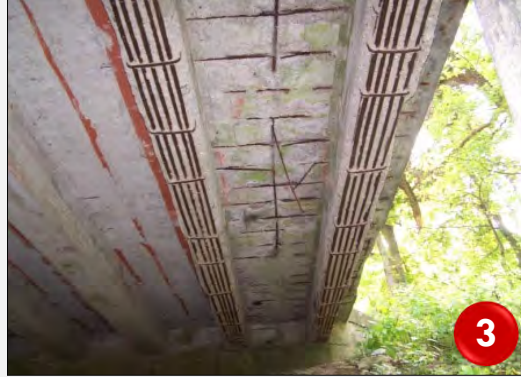
- T-Beam
- Concrete spalling with reinforcement exposed
- 40% section loss in exposed primary reinforcement

**SERIOUS.** Primary reinforcing steel exposed with **section loss** up to 50% on a 6' width for slabs or cross section for beams, up to 100% section loss of compression surface area in a 6' width of slab or beam cross section, up to 50% section loss of the concrete cross section of a beam, channel beams spalled or delaminated around the bottom primary reinforcement steel within 4' of beam ends.

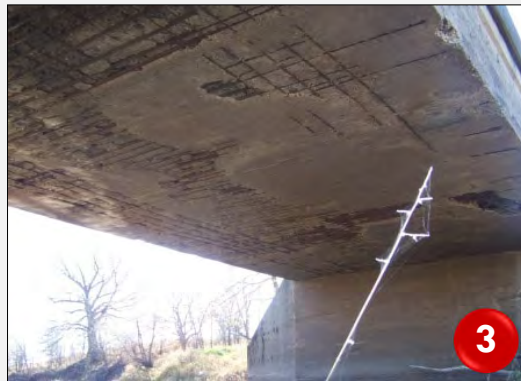
- Through Girder
- Concrete spalling with reinforcement exposed
- 35% section loss in exposed primary reinforcement

**SERIOUS.** Primary reinforcing steel exposed with **section loss** up to 50% on a 6' width for slabs or cross section for beams, up to 100% section loss of compression surface area in a 6' width of slab or beam cross section, up to 50% section loss of the concrete cross section of a beam, channel beams spalled or delaminated around the bottom primary reinforcement steel within 4' of beam ends.

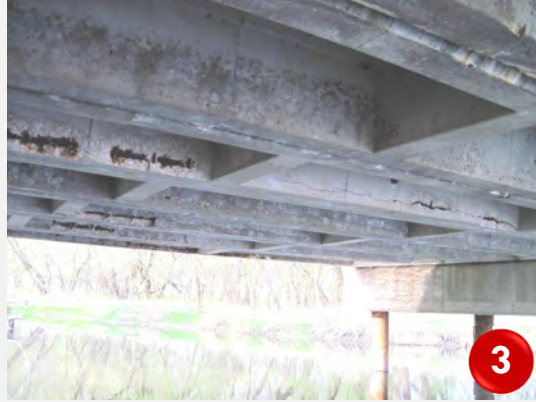
- Channel Beam
- Concrete spalling with reinforcement exposed
- 35% section loss in exposed primary reinforcement

**SERIOUS.** Primary reinforcing steel exposed with **section loss** up to 50% on a 6' width for slabs or cross section for beams, up to 100% section loss of compression surface area in a 6' width of slab or beam cross section, up to 50% section loss of the concrete cross section of a beam, channel beams spalled or delaminated around the bottom primary reinforcement steel within 4' of beam ends.

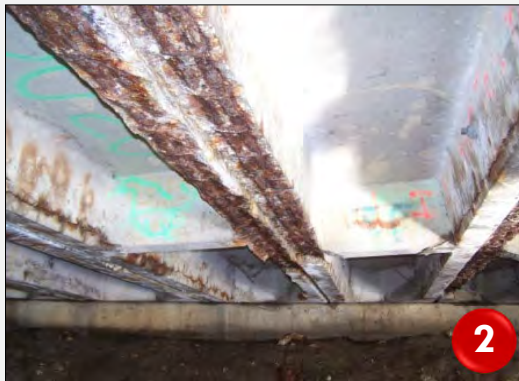
- Channel Beam
- Concrete spalling with reinforcement exposed
- 40% section loss in primary reinforcement
- Broken stirrups at beam ends
- Bureau of Bridges and Structures should be notified immediately!

**CRITICAL.** Similar to the description for a condition rating of "3" although more extensive with over 50% **loss of reinforcing steel**, channel beams fully delaminated or **spalled at ends with broken stirrups**, requires special feature inspections, temporary support or repairs may be required to remain open to traffic. The Bureau of Bridges and Structures shall be notified immediately.

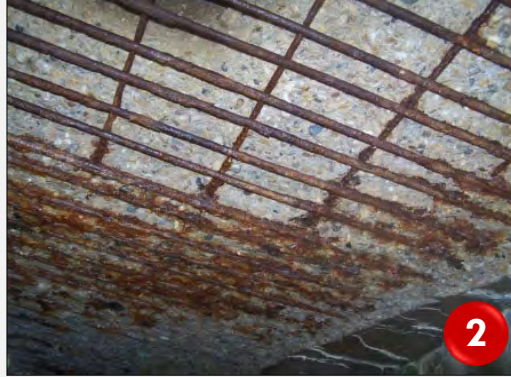
- Slab
- Large spall with two layers of exposed reinforcement
- 50% section loss in bottom reinforcement
- Full-depth hole through slab above reinforcement
- Middle third of soffit is delaminated and sagging

**CRITICAL.** Similar to the description for a condition rating of “3” although more extensive with over 50% loss of reinforcing steel, channel beams fully delaminated or spalled at ends with broken stirrups, requires special feature inspections, temporary support or repairs may be required to remain open to traffic. The Bureau of Bridges and Structures shall be notified immediately.

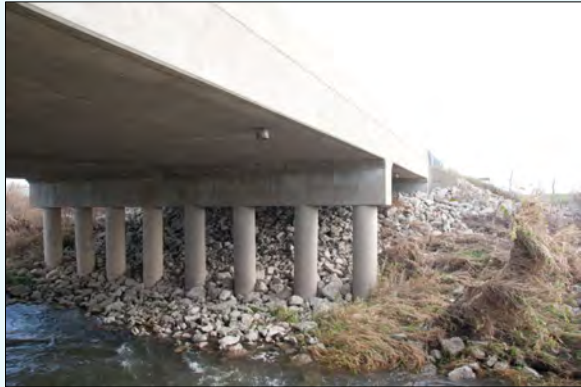
### Typical Elements

- Abutments
- Piers
- Piles
- Footings
- Fenders

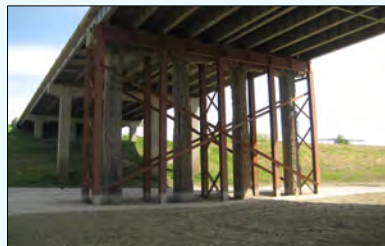
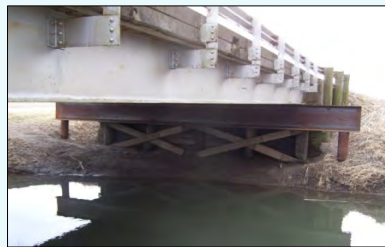
### Temporary Shoring

- If left in place for 5 yrs. or more, temporary supports are considered the Substructure
- The rating coded for Item 60 would be based on the criteria for the material used for the former “temporary” support
- Steel shoring, similar to the example in the lower photo, becomes a Fracture Critical Member in the Substructure

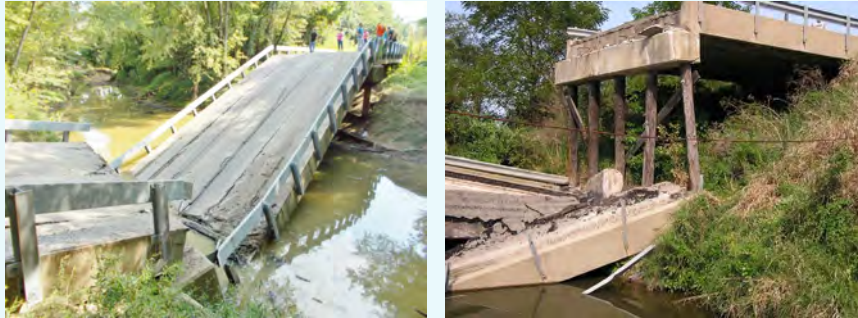
### Excessive Deterioration in Exposed Piling:

- Heavy damage too exposed piles is a problem and has caused multiple bridge failures and closures
- Inspectors need to pay extra attention to these types of piles

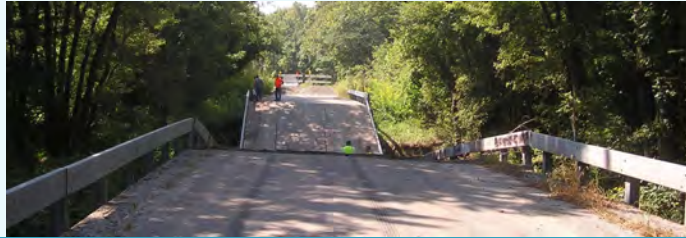
### IL County Bridge Failure

- Pier collapsed on 4 span bridge in September 2013
- Collapse immediately preceded by a < legal loads truck crossing bridge
- Failure of deteriorated piling was the cause

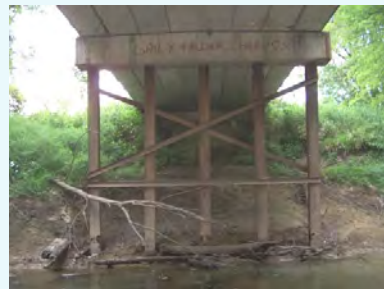
- Exposed steel H-Piles
- Accelerated deterioration and section loss occurred
  - At the water line
  - In areas with frequent wetting and drying
- Difficult location to easily see during inspection

**Pier similar to the one that failed**

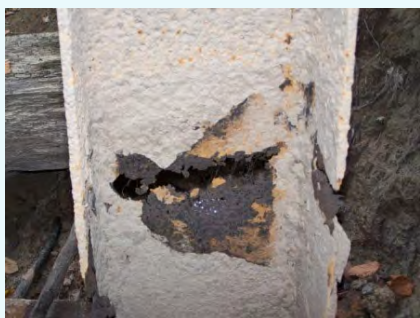
#### Steel H-piling

Heavy section loss

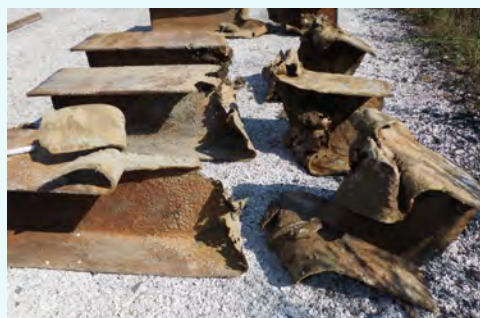
Failed pile sections

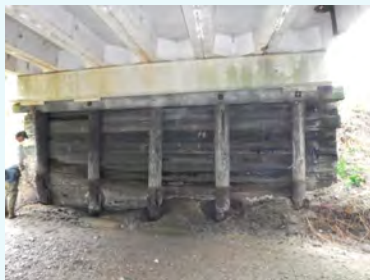
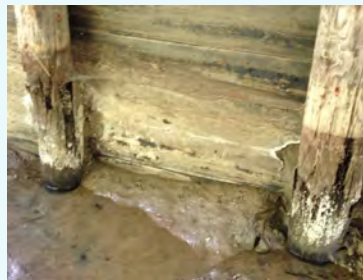
- Damaged Timber Piling
- Heavy deterioration found just below the mud-line

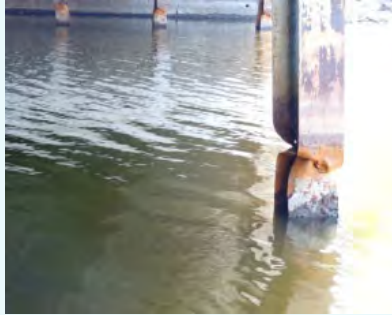
2016 State Rte. Bridge closure in [Ohio](#) due to deteriorated exposed steel piles at the water line. SUBSTRUCTURE Rating was a "7".

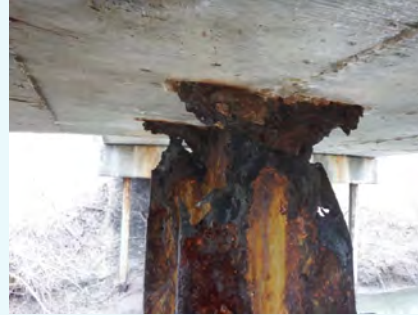
2016 Local Rte. Bridge closure in [Illinois](#) due to deteriorated exposed steel piles just below the pier cap.

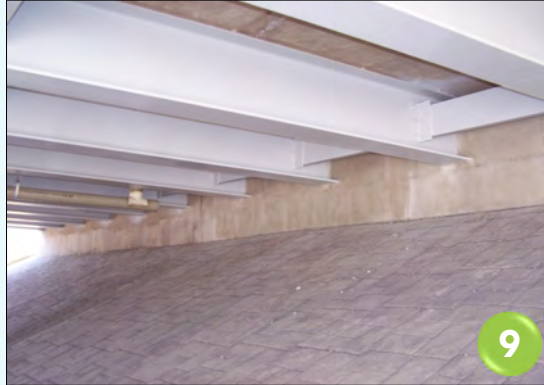
L-17

**New  
Construction**

**Note Integral  
Abutment**

Allowed 1<sup>st</sup> inspection only.

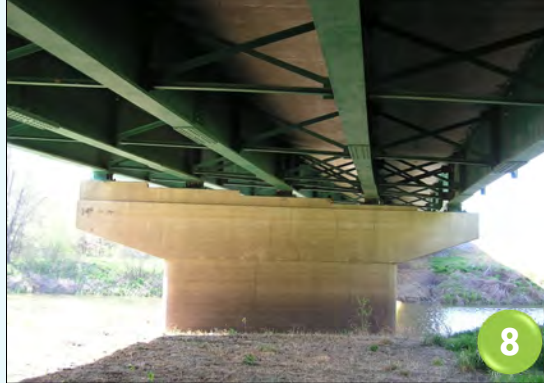
**VERY GOOD.** No significant defects. Shrinkage cracks, very light surface **scaling**, spalling or pop-outs which do not expose reinforcing steel. Insignificant damage caused by drift or collision with no misalignment and no corrective action warranted.

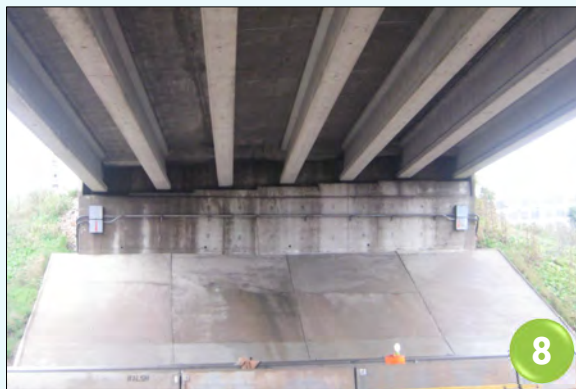
**VERY GOOD.** No significant defects. Shrinkage cracks, very light surface **scaling**, spalling or pop-outs which do not expose reinforcing steel. Insignificant damage caused by drift or collision with no misalignment and no corrective action warranted.

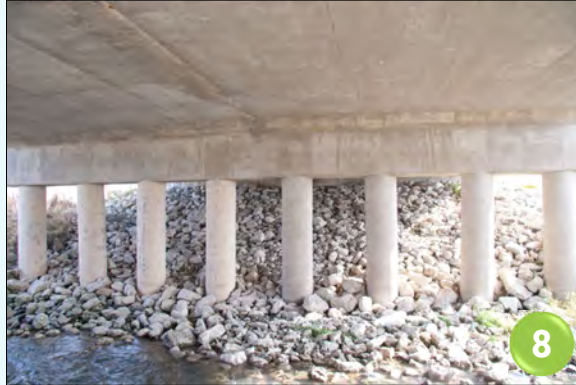
No noted defects

**VERY GOOD.** No significant defects. Shrinkage cracks, very light surface scaling, spalling or pop-outs which do not expose reinforcing steel. Insignificant damage caused by drift or collision with no misalignment and no corrective action warranted.

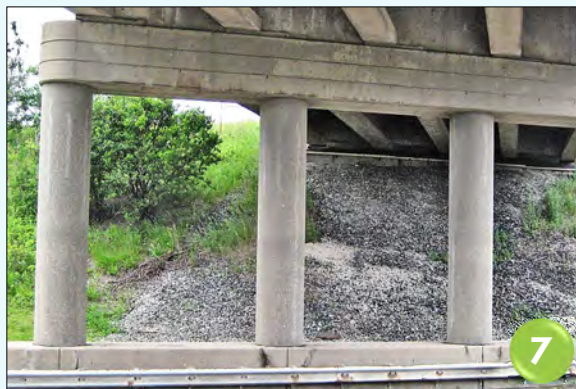
**GOOD.** Minor **cracking**, spalls or **scaling** with few incidences of exposed reinforcement with only surface rust. Minor scour may have occurred at the foundation.

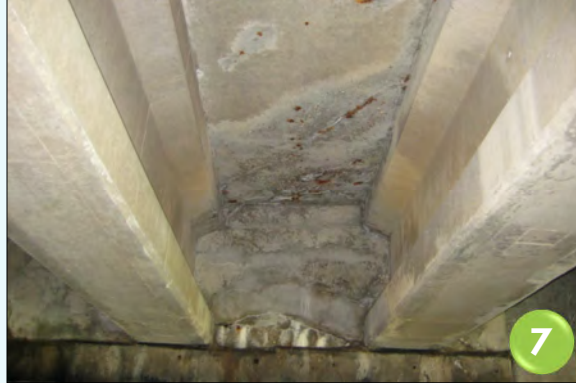
GOOD. Minor **cracking**, spalls or **scaling** with few incidences of exposed reinforcement with only surface rust. Minor scour may have occurred at the foundation.

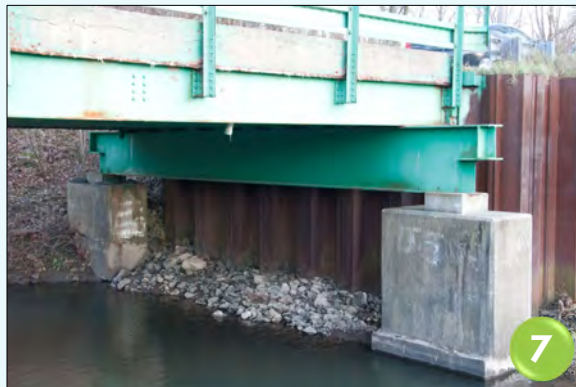
GOOD. Minor **cracking**, spalls or **scaling** with few incidences of exposed reinforcement with only surface rust. Minor **scour** may have occurred at the foundation.

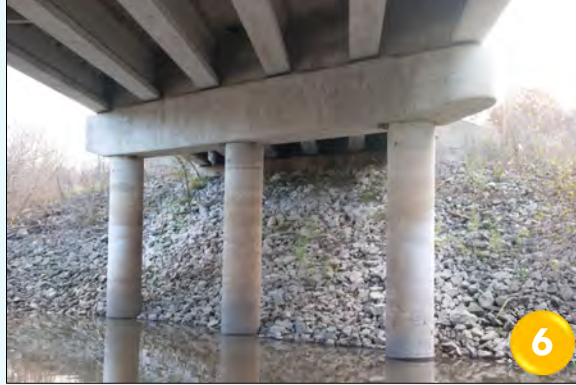
**SATISFACTORY.** Moderate deterioration or disintegration, **spalls, cracking** and leaching on concrete or masonry units with up to 2% section loss or loss of bearing area. Shallow, local scour may have occurred near foundations with exposure of top of pile supported footings, less than 2' deep scour around pile bents. No exposed piles.

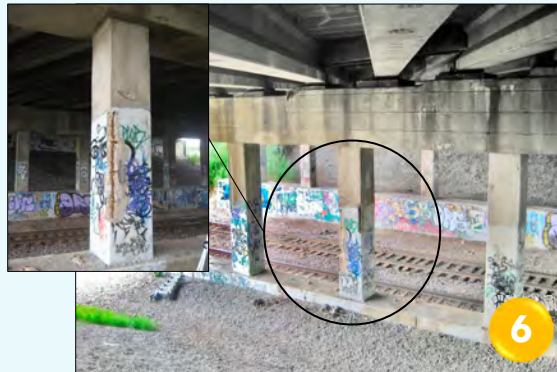
**SATISFACTORY.** Moderate deterioration or disintegration, **spalls, cracking** and leaching on concrete or masonry units with up to 2% section loss or loss of bearing area. Shallow, local scour may have occurred near foundations with exposure of top of pile supported footings, less than 2' deep scour around pile bents. No exposed piles.

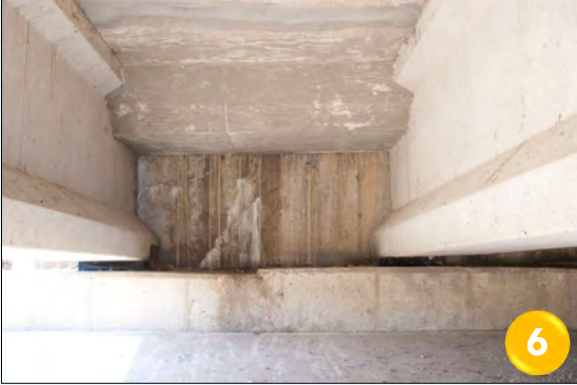
**SATISFACTORY.** Moderate deterioration or disintegration, spalls, **cracking** and leaching on concrete or masonry units with up to 2% section loss or loss of bearing area. Shallow, local scour may have occurred near foundations with exposure of top of pile supported footings, less than 2' deep scour around pile bents. No exposed piles.

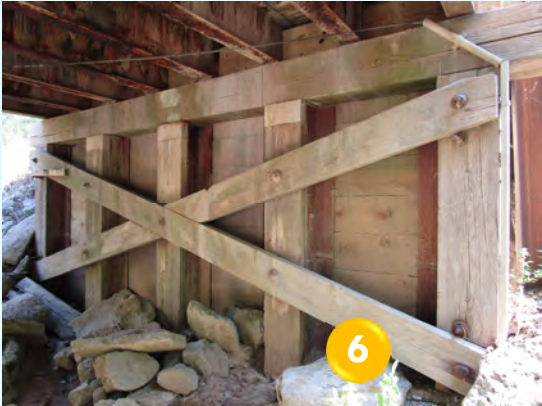
**SATISFACTORY.** **Surface decay, cracking, splitting of timber,** fire damage limited to surface scorching of timber with up to 2% section loss, shallow, local scour may have occurred near foundations. No exposed piles.

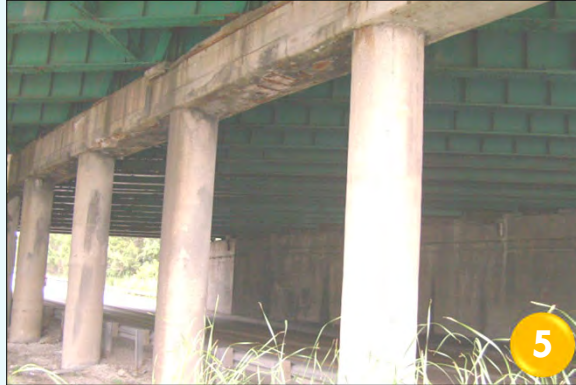
FAIR. Large portions of concrete or masonry units are **spalled**, scaled, or delaminated with **exposed reinforcing steel** up to 10% loss of concrete (horizontal cross section), up to 10% **loss of reinforcement** steel, extensive map cracking with leaching, spread footings with no undermining on soil and up to 5% undermining on rock, less than 2' of exposed piles or seal coat below pile supported footings, less than 6' deep scour around pile bents, up to 10% section loss of bearing seats or piles.

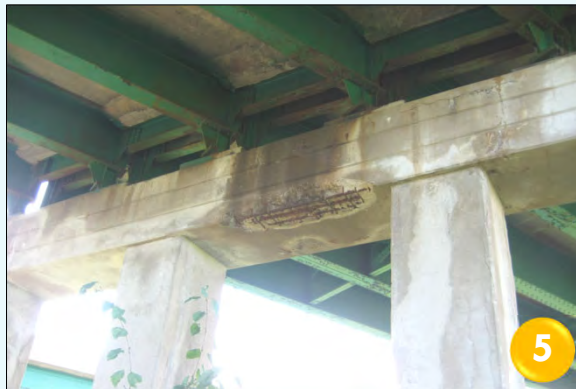
FAIR. Large portions of concrete or masonry units are **spalled**, scaled, or **delaminated** with exposed reinforcing steel up to 10% loss of concrete (horizontal cross section), up to 10% **loss of reinforcement** steel, extensive map cracking with leaching, spread footings with no undermining on soil and up to 5% undermining on rock, less than 2' of exposed piles or seal coat below pile supported footings, less than 6' deep scour around pile bents, up to 10% section loss of bearing seats or piles.

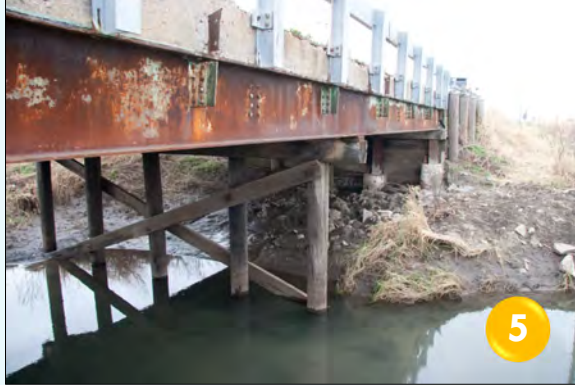
**FAIR.** Minor decay, cracking or splitting of timber, a few secondary members may need replacement but primary members are performing their function as designed with section loss up to 10%, fire damage limited to surface charring of timber with minor section loss up to 10%, spread footings exposed with no undermining on soil and up to 5% undermining on rock, less than 2' of piles or seal coat exposed below pile supported footings, less than 6' deep scour around pile bents with pile caps installed above the ground, no misalignment or settlement noted.

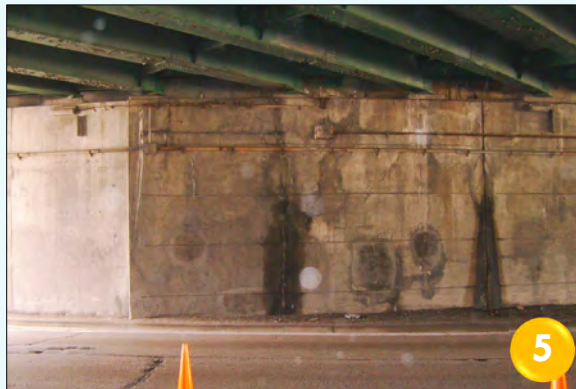
**FAIR.** Large portions of concrete or masonry units are spalled, scaled, or delaminated with exposed reinforcing steel up to 10% loss of concrete (horizontal cross section), up to 10% loss of reinforcement steel, extensive map cracking with leaching, spread footings with no undermining on soil and up to 5% undermining on rock, less than 2' of exposed piles or seal coat below pile supported footings, less than 6' deep scour around pile bents, up to 10% section loss of bearing seats or piles.

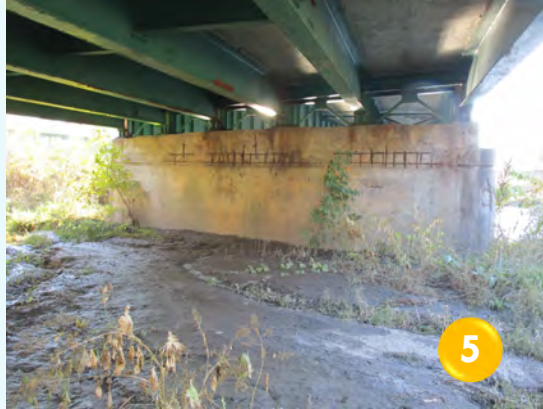
**FAIR.** Large portions of concrete or masonry units are spalled, scaled, or delaminated with exposed reinforcing steel up to 10% loss of concrete (horizontal cross section), up to 10% loss of reinforcement steel, extensive map cracking with leaching, spread footings with no undermining on soil and up to 5% undermining on rock, less than 2' of exposed piles or seal coat below pile supported footings, less than 6' deep scour around pile bents, up to 10% section loss of bearing seats or piles.

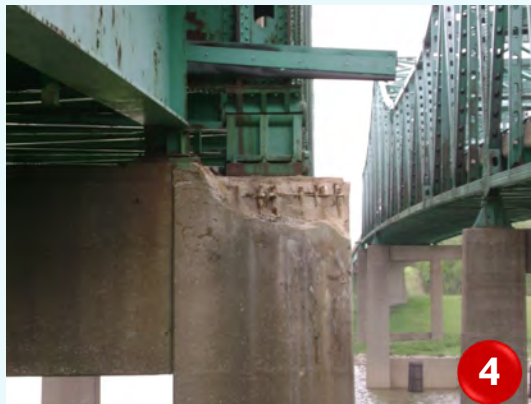
**POOR.** Active cracks in concrete and masonry units that indicate a reduction in the substructure unit's capacity to support the superstructure loads, up to 30% section loss of bearing seat(s) or pile(s), section loss of primary steel reinforcement up to 30%. Section loss of concrete up to 30%, undermining of spread footing which may be affecting the stability of the unit but no significant settlement has yet occurred, worst condition or combination of deterioration stated in condition rating "5". If the rating of this item is due to scour, the rating for Item 113 shall be re-evaluated.

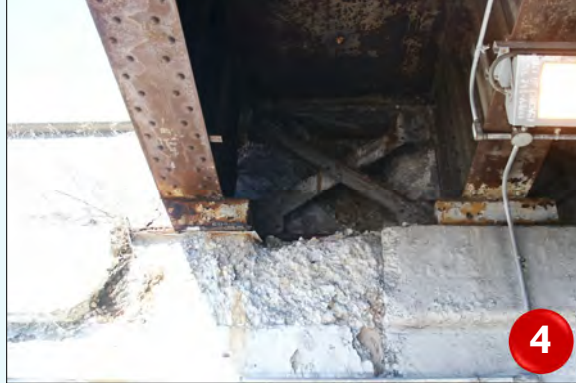
POOR. Active cracks in concrete and masonry units that indicate a reduction in the substructure unit's capacity to support the superstructure loads, up to 30% section loss of bearing seat(s) or pile(s), section loss of primary steel reinforcement up to 30%. Section loss of concrete up to 30%, undermining of spread footing which may be affecting the stability of the unit but no significant settlement has yet occurred, worst condition or combination of deterioration stated in condition rating "5". If the rating of this item is due to scour, the rating for Item 113 shall be re-evaluated.

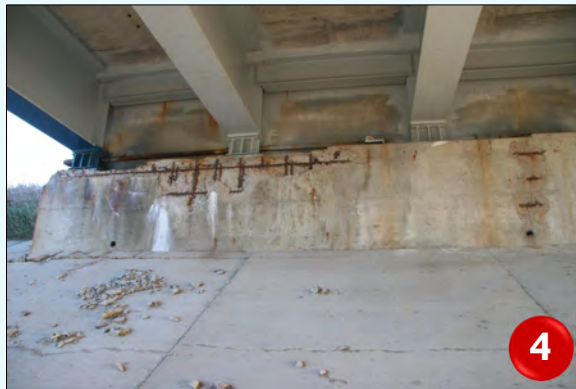
POOR. Active cracks in concrete and masonry units that indicate a reduction in the substructure unit's capacity to support the superstructure loads, up to 30% section loss of bearing seat(s) or pile(s), section loss of primary steel reinforcement up to 30%. Section loss of concrete up to 30%, undermining of spread footing which may be affecting the stability of the unit but no significant settlement has yet occurred, worst condition or combination of deterioration stated in condition rating "5". If the rating of this item is due to scour, the rating for Item 113 shall be re-evaluated.

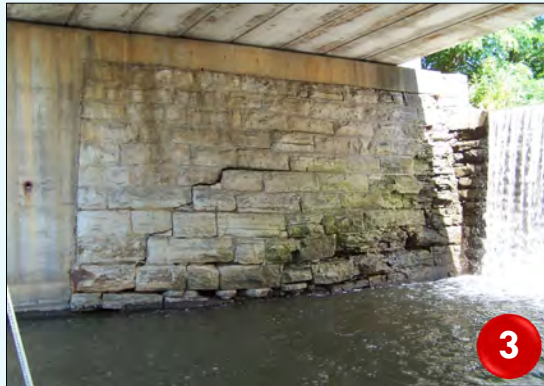
**SERIOUS.** Section losses up to 50%, loss of bearing seat area to cause more than 2" drop, adjacent column ties are broken causing the vertical reinforcement to be ineffective, **severe scour or undermining of footings affecting the stability of the unit with some settlement of the substructure.** If the rating of this item is due to **scour**, the rating for Item 113 shall be re-evaluated.

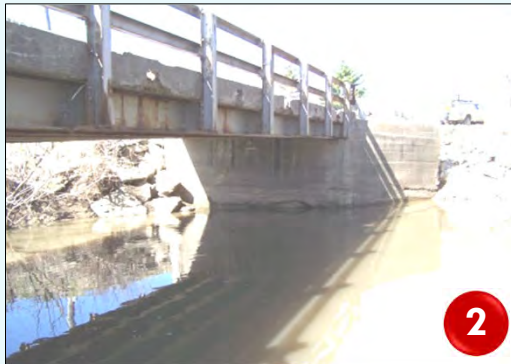
**CRITICAL.** Conditions worse than condition rating of "3", section loss greater than 50%, special feature inspection is required to allow bridge to remain open, **measurable lateral or vertical movement, unstable structures.** The Bureau of Bridges and Structures shall be notified immediately. If the rating of this item is due to scour, the rating for Item 113 shall be re-evaluated.
