**ACCESS METHODS, COORDINATION,  
TEST EQUIPMENT & MOT**

3/7/2024 IL NBI Refresher Course 2024

**Access Methods, Coordination, Test Equip. & MOT**

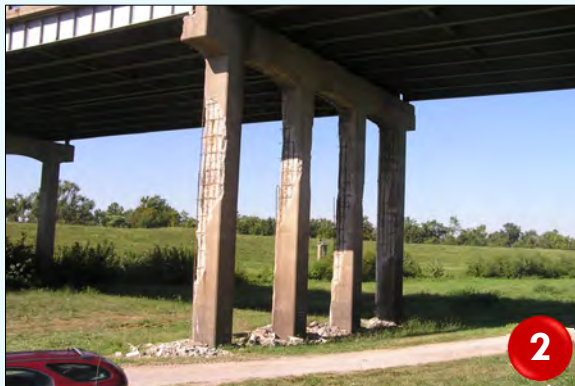
CRITICAL. Conditions worse than condition rating of "3", **section loss greater than 50%**, special feature inspection is required to allow bridge to remain open, measurable lateral or vertical movement, unstable structures. The Bureau of Bridges and Structures shall be notified immediately. If the rating of this item is due to scour, the rating for Item 113 shall be re-evaluated.

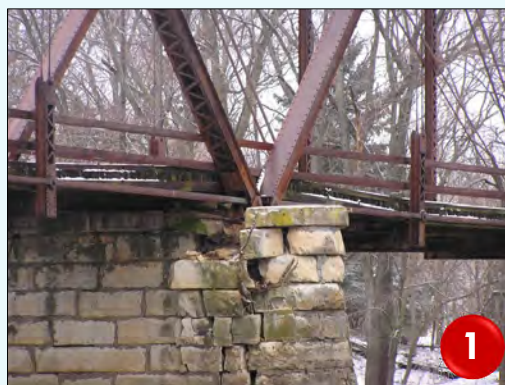
Substructure in **"imminent failure" condition** requiring bridge closure or temporary measures to allow structure to remain open.

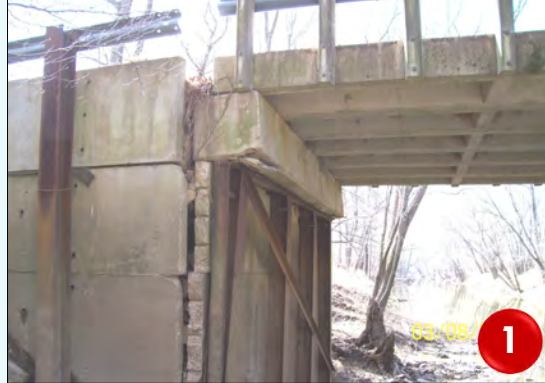
Substructure in **“imminent failure” condition** requiring bridge closure or temporary measures to allow structure to remain open.

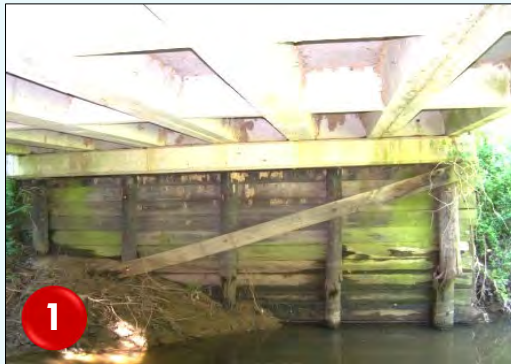
Substructure in **“imminent failure” condition** requiring bridge closure or temporary measures to allow structure to remain open.
