Mitigation Banking Instrument
Portage Reserve Mitigation Bank
Portage, Alaska

Submitted to:
Interagency Review Team
May 2019

EXHIBIT B
MITIGATION PLAN

Appendix A
Portage Reserve Mitigation Bank
Jurisdictional Determination Report and REV
Classification

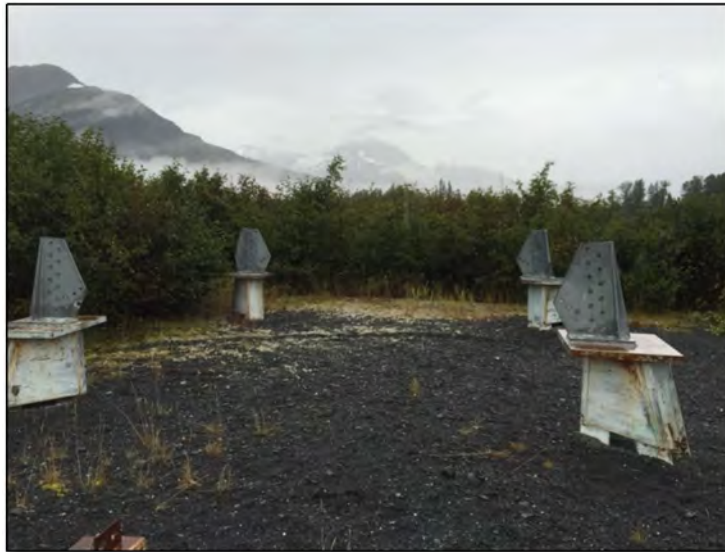
Inset 1. Abandoned microwave tower pad. September 6, 2016.

The Restoration Area is centered on a wetland re-establishment project that will remove an abandoned gravel road and microwave tower pad (Inset 1; Figure 9). The road, constructed in the early 1970s, is approximately 2,600 feet long, and extends south from Portage Glacier Road beginning approximately 0.15 mile east of the Seward Highway. The road is occasionally used as a ski trail in the winter and spring and as an access route for waterfowl and game hunting. The project will re-establish wetland functions to 2.119 acres of wetlands that were previously filled and converted to upland for the road and pad, and will also re-establish hydrologic connectivity within the larger wetland complex. The limits of the roadway and pad to be removed are shown in Figures 9 and 10.

The existing fill (approximately 15,000 cubic yards) will be removed through the use of excavators, dump trucks, and other heavy equipment as necessary. Excavation will begin in spring or early summer. The fill will be over-excavated to below the ground surface, because the ground surface has likely been compacted below the original elevation. Compacted soils beneath the fill material will be loosened by mechanical means. Clean topsoil or stockpiled peat soils from permitted off-

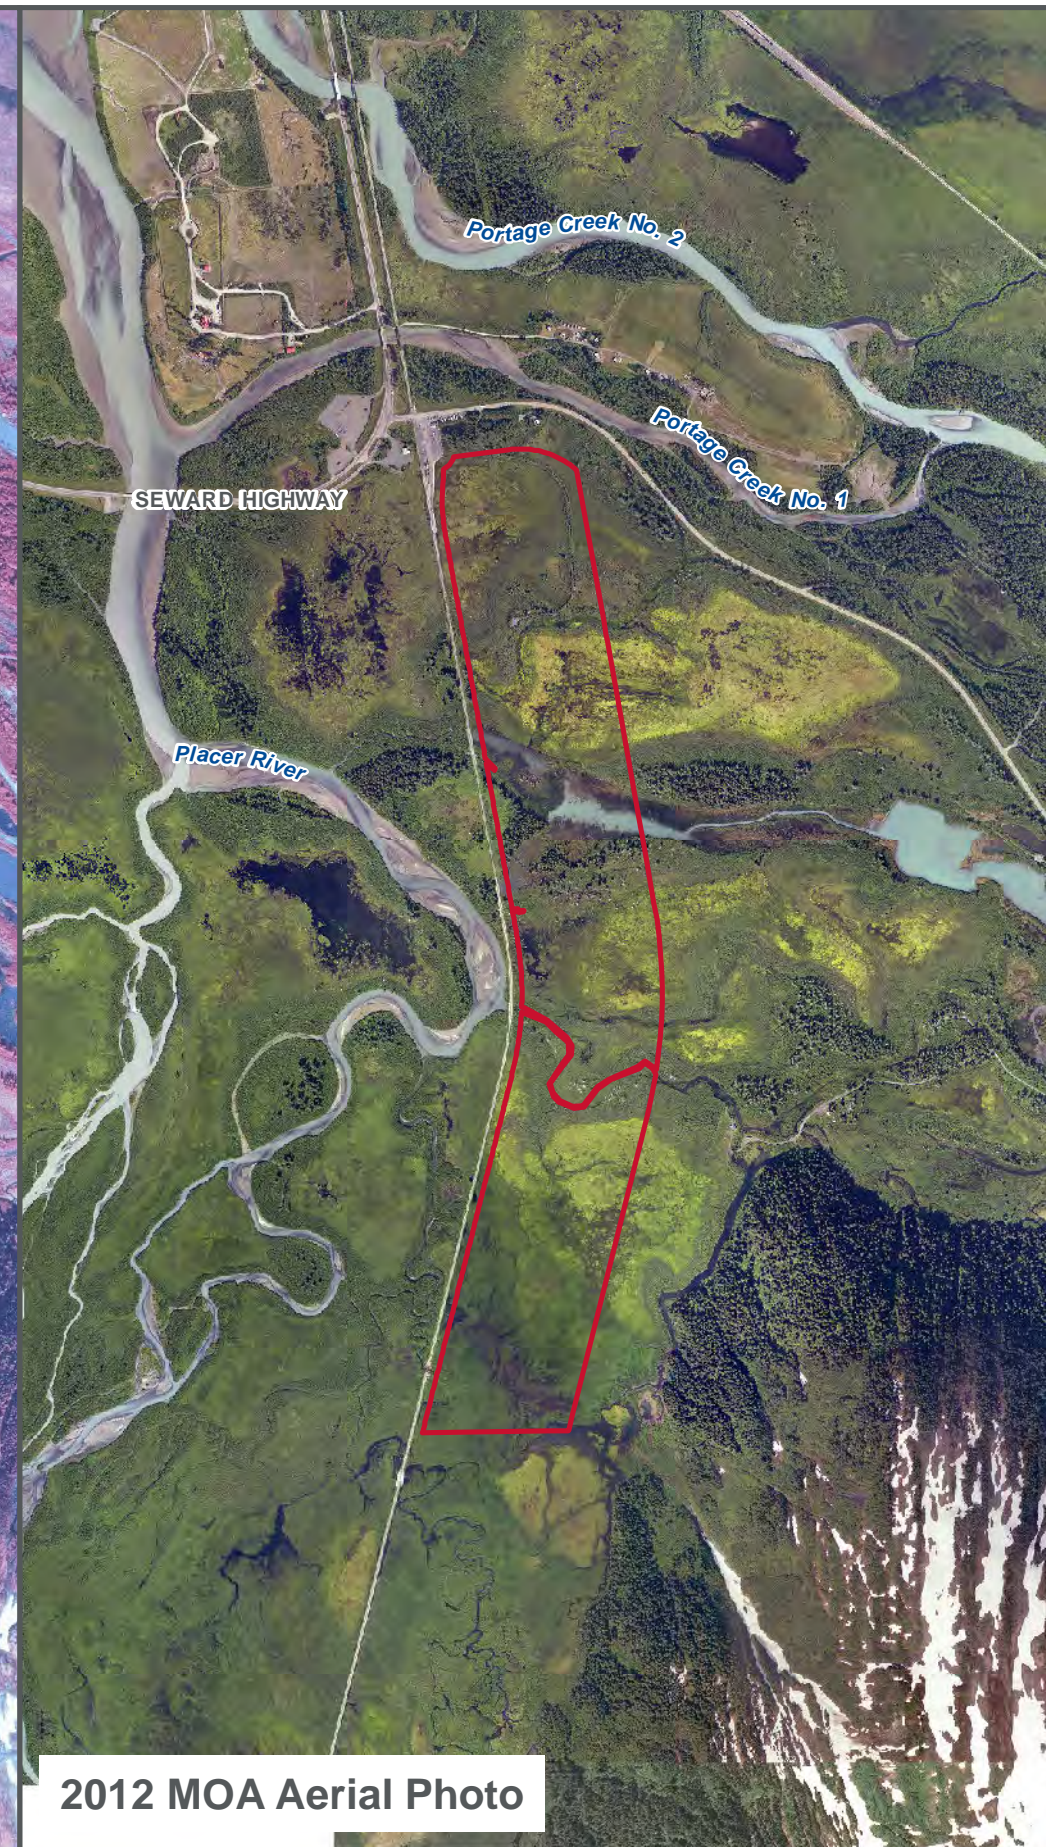
2012 MOA Aerial Photo

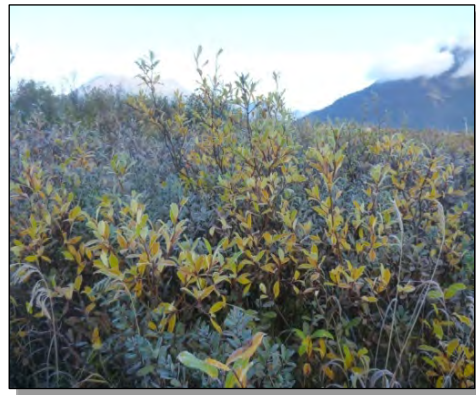
Inset 2: Semipermanently flooded broad-leaved deciduous scrub-shrub/persistent emergent wetland (PSS1/EM1F) at Site 1

Broad-leaved deciduous scrub-shrub (PSS1) wetlands occupy 98.5 acres (approximately 32 percent) of the PRMB area (Inset 2). These wetlands are found throughout the PRMB area, especially in the southern half adjacent to the rail line.

Vegetation is typically dominated by sweetgale (*Myrica gale*), Barclay's willow (*Salix barclayi*), Sitka alder (*Alnus viridus*), and squashberry (*Viburnum edule*). Common herb species include bluejoint reedgrass, water horsetail (*Equisetum fluviatile*), tall cotton-grass (*Eriophorum angustifolium*), and mud sedge (*Carex limosa*).

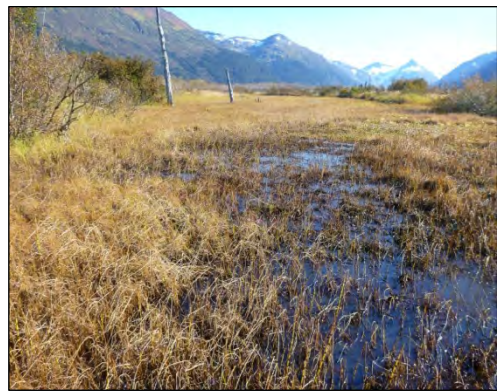
Inset 3: Permanently flooded persistent emergent wetland (PEM1H) at Site 65

Persistent emergent (PEM1) wetlands comprise 164.6 acres (approximately 53 percent) of the PRMB area (Inset 3). These wetlands are part of large wetland complexes and found directly adjacent to waterbodies within the PRMB area.

Vegetation is typically dominated by bluejoint reedgrass, water horsetail, and Northwest Territory sedge (*Carex utriculata*).

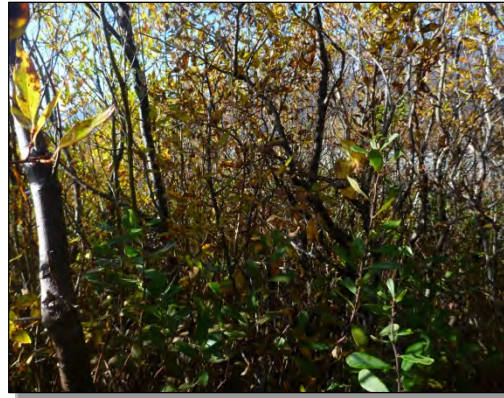
Inset 6: Upland (U) tall closed willow shrub at Site 6

Uplands account for 38.4 acres (approximately 12 percent) of the PRMB area. Forty-three percent of the mapped uplands are disturbed and have been filled, including the rail line and a parking lot off Portage Glacier Road. The ARRC main line is a narrow band of gravel fill running along the western boundary of the PRMB area. The fill prism is typically bordered by a narrow band of natural or naturalized uplands. The north section of the PRMB area also contains an overgrown gravel road and abandoned microwave tower pad.

Local topography is a major factor influencing wetland/upland status within the PRMB area, with uplands present on elevated ground surfaces above the influence of the water table. Upland vegetation communities in the PRMB area include closed alder thicket, spruce forest, or tall closed willow shrub. Common trees and shrubs in upland areas include Sitka alder, white spruce (*Picea glauca*), cottonwood (*Populus balsamifera*), diamond-leaf willow (*Salix pulchra*), and squashberry. Common herbs found include narrow-leaf fireweed, bluejoint reedgrass, and spreading wood fern (*Dryopteris expansa*). Soils at upland sites were generally well-drained and sandy with no indicators of hydrology.

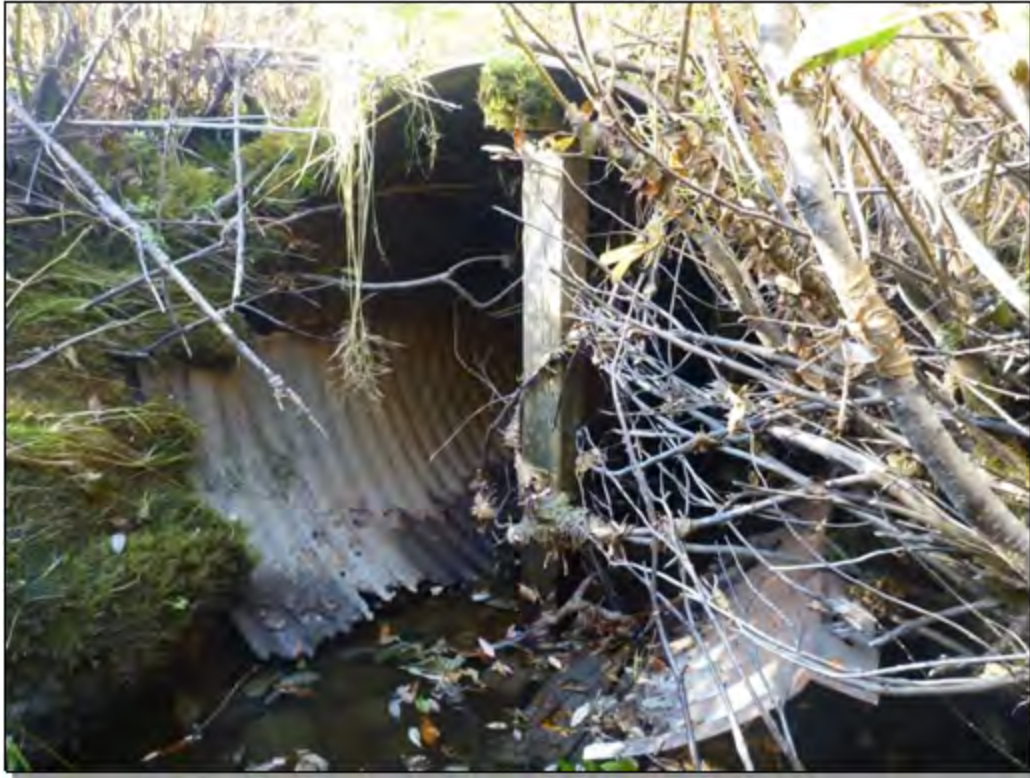
Site 9: Culvert. Photo taken September 29, 2016

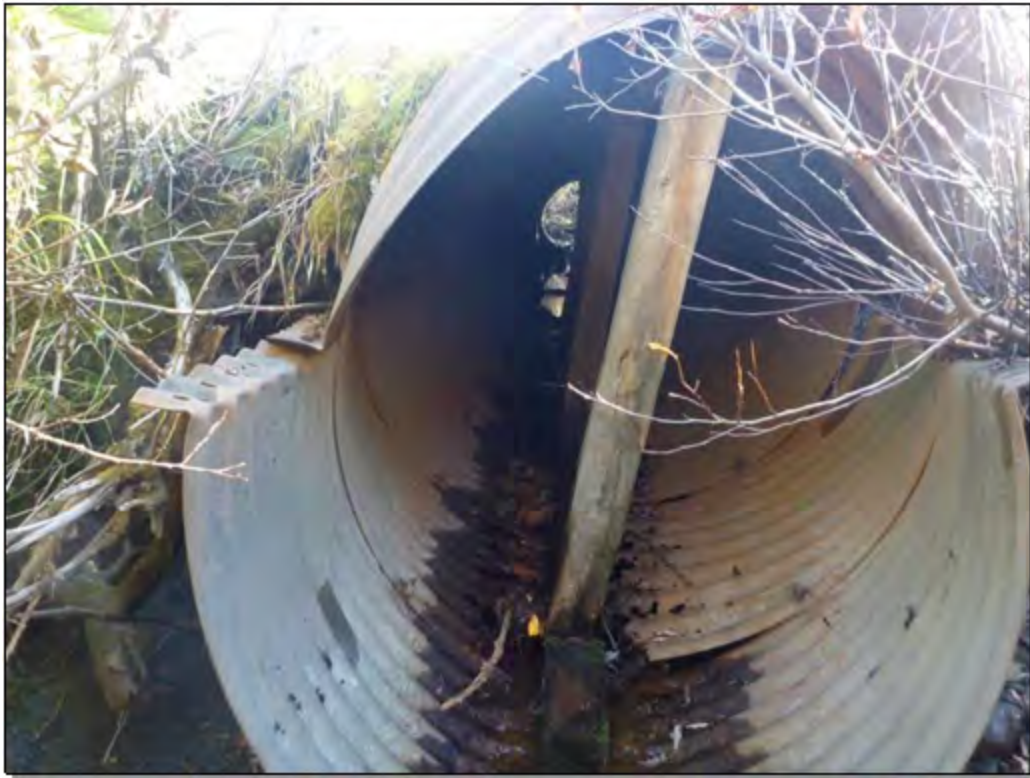
Site 10: Culvert. Photo taken September 29, 2016

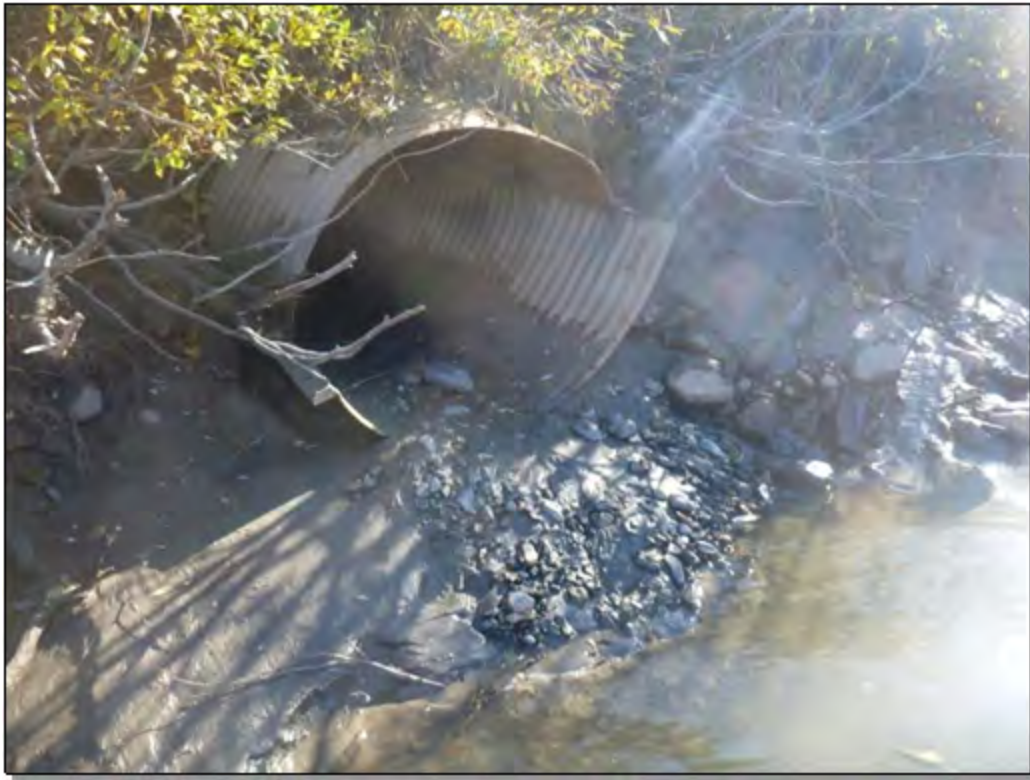
Site 15: South culvert. Photo taken September 29, 2016

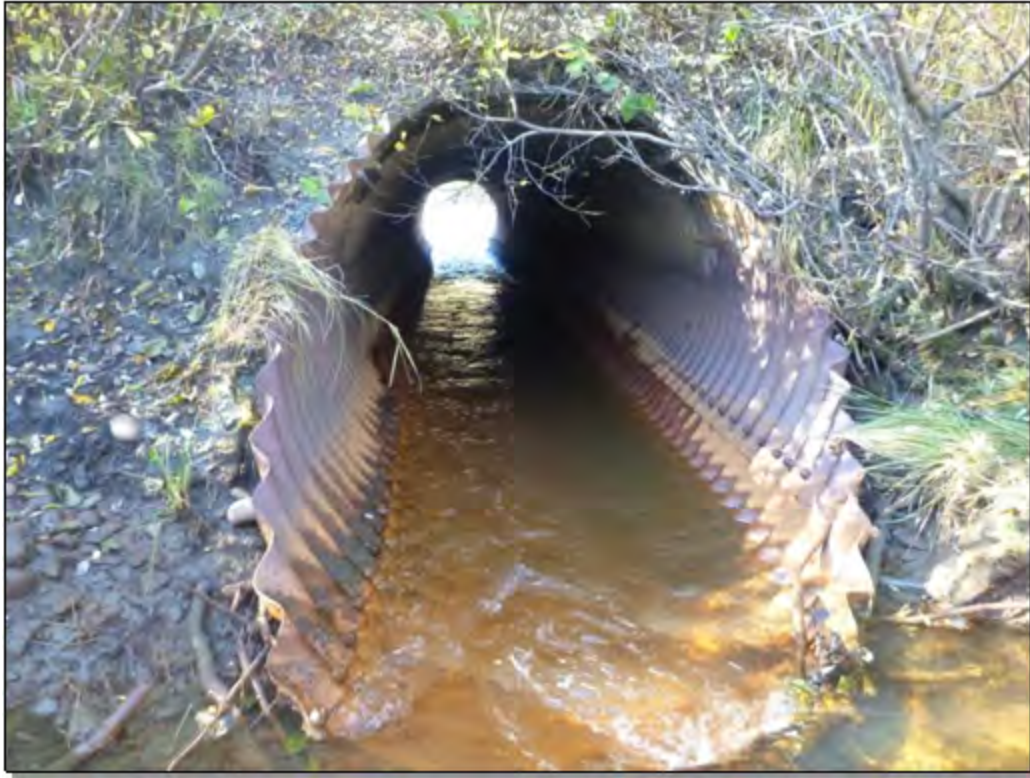
Site 16: Culvert. Photo taken September 29, 2016
