GEOLOGY FOUNDATION REPORT

Seward Hwy MP 18-25
Trail River Bridge No. 610

Project# STP-031-1(27)

October 2003

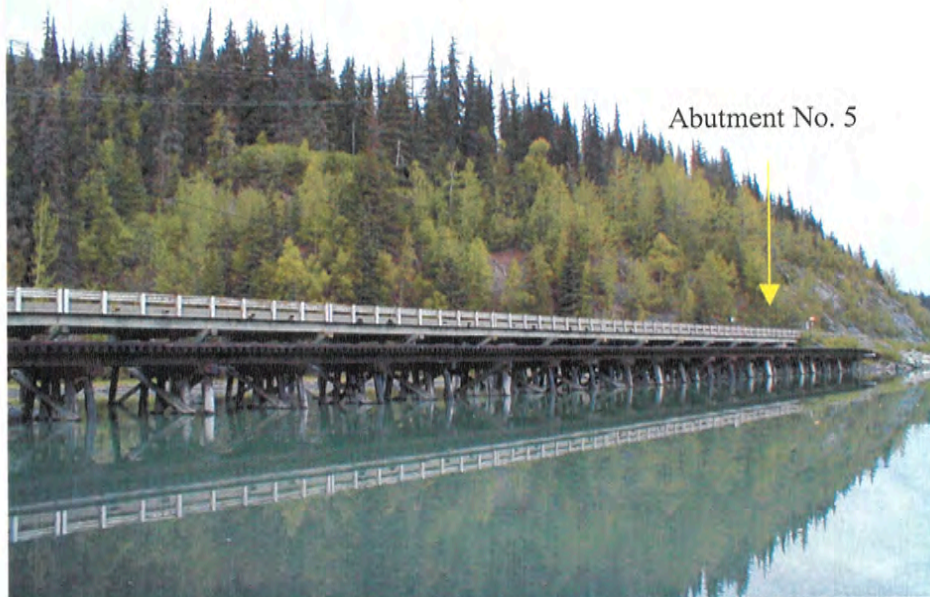
Looking northwest at the Alaska Railroad bridge in front of the highway bridge. Overhead power lines span the river from the top of the hill in the background.

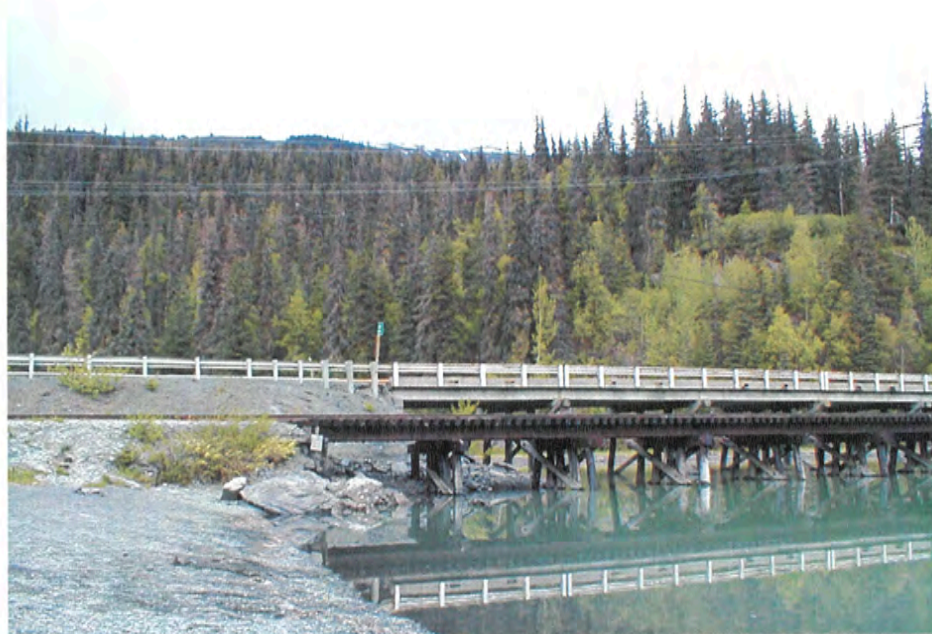
Looking west at the existing southern abutment of the highway and AKRR bridges. Only about 6 m separates the two bridges.

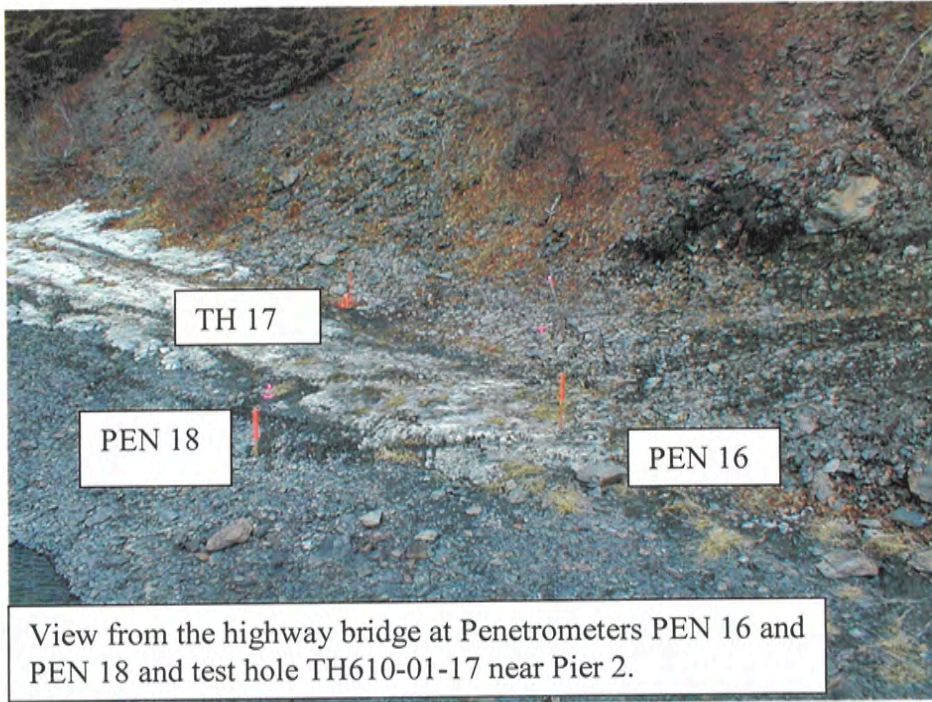
View from the highway bridge at Penetrometers PEN 16 and PEN 18 and test hole TH610-01-17 near Pier 2.

Pier 4: Penetrometer PEN 16 and PEN 18 hit refusal at about 2.7 m in depth. TH-17 showed sandy gravel with cobbles to a depth of 2.6 m over phyllite bedrock.

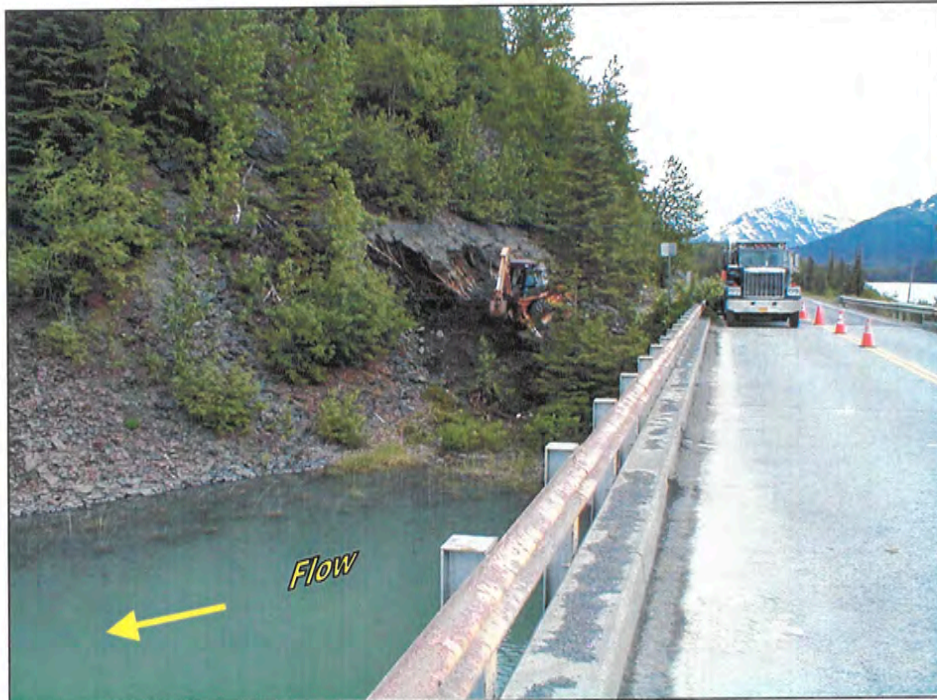
Looking at the proposed location of Abutment No. 5 from center of the existing bridge. The excavator is at the location of Test Pit 13.

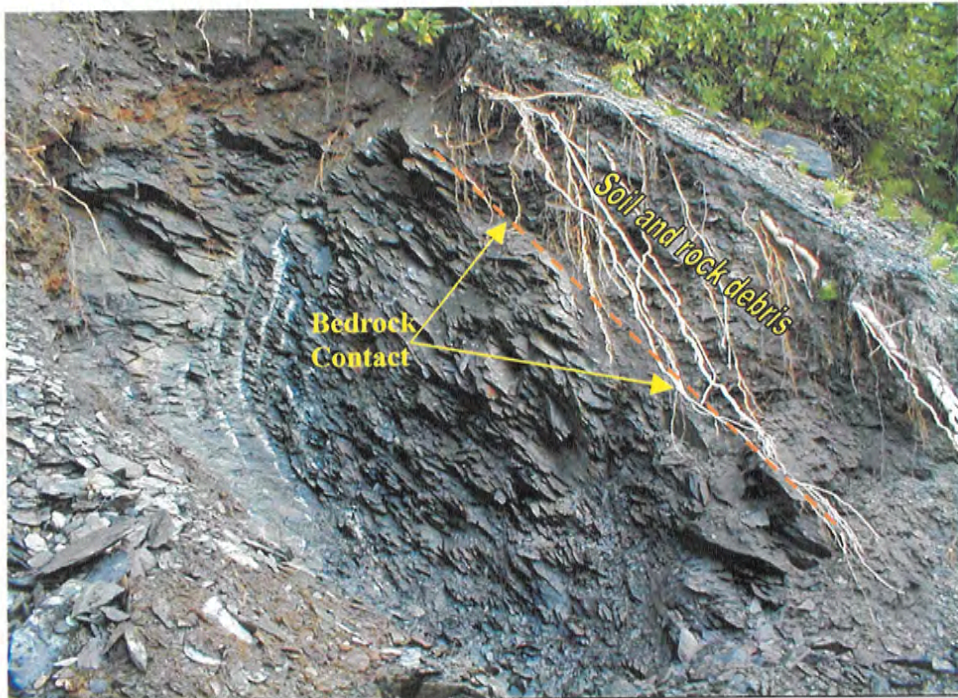
Soil type and bedrock at Test Pit 13 near Abutment No. 5.

Abutment 5: Test pits TP-13 through TP-15 showed about 0.2 m of surface organics, over slightly organic silty gravelly silt with cobbles and boulders to 1.2 m, over 1 m of weathered bedrock, over thinly bedded phyllite bedrock.

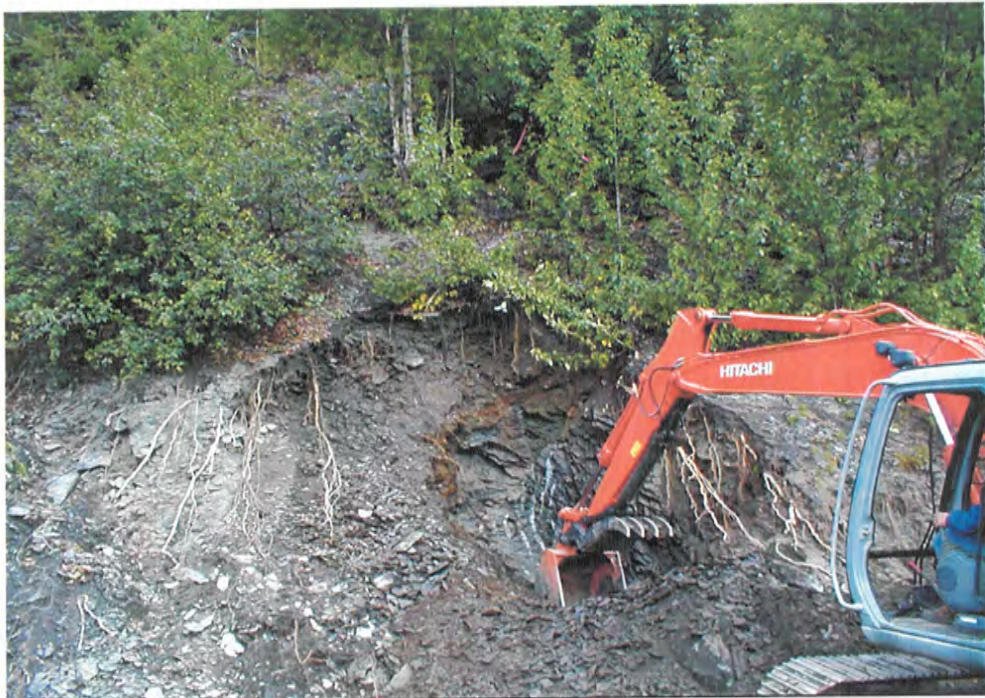
Excavator at Test Pit 13 near Abutment No. 5.

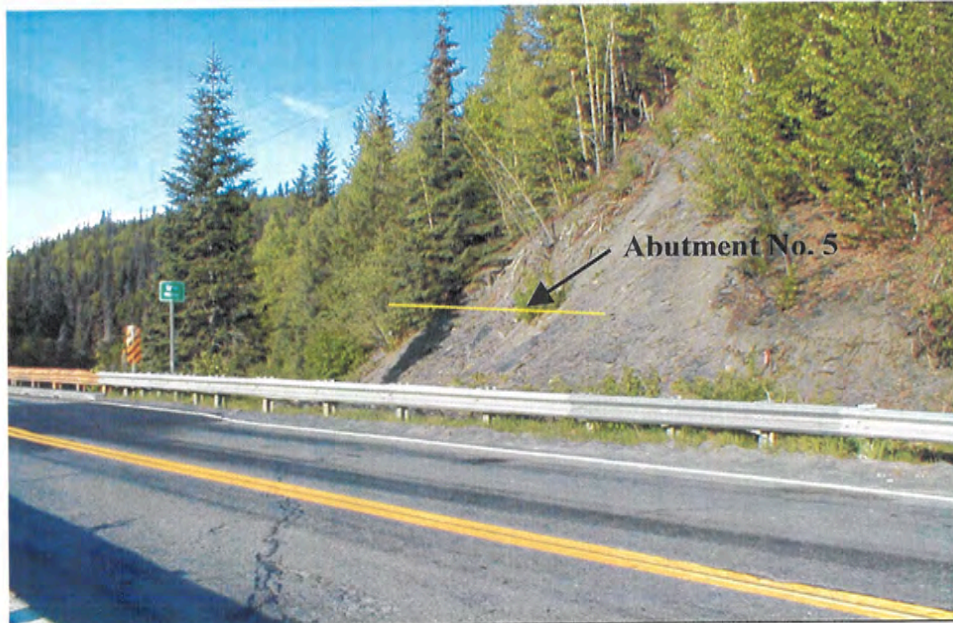
View of proposed Abutment 5. Note the very steep hillside debris and bedrock slope.

Abutment 5 is located at the base of a steep hillside west of the highway that rises about 25 m above Trail River. Abutment 5 encroaches the highway ditchline on the downstream side of the existing bridge. Steeply dipping bedrock is exposed near this location with overburden soils and debris covering the slope above the existing ditchline.

Exposed bedrock at Abutment No. 5 dips steeply towards the Seward Highway and Lower Trail Lake. The bedrock is a thinly bedded argillite and phyllite that has historically weathered and broken off in slabs and landed in the ditch line of the highway.

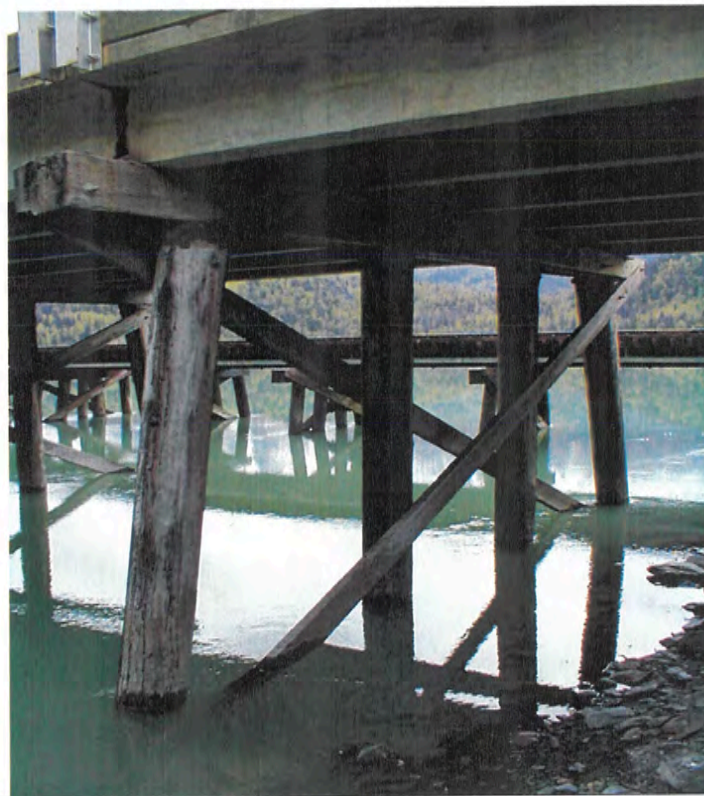
Photo showing the wood piling supports for the highway bridge. The Alaska Railroad bridge is in the background of the photo.

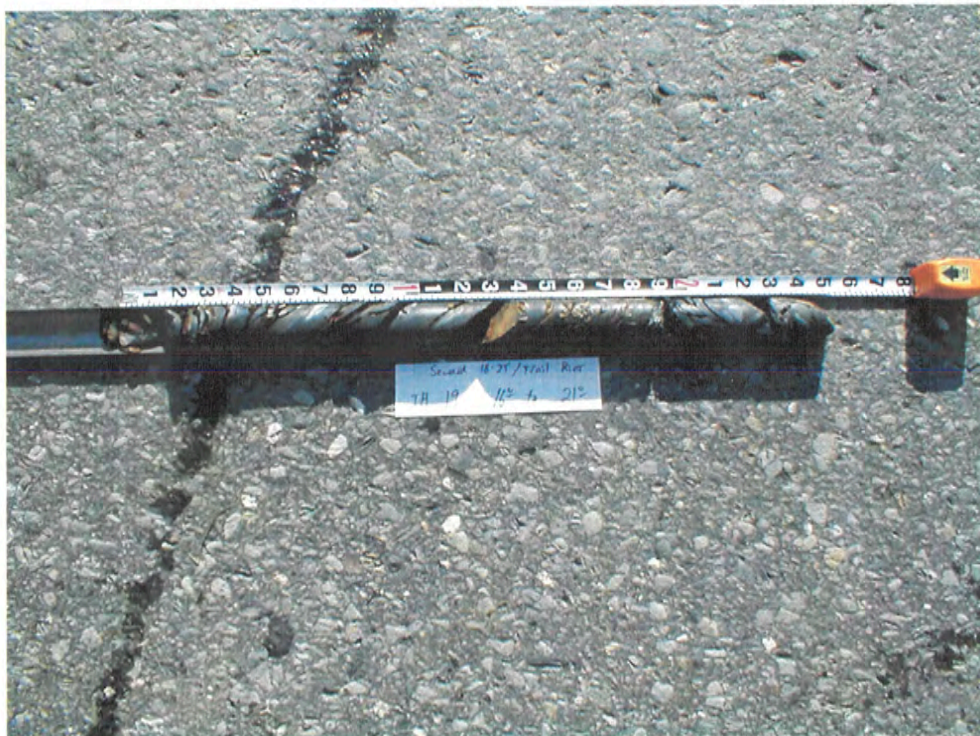
Abutment 5, TH 19 rock core from 4.87 m to 6.4 m in depth.

TH-19 located in the Seward bound lane of the existing highway showed 75 mm of asphalt pavement over 1.2 m of silty sandy gravel fill over silty sandy gravel with seams of fine fibrous organics to 6 mm thick to 3.8 m in depth. At 3.8 m in depth severely weathered bedrock was encountered. The severely weathered bedrock transitioned to thinly bedded fractured, moderately hard, weathered argillite bedrock.

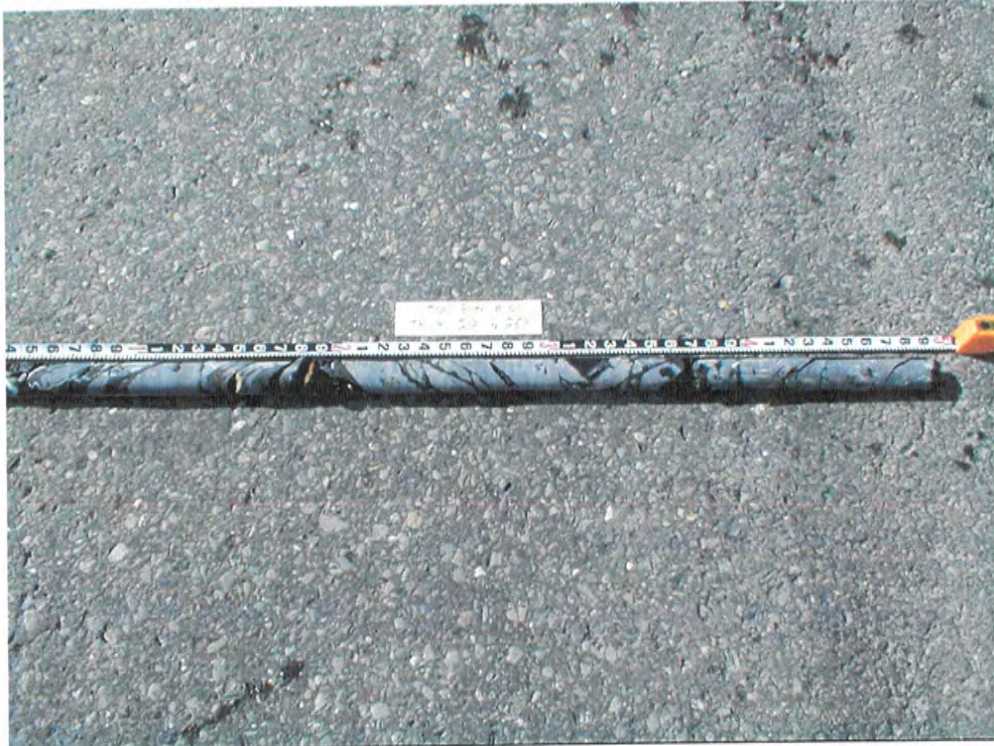
Abutment 5, TH 19 rock core from 7.92 m to 9.45 m in depth.

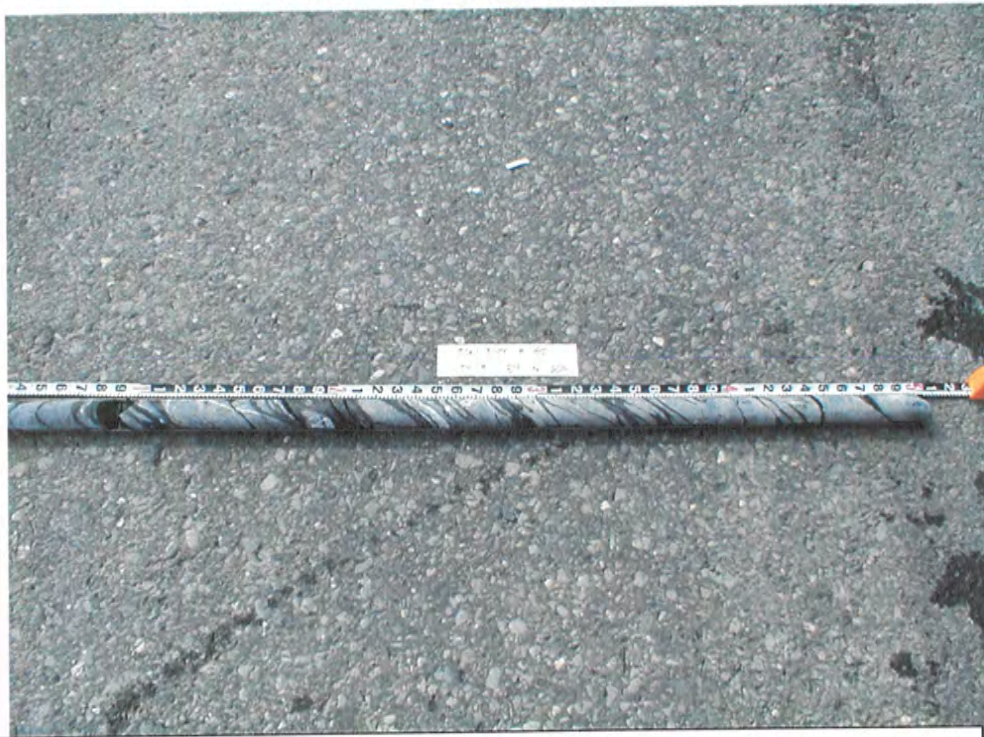
Abutment 5, TH 19 rock core from 9.45 m to 10.97 m in depth.

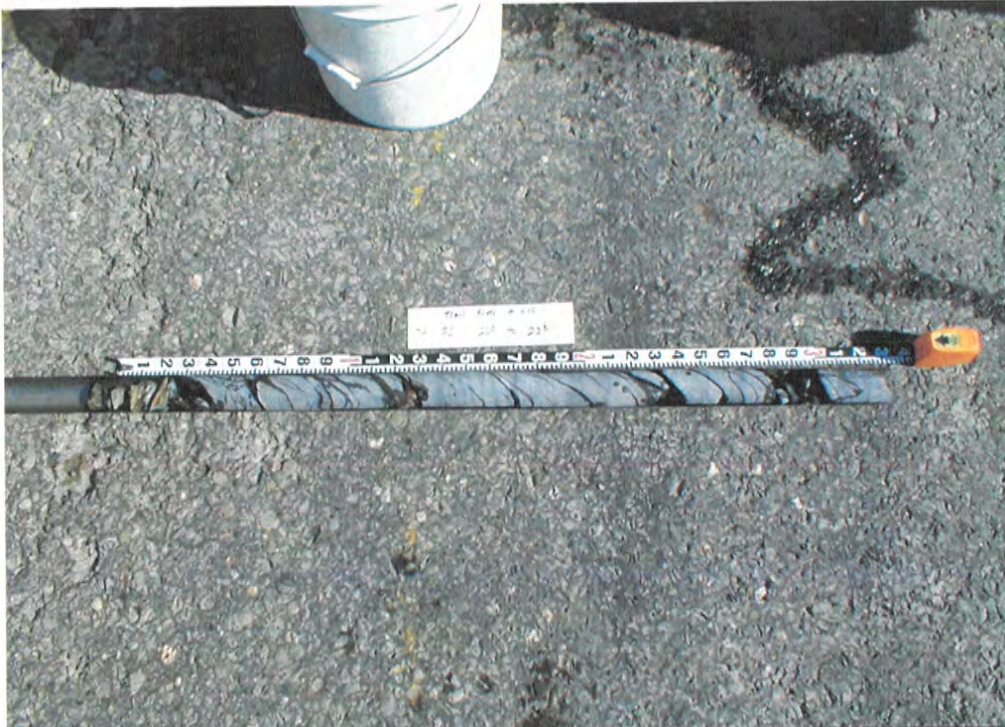
Abutment 5, TH 20 rock core from 6.1 m to 7.01 m in depth.

TH-20 was located in the Anchorage bound lane of the existing highway showed 75 mm of asphalt over silty sandy gravel fill 6.2 m in depth. At 6.2 m thinly bedded, slightly weathered, fractured, moderately hard argillite bedrock was encountered.

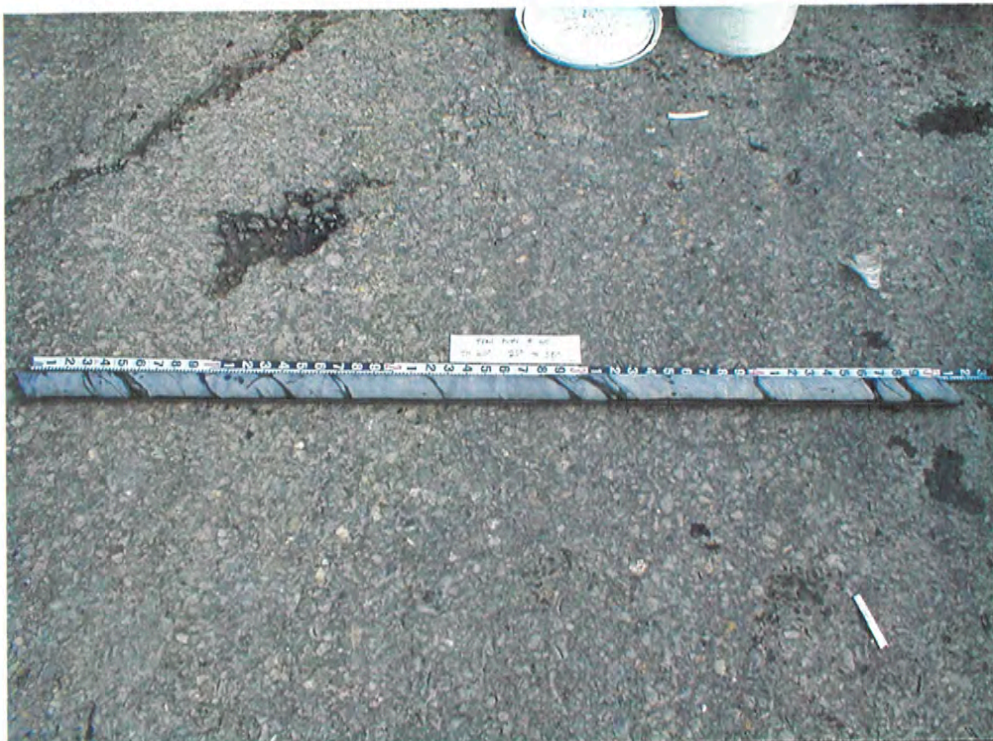
Abutment 5, TH 20 rock core from 7.62 m to 9.14 m in depth.

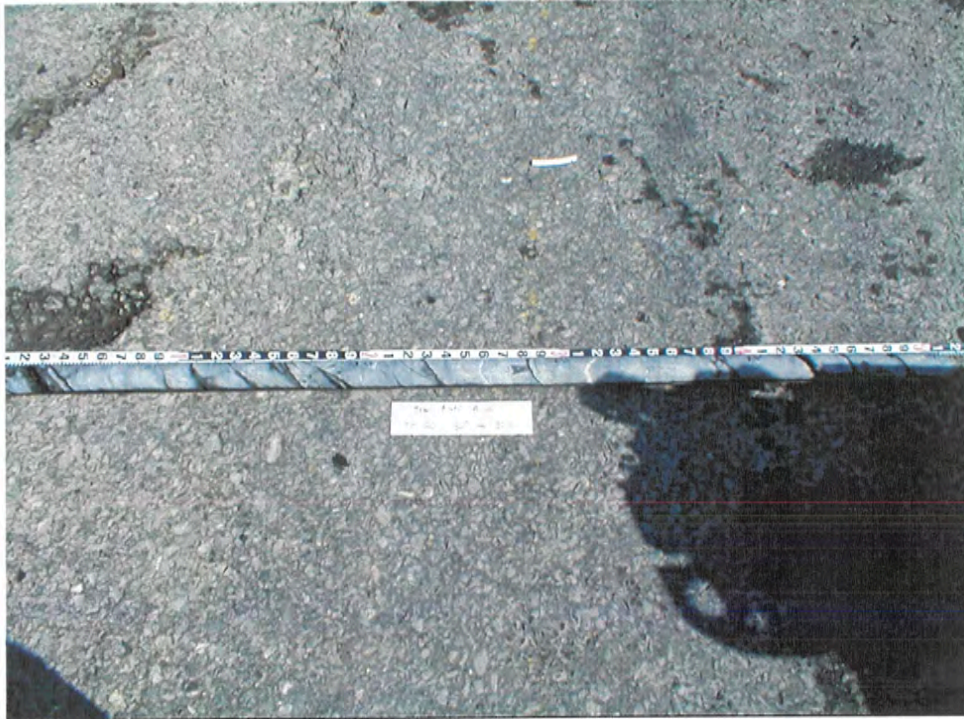
Abutment 5, TH 20 rock core from 9.14 m to 10.67 m in depth.

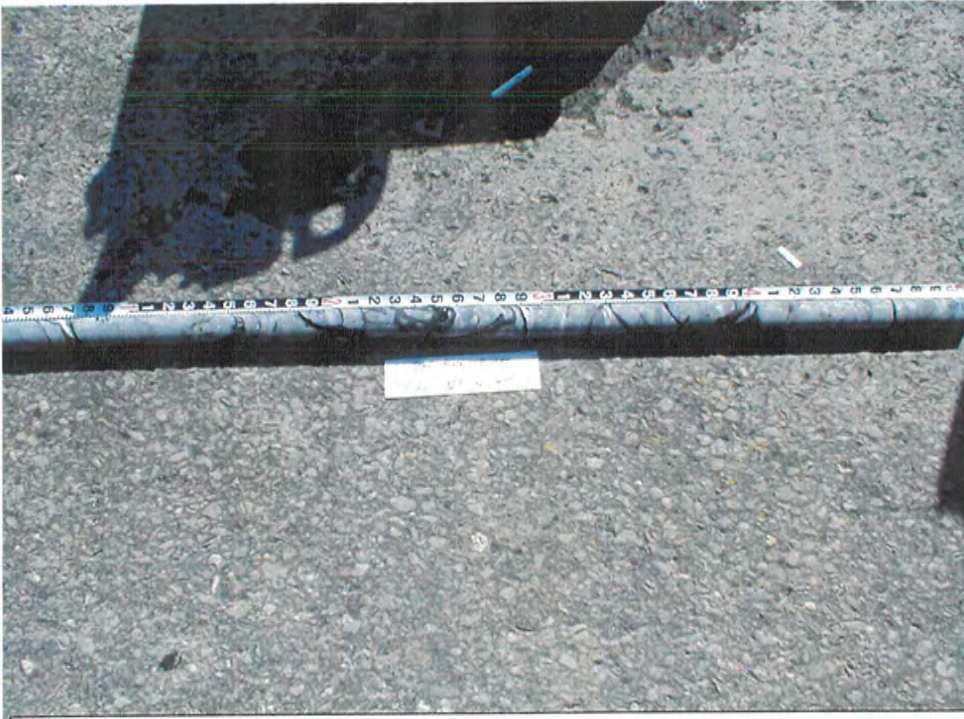
Abutment 5, TH 20 rock core from 10.37 m to 12.19 m in depth.

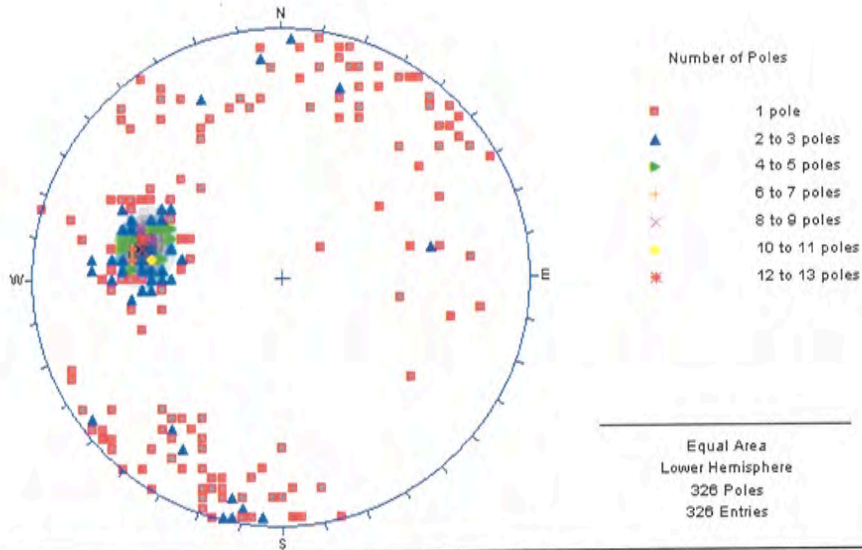
The following stereonet graphically shows the orientation of the rock structure from rock mapping data collected along the existing cut next to the highway. The rock was mapped from about Station 40+800 to 41+200.

The rock mapping indicates that the eastward dipping bedding structure is the predominant structure for this area. The bedding dips toward the road at an average angle of 48 degrees. There have been large detached blocks resulting from this bedded structure. There are also some joints that will form wedge failures.

The results of the rock structure analysis indicated that bedding planes are the dominant structure in the rock. The bedding dips east toward the road at an average angle of 48°. There are also two persistent joint sets that dip northeast and southwest at about 52° to 87°. A less persistent joint set dips west into the hillside at about 38° to 58°. Bedrock is thin to moderate bedded argillite and phyllite. See the collected data and petrographic graphic analysis reports in Appendix F. The following table summarizes the results of the structural analysis.

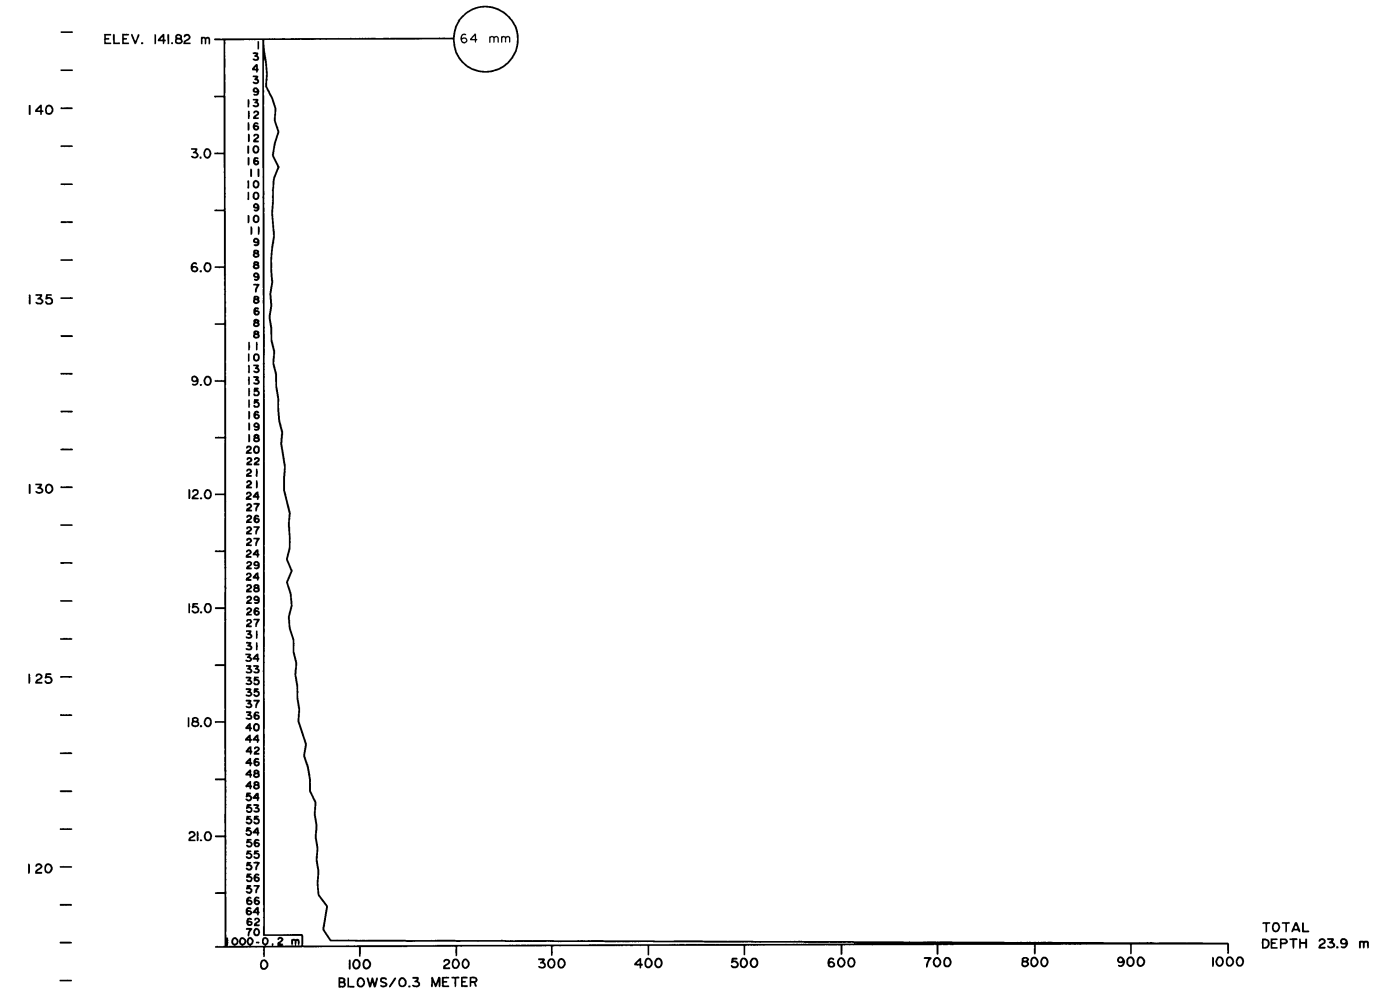
PENETROMETER 3
STA. 40+604.3, 2.0 m LT.
6/8/00-6/9/00
N 46144.6295, E 16363.1014

- NOTES
- RODS WON'T TURN USING A PIPE WRENCH.
 - PENETROMETER PULLOUT BREAK FORCE IMMEDIATELY AFTER DRIVING WAS 91.2 kN.

Near End Abutment 1: Penetrometer PEN-3 hit refusal 23.9 m in depth. Test hole TH-4 located on the highway embankment, showed silty sandy gravel with cobbles to 3.6 m (highway embankment), sandy gravel and gravelly sand to 12.2 m, sandy silt to 28.6 m, over phyllite bedrock.

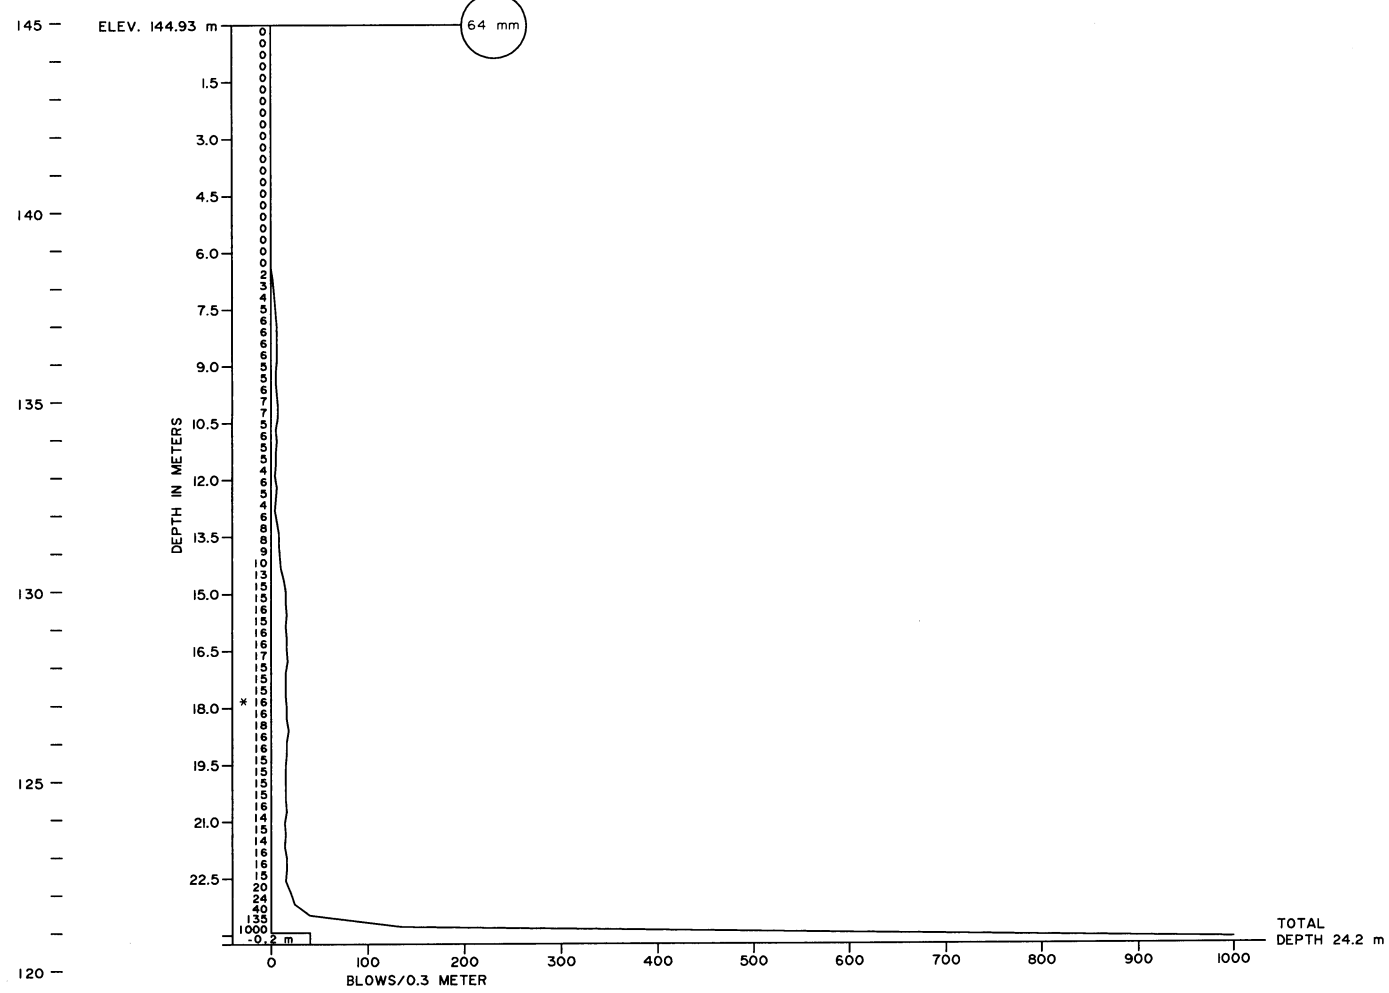
PENETROMETER 2
 STA. 40+689.6, 9.8 m RT.
 6/7/00-6/8/00
 N 462285.025, E 16382.9517

- NOTES**
- RODS WON'T TURN USING A PIPE WRENCH.
 - PENETROMETER PULLOUT BREAK FORCE IMMEDIATELY AFTER DRIVING WAS 37.7 kN.
 - PENETROMETER ROD LOWERED THROUGH EXISTING BRIDGE DECK AT ELEVATION 144.930 m TO MUDLINE AT ELEVATION 137.61 m.

Pier 3: Penetrometer PEN 2 hit refusal at 24 m in depth. Test hole TH-1 showed gravelly sand from the river bottom mud line to 13.7 m, silty sand to 16.7 m, sandy silt to 23.7 m, gravelly sand to 26 m, over phyllite bedrock.

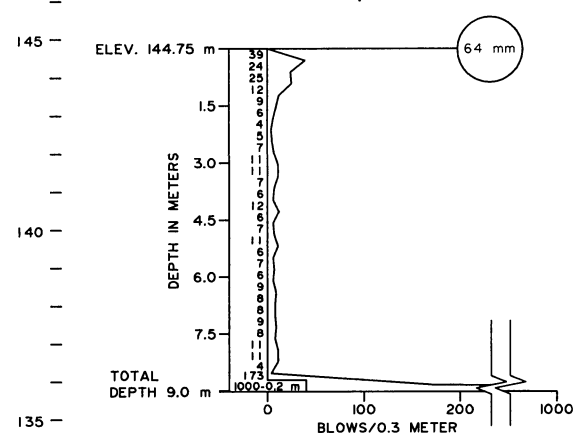
PENETROMETER 21
STA. 40+767.8, 15.3 m RT.
5/30/03-5/30/03
N 46305.7±, E 16396.2±

I. PENETROMETER PULLOUT BREAK FORCE IMMEDIATELY AFTER DRIVING WAS 50 PSI.

Penetrometers PEN 21 and PEN 22 were located in the Anchorage bound lane. PEN 21 located 18.2 m away from the existing abutment hit refusal at 9 m and depth. PEN 22 located 28 m away from the existing abutment hit refusal at 4.9 m in depth.

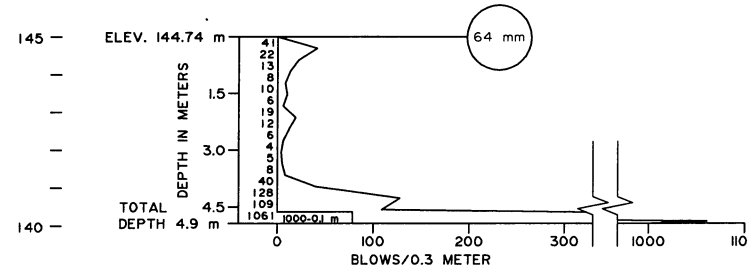
PENETROMETER 22
STA. 40+777.6, 15.3 m LT.
5/30/03
N 46315.5±, E 163397.2±

I. PENETROMETER PULLOUT BREAK FORCE IMMEDIATELY AFTER DRIVING WAS 250 PSI.
