GEOTECHNICAL FINDINGS REPORT
on
**FOUNDATION SUBGRADE &
APPROACH EMBANKMENT CONDITIONS**
at
**ARRC BRIDGE 127.5
EAGLE RIVER, ALASKA**

NGE-TFT Project #5894-20

**RE: GEOTECHNICAL FOUNDATION SUBGRADE & APPROACH EMBANKMENT
CONDITIONS AT ARRC BRIDGE 127.5 – EAGLE RIVER, ALASKA**

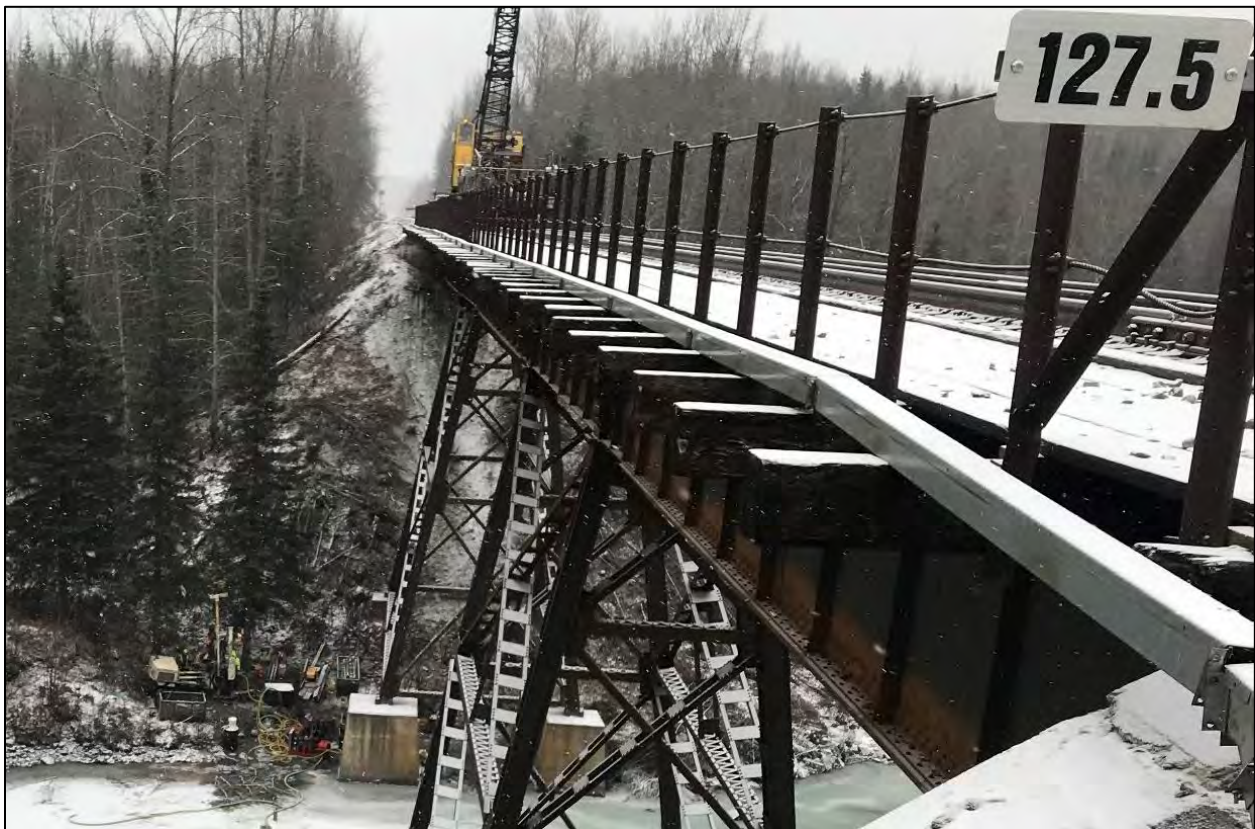
PHOTO: Drilling of Exploration B3 at north pier site of Bridge 127.5

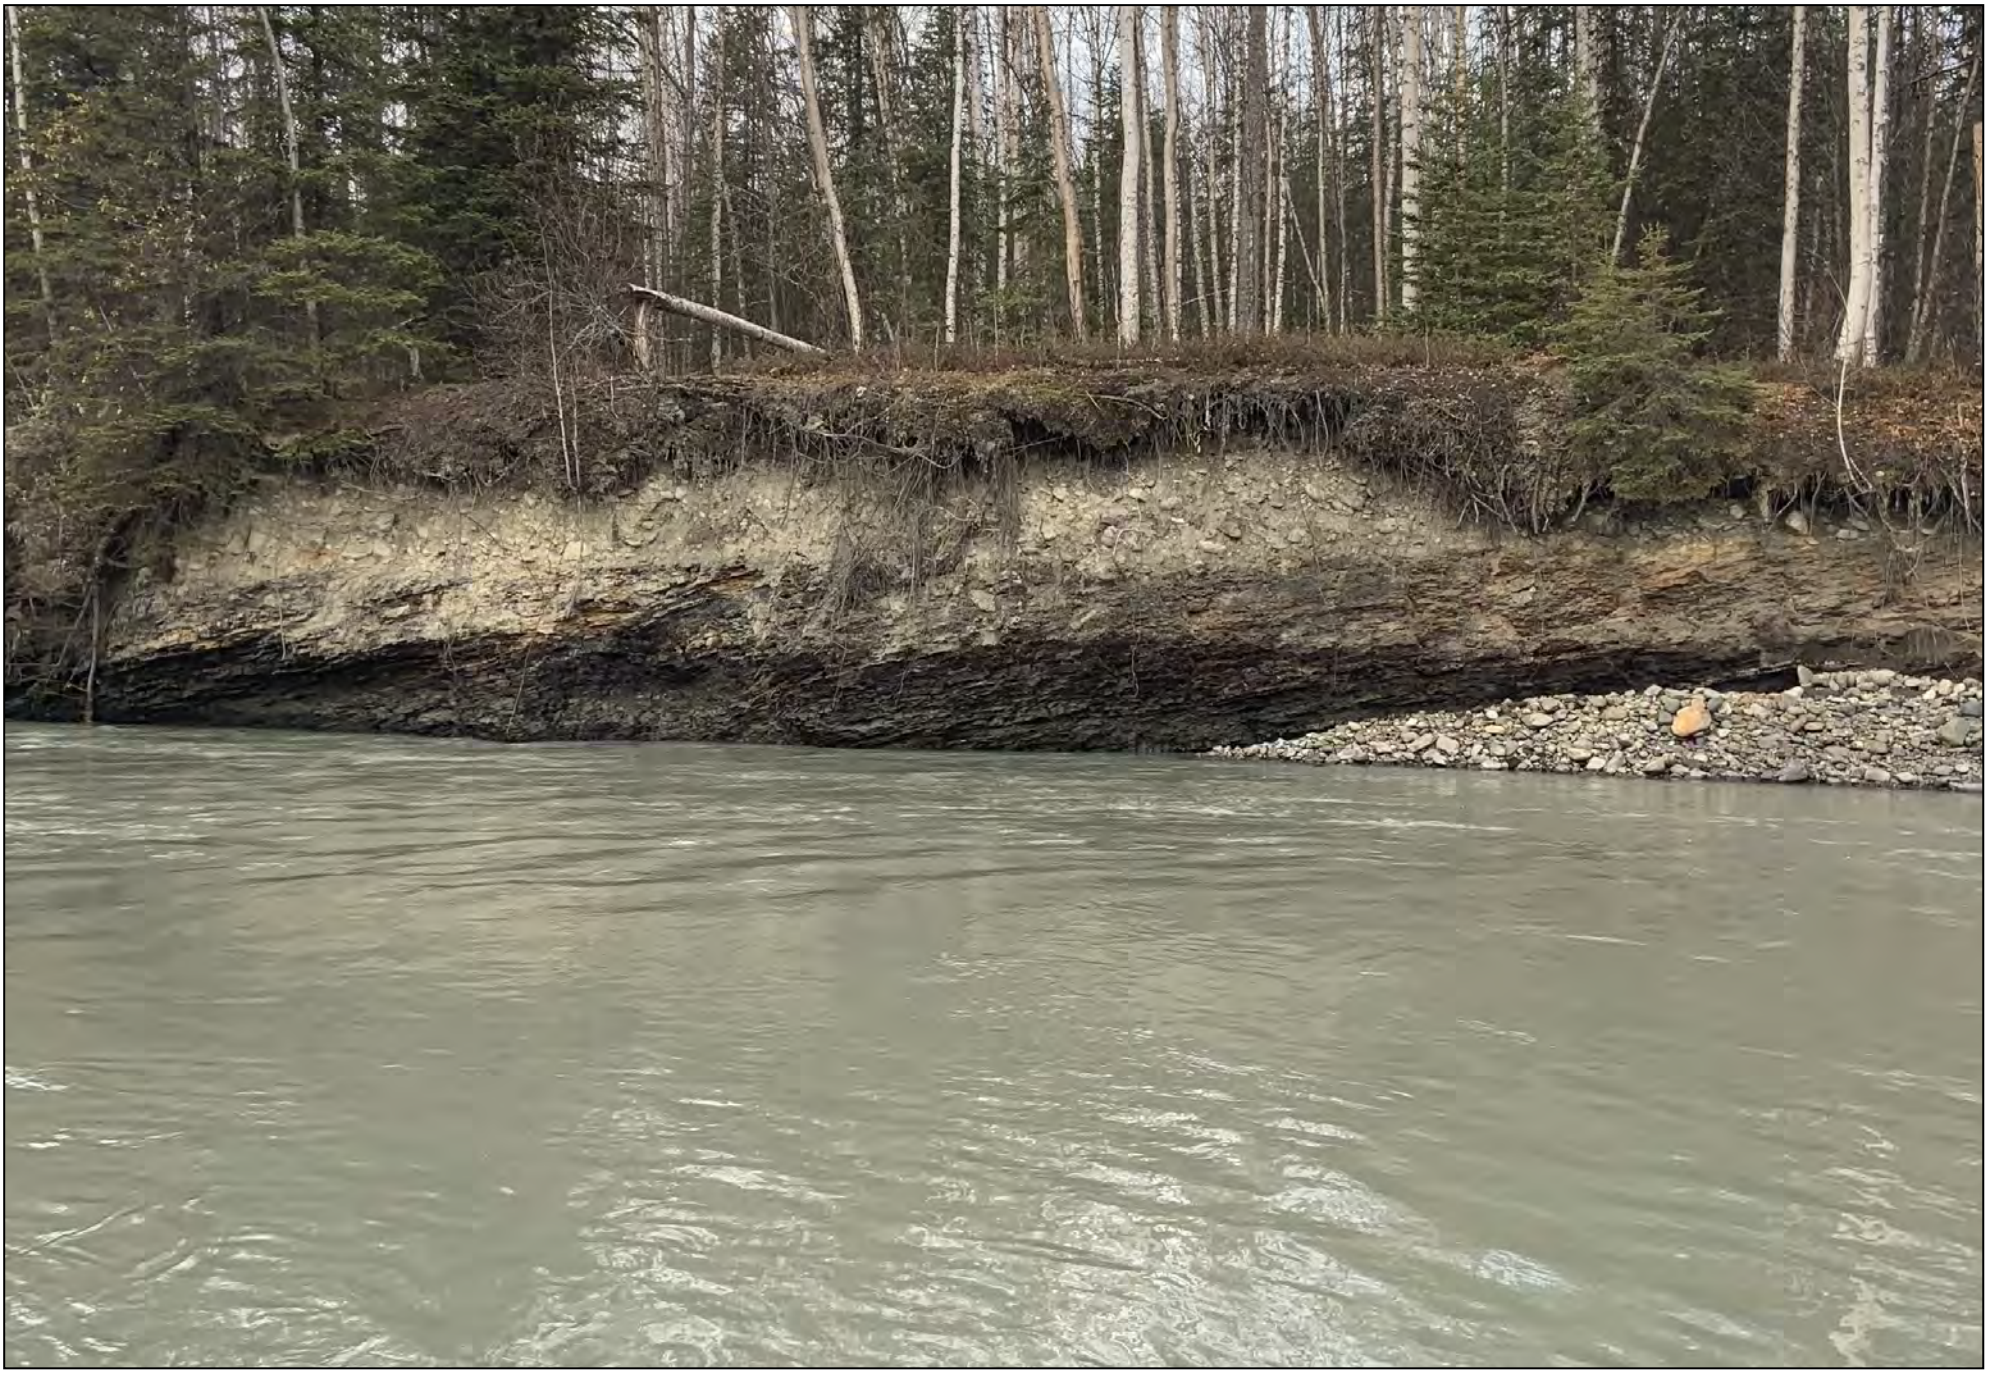
FIGURE NUMBER:
4

FIGURE TITLE:
BEDROCK OUTCROP DOWNSTREAM OF BRIDGE 127.5 (NORTH BANK)
