Jurisdictional Determination Report

Bridge 127.5 Eagle River

Eagle River, Alaska

Prepared by:
HDR Engineering, Inc.
2525 C Street, Suite 500
Anchorage, Alaska 99503

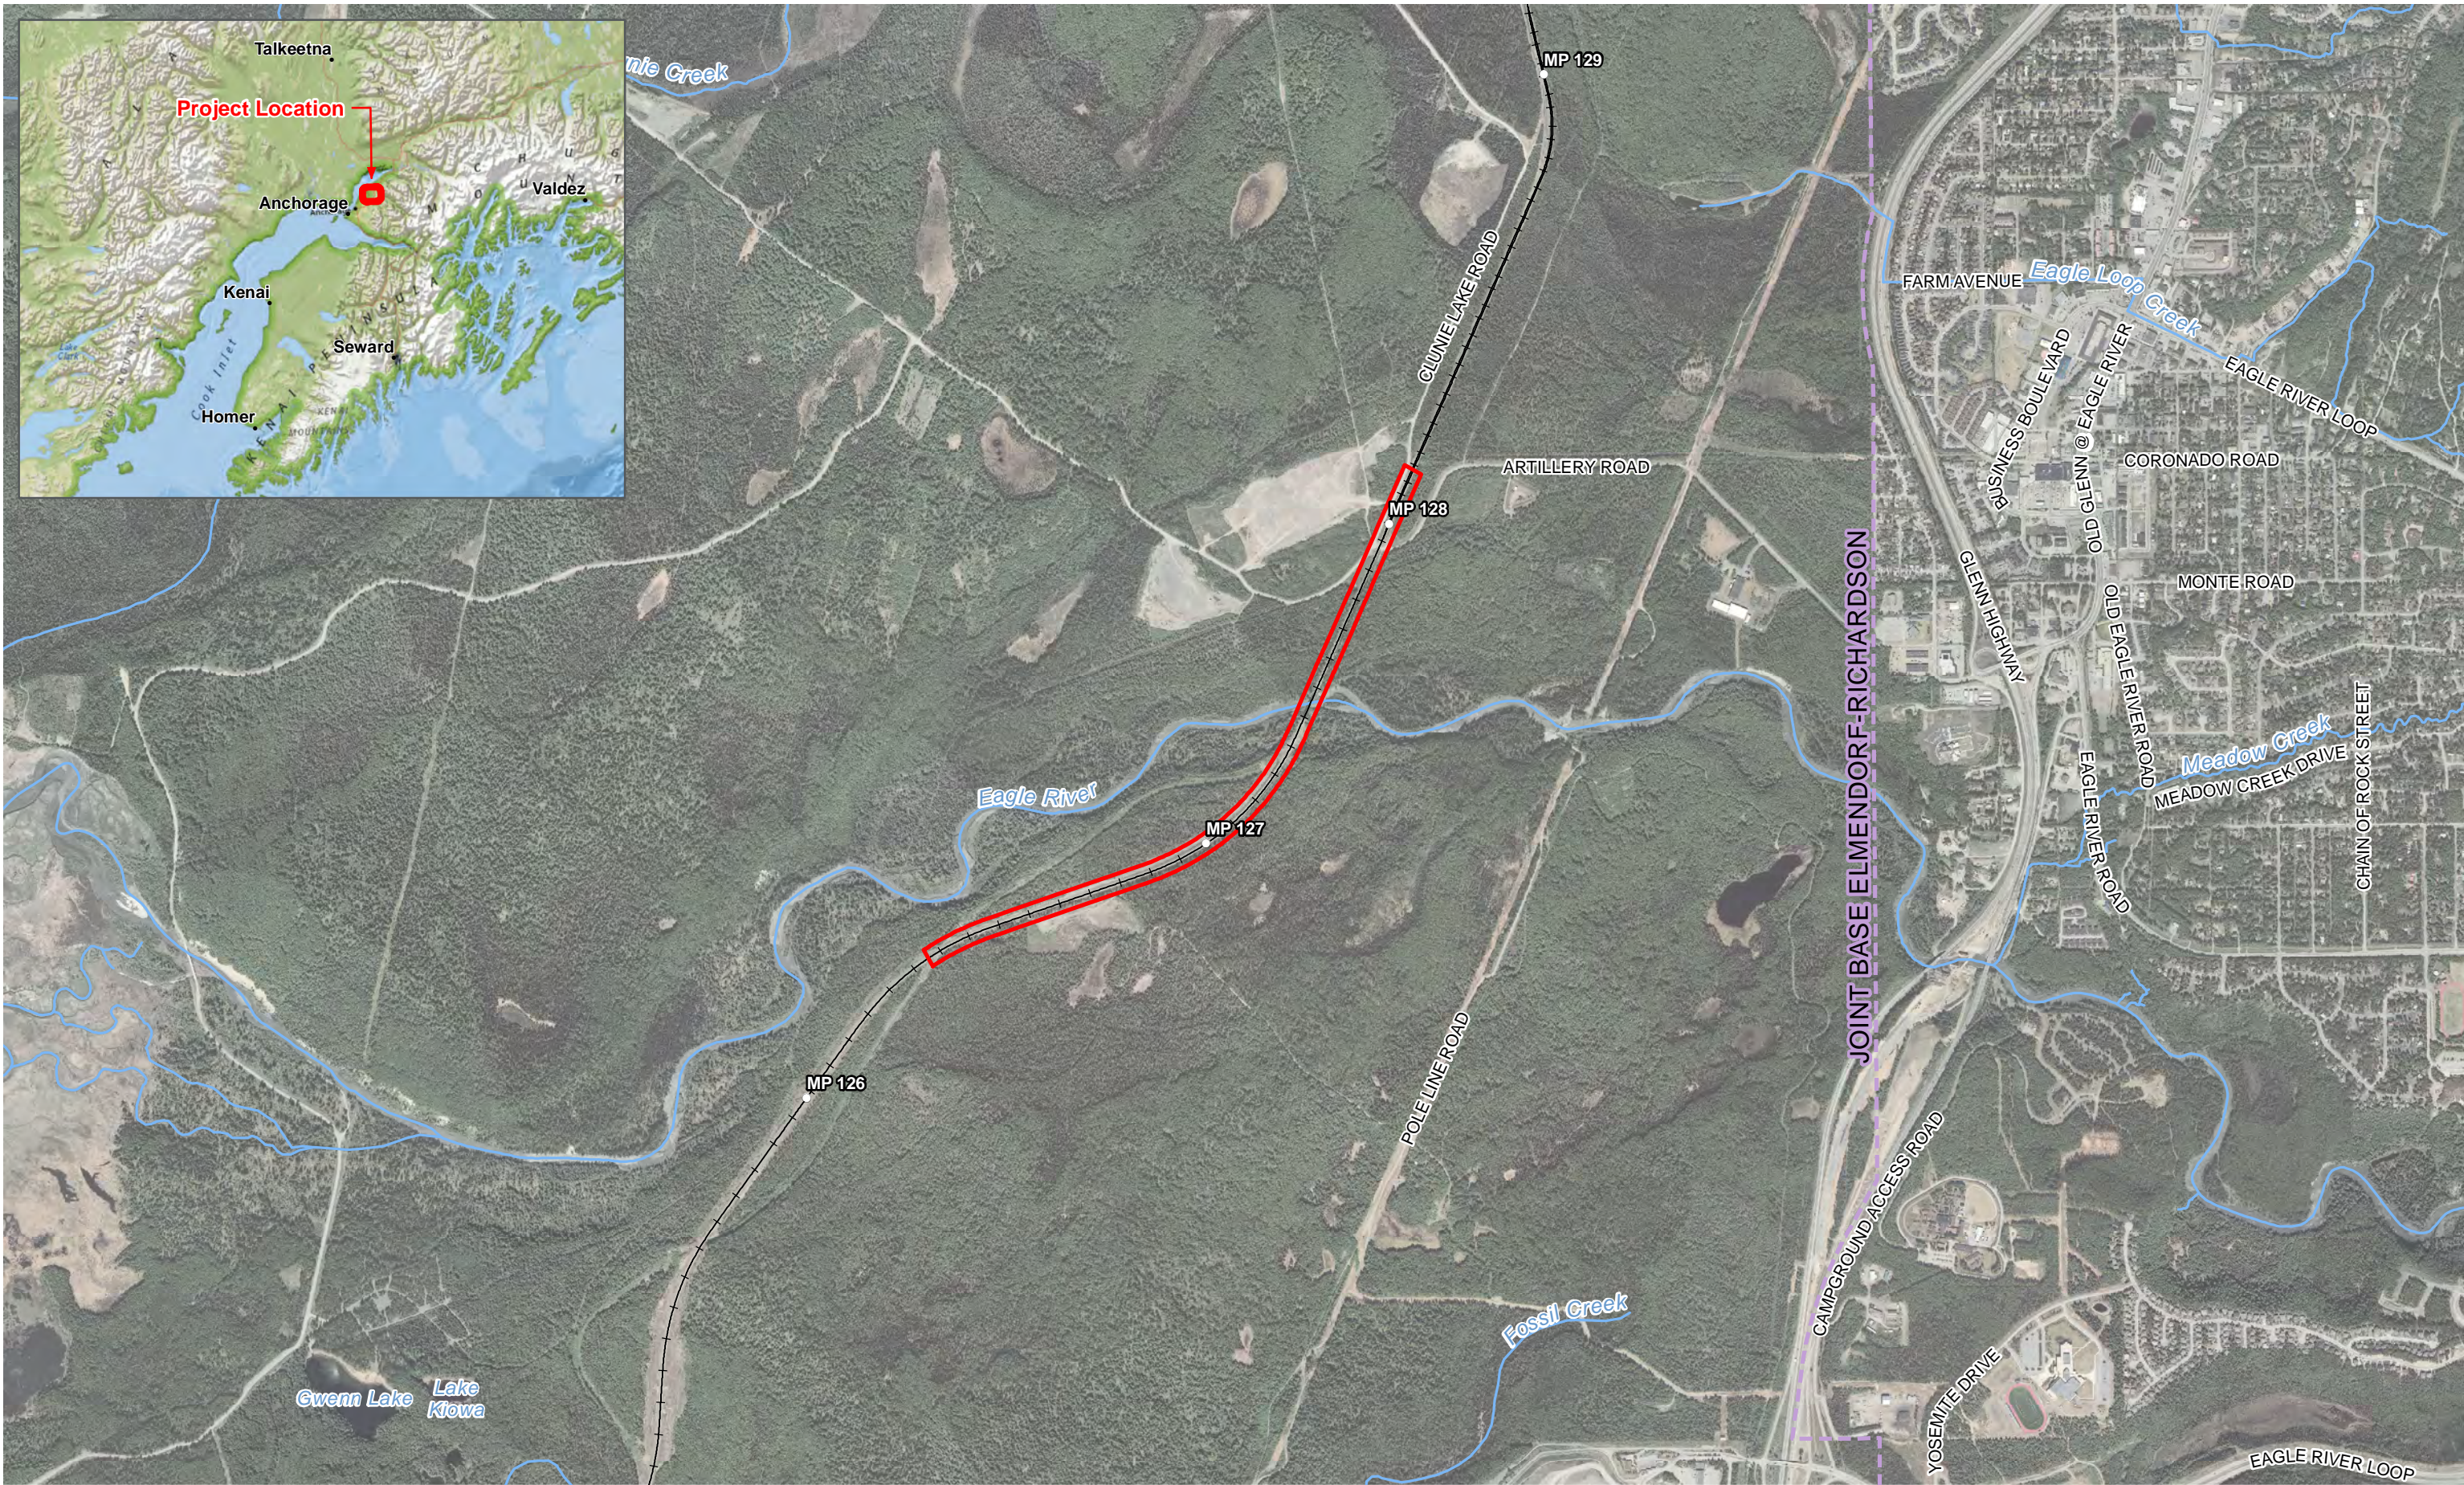
FIGURE 1. STUDY AREA

The 36.4-acre study area is located in Eagle River within the Municipality of Anchorage (MOA; Inset 1) and consists of a 200-foot corridor along a 1.7-mile stretch of the rail line, between approximately ARRC mileposts (MP) 126.4 and 128.1. The study area is limited to the ARRC right-of-way (ROW). Land outside of the ROW is military land within Joint Base Elmendorf–Richardson (Figure 1). Within the study area the railroad alignment transects the Elmendorf Moraine, which consists of discontinuous, unconsolidated glacial till.

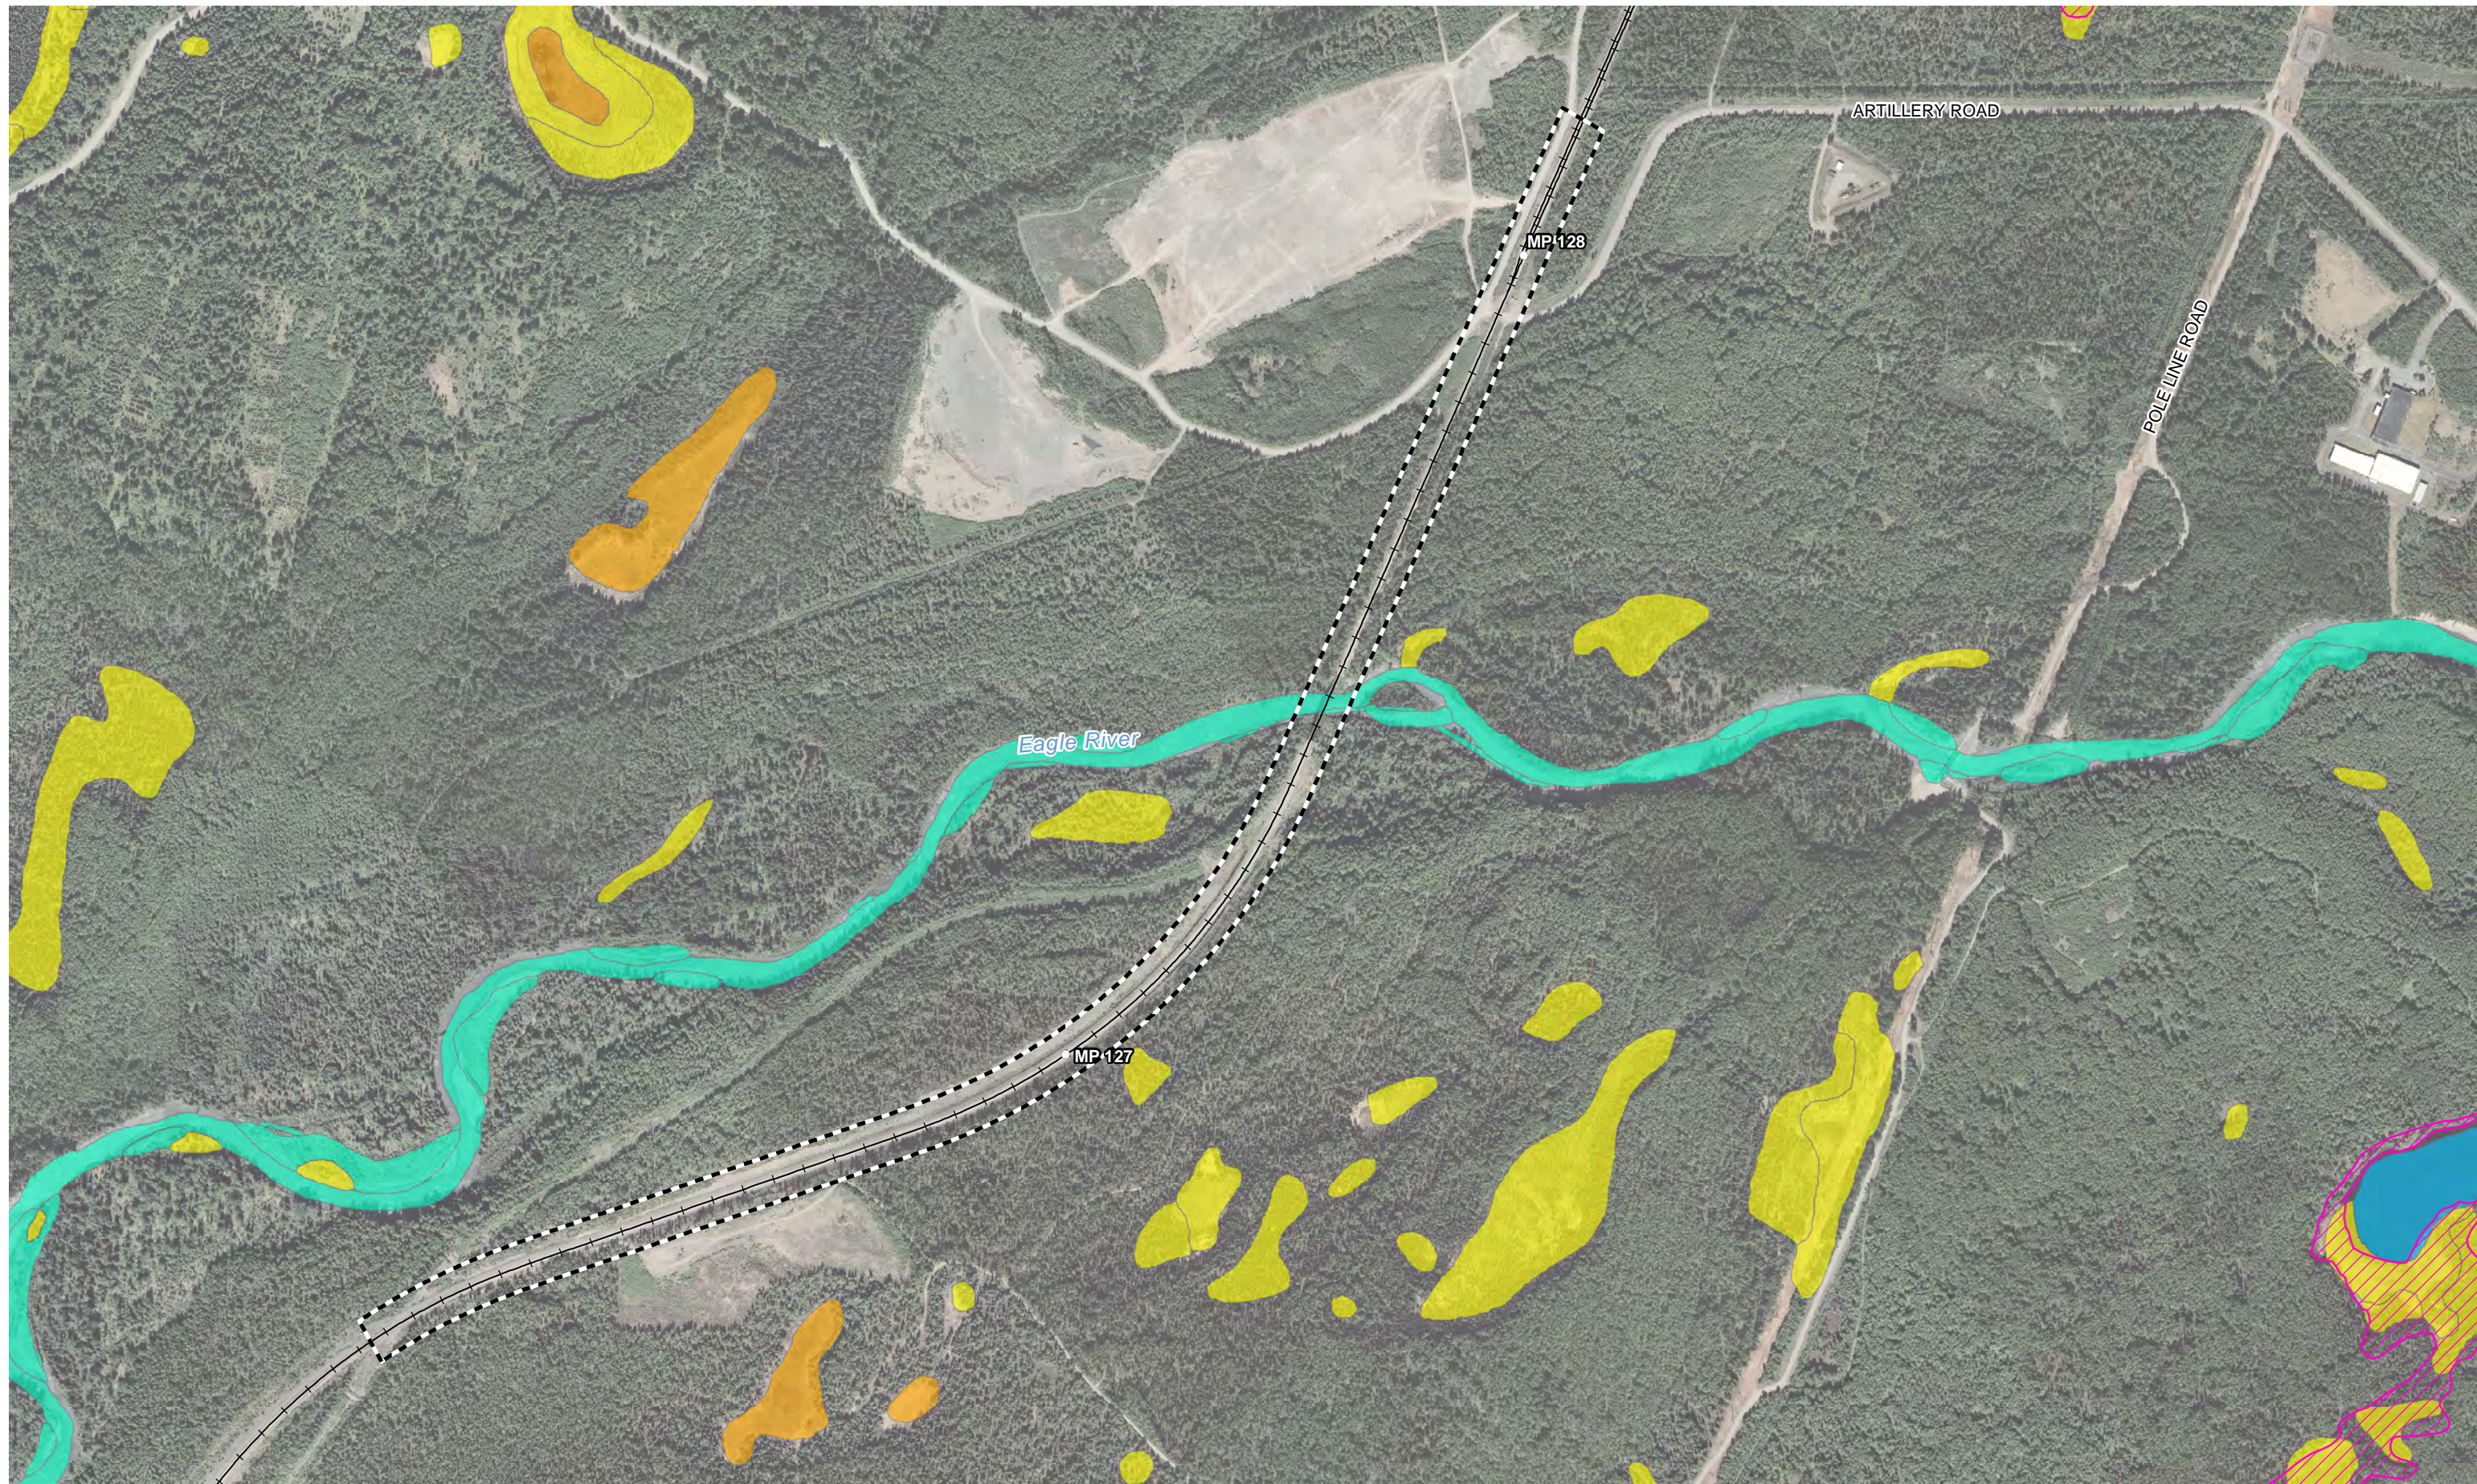
ALASKA RAILROAD MP 127.5 BRIDGE EAGLE RIVER
JURISDICTIONAL DETERMINATION REPORT
 FIGURE 2. EXISTING WETLAND MAPPING

- Digital color ortho-rectified aerial photography at sub-meter ground pixel resolution (MOA 2015a)
- Digital terrain model (DTM) raster dataset at a 3-foot ground pixel resolution (MOA 2015b)
- Light Detection and Ranging (LiDAR)-derived 1-foot topographic contours (MOA 2015c)
- National Hydrography Dataset (USGS 2021b)
- U.S. Fish and Wildlife Service (USFWS) National Wetlands Inventory (NWI) mapping for USGS quadrangles Anchorage B-7 and B-8 (USFWS 2021; Figure 2)
- MOA wetland mapping (MOA 2021; Figure 2)
- Natural Resources Conservation Service (NRCS) soil survey mapping (NRCS 2020; Figure 2)

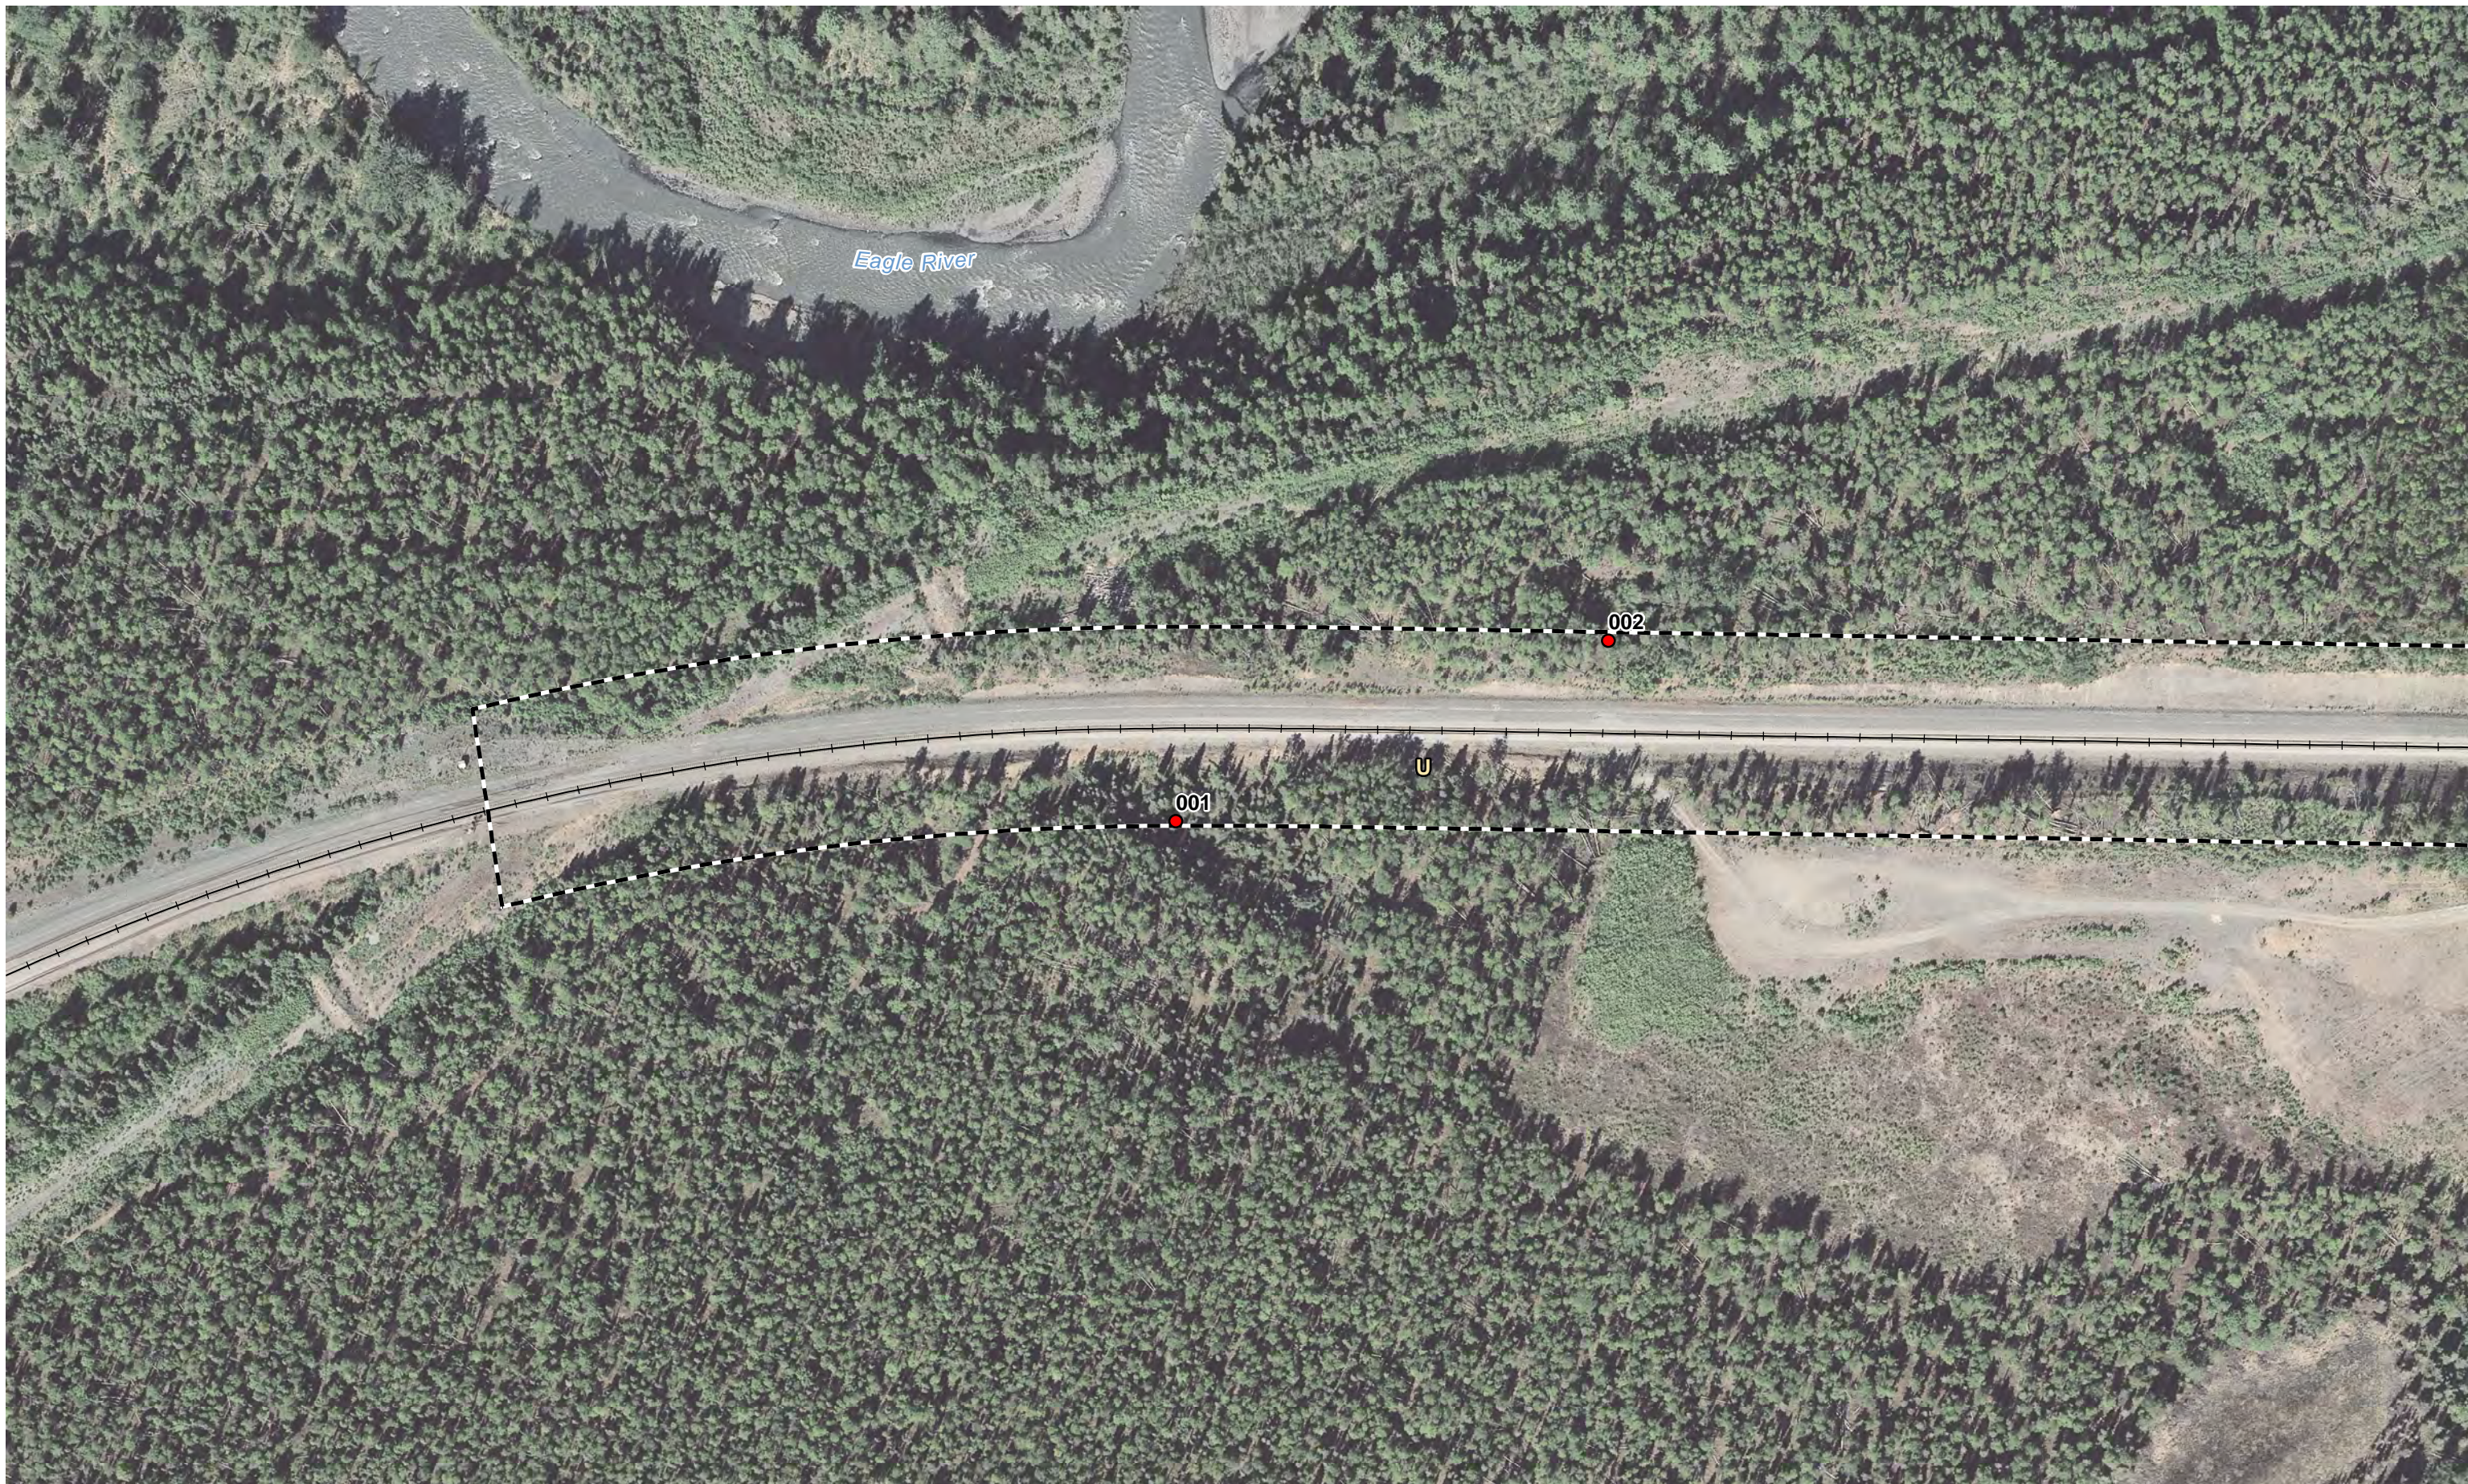
FIGURE 3. WETLAND AND WATERBODY MAPPING, PAGE 1 OF 4

Standard Wetland Determination Forms were completed at three sites within the study area (Appendix B). Observation Points were collected at an additional 12 locations (Appendix C). Data points are listed in Table 1 and shown on Figure 3.

Figure 3 displays wetland, upland, and waterbody boundaries. Locations of the Wetland Determination Form sites and Observation Points are also shown.

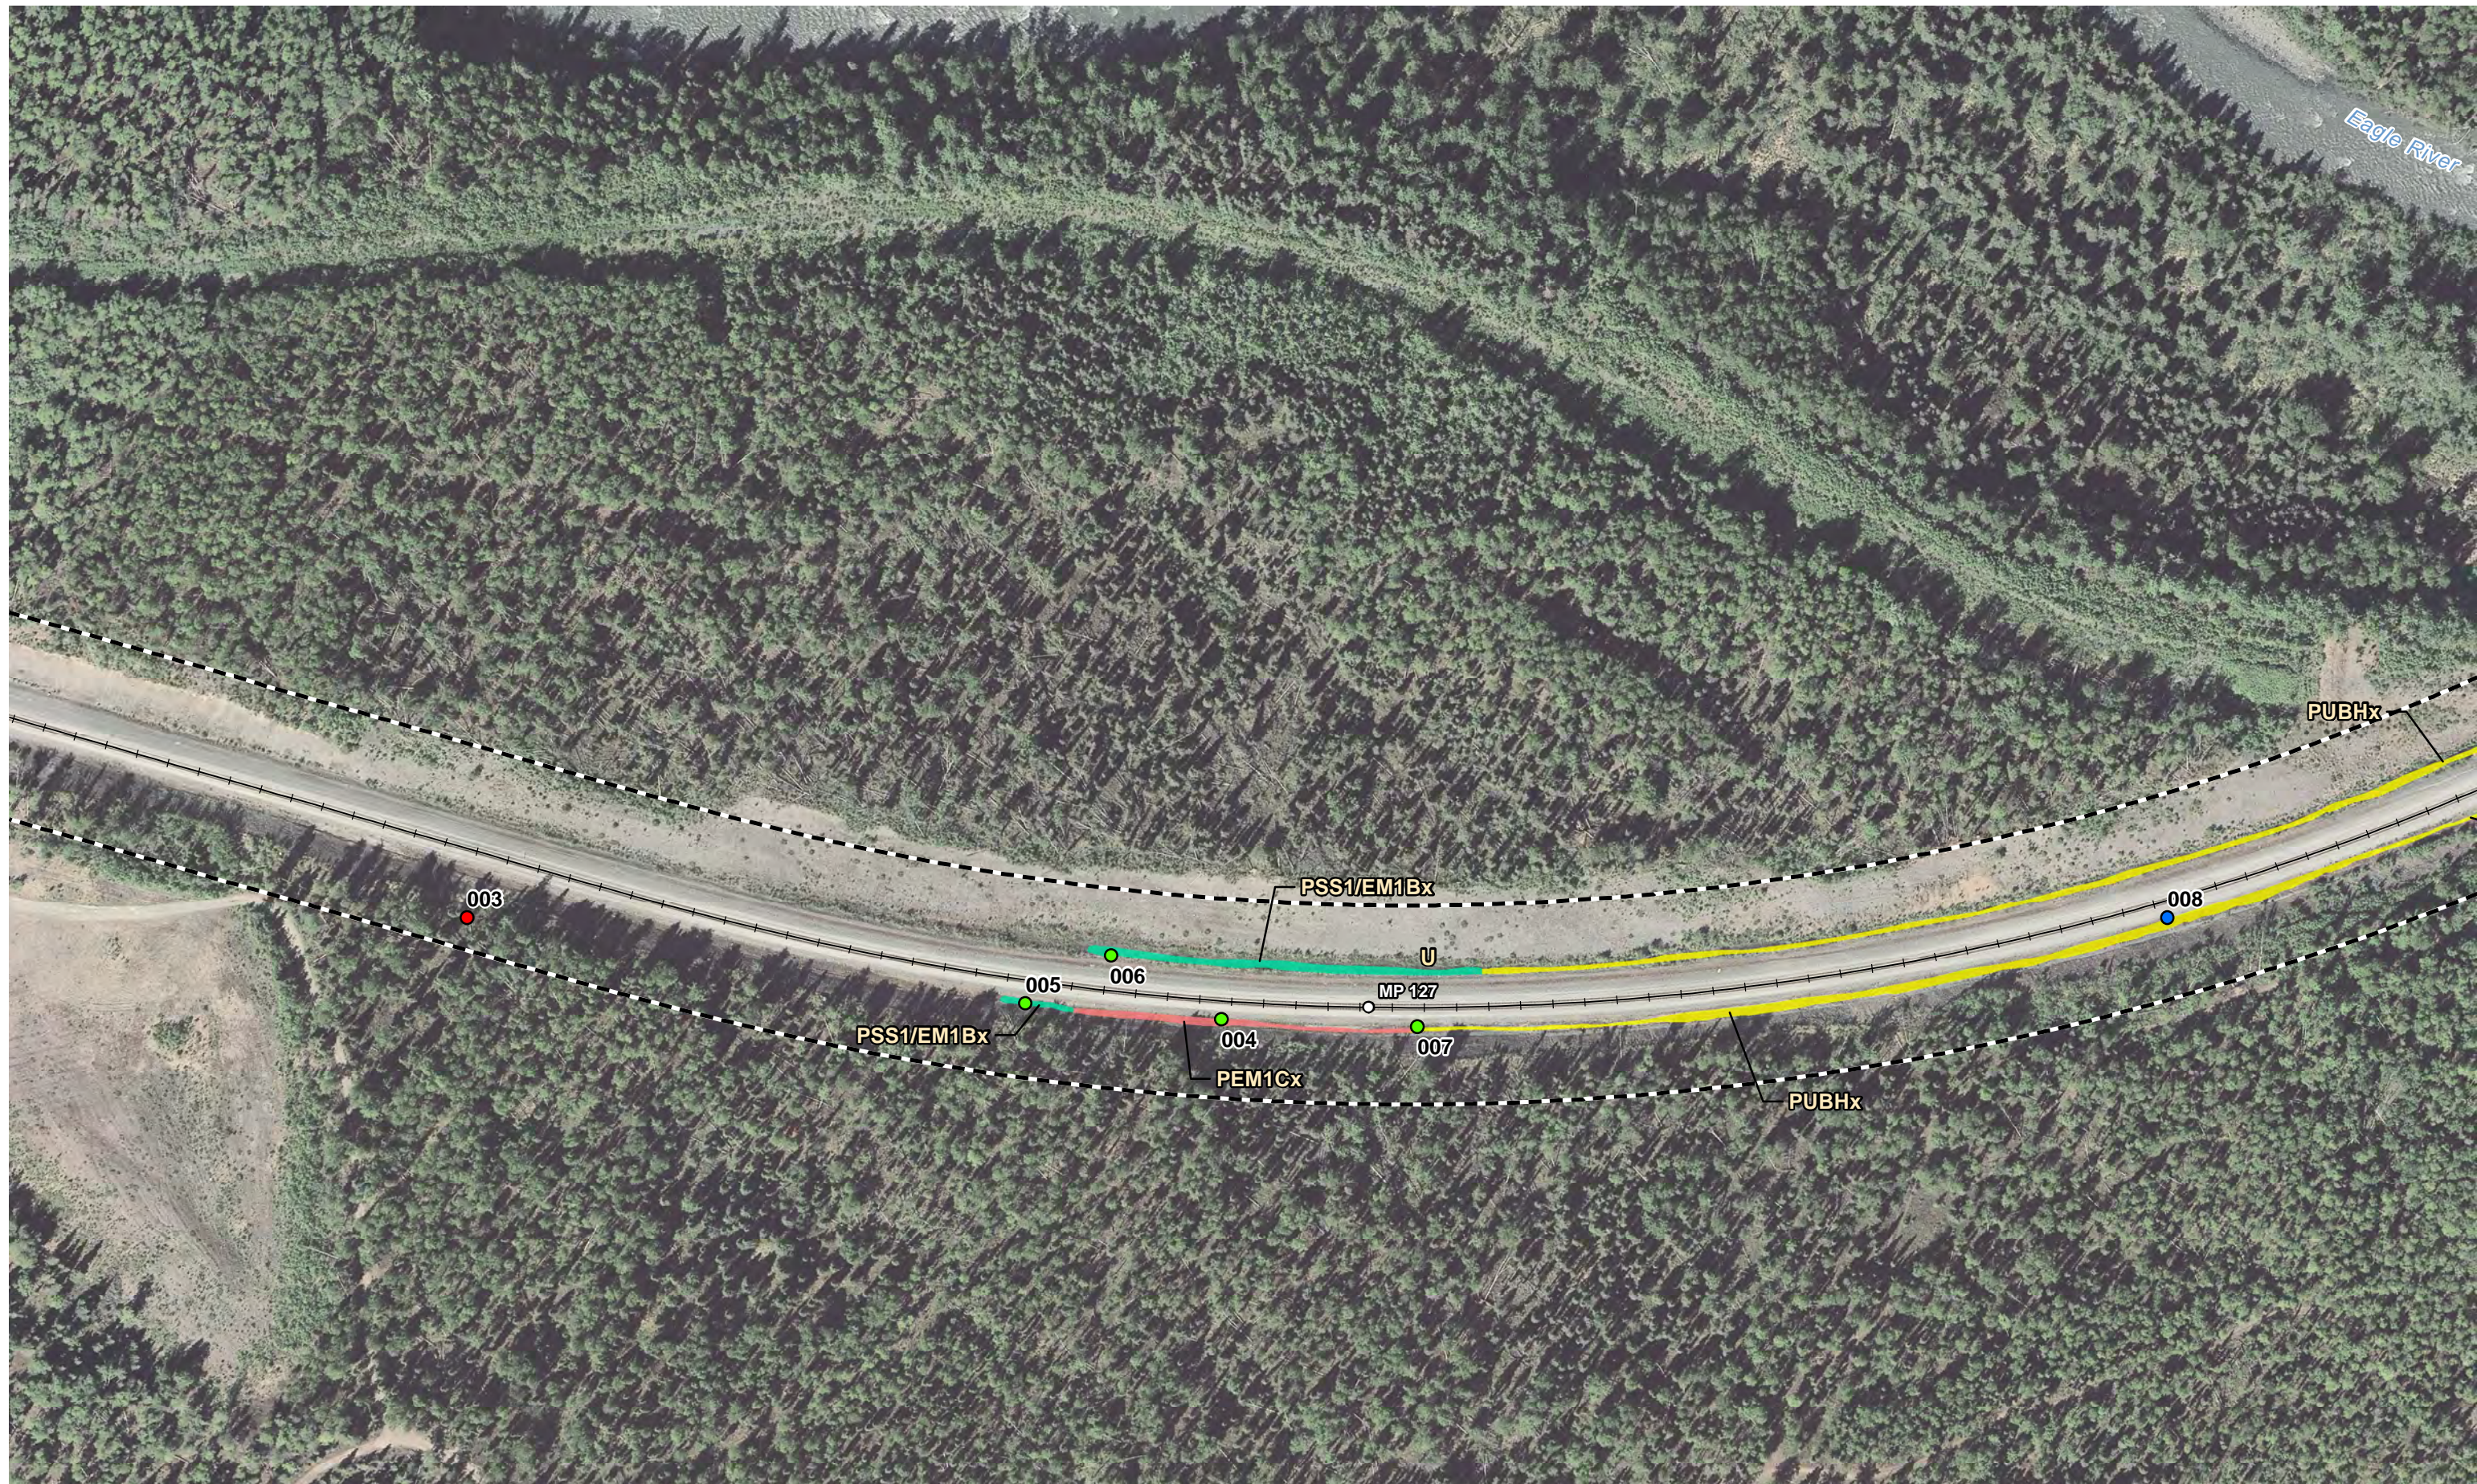
ALASKA RAILROAD MP 127.5 BRIDGE EAGLE RIVER
 JURISDICTIONAL DETERMINATION REPORT
 FIGURE 3. WETLAND AND WATERBODY MAPPING, PAGE 2 OF 4

Two wetland and waterbody complexes were identified in the ditches on either side of the railroad embankment. These complexes consist of excavated saturated and seasonally flooded wetlands and excavated seasonally flooded and permanently flooded ponds. Wetlands were documented to be dominated by emergent and shrub species including water horsetail (*Equisetum fluviatile*), tall cottongrass (*Eriophorum angustifolium*), paper birch saplings (*Betula papyrifera*) and balsam poplar saplings (*Populus balsamifera*). Evidence of regular vegetation clearing along the railroad embankment that inhibits shrub growth was observed. Soils consist of a thin layer of organic material overlying glacial till with minimal soil development. Hydrogen sulfide odor was detected within the first three inches of the soil surface at all sites where

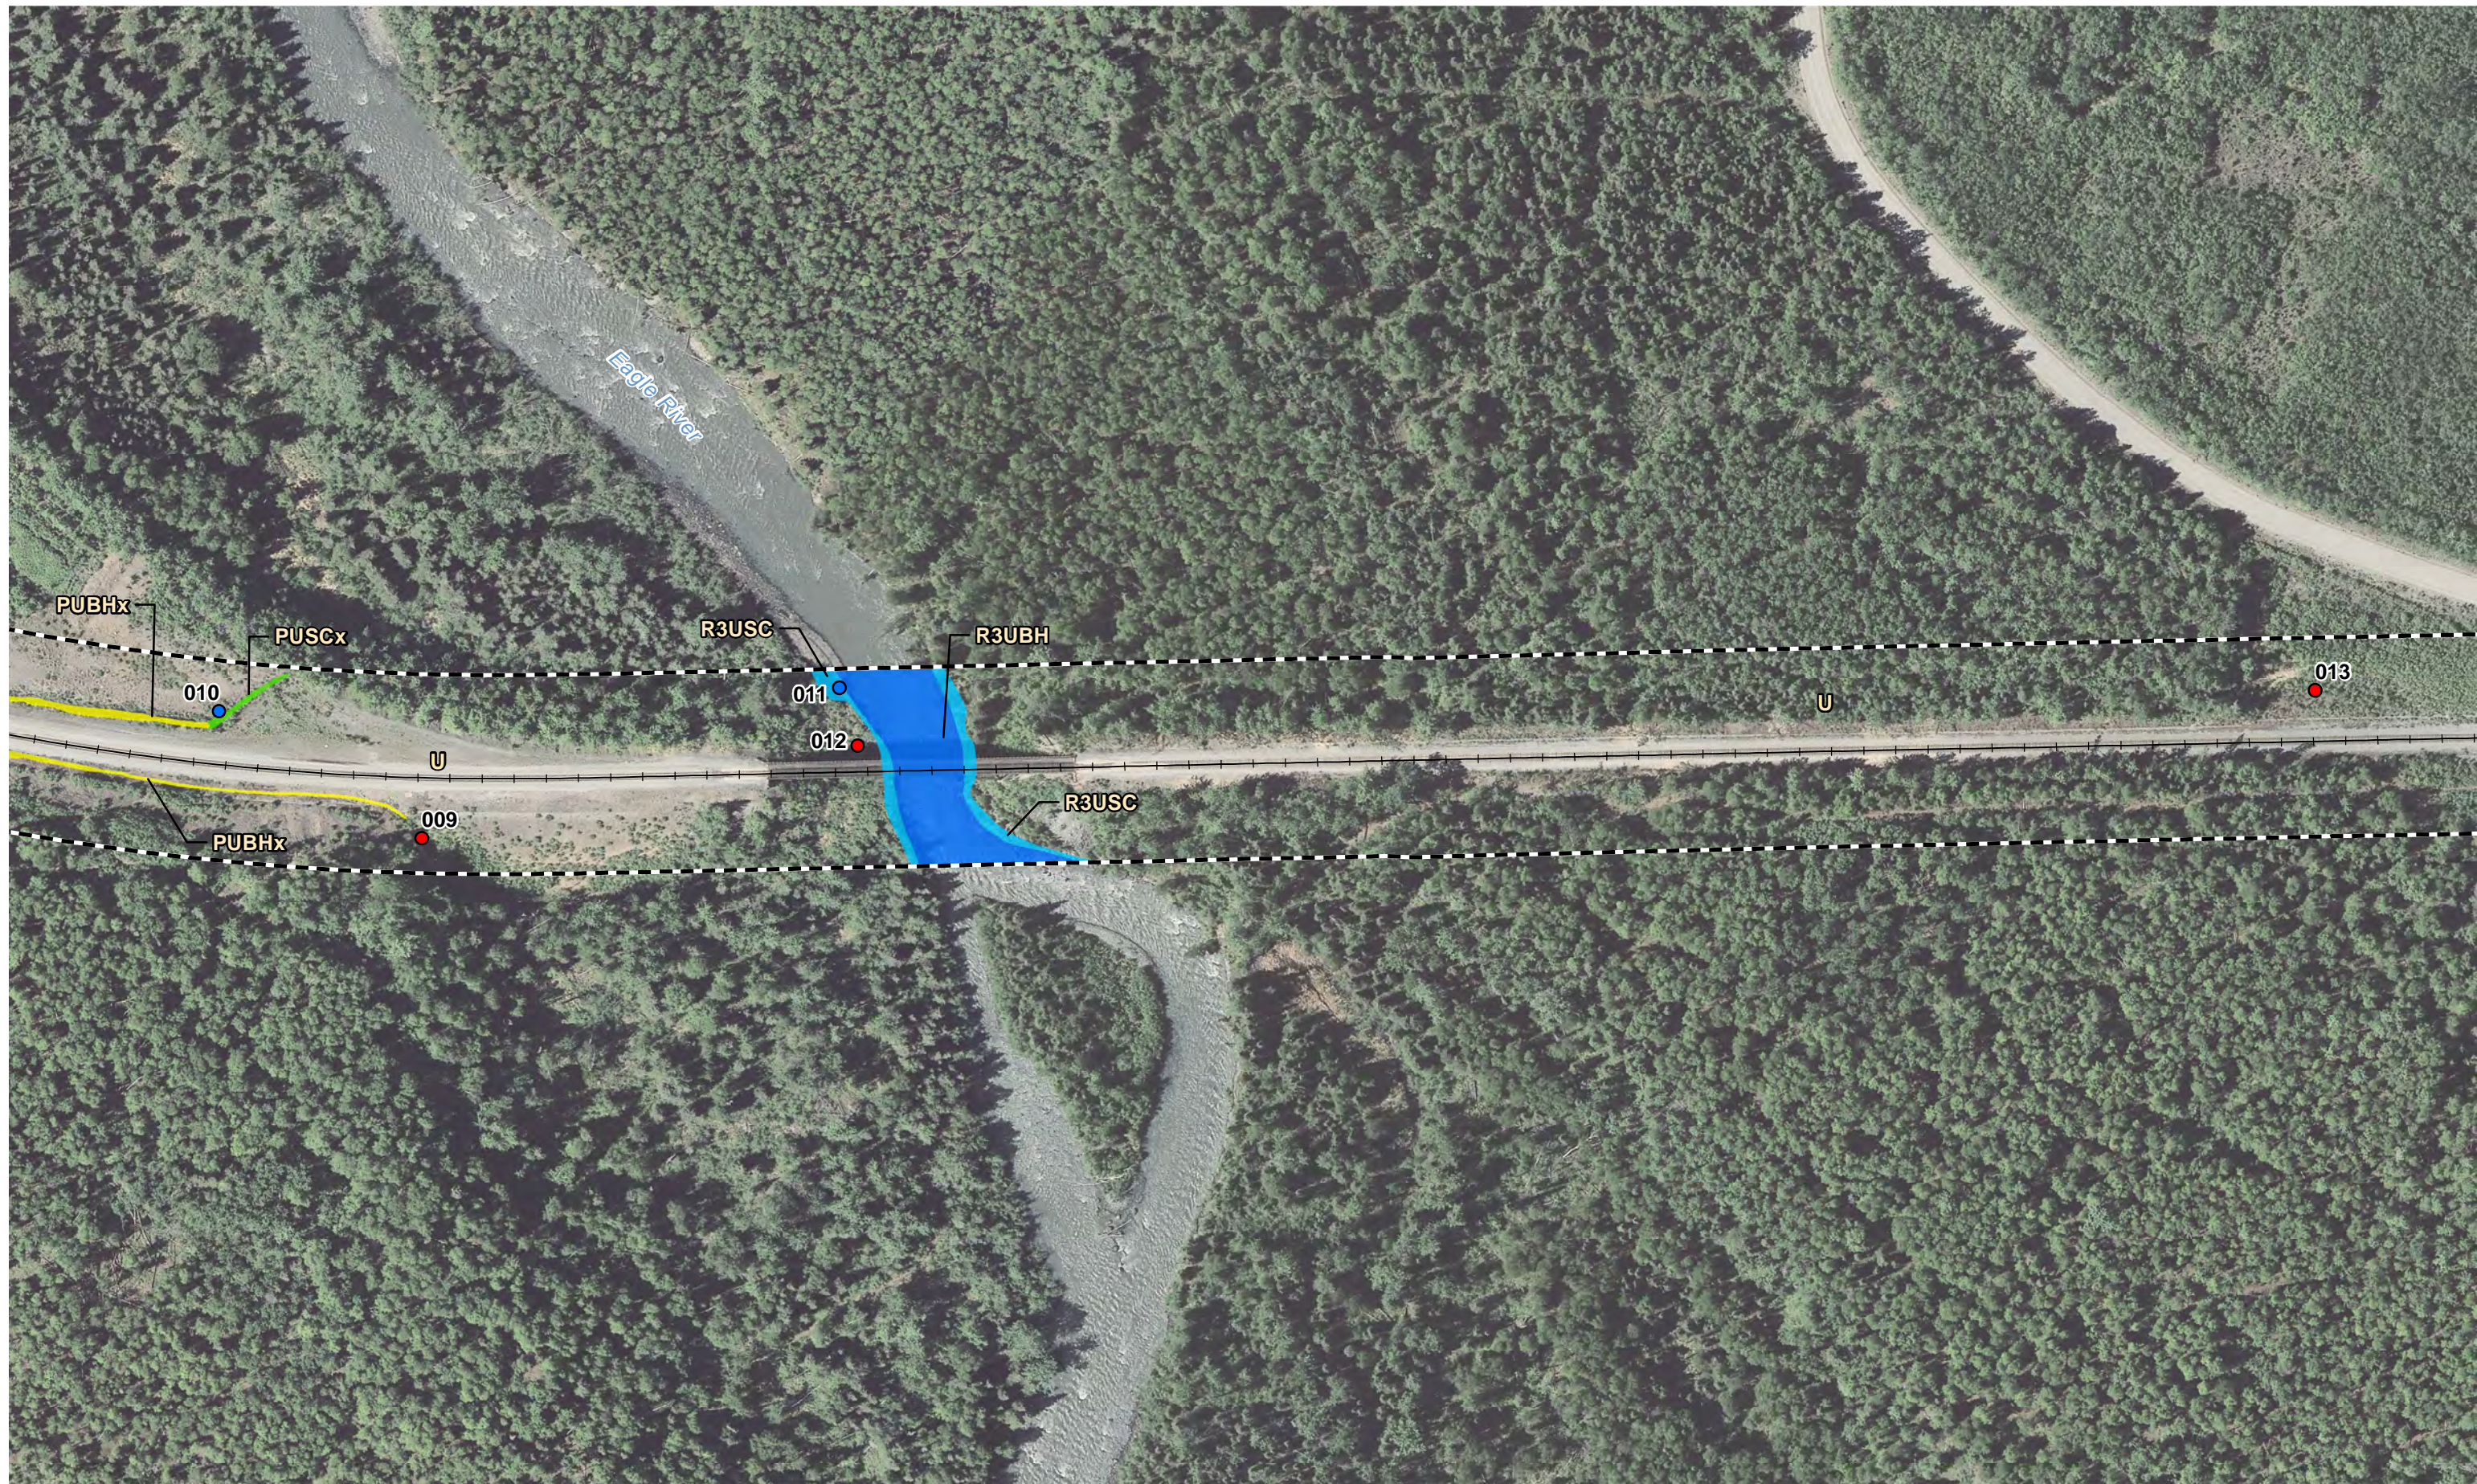
FIGURE 3. WETLAND AND WATERBODY MAPPING, PAGE 3 OF 4

The study area includes the main channel of Eagle River and seasonally flooded unconsolidated shoreline below the OHW line.

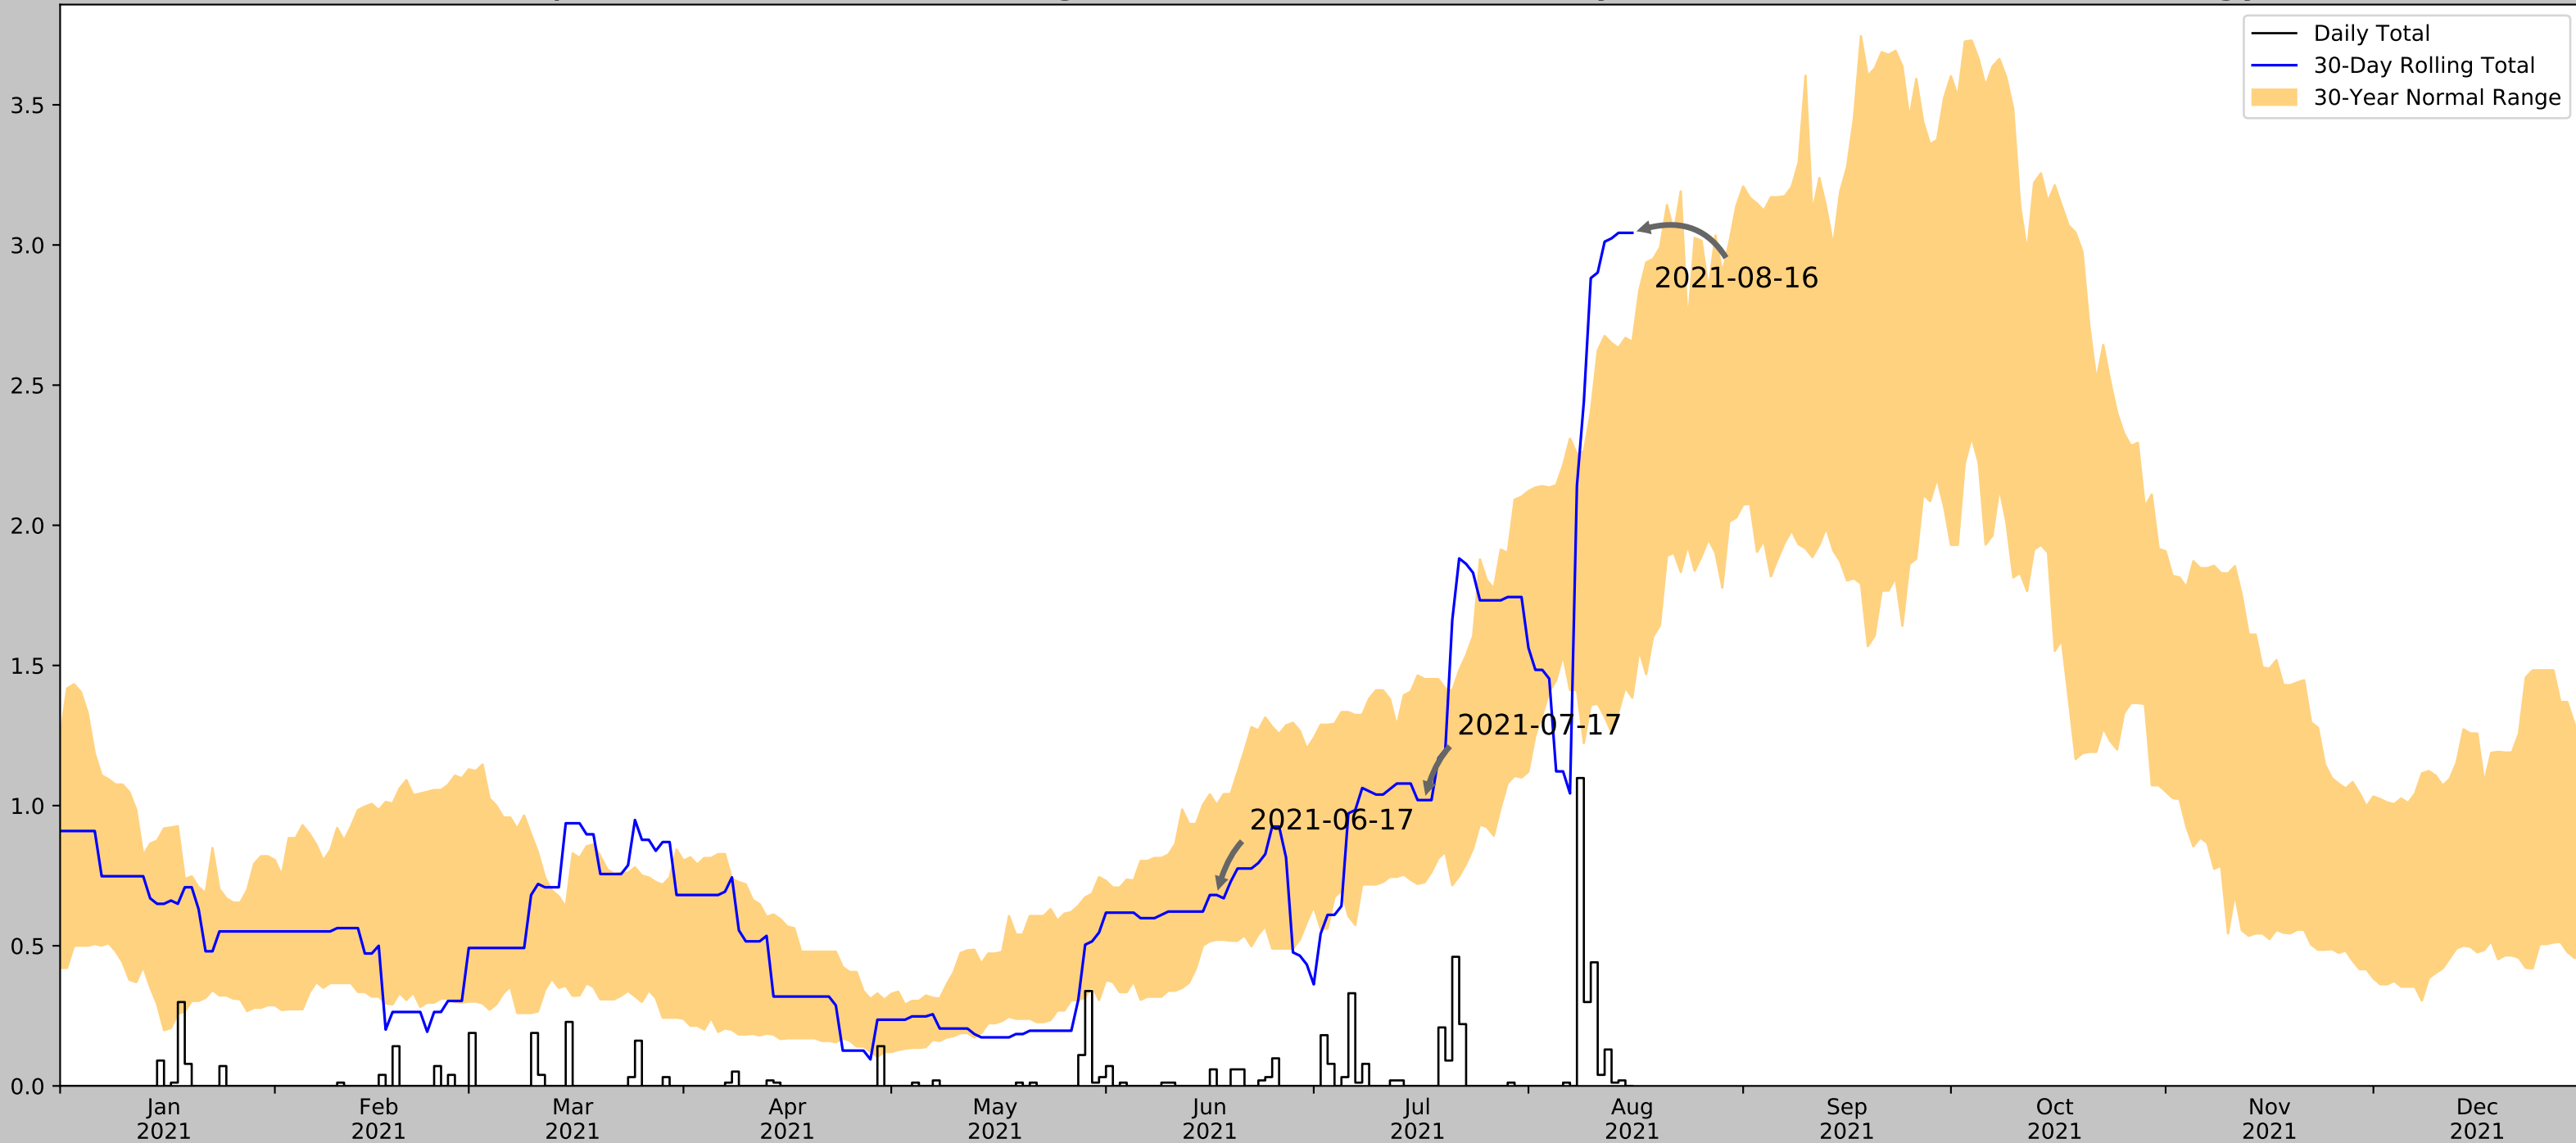
The USACE Antecedent Precipitation Tool (APT) was used to determine the degree to which any recent climatic events (e.g., abnormally wet or dry conditions) may have influenced hydrology conditions during the time of the field investigation. The APT utilizes 30 years of data on precipitation, drought, and other climatic factors to determine “normal” conditions (Deters 2020). Hydrologic indicators observed in the field on August 16, 2021 would be expected to correlate with the APT output (Appendix A). The APT calculated that the field survey occurred during the dry season and that the antecedent precipitation conditions were wetter than normal, which is consistent with field observations.

Antecedent Precipitation vs Normal Range based on NOAA's Daily Global Historical Climatology Network

Coordinates	61.316450, -149.620775
Observation Date	2021-08-16
Elevation (ft)	183.48
Drought Index (PDSI)	Not available
WebWIMP H ₂ O Balance	Dry Season
