Jurisdictional Determination Report

Bridge 127.5 Eagle River

Eagle River, Alaska

Prepared by:
HDR Engineering, Inc.
2525 C Street, Suite 500
Anchorage, Alaska 99503

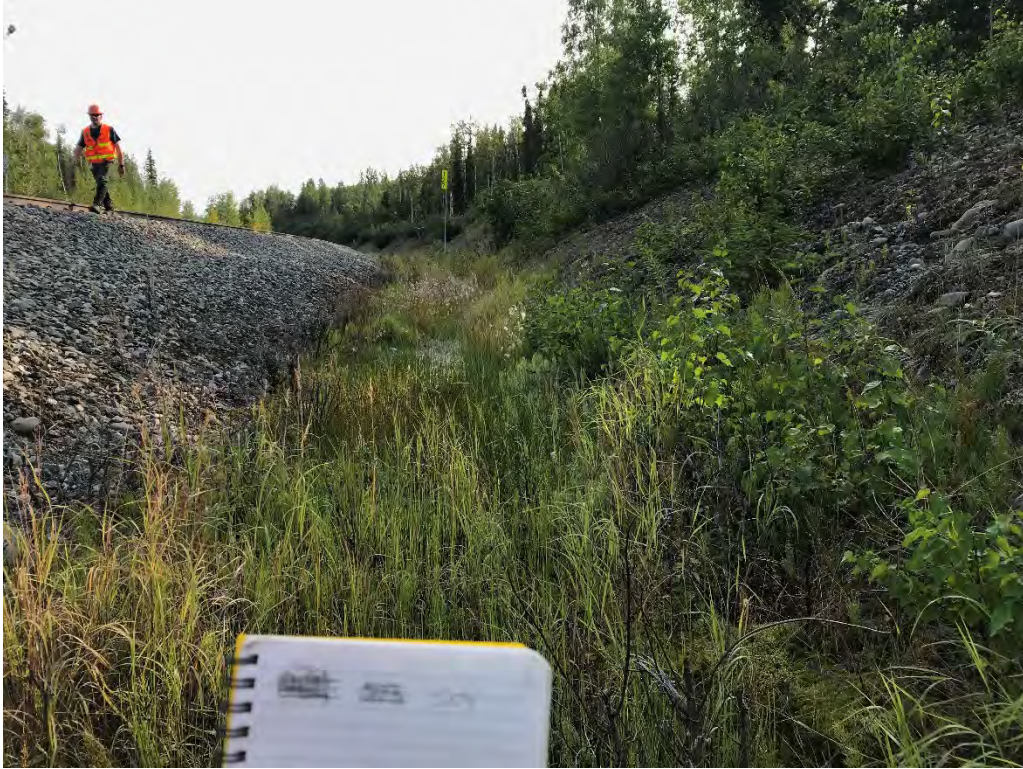
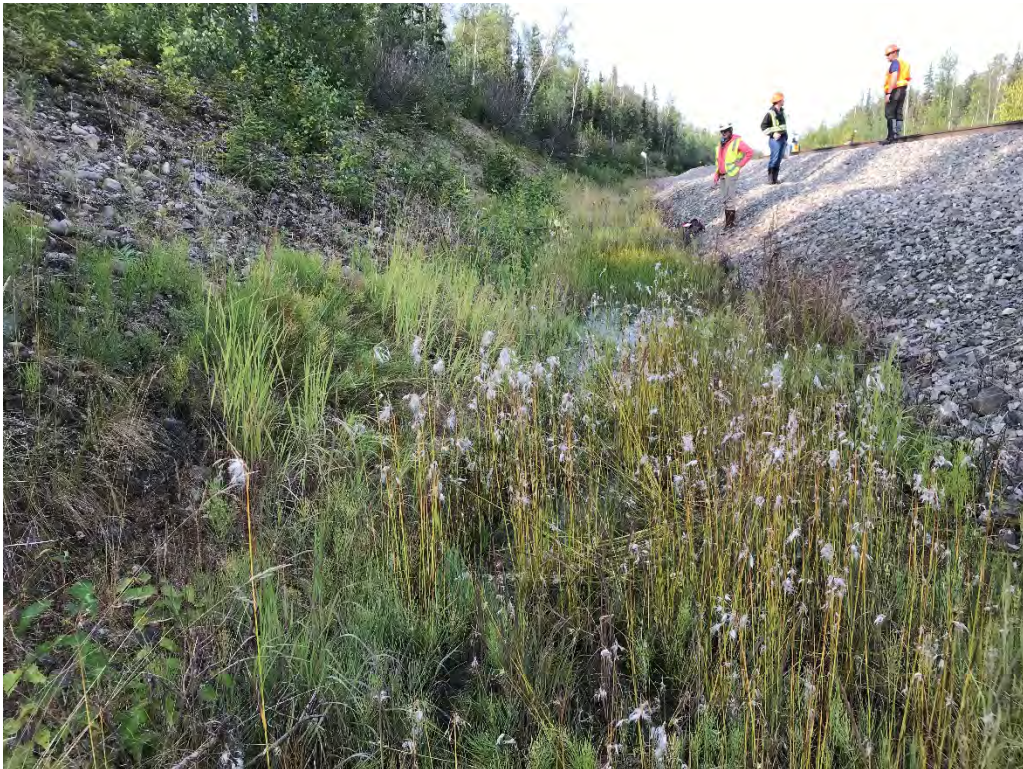
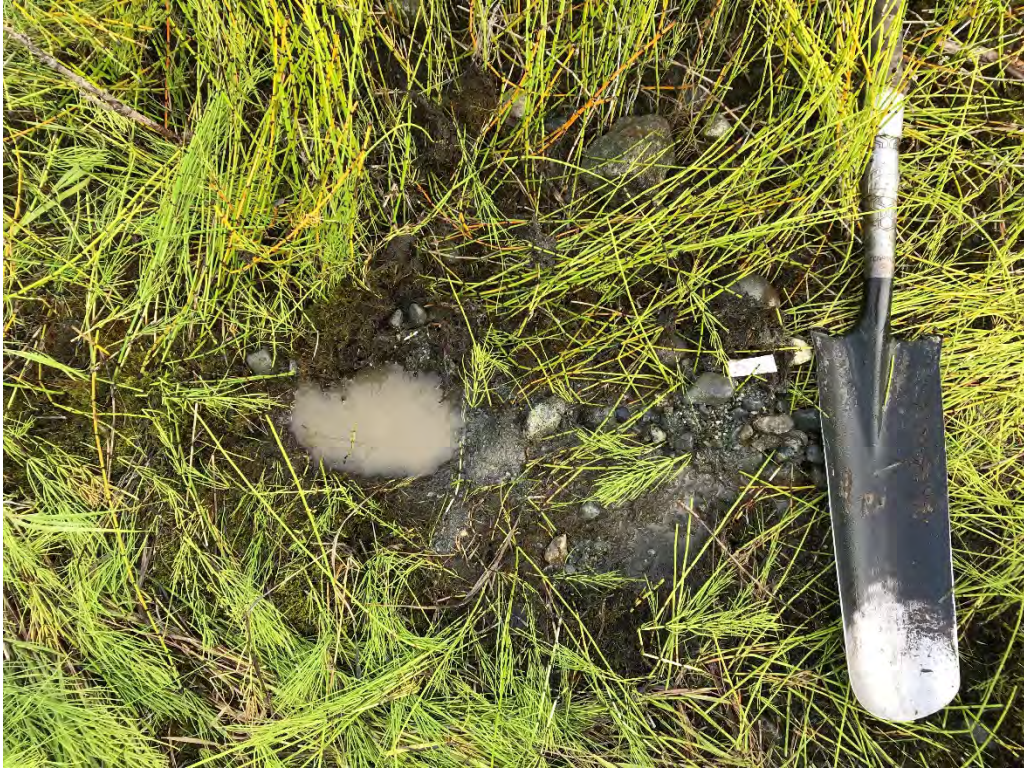
Remarks:
cut for embankment intersects GW. no evidence of wetlands in undisturbed mixed forest above cut slope. wetlands also present on ditch on other side of tracks but no connectivity.

No evidence of flow throughout wet ~225 ft to WSW. wetland begins near culvert. Porcupine in culvert!

Site 004. Vegetation, north view. August 16, 2021.

Site 004. Vegetation, south view. August 16, 2021.

Site 004. Soil. August 16, 2021.

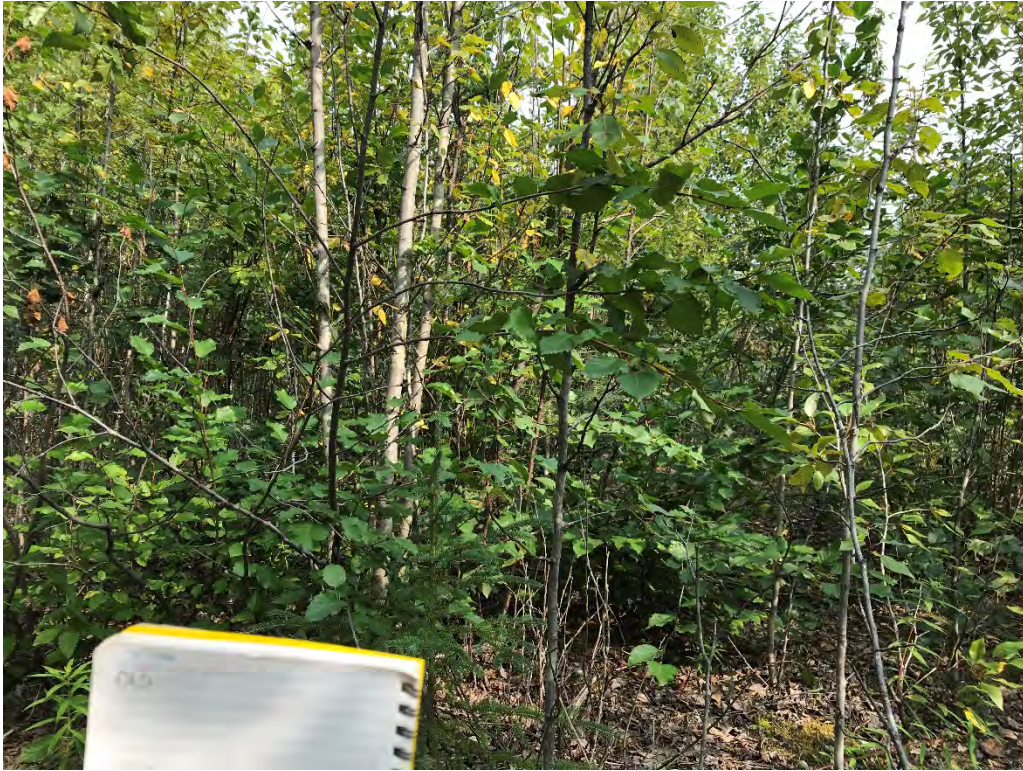
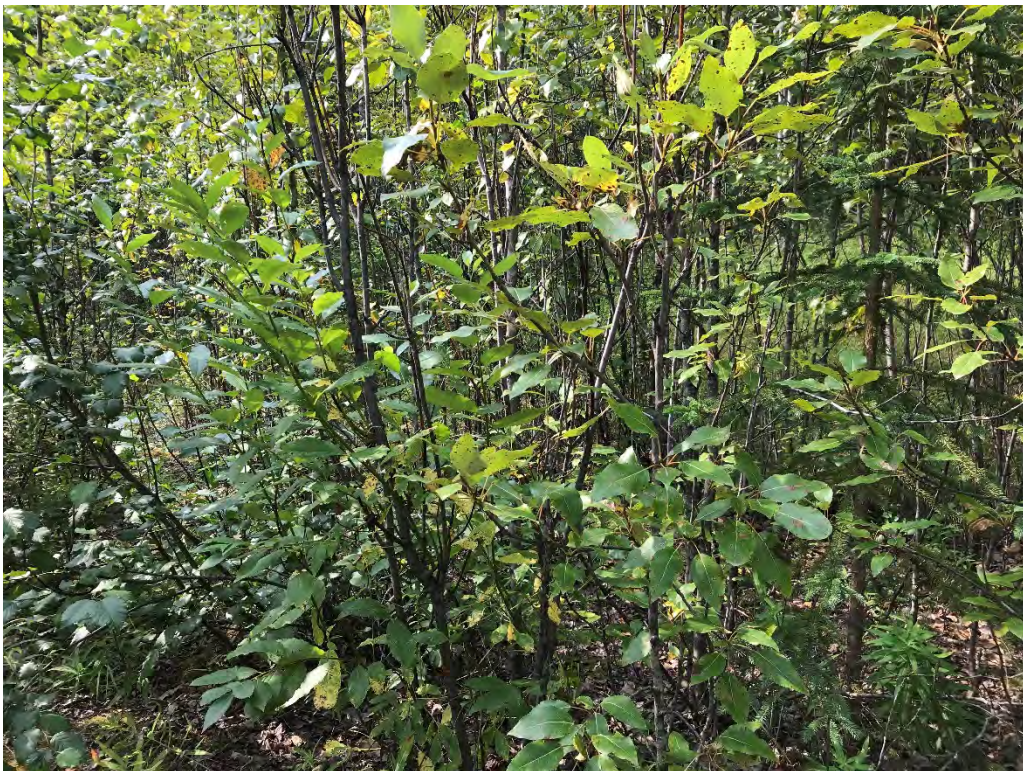
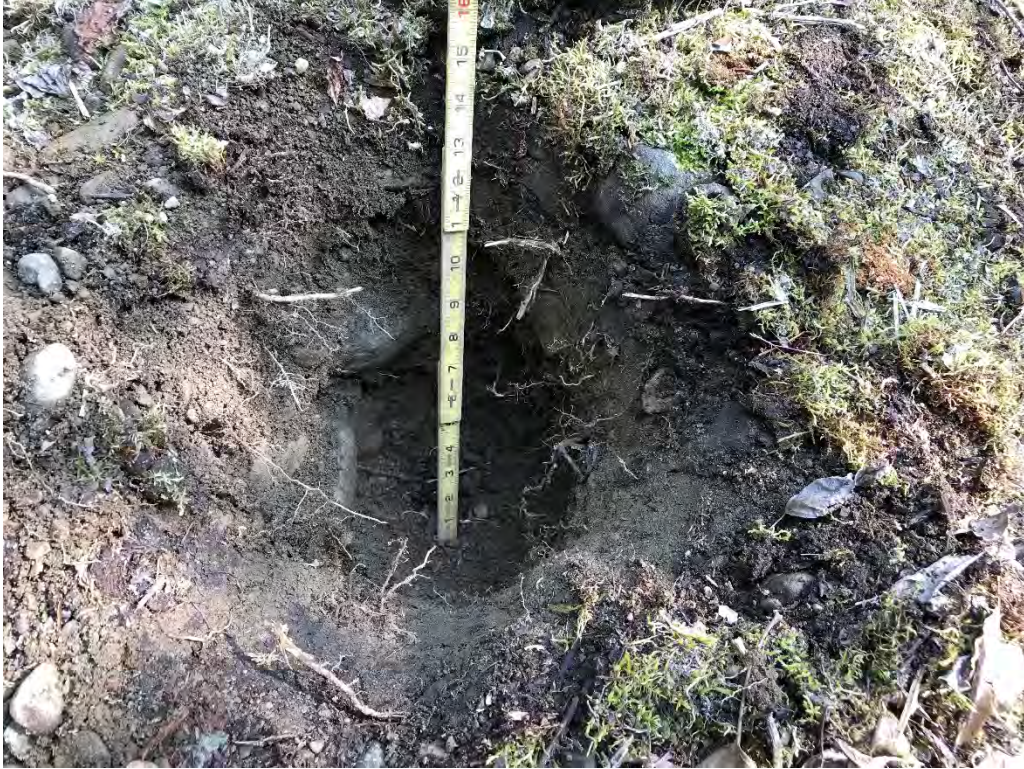
Remarks:
plot at lowest spot in swale between ARK tracks + Artillery Road

Site 013. Vegetation, north view. August 16, 2021.

Site 013. Vegetation, south view. August 16, 2021.

Site 013. Soil. August 16, 2021.
