E. STEVEN TOTH

**Consulting Geomorphologist
Licensed Engineering Geologist**

June 6, 2024

**Subject: Slope Stability Evaluation for the Proposed Construction of the Alpha Access Road
in Parcel No. 021655001000, Lewis County**

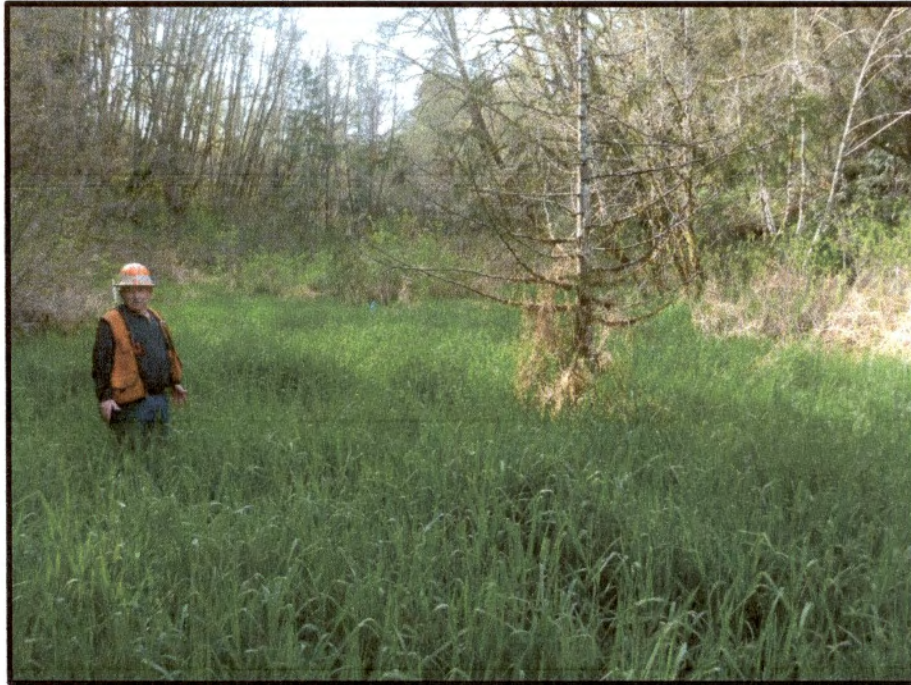
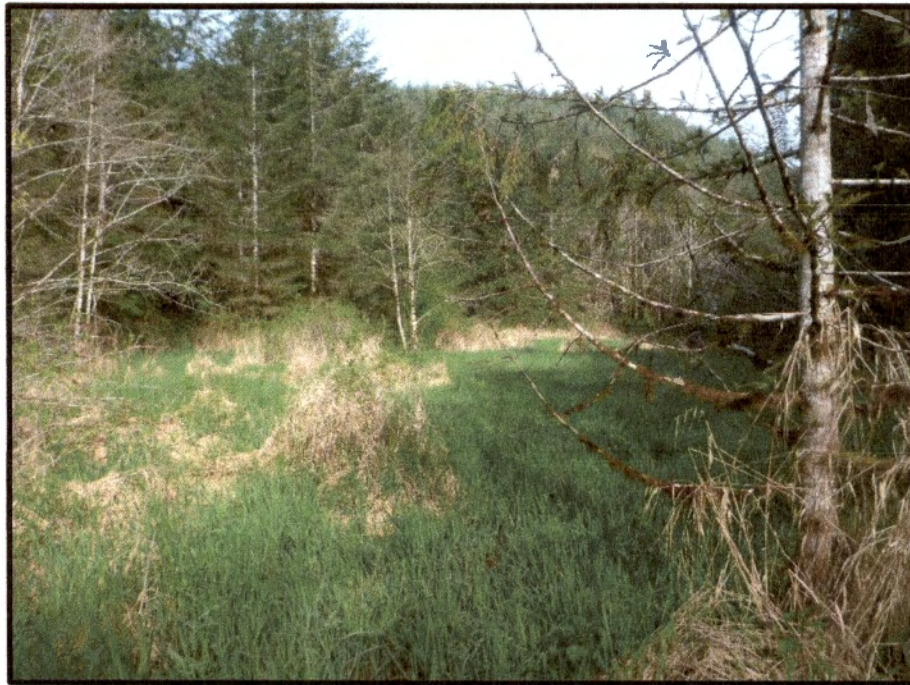
The road enters a roughly 100-foot-wide wet meadow at the confluence of Creek 1 and Creek 1b (Figure 7). The valley bottom is dominated by reed canary grass (*Phalaris arundinacea*), with a few young alder and cedar trees scattered across the wetland area (Figure 9). The saturated mineral soils are generally characterized as a clayey silt (ML) but can be variable across the valley bottom, with lenses of sand and small gravel (SM or GM) within the finer sediments. The proposed road crossing of the wet valley bottom is being designed with 40-foot logs buried in the saturated soils to serve as a foundation for the road. The anaerobic conditions in the saturated soils of the wet meadow are expected to preserve the buried logs for the life span of the road. Geotextile fabric will cover the soil and log foundation before it is buried with pit-run rock and clean fill for the base course material and then finer aggregated compacted to cover the road grade. The road is expected to be elevated about 10 feet above the valley bottom. Two pipes are being proposed through the road grade, including a 78-inch diameter corrugated steel pipe towards the right bank (eastern edge) of the valley along Creek 1b and a 96-inch diameter corrugated steel pipe towards the left bank (western edge) of the valley for Creek 1. The culverts should follow stream simulation design guidelines and be bedded in at least 8 inches of compacted 3" minus rock. The road fill and culvert inlets will be protected by larger quarry spalls at the base of the road grade.

Figure 9. Looking upstream and downstream at the wet meadow area around Station 12+00 of the proposed Alpha Access Road.

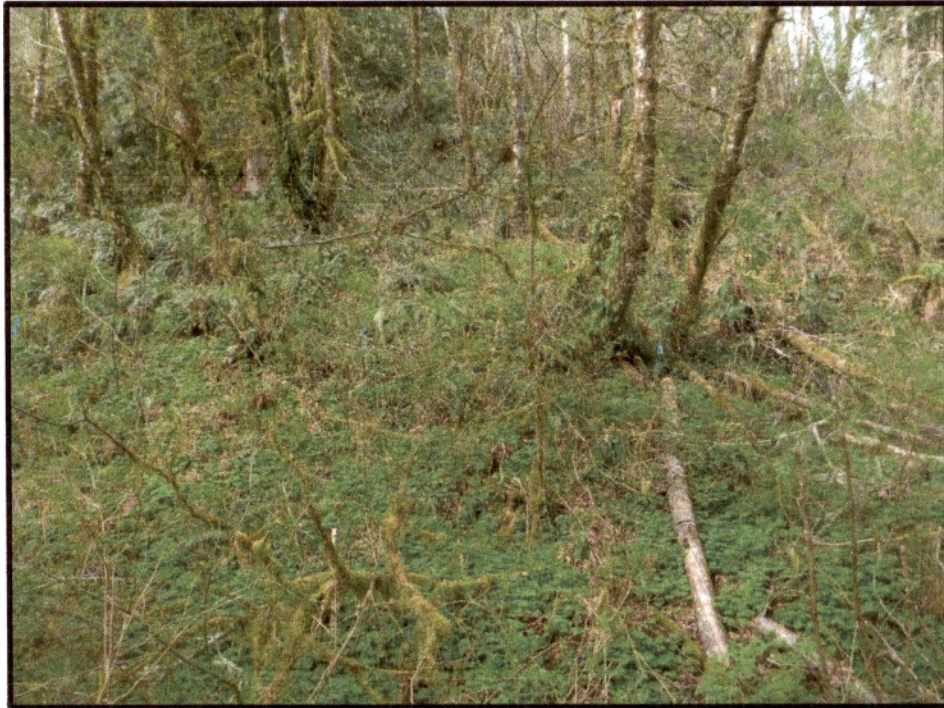
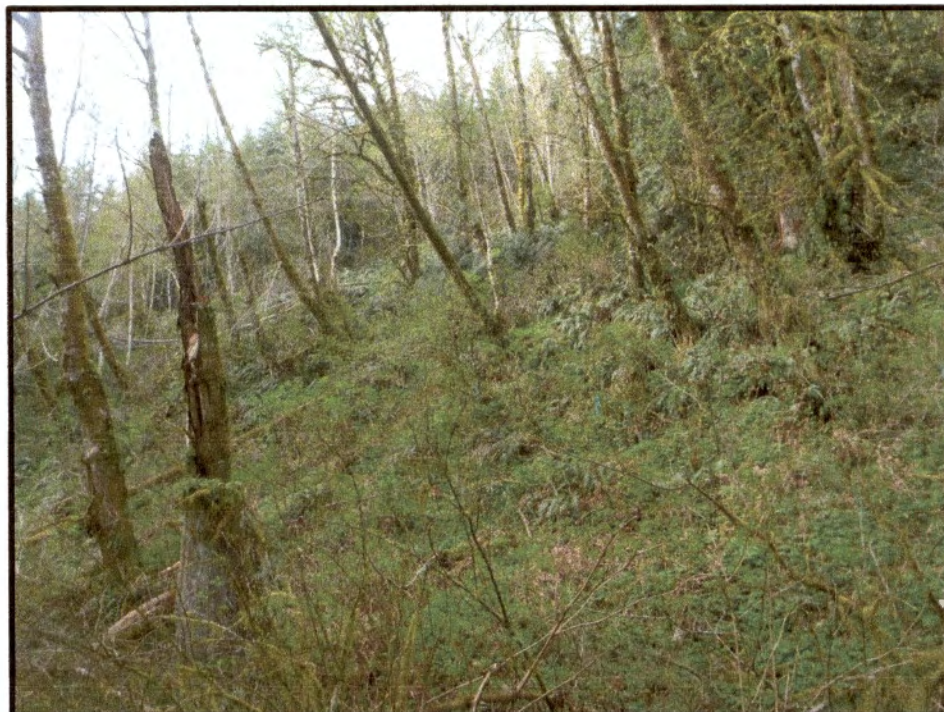
As the road leaves the wet meadow, it climbs at a favorable grade of 10 percent across steep inner gorge slopes on the west side of Creek 1 from Station 12+00 to 17+00. The inner gorge terrain consists of planar slopes of 70 to 100 percent gradient (Figure 10). The trees on the lower slopes consist primarily of mature alder, but patches of western red cedar are also present. While a few old-growth stumps are scattered on the steep hillside, the slopes generally show signs of significant soil creep and small colluvial slumps. Many of the trees on the steeper slopes are pistol-butted and have buttressed roots. While no bedrock outcrops were found within the road centerline, the rock fragments in the colluvium (GM or SM) indicate the presence of siltstone and fine-grained sandstone. The sedimentary rock is likely to be highly weathered and fractured, so that mechanical excavation will likely be feasible for road construction, with minimal, if any, need for drilling and shooting explosives. Full bench road construction will be required through the rule-identified landform, and waste material will need to be pushed or end-hauled to a safe location. Depending on the depth of the colluvium, large, angular 2- to 3-man quarry rocks may need to be stacked between 3 to 6 feet high and keyed into the hillside to prevent cut-slope failures, particularly if groundwater seepage is intercepted. The cut-slope will be constructed at a ¾:1 slope and be roughly 10 to 15 feet high. Additional 2- to 3-man quarry rock may also be used along the outside edge of the road to help stabilize the road grade and minimize the potential for colluvial slumps. Road drainage will have to be carefully managed to avoid placing additional water onto steep, potentially unstable slopes. Colluvial slumps from the steep cutslope may also periodically fill the ditchline and cause water to flow onto the road prism. Strategic placement of water-bars

Figure 10. Inner gorge terrain on the west side of the Creek 1 valley.

is recommended to minimize road surface runoff and to provide a back-up drainage system for the road runoff in case a portion of the ditch becomes plugged.

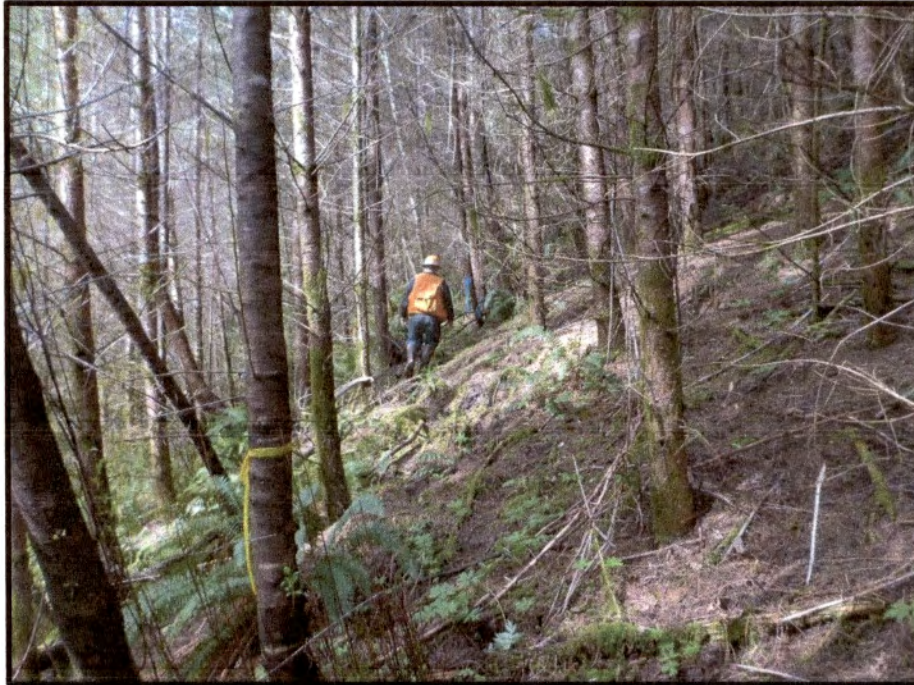
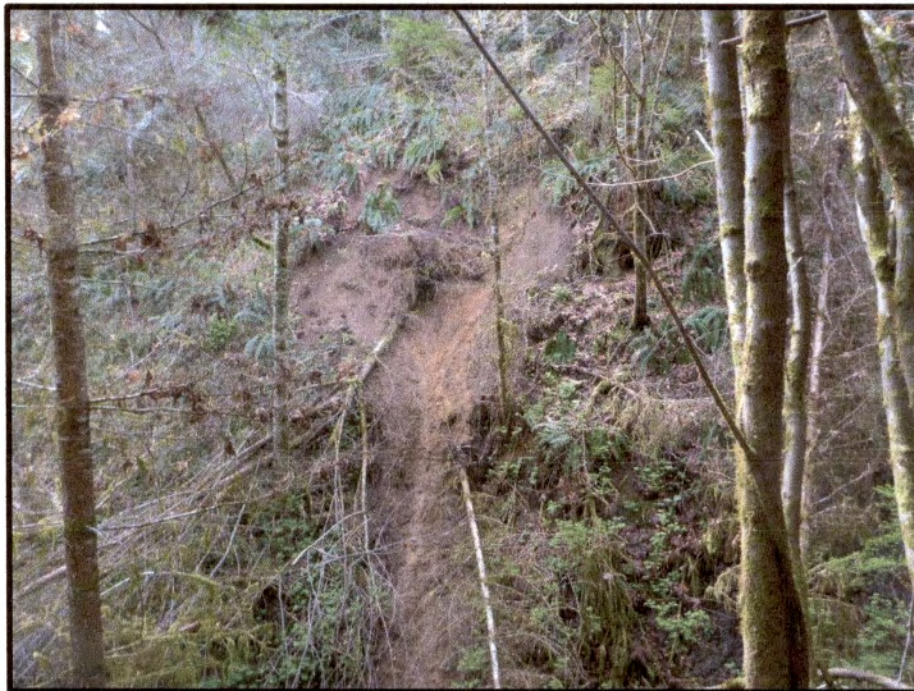
The proposed access road cuts through the ridgeline at Station 17+00 and then climbs parallel to Creek 2 for about 400 feet to Station 21+00 (Figure 7). Full bench road construction will be required as the road follows along the edge of 60 to 90 percent gradient rule-identified inner gorge terrain (Figure 11). A recent translational landslide that deposited into Creek 2 was observed from the inner gorge slopes on the opposite side of the draw. The road also crosses a small 2-foot-wide perennial tributary stream (Creek 2a) at about Station 19+50. A 24-inch diameter pipe will be added for this stream crossing.

Figure 11. Typical slope along the Creek 2 road location at about Station 18+00 and a recent shallow-rapid landslide from the inner gorge along Creek 2.

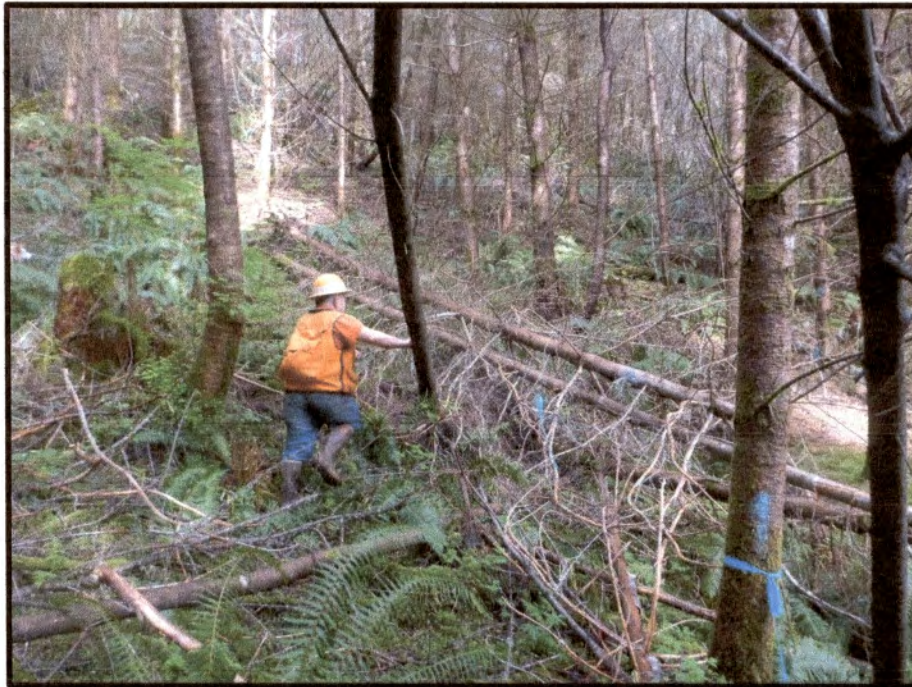
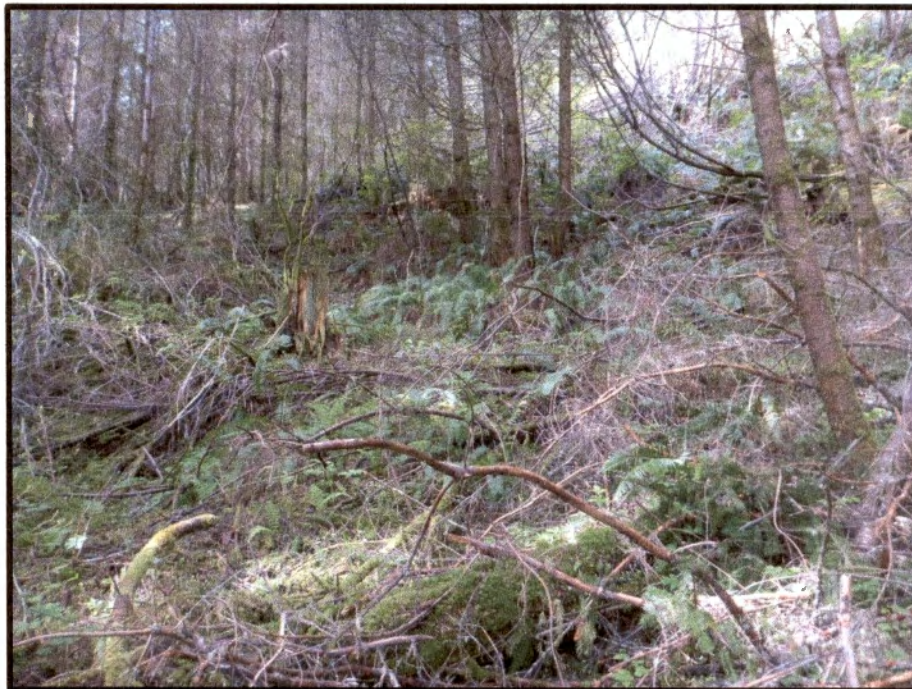
The road then switchbacks up the hill twice between Station 20+00 and Station 27+00 (Figure 7). The road will maintain a consistent grade of about 12 percent as it climbs away from the larger non-fish-bearing stream between Station 20+00 and Station 23+00. At the first switchback at about Station 21+50, the road will be cut from 5 to 7 feet below the ground surface (Figure 12). An 18-inch diameter cross-drain structure will be placed at this location because of the high likelihood for groundwater interception from the steep convergent terrain upslope from the road. The road grade flattens at the second switchback at about Station 23+00 and will serve as a waste area for excess material. The road crosses through one additional steep section of 60 to 80 percent gradient slopes between Station 26+50 and 27+50 that will require full bench construction and end-haul of waste material (Figure 8). These steep planar slopes feed into the first switchback area and could potentially impact the small tributary stream at Station 19+50 (Figure 12).

Figure 12. First switchback at Station 21+50 with 5 to 7 feet of road-cut and the steep upslope area above the switchback and below Stations 26+00 and 27+50.
