FIDALGO BAY CAUSEWAY FEASIBILITY STUDY REPORT

FIDALGO BAY, WASHINGTON

PREPARED FOR THE
SAMISH INDIAN NATION

Prepared by
RIDOLFI Inc.

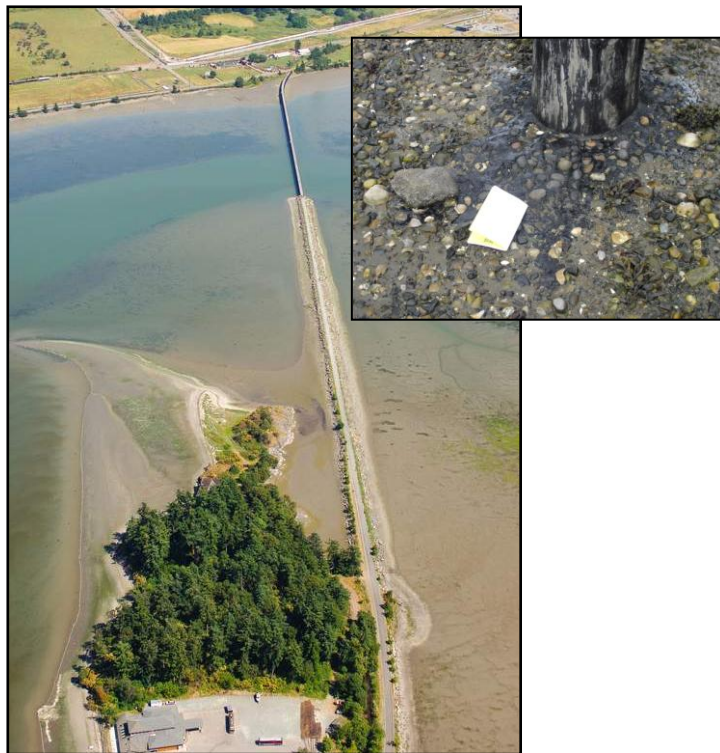
trip to the Site, Ridolfi staff observed creosote dripping from several of the newer pilings (see cover photo). As a result, layered creosote rings surround the bases of the several of the newer creosote-pilings (see cover photo).

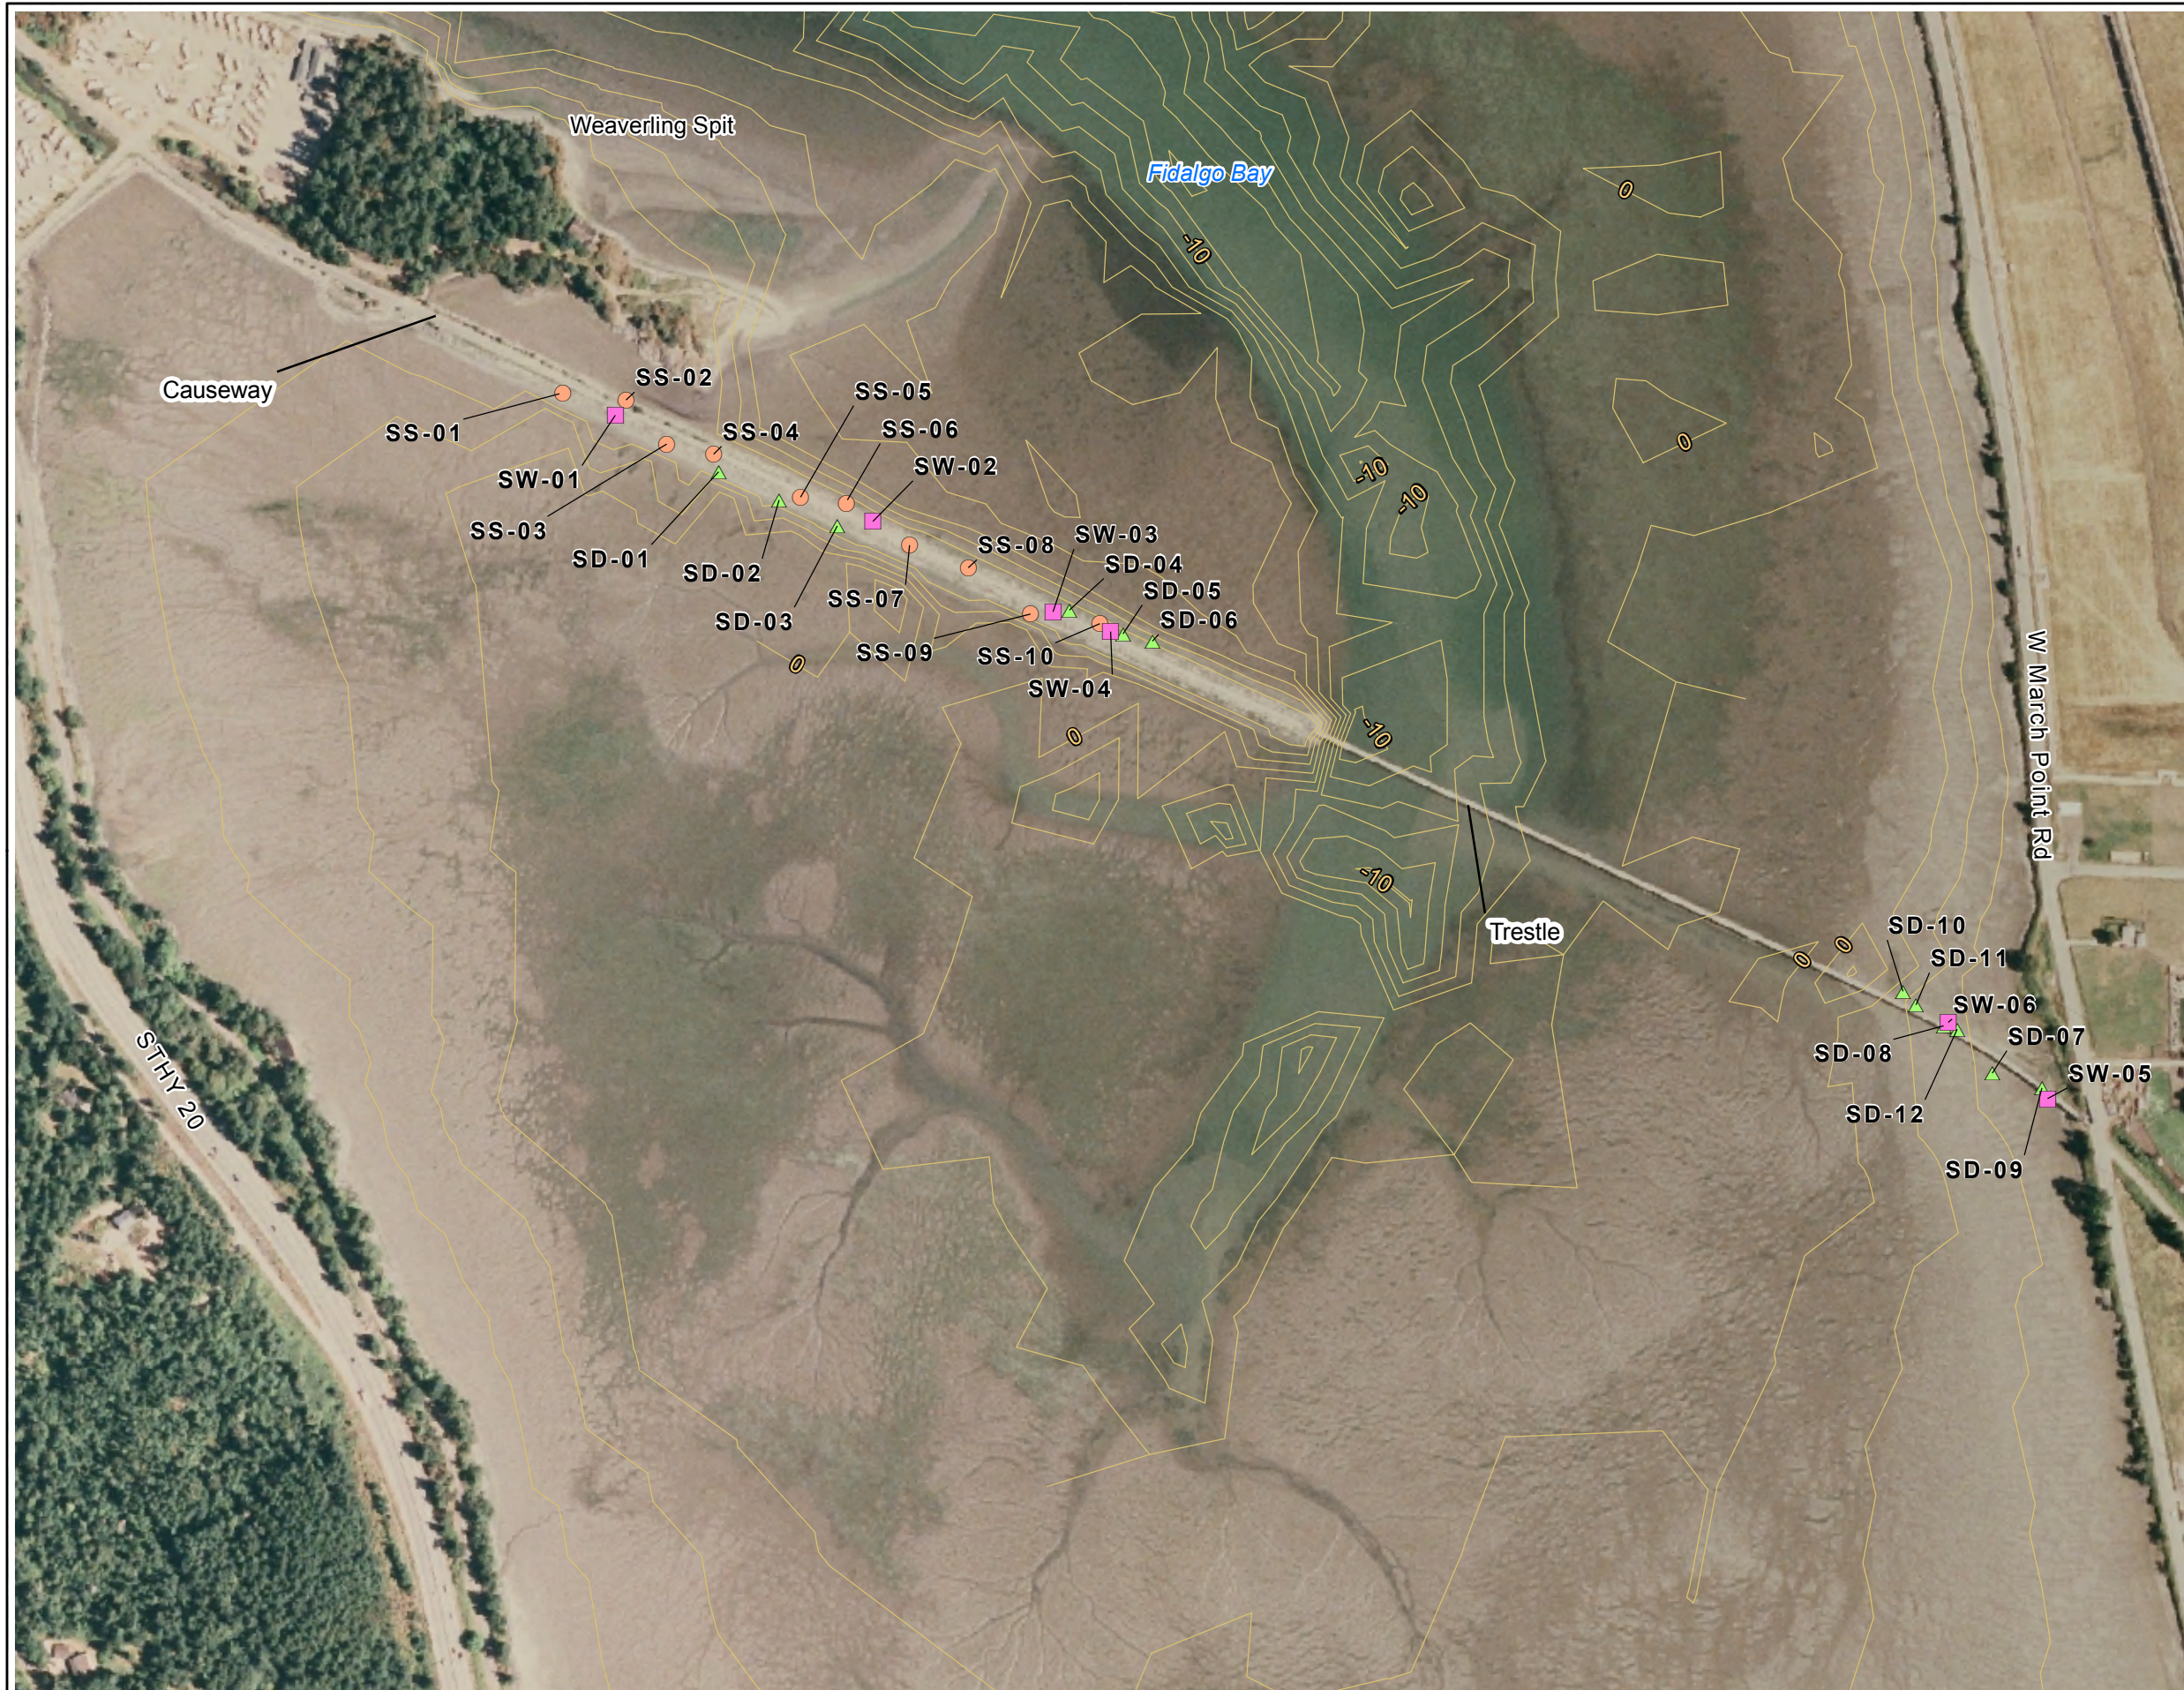
- Legend**
- ▲ Sediment Sample
 - Soil Sample
 - Surface Water Sample
 - ~ Bathymetry 2ft Interval

Each biological survey station occupied a sediment sample location as determined with a handheld GPS unit. The sediment sample locations are on the north and south of the causeway and trestle. Six stations are adjacent to the causeway and six stations are adjacent to the trestle. Table 3 provides the horizontal coordinates for each sediment sample location and Figure 2 provides an aerial overview of the sediment sample locations.

Ridolfi staff collected soil, sediment, and surface water samples on and adjacent to the causeway in 2007 as described in detail in Appendix A. This section provides a brief summary of the important findings. Figure 2 shows where the samples were collected.

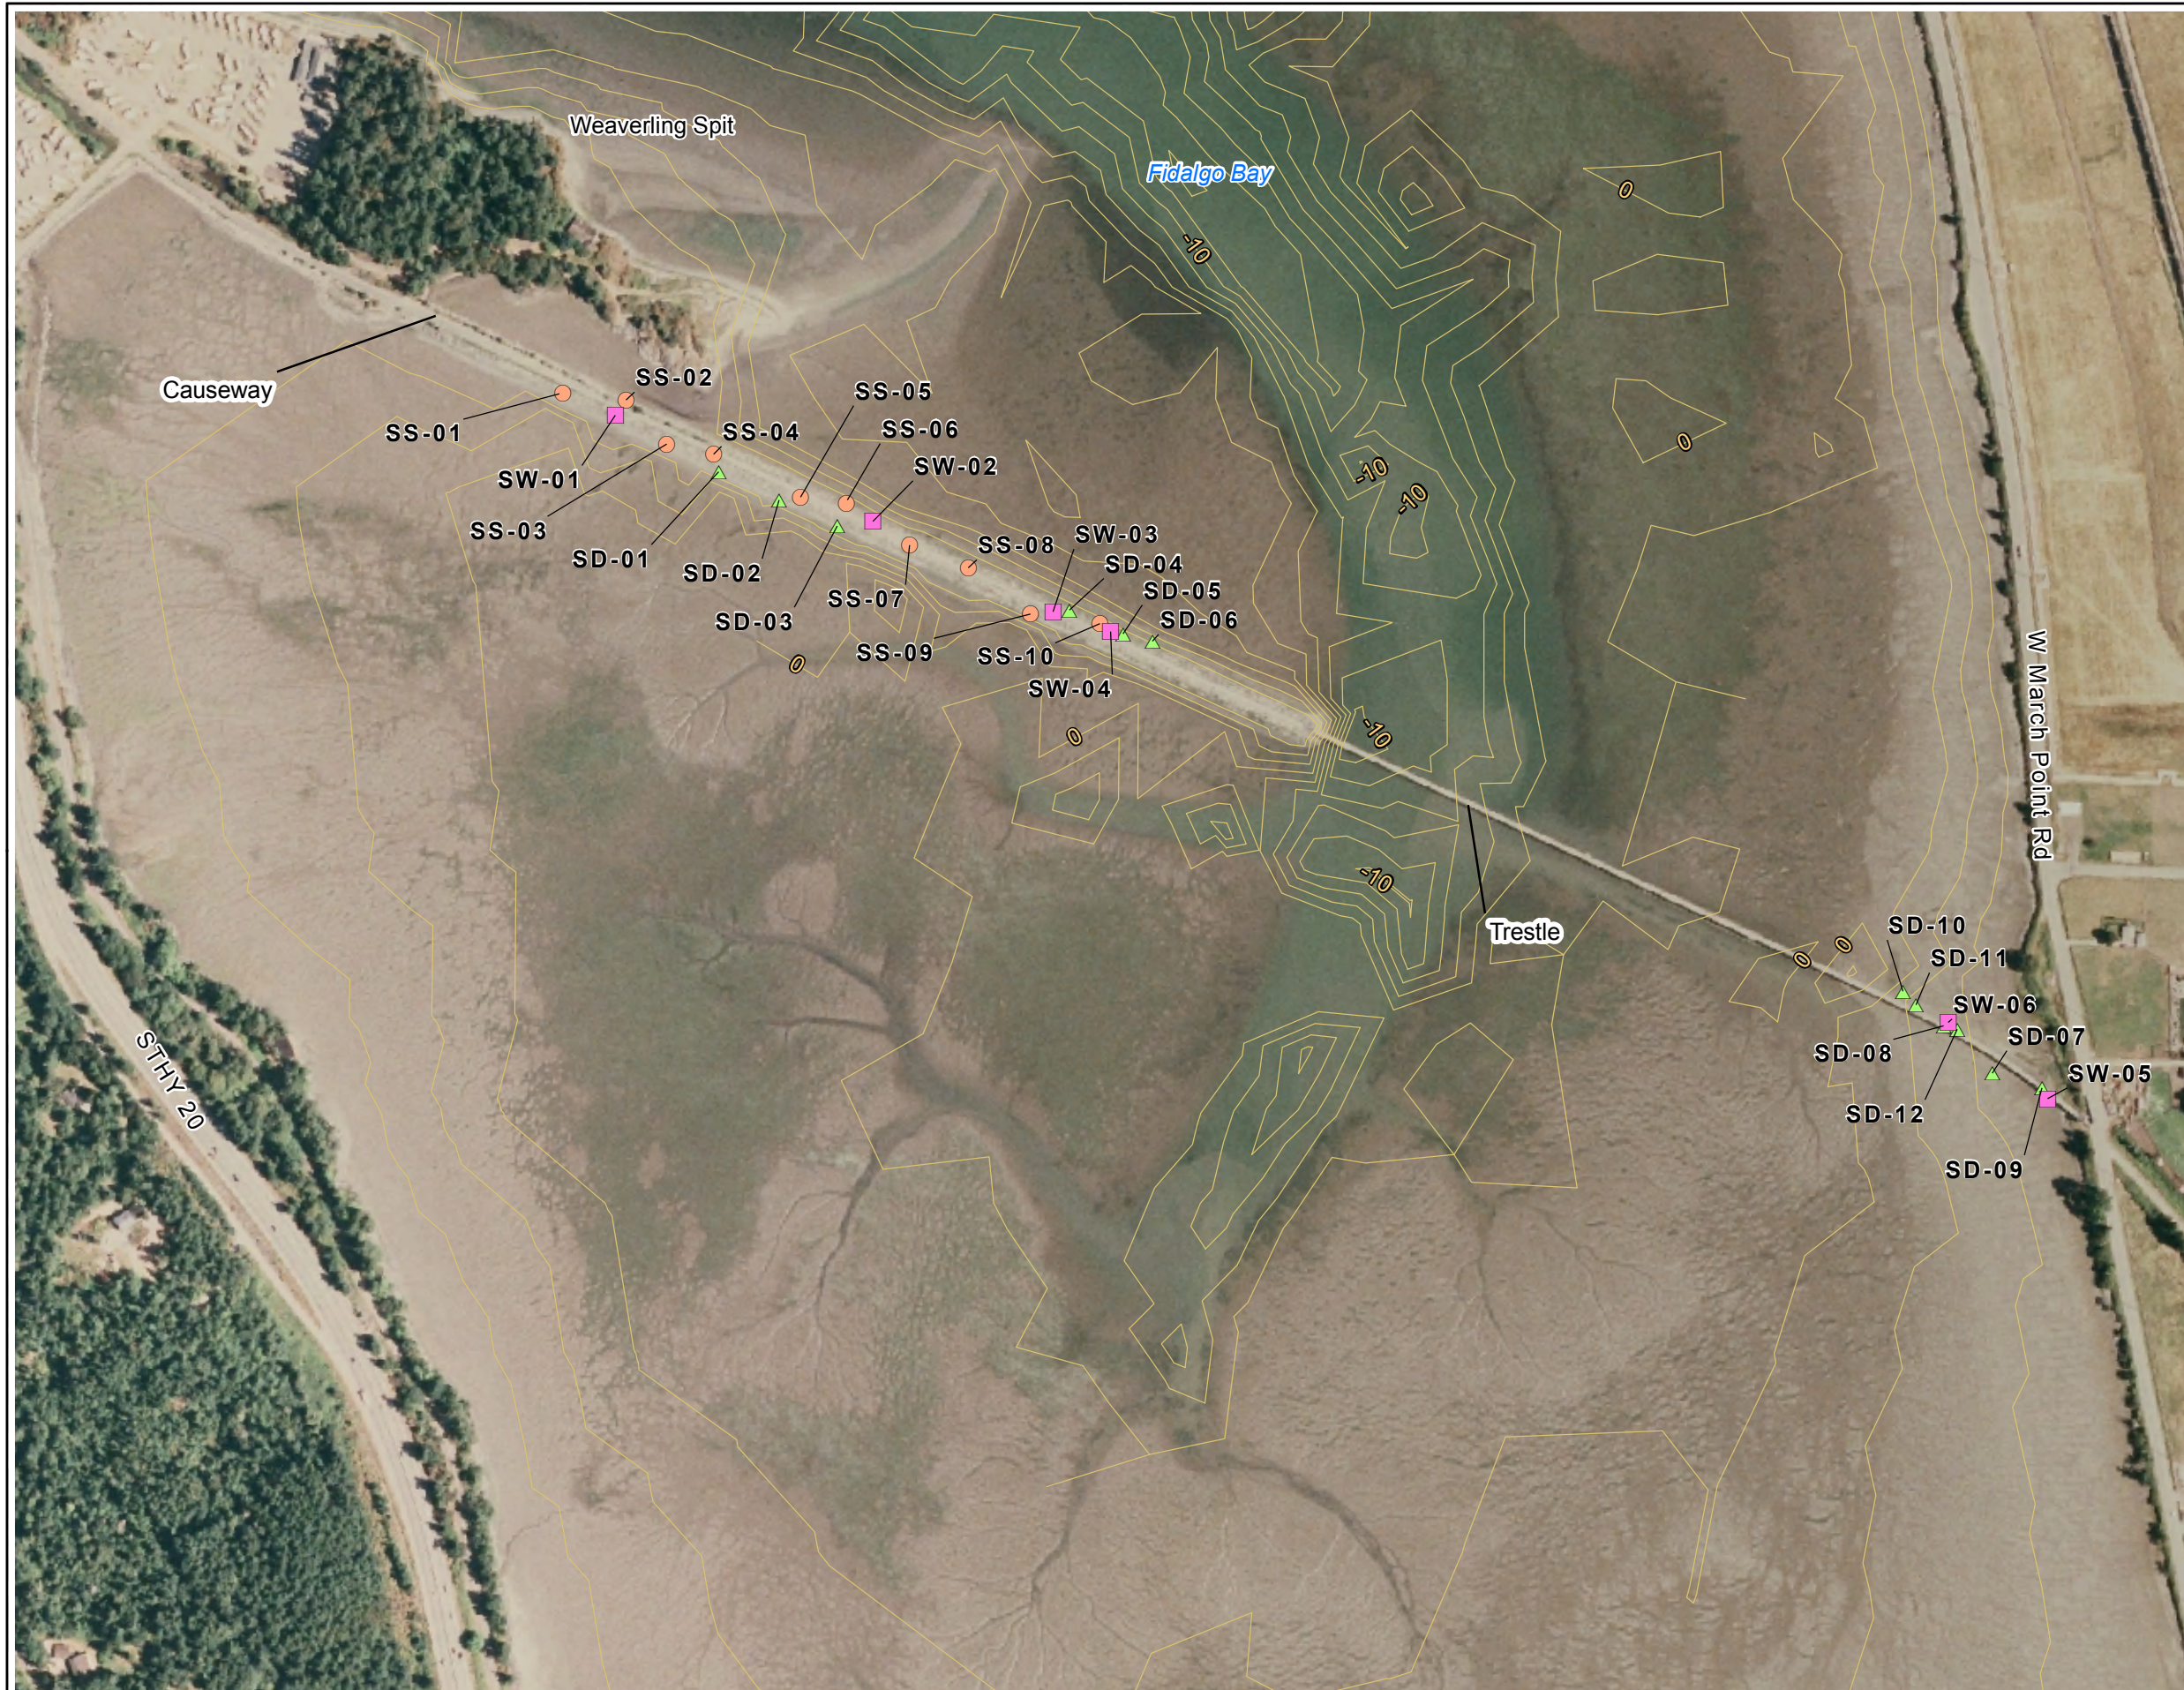
- Legend**
- October 2007 Sampling**
- ▲ Sediment Sample
 - Soil Sample
 - Surface Water Sample
 - ~ Bathymetry 2ft Interval

Sediment, soil, and surface water samples were collected at the Site, according to procedures described in the Sampling and Analysis Plan for the Fidalgo Bay Causeway Feasibility Study (Ridolfi, 2007). Figure 2 shows the locations where the samples were collected.

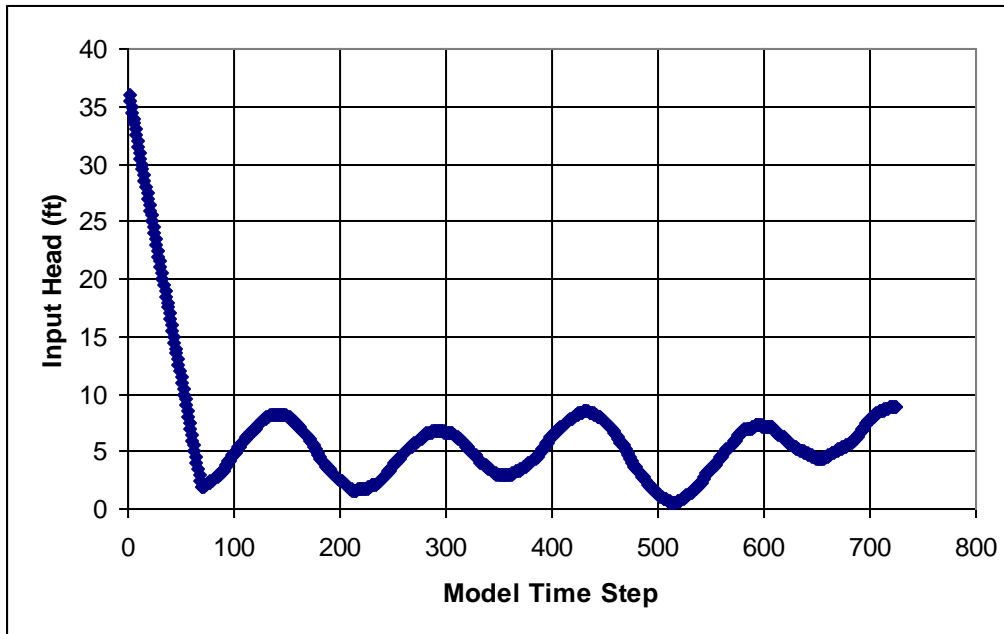
Figure 1. Tidal Data Input

approximately 5,500 nodes and 2500 elements and completes 751 individual time steps. Input data from the model can be seen in Figure 1. Note the “spin-down” data over the first 70 steps.
