# Geologic Mapping with Lidar: Examples of Deep-seated Landslides and Faults from the Summit Lake Quadrangle (and Others)

Timothy J. Walsh

Washington Department of Natural Resources

Division of Geology and Earth Resources

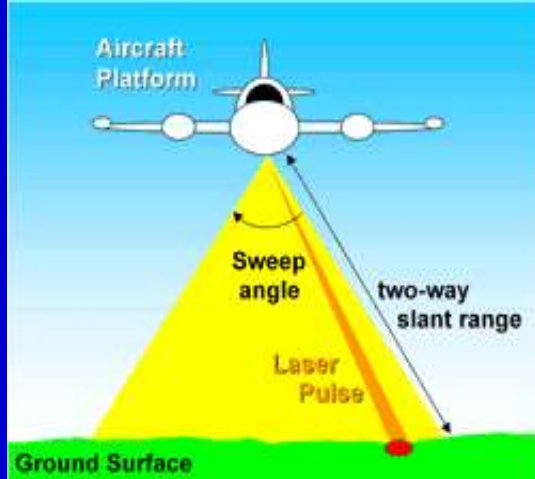
New mapping technology is becoming increasingly available, particularly in the urban areas of western Washington, that enable accurate digital mapping of fault scarps, landslides, and other geologic features for which a synoptic view is necessary for accurate identification. LiDAR (Light Detection and Ranging) allows for accurate imaging of topography by digitally removing the forest cover (virtual deforestation) demonstrated in the next slide.

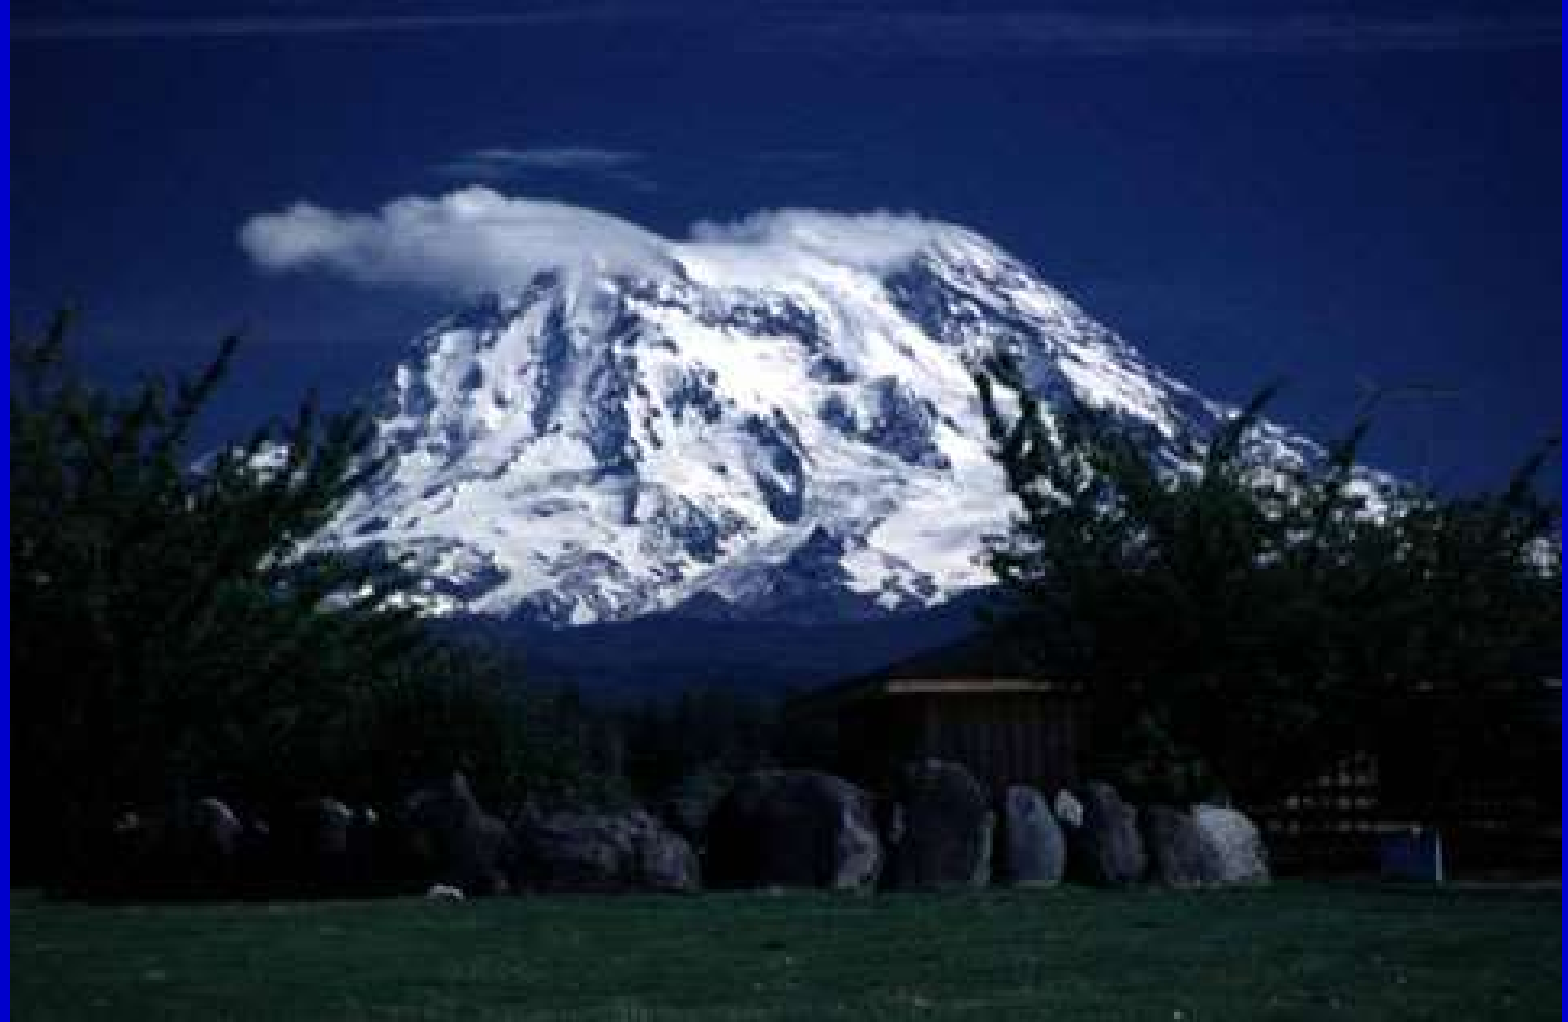
One of these terraces is littered with andesitic boulders, such as these at "Stonehenge", along State Route (SR) 7 about 1.5 mi south of SR 702, were deposited by the great Tanwax Creek-Ohop Valley late-glacial flood (From Pringle, Goldstein, and Anderson)
