Ground Failures in the Southern Puget Sound Lowlands Caused by the Nisqually Earthquake

WALSH, Timothy J., WEGMANN, Karl W., LINGLEY, William S., DRAGOVICH, Joe, D., PRINGLE, Patrick T., PALMER, Stephen P., NORMAN, David K., POLENZ, Michael, LOGAN, Robert L., MCKAY, Donald T. Jr, MAGSINO, Sammantha L., and SCHASSE, Henry W.
Washington Department of Natural Resources, Division of Geology and Earth Resources, P.O. Box 47007 Olympia, WA 98504-7007

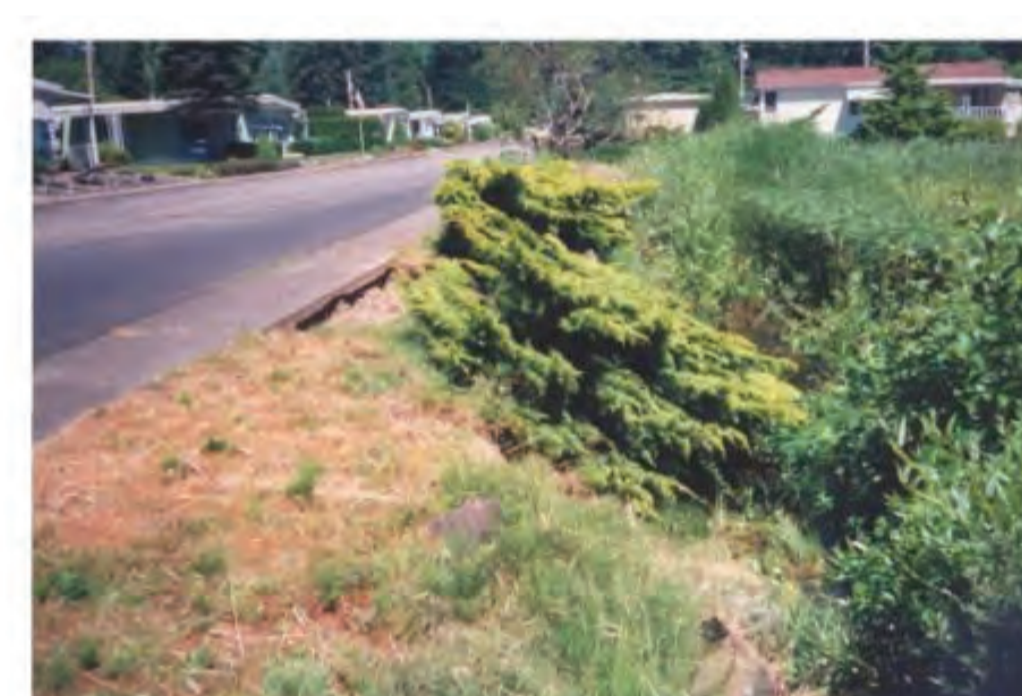
1999 Satsop Earthquake

Sunset Lake embankment failure

A road embankment at Sunset Lake that partially failed in the M5.8 Satsop earthquake in 1999 failed again during the Nisqually earthquake
