# Habitat Conservation Plan for State Trust Lands 2006 Implementation Monitoring Report

# Habitat Conservation Plan for State Trust Lands **2006 Implementation Monitoring Report**

Ecosystem Services Section  
Land Management Division

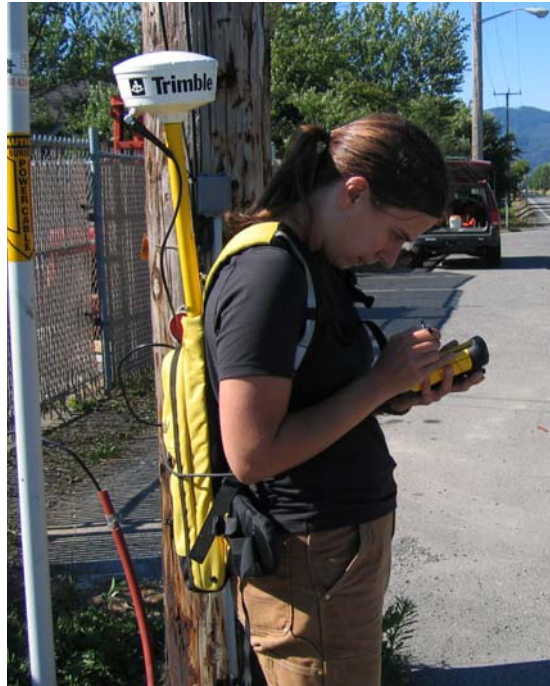
**Figure 2.3.** A member of the field crew using the Trimble Pro XR to collect GPS data at a survey monument

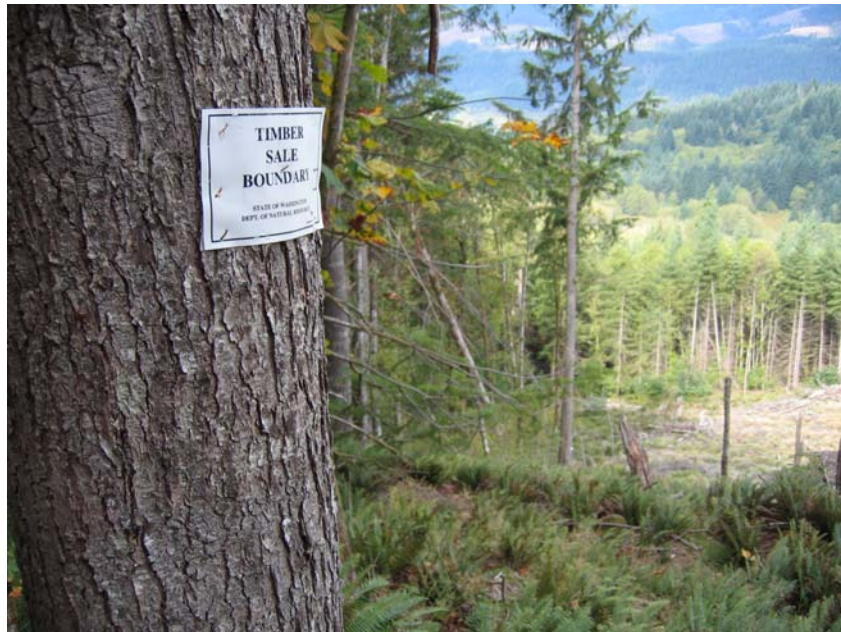
**Figure 2.5.** Boundary tag marking the outer edge of an RMZ

There are several opinions regarding where an RMZ stops and a timber harvest begins. We chose a point on the outer edge of the RMZ, typically at a tagged tree (Figure 2.5). However, if there was a stump on the line, we selected a location on the RMZ side of the stump to collect GPS data. When a tagged tree had fallen, we approximated a location between the root wad or hole left by the fallen tree and the nearest stump. In most cases, stream segments were on the edge of timber sale units, so RMZs only needed to be measured on one side. When a stream ran through the middle of a timber sale unit, we measured RMZs on both sides of the stream.

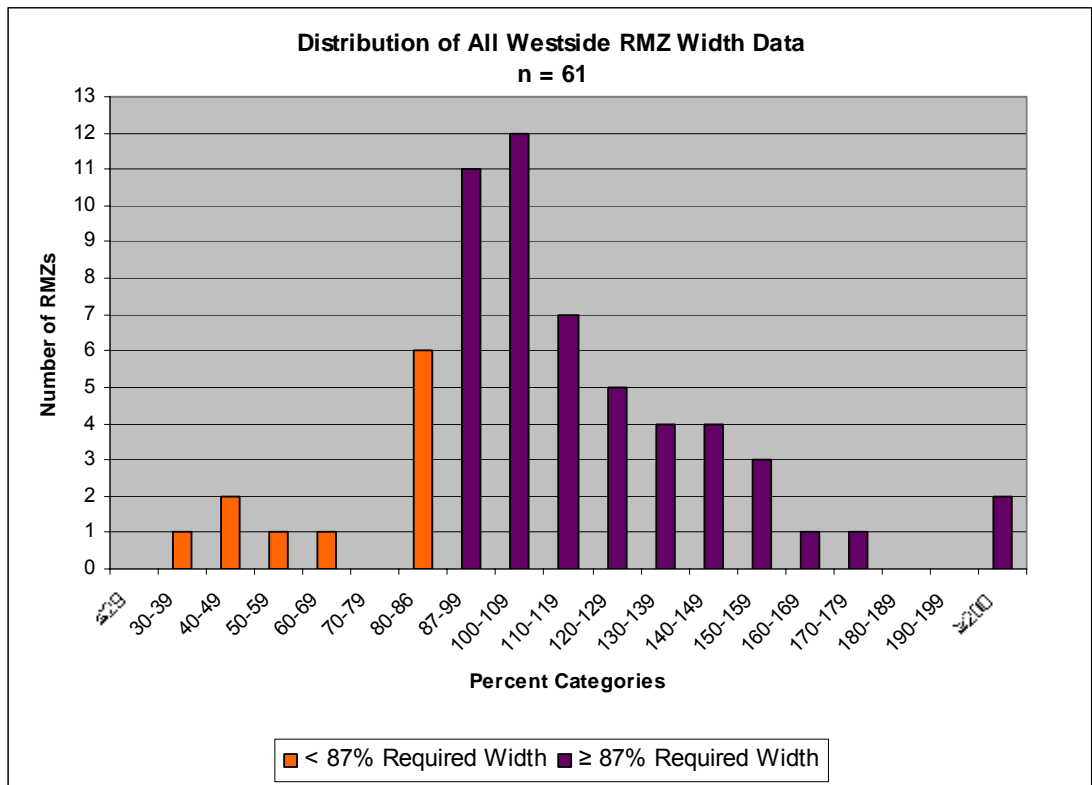
Of the 61 RMZ widths we measured in all Westside regions, 11 (18 percent) were less than 87 percent of the required width and 50 RMZs (82 percent) were at least 87 percent (Figure 3.1). Results are displayed first, by distribution of RMZ compliance for all RMZs by region; and second, by compliance for RMZ width for each stream, by region.

**Figure 3.1.** Distribution of all Western Washington 2006 RMZ width compliance data

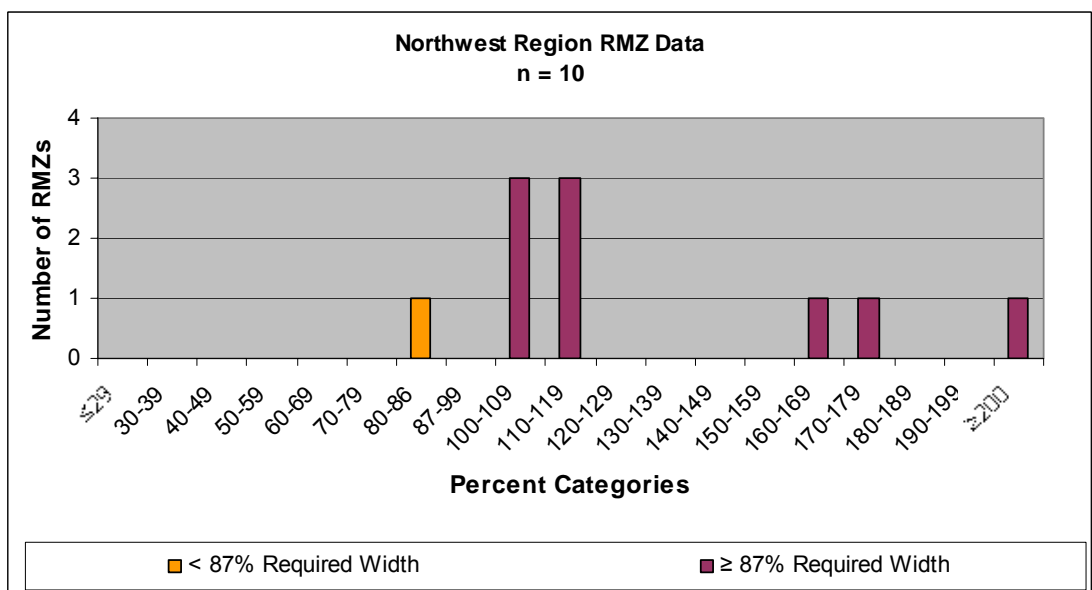
In Northwest Region, one RMZ was less than 87 percent of the required width and nine were at least 87 percent (Figure 3.2).

**Figure 3.2.** Distribution of Northwest Region 2006 RMZ compliance data

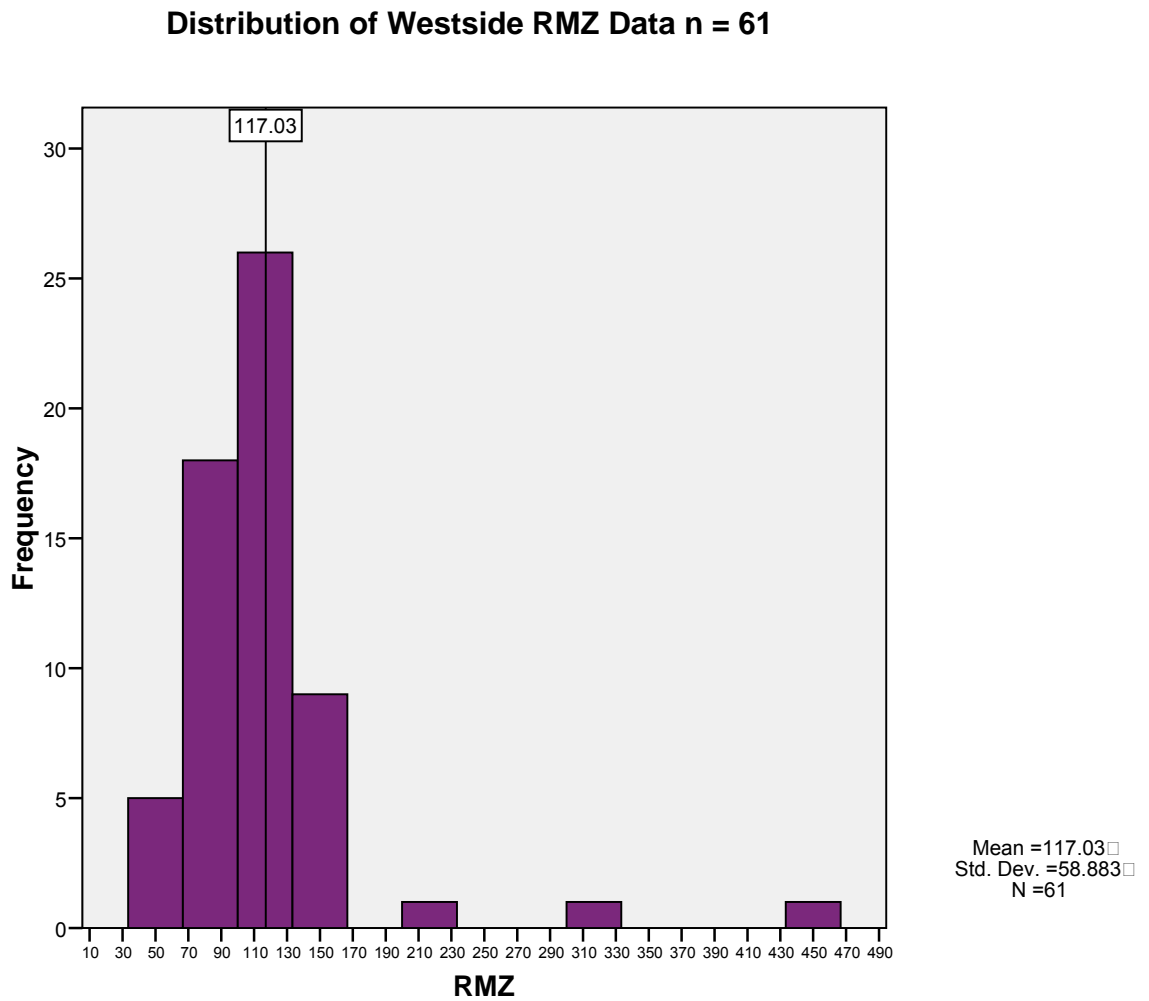
Overall, 82 percent (50 of 61) of RMZs were compliant. The distribution of the results for RMZs was not normal because of events occurring at the lower and upper ends of the distribution (Figure 4.1). On average, RMZs were 117 percent of the required width.

**Figure 4.1.** Distribution of 2006 RMZ data across all Westside regions

The RMZ compliance data is not normally distributed because the majority (39 of 61, or 64 percent) of measured RMZ widths was more than 100 percent of the required width. This causes the distribution to be weighted to the right, giving it a positive skew. The
