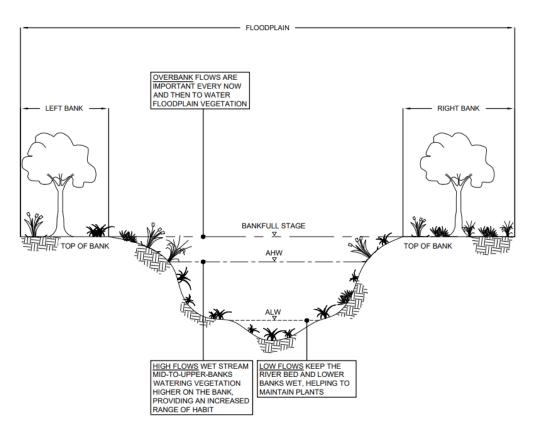
Figure 1-1: Schematic representation of river channel cross-section showing hydrological zones, vegetation distribution and the effects of varying water levels on streambank stability.

Bankfull discharge is the water level, or stage, at which a stable stream or river reaches the top of its banks, and any further rise results in water spilling onto the floodplain. The bankfull stage has been shown to be strongly correlated to a channel's effective discharge and represents that flow stage that passes most of the annual sediment load over time. As such, it is the discharge or river flow that forms and maintains the channel's form. Average High Water (AHW) refers to the average position of the high-water mark over a prolonged period of time. Also known as Ordinary High Water, it represents the boundary between the aquatic and terrestrial environments in federal law under the US Clean Water Act. Average Low Water (ALW) is the counterpart to AHW. ALW marks the average position of the low water mark over an extended period, corresponding to the elevation where the water surface is at its lowest average level, often visible as a distinct line on the streambank. Bankfull, AHW, and ALW stages are shown in Figure 1-1.

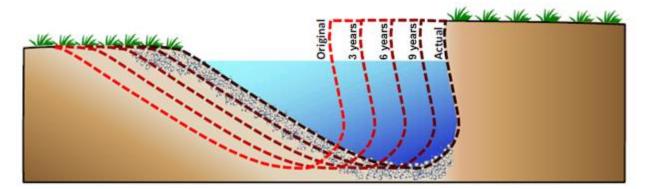
Figure 1-2: Conceptual profile showing a migrating river or stream channel through its floodplain over the years, while maintaining its channel's dimension or flow capacity. Source: DNER, 2016.¹

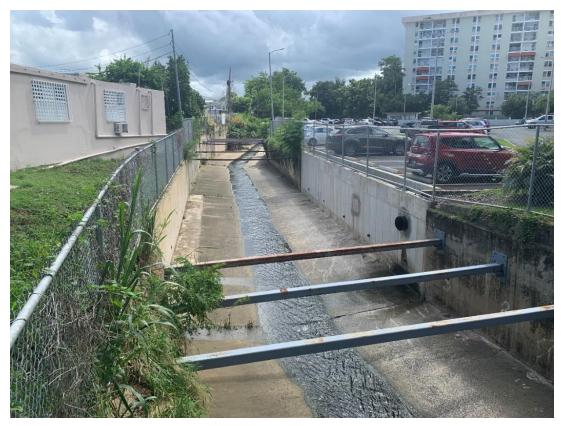
Figure 1-3: Trapezoidal channel concrete walls failing along the Quebrada Buena Vista Stream, between the Jardines Metropolitanos residential building complex and the Ramón Nevárez community in San Juan. (2023).

- Portland cement, constructing concrete bottoms and vertical walls, or installing sheet steel pilings along riverbanks to prevent erosion, or even completely encasing the stream in buried pipelines, in many instances creating an impermeable funnel or canal. While effective as a short-term way to manage peak flows, these practices alter natural river dynamics and habitats by inhibiting the natural migration of rivers and isolating them from the surrounding floodplain. Their lack of rugosity leads to faster flows, causing severe erosion and scouring immediately downstream, which in turn leads to sedimentation farther downgradient. In addition, the altered, armored stream segment usually requires regular maintenance because it will tend to collect sediment due to the lack of frequent, strong flows that would otherwise wash materials downstream; in some instances, culverts can become completely blocked by sediment. Furthermore, these walls can fail and fall into the stream channel, leading to sudden, catastrophic effects: the fallen wall can obstruct flow and/or cause the adjacent downstream panels of the walled section to be undermined and detach, leaving the remaining steep slope and soil surface exposed to severe scouring. An example of this is shown in Figure 1-3.

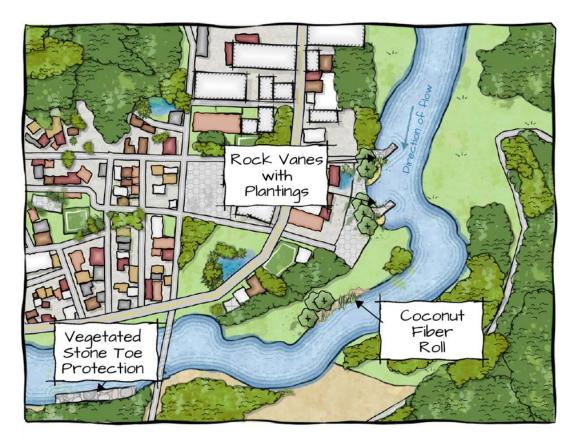
Figure 1-4: Example illustration of three types of streambank stabilization NNBS discussed in this guide. Solutions can work together to benefit both the natural riverine system and communities.

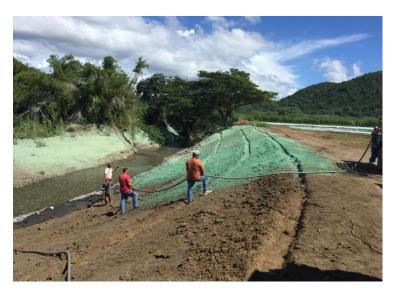
Figure 2-1: Hydroseeding performed by Protectores de Cuencas to help restore the banks of the Río Loco in Yauco (Photo credit: PDC)

- Hydroseeding (Figure 2-1) can be an efficient technique for rapidly establishing vegetation cover on streambanks and slopes, and has a history of success in Puerto Rico.⁴ Hydroseeding involves spraying a mixture of seeds, mulch, fertilizer and water directly onto the soil. This method is particularly effective in high slope areas or locations where traditional planting is challenging. Hydroseeding stabilizes the soil temporarily, providing a protective layer that reduces erosion and supports the growth of vegetation. When used in tandem with other practices, such as the strategic placement of native plants and coir products, hydroseeding contributes to both immediate soil stabilization and the long-term enhancement of ecological integrity.

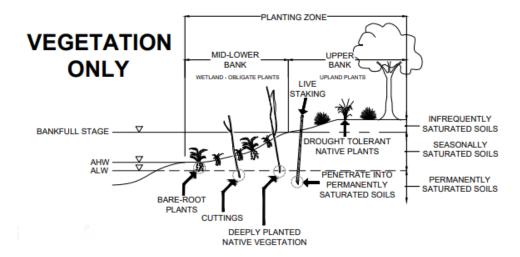
In Figure 2-2, a typical section showing the "vegetation only" strategy for riparian stabilization is illustrated, incorporating specific planting techniques suited to the hydrological and soil conditions of each bank zone. When planning for vegetation across these zones, environmental considerations such as expected water elevations, flow velocities, soil type and bank steepness must inform the design. The integration of structural support with vegetative techniques helps increase the resilience of the vegetative cover against erosive forces. Table 2-2 provides an overview of plant habits, wetland status and their applications for streambank stabilization across different zones. Table 2-3 breaks down specific native species, detailing their habits, best uses, heights, soil types, root types, uses in nature-based solutions and maintenance requirements. For a detailed definition of each plant habit and wetland status, see the appendix of this document.

Figure 2-2: Typical section for using vegetation only for stabilization. Adapted from McCullah and Gray, 2005.⁷

- Upper Bank (Upland Plants Zone): The highest zone, inundated by only the most extreme floods, calls for species adapted to dry, infrequently saturated soils. For this upper bank area, it is recommended to prioritize tree species, such as wild banyantree (*Ficus citrifolia*), Santa Maria (*Calophyllum antillanum*) and pink trumpet tree (*Tabebuia heterophylla*) over other plants like shrubs. These trees provide stability and erosion control, and are suitable for the drier conditions near the bank's top. Hydroseeding, a planting process that uses a slurry of seed and mulch, can establish a first line of defense with a blend of seeds, mulch and stabilizers that adhere to the soil surface. In cases where the existing soil is an engineered type lacking organic richness, rooted transplants such as Puerto Rican native grasses, including species like pink muhly grass (*Muhlenbergia capillaris*), may be introduced into enhanced soils.

- Toe (Inundation Zone): At the water's edge, the focus shifts to species that can survive permanently saturated soil conditions and frequent submersion. Here, plants must resist shear stresses equivalent to those withstood by established reed plantings, up to 30 N/m² (0.6 lb/sq ft), and flow velocities potentially over 1.5 meters pers second (m/s) (5 feet per second [ft/s]).8 Additional structural support, such as erosion control blankets, may be necessary to protect the

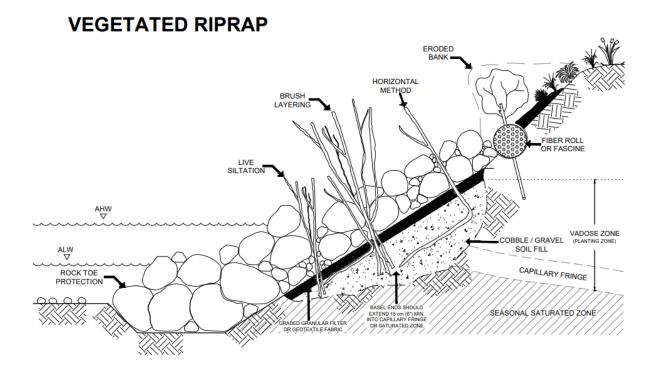
The typical section shown in Figure 2-5 depicts methods for constructed vegetated riprap. This method incorporates hard rock riprap with live vegetation to establish a dynamic revetment system, which functions effectively between the AHW and ALW levels of the water body it protects.

Figure 2-5: Typical section of vegetated riprap. Adapted from McCullah and Gray, 2005.18

The riprap system begins with a solid foundation of rock toe protection. This protection consists of a graded stone assembly installed at the ALW mark, which serves as the frontline defense against erosion. Construction starts by laying the bank slope back to an angle slightly less than the desired final slope and, if necessary, a toe trench is dug and filled with key rocks, with filter gravel placed between the soil and rocks, extending 0.9 to 1.2 meters (3 to 4 feet) up the bank.

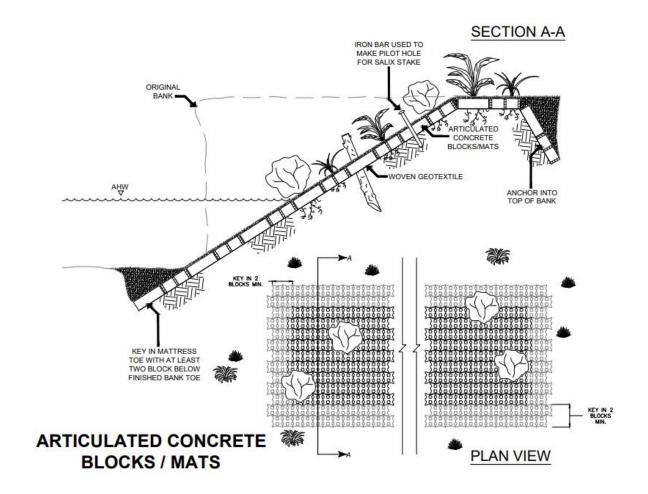
Vegetated ACBs, as depicted by the typical section in Figure 2-7, are a hybrid erosion control system designed for areas subject to high velocities and shear stresses where softer armoring methods are not feasible. These blocks, interconnected or bonded to geotextile fabric, offer durable protection against erosion and can be integrated with biotechnical planting methods.

Figure 2-7: Typical section of articulated concrete blocks. The top shows a cross-sectional view; the bottom is a plan view of that cross-section. Adapted from McCullah and Gray, 2005.²⁰

Installation begins with grading the bank to a stable angle and preparing the site. The pre-assembled mats of ACBs are laid down, ensuring that each is keyed into the bank with a minimum of two blocks below the anticipated finished bank toe level to secure the system against flanking or subgrade loss. This keying process locks the blocks into position, providing a more uniform and stable revetment capable of resisting the forces exerted by water and wave action.

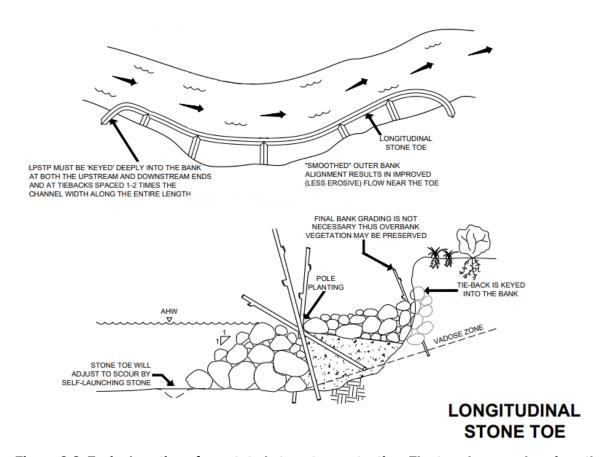
Figure 2-8 depicts a typical section for longitudinal stone toe protection. The diagram details a cross-section of such a structure, demonstrating its alignment with the AHW level, positioning within the vadose zone, and its integration with live plantings for ecological enhancement. The structure is designed to be integrated to the existing ecological conditions, with the intention of preserving overbank vegetation. By avoiding unnecessary grading or reshaping of the bank, the longitudinal stone toe protects the streambank while minimizing the disturbance to existing plant life and habitat, offering a blend of structural defense and environmental consideration.

Figure 2-8: Typical section of vegetated stone toe protection. The top shows a plan view; the bottom is a cross-section. Adapted from McCullah and Gray, 2005.²¹

At the core of the longitudinal stone toe is a formation of graded rock. This rock layer is positioned along the toe of the streambank parallel to it, effectively armoring it against erosion and undercutting. The weight and arrangement of the stones are carefully considered to ensure these can adjust to scour through self-launching. The stone toe does not need to precisely follow the bank toe but is designed to form an improved or "smoothed" alignment through the stream bend. This "smoothed" alignment enhances flow dynamics near the toe, reducing turbulence and erosive forces.

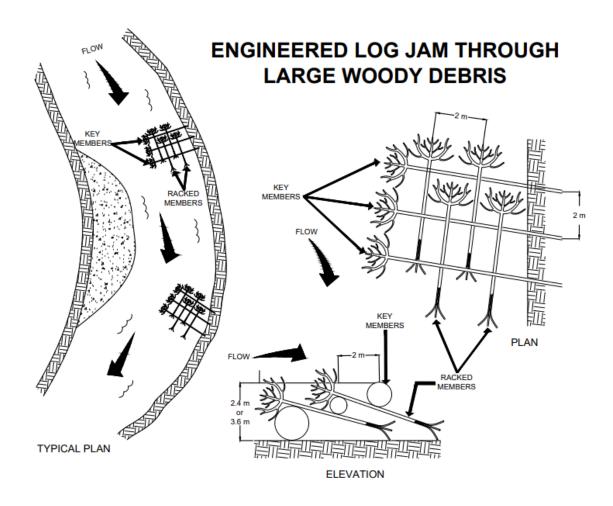
The typical design for an ELJ through LWD integrates key members and racked members to stabilize streambanks and enhance aquatic habitats (Figure 2-9). The key members are installed parallel to the stream flow, acting as the primary structural supports. They are typically larger logs or timbers that are anchored into the streambed, forming the backbone of the ELJ. Perpendicular to the stream

flow, the racked members are positioned to capture and accumulate debris and sediment. This feature of the design serves to increase the ELJ's structural complexity and promotes sediment deposition, which is crucial for the stability of the ELJ.

Figure 2-9: Typical section of an ELJ through LWB. The left side shows the typical orientation in the stream in plan view, the right top shows a zoomed-in configuration of the LWD, and the bottom shows a cross-sectional view. Adapted from McCullah and Gray, 2005.²²

The overhead plan view of a typical design in Figure 2-9 shows the strategic spacing between the key and racked members. This specific 2x2-meter spacing is critical to the design's functionality, allowing for controlled water flow and the strategic collection of sediment and organic material. Such accumulation is essential for creating pools and varied habitat features that support diverse aquatic life. The cross-sectional view in Figure 2-9 details how the key members are set at a depth from 2 to 3 meters, which allows the ELJ to interact effectively with water at different levels, accommodating a range of flow conditions from low to high. This is particularly important for adapting to fluctuating

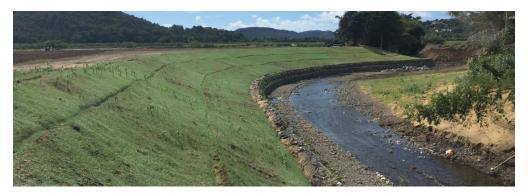
Figure 3-1: Hydroseeding along the Río Loco channel banks. (Photo credit: PDC)

cover to combat erosion and enhance the riparian buffer (Figure 3-1). In addition to vegetation-focused strategies, the project addressed structural issues contributing to habitat degradation and stream instability. The removal of obsolete and abandoned irrigation infrastructure from within the river was a critical step toward restoring natural flow patterns and reducing sediment buildup, helping in mitigating flooding and erosion risks and playing a part in improving the overall ecological health of the river system (Figure 3-2).

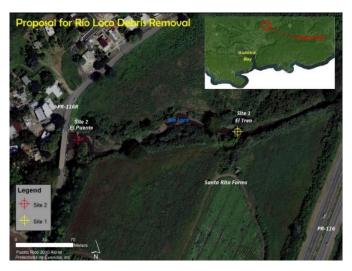
Figure 3-2: Debris removal locations along Río Loco. (Photo credit: PDC)

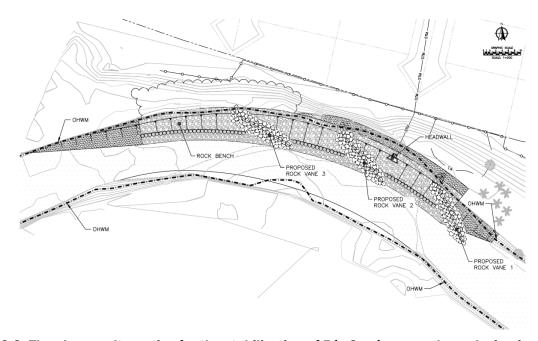
Figure 3-3: The chosen alternative for the stabilization of Río Canóvanas, whose design involved constructing a rock bench and vanes, and relocating the channel thalweg.

GLM highlights that a significant constraint on the project was a nearby raw water intake dam, which accumulates sediment and serves as grade control for the Río Canóvanas. This feature was crucial in shaping the design approach and required consideration to prevent lowering riverbed elevations.

The incorporation of vegetation on the rock vanes provided additional benefits beyond structural stabilization. Planting native species on these structures not only contributed to reducing erosion by reinforcing the soil but also enhanced habitat diversity and water quality through natural filtration processes. By leveraging the compounded protection offered by structural and vegetative elements, projects like this can achieve a more sustainable balance between human needs and environmental integrity. Future endeavors could benefit from considering such integrations from the outset, ensuring that efforts to protect infrastructure and property also contribute to the restoration and preservation of natural riverine ecosystems, though the project's emphasis on minimizing environmental impact during the selection of stabilization methods highlights a conscious move toward more sustainable practices. However, the success of such a project is not measured solely by immediate post-construction assessments. Ongoing monitoring is essential to evaluate the project's continued effectiveness. The tracking of geomorphic and topographic changes will inform any required adjustments and ensure the stability and integrity of the riverbanks within the River Gardens residential community.
