UNIVERSITY OF NAIROBI

**Evaluation of volcanic ash along Maai Mahiu-Narok road and its effect on road stability
after long rains**

BACHELOR OF SCIENCE IN CIVIL ENGINEERING

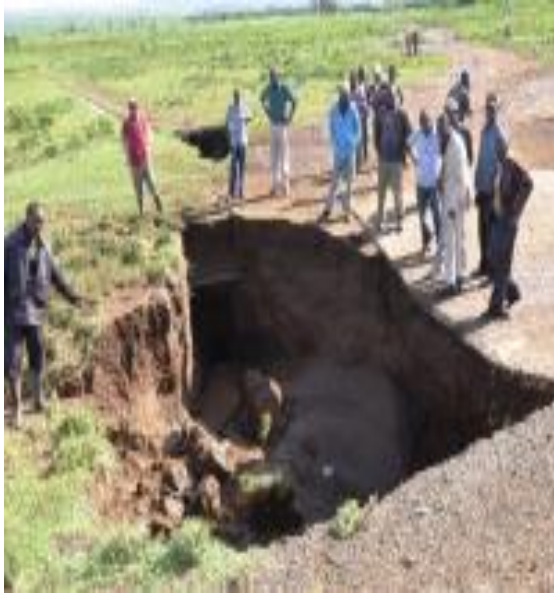
The Maai Mahiu - Narok highway in Kenya (Fig. 1) was closed on May 19, 2012 by the Kenya National Highway Authority after cracks emerged on the surface of the road. The width of the cracks when measured varied from 25.0 mm to 2.0 m (Fig. 2a). This came just days after huge gullies erupted in the surrounding region swallowing a house, trees and farmland. The gullies extended progressively and approached the main highway. Temporary repair works commenced immediately (Fig. 2b) to seal the cracks from May 19 to May 23 after which traffic flow was resumed.

Figure 2: (a) Cracks along the road and (b) Repair works at the damaged section which started on May 19, 2012 causing a heavy traffic snarl-up

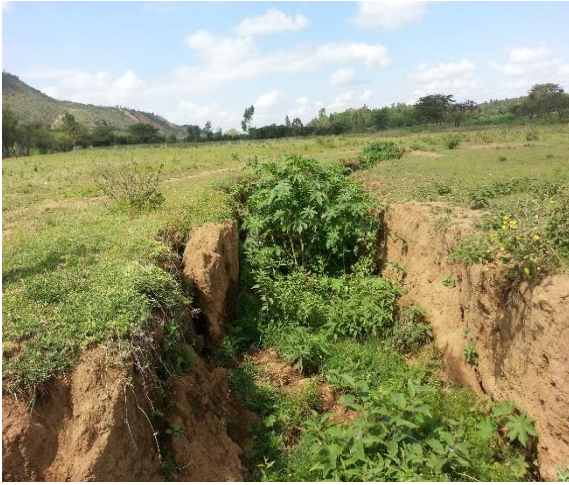
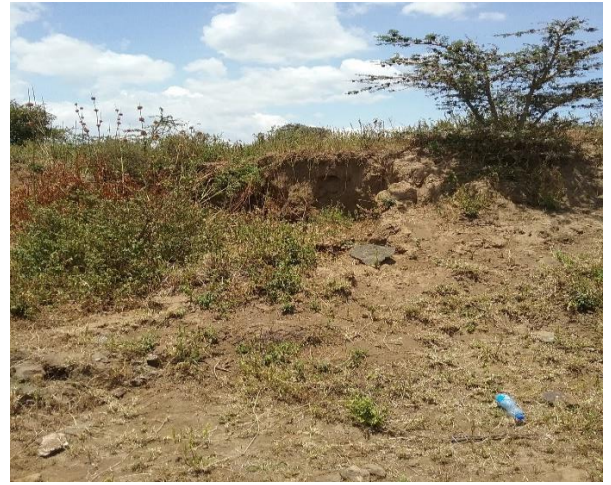
After consultations with the officers from these departments; Mr. George O. Ogutu (MTRD) and Eng. Koskei (KRB), including looking into the minutes of an initial briefing that took place on 17th June 2015 at KRB offices, a site visit of the area was made and it was observed that the fissures still existed (Fig. 3a and b), with overgrown vegetation covering some of the cracks. Despite the repair work done, it was observed that the cracks have started developing again, which is an indication that the problem is eminent and not yet resolved.

Figure 3: Pictures taken on 10th October, 2015 showing the current status of the fissures that formed on 19th May 2012

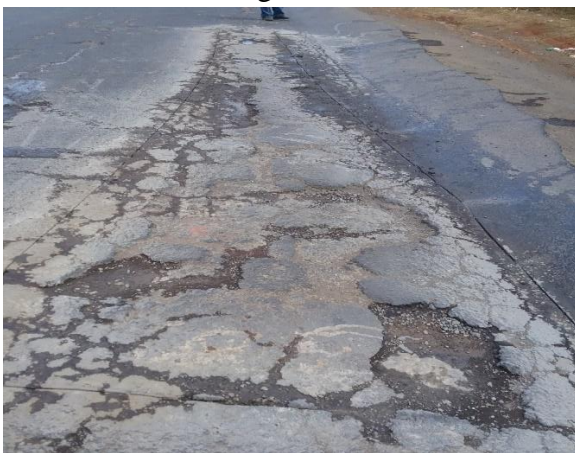
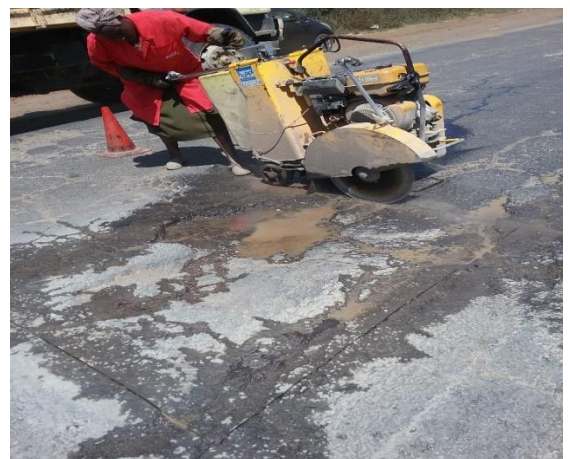
- a) At Km 1+900 from Maai Mahiu shopping center, a recurrent road failure occurring on a 5m wide spot had emerged (Fig. 4). On further inspection, it was noted that it could be a localized failure of pavement due to weak construction materials or poor subgrade. The pavement was also vibrating when trafficked by HGV ($\geq 30T$ trucks). The section of the road was currently being repaired by West Minister contractors who were working on site.

Figure 4: A section of recurrent pavement failure

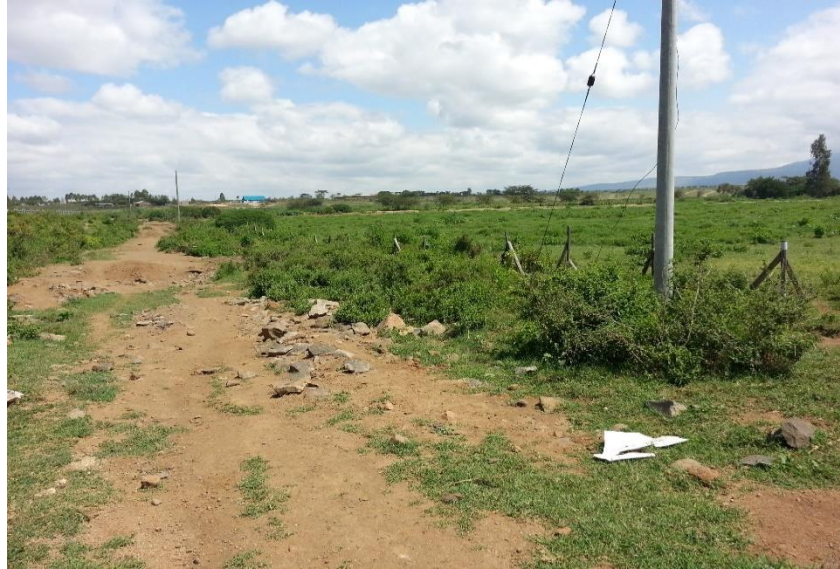
- b) On the RHS there was no indication of fissures but the local Chief reported that this particular side is a flood plain (Fig. 5) with extensive silt deposits. A box culvert was placed approximately 50m from where the fissures occurred to help drain storm water.

Figure 5: RHS of the fissure on Maai Mahiu road

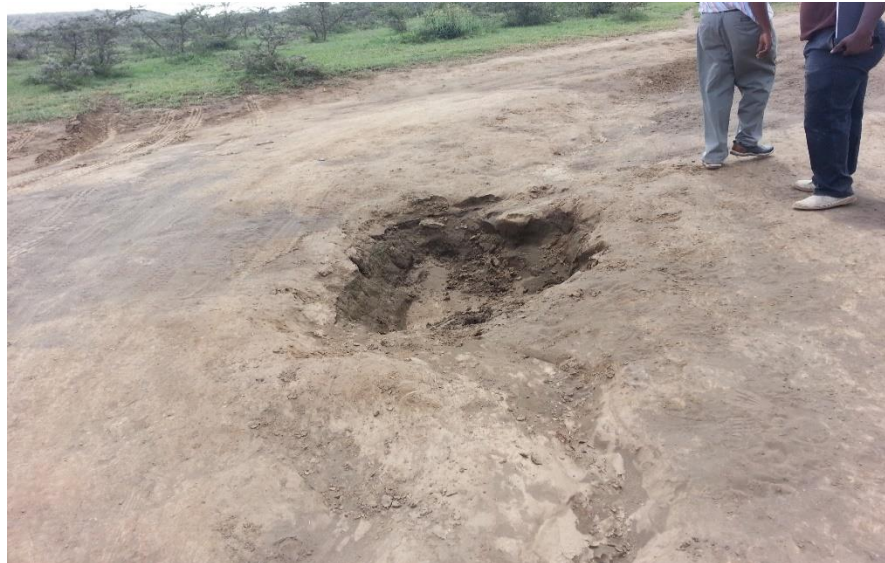
- c) At Km 9+400, occurrence of similar nature was observed (Fig. 6). On inspection it was concluded that there was manifestation of developing fissures from offsets where river flows. A cross culvert has been constructed at this locations.

Figure 6: Other developing fissure on Maai Mahiu-Narok road

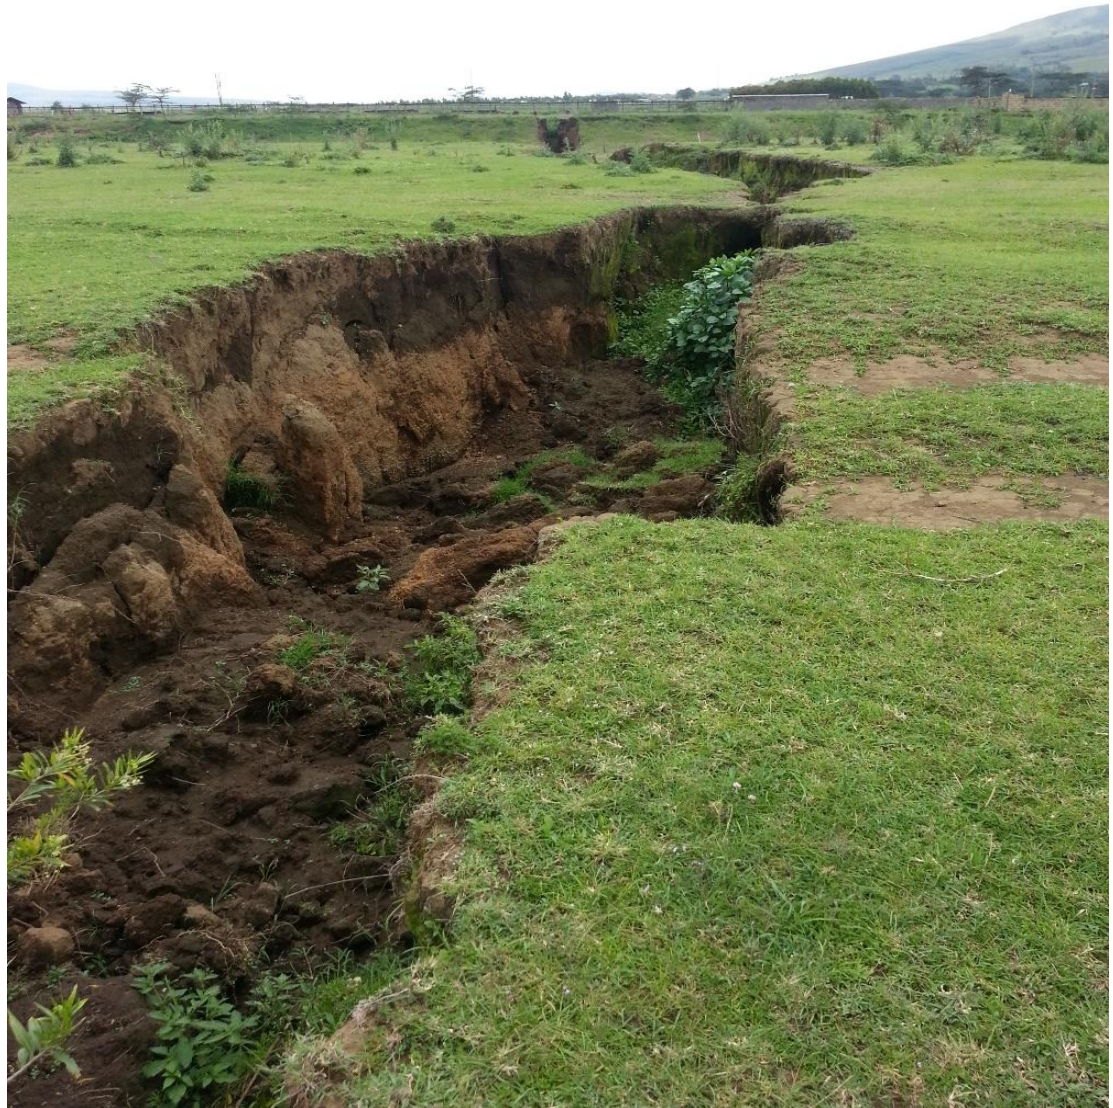
- d) At a completely different location, at Km 5+500 from Maai Mahiu shopping centre 200m off the Maai Mahiu – Naivasha road, a similar manifestation of fissures was observed. The fissure here is as wide as observed on the Maai Mahiu – Narok B3 road but is far from the road (Fig. 7). The Chief explained that there was a water pan on a borrow pit previously excavated for rehabilitation of the road. The fissure drained all the water and cutting an access road. The exact timing of occurrence was not given but comparing the shape and status of the vegetation it was likely around the same time.

Figure 7: The Maai Mahiu-Naivasha C88 Road fissure

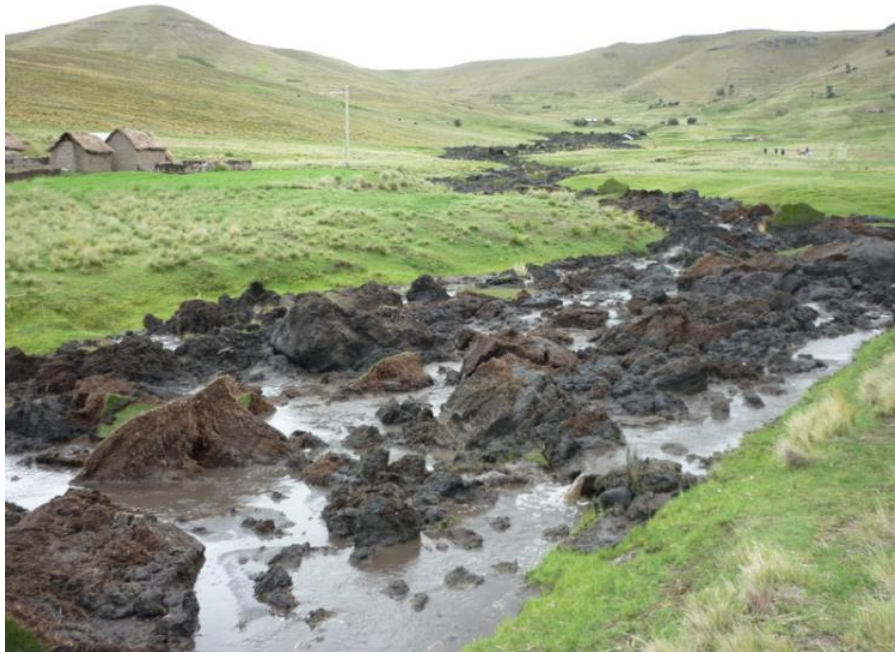
The sudden appearance early in the morning of an enormous crack, measuring 100 m wide and 3 km long caused confusion among residents of the Huacullani District in the Chucuito Province, Southern Peru (Fig. 8).

Figure 8: *The mysterious crack measures 100m wide and 3km long. (Courtesy; pan P, 2011)*

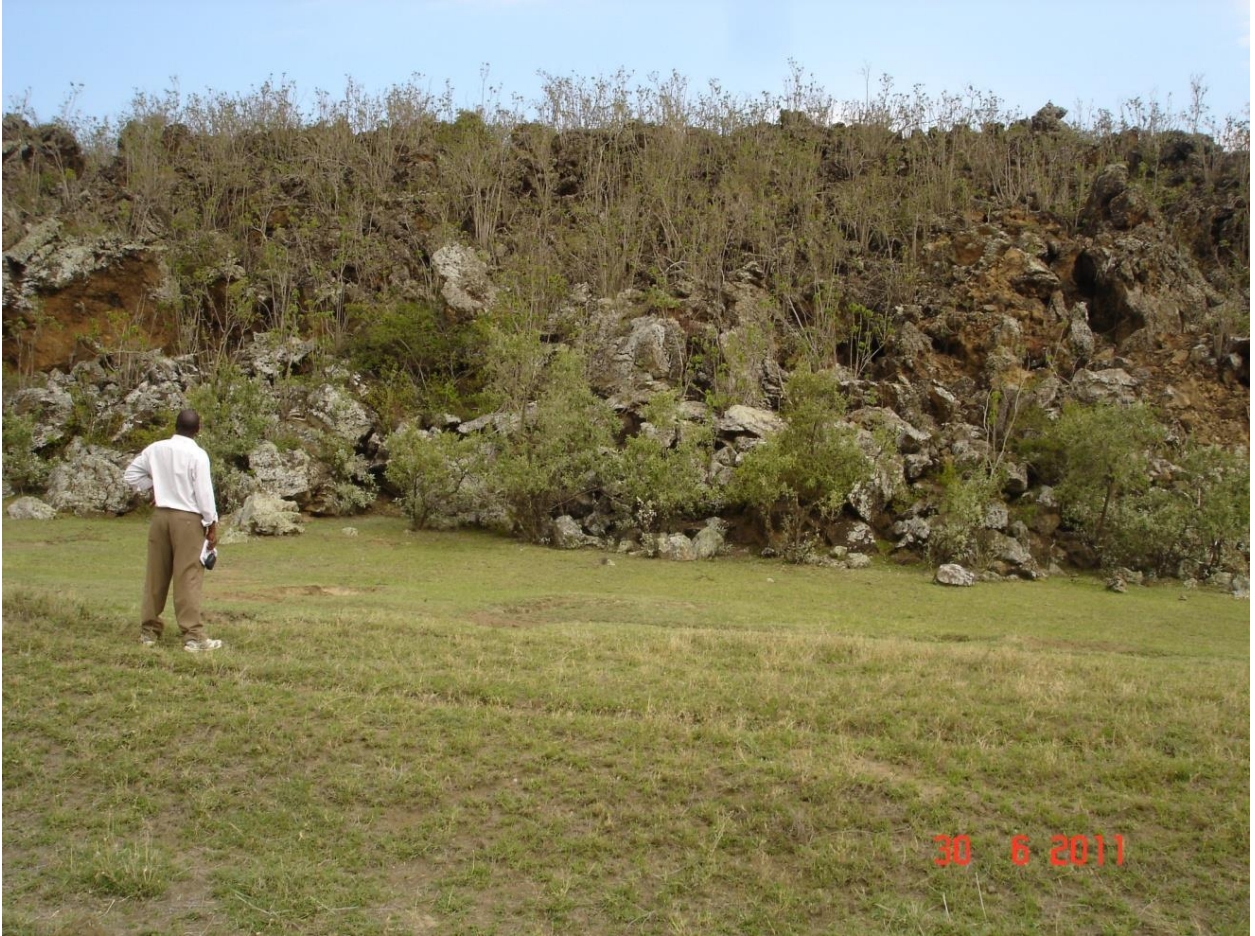
The study area is covered by very fine brownish soil derived from the underlying trachytes and basalts of Upper Pleistocene age. These are underlain by pyroclastics and sediments of Middle Pleistocene and lacustrine deposits which are of Quaternary age. To the south of the investigated area, the Quaternary pyroclastics and lacustrine deposits are exposed. Much of the pumice in the area is probably of normal rhyolitic composition, and it is known that some of the most recent phases of volcanicity have been characterized by pumice ejection. The pumiceous rhyolites are spongy, highly porous whitish to dirty grey rocks, usually able to float on water for a limited period.

Figure 11: *Vesicular basalts within the project area*

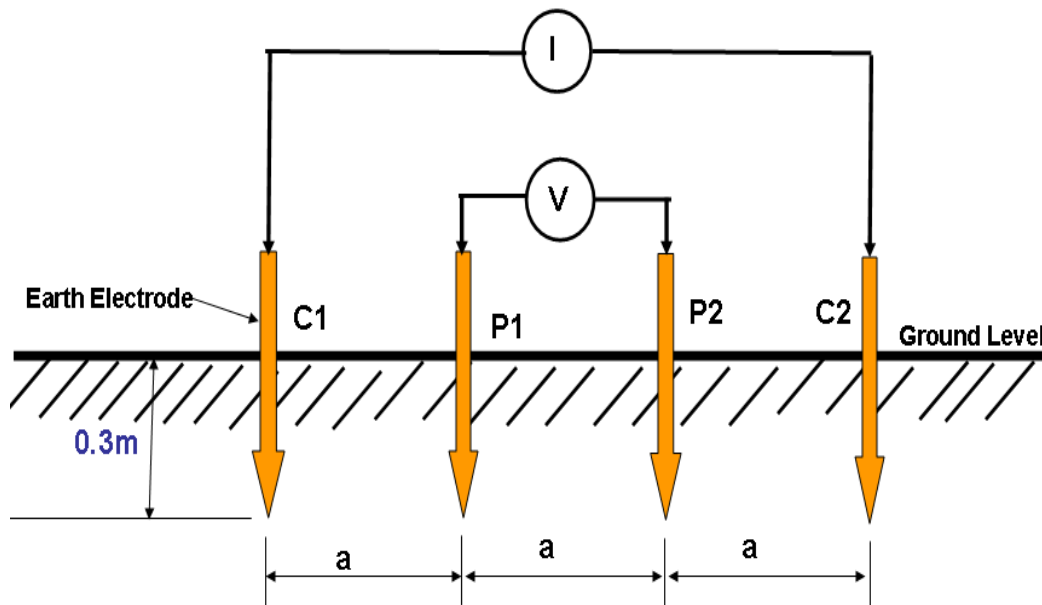
Currently, electrical resistivity imaging methods are mostly used in geohazard and environmental investigations to help characterize the liquefaction potential region. In many geological situations, 2D imaging surveys can give useful results that are complementary to the information obtained by other geophysical methods. The Schlumberger array is very sensitive to horizontal changes in resistivity, so it can be addressed to map vertical structures such as cavities, and buried objects. On the other hand, Wenner array can give useful information on vertical discontinuities, so the integration of the two methods (Wenner-Schlumberger) can be very important to understand the subsurface structure (McNeill, 1994; Jordant and Costantini, 1995; Loke, 1999). These two resistivity methods were used in the present research work. The objective of electrical sounding was to deduce the variation of electrical resistivity with depth below a given point on the surface, and to correlate it with geological knowledge in order to infer the subsurface structure in the greater detail. The horizontal resistivity profiling technique was used for the detection of lateral variation in a certain subsurface layer. Generally, the Wenner and Schlumberger arrays provided good vertical resolution for horizontal structures (Barker, 1981; Dahlin and Zhou, 2004). The technique involved measurements at a grid of observation points using an electrode array deployed at a fixed spacing.

Figure 12: Wenner Method Test circuit arrangement

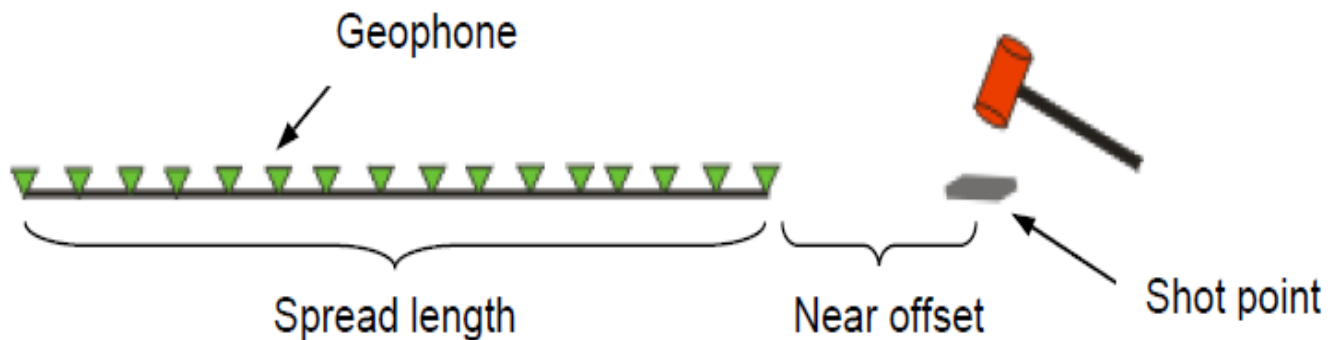
For data acquisition, 24 geophones were distributed in a line at spacing of 3 metres so as to achieve a depth of at least 30 metres below the ground level. A sledge Hammer of 20lbs was used to generate energy for the active 1D MASW data acquisition. For 1D MASW surveying, a linear spread configuration was used (Fig. 14 below). The geophones were configured in a straight line on the ground and interconnected with a spread cable (black line). The distance between the first and last active geophone was the *spread length* or *total offset* and the distance between the shot location and the nearest active geophone was the *near offset*. The resultant Vs curve was the average over the spread and accordingly was located at the centre of the spread.

Figure 14: 1D MASW survey spread configuration

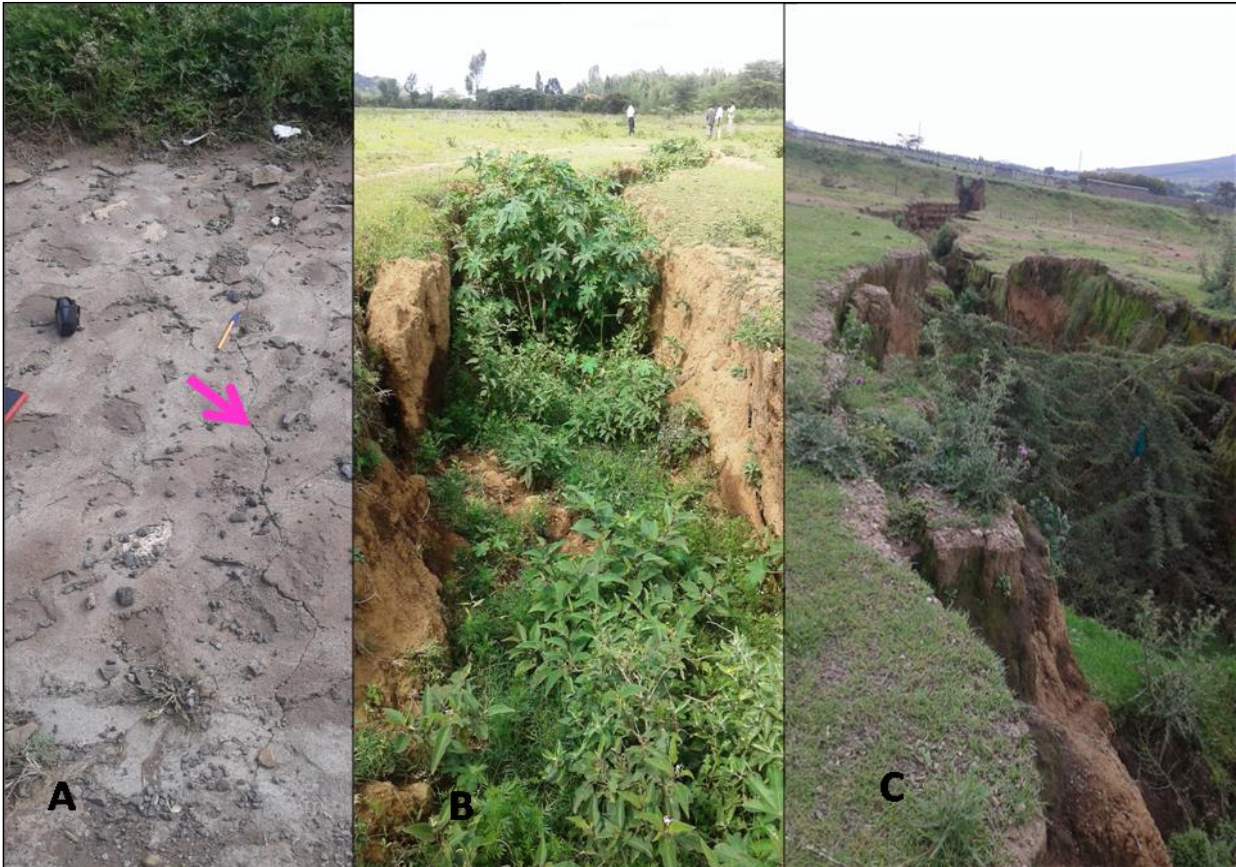
Figure 18: A) Fresh developing crack on the road pavement; B) Fissure developed during the period when the road was cut off; and C) Wide fissure formed northwest of the research project area.

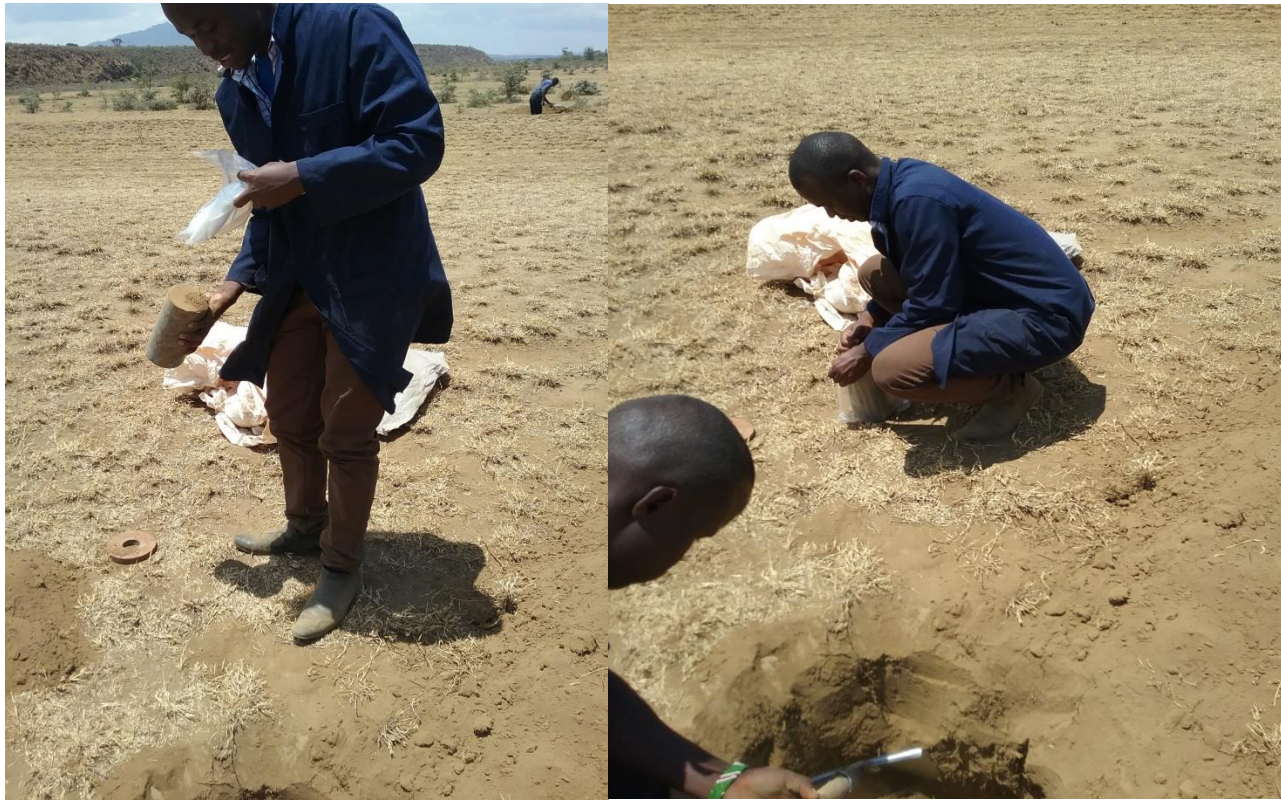
Sampling of the undisturbed soil sample was done in the field to ascertain the bulk density of the soil. The sampling was done at an interval of 0.5m depth up to a depth of 1.5m. The samples were then taken to the laboratory for test and results computed. The sampling process is as described in fig. 20 (a) below and samples were wrapped in polythene bags to avoid loss of moisture as described in figure 20 (b).

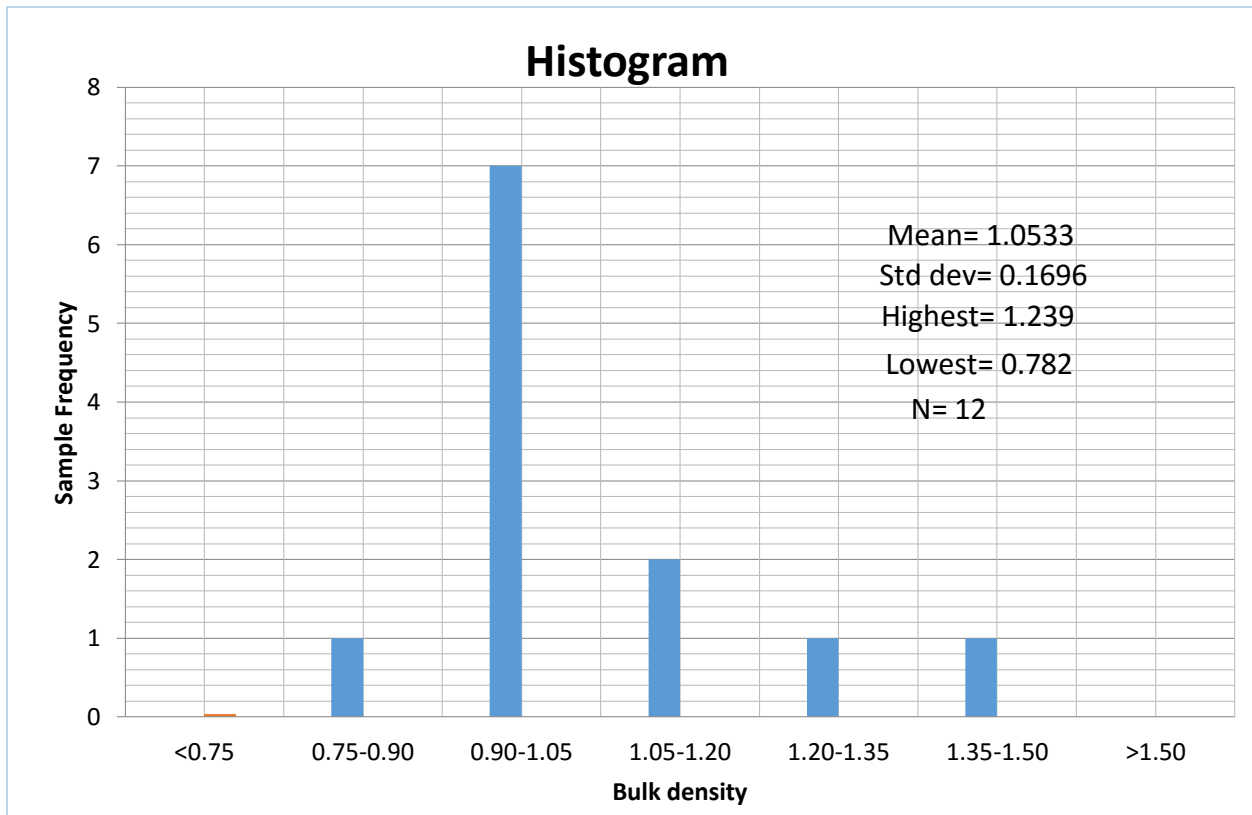
Depth/Test pit	TP1	TP2	TP3	TP4
0.5m	1.176	0.945	0.782	0.981
1m	1.177	0.997	1.239	0.939
1.5m	1.447	0.934	1.031	0.992

Figure 21: Bulk density histogram

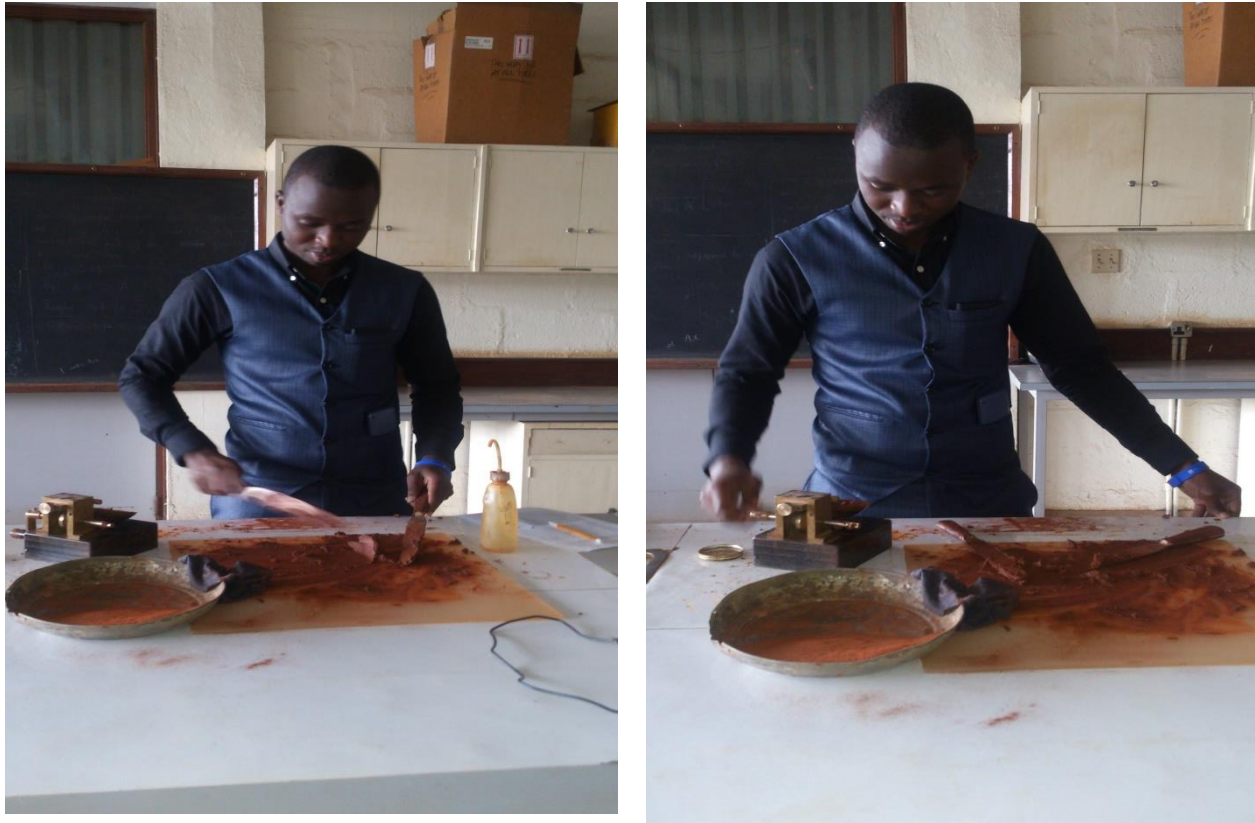
The samples were taken to the laboratory and atterberg classification test conducted according to BS 1377 Part 2:1990. The other test done to ascertain the plasticity of the soil included Liquid limit, Plastic limit and shrinkage limit of the soil (fig.22)

Figure 22: *Plastic limit by casagrande method*

The result of the plasticity investigation denoted that the volcanic ash is non-plastic and highly silt in nature (Appendix IX).

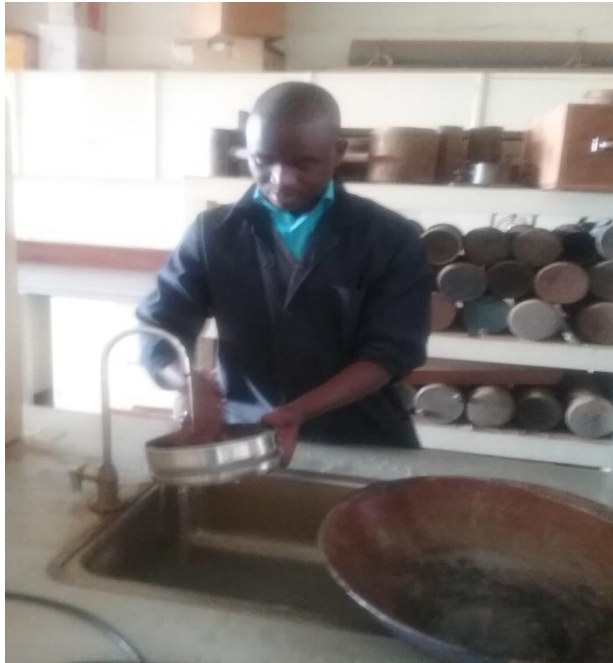
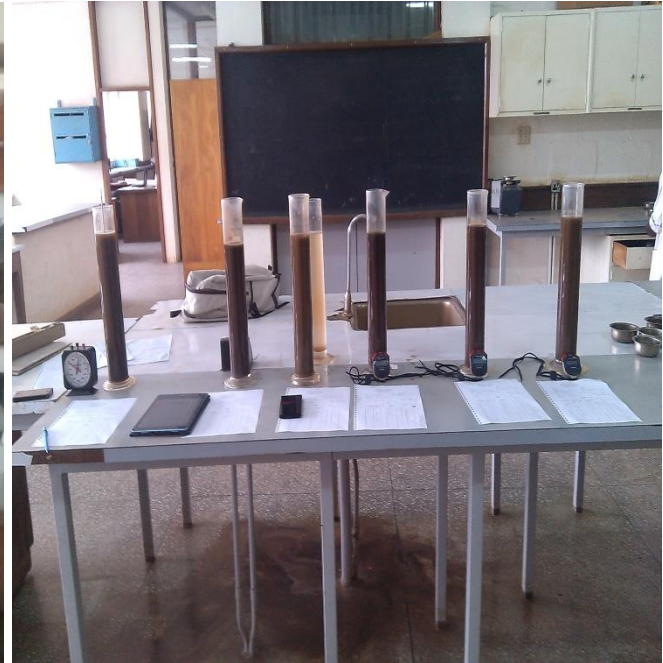
Wet sieving was done to the samples and what passed through sieve 200 was oven dried and hydrometer analysis conducted on it; as shown in fig. 23. The results for each sample are in appendix IV. The sieve analysis curves were constructed for every test pit to analyze the particle size distribution.

(a)Wet sieving

(b) Hydrometer analysis

Figure 23: Wet sieving and hydrometer analysis

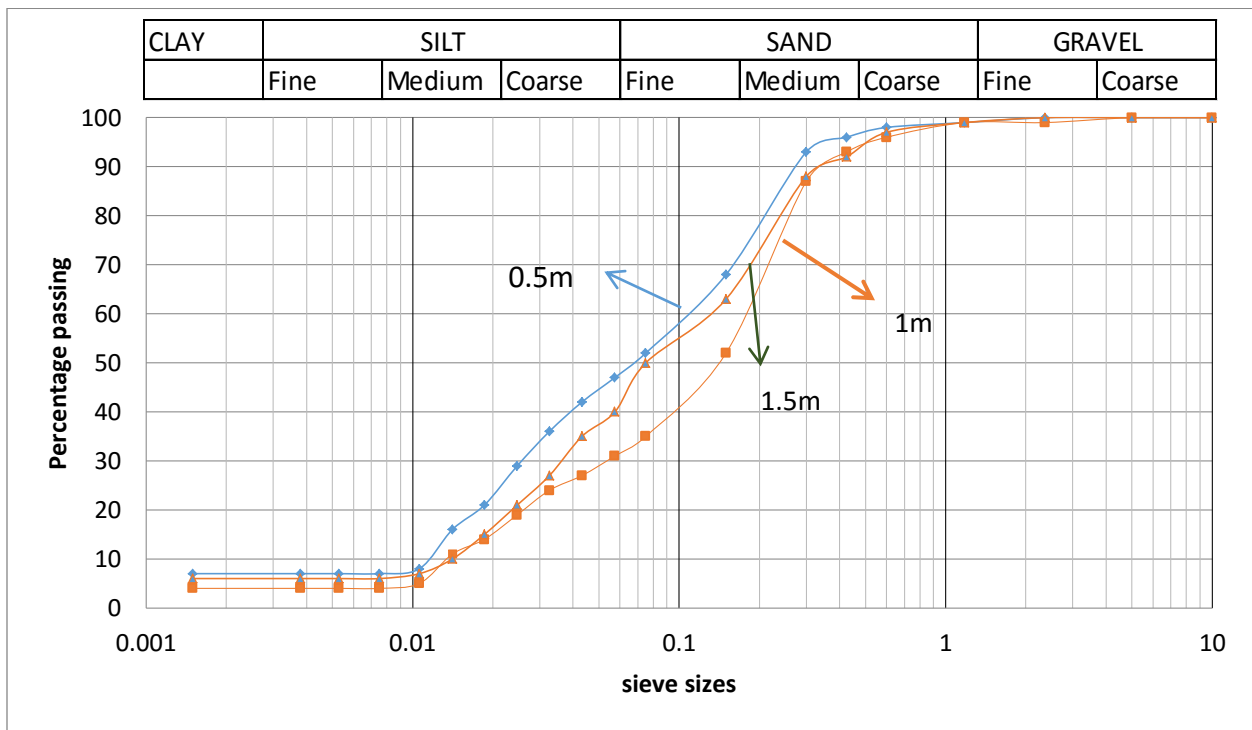
Figure 24: Particle size curve for trial pit 1

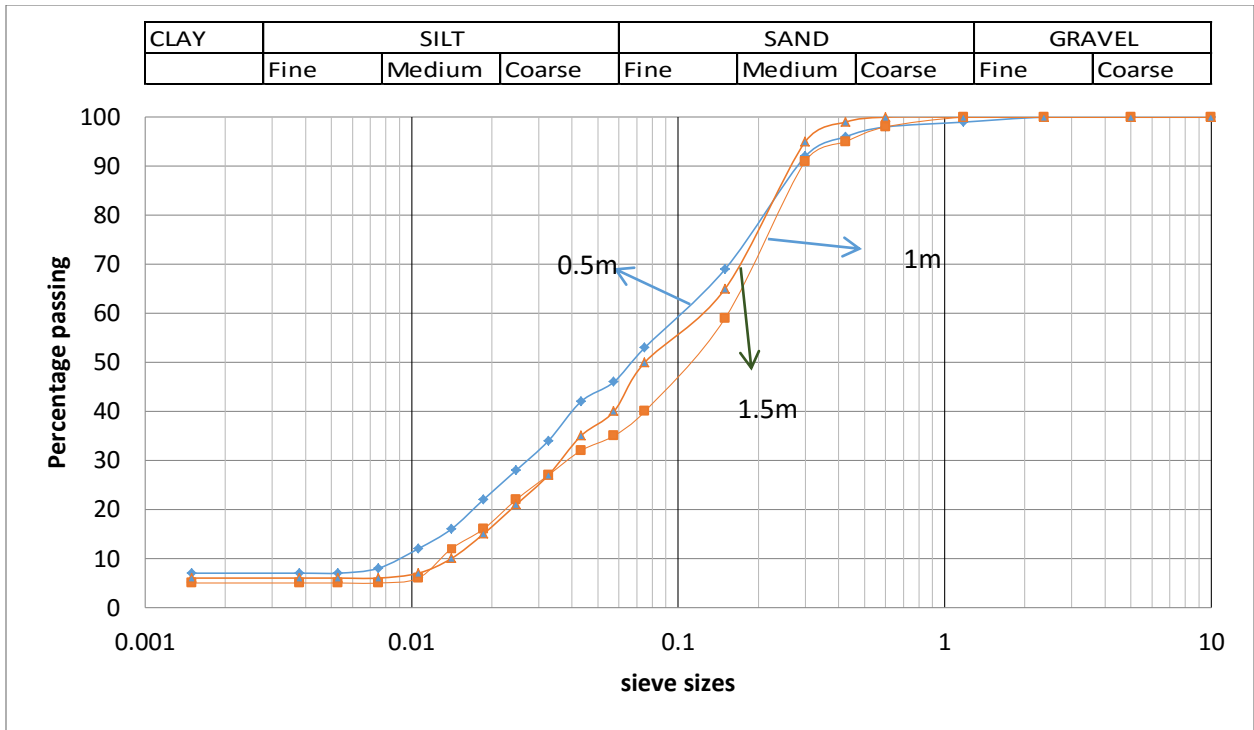
Figure 25: Particle size curve for trial pit 2

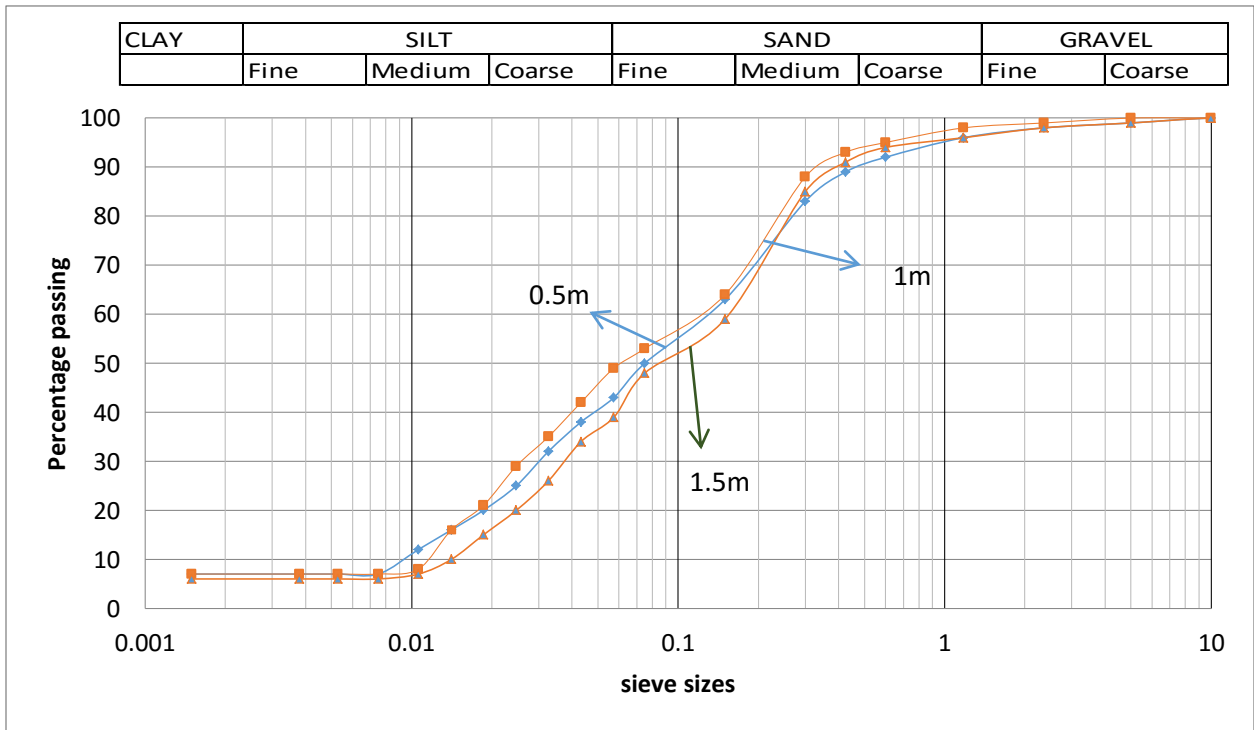
Figure 26: Particle size curve for trial pit 3

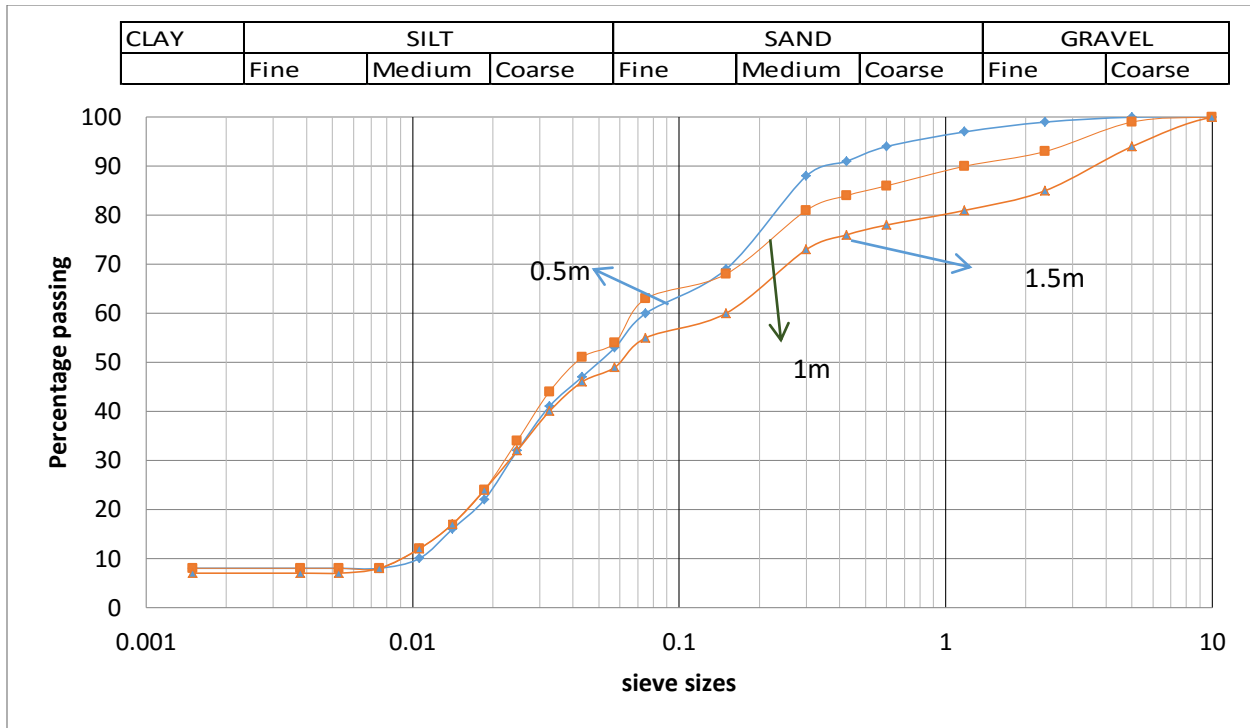
Figure 27: Particle size curve for trial pit 4

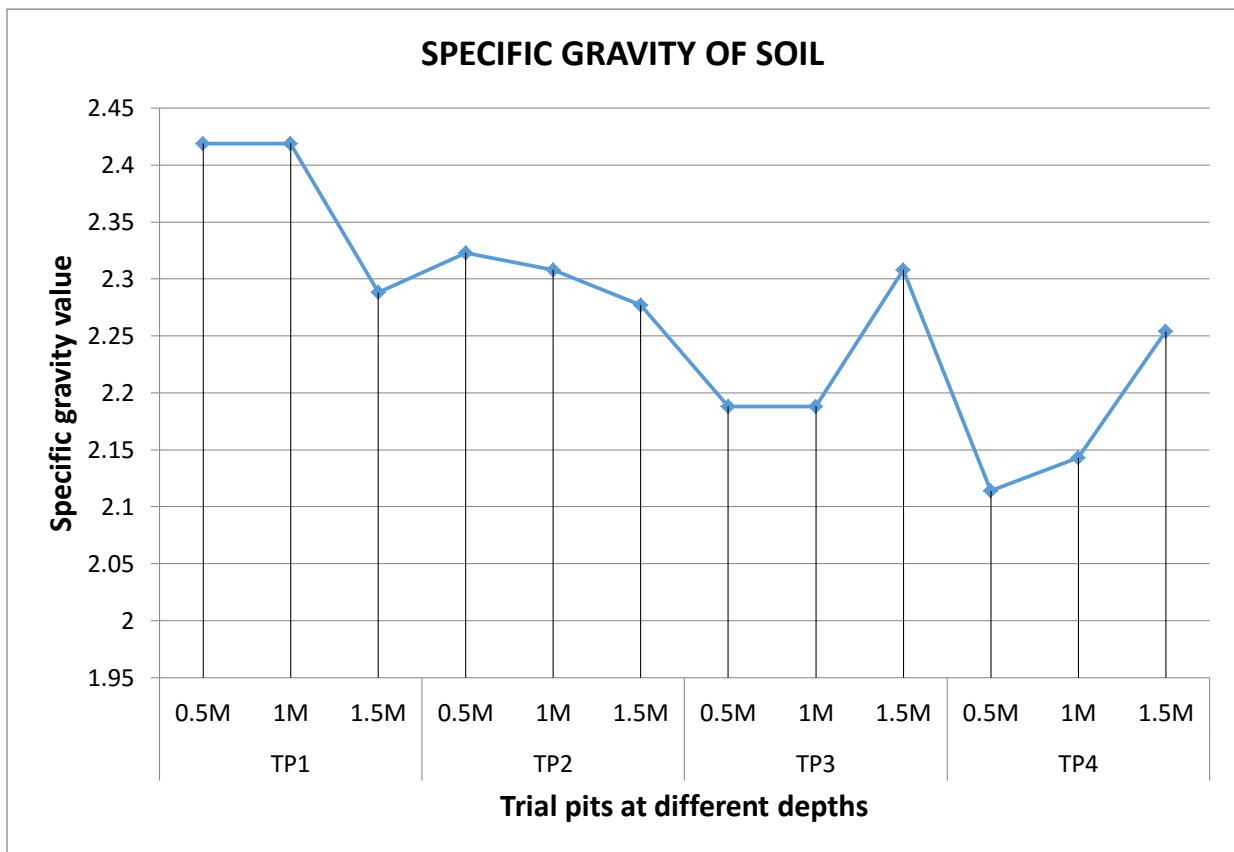
TEST PIT	DEPTH	SPECIFIC GRAVITY	AVERAGE
TP1	0.5M	2.419	2.375333
	1M	2.419	
	1.5M	2.288	
TP2	0.5M	2.323	2.302667
	1M	2.308	
	1.5M	2.277	
TP3	0.5M	2.188	2.228
	1M	2.188	
	1.5M	2.308	
TP4	0.5M	2.114	2.170333
	1M	2.143	
	1.5M	2.254

Figure 29: Line graph comparing specific gravity of samples tested

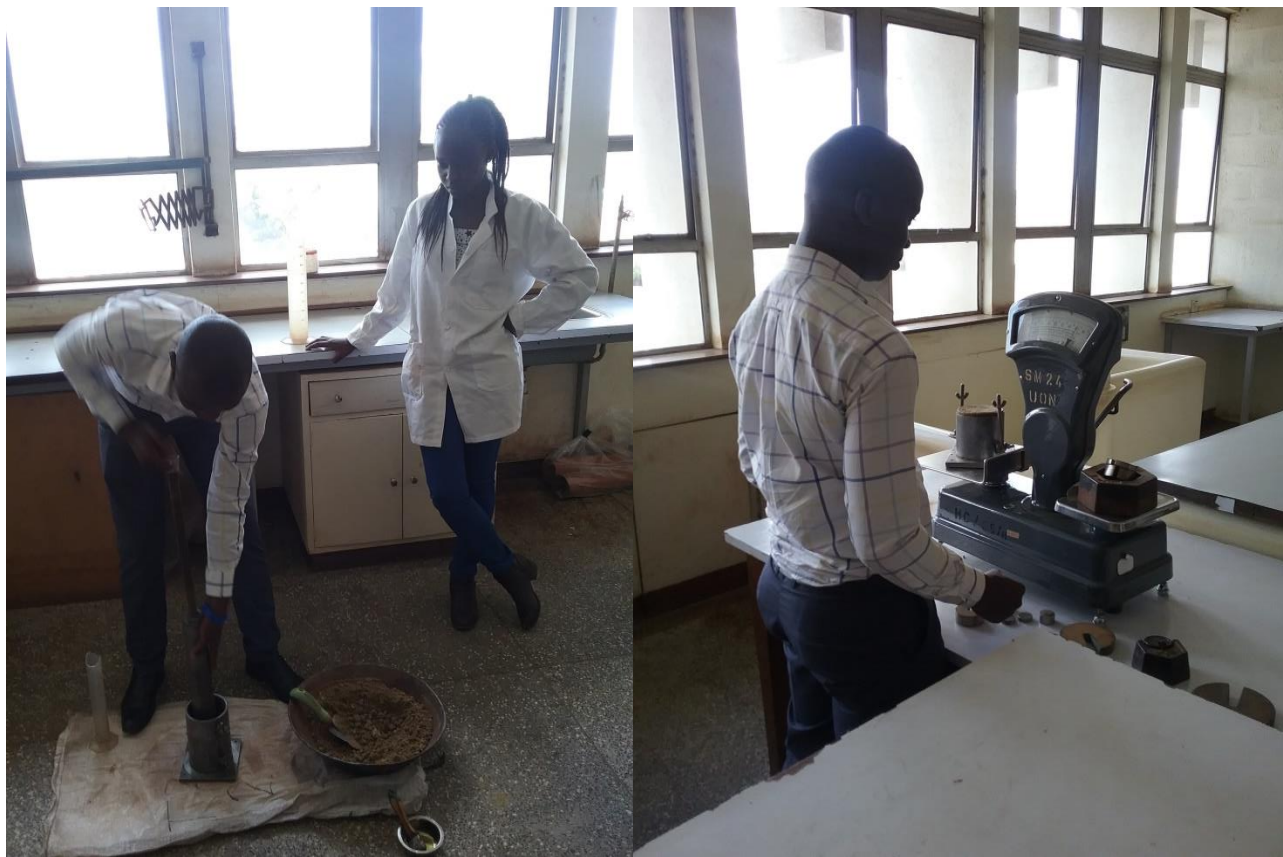
Compaction test was done in order to determine the maximum dry density and the optimum moisture content of the soil sample (fig.30).

Figure 30: *Compaction test*

The Proctor compaction test is a laboratory method of experimentally determining the optimal moisture content at which a given soil type will become most dense and achieve its maximum dry density. The results were tabulated as below:

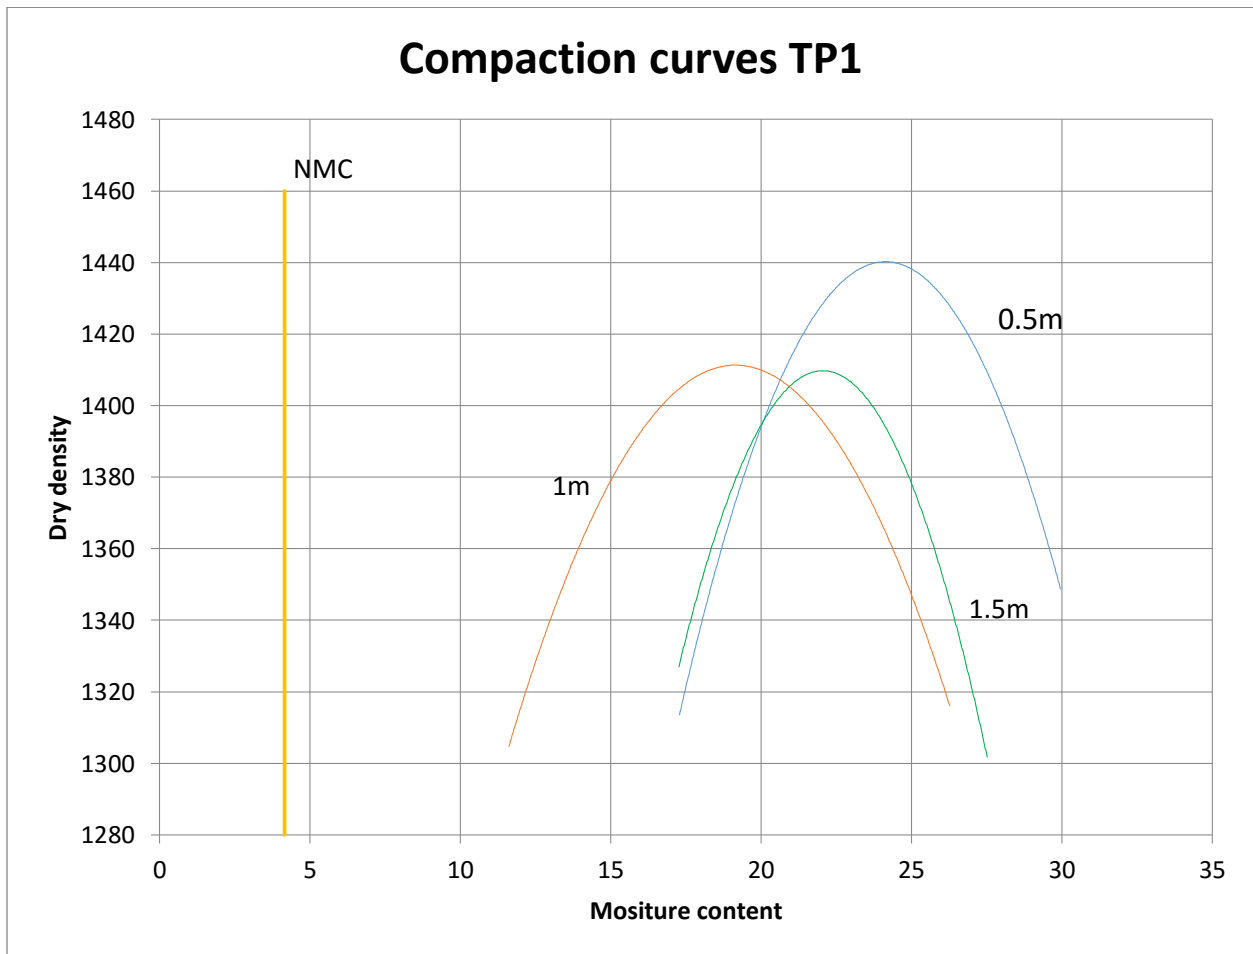
Test Pits	Depth	NMC	OMC	MDD
TP1	0.5M	4.06	24.9	1443.3
	1M	4.1	20.6	1416.9
	1.5M	4.3	23.7	1420
TP2	0.5M	4.64	24.1	1402.2
	1M	4.82	23.3	1441.9
	1.5M	6.43	25.6	1435.7
TP3	0.5M	7.77	20.6	1487.2
	1M	8.56	25.4	1433.3
	1.5M	8.7	24.5	1417.4
TP4	0.5M	5.04	24.8	1435.4
	1M	16.2	30.3	1351.4
	1.5M	17.37	32.4	1309.4
AVERAGE		7.665833	25.01667	1416.175

Figure 31: Compaction graph TP1

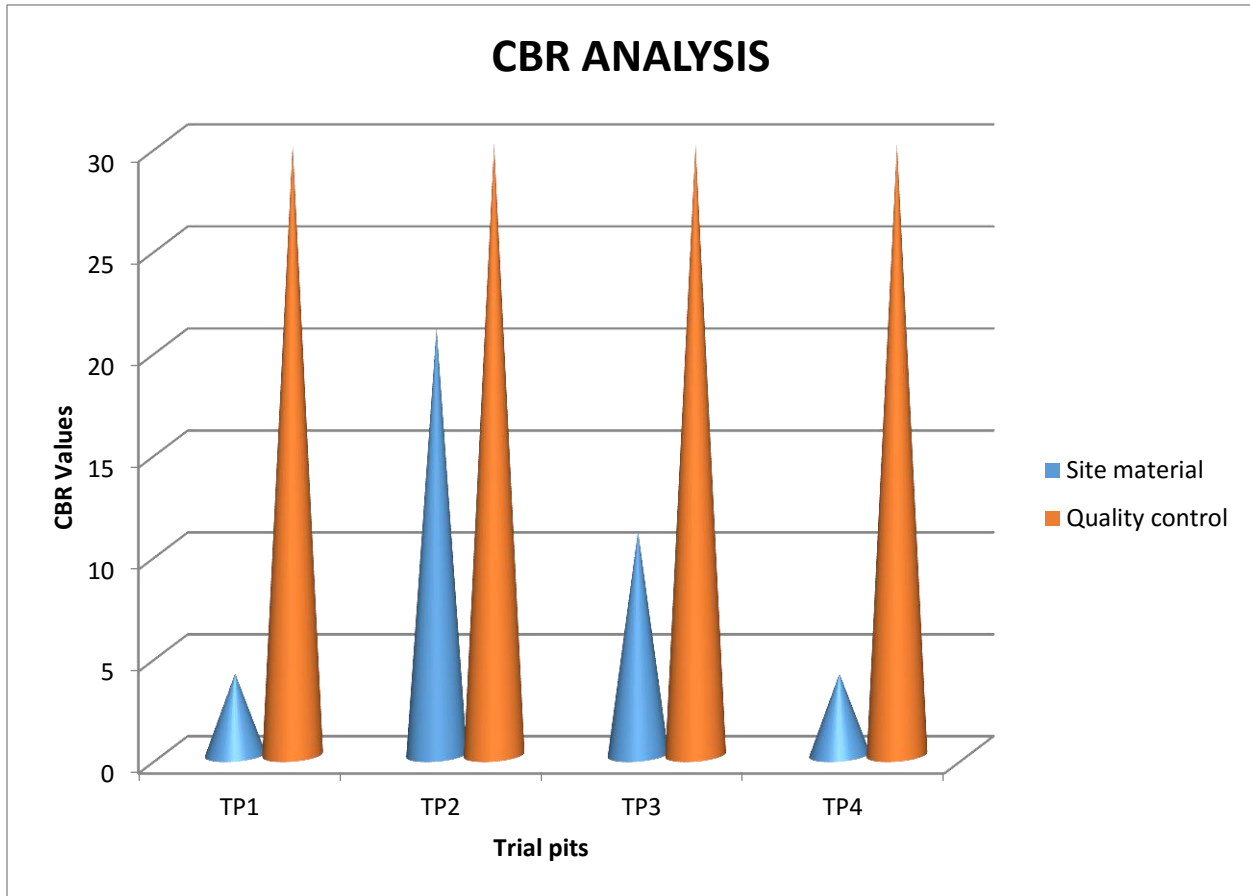
Test Pit	Depth	CBR (%)	Soil class
TP1	1.5M	4	S1 (poor quality soils)
TP2	1.5M	21	S5 (unsoaked and scattered soil)
TP3	1.5M	11	S5 (unsoaked and scattered soil)
TP4	1.5M	4	S1 (poor quality soils)

Figure 35: CBR values analysis

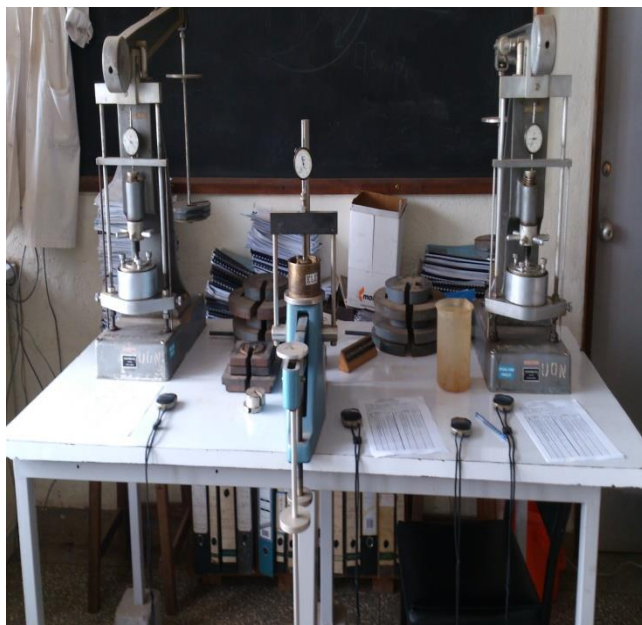
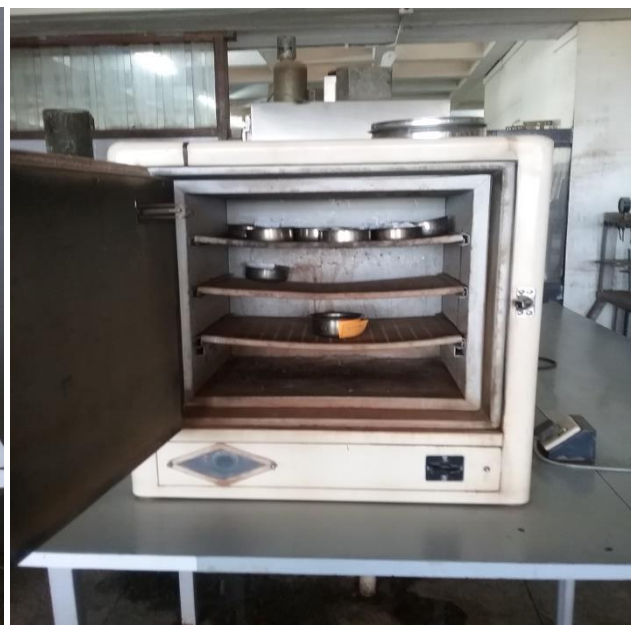
Figure 36: (a) Shear box test being conducted; (b) Oven drying of the samples after being tested
