UNIVERSITY OF NAIROBI

**Evaluation of volcanic ash along Maai Mahiu-Narok road and its effect on road stability
after long rains**

BACHELOR OF SCIENCE IN CIVIL ENGINEERING

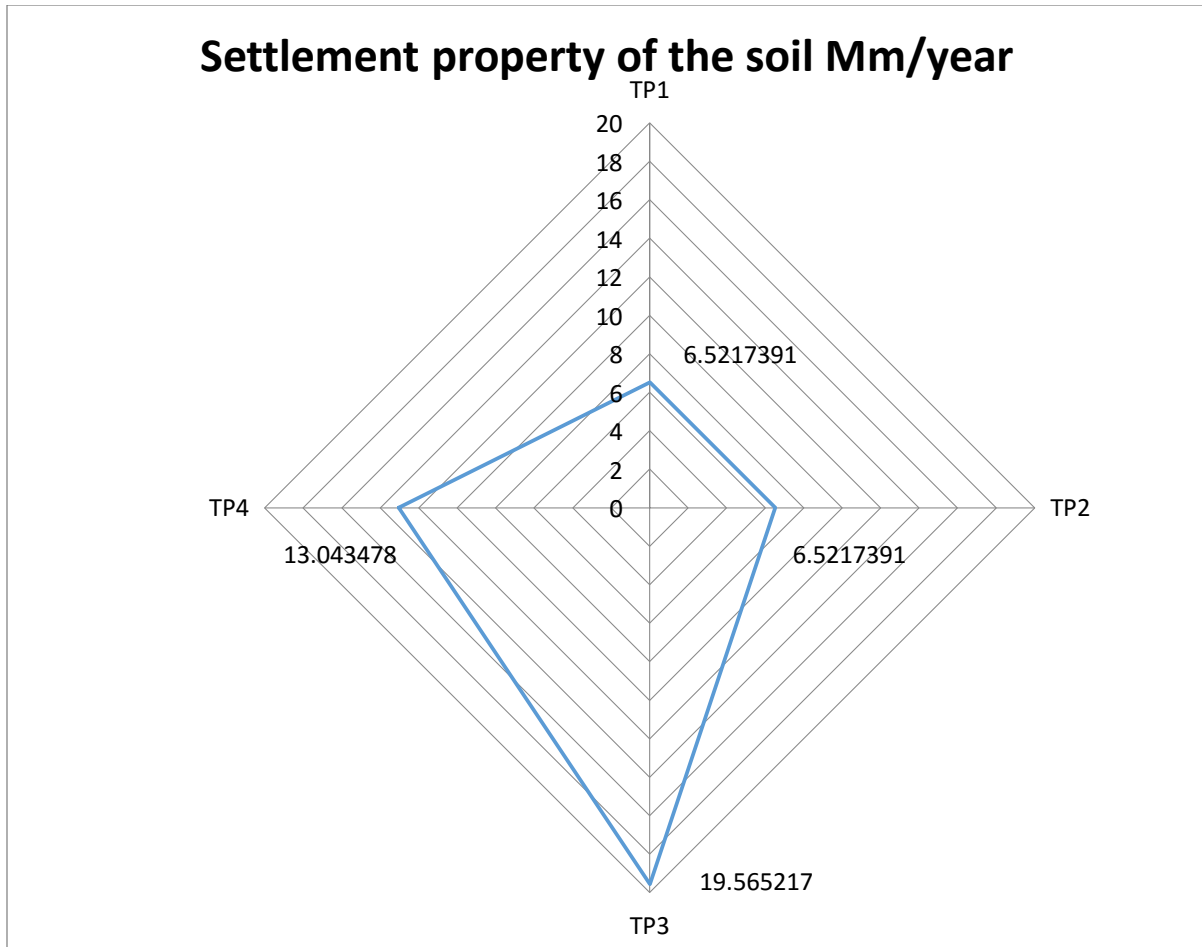
Test Pit	$m_v = (dH/H1) * 1/dp * 10^{-4}$	$cc = (e^1 - e^0) / \log_{10}(\sigma^1 - \sigma^0) * 10^{-2}$	Settlement * 10 ⁰
	(m ² /KN)	mm ² /s	Mm/year
TP1	0.3	0.435	6.5217391
TP2	0.3	0.435	6.5217391
TP3	0.9	1.304	19.565217
TP4	0.7	0.87	13.043478

Figure 37: Settlement analysis of the samples

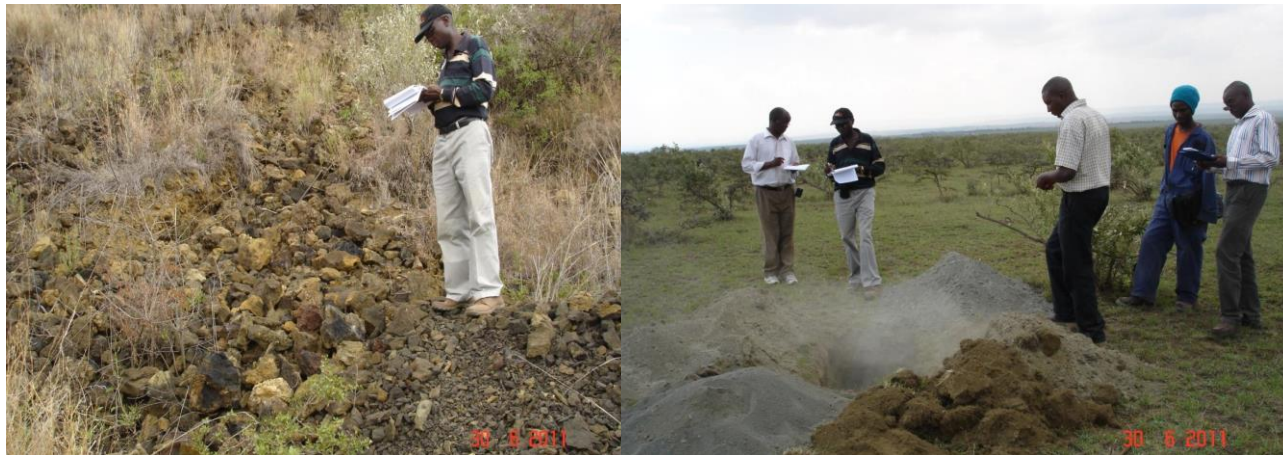
The project area is occupied by an alternation of lapili and ash/ black sand. This means that the ejection of lava from Mt. Longonot took place at different episode with difference in temperature/ pressure and chemical composition. This type of volcano is referred to as a strato volcano.

Figure 42: (a) Pumice observation on the southern part of the project area (b) Volcanic ash and black sand (GPS reading 37M0216126, 9904912)

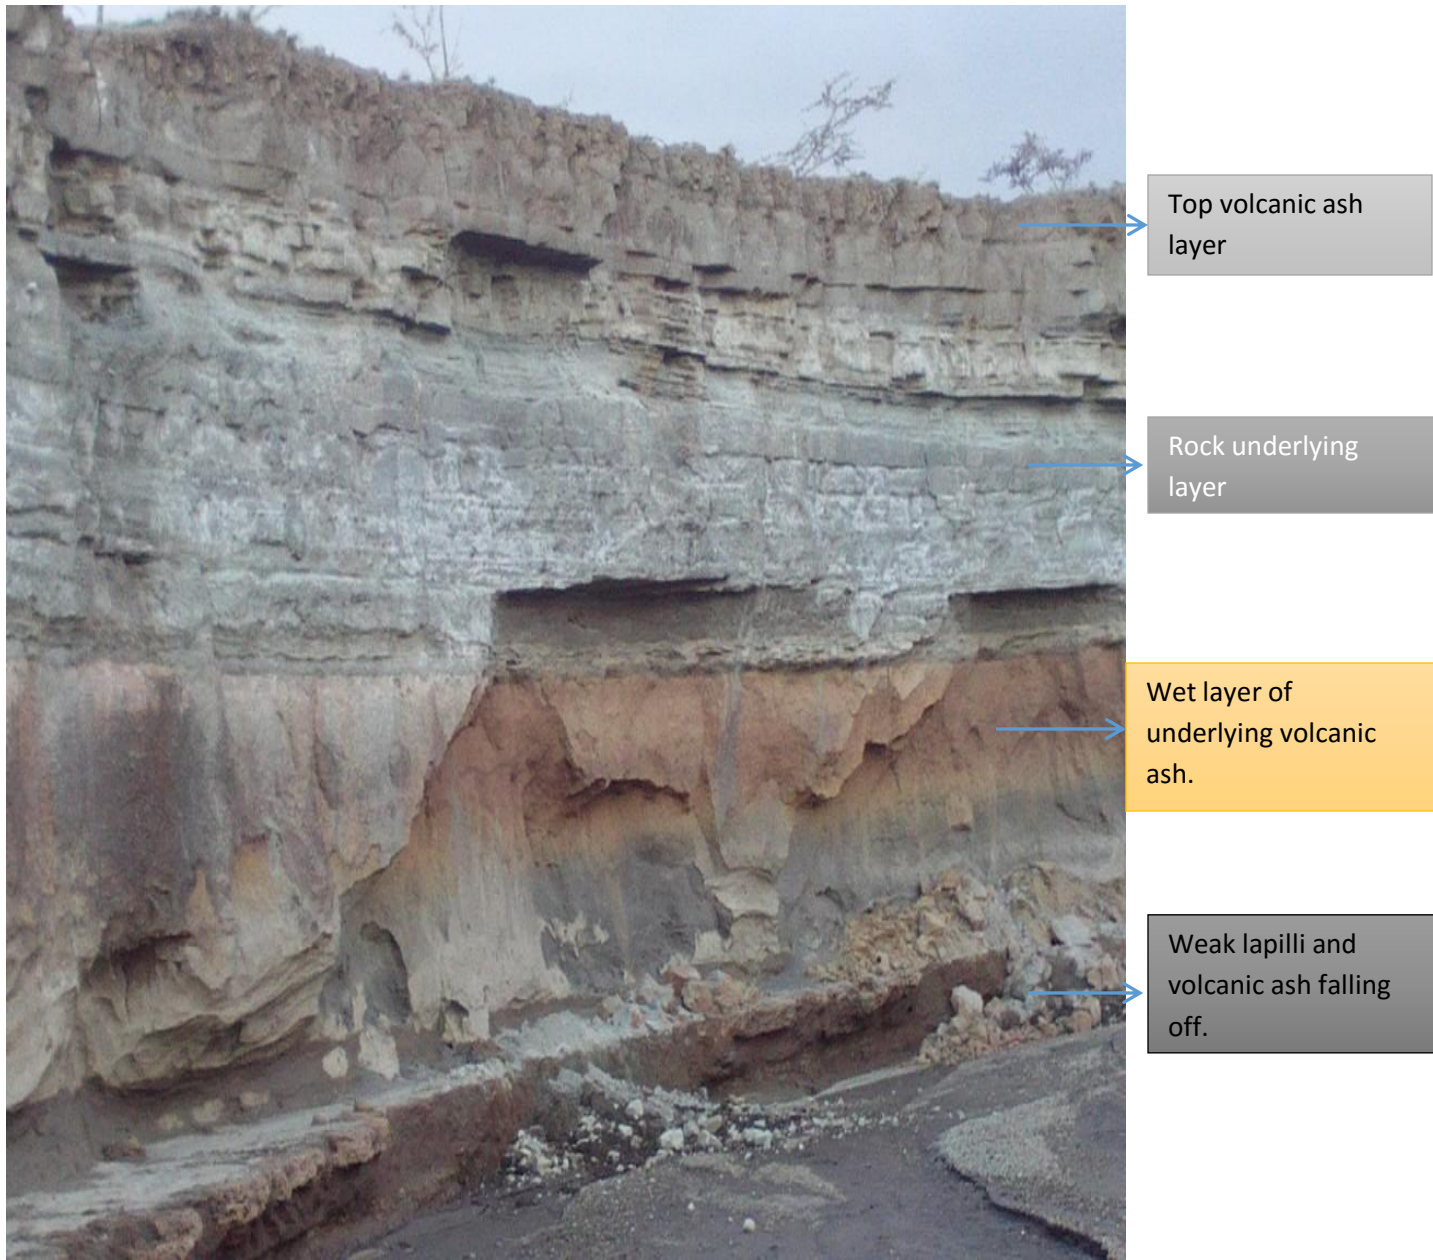
Figure 44: *Stratigraphy of the volcanic ash is well displayed on river bank cut (River Kedong)*

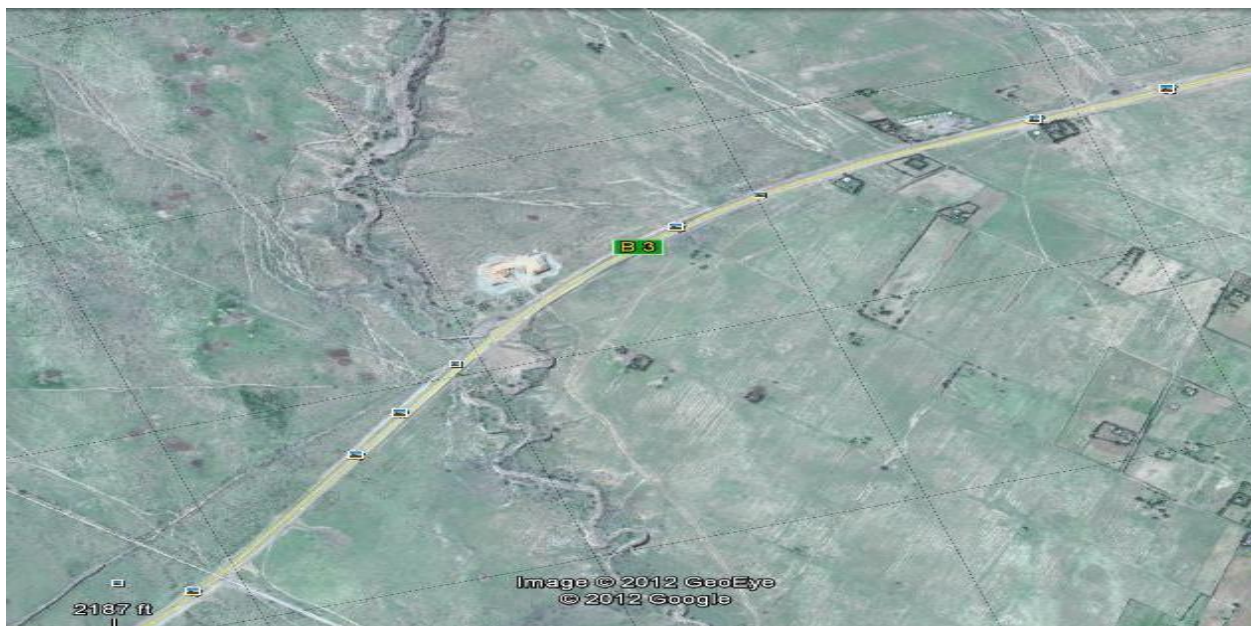
It is observed that all the perennial rivers that existed in the area in the past few decades had dried and in their place were gulleys and dry river beds. With the climate variations, a section of the Maai Mahiu – Narok Road got washed away by the recent floods in the district. On a visit to the scene where the Maai Mahiu – Narok had shown cracks forcing the closure of the road on the 17th of May, 2012, it is noted that the area lied on an extinct river. Due to the heavy downpour the water had found its way to the river bed and this led to the washing away of the section of the road. As shown in the image below, figure 47, the section of the road lied directly on an extinct waterway.

Figure 47: *Section of the road that was washed away*

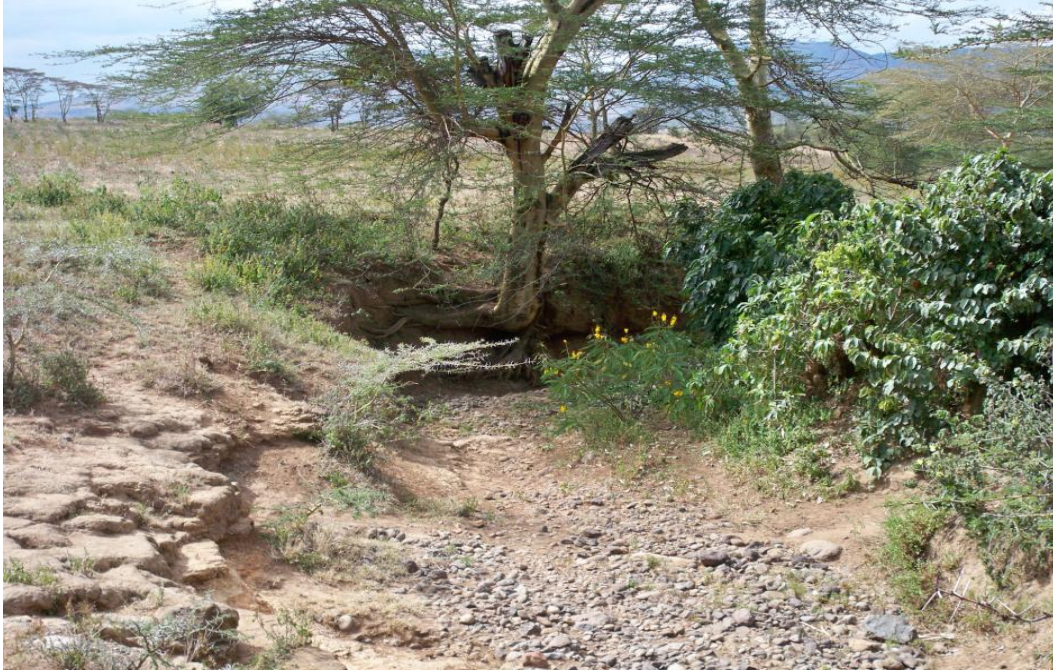
Figure 48: *Part of the Dry Water Bed of river Tongi Tongi*

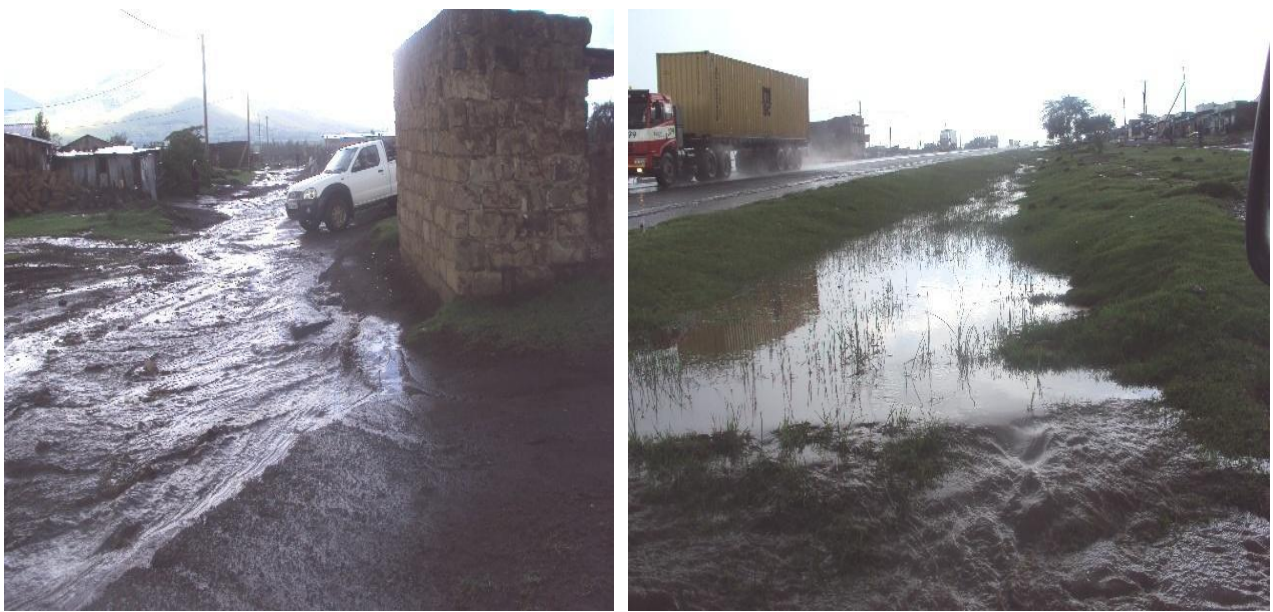
The pictures below indicate two scenarios on the situation in Maai Mahiu during the long rains. In the first picture, an entire internal road has been turned into a waterway due to the lack of a proper road and drainage system which can be attributed to poor planning. The second shows a section of the Longonot Township, along the Nairobi-Maai Mahiu-Naivasha Road during the same period. This is a clear indication of plenty of water going down the drain.

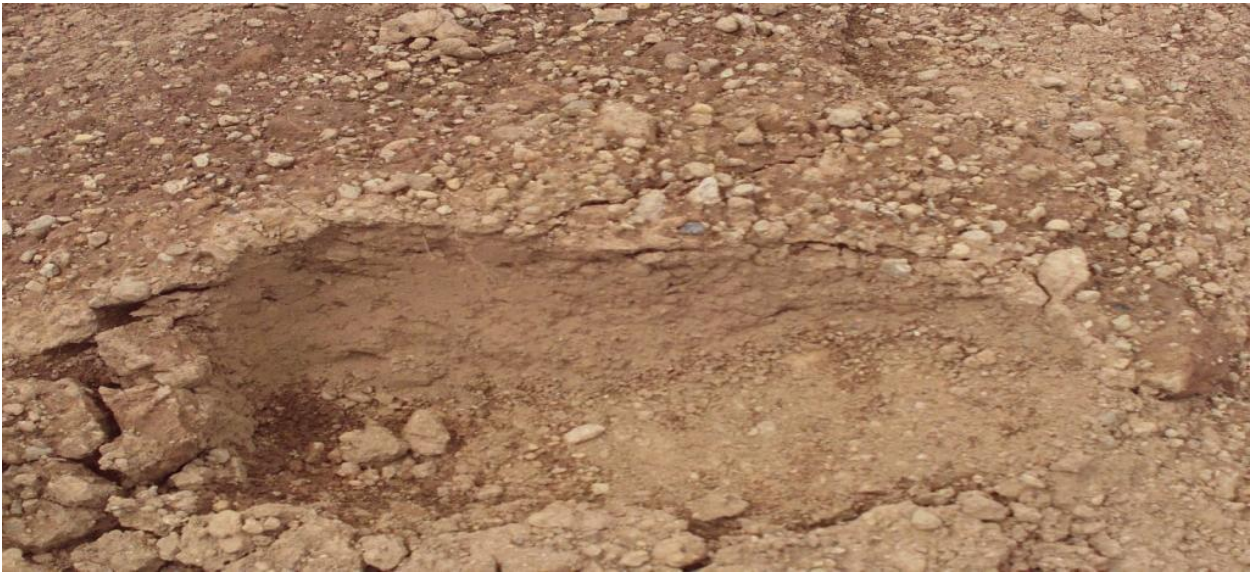
Figure 51: *Gravelly to loamy fine sand formation*

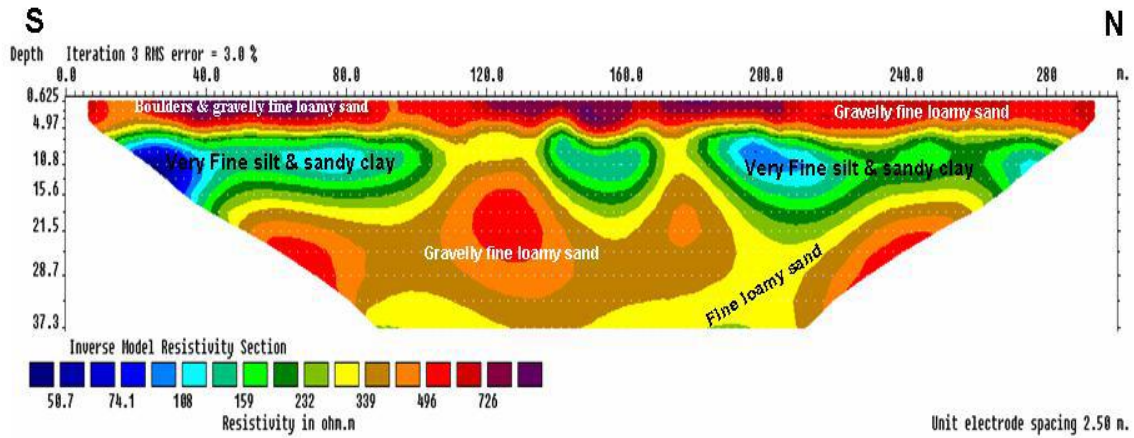
Figure 52: Modeled resistivity section along the Electrical Resistivity Tomography (ERT) Profile 1

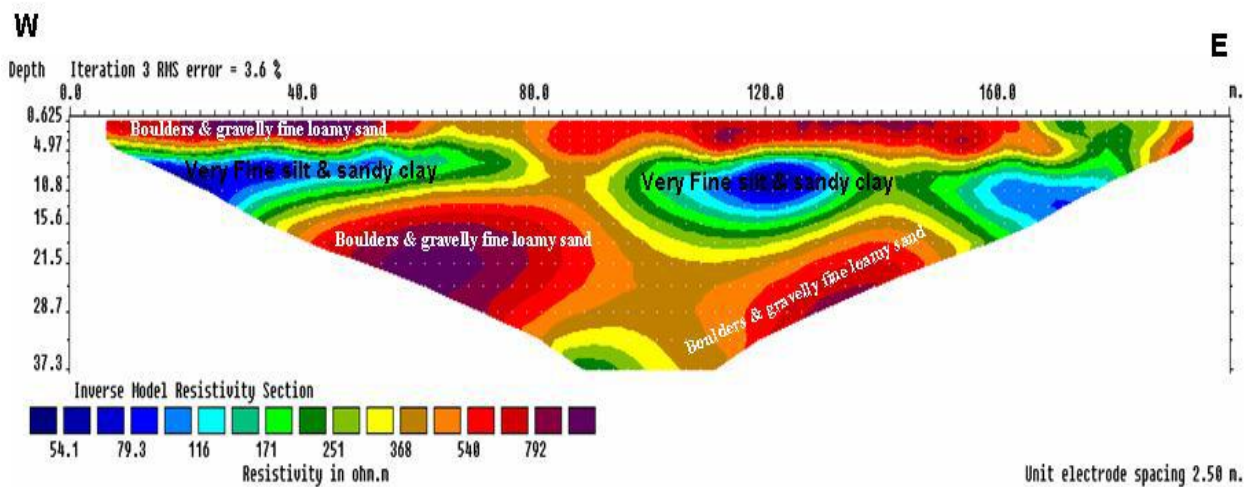
The tomogram for the profile 3 is presented in Figure 54. The total length of the profile is 300 metres and oriented in a W- E and electrode spacing along the profile was also 5 metres, which still probed to a depth of 37.3 metres below the ground surface. The resistivity distribution for this model is more or less similar to the two models described above with resistivity ranging from 54 Ω m to 792 Ω m.

Figure 54: Modeled resistivity section along the Electrical Resistivity Tomography (ERT) Profile 3

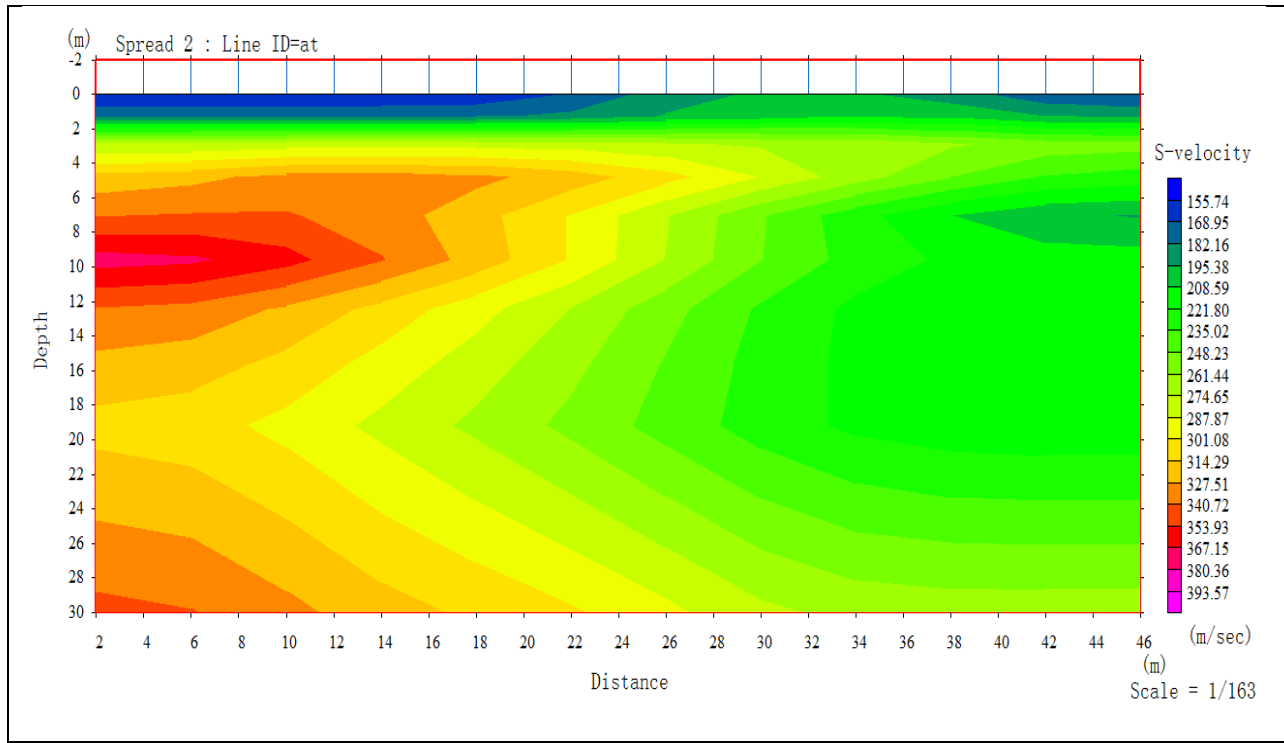
327.51 m/sec to over 393.57 m/sec (partially fractured and marginally weathered basement rock composed of trachyte).

Figure 57: a) Dispersion Curve, b) 1D shear wave velocity and c) 2D shear wave velocity model

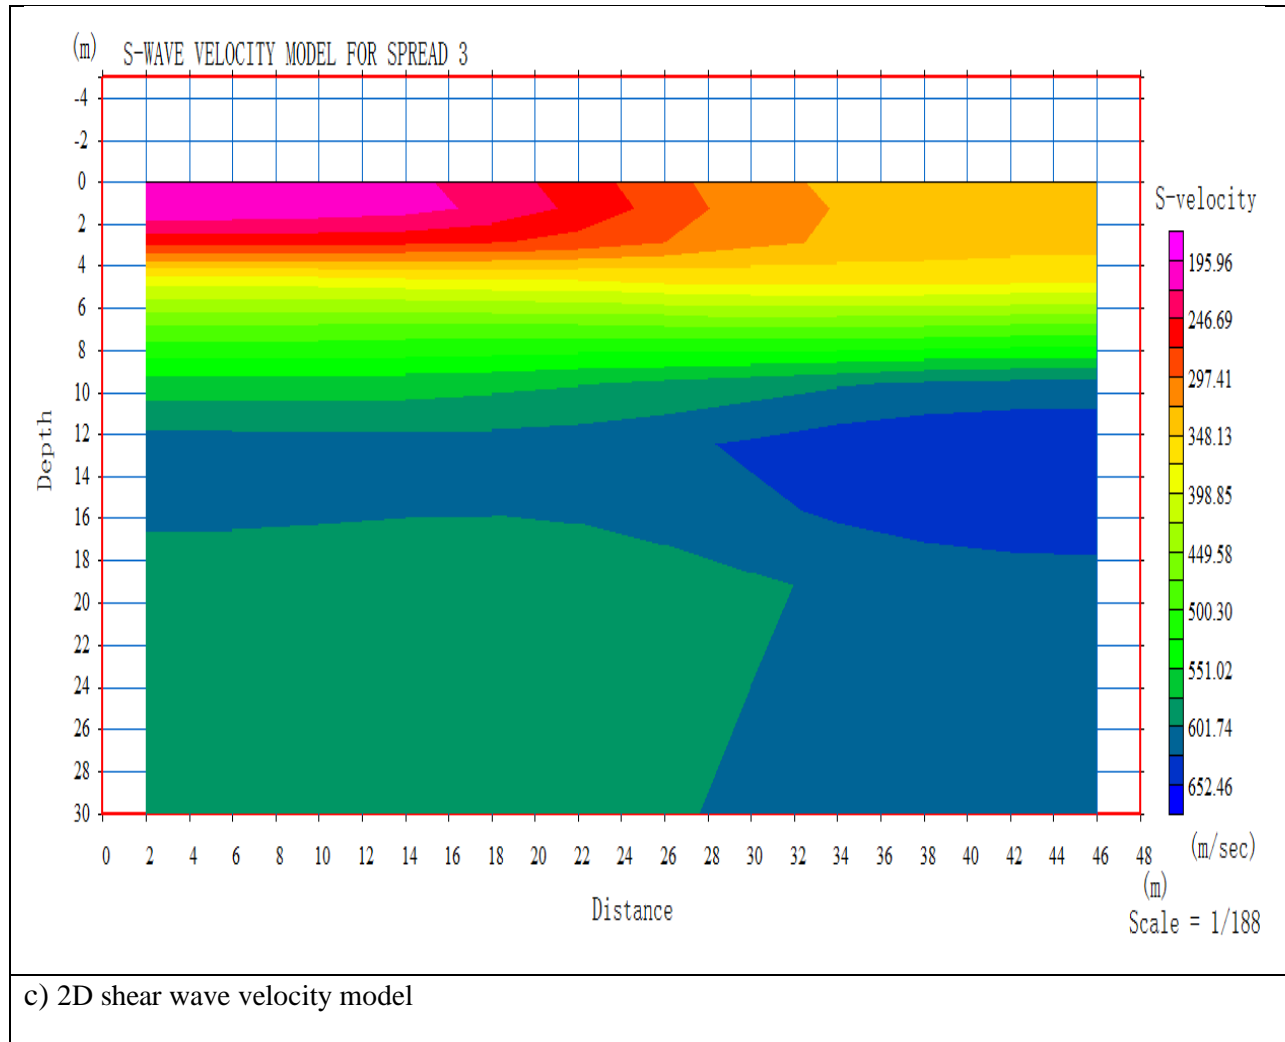
The results of MASW data (Fig.58) indicated that the site has four layers. The upper layer has VS ranges from 195.96 m/sec to 297.41m/sec (overburden material). The middle layer VS ranged between 297.41 m/sec to 551.02 m/sec (fractured and weathered trachyte). The third layer had Vs ranges between 505.68 m/s to 601.74m/sec (competent rock) and finally the lower layer had VS ranges between 601.74 m/sec to over 652.46 m/sec (fractured and weathered trachyte). The volcanic flow/intrusion (possibly basalt) is captured between a depth of 12 m and 17 below the ground level and is interpreted as a lens of sill structure. The rock sill is overlain by pumitic rock and underlain by trachyte between the horizontal distance 0 m mark and 28 m mark before widening out to form dyke whose depth root goes beyond 30 m below the ground level. Both sill and dyke is characterized by high velocity values.

Figure 58: a) Dispersion Curve, b) 1D shear wave velocity and c) 2D shear wave velocity model for spread 3

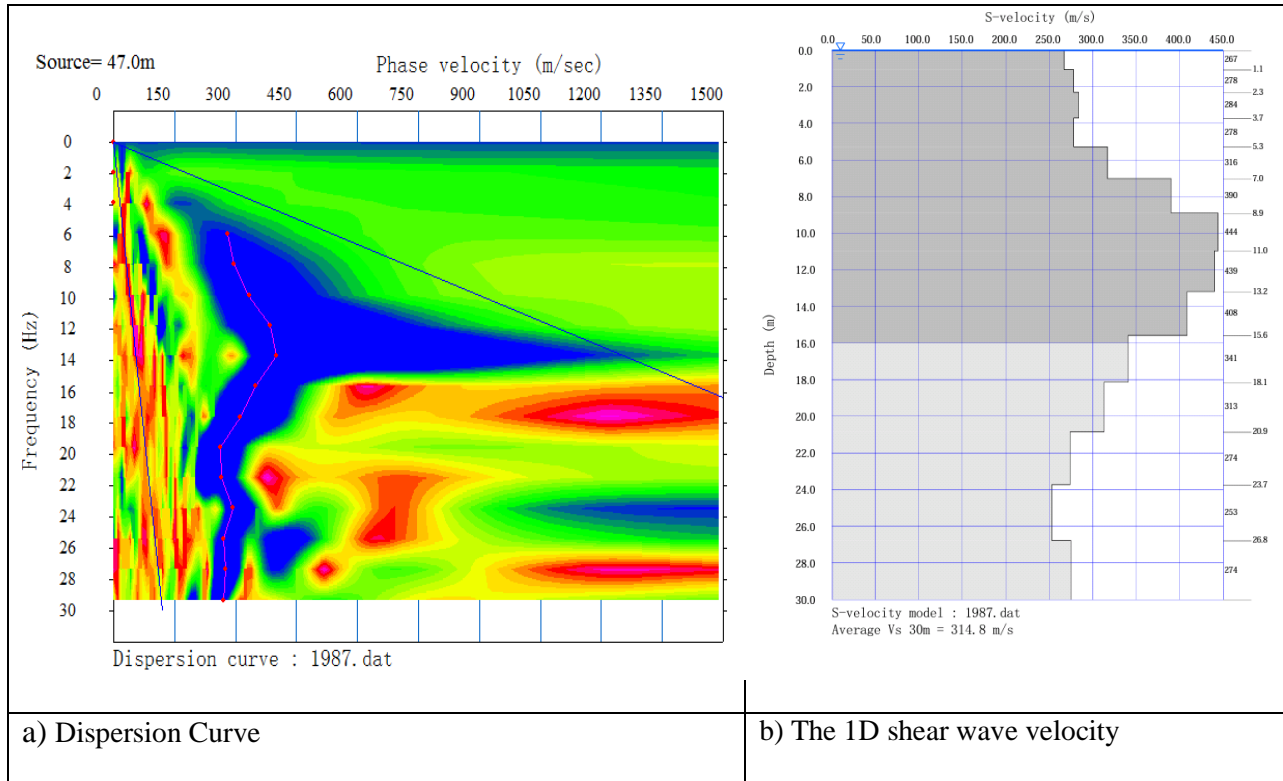
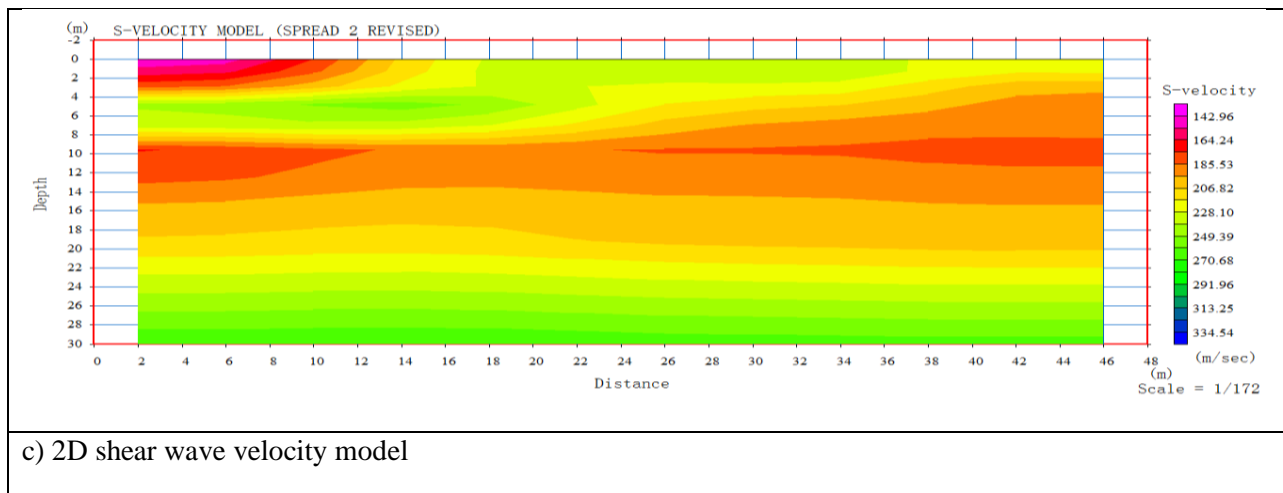
trachytes. The second layer which is the basal layer has VS ranges between 185.53 m/sec to 270.68 m/sec and is interpreted as fractured and weathered trachyte. The fractured and weathered rock is outcropping on the surface between 18 m mark and 36 m mark. The depth ranging between 8 m and 18 m is characterized by highly weathered and fractured rock (decomposed). Beyond 18 m below the ground level is composed of marginally weathered and partially fractured trachyte (rock).

Figure 60: a) Dispersion Curve, b) 1D shear wave velocity and c) 2D shear wave velocity model for spread 2

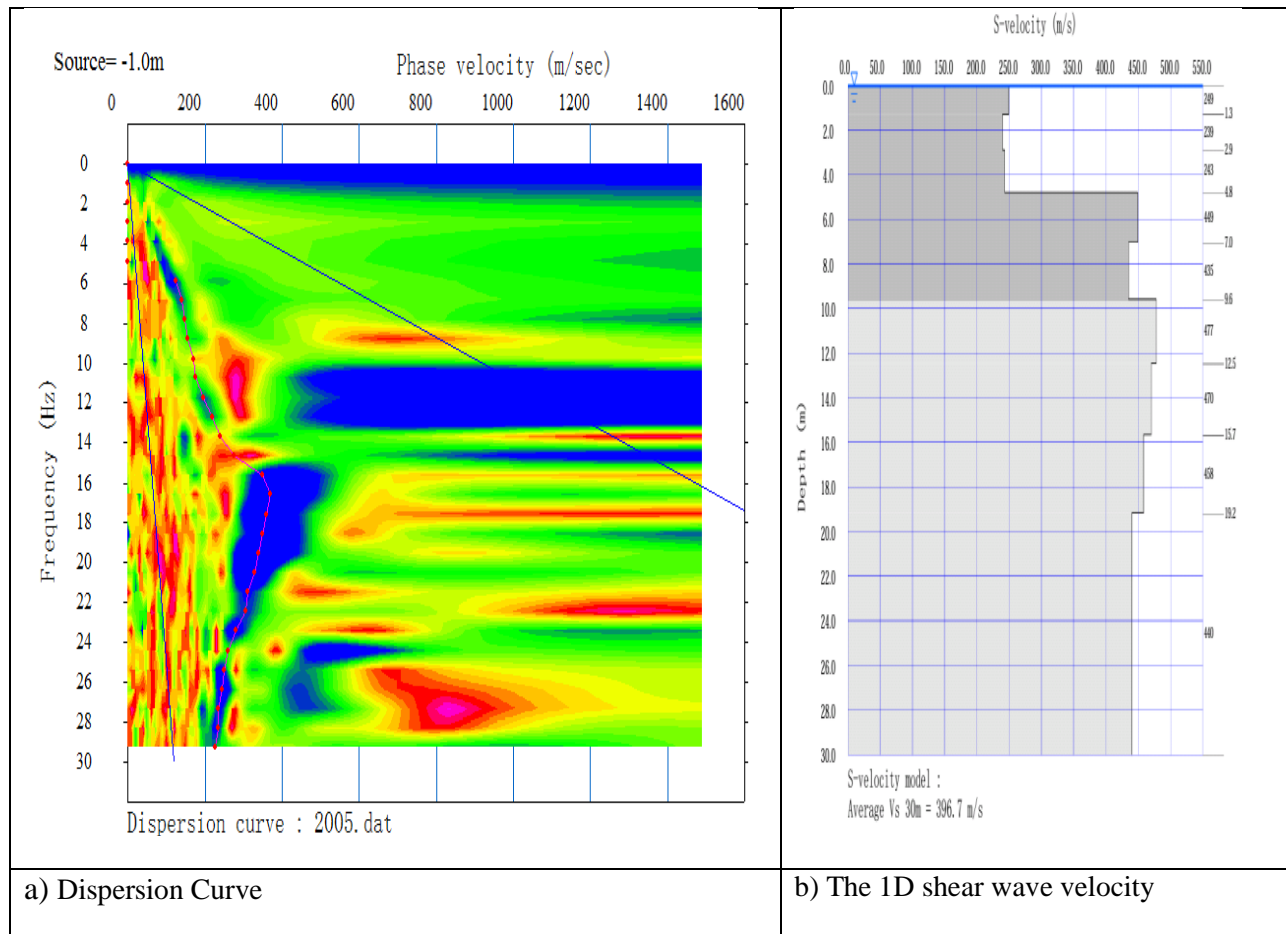
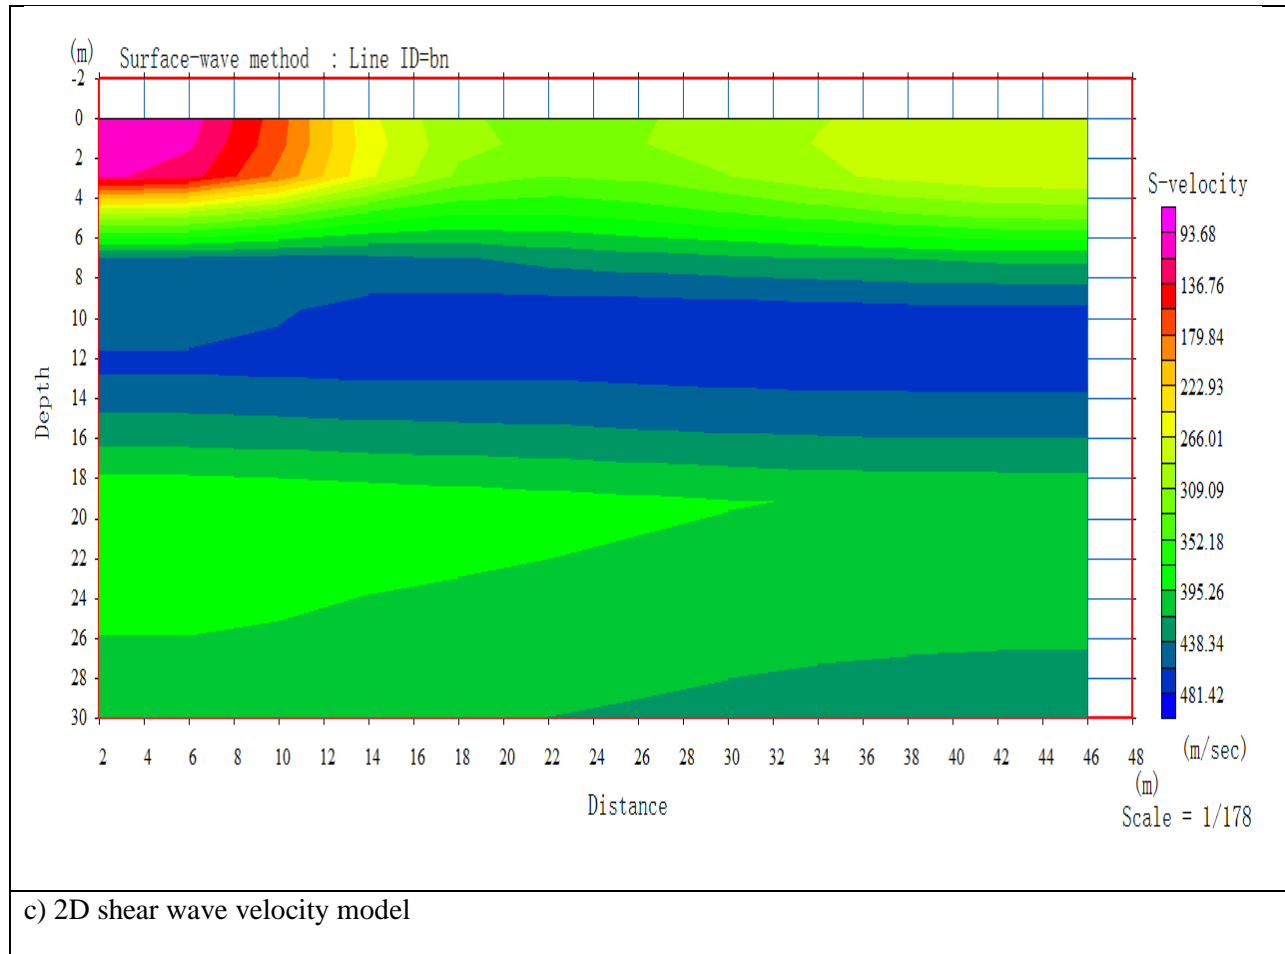
Figure 61: a) Dispersion Curve, b) 1D shear wave velocity and c) 2D shear wave velocity model for spread 3

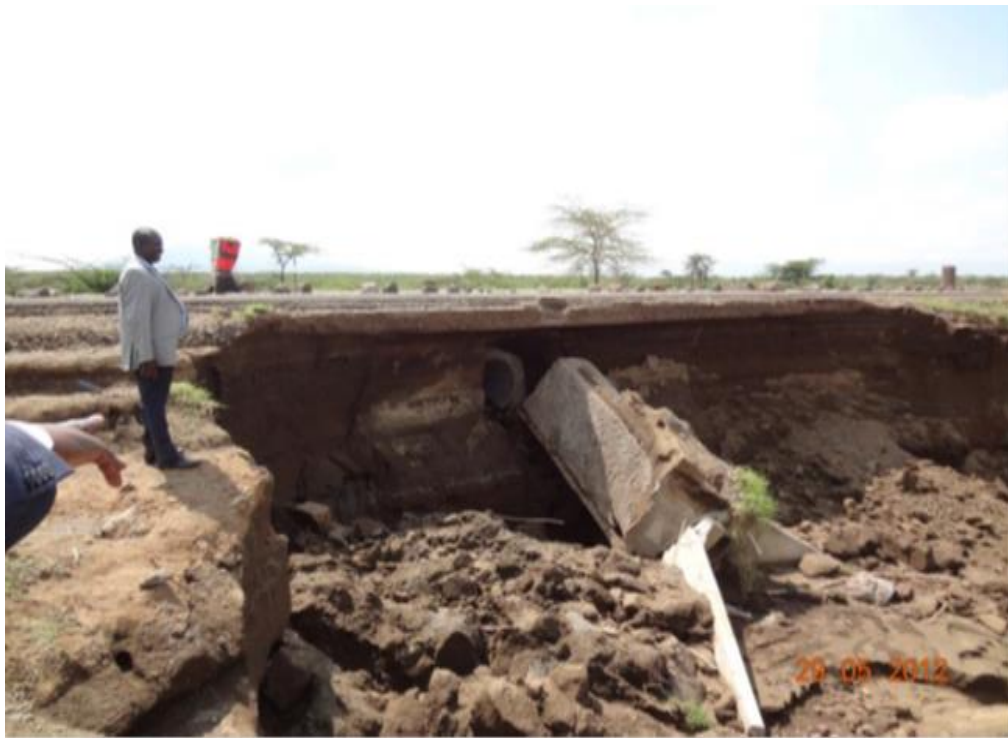
Figure 62: *Road surface remained intact.*

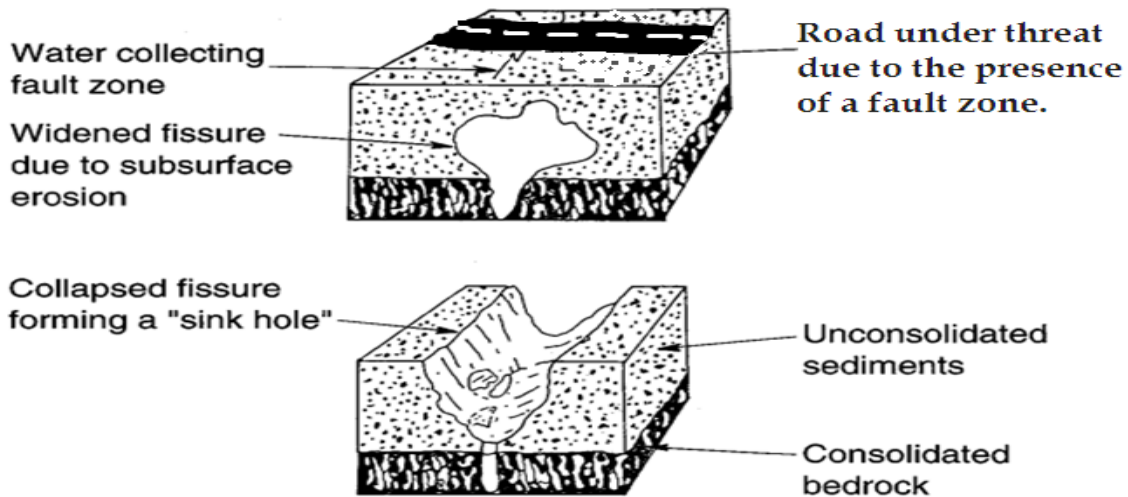
Figure 63: *Development of sink holes as a result of subterranean erosion.*

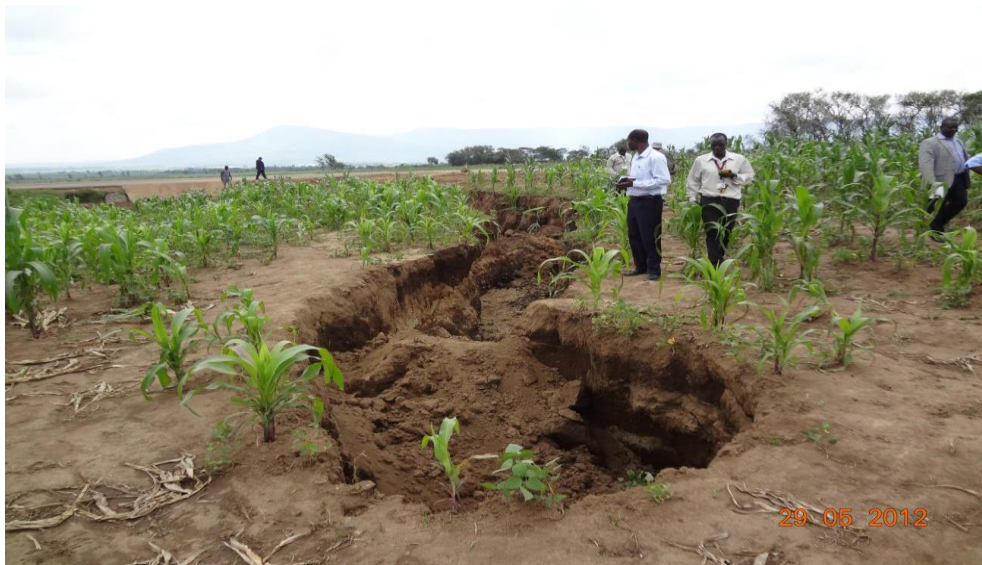
Figure 64: *No horizontal or vertical displacements occurred.*

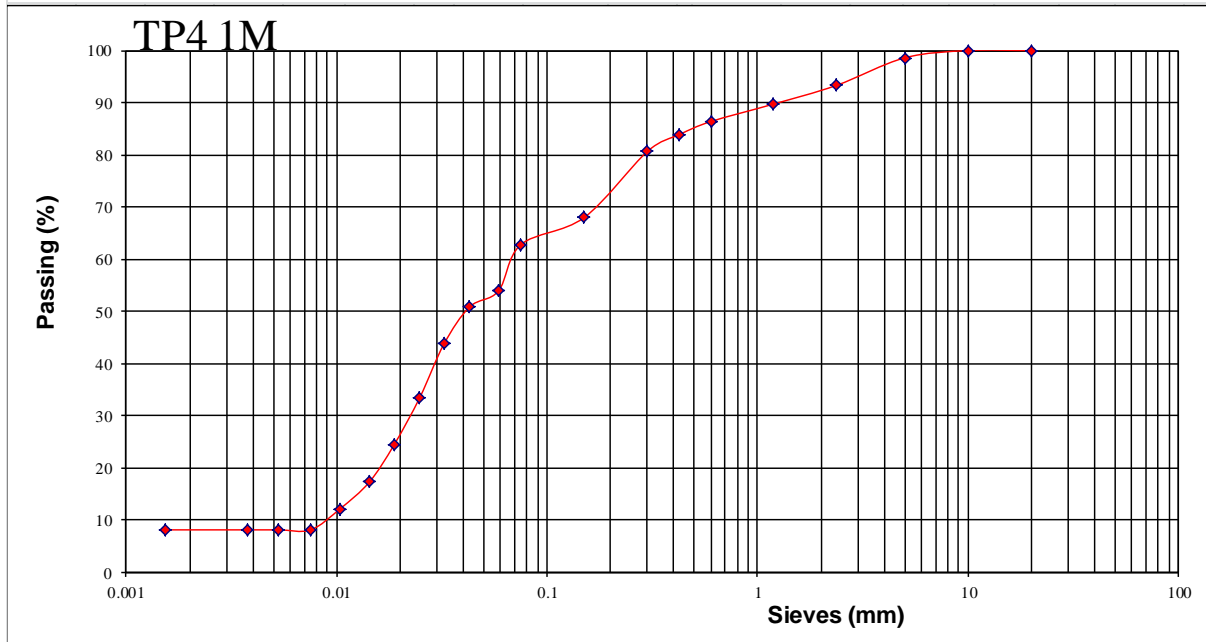
GRADING CURVE - HYDROMETER ANALYSIS

SITE	Maai Mahiu-Narok road		
Depth (m)	TP4	S/No	1.5M
Test date:	22-Oct-15		
Specification	According to BS 1377:1990
