APPENDIX A

NCHRP Project 12-81

Evaluation of Fatigue on the Serviceability of Highway Bridges

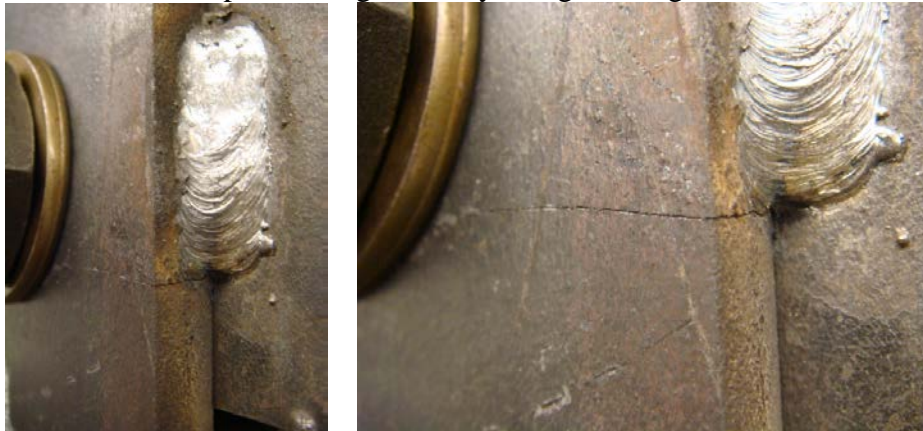
Two fatigue cracks were observed in the lower tack welds. The fatigue cracks started in the toe of the welds and spread into the splice plate transversely. This is a more critical fatigue failure case than if the crack spreads longitudinally along the length of the tack weld.

Fig C-4: Fatigue crack in lower right weld on front side of specimen spreading transversely into the splice plate

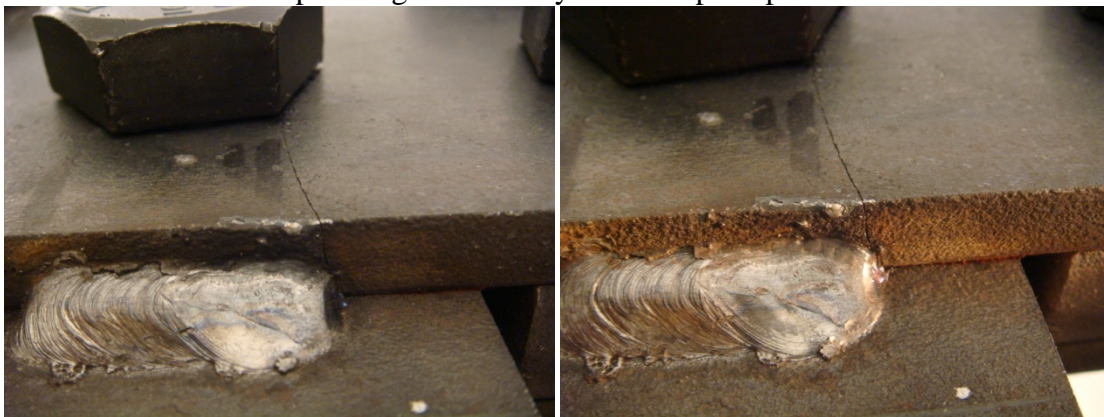
Fig C-5: Fatigue crack in lower left weld on back side of specimen spreading transversely into the splice plate

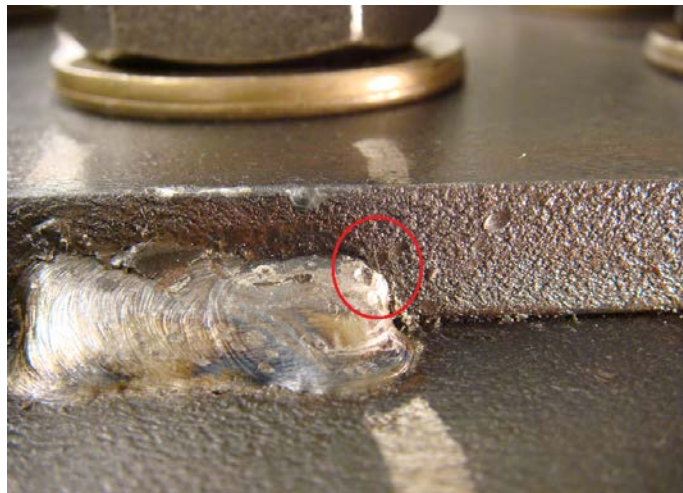
Once crack at lower left tack weld toe on front face just starting to spread into plate thickness.

Figure C-10: Front face lower left tack weld toe crack for specimen TW-3LN-20-3

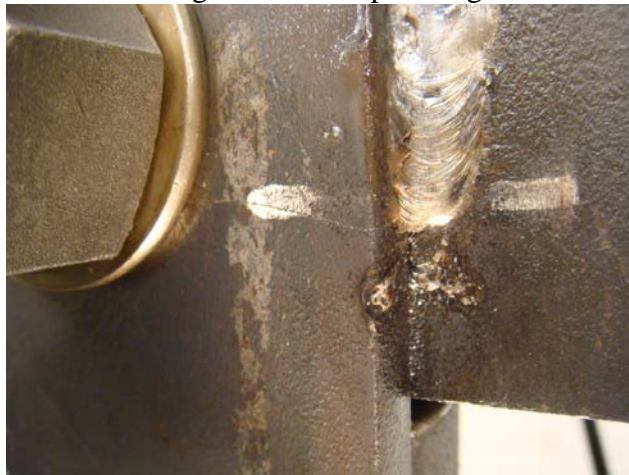
One crack at front face lower right weld toe spreading into bolt hole.

Figure C-12: Fatigue crack at front face lower right tack weld toe for specimen TW-3LN-12-3

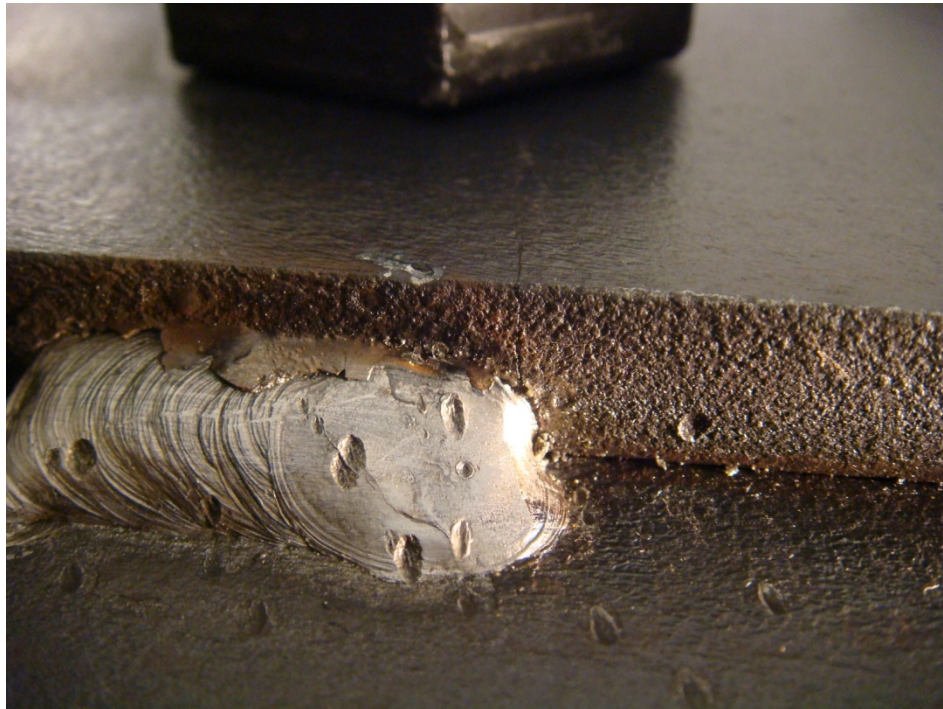
One crack at back face lower left weld toe that grew to a length of 21/32 inches.

Fig C-15: Fatigue crack at tack weld toe for specimen TW-2LN-12-1

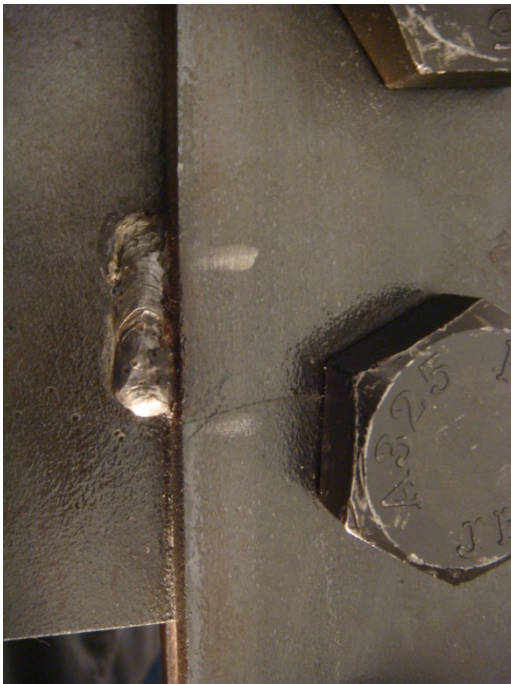
Once crack at back face lower left weld toe spreading into bolt hole.

Fig C-21: Specimen TW-2LM-12-1 Crack

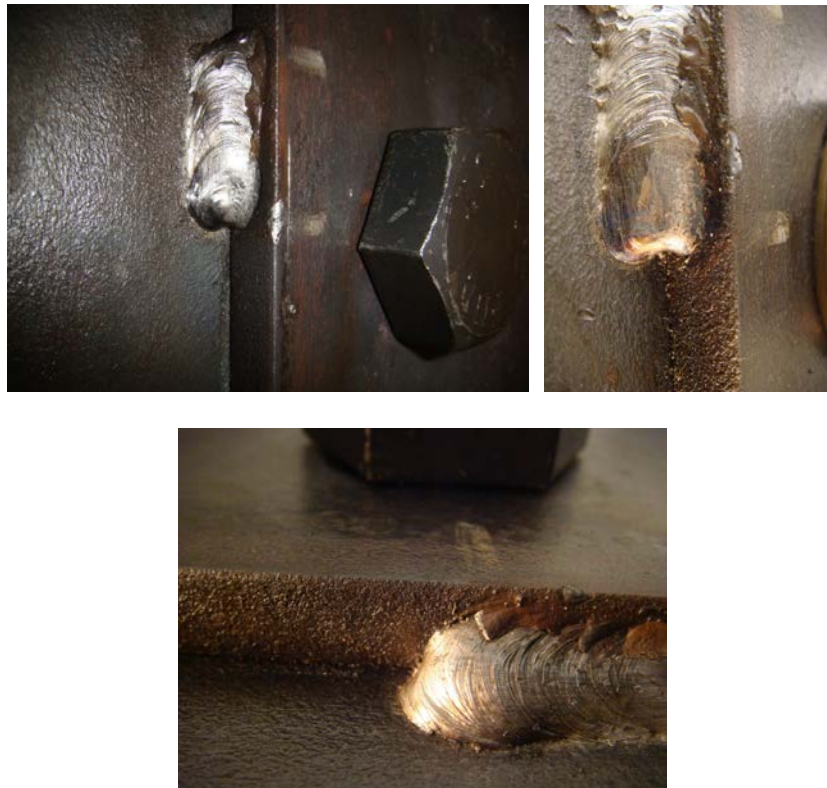
Three cracks; Two cracks at front face lower left weld toe and back face lower left weld toe spreading into bolt hole and the other at back face lower right weld toe spreading $\frac{1}{4}$ inch across plate width.

Fig C-23: Specimen TW-2LM-12-2 Tack Weld Cracks

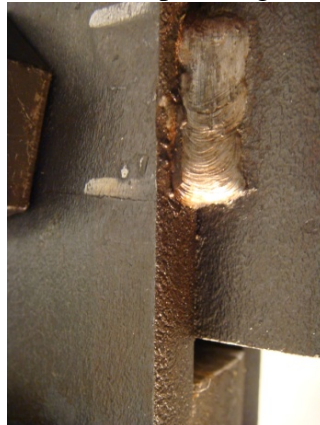
Crack at back face lower right weld toe spreading into bolt hole.

Figure C-29: Longitudinal weld fatigue crack in specimen TW-2TN-12-1

Failure occurred after 5,513,000 cycles of loading.

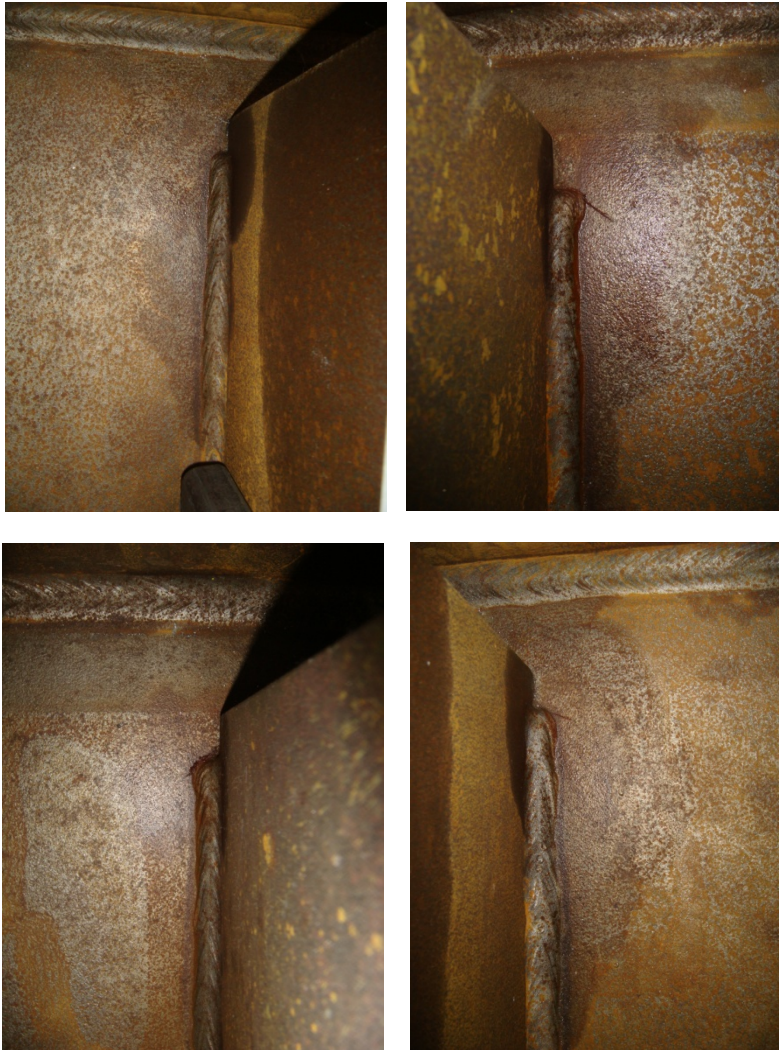
Cracks initiated at the stiffener-to-web weld toes at both ends.

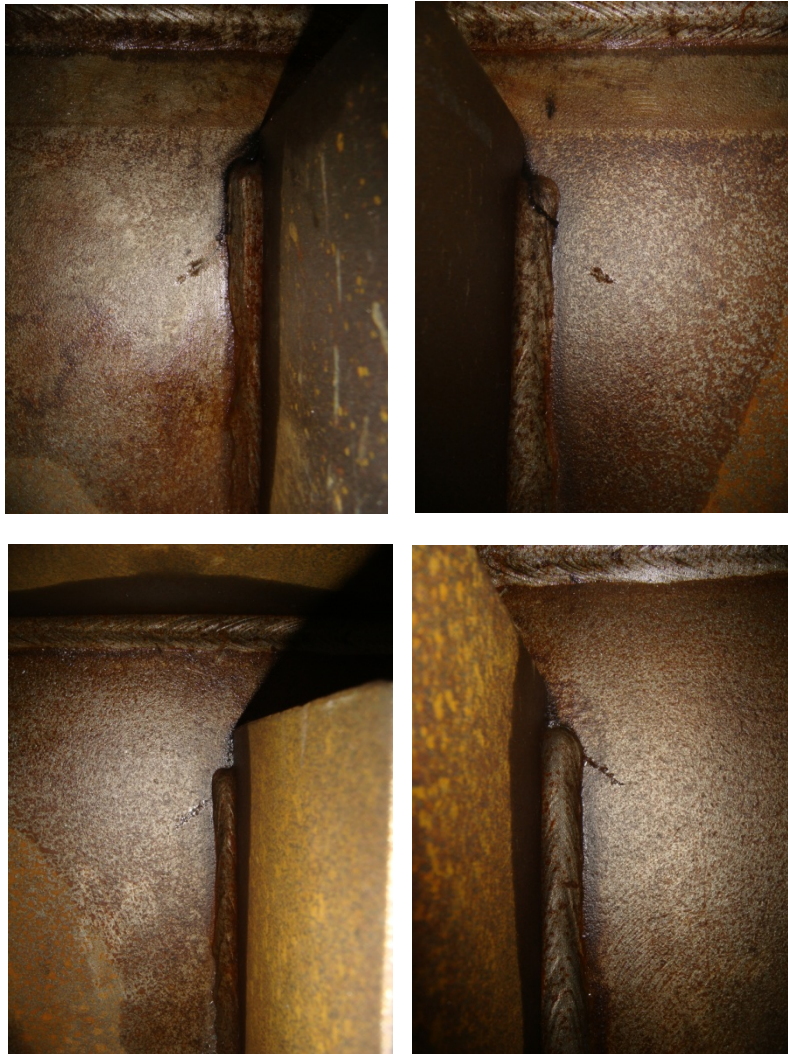
Cracks initiated at the stiffener-to-web weld toes at both ends.

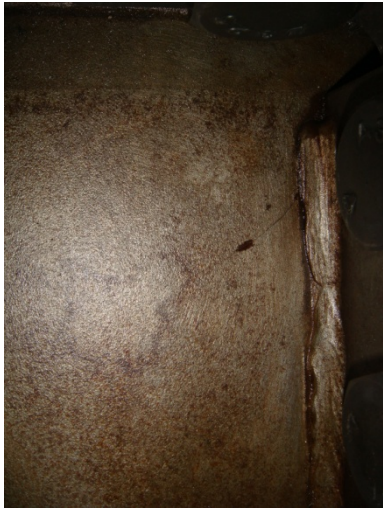
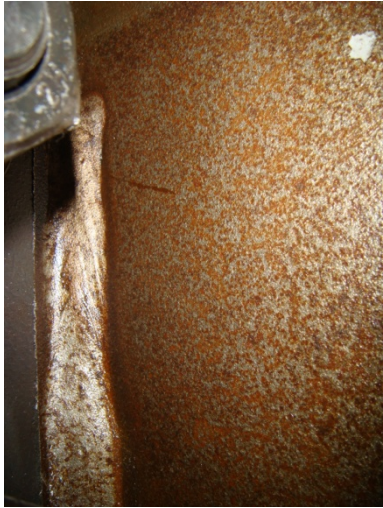
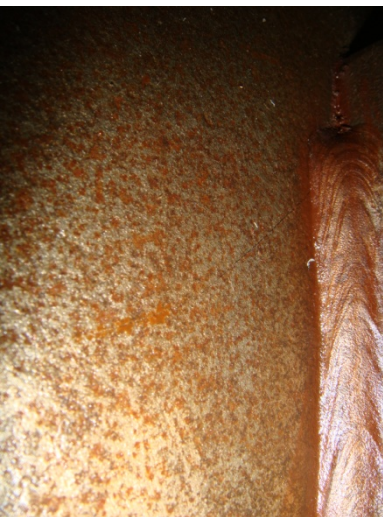
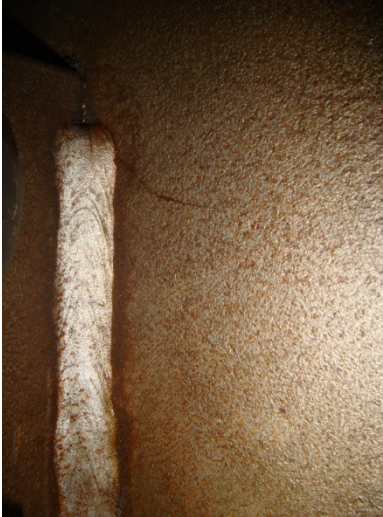
Cracks in the web of the retrofit had grown in length at the end of cycling.

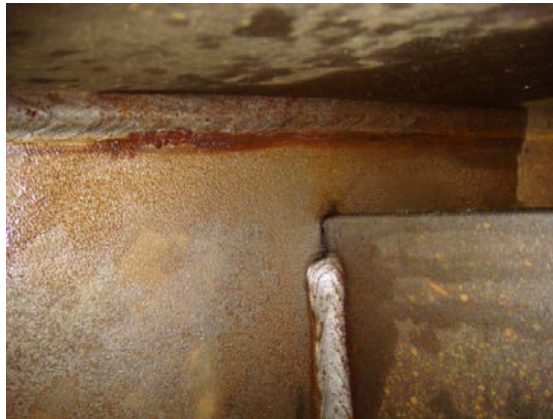
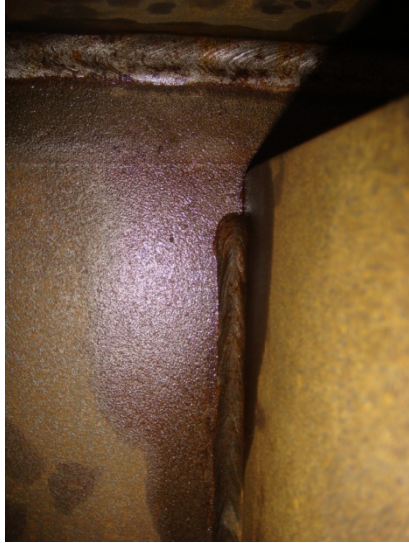
Cracks initiated at the web-to-flange weld toe at one end and at the stiffener-to-web weld toes at the other end.

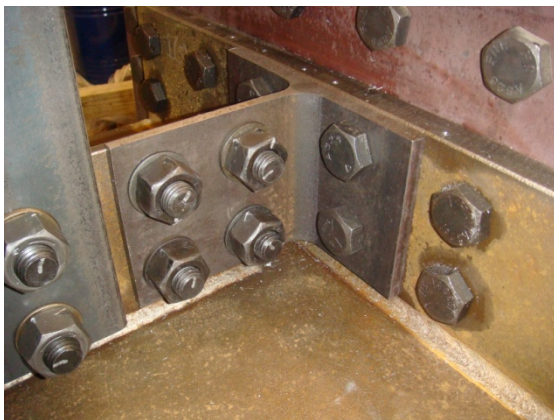
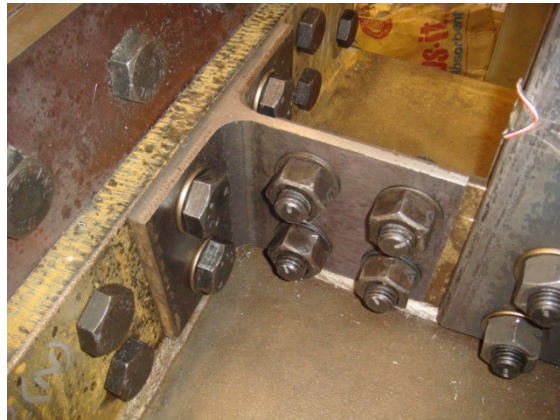
WT retrofits were installed at both ends. The WTs had a flange thickness of 0.50 inches.

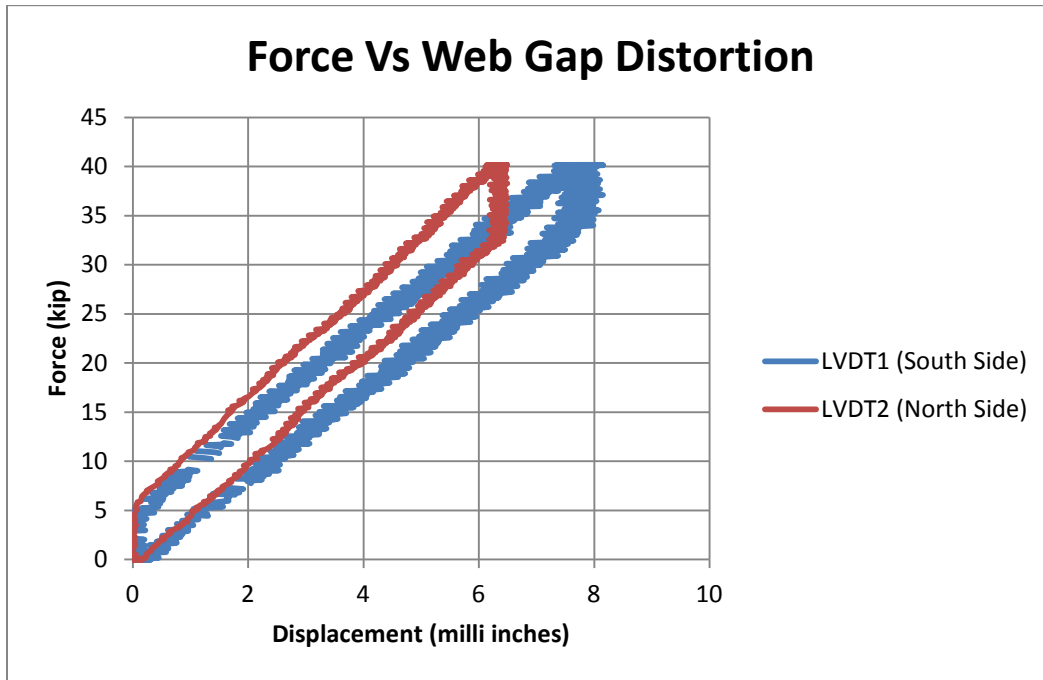
The specimen was cycled at a constant load of 40 kips after retrofitting for 5 million cycles. A total of 5,049,000 cycles were applied on the specimen.

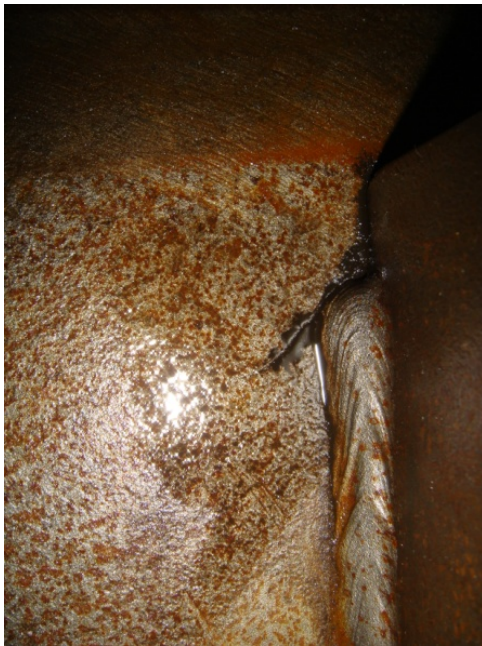
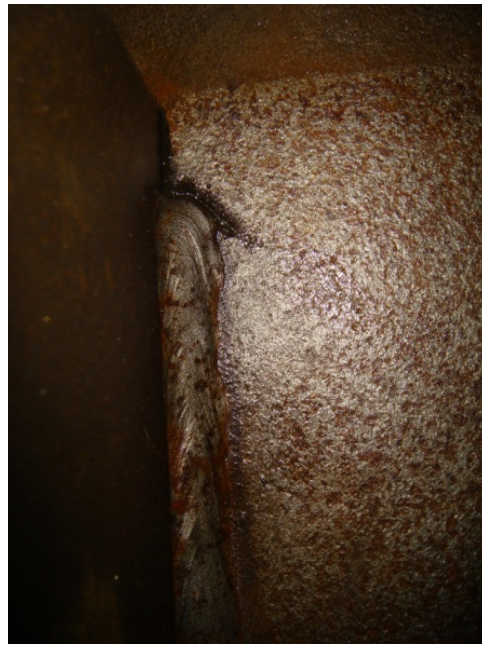
Cracks initiated at the stiffener-to-web weld toes at both ends.

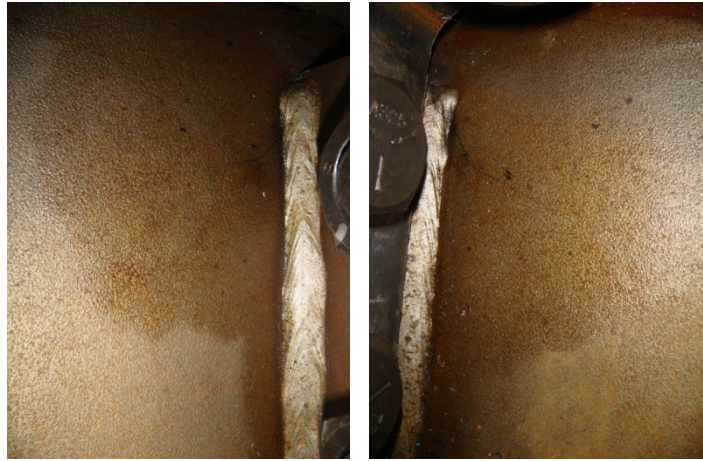
No new cracks initiated in the retrofit. However, the existing cracks at the stiffener-to-web weld toe increased in length.

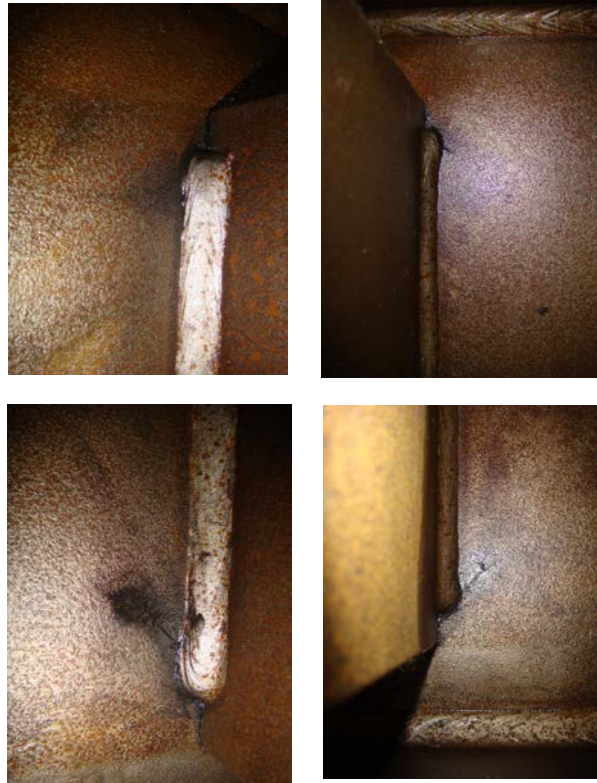
Cracks initiated at the stiffener-to-web weld toes at both ends.

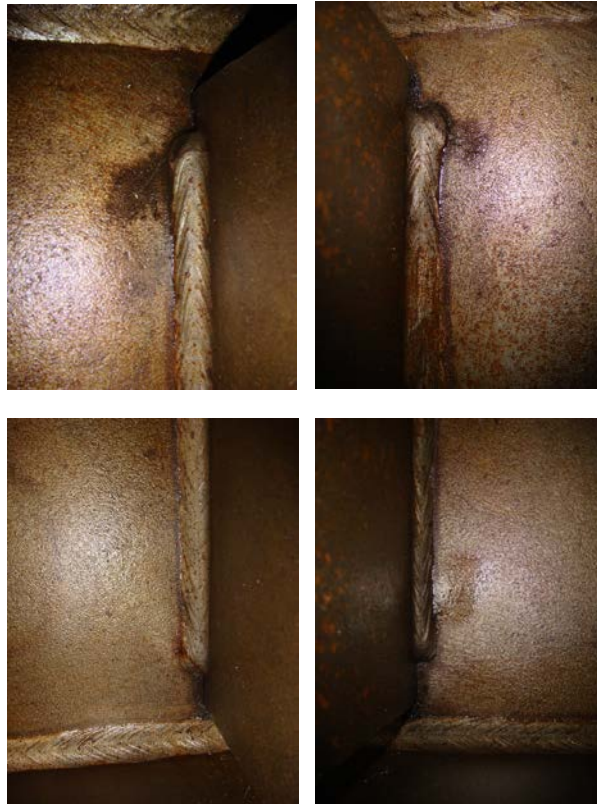
Cracks initiated at the stiffener-to-web weld toes at both ends.

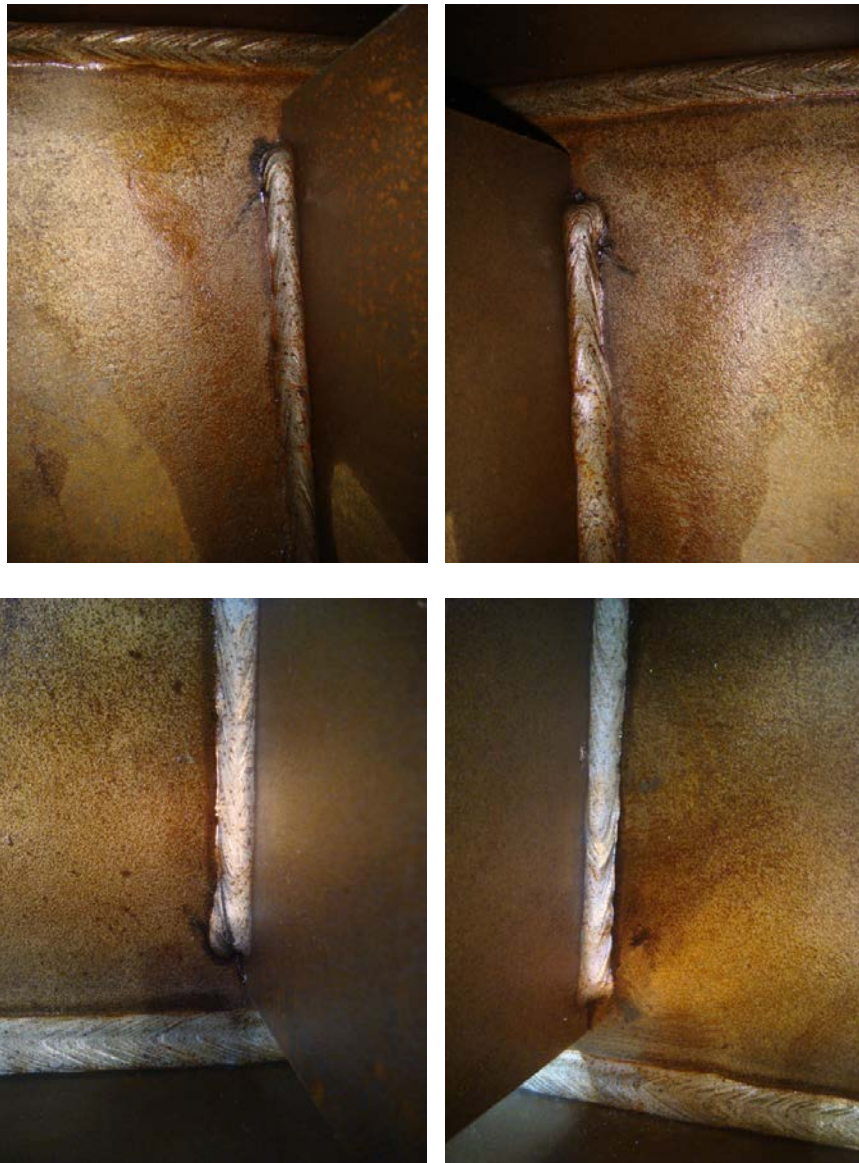
Cracks initiated at the stiffener-to-web weld toes at both ends.

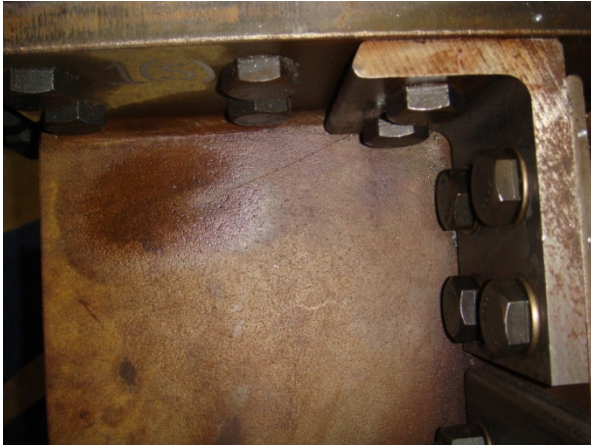
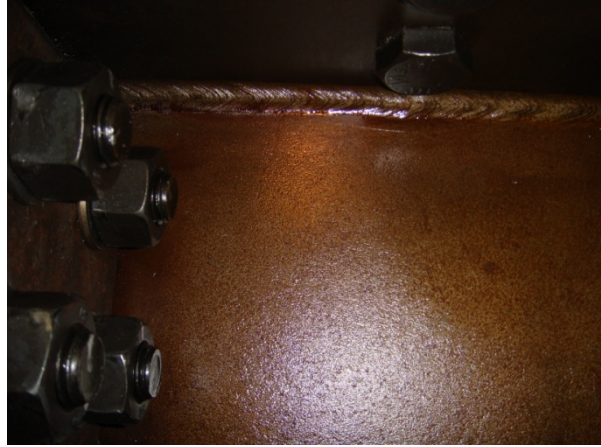
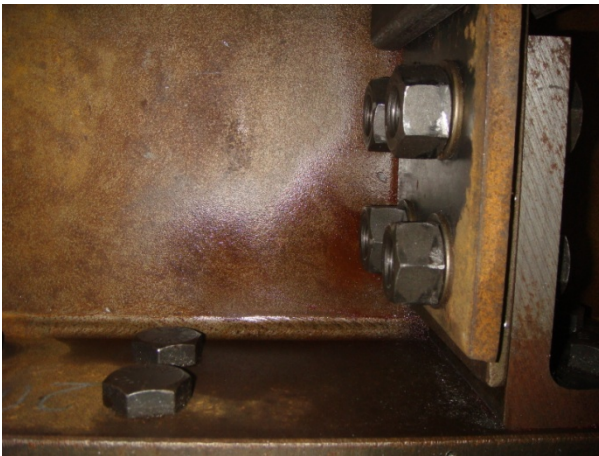
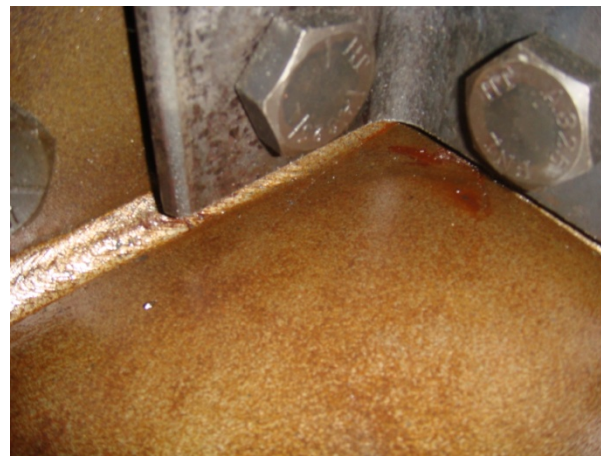
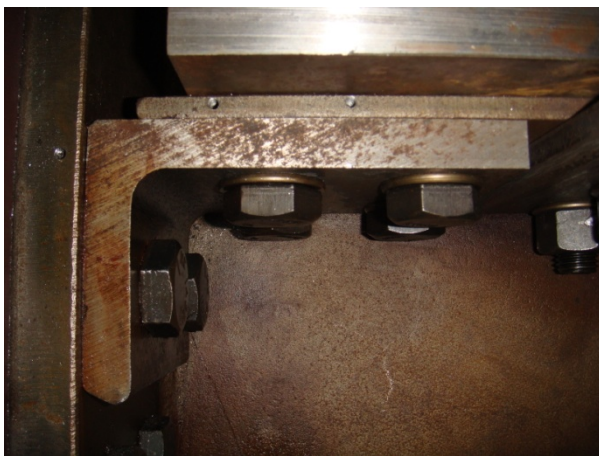
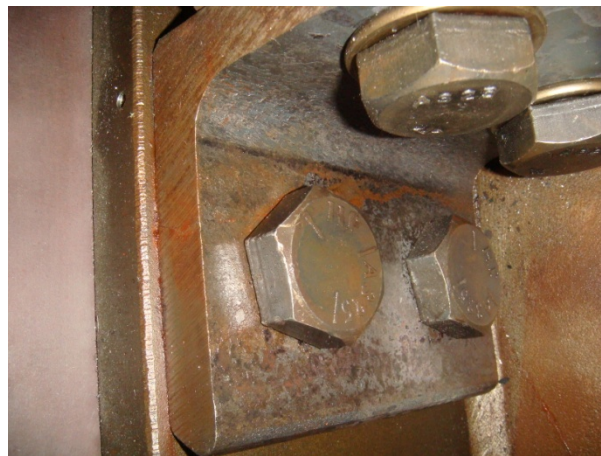
New cracks formed in the web-to-flange welds at both ends which grew significantly in length. A crack also formed in the retrofit at one end. The crack in the retrofit seemed to initiate on the top side of the flange of the retrofit. The crack spread 0.5 inch into the flange on the top surface and also grew 7/8 inch downwards towards the lower bolt.

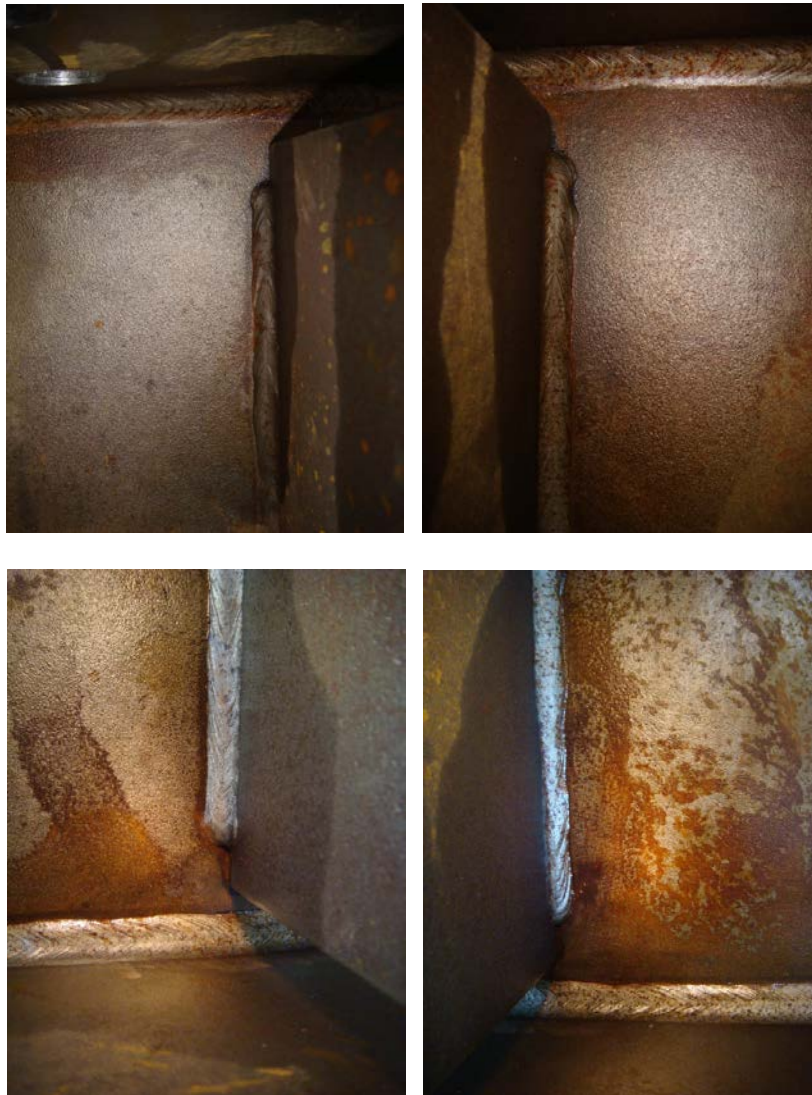
Cracks initiated at the stiffener-to-web weld toes at both ends. Although no cracks could be observed at web-to-flange welds at both ends of the specimen, presence of black residue at one of the ends at the weld toe indicated probable presence of cracks.

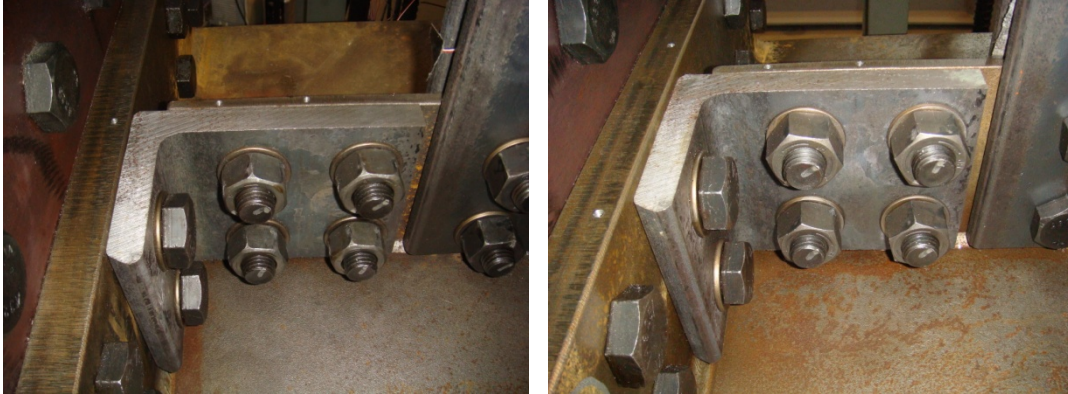
Single angle retrofits were installed at both ends. The angles had a thickness of 0.75 inches.

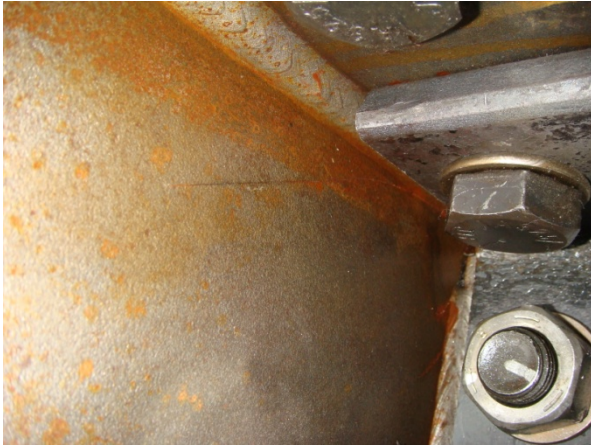
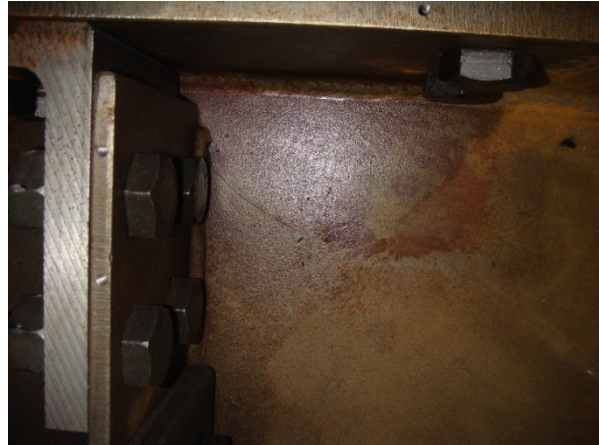
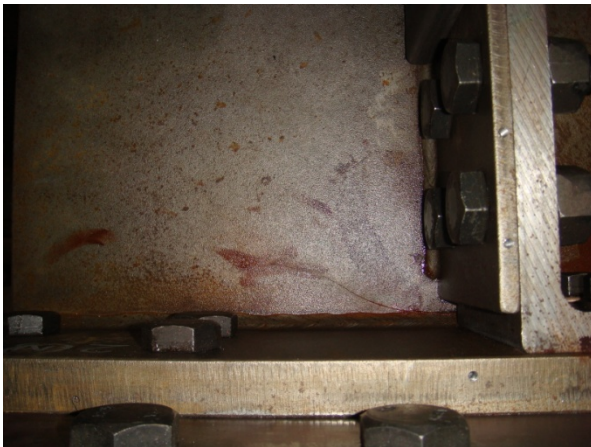
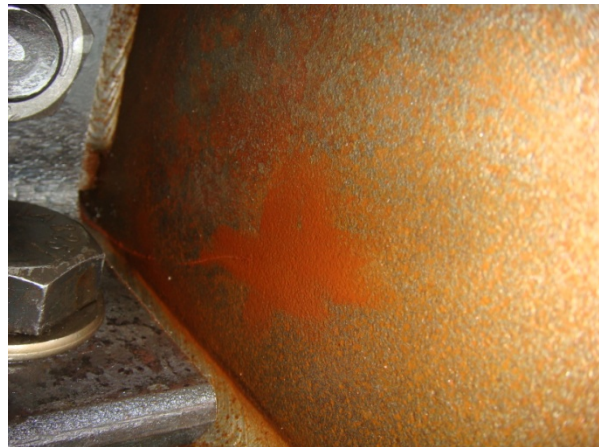
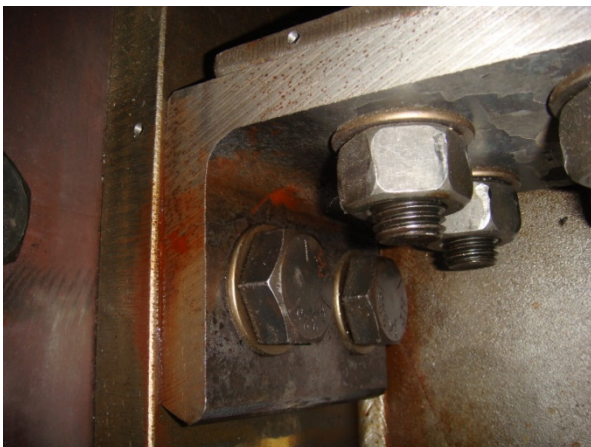
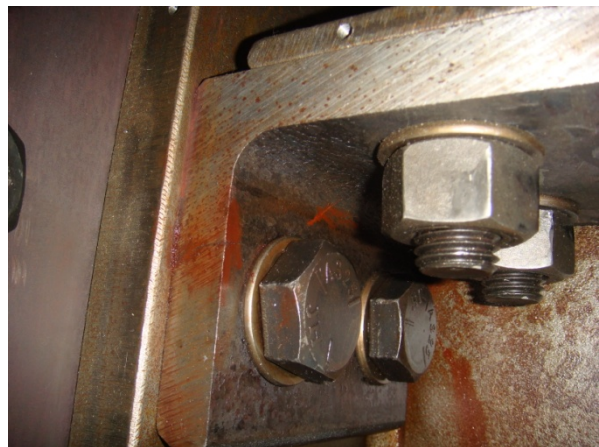
New cracks formed in the web-to-flange welds at both ends which grew significantly in length. Cracks also initiated in the single angle retrofits at both ends. The cracks in the retrofits seemed to initiate on the top side of the flange of both the retrofits. The cracks spread into the flange on the top surface and also grew downwards and across into the web-flange junction of the single angle retrofits.
