Technical Report

Door gaps and natural ventilation with adjoining rooms

Date: 03.21.2022

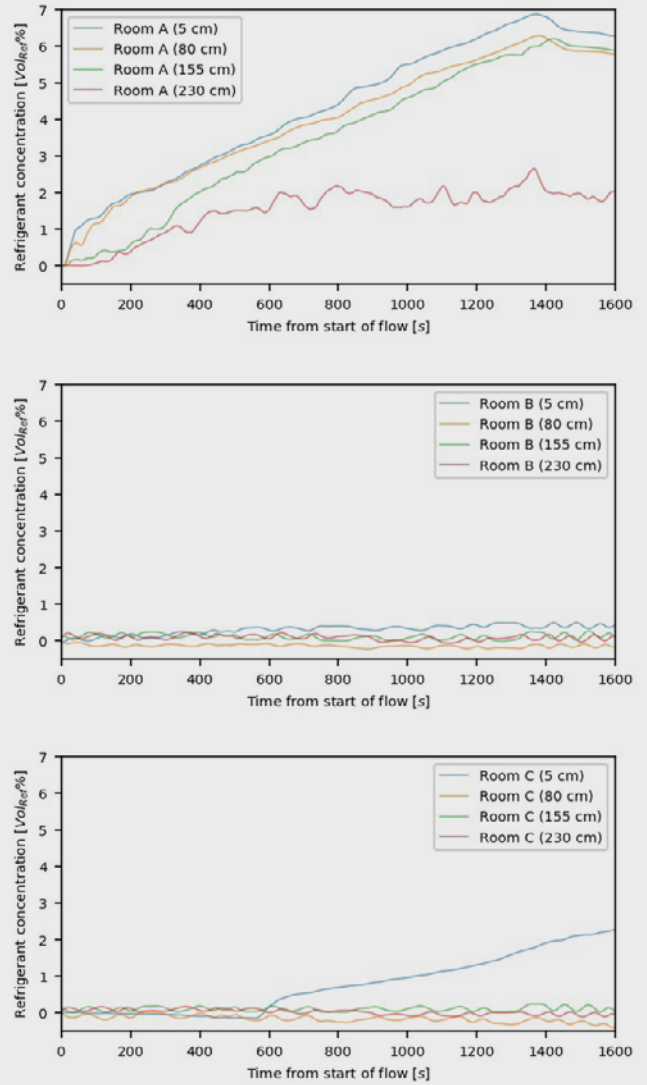
Figure 4 – Room tightness concentrations

From this data we can see that the majority of the refrigerant released stays within the room where it was released. At the start of the release, the refrigerant sensor closest to the floor responds quickest, with the sensors at 80 cm and 155 cm responding to a significant refrigerant rise at 200 s and 600 s, respectively. At the end of the release the refrigerant concentration was approximately 6.5% for all sensors located up to 155 cm (61 in) height. The floor area of the room A is 15 m², so the volume of refrigerant remaining in the room was estimated at 15 x 1.55 x .065=1.51 m³ (53.33 ft³). This corresponds to 3.2 kg (7 lbs) of refrigerant.

There is a concentration rise at the lower sensor in Room C, which starts 600 s after the start of the release. We do not see this same concentration rise in Room B, so there must have been an opening that was not completely sealed.

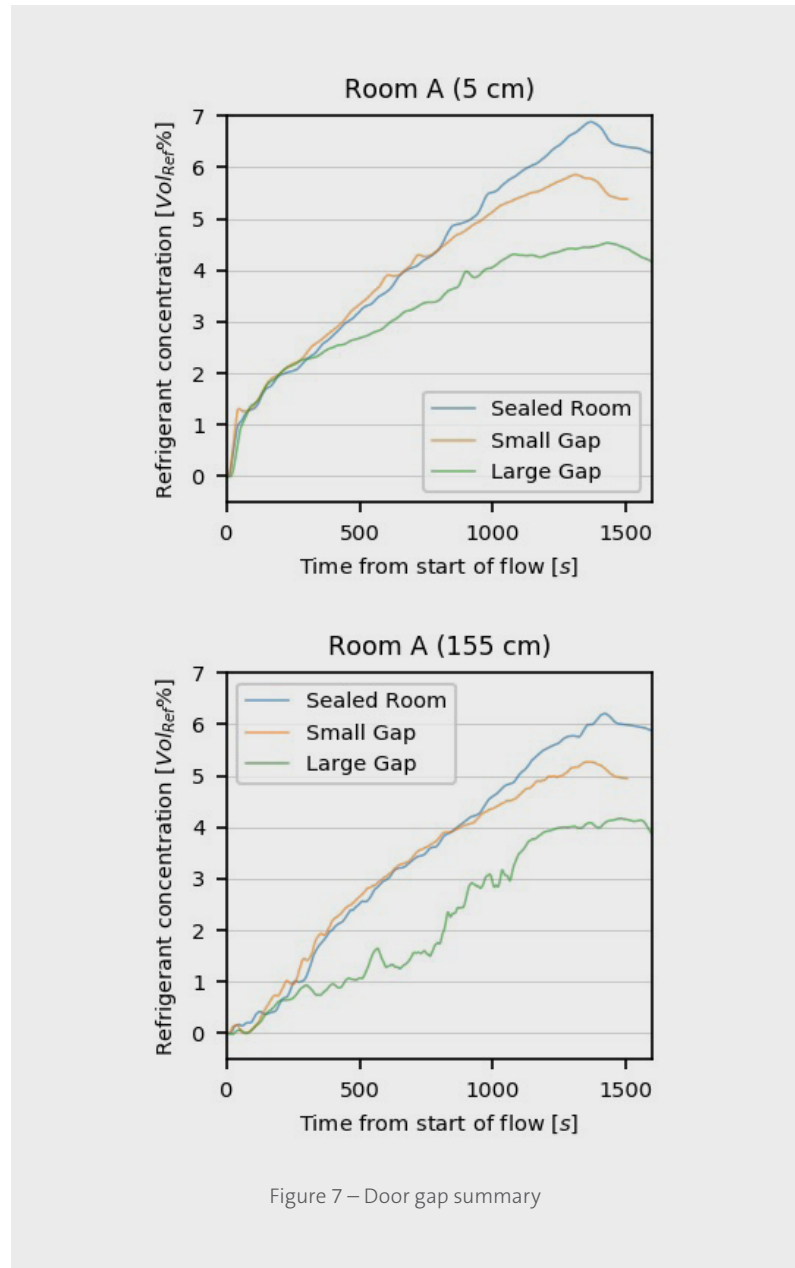
Figure 7 – Door gap summary

Interior rooms of buildings are not tightly constructed. A small opening — such as a 4 mm (0.16 in) gap at the bottom of the door — has a significant impact on maximum concentration of leaked refrigerant in the space. Gaps are always present at the bottom of an ordinary door to facilitate the easy opening and closing of the door. In addition, rooms having only one door and no other opening are very limited. Most rooms have multiple doors, window(s) and closets or similar connected spaces. As the safety standards cannot verify the arrangement and construction of the rooms that the products are installed in, it is important for the installation codes to clarify if door gap sizes can be used as a method to disperse refrigerant. The opening under the door has a significant effect on the amount of refrigerant flowing out of that room. Figure 6 details individual sensors for the test conditions in the previous sections.

There is a 1% absolute refrigerant concentration between the sealed room and small door gap. As the refrigerant concentration increases towards the lower flammability limit (LFL), the pressure differential between the rooms would increase, and the refrigerant velocity into the other rooms would increase. Fluid velocity at a hole is generally proportional to square root of pressure difference, so velocity is almost proportional to square root of the concentration. In addition, refrigerant concentration increases proportionally to the escaping mass of refrigerant. The tests in this study were conducted below half of LFL. If concentration in the room approaches LFL, it is expected that the refrigerant velocity from the room is expected to be increased by a factor of 2.8.
