Erosion Rate Update Study

Margery F. Overton
John S. Fisher
Department of Civil Engineering
North Carolina State University

APPENDIX A. Oceanfront Erosion Rate Setback Factor Maps Prepared by the North Carolina Division of Coastal Management (DCM)

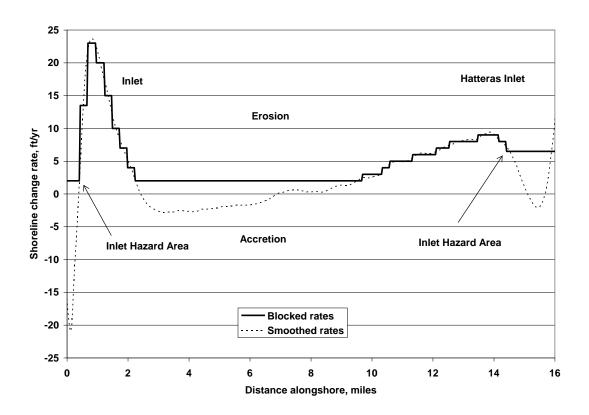
Figure 2. Blocked and smoothed shoreline change rates on Ocracoke Island.

Figure 2 below illustrates the use of these blocking procedures on the Ocracoke data. The blocking procedure captures the variation in rate while meeting the management goal of having common rates among property owners within specified distances. In addition, this figure illustrates the portion of the island that is has a less than 2 ft/yr erosion rate, but that is blocked at 2 ft/yr. Finally, the application of the blocked rate into the Inlet Hazard Area is also illustrated.

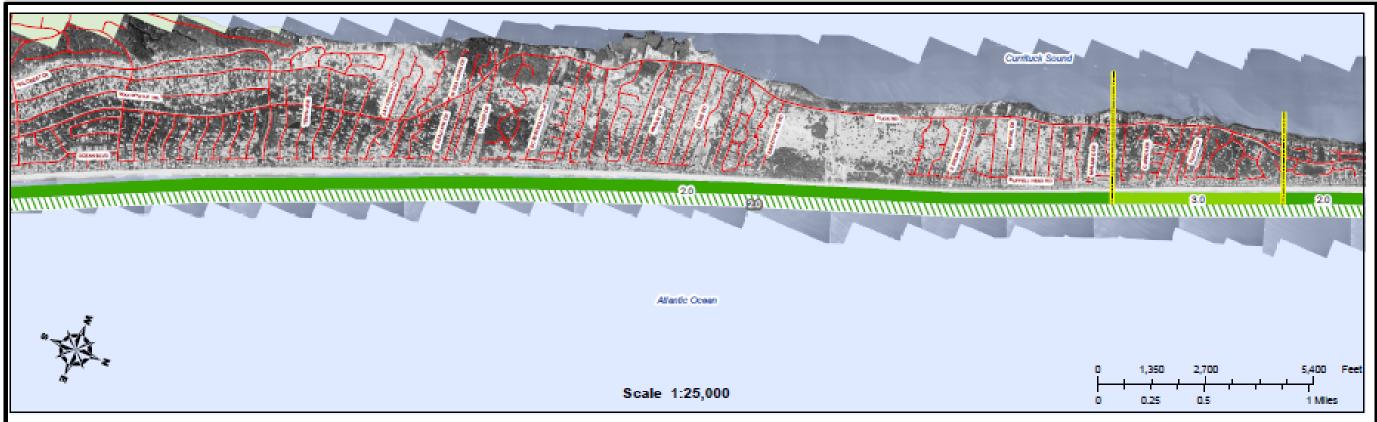
Duck to Sanderling - South

This general area has been influenced by beach nourishment either for beach protection or dredge disposal. This action artificially lowers the erosion rate in these areas.
