Inlet Hazard Area Boundary, 2019 Update:

Science Panel Recommendations to the
North Carolina Coastal Resources Commission

February 12, 2019

NC Coastal Resources Commission's Science Panel on Coastal Hazards
& NC Division of Coastal Management

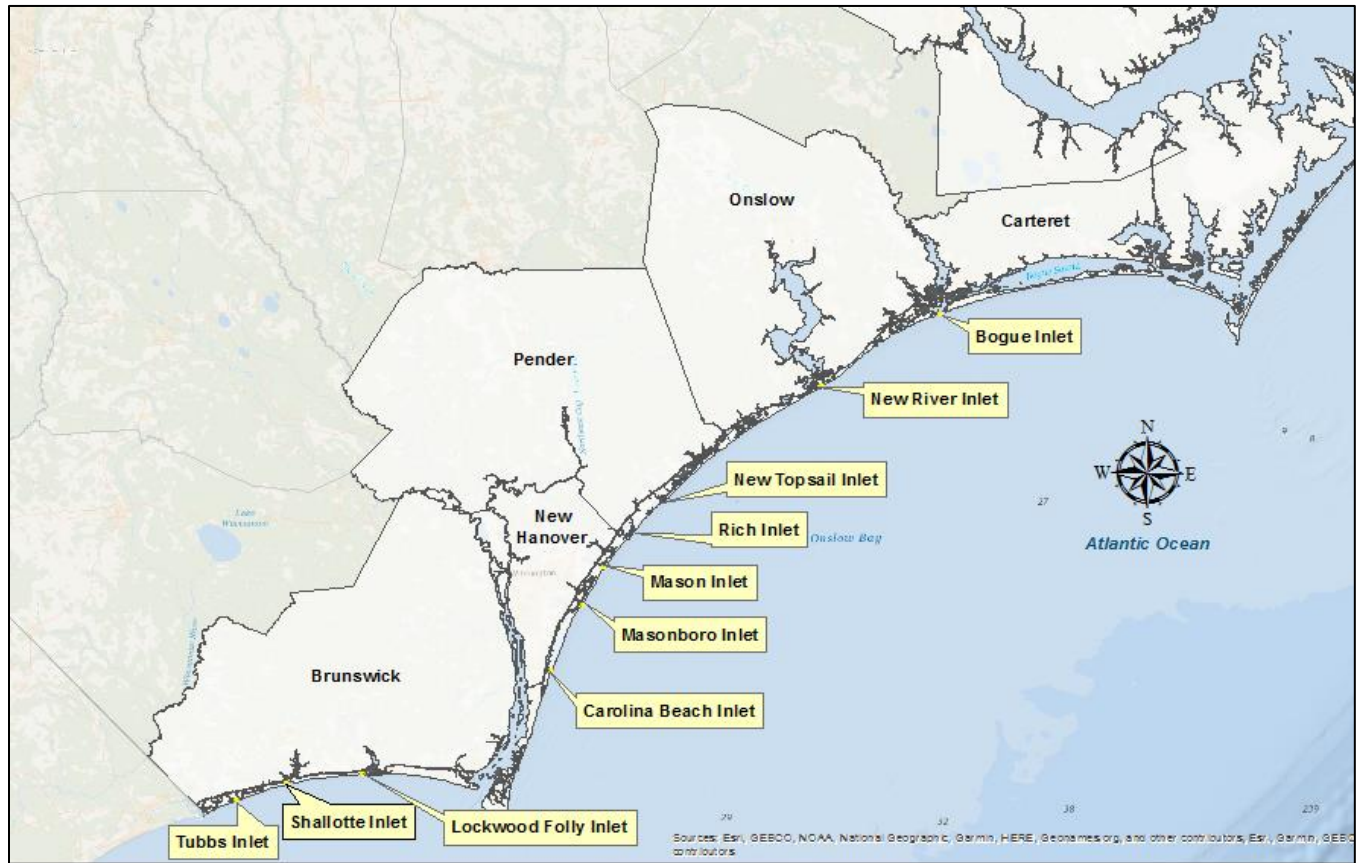
Figure 1. Study area includes Tubbs, Shallotte, Lockwood Folly, Carolina Beach, Masonboro, Mason, Rich, New Topsail, New River and Bogue Inlets. At least one side of each inlet is developed.

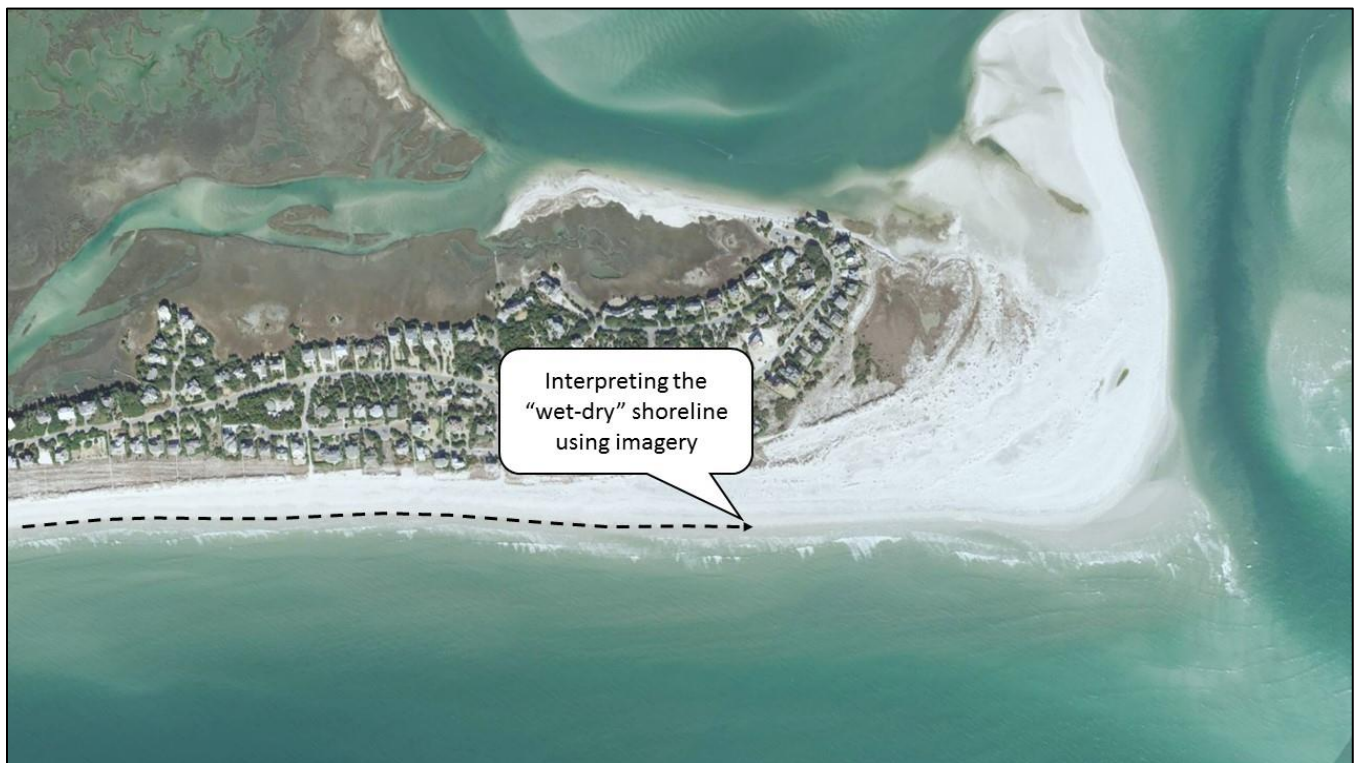
Figure 4. Interpretation of the "wet-dry" shoreline using orthophotography.

DCM's growing database of oceanfront and inlet shorelines facilitated this study by allowing many different approaches to be tried and tested. Most of the shorelines used were mapped using historic orthophotography to digitize the wet-dry line (Figure 4), considered a proxy for the Mean High Water (MHW) line. Three shorelines represented the location of MHW - either derived from lidar (1997 and 2004), or NOS T-Sheets (either from the 1930s or 1940s). Two studies carried out by DCM (Limber et al., 2007a; 2007b) indicated that the lidar-derived MHW line could be used interchangeably with the wet-dry shorelines.

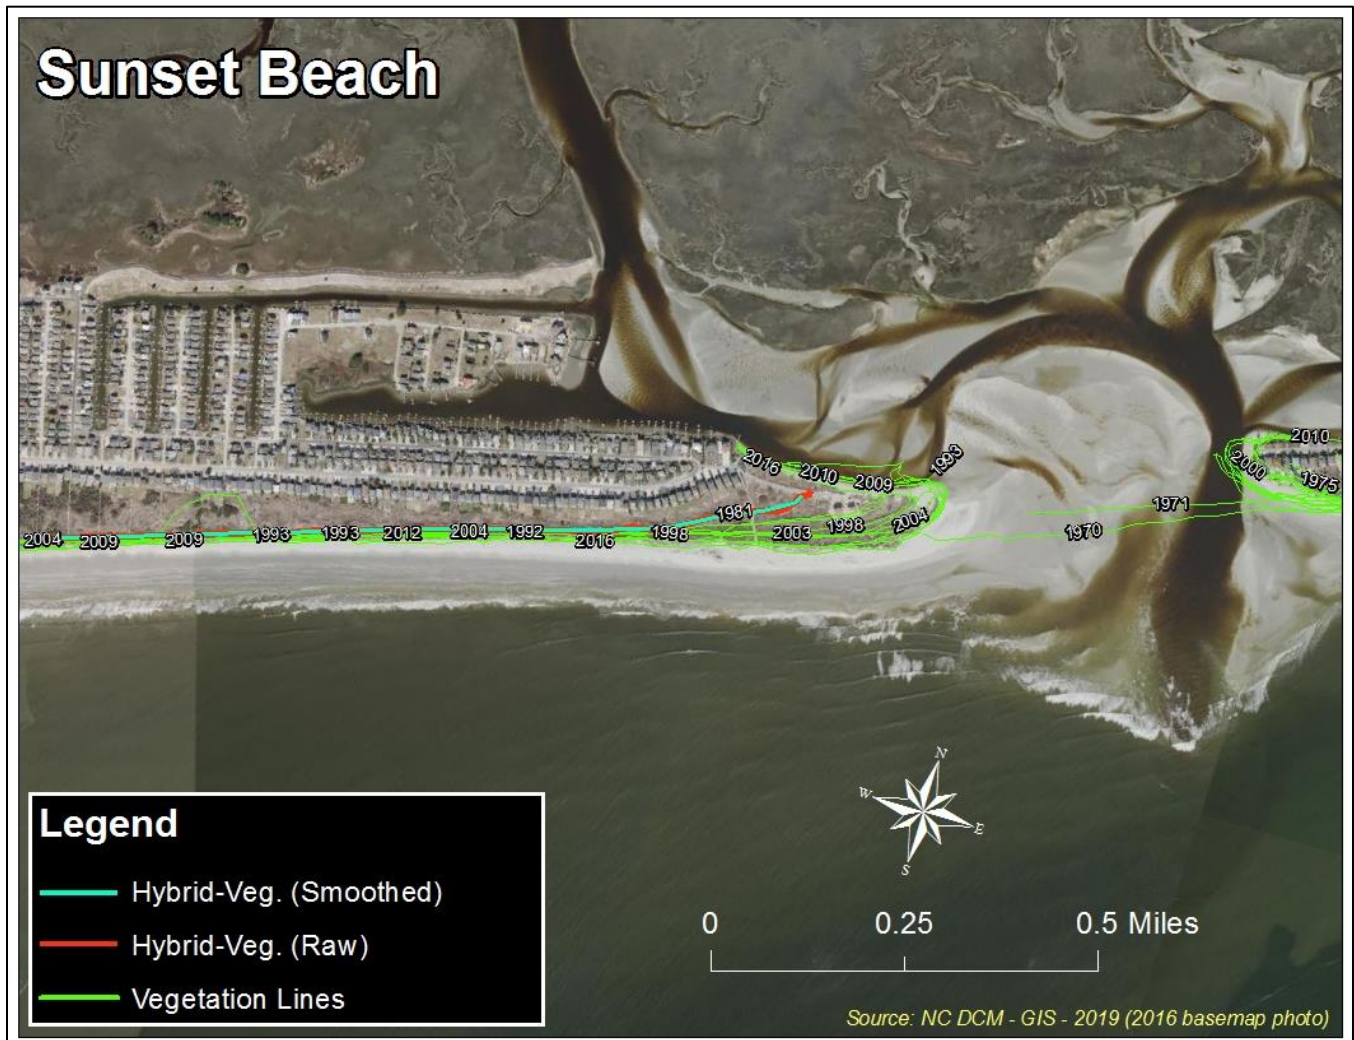
Figure 7. Tubbs Inlet at Sunset Beach. Vegetation Lines mapped: 1981, 1992, 1993, 1998, 2003, 2004, 2009, 2010, 2012, 2016. Vegetation line segments making up the Hybrid-Vegetation Line: 1981, 1993, 1998, 2003, 2004.

applying the IHAM (Figures 7, 8). The oceanfront shoreline boundary of inlet influence is inlet transect-210 (Figure 9). The 90-Year Risk Line is the recommended landward boundary (Figure 10).

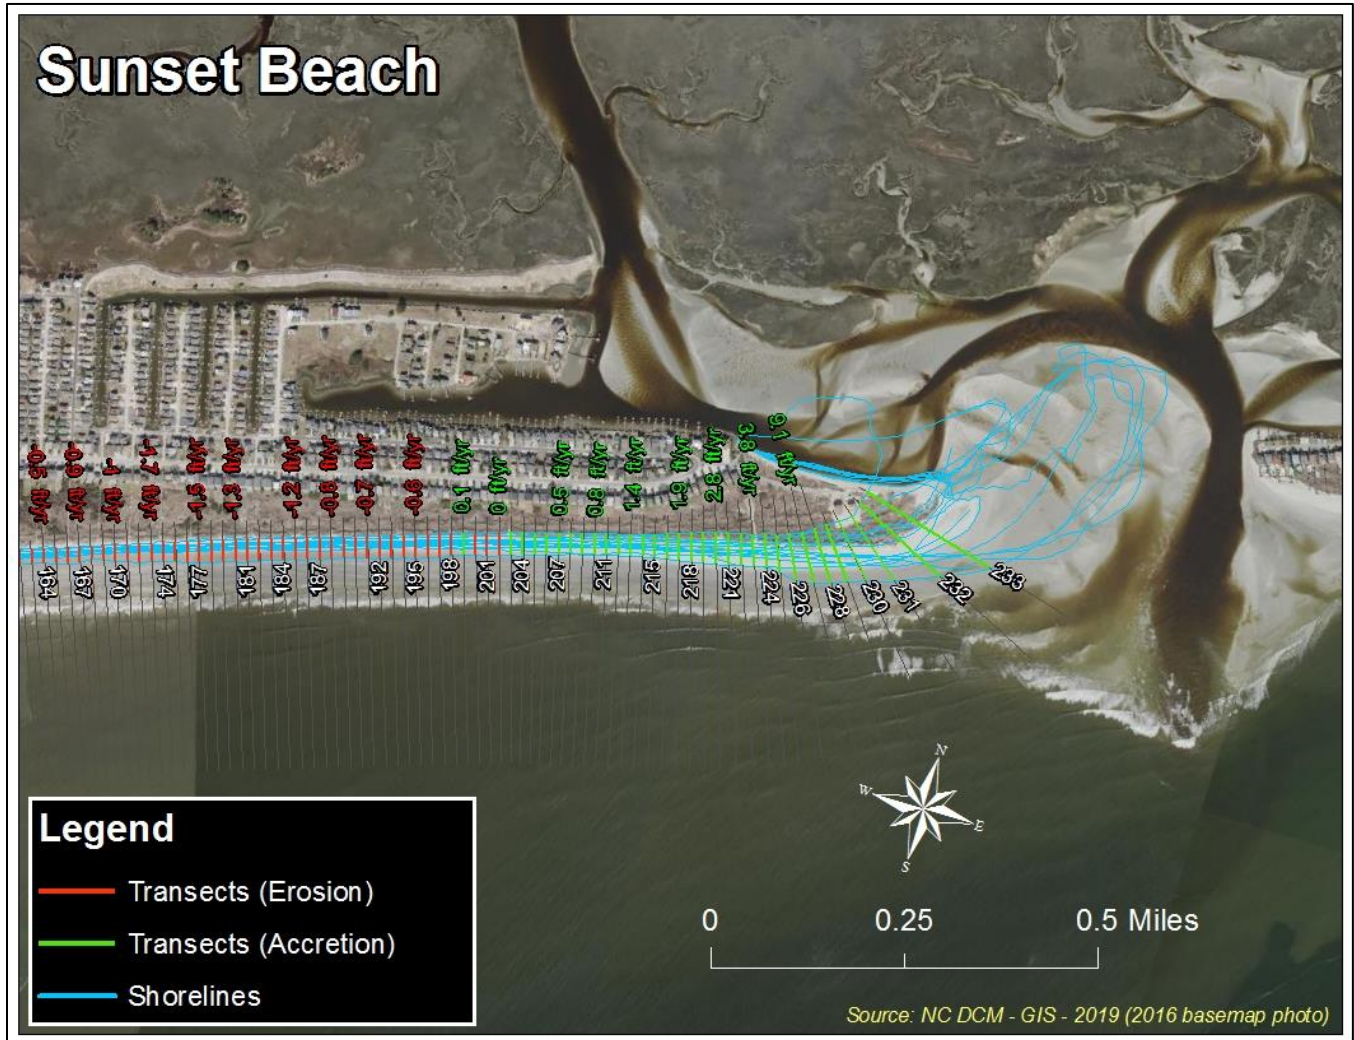
Figure 8. Tubbs Inlet at Sunset Beach. Shorelines included in the analysis: 1981, 1992, 1993, 1997, 1998, 2003, 2004, 2006, 2008, 2009, 2010, 2012, 2016.

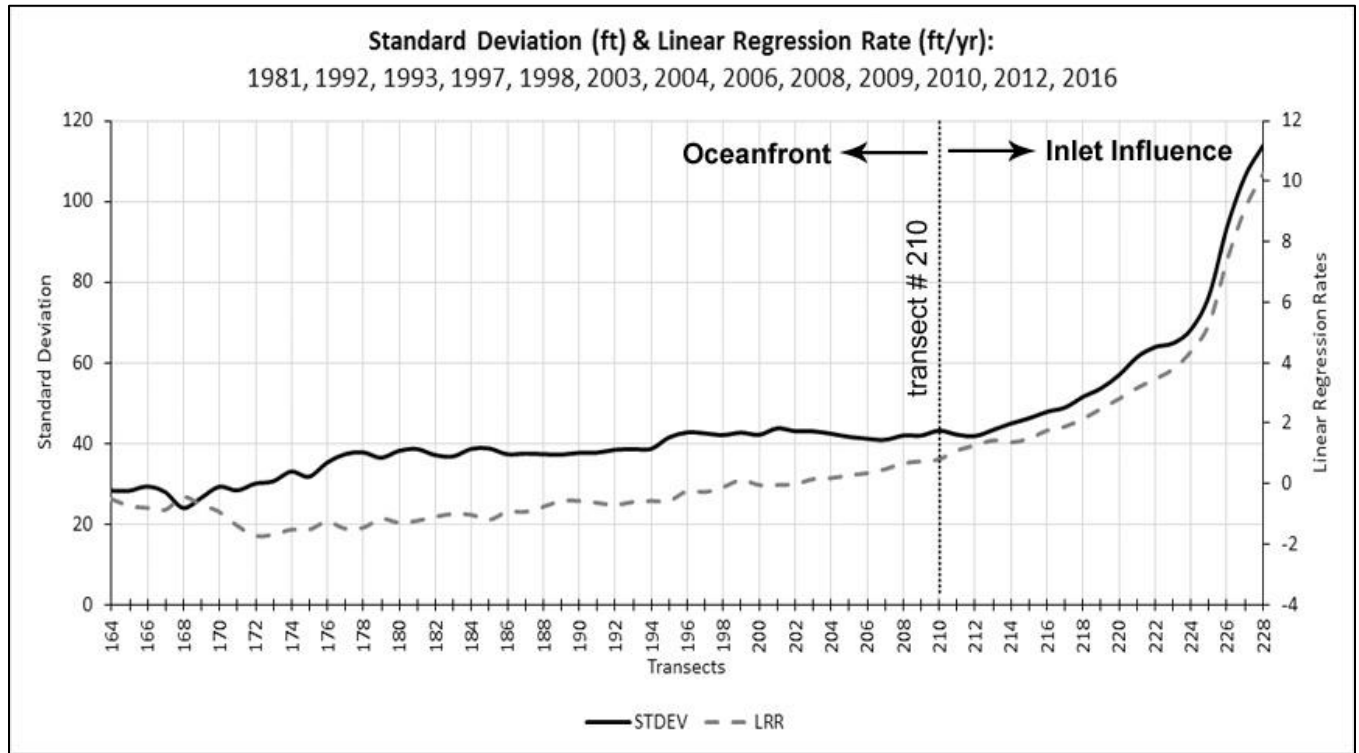
Figure 9. Based on standard deviation of shoreline position at Tubbs Inlet-Sunset Beach, transect-210 is recommended as the inlet-ocean transition boundary. Negative Linear Regression Rates indicate erosion, while positive values represent accretion (right axis).

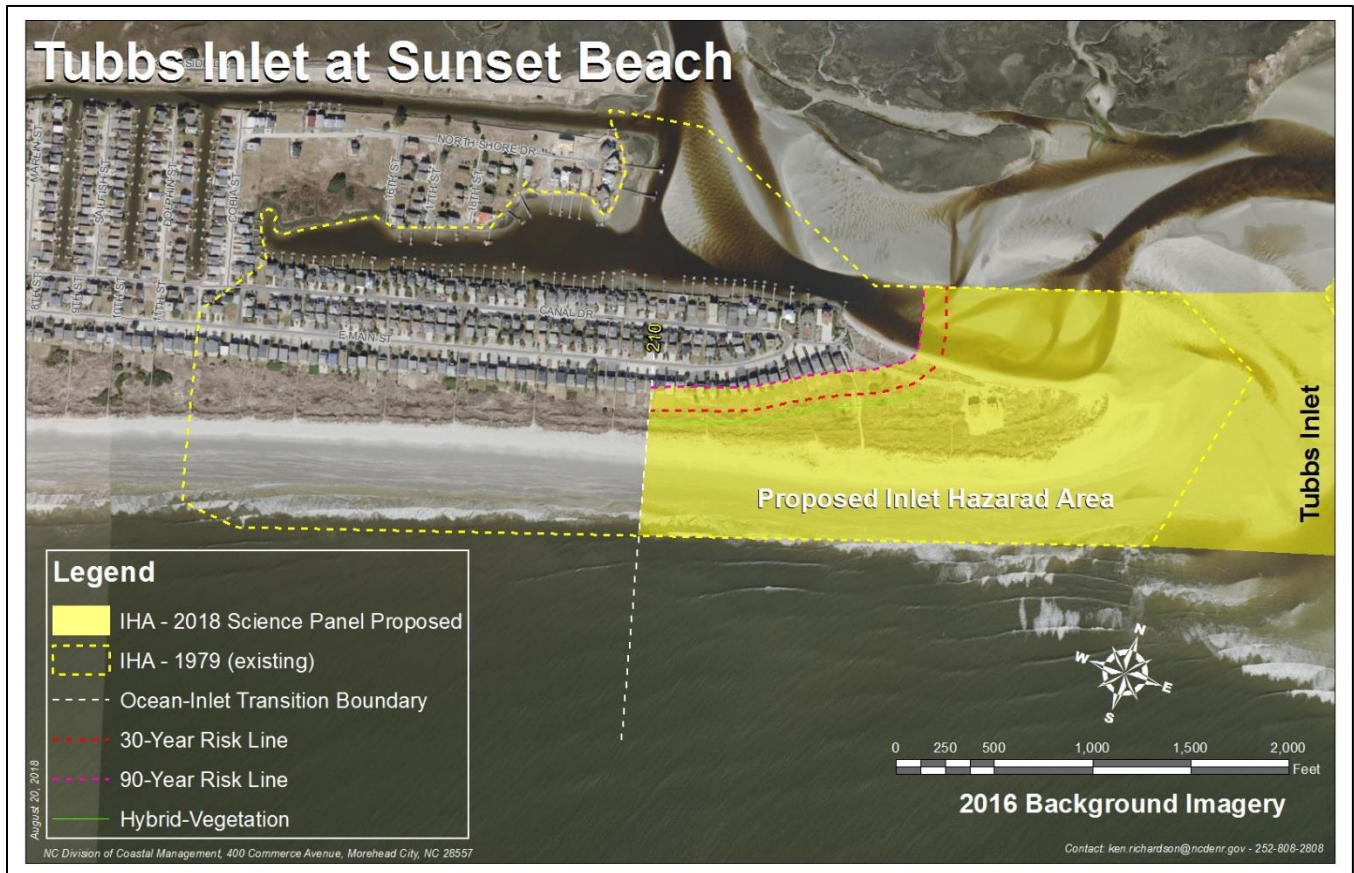
Figure 10. Tubbs Inlet at Sunset Beach Hybrid-Vegetation Line and the recommended IHA boundary with the 30- and 90-Year Risk Lines.

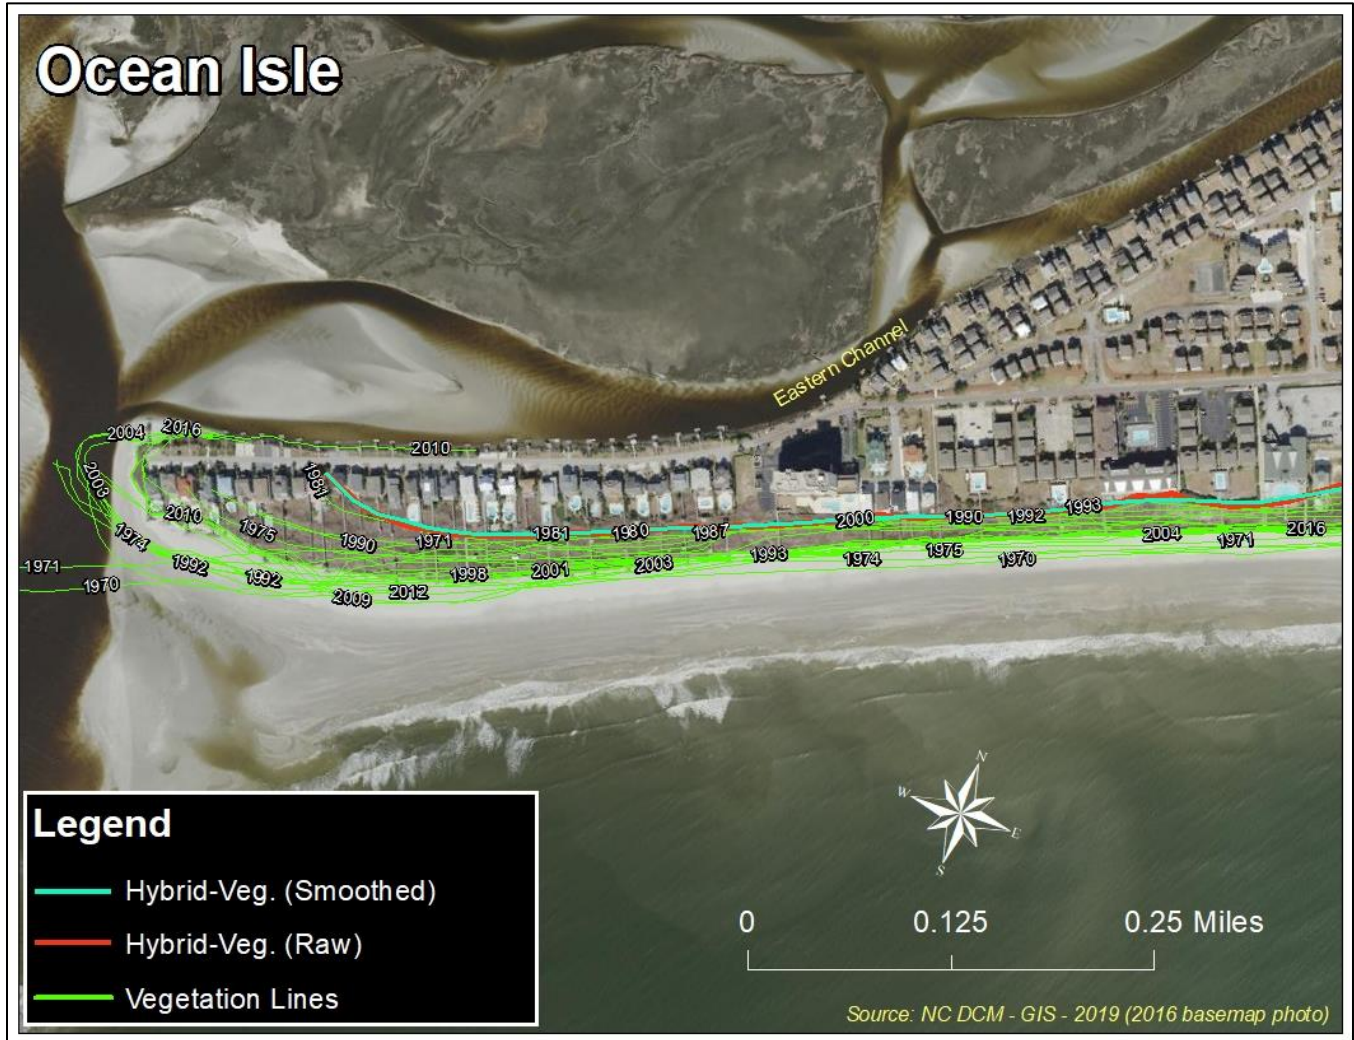
Figure 11. Tubbs Inlet at Ocean Isle. Vegetation Lines mapped: 1974, 1975, 1980, 1981, 1987, 1990, 1992, 1993, 1998, 2000, 2001, 2003, 2004, 2009, 2010, 2012, 2016. Vegetation line segments making up the hybrid-vegetation Line: 1980, 1981, 1990, 1993, 2000.

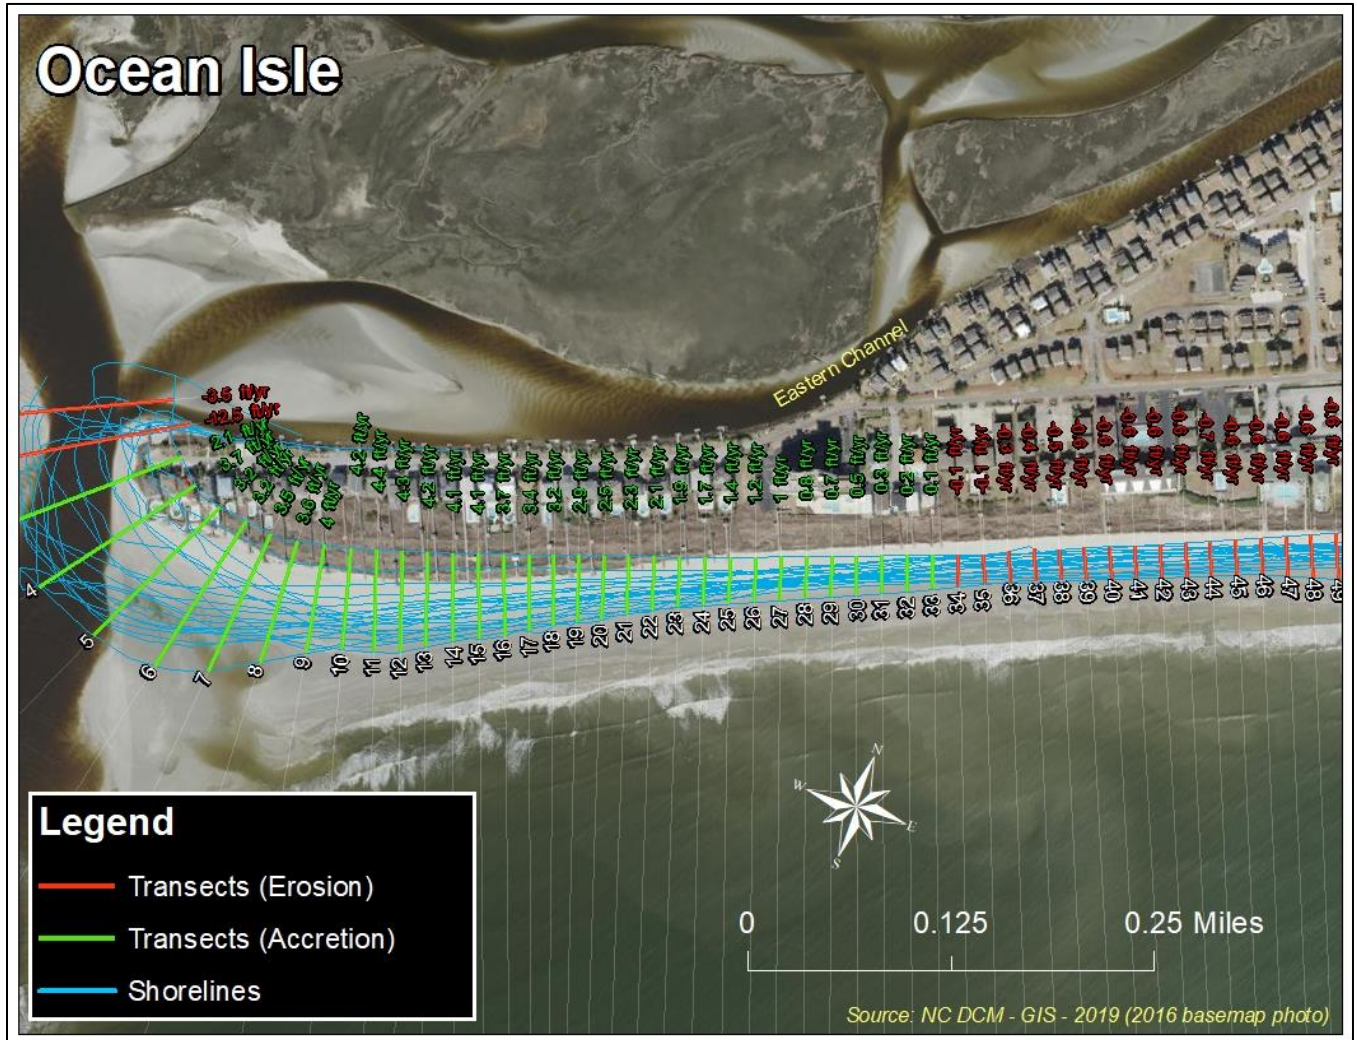
Figure 12. Tubbs Inlet at Ocean Isle. Shorelines included in the analysis: 1974, 1975, 1980, 1981, 1987, 1990, 1992, 1993, 1997, 1998, 2000, 2001, 2003, 2004, 2006, 2008, 2009, 2010, 2012, 2016.

Using the IHAM, transect-28 is the boundary of inlet influence (Figure 13); the recommended landward boundary is the 90-Year Risk Line (Figure 14).

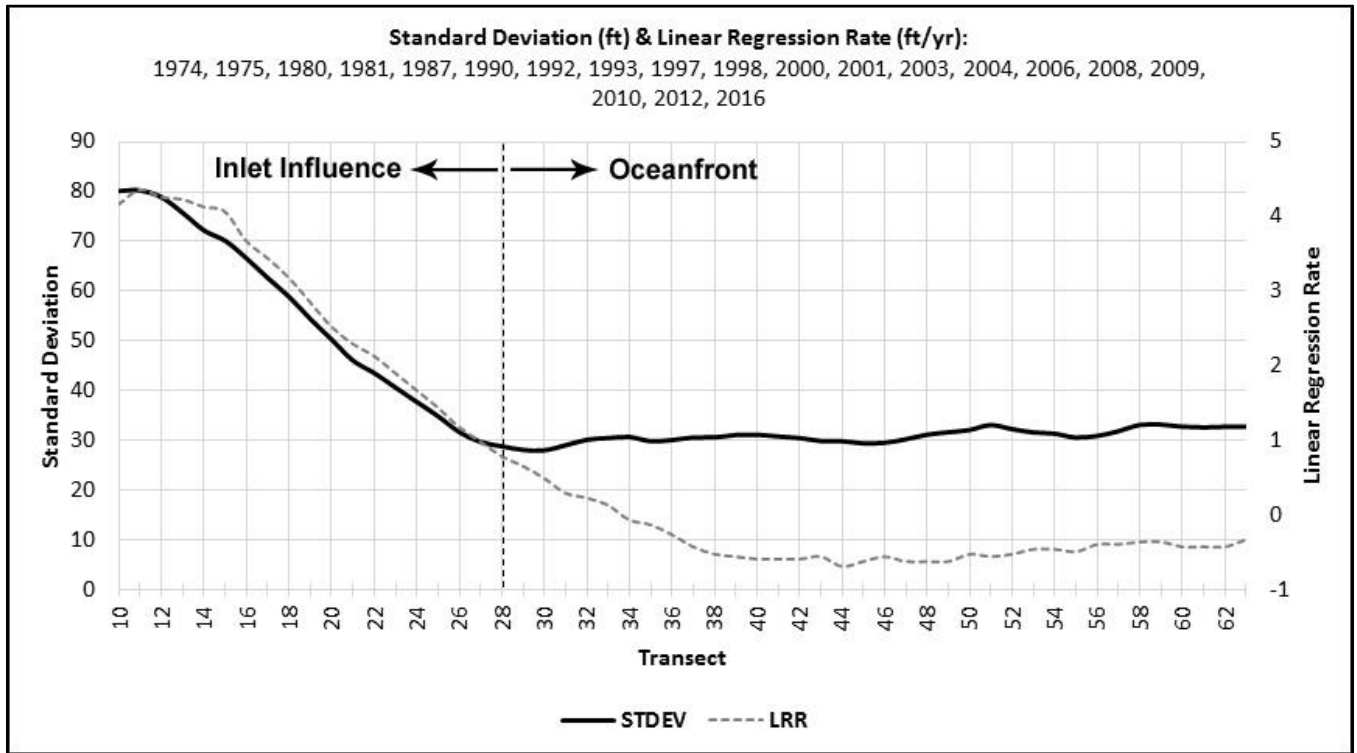
Figure 13. Based on standard deviation of shoreline position at Tubbs Inlet-Ocean Isle Beach, transect-28 is recommended as the inlet-ocean transition boundary along the shoreline. Negative Linear Regression rates indicate erosion, while positive values represent accretion (right axis).

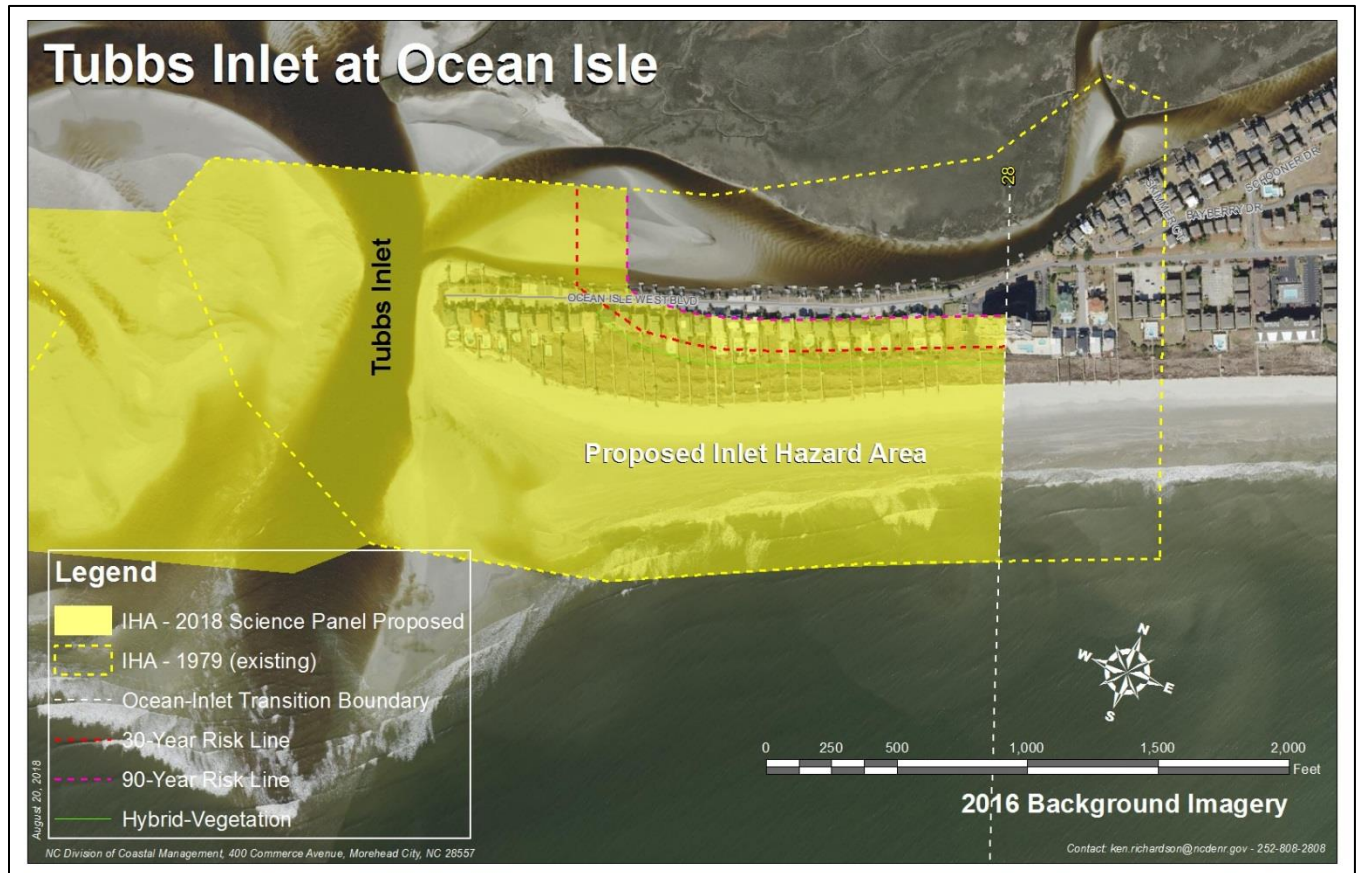
Figure 14. Map of Tubbs Inlet at Ocean Isle Beach Hybrid-Vegetation Line and the recommended IHA boundary with the 30- and 90-Year Risk Lines.

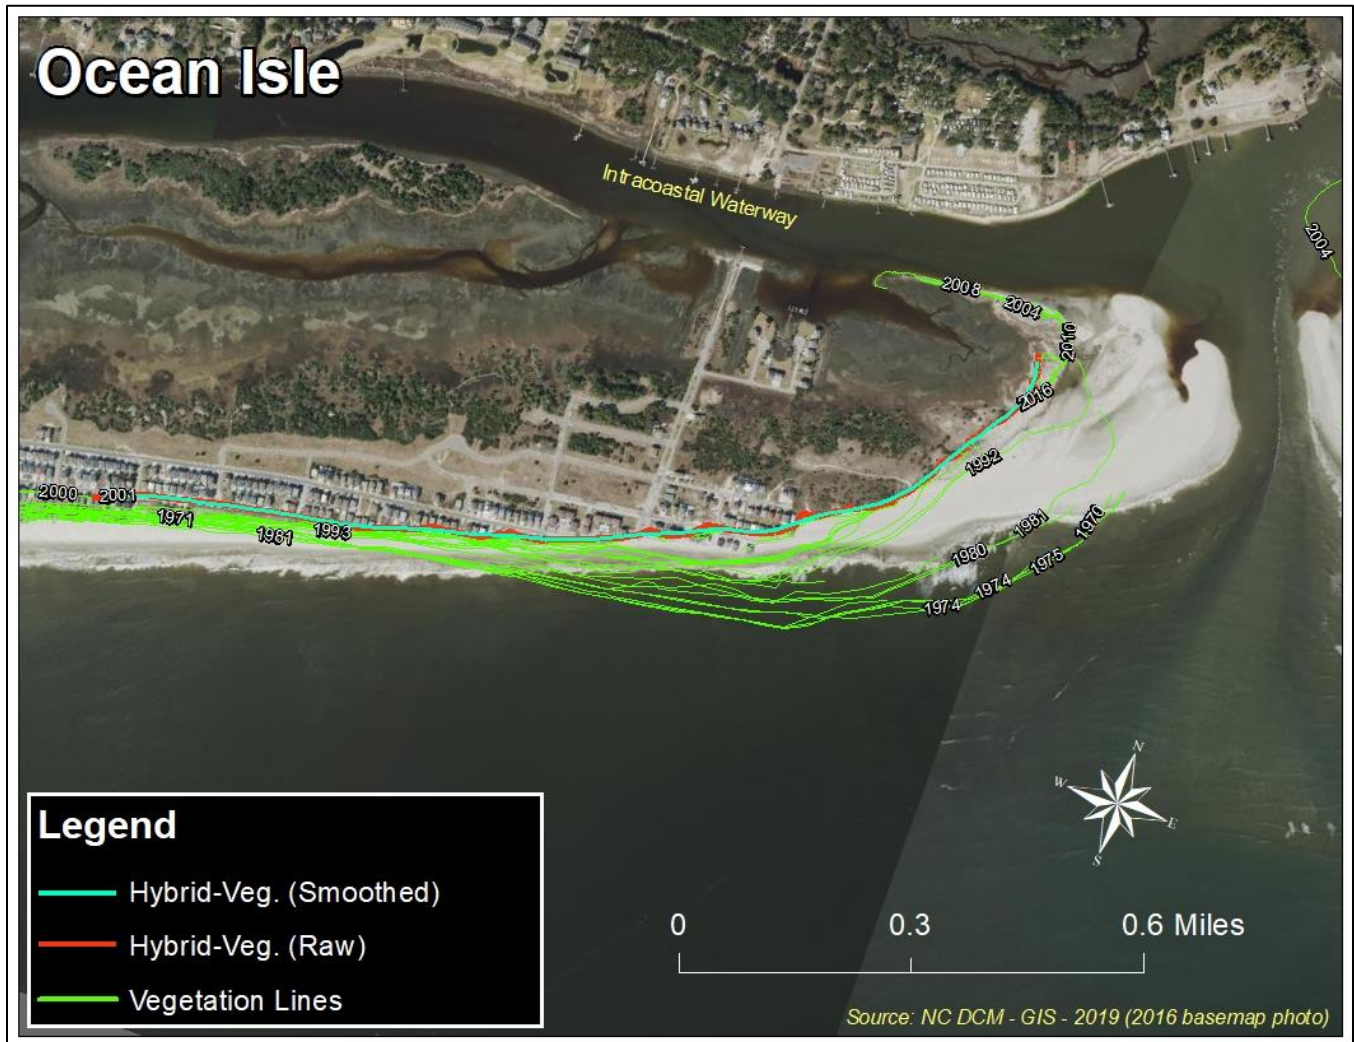
Figure 15. Shallotte Inlet at Ocean Isle. Vegetation Lines mapped: 1970, 1974, 1975, 1980, 1981, 1987, 1990, 1992, 1993, 1998, 2000, 2001, 2003, 2004, 2008, 2009, 2010, 2012, 2016. Vegetation line segments making up the Hybrid-Vegetation Line: 1998, 2000, 2001, 2003, 2004, 2008, 2009, 2010, 2012, 2016.

Although the channel's midpoint has been relatively stable since 1938, the shoulders of both Ocean Isle Beach and Holden Beach have experienced erosion and accretion. The impact of Hurricane Hazel in 1954 caused the reorientation of the channel to move in a more easterly direction, which made Ocean Isle Beach experience accelerated erosion. Therefore, shoreline data beginning in 1933 was used for the statistical analysis (Figures 15, 16). Inlet transect-291 is the boundary along the oceanfront shoreline where erosion rates start to accelerate approaching the inlet, and inlet processes start to affect the shoreline's position (Figure 17)¹. Because of the high erosion rates near the inlet (upwards of ~15 ft/yr), the Panel decided, based on the underlying geology and surface dune topography, that the 90-yr Risk Line mapped using the IHAM fell too far inland, into an area where an increased inlet threat is unlikely. The Panel recommends moving the 90-Year Risk Line and establishing the landward limit of the recommended IHA closer to the 30-Year Risk Line (Figure 18).

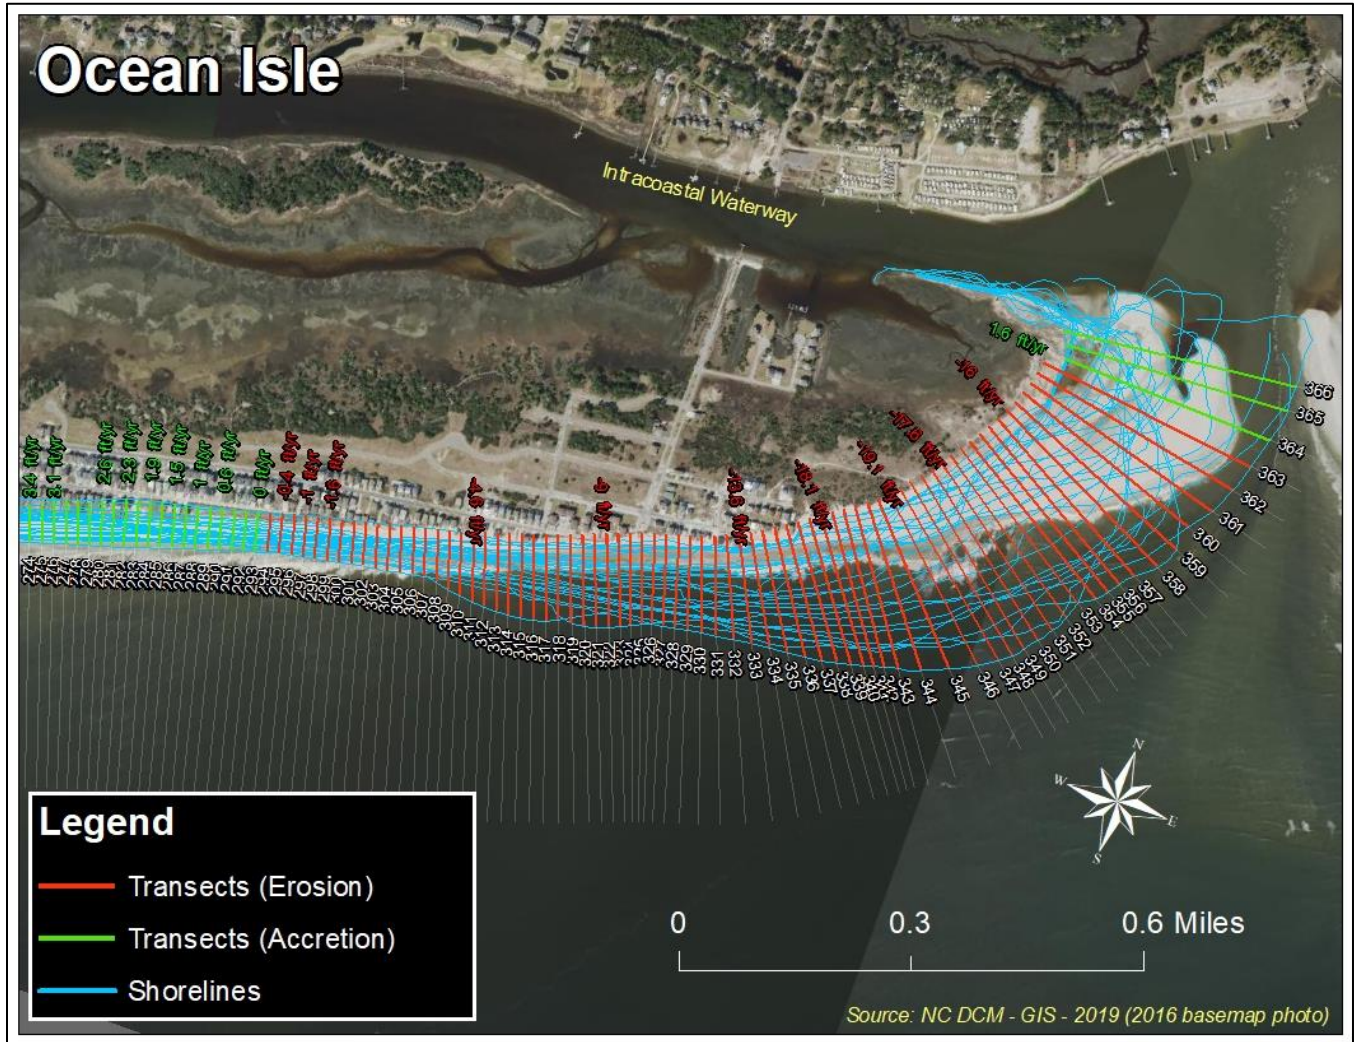
Figure 16. Shallotte Inlet at Ocean Isle. Shorelines included in the analysis: 1933, 1938, 1944, 1970, 1974, 1975, 1980, 1981, 1987, 1990, 1992, 1993, 1997, 1998, 2000, 2001, 2003, 2004, 2006, 2008, 2009, 2010, 2012, 2016.

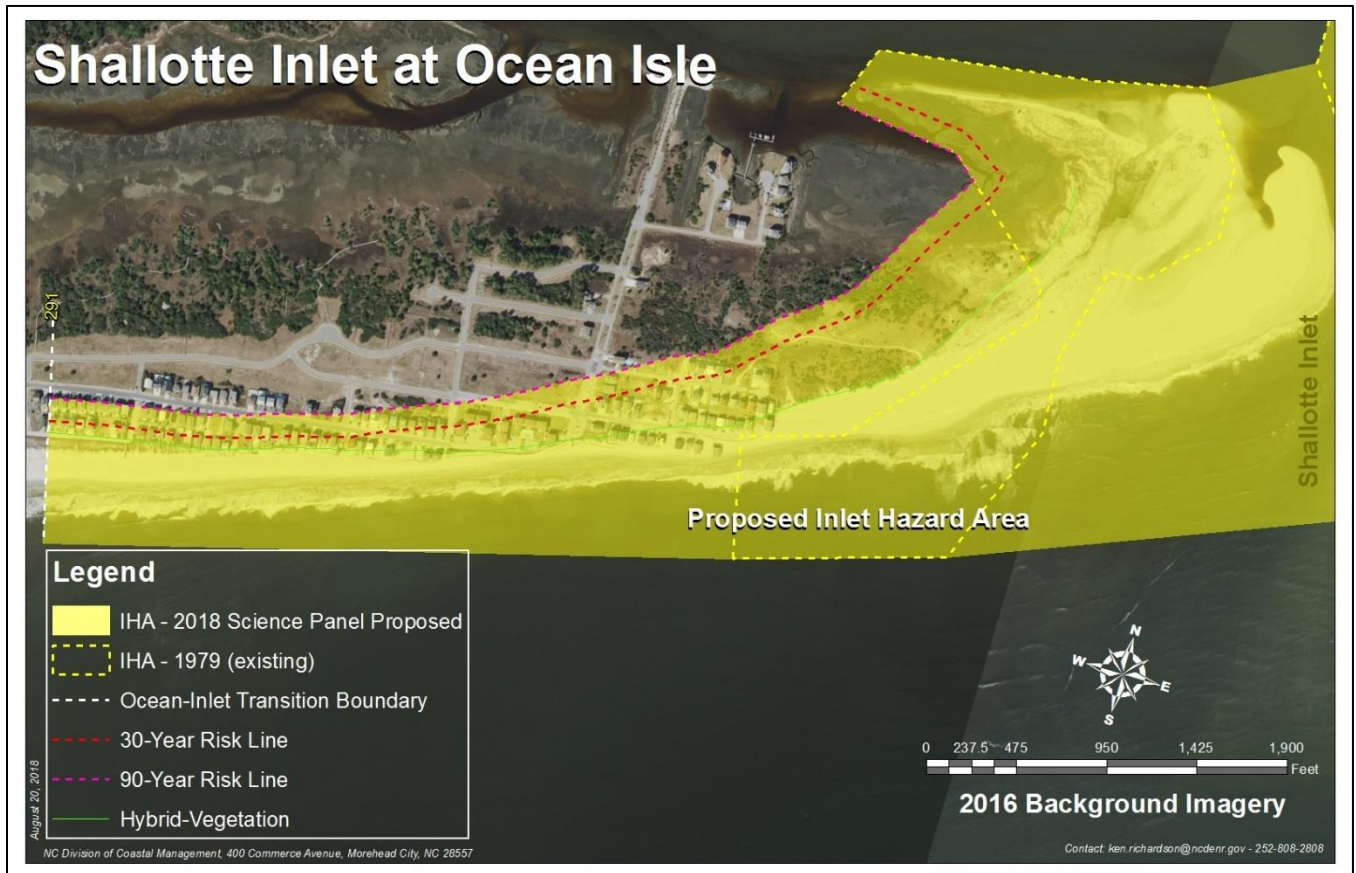
Figure 18. Shallotte Inlet at Ocean Isle Beach Hybrid-Vegetation Line and the recommended IHA boundary with the 30-Year Risk Line and modified 90-Year Risk Lines.

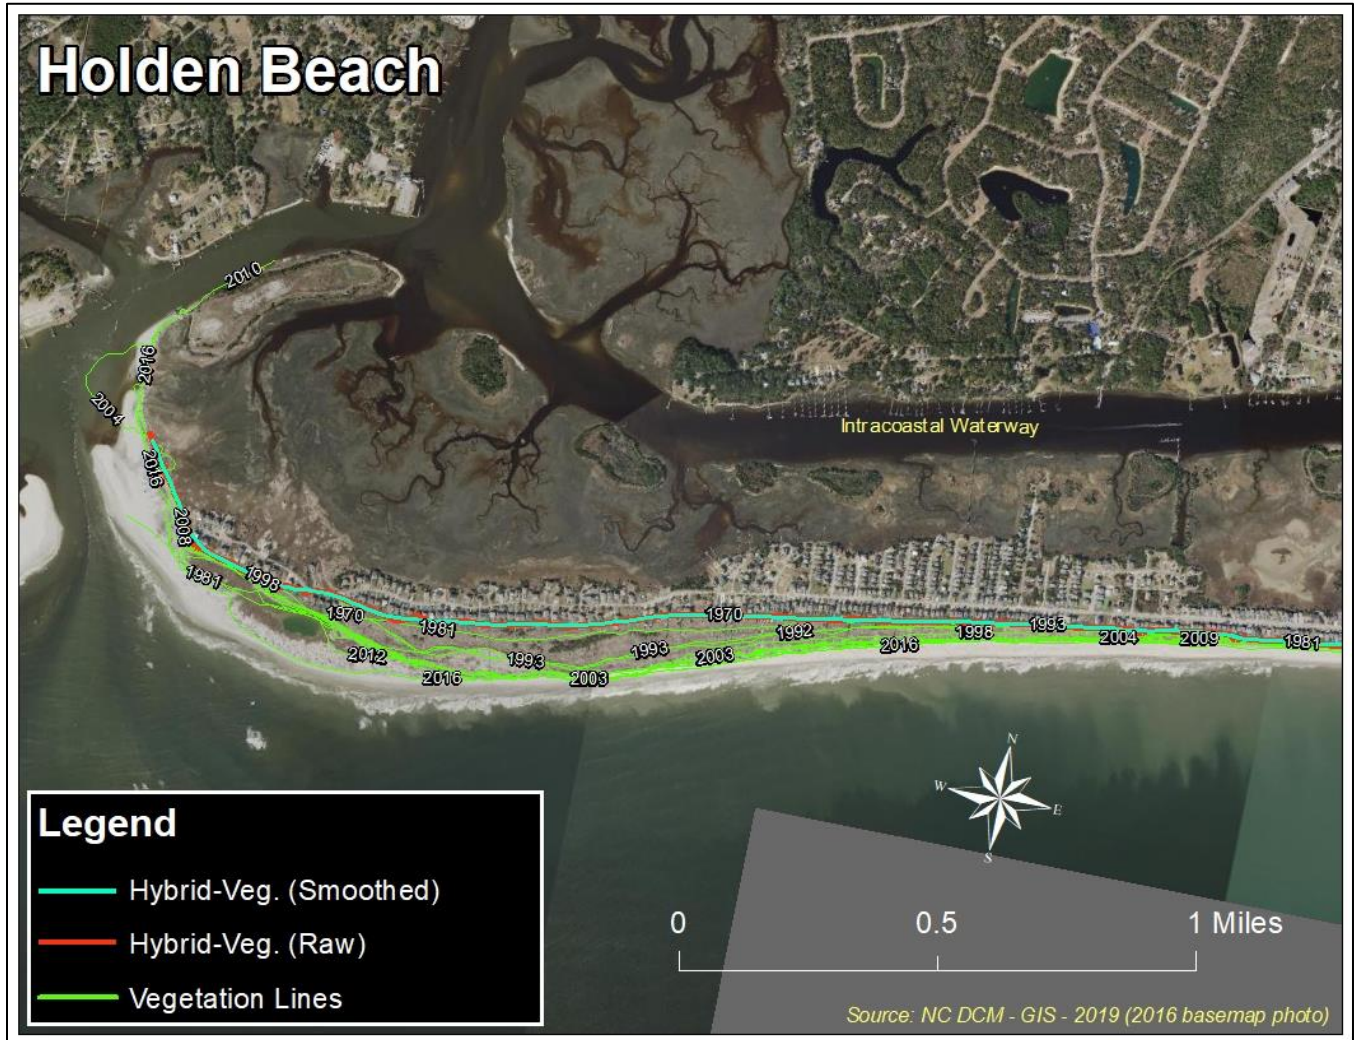
Figure 19. Shallotte Inlet at Holden Beach. Vegetation Lines mapped: 1970, 1981, 1992, 1993, 1998, 2003, 2004, 2008, 2009, 2010, 2012, 2016. Vegetation line segments making up the Hybrid-Vegetation Line: 1970, 1981, 1992, 1993, 1998, 2003, 2004, 2008, 2009, 2010.

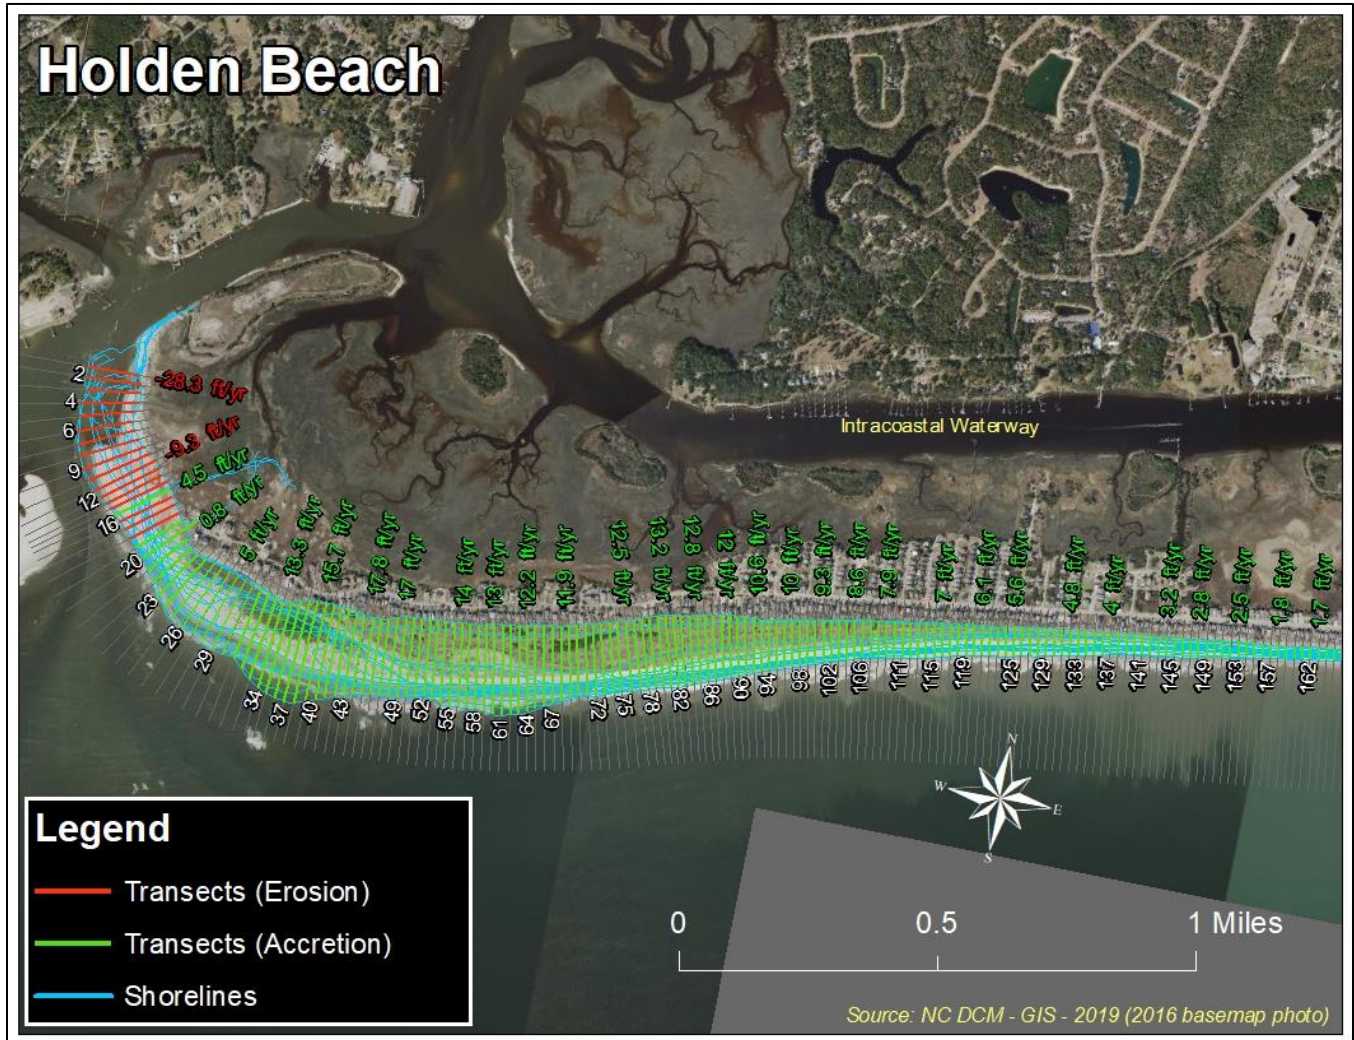
Figure 20. Shallotte Inlet at Holden Beach. Shorelines included in the analysis: 1970, 1981, 1992, 1993, 1997, 1998, 2003, 2004, 2006, 2008, 2009, 2010, 2012, 2016.

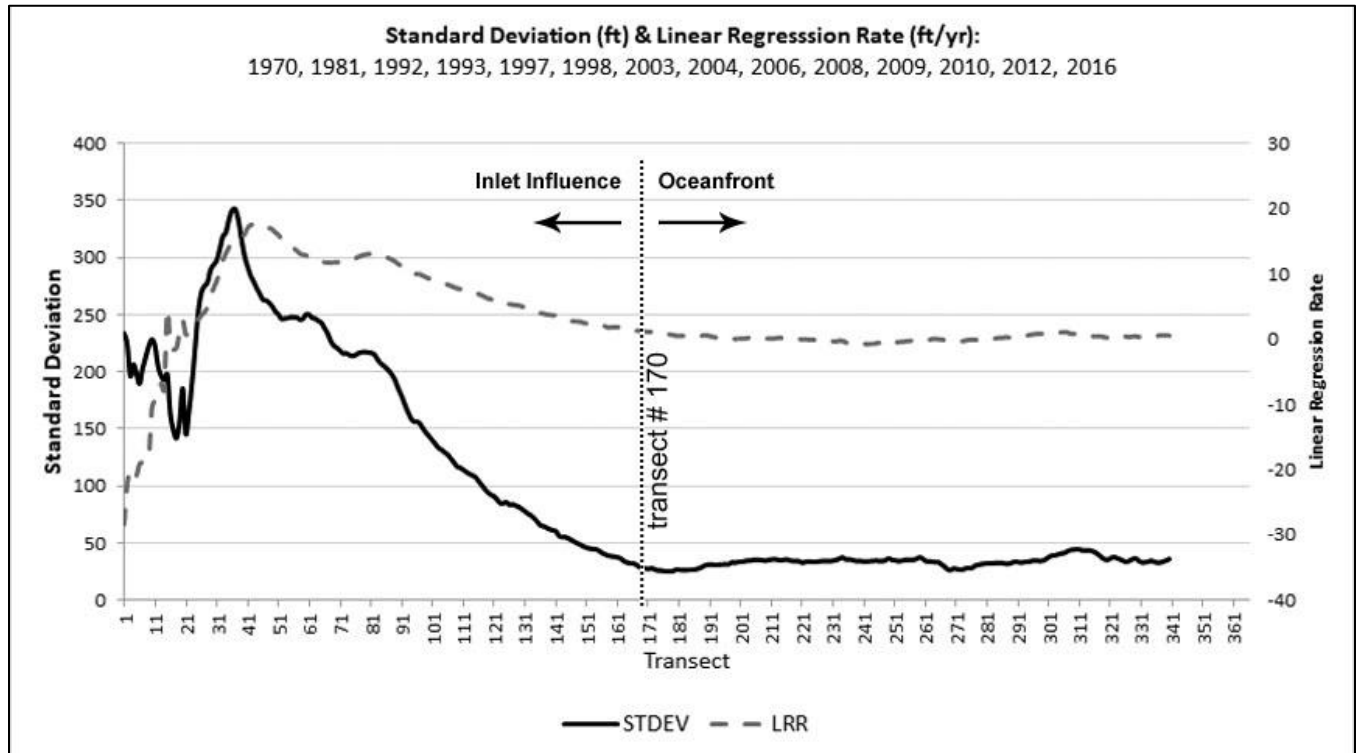
Figure 21. Based on the standard deviation of shoreline position at Shallotte Inlet-Holden Beach, transect-170 is recommended as the inlet-ocean transition boundary along the shoreline. Negative Linear Regression rates indicate erosion, while positive values represent accretion (right axis).

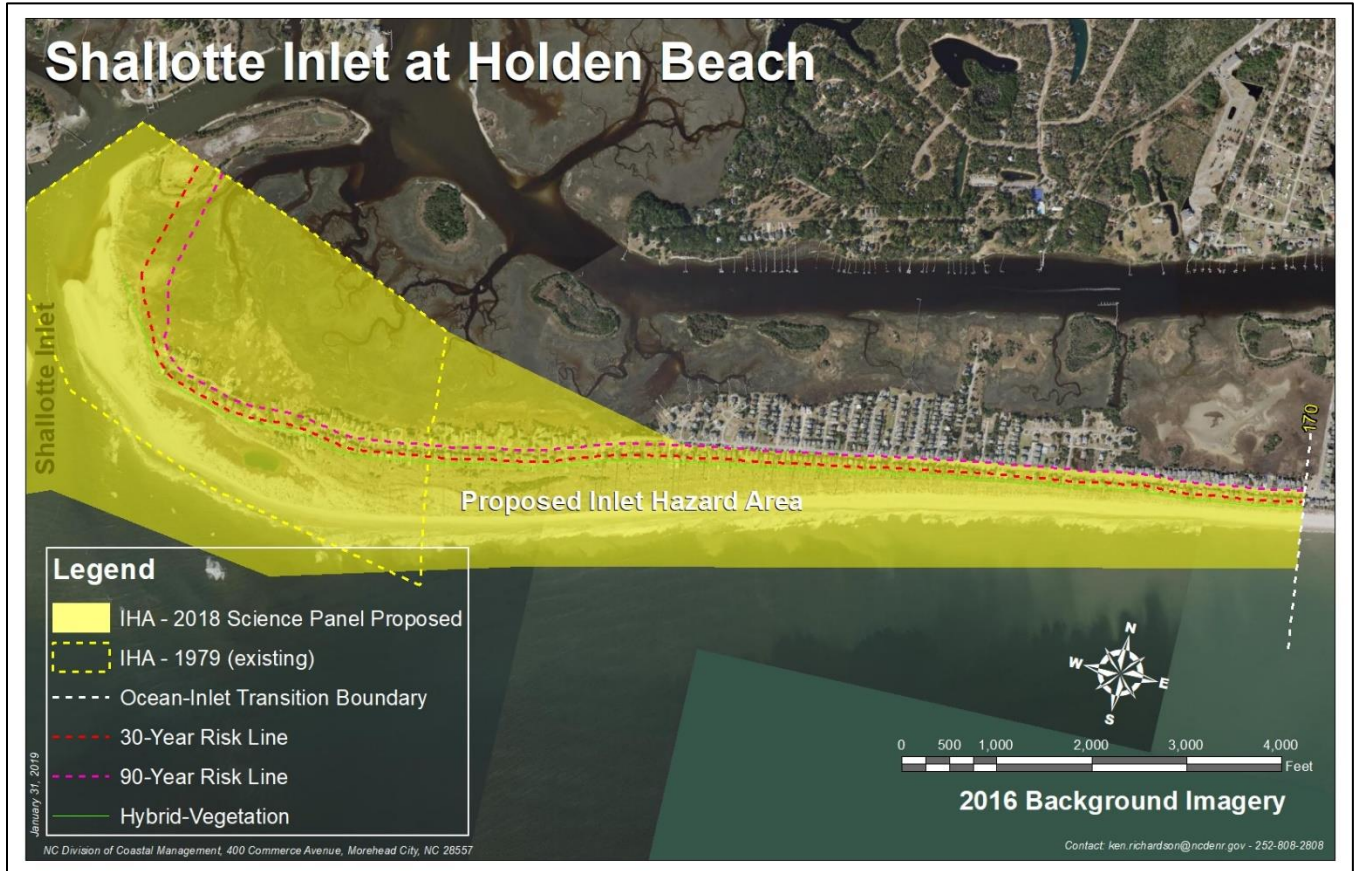
Figure 22. Shallotte Inlet at Holden Beach Hybrid-Vegetation Line and the recommended IHA boundary with the 30- and 90-Year Risk Lines. Black dashed line indicates Transect-90 where the IHA boundary was adjusted to match the existing IHA line (yellow dashed line).
