Inlet Hazard Area Boundary, 2019 Update:

Science Panel Recommendations to the
North Carolina Coastal Resources Commission

February 12, 2019

NC Coastal Resources Commission's Science Panel on Coastal Hazards
& NC Division of Coastal Management

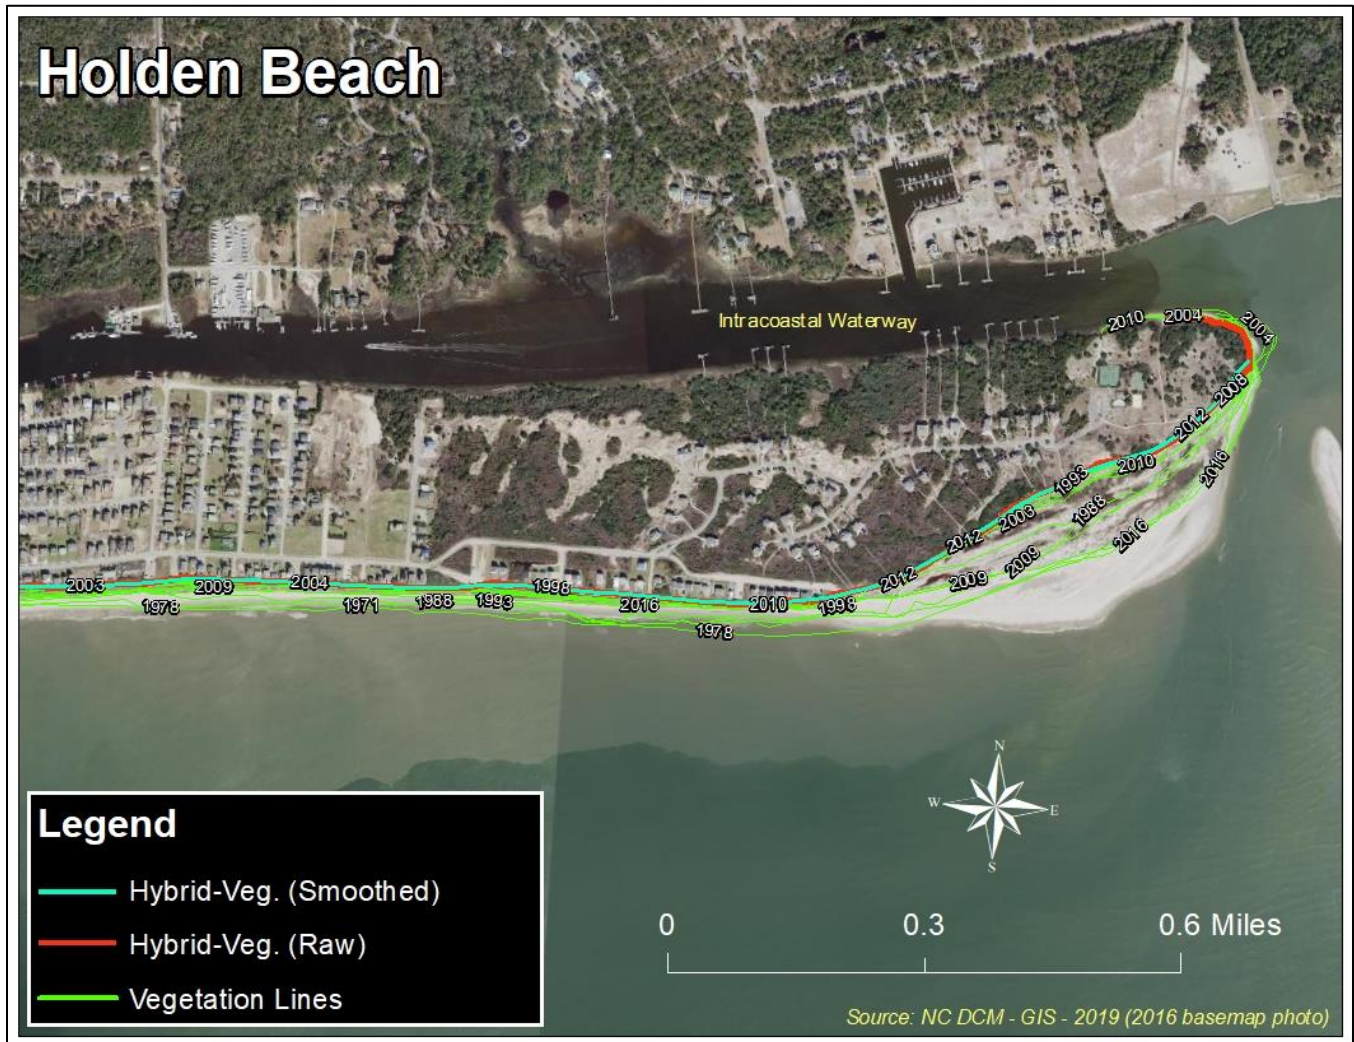
Figure 23. Lockwood Folly Inlet at Holden Beach. Vegetation Lines mapped: 1971, 1978, 1988, 1993, 1998, 2003, 2004, 2008, 2009, 2010, 2012, 2016. Vegetation line segments making up the Hybrid-Vegetation Line: 1971, 1988, 1993, 1998, 2003, 2004.

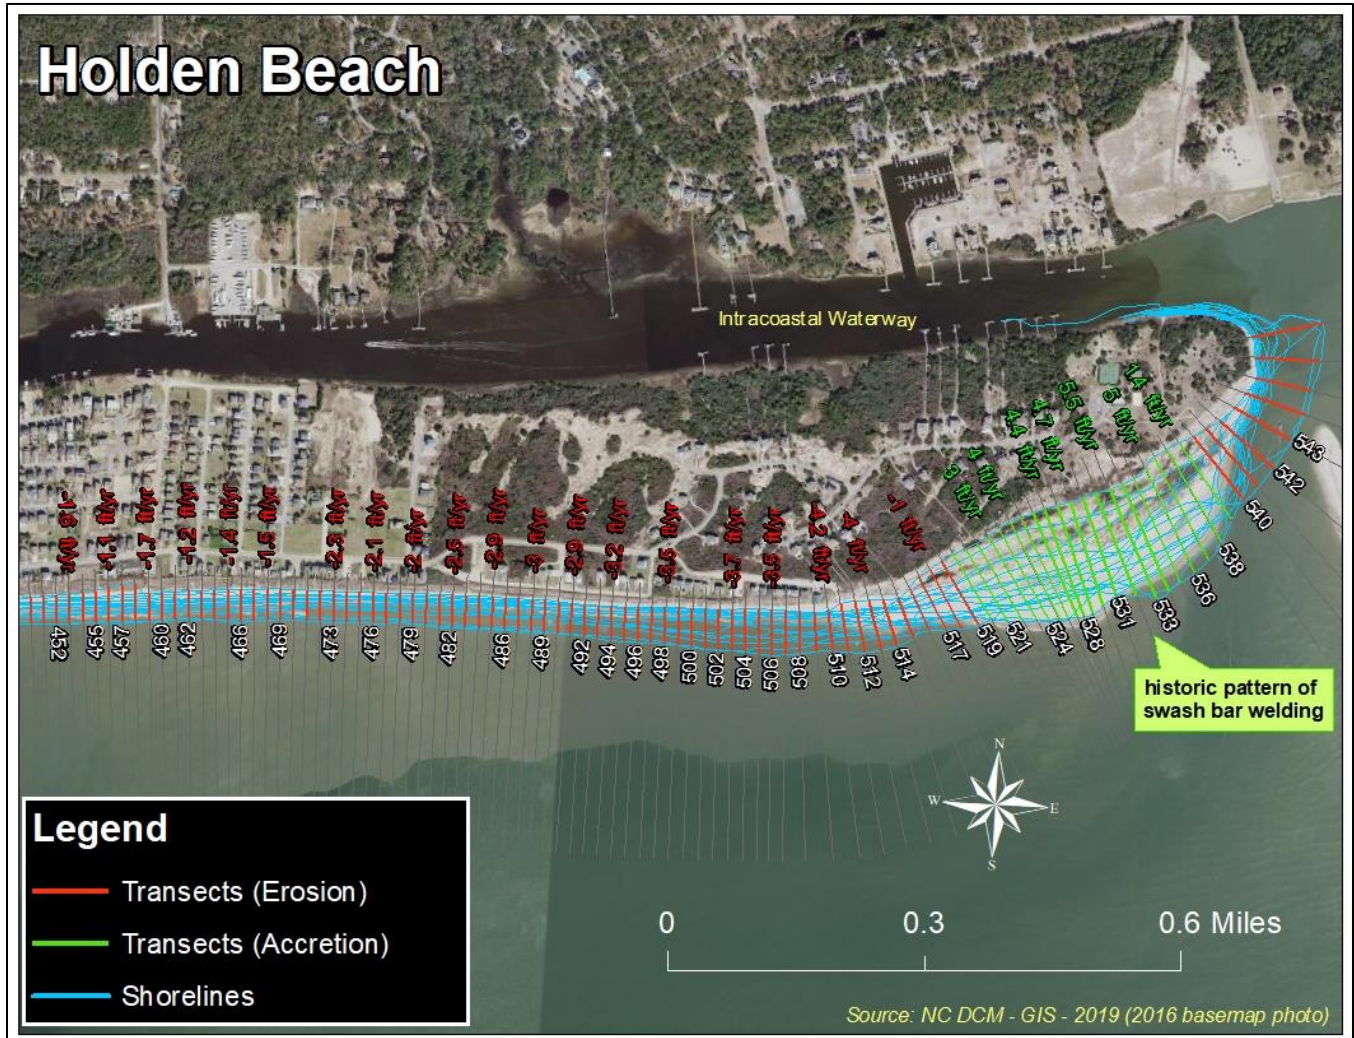
Figure 24. Lockwood Folly Inlet at Holden Beach. Shorelines included: 1970, 1971, 1978, 1988, 1993, 1997, 1998, 2003, 2004, 2006, 2008, 2009, 2010, 2012, 2016.

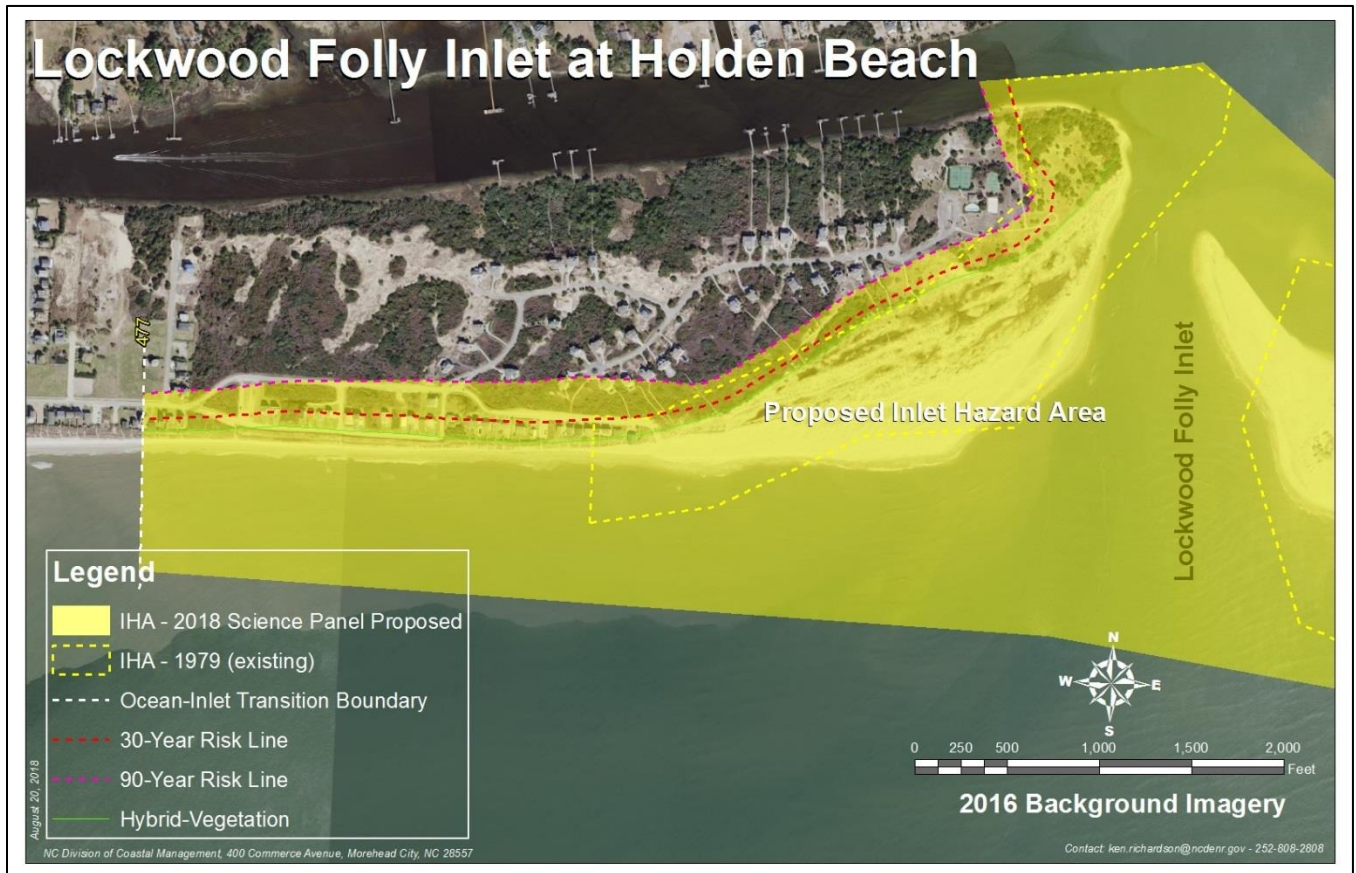
Figure 26. Lockwood Folly Inlet at Holden Beach Hybrid Vegetation Line and the recommended IHA boundary with the 30- and 90-Year Risk Lines.

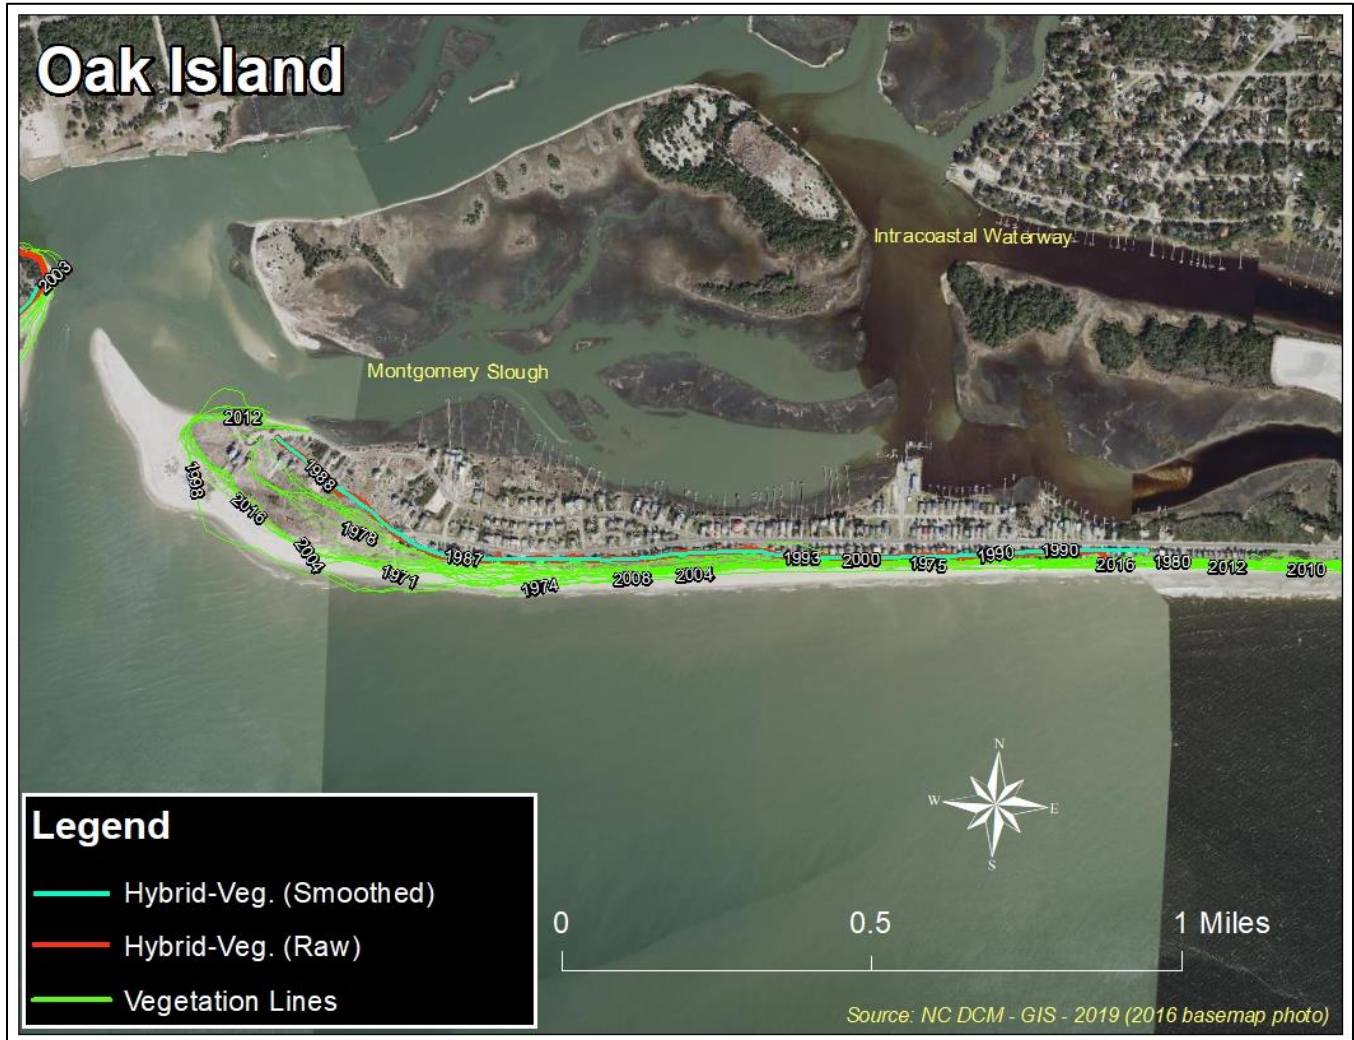
Figure 27. Lockwood Folly Inlet at Oak Island. Vegetation Lines mapped: 1971, 1974, 1975, 1978, 1979, 1980, 1987, 1988, 1990, 1993, 1998, 2000, 2003, 2004, 2008, 2009, 2010, 2012, 2016. Vegetation line segments making up the Hybrid-Vegetation Line: 1971, 1987, 1988, 1990, 1993, 2016.

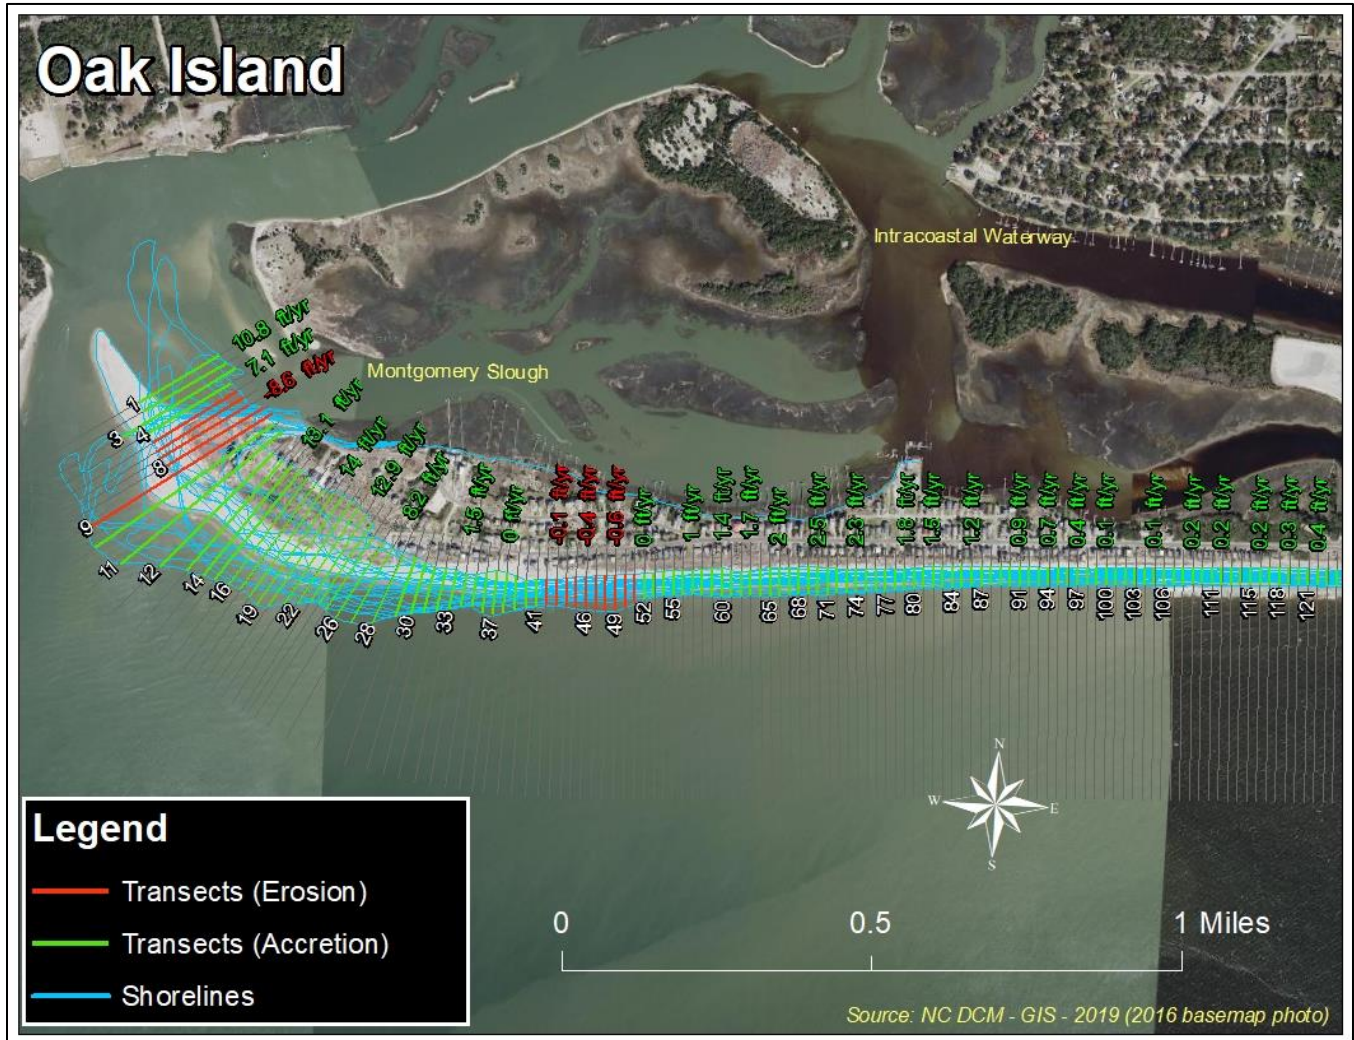
Figure 28. Lockwood Folly Inlet at Oak Island. Shorelines included: 1970, 1971, 1974, 1975, 1978, 1979, 1980, 1981, 1987, 1988, 1990, 1993, 1997, 1998, 2000, 2003, 2004, 2006, 2008, 2009, 2010, 2012, 2016.

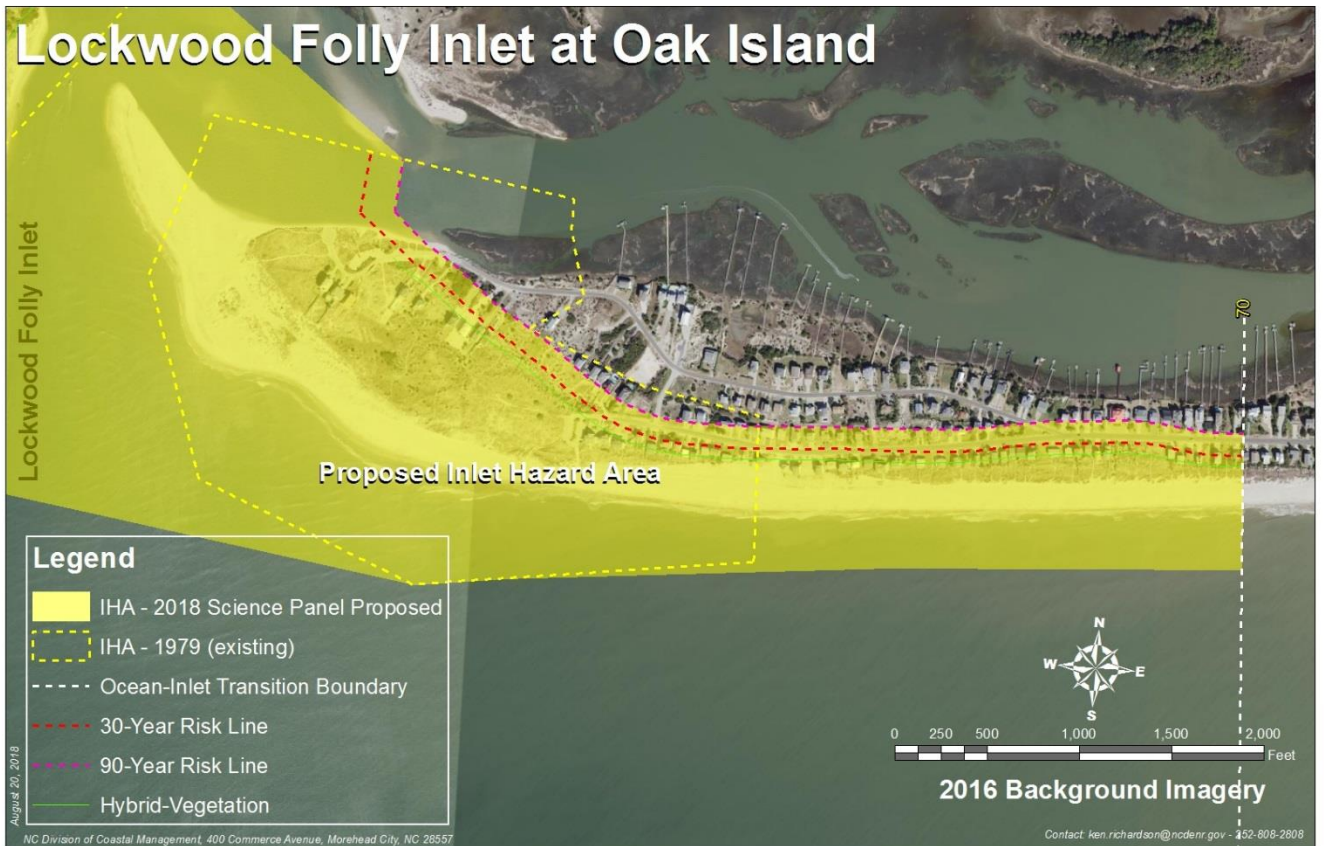
Figure 30. Lockwood Folly Inlet at Oak Island Hybrid Vegetation Line and the recommended IHA boundary with the 30- and 90-Year Risk Lines.

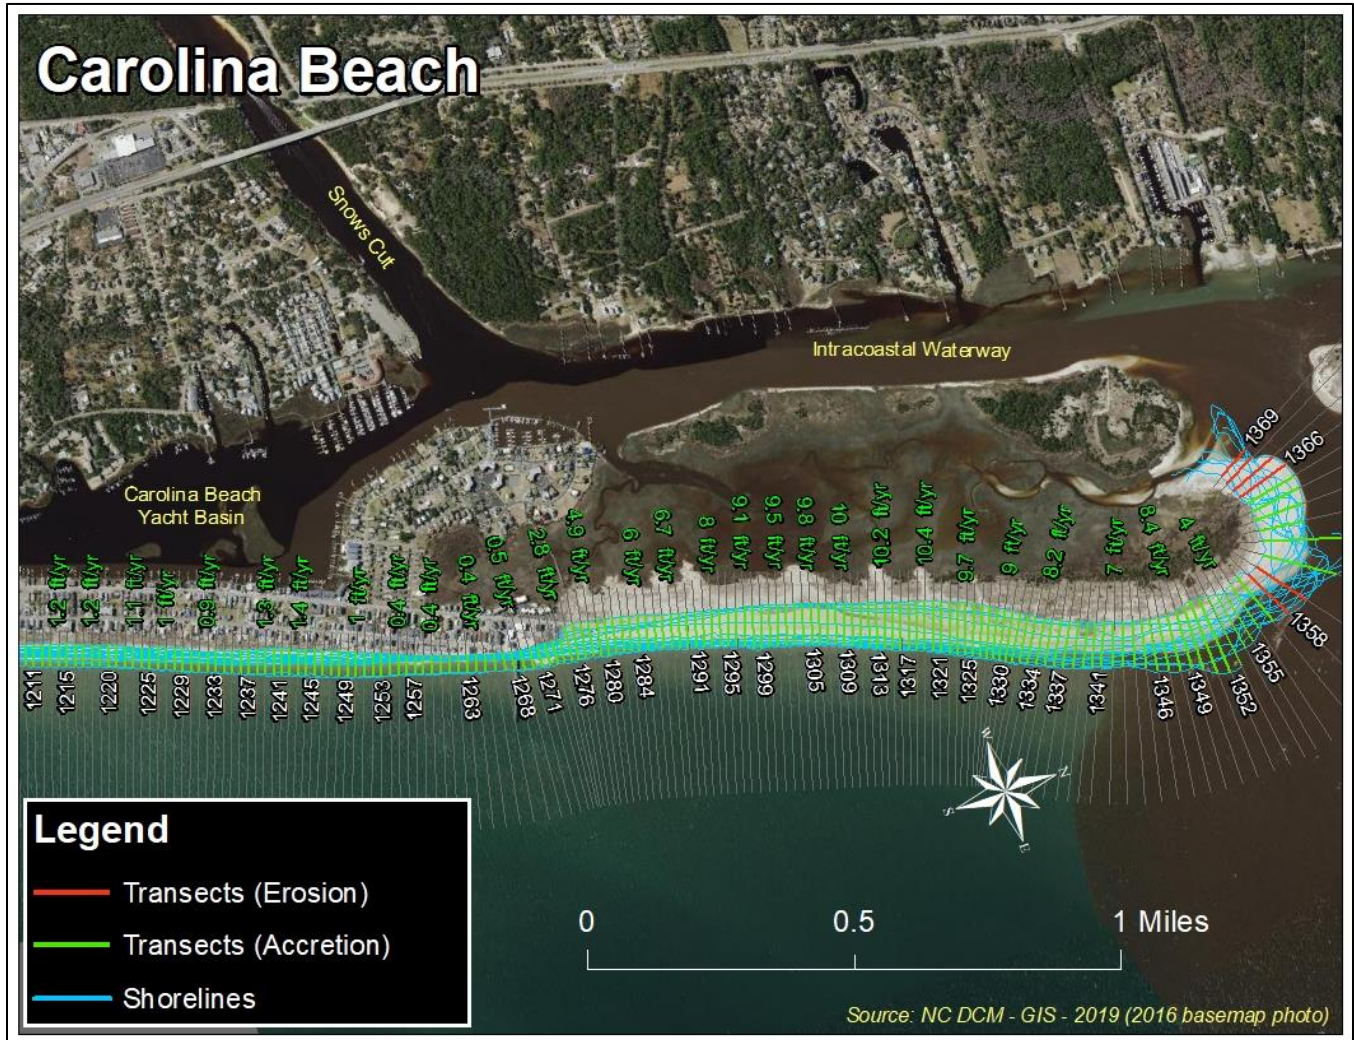
Figure 32. Carolina Beach Inlet at Carolina Beach. Shorelines included in the analysis: 1971, 1973, 1974, 1977, 1984, 1992, 1997, 1998, 2002, 2003, 2004, 2006, 2008, 2009, 2010, 2012, 2016.

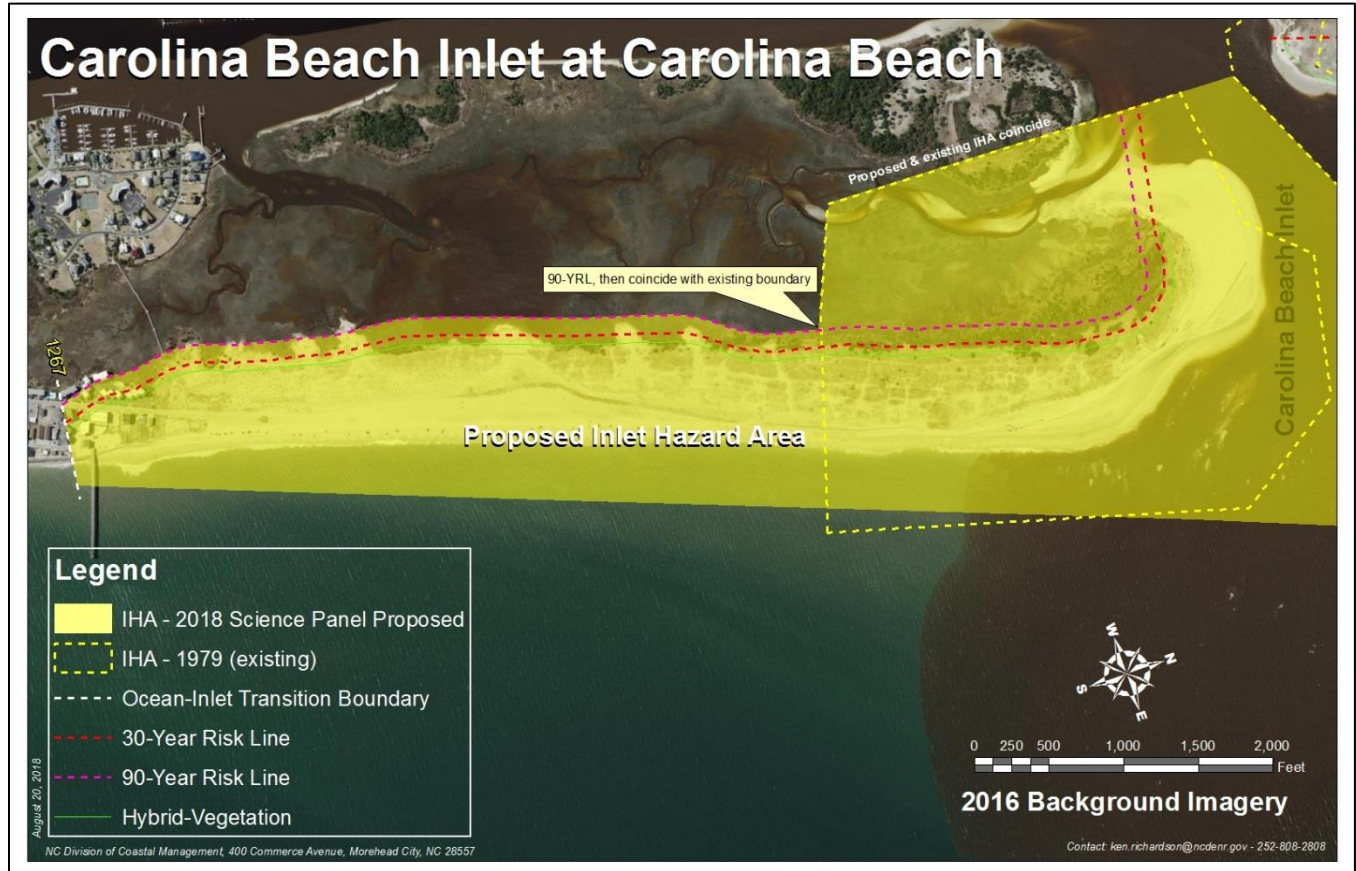
Figure 34. Carolina Beach Inlet at Carolina Beach Hybrid Vegetation Line and the recommended IHA boundary with the 30- and 90-Year Risk Lines.

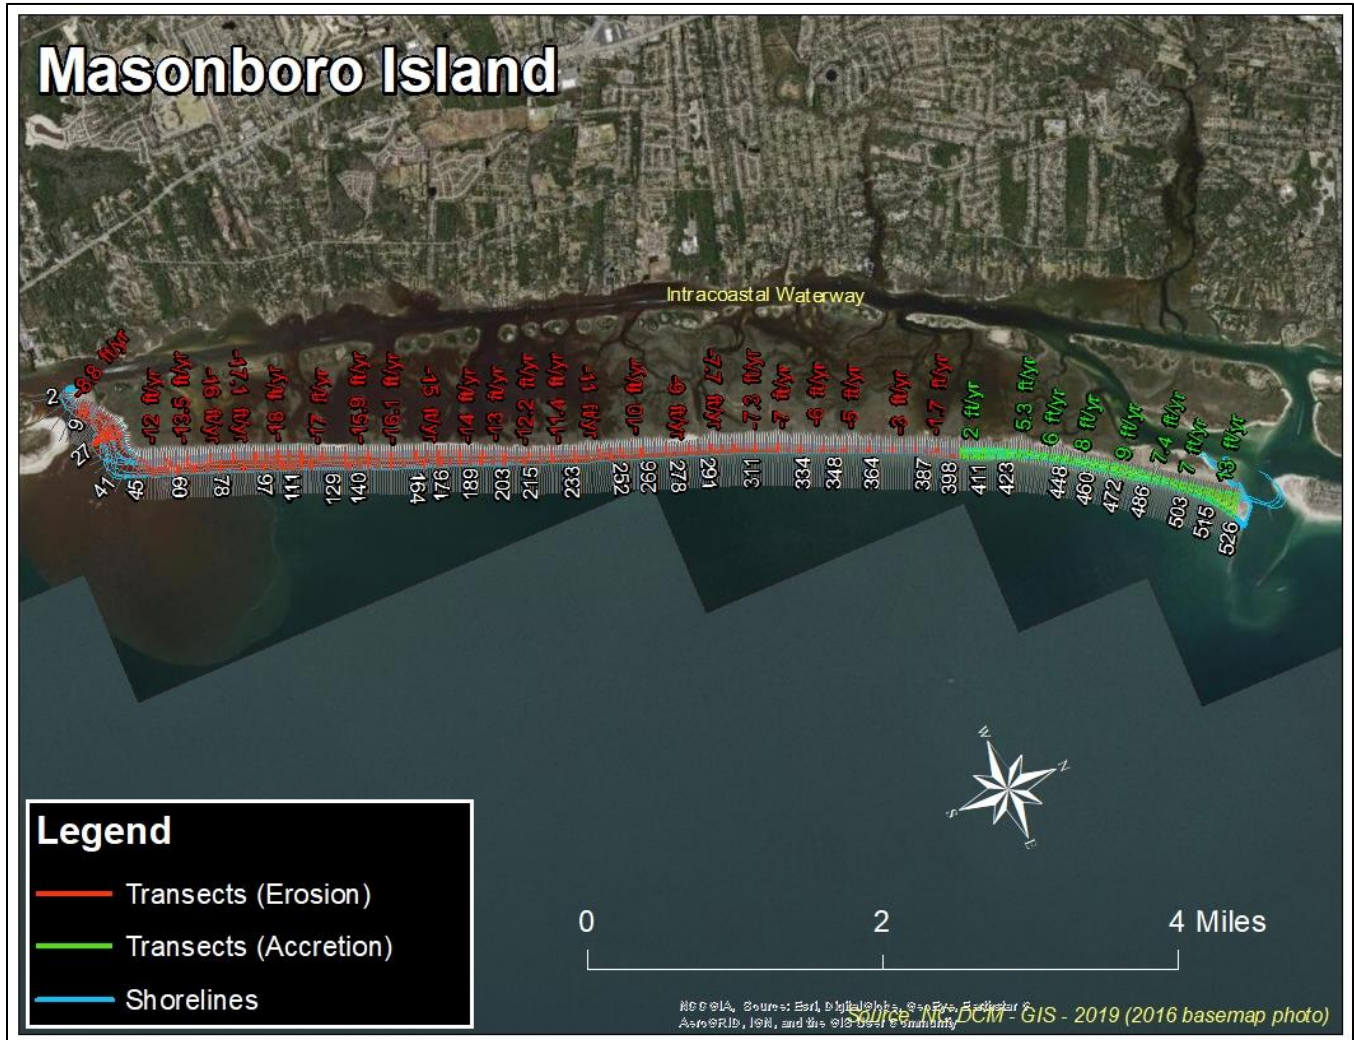
Figure 36. Carolina Beach and Masonboro Inlets at Masonboro Island. Shorelines included in the analysis: 1971, 1974, 1977, 1984, 1992, 1997, 1998, 2000, 2002, 2003, 2004, 2006, 2008, 2009, 2010, 2012, 2016.

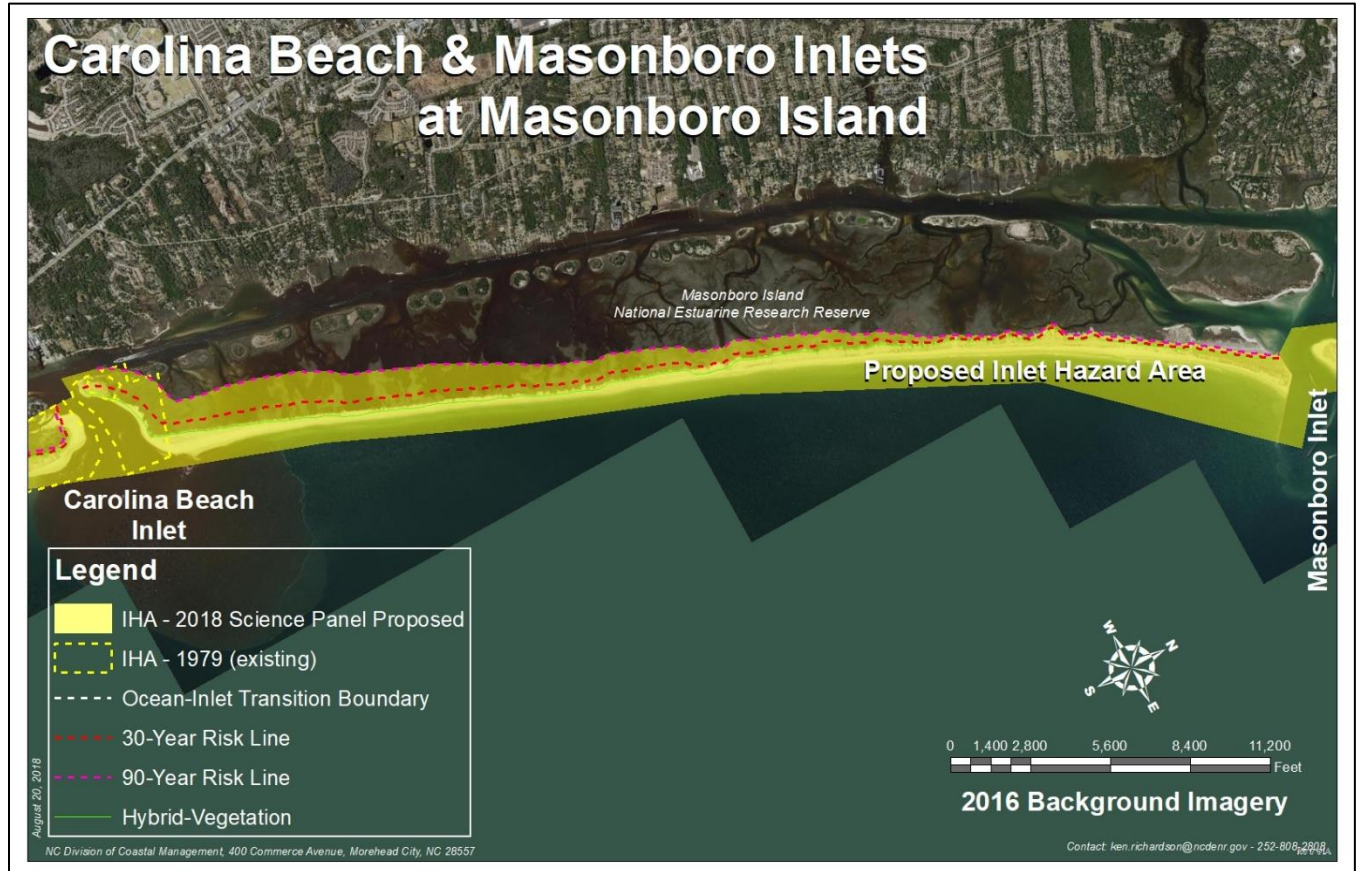
Figure 38. Carolina Beach and Masonboro Inlets at Masonboro Island Hybrid Vegetation Line and the recommended IHA boundary with the 30- and 90-Year Risk Lines.

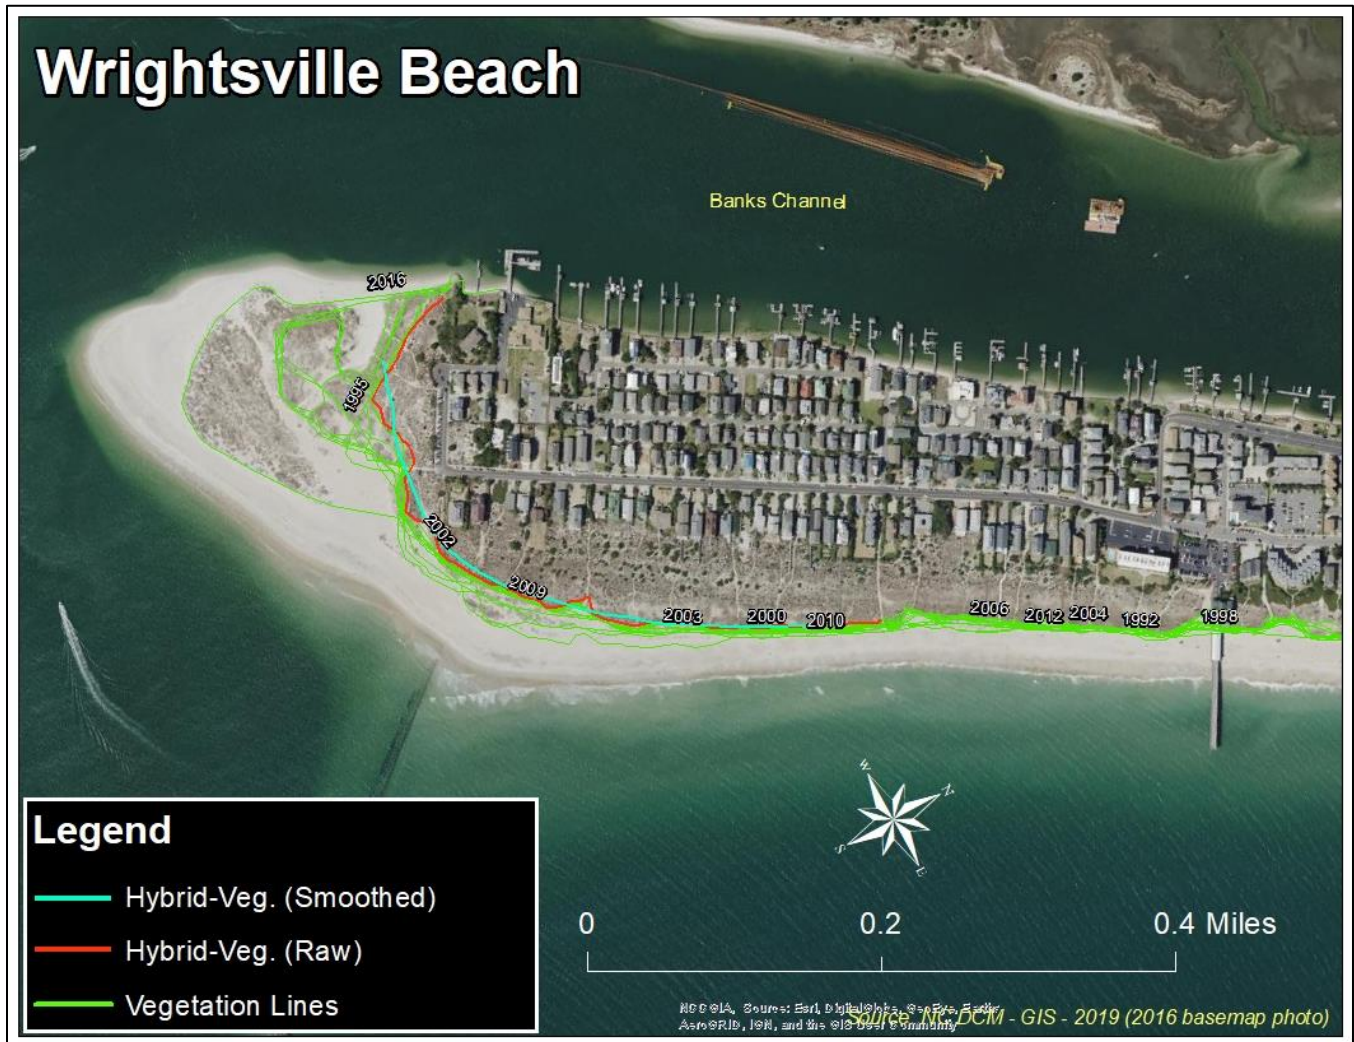
Figure 39. Masonboro Inlet at Wrightsville Beach. Vegetation Lines mapped: 1992, 1995, 1998, 2000, 2002, 2003, 2004, 2006, 2009, 2010, 2012, 2016. Vegetation line segments making up the Hybrid-Vegetation Line: 1992, 1998, 2000, 2002, 2003, 2004, 2009, 2010.

Vegetation and shoreline data for Wrightsville Beach at Masonboro Inlet are shown in Figures 39 and 40. After the north jetty construction caused an initial accretion, the ocean shoreline has been relatively stable since the 1970s for more than a mile north of the structure. Prior to construction of the north jetty and beach nourishment in 1965, the NC General Assembly declared the oceanfront dunes and beach, including all sand trapped by the jetty, were state-owned. Construction of the south jetty in 1980 reversed the previous northward migration of the inlet. Because of this, only shorelines since 1992 were used for analysis.

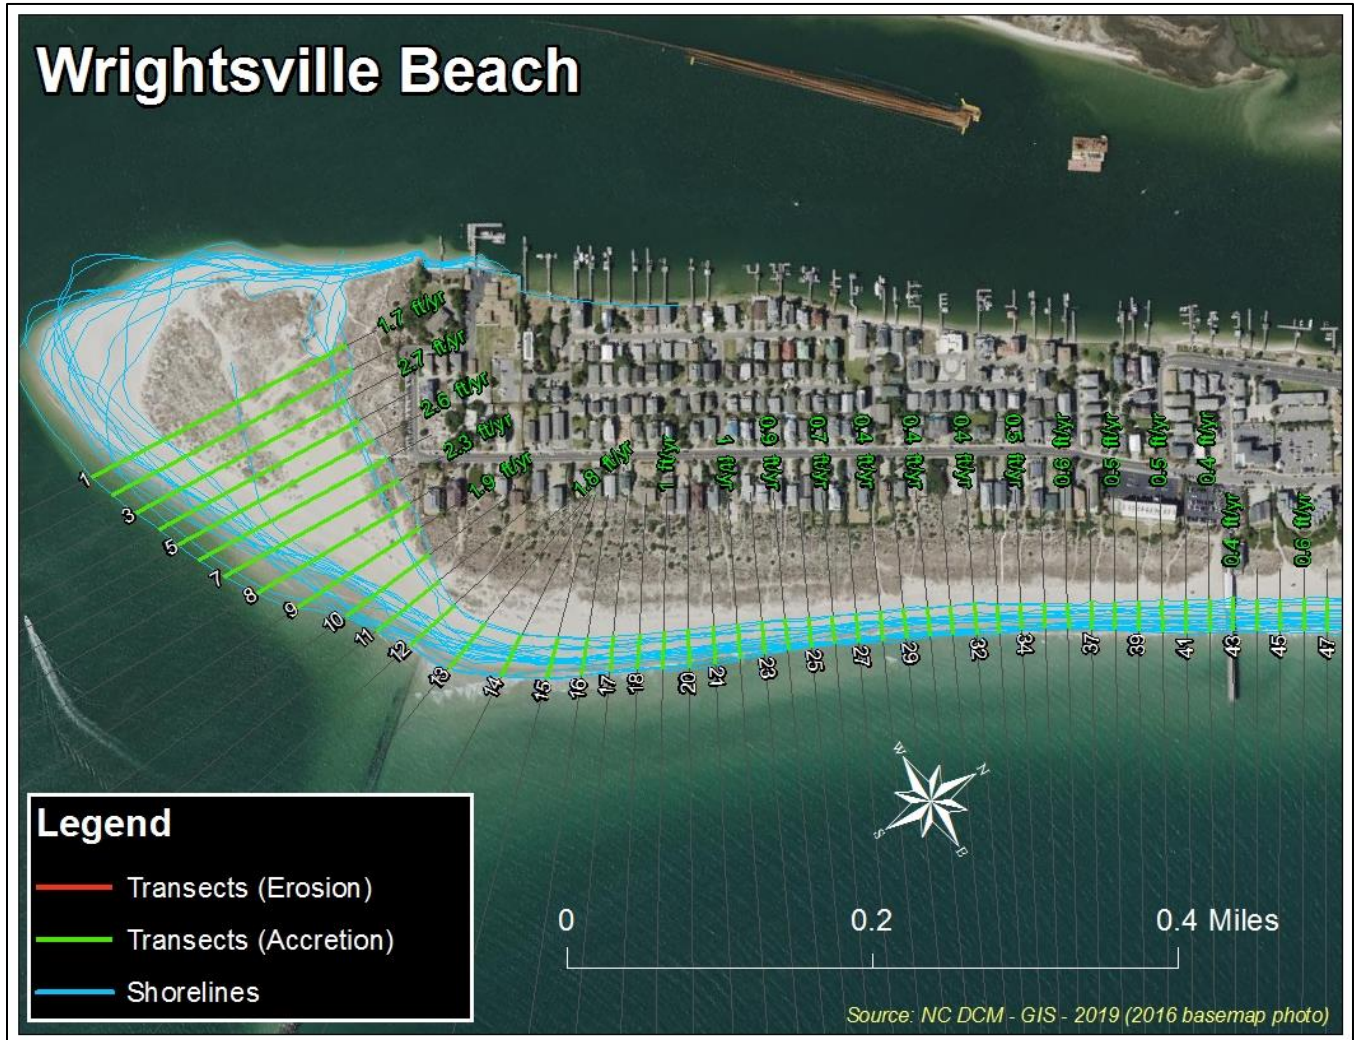
Figure 40. Masonboro Inlet at Wrightsville Beach. Shorelines included: 1973, 1974, 1977, 1984, 1992, 1995, 1997, 1998, 2000, 2002, 2003, 2004, 2006, 2009, 2010, 2012, 2016.

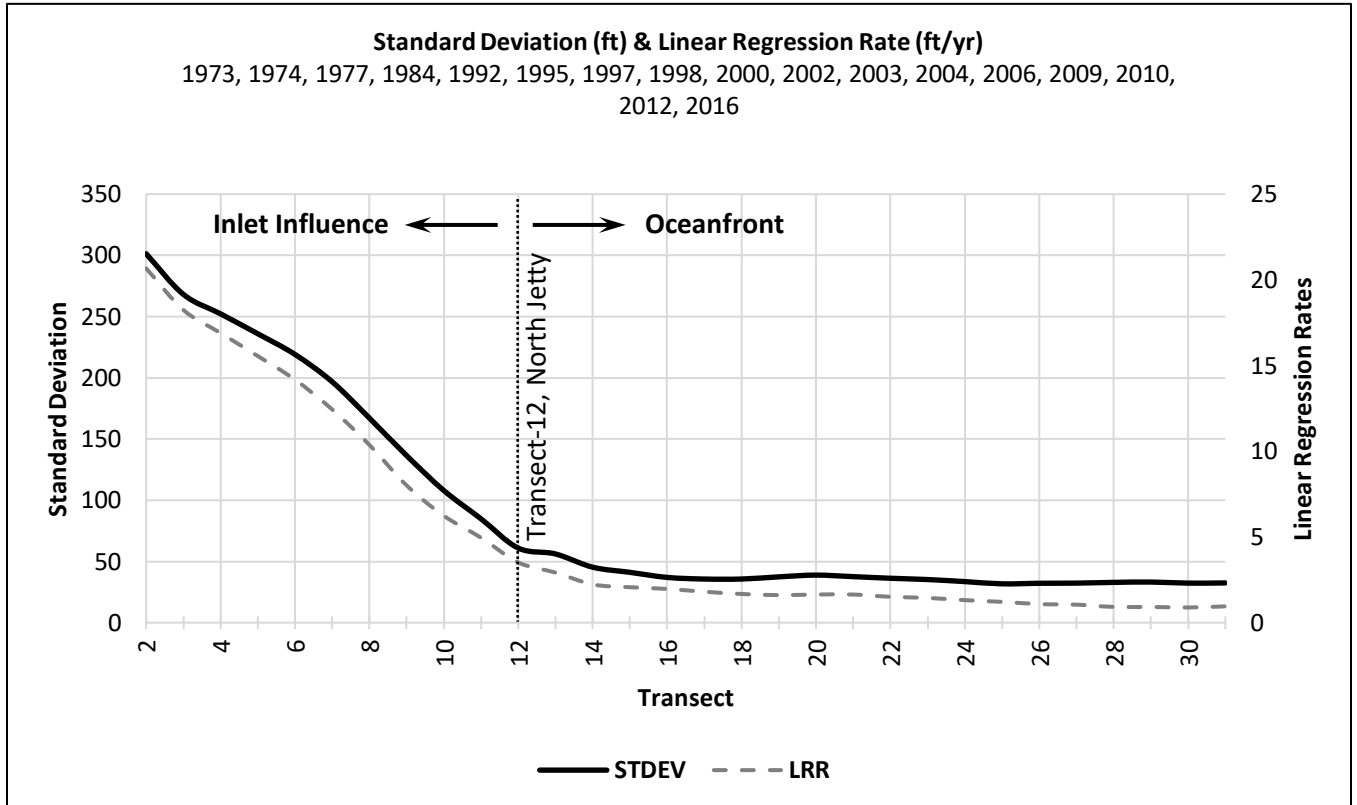
Figure 41. At Masonboro Inlet-Wrightsville Beach, the standard deviation of shoreline position has a break in slope around transect-16. Transect-12 is the anchor point of the north inlet jetty, and since its standard deviation is only slightly higher it is recommended as the IHA boundary between inlet and oceanfront influence. Negative Linear Regression rates indicate erosion, while positive values represent accretion (right axis).

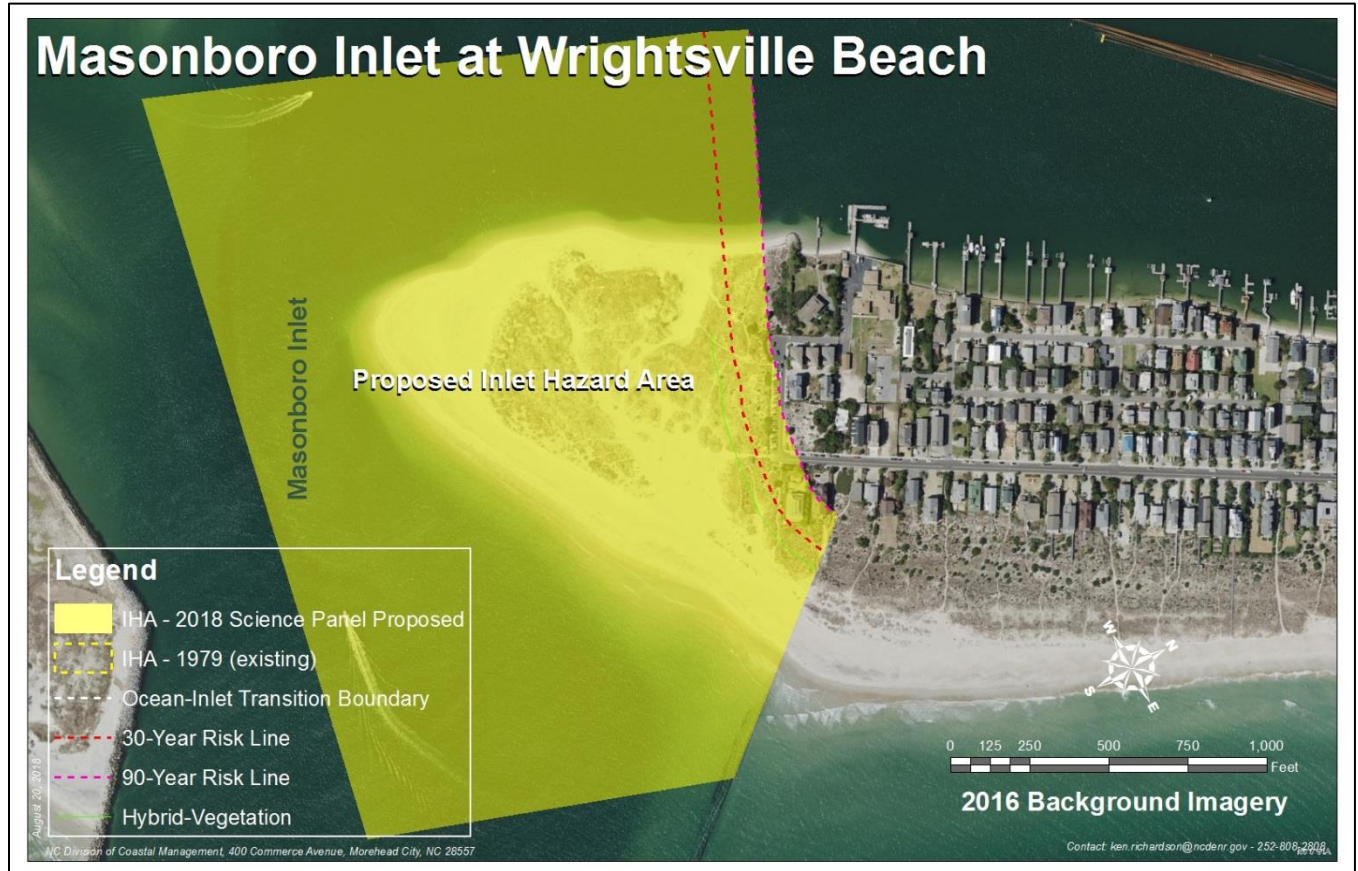
Figure 42. Masonboro Inlet at Wrightsville Beach Hybrid-Vegetation Line and the recommended IHA boundary with the 30- and 90-Year Risk Lines.

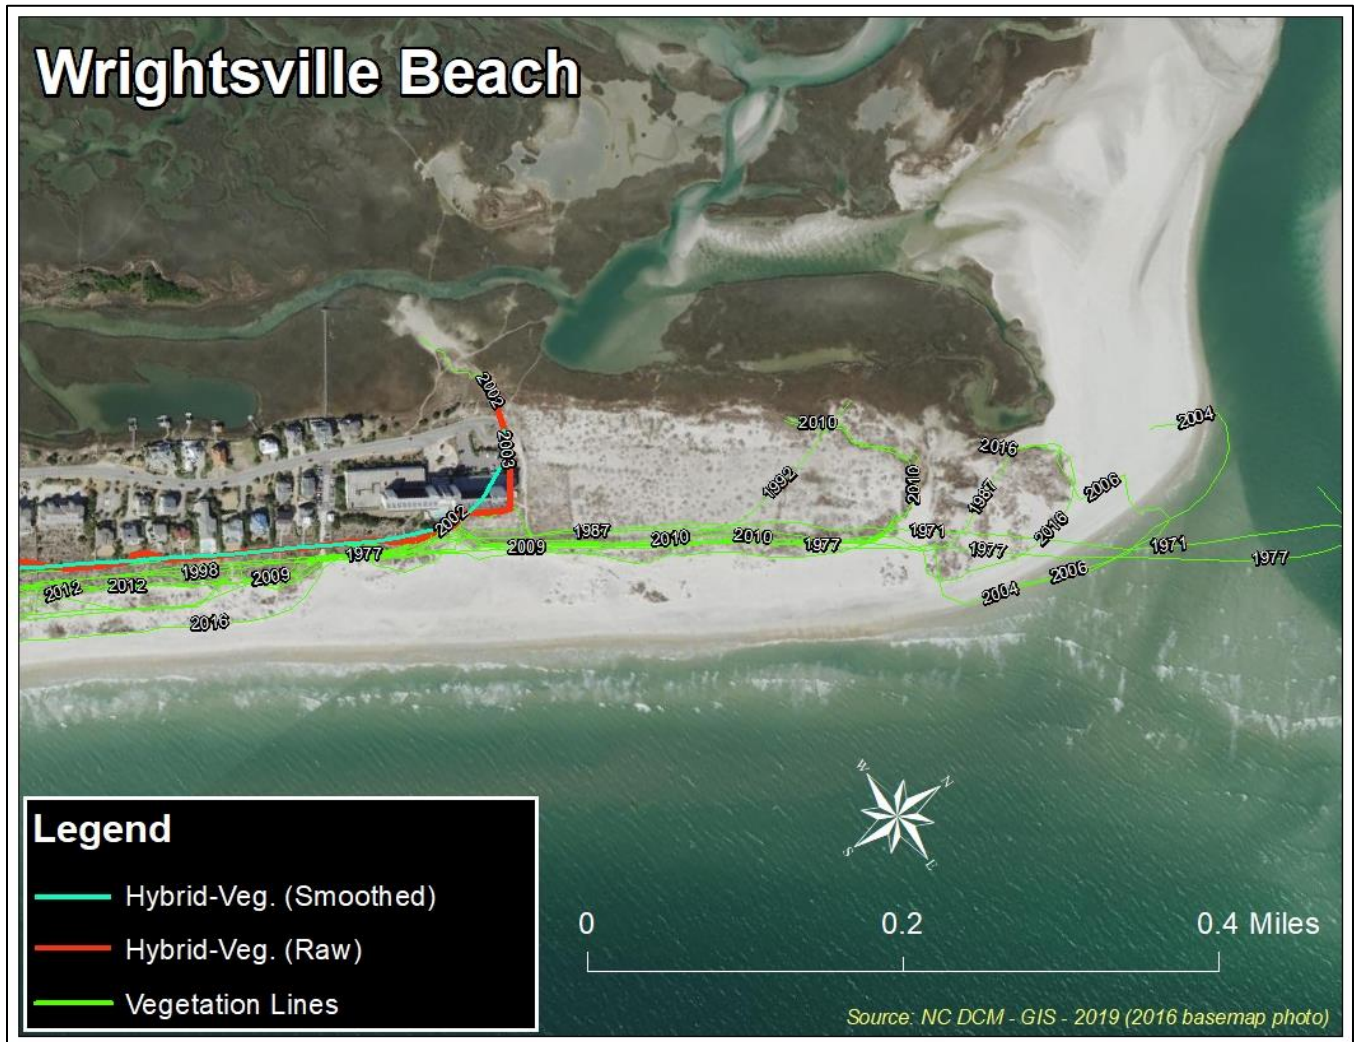
Figure 43. Mason Inlet at Wrightsville Beach. Vegetation Lines mapped: 1971, 1977, 1984, 1987, 1992, 1995, 1998, 2000, 2002, 2003, 2004, 2006, 2009, 2010, 2012, 2016. Vegetation line segments making up the hybrid-vegetation line: 1971, 1977, 1984, 1987, 1998, 2000, 2002, 2003, 2006, 2009, 2010.

The vegetation and shoreline data for the Wrightsville Beach side of Mason Inlet are shown in Figures 43 and 44. Using the IHAM, transect-258 is the southern boundary of inlet influence along the oceanfront shoreline, near the current IHA boundary (Figure 45). The 90-Year Risk Line is recommended as the landward IHA boundary (Figure 46).

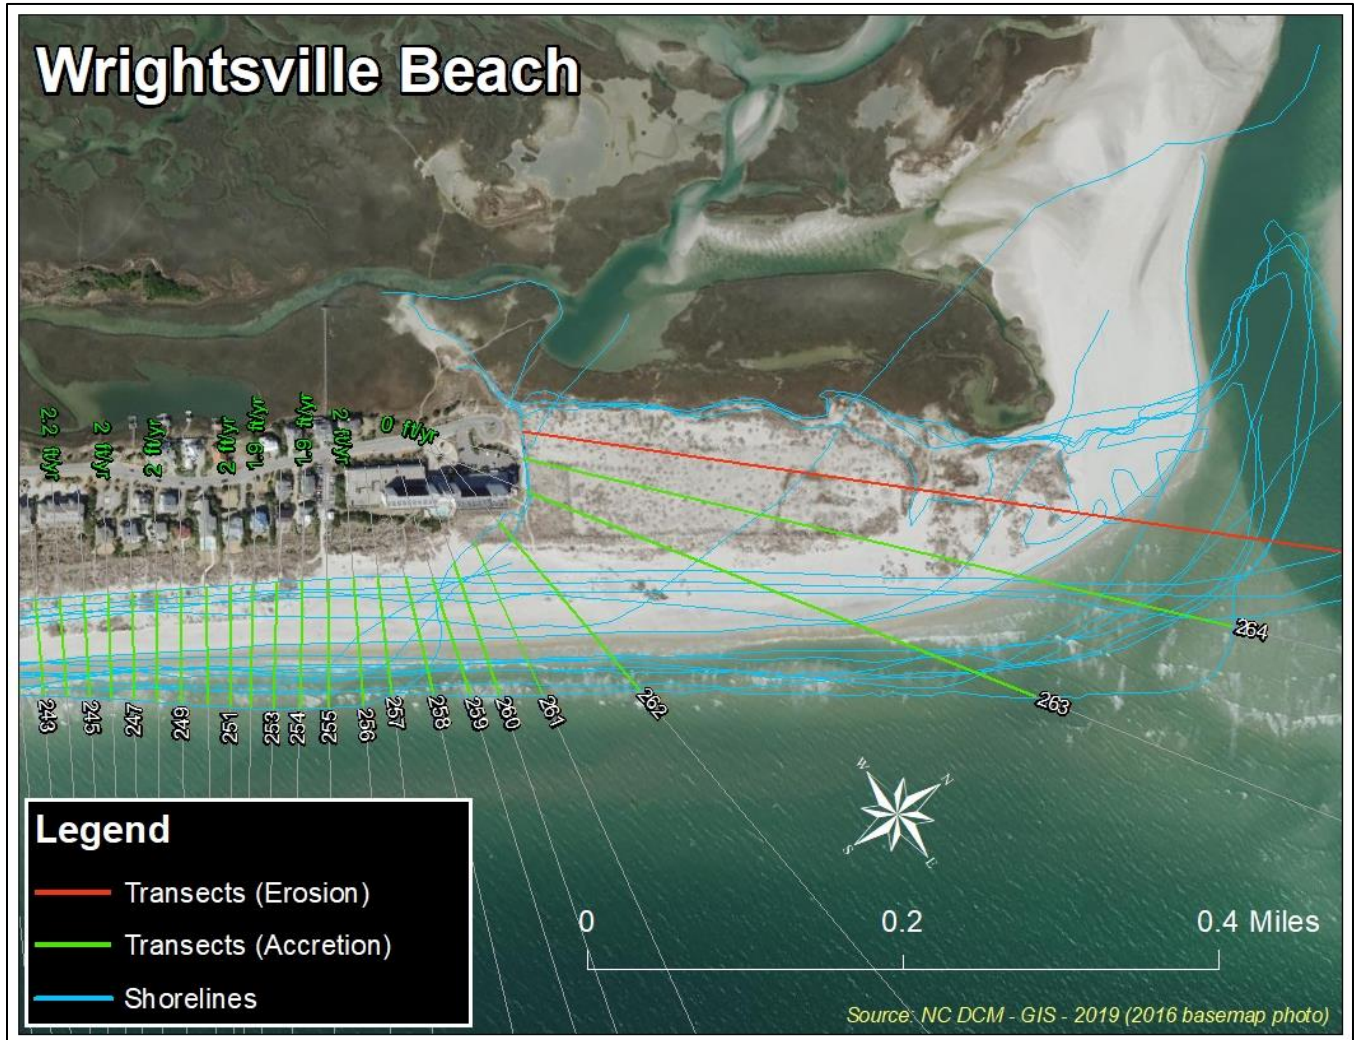
Figure 44. Mason Inlet at Wrightsville Beach. Shorelines included: 1971, 1973, 1974, 1977, 1984, 1987, 1992, 1995, 1997, 1998, 2000, 2002, 2003, 2004, 2006, 2009, 2010, 2012, 2016.
