Inlet Hazard Area Boundary, 2019 Update:

Science Panel Recommendations to the
North Carolina Coastal Resources Commission

February 12, 2019

NC Coastal Resources Commission's Science Panel on Coastal Hazards
& NC Division of Coastal Management

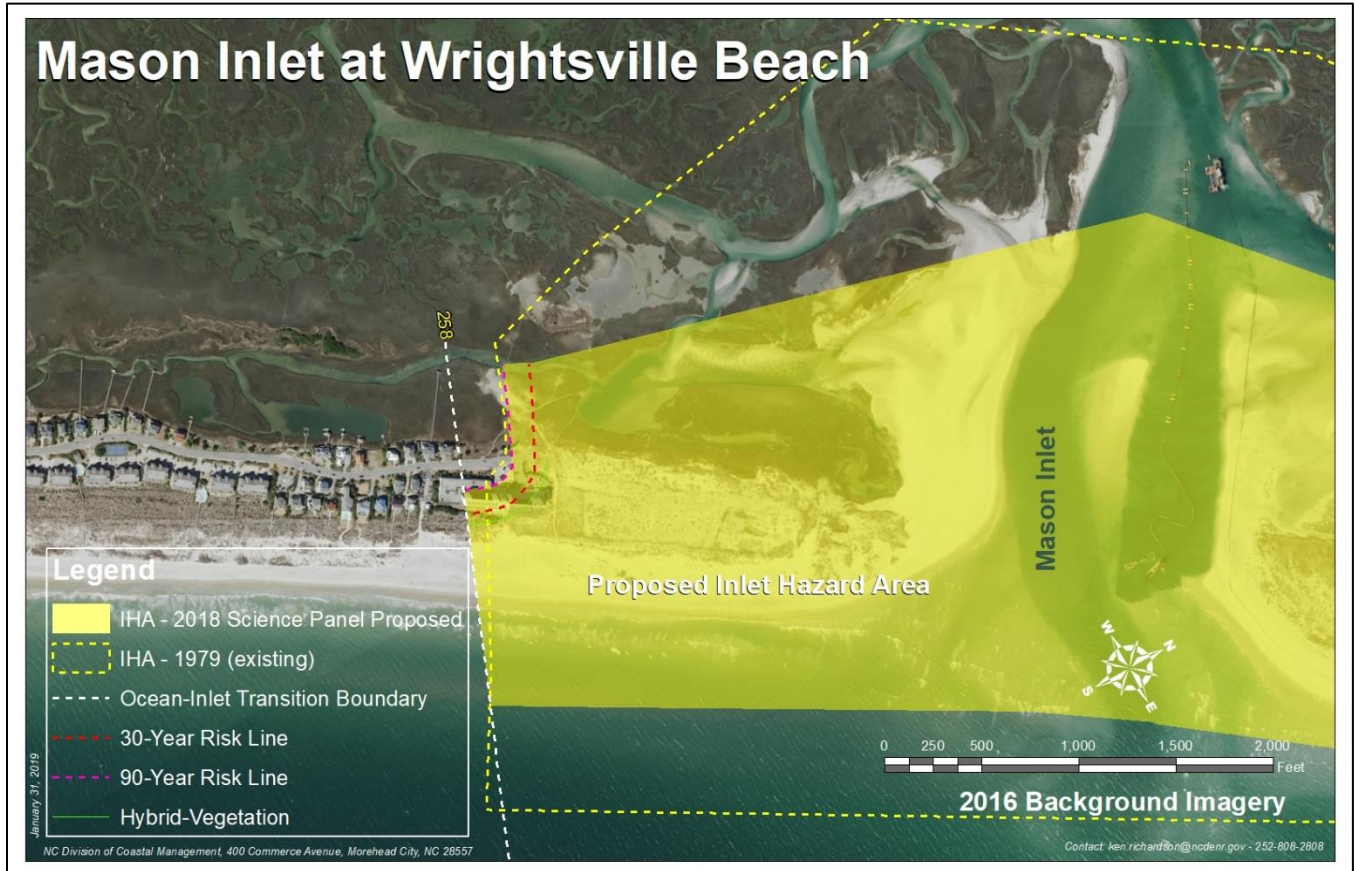
Figure 46. Mason Inlet at Wrightsville Beach Hybrid-Vegetation Line and the recommended IHA boundary with the 30- and 90-Year Risk Lines.

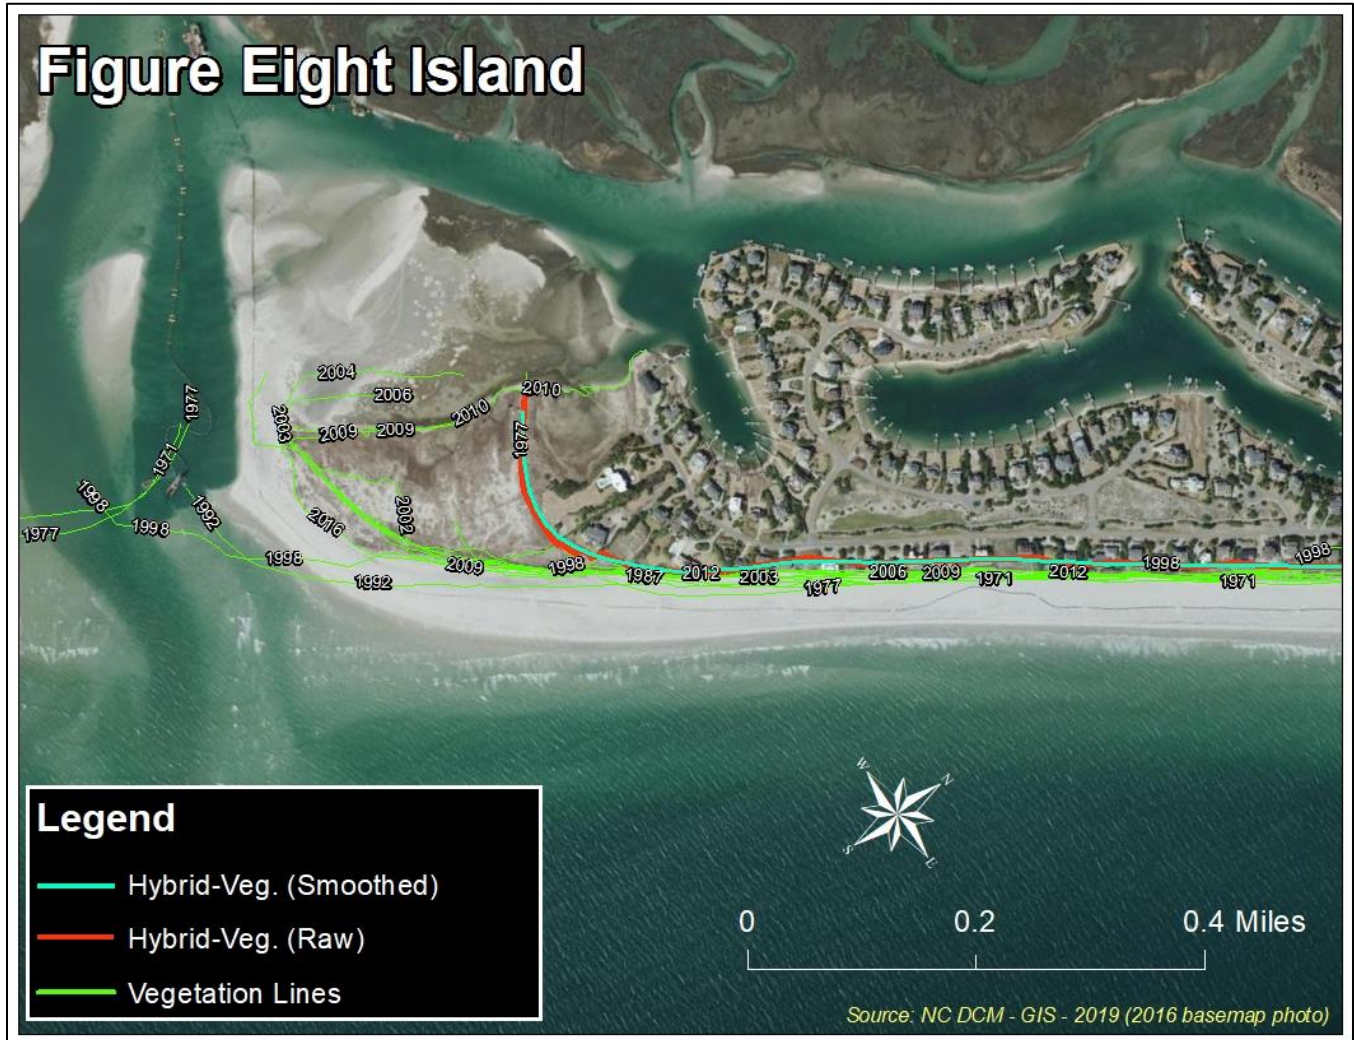
Figure 47. Mason Inlet at Figure Eight Island. Vegetation Lines mapped: 1971, 1973, 1977, 1987, 1992, 1998, 2002, 2003, 2004, 2006, 2009, 2010, 2012, 2016. Vegetation line segments making up the Hybrid-Vegetation Line: 1971, 1977, 1998, 2002, 2004, 2012.

The vegetation and shoreline data for the Figure Eight Island side of Mason Inlet are shown in Figures 47 and 48. Although the IHAM identified transect-31 as the inlet-ocean boundary (Figure 49), the Panel agreed that the risk related to the inlet actually extended further north. It is expected that without regular management, the inlet related erosional risk would encompass the area up to transect-45, which is approximately the start of truncated dunes, indicating relative stability of the oceanfront shoreline’s position over time with continued nourishment. This stability can also be seen in the shoreline change rate (LRR), which stabilizes after transect-45 (Figure 49). The recommended landward boundary is the 90-Year Risk Line (Figure 50).

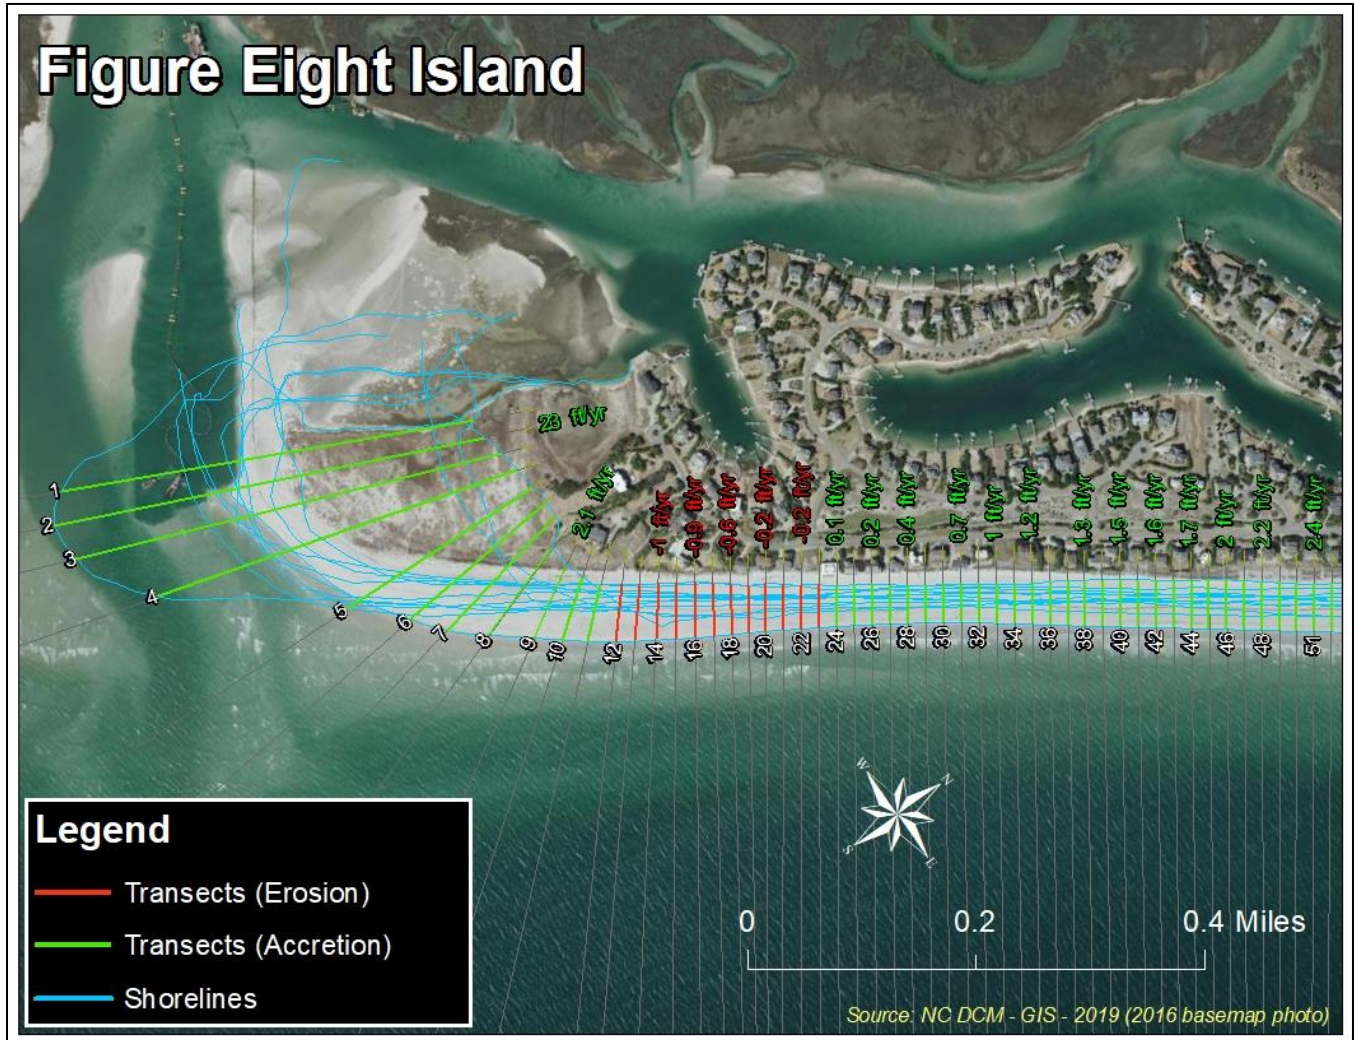
Figure 48. Mason Inlet at Figure Eight Island. Shorelines included in the analysis: 1971, 1973, 1977, 1987, 1992, 1998, 2002, 2003, 2004, 2006, 2009, 2010, 2012, 2016.

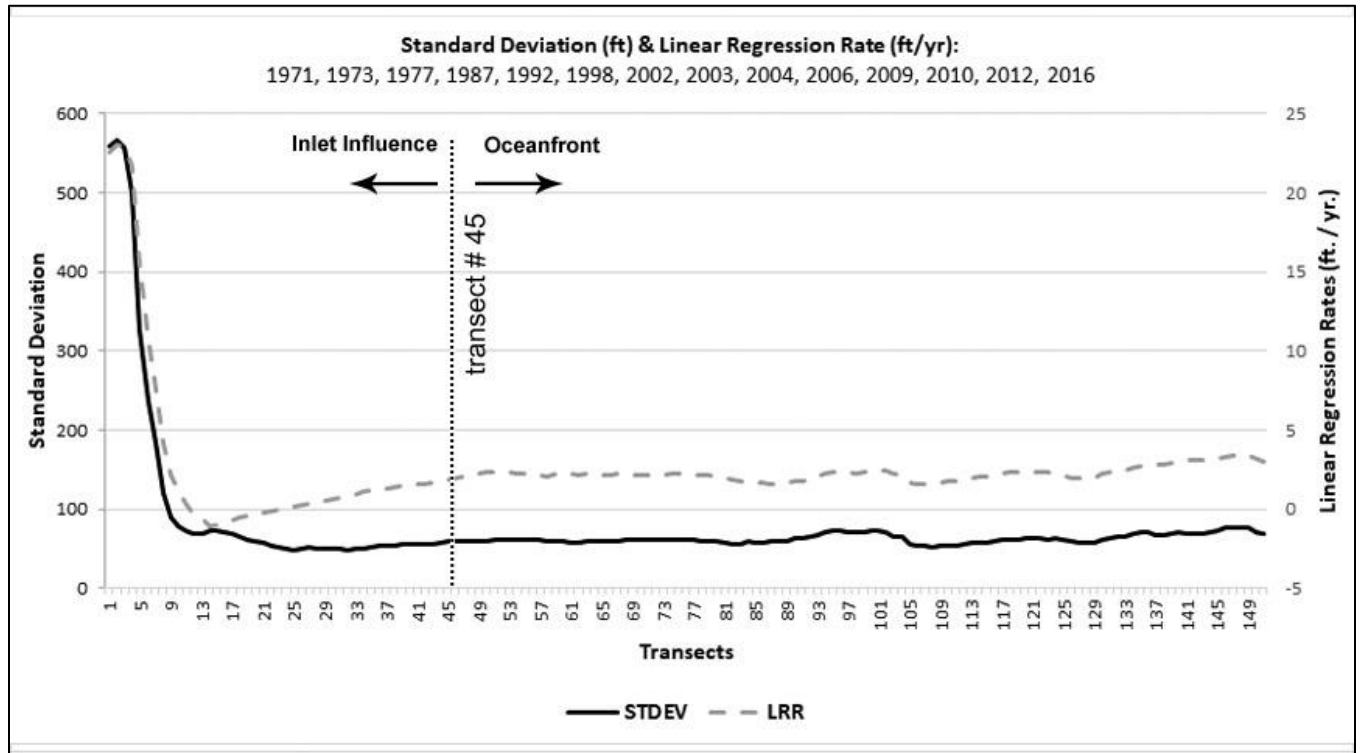
Figure 49. Based on the increased potential for erosion at Mason Inlet-Figure Eight Island, transect-45 is recommended as the inlet-ocean transition boundary along the shoreline. Negative Linear Regression rates indicate erosion, while positive values represent accretion (right axis).

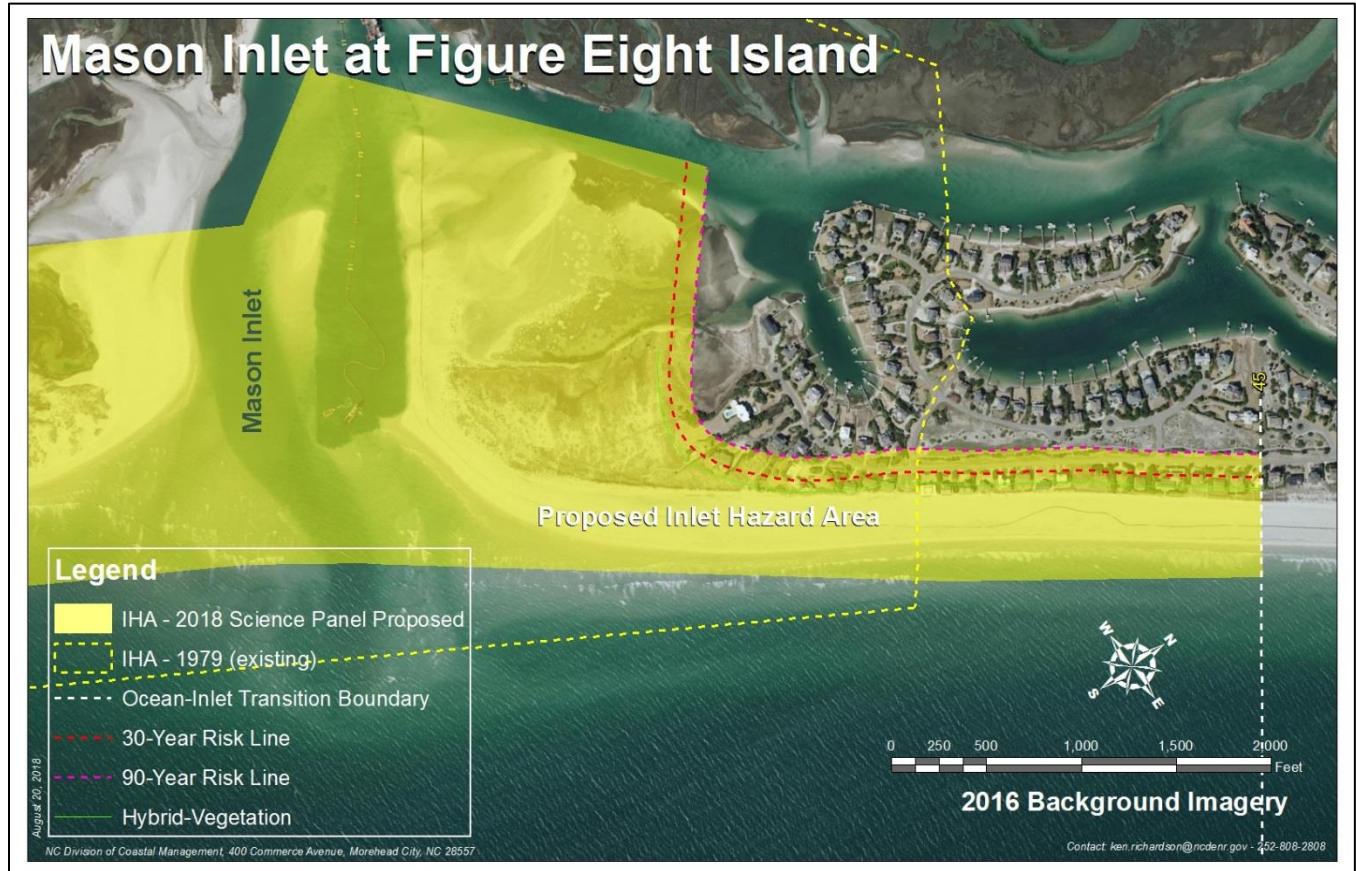
Figure 50. Map of Mason Inlet at Figure Eight Island Hybrid-Vegetation Line and the recommended IHA boundary with the 30- and 90-Year Risk Lines.

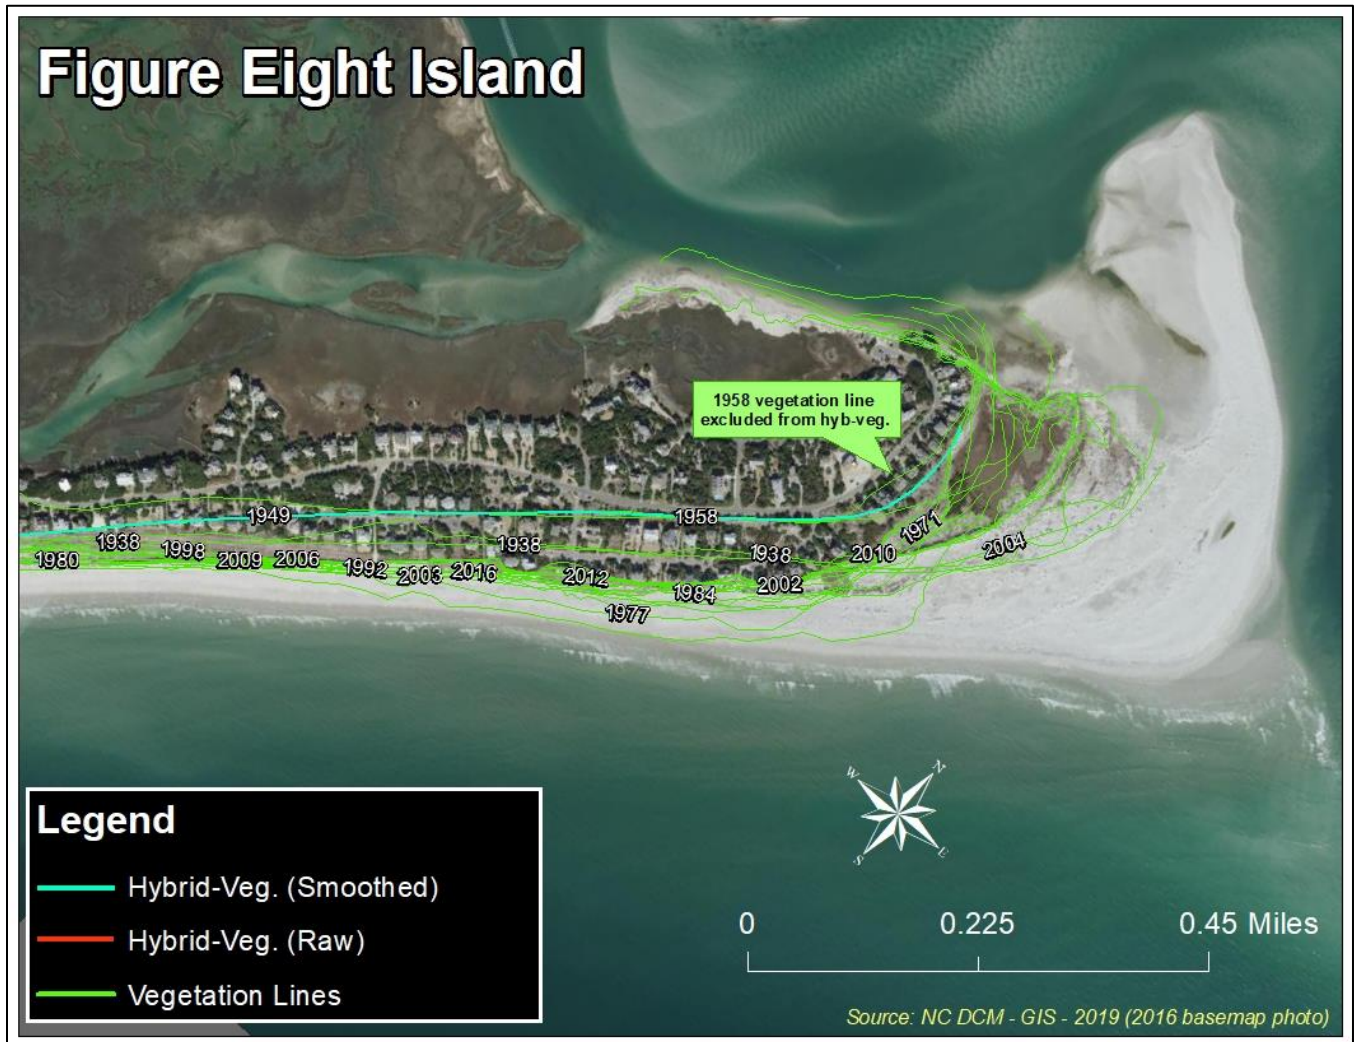
Figure 51. Rich Inlet at Figure Eight Island. Vegetation Lines mapped: 1938, 1949, 1958, 1971, 1977, 1980, 1984, 1992, 1998, 2002, 2003, 2004, 2006, 2008, 2009, 2010, 2012, 2016. Vegetation line segments making up the Hybrid-Vegetation Line: 1984, 1998, 2002, 2006, 2009, 2010, 2012, 2016.

The vegetation and shoreline data for Figure Eight Island at Rich Inlet are shown in Figures 51 and 52. Because it is an outlier, the 1958 post-hurricane vegetation line was not included in the analysis. To better reflect the shoreline oscillations, shorelines beginning in 1934 were considered. Using the IHAM, the standard deviation suggests that inlet influence extends to at least transect-163. However, transect-181, closer to the inlet, is located near the start of a primary dune line that has remained unchanged for the time period. It also falls within a peak in shoreline accretion (LRR). Based on their knowledge of the inlet, the Panel recommends transect-181 as the boundary of inlet influence along the oceanfront shoreline (Figure 53). The 90-Year Risk line is recommended as the landward limit of the IHA. (Figure 54).

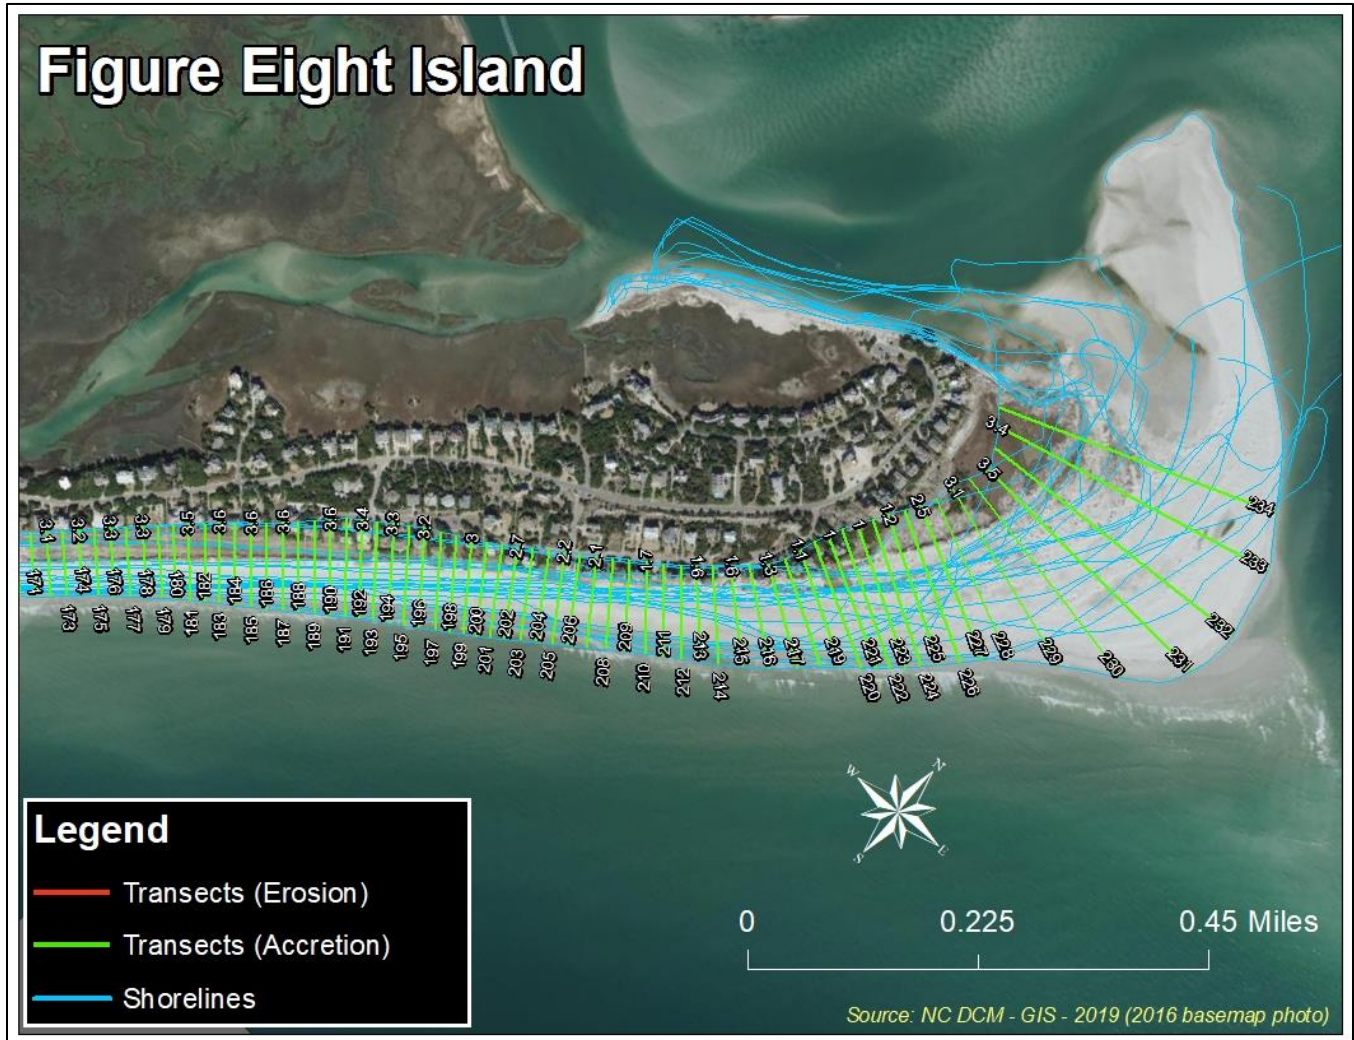
Figure 52. Rich Inlet at Figure Eight Island. Shorelines included: 1934, 1938, 1944, 1949, 1958, 1971, 1973, 1977, 1980, 1984, 1992, 1998, 2002, 2003, 2004, 2006, 2008, 2009, 2010, 2012, 2016.

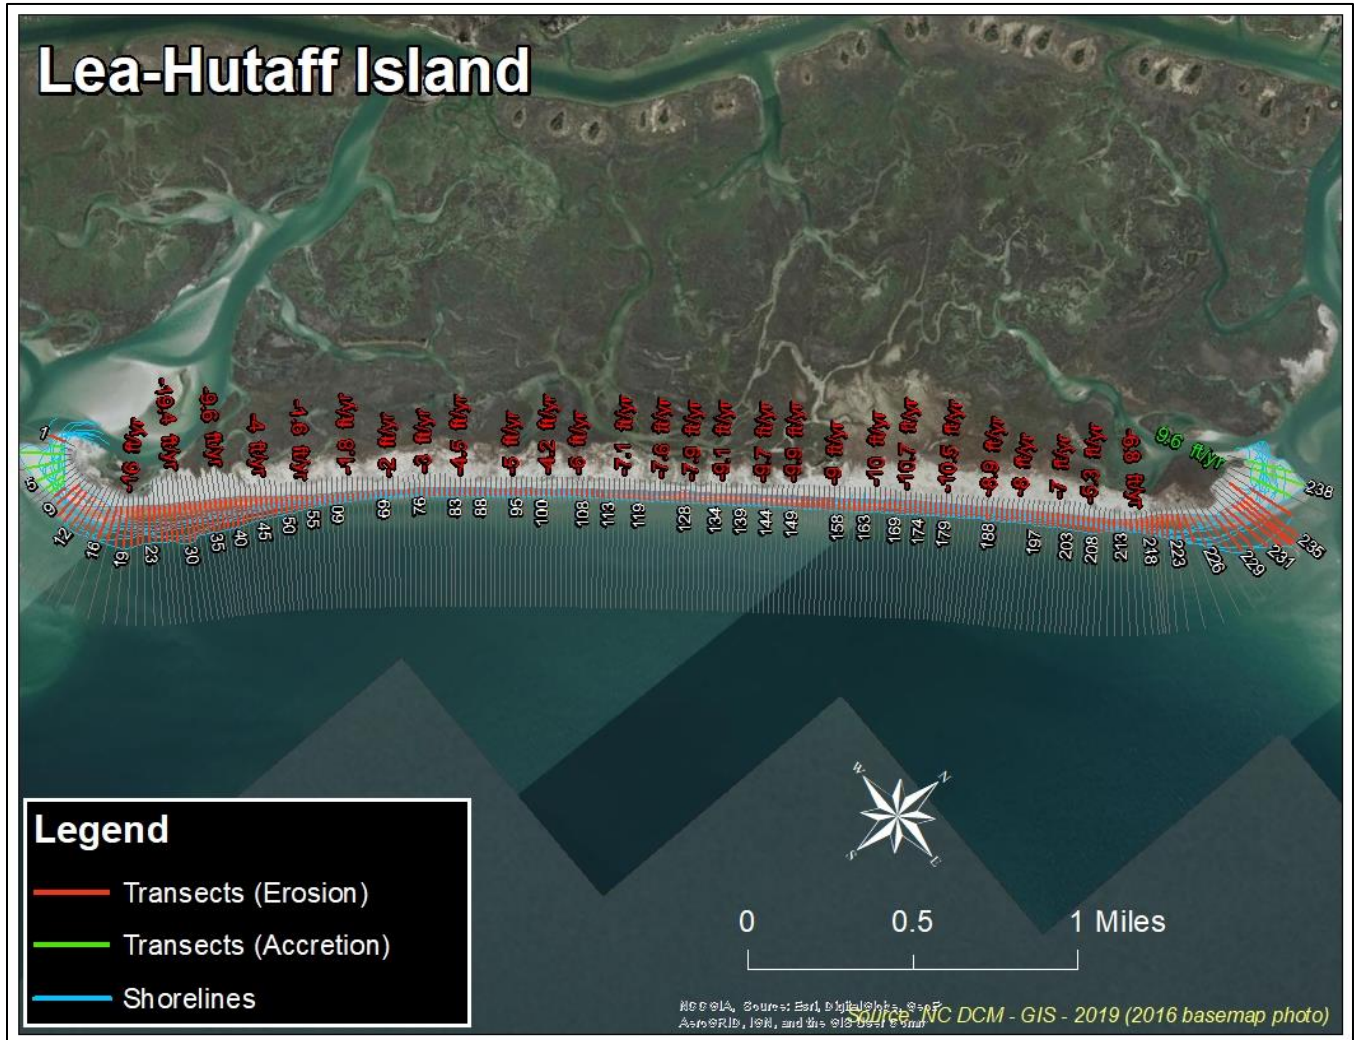
Figure 56. Shorelines included in the analysis: 1997, 1998, 2000, 2004, 2006, 2008, 2009, 2010, 2012, 2016.

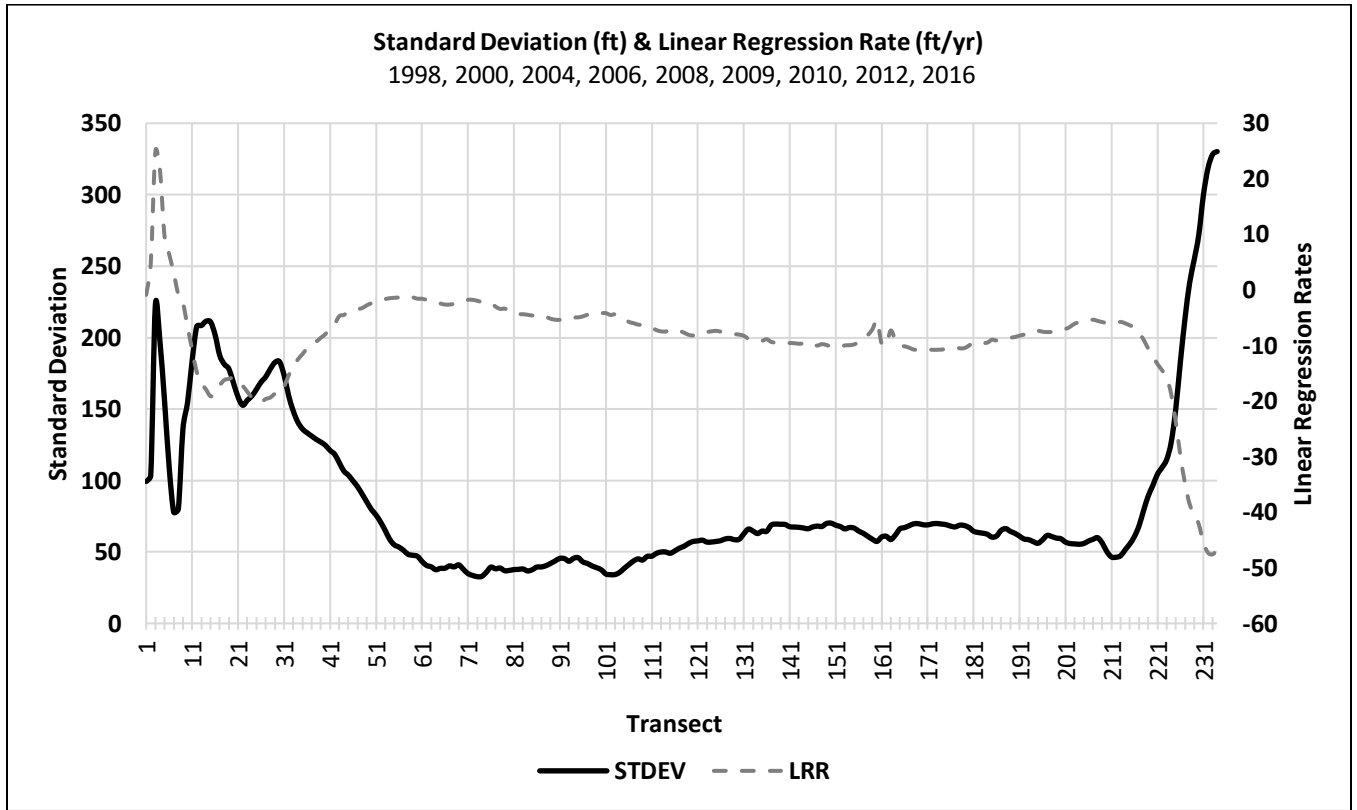
Figure 57. Because Lea and Hutaff Island welded together in 1997, have low topography and are heavily influenced by both Rich and New Topsail Inlets, the Panel recommends including all Lea-Hutaff Island in the IHA. Negative Linear Regression rates indicate erosion, while positive values represent accretion (right axis).

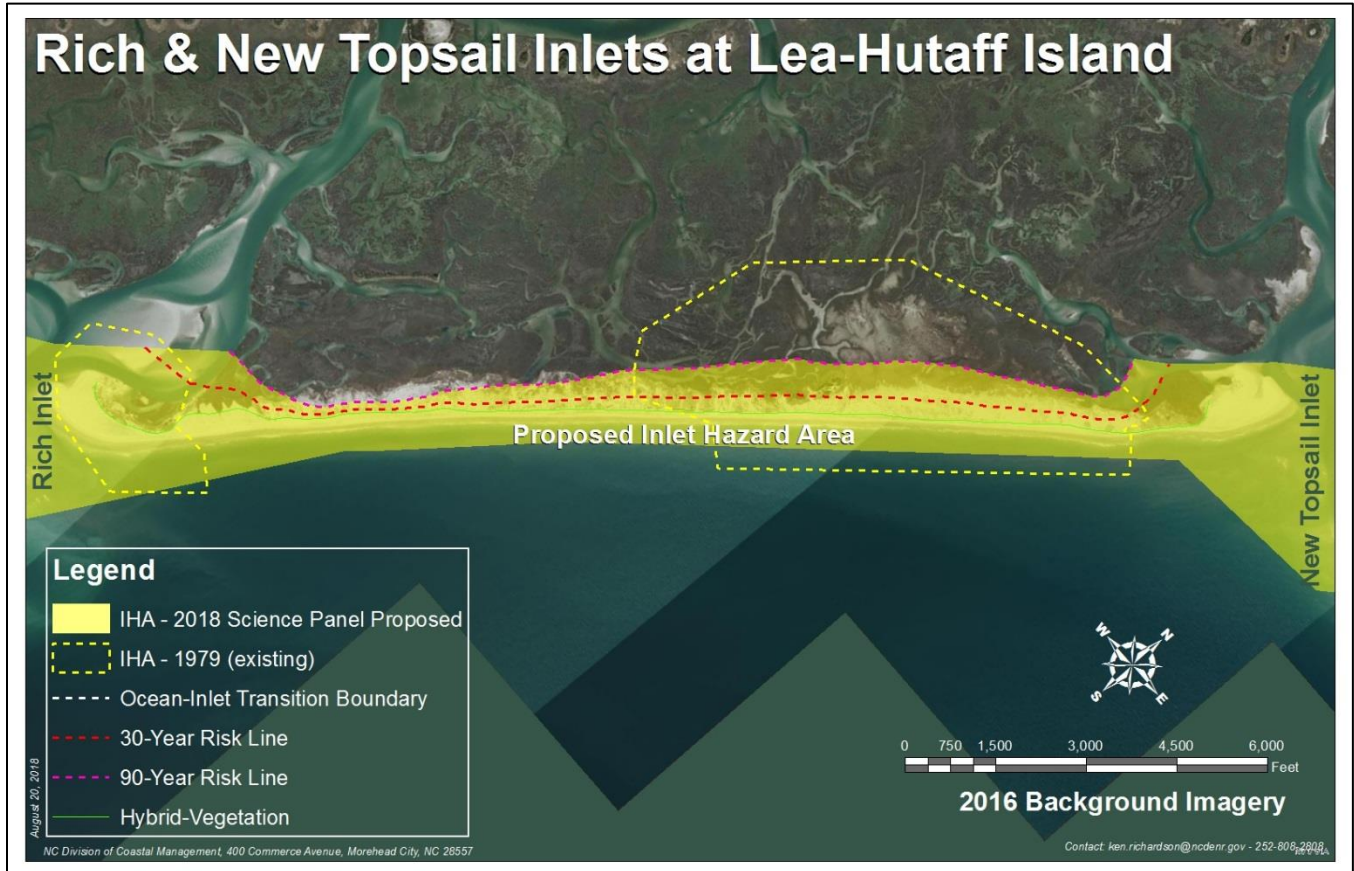
Figure 58. Rich and New Topsail Inlets at Lea-Hutaff Island Hybrid-Vegetation Line and the recommended IHA boundary with the 30- and 90-Year Risk Lines.

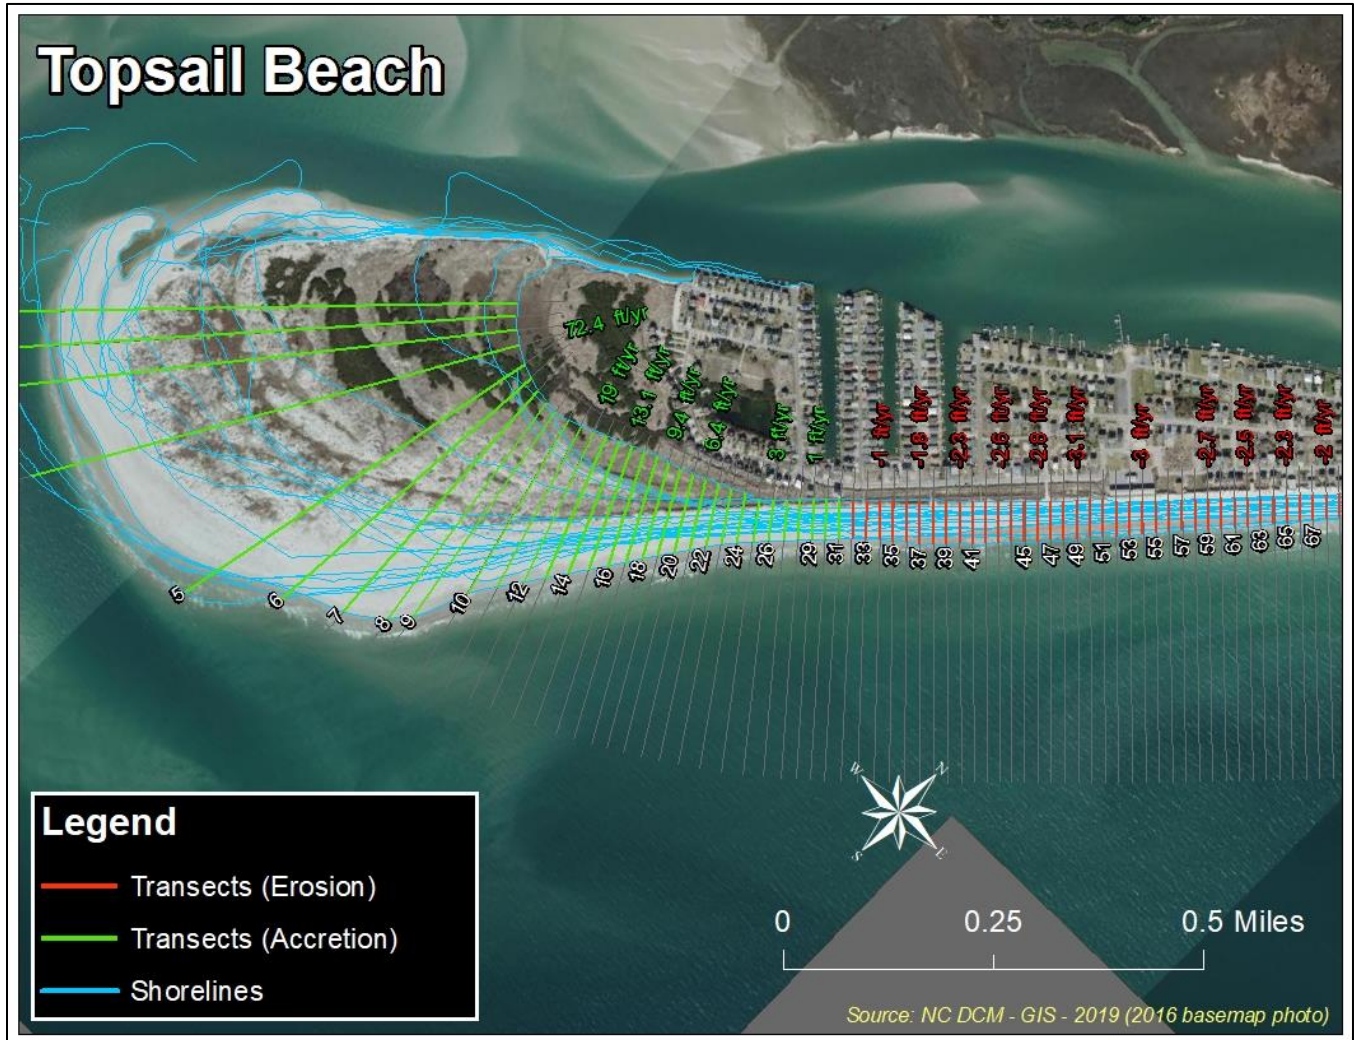
Figure 60. New Topsail Inlet at Topsail Beach Shorelines included: 1971, 1973, 1974, 1976, 1984, 1992, 1995, 1997, 1998, 2000, 2003, 2004, 2006, 2008, 2009, 2010, 2011, 2012, 2016.

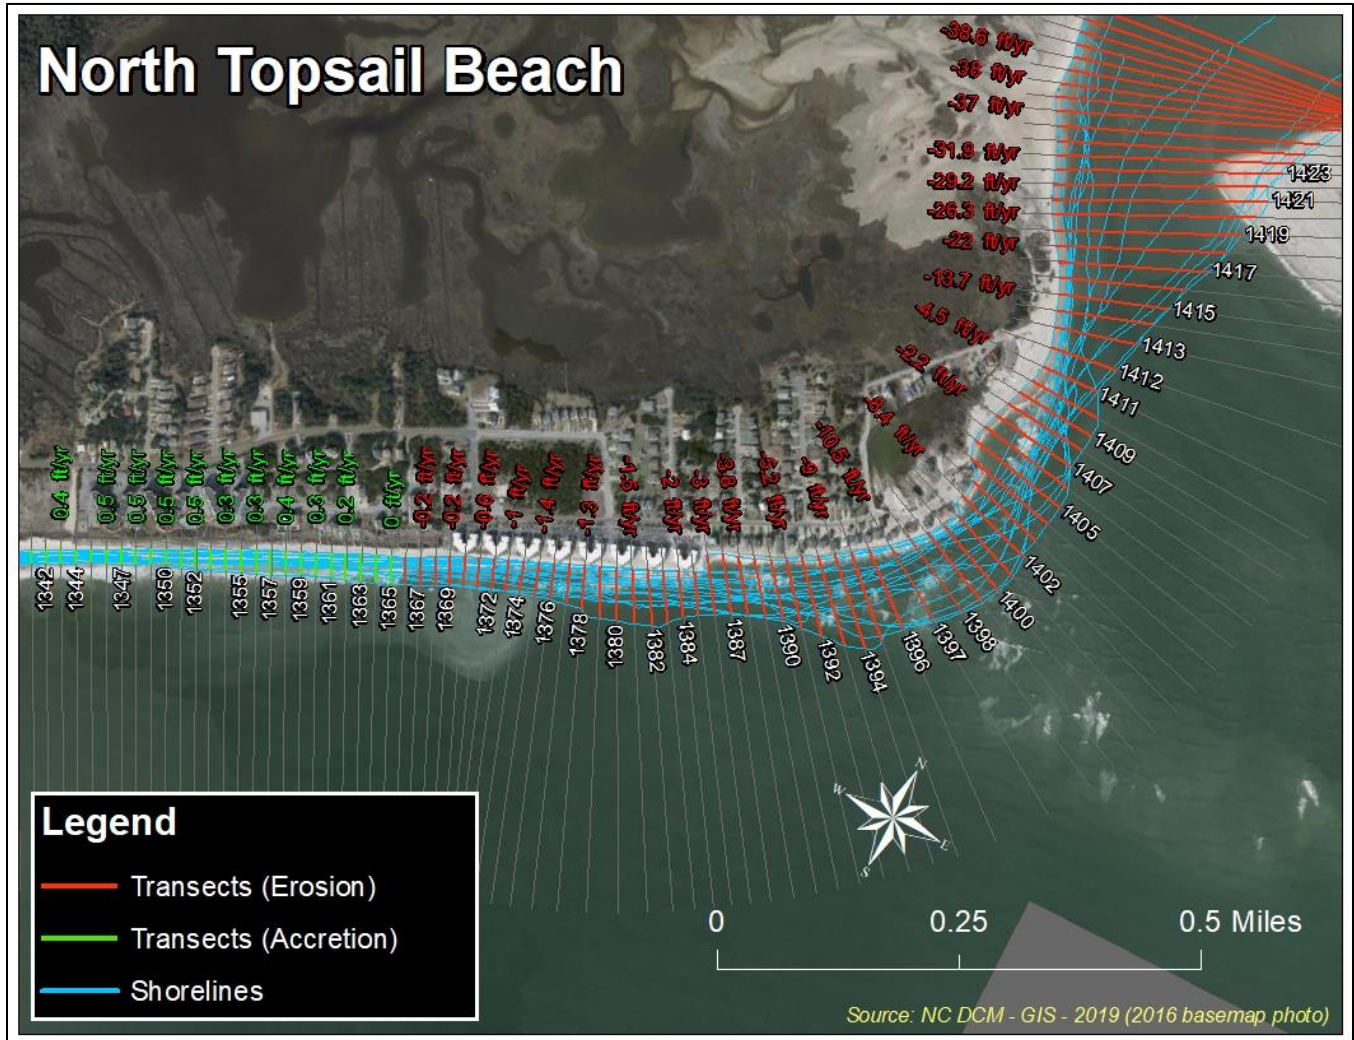
Figure 64. New River Inlet at North Topsail Beach. Shorelines included: 1971, 1973, 1974, 1977, 1984, 1992, 1995, 1997, 1998, 2000, 2003, 2004, 2006, 2009, 2010, 2012, 2016.

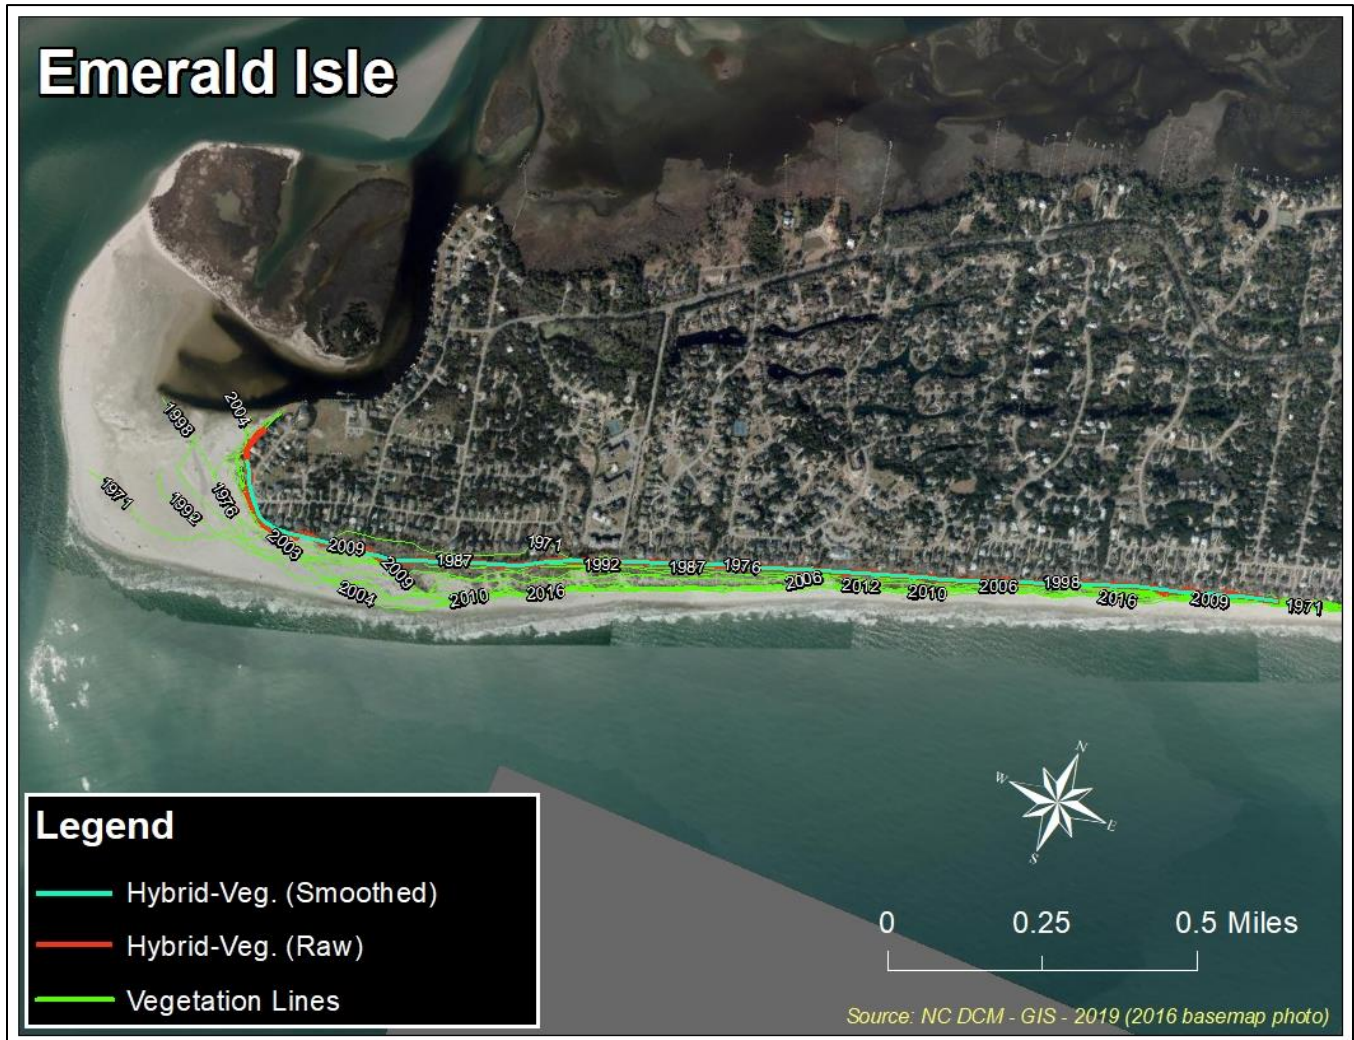
Figure 67. Bogue Inlet at Emerald Isle. Vegetation Lines mapped: 1971, 1976, 1987, 1992, 1998, 2003, 2004, 2006, 2009, 2010, 2012, 2016, and; vegetation line composite segments making up the Hybrid-Vegetation Line: 1971, 1976, 1987, 1992, 1998, 2004, 2006, 2009, 2010, 2012.

The vegetation and shoreline data for the Emerald Isle side of Bogue Inlet are shown in Figures 67 and 68. Using the IHAM, inlet transect-81 defines the boundary of inlet influence along the oceanfront shoreline (Figure 69). The 90-Year Risk Line is recommended as the landward boundary of the IHA (Figure 70).

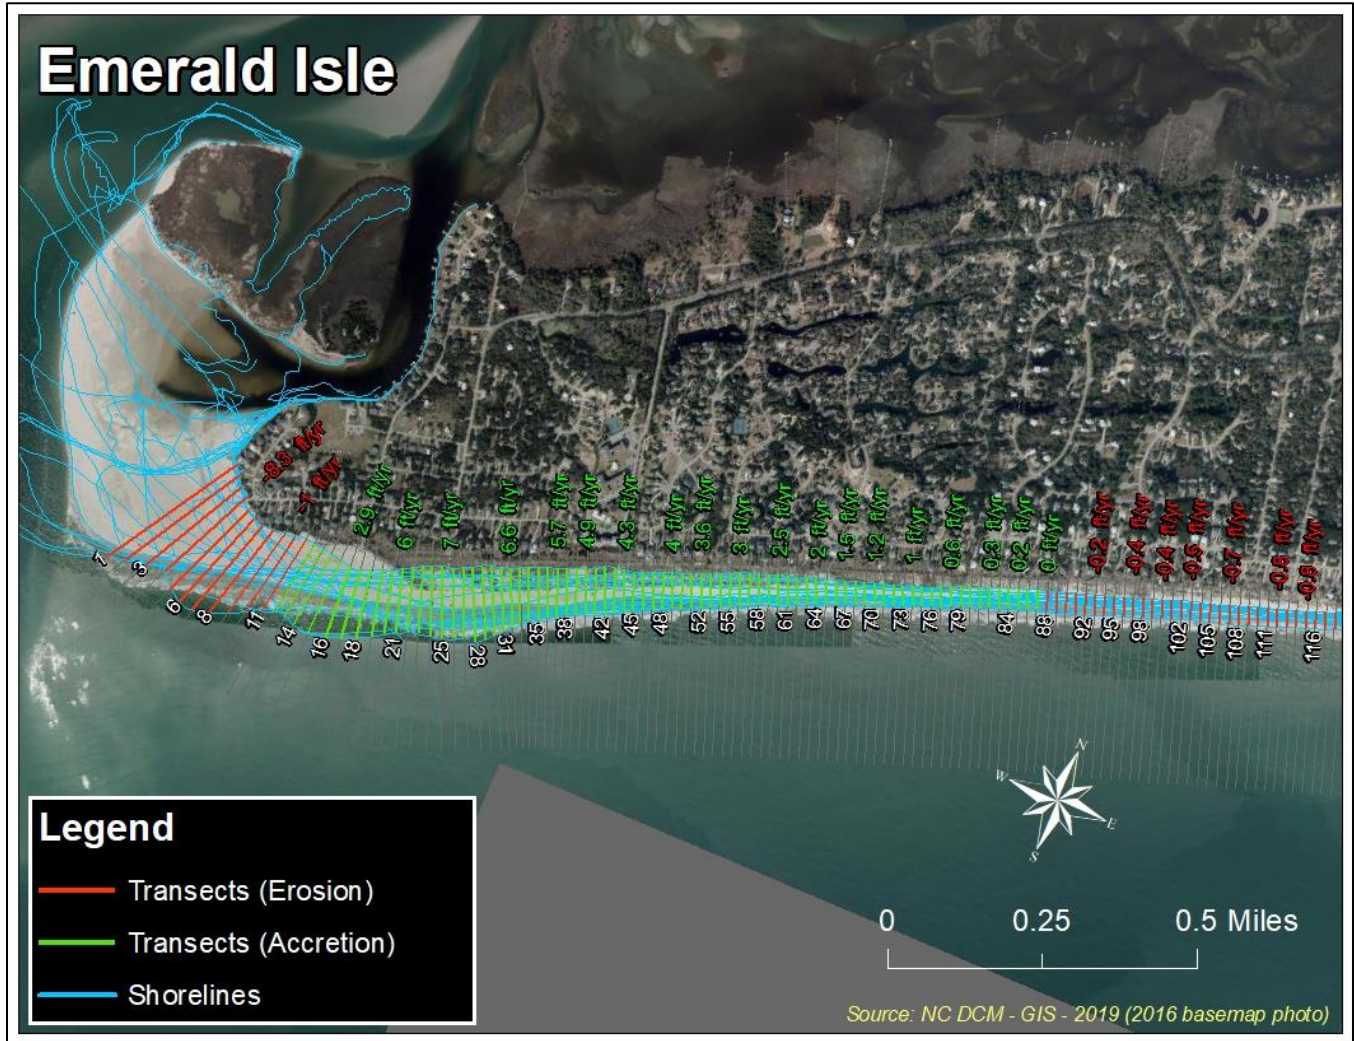
Figure 68. Shorelines included in the analysis: 1949, 1956, 1958, 1960, 1971, 1973, 1976, 1987, 1992, 1997, 1998, 2003, 2004, 2006, 2009, 2010, 2012, 2016.
