Inlet Hazard Area Boundary, 2019 Update:

Science Panel Recommendations to the
North Carolina Coastal Resources Commission

February 12, 2019

NC Coastal Resources Commission's Science Panel on Coastal Hazards
& NC Division of Coastal Management

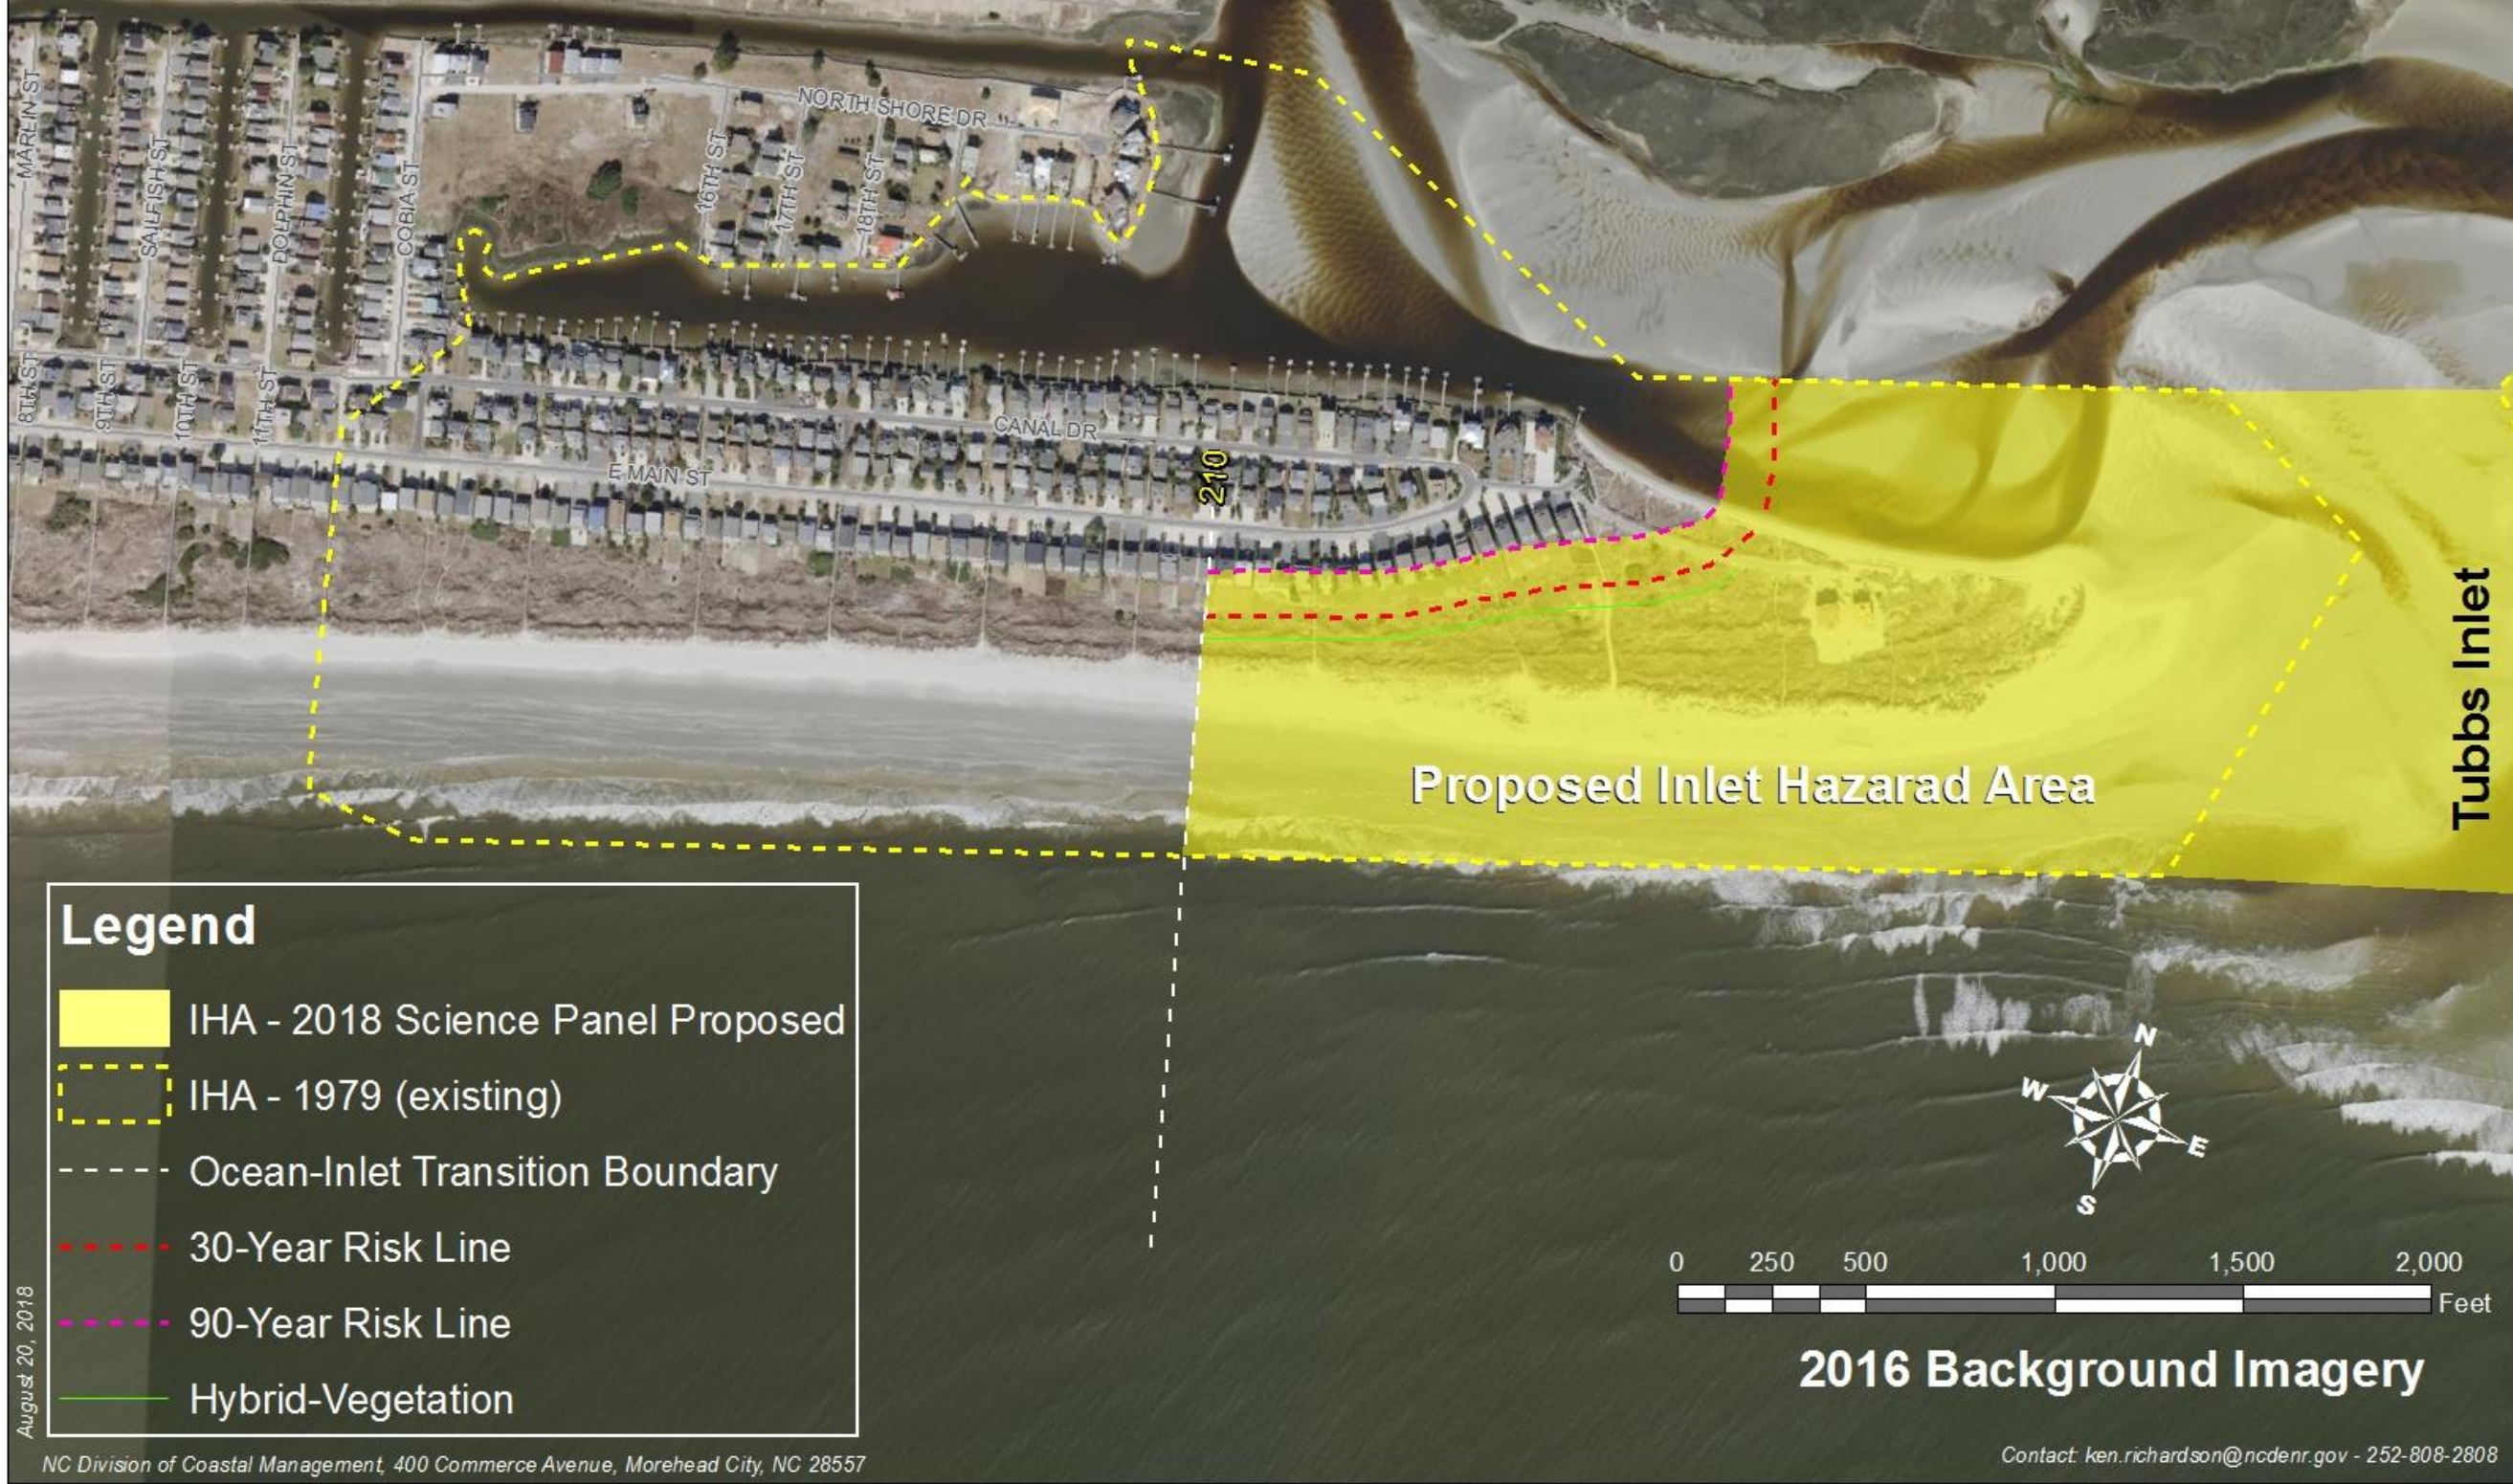
Figure C1. Proposed Inlet Hazard Area at Tubbs Inlet (Sunset Beach).

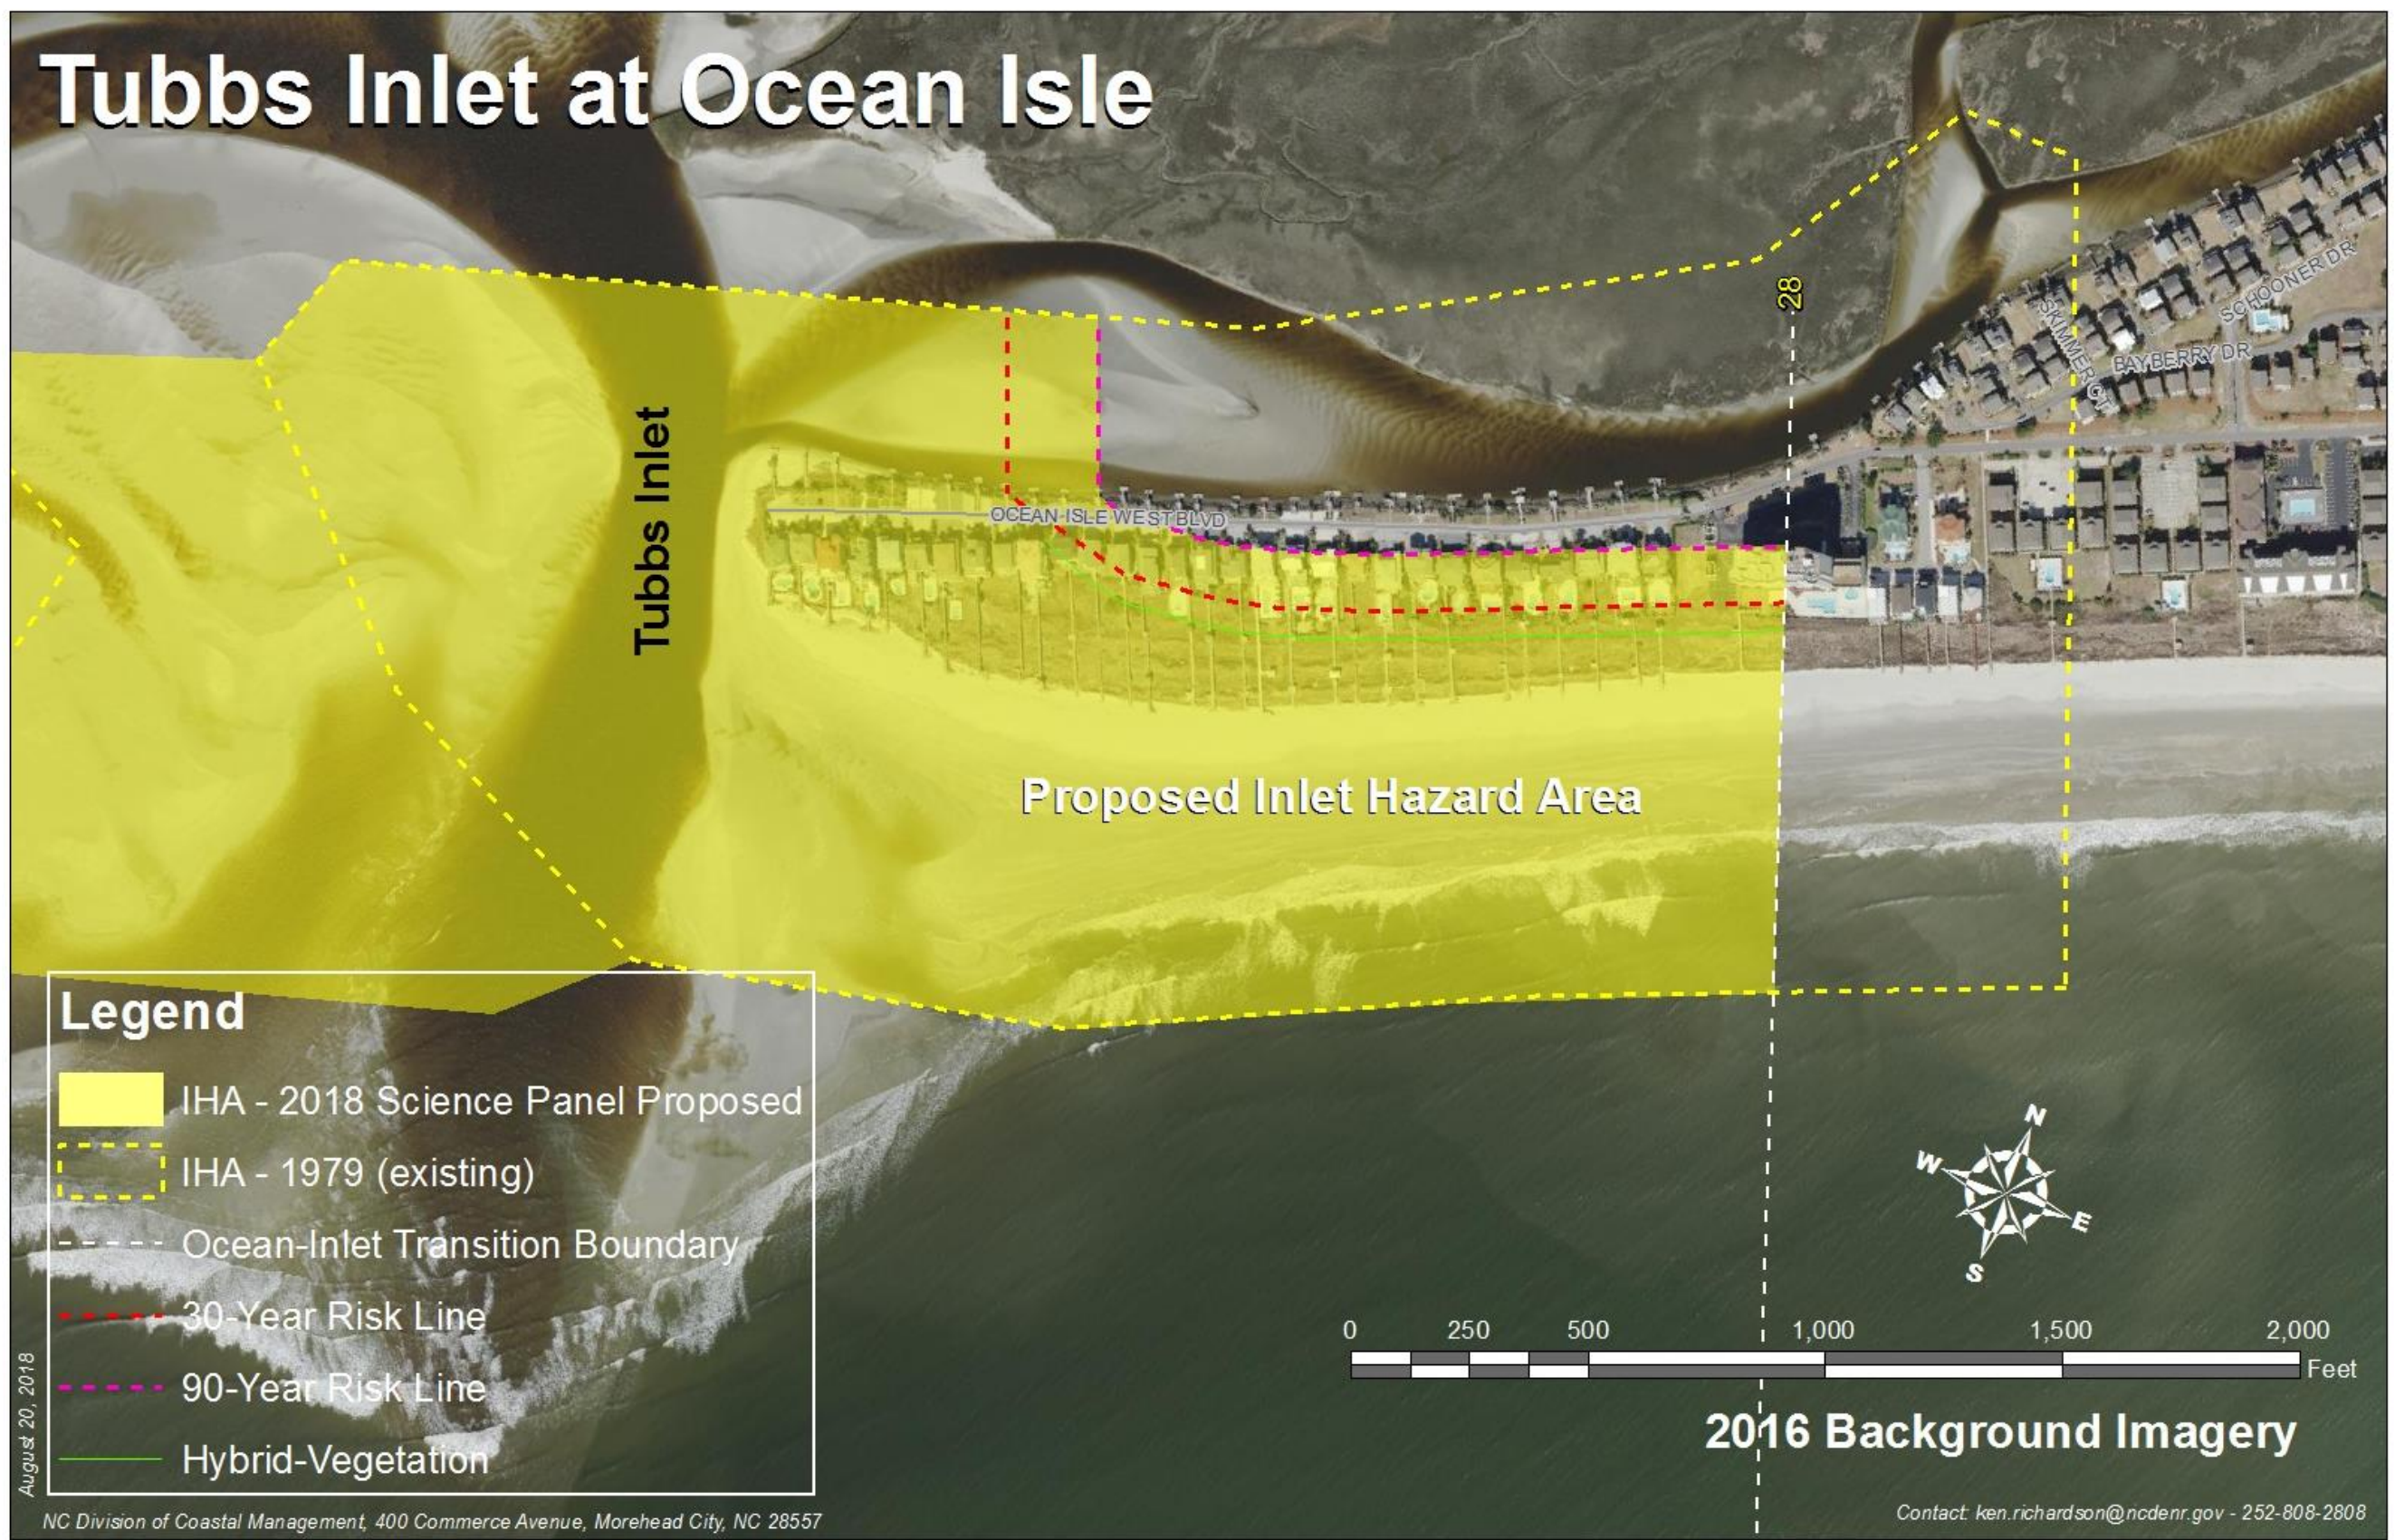
Figure C2. Proposed Inlet Hazard Area at Tubbs Inlet (Ocean Isle Beach).

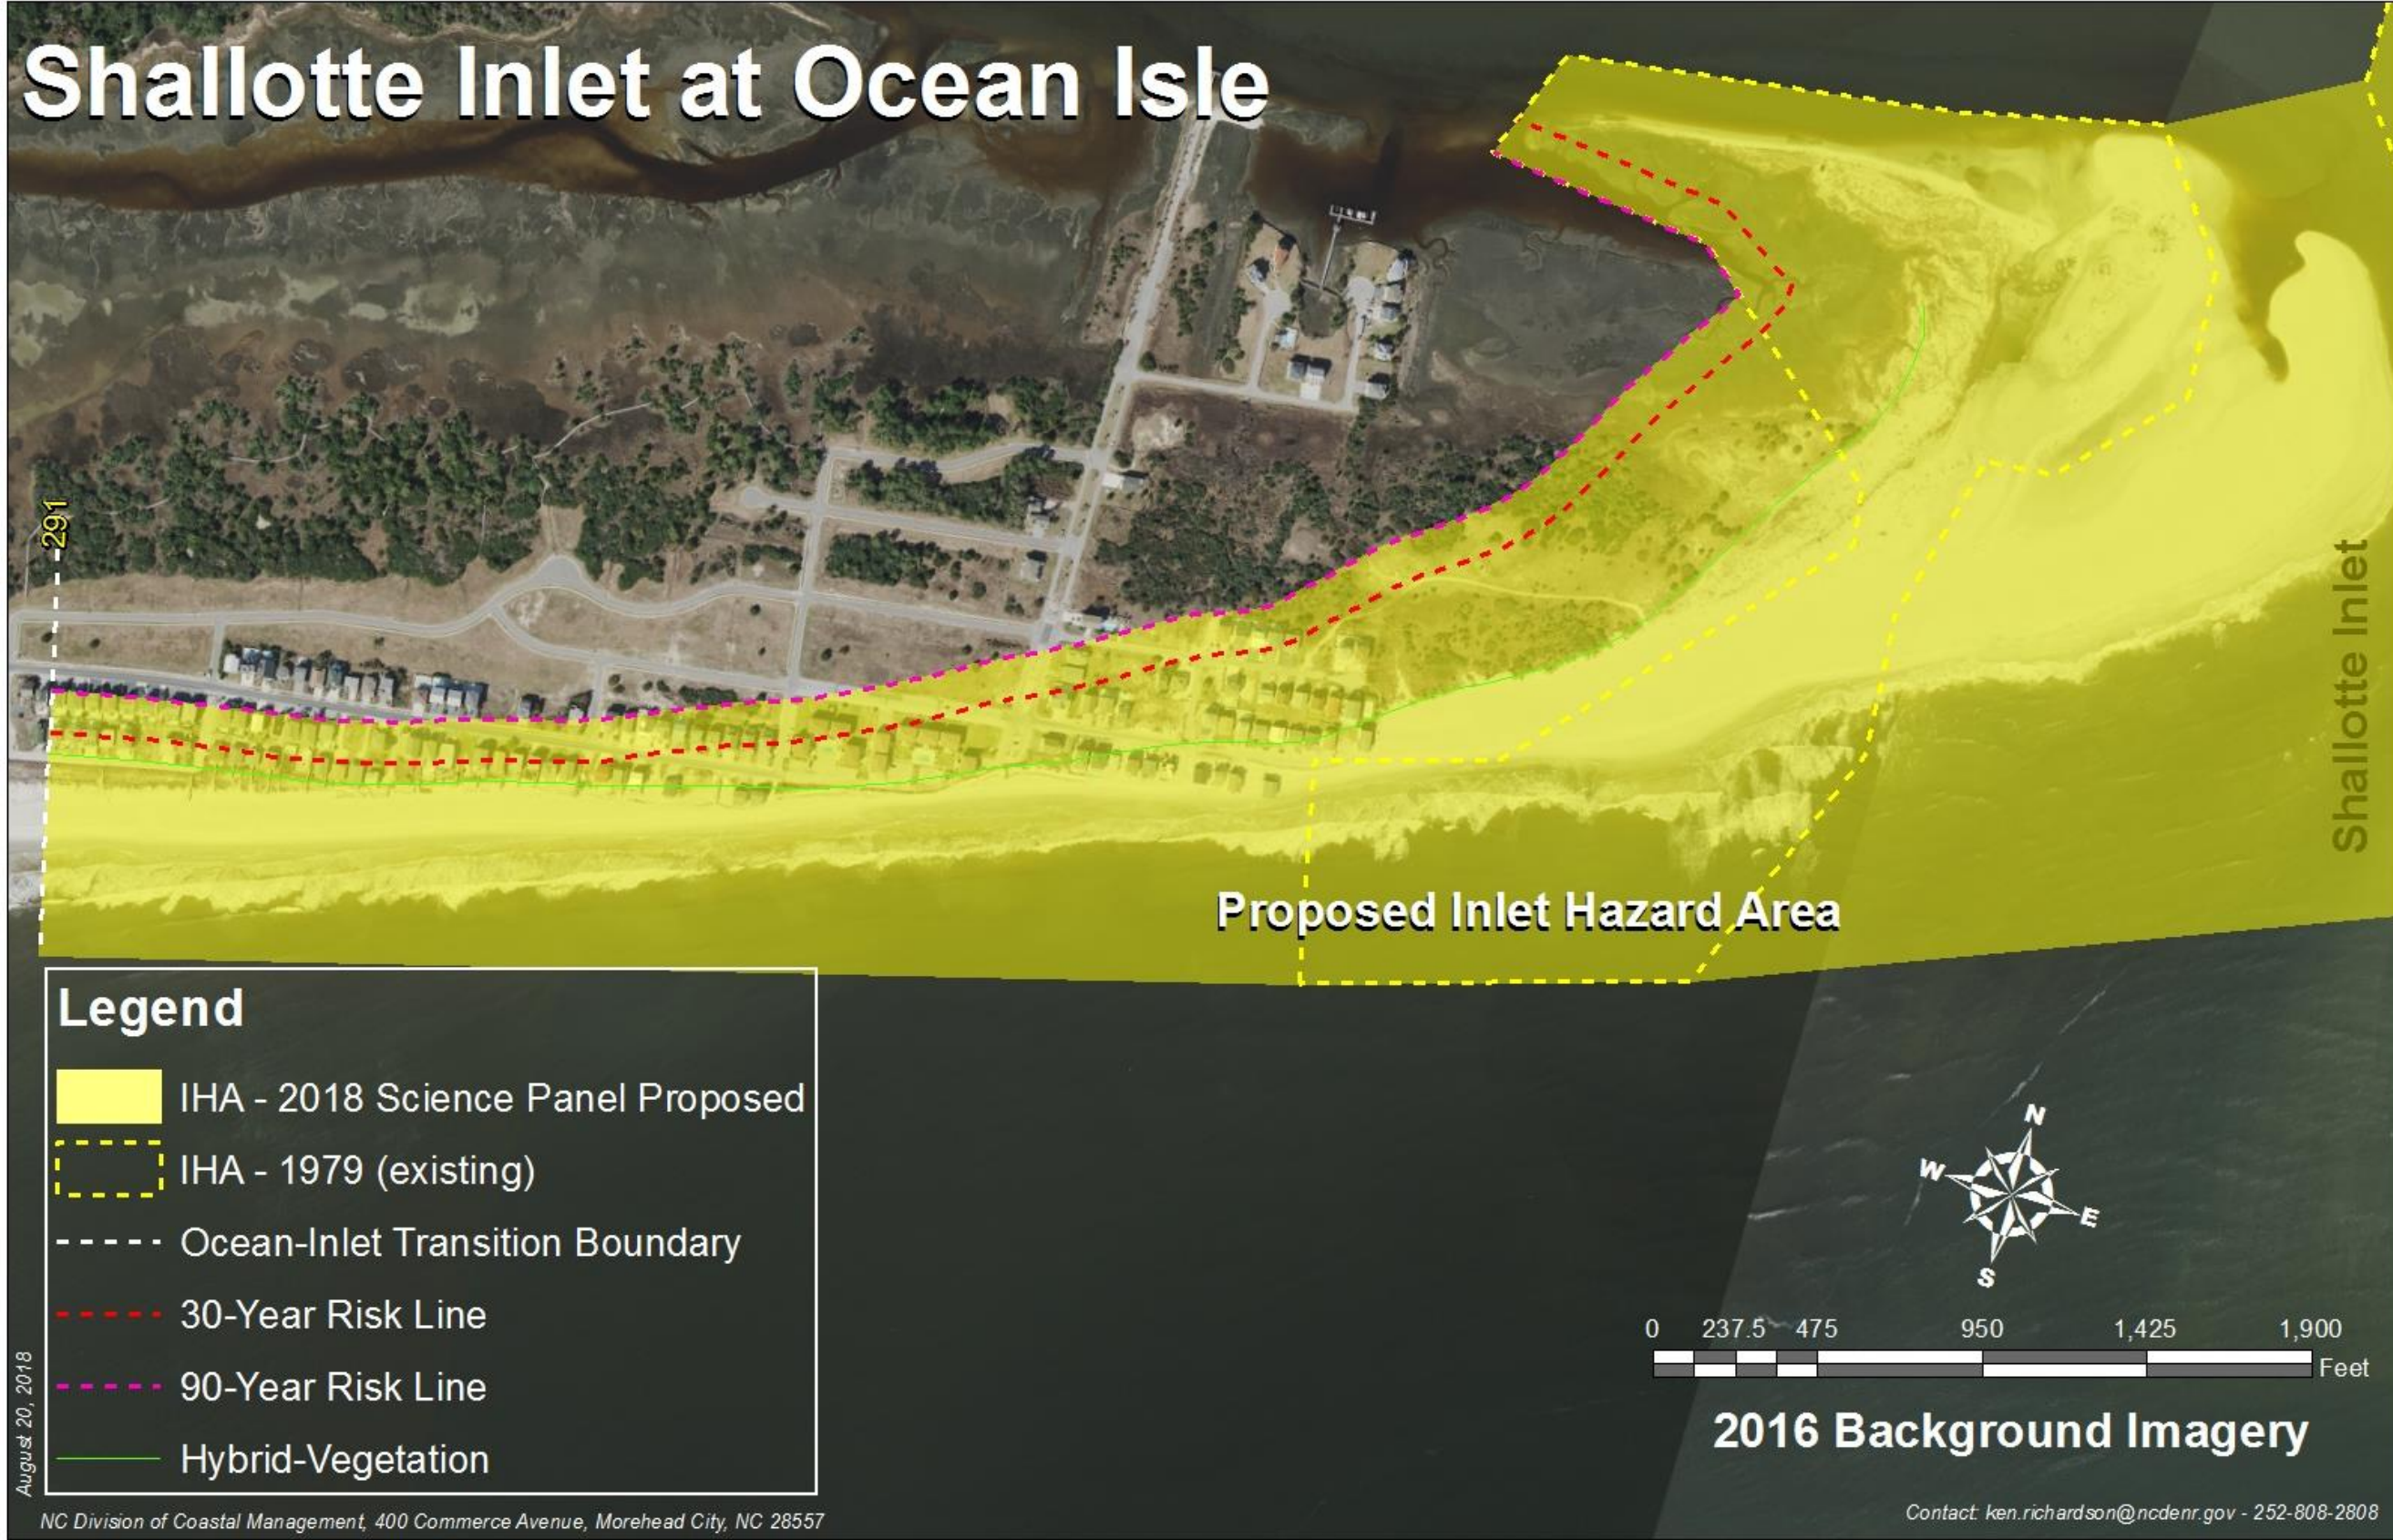
Figure C3. Proposed Inlet Hazard Area at Shallotte Inlet (Ocean Isle).

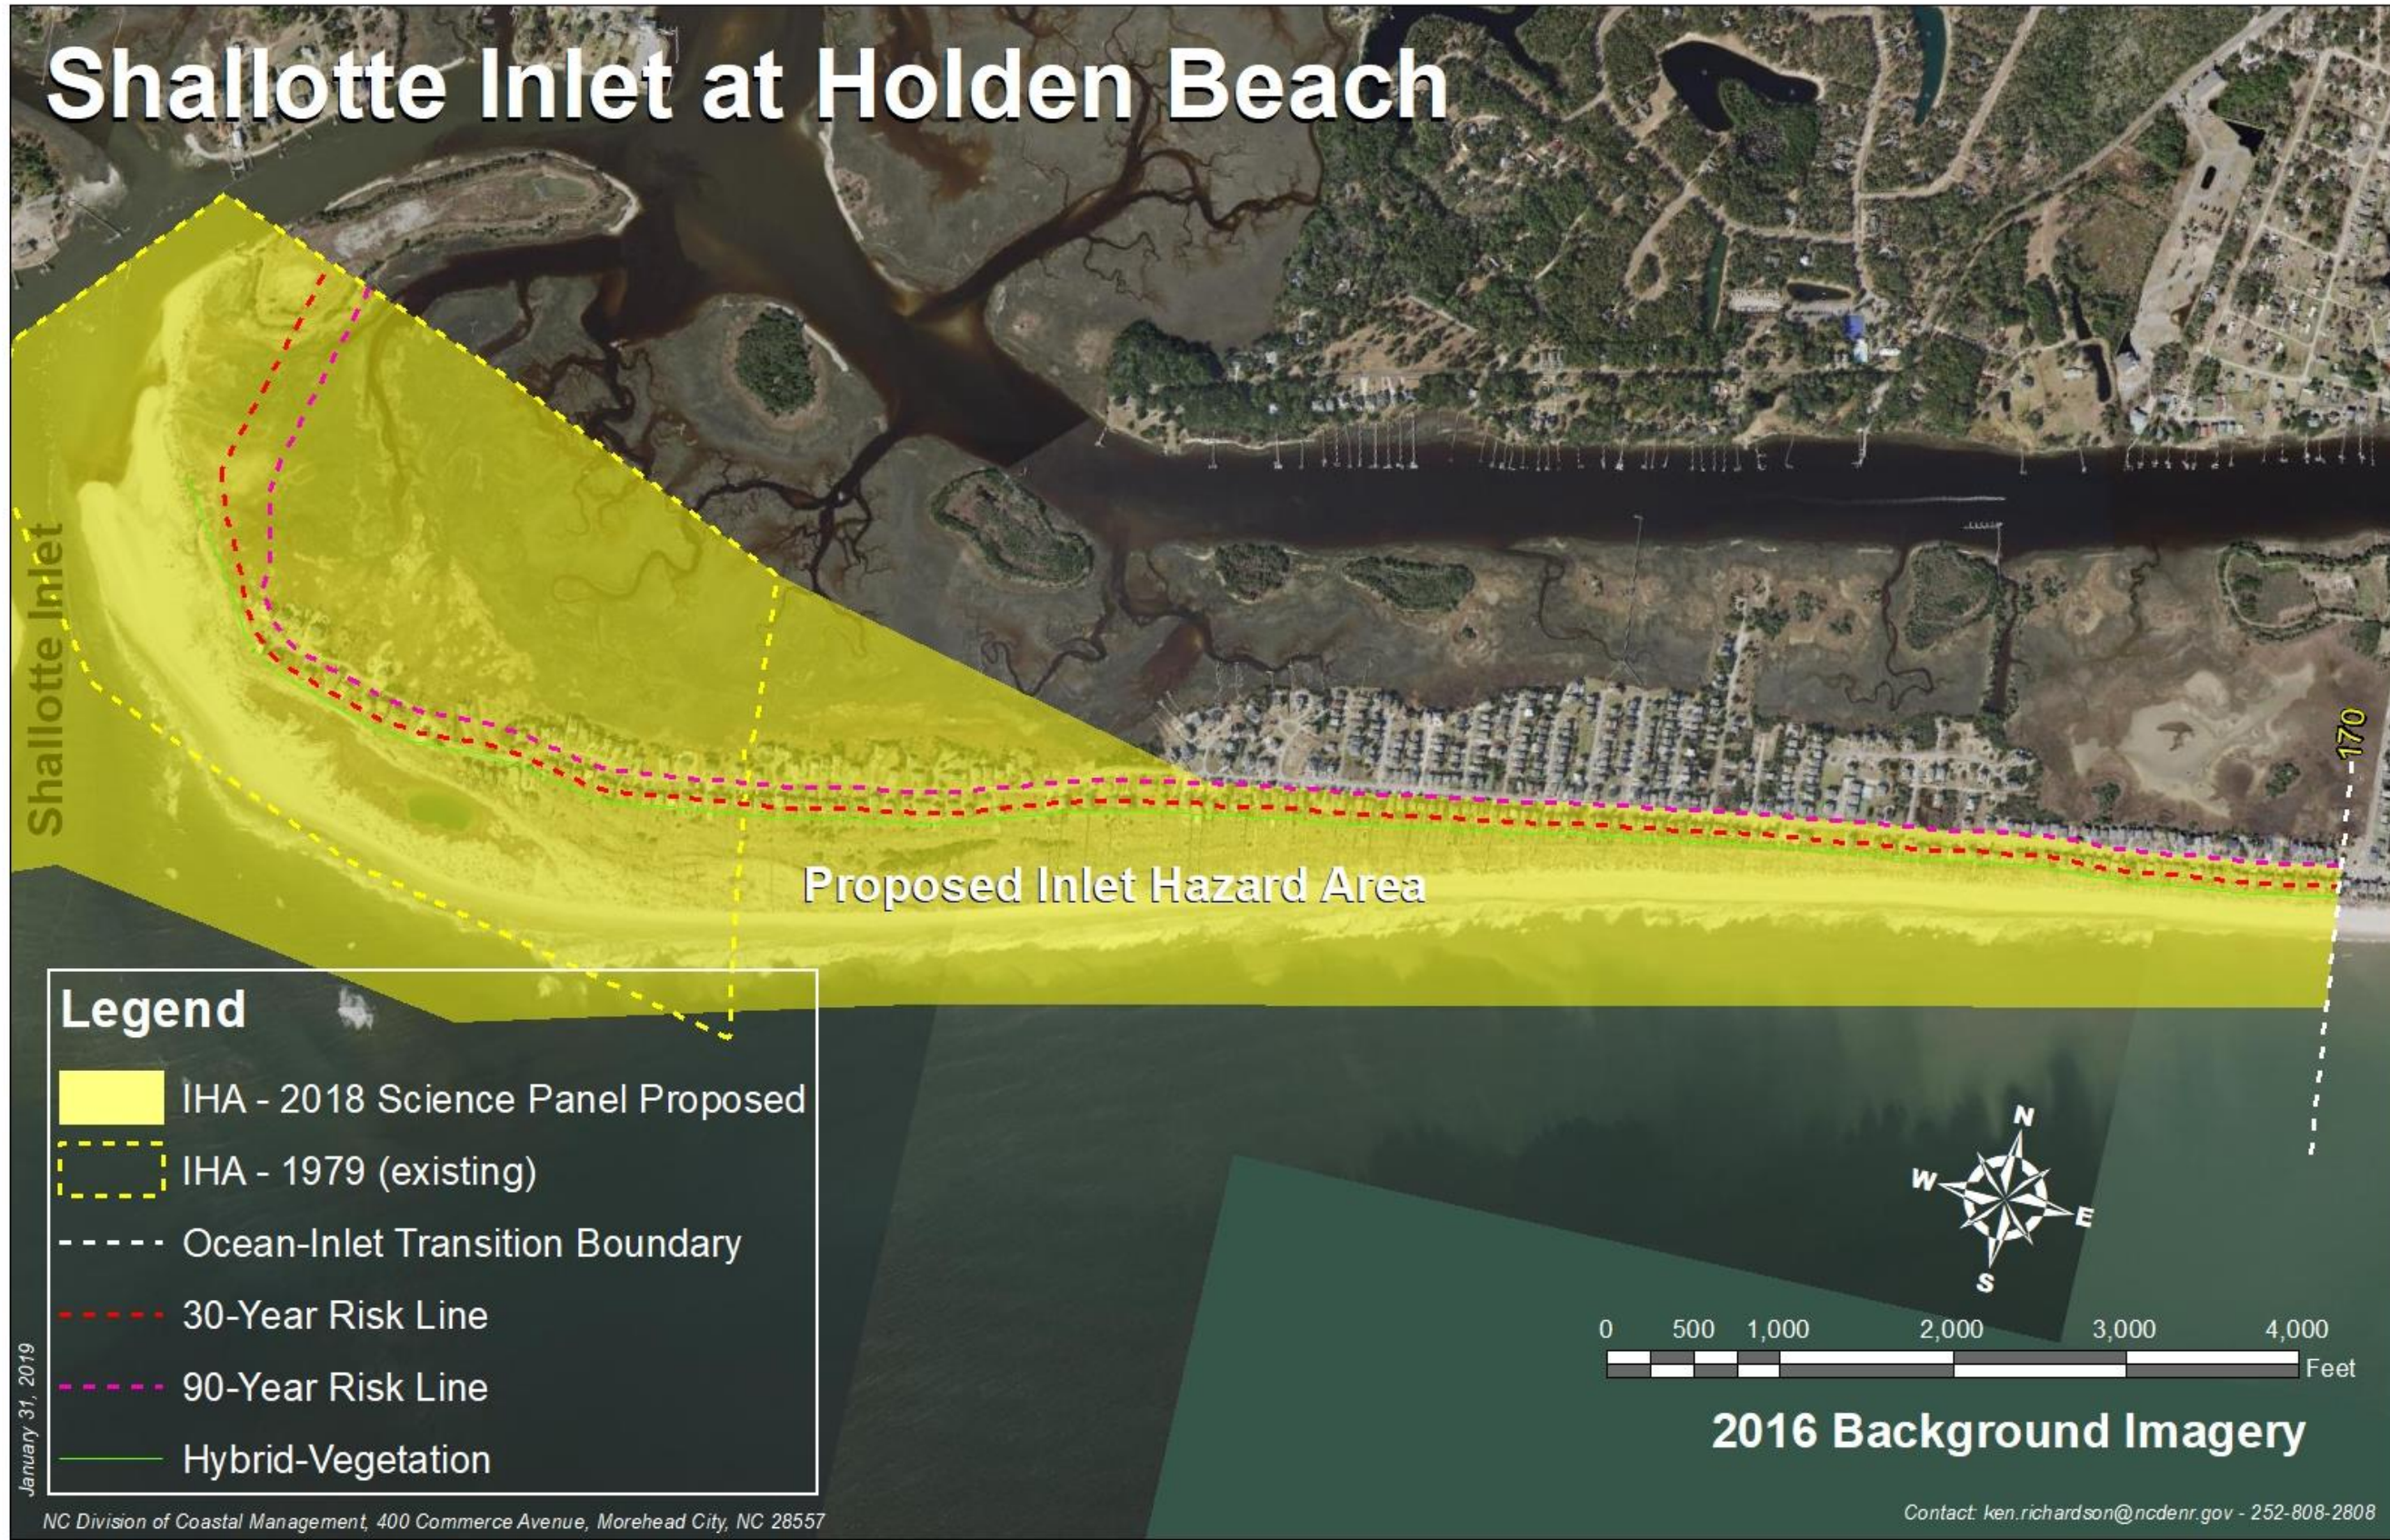
Figure C4. Proposed Inlet Hazard Area at Shallotte Inlet (Holden Beach).

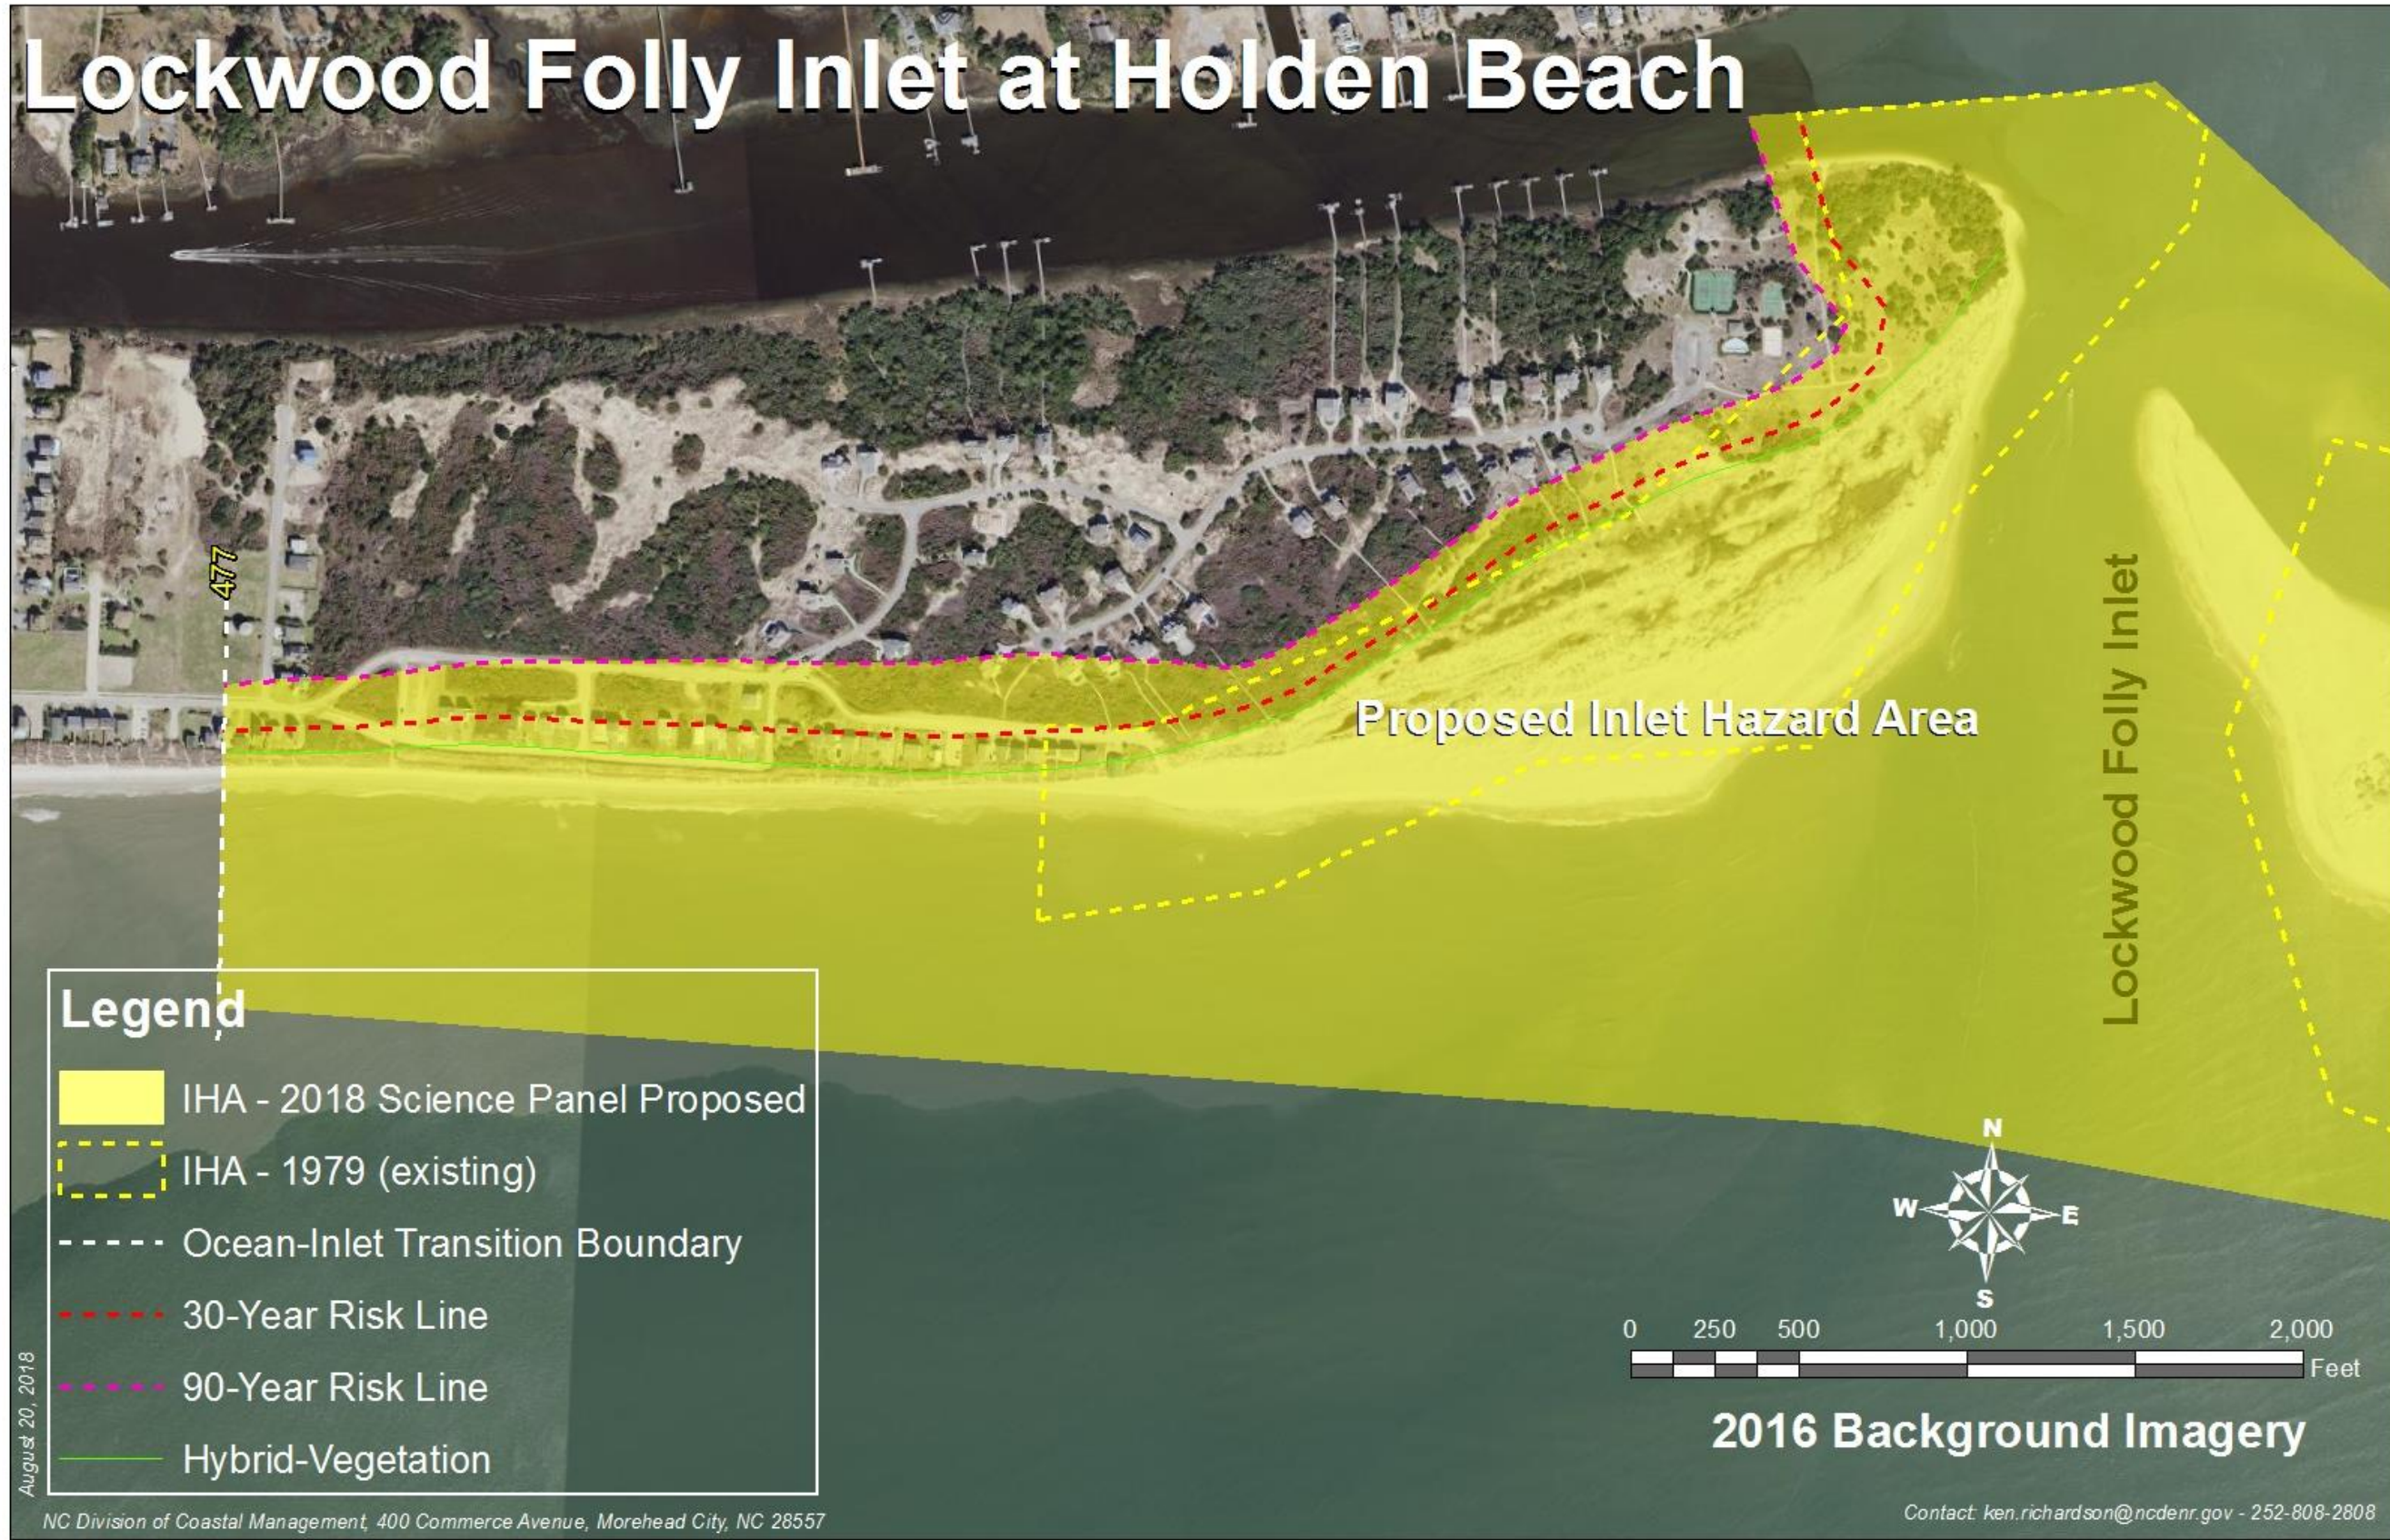
Figure C5. Proposed Inlet Hazard Area at Lockwood Folly Inlet (Holden Beach).

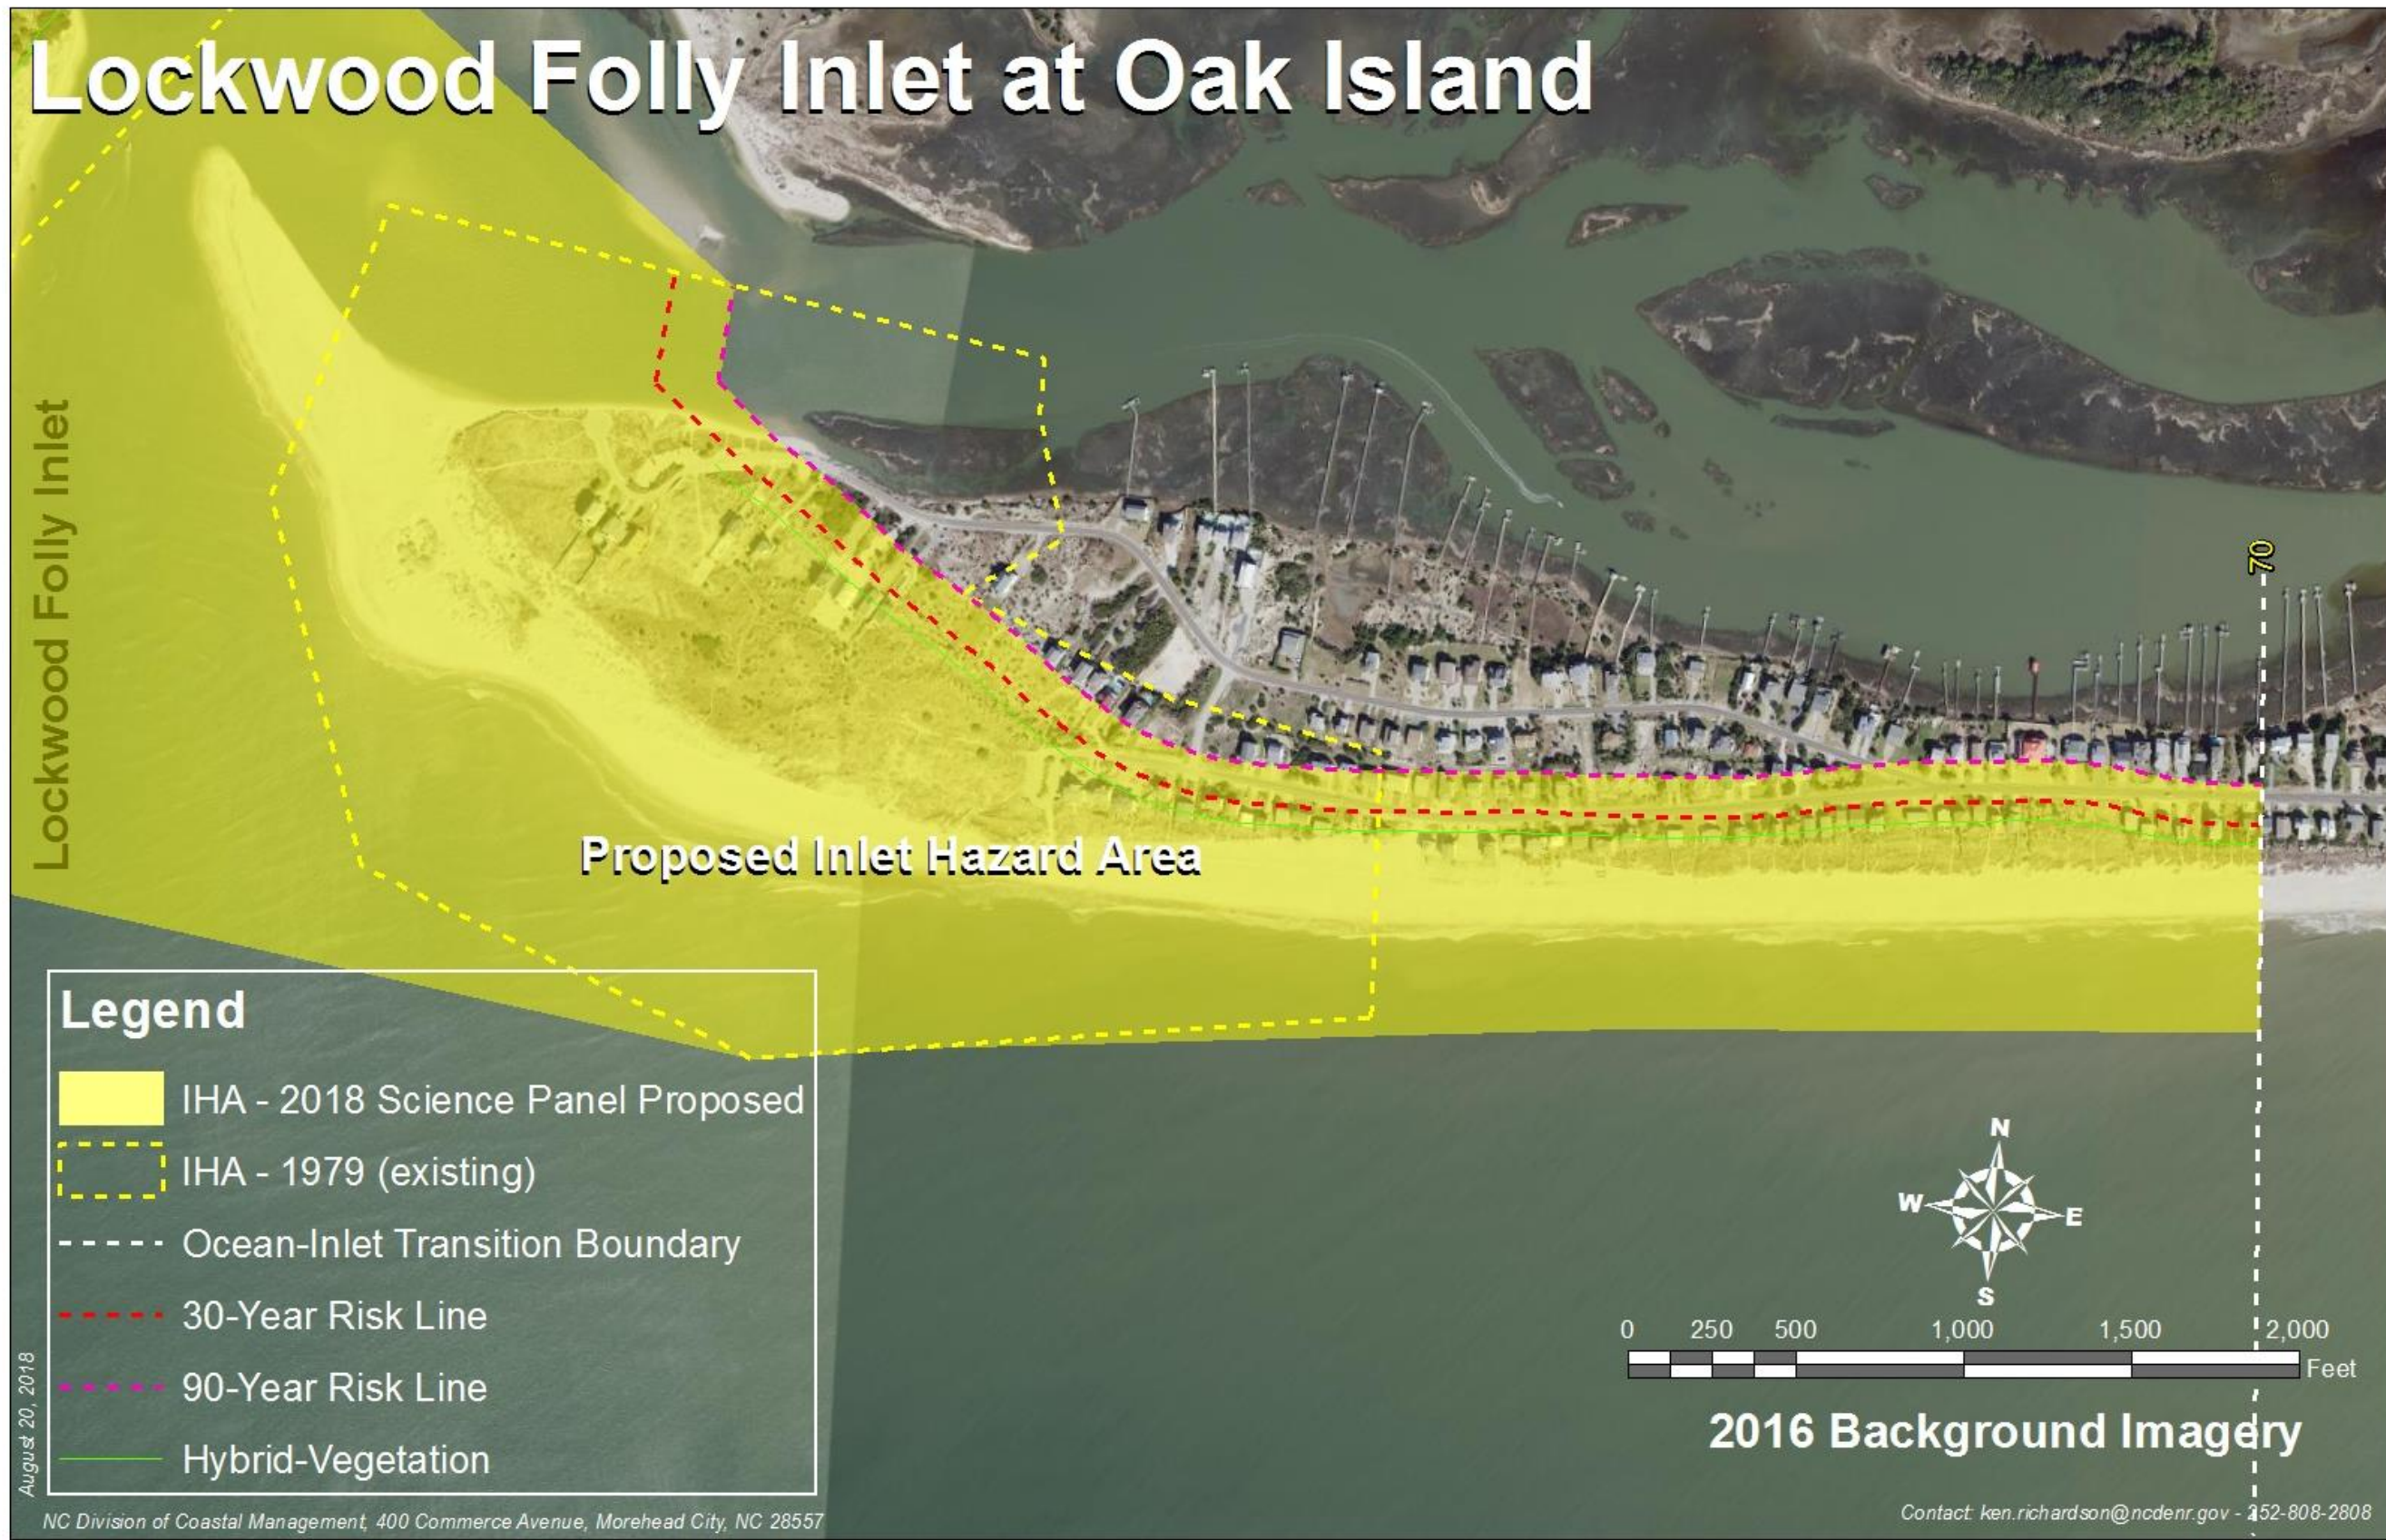
Figure C6. Proposed Inlet Hazard Area at Lockwood Folly Inlet (Oak Island).
