Inlet Hazard Area Boundary, 2019 Update:

Science Panel Recommendations to the
North Carolina Coastal Resources Commission

February 12, 2019

NC Coastal Resources Commission's Science Panel on Coastal Hazards
& NC Division of Coastal Management

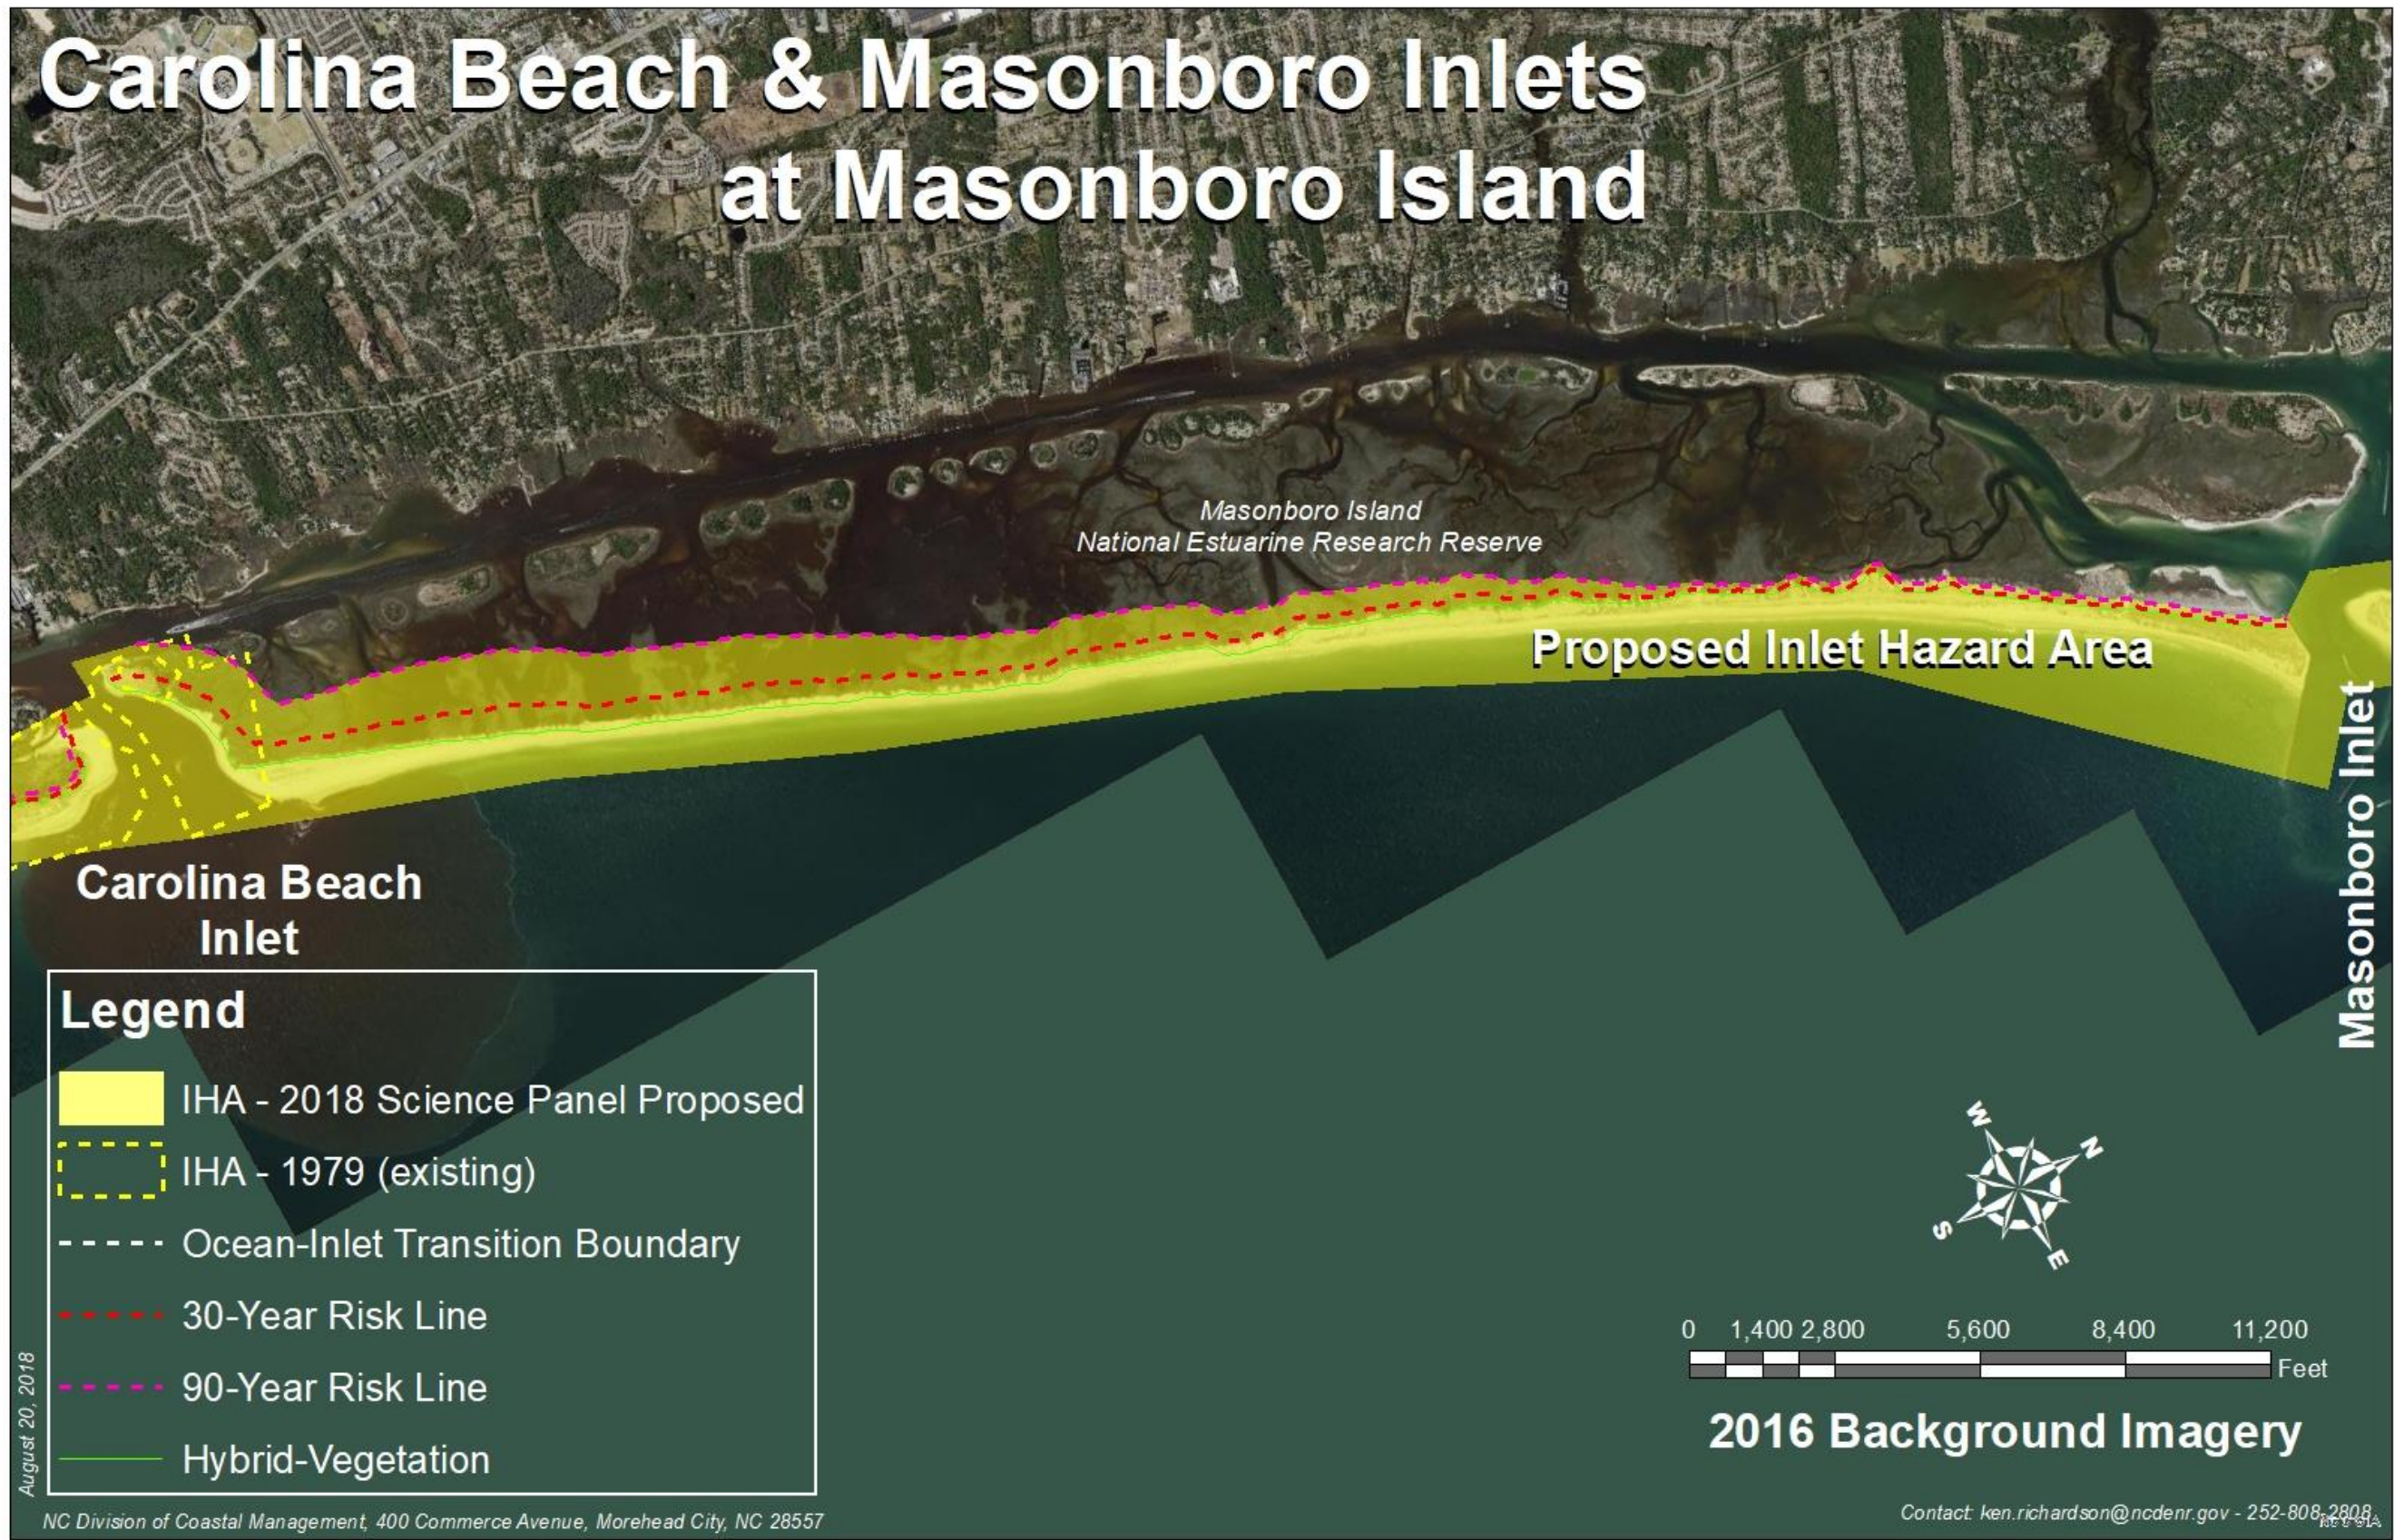
Figure C8. Proposed Inlet Hazard Area for Masonboro Island.

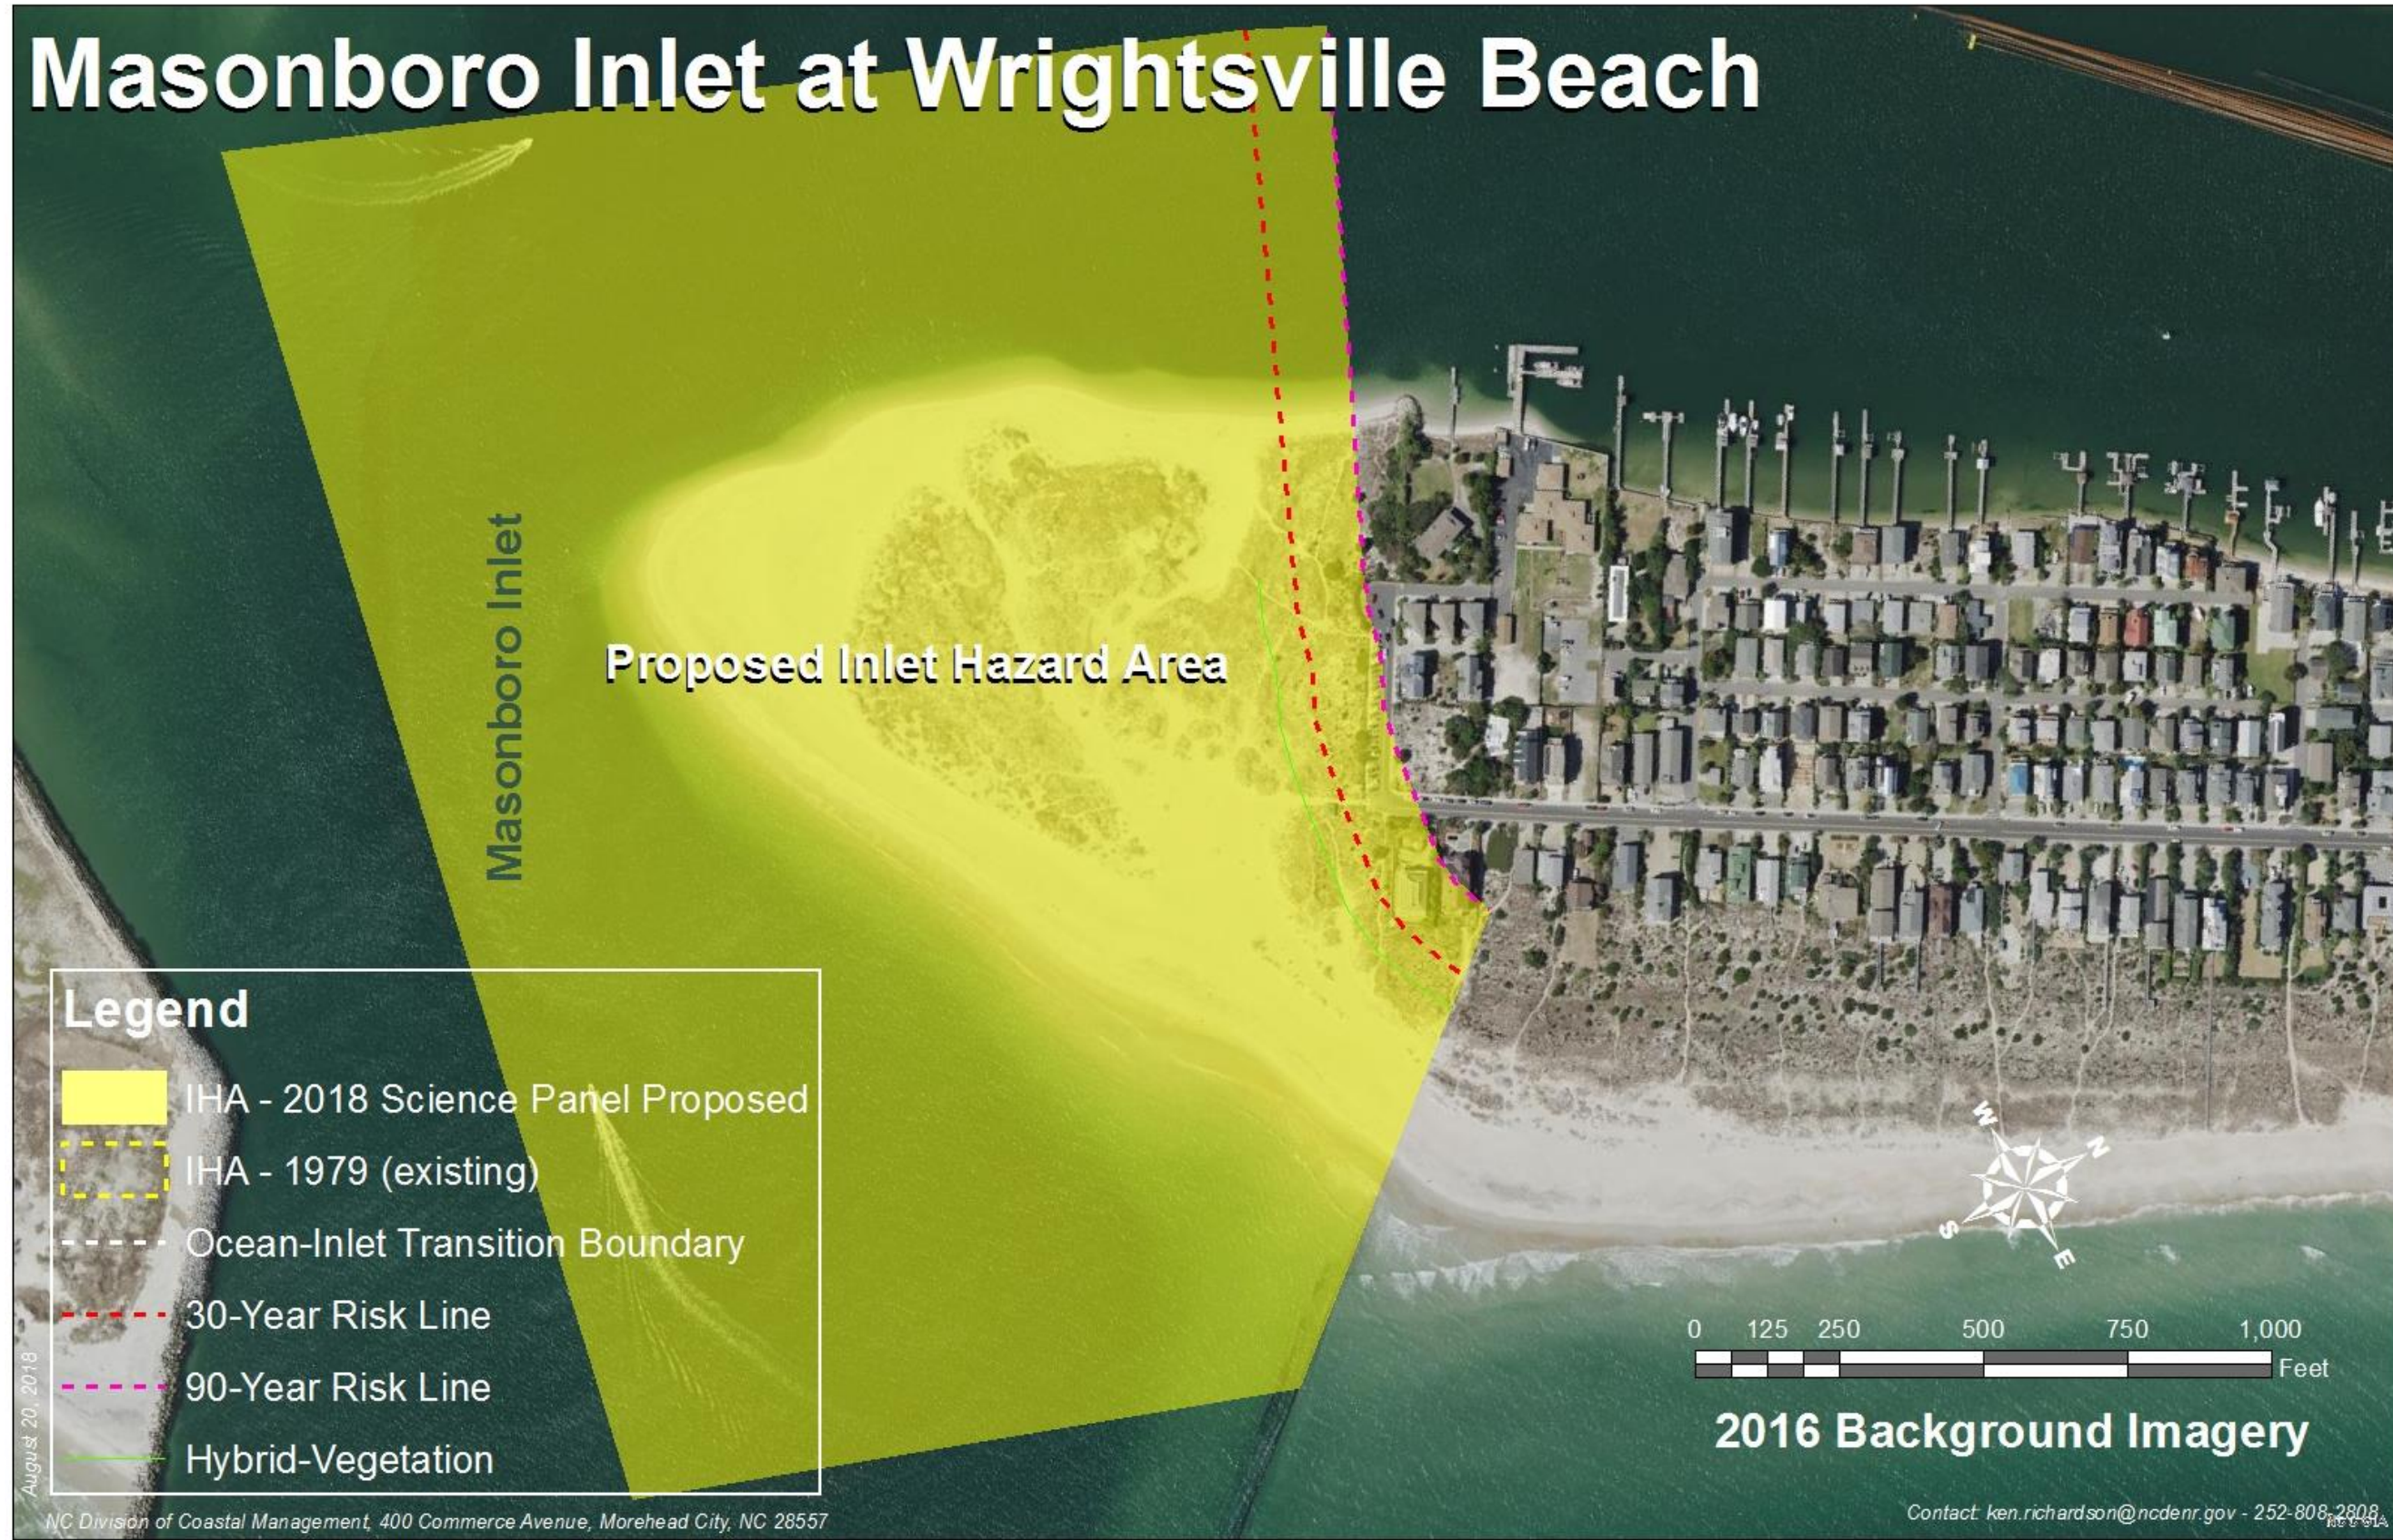
Figure C9. Proposed Inlet Hazard Area at Masonboro Inlet (Wrightsville Beach).

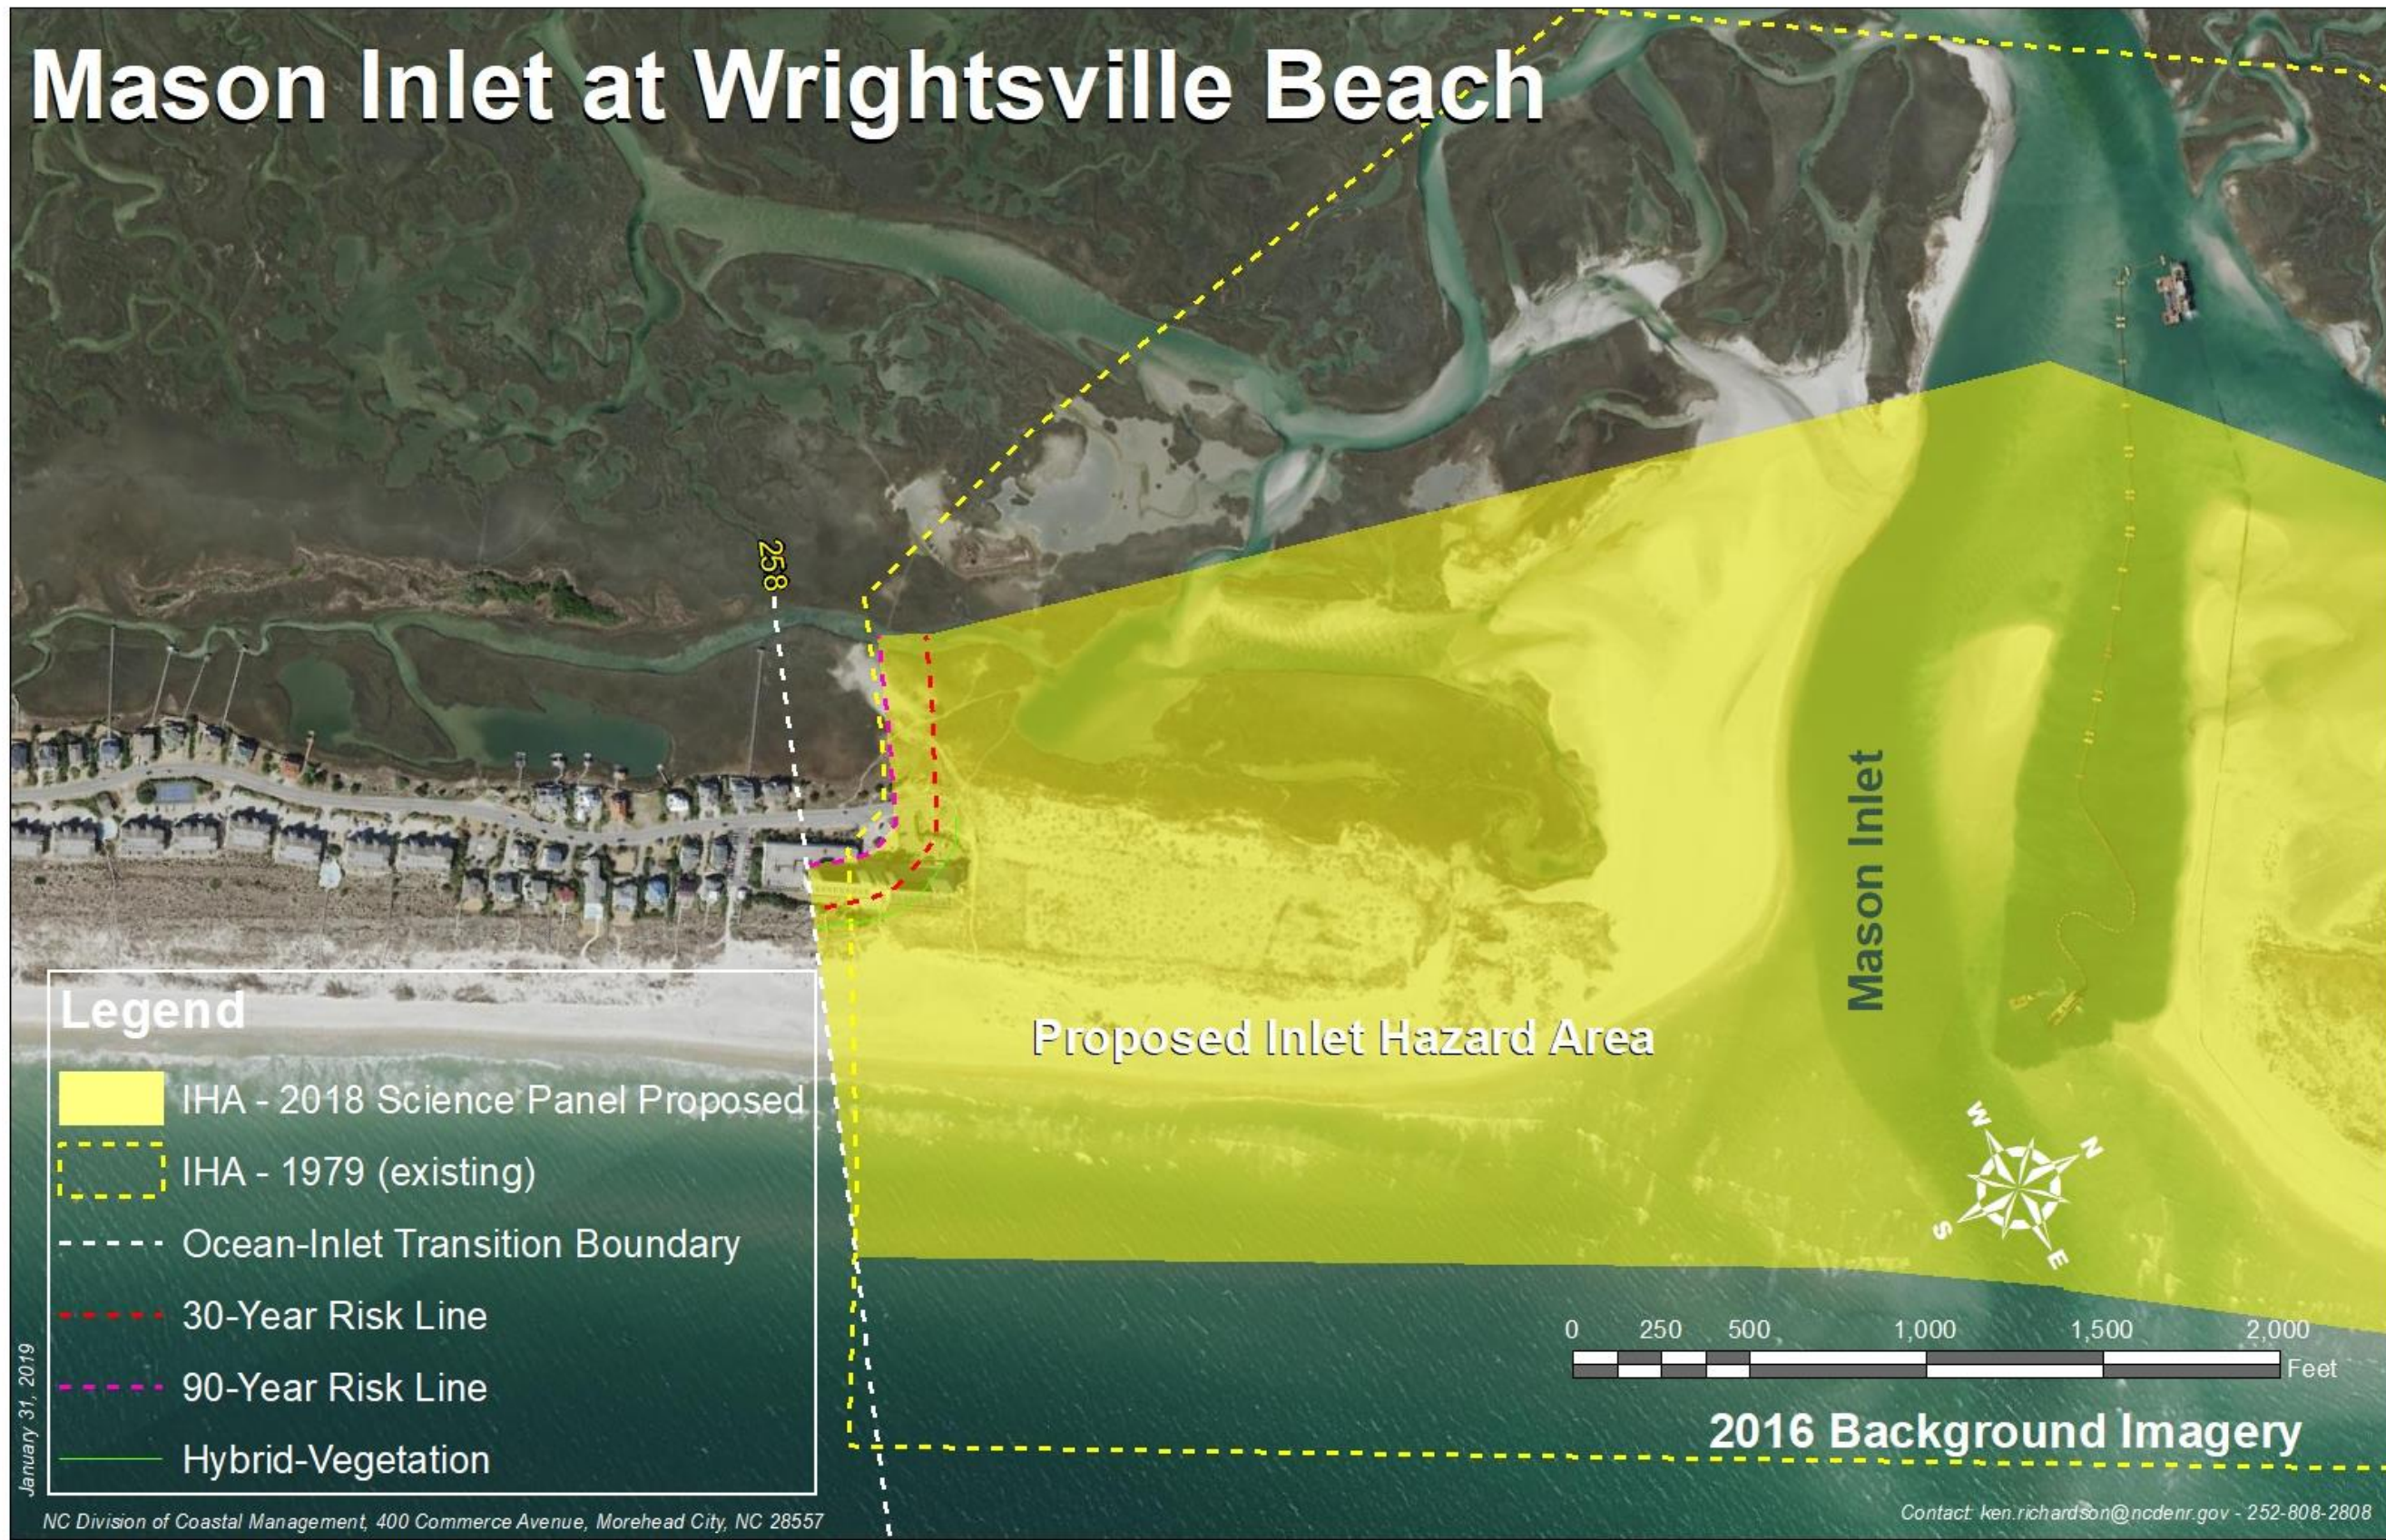
Figure C10. Proposed Inlet Hazard Area at Mason Inlet (Wrightsville Beach).

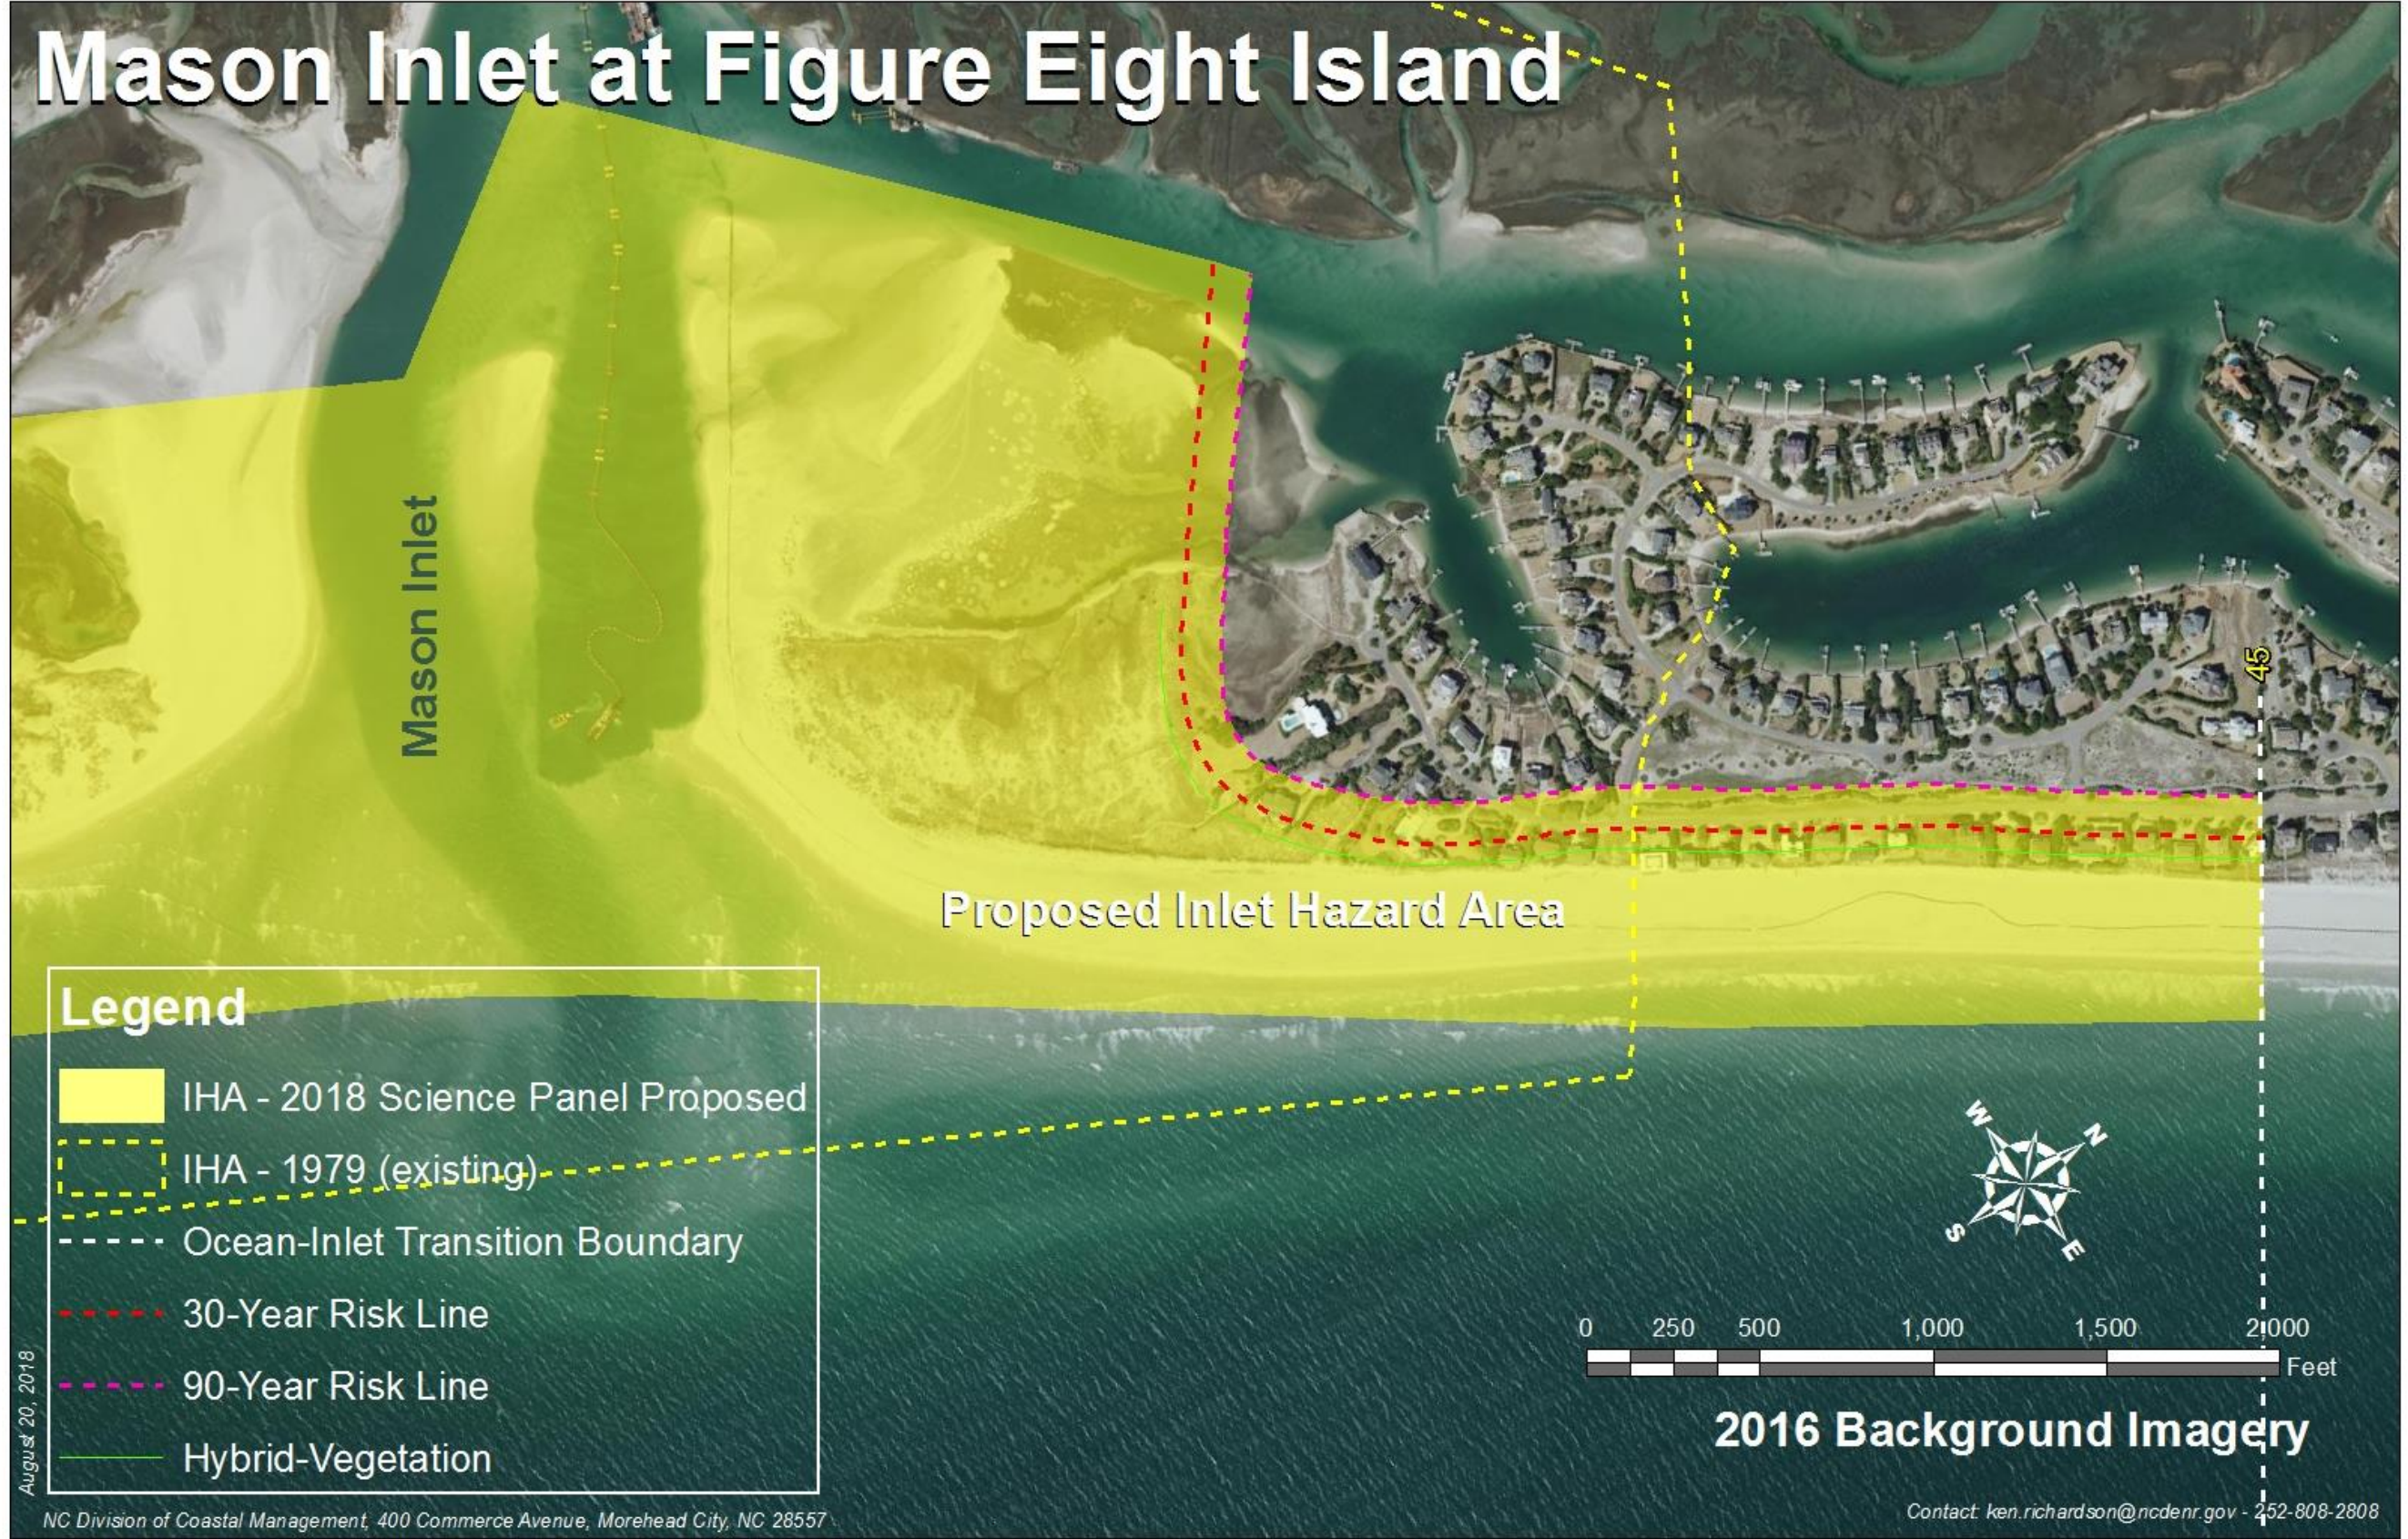
Figure C11. Proposed Inlet Hazard Area at Mason Inlet (Figure Eight Island).

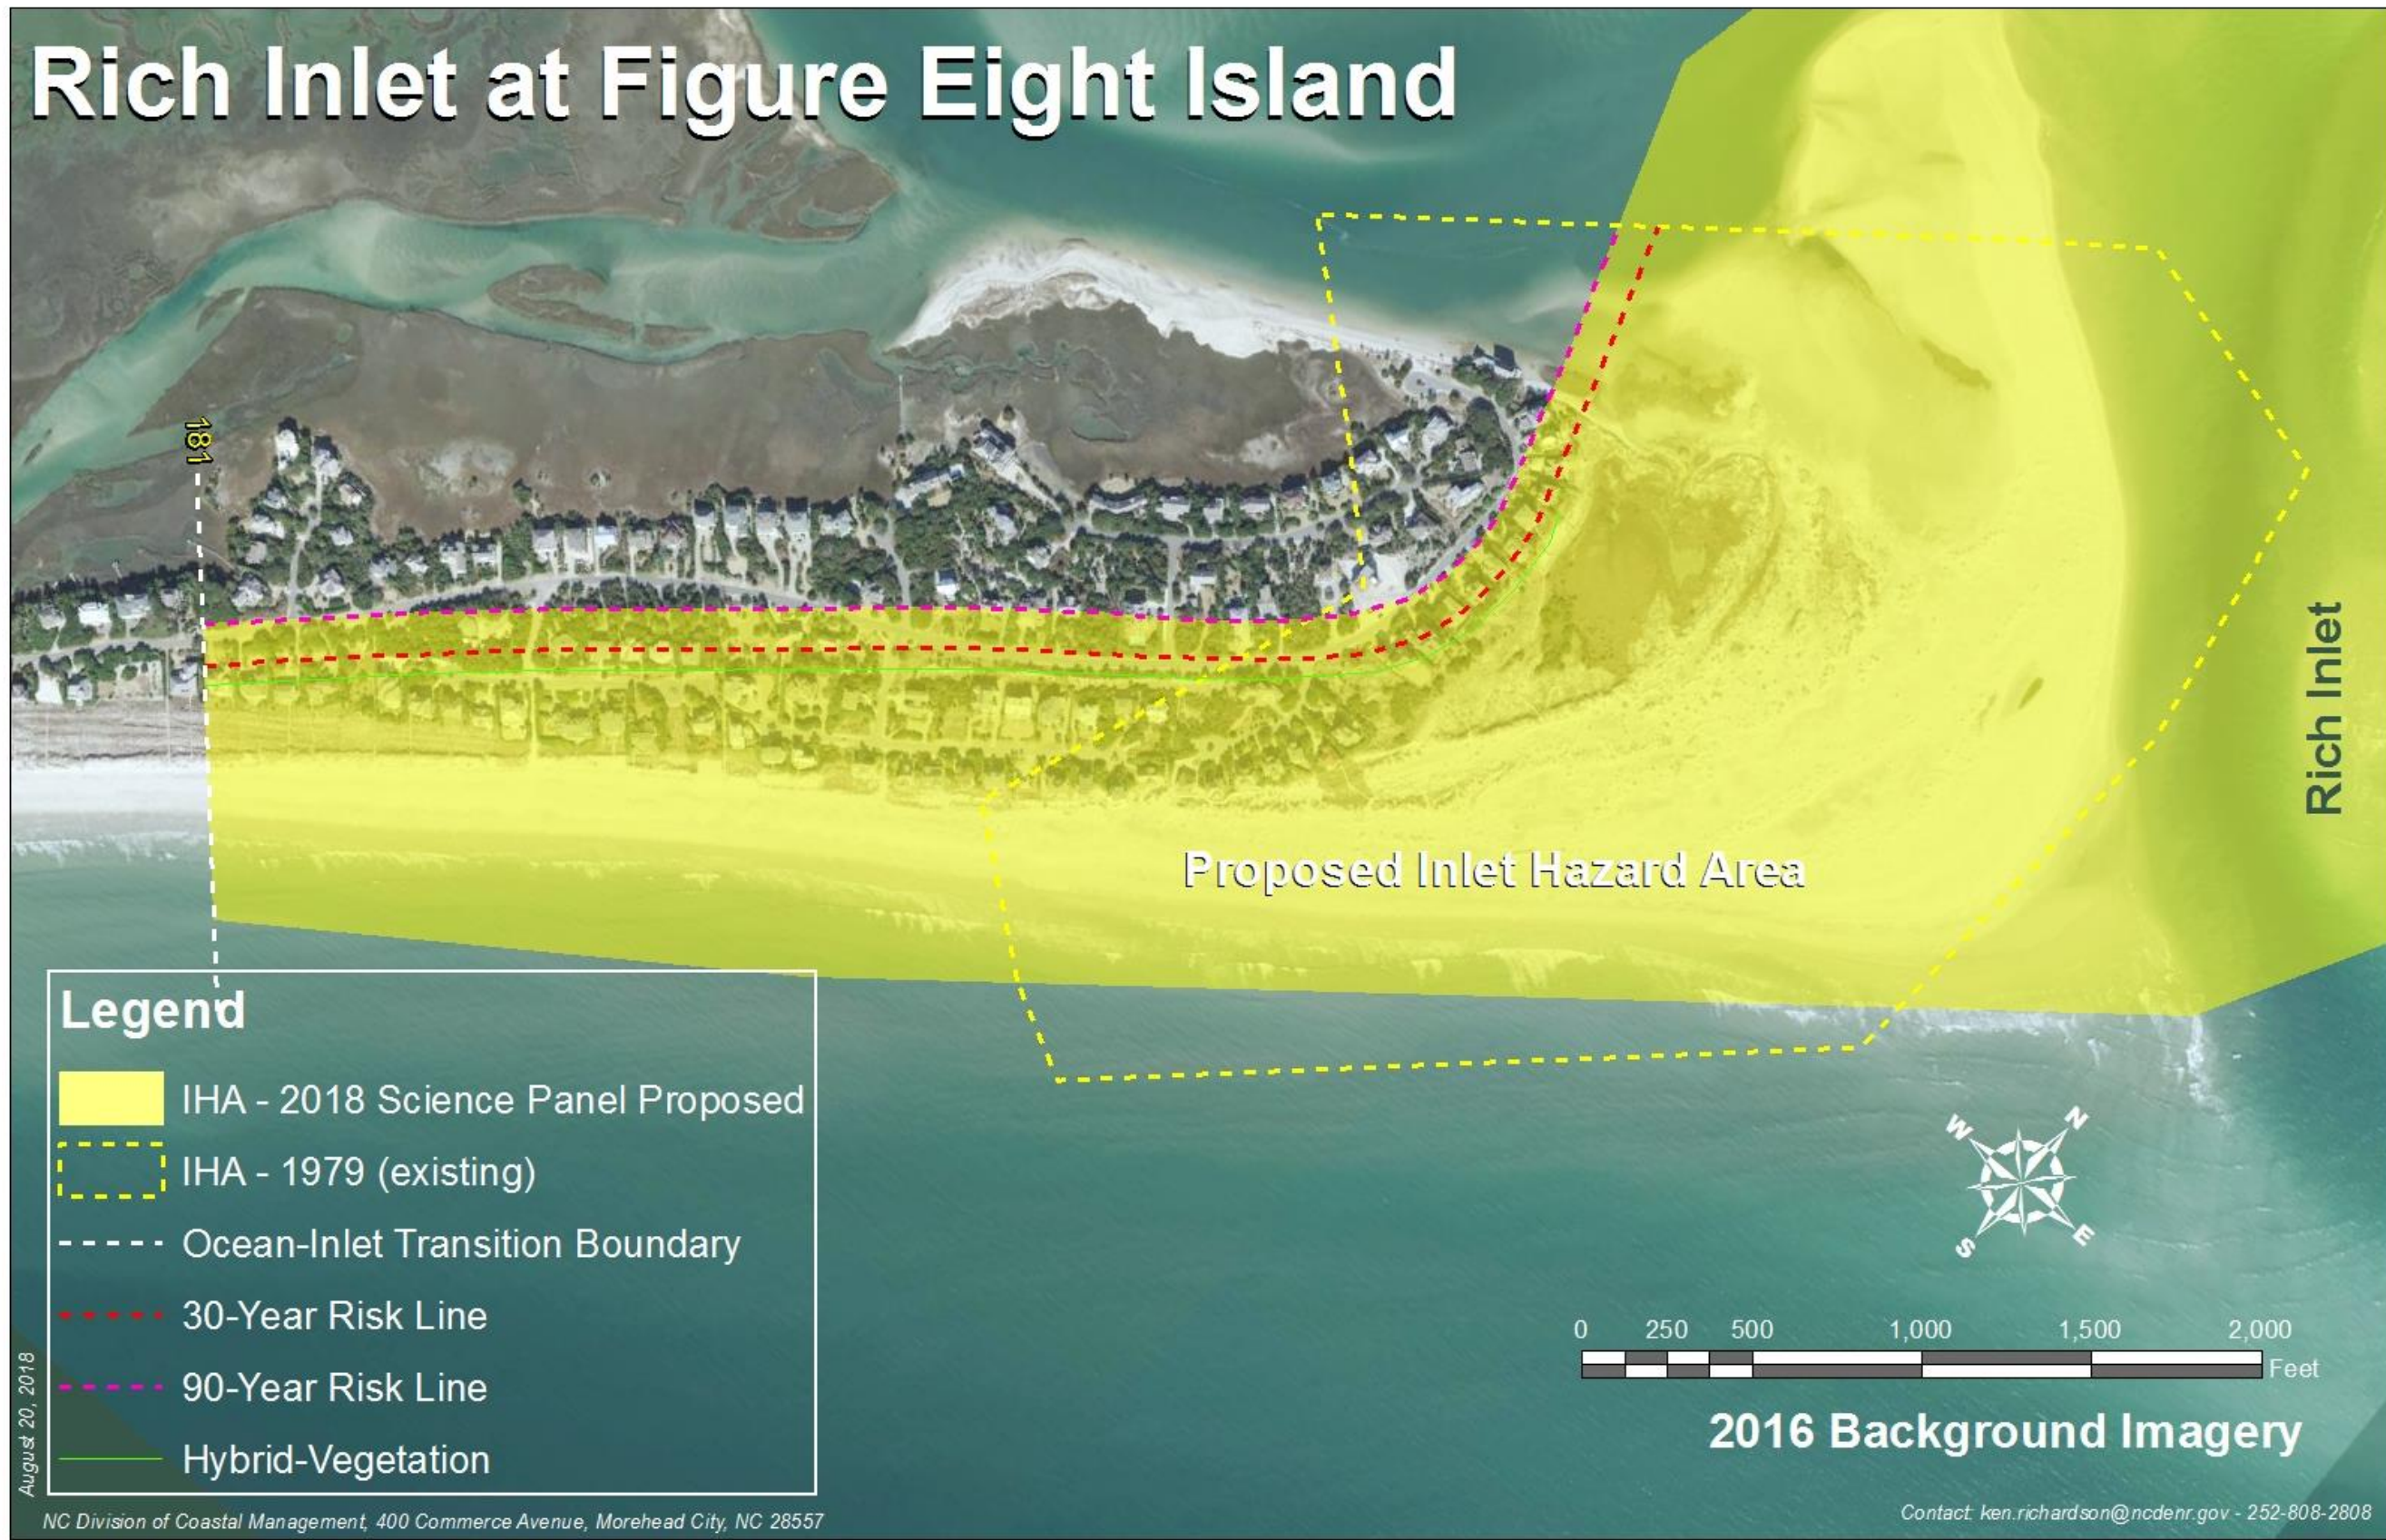
Figure C12. Proposed Inlet Hazard Area at Rich Inlet (Figure Eight Island).

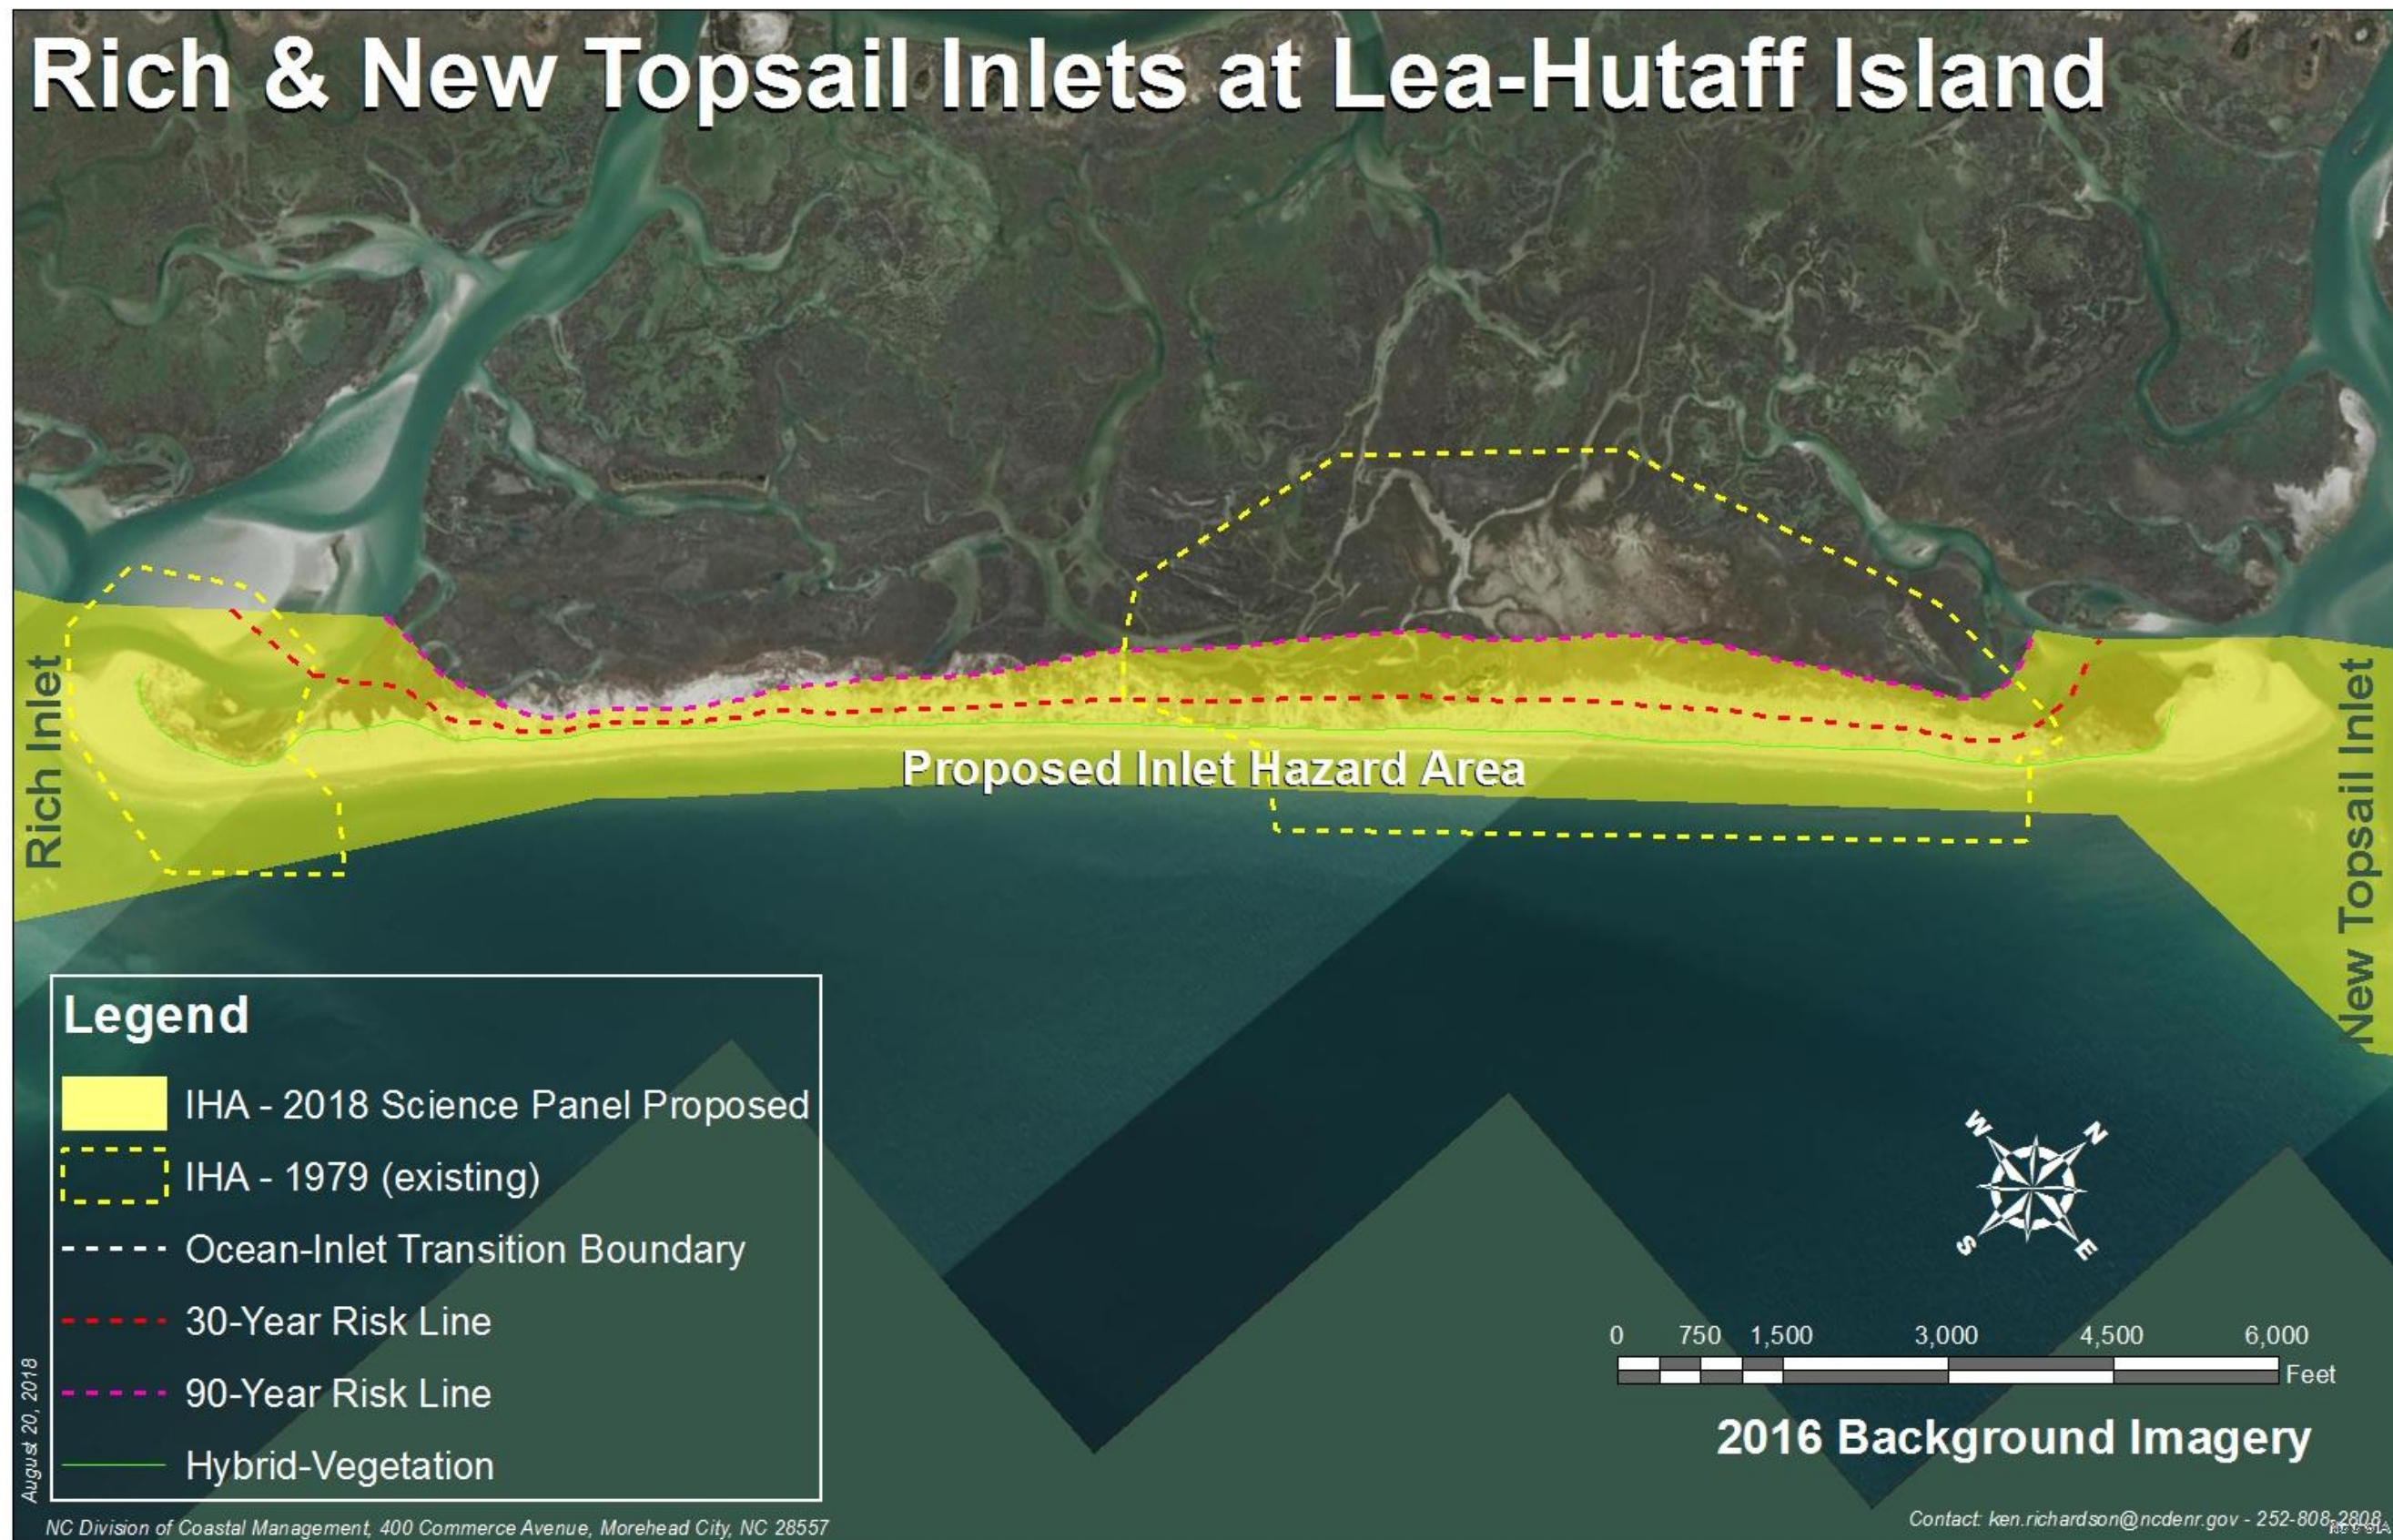
Figure C13. Proposed Inlet Hazard Area at Rich & New Topsail Inlets (Lea-Hutaff Island).
