Inlet Hazard Area Boundary, 2019 Update:

Science Panel Recommendations to the
North Carolina Coastal Resources Commission

February 12, 2019

NC Coastal Resources Commission's Science Panel on Coastal Hazards
& NC Division of Coastal Management

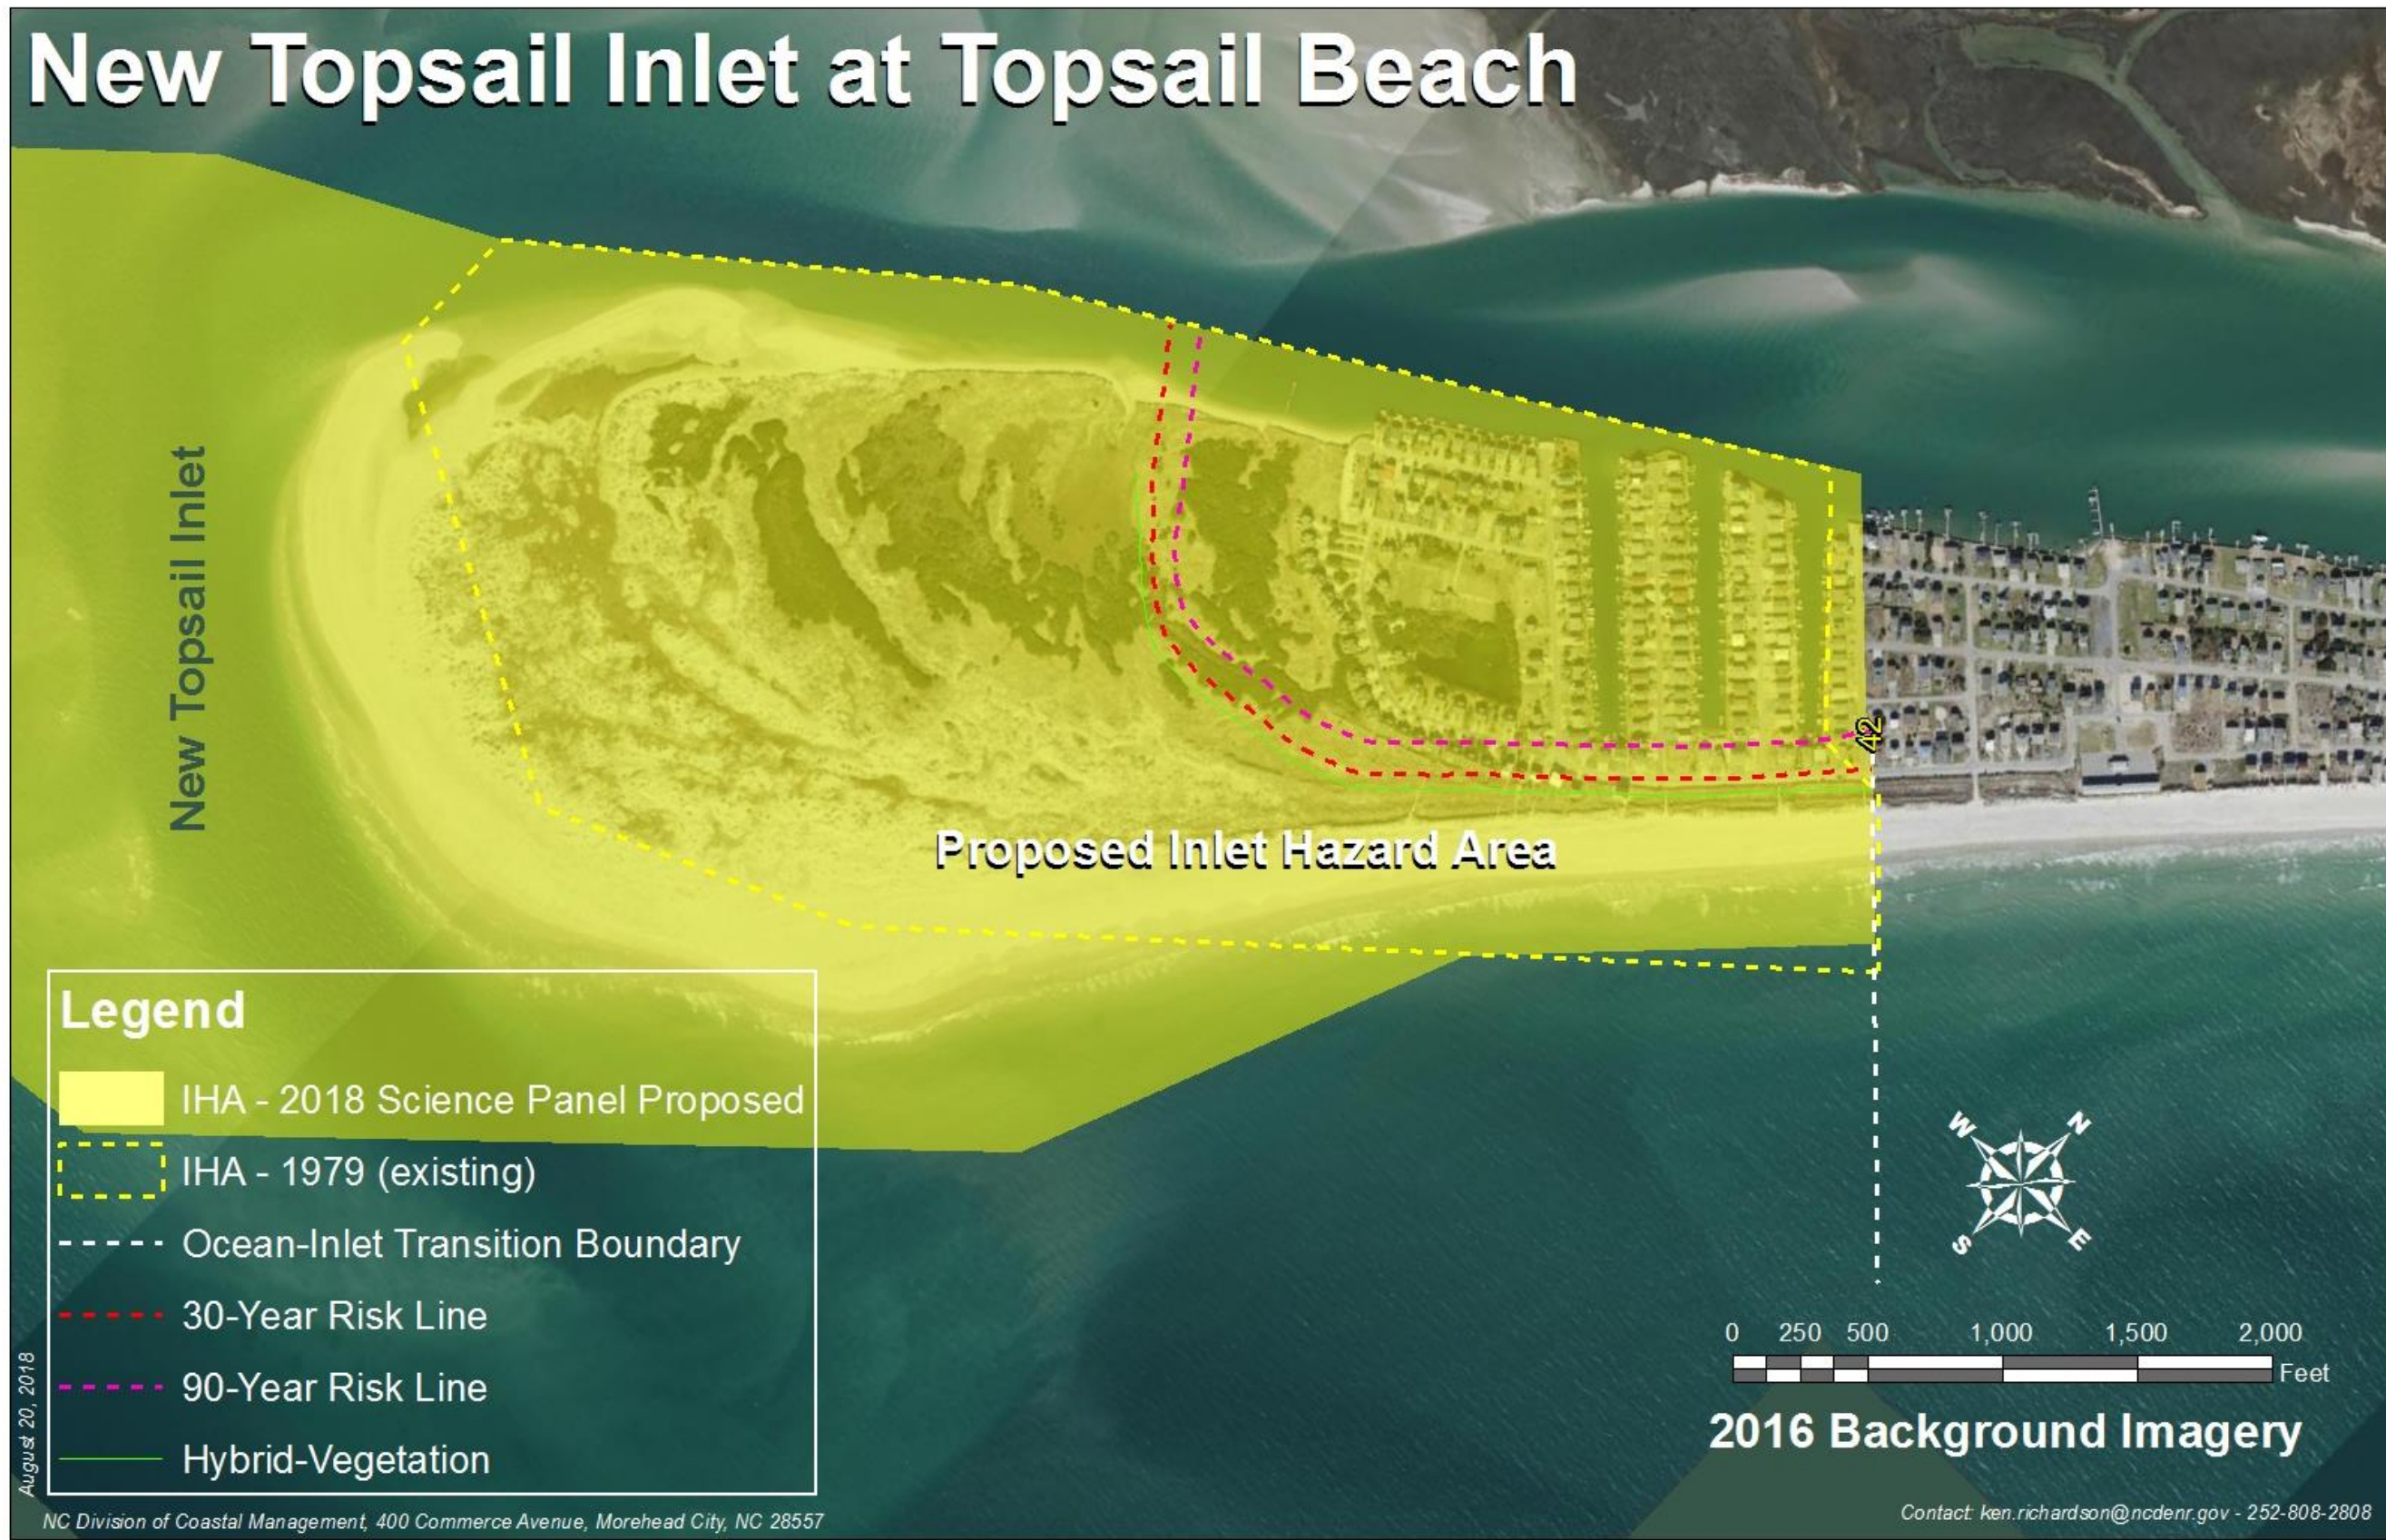
Figure C14. Proposed Inlet Hazard Area at New Topsail Inlet (Topsail Beach).

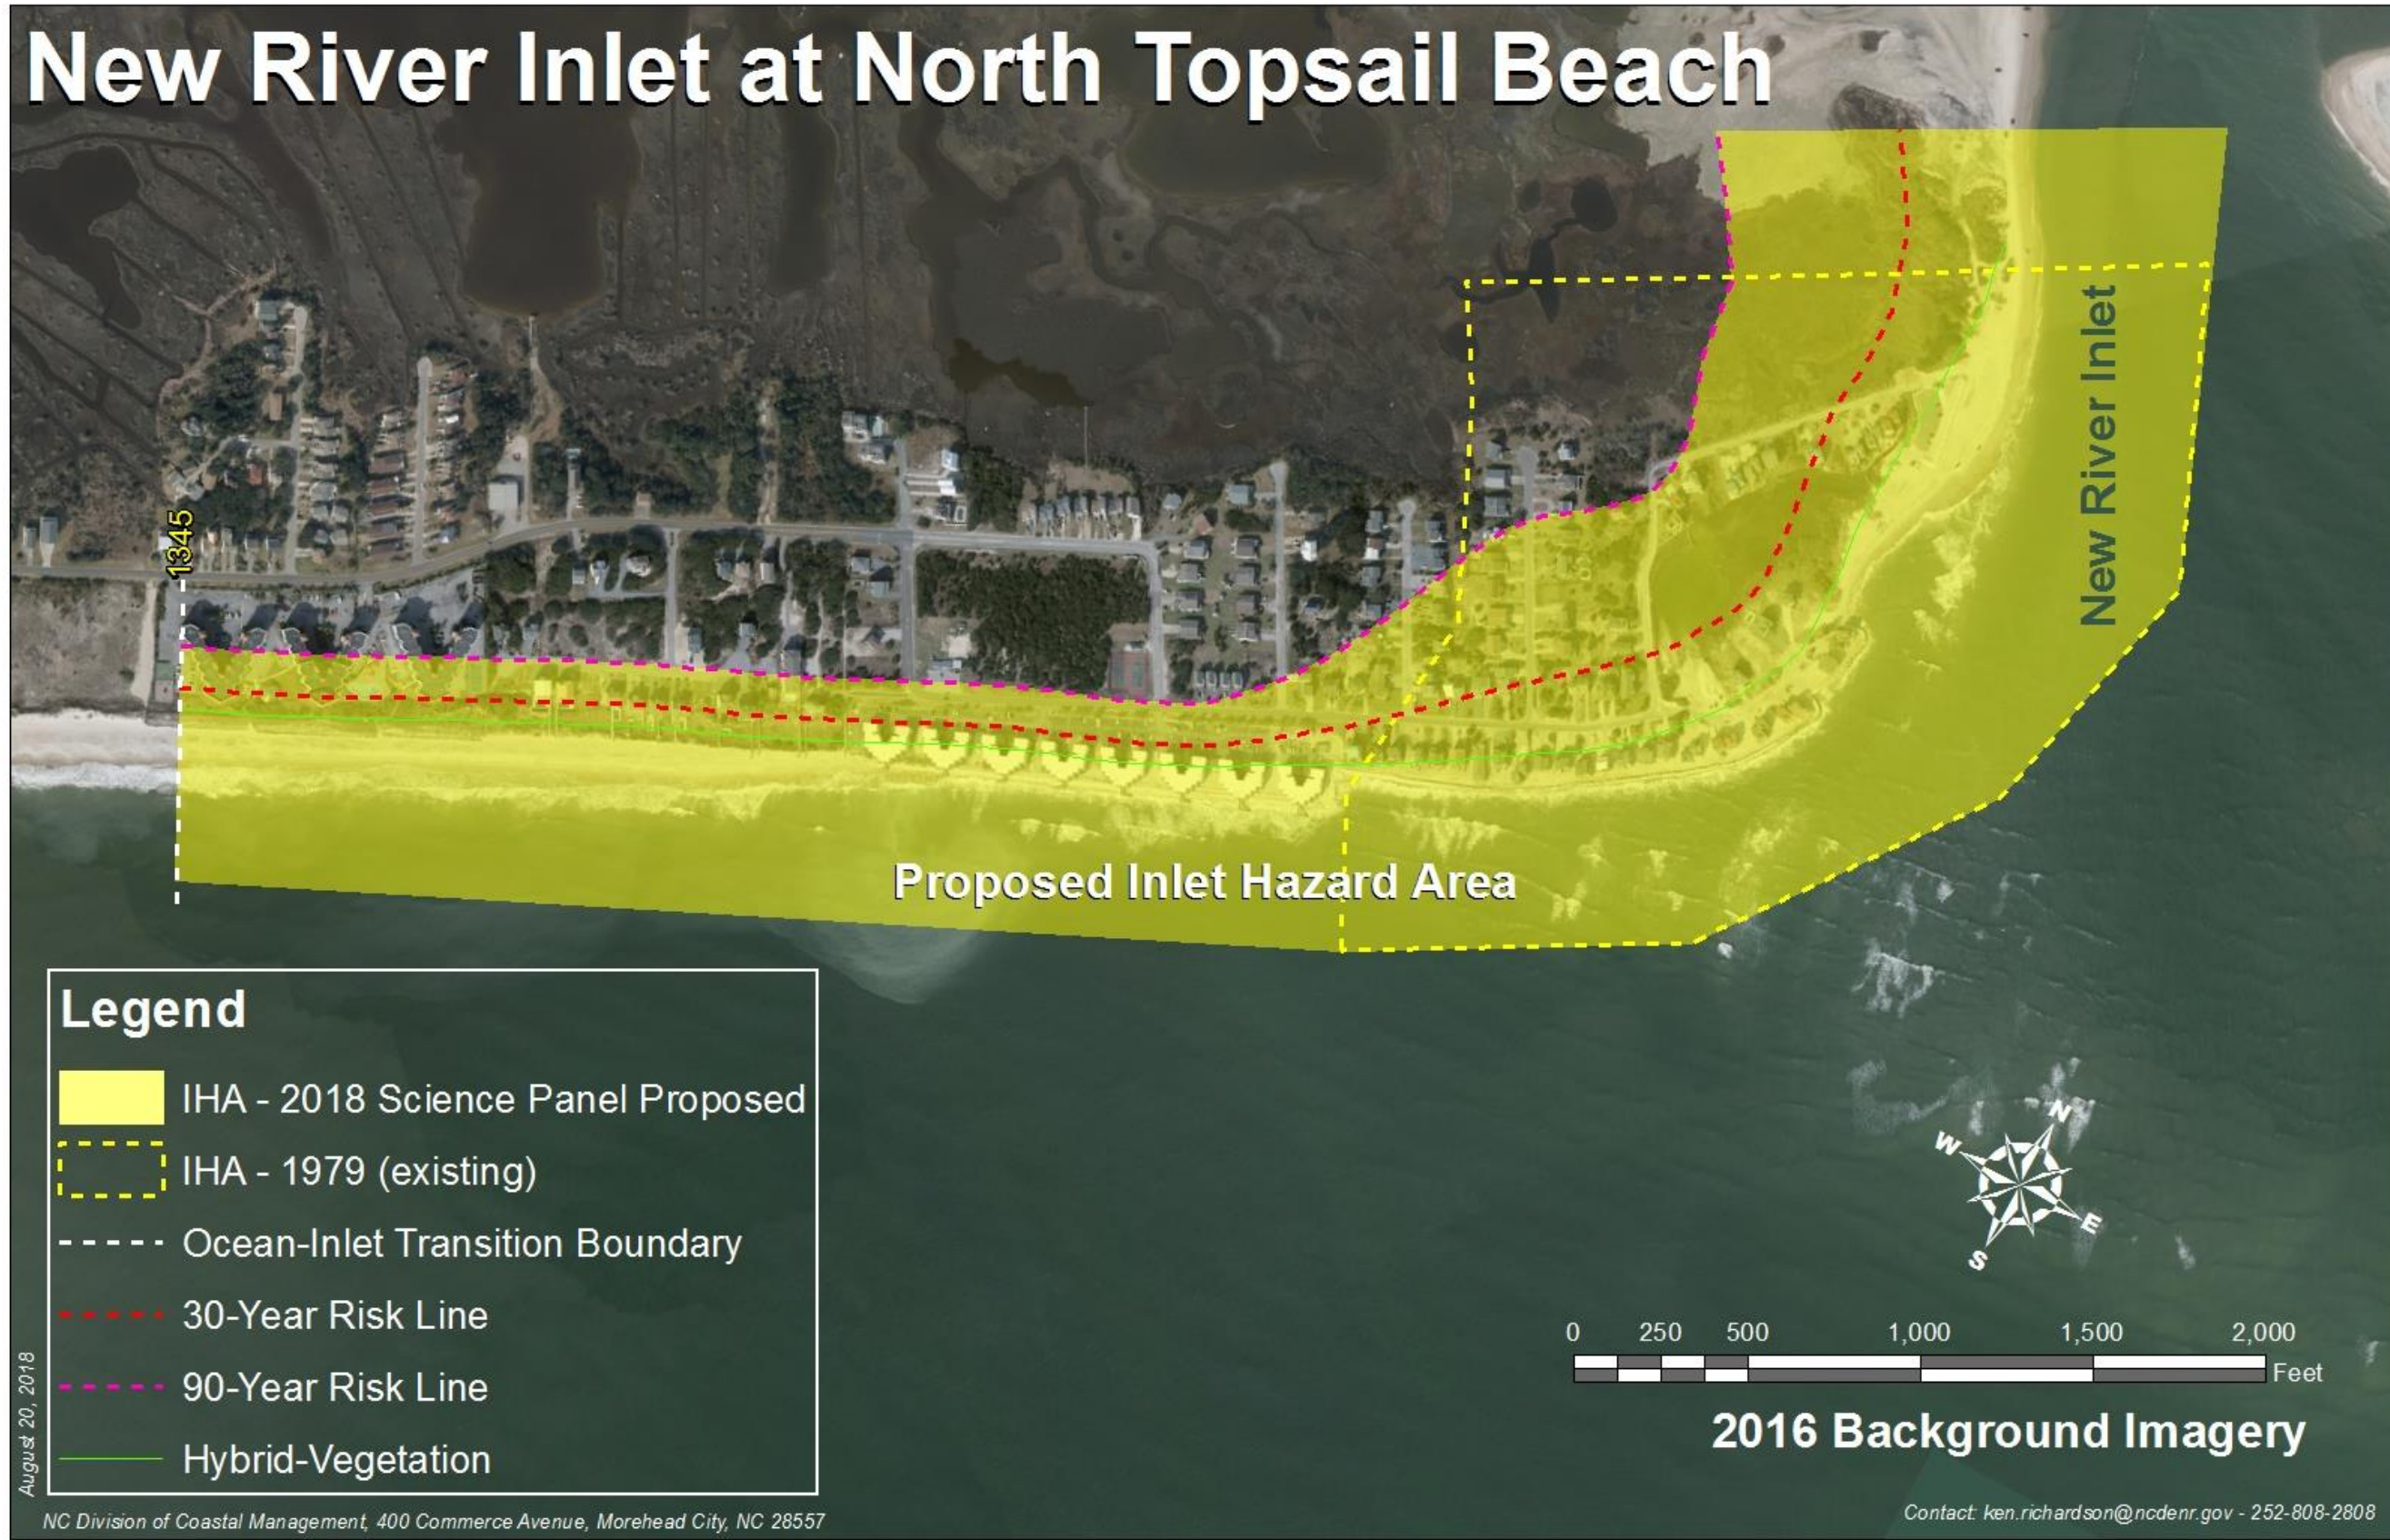
Figure C15. Proposed Inlet Hazard Area at New River Inlet (North Topsail Beach).

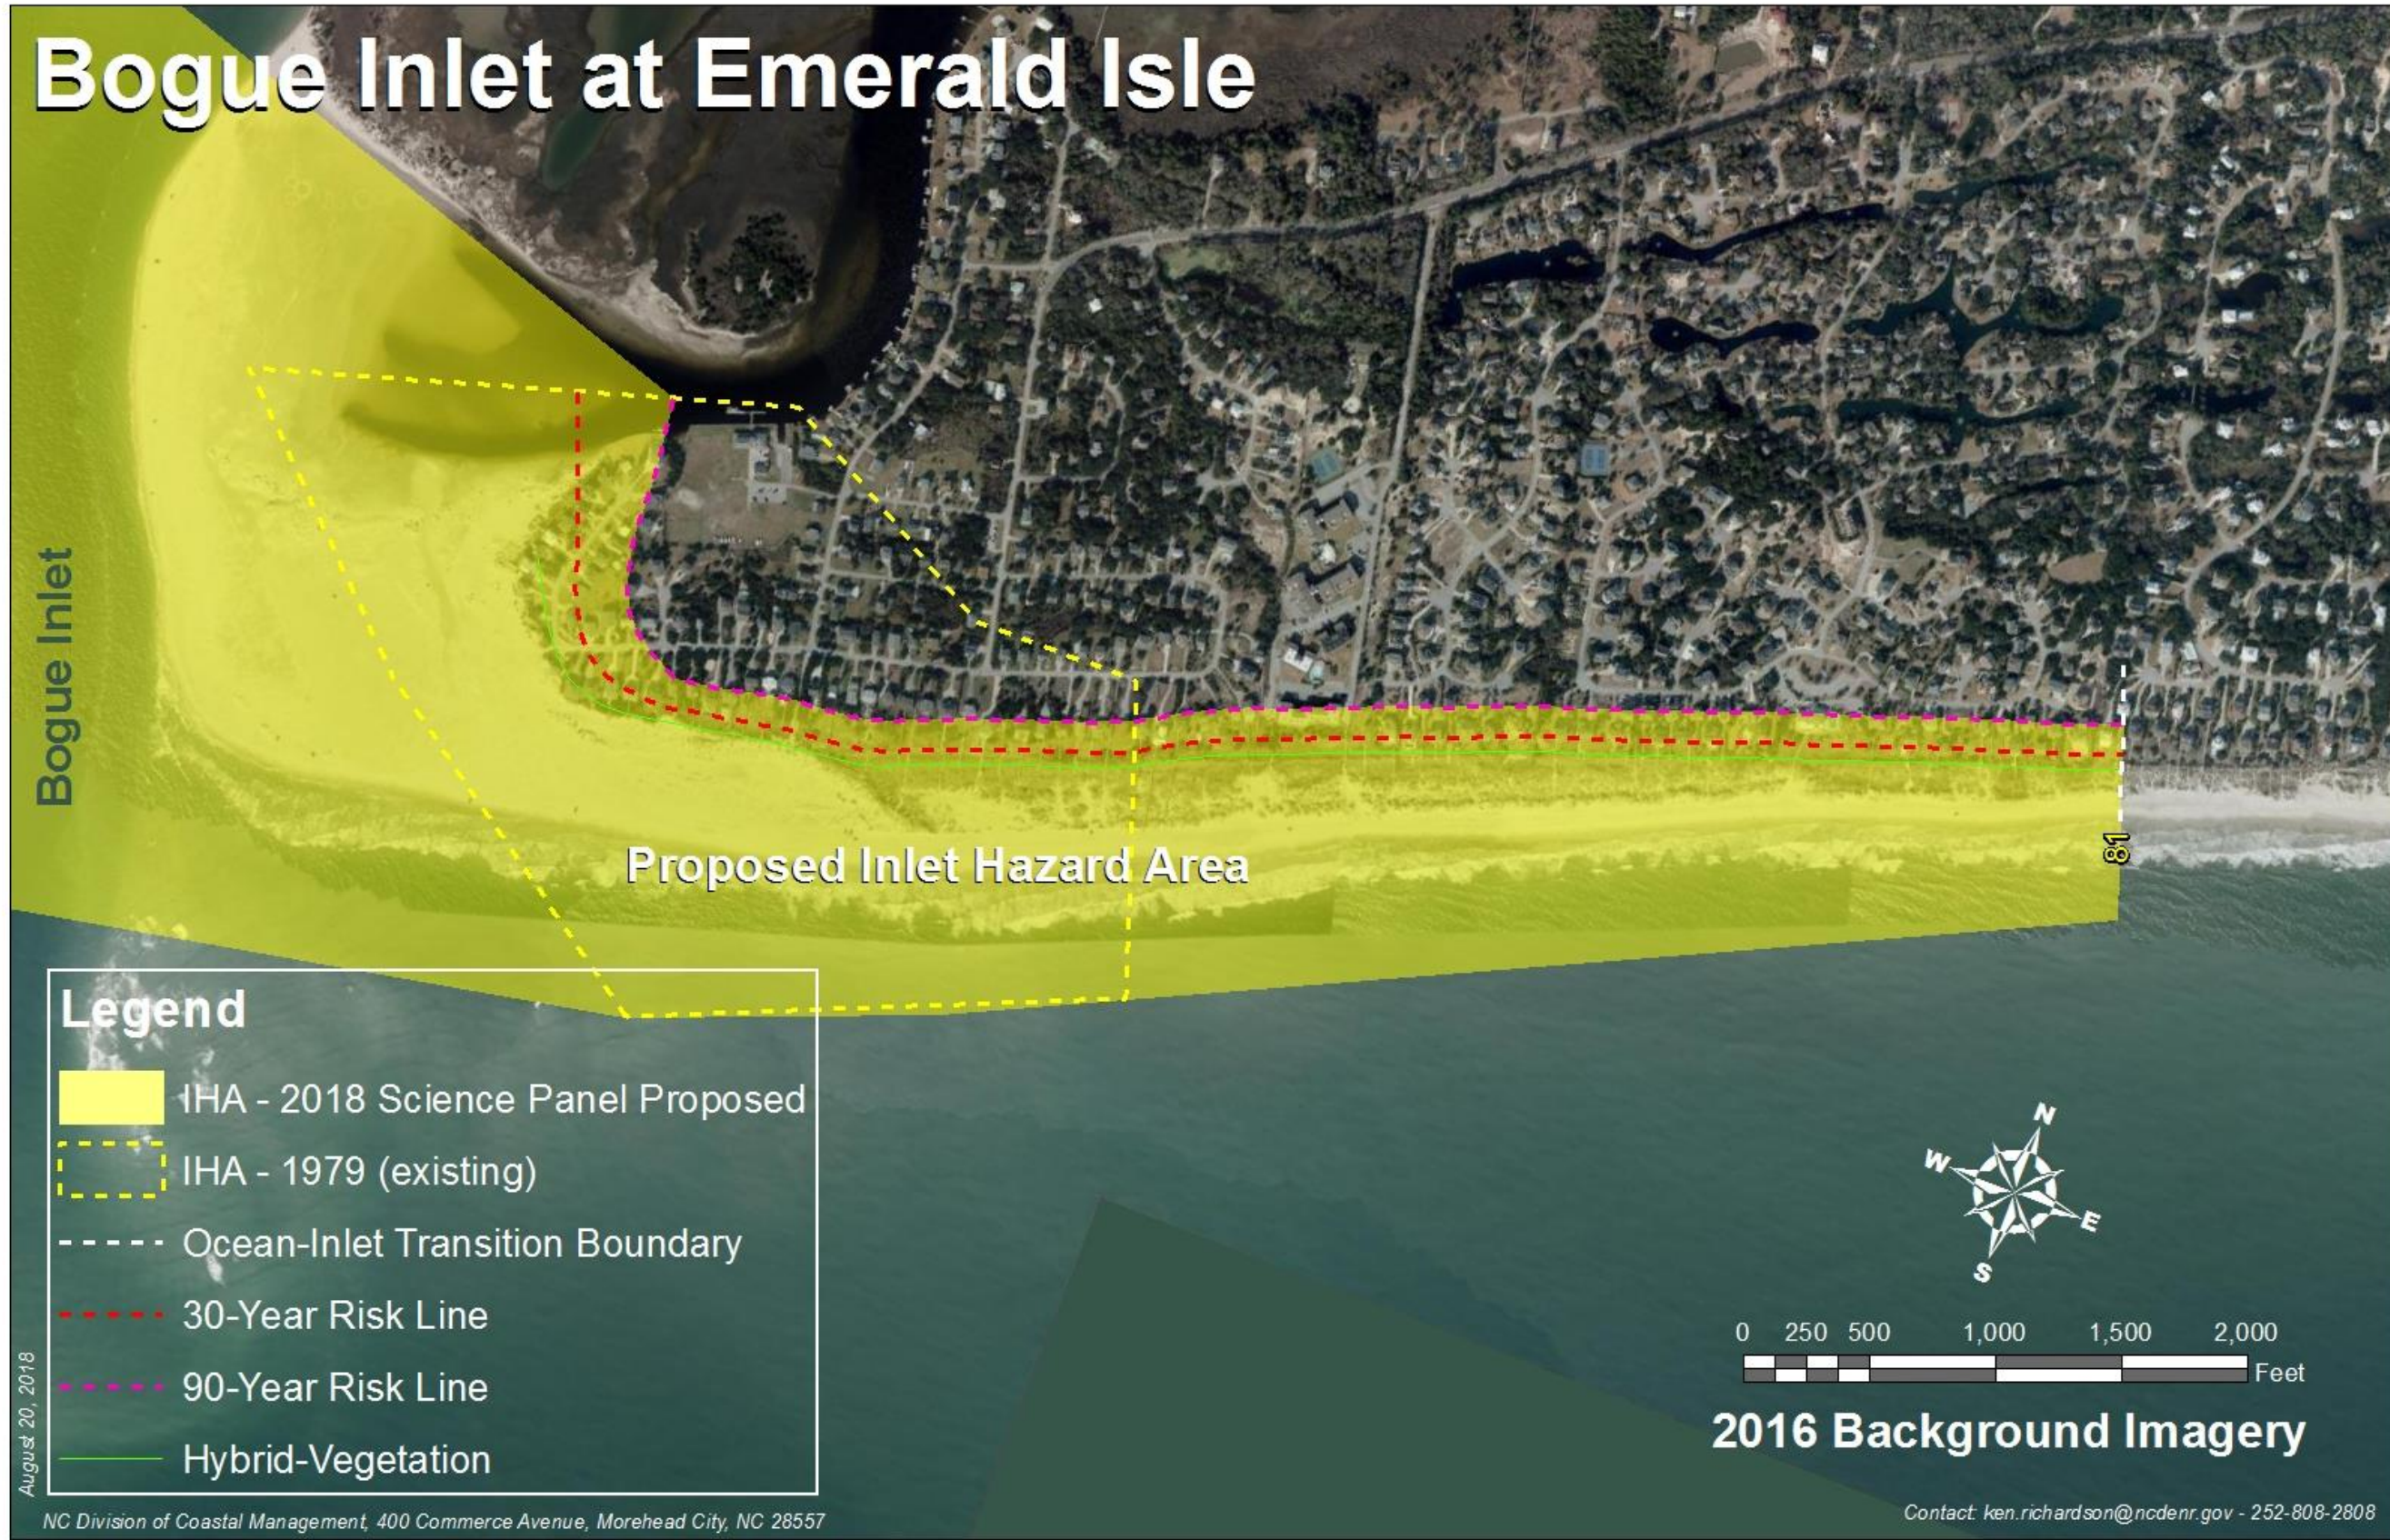
Figure C16. Proposed Inlet Hazard Area at Bogue Inlet (Emerald Isle).
