The 1964 Great Alaska Earthquake and Tsunamis—A Modern Perspective and Enduring Legacies

Earthquake Science Center
U.S. Geological Survey
Menlo Park, CA 94025
<http://earthquake.usgs.gov/>
Earthquake Information Hotline: (650) 329-4085
This Fact Sheet and any updates to it are available online at
<http://pubs.usgs.gov/fs/2014/3018/>

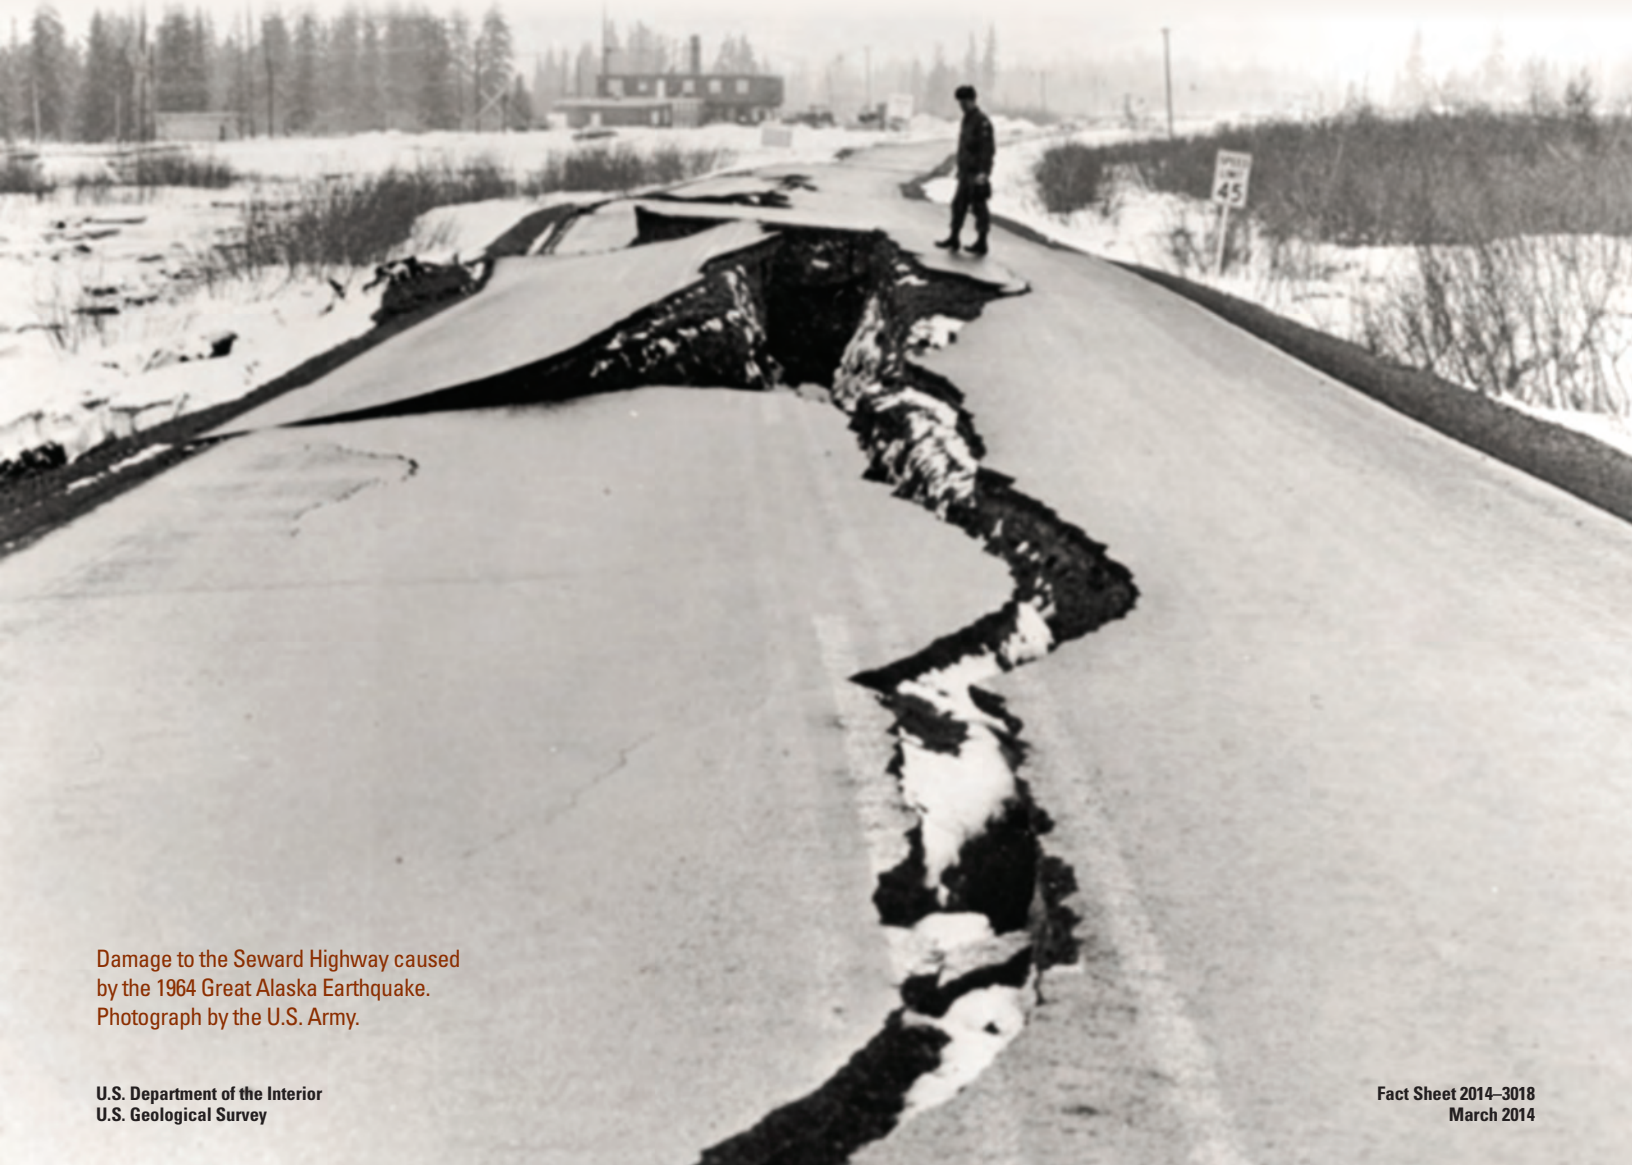
Damage to the Seward Highway caused by the 1964 Great Alaska Earthquake. Photograph by the U.S. Army.

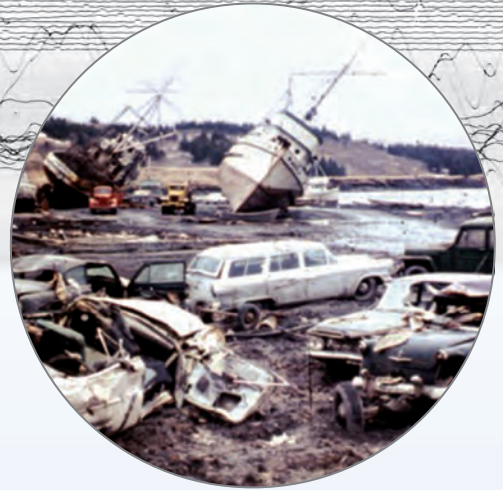
Tsunami damage to the waterfront area of Kodiak, Alaska. USGS photograph by George Plafker.

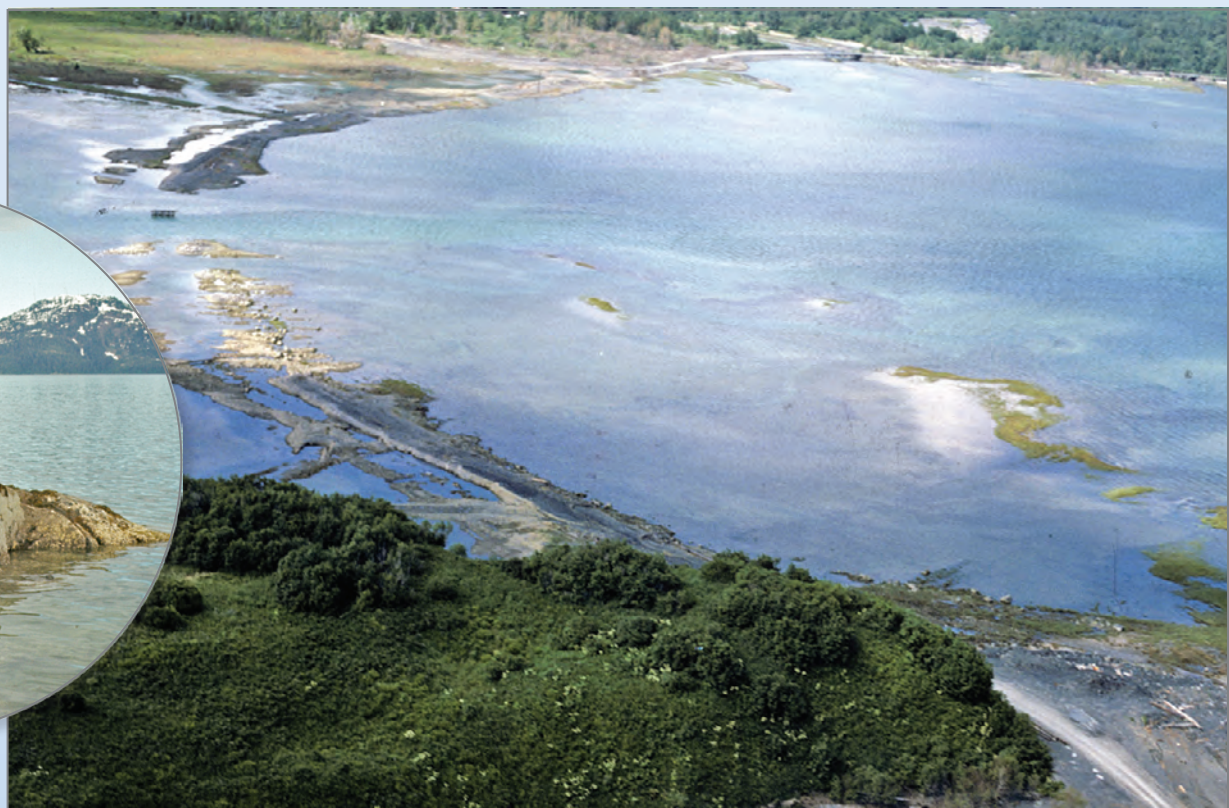
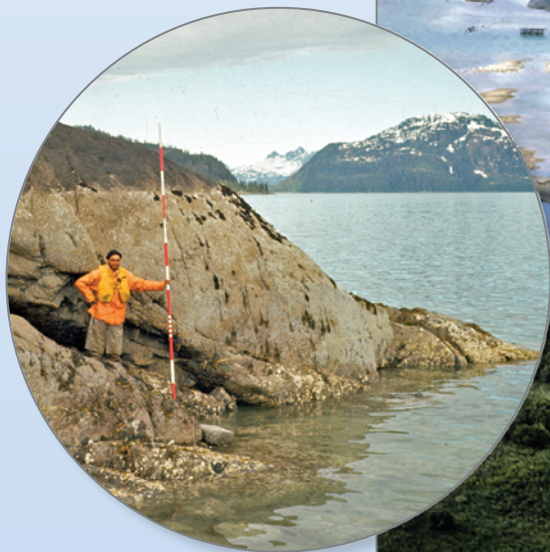
The movement of the Pacific Plate northward beneath the North American Plate resulted in subsidence in some areas and uplift in others. Whale Bay, on Prince William Sound (inset), rose nearly 10 feet, but a roadway on the Kenai Peninsula sank beneath sea level and was washed out. Both USGS photographs by George Plafker.

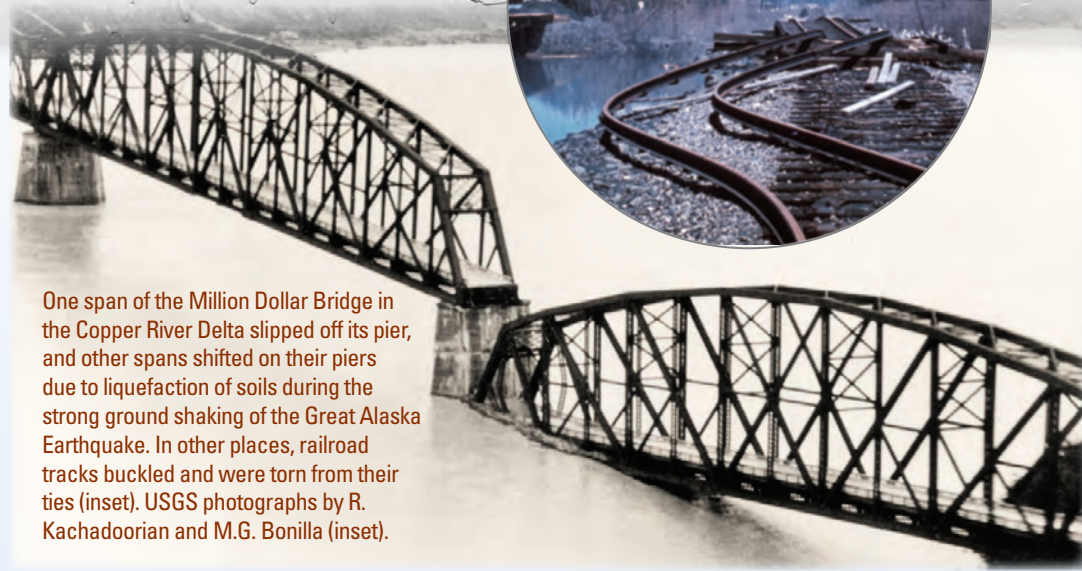
One span of the Million Dollar Bridge in the Copper River Delta slipped off its pier, and other spans shifted on their piers due to liquefaction of soils during the strong ground shaking of the Great Alaska Earthquake. In other places, railroad tracks buckled and were torn from their ties (inset). USGS photographs by R. Kachadoorian and M.G. Bonilla (inset).

railroad bridges were destroyed when their pilings and piers sank or spread apart because the underlying soils flowed. Parts of the railroad were out of service for nearly six months. The 1964 Alaskan and Japanese earthquakes prompted extensive government-funded research by geotechnical engineers in both countries on the physics of liquefaction and implications for structural stability. Their findings led to the development of field-based methods to determine liquefaction potential of coarse-grained soils; these methods are used around the world by civil engineers to ensure the safety of structures in earthquake-prone areas.

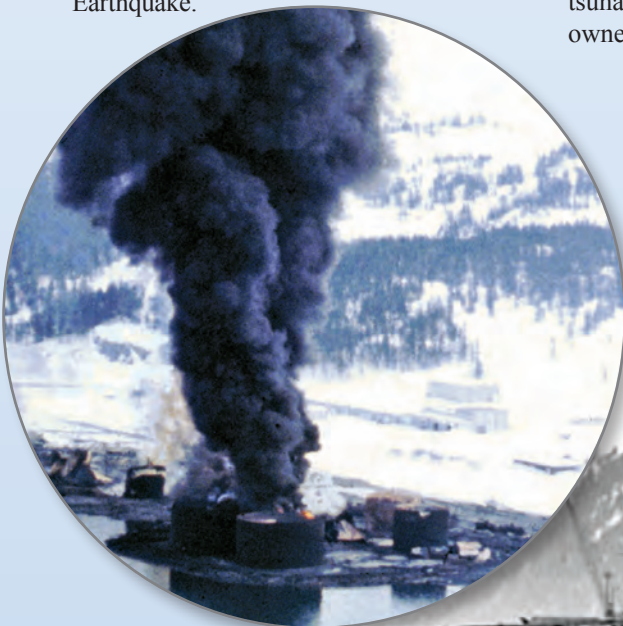
The waterfront of Whittier, Alaska, was heavily damaged by tsunamis generated by underwater landslides. Whittier was an important all-weather port for both governmental and industrial groups, but the dock facilities were destroyed and were inoperable for months following the earthquake, tsunamis, and a major fire at a fuel-tank farm. Left photograph, aerial view of the waterfront during the fire; right photograph, railroad tracks and tanks that were mangled by the ground shaking and subsequent landslides.

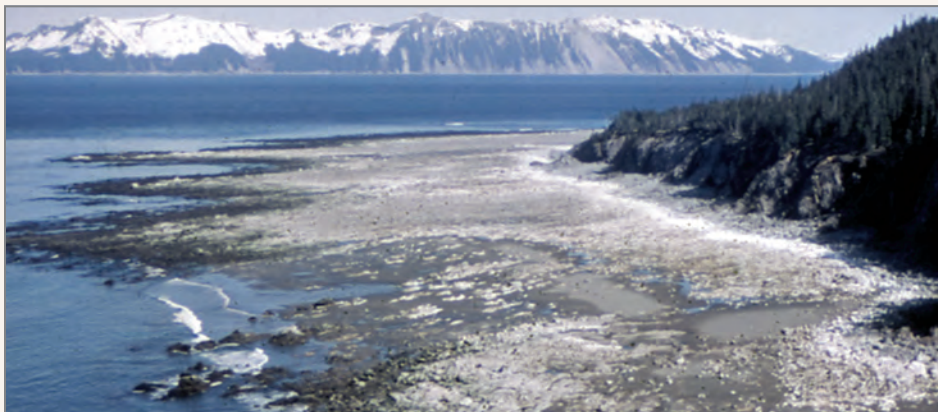
Cape Cleare on Montague Island was uplifted 33 feet during the 1964 Great Alaska Earthquake, creating the new terrace shown here. The white coating on the rocks—about a quarter of a mile wide—is the remains of marine microorganisms that were desiccated when the seafloor was uplifted out of the water. On the mountains in the background, light gray patches are landslides triggered by ground shaking. Photo at top right shows ground failure and damage to homes in the Turnagain Heights area of Anchorage, Alaska. USGS photographs by George Plafker.
