Report Number 2023-022231 - Traffic Crash - 1 Report

TRAFFIC CRASH LOCATION
DEXTER AVE N & THOMAS ST, SEATTLE, WA 98109

Case Investigation Report: #2023-022231 TCIS #23-003

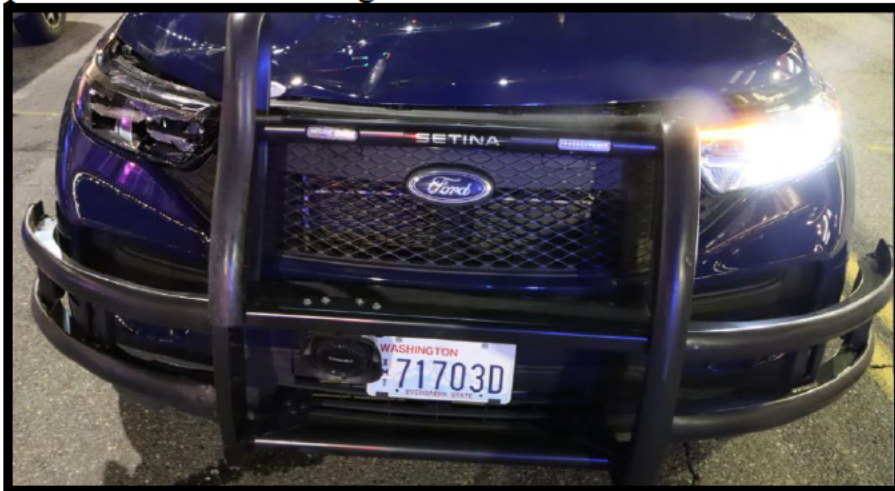
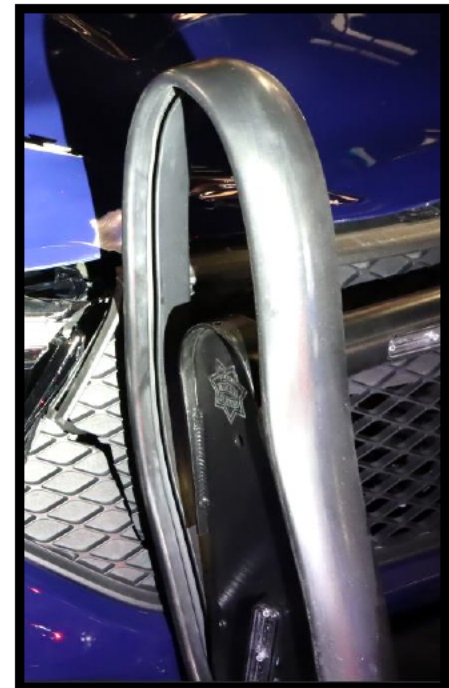
The Ford had damage to the front push bar. The push bar on the vehicle was manufactured by Setina and appeared to be their PB 450L model which consisted of two vertical bars supported by two horizontal center support bars. The push bar was supplemented on the outsides by a Setina P89 fender guard which were two horizontal bars that extended out from the push bar and around to the front wheel opening on both the passenger and driver sides of the vehicle. The push bar and fender guard created the leading edge of the vehicle. The horizontal portions were mounted essentially in-line with the height of the bumper. The two vertical portions of the push bar were mounted inboard of each headlight assembly. The push bar’s vertical portions and portions of the horizontal bars were equipped with rubber protectors.

The rubber protector on the passenger side vertical push bar was pushed upward but was still on the push guard. The bolts in the top bracket for the push bar were damaged and/or missing on the passenger side mount. The bumper cover on the passenger side had damage consistent with the horizontal guard being pushed back and making contact with it.

**Top: Overview of push bar and damage.
Right: Rubber covering after the collision**

The Ford had damage to the front push bar. The push bar on the vehicle was manufactured by Setina and appeared to be their PB 450L model which consisted of two vertical bars supported by two horizontal center support bars. The push bar was supplemented on the outsides by a Setina P89 fender guard which were two horizontal bars that extended out from the push bar and around to the front wheel opening on both the passenger and driver sides of the vehicle. The push bar and fender guard created the leading edge of the vehicle. The horizontal portions were mounted essentially in-line with the height of the bumper. The two vertical portions of the push bar were mounted inboard of each headlight assembly. The push bar's vertical portions and portions of the horizontal bars were equipped with rubber protectors.

The rubber protector on the passenger side vertical push bar was pushed upward but was still on the push guard. The bolts in the top bracket for the push bar were damaged and/or missing on the passenger side mount. The bumper cover on the passenger side had damage consistent with the horizontal guard being pushed back and making contact with it.

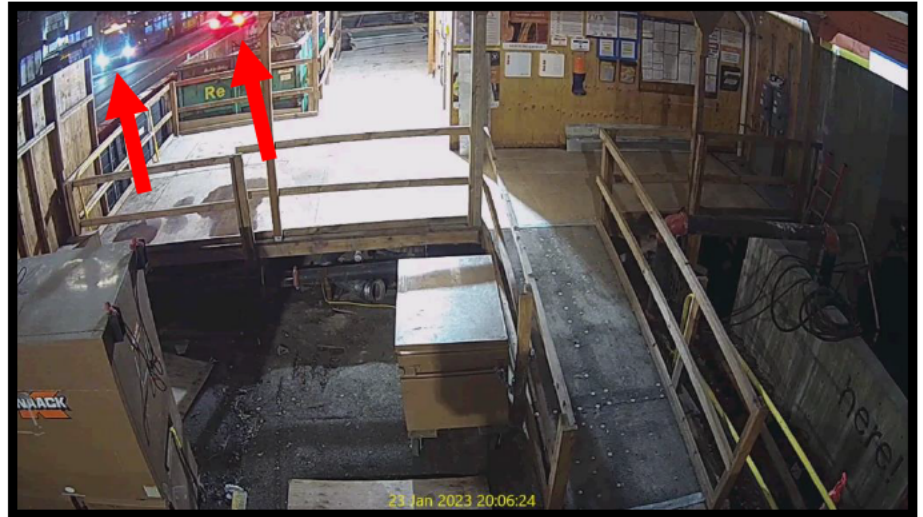
At 20:06:24 (1:25) the Ford can be seen northbound on Dexter Ave N with its overhead lights on. The next position showed the Ford further north along Dexter Ave N with all 3 of its brake lights (left, right and center elevated or third) illuminated. It is difficult to place the vehicle in the roadway in relation to the objects around it, but it appears to be just south of the beginning of the pylons and in-line with the passing KCM bus. At 20:06:25 (1:25) the Ford can no longer be seen but the reflection of the emergency lights can be seen on the side of the bus.

View from Camera 7. The Ford can be seen with its brake lights illuminated. KCM bus and Ford pointed out with arrows.

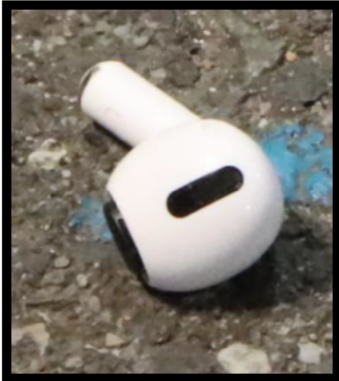
2023-022231-2 Left
Airpod without
rubber tip.

Three pieces of evidence indicated that 1(f), 1(d) possibly had Apple Airpod Pros inserted in her ears at the time of the collision. This was based on the locations and distances from each other that they were found within the scene. Additionally, the position of the portions of both detachable rubber tips that are inserted into the ear being pulled outward indicated that they came out in a manner not consistent with someone casually pulling them out. It would be expected that if the AirPods were stored in the provided storage case at the time of the collision, the storage case would have been found in the roadway.

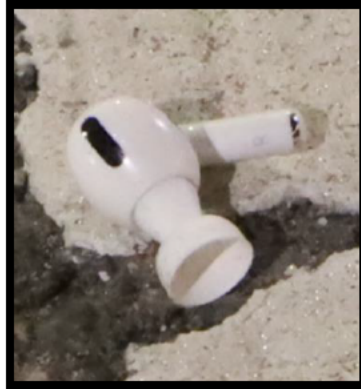
2023-022231-3 Right
Airpod with rubber tip.

2023-022231-3: This was identified as a right-side Apple Airpod Pro. It had a model number of A2083. It contained the rubber tip on the end. The rubber tip was pulled outward from its original position. This was found approximately 57.5 feet north of the northern edge of the crosswalk. It was approximately 4 feet to the east of the western edge of the east fog line for the northbound lane of travel on Dexter Ave N.

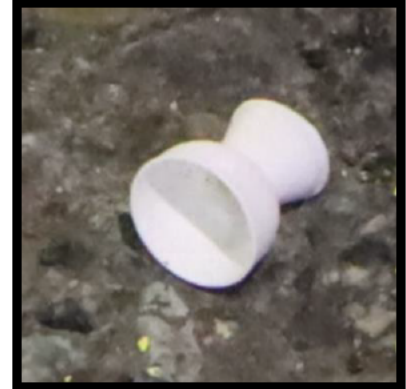
2023-022231-4
Detachable rubber tip
for Airpods.

2023-022231-4: This was a detachable rubber tip believed to have been associated with the left-side Apple Airpod Pro. The tip’s end that was inserted in the ear was pulled outward from its original and intended position. This was found approximately 28.3 feet north of the northern edge of the crosswalk. It was approximately 1.5 feet to the east of the western edge of the eastern fog line for the northbound lane of travel on Dexter Ave N.

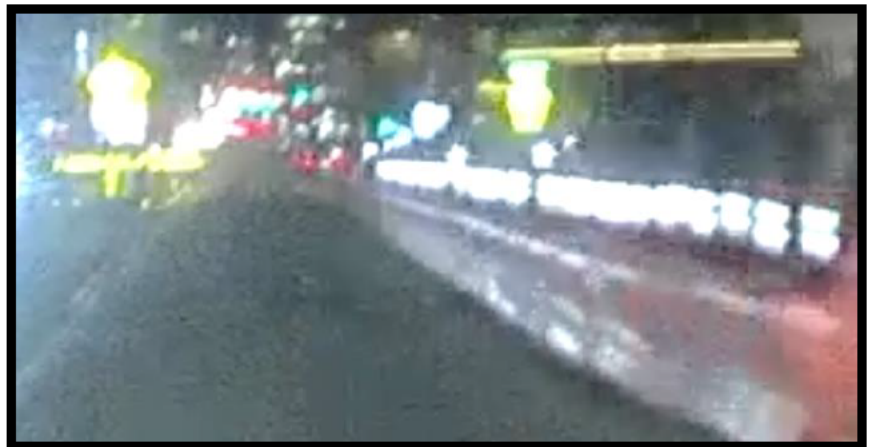
The pylons and signs affixed in the roadway had reflective material that would reflect light back toward approaching vehicles. The vertical pylons were bright yellow. They contained two horizontal yellow stripes of reflective material near the top. There were four signs affixed to the roadway in the south side of the pylon barrier. There was a short sign with yellow and black diagonal stripes. This sign had graffiti on the face of it. The yellow portions of the sign were reflective. 3 signs were affixed to one post behind the short sign. The top of the post had a diamond shaped yellow sign with a black figure in a “walking position” generally indicating a pedestrian crossing. Below that sign was a rectangular yellow sign with black arrows pointed outward from each other and slightly downward indicating the location of the crosswalk. The bottom sign was a square white sign with a red circle and a line through it on top of a 90-degree left arrow indicating “no left turn,” All three of these signs were reflective.

An emergency vehicle with its emergency lights activated approaching this intersection faced a unique scenario. When approaching the intersection, the lights from the emergency equipment would flash off of the signs and the reflective material on the pylons backward toward the driver. This included both the yellow pylons placed in the roadway and the orange pylons placed in the construction zone along the fence line. The reflection of the light made it more difficult to see objects in or beyond the intersection.

Still shot from ICV of the reflective properties of objects when approaching Thomas St.

I drove the PIU northbound on Dexter Ave N with the emergency lights activated. I noted that there was significant reflection from the signs and pylons as we approached the intersection.

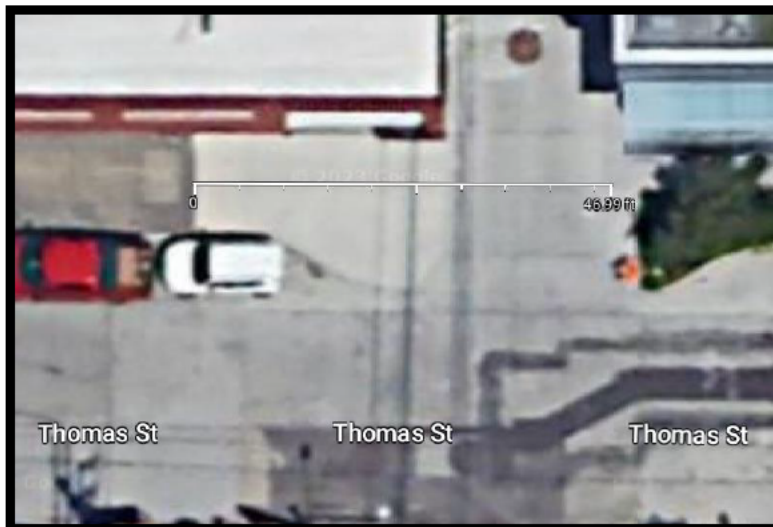
Camera 2 from the construction site that captured **1(f), 1(d)** approaching Dexter Ave N from the east was used to also find a walking pace. Fixed points were found on the video and the embedded time stamp⁵ was used to measure the time it took **1(f), 1(d)** to travel that distance. The first fixed point was where **1(f), 1(d)** had entered into the alley. The affixed time stamp for this was 20:05:51. The second point was where **1(f), 1(d)** was passing a point on the sidewalk that was a different color than the rest of the sidewalk. The embedded time stamp for this was 20:06:02. The distance between these two points were measured using Google Maps and was approximately 47 feet. It took **1(f), 1(d)** approximately 11 seconds to travel the 47 feet which gave an average walking pace of 4.3 FPS.

Upper Left: Starting point for 1(f), 1(d) walking pace.
Upper Right: Ending Point for 1(f), 1(d) walking pace.
Below: Google Maps measurement of the distance.

Camera 2 from the construction site that captured 1(f), 1(d) approaching Dexter Ave N from the east was used to also find a walking pace. Fixed points were found on the video and the embedded time stamp[5] was used to measure the time it took 1(f), 1(d) to travel that distance. The first fixed point was where 1(f), 1(d) had entered into the alley. The affixed time stamp for this was 20:05:51. The second point was where 1(f), 1(d) was passing a point on the sidewalk that was a different color than the rest of the sidewalk. The embedded time stamp for this was 20:06:02. The distance between these two points were measured using Google Maps and was approximately 47 feet. It took 1(f), 1(d) approximately 11 seconds to travel the 47 feet which gave an average walking pace of 4.3 FPS.

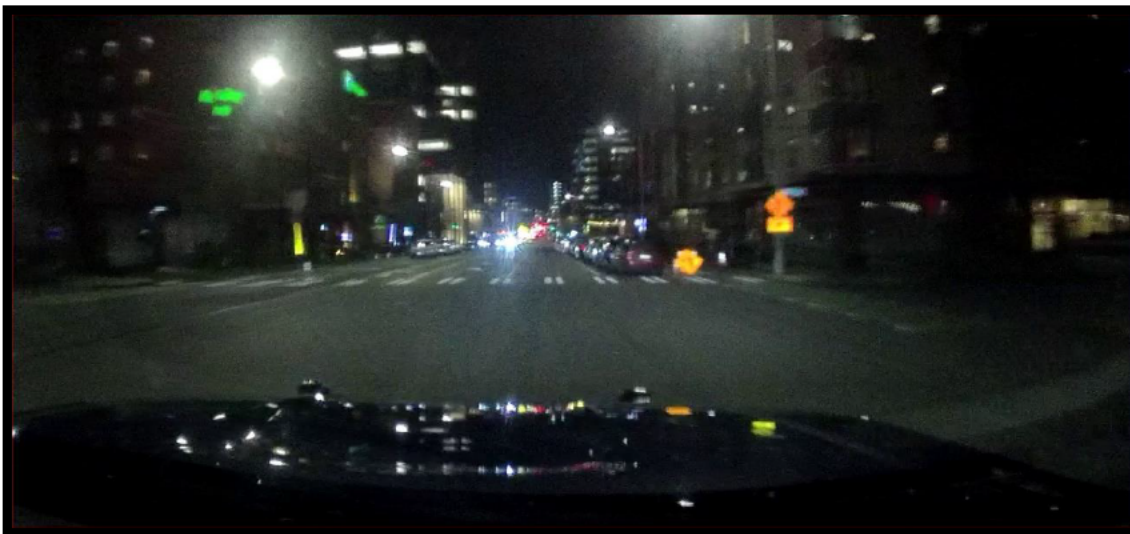
$$t = \frac{d}{S} \quad t = \frac{17.6 \text{ ft}}{4.30 \text{ FPS}} \quad t = 4.09 \text{ seconds}$$

The Ford's ICV was then moved back approximately 4.09 seconds from this point and to measure how far to the south of the northern crosswalk it was when 1(f), 1(d) was estimated to have entered the roadway. The Ford was just entering the intersection of John St approximately 475 feet to the south of the northern crosswalk at Dexter Ave N and Thomas St.

Ford's approximate position when 1(f), 1(d) began entering the crosswalk using a 4.3 FPS

It is likely that 1(f), 1(d) pace would not have changed much between her approach to the intersection and when she was crossing Dexter Ave N. The 4.3 FPS pace was used to determine where the Ford approximately was on Dexter Ave N when 1(f), 1(d) entered the crosswalk. The point where 1(f), 1(d) (17.6 feet from the east sidewalk) transitioned to a run was used as she could more accurately be placed in the roadway. A measurement of time was found to see how long it took her to reach this position from the east sidewalk.
