# 1978 C-b ANNUAL REPORT

### SUMMARY OF DEVELOPMENT ACTIVITIES, COSTS AND ENVIRONMENTAL MONITORING

C-B SHALE OIL PROJECT  
OCCIDENTAL OIL SHALE, INC., LESSEE

APRIL 20, 1979

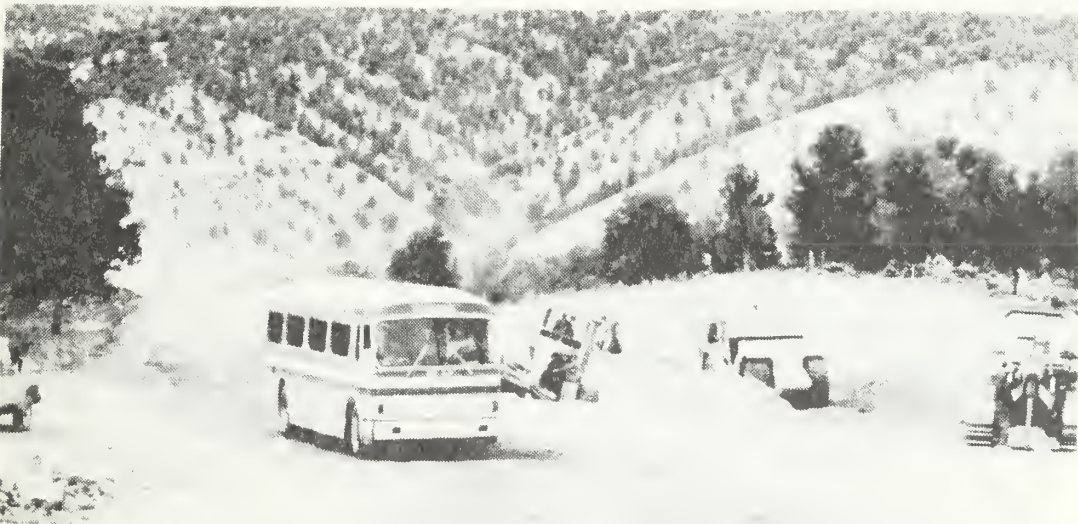
New cut for the main access road showing a bus on the old road

Preparation for construction of the main access road began in March 1978 and actual construction began in April. The main road accesses the property from the north via Piceance Creek road; it is an all-weather road.

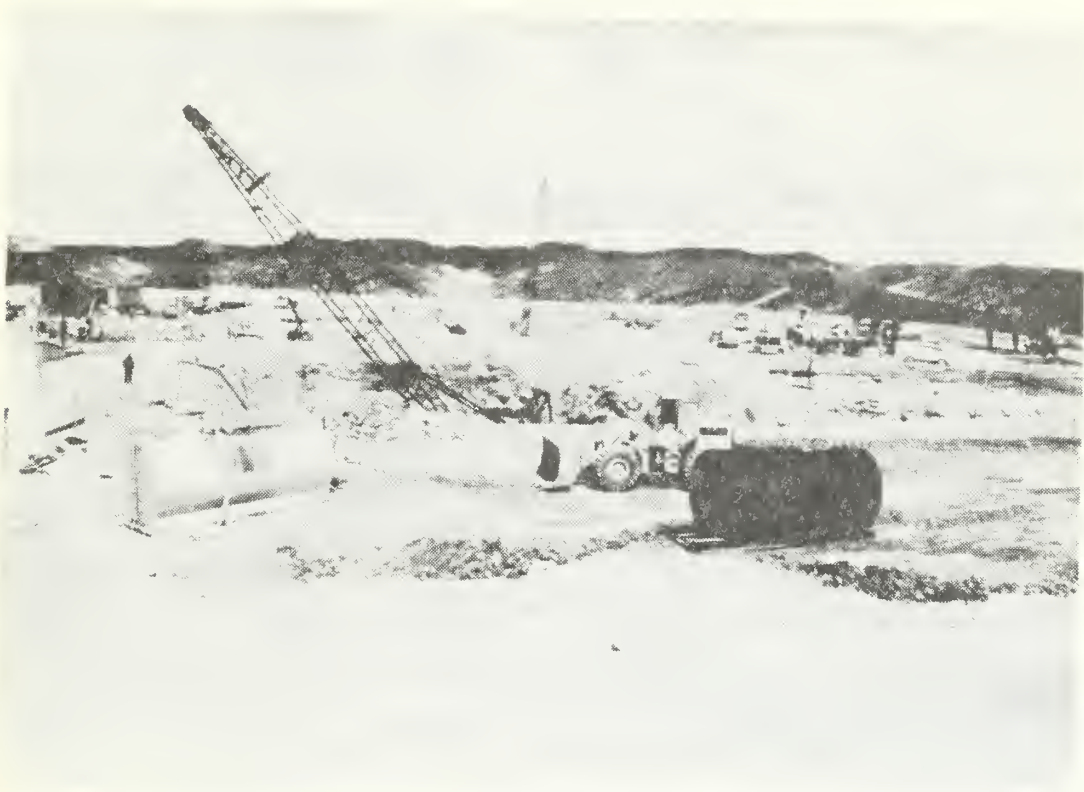
Shaft collar and foundation excavation in the Mine Support Area  
and erection of temporary Maintenance Building

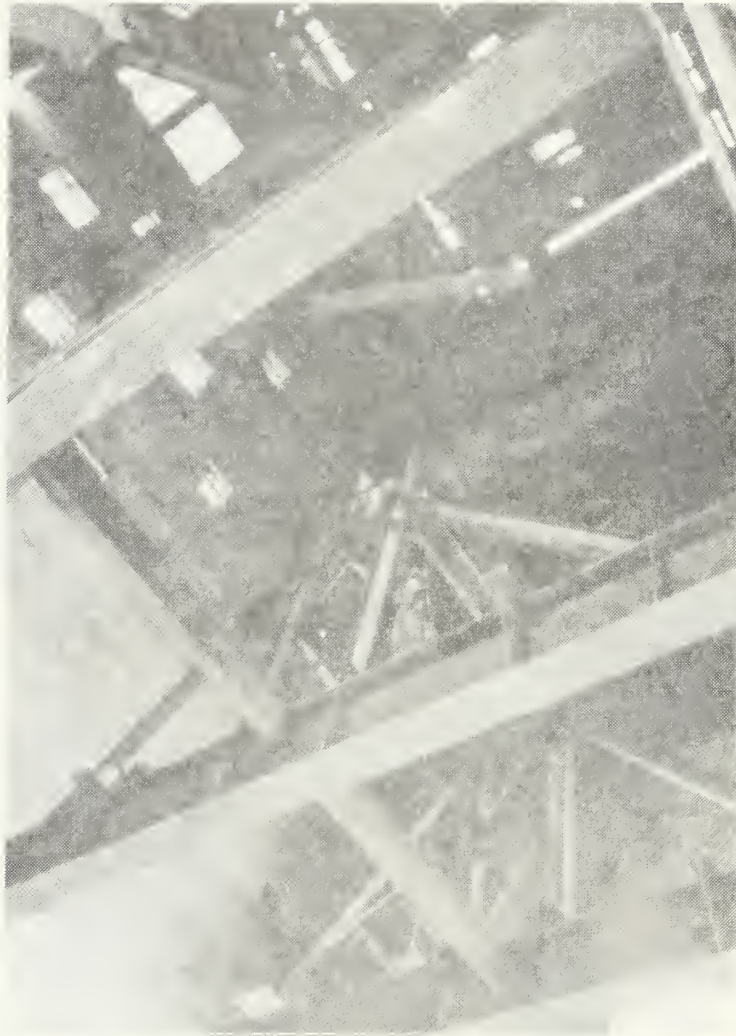
Installation of interior steel begins in the  
Production Shaft

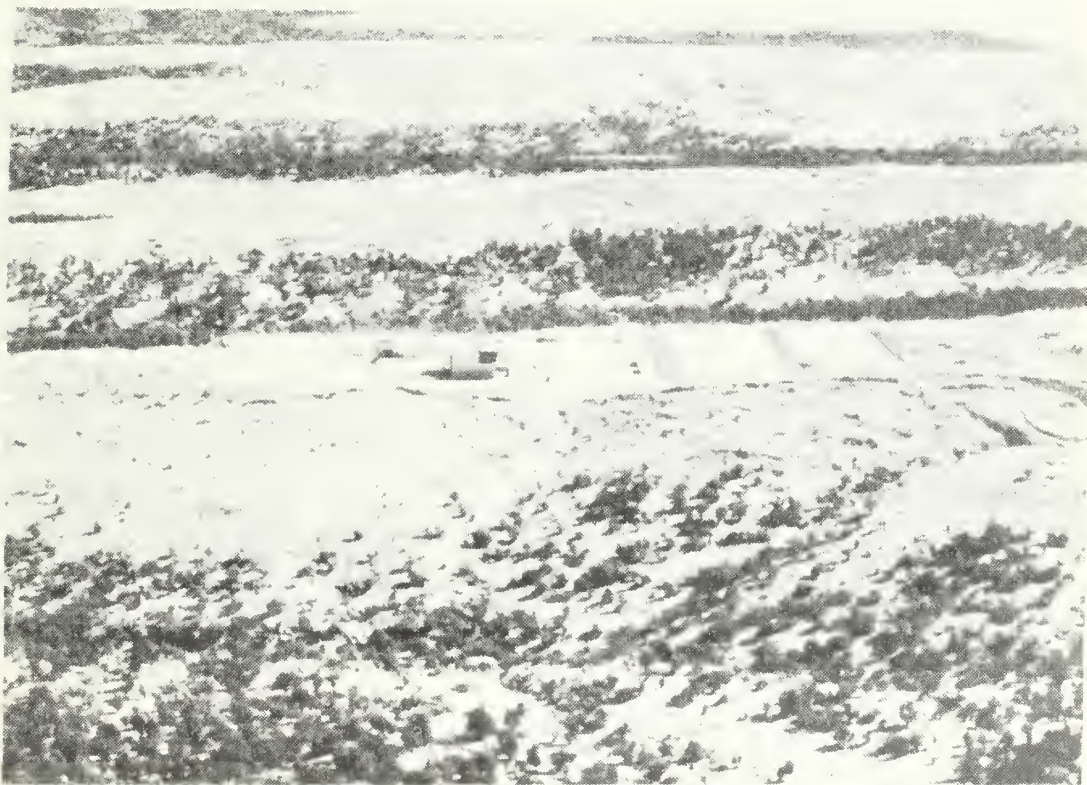
Ventilation/Escape Shaft - start of Headframe and Hoist-house construction

The 15-foot diameter Ventilation Escape Shaft was begun in May. The collar and headframe foundation was completed in June. The structural steel
