Washington State Aquatic Habitat Guidelines Program

Marine Shoreline Design Guidelines

Final

**Prepared for:
The Aquatic Habitat Guidelines Program
2014**

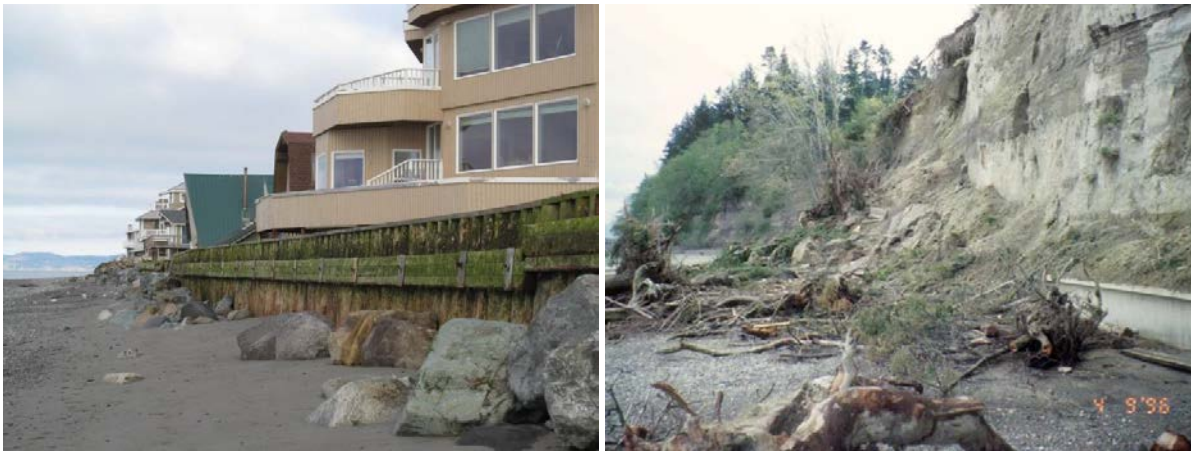
Figure 1. Examples of hard armor in Puget Sound. Armor is required due to inadequate setback distance and high fetch (left). Armor is ineffective at preventing landslides in unstable areas with significant upland clearing and development (right).

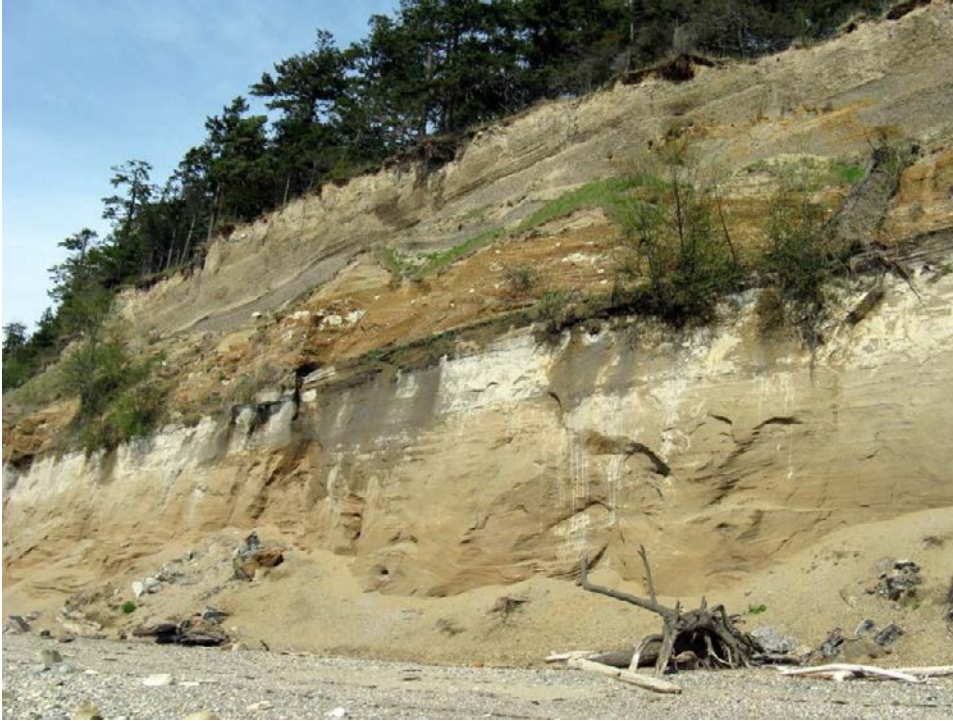
Figure 1-3. Eroding bluff on Guemes Island. 100-130 ft high bluff consists of a diverse assemblage of Pleistocene glacial and glaciofluvial units and a wide range of sediment types, from silt to coarse gravel and boulders.

Eroding coastal bluffs are the primary source of beach sediment on most Puget Sound beaches (Keuler 1988, Johannessen and MacLennan 2007), although sediment abundance and size varies significantly, even over short reaches (Figure 1-3). Small streams may be a source of sediment on some shorelines where coastal drainages yield large amounts of sediment and where the configuration of the stream mouth allows transfer of sediment out of the estuary into the beach system. Conversely, larger rivers such as the Skagit, Nooksack, or Nisqually carry large volumes of material into Puget Sound (Downing 1983), but are not considered major sources of beach sediment, as most empty into the heads of bays, where the coarser grained sediment is retained within the river delta. The Elwha River is a notable exception, as its configuration and location along the Strait of Juan de Fuca make it a significant element of the local coastal sediment budget (Galster and Schwartz 1990).

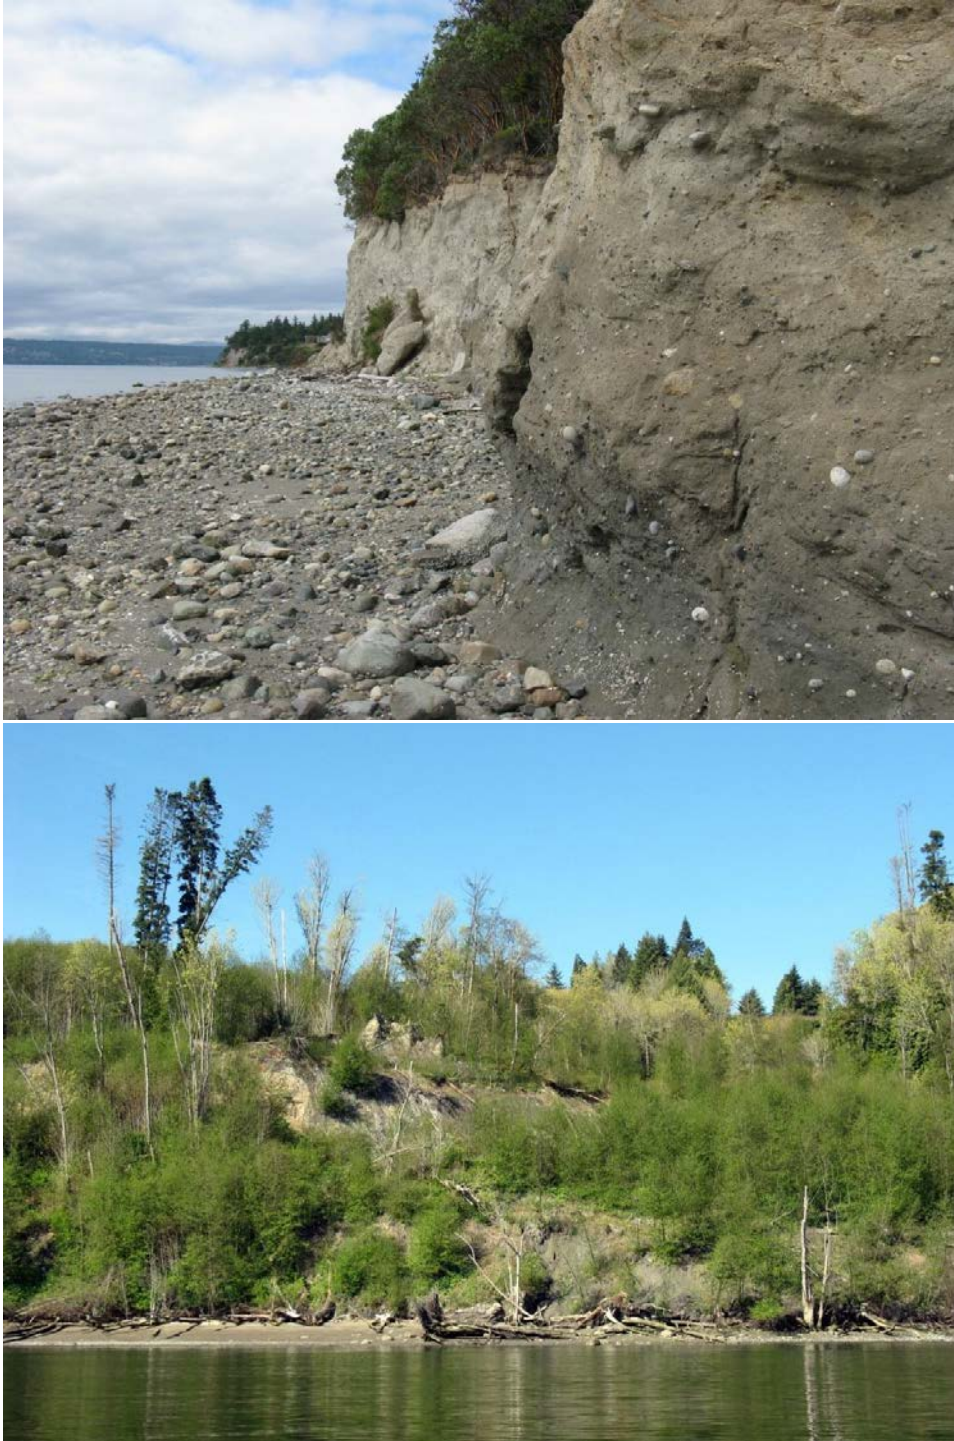
Figure 1-4. Contrasting examples of bluff erosion and mass wasting in Kitsap County. Top photo, low bluff of glacial till subject to wave-induced erosion. Bottom photo, large deep-seated landslide.

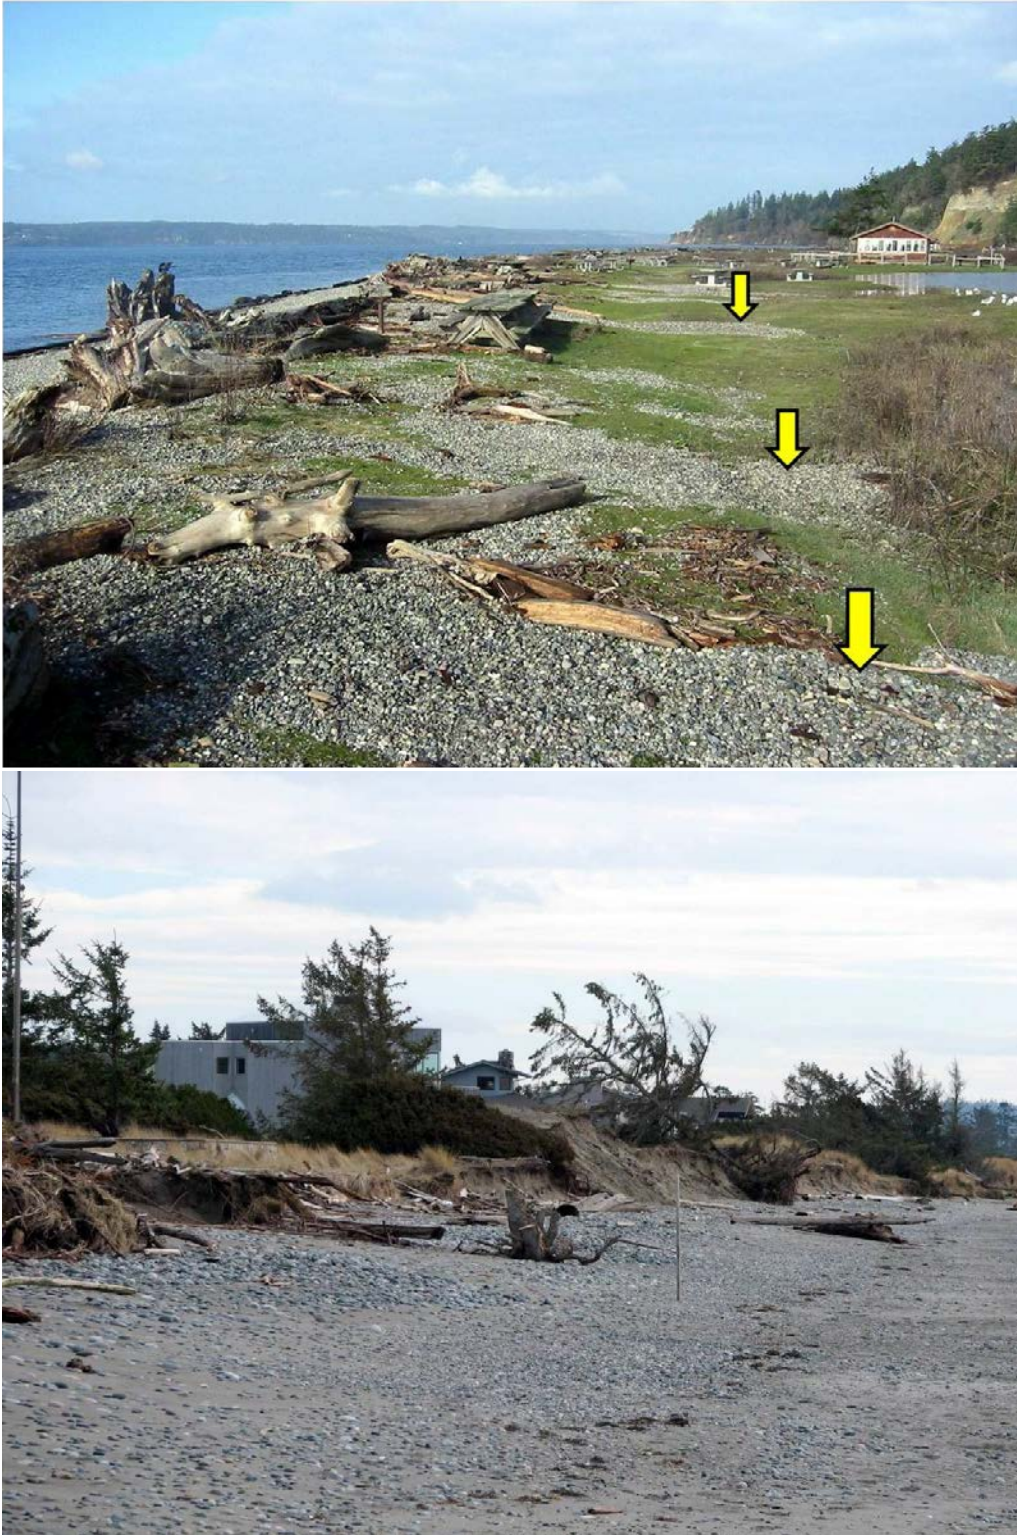
Figure 1-5. Examples of barrier beach erosion. Top photo, barrier beach on Camano Island. Gravel deposits on the landward side of the berm (arrows) are recent overwash from a major high tide storm. Bottom photo, eroding barrier and dunes on northwestern Whidbey Island, indicated by fresh scarp and fallen trees.

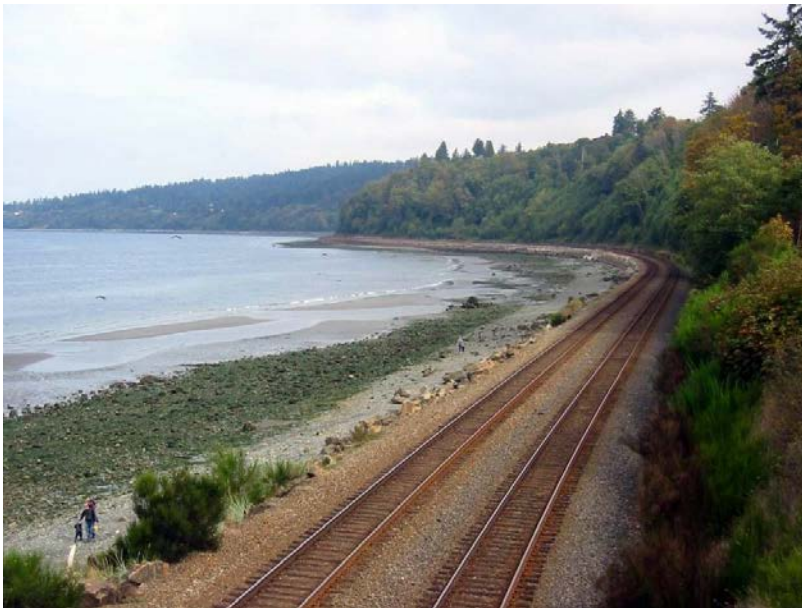
Figure 1-6. Railroad along the shoreline between Seattle and Everett. The seawall was constructed in the early 1900s to protect the railroad, which had been built on the beach below the high bluffs (Johannessen et al. 2005). The upper beach is buried by the railroad grade. This photograph was taken at an extreme low tide; a normal high tide would extend to the seawall, leaving no beach exposed.

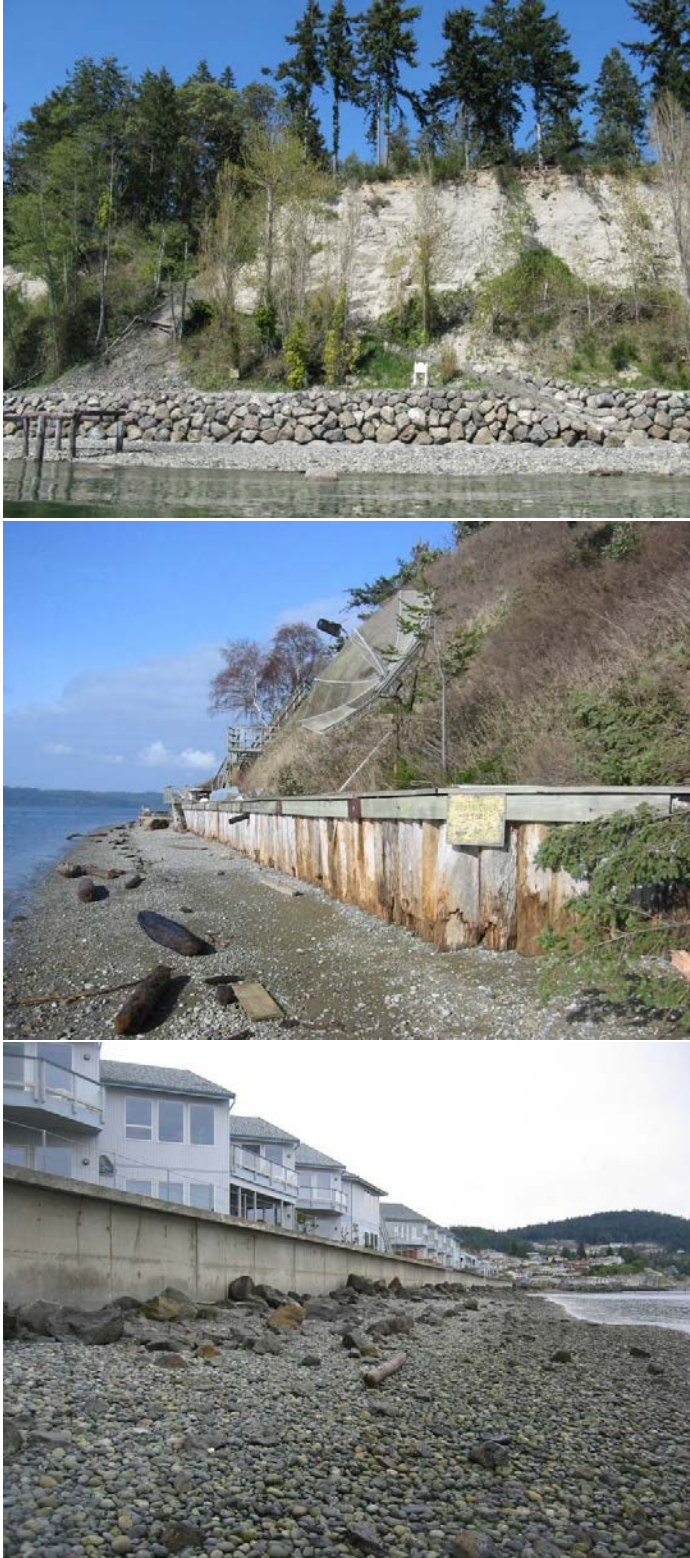
Figure 1-7. Typical examples of residential erosion control on Puget Sound. In each case, high tides would reach the seawall. Top photo, rock seawall in Kitsap County. Middle photo, timber pile bulkhead on Camano Island. Bottom photo, concrete bulkhead on a barrier spit in Anacortes.

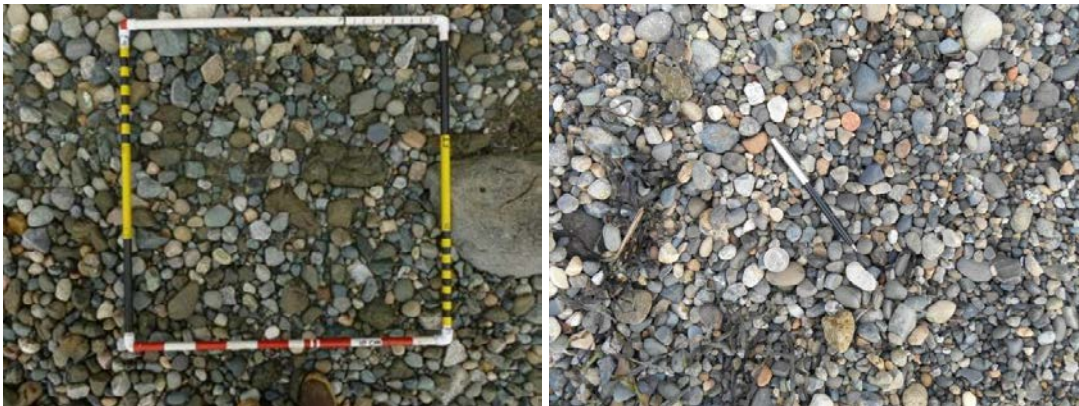
Figure 3-4. Documentation of beach sediment size through photos with a scaled grid or a common object such as a pencil.

Beach sediment and grain size should be documented at different elevations on the beach, such as in the upper intertidal beach and in the backshore. This informs the determination of habitat conditions and potentially design details. Describing beach sediment size also has relevance for potential future monitoring and seasonal changes to the beach profile. Sediment composition can be documented during the site visit with a scaled grid or common objects for reference (Figure 3-4). Various sampling methods for beach sediment size classification exist, including surface and subsurface sampling at distinct beach elevations. For larger sites a sieve analysis of the samples can then be conducted and categorized based on the Wentworth Size Class (Wentworth 1922), which offers a size scale of grade and associated terms of clastic sediments, or on the Unified Soil Classification System (USCS), which classifies soils based on texture and grain size (ASTM 1985). Natural seasonal variation of beach elevation and sediment size may occur at the site and may require additional assessment during different seasons.

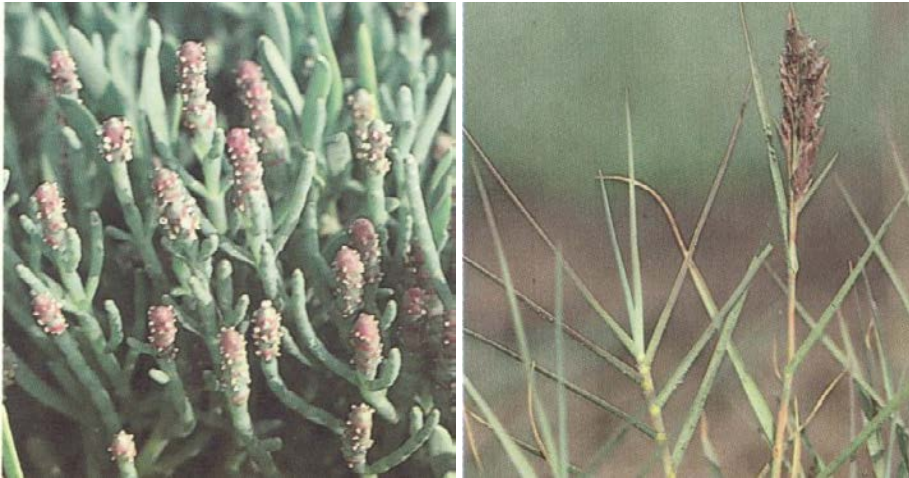
Figure 3-8. Pickleweed (left) and saltgrass (right) are vegetation indicators of tidal elevations (Photos from Weinmann et al. 1985.)

Vegetation present at a site can indicate processes operating at the site. For instance, hydrophilic vegetation (see Figure 3-3) can inform slope processes and nearshore salt-tolerant vegetation can inform extent of coastal processes (Figure 3-8). The presence of salt-tolerant species can offer visual indication of local tidal elevations or areas that are susceptible to wave runup and inundation.

- ◆ Salt-tolerant vegetation such as pickleweed (*Salicornia virginica*) and saltgrass (*Distichlis spicata*) typically grows in the upper intertidal and above (Figure 3-8).
- ◆ Backshore vegetation communities, including dunegrass (dune wild rye; *Leymus mollis*), add an erosion control component to the nearshore.
- ◆ Marine riparian vegetation provides benefits for habitat and erosion control.

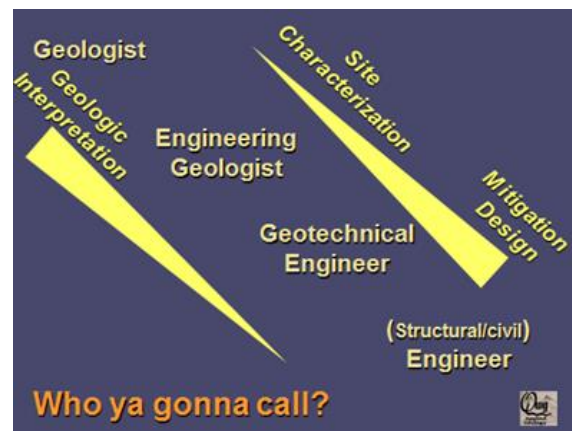
Figure 3-11. Graphic showing the range of site issues from geologic interpretation to engineering, and the related spectrum of professionals.

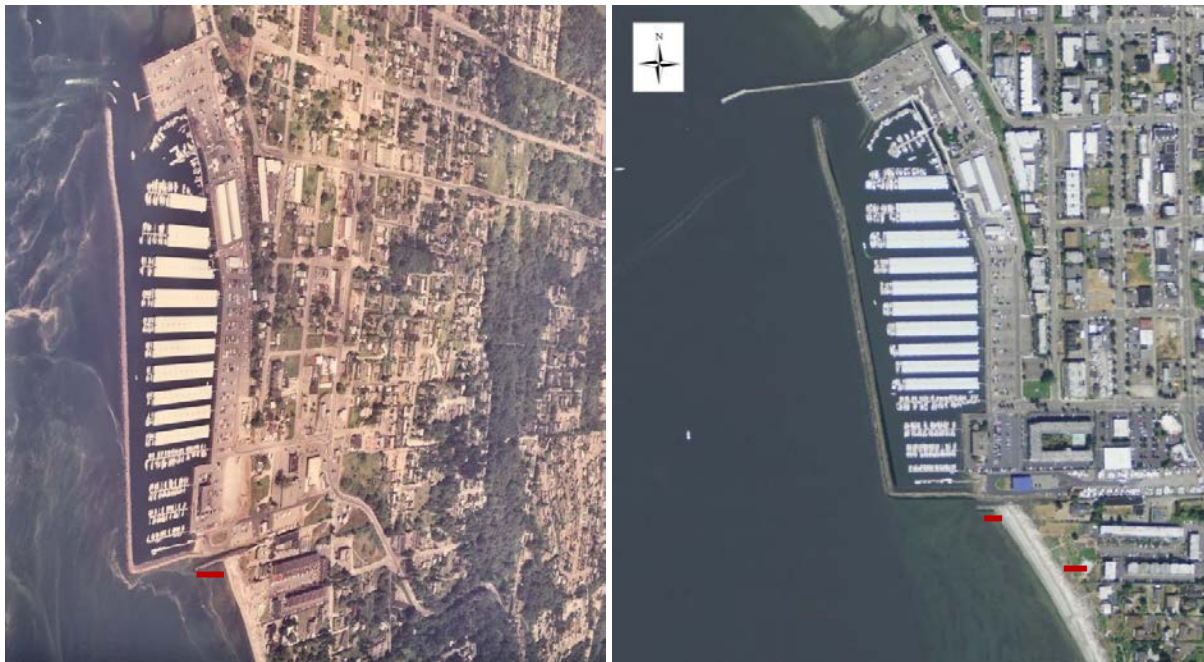
Figure 4-5. Northward sediment transport is impeded by the Des Moines marina breakwater, located south of Seattle. Note beach progradation south of marina breakwater between 1977 (left, Ecology oblique image) and 2011 (right, NAIP imagery) and vegetation landward of beach (waterward of pool).

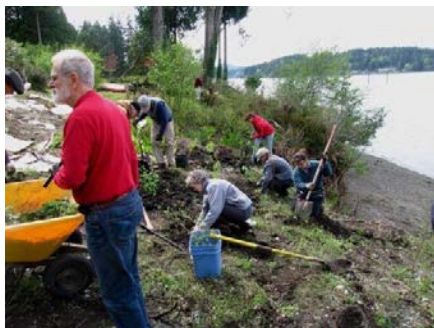
Planting native vegetation to manage bank erosion

Figure 5-2. Examples reflecting a range of management approaches.

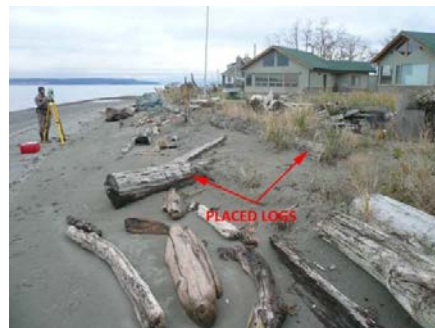
Large wood used to enhance storm berm

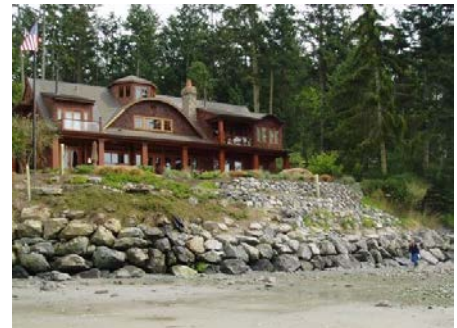
Rock revetment used to prevent bank erosion

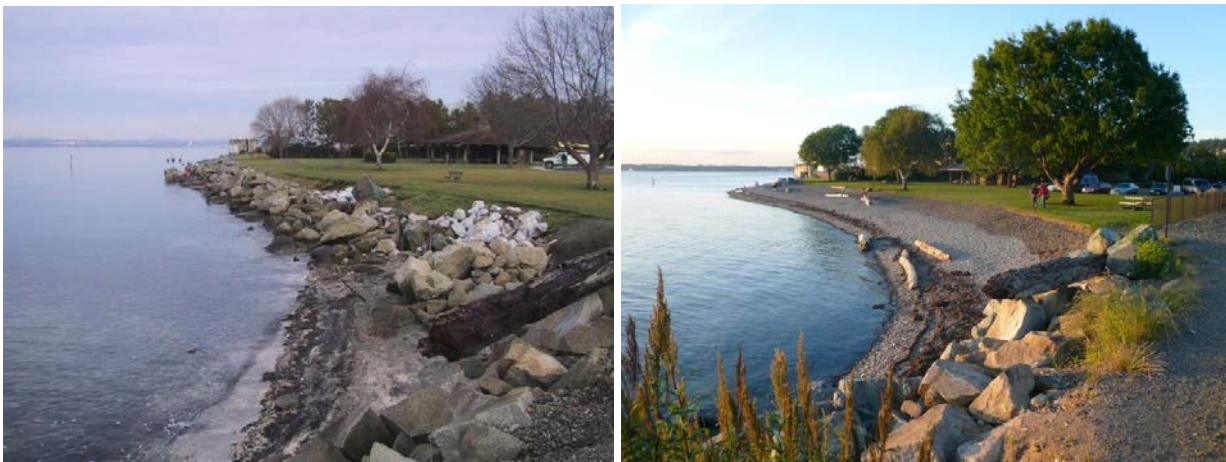
Figure 5-3. Before (left, 2004) and after construction (right, 2007) at Marine Park in Bellingham, Washington. This project is an example of multiple design techniques employed at one site: bulkhead and partial fill removal, with beach nourishment and a rock drift sill to contain sediment (partially visible in far end of beach), and adjacent revetment maintained to protect railway (on right).

enhancement. For many of these cases, beneficial actions can still be taken at the site. These actions include application of Best Management Practices (BMPs) such as increasing shoreline vegetation cover, reducing non-point pollution, and increasing awareness of coastal property stewardship. In some cases, landowners are receptive to reducing the amount of armor or moving armor further landward. Where the existing armor is both failing and not necessary, but is also not causing an immediate problem, landowners may decide to simply allow the armor to fall apart over time, or to remove it piece by piece to avoid the expense and disruption of a larger project. All of these actions represent steps along the desired stewardship trajectory. Based on working with shoreline planners and landowners in Port Susan, including multiple evaluation steps (EE Outcomes 2013), an outline of goals and steps was developed for improving stewardship through armor removal and incremental enhancement of processes and ecological function (Figure 5-3).

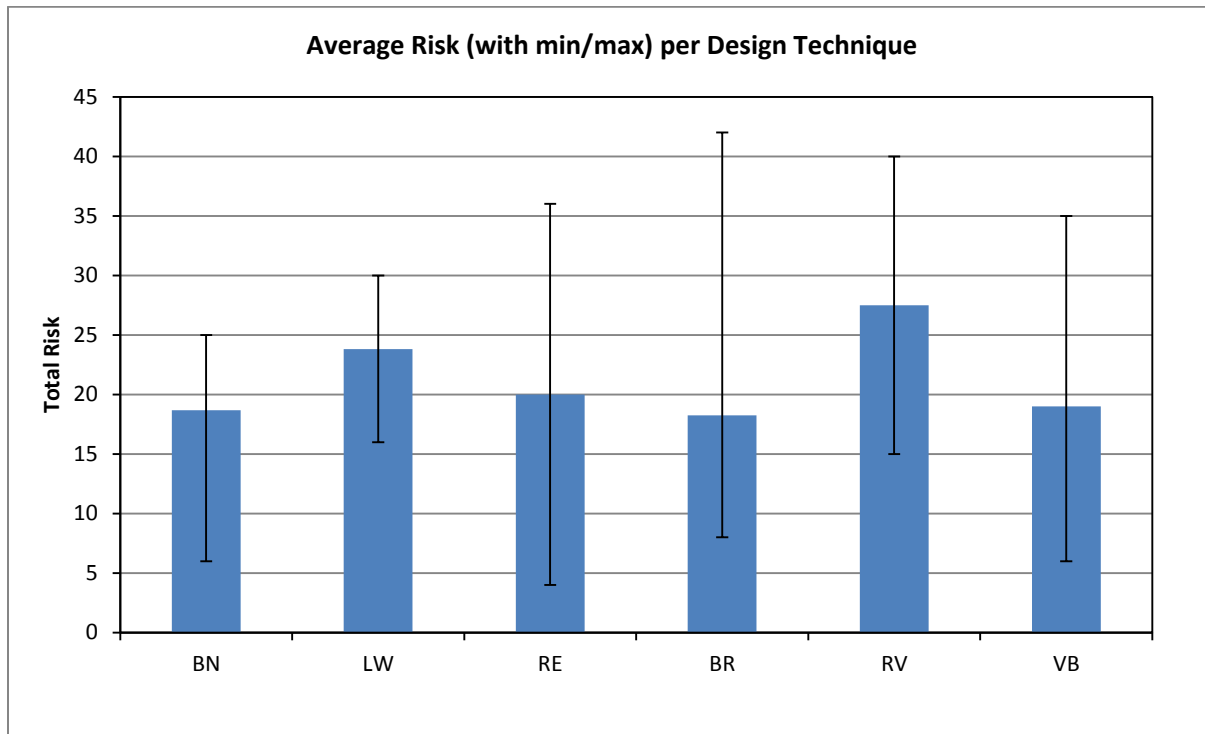
Figure 5-6. Average risk and range of risk from the 25 case study sites, grouped by design technique. BN = beach nourishment, LW = large wood, RE = reslope/revegetation, BR = bulkhead removal, RV = rock revetment, VB = vertical bulkhead.

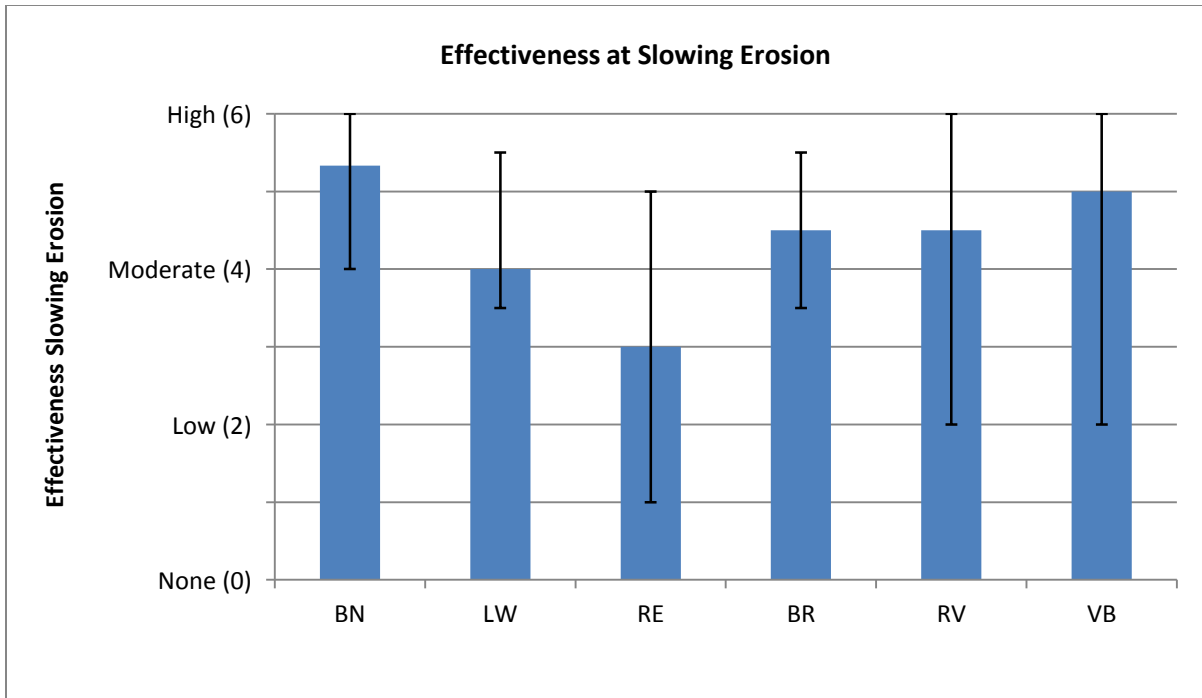
Figure 5-7. Average (and range) of effectiveness at slowing erosion from the 25 case study sites grouped by design technique. BN = beach nourishment, LW = large wood, RE = reslope/revegetation, BR = bulkhead removal, RV = rock revetment, VB = vertical bulkhead. Bulkhead removal was scored based on degree of restoring coastal processes.

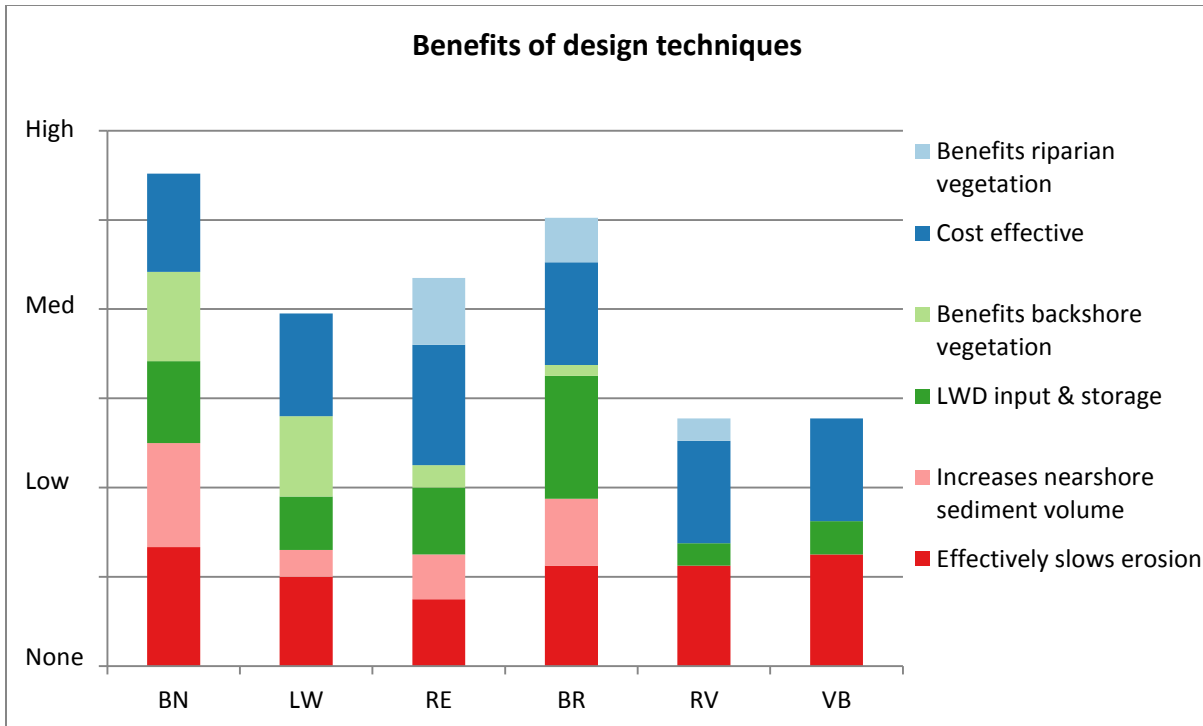
Figure 5-9. Benefits of different design techniques using average of scores of generally 4-6 case study sites per technique. BN = beach nourishment, LW = large wood, RE = reslope/revegetation, BR = bulkhead removal, RV = rock revetment, VB = vertical bulkhead. Bulkhead removal was scored based on degree of restoring coastal erosion processes.

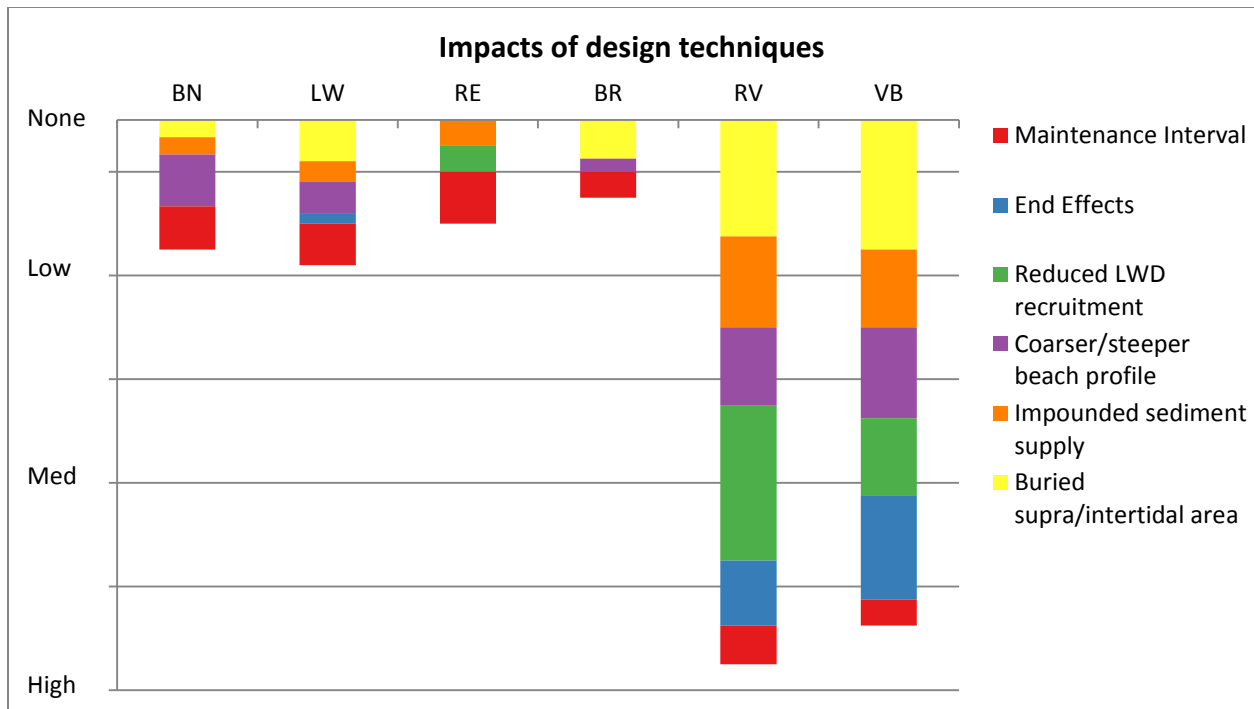
Figure 5-10. Average impacts of different design techniques based on case study data. BN = beach nourishment, LW = large wood, RE = reslope/revegetation, BR = bulkhead removal, RV = rock revetment, VB = vertical bulkhead.

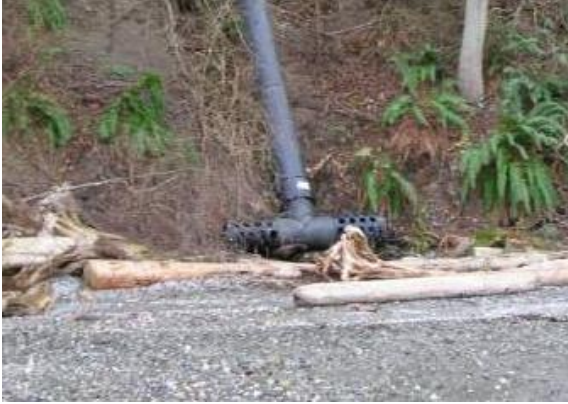
Figure 6-3. Diffuser tee mounted at the toe of the slope, upland of OHW, and behind existing drift logs. No rip rap pad was used.

Since stormwater is periodic it is possible to establish a bed of native vegetation for the diffuser tee that uses the root strength to resist erosion. In some instances the tee can be mounted in the backbeach area without any additional erosion protection (Figure 6-3).

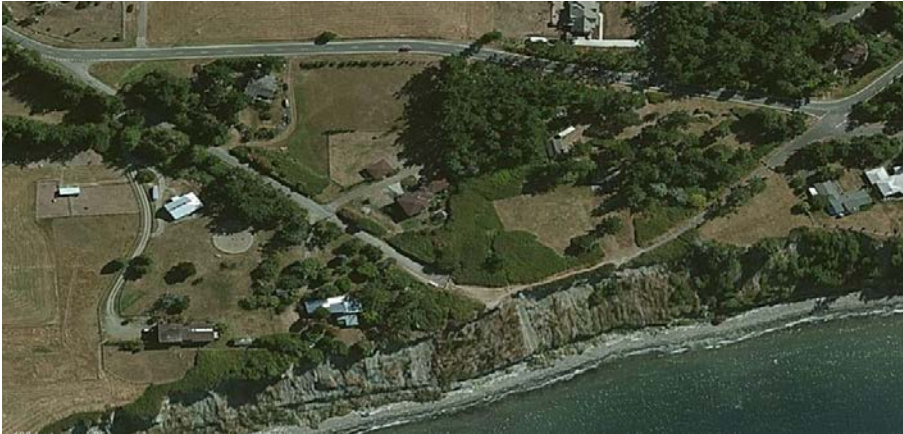
Figure 6-4. Cook Road located northwest of Port Townsend along the Strait of Juan de Fuca. The realigned road is at the top of the photograph and the abandoned road at the bottom where the corner has been cut away by bluff erosion. The narrow, steep beach and high energy waves cause persistent erosion with no backshore to locate a practical bulkhead. The relocation took place in the 1990s (Dept. of Ecology Digital Coastal Atlas).

Managed retreat is often used for coastal roads. In the following series of examples (Figures 6-4 to 6-7), relocation is shown as a practical alternative to protecting the road in place. Note that the roads in these examples are all local roads, not State highways. It is relative rare to move a highway because they are often part of a complex web of other roads, access points, and utility networks.

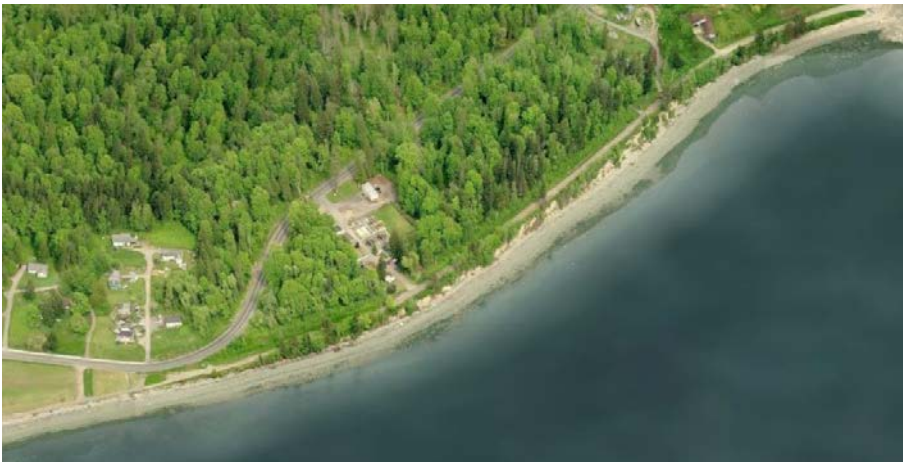
Figure 6-5. Lummi View Drive (Whatcom County) was relocated back away from an eroding shoreline about the year 2000. The old road was located on top of the bluff immediately adjacent to the shore. The new road is show above it and approximately parallel (Dept. of Ecology Digital Coastal Atlas).

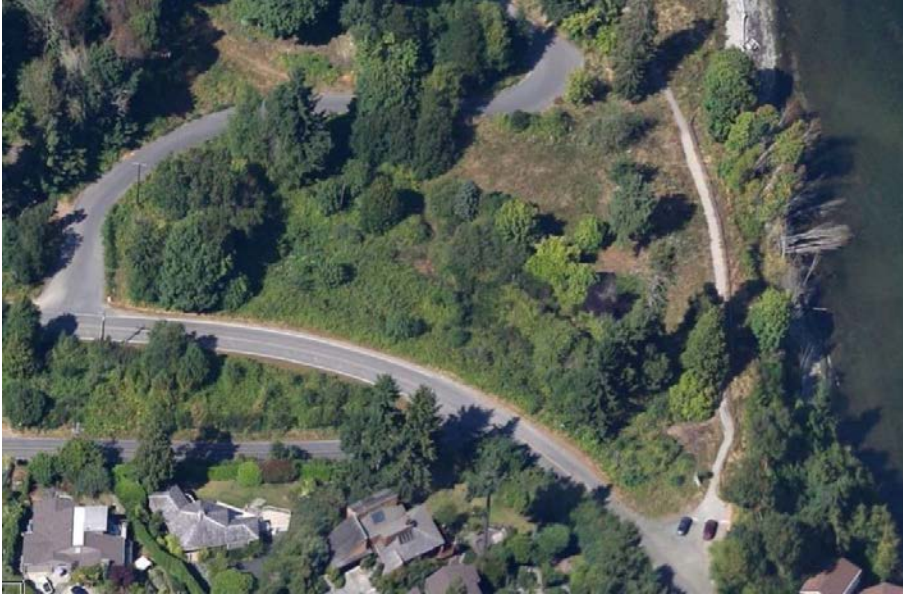
Figure 6-6. East Pritchard Park access road relocation and bulkhead removal project. Pritchard Park is located on Eagle Harbor, Bainbridge Island. The bulkhead at the toe of the bluff (shore on the right of the photo) below the original access road was removed, destabilizing the bluff. The road was relocated to the left in the photo to restore access to the southeast part of the park.

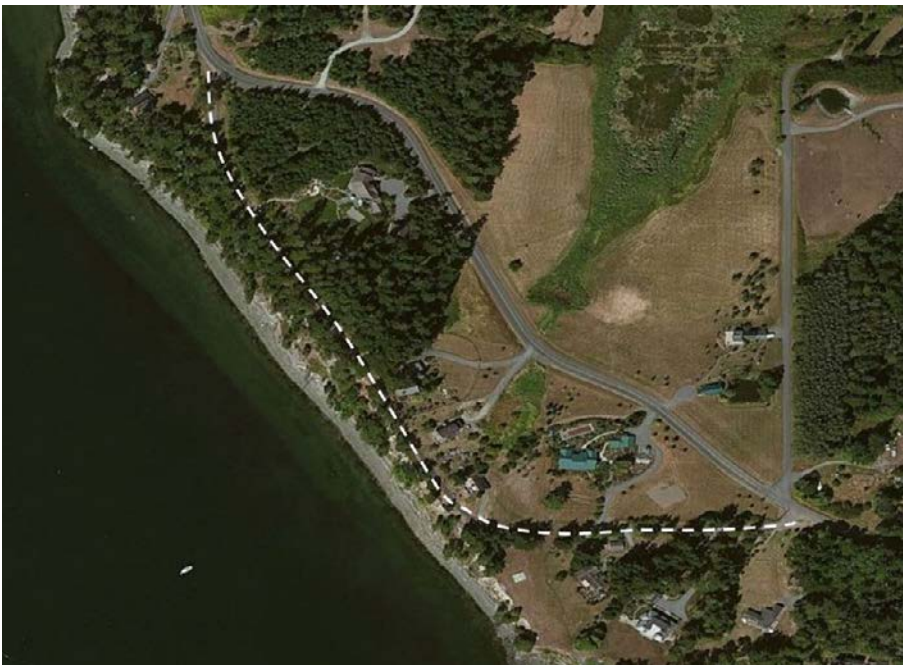
Figure 6-7. Deer Harbor Road on Orcas Island relocated away from an eroding bluff. The old road alignment was exposed to periodic bluff failure and is shown as a dashed white line. The new alignment runs roughly parallel to the right.

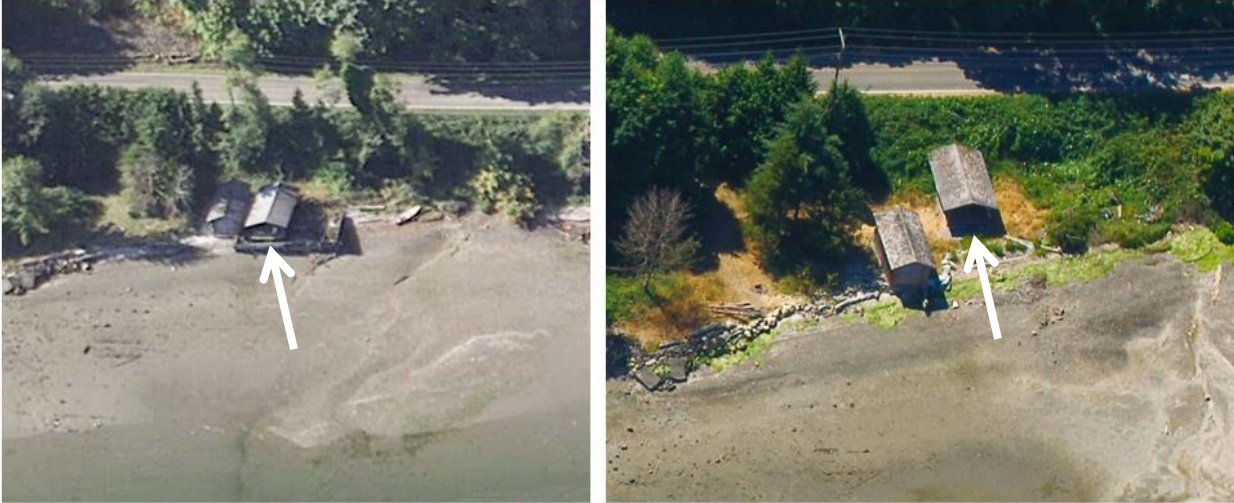
Figure 6-8. These two photos are of a section of shore near Dockton Park on Vashon Island. In the left photo, taken in 2001, a structure on the right (indicated by arrow) is protected by a bulkhead that protrudes out into the intertidal mud flat. In the right photo (2006) the structure has been moved back from the shore and the bulkhead removed (Dept. of Ecology Digital Coastal Atlas).

Road relocations are generally carried out by public entities with greater access to planning and engineering support with a responsibility to provide reliable transportation services to the public. Individual structures, on the other hand, are the responsibility of the owner who may have more modest resources. Two examples of structure relocation are shown in Figures 6-8 and 6-9.

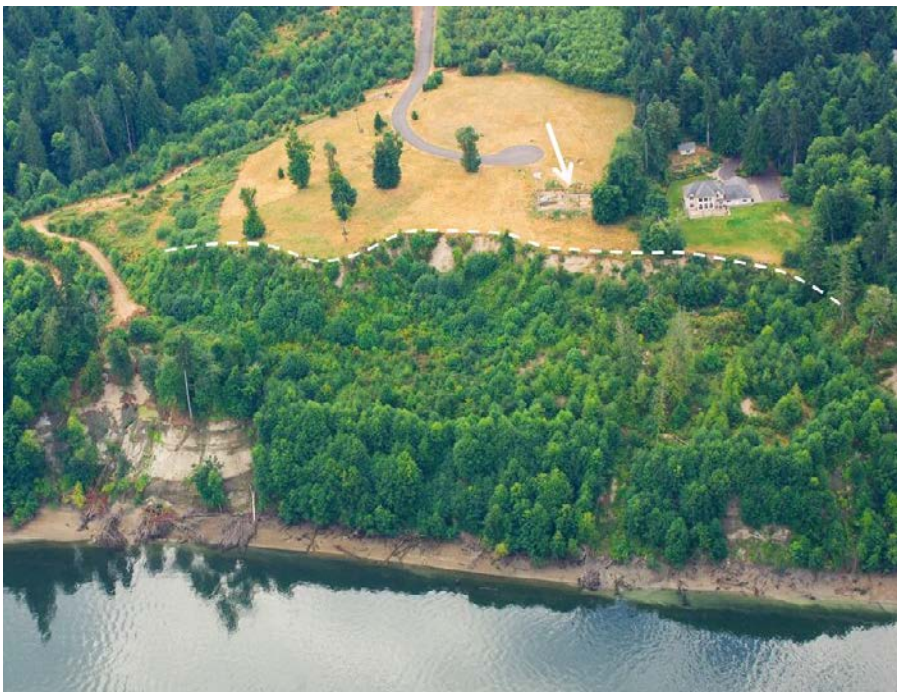
Figure 6-9. The large, deep seated slide on Hammersley Inlet caused the landowner to relocate their house. The slide can be seen in the middle of the photo and extends from the shore to lower edge of the cleared area (top of slide indicated by white dashed line). The foundation of the relocated house is below and to the right of the asphalt cul-du-sac (white arrow) (Dept. of Ecology Digital Coastal Atlas).

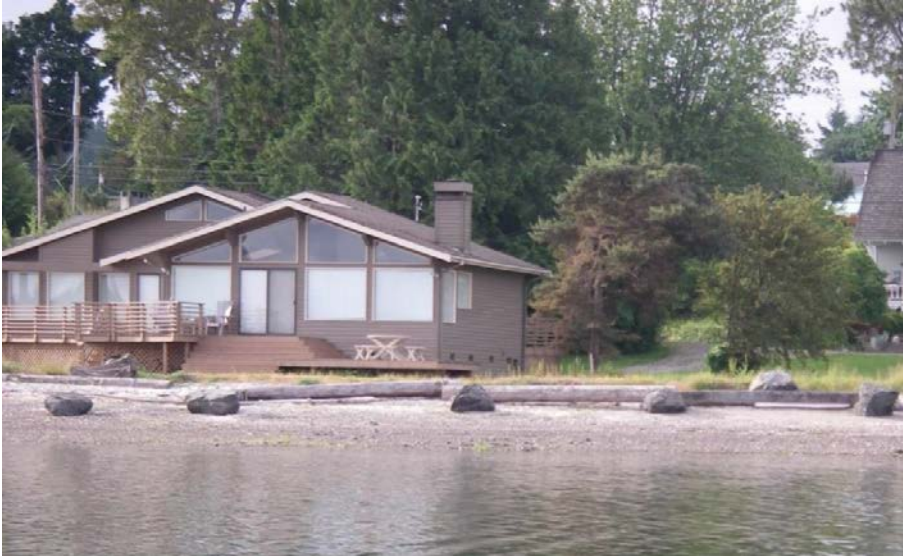
Figure 6-10. A Maury Island home elevated three feet above base flood elevation. Skirting hides the elevated part of the house, indicated by the square vent holes seen on the right side. The owner also replaced a bulkhead with softshore protection that allows for sediment movement and occasional flooding at high tide (photo K. Higgins).

A final example shows vertical relocation or retreat where a structure is elevated to allow water to flow beneath it to avoid damaging the structure itself. Vertical relocation reduces the need for shore armor. This is a common technique on river floodplains other areas prone to flooding.

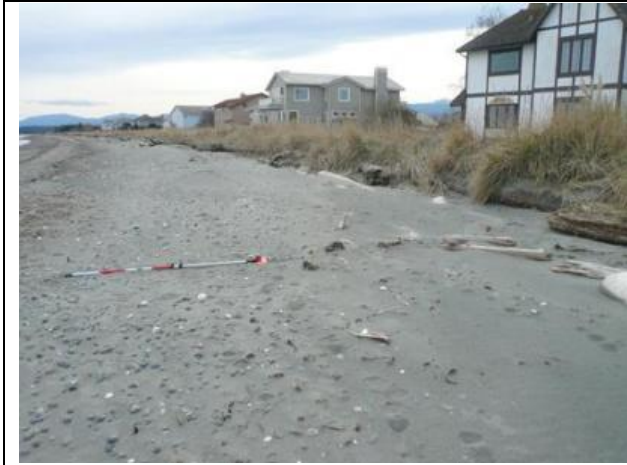
a) East Dungeness, Clallam County; backshore/dune placement

Figure 7.1-1. Examples of the range of different beach nourishment projects surveyed for this study (Appendix A), with placement approach noted in captions.

Beach nourishment projects selected for the case study assessment (Appendix A) were distributed between the Nisqually Reach, the Strait of Juan de Fuca, and Whatcom County. Photos of these sites are shown in Figure 7.1-1 as examples of Puget Sound nourishment projects. Sites assessed for the study covered a wide range of conditions and design approaches, and were installed between 1972 and 2005, with the majority installed between 2002 and 2005. Because there were more beach nourishment projects than projects using other soft shore protection design techniques, most project case studies selected have been in place for 7 to 10 years, allowing assessment of medium-term performance. Table 7.1-1 summarizes conditions at the 6 case study sites. The range of beach nourishment project sites surveyed for preparation of these guidelines is also discussed in Chapter 5, *Alternatives Analysis*.

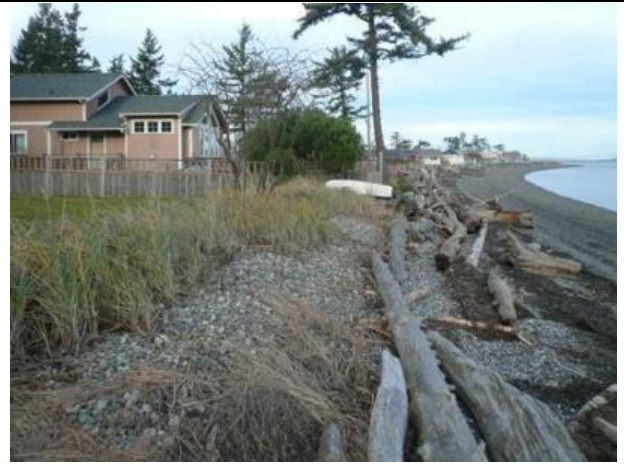
b) East Lummi Island, Whatcom County; MHHW-backshore placement

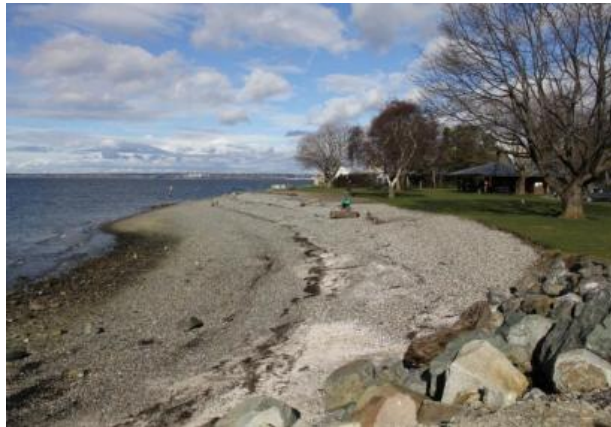
c) Marine Park, Bellingham; lower intertidal to backshore placement

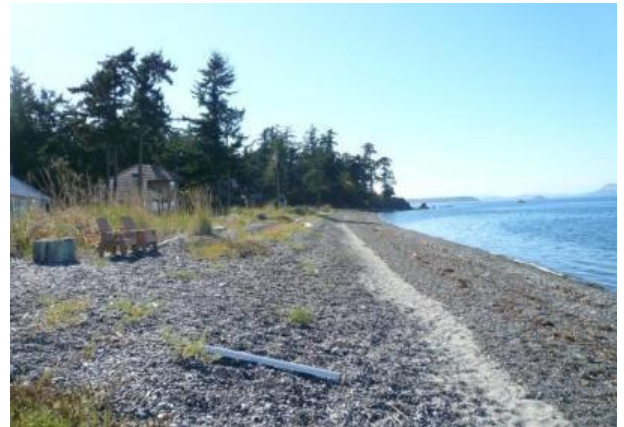
d) North Beach, Orcas Island; lower intertidal to backshore placement

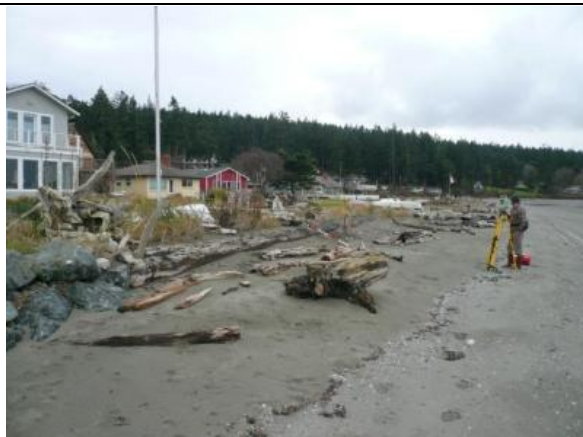
e) Snakelum Point, Penn Cove, Whidbey Island; MHHW-backshore placement

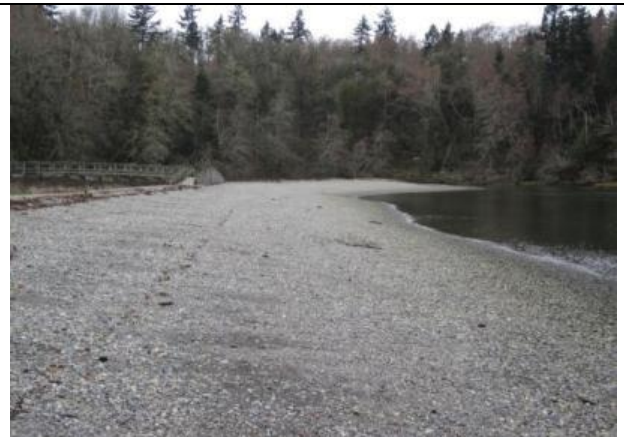
f) Tolmie State Park, Thurston County; lower intertidal to backshore placement

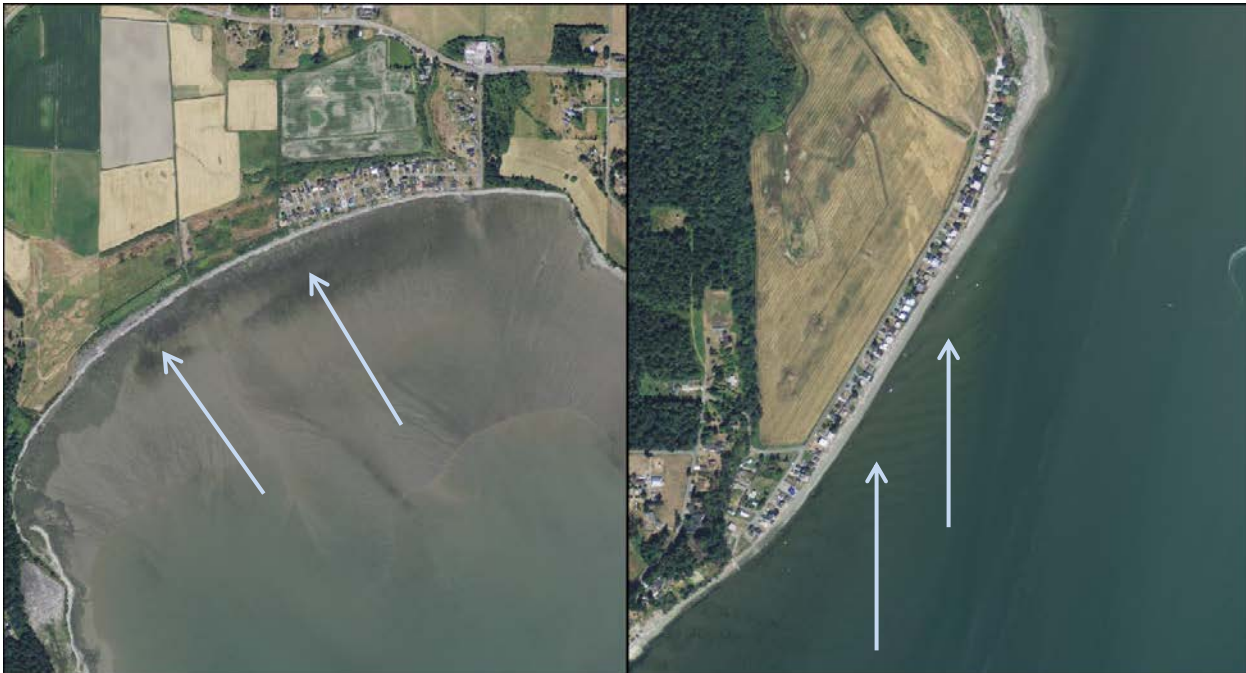
Figure 7.1-5. Examples of swash aligned (left) and drift aligned beaches (right) from the Livingston Bay area of northeast Camano Island. Arrows indicate prevailing wave direction.

A *swash aligned* beach is oriented facing the predominant waves at the site, such that the larger wave fronts tend to reach the beach (after the waves are refracted by the shallow bay bottom) parallel to the beachface (Bird 2005). This is typically the case at a pocket beach, and is not uncommon at some accretion shoreforms. However, most spits and bluff-backed beaches in the Puget Sound region are not swash aligned, but rather *drift aligned* (Figure 7.1-5). Along drift aligned shores the dominant waves break at an oblique angle, which generates littoral drift parallel to the shore. Many beaches are intermediate between the two conditions, such that in practical application beaches that are oriented close to the direction of drift generally are considered drift aligned, and those aligned closely with the dominant wave approach swash aligned.

Beach nourishment projects are more likely to succeed at swash-aligned beaches because the losses of sediment due to littoral drift are often negligible. These beaches have a greater number of options in terms of specific design elements and often beach nourishment can be successful even where wave energy is high. Examples of this are North Beach on Orcas Island (Appendix A) and nourished pocket beaches. Similarly, beaches which are very close in orientation to swash aligned are favorable for nourishment. Beaches where the refracted waves reach the beachface at a 45-degree angle tend to have the highest littoral transport rates and design development needs to be quite conservative; these drift-aligned beaches are not generally suitable for nourishment where moderately high wave energy is present.
