Washington State Aquatic Habitat Guidelines Program

Marine Shoreline Design Guidelines

Final

**Prepared for:
The Aquatic Habitat Guidelines Program
2014**

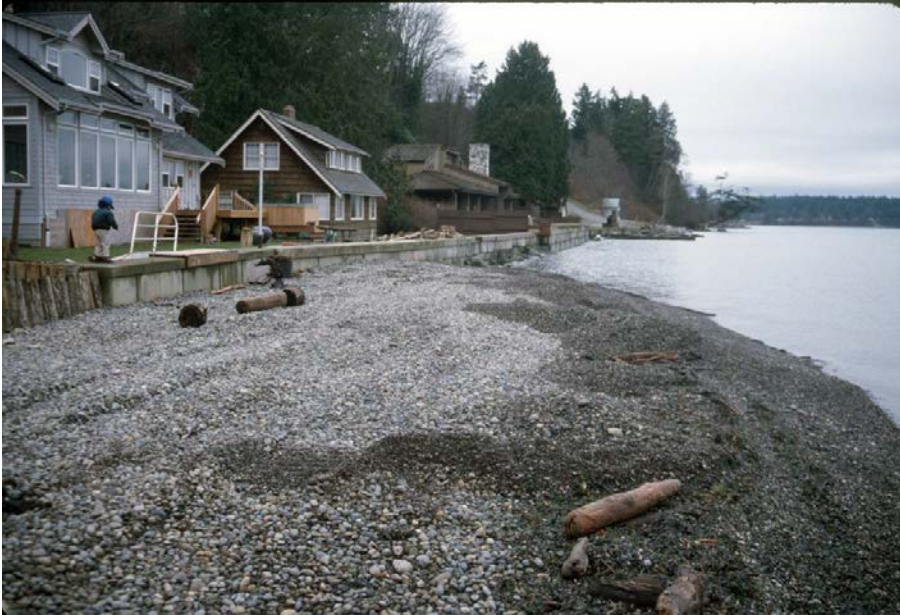
Figure 7.1-6. Example of an up-drift feeder beach, also termed advance nourishment, which was located on property adjacent to the main project area. The site is North Beach Samish Island, during initial placement in January 1999 (Johannessen photo).

Several proven variations on beach nourishment exist for extending the nourishment project life where the site geometry is not ideal. The methods can supplement the basic rectangular planform of nourishment design by placing additional nourishment sediment at an erosional site. One approach is to simply extend the nourishment area up-drift of the subject property or properties. This approach was termed a *feeder beach* by Wolf Bauer and is sometimes referred to as *advance nourishment*. An example of a feeder beach is shown in Figure 7.1-6 at North Beach on Samish Island. This was a privately-funded nourishment project to rebuild a beach which was largely eroded due to the cumulative impacts of extensive up-drift armor (Shipman 1998, Johannessen 2002).

The direct project area was an 850-ft-long barrier beach fronting multiple houses and cabins (Johannessen 2002, Zelo et al. 2000). The nourishment footprint was extended approximately 90 ft up-drift onto an adjacent property to allow for the placement of additional nourishment volume; the project has not required any maintenance nourishment in over 15 years.

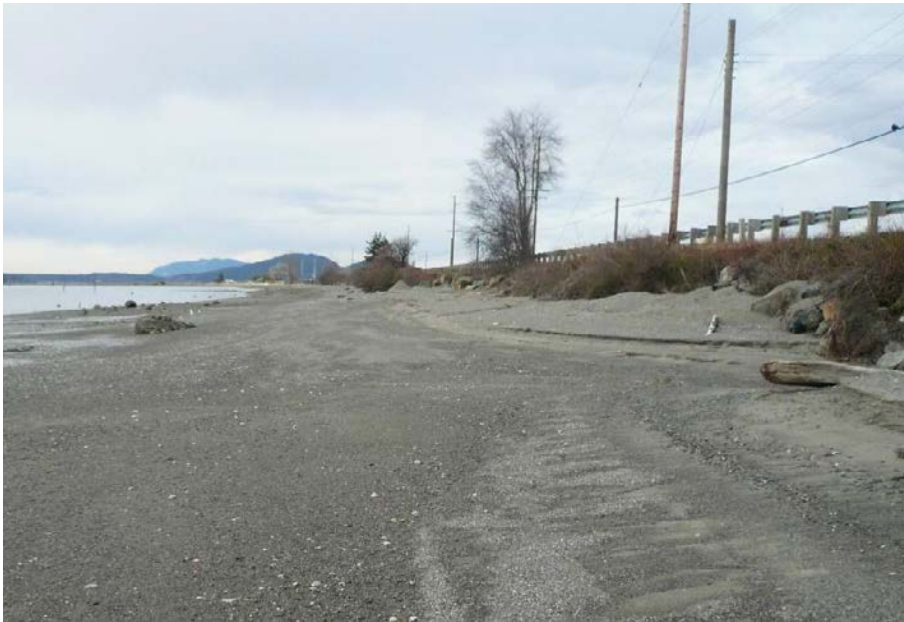
Figure 7.1-7. West Marchs Point, Skagit County, WA. Advance nourishment used a widened lower intertidal to backshore nourishment profile at the up-drift end of a surf smelt spawning habitat enhancement project (Johannessen photo).

A second approach for modifying the basic nourishment planform is placement of additional nourishment volume in a wider reach within the up-drift end of the nourishment area. An example of this was constructed along the west shore of Marchs Point in Skagit County in 2010 (Figure 7.1-7). This project used easily transported sand with fine gravel in a low-wave-energy setting as the project recreated lost surf smelt spawning habitat. Tolmie State Park is another example of advance nourishment (Appendix A).

A limited number of nourishment projects have been carried out with the goal of habitat enhancement, and not for erosion control (Figures 7.1-7 and 7.1-14). One large project was designed for mitigation of the impacts from a new rock revetment constructed along approximately 1.5 miles of the north shore of Bellingham Bay for defense of the rebuilt Lummi Shore Road. The space for relocation of the road away from the unstable and eroded bluff shore was limited in some areas, and the US Army Corps of Engineers designed and built a substantial rock revetment that extended from +8 to +18 ft MLLW. In order to offset the loss of feeder bluff function and burial of the upper beach, a beach nourishment program was designed to routinely replenish the beach with sediment (Johannessen and Dillon 1998). In the short term, this resulted in more suitable surf smelt spawning habitat and surf smelt spawning than before the project (Figure 7.1-14). However, this is not sustainable over decades in a high erosion area such as this. Nourishment was not continued beyond the first five years, and in subsequent years the amount of potential spawning habitat appeared to have been significantly reduced.

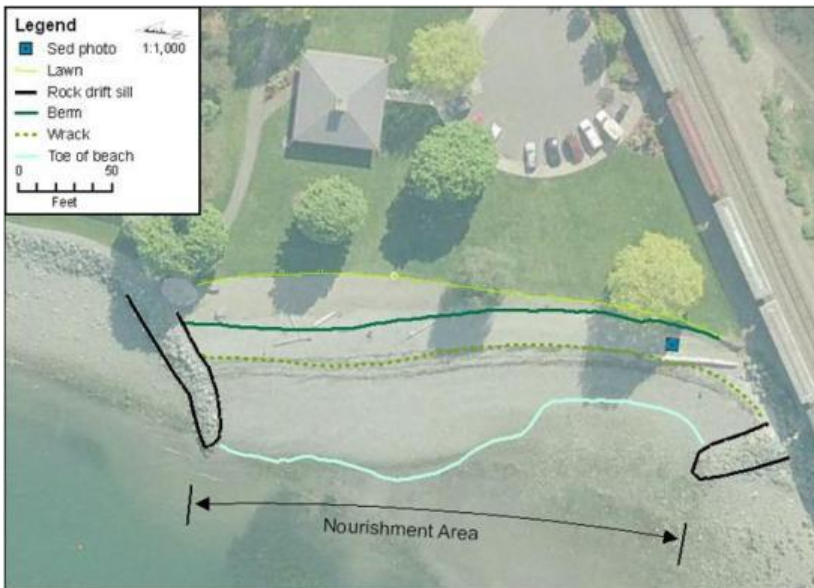
Figure 7.1-8. Marine Park, Bellingham, WA. The nourished beach is confined between drift sills (outlined in black) in this urban shore dominated by railway revetments, fill, and Chuckanut sandstone cliffs.

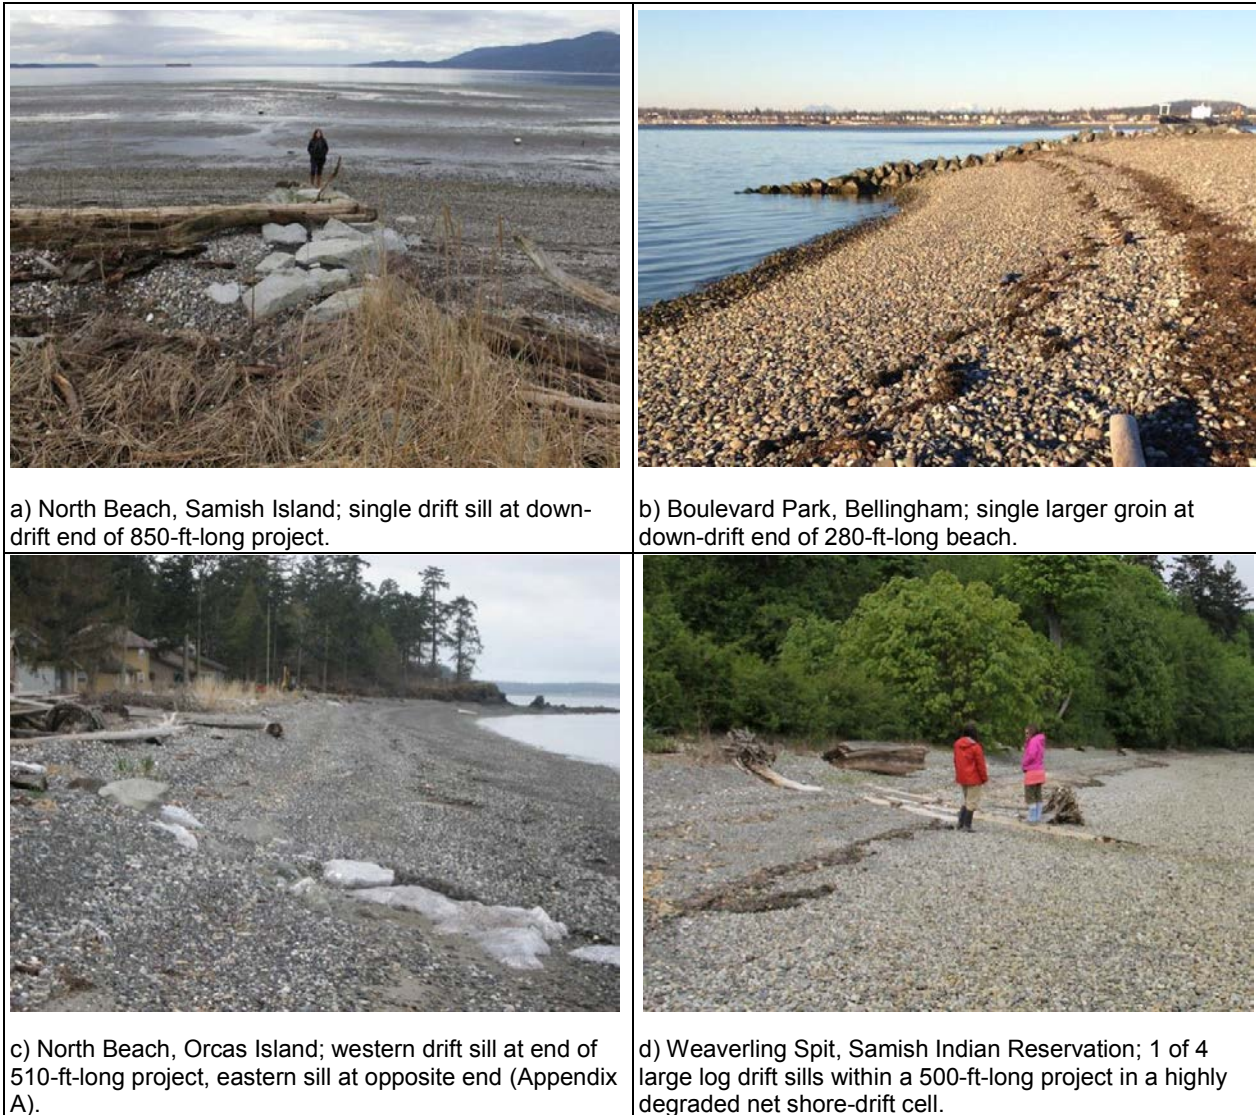
Figure 7.1-9. Examples of drift sill installation at beach nourishment sites. Samish Island is summarized in Zelo et al. (2000) and Gerstel and Brown (2006). North Orcas is in Appendix A.

A drift sill is a term coined by Wolf Bauer for a low-elevation and relatively short groin (cross-shore structure) constructed at, or minimally above, the nourished beach profile. Drift sills have typically been constructed out of angular rock. These sills generally do not typically extend below the lower intertidal; however, at highly modified, urban sites, they may need to extend down to several feet below MLLW. Drift sills should be avoided at most sites as these groin structures can interrupt littoral transport and cause wave refraction adjacent. Drift sills have been utilized in the Puget Sound region at degraded urban settings where fill has pushed the shore into deeper water and no sources of up-drift sediment exist. They have also been used at drift-aligned beaches with moderate or greater wave energy and limited other options. Examples of sites that required drift sills installed with beach nourishment projects in greater Puget Sound include the drift-aligned North Samish Island site (Johannessen 2002), and the constructed pocket beach at Marine Park in Bellingham (Figure 7.1-8 and Appendix A). Examples of drift-aligned beaches coupled with greatly reduced sediment supply due to up-drift armored bluffs where small drift sills were used are shown in Figure 7.1-9. A newer project with similar conditions which will also have a large rock drift sill will be constructed in 2014 at North Seahurst Park in Burien.

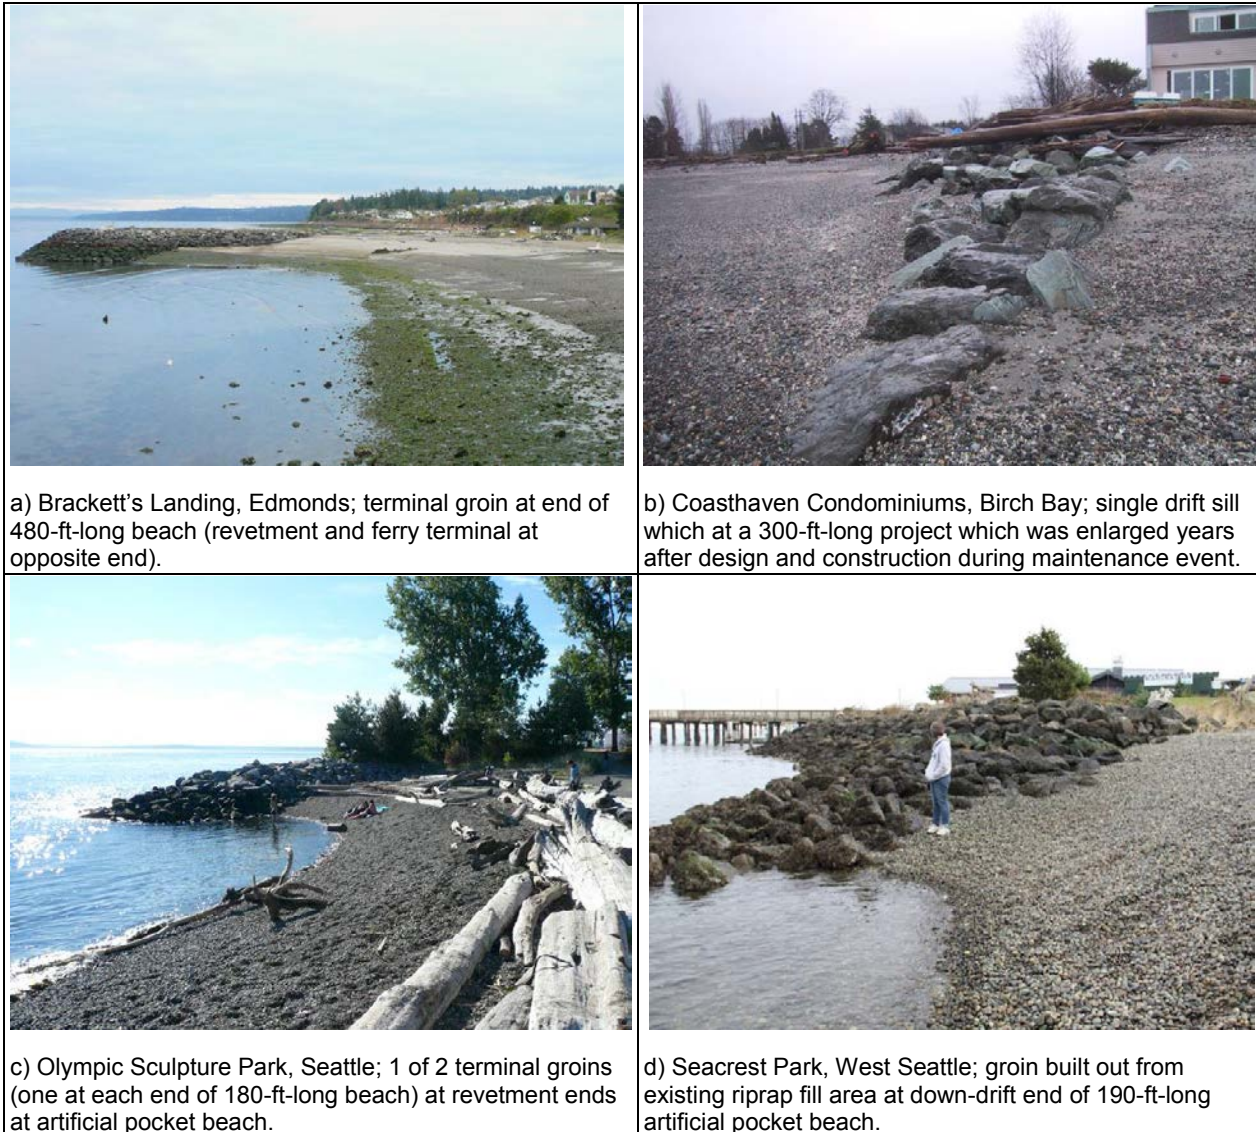
Figure 7.1-10. Examples of large rock groins installed at beach nourishment sites. Olympic Sculpture Park is summarized in Toft et al. 2012 (J. Johannessen photos).

Rock groins larger than drift sills have been constructed at a limited number of nourishment sites around the region, including Brackett's Landing in Edmonds; Olympic Sculpture Park in Seattle; and Seacrest Park in West Seattle where the sill was incorporated into a large revetment (Figure 7.1-10). The Edmonds groin also provides public access to its end. These structures were designed very conservatively in terms of the application of engineering standards and as a result are quite large. Attempts to minimize the burial of intertidal area should be carried out at all future projects, including those at urbanized shores. The Birch Bay example shown was originally a smaller drift sill structure which was later expanded during maintenance following a major winter storm.

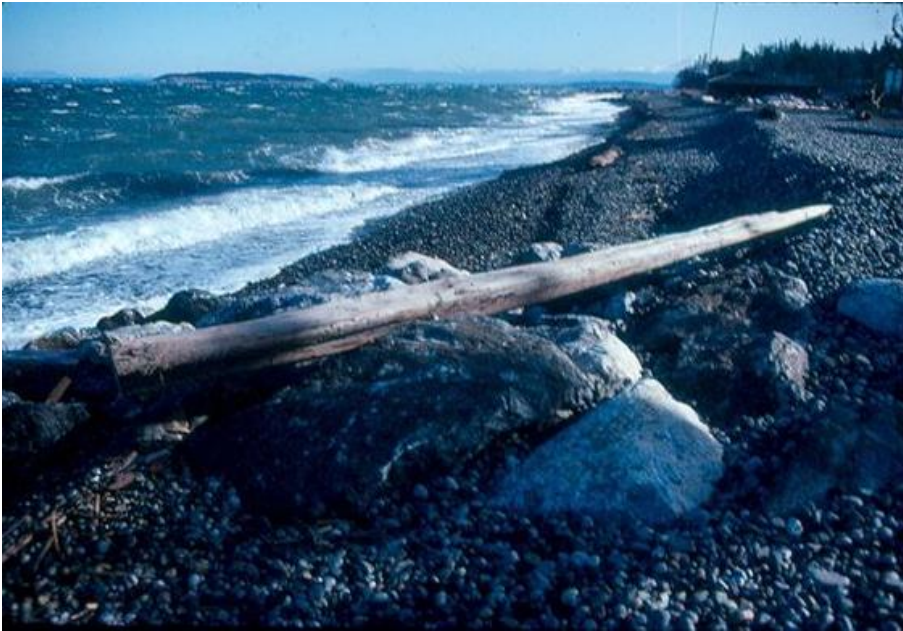
Figure 7.1-11. Beach scarps formed during storms soon after lower intertidal to backshore nourishment placement at North Orcas Island site (Appendix A), also showing exposed west drift sill in foreground (J. Ellis photo).

The berm elevation should also not be set too high such that cross-shore sediment transport results in the formation of a scarp (steep erosion feature) into an artificially high beachface. An example of a moderate sized scarp is presented in Figure 7.1-11 from North Beach on Orcas Island soon after initial placement. Designing a berm which is lower than optimal can result in frequent overwash and significant onshore translation of the

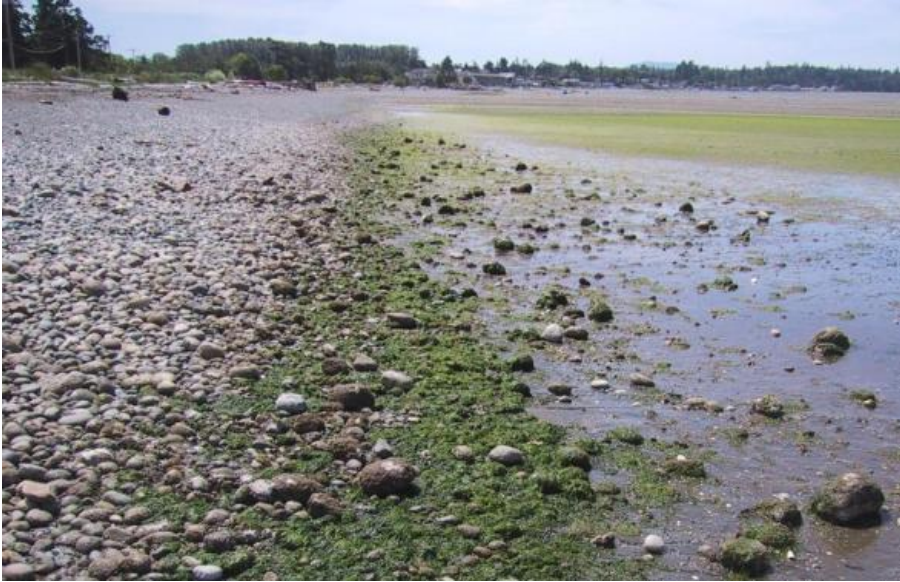
Figure 7.1-13. Large cobble (3–8 in) added to the upper beachface during nourishment was sorted by waves to the toe of the high-tide beach and over the low-tide terrace, altering habitats and making wading difficult at this popular recreational beach on central Birch Bay Drive, Whatcom County, 2002 (J. Johannessen photo).

It is important to understand that the force of the waves moving a given gravel size up the beach must exceed the forces of gravity and backwash moving it down the beachface. These conditions are different for each site and the specified nourishment sediment must be tailored to a given situation. Gravel particles that are too large typically end up at the toe of the high-tide beach. A good example of this occurred in Birch Bay in Whatcom County, where renourishment of oversize cobble in the 3- to 8-inch range resulted in the larger clasts moving downslope to the toe of the high tide beach (Figure 7.1-13). This sediment was not the size specified in the earlier design by Bauer. Bauer had warned against up-sizing nourishment sediment based on the false assumption that larger substrate makes for a more successful project in terms of gravel stability. His reasons

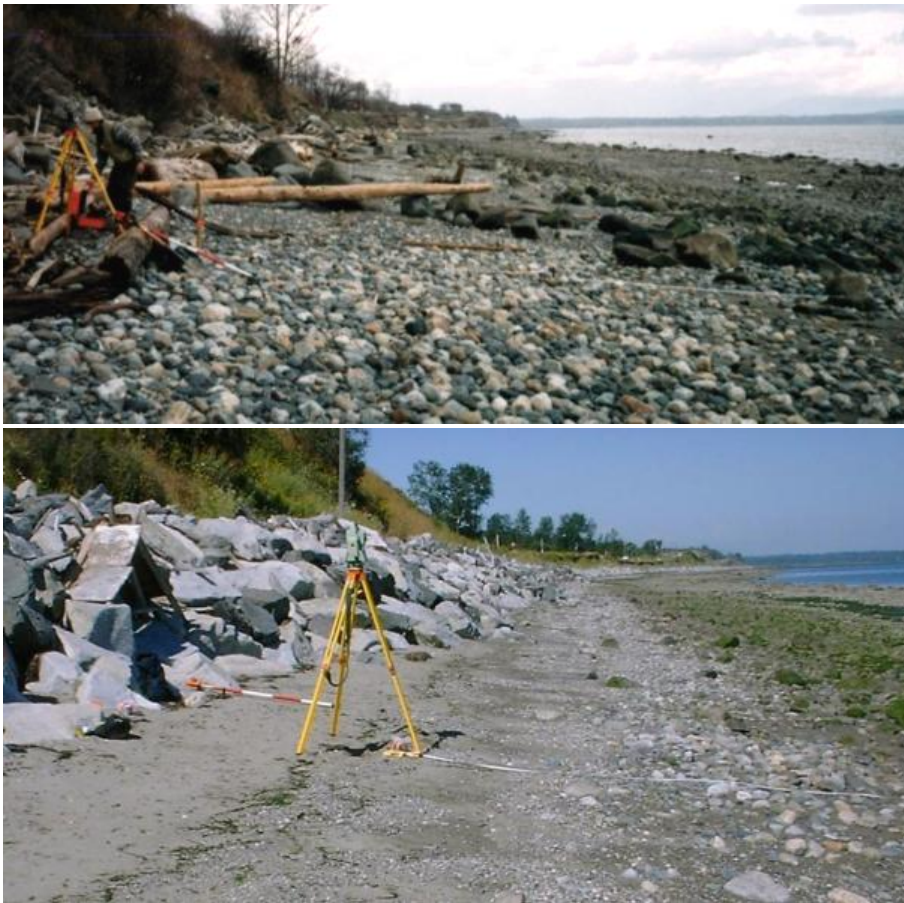
Figure 7.1-14. Lummi Shore Road on Bellingham Bay, Lummi Reservation at the same location in the central reach. Prior to revetment construction (top, 1998) and after (bottom, 2000). After revetment was built beach nourishment was applied for mitigation. However, without continued nourishment, the beach is much coarser in 2014 (J. Johannessen photos).

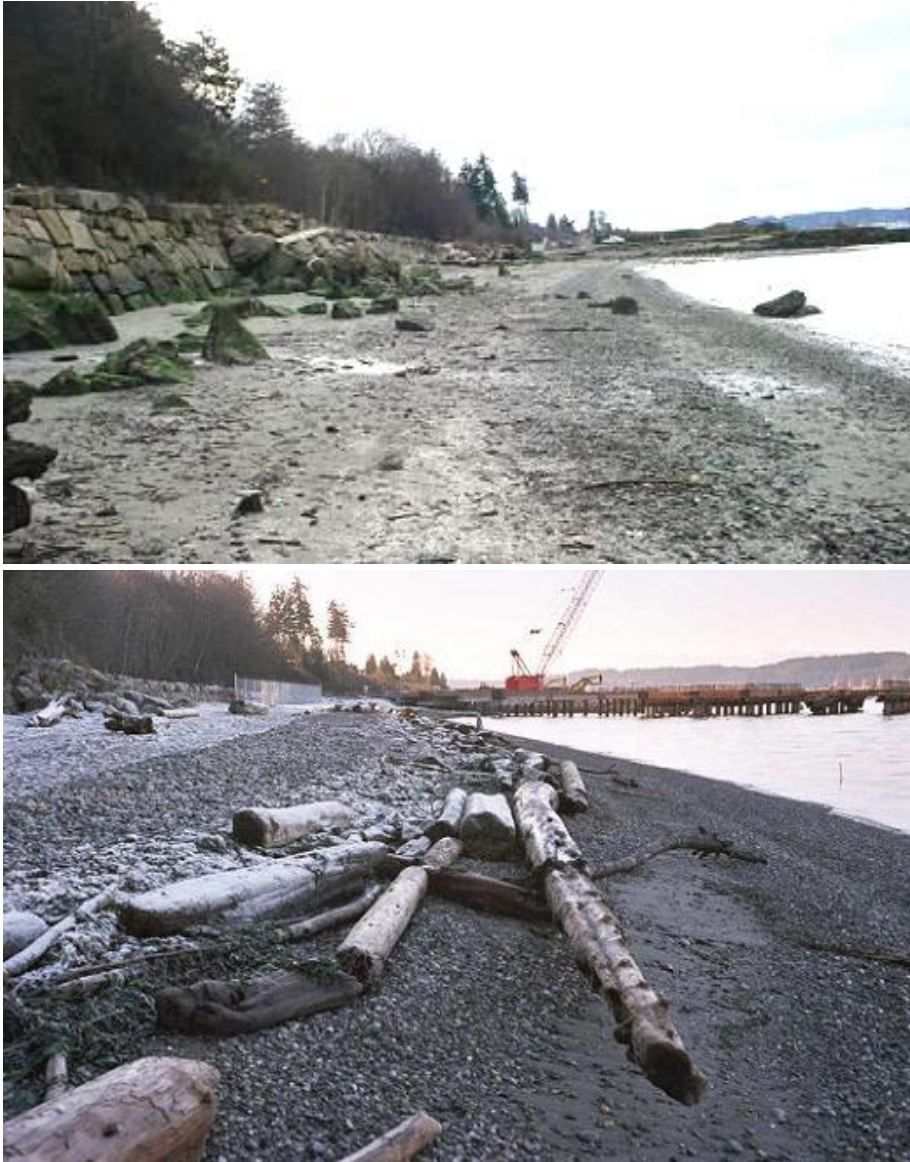
Figure 7.1-15. Before (top, pre-2005) and after (bottom, late 2005) beach nourishment for mitigation at approximately same location, Mukilteo, WA (Port of Everett photos).

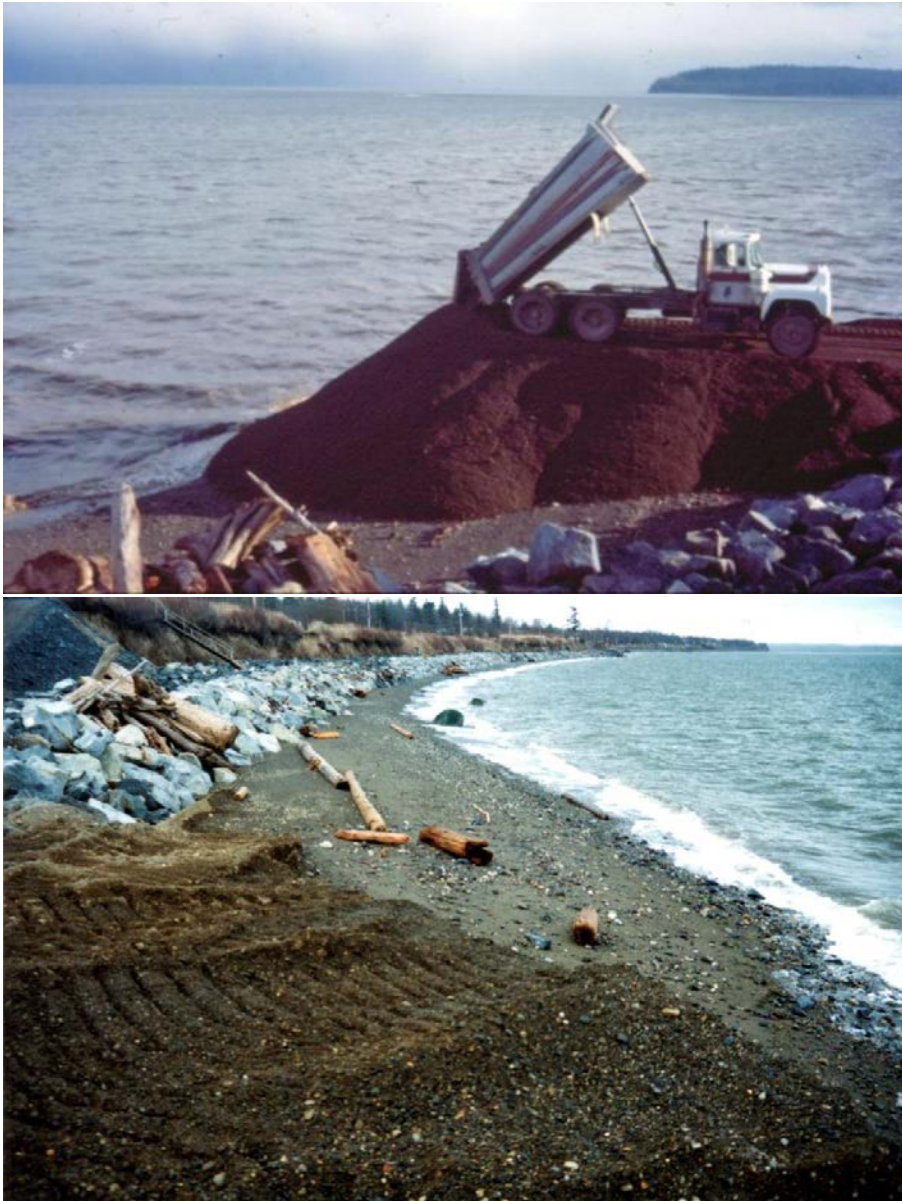
Figure 7.1-16. Beach nourishment placement with almost no grading at Lummi Shore Road, Whatcom County, WA, during early February 1999 placement (above) and 10 days later in same location showing effectiveness of allowing winter waves to accomplish grading (remaining sediment in foreground is atop revetment extension (J. Johannessen photos).

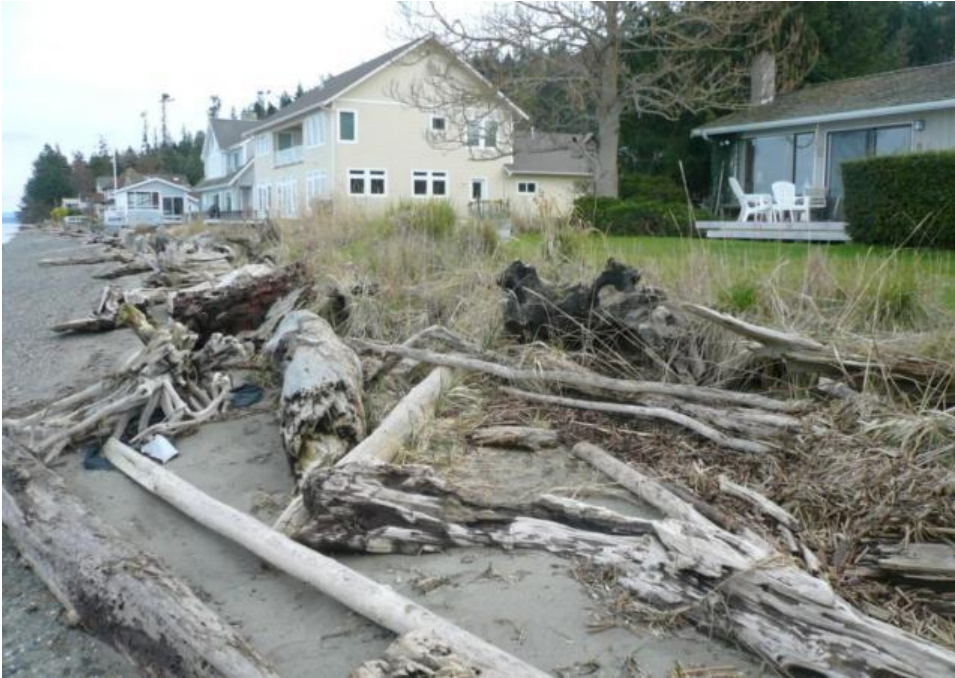
Figure 7.2-1. Barrier beach in developed area with abundant, natural large wood on northeast Whidbey Island (J. Johannessen photo).

The added structure and elevation of a large wood enhanced storm berm can reduce wave-induced erosion, promote deposition of fine sediment in areas with wind-blown sand (aeolian sediment transport), and facilitate increased species richness in backshore vegetation. Winds transport and deposit fine sediment on the leeward side of large wood in some exposed areas in the region, such as along the shores of the Strait of Juan de Fuca. The accretion of fine sediment enhances beach microtopography such as storm berms or depressions in salt marshes. Buried large wood is a natural and historical structural element of Pacific Northwest beaches and can also function as substrate for backshore and riparian vegetation resulting in increased species richness (Guttman 2009, MacLennan 2005). Large wood on beaches is also associated with increased invertebrate abundance and biomass (Tonnes 2008) that serve as food for a number of nearshore species, including salmonids. Large wood on beaches produces microclimate effects, such as increased soil moisture and temperature (Tonnes 2008), with known benefits to surf smelt (*Hypomesus pretiosus*) embryo survival (Rice 2006). Barrier beaches are often associated with larger quantities of large wood due to the depositional nature of the shoreform. Figure 7.2-1 shows a barrier beach with moderate amounts of naturally-deposited large wood, which is one of a number of natural models for large wood installation.

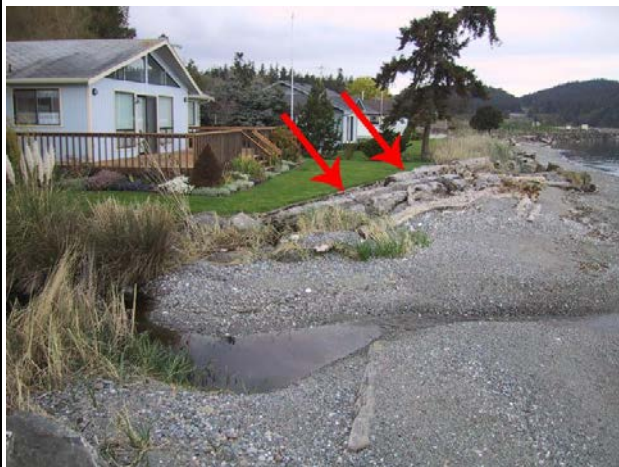
a) Backshore linear logs, minor nourishment for backshore erosion control (Oak Bay)

Figure 7.2-3. Examples of backshore log installations for different intents at erosion control sites in the Puget Sound region. Arrows point at anchored logs where not obvious. Case study sites indicated in parenthesis; see Appendix A (photos J. Johannessen).

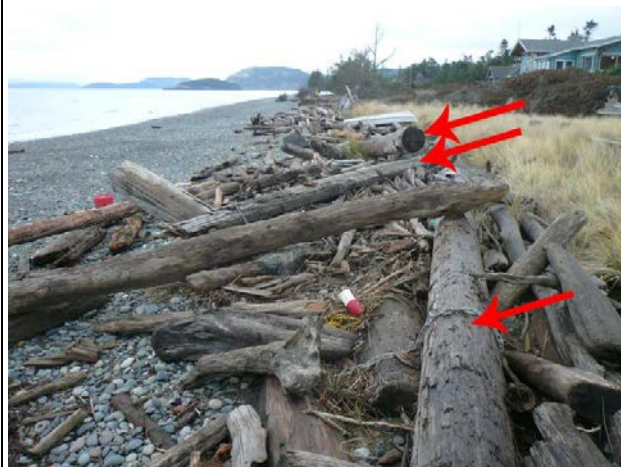
b) Complex log pattern to trap logs (NW Whidbey)

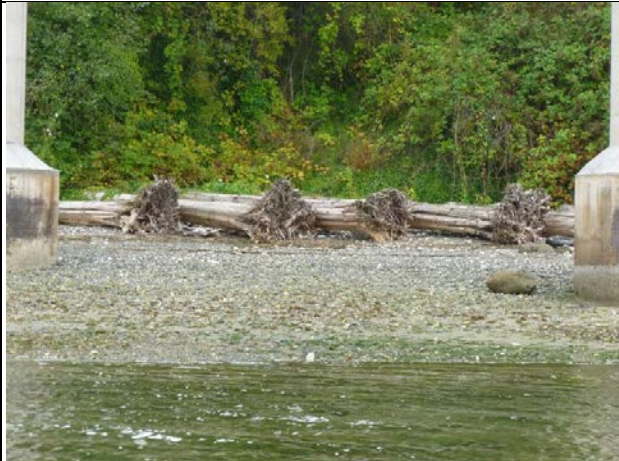
c) Backshore placement at east end Hood Canal bridge

One site with a 6 mile southwest fetch was visited briefly in preparation of the MSDG where logs were anchored in the intertidal (Bloomquist site in Zelo et al. 2000, Figure 7.2-3 frame c). Beach erosion did not appear to have occurred at this site when observed in 2012 and the project has fared quite well, perhaps as beach erosion was not occurring at this site. Another site with anchored logs in the intertidal in Suquamish has reportedly experienced scour around the logs (Waldbilling pers. com. 2013).

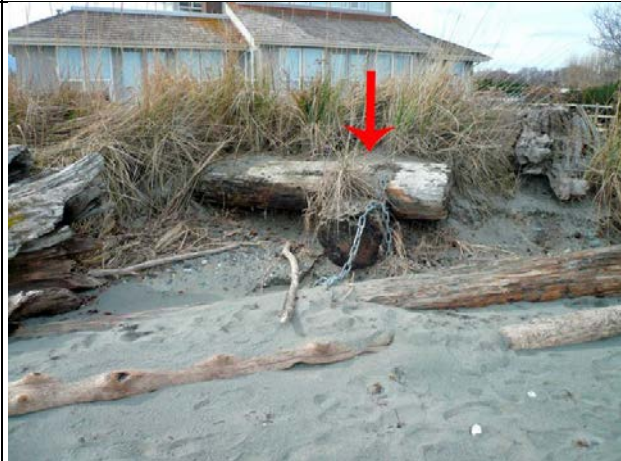
d) Logs interlocking with dune (East Dungeness)

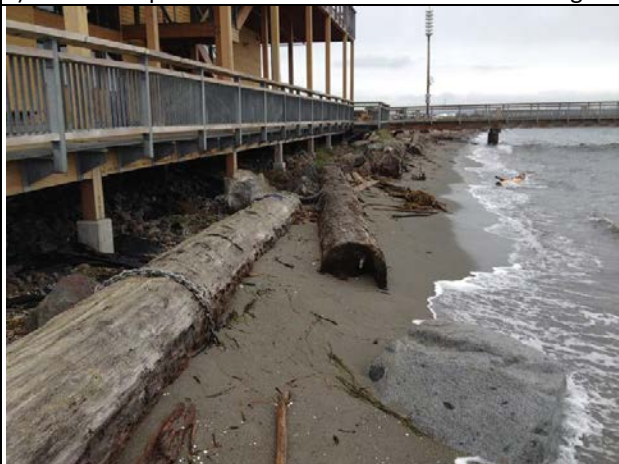
e) Anchored and placed high on the beach for erosion control immediately adjacent to the Northwest Maritime Center in Port Townsend.

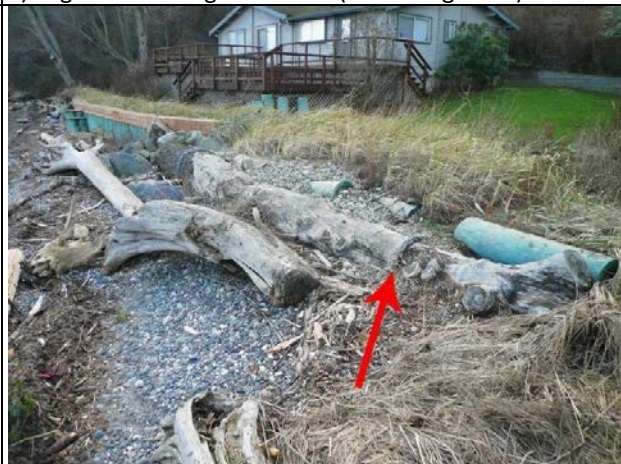
f) Minimizing end erosion at the ends of bulkheads and transitioning into a soft shore protection project.

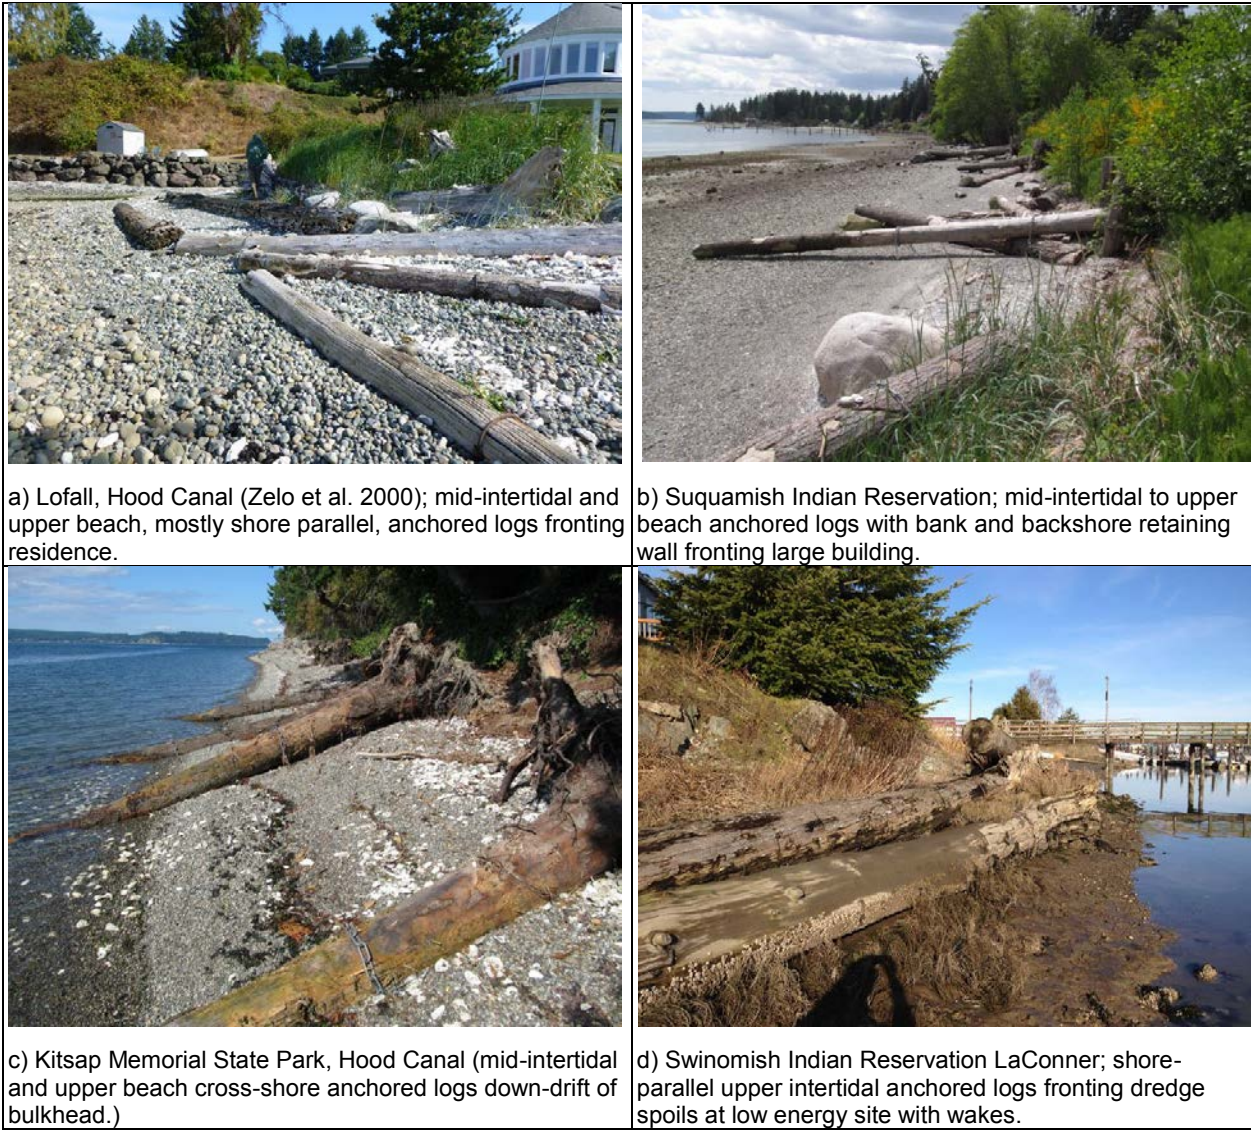
Figure 7.2-4. Anchored logs placed in the intertidal for erosion control (photos (a) and (d) J. Johannessen; photos (b) and (c) H. Shipman).

Logs have sometimes been used as a transition feature from a bulkhead to a more natural shore. In these applications logs have been used to try to reduce the effects of end erosion in the area immediately adjacent to the end of a bulkhead, as in Figure 7.2-3 frame f. The intent is to provide an enhanced upper beach or backshore

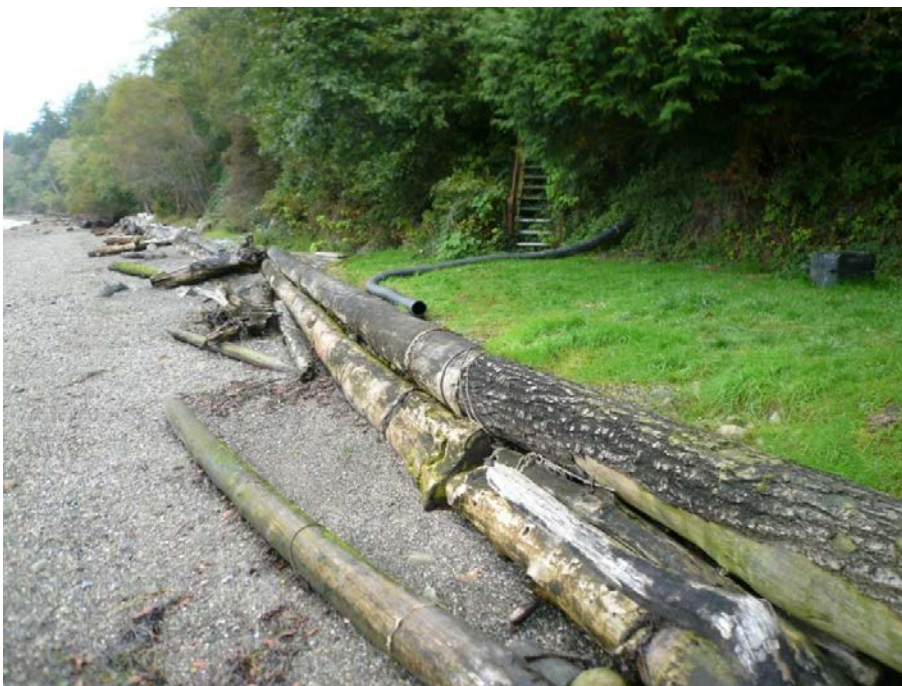
Figure 7.2-5. Example of inappropriate large wood project on south Whidbey Island which was constructed with fixed, stacked logs placed lower and more vertically than designed or permitted, here retaining fill gravel and creating usually dry land where beach existed prior.

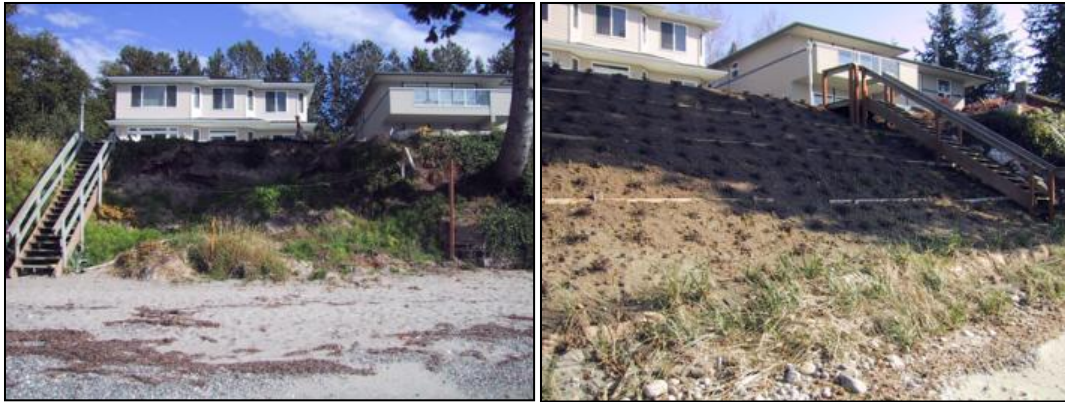
Figure 7.3-1. Example of reslope revegetation project in the Puget Sound. The two photos show before (top left) and after (top right) reslope and revegetation treatment of a medium-high bank site in northern Puget Sound. Treatment was initiated as a result of a soil slump that left the upper portion of the bluff oversteepened and unstable, and the deposited sediment at the toe. The sketched cross-section shows the post-slump profile of the slope and the design plan for regrading. In this case, because slumping was attributed to wave impacts at the toe, the entire slope was regraded to about 30° and planted with kinnikinnick (*Arctostaphylos uva-ursi*), dunegrass (*Leymus mollis*), and several other species. Modified from Western Geotechnical Consultants, Inc.

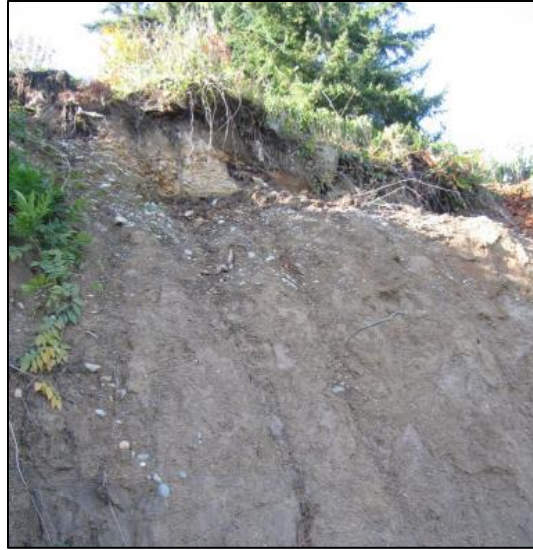
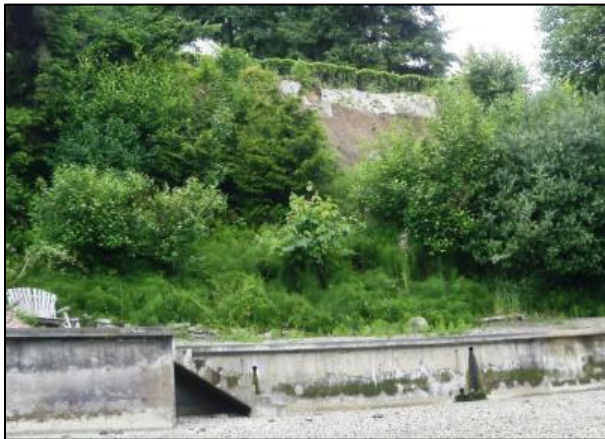
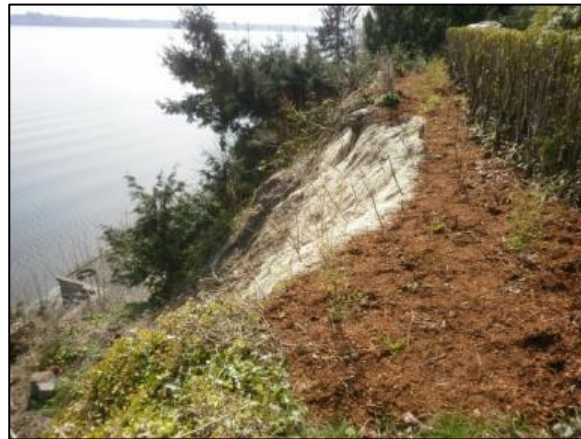
Figure 7.3-2. These three photos are of a site on Eld Inlet, South Puget Sound, where coarse unconsolidated sediment overlies denser sand, silt, and gravel. The top photo shows the differential rate of erosion between the two geologic units prior to treatment, the effects of groundwater perching on the lower unit, and the greater stability of the lower unit except for some surface rilling on the steep face. In the lower right photo, a natural-fiber geotextile is visible fastened to the slope to reduce the potential for surface soil erosion until vegetation is established. Additional challenges at the site included burrowing mountain beavers in the sloughed sediment at the base of the bluff, springs discharging along burrows, and mortality and poor “pruning” caused by the beavers. According to the property owners, slope crest retreat prior to the planting appeared subsequent to increased development upslope and an associated increase in stormwater runoff. In this case, toe erosion is not an issue (bottom two photos by Ben Alexander).

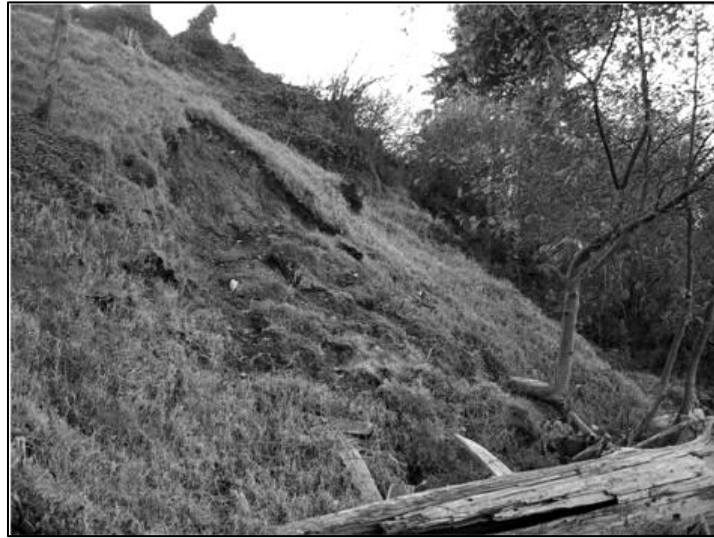
Figure 7.3-5. The slope shown above in unconsolidated sediments was too steep and the roots of the grasses planted too shallow to hold up without some combination of deep-rooted vegetation, contour brush layering, stepped slope contouring, and temporary geotextile or other engineered structure (preferably including vegetation).

In the case of steep slopes, shallow-rooted plants such as grasses may be inappropriate (Figure 7.3-5), and deeper-rooting species might require special techniques to stabilize the soils until root systems can expand and enhance soil stability. It should be mentioned that root systems do little to mitigate failures occurring below the rooting depth of plants; however, vegetation can mitigate the potential for deep-seated failures through precipitation interception and evapotranspiration processes (Macdonald and Witek 1994; Myers et. al. 1995).

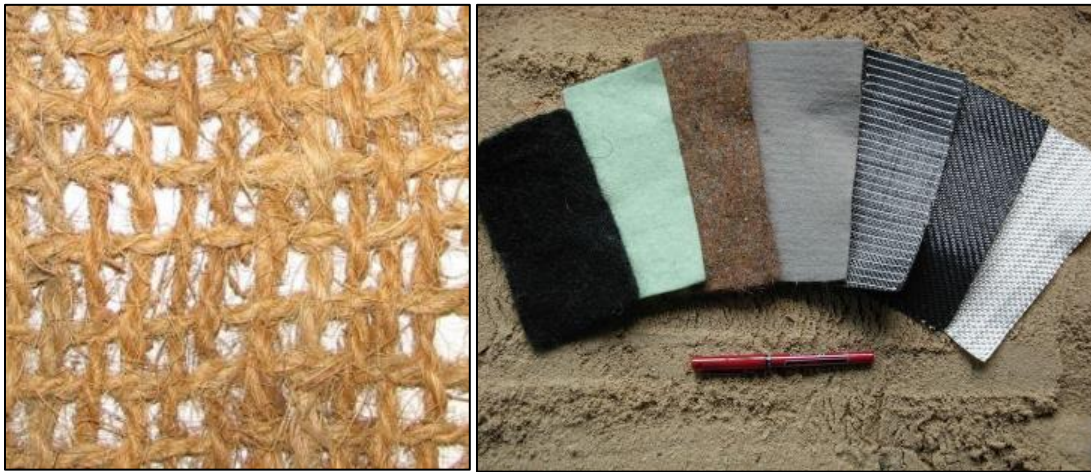
Figure 7.3-7. Examples of natural (left) and synthetic (right) geotextiles. Additional geotextile fabrics incorporate a combination of natural and synthetic fibers. Generally, natural-fiber fabrics deteriorate more rapidly than synthetic, and may be an appropriate choice where soil instability is a short-term issue and additional stabilization is only needed until plants are established. (Source: Wikipedia public domain; <http://upload.wikimedia.org/wikipedia/commons/c/c8/Geotextile-GSI.JPG>)

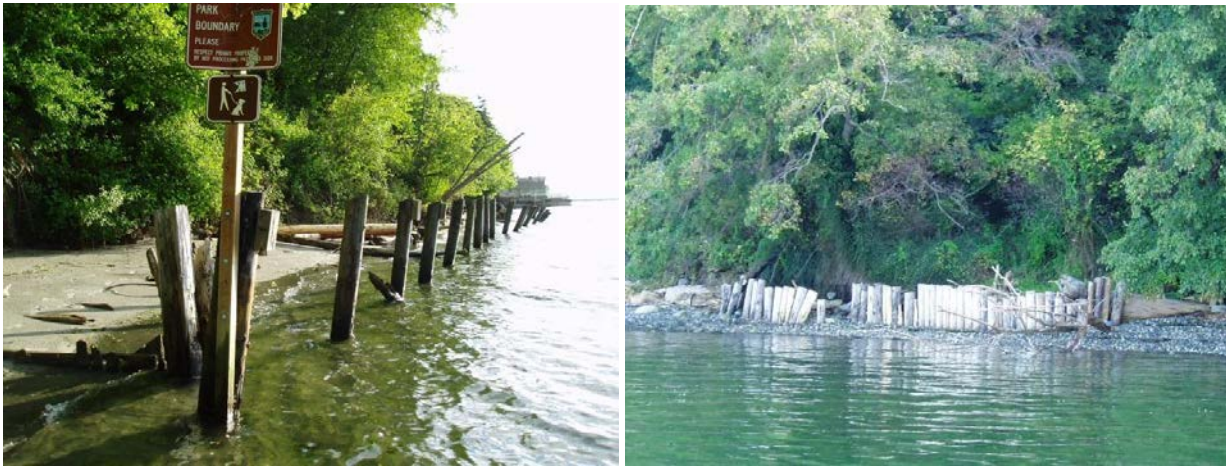
Figure 7.4-2. Degraded bulkheads deteriorating in place.

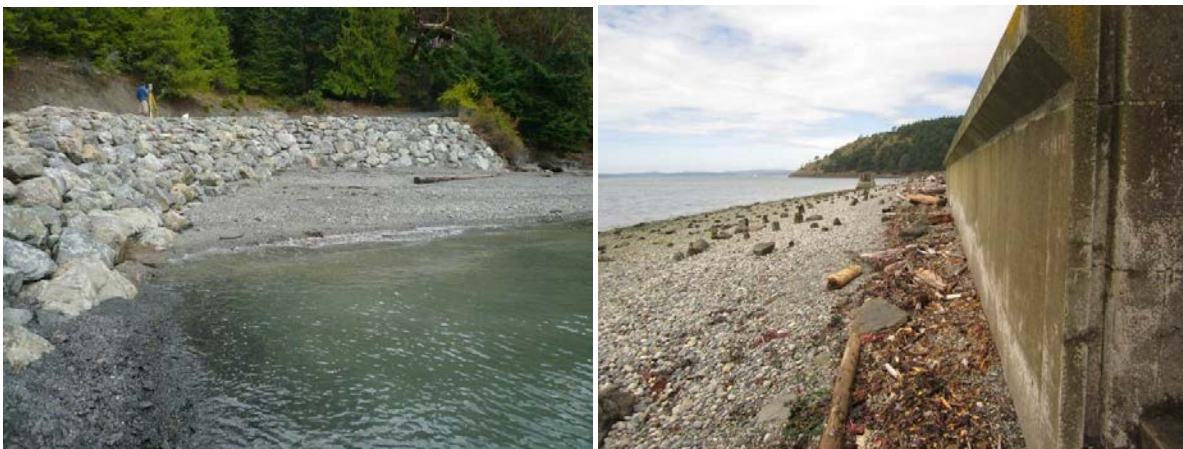
Figure 7.5-1. Photos showing a revetment (left) and vertical bulkhead (right).

It should be noted that locally in the Puget Sound region that the terms ‘bulkhead’, ‘revetment’, ‘rockery’, and ‘seawall’ are commonly used for hard armor structures. The most common term used for coastal armor is ‘bulkhead’. To differentiate between the different techniques and the varying associated design constraints, ‘revetment’ will be used for structures made of sloping, stacked armor stones while ‘vertical bulkhead’ will be used in this report for vertical structures. Figure 7.5-1 below shows examples of a typical bulkhead and revetment used in the context of this report.

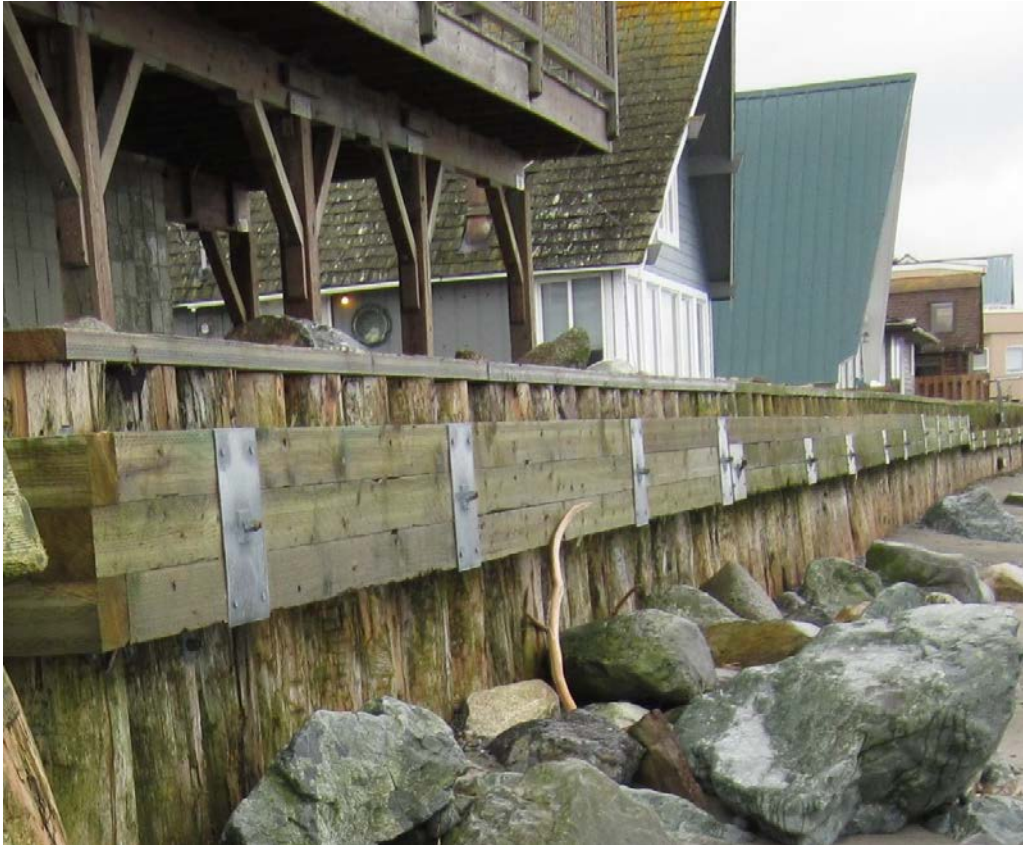
Figure 7.5-13. Armor stone toe protection at a Puget Sound vertical bulkhead.

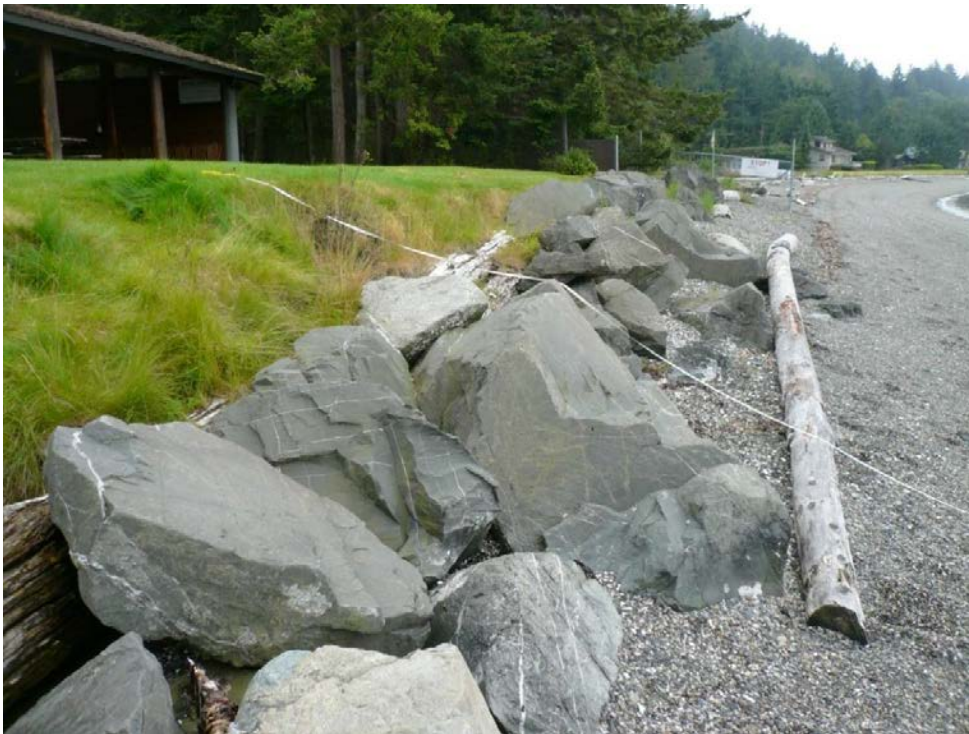
Comparison of the existing profile to the design reveals that the original Blakely Island design did not have adequate design height. Field observations showed scarping and LWD landward of the rock structure, as well as inconsistent rock sizing and structure slope as seen in the field photo below. (Figure 7.5-16).

Figure 7.5-16. Field photo from Blakely Island assessment.
