Washington State Aquatic Habitat Guidelines Program

Marine Shoreline Design Guidelines

Final

**Prepared for:
The Aquatic Habitat Guidelines Program
2014**

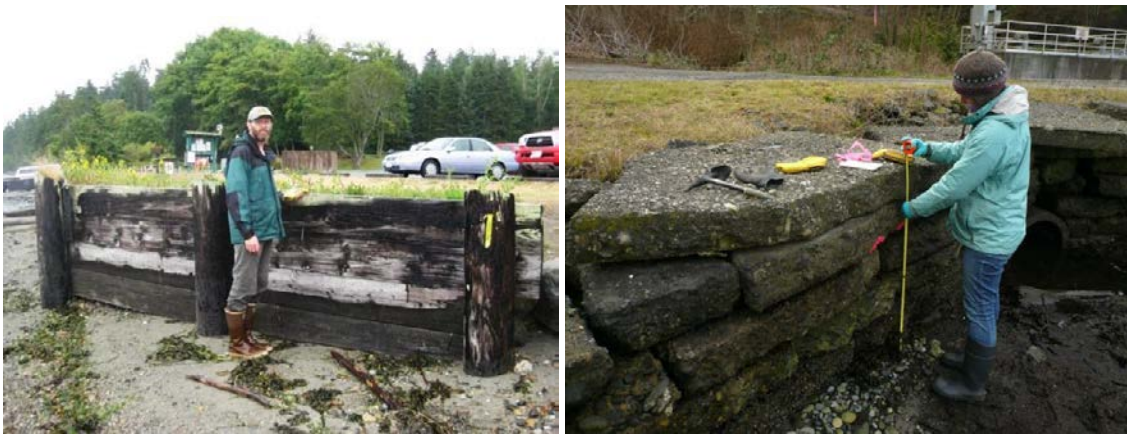
Figure 7.5-17. Simple physical monitoring of a bulkhead showing the scalable photographic technique of using a person or measuring tape in the picture. Photographic monitoring should be biannually at a minimum and in the same location with the same reference. In this case, the same adult should be photographed next to the bulkhead every monitoring cycle. Note pink spray paint line showing king tide elevation extent in the picture on the right as another method of monitoring that can be used.

Due to the static nature of hard armor the installations can be assumed to be immobile. Therefore, hard armor installations can be their own baselines. Physical and photographic monitoring techniques can be used to monitor a hard armor project (Figures 7.5-17 and 7.5-18). Physical monitoring consists of simple twice-annual measurements of topography of the structure crest, structure toe elevation, and beach profiles to provide baseline data and characterize seasonal beach cycles to determine interannual variability. Beach sediment composition in front of hard armor is also important to record during sampling events. Hard armor should be physically monitored for structure-caused erosion (both end erosion and waterward beach coarsening) and rock toppling. Spray paint or pin flags can be used to mark landward extents of tidal waters and wave climate.

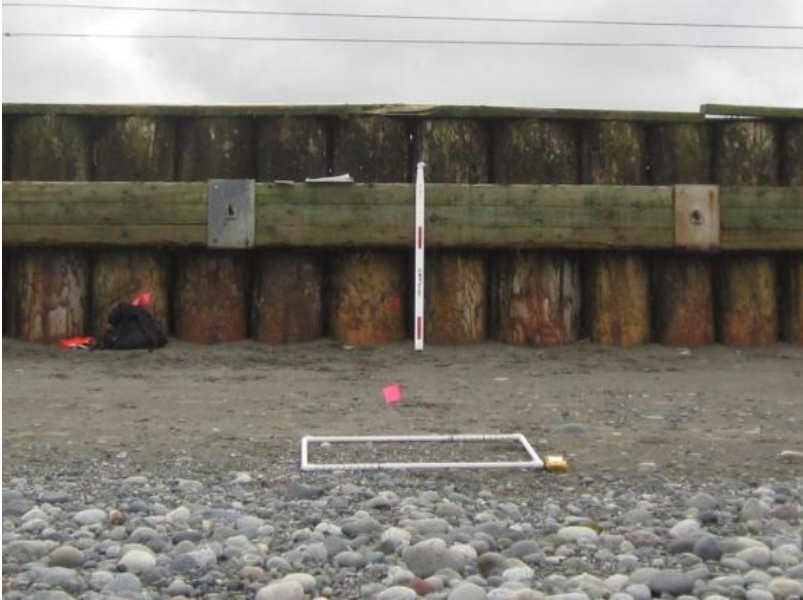
Figure 8-1. Photographic monitoring looking onshore with scalable reference at vertical bulkhead. Photographic monitoring should be done yearly at a minimum in the same location with the same reference. In this case, the same stadia rod or other known length scale should be used. Beach sediment quadrat also in photo for spatial location reference.

Scaled photographs may also be taken of specific beach locations and elevations for a more qualitative analysis of change over time. Photographs taken at specific sampling times from fixed locations with a scalable and consistent reference are best (Figure 8-1). Beach sediment composition can be quickly documented using a quadrat with scale markings during and potentially between the main sampling events. Photographs of the substrate waterward of soft shore or hard armor installations should be documented while monitoring.

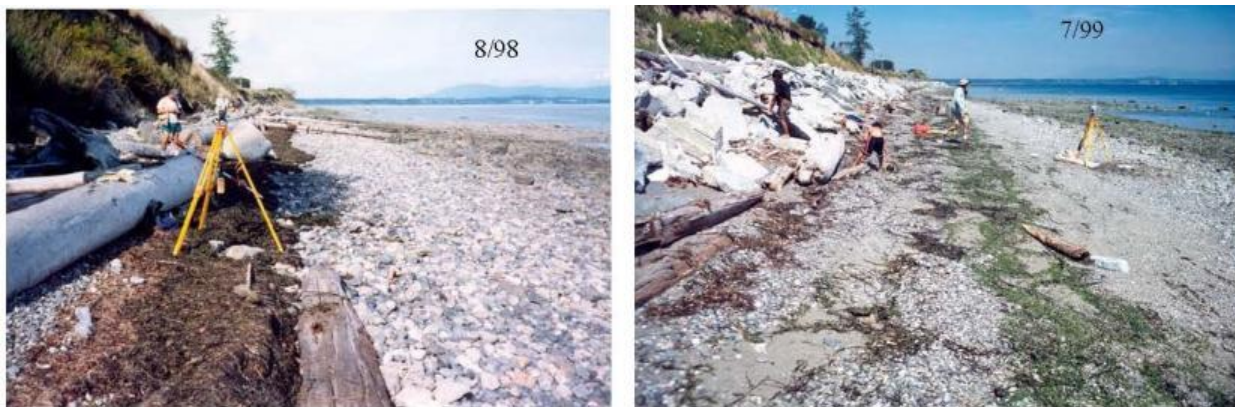
Figure 8-2. An example of the beginning of photo monitoring from a fixed point over the first year post-project looking alongshore, with a rebar monument and conifer in the background as consistent reference points.

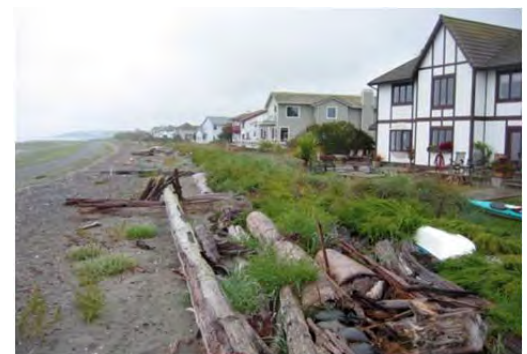
Southeastward view of the project site prior to implementation. Note accumulation of drift logs in the backshore and proximity of houses to the beach.

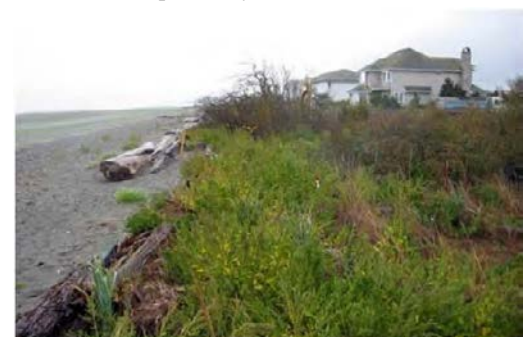
Southeastward view of the project site prior to implementation, showing lack of backshore relief.

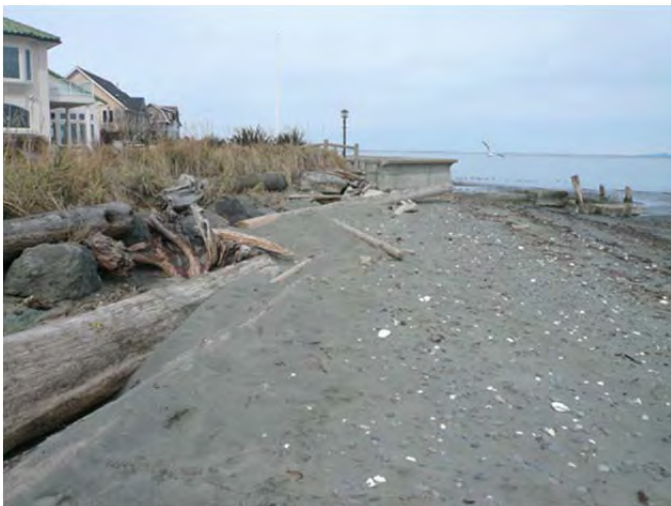
Northwesternmost portion of project looking northwest toward the adjacent bulkhead and outfall. Note rocks added after initial dune enhancement to mitigate erosion at this end of the treatment area.

Technique condition – Most of the constructed berm appeared in good condition, with only minor scarping of the waterward face. The northwest portion of the dune showed more severe erosion. The periodic shift in the direction of alongshore sediment transport and local wave refraction around the western bulkhead and tide gate likely caused exposure and undercutting of the dune and internal log structure. The Type III berm profile was located at the most heavily impacted site, where end effects from the adjacent bulkhead resulted in severe erosion of the berm. Additional large rock and logs were brought into this site at the northwest end of the treatment area shortly after project completion to prevent further loss of uplands.

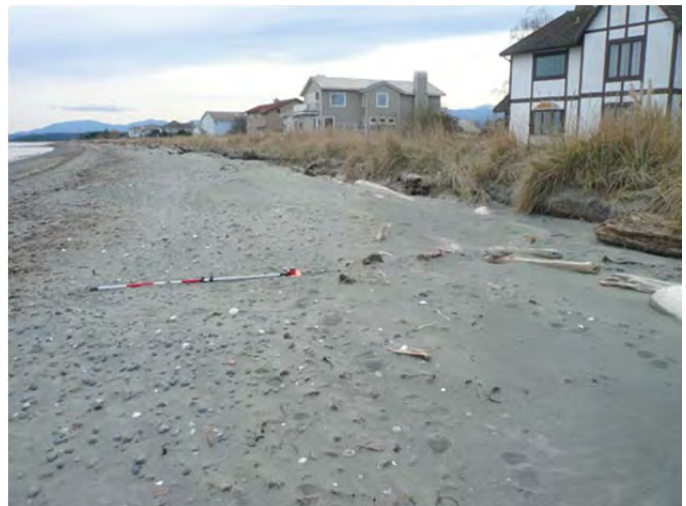
Project site looking southeast. Note dense dune grass growing atop the nourished dune, with some installed berm logs exposed in the foreground.

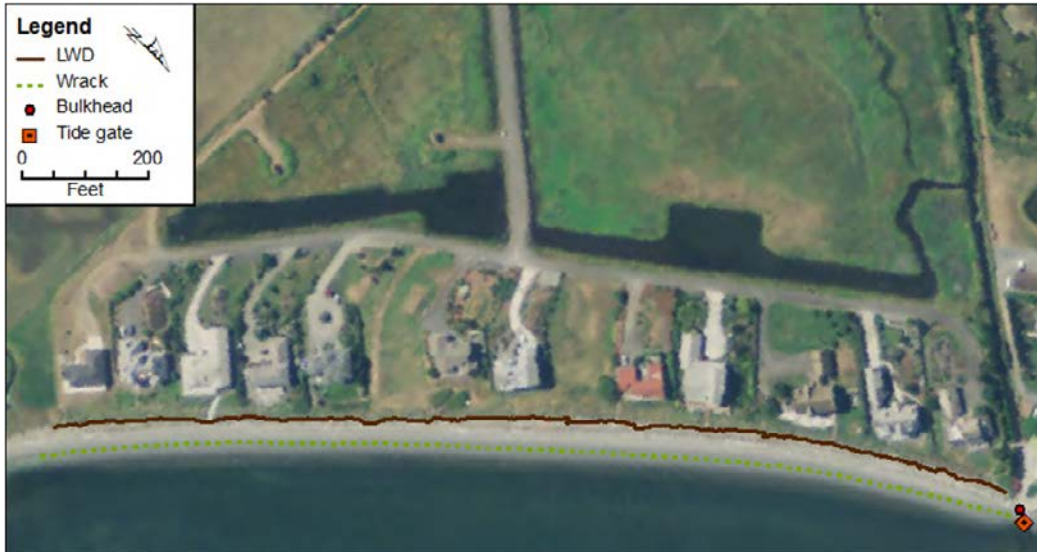
General beach features mapped during the 2012 site visit.

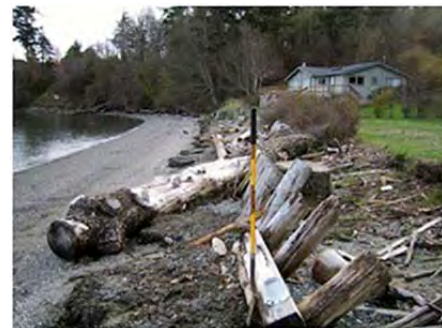
Southward view of the site prior to implementation. Note failed soldier pile wall in the foreground, along with erosion scarp.

Two segments of a failing wood pile bulkhead located 5 to 10 ft waterward of the OHWM fronted the property. A 25-ft-long segment provided minimal protection to the drainfield and yard. The second 20 ft long bulkhead segment also extended north beyond the property line. Piles typically extended 2.5 ft above the beach, and averaged 0.8 ft in diameter. Erosional end effects caused by the bulkhead segments resulted in approximately 5 ft of horizontal erosion.

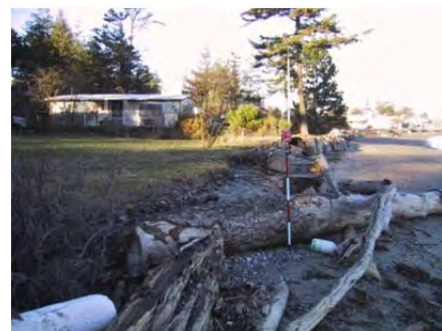
Northward view of the project site prior to implementation.

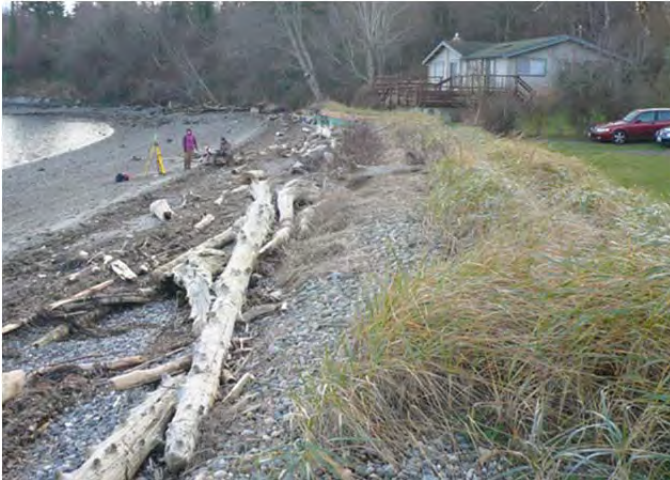
Westward view of project site in 2012. Note thick dunegrass growing on constructed berm.

Technique condition - The gravel berm remained in place in good condition at the time of the site visit. Dense dunegrass vegetation has provided stability to the berm, and no evidence of overwash was seen. The driftwood accumulation waterward of the berm appeared similar in density and width to the up-drift reference beach. Surface change analysis in AutoCAD between the preproject survey and the 2012 survey revealed that the majority of the storm berm area was 1.5 to 2.0 ft higher, with maximum elevation gain of 3.26 ft.

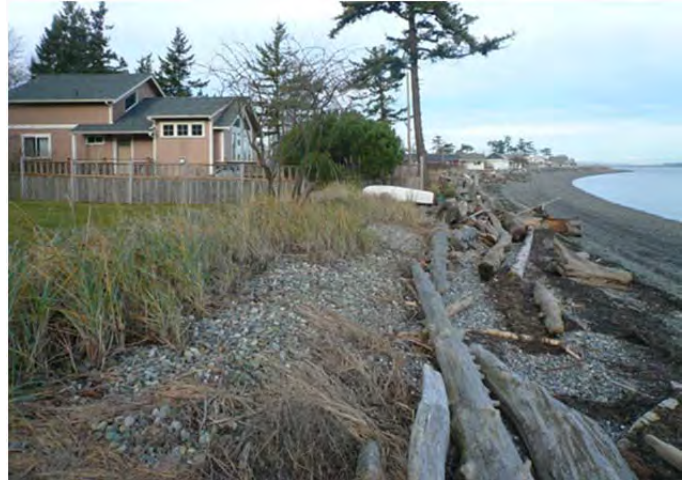
Eastward view of project site in 2012.

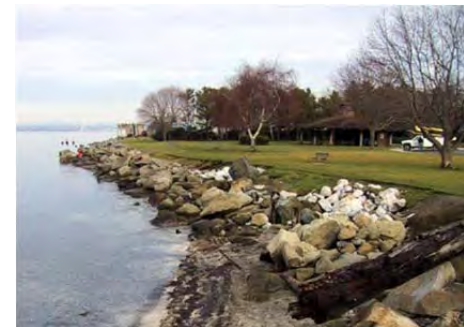
Looking north in 2000. Revetment consisted of boulder and concrete debris dumped on the shoreline.

- Rock revetment previously extended for the entire length of Marine Park and onto neighboring properties, including the BNSF railway to the south. The revetment consisted of rock, concrete slabs, and debris ranging in size from 1 to 8 ft. Revetment material was apparently placed as it became available. Placement was loose and irregular, lacked geotextile filter fabric, and was not keyed into the beach substate.

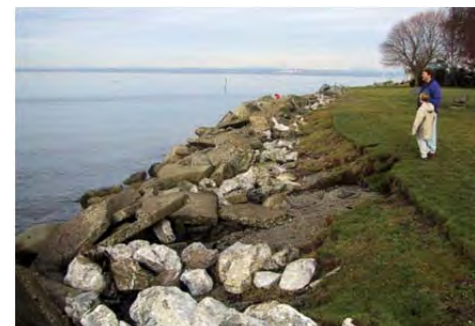
Revetment looking north. Note erosion behind the rock due to wave overtopping. Lighter-colored rock was a more recent addition in response to continued erosion.

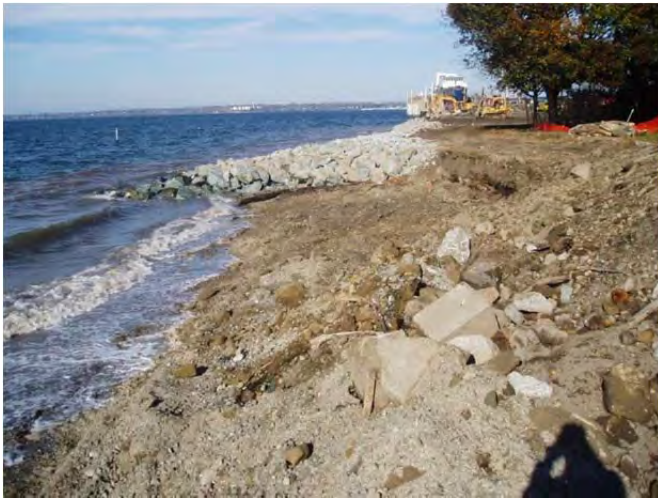
Looking north toward construction of north drift sill and limit of excavation of fill and debris in late October 2004.

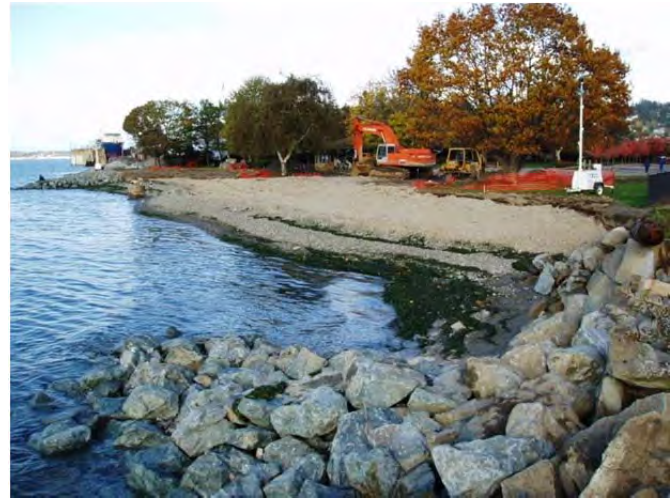
Looking north toward initial grading and placement of gravel between drift sills in early November 2004.

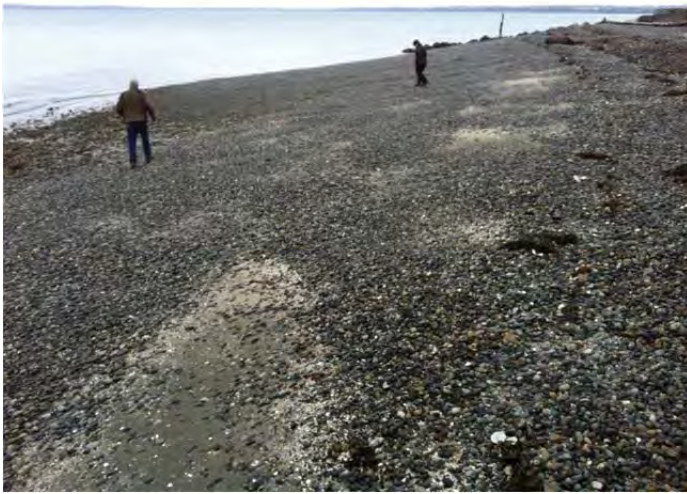
Upper intertidal beach at the site looking north in 2012. Nourishment gravel dominates, but sand can be seen mixed in the foreground.

Beach characteristics - Beach sediment was dominated by medium to coarse pebble nourishment, but has become mixed with sandy backshore sediment, sand from the low-tide terrace, and shell hash. This has resulted in a beach suitable for forage fish spawning under most conditions (Penttila 2010 pers. comm.).

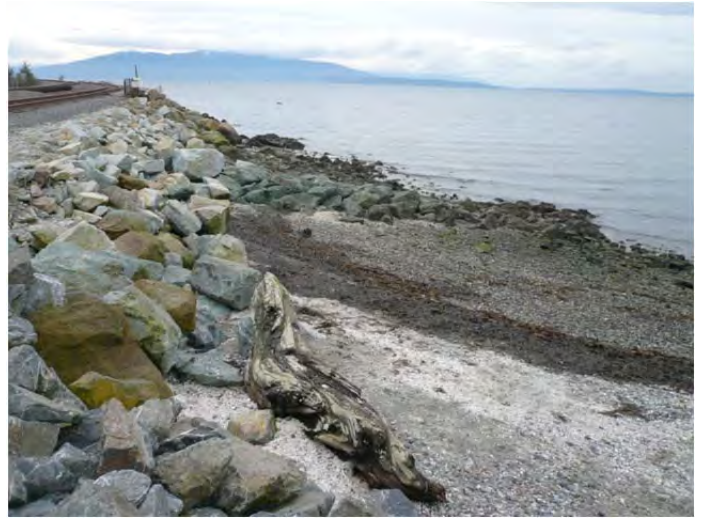
Project site looking south along the BNSF rail causeway in 2012. The southern drift sill (low groin) is in the center of the photo, with a large accumulation of shell hash in the foreground.

- Some sediment has overtopped the gaps in the north drift sill. Drift sills are very difficult to construct with a near-even crest. At this site the fact that the drift sill was half deconstructed during replacement of the wastewater overflow line, then rebuilt during less-than-optimal tide windows may have resulted in additional northward transport.

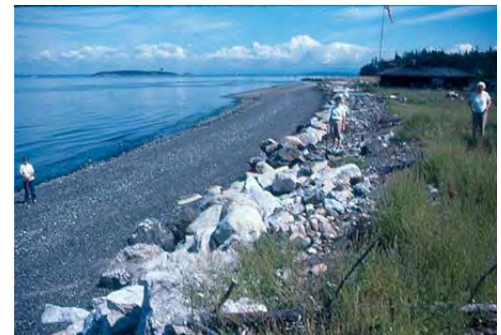
Eastward view from near the middle of the project site prior to implementation. Note largely scattered rock revetment with landward erosion.

Prior to the nourishment project, a rock revetment stretched across the entire four-property site for shore protection. The revetment had become severely damaged in the central and eastern portions of the site, with extensive rock toppling. Erosion landward of the revetment had begun, with scarping and removal of sediment and vegetation. Erosion landward of the revetment was substantial throughout the site during windstorms of winter 1989–1990. The eastern house was very close to the active wave erosion, and had damage and gravel overwash onto the attached deck. Revetment rocks were toppling and sinking into the gravel beach, and owners complained of the lack of a dry beach and of a place to store small boats at high tide. Additionally, older residents and guests had difficulty getting over the revetment.

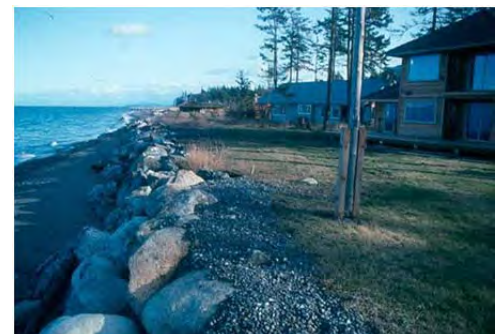
Eastward view of the western portion of the project site prior to implementation. Note the higher backshore and intact revetment in this area.

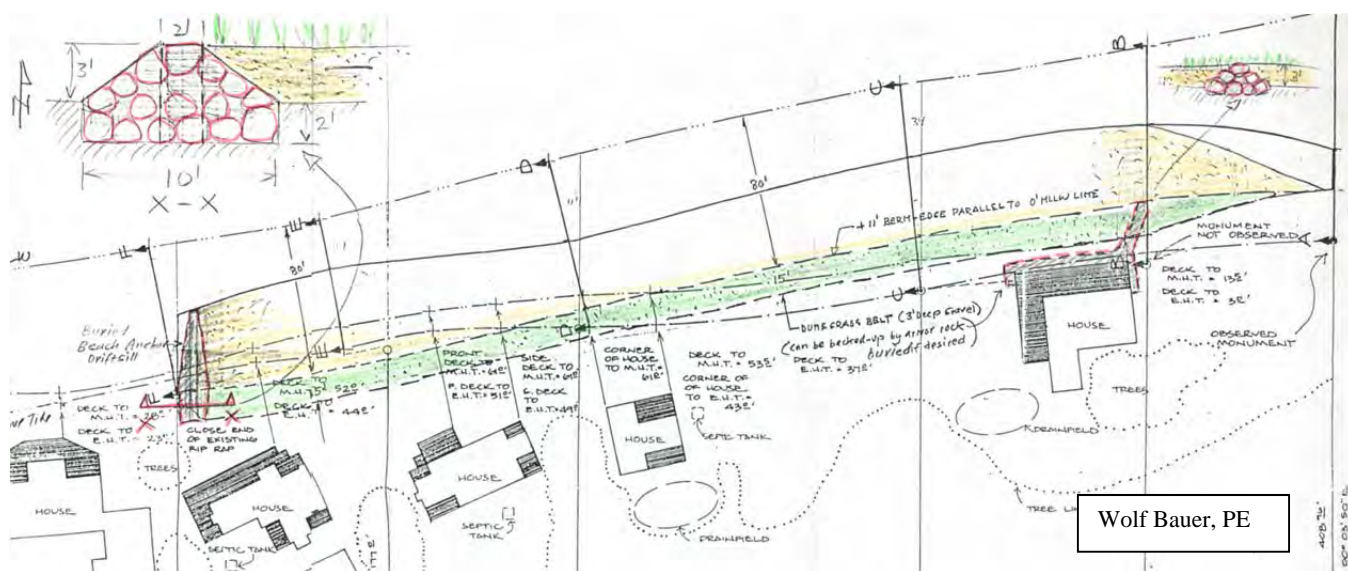
Project design drawing.

This Wolf Bauer-designed beach nourishment project was intended to allow for removal of a rock revetment and to mitigate for potential beach erosion along 510 ft of barrier beach located on the north shore of Orcas Island. Following removal of the revetment and debris, design drawings called for 2,400 CY of washed gravel (½- to 2-in-diameter “drain rock” from a local source) to be graded across the beachface. There was no initial sediment removal from the beachface, but some of the backshore sand and adjacent soil was removed along with the rock revetment. Many of the rocks were buried in the back of the excavated trench, while others were used for upland landscaping. The gravel was partially contained by two large terminal drift sills composed of 3- to 5-ft-diameter boulders. The eastern sill, which did not extend across the nourished beach width, angled towards the north-northeast, not perpendicular to the trend of the beach. The western drift sill design was for a larger structure that extended approximately 3 ft above preproject grade, with 2 ft of rock burial below preproject grade. The design was similar to the single drift sill placed at North Beach on Samish Island and described by Zelo et al. (2000). The smaller, eastern drift sill included nourishment on the east side, providing added stability to the imported sediment near the eastern house in the project area.

The imported gravel was graded to a 6:1 slope from elevation +4.0 to +11 ft MLLW, which was 2.3 ft above local MHHW. A 15-ft-wide storm berm was constructed landward of the new berm crest. The eastern end of the nourishment area moved the beachface farther waterward as a low-elevation house was very close to the active beach at this end. The project was implemented in December of 1992. Shortly thereafter a large storm naturally regraded the nourishment sediment, transporting sediment onshore and leading to the development of a storm berm, which was present during field surveying in 2012.

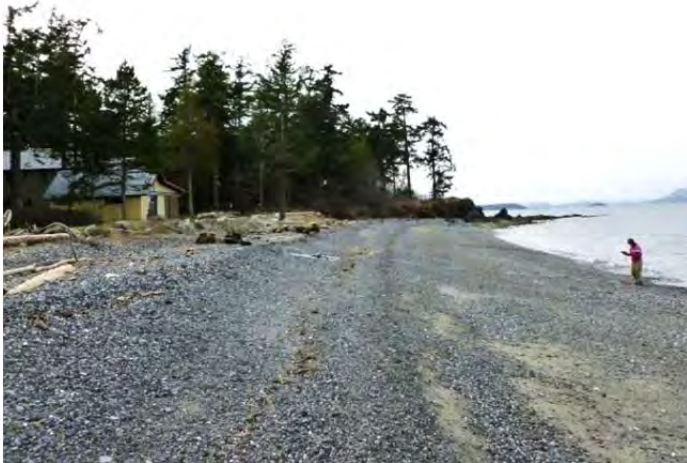
Project site looking up-drift (west) in 2012.

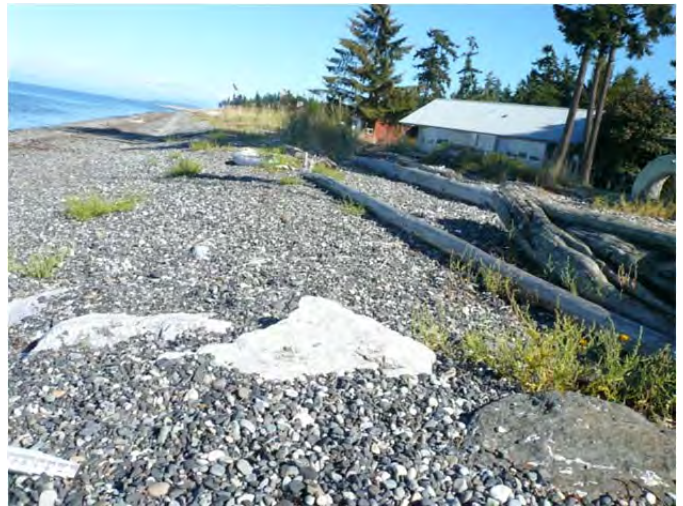
West drift sill looking down-drift (east) towards project, 2012.

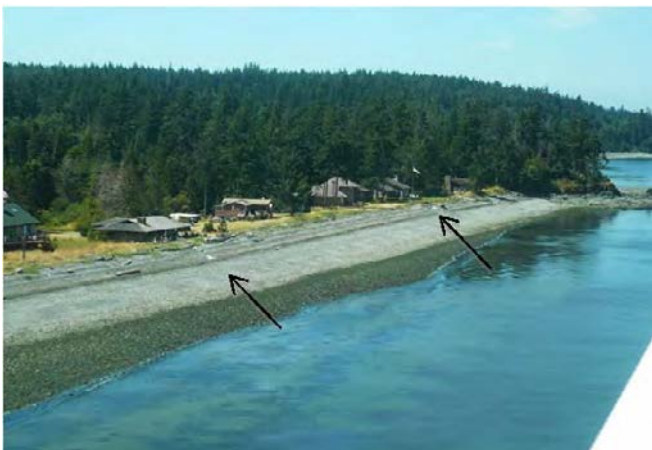
Project area in 2008 with drift sills (at arrows) barely visible on uppermost beach.

Beach characteristics - The beach elevation appeared to have risen as much as 4 ft in the central project area. Drift sills at each end were almost entirely below grade, indicating that the beach has accreted since the storm soon after nourishment. The area immediately east of the east drift sill was included in the nourishment area, as reflected in the down-drift beach profile. The backshore storm berm here extended up to elevation +12.4 ft MLLW, equal in elevation to the project profile location.

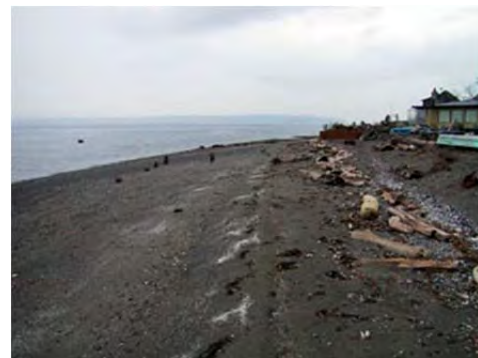
Northeastward view of the project site prior to implementation in 2002.

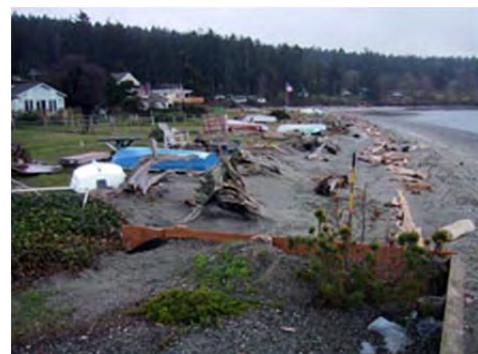
Southwestward view prior to implementation in 2002. Note the large offset of the adjacent wooden bulkhead.

Erosion at the property was clearly exacerbated by a vertical wooden bulkhead constructed over the upper beach immediately down-drift (east) of the site. The bulkhead had a 90° corner located 18 ft from the erosional scarp. This caused the site to experience end effects (due to wave refraction) around the wooden bulkhead during times of southeast to northeast winds. After the soft shore project had been in place for several years, the adjacent wooden bulkhead was replaced with a rockery wall.

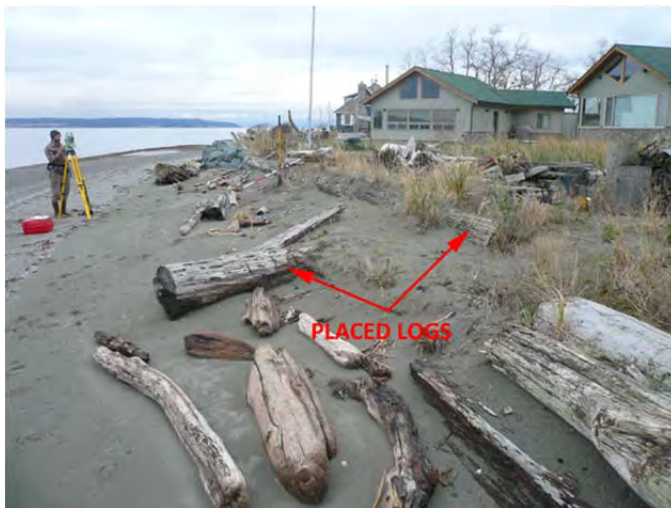
Project looking down-drift (northeast) in 2012. Note dunegrass growing in the backshore and sandy upper beach sediment.

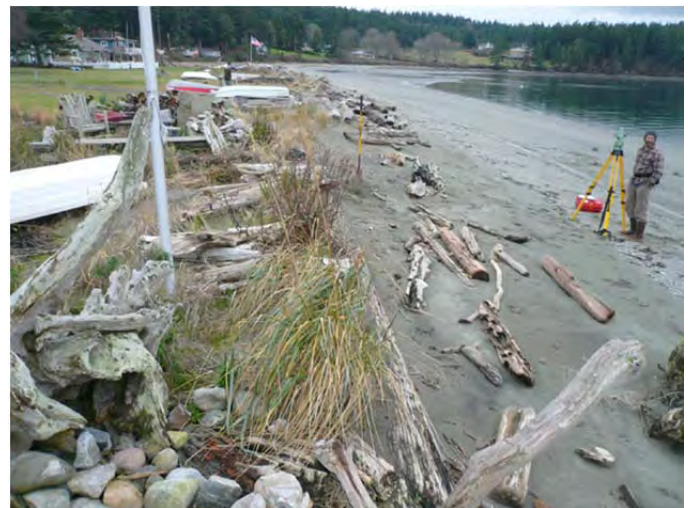
Project site looking up-drift in 2012.

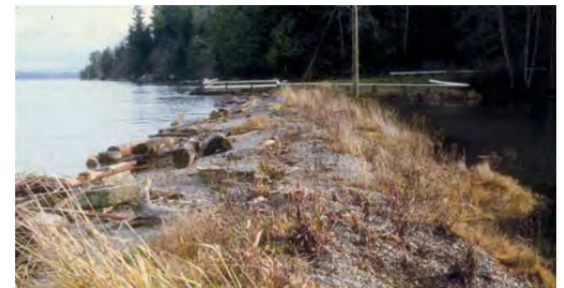
The spit at Tolmie State Park prior to beach nourishment. The old parking lot and bulkhead can be seen in the background (Wolf Bauer).

The site lies within one end of a short (0.6 mi long) drift cell, so sediment supply is naturally limited. Residential development with associated shore modifications up-drift of the park significantly impacted the already-limited sediment supply for the spit. The spit was slowly eroding when Washington State Parks acquired the property. A bulkhead constructed over the beach to create a parking lot at the base of the spit had effectively blocked much of the upper-beach littoral transport to the spit. As the spit narrowed it became more susceptible to erosion and potential breaching through overwash or rollover processes, where sediment is washed over the top of the barrier spit during storms. The project, initiated for habitat reasons, was the first Wolf Bauer beach-enhancement design implemented in Puget Sound.

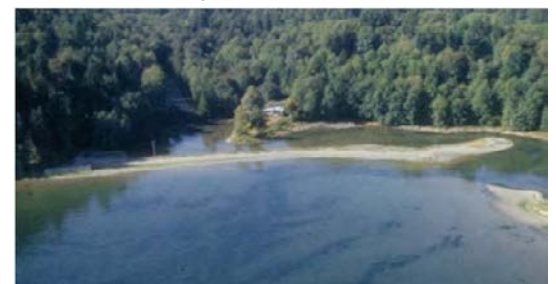
Aerial view of Tolmie State Park prior to beach nourishment. The old parking lot can be seen at the left (Wolf Bauer).

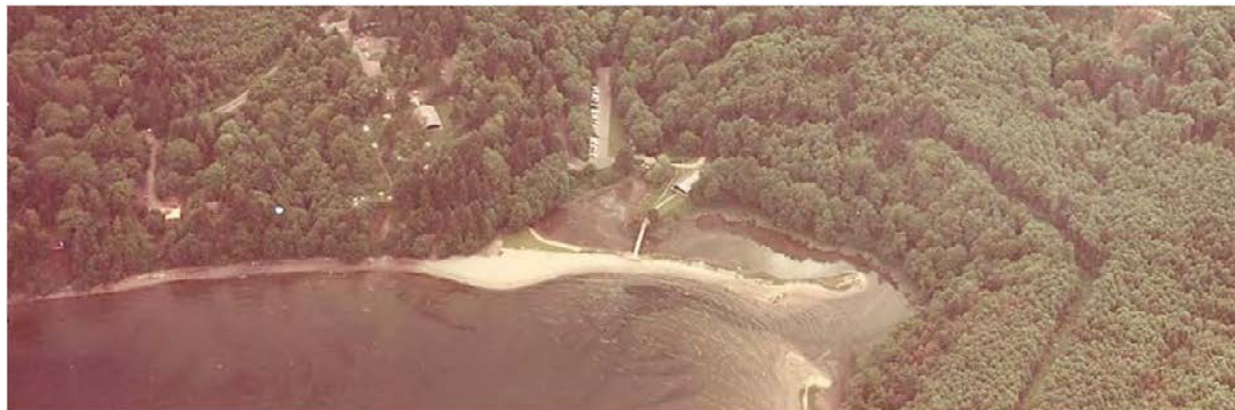
Oblique aerial photograph from summer 1977 (WA Ecology). Note large nourishment gravel lobe still present along up-drift end of the spit.

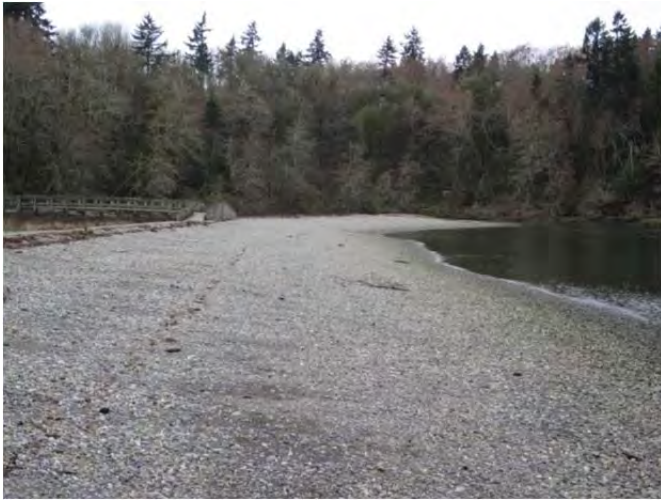
Nourishment area looking west toward the end of the spit, 2012.

Technique condition – The majority of beach nourishment appeared to have remained within its original footprint except in the broad nourishment bulge area. Scattered gravel was left on the low-tide terrace within what appeared to be the beach feed area. Overall the project appeared to have performed quite well, having accomplished the goal of maintaining the spit for nearly 40 years.

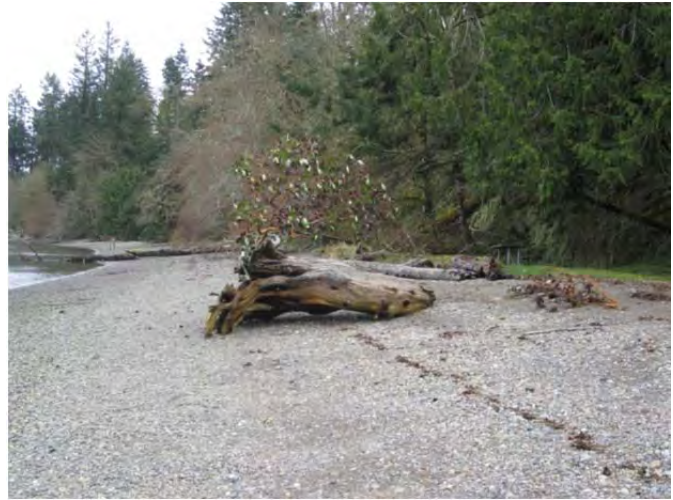
Nourishment area looking east from spit in 2012.

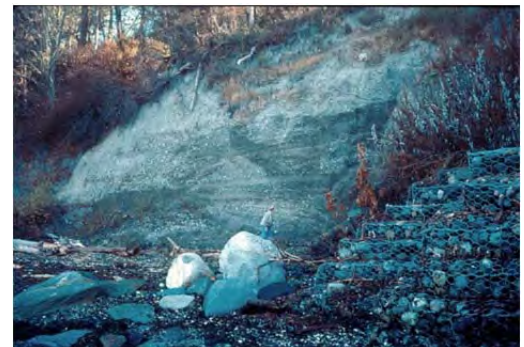
Bluff face devoid of vegetation adjacent to gabion baskets (right). Person for scale above boulders.

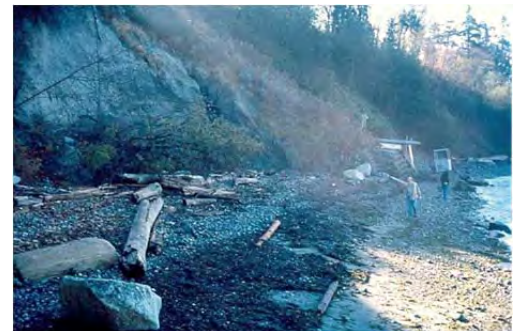
Natural recruitment of large woody debris (LWD) in the eroded backshore area north of gabion-basket bulkhead.

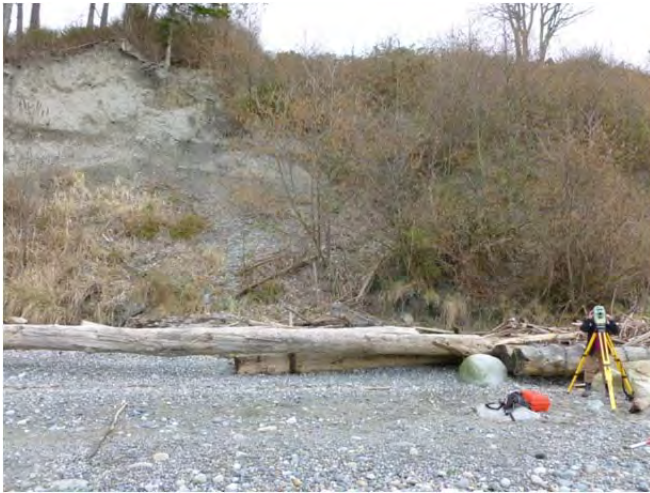
Project site looking onshore in 2012. Two pairs of anchored logs are visible along with some chain, as are relatively recent landslides.

Technique condition - The LWD structure was in moderately good condition at the time of the site visit. One pair of logs had loose anchor chain; these were located where the beach had lowered the most, near the north end of the bulkhead-removal area that lay within the south end of the anchored log project. Some smaller pieces of LWD had accumulated around the structure. About half of the imported cobble nourishment had persisted well with some of the higher elevation cobble removed from the waterward portion of the placement area.

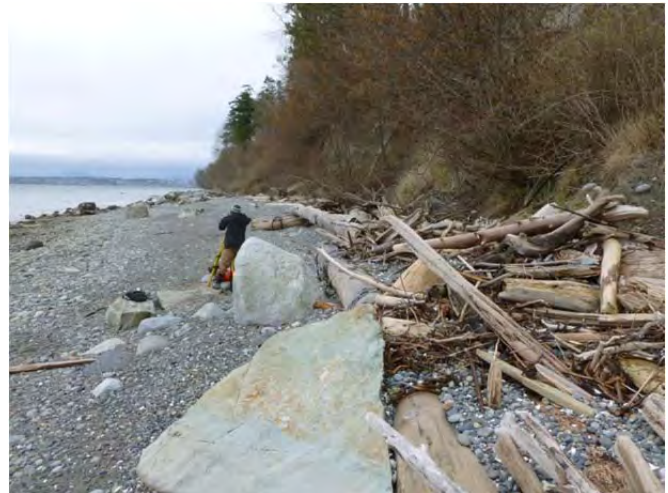
Project site looking down-drift in 2012. Note anchored logs and large accumulation of LWD landward of logs. Boulders were present prior to the project.

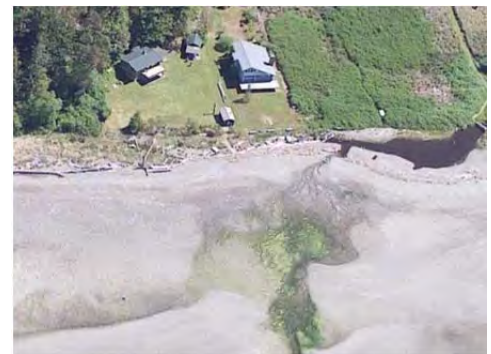
Looking northeast to site in May 2001 prior to construction (Washington State DOE photo).

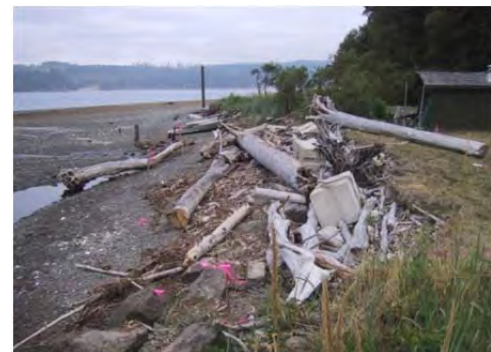
Looking northwest at site in July 2002 prior to the project. Ecology blocks were recently undercut by the stream and wave attack.

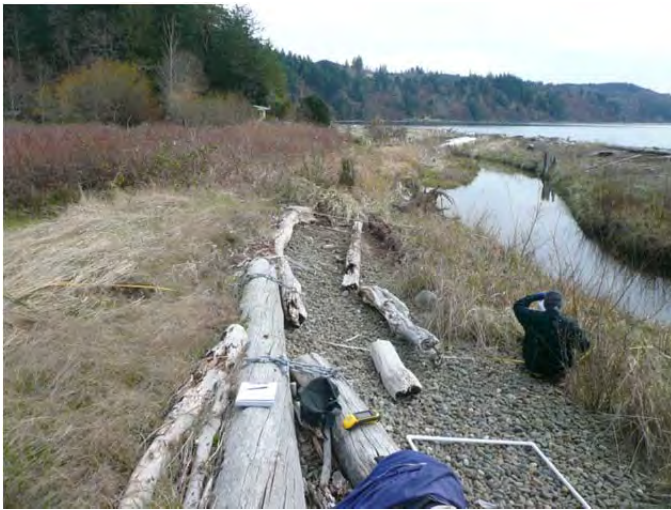
Project site looking south along shore in 2012 and showing cobble berm and anchored logs, with full gravel cover landward of logs.

Technique condition – The entire project remained very similar to its original condition. The logs were sound, the hardware had not corroded, and the placed gravel did not appear moved from the original footprint. The beach profile was slightly higher and the logs were slightly farther waterward than the design called for. This may have been due to either the logs being placed there or to settling, but because no as-built conditions were recorded this could not be determined. Vegetation was well established, except in the center of the coarse gravel area. Very young trees were coming in waterward of the berm.

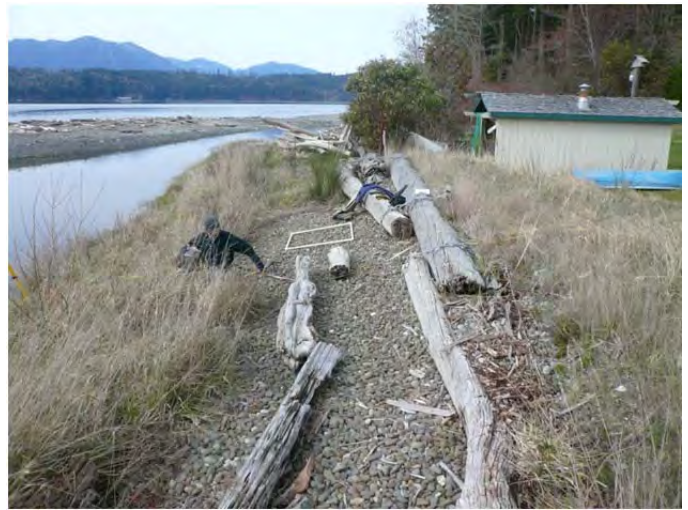
Project site looking north along shore in 2012, landward of the creek channel.

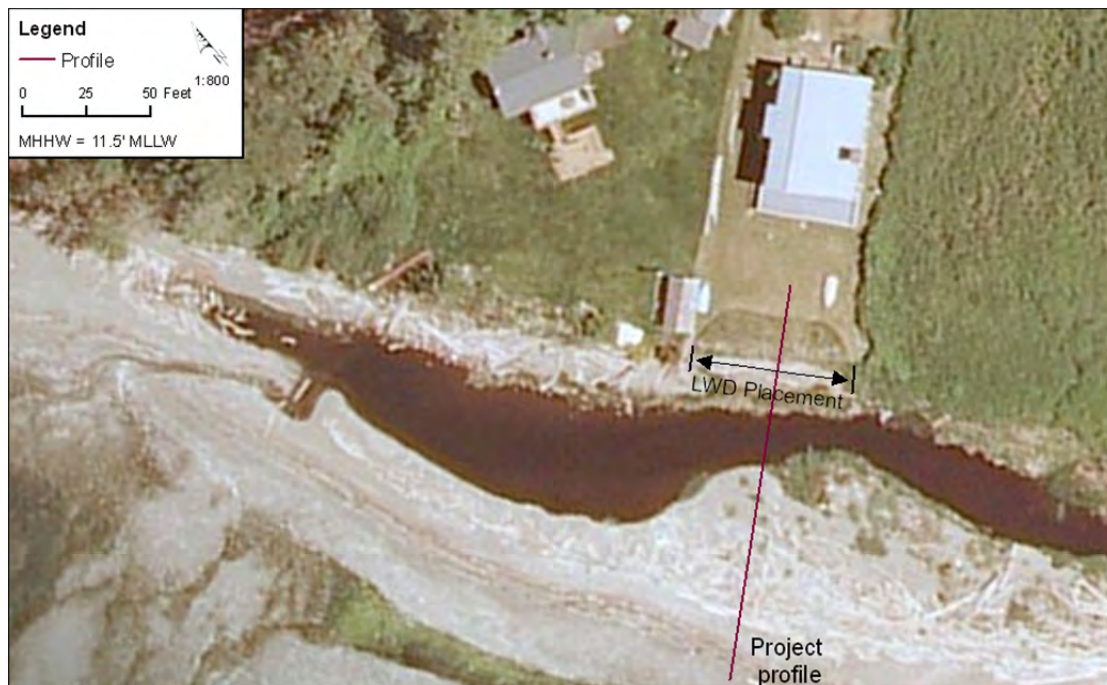
Aerial view of project site showing location of beach profile.

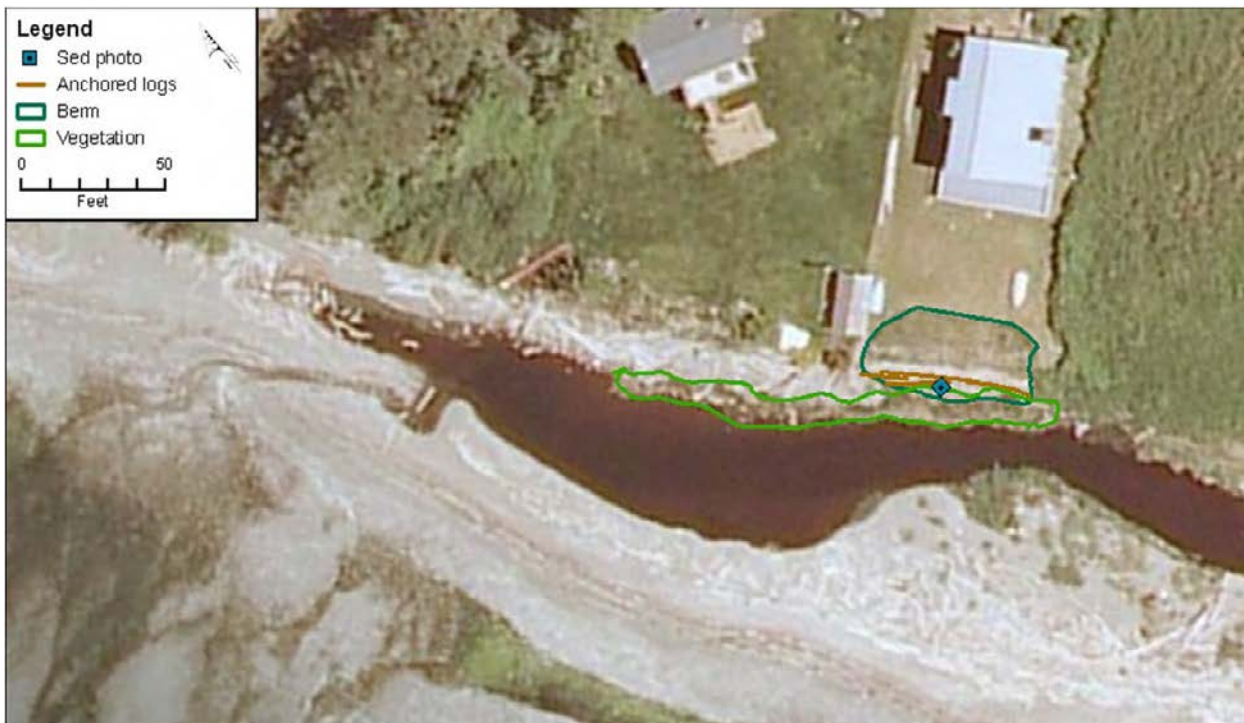
General beach features mapped during the 2012 site visit.

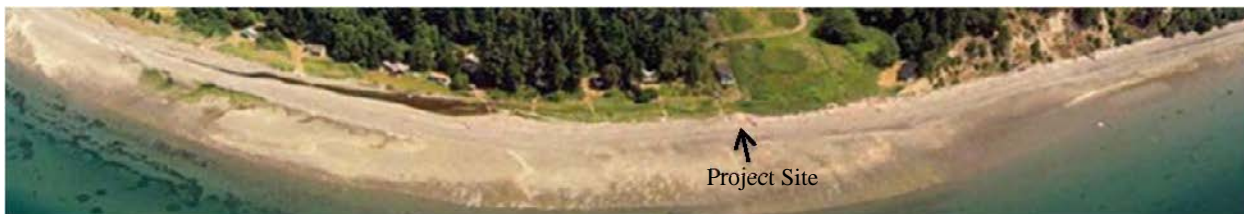
Oblique aerial photo taken 7/11/94 showing the creek extending landward of the beach berm for more than 1,000 ft north. Photos by Washington State Department of Ecology.

Camp Discovery Creek reaches the beach area south of the site. The lower reach of the creek channel often runs northward across beach area in the vicinity of the site. Erosion of the high-tide beach in the few years prior to the 2002 project had exposed postglacial peat on the beachface near the northern property line. This suggested that the beachface had experienced significant erosion over recent decades or centuries and has retreated landward over the old marsh area, exposing the peat. The largest change at the beach has been the movement of the mouth of Camp Discovery Creek. The intertidal creek mouth has usually been located a considerable distance north of the site, with the creek channel in the backshore of the site. The landowner stated that there had been approximately three “blowouts” of the creek mouth in the 40 years before 2002. At such times, the creek channel cut directly through the berm immediately south of the site during high flow periods. This occurred soon after the summer of 1994, reportedly when a logging road failure upstream triggered a flood event.

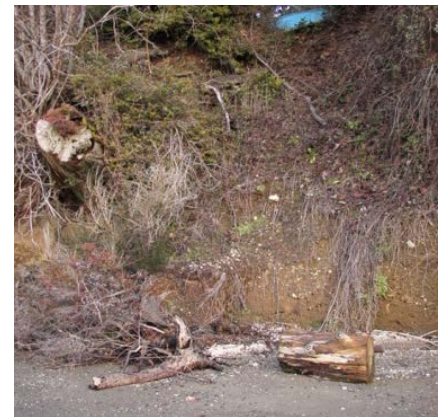
Project site before large wood treatment (2006). Photo courtesy of site owner.

The site is in a relatively unmodified stretch of shore. Wave-induced erosion had produced a near-vertical scarp throughout this stretch of shore that varied between approximately 4 and 10 ft in height. A wooden staircase had been constructed in a portion of the property where the bank toe erosion scarp was lowest. Subsequent windstorms had begun to erode the area around the stairs, hindering access to the beach for the landowner. The owners had several other objectives, including removing 70 ft of creosoted railroad ties on the pathway and protecting large shoreline trees, a Pacific Madrone and four Douglas fir. They did not desire to construct a bulkhead and were very interested in an approach that utilized more natural material such as logs.

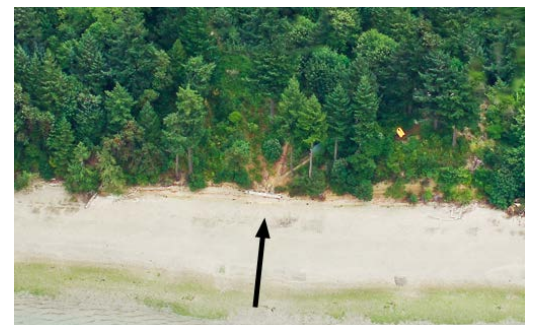
Oblique aerial photo shows old treated wooden steps (arrow) installed in the 1970s.

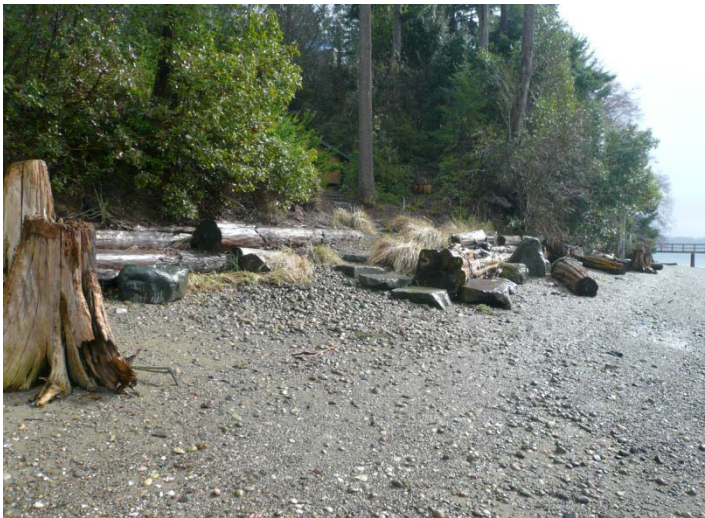
Looking at treatment facing S along beachface in 2012. Note rock steps and logs extending below wrack onto active beach area.

Technique condition – The logs and root masses appeared to have remained mostly in place, although this required additional anchoring after initial construction. Initial rebar pinning appeared to have been unsuccessful. It appears that a greater number of logs were added than included on the site plan sketch map. The logs placed against the bank toe were stacked one to two high, although the majority of logs on site are laying on beach grade. Boulders placed during construction remained near the bank toe, and appeared to help in recruiting additional driftwood. Logs apparently were not set below beach grade, and wave energy appeared to reach beneath some logs. Marine riparian vegetation was still overhanging the beach within most of the project area, providing a good amount of shading to the uppermost beachface.

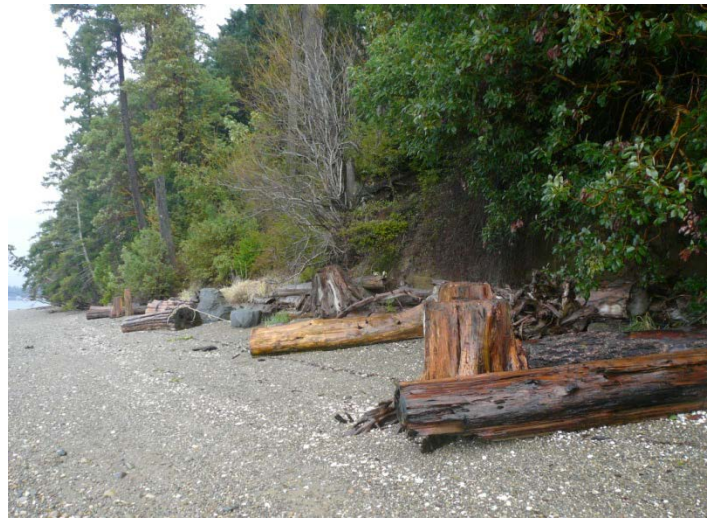
Looking at treatment facing NE along beachface in 2012. Note upright placement of root masses and generally well-vegetated bank.

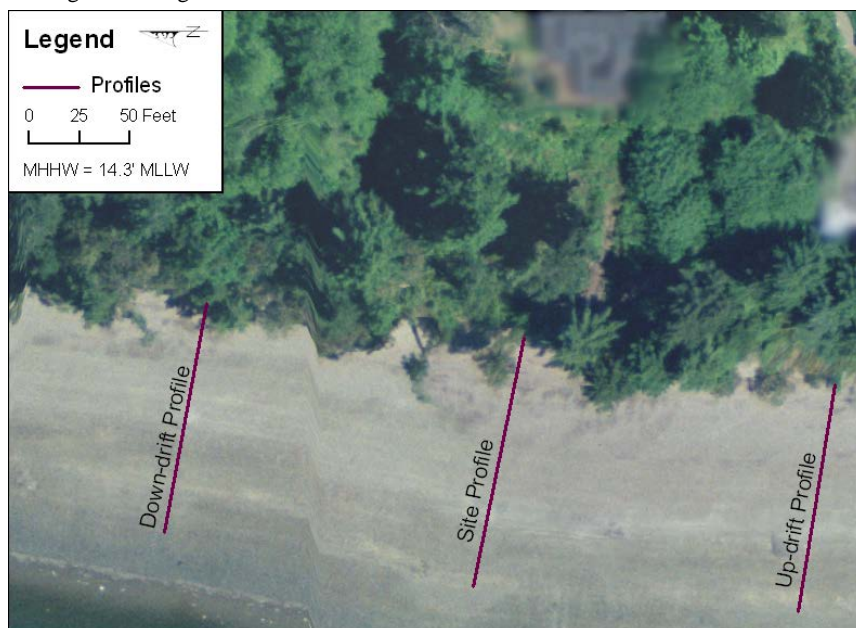
Aerial view of the project site showing location of cross sections.

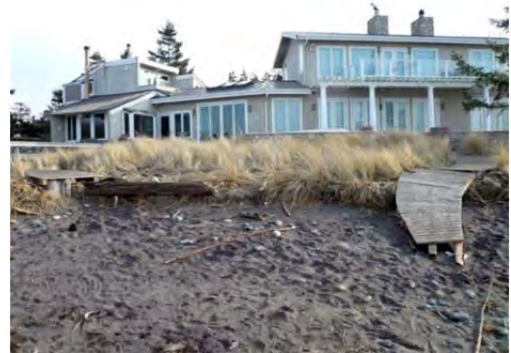
Before construction in 2007, showing low erosional scarp and evidence of recent recession of the backshore scarp.

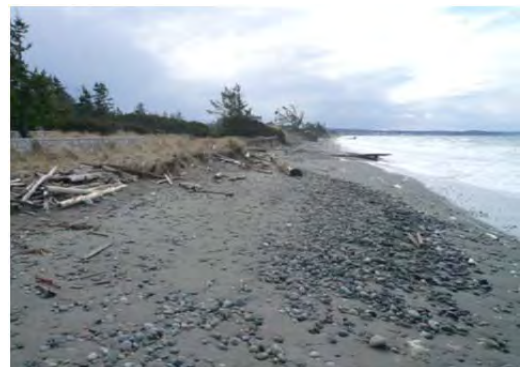
Before construction in 2007, with sand and cobble beach sediment, and minimal drift logs.

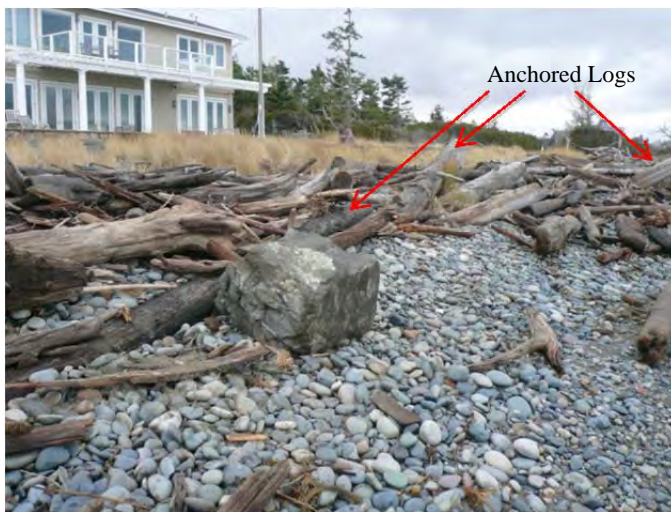
Looking south at northern portion of project site. Note recruited LWD among and up-drift of the anchored logs and placed boulder amid logs.

Technique condition – The original anchored logs, which remained in place at the site, have accumulated significant quantities of additional driftwood. Compared to the waterward extent of driftwood preproject, as documented by the 2007 aerial photographs shown below, the driftwood line extended much farther waterward following installation of the anchored logs. This included the northern portion of the project, away from the very large cottonwood tree at the southern end, lower on the upper beach. The project site beach has accreted approximately 2 ft since the preproject survey (without any beach nourishment).

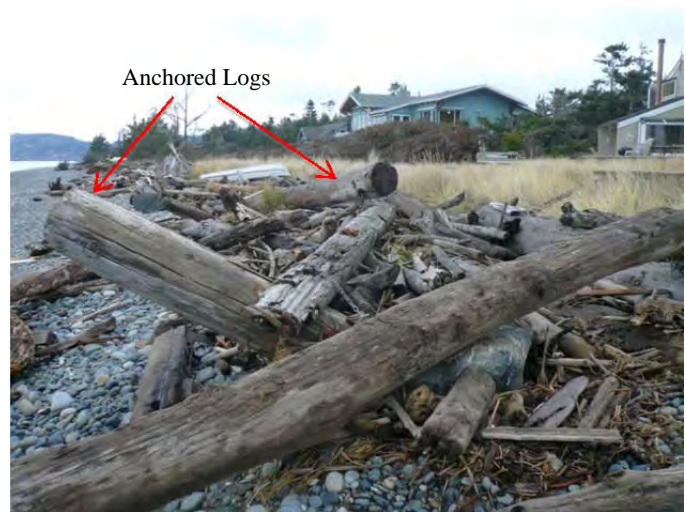
Looking north at central project site. Logs anchored with one end buried (left and central back), with substantial recruited LWD.
