Washington State Aquatic Habitat Guidelines Program

Marine Shoreline Design Guidelines

Final

**Prepared for:
The Aquatic Habitat Guidelines Program
2014**

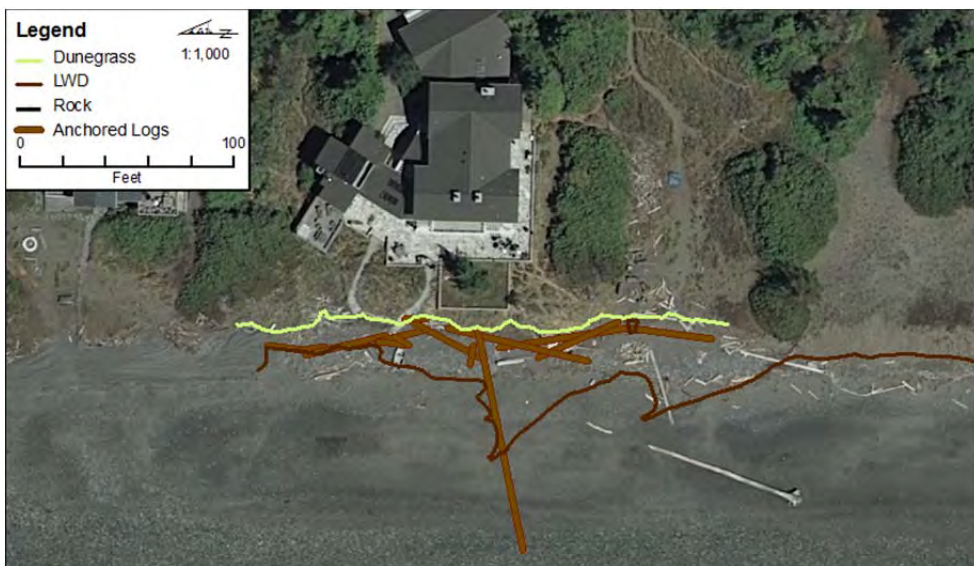
General beach features mapped during the 2012 site visit.

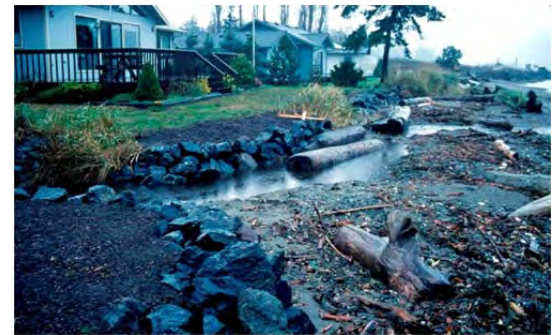
Site before removal of small rockery and installation of treatment in 1998. Note constricted creek and backshore encroachment.

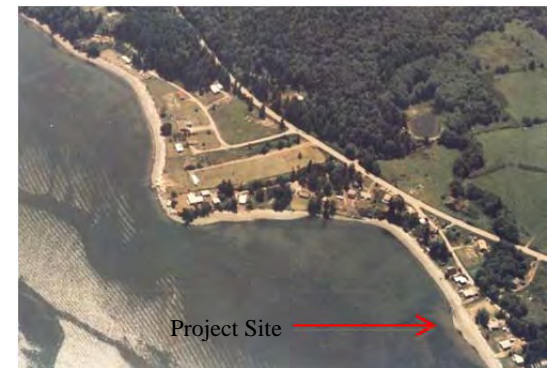
Site prior to development in 1977, seen in lower right with creek crossing berm.

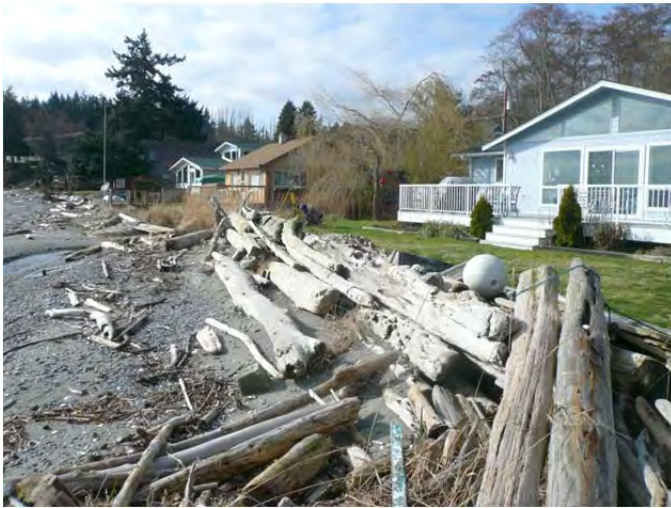
Technique condition - The anchored logs remained in place, along with most of the placed gravel. Additional drift logs had been placed atop the anchored logs by the owner in recent years to augment the log zone. No other actions had been taken by the owner. Natural drift-log recruitment had also occurred just waterward of the anchored logs. Anchoring hardware weathered well. Both of the large anchored logs, one of which had a small amount of rot upon installation, had areas of rot above beach level. Backshore vegetation, primarily dunegrass, was dense in places.

Looking up-drift in 2012. Placed logs are just landward of the smaller logs atop the berm area.

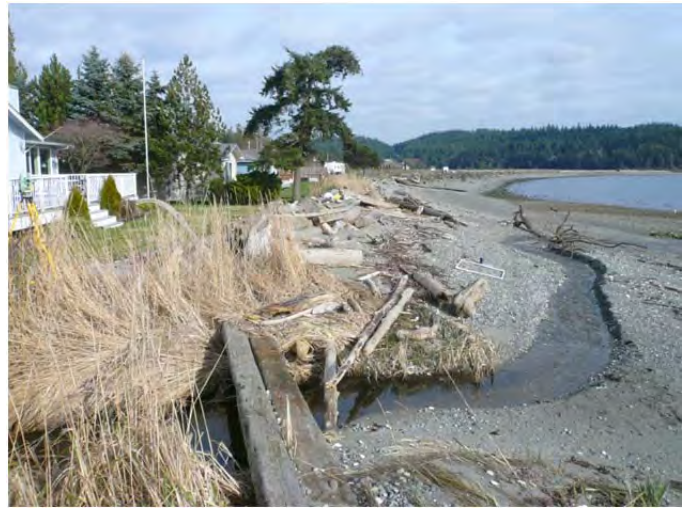
Looking down-drift in 2012. South log is visible behind dunegrass.

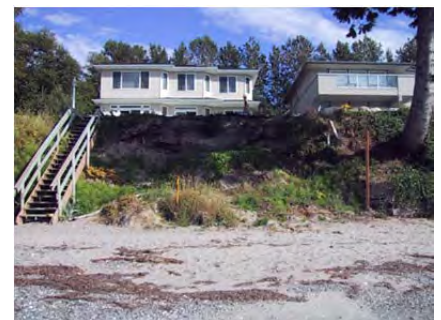
- An oversteepened head scarp at the slope crest, with tension cracks landward of the crest. The old stairway was undermined.
- An eroded and oversteepened bank toe, allowing for potential further crest retrogression.
- Bank sediment consisting entirely of silty fine sand to sandy silt.
- Intermittent bank toe erosion that occurred during high-energy northwesterly waves, particularly during storms coinciding with high tides and storm surges.

Project site before treatment in 2002.

The design included pulling the steep bluff crest back 4 to 6 ft and regrading the slope to a ratio of 2:1 (horizontal to vertical). An erosion-control mat was then to be installed over the regraded bank face. Note the optional terrace was not installed on the bank face. The "Bon Terra Straw Fiber Blanket" (SFB 2) was recommended, with 1 in diameter anchor pins installed into the bank face on a 3-ft by 3-ft grid. It is not known if this material was installed. Once the regrading was completed and the soft shore protection was installed, the marine bank was planted with low-growing native vegetation. It was also recommended that trees be planted on the bank to provide for recruitment of woody debris in the future.

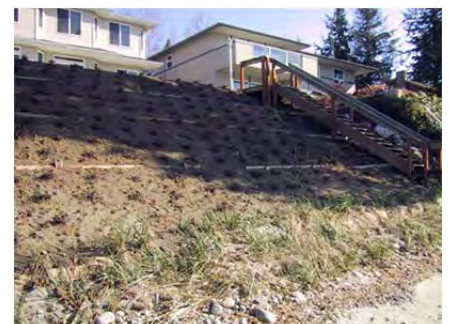
Revegetation in progress in 2004.

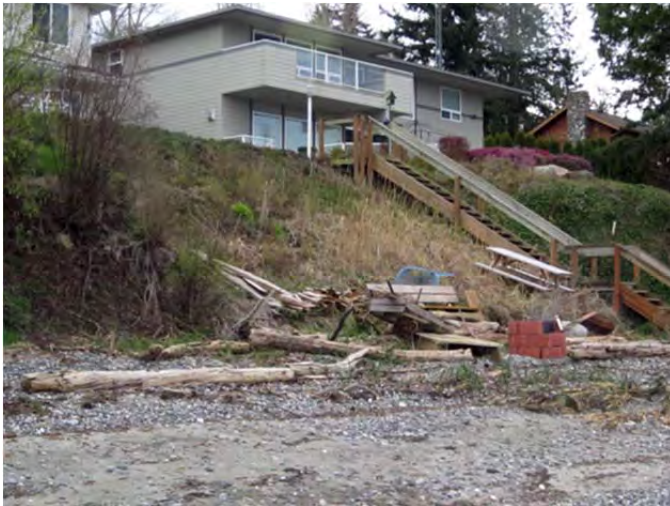
Technique condition – The slope appeared stable, with good vegetation cover dominated by shrubs and groundcovers. Some grasses have naturally established themselves on the slope along with the planted vegetation. The bank appeared to have been graded to a consistent slope that has persisted since installation in 2003.

Revegetated project site in 2012. Note vegetation covering slope, expanded area of dunegrass, and recruited large wood.

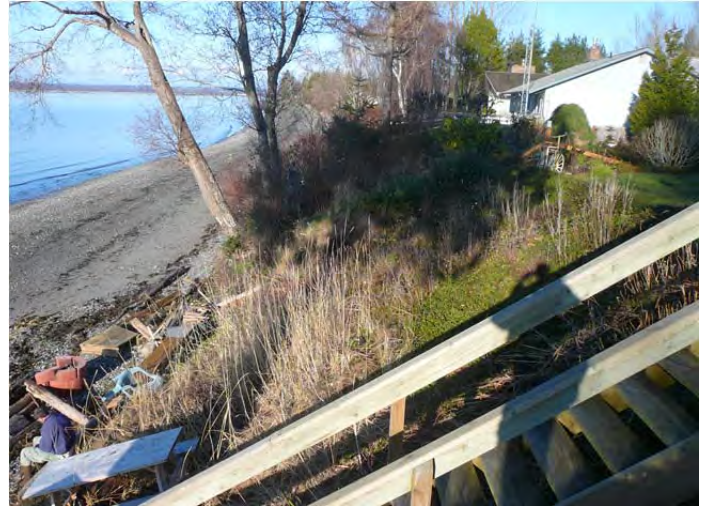
View of bank looking north (down-drift) at revegetated project site in 2012. Groundcovers are more prevalent in foreground; shrubs such as snowberry are dominant in background.

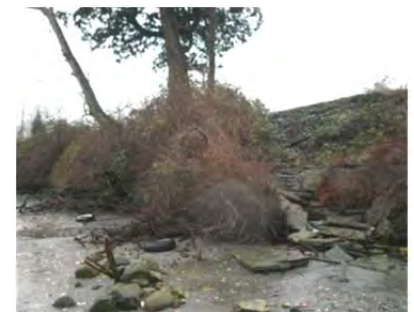
Looking northward along treatment area before treatment. Note trees and debris on the bank and beach.

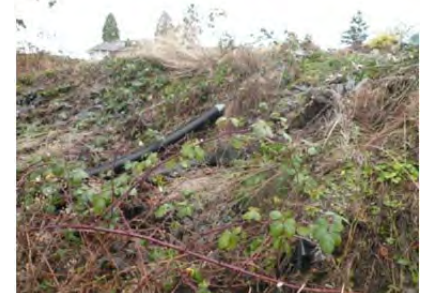
Bluff before treatment. Note drainage pipes and invasive Himalayan blackberries.

The treatment was to remove concrete and other debris from the bank face, remove invasive plants such as Himalayan blackberries, and plant native vegetation. Fill placed at the crest of the slope prior to 2007 was to be removed. The project was not well documented. A summary of activities from the contractor (shown below) included work in 2008 and spring 2009. Additional maintenance and planting was completed in 2010 to early 2012.

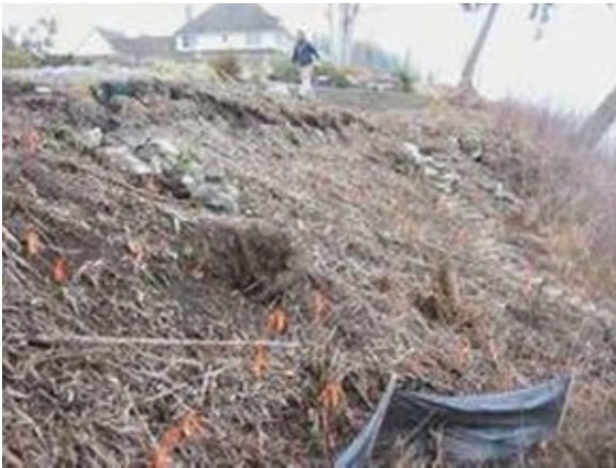
View looking south shortly after cleanup and removal of invasive vegetation and initial planting of native vegetation. Note tension crack at top of slope and slumping of soil and mantle of fill and topsoil.

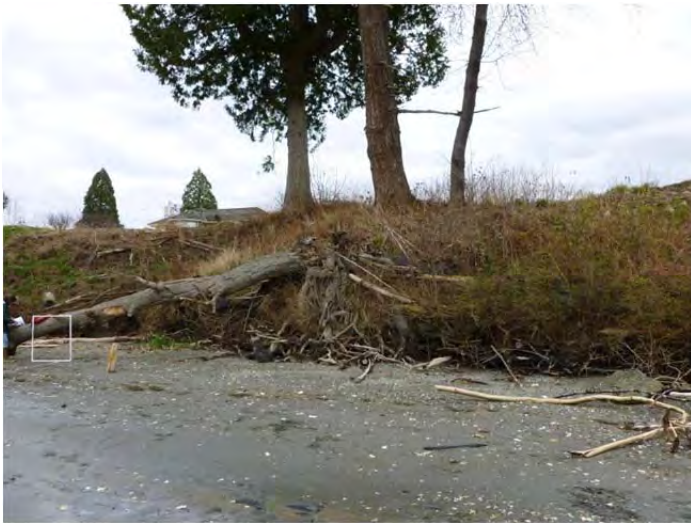
Technique condition - The project has experienced mixed success in the survival and proliferation of native plantings; some invasive plants still had a good hold on the bank. Large discarded items (e.g., an aluminum ladder) remained on the slope in some places, and the topsoil fill excavated from the neighbor had not been moved, or at least not fully removed as recommended. Shallow slope instability continued, although trees on the lower part of the slope were still standing (except the cherry, which had been cut down).

View of treatment area looking northeast. Note fallen cherry tree. Photo taken in spring 2012, so vegetation had not yet leafed out.

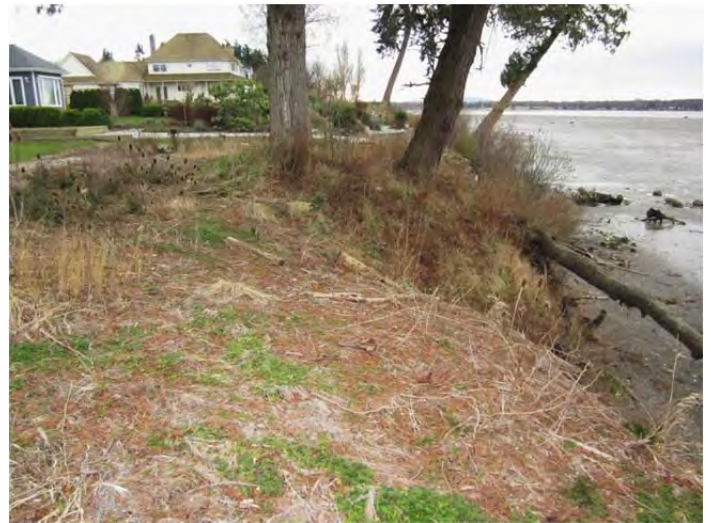
Looking south over treatment site where nonnative plants were removed and upper bank was replanted with native plants in 2012.

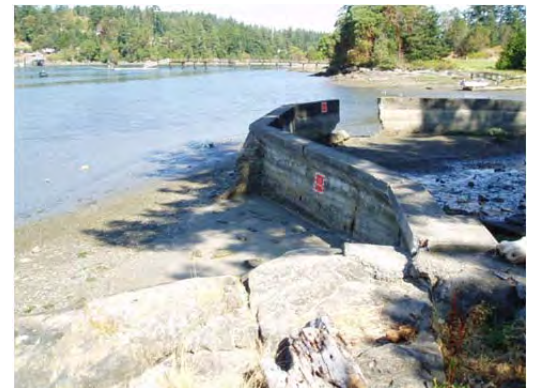
The Kaiser pool was constructed in 1935 within the northeastern portion of Deer Harbor on western Orcas Island. Built from the low bank over the upper intertidal beach, this saltwater pool extended down to +5 ft MLLW. It had not been functioning for a long time. The 1977 aerial photo showed the pool walls still upright, but no water inside the pool. When assessed in 2006, two sections of wall had fallen. Other wall sections were cracked, and the concrete footing was exposed in a number of places.

Remains of concrete pool outside pool before removal, looking down-drift in 2006.

- An excavator and trucks removed the pool in 2008, hauling away debris via a temporary road. Because it would have required a more involved and lengthy federal permitting process, no sediment for beach nourishment was placed in the depression left by removal of the pool walls. In the absence of sediment placement, the beach was given time to adjust to the restored conditions, so saltmarsh vegetation was not replanted. Marine riparian planting was carried out, as well as restoration of the temporary road and installation of trails for public access.

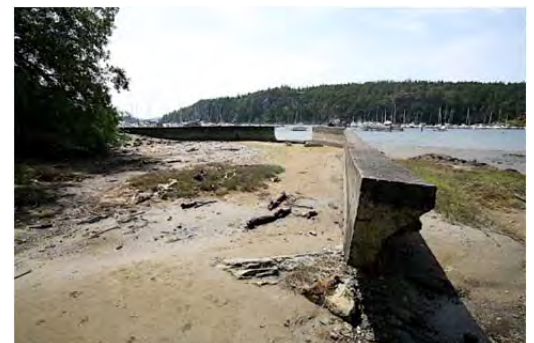
Inside of the pool, looking up-drift in 2007.

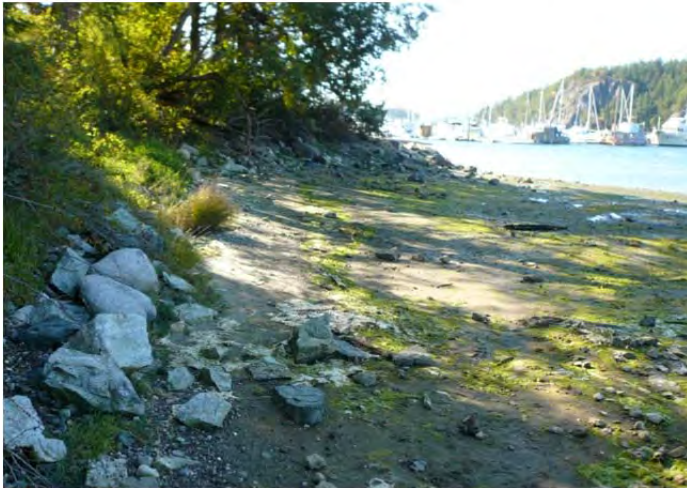
Former pool area 2.5 years after removal in late 2009, looking up-drift.

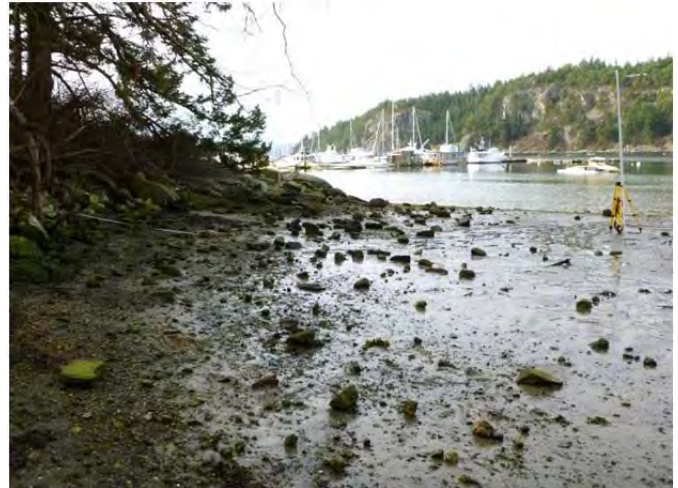
Technique Condition – The project site has very low wave energy and is very slowly adjusting to the altered conditions. A small but conspicuous amount of rock and debris remained on the upper intertidal and along the bank toe. The depression left by the pool wall removal had still not filled to the elevation of the adjacent shores, suggesting that the amount of net shore-drift on the upper beach was limited. Additional rock had apparently migrated waterward from the old bank toe or the upper beach was slightly lower in 2012 than it had been in late 2009, resulting in persistence of the void in the saltmarsh through the fourth year after removal. The low bank was slowly beginning to naturalize. A portion of the rock and debris left during removal was being covered by sand, but not across the entire former pool site.

Former pool area 4 years after removal in 2012, looking up-drift. Note boulders on upper beach and lack of saltmarsh vegetation.

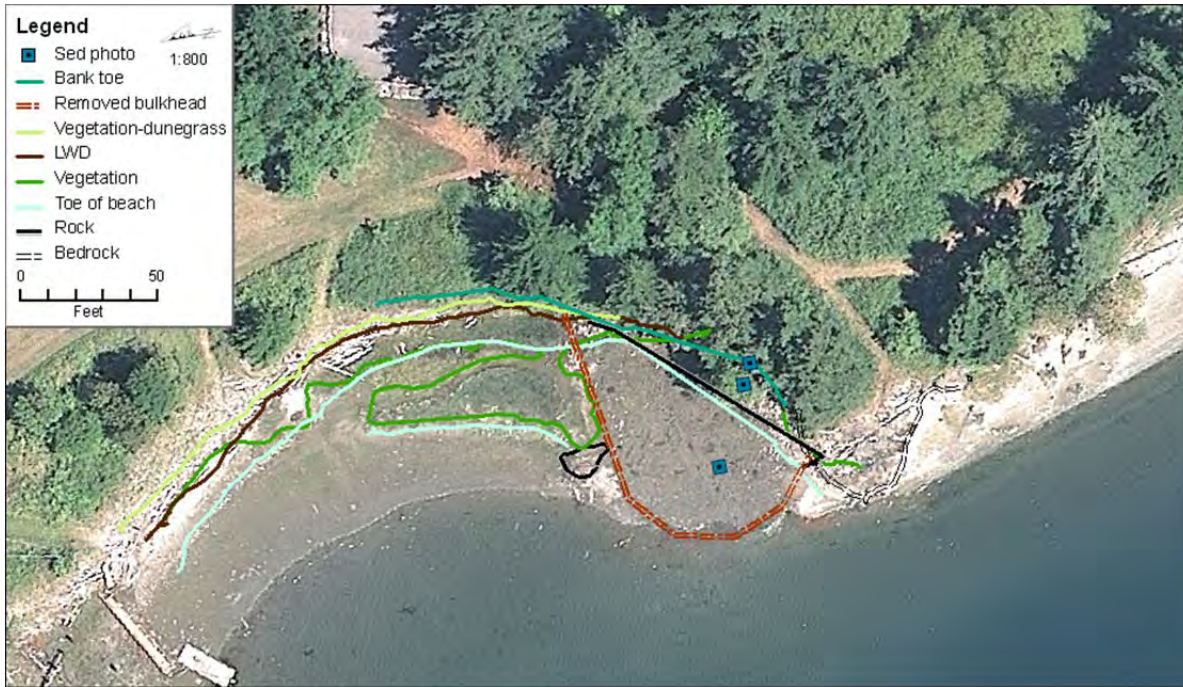
Features mapped during the 2012 site visit.

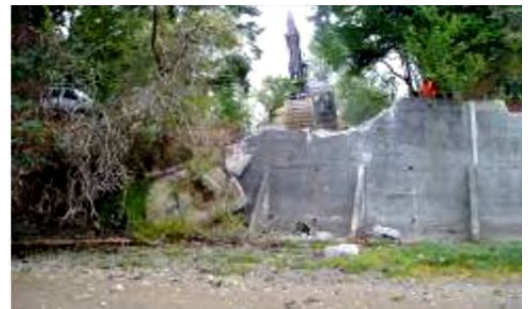
Removal of the concrete bulkhead in progress in 2005 at the western portion of the site.

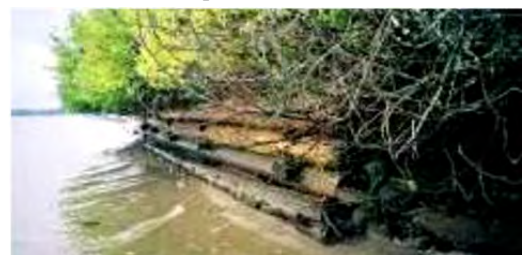
Log bulkhead at the site in 2005 shortly before removal.

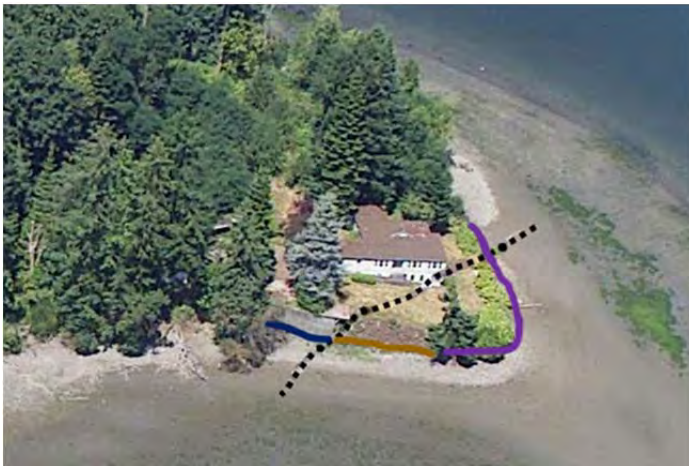
Oblique view of project site prior to bulkhead and structure removal. Dashed black line shows the approximate original shoreline. Solid blue, brown, and purple lines delineate the concrete, rock, and log sections, respectively, of bulkhead planned for removal. Note overhanging concrete pad just left of the pit-run rock bulkhead and waterward of the house. This platform atop the concrete bulkhead was the site of the boathouse.

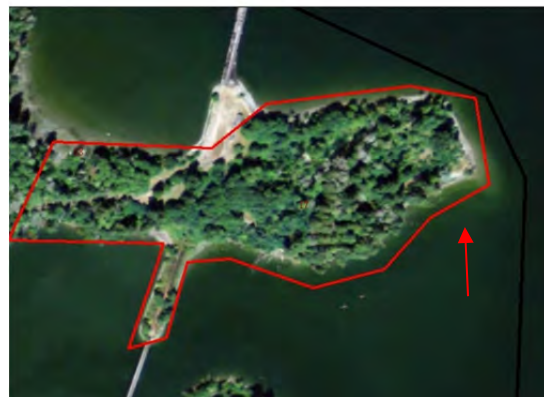
WEYER POINT RESTORATION SITE PLAN RCO#10-1353

Weyer Point restoration site plan provided by DNR showing outline of the larger site, which included structure removal, weed control on 17 acres of riparian habitat, and native vegetation installation areas. Red arrow indicates site location.

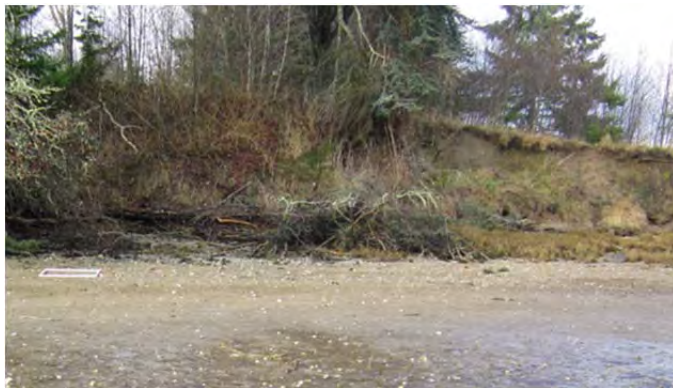
The reach from which the concrete bulkhead (left half of photo) and the pit-run rock bulkhead (right half of photo) were removed. Note the willow growing from the left portion of the bank. Here, the bluff was regraded to a gentler angle and planted with willow stakes. The extent of pickleweed, visible growing in front of the right portion of the bank, appears to have been slightly reduced through burial by eroding sediment since bulkhead removal.

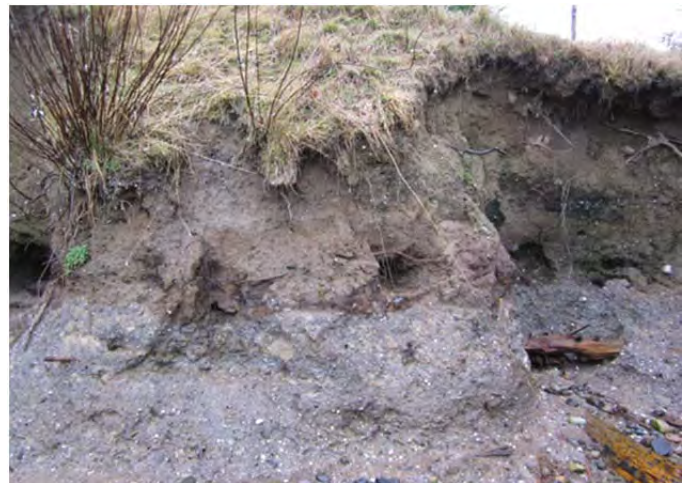
Two units of fill burying the log crib wall along the portion of the bluff where the pit-run rock bulkhead was removed. The lower fill unit appears to be dredged material composed of fine silt and tidal muds with shell fragments. The upper fill unit appears to be the sand/silt component of coarse outwash excavated next to the treatment site.

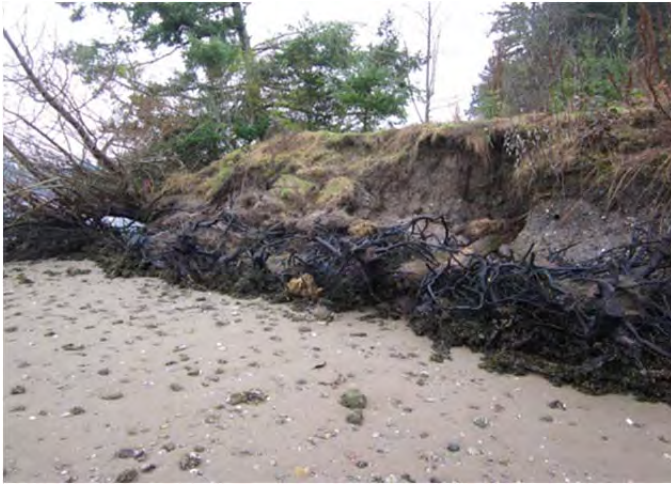
Reach where log bulkhead was removed. Exposure is towards the north and prevailing winds. Dark roots are remnants of a laural hedge that lined the top of the bluff and that is shown alive in pretreatment photos. This hedge was cut before or during the initial restoration effort.

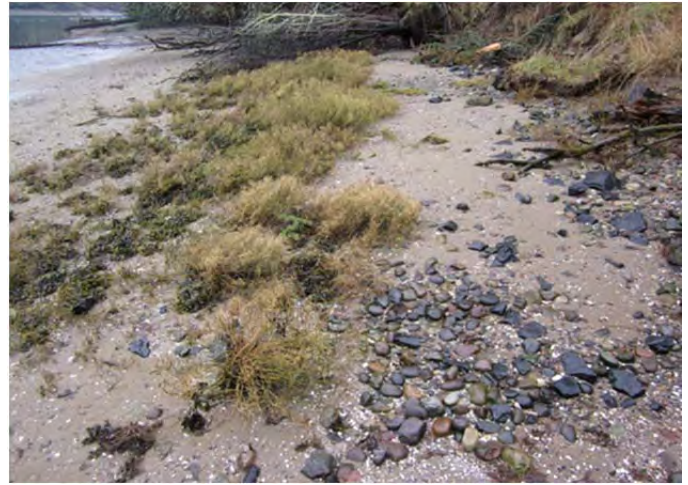
Remnants from rock bulkhead as well as accreted sand from eroding bank, some of which might also be washed from coarser material west and up-drift of the treatment site. These sediments have buried the upper intertidal extent of the pickleweed.

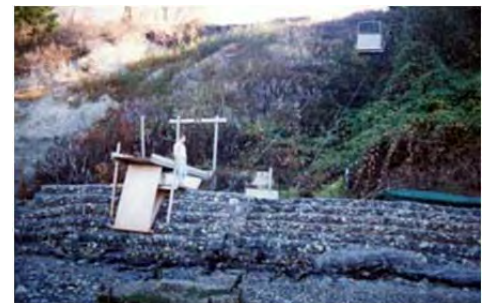
Gabion basket bulkhead in 1999 looking east. Note poorly vegetated bluff face, aerial tram, and lower gabions failing to south (right).

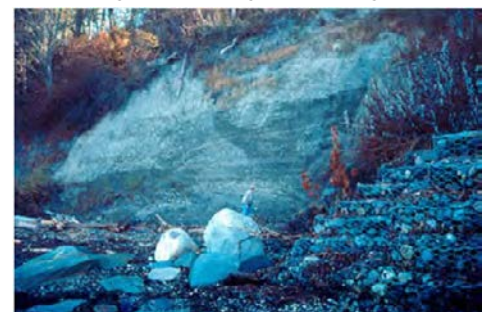
Note recently eroded bluff immediately north of the bulkhead due to end effects/wave refraction around the structure in 1999. Person above boulders for scale.

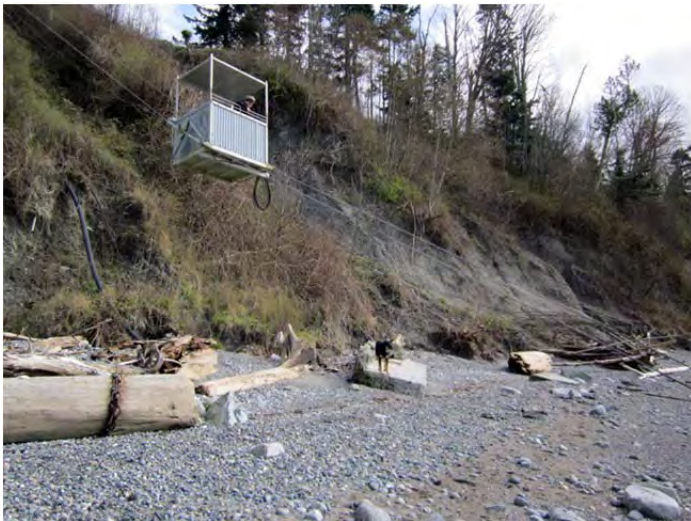
Gabion bulkhead removal area in 2012. Note extensive recent landslides both on site and farther south (up-drift), as well as remaining concrete debris.

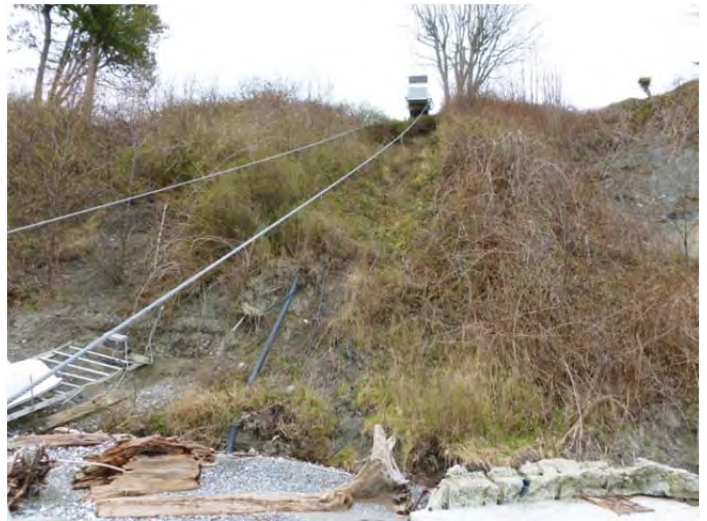
Gabion removal area in 2012 showing both immature vegetation and recent slope failures.

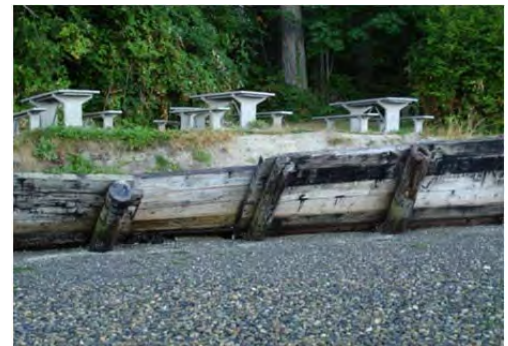
Wooden bulkhead mostly collapsed to expose fill and landslide deposits in 2006. Note waterward lean.

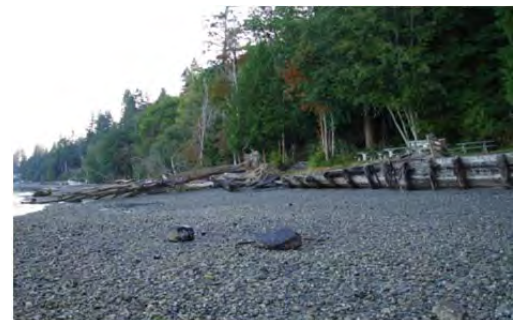
Bulkhead looking north in 2006.

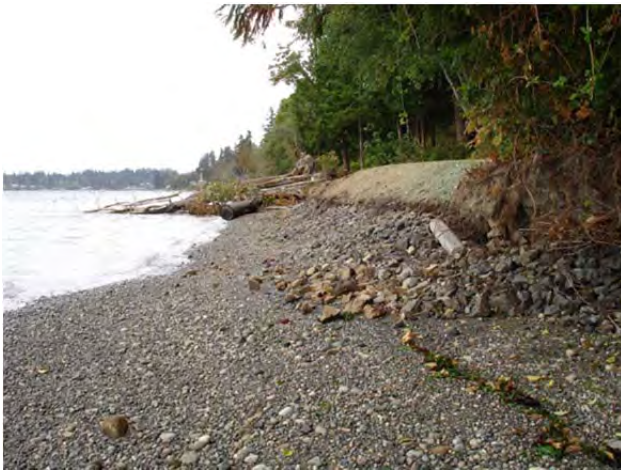
Photo looking north taken shortly after the bulkhead was removed looking northeast. Quarry spall was left on site. The steep bank was regraded and seeded with grass.

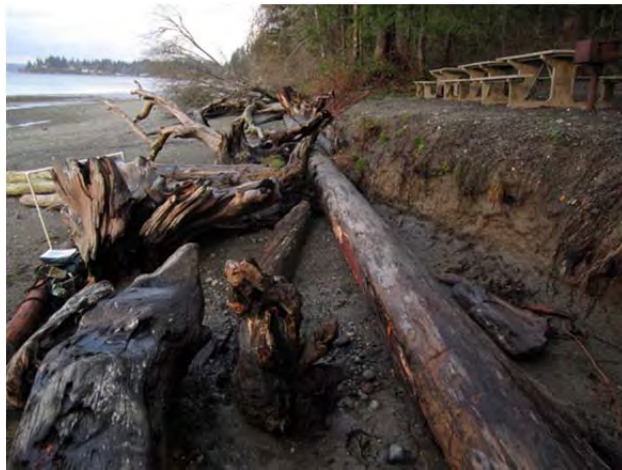
Picnic area in 2012 where bulkhead was removed, looking northeast. Regraded slope has since been eroded. Large wood is naturally recruiting, and sand and gravel are accumulating up-drift of the large wood. Some of the remaining natural log bulkhead is visible down-drift (north) of the treatment area.

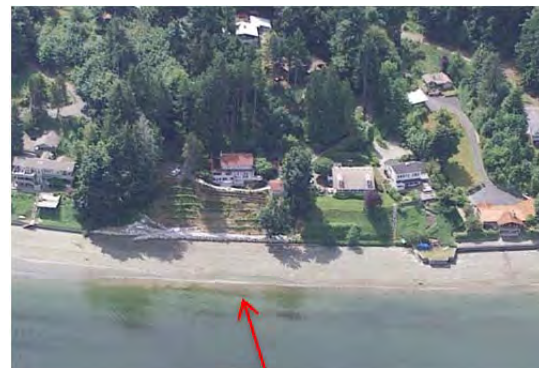
2006 oblique aerial photo of project site. Note the vegetation condition.

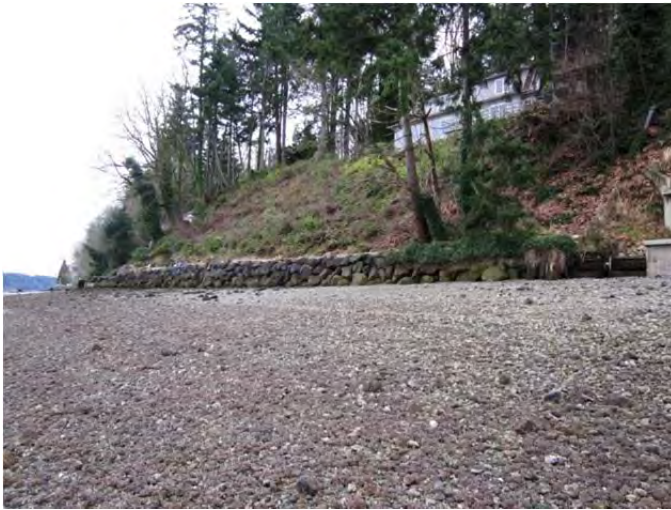
Project site looking up-drift in 2012.

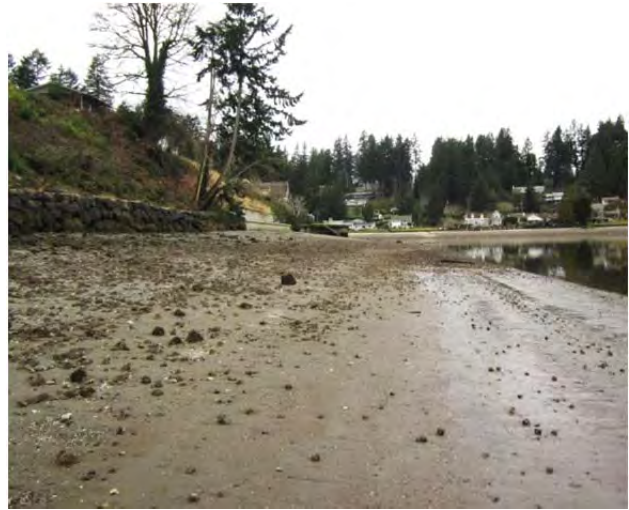
Project site looking down-drift in 2012.

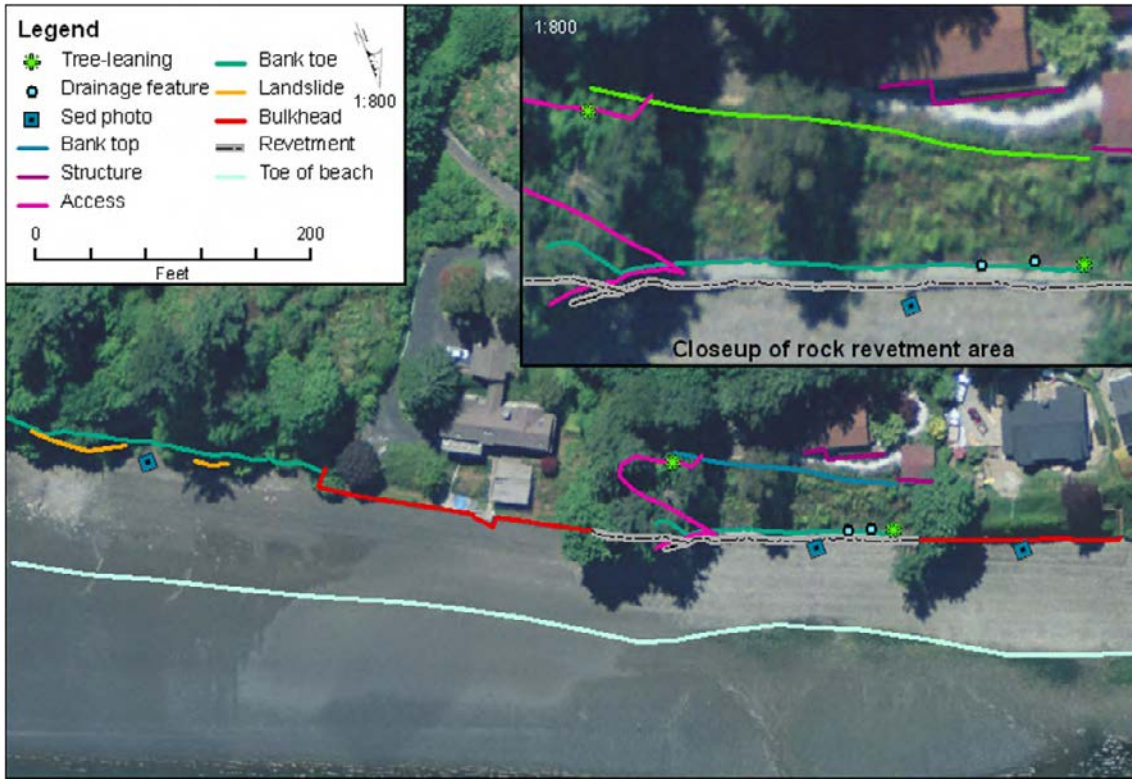
General beach features mapped during the 2012 site visit.

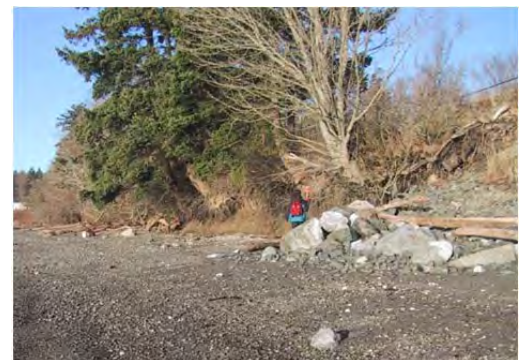
Photo taken in January 2003 of the north end of the project revetment. Degradation—already apparent—began within 2 years of installation.

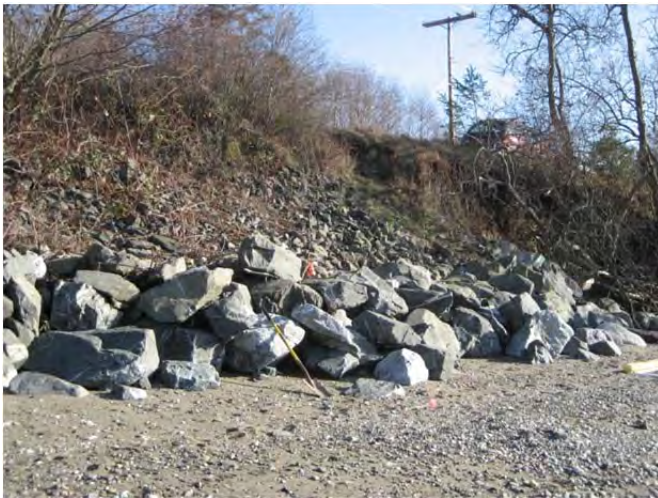
Project site revetment in 2012 near the south, up-drift end with a shovel in the photo for scale. Note slope-buttrressing small rock above revetment.

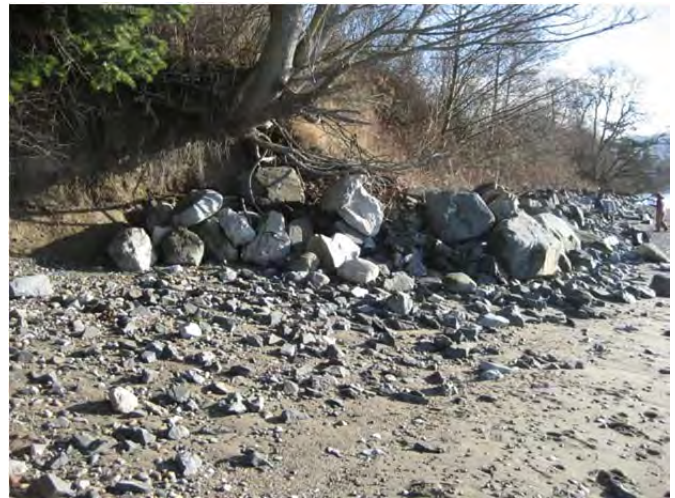
Project site revetment north end in 2012 looking up-drift of the structure end. Note toppled armor rock and quarry spall, which has moved out of the structure.

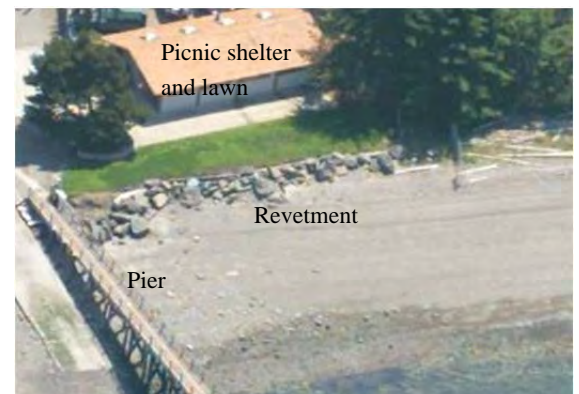
Project location in 2002. Note the toppled rock and intertidal beach debris.

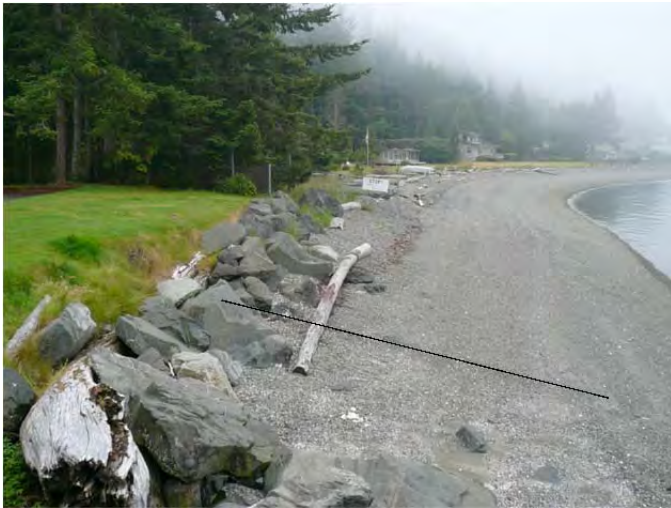
Technique condition- Armor rock has toppled onto the beach along many portions of the revetment. The western portion, which was constructed higher on the beach and has a higher crest elevation, was in the best condition with the fewest rocks toppled on the beach. The central and eastern portions contained several small gaps and several low-elevation crest areas, with erosion scarps cut into the adjacent fill. Toppled rock was present over portions of the upper beach. The toppled rocks have been moved back upslope on one occasion in the past 15 years. Some juniper bushes have been removed in the last 5 years and there has been erosion in those areas.

Project site and profile location looking up-drift in 2012. Note toppled rock in foreground and erosion of backshore fill with fewer toppled rocks on beach within the further section of revetment.

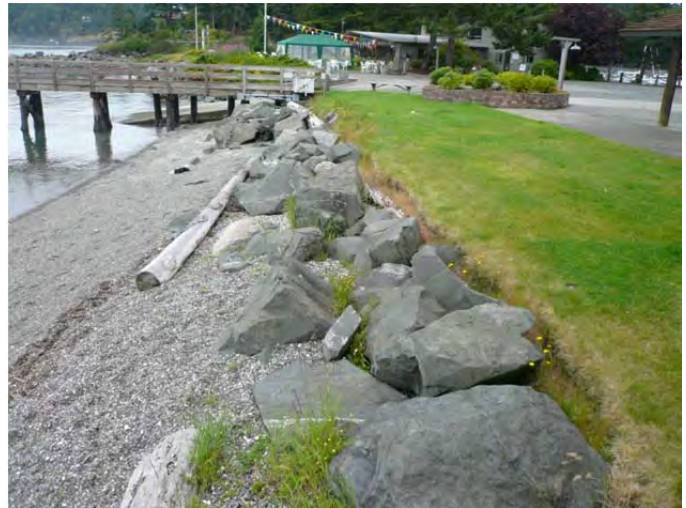
Project site and profile location looking down-drift in 2012. Note rock toppling and lower elevation of eastern portion of revetment.

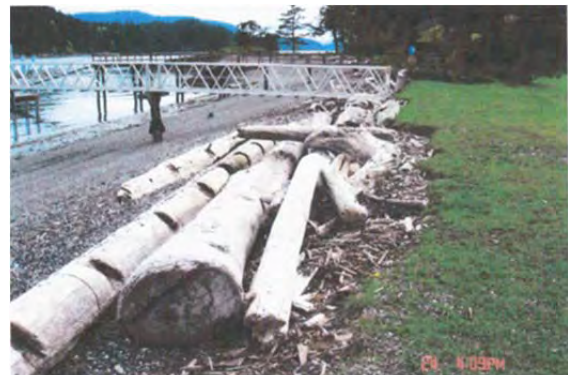
Erosion along shore looking SW, preproject.

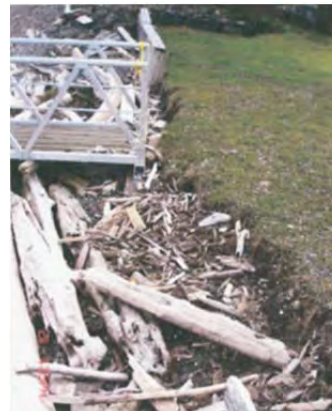
Erosion at dock looking SW, preproject.

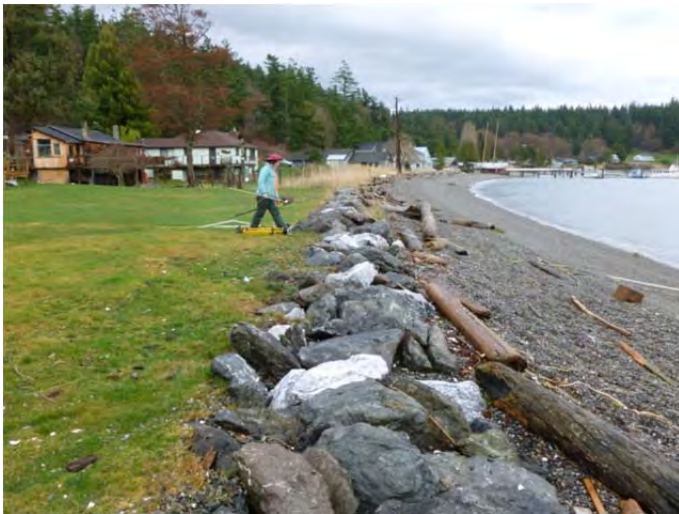
Technique condition - The revetment had a varying crest height and waterward slope throughout, most likely due to imprecise rock placement during installation. Geotextile fabric was exposed intermittently throughout the length of the structure, which has been overwashed an average of 4 ft landward, up to a maximum of 12 ft. Imported gravel placed on top of the revetment had eroded, exposing the entire top layer of armor stones. The exposed toe of the structure was barely above MLLW at the time of the field assessment. A small width of large woody debris (LWD) lay waterward of the structure.

Project site looking down-drift in 2012. Note landward overwash of the revetment, exposed rock and geotextile fabric, and small log zone waterward of structure.

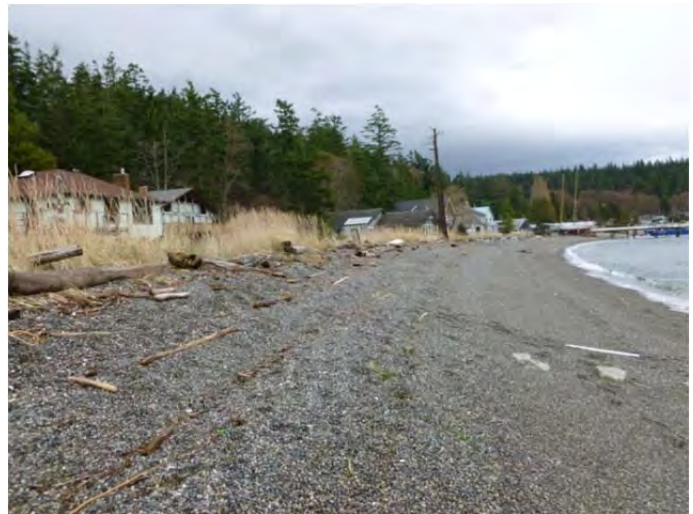
Down-drift profile looking down-drift in 2012. Note the backshore vegetation.

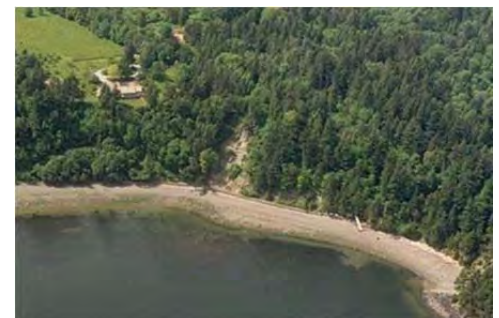
Oblique 1994 aerial view with an older bulkhead present. Large landslide visible in east-central bulkhead area, with smaller failure to right.

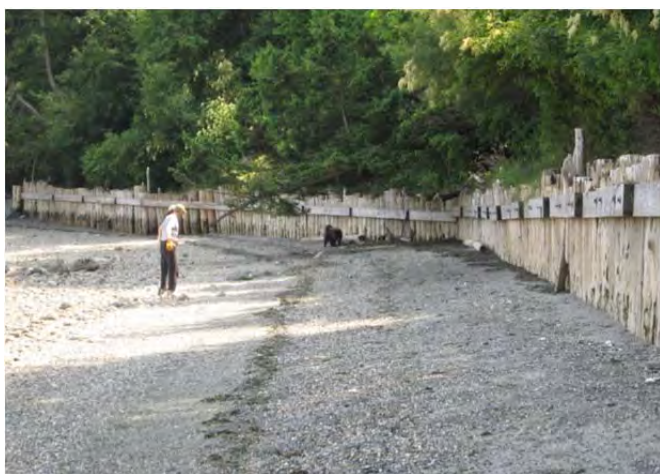
Technique Condition – Degradation of the piles immediately above beach level and on the tops of piles was minor to moderate. Many portions of the bulkhead had damage to the piles from rot. The most deterioration was in the sediment line where landslides had caused some piles to lean waterward, but gaps were still minimal and limited to several inches. Whalers all appeared to be sound. Flanking erosion had not gotten behind either wall end, but small amounts of wood appeared to have been added to the ends over the years.

Eastern portion of vertical soldier pile bulkhead looking down-drift in 2012.

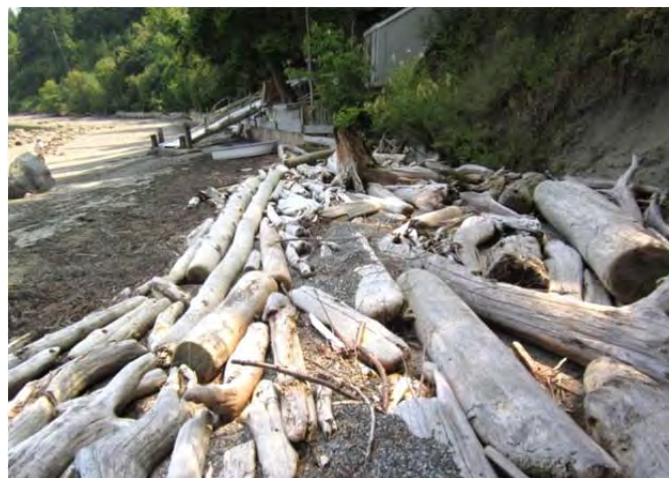
Up-drift beach and vertical soldier pile bulkhead looking down-drift in 2012.

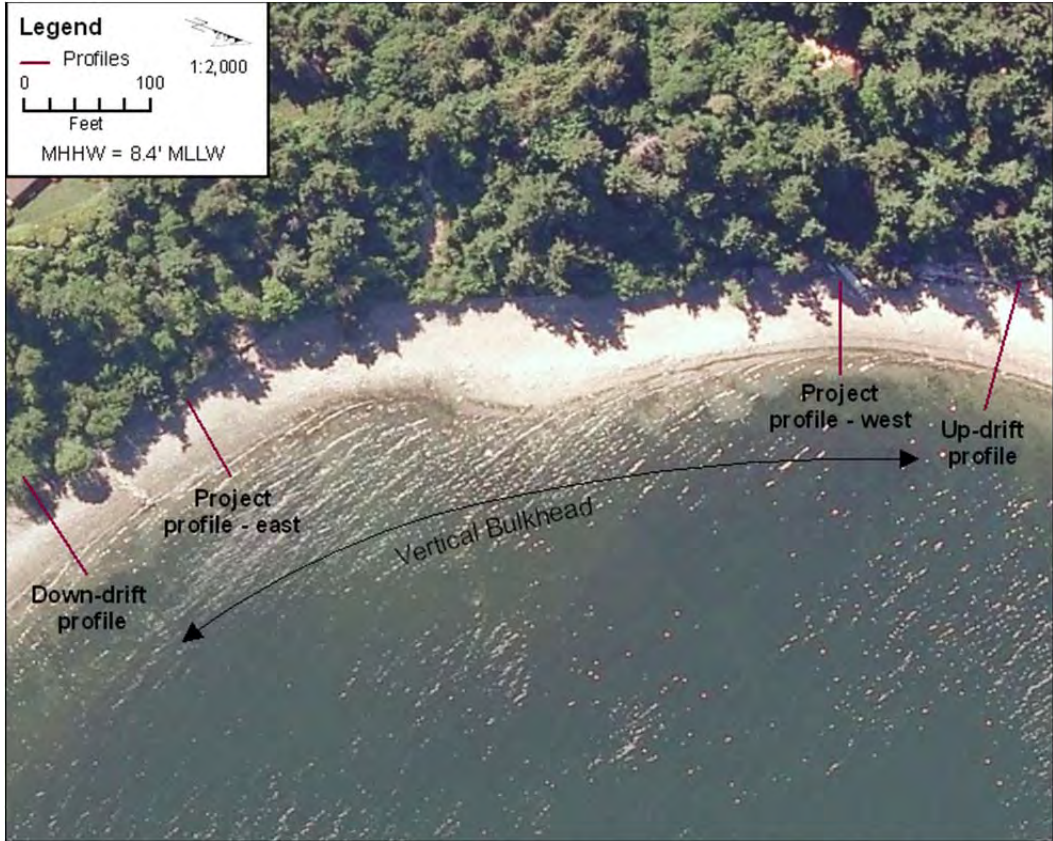
Project site map with profile locations.

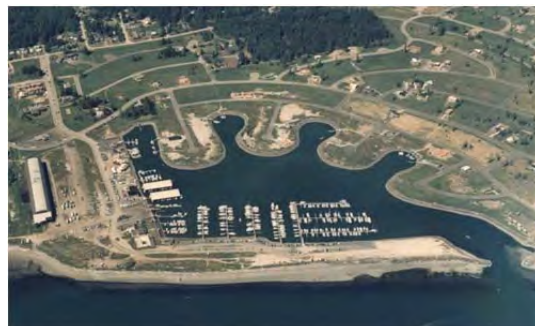
Oblique aerial photo from 1977 before the condominium complex and vertical bulkhead installation, and before the marina jetty was installed up-drift of the project site (Washington State Department of Ecology photo).

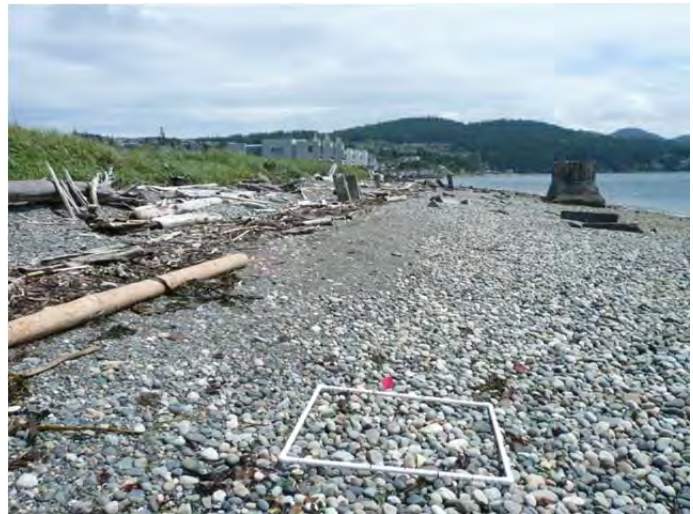
Down-drift reference site profile looking towards project site in 2012. 1 m² quadrant for reference.

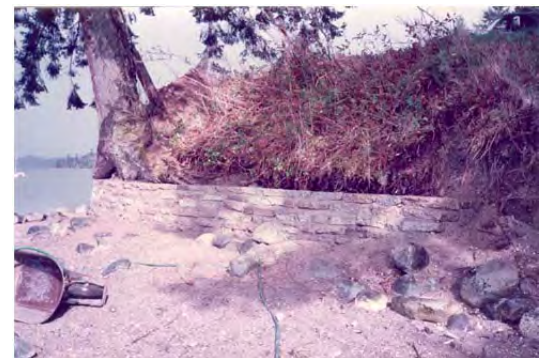
Earlier bulkhead looking northeast in the 1970s.

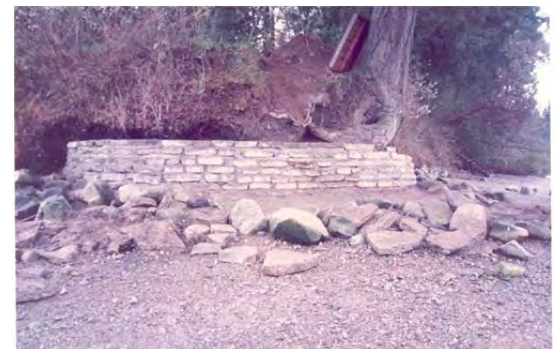
Earlier, shorter bulkhead looking southeast in the 1970s.

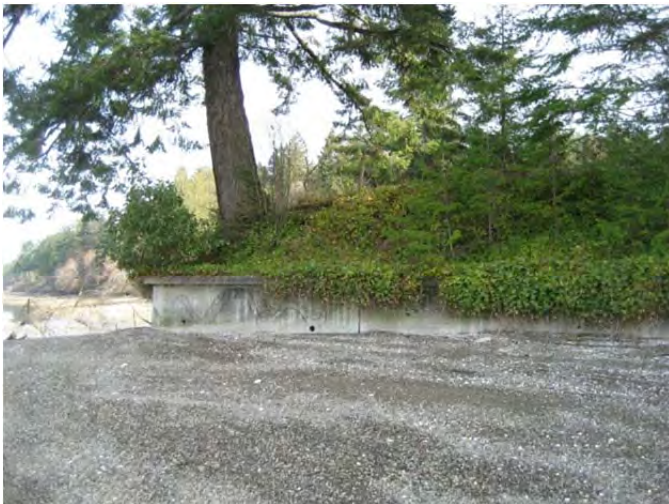
Bulkhead looking northeast in 2009.

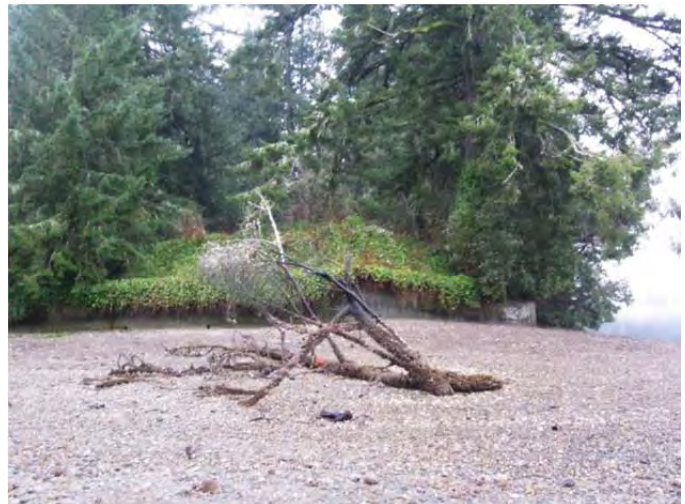
Technique condition - The bulkhead measured 216 ft long, including the return walls at each end. Concrete stairways that served as the main access to the beach were found at both ends of the wall. The top of the bulkhead was +18.5 ft MLLW and this remained fairly constant throughout its length. Approximately 60 ft of bulkhead had a toe elevation below MHHW. The lowest bulkhead toe elevation, +13.9 ft MLLW, was found at the very tip of Snyder Point, immediately waterward of a large Douglas fir tree. The bulkhead measured 5.75 ft high from the bottom of the footing to the top. The bulkhead footing consisted of unformed poured concrete, while the wall and cap were composed of 10- to 30-ft formed sections. Drain holes were at 10-ft intervals in the forms using 4-in plastic pipe with wire mesh behind. Investigation through the drain holes revealed the bulkhead thickness at 1.0 ft. It appeared that there was fill behind the wall, specifically at the north point where the large Douglas fir tree was protected. Based on the distance that the bulkhead appeared to be from the location of the natural bank, it seemed likely that the original concrete rubble and mortar bulkhead built in the 1980s still remained behind the concrete structure. Excavations were made to the base of the wall footing, and it appeared that the wall was constructed directly on the firm surface below the beach level.

Bulkhead looking southeast from the point of Snyder Point in 2012.

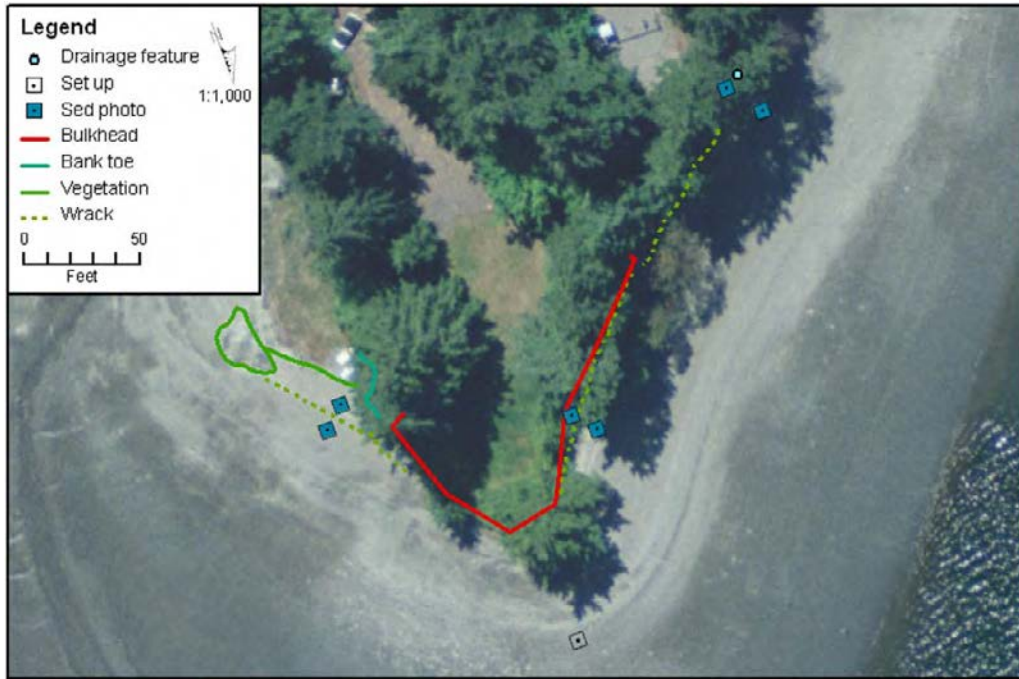
Map of field data obtained with GPS.

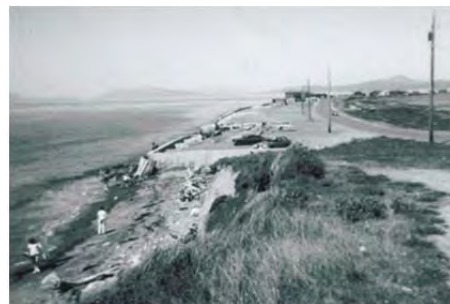
Swan Lake project site in about the early 1970s, looking down-drift. Vertical concrete bulkhead and backfill at up-drift end of study area failed soon after construction.
