Washington State Aquatic Habitat Guidelines Program

Marine Shoreline Design Guidelines

Final

**Prepared for:
The Aquatic Habitat Guidelines Program
2014**

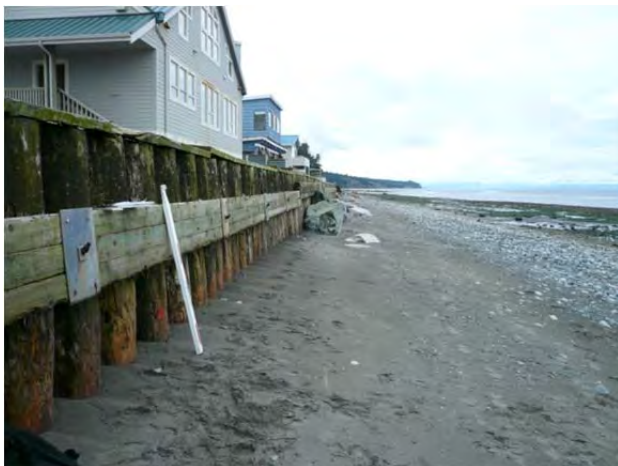
Technique Condition – Soldier piles generally were in good condition, with minor abrasion near beach level but generally sound wood. Piles remained vertical. Small gaps of up to 0.15 ft between piles appeared to have been the source of backfill loss. Some overtopping appeared to have occurred, likely during extreme wind-wave events coincident with very high tides. Corrosion of tie-backs and associated hardware was evident during the site visit.

On-site profile location (indicated by rod) looking up-drift in 2012.

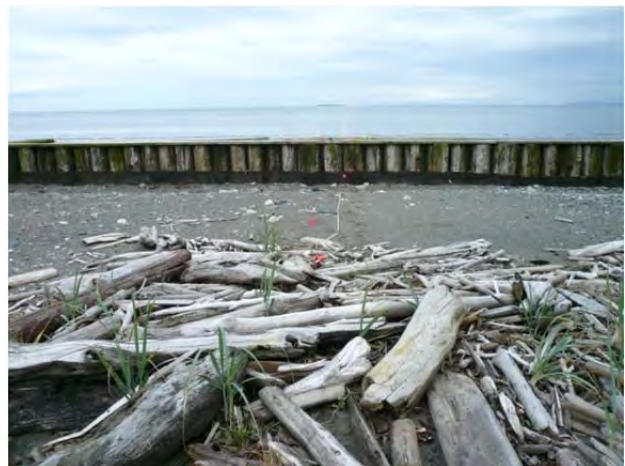
Sandy continuation of the beach, backshore, and drift logs behind soldier pile wall looking waterward in 2012.
