Rapid Environmental Assessment of Kakhovka Dam Breach

Ukraine, 2023

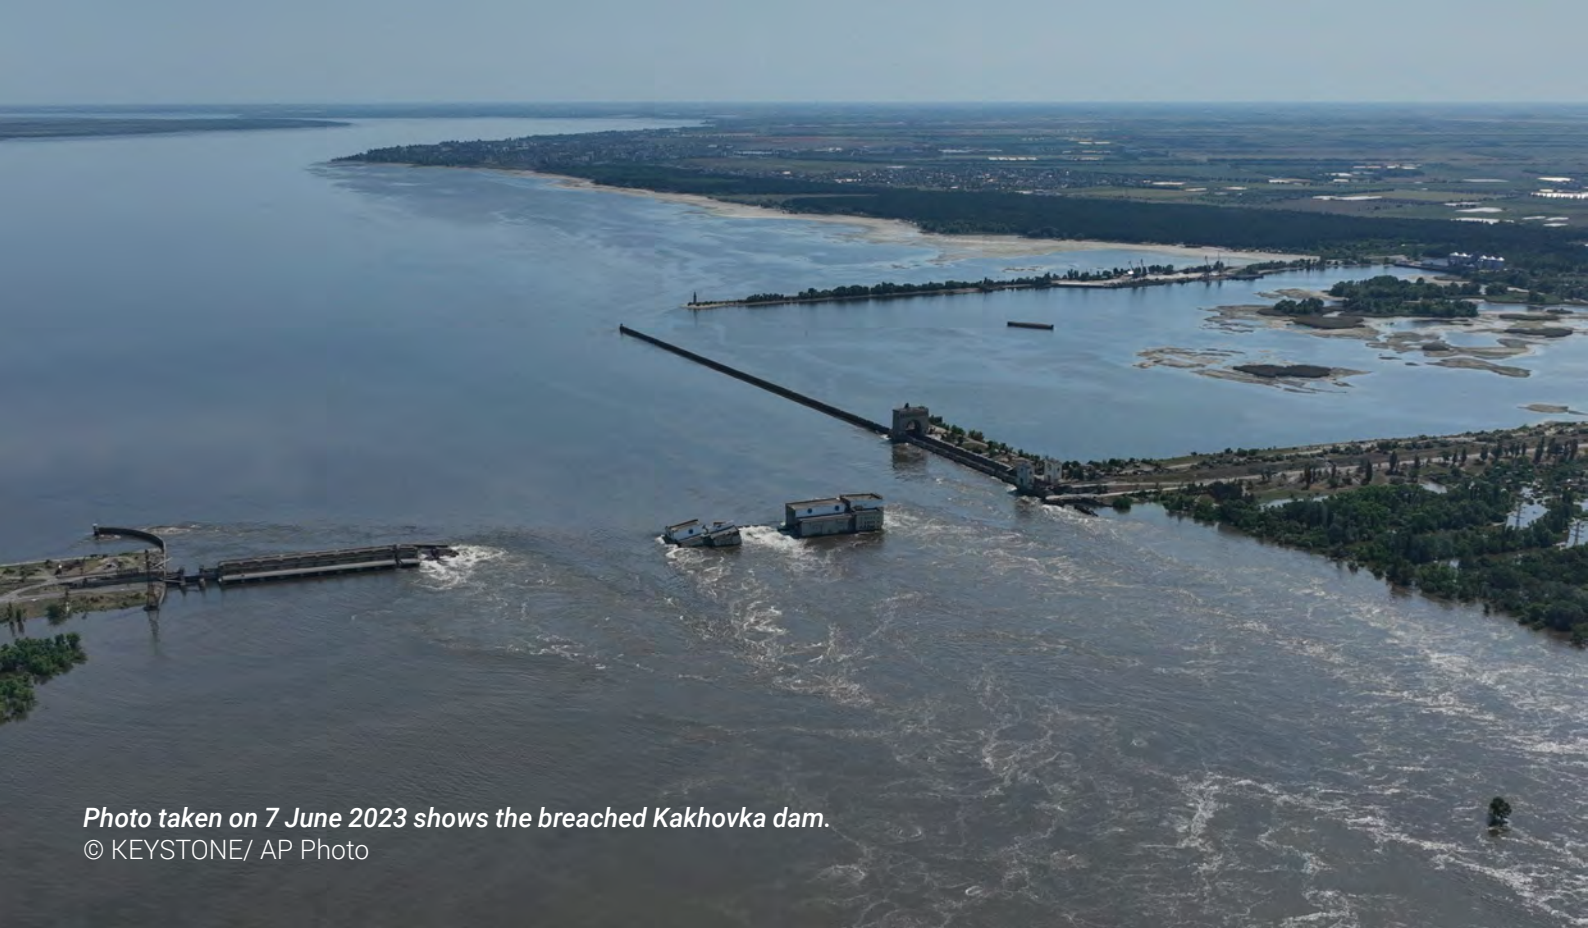
Photo taken on 7 June 2023 shows the breached Kakhovka dam.
© KEYSTONE/ AP Photo

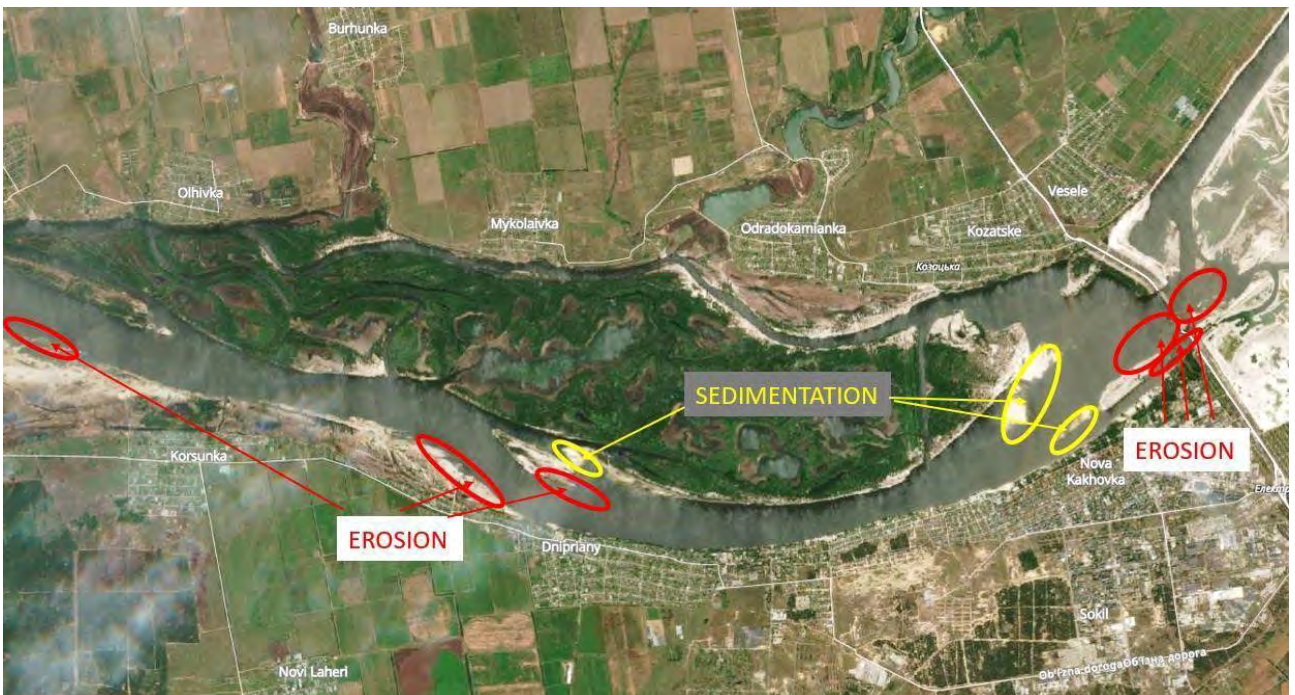
Figure 12. Localities with major erosion and sedimentation at the dam breach site and close downstream, identified on satellite images Sentinel-2 (Source: Sentinel-hub EO-Browser3 2023)

Locations with major erosion and sedimentation at the dam breach site and downstream are visible on satellite images (Figure 12)

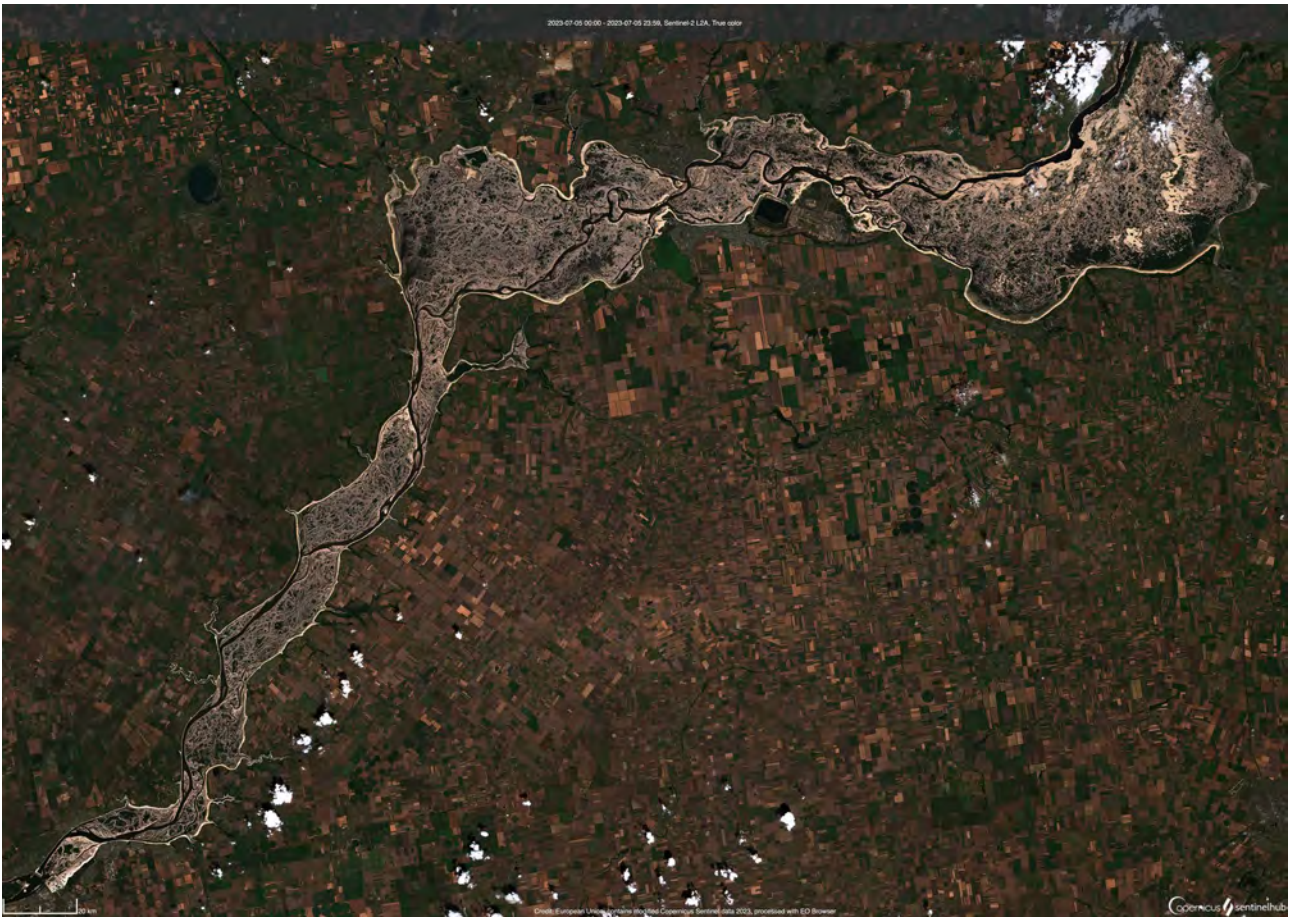
Figure 14. The upstream area of the breached Kakhovka dam (5 July 2023) (Source: Sentinel-hub EO-Browser3 2023)

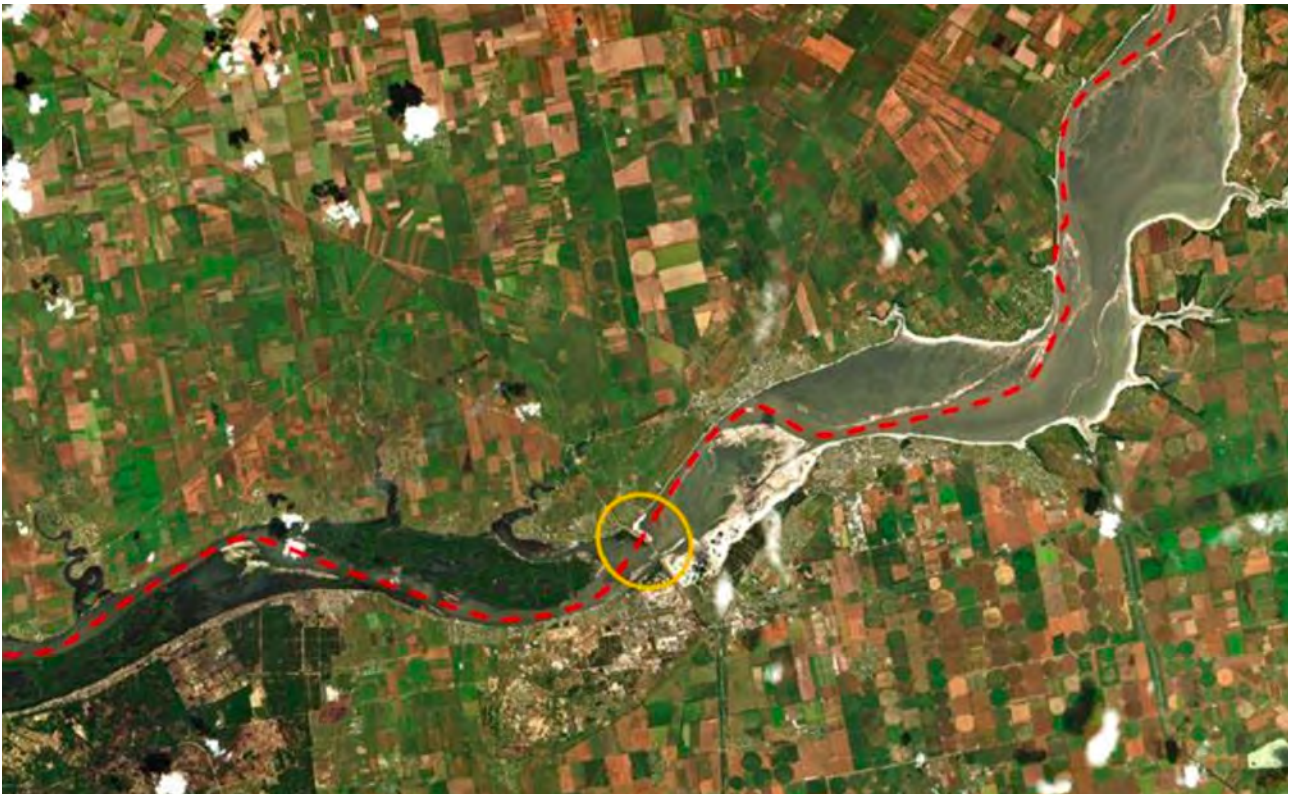
Figure 15. Main channel (dotted red line) near the dam (denoted with the yellow circle in the top image) on 18 June 2023 and from a 1940s map (before implementation of dam) (Source: UK CEH 2023)

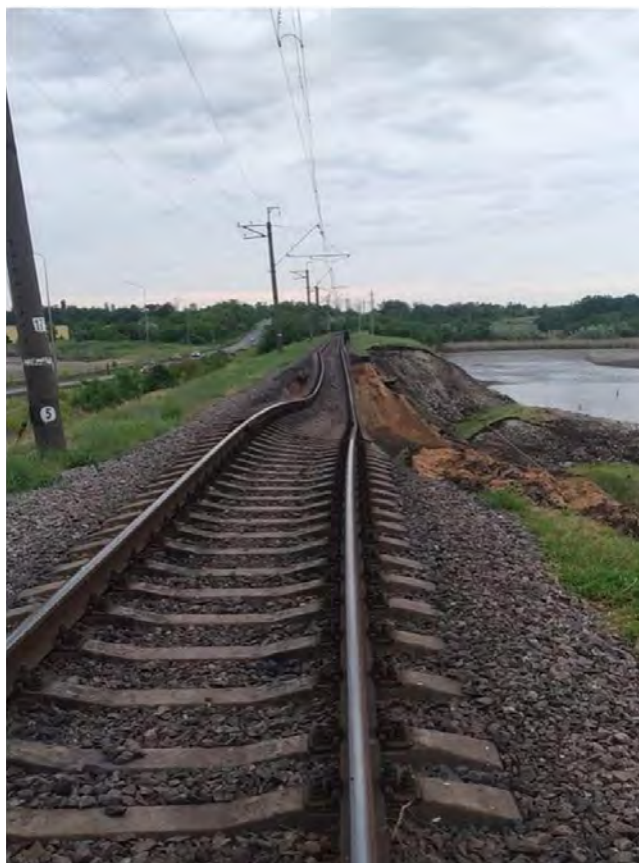
Figure 20. Compressed railroad bed and landslide on the bank of the Kakhovka reservoir after its depletion (near Nikopol)
(Source: Yakovlev and Stefanyshina 2023)

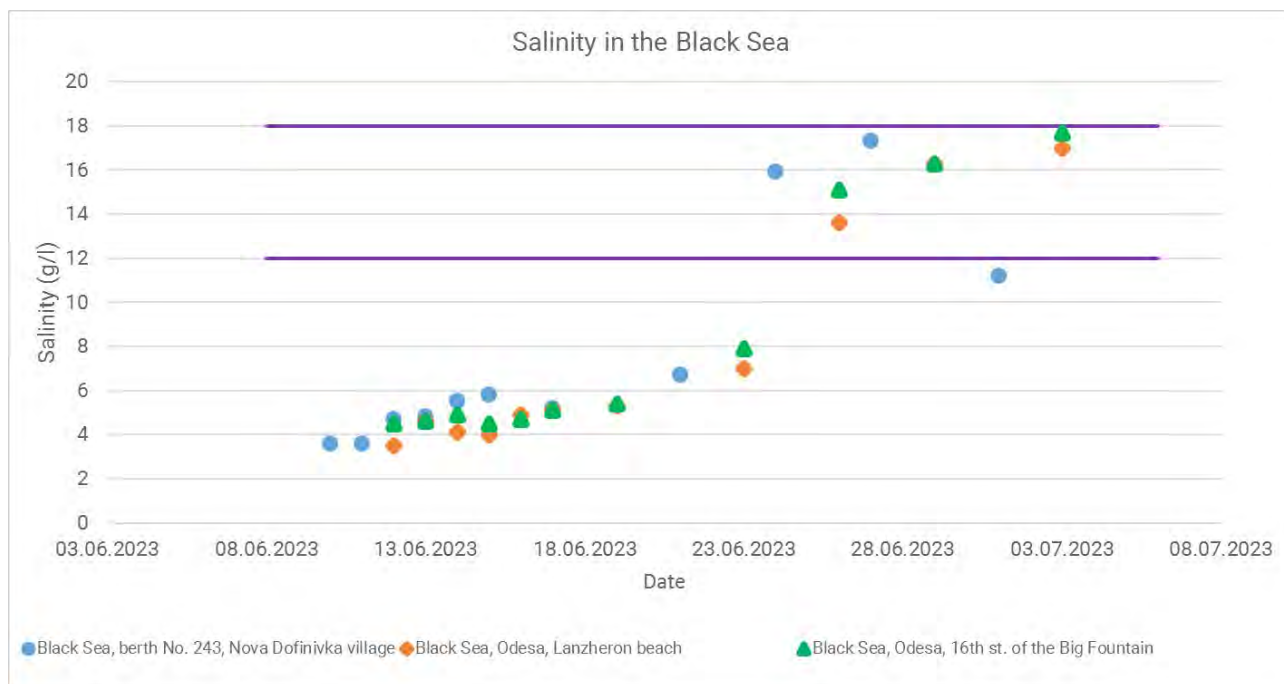
Figure 22. Salinity changes after the breach. Note normal ranges are between the purple lines
(Source: Created by the authors using data from Ukraine, State Agency of Water Resources 2023)

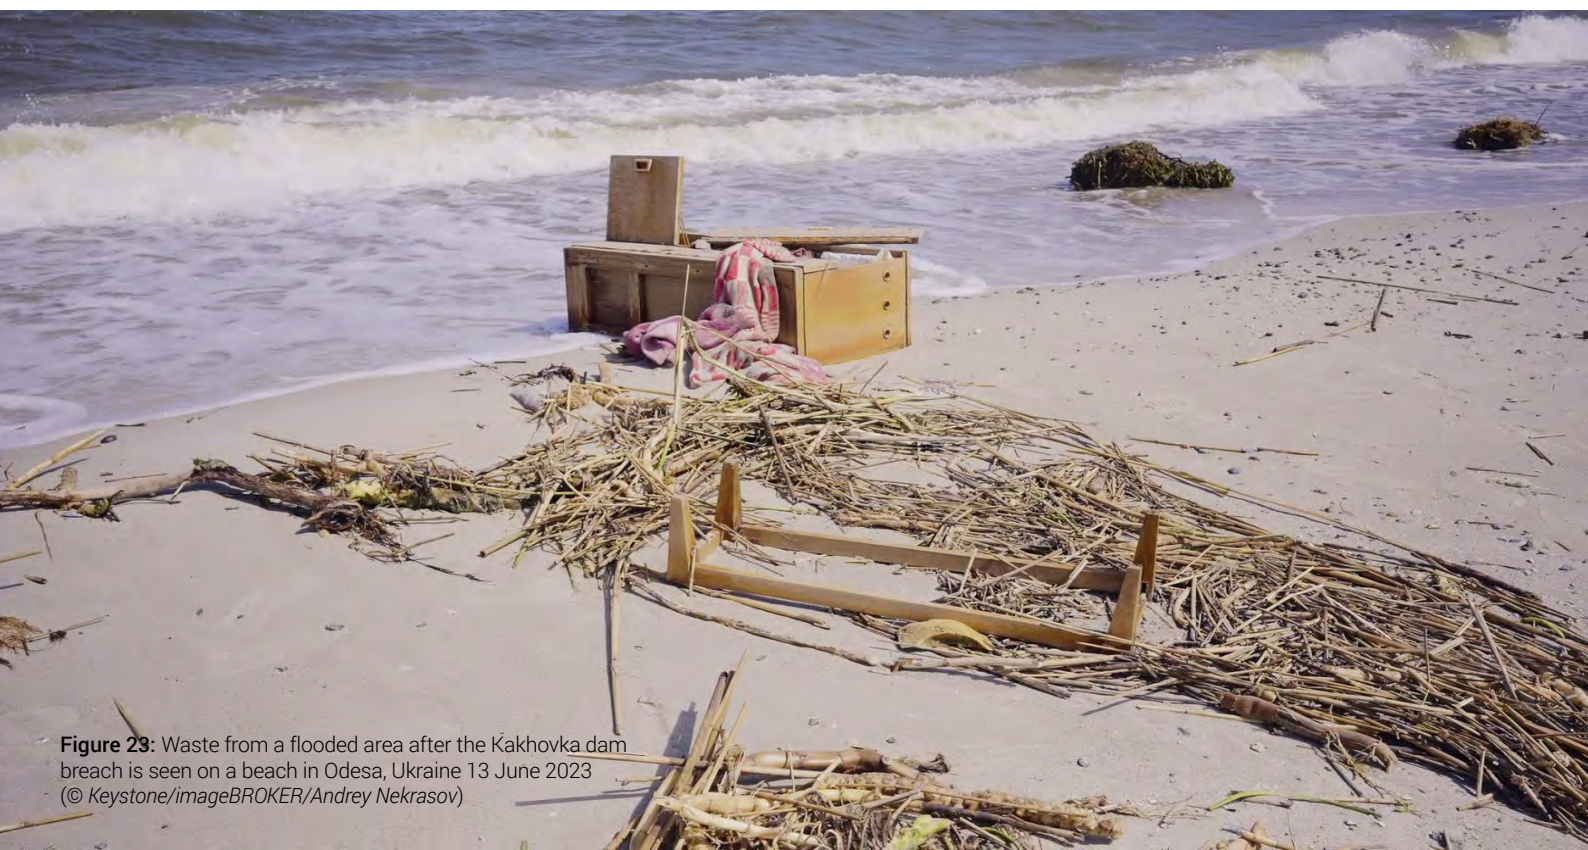
Figure 23: Waste from a flooded area after the Kakhovka dam breach is seen on a beach in Odesa, Ukraine 13 June 2023
(© Keystone/imageBROKER/Andrey Nekrasov)

Besides nutrients and organic matter, sewage and manure discharges into aquatic ecosystems and drinking water pose a risk of microbiological contamination (Ukraine Government 2023). Waste from the flooding transported all the way to Odesa oblast is shown in Figure 23. Results of sampling carried out after the breach by the Centers of Disease Control and Prevention show that bacteria and viruses (lactose positive *E. coli*, *E. coli*, cholera like vibrio, amoebae, giardia, enterococci, Rotavirus, Salmonella, Astrovirus, cryptosporidium, trichocephalosis, toxocarasis, strongyloidiasis, human roundworm and staphylococci) that may cause human disease were present in the river basin and in the Black Sea (CDC 2023), yet the exact source of these contaminants is unclear. Freshwater organisms killed as a result of the dam breach have been washed upon the shores near Odesa (Ukraine, MEPNR 2023). Dying organisms can release organic matter and nutrients leading to algal blooms as well.

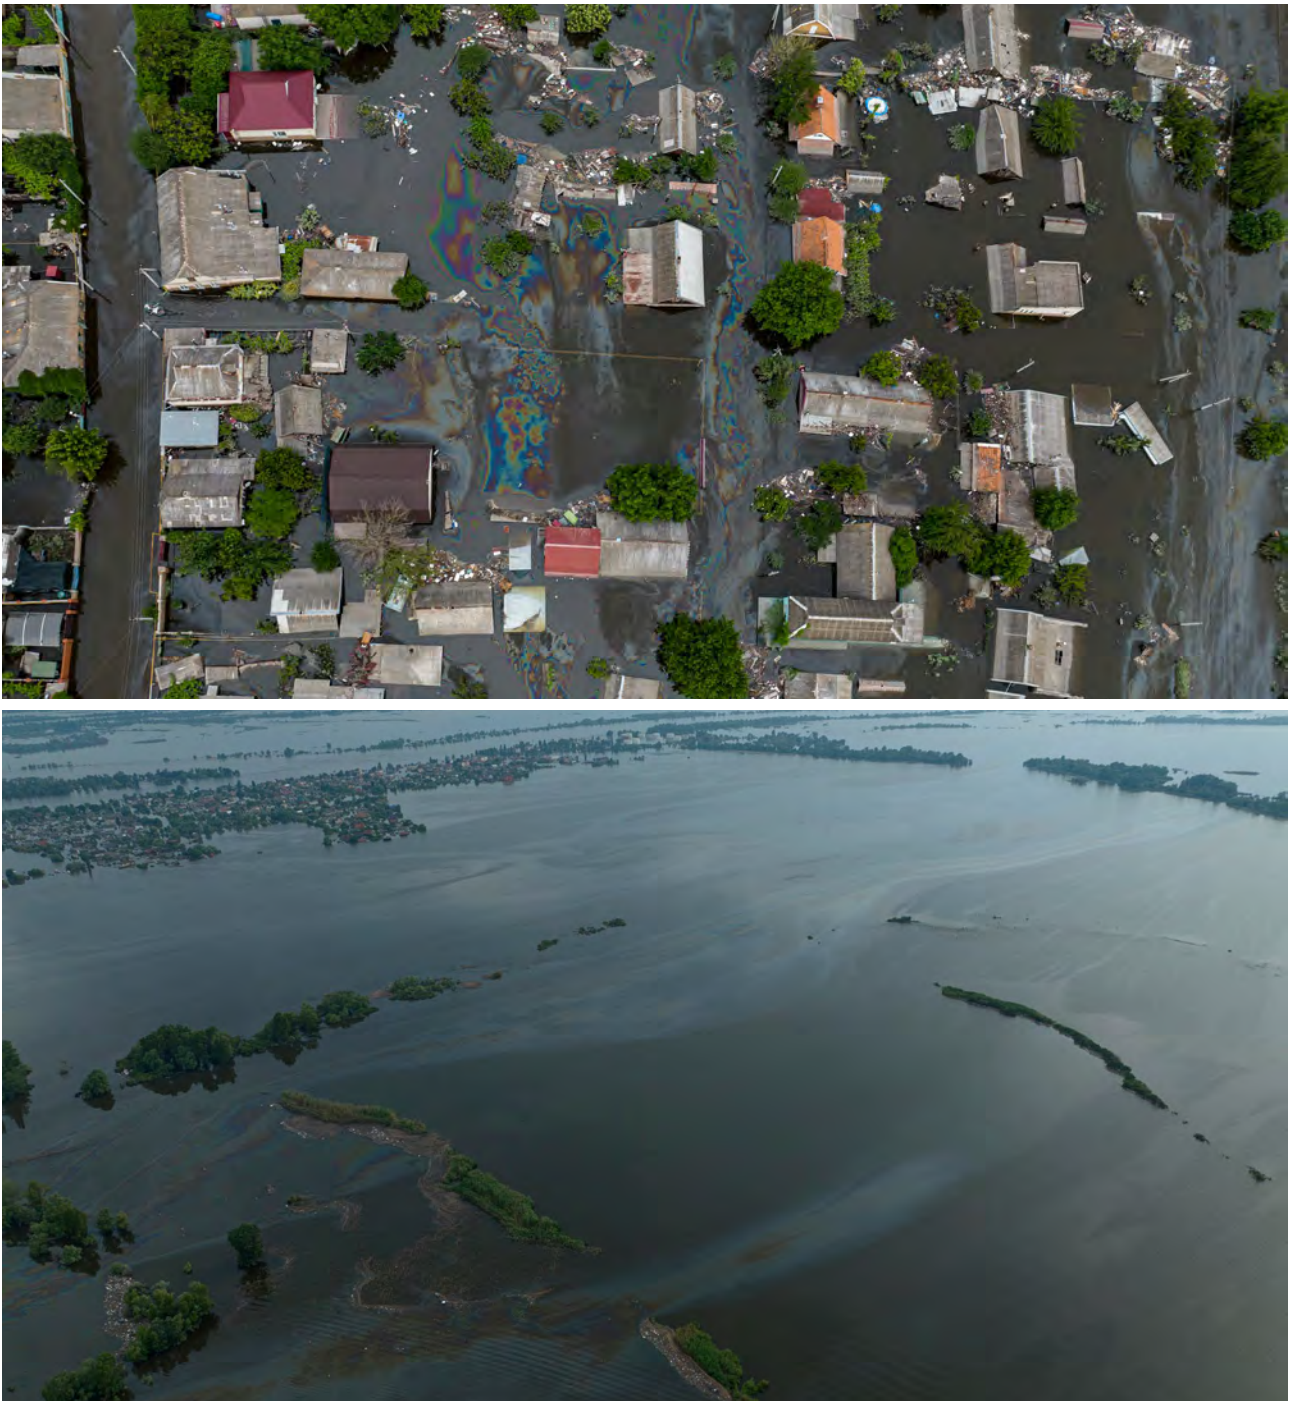
Figure 26. Aerial photos taken on 10 June 2023 show oil slick on flood water in Kherson area Top: Contaminated water: Gasoline can be seen next to flooded houses in a district of Kherson Bottom: Large amounts of leaked fuel are washed through the flood areas in the Dnipro (© KEYSTONE/ AP Photo)

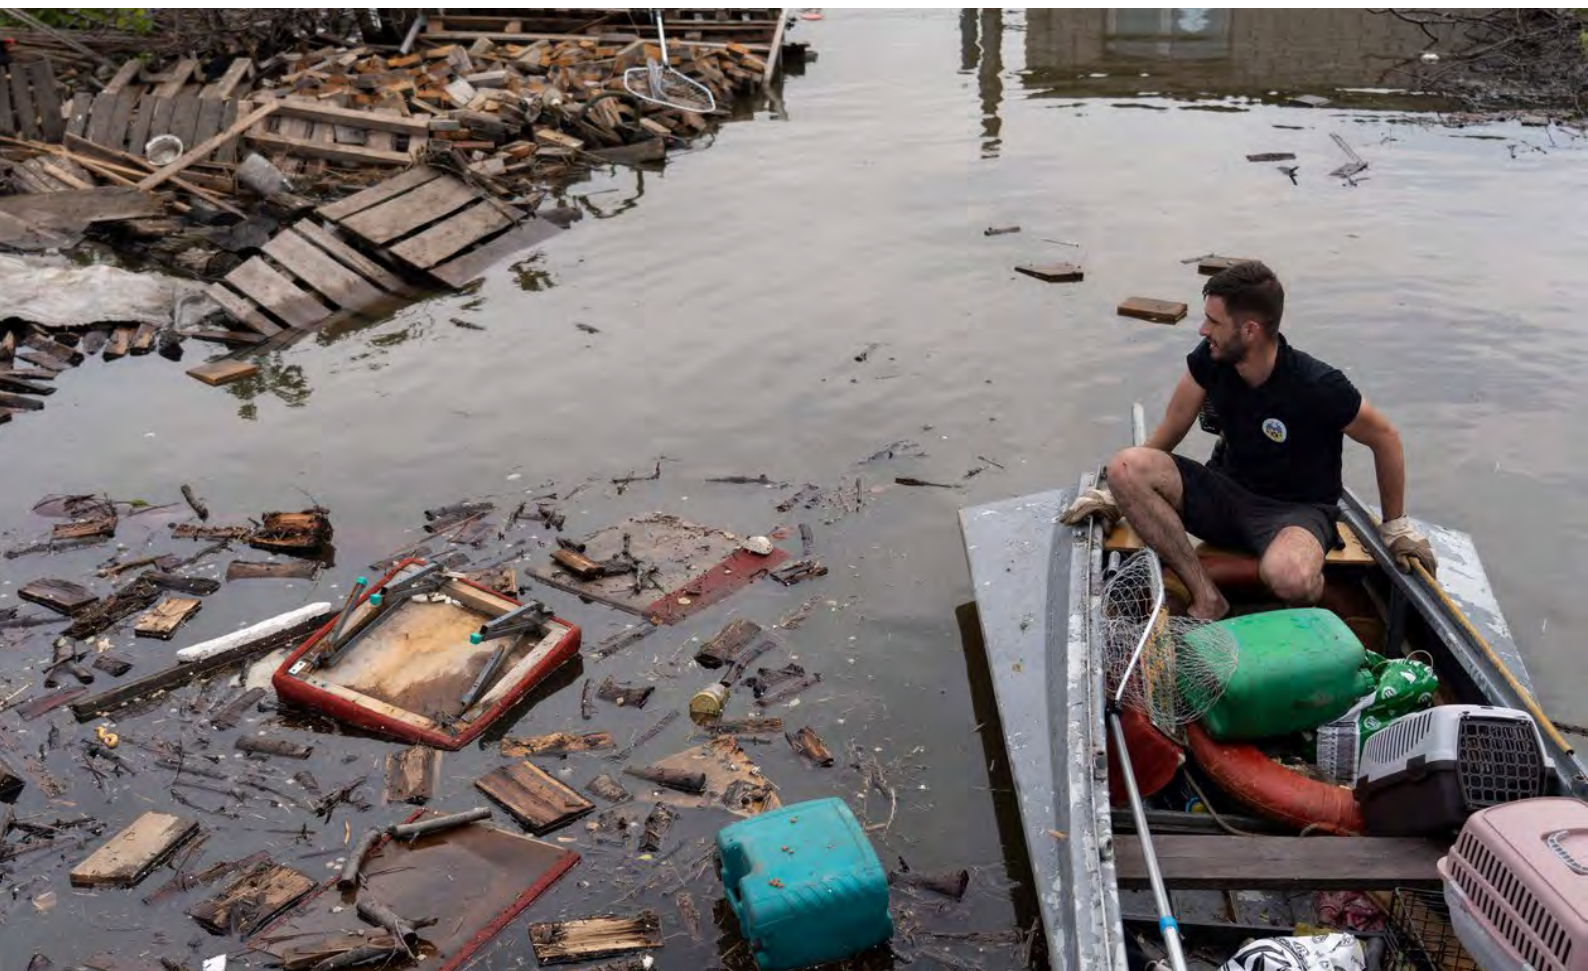
Figure 30. An animal rescue volunteer moves among floating debris on a boat in floodwaters at Kherson on 8 June 2023
(© 2023 Aleksey Filippov/AFP via Getty Images)

Biological hazards related to dead domestic or wild animals is not considered in detail here, even though it was considered a significant concern following the dam breach (Figure 30). This is due to the fact that biological waste is not considered by various disaster waste conceptual models, and the information on biological waste was unavailable. No reports of larger deposits of mud have been found and the post disaster handling of mud will probably not require significant management responses. Neither will this report focus on other types of natural materials such as dead trees. Assessment of waste within this report is mainly focused on inert debris (concrete, wood and metal) from residential buildings. While the potential chemical waste from companies and operations is considered in section 3.3.2, the creation of debris waste from industries and operations is considered to a lesser extent. This is considered warranted as:

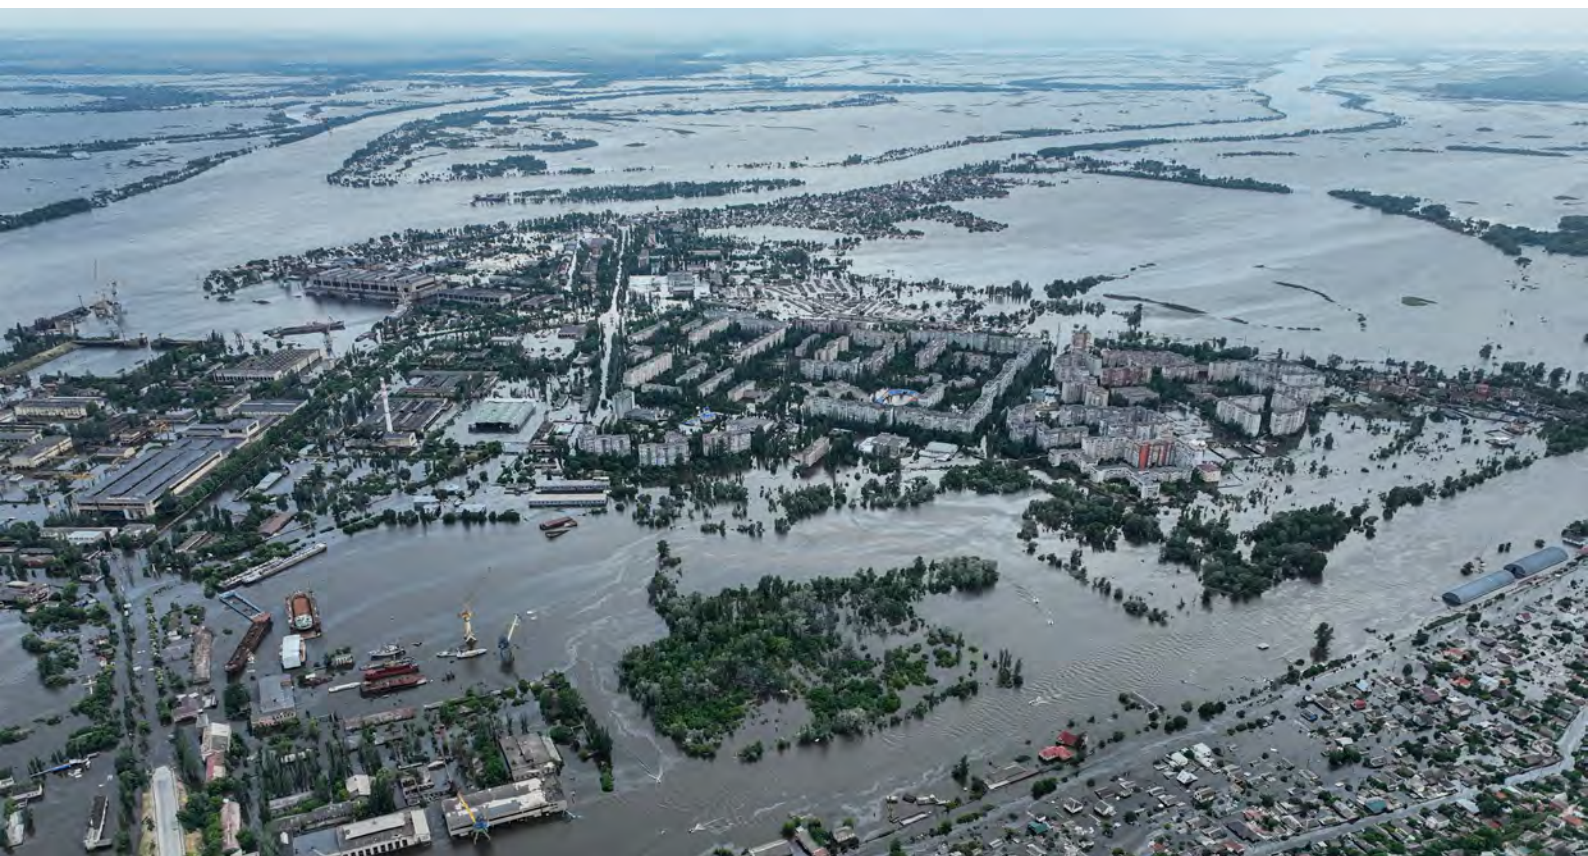
Figure 31. The photo taken on 10 June 2023, shows flooded area west of Kherson on the northern side of the river. Heavy industry and residential areas are located close together (© KEYSTONE/ AP Photo)

The northern shore, where the city of Kherson is situated, contains areas of heavy industry such as the wharf and the former brick work in close proximity to residential buildings (Figure 31). Downtown Kherson contains larger, higher buildings, surrounded by suburban quarters, which were mainly unaffected by flooding. Meanwhile, the southern side is more rural with less industry, smaller settlements as well as smaller buildings with mainly one storey and more dependent on farming (Figure 32). In several settlements, Korsunka for example, every household has its own greenhouse of several hundred square metres. The three larger towns in the affected area, Nova Kakhovka, Oleshky and Hola Prystan contain more residential areas without farming, but still consist of mainly smaller buildings.

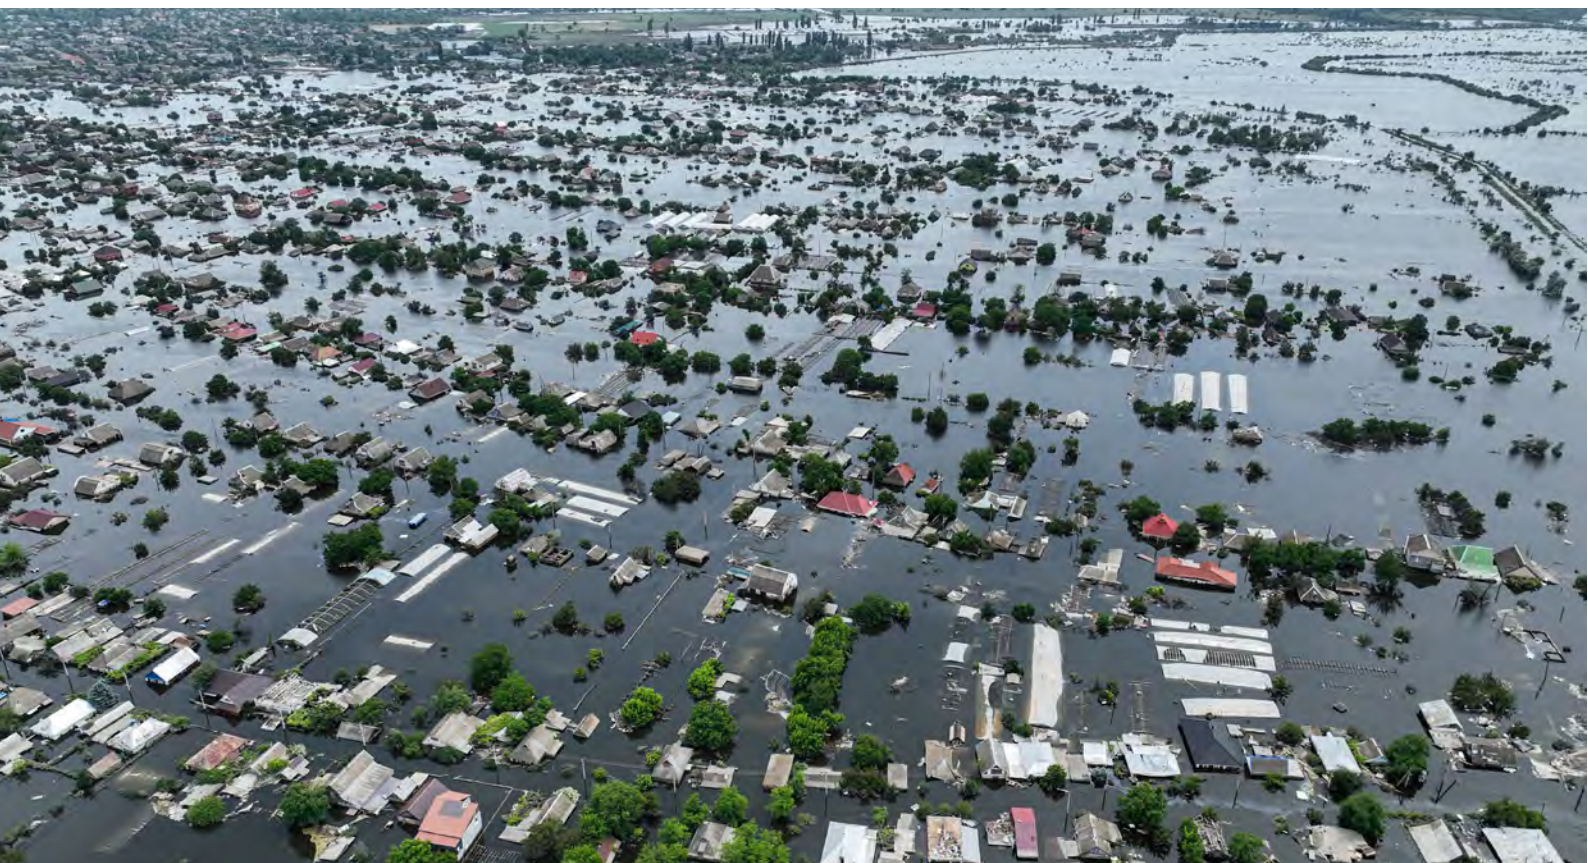
Figure 32. The photo taken on 10 June 2023, shows a flooded settlement of Oleshky on the southern side of the river. The buildings are smaller and the settlements more rural on the south side of the river (© KEYSTONE/ AP Photo)

The disaster waste on the southern side is expected to consist mainly of waste from small residential buildings and from greenhouses. Many buildings will have been fully flooded but it is difficult to estimate the extent to which greenhouses have been damaged. Within the delta, a couple of smaller settlements with small buildings are located on the waterfront by the river and have been heavily affected by the flooding.

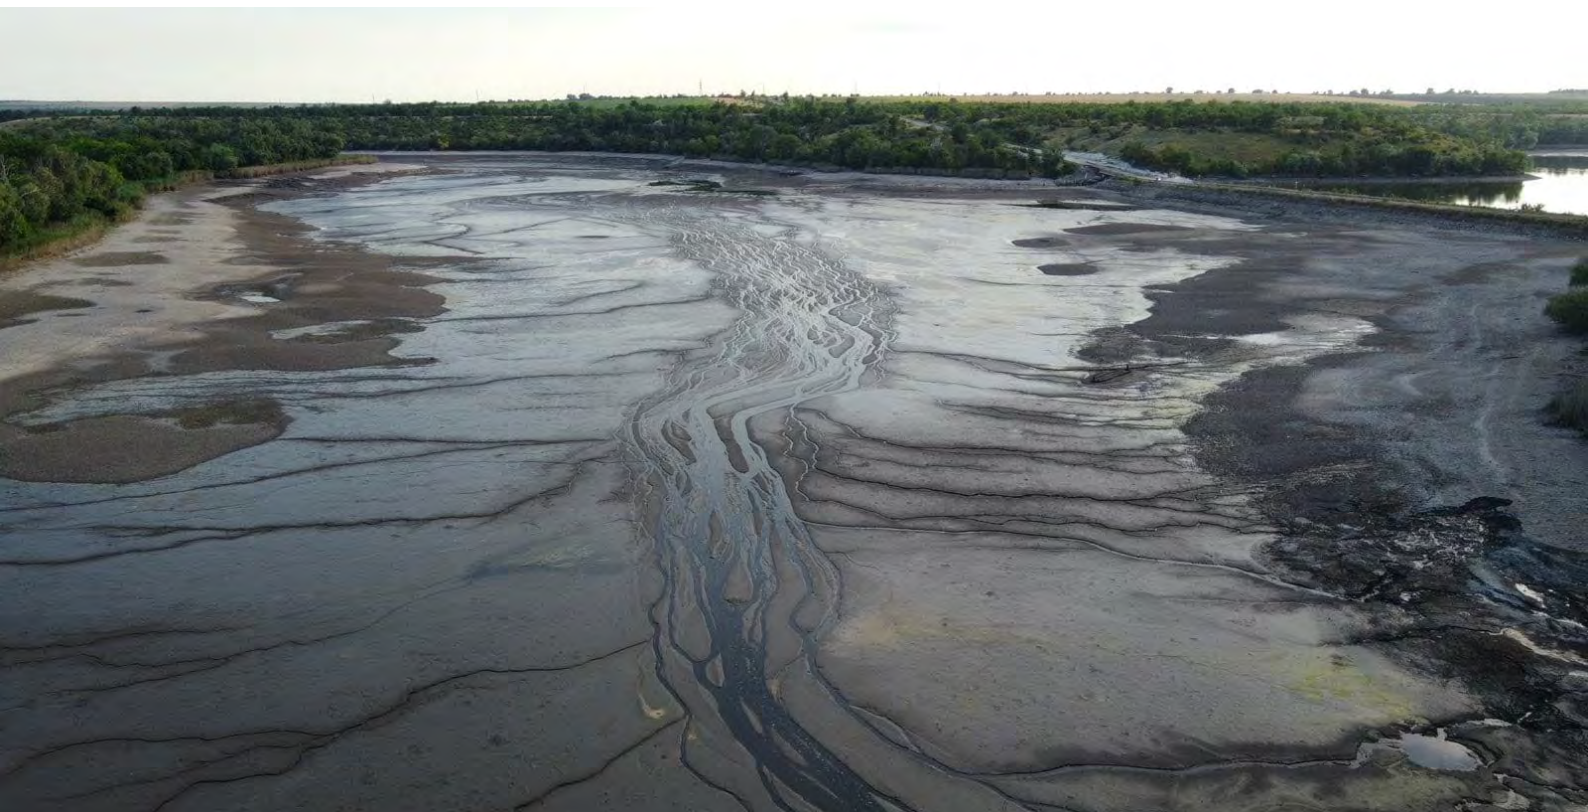
Figure 36. Water levels decreasing at Kamianska Sich National Nature Park immediately after the dam breach (© Serhii Skoryk)

The other group of PAs located upstream of the dam and likely to be affected by changed conditions in the coming months, are those located in the larger surrounding region whose vegetation depends on water provided by irrigation channels, previously supplied by the Kakhovka reservoir. The desertification of larger areas due to the lack of water, e.g. the North Crimean Canal, and the lowering of the groundwater level is highly likely to threaten not only the agricultural production in the region, but also its PAs, regardless of their distance from the Kakhovka dam. A photo showing the decrease in water levels is provided in Figure 36.

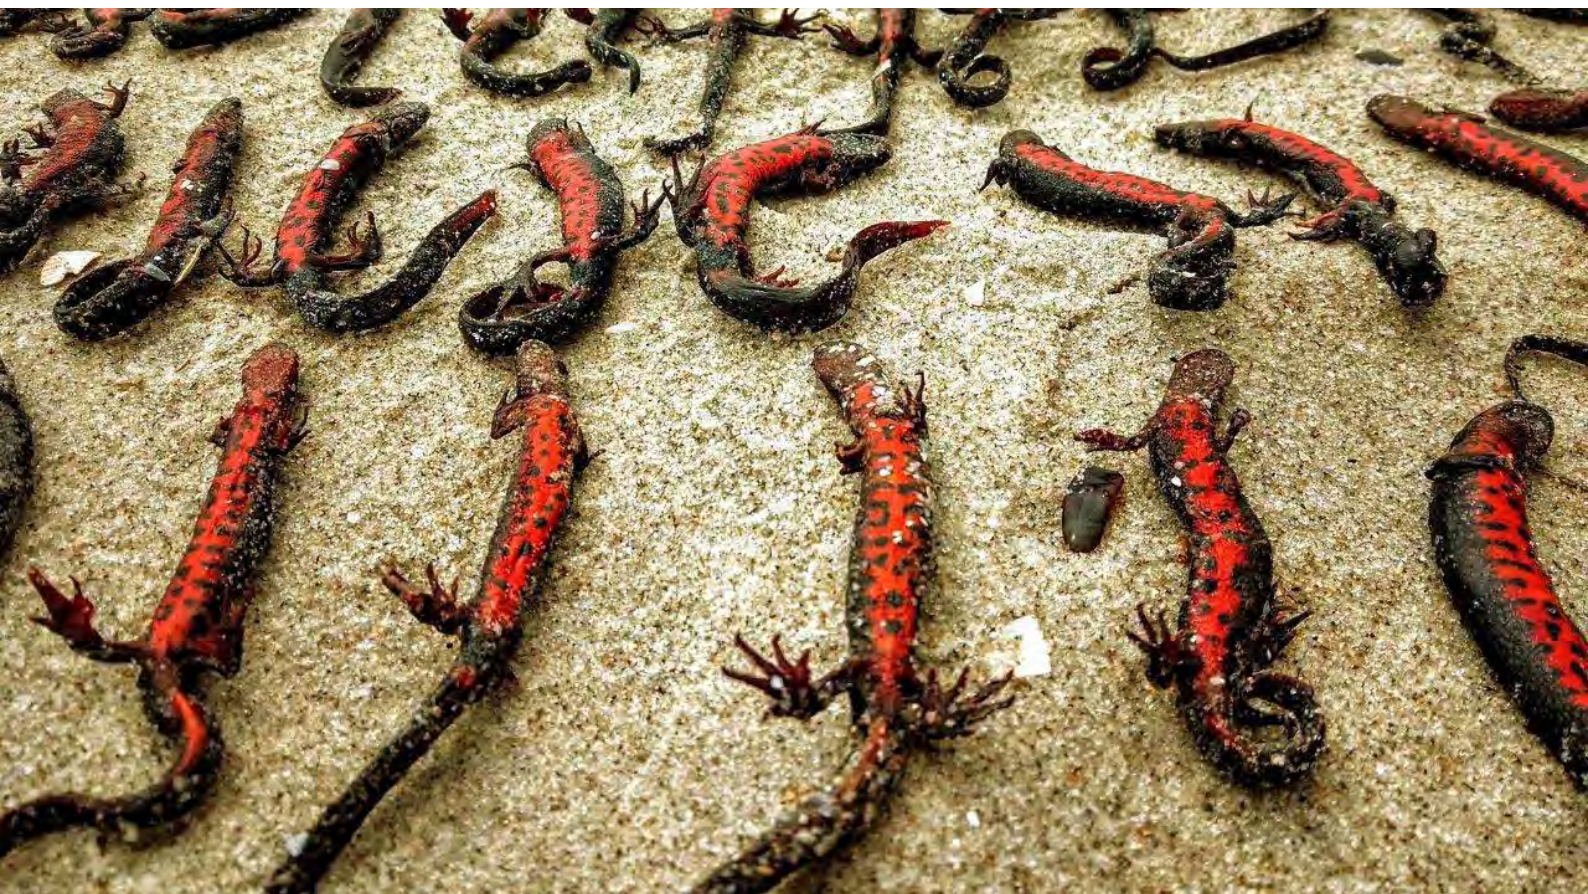
Figure 37: Around 150 rare newts are reported dead following the Kakhovka dam breach (Source: Ukraine, MEPNR 2023)

- The high-velocity water washed away the soil, vegetation and specimens of aquatic and terrestrial species, causing them to drown or be dragged downstream and potentially perish due to changed environmental conditions. Evidence gathered after the breach includes well-documented cases of animals deployed as far as into the Black Sea, where the higher salinity of waters was lethal for the specimens of freshwater species (Figure 37).

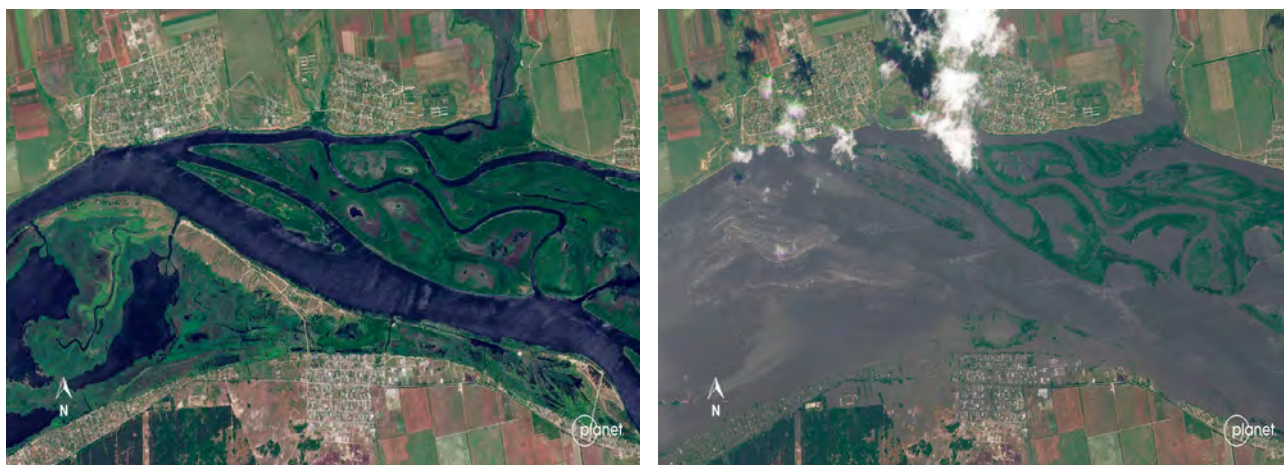
Figure 38. Satellite imageries from 5 and 6 June 2023 shows the extent of flood in the riverine area at Korsunka town (Source: Sadler 2023; © 2023 Planet Labs PBC)

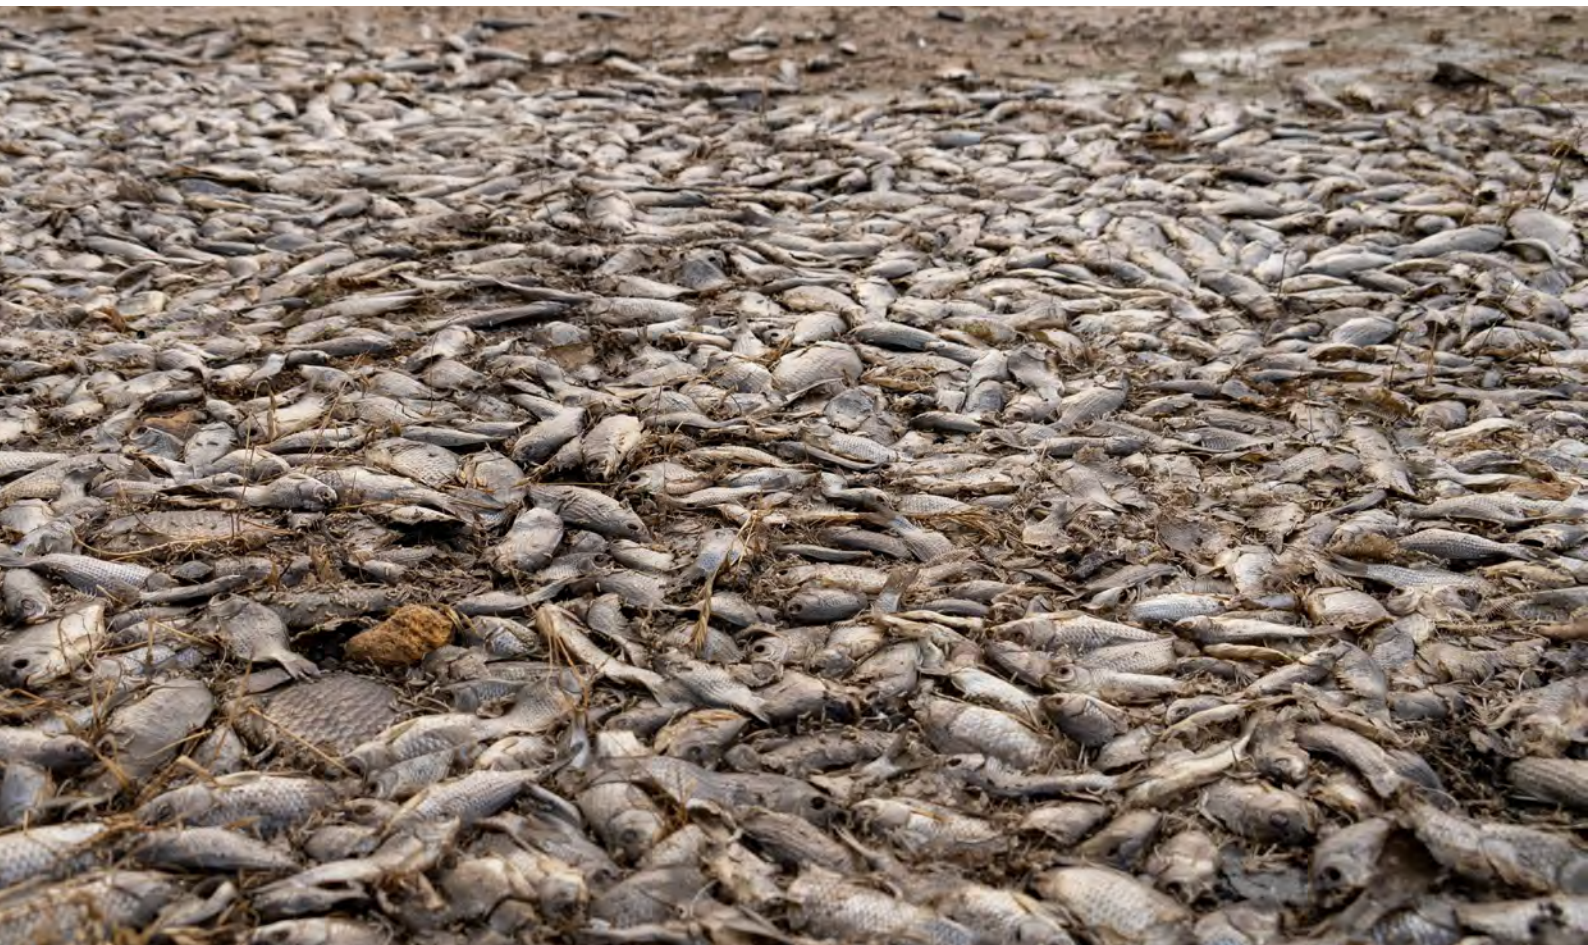
Figure 39. Dead fish are seen on the drained bottom of the Kakhovka reservoir (© KEYSTONE/AP Photo/ Mstyslav Chernov)

The dam breach has been catastrophic for marine life and national authorities report that tens of thousands of kilograms of fish have been affected, including commercial species, with the majority affected by the desiccation of the Kakhovka reservoir (Figure 39). The Ukrainian Government has confirmed the loss of 11,388 tons of fish (Ukraine, Ministry of Agrarian Policy and Food 2023b). As the breach occurred during the spawning season, fisheries have been impacted for coming seasons.

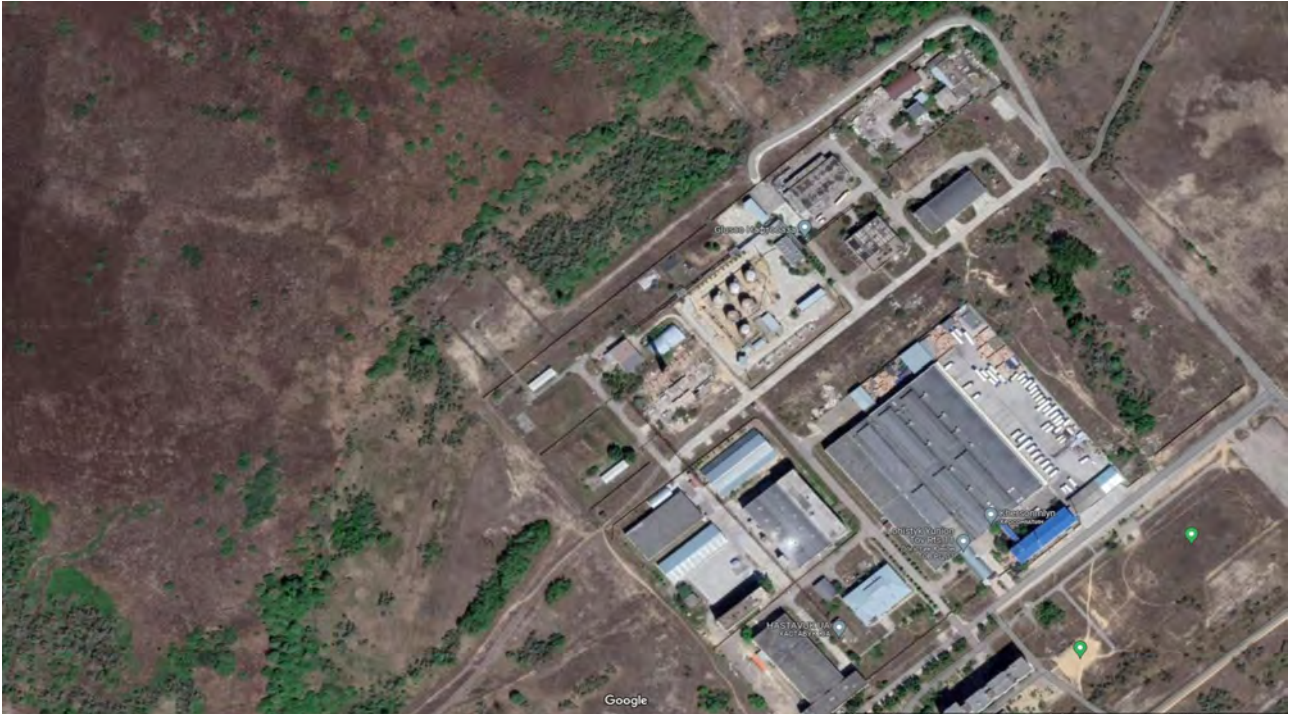
Figure 45. Glusco fuel storage area (Source: Map data @2023 Google)

At the Glusco fuel storage area (Figure 45 located at 46.625226; 32.789267) located beyond the control of Ukraine fuels were stored. It is unknown whether this oil was still present during the flood and what the integrity of the tanks was before or after the flood.

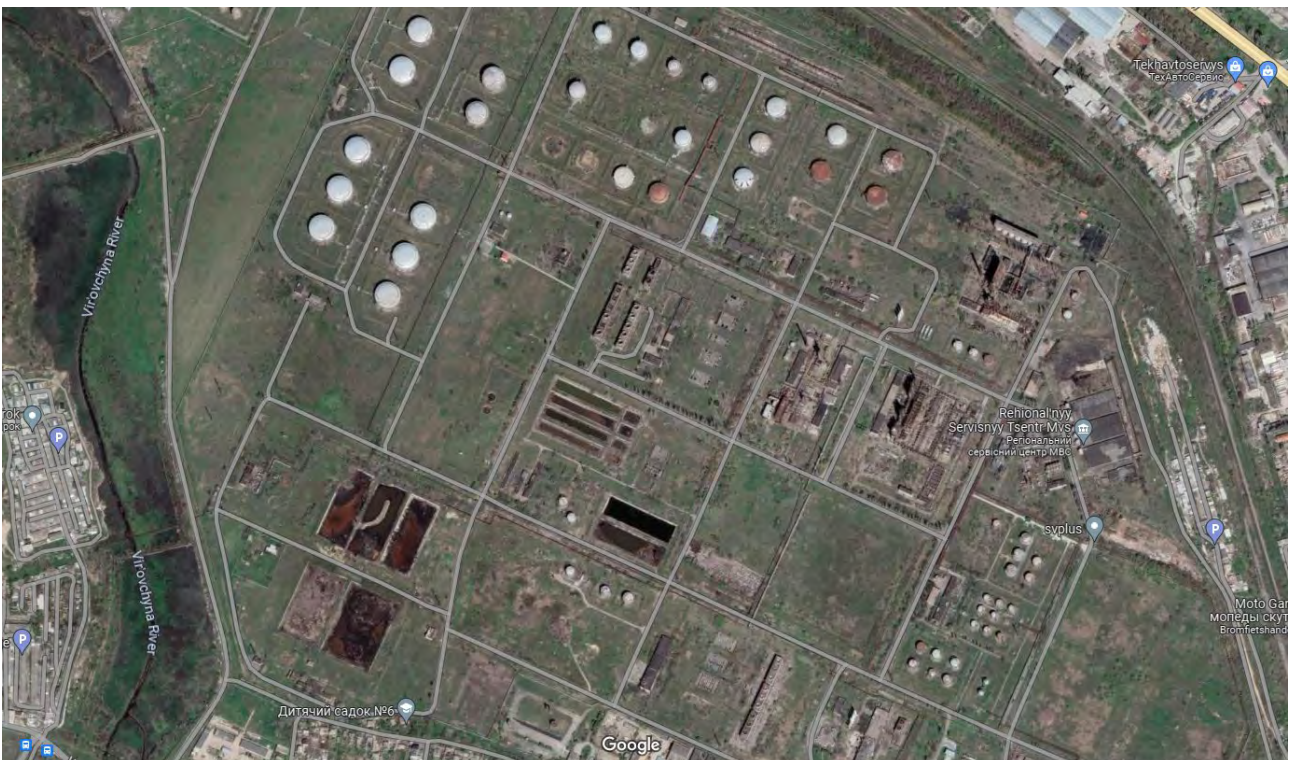
Figure 46. Fuel storage area in northern Kherson (Source: Map data @2023 Google)

At a site located in northern Kherson several huge storage tanks for fuel were located (Figure 46 located at 46.675692; 32.559648). It is unknown whether this oil was still present during the flood and what the integrity of the tanks was before or after the flood.
