Rapid Environmental Assessment of Kakhovka Dam Breach

Ukraine, 2023

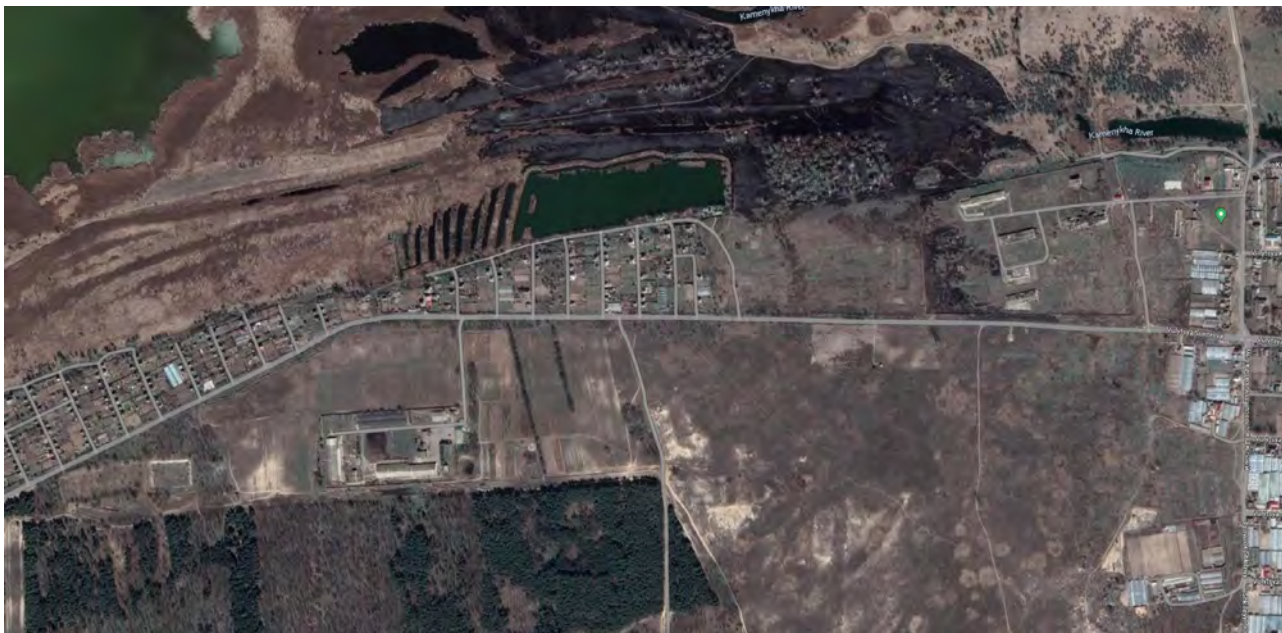
Figure 47. Farm area in Korsunka located in the area beyond the control of Ukraine (Source: Map data @2023 Google)

Large scale livestock and poultry farms can pose a double risk, if the animals were still present during the flood. Drowned animals pose a risk to human health as well as through large amounts of manure entering the surface water. Manure in the water poses a biological hazard due to microorganisms present in the manure and can also cause eutrophication due to the large amounts of nutrients present. Large scale farms located in the flooded area are shown in Figure 47 and Figure 48.

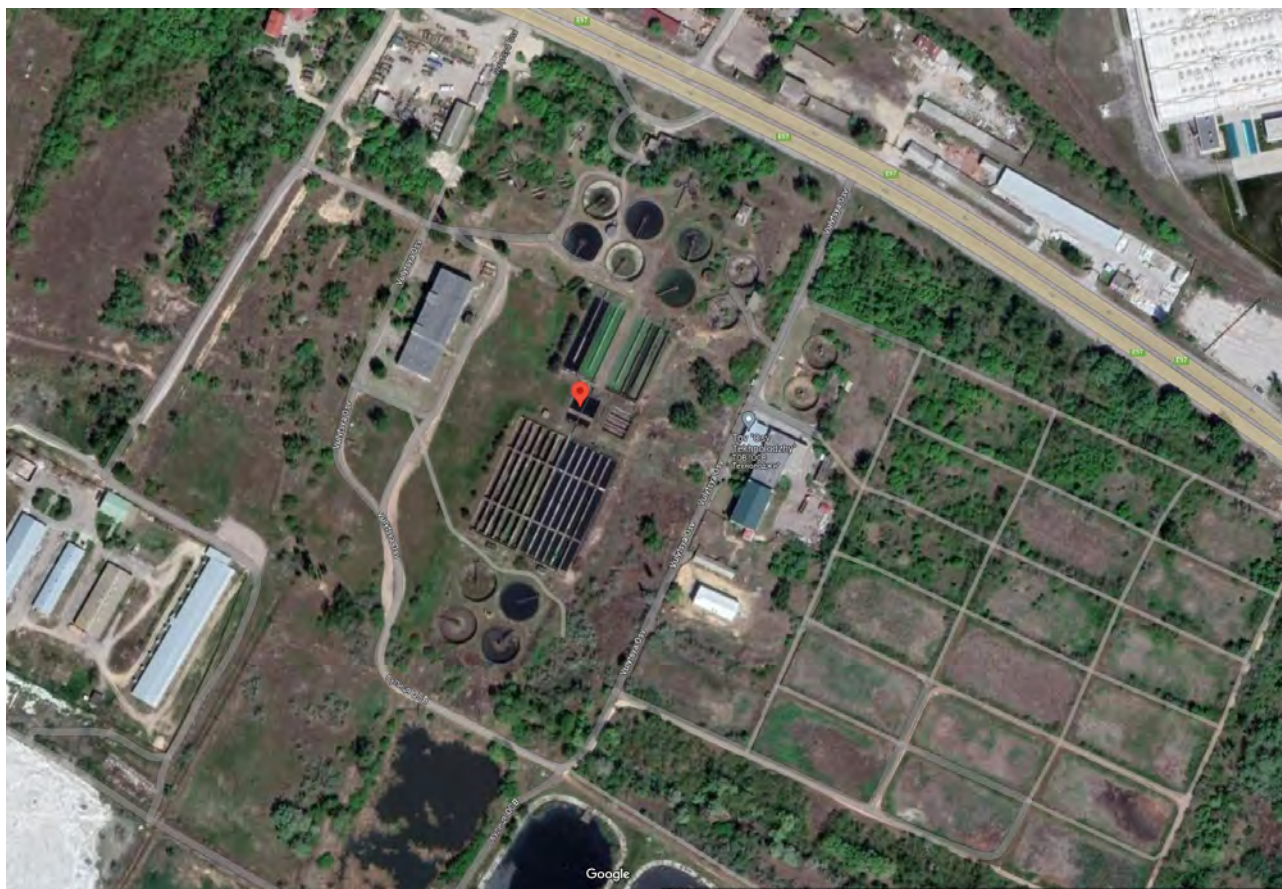
Sewage treatment plants are reported to have been flooded with the Oleshki wastewater treatment plant (location 46.622327; 32.769576) shown in Figure 49.

Figure 49. Oleshki wastewater treatment plant (Source: Map data @2023 Google)
