# **Fort Ward Park Playground Accessibility Community Meeting #3**

Department of Recreation, Parks and Cultural Activities  
Office of Historic Alexandria  
June 22, 2022

# Fort Ward Park Playground Accessibility

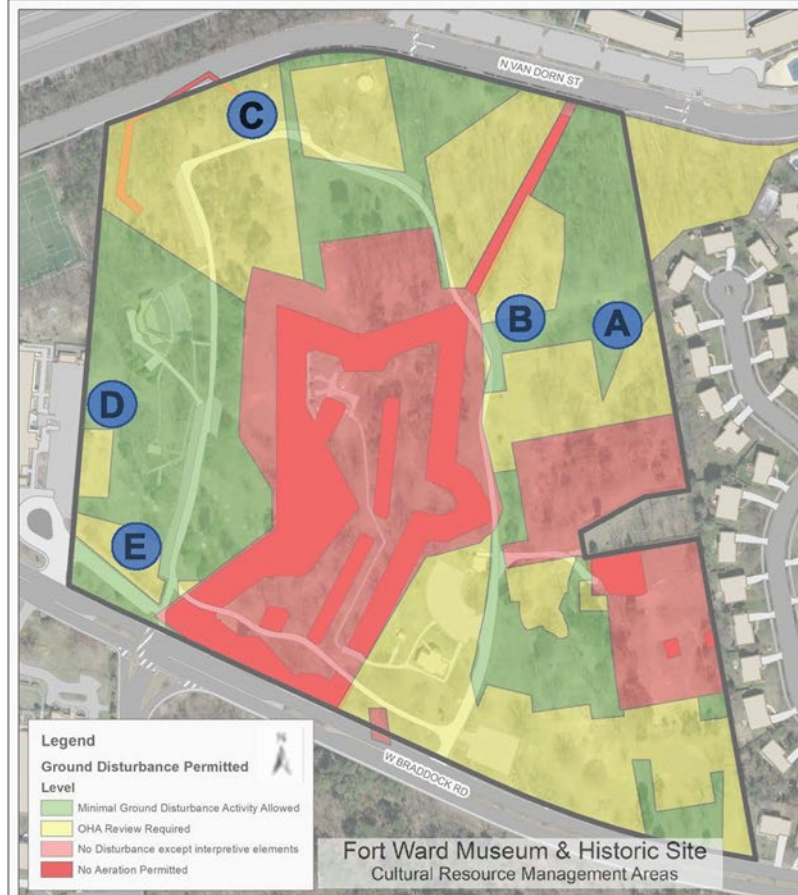
Fort Ward Museum & Historic Site  
Cultural Resource Management Areas

**Ground Disturbance Permitted Level**

- Minimal Ground Disturbance Activity Allowed
- OHA Review Required
- No Disturbance except interpretive elements
- No Aeration Permitted

- A** Retain playground in current location; build accessible path
- B** Relocate playground to top of hill
- C** Relocate playground to the area west of the picnic shelter
- D** Relocate playground to area south of amphitheatre
- E** Relocate playground to area south of area 5

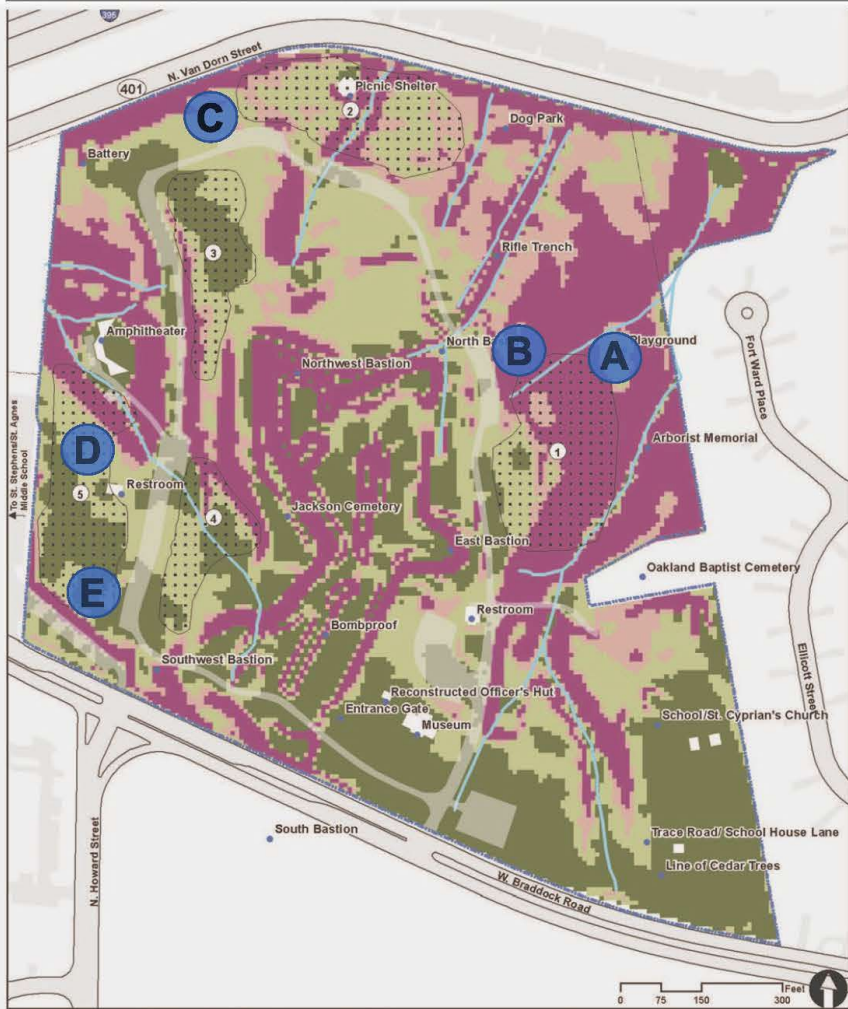
**Fort Ward Park and Museum Area Management Plan**  
City of Alexandria, Virginia

Management Plan Boundary	Percent Slope (per ORAR guidelines)
Road or pavement	0% - 5%
Drainage flowlines	5.00000001% - 8.3%
Park Feature	8.30000001% - 10%
Picnic Area	10.00000001% - 80%
Contour 2'

**ORAR\* Slope Intervals**  
\* According to the Access Board Outdoor Recreation Access Route (ORAR) Guidelines for Outdoor Developed Areas (Oct. 19, 2009), "1016.7.1 Running Slope: The running slope of any segment of an outdoor recreation access route shall not be steeper than 1:10. Where the running slope of a segment of an outdoor recreation access route is steeper than 1:20, the maximum length of the segment shall be in accordance with Table 1016.7.1, and a resting interval complying with 1016.8 shall be provided at each end of the segment."  
Slope intervals shown on this map correspond with the slope guidelines for Outdoor Recreation Access Routes indicated above. Slopes steeper than 1:20 (5%) but not steeper than 1:12 (8.3%) can have a maximum segment length of 50 feet. Slopes steeper than 1:12 (8.3%) but not steeper than 1:10 (10%) can have a maximum segment length of 30 feet. Slopes greater than 1:10 (10%) are too steep for outdoor recreation access routes.

<b>Natural Resources</b>	Mature trees surround the current playground site. Species include Red Oak, tulip tree, hickory, maple, persimmon, service berry, dogwood.	The top of hill has sparser trees that include a white oak, dogwood, black cherry, and hickory.	The grove of trees located to the west contains black gum, hickory, red oak, chestnut oak, and persimmon. Vegetation lines the north side of the park along Van Dorn Street.	A grove of trees is located to the east containing pine, willow oak, white oak, persimmon, and black cherry trees. Two kousa dogwood trees are located in the middle of the grass area. Several black cherry trees are located to the west and north.	A 28" cal. willow oak tree is located to the east. Shrubs line the south side. Tree grove located north of area.
<b>Existing Topography</b>	Existing slopes are greater than 10%. Some areas are steeper, 22% slope. Elevational change from the parking lot to playground is approximately +/- 28 feet	Existing slopes range from 10 to 14 %.	Existing slopes are approximately 7.5 - 9.0%	Existing slopes range from 6.0 to 8.0 %	Existing slopes range from 6.0 to 8.0 %
