BAR Review Levels

SIDING+TRIM

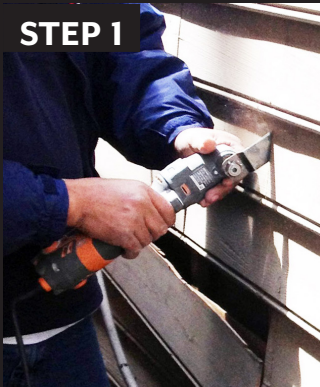
STEP 1

Carefully remove a 2 foot by 2 foot portion of the surface siding.

Intact historic siding may be hidden beneath layers of siding, such as aluminum, vinyl, artificial brick, or stone. To determine if multiple layers of siding exist, remove at least one portion a minimum of 2 feet by 2 feet to reveal the first layer of siding. Staff will inspect the mock-up in the field prior to any approval. The graphic on the following page gives an overview of this process.

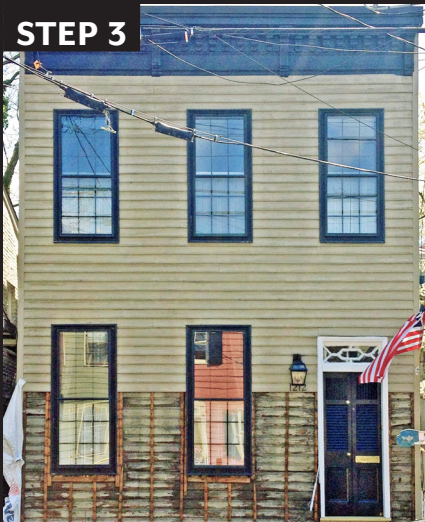
STEP 3

^ BEFORE

More of the historic siding is exposed for Staff to assess its condition. In this case, the historic siding is in very good condition and will be stripped and painted for reuse on this building.
