Camden County Superstructure Repairs

**Camden County Department of Public Works
Division of Engineering
Superstructure Repairs for Cuthbert Boulevard (CR 636) Bridge and
Grove Street (CR 644) Bridge over Cooper River
Camden County, New Jersey
Weekly Progress Report No. 1
July 30, 2018 to August 4, 2018**

**Superstructure Repairs for Cuthbert Boulevard (CR 636) Bridge
and Grove Street (CR 644) Bridge over Cooper River
Camden County, New Jersey
Weekly Progress Report No. 1: 7/30/18-8/4/18**

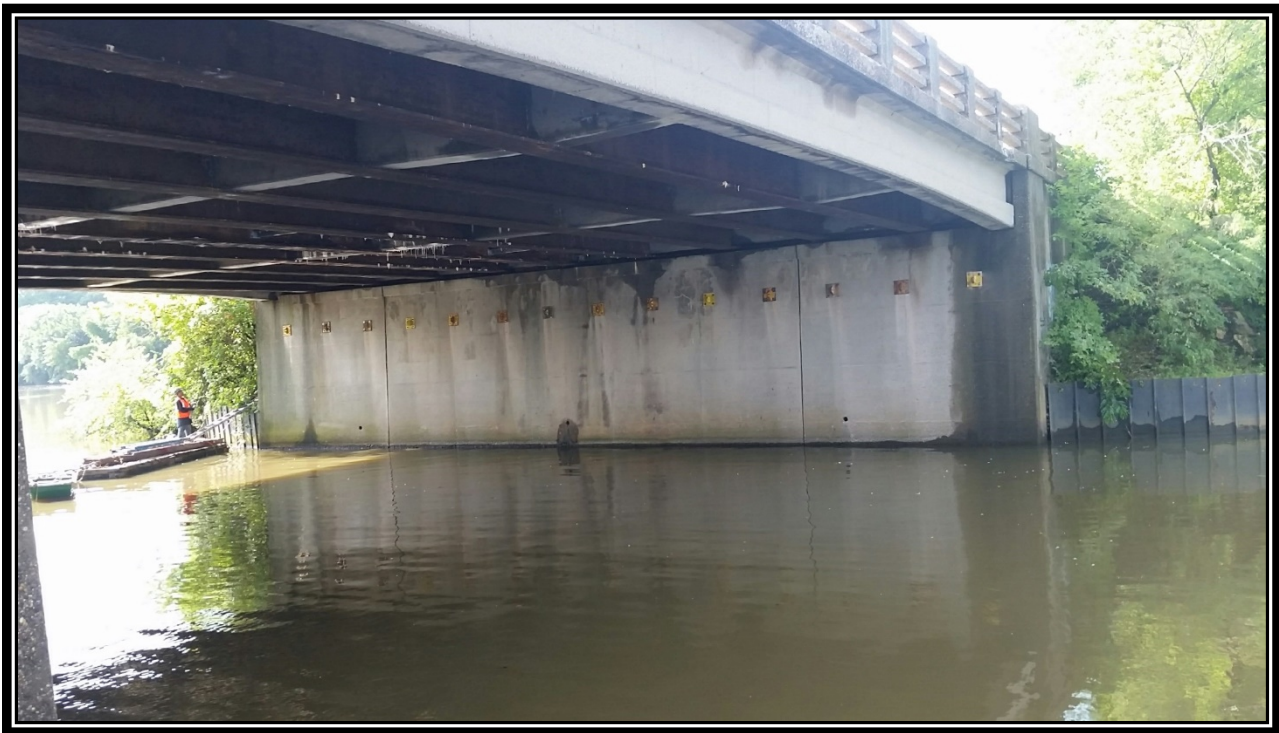
Figure 1: Cuthbert Blvd - Shielding Setup – 8/1/18

South State Inc. (SSI) employed their subcontractor, Allied Painting Inc (API) to install shielding starting at Cuthbert Blvd. The contractor installed the shielding and work platform per the approved shop drawing. The metal decking was hung by cables from the concrete deck.

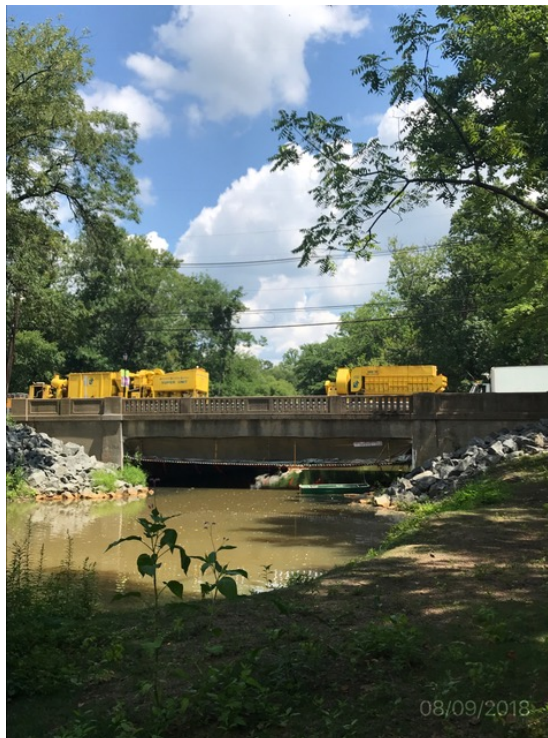
Figure 1: Grove St. Bridge Near-White Blast & Paint

South State Inc. (SSI) had their subcontractor, Allied Painting Inc (API) install Pollution Control System shielding at Grove St. The contractor installed the shielding and work platform per the approved shop drawing. The metal decking was hung by cables from the concrete deck. Tarps were installed at both East & West sides of bridge. Crew then preform Near-White Blast and applied Primer paint coat. SSI set in place MPT for Detour assisted by Haddonfield Police for the two days of Near-White Blasting and Primer application. JMT representative visited the site to perform inspection of the steel once blasted.

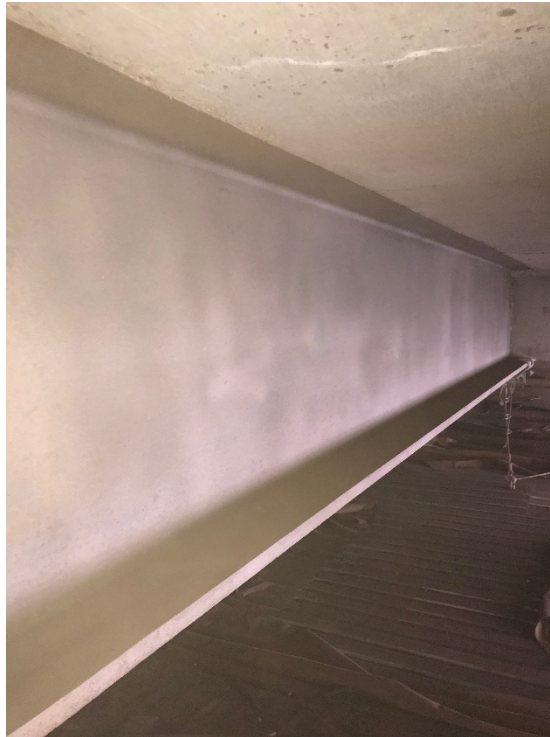
Figure 2: Cuthbert Blvd. Bridge Prime Coat

South State Inc. (SSI) along with Haddon Twp. Police set in place MPT for right lane closure during Near-White Blast & Primer application. Allied Painting Inc. (API) finished installation of Pollution Control System tarps at both the East & West sides of bridge. Crew then set up equipment and proceeded to perform the Near-White Blast & Primer paint application as per specifications. JMT representative visited the site to perform inspection of the steel once blasted.

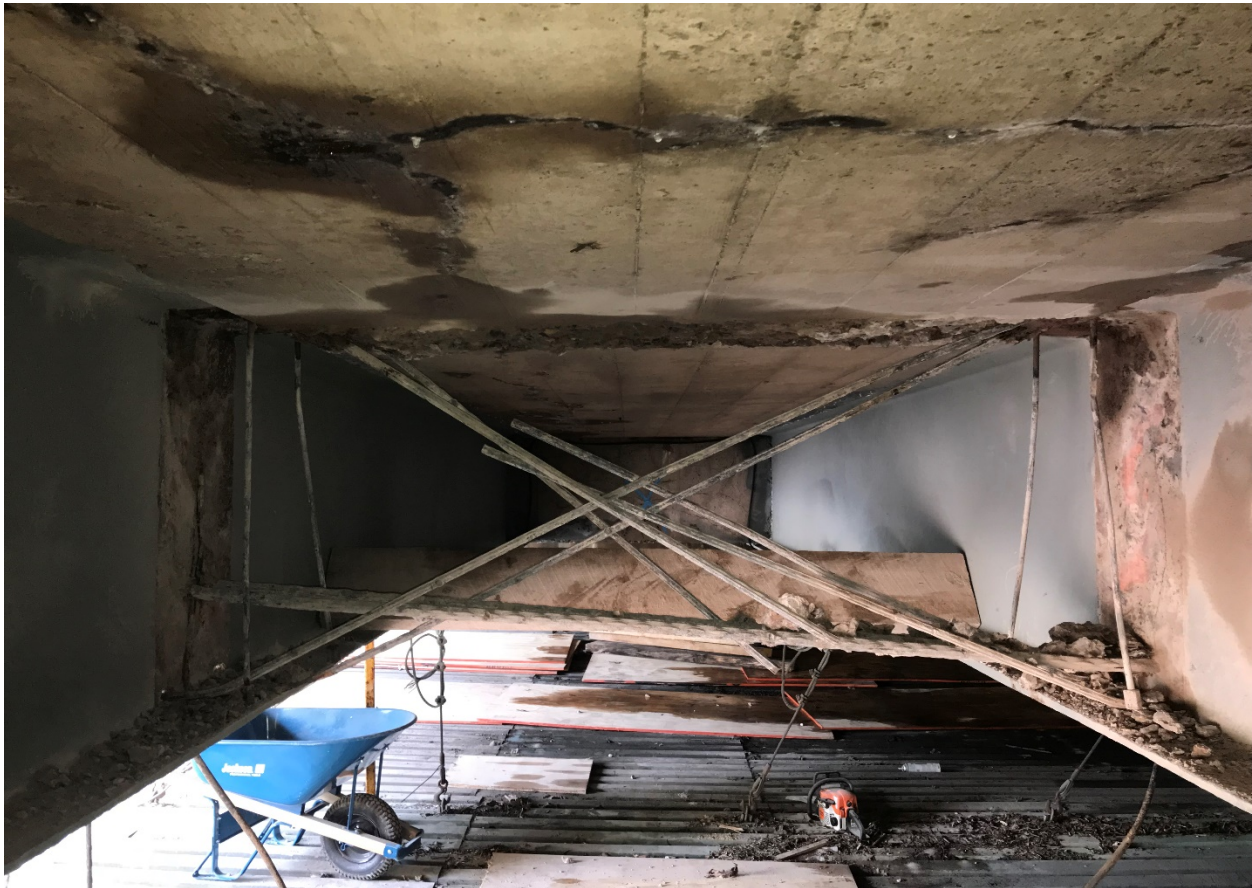
Figure 1: Grove St. Bridge Demolition of Concrete Diaphragms Beam G-9 – G-8

South State Inc. (SSI) had their subcontractor deliver additional construction signage to site and place on the ready at all the intersections on Grove Street. Materials consisted of Type III Barricades and appropriate signage pertaining to detour route. SSI crews set in place detour on Monday, August 27, 2018. Once detour was in place and police in position SSI place concrete construction barrier at bridge. Crew placed Traffic Control Truck with Crash Cushion. All MPT devices are in place. SSI crew then proceeded to start demolition to concrete diaphragms at beams G-10 to G-9 north end. Crew has completed demolition of concrete diaphragms between G-10 to G-9, G-9 to G-8 and G-8 to G-7 all on North side and are now in process of completing demolition of concrete diaphragms at same locations on South side of bridge.

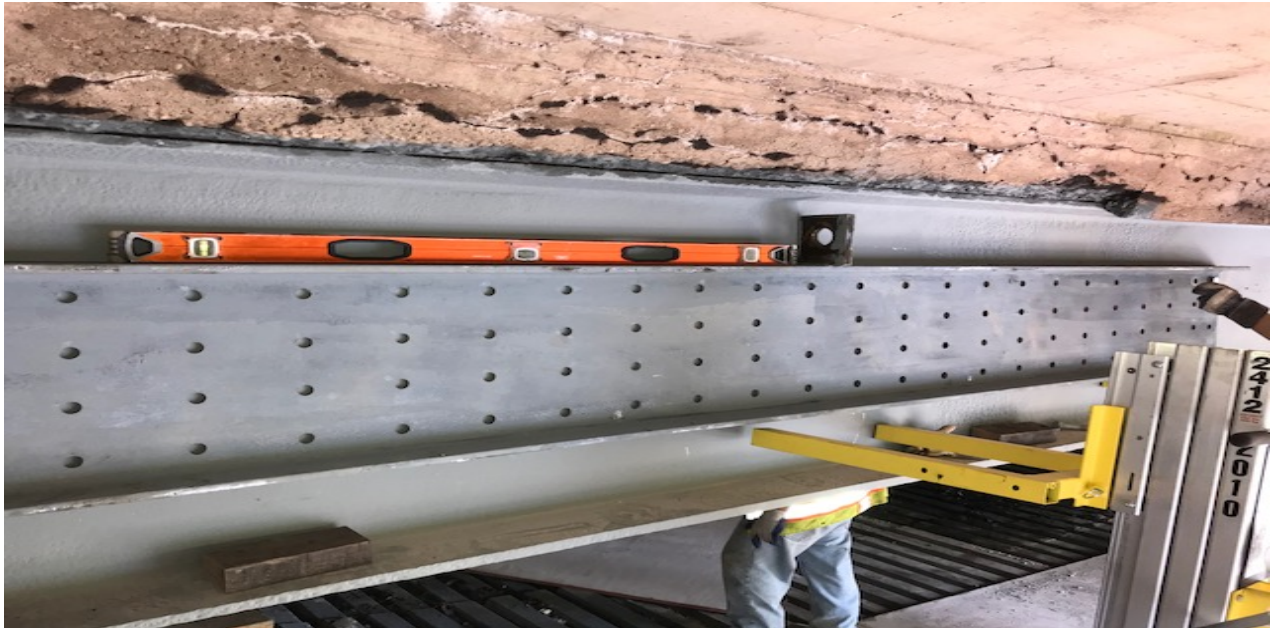
Figure 1: Grove St. Bridge Installation of Structural Steel Channel Beam G-9

- Layout for steel repairs at Beams G-9, G-8 and G-3
- Unload all structural steel material on site and to platform.
- Start repairs to steel beams starting with steel channels at G-9 and G-8
- Structural steel channels complete at G-9 and G-8

South State Inc. (SSI) had their subcontractor deliver structural steel to site and place on the closed section of road northbound direction to sort. Crew used excavator to transfer equipment and materials from roadway to work platform as needed. Crew had set up lifts and assorted equipment for moving structural steel into position. Once ready crew then erected into position the steel channels starting with beams G-9 and G-8. Crew installed and completed structural steel channels at G-9 and G-8 as per plan. Crew then relocated equipment to beam G-3 for structural steel channel installation.

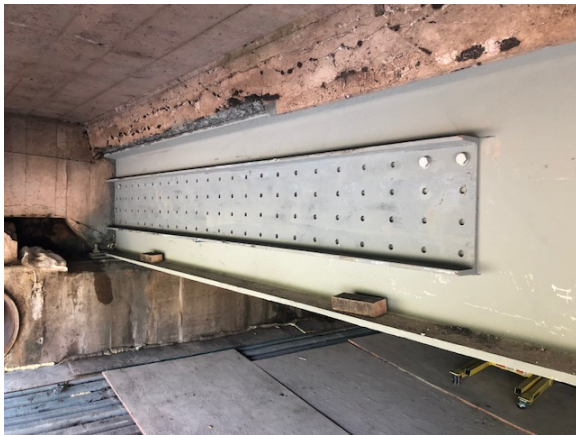
Figure 2: Grove St. Bridge Installation of Structural Steel Channel Beam G-9

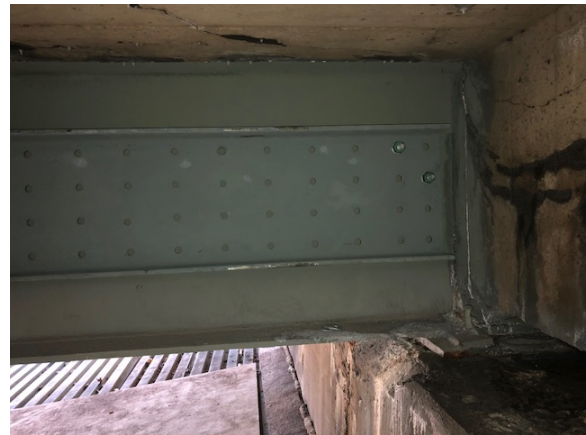
Figure 3: Grove St. Bridge Installation of Structural Steel Channel Beam G-8

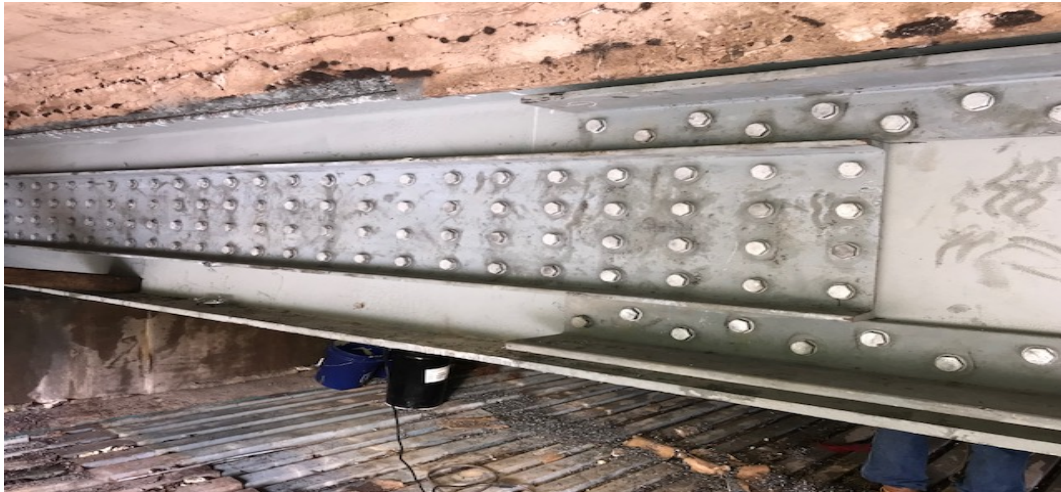
Figure 1: Grove St. Bridge Structural Steel Channel Beam Bolted G-9

- Bolt installation of Structure Steel Repairs to Beams G-9, G-8 and G-3
- All structural steel material as per plan has been installed and bolted to existing steel Beams.
- Start installation of bolts to steel beams starting with steel channels at G-9 and G-8, then finish with G-3.
- Performing Skidmore testing on bolts

South State Inc. (SSI) subcontractor continues to install remainder of structural steel repairs to existing steel beams as per plan. Crew used fork jack lifts equipment to raise materials from work platform into position at individual beams. Crew slid proposed steel channels and angles from lifts to mount to existing beams. Once clamped in position workers then used mag-drill to drill holes into existing steel beams matching proposed steel repairs. Crew finished installation of repair material to G-3. While G-3 was being installed two ironworkers started drilling steel at G-9 and G-8. Once additional holes were drilled, crew started installing bolts. At days end on Friday the 14th of September all steel repairs have had bolts installed. Crew then started with Skid Moore test and bolt torque, however due to weather conditions crew postponed test and torque till Monday.

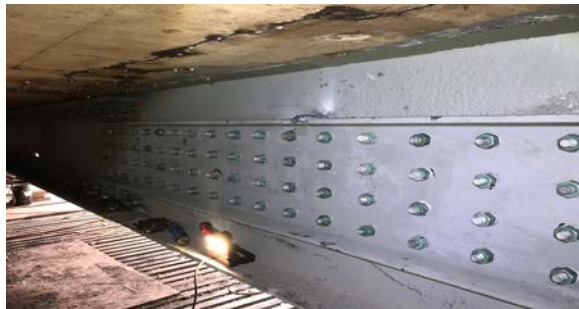
Figure 2: Grove St. Bridge Installation of Structural Steel Channel Beam G-8

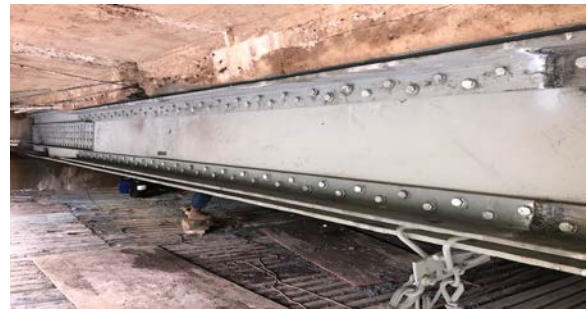
Figure 3: Grove St. Bridge Installation of Structural Steel Channel Beam G-9

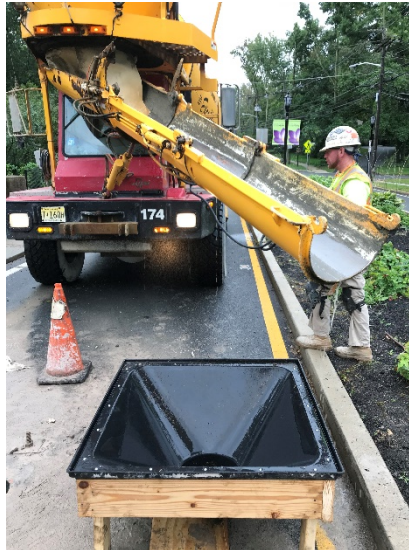
Figure 1: Grove St. Bridge – Concrete Placement

South State Inc. (SSI) carpenters completed form work and core drilling of road deck on and will place HPC concrete for diaphragm replacement. HPC concrete was delivered and placed on 9/25/2018 for the concrete diaphragm repairs. Craig Testing ACI technician on site for testing, sampling and documenting procedures of the HPC installation. Contractor completed HPC placement of the new concrete diaphragm pours and started to do clean up procedures of the road deck removing debris.

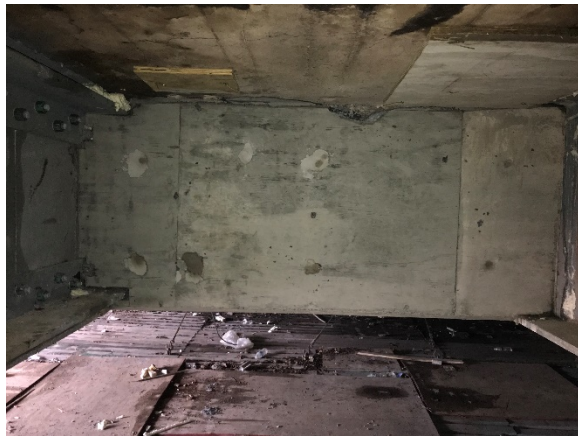
Figure 2: Grove St. Bridge Concrete Diaphragm

- Core drilling completed on 9/24/2018 for concrete diaphragm pour from North and South Diaphragms at G-10 to G-9, G-9 to G-8 and G-8 to G-7.
- Form work and bracing completed on 9/24/2018 for concrete diaphragm pour from North and South Diaphragms at G-10 to G-9, G-9 to G-8 and G-8 to G-7.
- HPC poured on 9/25/2018 for concrete diaphragm repairs for North and South Diaphragms at G-10 to G-9, G-9 to G-8 and G-8 to G-7.
- Craig Testing on site providing Quality Assurance testing for concrete and collected cylinders for break tests and also reports.

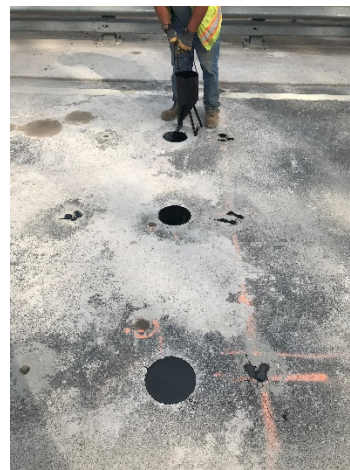
Figure 3: Grove St. Bridge Roadway Restoration

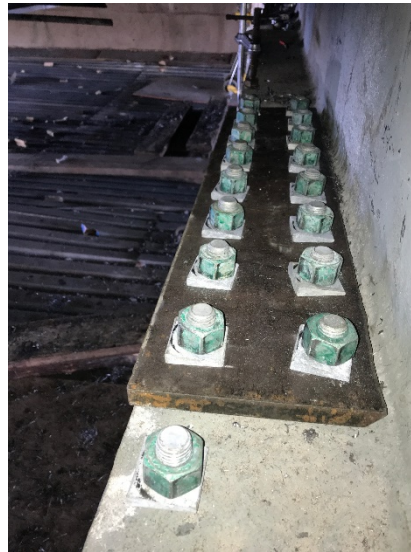
Figure 1: Cuthbert Blvd. Bridge – Steel Installation

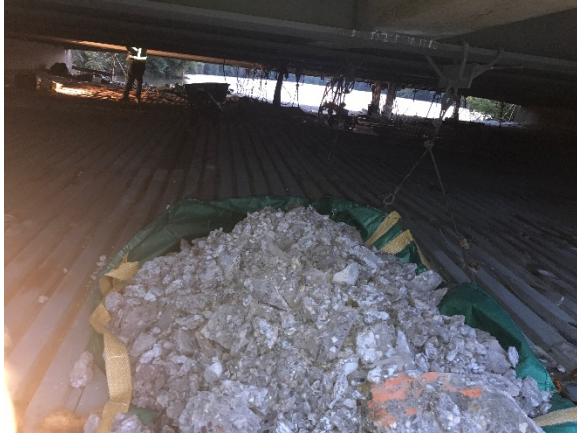
*Figure 2: Cuthbert Blvd. Bridge –
Diaphragm Demolition*

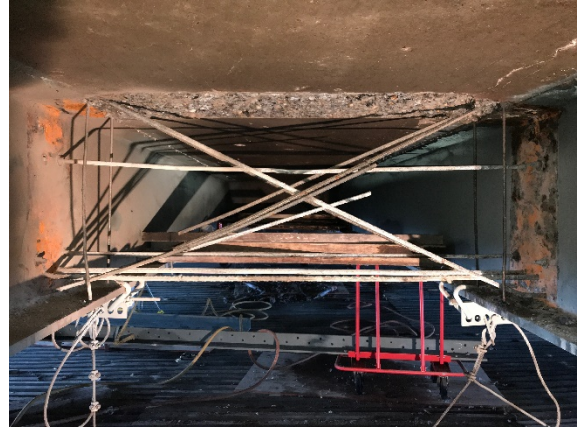
*Figure 3: Cuthbert Blvd. Bridge –
Diaphragm Reconstruction*

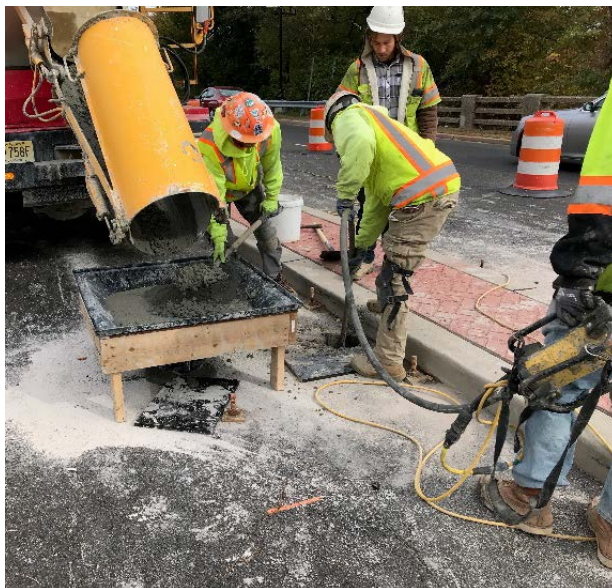
Figure 1: Cuthbert Blvd. Bridge – Concrete Pour

- Completed steel repairs
- Torque and Skidmore-Wilhelm test conducted on bolts
- Installed forms for concrete diaphragms
- Concrete pour

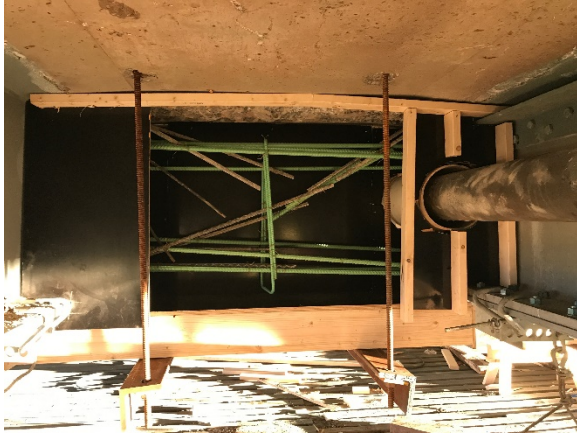
Figure 2: Cuthbert Blvd. Bridge – Rebar and Forms set for Diaphragms
