# Social and Environmental Resource Analysis

# Problems on the 16th Street Mall

## Failing and Outdated Infrastructure Causes Frequent, Disruptive Maintenance

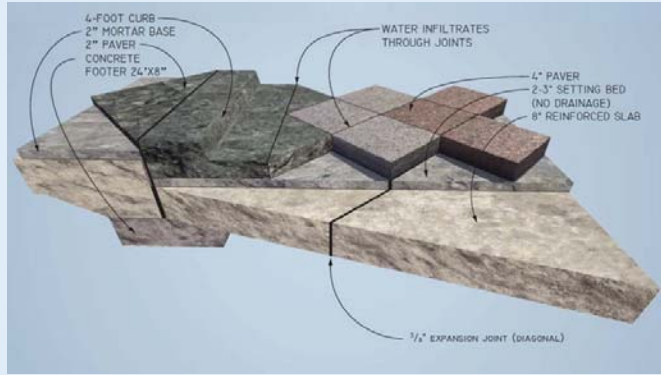
Pavement system traps water, causing paver failure.<sup>1</sup>

**A poorly constructed and failing pavement system** is unable to handle the wheel loads (weight of buses) and lacks drainage under the pavers.

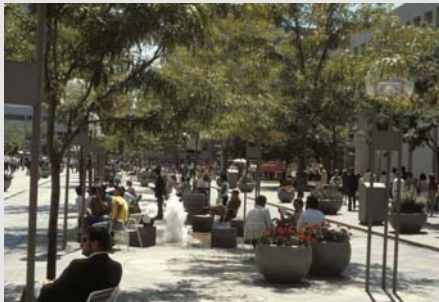
**28%**  
Of trees have died and not been replaced

**23%**  
Of trees are not in good health

**Root boxes 300%**  
smaller than current best practices

**The outdated underground tree structure** does not allow for conditions which support tree health.<sup>2</sup>

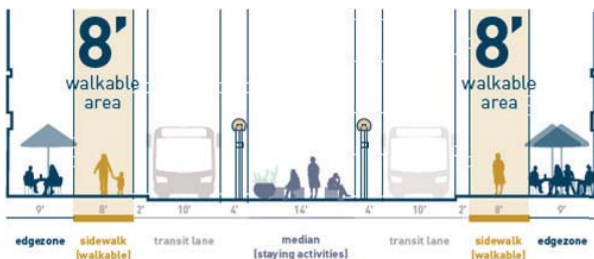
3,840 people/hour on two 8-foot walks<sup>1</sup>

8' walks narrower than 10' recommended width for pedestrian volumes and individuals with disabilities<sup>4</sup>

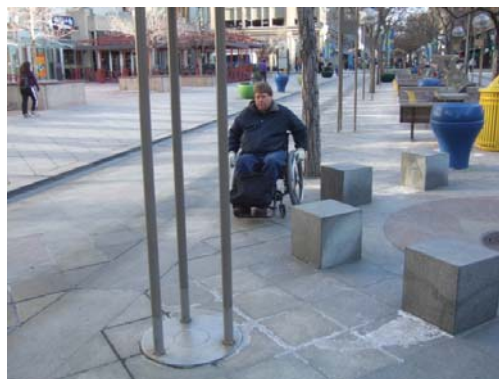
Less than 3' clear at median fountain<sup>5</sup>
