Mapping Puget Sound's Artificial Reefs Report prepared for DNR Aquatic Lands Restoration Team

August 16, 2023

Mapping Puget Sound's Artificial Reefs: Identifying Automobile Tires for Removal

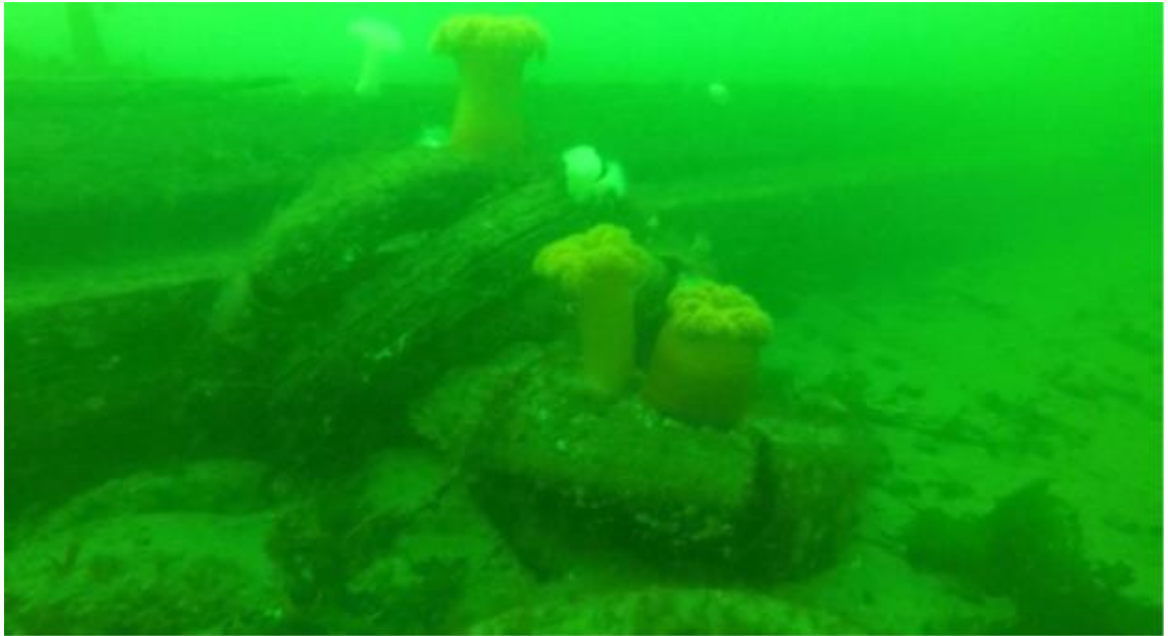
Cover Photo: Tires entangled in wooden barge at Tolmie State Park, WA. Photo by DNR dive team.

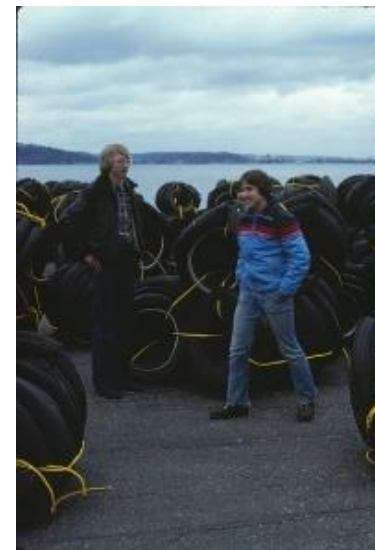
Figure 3. An example of a tire module banding jig which could be rented from the Bridgestone Tire Company (D’itri, 2018). Tires barrel joined and secured in pyramid formations like these were found in many reefs mapped for this project.

Barrel stacks were often banded together to build larger reef features such as pyramid shapes (Figure 3). Tires were also banded together in the center to form daisy formations or tied into loose, jumbled formations. In some cases, the bottom row of tires in these modules may have been filled with cement to keep the entire bundled feature anchored in place (Figure 3). While ballasting tires and tire reefs in this fashion has occurred in other parts of the world, the practice has not been confirmed in Puget Sound.

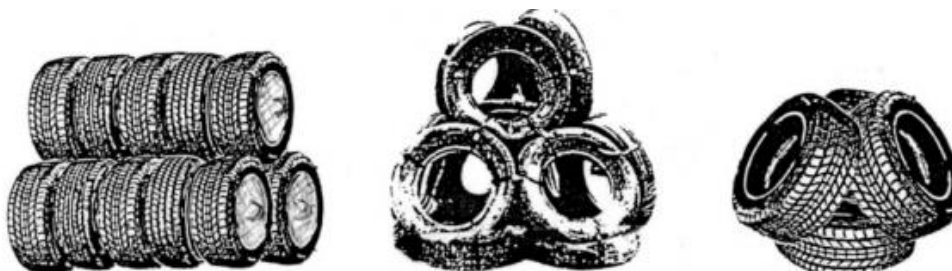
Figure 4. Different types of tire modules utilized to enhance structural complexity.

Tires were often bundled together into modules of different sizes and shapes (Figures 4 & 5). Modules were typically bound with propylene rope of various lengths and diameters. In the 1970s, the DNR used a compression, banding, and cutting machine to bail tires into “barrel” stacks (Figure 3) whereby 5 to 8 tires were stacked and compressed together with steel bands. Each tire stack was then secured with polypropylene rope. Afterward, the steel bands were cut, allowing the tire stack to “relax” into an overall form, which increased the available surface area and crevasses for reef dwelling species. Finally, tires were sliced to allow for air escapement while the tire modules sank to the bottom. Later, the WDF borrowed the compression and banding equipment from DNR for their reef construction efforts DNR (Hueckel, G. J. 2022. Personal communication February 4, 2022).

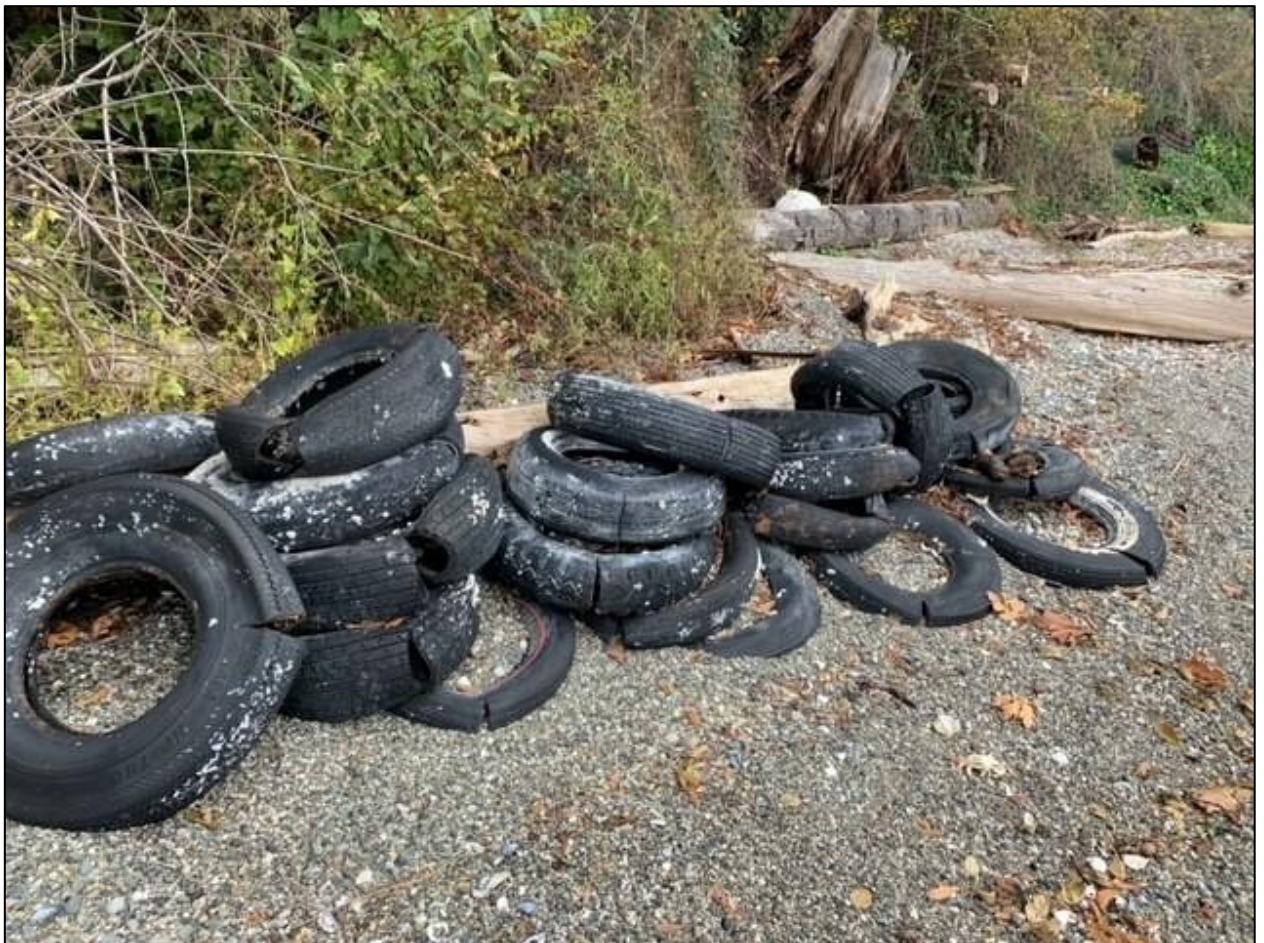
Figure 5. Pile of tires that have washed ashore from failed reef bundles in Budd Inlet just south of the Burfoot County Park Reef. These tires have slices through the sidewall similar to tires found in other reefs. The cuts are made to promote air escapement, which allows them to sink during placement.

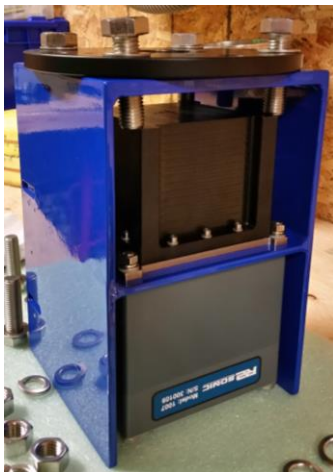
Figure 7. Close-up of R2Sonic 2020 multibeam sonar head (bottom, grey) and Applanix IMU (top, black) with mount (blue).

The 2020 sonar is a small flat-array multibeam unit that combines a transmitter and receiver into a single instrument. This design has several advantages; along with its small size it also acts as a single reference point for both the transmit and receive nodes, which simplifies the number of calculations required by the navigation software (R2Sonic 2021). The 2020 system has an onboard surface computer and navigation system - position, heading, pitch, yaw, and roll are all recorded with an Applanix Inertial Motion Unit (IMU) and Trimble GNSS positioning system. Applanix POS PAC software (Applanix Corporation 2011) is used to post process raw motion and heading data collected in the field.

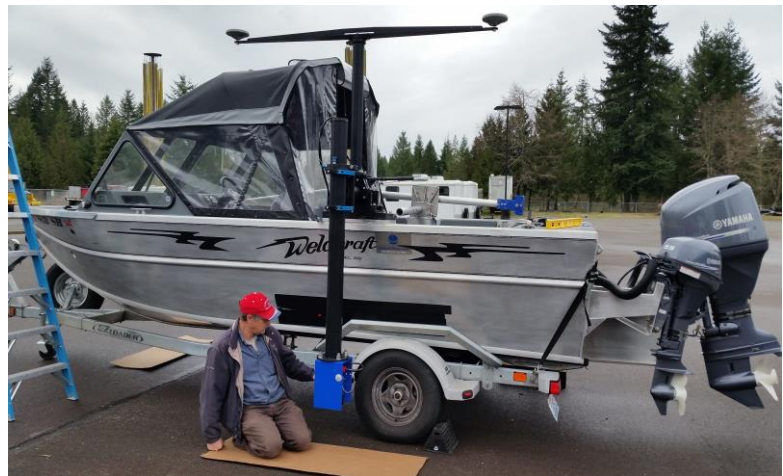
Figure 8. R/V Neap with R2Sonic 2020 multibeam sonar system.

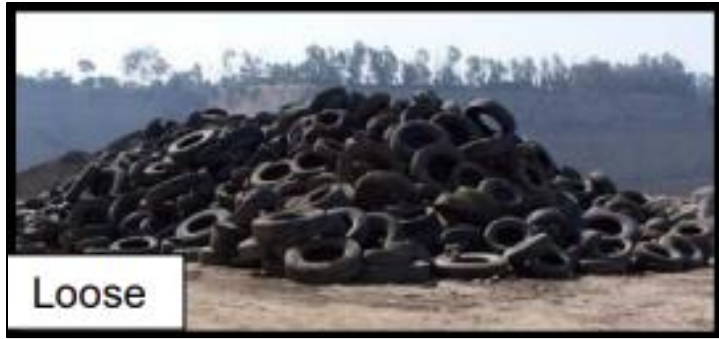
Figure 12. An example of loose tire stacking. Image from Calrecycle.gov.

Loose stacked formations are those where loosely piled tires are placed in an unorganized mound. Tires within this mound are often bound with polypropylene line. Barrel stacked tires, on the other hand, are those banded with strapping (usually polypropylene line) into a machine-assisted cylinder shape. Figure 13 shows barrel stacking for tires stacked upright. Barrel formations within tire reefs were dropped by boat and are usually laying parallel to the sediment surface - they can be grouped in barrels of three or more to create pyramid shaped features. Because tires are neatly stacked next to one another in a barrel stack, the number of tires per unit area is higher than for loose stacking (Table 3).

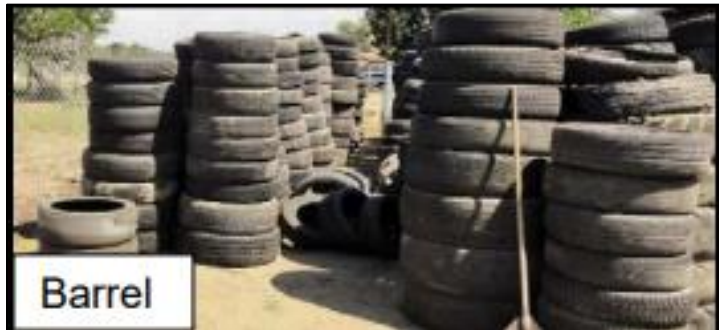
Figure 13. An example of barrel stacking. Image from Calrecycle.gov.

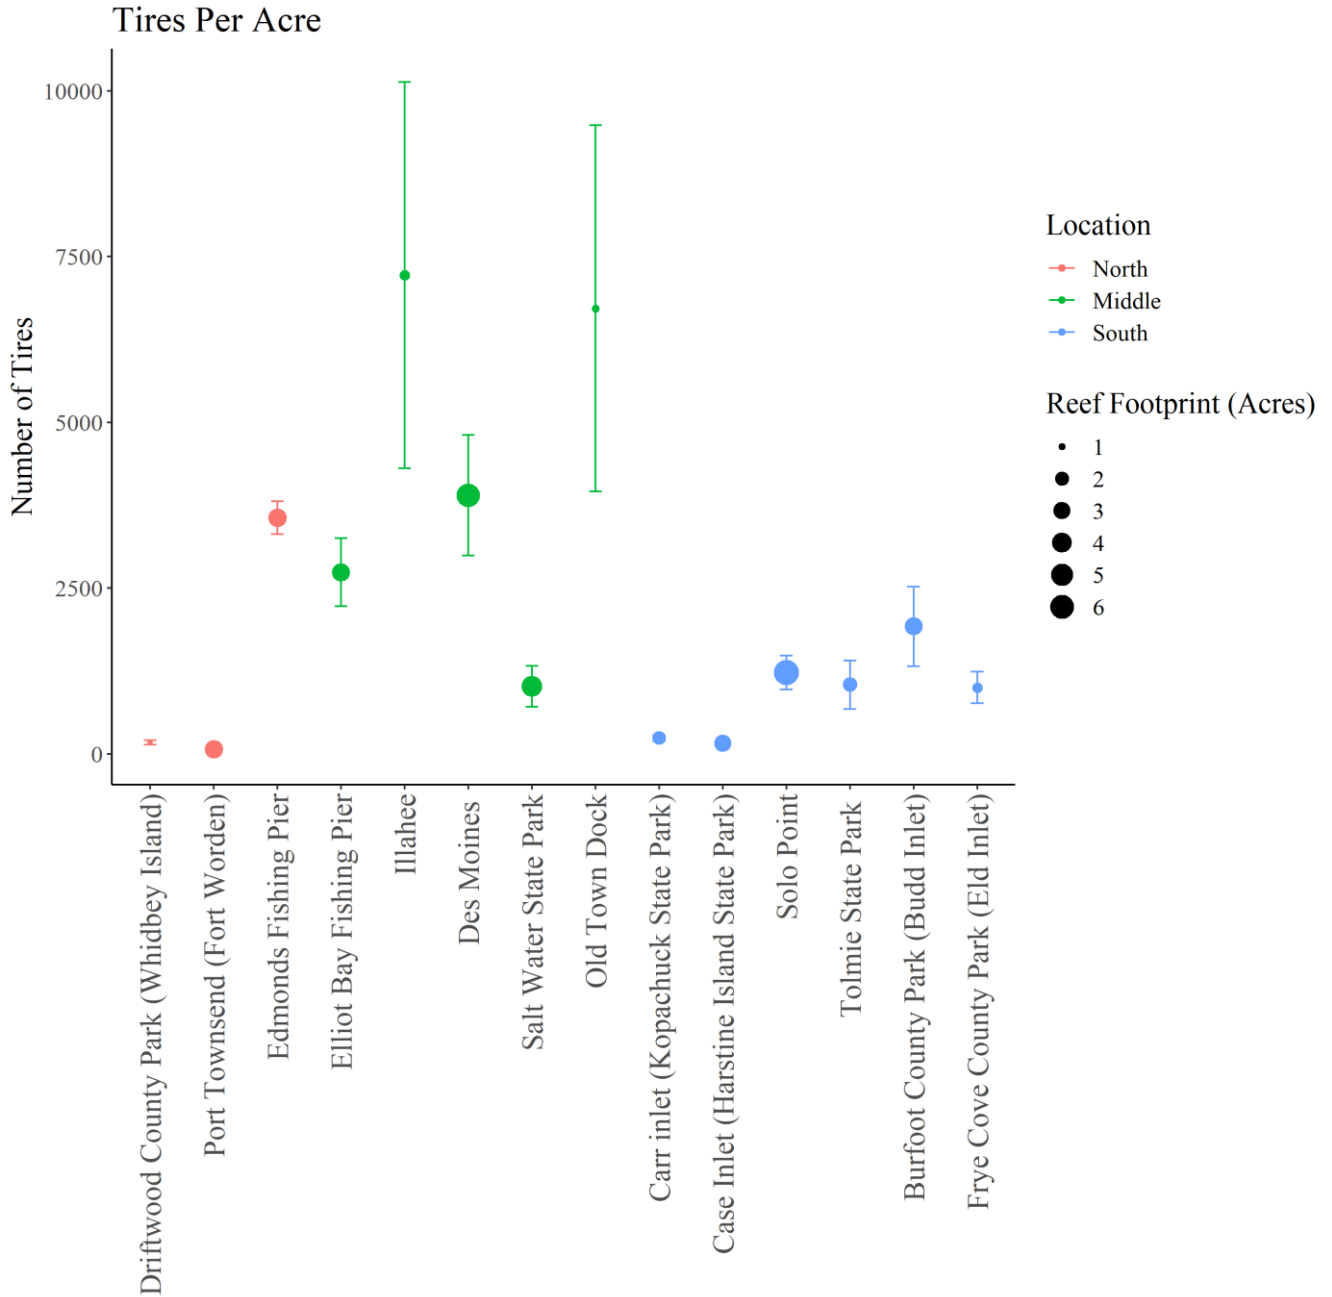
Figure 18. Number of tires per acre. A high estimate (density-based calculation) was used to establish these values. Error bars indicate standard error.

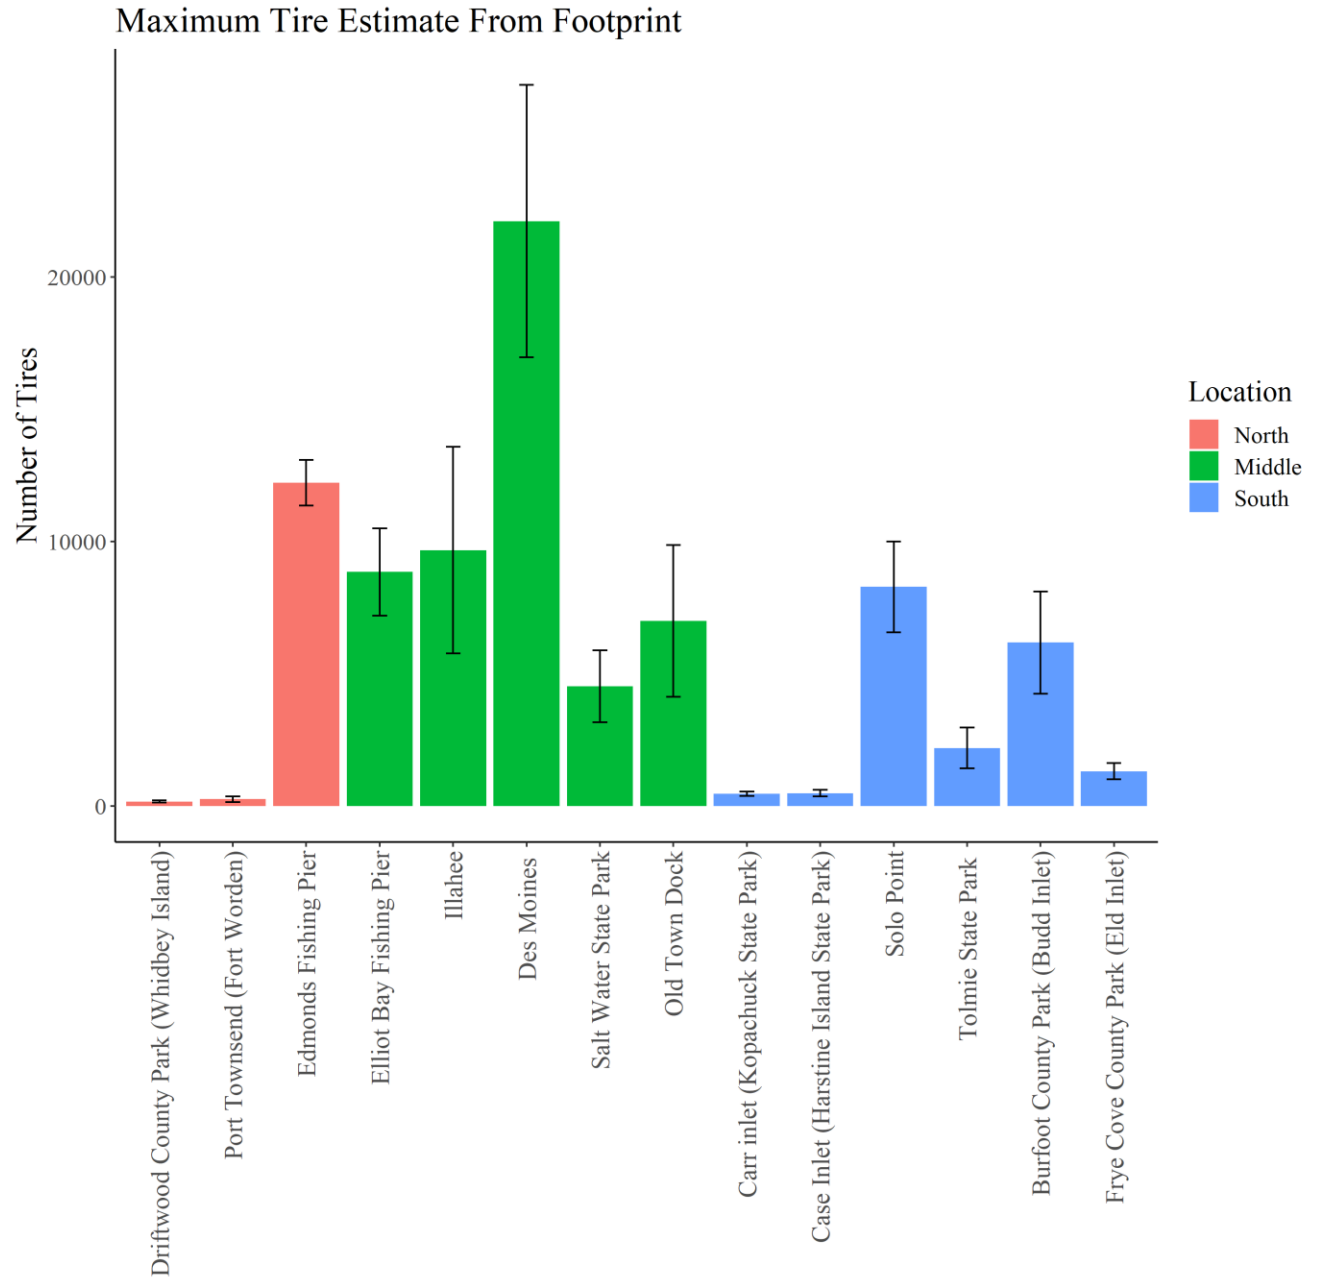
Figure 20. Total number of tires estimated from maximum estimate (footprint - density method). Error bars indicate standard error. Note: only a fraction of the Frye Cove County park site was mapped in DNR surveys (realized after the fact), and it is likely that many more tires exist there. This is also the case for Saltwater State Park. Sites with extensive burial may also have additional tire features that are not represented by these estimates.

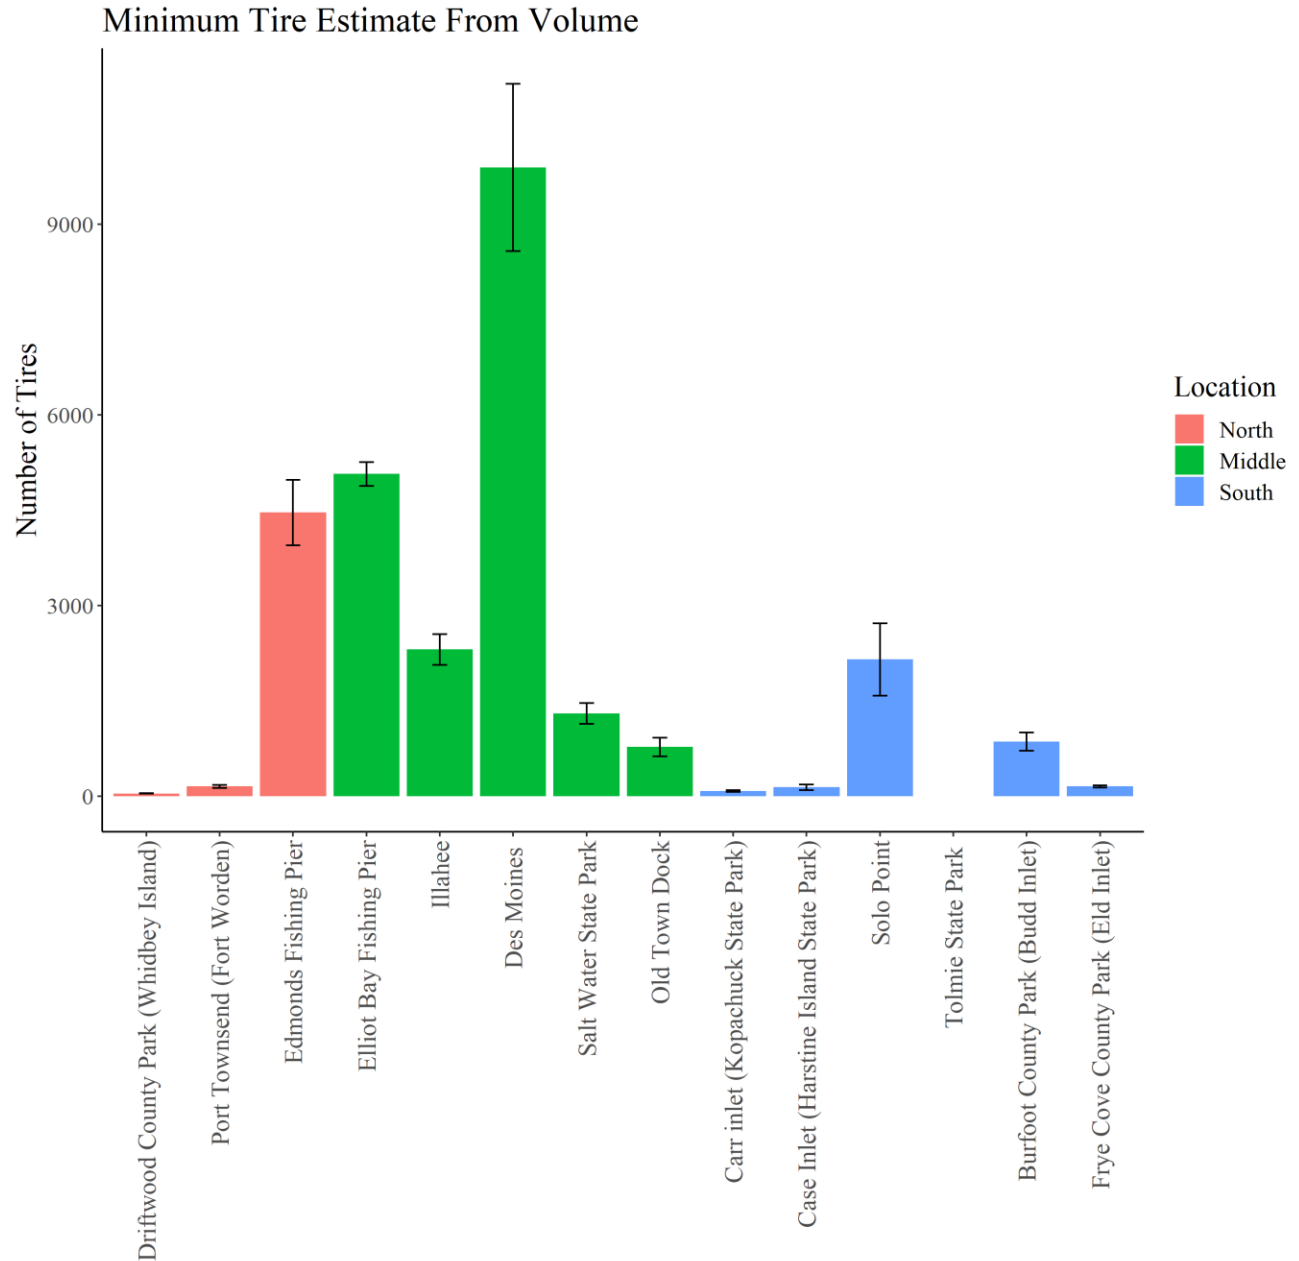
Figure 22. Total number of tires estimated from low estimate (volume method). Error bars indicate standard error. Note: only a fraction of the Frye Cove County park site was mapped in DNR surveys (realized after the fact), and it is likely that many more tires exist there. This is also the case for the Saltwater State Park site. Sites with extensive burial may also have additional tire features that are not represented by these estimates. Due to errors during the processing of the Tolmie State Park survey, a minimum tire estimate by volume is not producible and is not shown here.
